**The Bowman-Hite Property  
Warren County, Virginia**

**Bowman-Hite Farmhouse  
Historic Structures Report**

**Final Submission**

*October 2013*

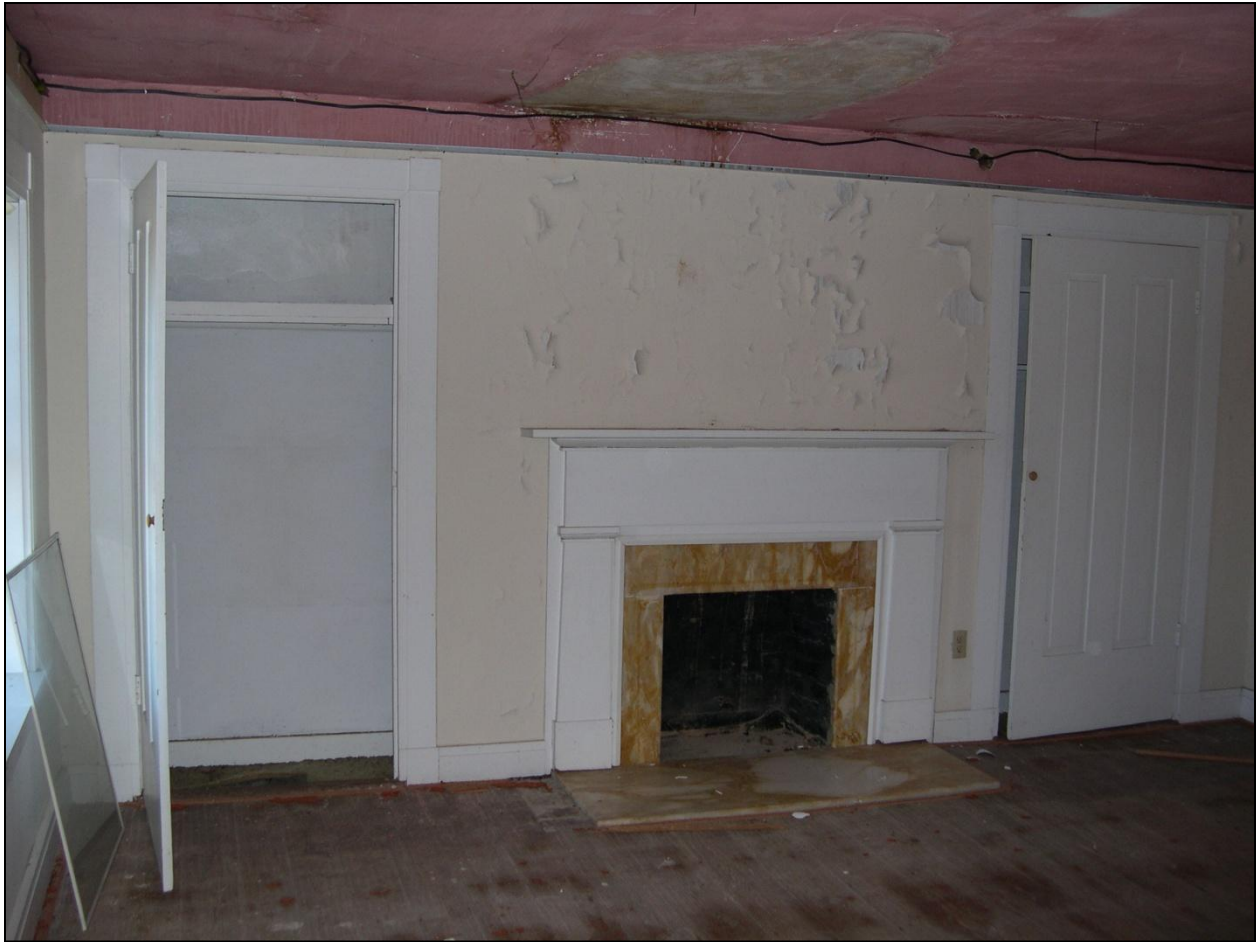
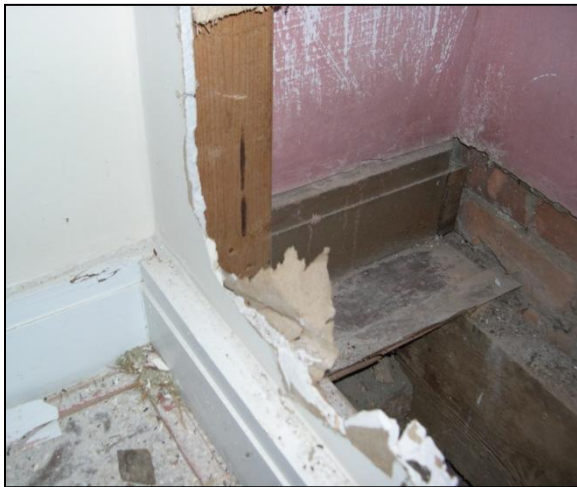
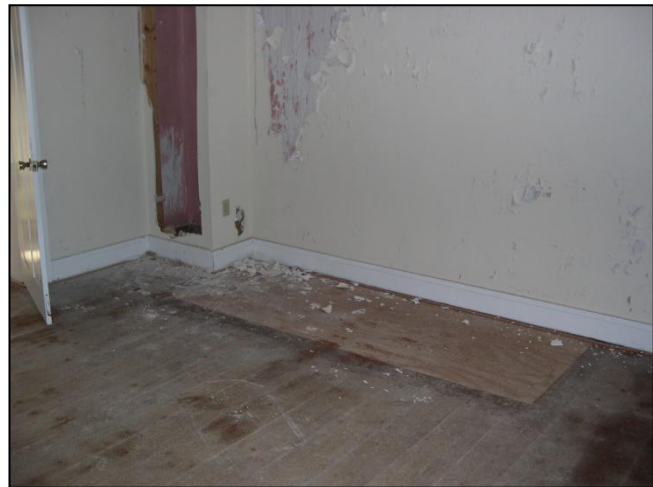
Figure 75: The top image shows the east wall of the second floor's east bedroom. The mantle, like the one in the other bedroom, is original, although marble veneers have also been added. Note the flanking closets. The lower left image shows original baseboards concealed by ductwork, still complete with early gold colored paint. The lower right image shows the ghosting of the secondary staircase on the second floor.

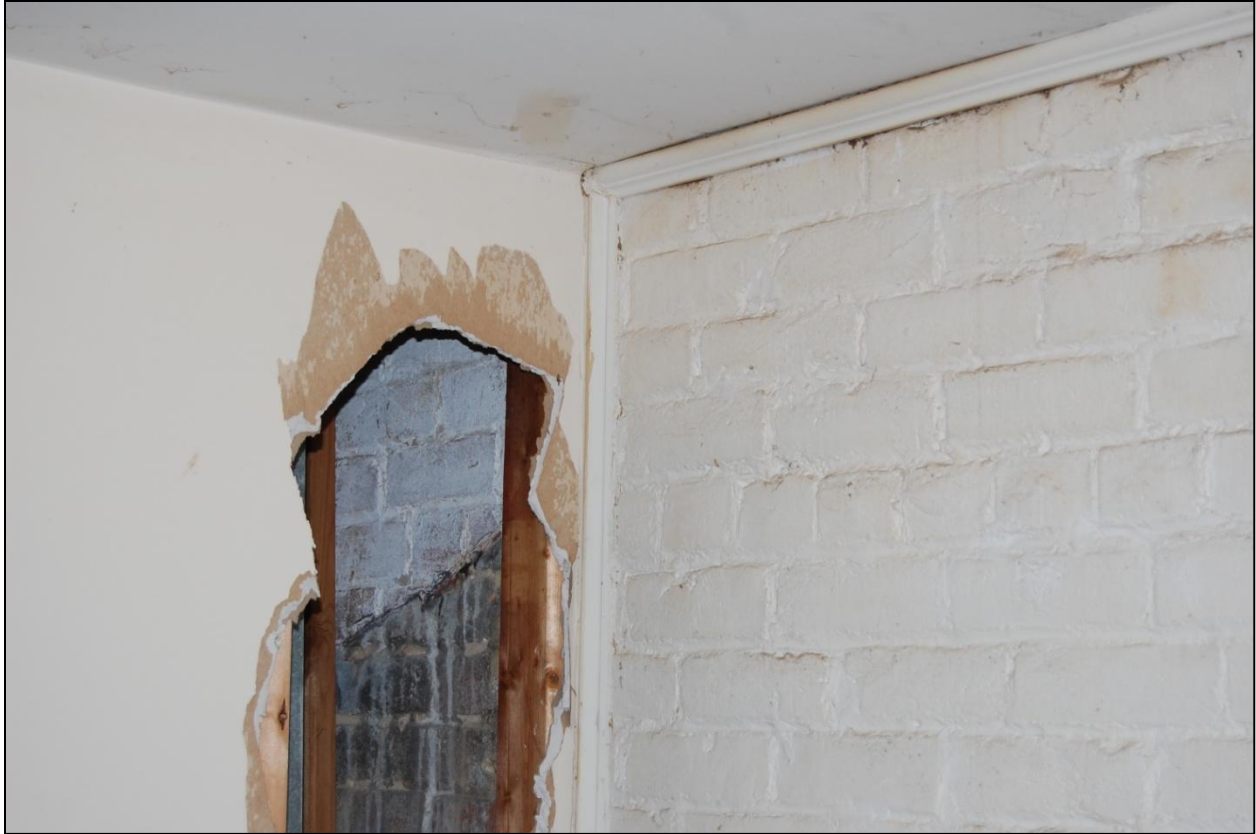
Figure 76: Pictured above is the exterior east wall of the original 1850's brick ell. The area concealed by ductwork shows the original roof pitch of the 1876-1880s frame addition, and assisted in dating whitewashing campaigns.

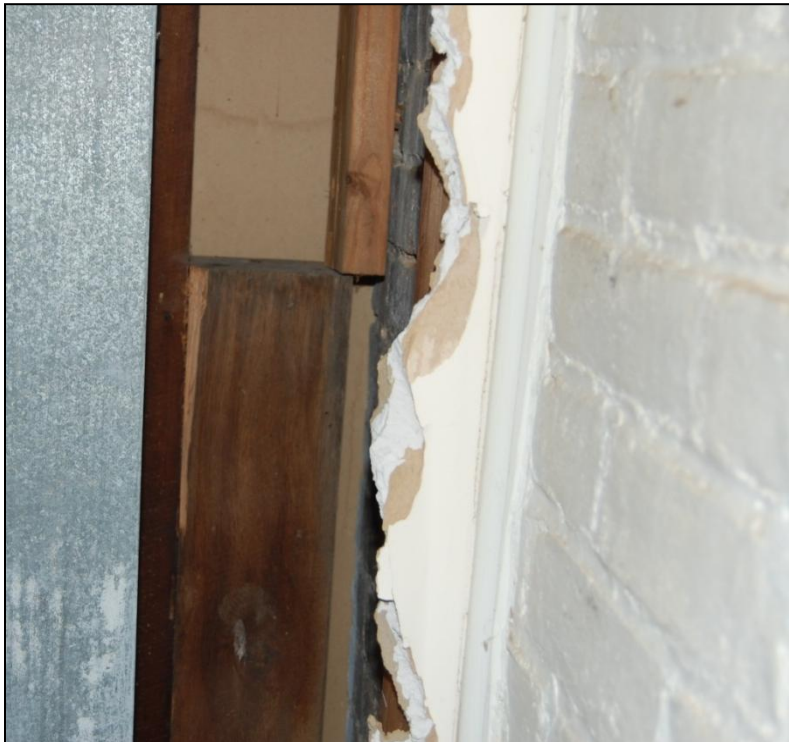
Figure 77: Concealed in the same ductwork was a corner post from the 1876-1880s rear frame addition.

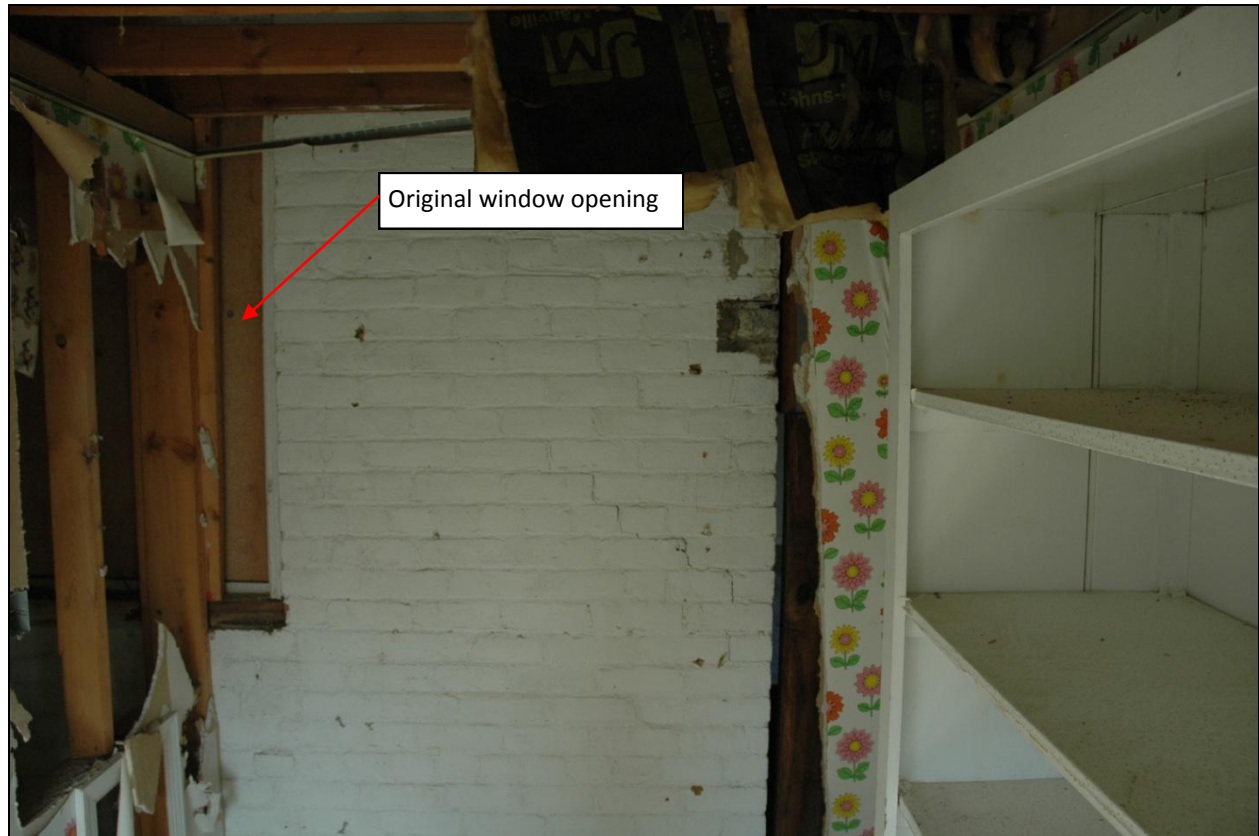
Figure 78: The laundry room, above, shows the southeast corner of the 1850s brick ell. Also of note are areas of discoloration indicating possible downspout attachments. Barely visible to the left of the image, along the brick wall is a concealed window.

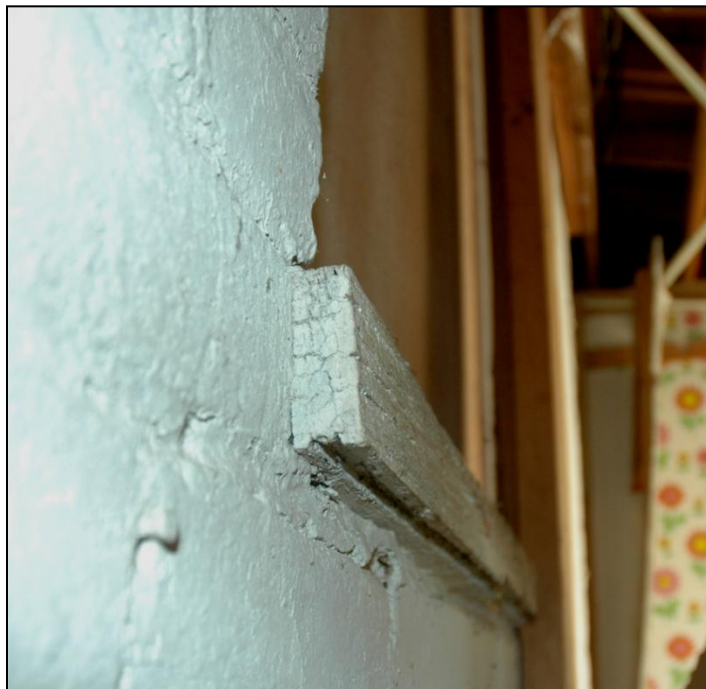
Figure 79: A close-up of the window noted above showing the intact wood window sill, complete with drip edge.

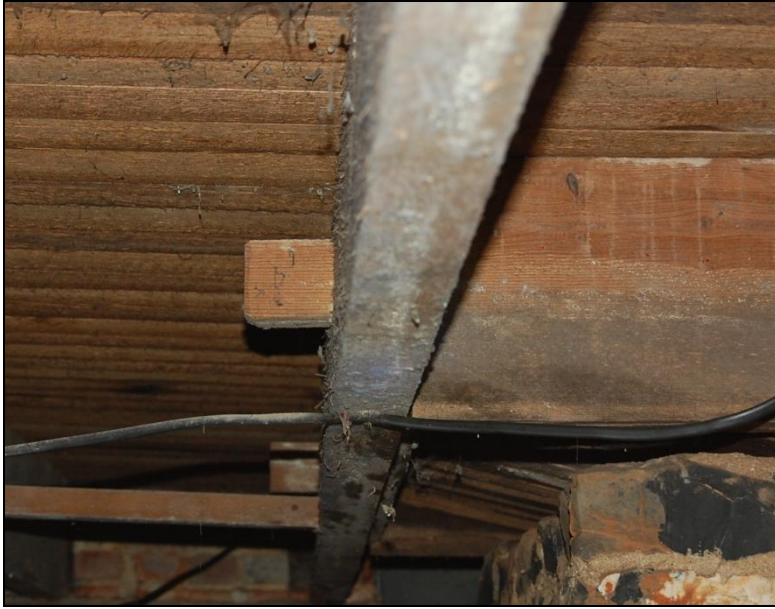
Figure 80: Located in the cellar, this image shows the trimmers used to support the brick hearth in the first floor parlor. Note the through tenon. The other hearth support in the basement is butt nailed together, indicating possible alterations.

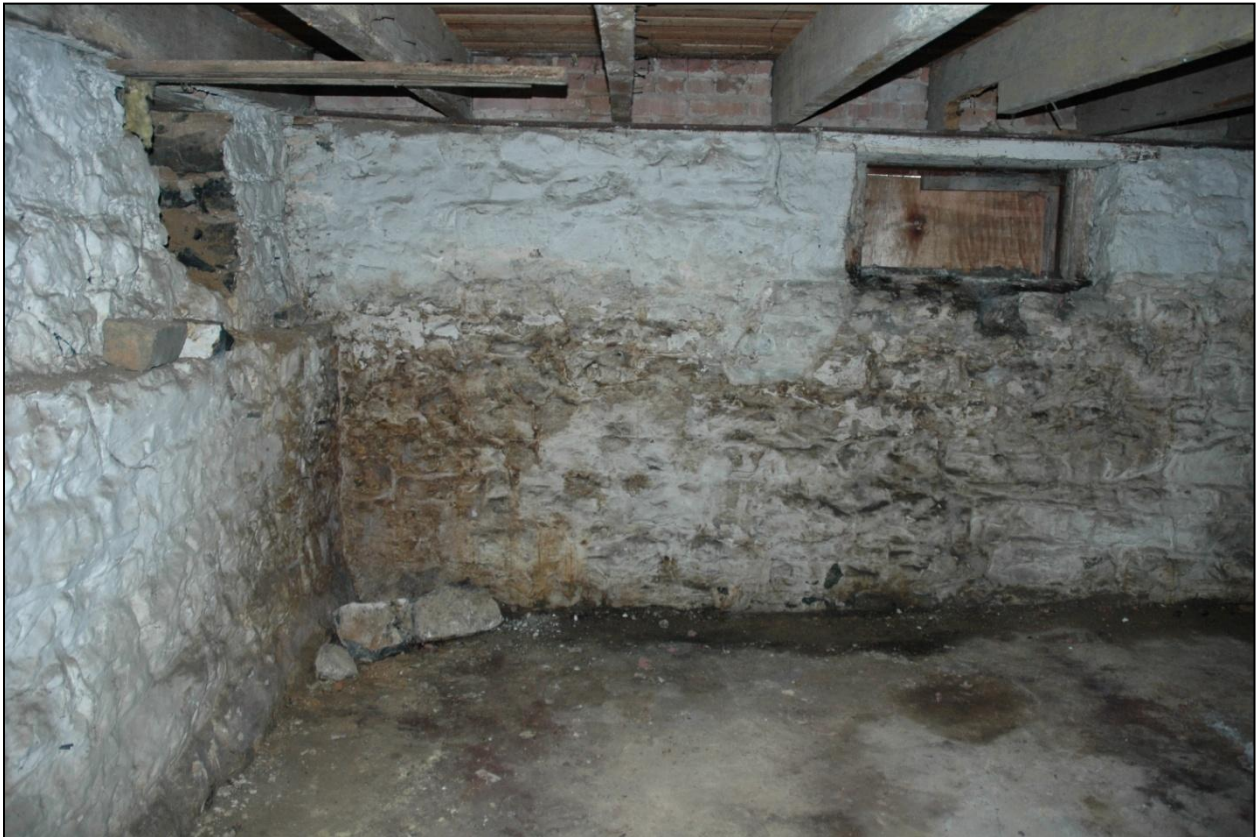
Figure 81: The northwest corner of the cellar after removal of the furnace and other HVAC equipment. The north window can be clearly seen, as can the stepping out of the foundation wall.

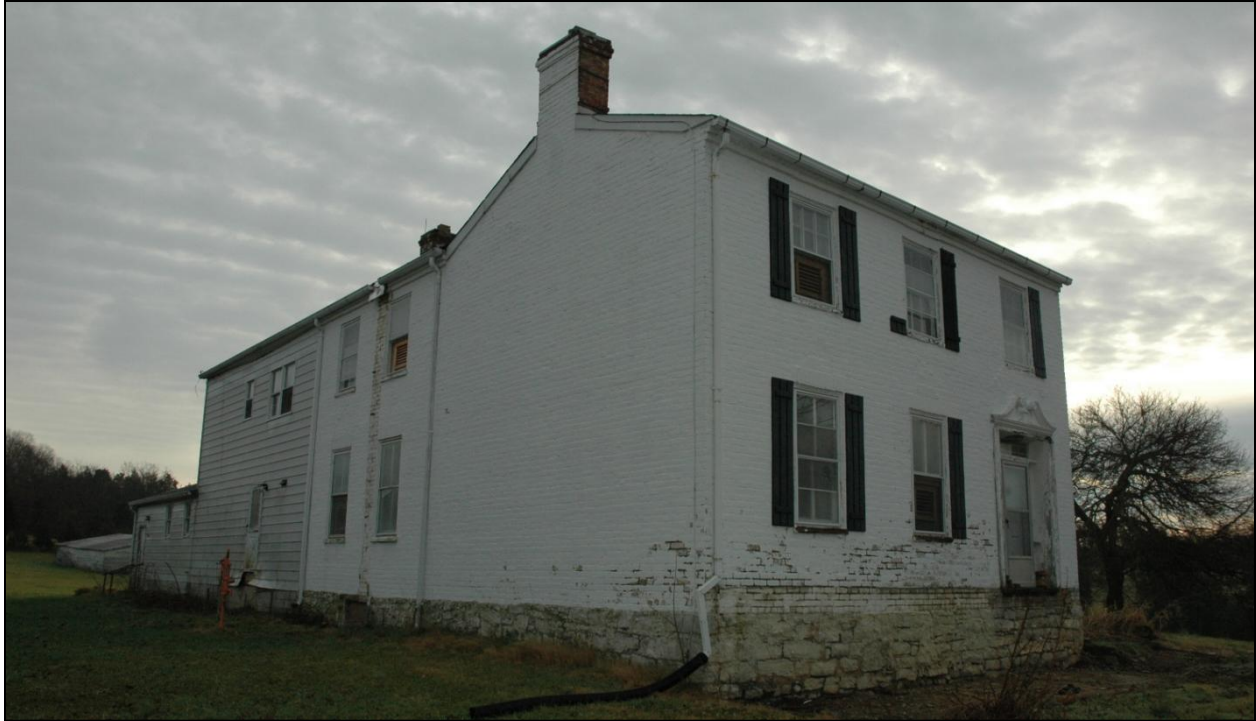
Interior brick end chimneys rise above the north and east gables of the original portion of the house. The chimneys are detailed with simple corbelled caps and exhibit eroded and deteriorated mortar joints. The chimneys appear to be capped, and the exposed stack of the east chimney has been reinforced through the use of steel angles and bars. The interior placement of the chimneys is typical of the Greek Revival style, where the suppression of the chimneys by placing them within the exterior walls was desired to create simple, clean profiles. Additionally, the placement of interior end chimneys maximized the warmth that was retained within the house's interior. The floor space that the interior chimneys and fireplaces occupied was not a factor due to the generous size of the original rooms in the Bowman-Hite Farmhouse.

Figure 82: The Bowman-Hite farmhouse (above) was constructed in the 1850s in the Greek Revival style. The image shows the northwest perspective. Note the removed front porch as well as the unpainted portion of the brick chimney.

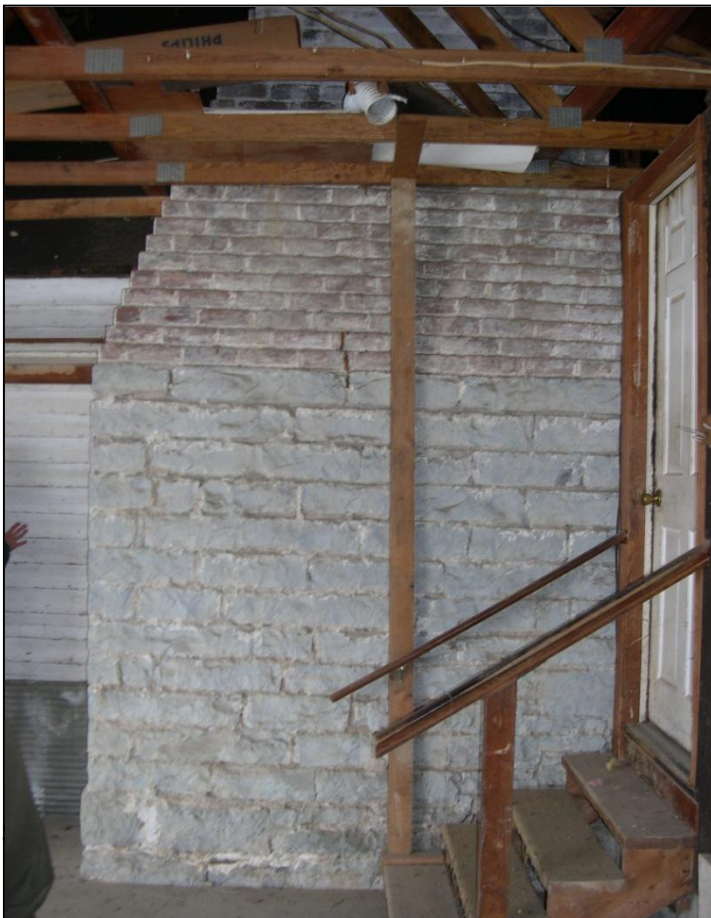
The later frame rear ell was constructed with an exterior end chimney at the eastern end of the structure. Although the base of the chimney is fashioned with stone, a brick stack is placed above. The narrower brick stack transitions to the wide stone base through the use of stepped brick courses. The brick retains traces of white paint or whitewash where it has been protected under the enclosure of the modern garage roof. The original brick portion of the chimney utilizes units that are identifiable as hard-fired, pressed brick, typical of the late 1870's. The upper portion of the ell's chimney was extended in the course of the modern alterations that raised the roof height of the frame ell and thereby necessitated a taller chimney stack. The transition between the modern and original portion of the stack is clearly visible from the exterior. The mortar joints in the upper portion of the chimney are eroded and deteriorated.

Figure 83: Added ca. 1876-1880s, the wood frame addition was used as an interior kitchen and therefore required a fireplace. Built with the stone foundation, the frame addition fireplace (left) is now encapsulated by the modern garage addition.

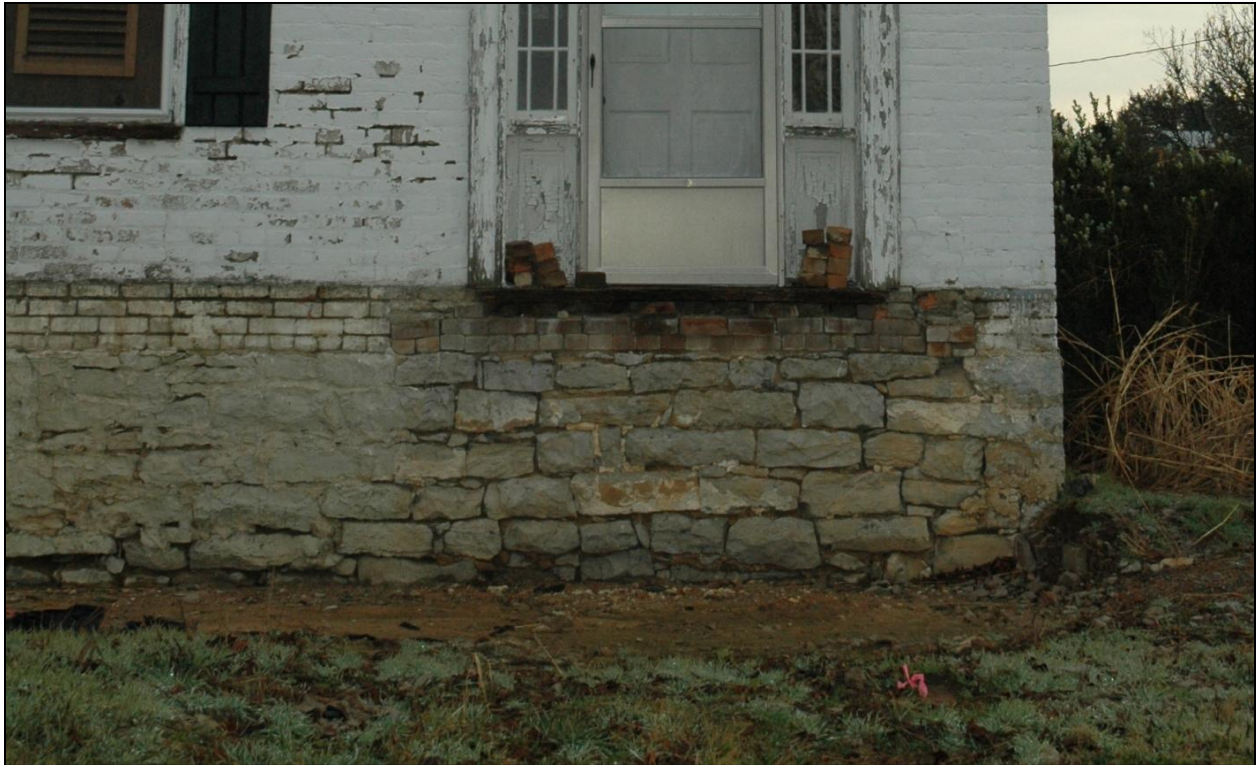
Figure 84: The rough-cut, irregular coursed limestone walls of the original 1850s portion of the structure can be clearly seen where the front (west elevation) porch used to exist. Few tool marks exist on the surface of the stones indicating the use of a pitching chisel. This tool uses natural bedding planes to cleave off portions of the stone, leaving behind a smooth surface.

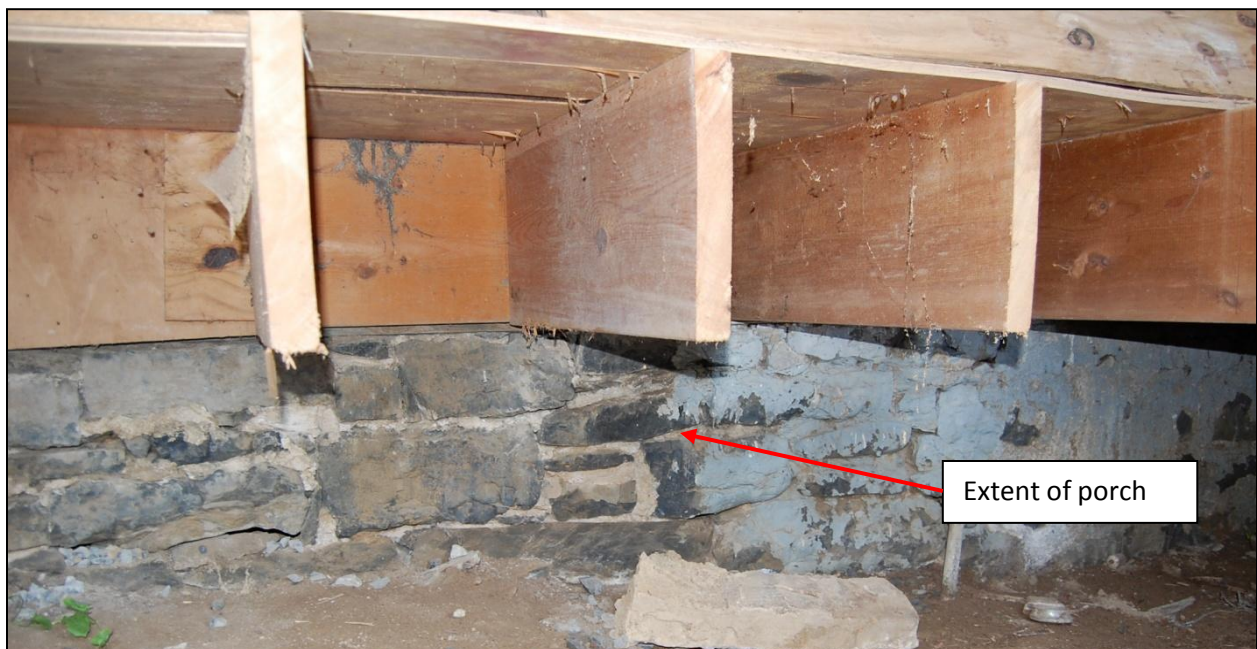
Figure 85: This image was taken under the current south enclosed porch added in 1971, during the Whitham's tenure. Shown is the 1876-1880s, frame addition, stone foundation wall, with the extent of the 1876-1880s south porch indicated by the grey paint line.

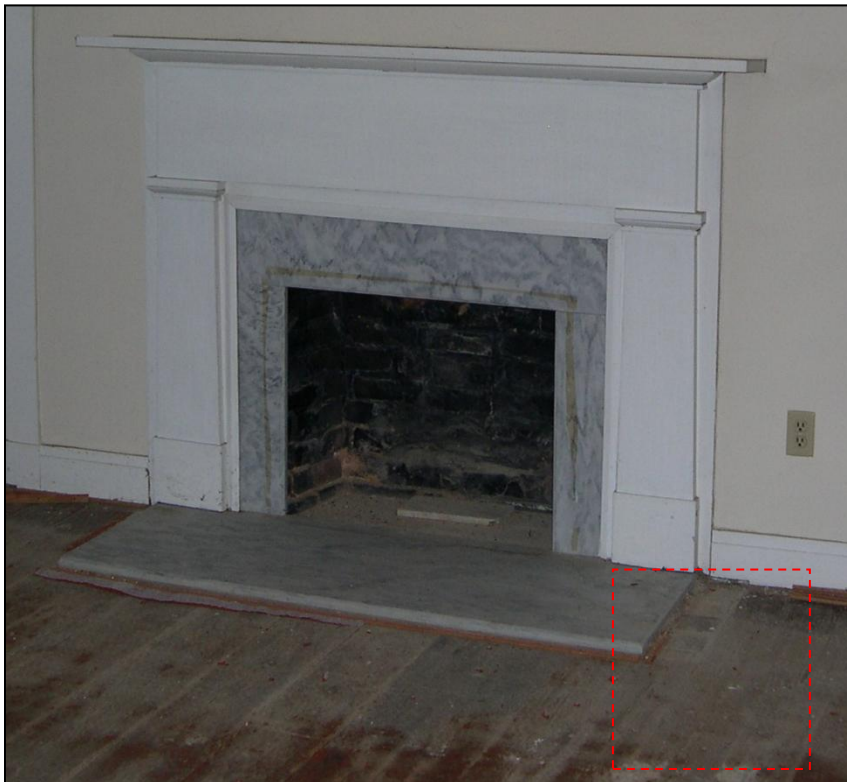
Figure 96: The mantle in the upstairs, west bedroom, is similar to the downstairs mantle, pictured above. The original brick hearth can be seen to the right of the 1971 marble hearth (box). Note that it is off center with the original mantle.

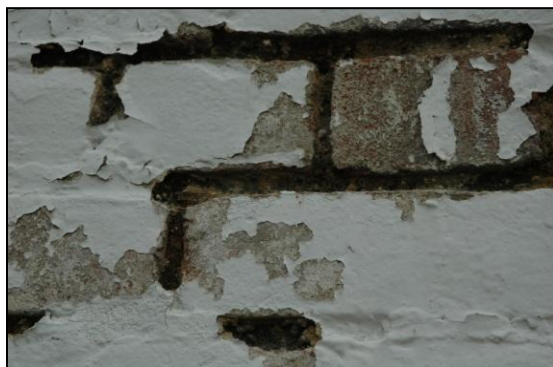
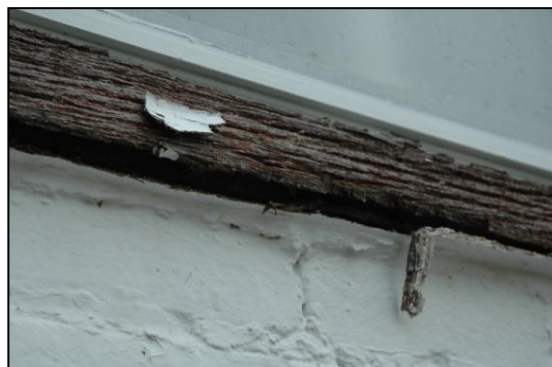
Figure 104: The image on the top right shows the brown or cubical rot affecting one of the original window sills. Top left is an example of a deteriorated mortar joint on the west elevation.

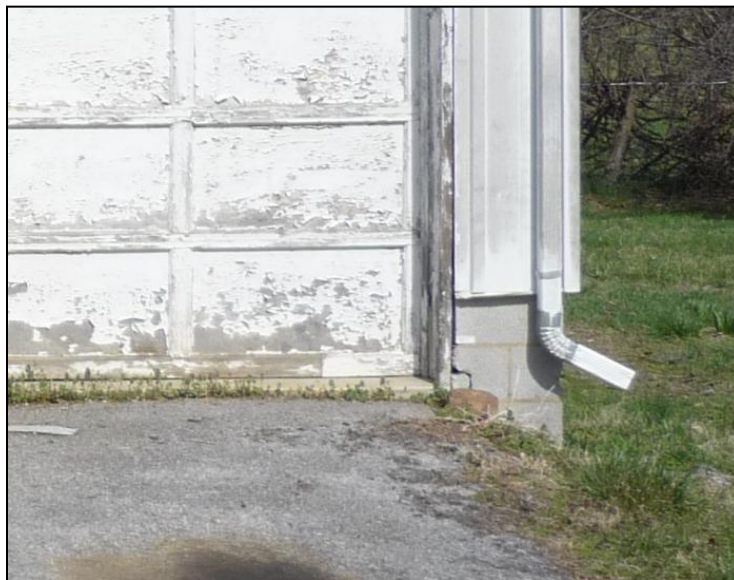
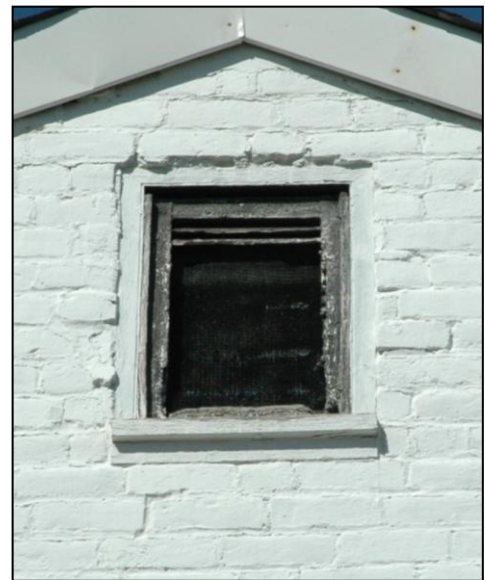
Figure 106: The top left image shows the garage doors and step crack in the CMU foundation possibly caused by poor drainage away from the structure's foundation. The bottom right image shows a close-up of the once louvered vent. Despite the deterioration on the outside the interior of the frame and sash remains in good condition.

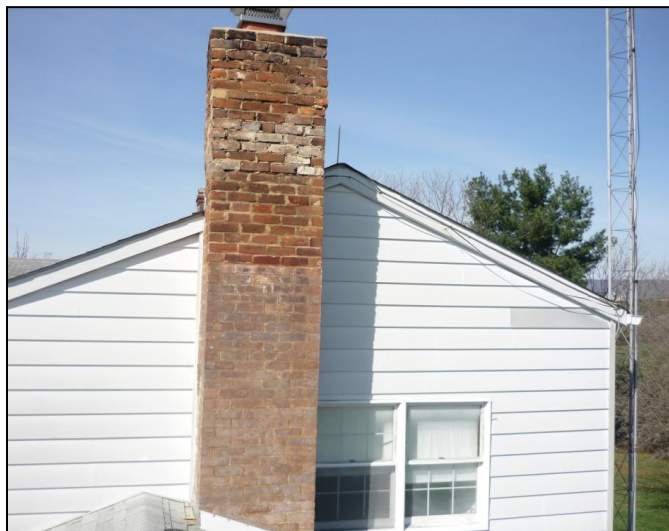
Figure 107: The top image shows the east elevation with the ca. 1876-1880s chimney. Noted at the top of the chimney is the need for re-pointing work. The left image clearly shows the change in brick type between the 1876-1880s portion of the chimney and the newer, ca. 1971 portion.

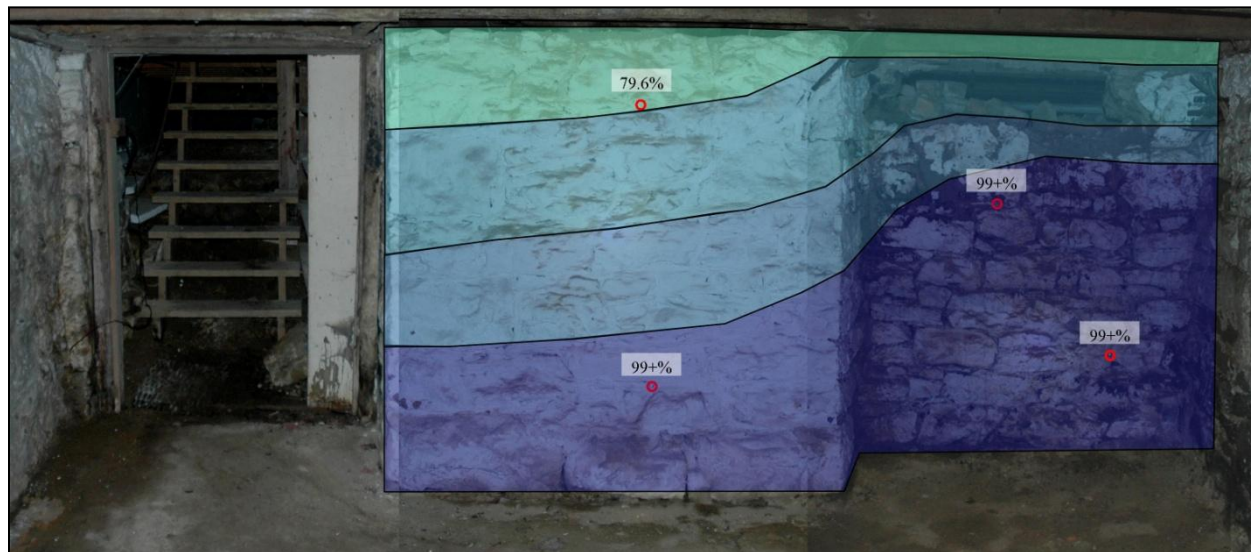
Figure 111: The graphic above of the east cellar wall, with projecting chimney mass, shows the high moisture readings prevalent at the base of the foundation which gradually decline higher up the wall. This is a clear indication of rising damp.

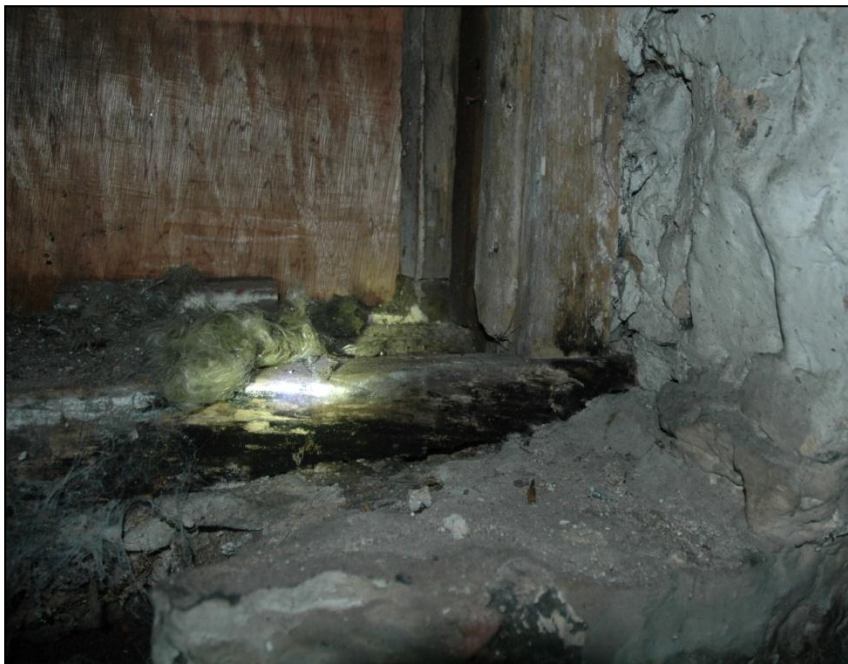
Figure 114: The image to the left shows the presence of black rot, typically found in very moist areas. This particular image is of the bottom right on the north cellar wall window.

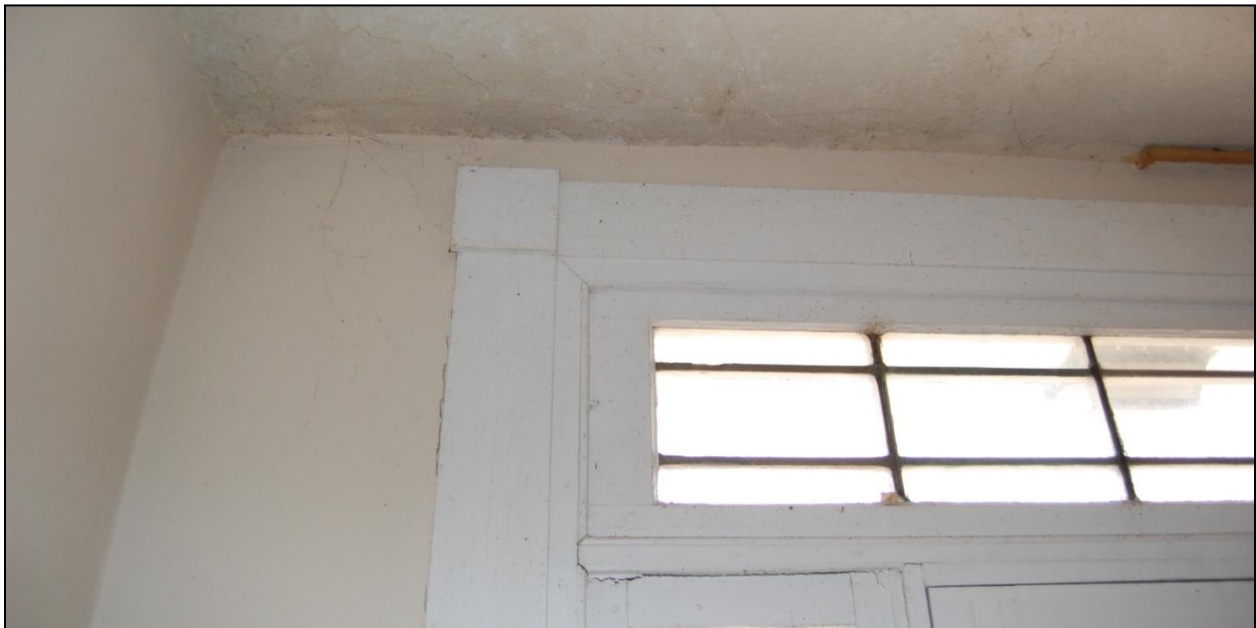
Figure 116: Hairline cracks can be seen in the ceiling as well as some discoloration likely caused by temperature fluctuations as well as moisture penetration.

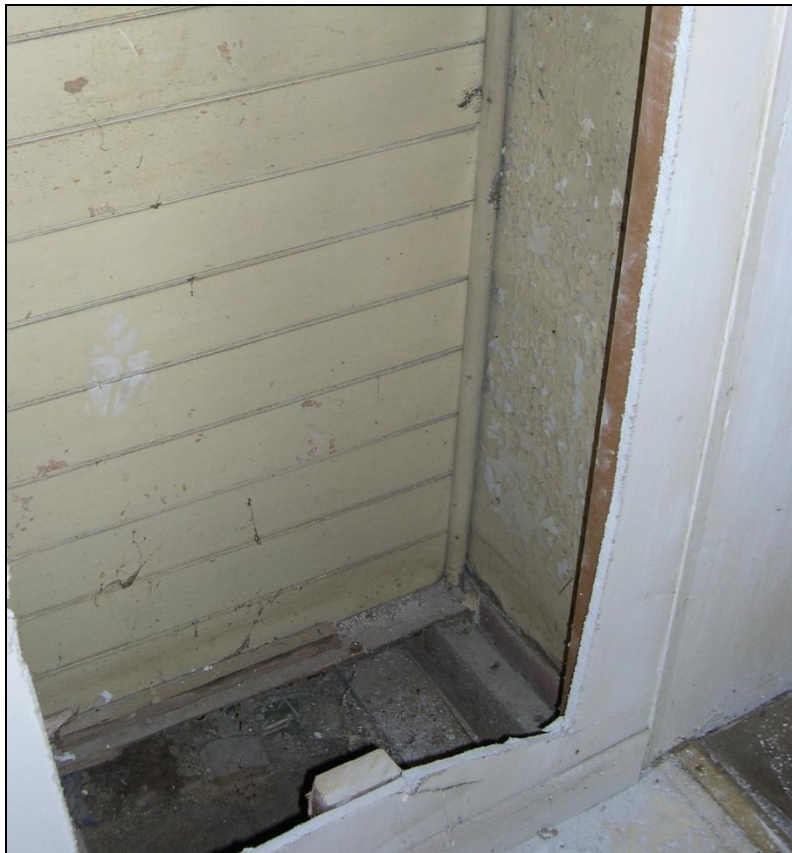
Figure 121: Concealed when ductwork was installed, the yellow paint, the only apparent coat, appears in relatively good condition on the interior beadboard but is flaking on the plaster.

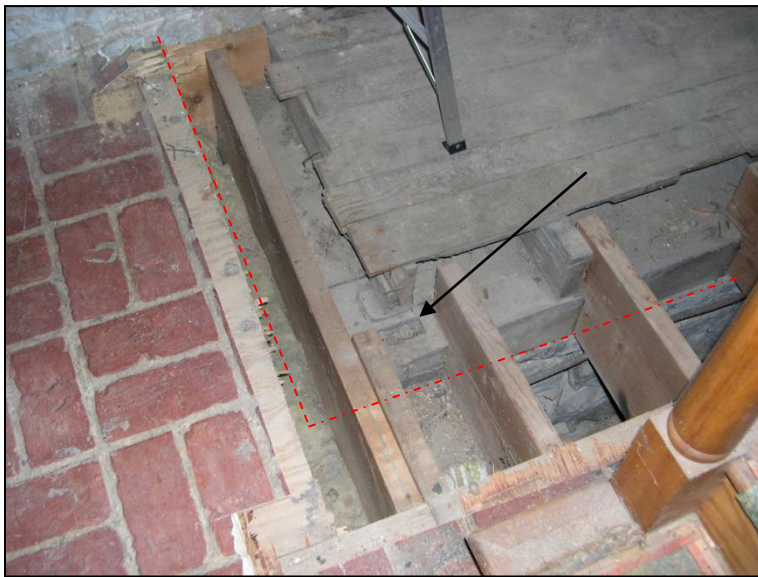
Figure 123: The later Whitham era additions were added to the 1870s wood frame encapsulating much of the foundation. The image shows the northeast corner of the structure with the mortise for the corner post tenon still visible (arrow).

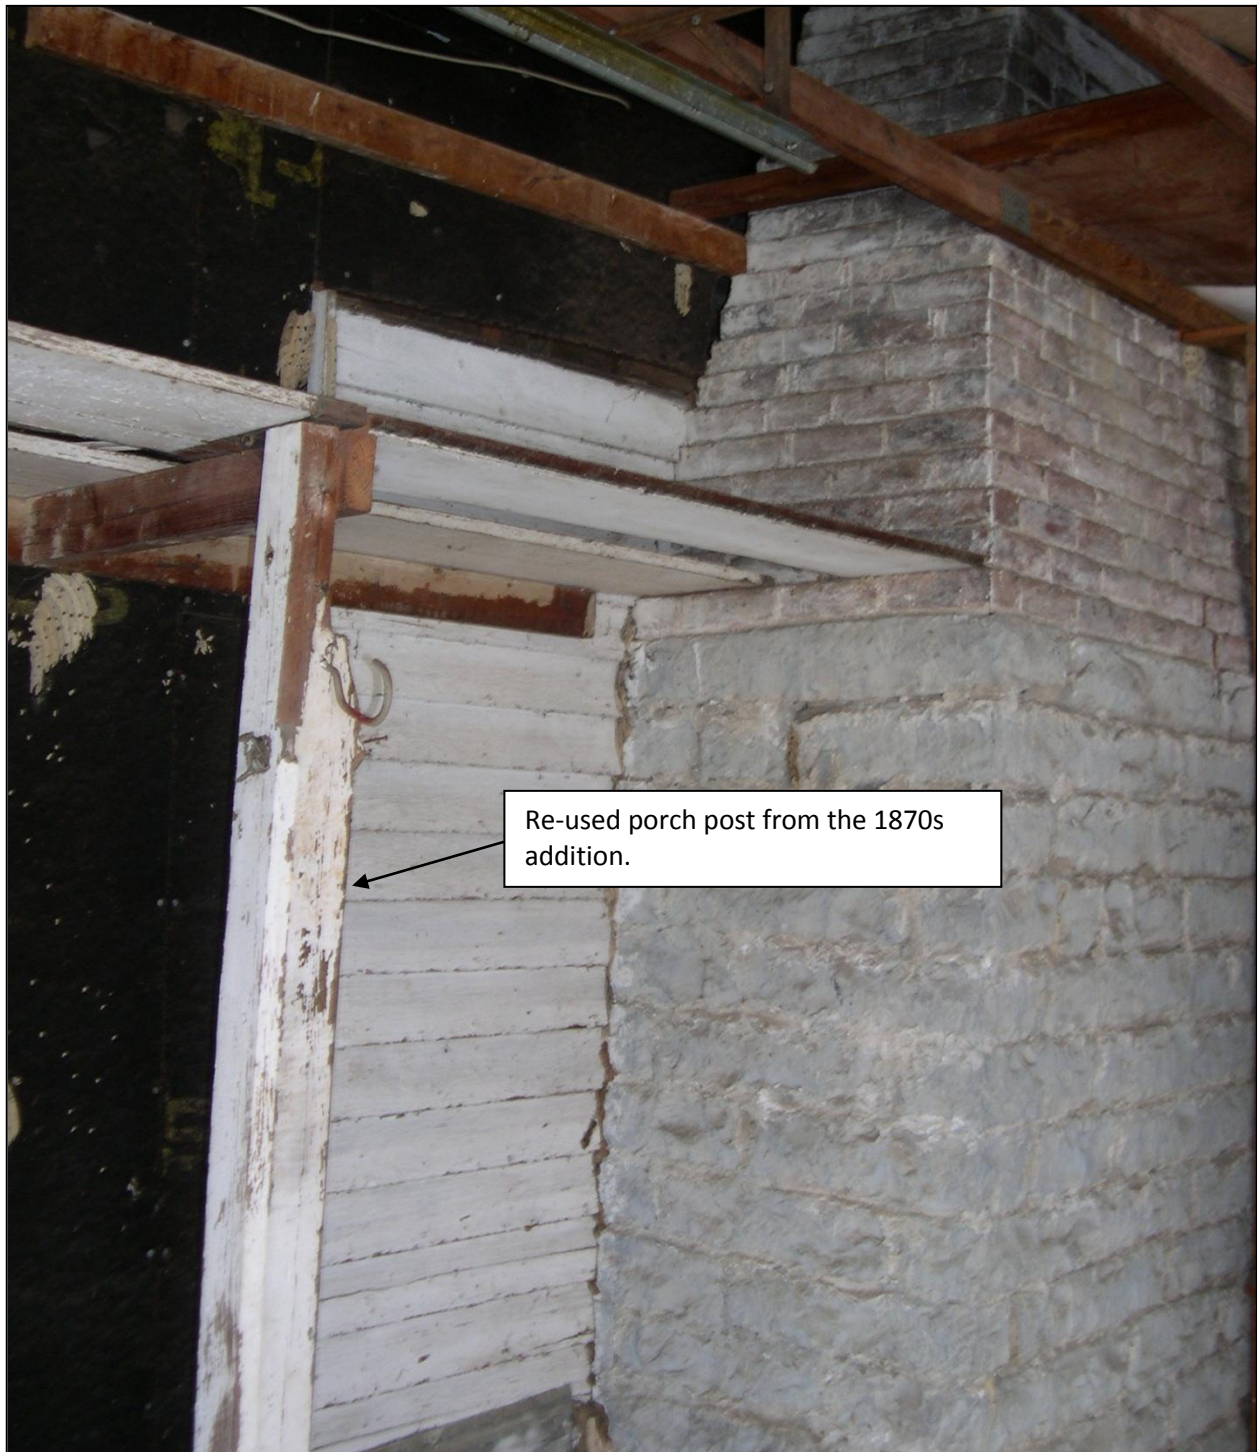
Figure 126: The large stone and brick chimney stack was built as part of the 1870s frame addition for the purpose of moving the kitchen from a dependency building back into the house. The size and design of the stack is typically found on older structures. On the left is one of the re-used posts (arrow) from the south porch, also dating to the 1870s.

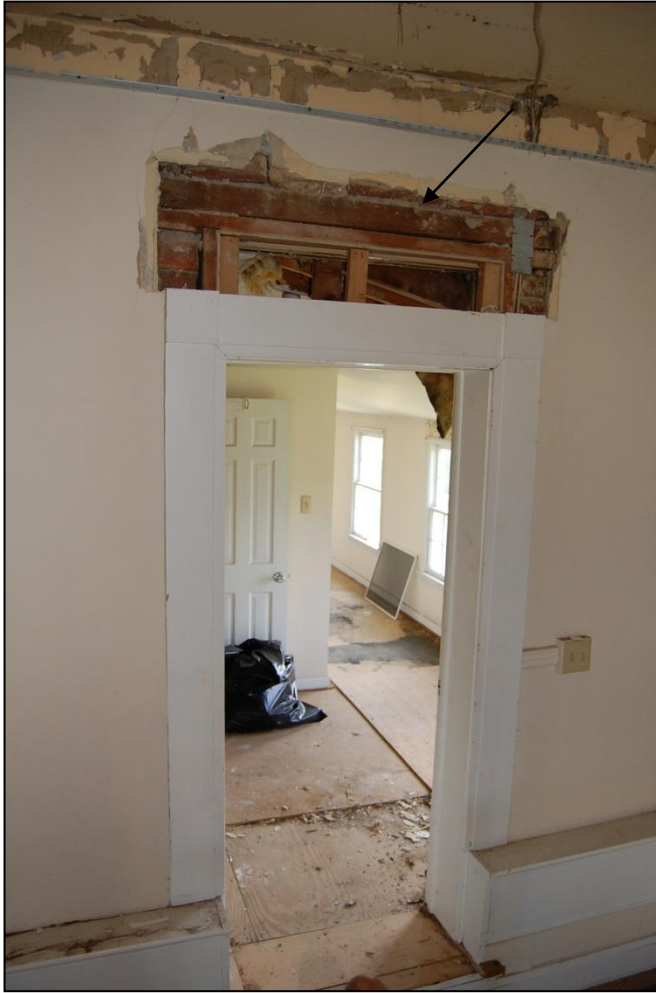
Figure 127: Converted into a doorway during the Whitham era, the east facing stairwell window still retain much of its original integrity even though the trim has been moved in some cases. The header for the window can still be seen above the current doorway (arrow). Stenciling can also be seen on the plaster wall just before the ceiling. This was covered for some time by the dropped ceiling.

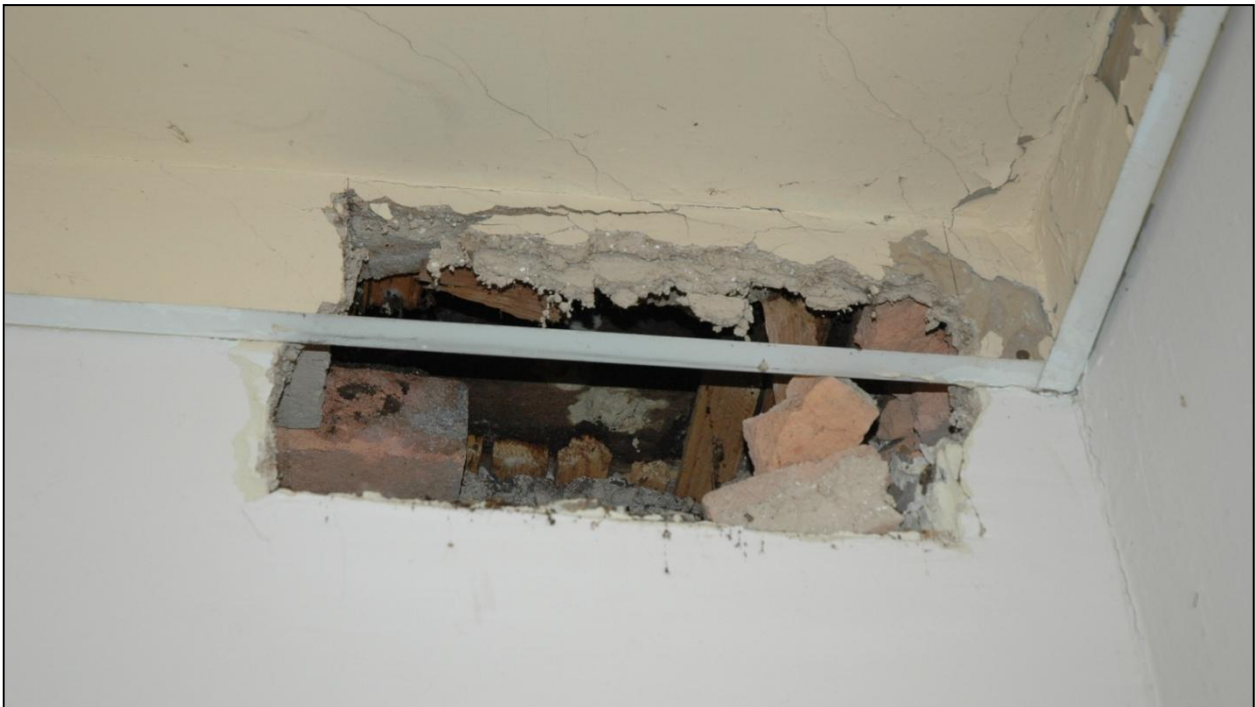
Figure 128: During the insertion of ductwork for the HVAC system holes were cut throughout the Bowman-Hite house. This hole is located on the north wall in the front entry hall.

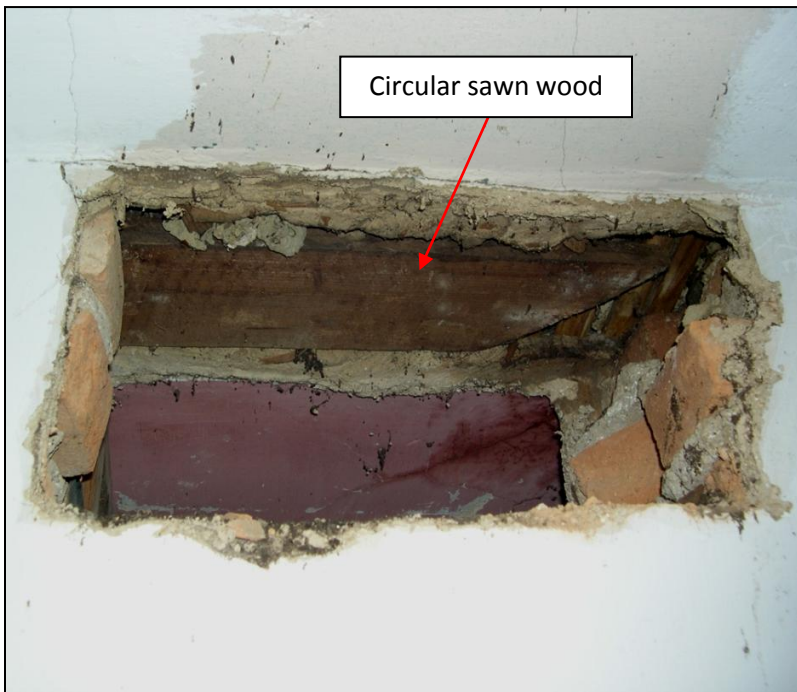
Figure 130: A close-up view of ductwork damage on the east wall of the bedroom. Note the presence of circular saw marks on the supporting wood lintel.

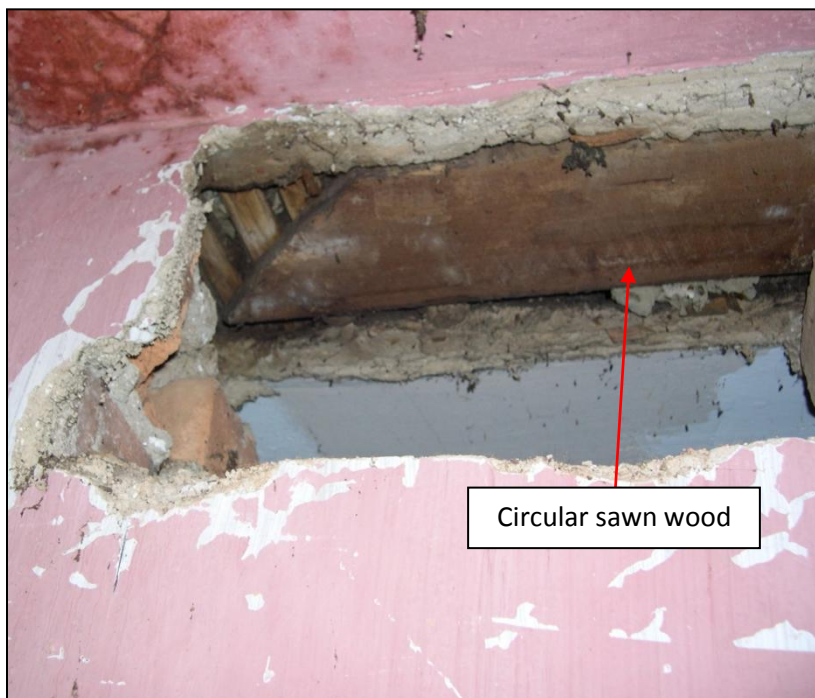
Figure 132: A close-up view of ductwork damage on the east wall of the bedroom. Note the presence of circular saw marks on the supporting wood lintel. A water stain can also be seen at the top left of the image.
