**The Bowman-Hite Property  
Warren County, Virginia**

**Bowman-Hite Farmhouse  
Historic Structures Report**

**Final Submission**

*October 2013*

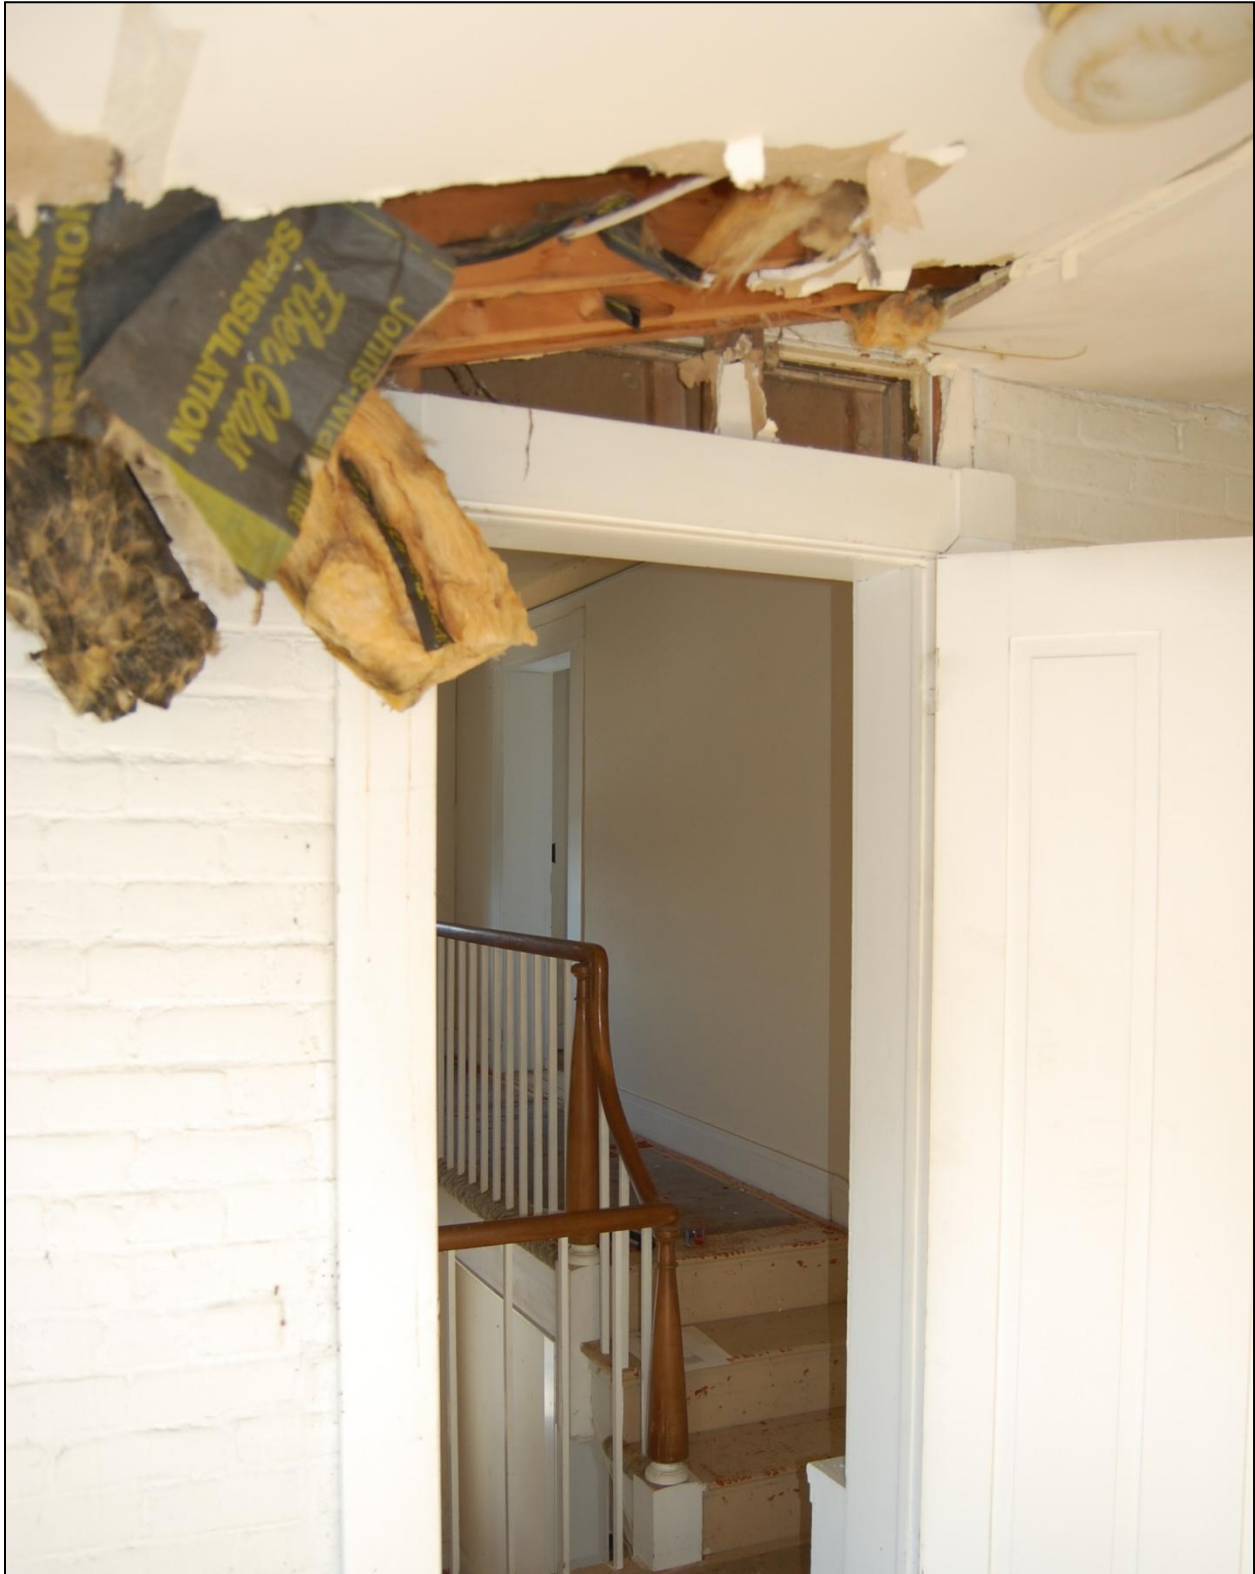
The second floor of the Bowman-Hite farmhouse remains structurally sound, with just a few areas of concern. Most notable is the damage being caused by failed roof flashing in room #204. Water penetration has caused the drywall ceiling to collapse in locations and has created an environment ideal for mold growth and rot. Other water damage can be seen in rooms #201, #202, and #203, where the plaster shows staining associated with water leaks. These leaks appear to be past occurrences, although the accumulation of bat guano and rodent waste in the 1850s attic has likely contributed to the staining and cracking of the ceiling plaster.

Figure 133: A view of the west wall of the room, through the converted 1850s stair hall window, now doorway. Note the damage to the ceiling above.

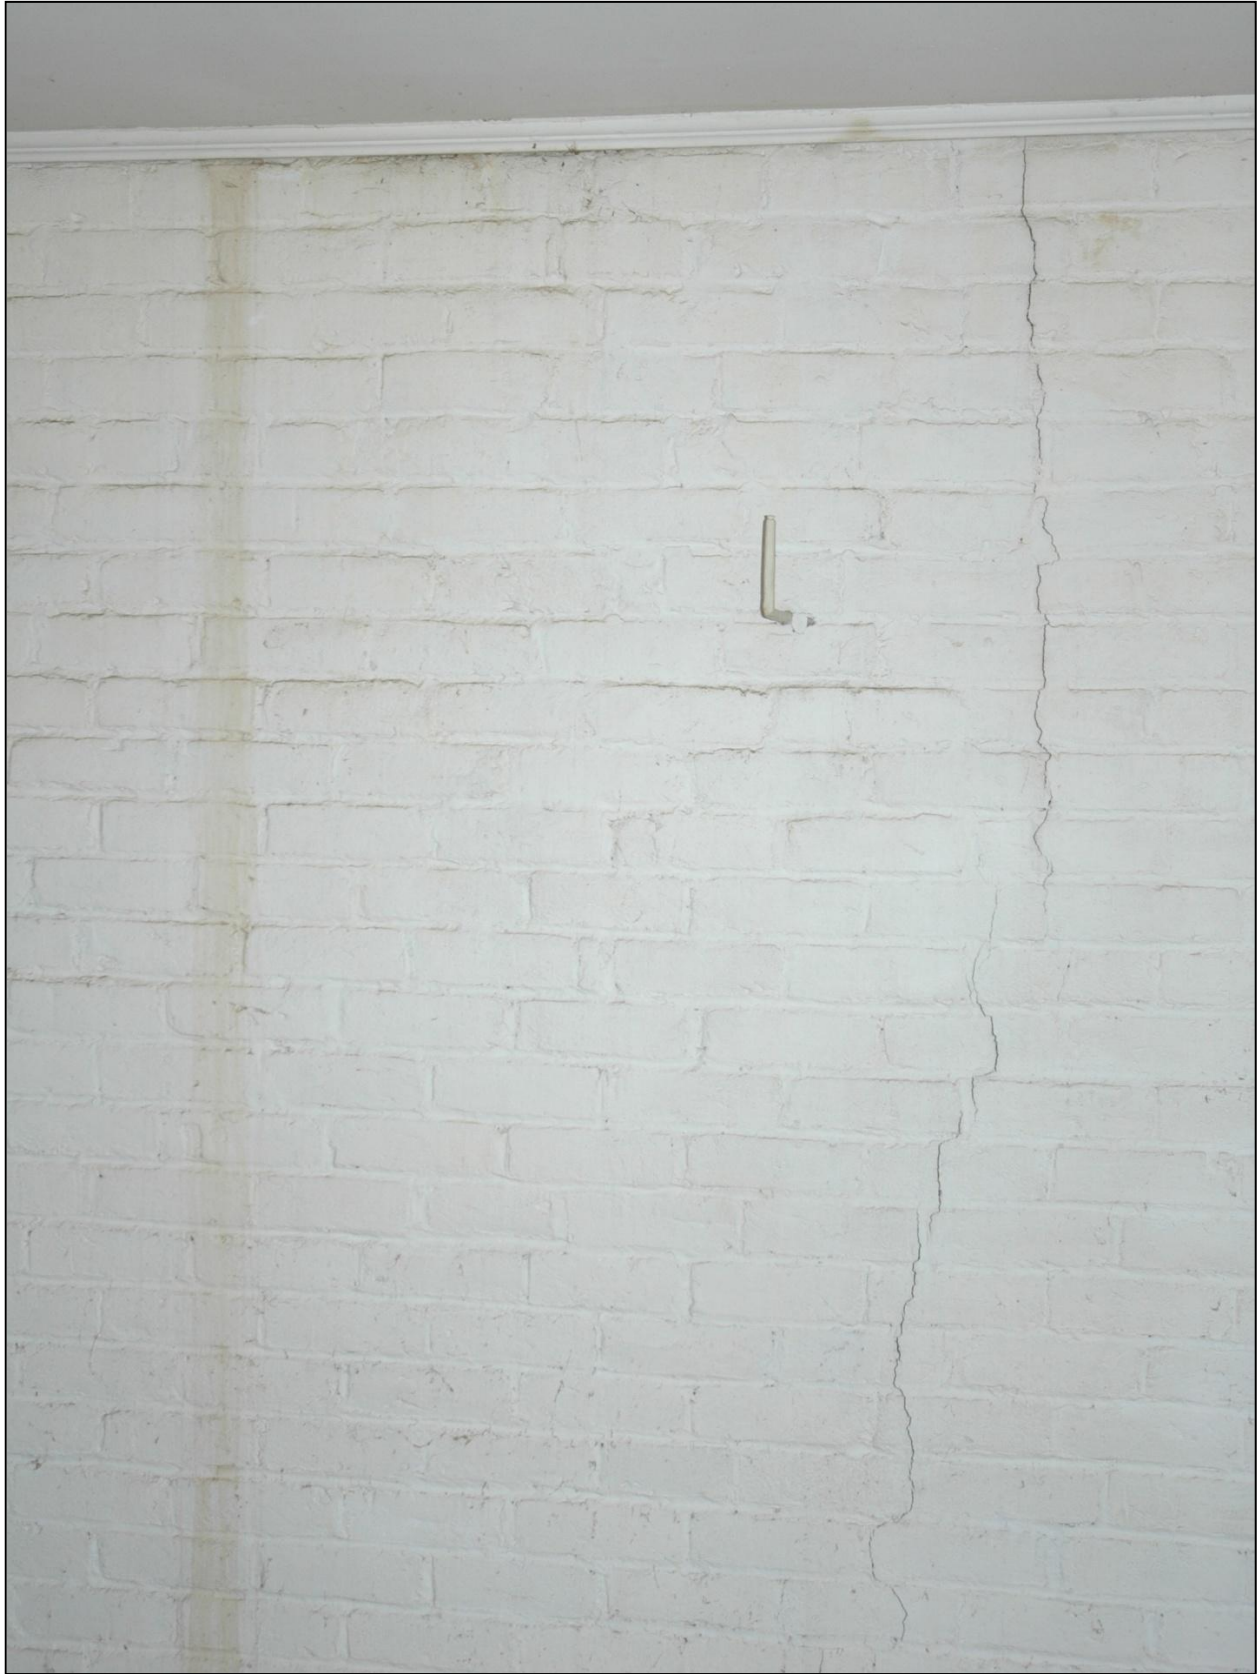
Masonry wall cracks are also a concern on the second floor. While nothing at the moment appears to be of immediate concern to the buildings structural integrity, cracks in room #207, and room #211 should be monitored to ensure no further movement. As both cracks contain no paint, their occurrence is more recent, likely after the early 1970s, when the Whitham addition was added and the interior walls repainted white.

Figure 134: A view of crack #1 on the west wall of room #207.

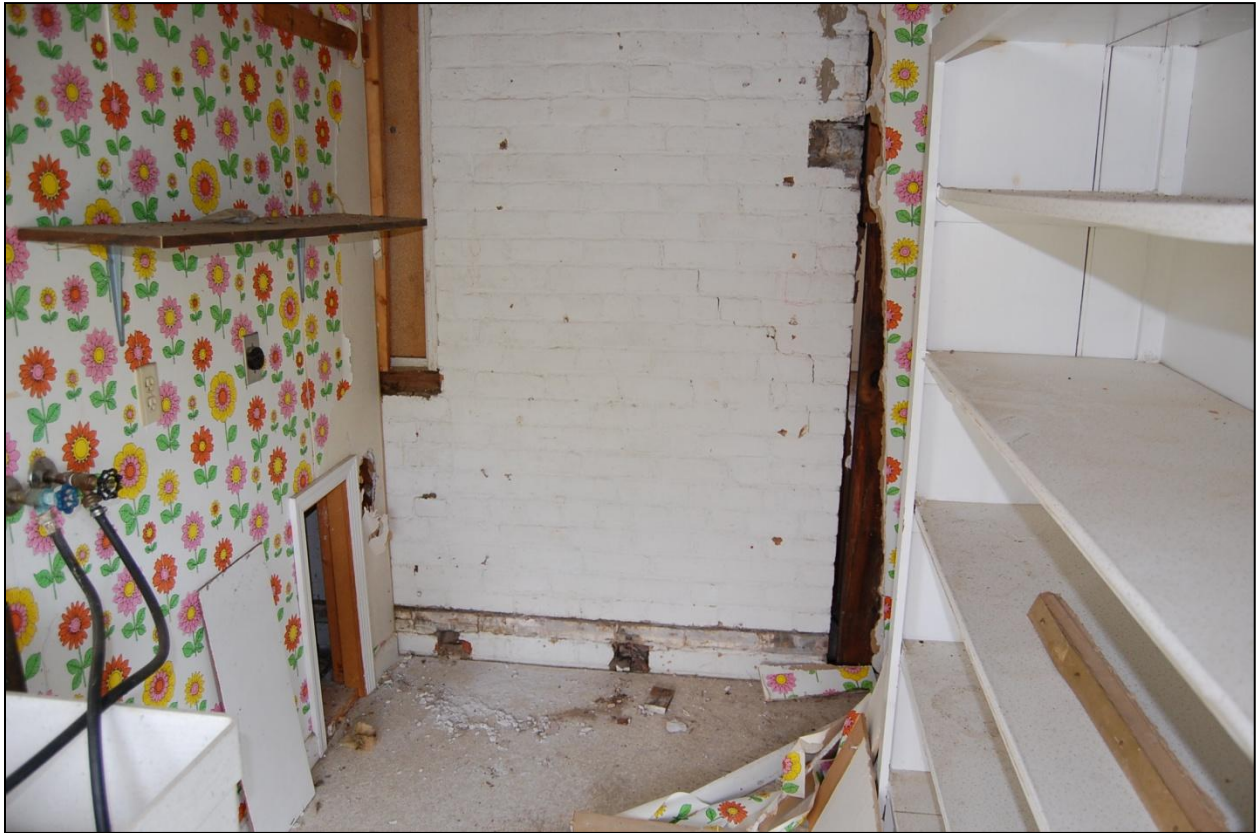
Figure 135: A view of the laundry room with crack #2 visible on the brick ells south exterior wall. Note the pockets in the brick wall for the exterior porch which once ran along the south side of the building.

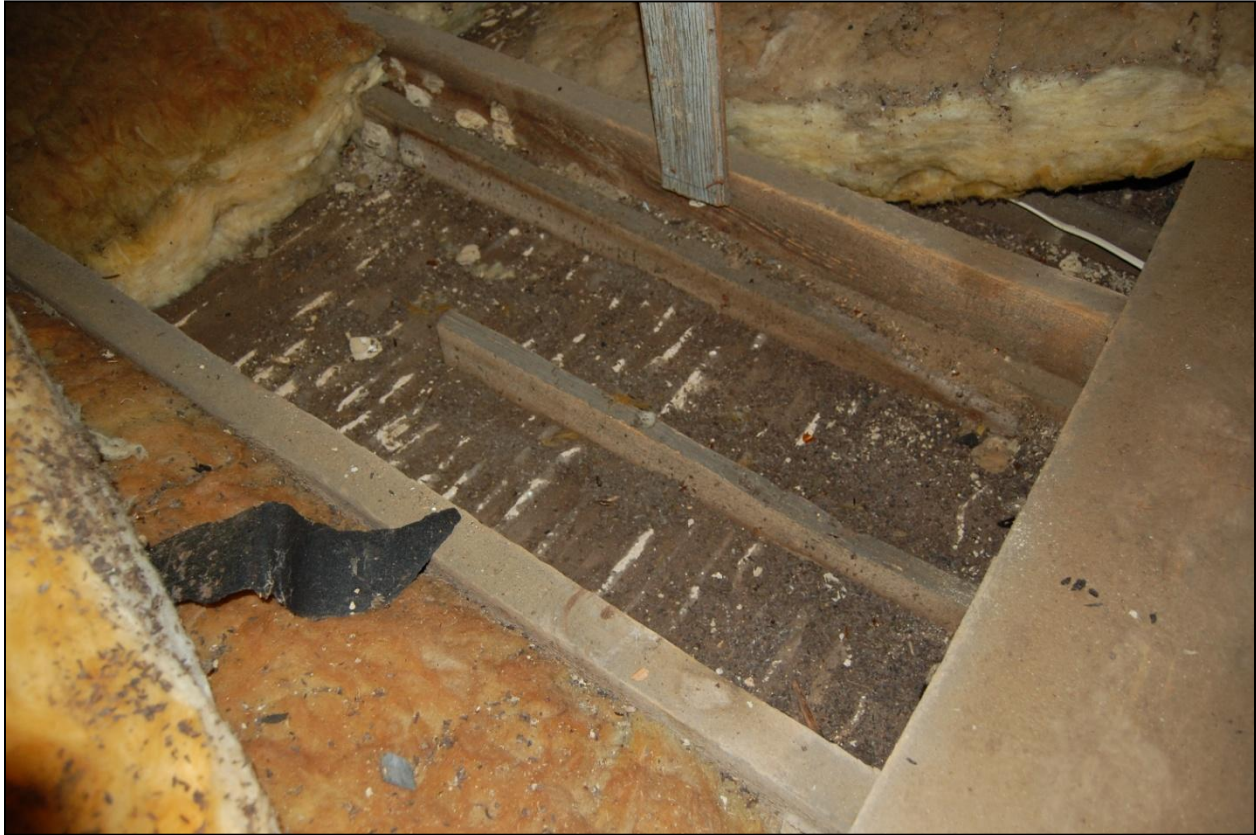
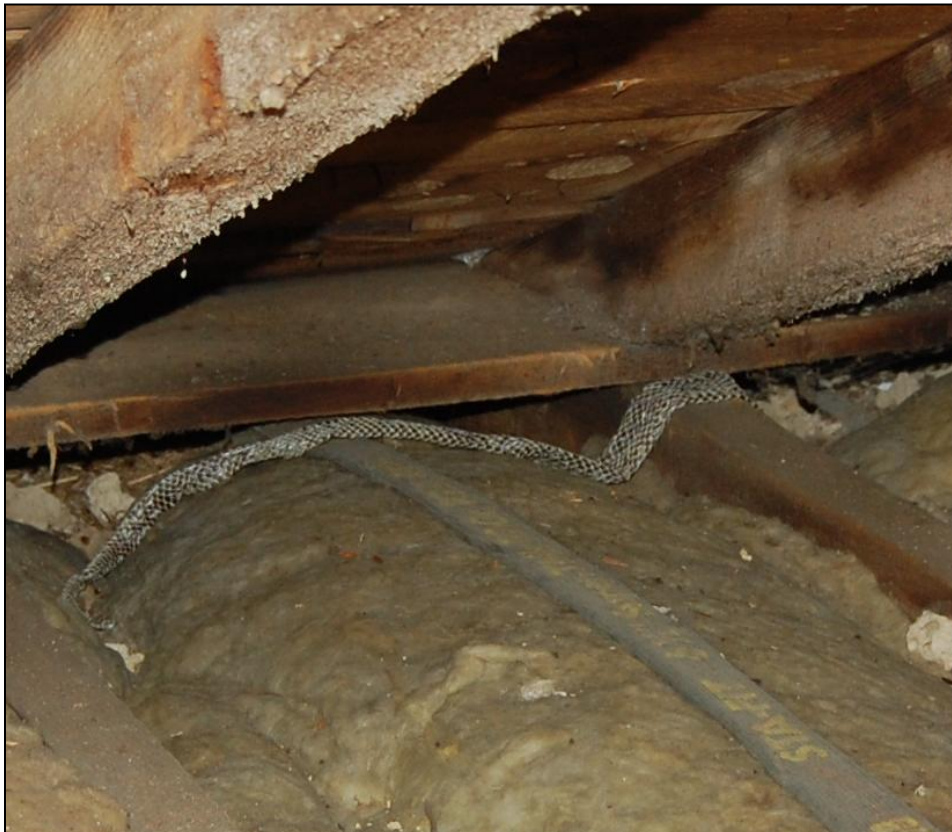
Evidence indicates that snakes, rodents, and bats reside in the attic space. Guano from the bats, as well as rodent droppings, piled between the floor joists, have caused staining as well as deformation of the plaster. These droppings are most prevalent in the 1850s, Hite era portion of the attic space.

Figure 136: The image above shows the space between the attic joists filled with bat guano and rodent droppings. Also evident are the lathe nailers, seen between the joists. The image to the left shows a large black snake skin indicating the presence of a food source, likely bats and rodents.

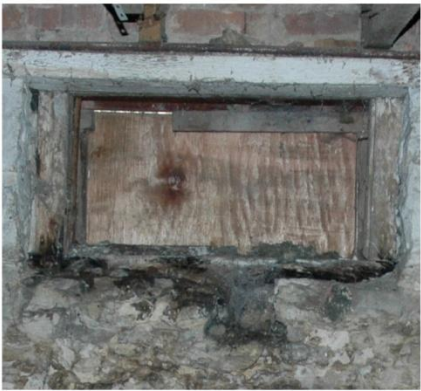
<b>Window Number:</b> 001 <b>Room Number:</b> 001 <b>Window Type:</b> A <b>Transom Type:</b> N/A	<b>Window Exposure:</b> North  <b>Functional:</b> <b>Yes:</b> <b>No:</b> X

Sash		Glazing	Top Rail	Bottom Rail	Left Stile	Right Stile	Muntins	
							Hor.	Vert.
Double/Single Hung	Upper							
	Lower							
Fixed (single)	Fixed	4	II,3,4	II,4	II,4	II,4	4	4

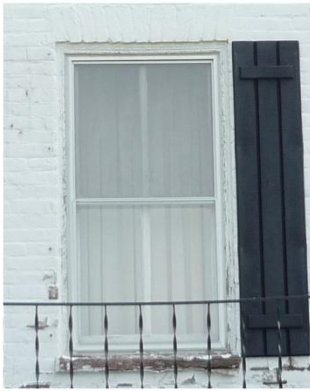
<b>Window Number:</b> 002 <b>Room Number:</b> 102 <b>Window Type:</b> B <b>Transom Type:</b> N/A	<b>Window Exposure:</b> West  <b>Functional:</b> Yes:    X                No:

Sash		Glazing	Top Rail	Bottom Rail	Left Stile	Right Stile	Muntins	
							Hor.	Vert.
Double/Single Hung	Upper	III	III, 1	III, 1	III, 1	III, 1	III, 1	III, 1
	Lower	III	III, 1	III, 1	III, 1	III, 1	III, 1	III, 1
Fixed (single)	Fixed

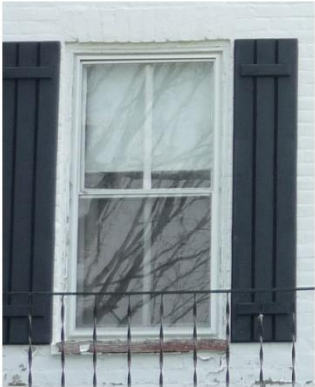
<b>Window Number:</b> 003 <b>Room Number:</b> 102 <b>Window Type:</b> B <b>Transom Type:</b> N/A	<b>Window Exposure:</b> West  <b>Functional:</b> <b>Yes:</b> X <b>No:</b>

Sash		Glazing	Top Rail	Bottom Rail	Left Stile	Right Stile	Muntins	
							Hor.	Vert.
Double/Single Hung	Upper	III	III, 1	III, 1	III, 1	III, 1	III, 1	III, 1
	Lower	III	III, 1	III, 1	III, 1	III, 1	III, 1	III, 1
Fixed (single)	Fixed

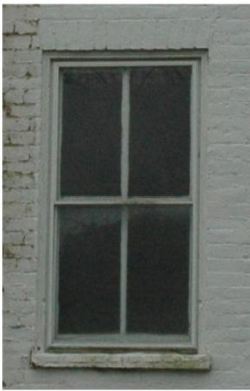
<b>Window Number:</b> 004 <b>Room Number:</b> 103 <b>Window Type:</b> B <b>Transom Type:</b> N/A	<b>Window Exposure:</b> North  <b>Functional:</b> Yes:    X                No:

Sash		Glazing	Top Rail	Bottom Rail	Left Stile	Right Stile	Muntins	
							Hor.	Vert.
Double/Single Hung	Upper	III	III, 1	III, 1	III, 1	III, 1	III, 1	III, 1
	Lower	III	III, 1	III, 1	III, 1	III, 1	III, 1	III, 1
Fixed (single)	Fixed

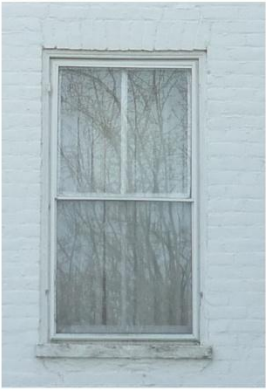
<b>Window Number:</b> 005 <b>Room Number:</b> 103 <b>Window Type:</b> B <b>Transom Type:</b> N/A	<b>Window Exposure:</b> North  <b>Functional:</b> <b>Yes:</b> X <b>No:</b>

Sash		Glazing	Top Rail	Bottom Rail	Left Stile	Right Stile	Muntins	
							Hor.	Vert.
<b>Double/Single Hung</b>	Upper	III	III, 1	III, 1	III, 1	III, 1	III, 1	III, 1
	Lower	III	III, 1	III, 1	III, 1	III, 1	III, 1	III, 1
<b>Fixed (single)</b>	Fixed

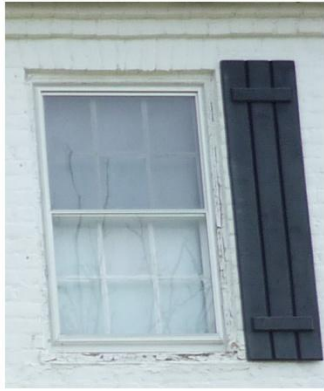
<b>Window Number:</b> 007 <b>Room Number:</b> 201 <b>Window Type:</b> C <b>Transom Type:</b> N/A	<b>Window Exposure:</b> West  <b>Functional:</b> <b>Yes:</b> X <b>No:</b>

Sash		Glazing	Top Rail	Bottom Rail	Left Stile	Right Stile	Muntins	
							Hor.	Vert.
Double/Single Hung	Upper	II	II, 1	II, 1	II, 1	II, 1	II, 1	II, 1
	Lower	II	II, 1	II, 1	II, 1	II, 1	II, 1	II, 1
Fixed (single)	Fixed

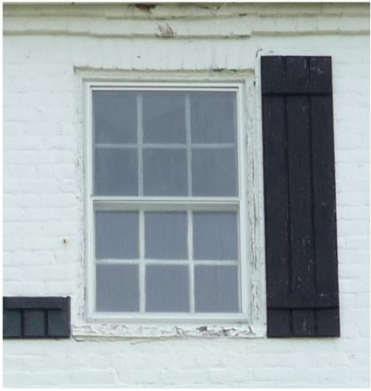
<b>Window Number:</b> 008 <b>Room Number:</b> 202 <b>Window Type:</b> C <b>Transom Type:</b> N/A	<b>Window Exposure:</b> West  <b>Functional:</b> <b>Yes:</b> X <b>No:</b>

Sash		Glazing	Top Rail	Bottom Rail	Left Stile	Right Stile	Muntins	
							Hor.	Vert.
Double/Single Hung	Upper	II	II, 1	II, 1	II, 1	II, 1	II, 1	II, 1
	Lower	II	II, 1	II, 1	II, 1	II, 1	II, 1	II, 1
Fixed (single)	Fixed

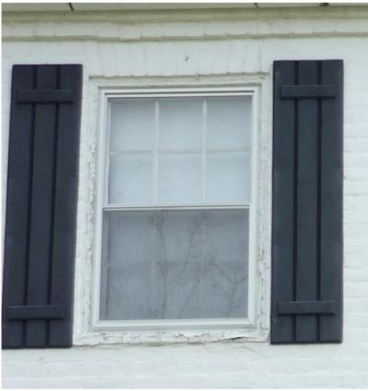
<b>Window Number:</b> 009 <b>Room Number:</b> 202 <b>Window Type:</b> C <b>Transom Type:</b> N/A	<b>Window Exposure:</b> West  <b>Functional:</b> <b>Yes:</b> X <b>No:</b>

Sash		Glazing	Top Rail	Bottom Rail	Left Stile	Right Stile	Muntins	
							Hor.	Vert.
Double/Single Hung	Upper	II	II, 1	II, 1	II, 1	II, 1	II, 1	II, 1
	Lower	II	II, 1	II, 1	II, 1	II, 1	II, 1	II, 1
Fixed (single)	Fixed

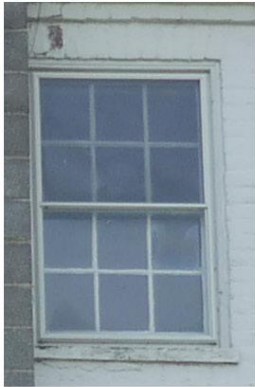
<b>Window Number:</b> 010 <b>Room Number:</b> 203 <b>Window Type:</b> C <b>Transom Type:</b> N/A	<b>Window Exposure:</b> North  <b>Functional:</b> Yes: <input checked="" type="checkbox"/> No: <input type="checkbox"/>

Sash		Glazing	Top Rail	Bottom Rail	Left Stile	Right Stile	Muntins	
							Hor.	Vert.
Double/Single Hung	Upper	II	II, 1	II, 1	II, 1	II, 1	II, 1	II, 1
	Lower	II	II, 1	II, 1	II, 1	II, 1	II, 1	II, 1
Fixed (single)	Fixed

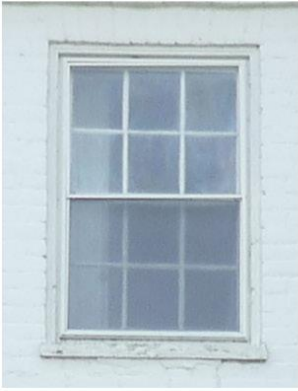
<b>Window Number:</b> 011 <b>Room Number:</b> 203 <b>Window Type:</b> C <b>Transom Type:</b> N/A	<b>Window Exposure:</b> North  <b>Functional:</b> Yes:    X                No:

Sash		Glazing	Top Rail	Bottom Rail	Left Stile	Right Stile	Muntins	
							Hor.	Vert.
Double/Single Hung	Upper	II	II, 1	II, 1	II, 1	II, 1	II, 1	II, 1
	Lower	II	II, 1	II, 1	II, 1	II, 1	II, 1	II, 1
Fixed (single)	Fixed

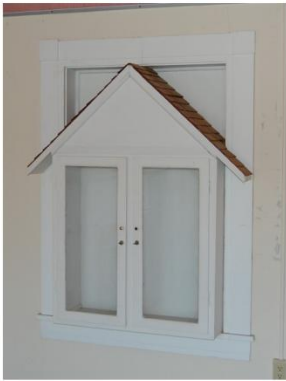
<b>Window Number:</b> 012 <b>Room Number:</b> 203 <b>Window Type:</b> C <b>Transom Type:</b> N/A	<b>Window Exposure:</b> South  <b>Functional:</b> <b>Yes:</b> X <b>No:</b>

Sash		Glazing	Top Rail	Bottom Rail	Left Stile	Right Stile	Muntins	
							Hor.	Vert.
Double/Single Hung	Upper	4	4	4	4	4	4	4
	Lower	4	4	4	4	4	4	4
Fixed (single)	Fixed

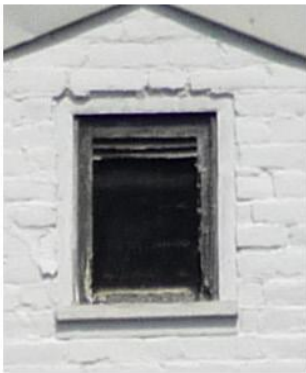
<b>Window Number:</b> 013 <b>Room Number:</b> 301 (attic) <b>Window Type:</b> D <b>Transom Type:</b> N/A	<b>Window Exposure:</b> South  <b>Functional:</b> Yes: No: X

Sash		Glazing	Top Rail	Bottom Rail	Left Stile	Right Stile	Muntins	
							Hor.	Vert.
<b>Double/Single Hung</b>	Upper							
	Lower							
<b>Fixed (single)</b>	Fixed	4	II, 1, 3	II, 1, 3	II, 1, 3	II, 1, 3	N/A	N/A

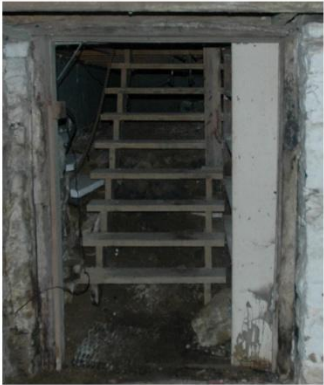
<b>Door Number:</b> 001 <b>Room Number:</b> 001 <b>Door Type:</b> A <b>Transom Type:</b>	<b>Door Exposure/Wall:</b> East <b>Functional:</b> <b>Yes:</b> X <b>No:</b>

Door	Glazing	Panels	Top Rail	Middle Rail	Bottom Rail	Left Stile	Middle Stile	Right Stile
Two Paneled								
Four Paneled	N/A	4	4	4	4	4	4	4
Six Paneled								
1/2 Glazed

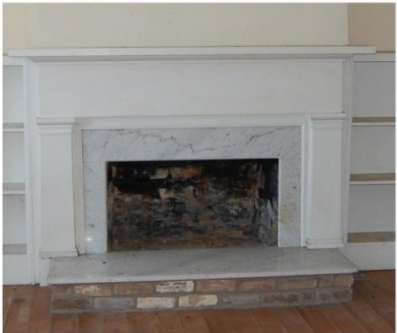
<b>Mantle Number:</b> 001 <b>Room Number:</b> 102 <b>Mantle Type:</b> A	<b>Mantle Location:</b> North Wall  <b>Fireplace Functional:</b> <b>Yes:</b> X <b>No:</b>

Mantle	Pilasters	Plinth Blocks	Mantle Shelf	Firebox Surround	Head/Fascia	Trim
Wood	II	II, 4	II	II (under), V	II	II

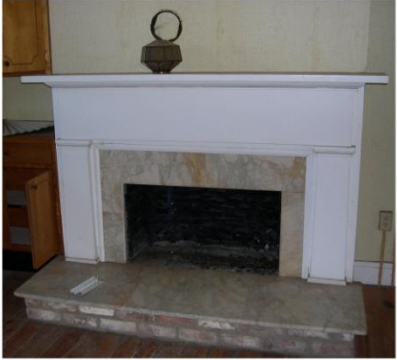
<b>Mantle Number:</b> 002 <b>Room Number:</b> 103 <b>Mantle Type:</b> B	<b>Mantle Location:</b> East Wall  <b>Fireplace Functional:</b> <b>Yes:</b> X <b>No:</b>

Mantle	Pilasters	Plinth Blocks	Mantle Shelf	Firebox Surround	Head/Fascia	Trim
Wood	II	II, 4	II	II (under), V	II	II

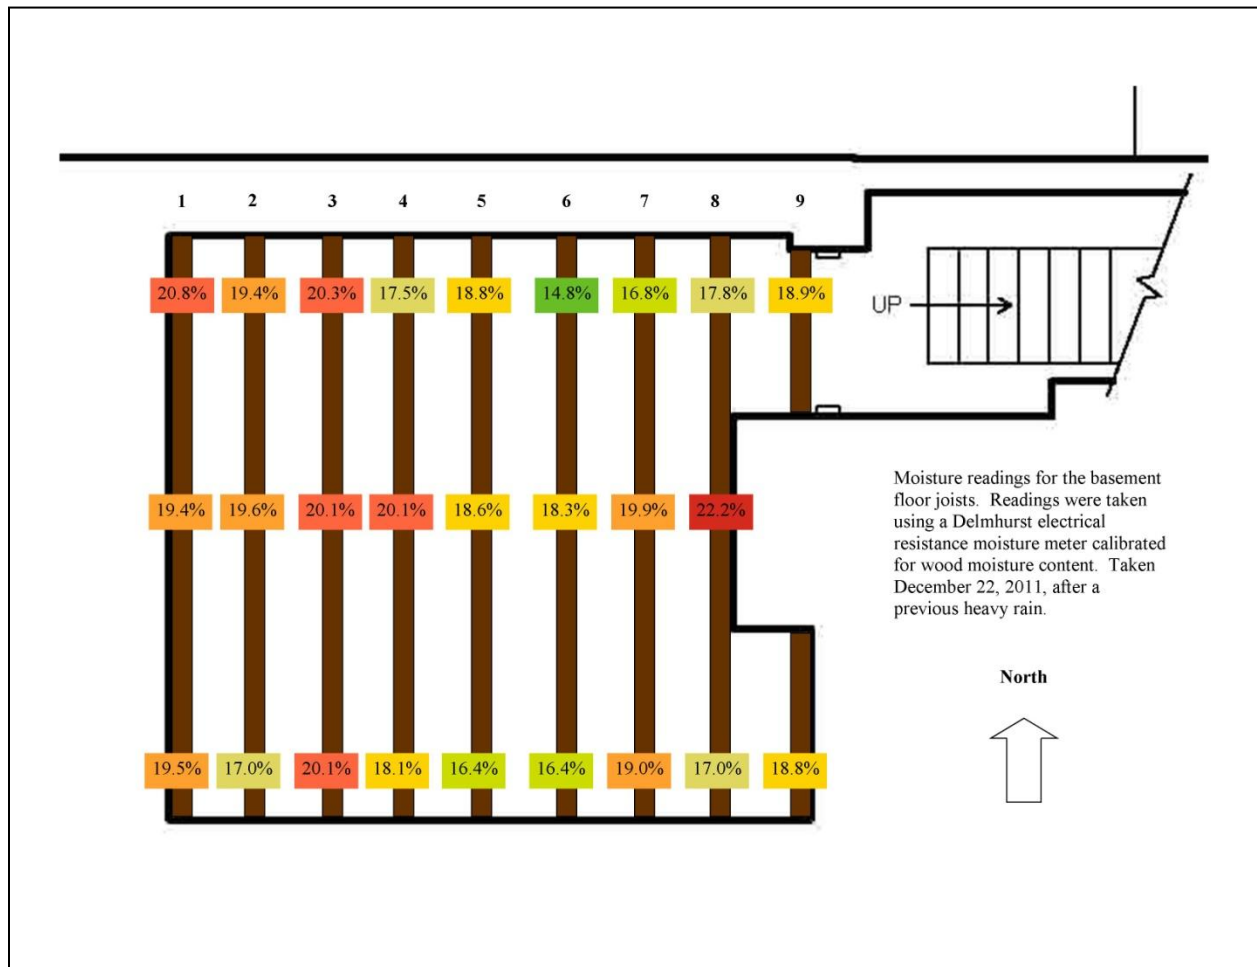
Figure 137: the schematic above shows the basement area in plan with individual floor joists labeled 1 (west) through 9 (east). There appear to be few discernible patterns to the moisture content distribution readings among joists. The highest level may be in part due to water penetration from the chimney above.

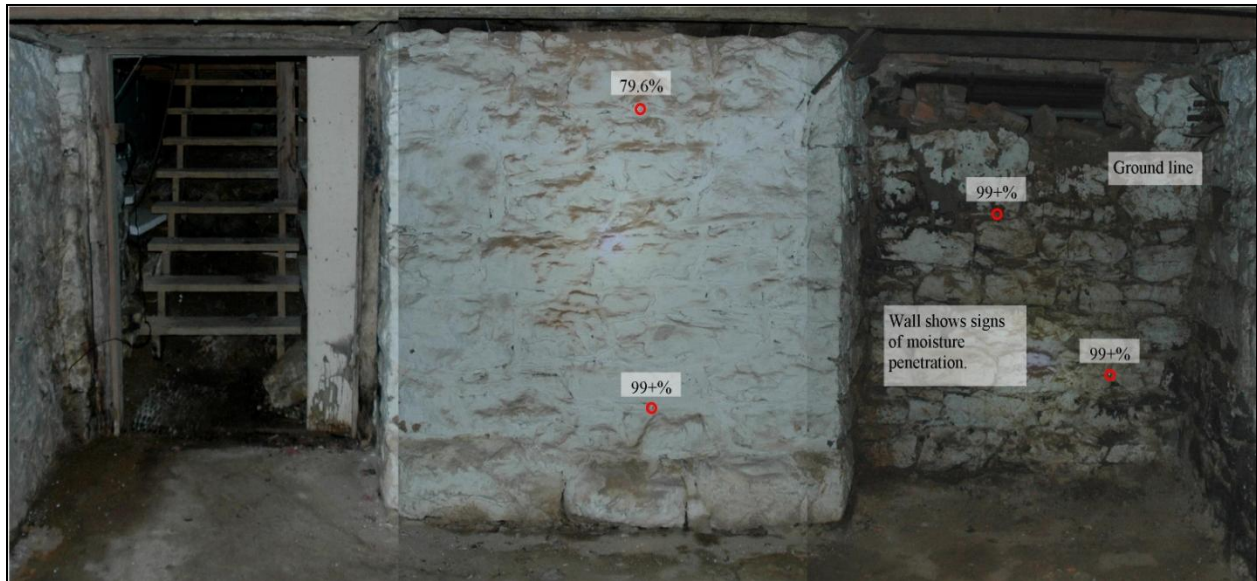
The stone walls in the basement were also tested at various intervals using a qualitative scale on the Delmhorst BD-2100. Results indicated that the stone walls were uniformly damp with the exception of the east wall. Here moisture levels decreased as the wall rose. Such results would be expected with rising damp.

Figure 138: The east basement wall showing areas measured using the Delmhorst moisture meter. The discoloration visible on the walls indicates the presence of efflorescence.

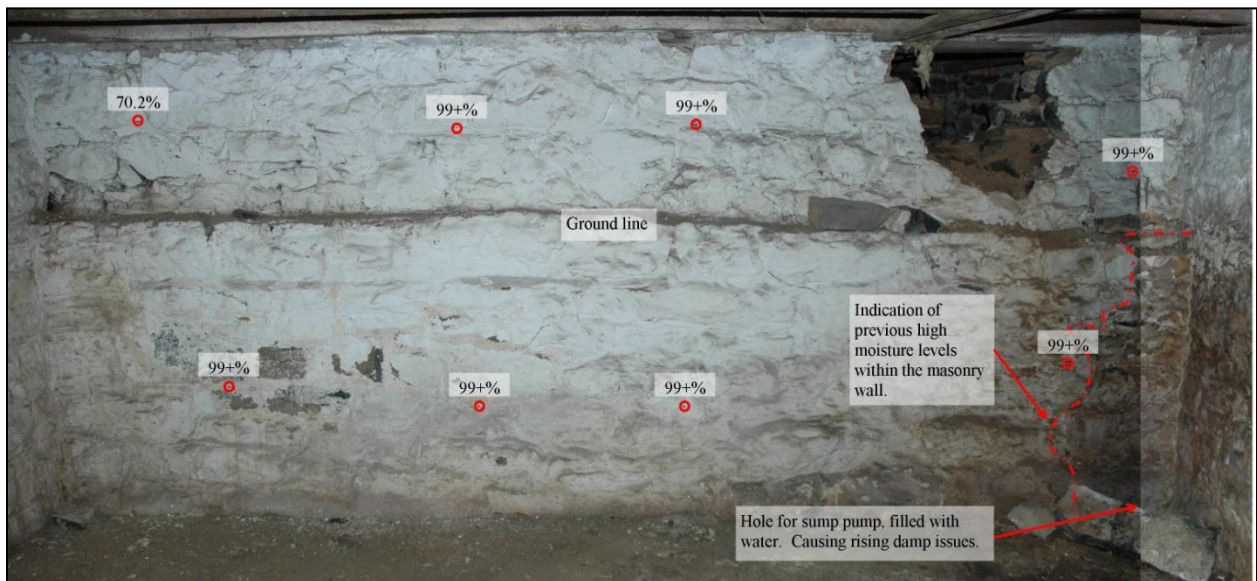
Figure 139: The west basement wall showing areas measured using the Delmhorst moisture meter. In the lower right of the image is the hole where the sump pump was kept. This is also the area where a downspout discharges, note the discoloration.

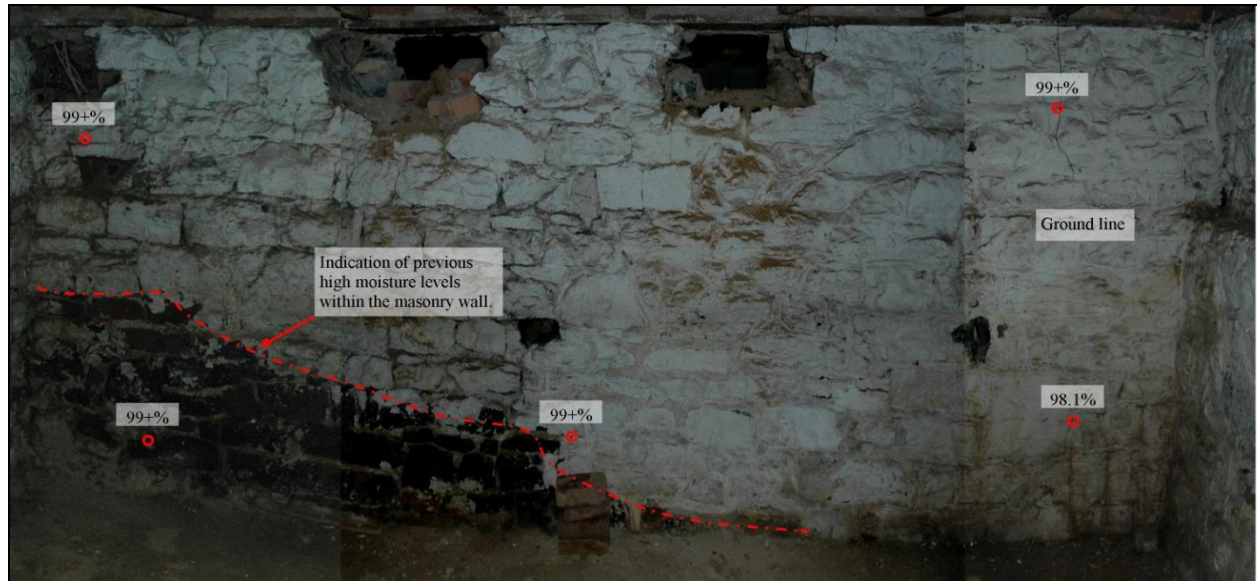
Figure 140: The south basement wall showing levels of rising damp indicated by the dashed line. At the time of the readings all moisture readings were high despite this wall being an interior wall. One reason behind this constant damp is the poured concrete floor which is helping increase capillary action within the stone walls.

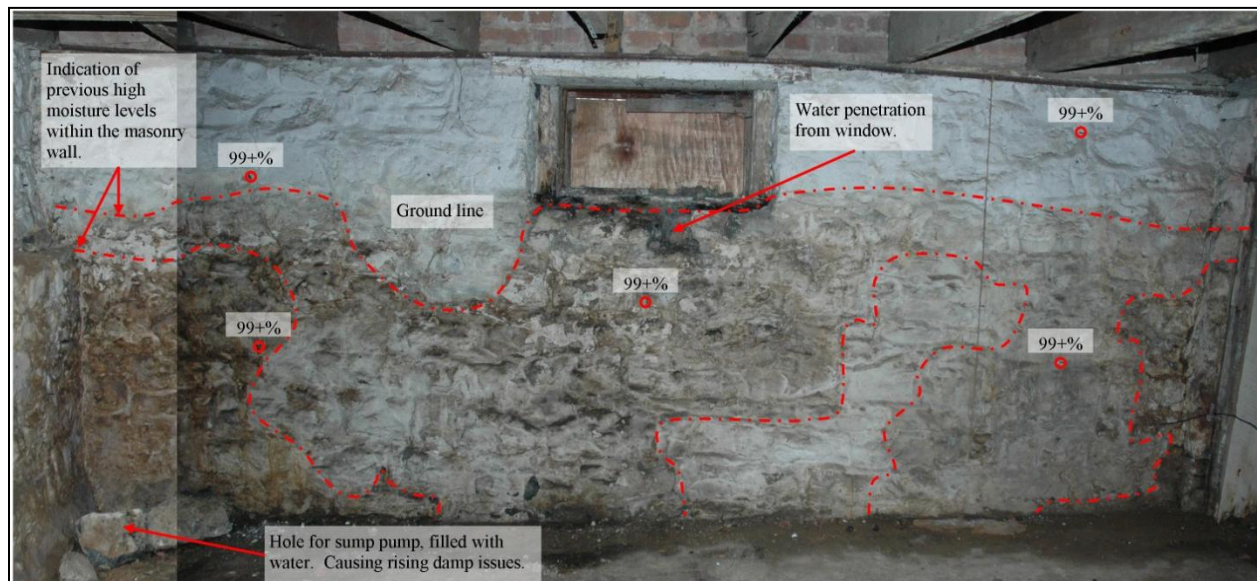
Figure 141: The north wall shows the greatest moisture problems. The various discolorations indicate rising damp levels as well as apparent moisture penetration from a clogged downspout (left) and the centrally placed window,.

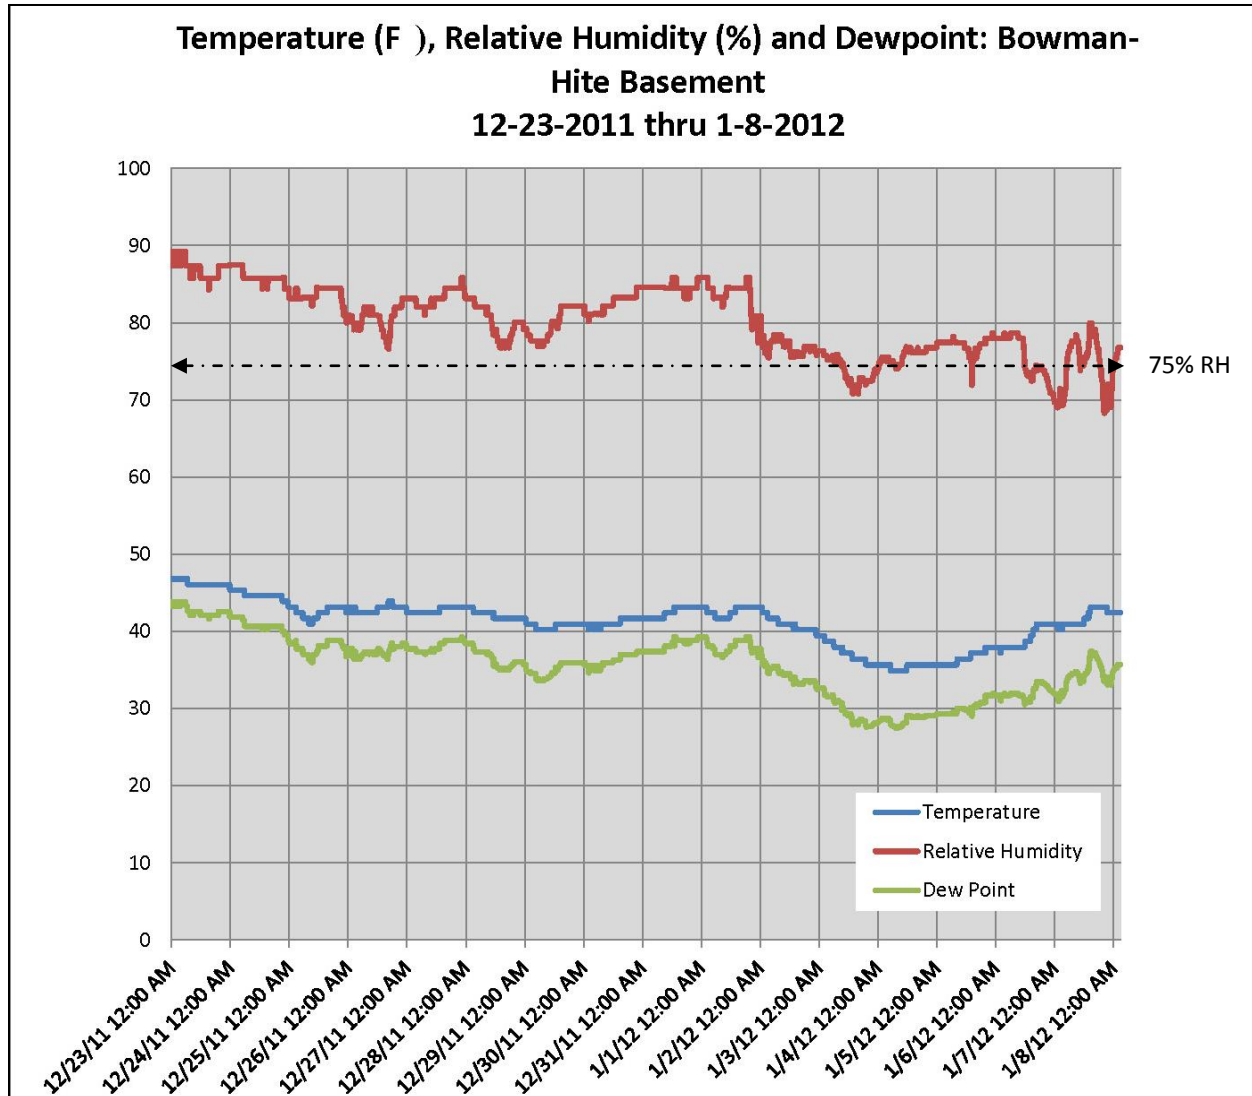
Information from a data logger placed in the basement over a sixteen day period helped confirm the presence of high relative humidity levels in the basement despite cold exterior temperatures and relatively little rain during the period. Relative humidity levels ranged from a high of 89.3% to a low reading of 68.3%. Placing that in context, relative humidity levels above 70% are considered high. Only for a few minutes during the sixteen days was the relative humidity ever below these high levels. While wood moisture content is the primary reason for rot to occur, high relative humidity levels allow for little evaporation of woods moisture, encouraging by proxy, mold growth and eventual rot. Additionally, relative humidity levels play a role in the presence of efflorescence and the eventual spalling of stone and brick. At RH levels above 75% sodium chloride goes into solution, whereas below 75% the solution re-crystallizes.<sup>248</sup> This fluctuation acts as like a "jack hammer", with expanding salt crystals prying against the stones surface causing spalling. The basement readings also indicated that temperature and dew point are constantly within 4-5°F of each other creating the "clammy" environment and leading to condensation at times.

Figure 142: This chart shows the relative humidity (RH%), temperature (F°) and dew point (F°) from the period starting on December 23<sup>rd</sup> and running through January 8<sup>th</sup> for the basement floor of the house. Note the high RH values, in excess of 70%, which can encourage mold growth, as well as the fluctuations above and below the 75% level. Such fluctuations encourage spalling in stone and brick caused by salt dissolution and re-crystallization.

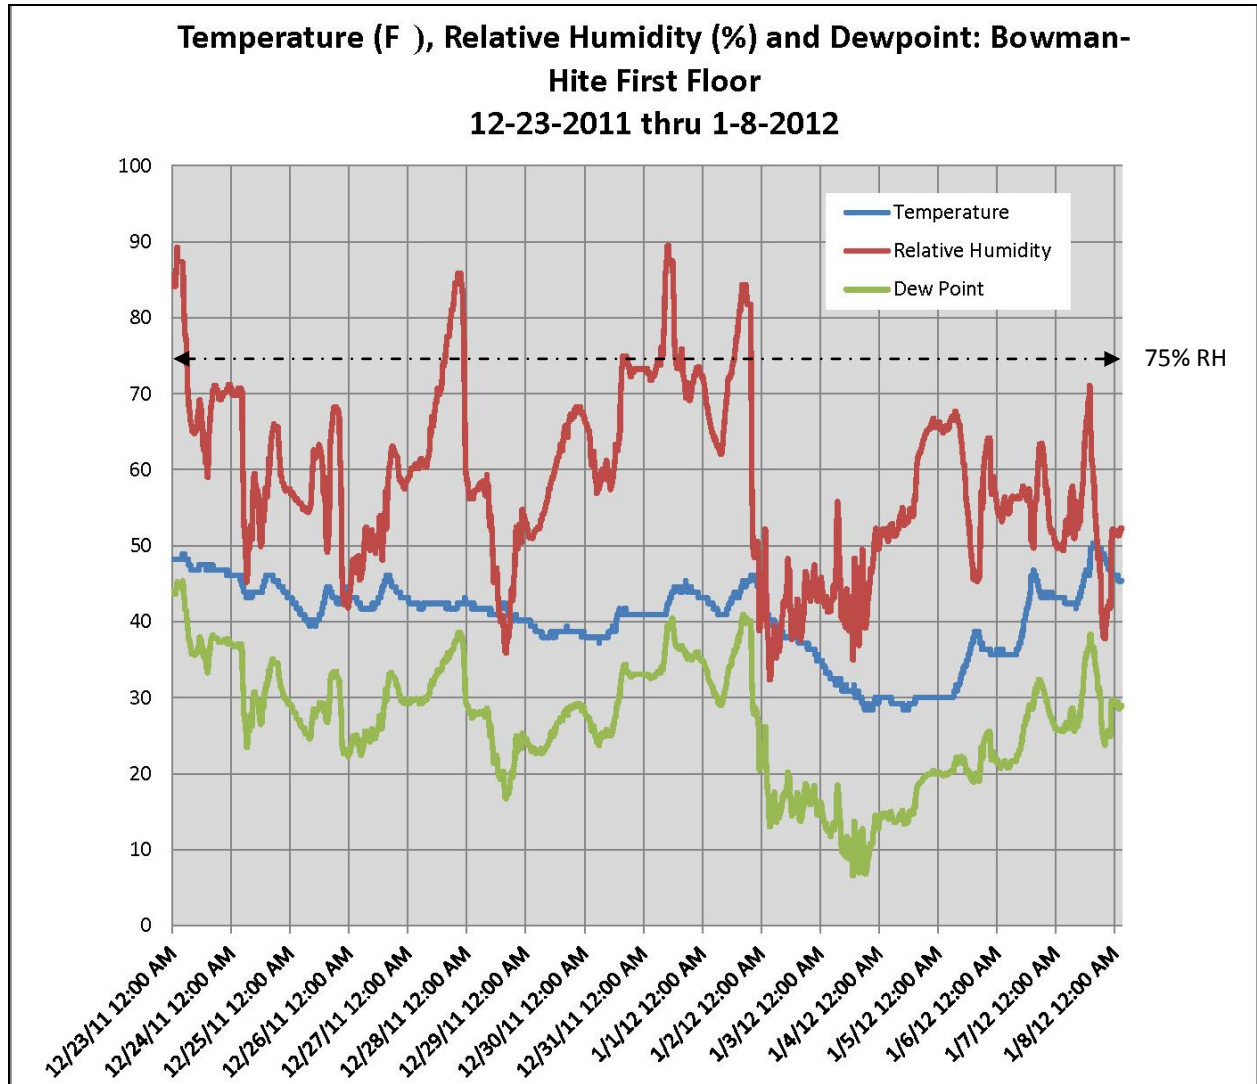
The first floor, as expected due to increased ventilation, showed different results when monitored for temperature, relative humidity and dew point. During the same sixteen day period, temperatures ranged from 50.38°F to 28.45°F and averaged 40.58°F. Relative humidity was also high at times with a max value recorded at 89.30%. While this value was high, it was a notable exception, as relative

humidity values only rose above 75% four times during the period and averaged just 68.30%, within acceptable limits. On one occasion temperature and dew point came within 4.41°F of each other likely causing some condensate to form within the structure. Such close values between temperature and dew point are relatively common in the basement and account for the “clammy” conditions often felt.

Figure 143: This chart shows the relative humidity (RH%), temperature (F°) and dew point (F°) from the period starting on December 23<sup>rd</sup> and running through January 8<sup>th</sup> for the first floor of the house.

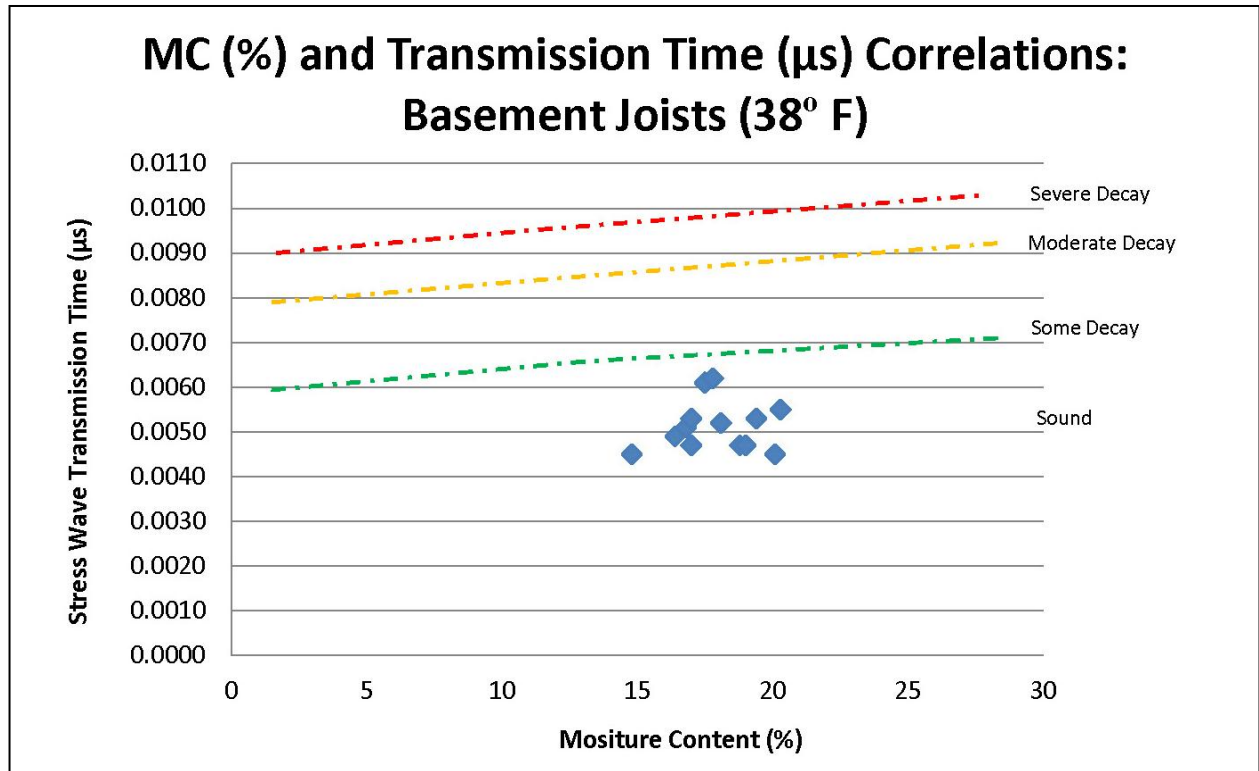
Further analysis of the findings involved plotting the relationship of stress wave timing values against wood moisture content values to determine if any correlations existed. Under circumstances where moisture was causing wood to rot there would be a direct correlation between higher wood moisture content and longer stress wave times. However, this was not the case in the basement where the results showed no correlation, further indicating the lack of significant degradation within the wood joists.

Figure 144: This chart shows the stress wave timing results in relation to moisture content. Note the lack of correlation between the two indicating that there is likely no degradation as a result of wood moisture content.

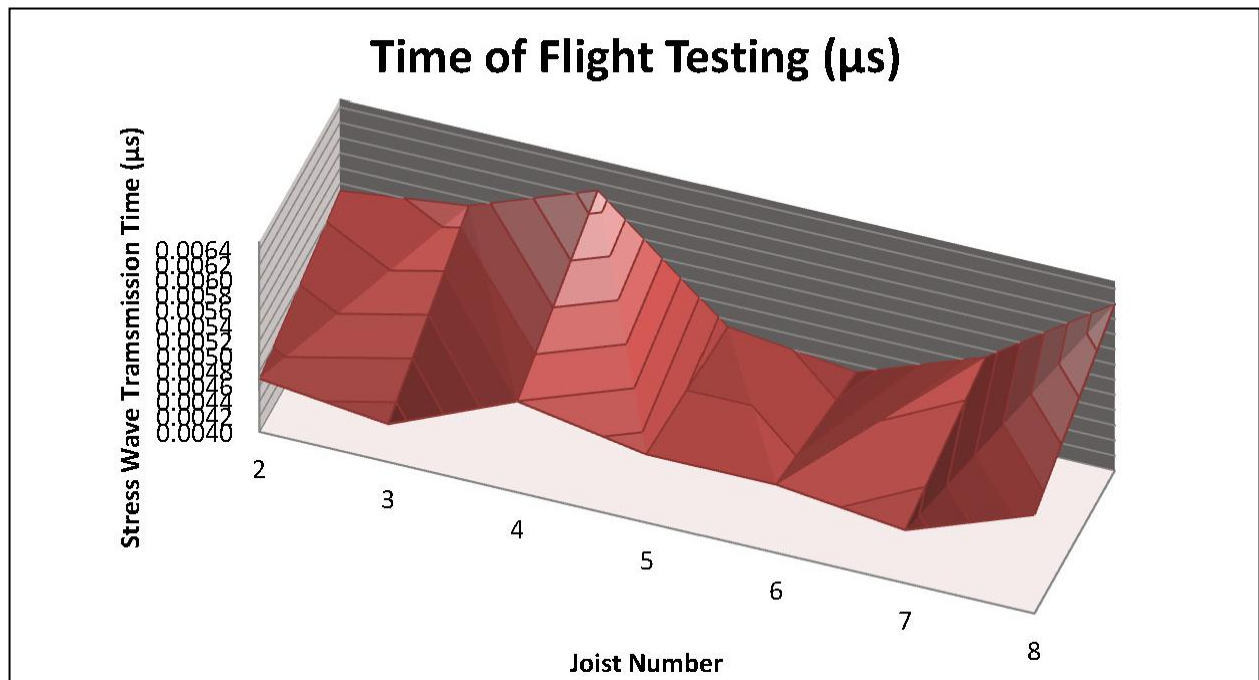
Findings from this investigation determined that despite high relative humidity and wood moisture content, the basement joists were in relatively good condition. Readings ranged between 42 $\mu$ s - 61 $\mu$ s (adjusted values), well within the acceptable range for yellow pine. Anything above 70 $\mu$ s, at the determined wood moisture content, would likely have indicated some rot.

Figure 145: This chart shows the results of the time of flight or stress wave timing tests conducted on the wood joists. The x-axis defines the joist number, with the top of the chart oriented towards the north wall, and the bottom the south. Higher values indicate the possibility of degradation within the wood, however all values obtained were well below levels of concern. Note the two “spikes” near the north wall.

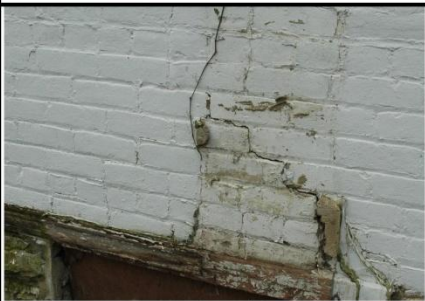
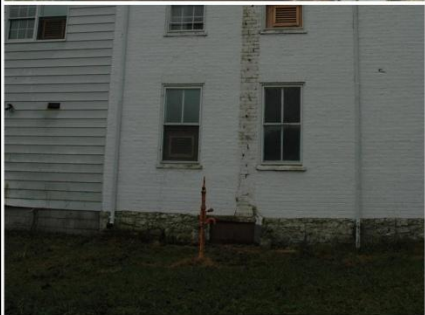
Cracks can occur in historic structures for a number of reasons; settlement, differential coefficients of expansion, incompatible materials, and failure of structural components. The Bowman-Hite farmhouse currently exhibits four cracks located on the period II structure. Three of these cracks are currently being monitored and the fourth was just recently discovered upon removal of the cinderblock chimney added in the late 20<sup>th</sup> century. From initial observations it appears that the cracks are currently growing; however further monitoring will be required to ensure that this is not the result of natural thermal expansions and contractions. Ambient temperature must also be monitored when crack measurements are taken to ensure that any movements are not the result of temperature fluctuations. While the first and second cracks appear to be perplexing in terms of their cause, cracks three and four appear straightforward. Crack three appears to be the result of mortar failure in the splayed jack arch. Without the arch in full compression the crack will continue to expand as the arch slowly falls. The fourth crack appears to be the result of a failed wood lintel creating a step crack.

<b>Crack Number:</b> 004 <b>Room Number:</b> Exterior <b>Type:</b> Structural	<b>Specific Location:</b> North Exterior Wall , Brick Ell  <b>Currently Moving:</b> <b>Yes:</b> X <b>No:</b>

\*Crack was located after the removal of the cinder block chimney at which point filed observations had ceased. Return trips are need to quantify distances and movement.
