**The Bowman-Hite Property
Warren County, Virginia**

**Bowman-Hite Farmhouse
Historic Structures Report
Part II**

Final Submission

June 2015

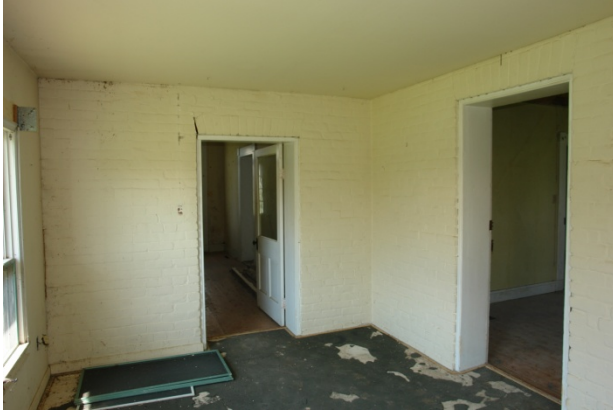
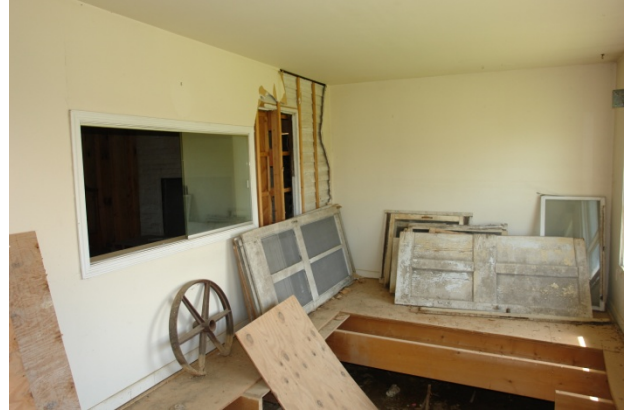
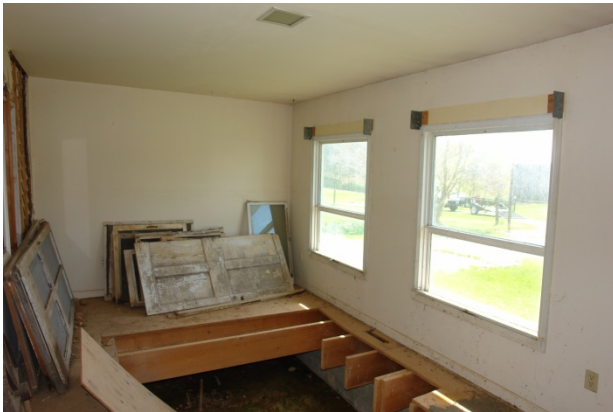
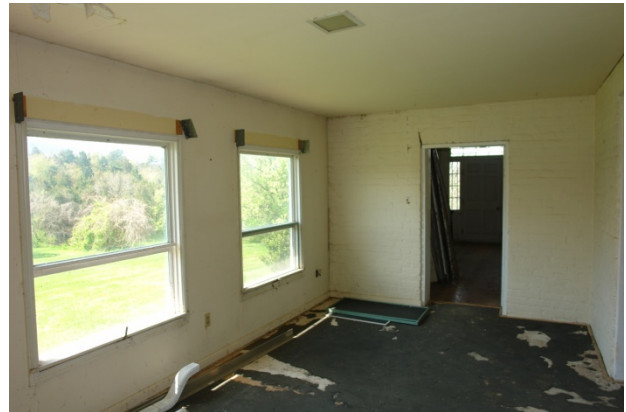
Room 107 - Long Room:

- Continue to monitor crack at jack arch above west door.
- Retain and preserve brick walls (west end wall and left side of north wall shared with Room 203 - East Bedroom). Perform additional paint analysis on brick walls.
- Retain and preserve stud walls from former 1870s addition (middle and right of north wall shared with Room 104 - Kitchen and Room 105 - Den). Remove gypsum wall board finish on stud wall. Retain and preserve siding. Perform additional paint analysis on siding. Locate framing of former door in the 1870s frame addition.
- Retain and utilize porch rafter pockets in north brick wall for reconstruction of 1870s porch.

- Reconstruct windows into Room 201 - Stair Hall and Room 203 - East Bedroom. Retain and preserve wood frame in window opening into Room 203 - East Bedroom. Provide Dutchman repair to sill of window into Room 203 - East Bedroom. Perform paint analysis on wood trim around window into Room 203 - East Bedroom.

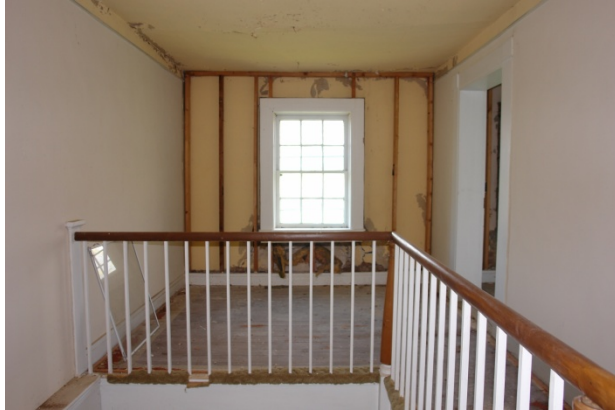
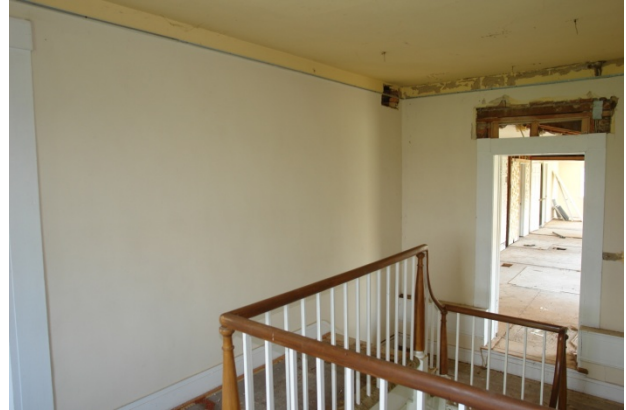
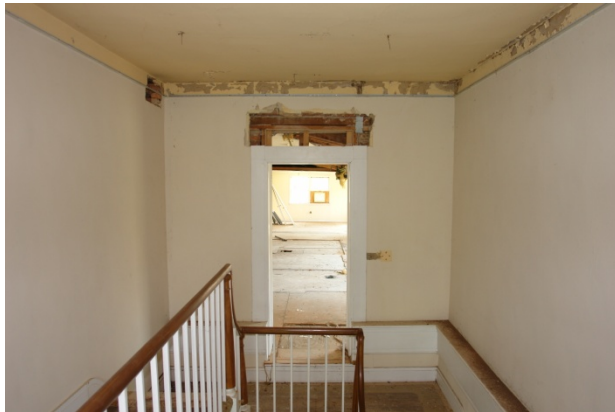
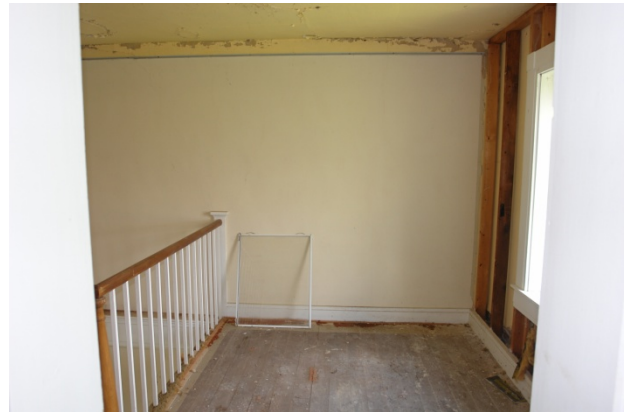
Room 201 - Stair Hall:

- Remove water-damaged plaster. Assess structural stability of roof joists. Repair as necessary. Patch plaster. Coordinate roof joists repair with roofing repairs (sheathing, roofing, and flashing).

- Retain existing plaster.
- Sound plaster walls. Remove loose plaster.
- Patch opening above door to Room 204 - Hall.
- Patch hole in the northeast corner (e.g. location of duct and vent removal).
- Remove flaking and loose paint.

- Clean floors.
- Remove carpet remnants from stair treads.
- Patch hole in the northeast corner (e.g. locations of duct and vent removal). Patch with replacement-in-kind wood flooring.
- Refinish floors.

- Perform additional paint analysis. Confirm all locations of stenciling.
- Remove wood framing along west wall.
- Sound plaster walls. Remove loose plaster. Repair and stabilize plaster.
- Patch opening above door to Room 204 - Hall. Patch with replacement-in-kind plaster.
- Patch hole in the northeast corner (e.g. location of duct and vent removal). Patch with replacement-in-kind plaster.
- Restore stenciling.
- Remove flaking and loose paint. Repaint.

- Perform additional paint analysis.
- Remove edge track from dropped acoustical panel ceiling.
- Remove water-damaged plaster. Assess structural stability of roof joists. Repair as necessary. Patch plaster. Coordinate roof joists repair with roofing repairs (sheathing, roofing, and flashing).
- Repaint.

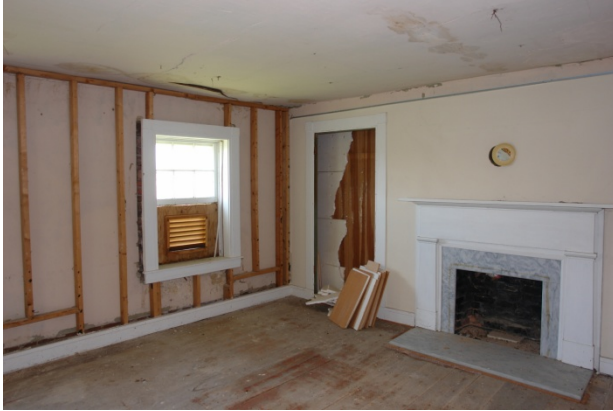
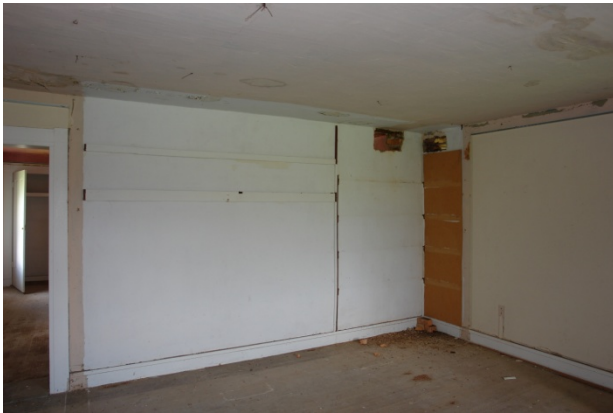
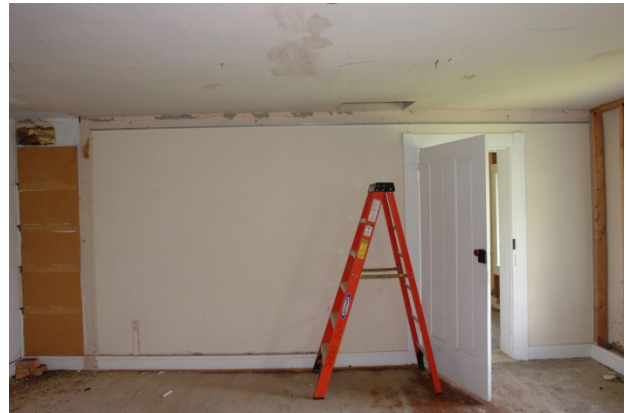
Room 202 - West Bedroom:

- Remove water-damaged plaster. Assess structural stability of roof joists. Repair as necessary. Patch plaster. Coordinate roof joists repair with roofing repairs (sheathing, roofing, and flashing).

- Retain existing plaster.
- Sound plaster walls. Remove loose plaster.
- Patch two holes in the southeast corner (e.g. locations of duct and vent removal).
- Remove flaking and loose paint.

- Perform additional paint analysis.
- Remove wood framing along north wall.
- Sound plaster walls. Remove loose plaster. Repair and stabilize plaster.
- Remove styrofoam panels inside the closets on the north wall. Assess finish of walls. Repair.
- Patch two holes in the southeast corner (e.g. locations of duct and vent removal). Patch with replacement-in-kind plaster.
- Remove flaking and loose paint. Repaint.
- Assess structural repairs for brick exterior walls.
- Consider adding insulation along exterior walls.

- Perform additional paint analysis.
- Remove edge track from dropped acoustical panel ceiling.
- Remove water-damaged plaster. Assess structural stability of roof joists. Repair as necessary. Patch plaster. Coordinate roof joists repair with roofing repairs (sheathing, roofing, and flashing).
- Repaint.
