# Historic Structure Assessment Report

Carderock Pavilion  
East Comfort Station  
West Comfort Station

Potomac, Maryland

Chesapeake & Ohio Canal National Historical Park

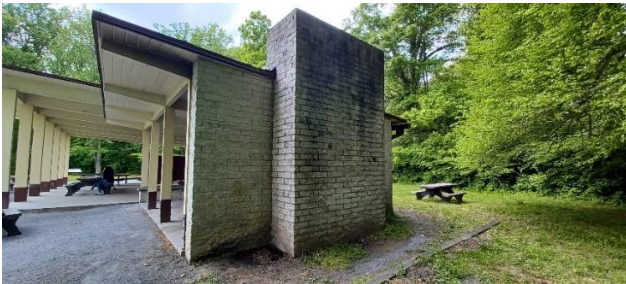
The open pavilion has no exterior walls except for the east, brick fireplace wall. Its condition is good with minor mortar repointing and cleaning recommended.

Pavilion – southeast brick wall.

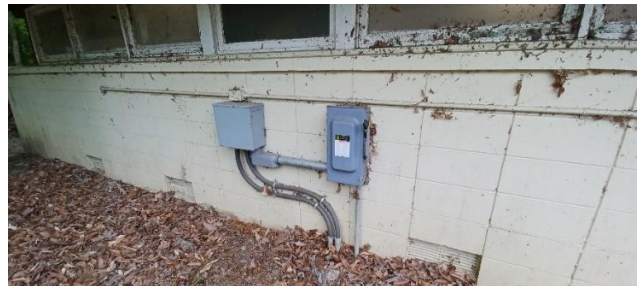
The West Comfort Station has stacked concrete block construction (CMU). There is minor rising damp on all walls caused by a lack of installed drainage gutters and downspouts. The walls are in minor need of paint. The CMU privacy wall and decorative ledge at the Men's Room has one corner that has broken off.

West Comfort Station – east wall.

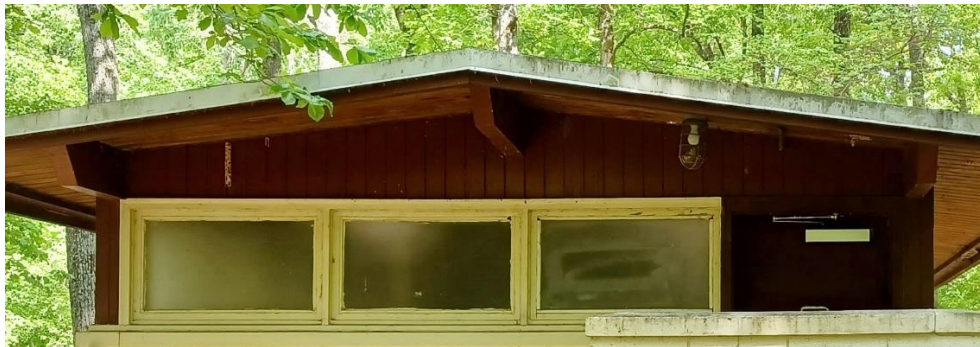
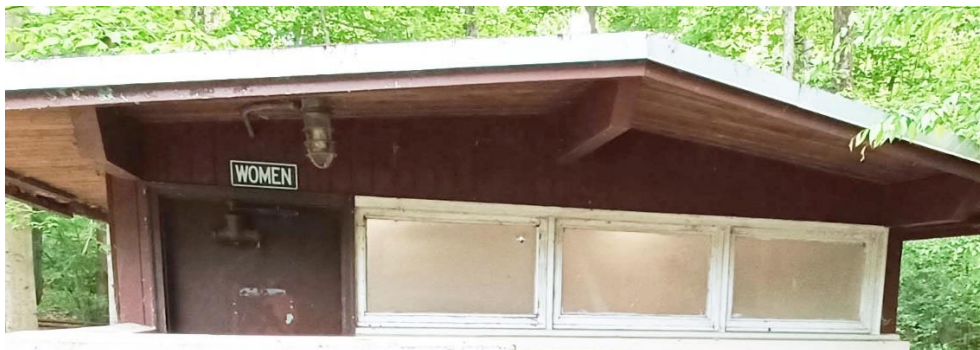
The gable ends of both Comfort Stations has vertical, T1-11 siding. This siding is in good condition on both Comfort Stations.

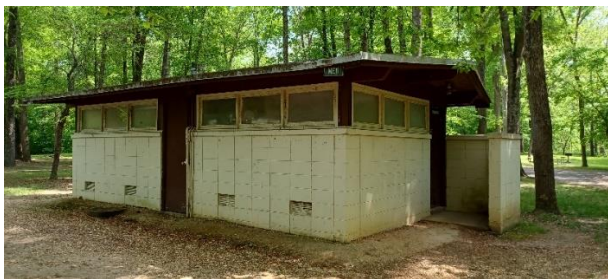
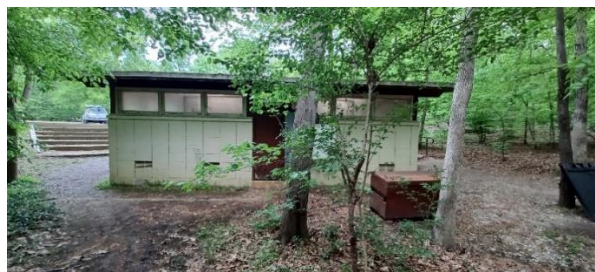
The Comfort Stations are lined at soffit level with ribbon window openings. Although they are inoperable (painted shut), they are secure and retain most of their original hardware. Some panes of glass have been replaced with frosted plexiglass in good condition. The remaining glass panes are in good condition.

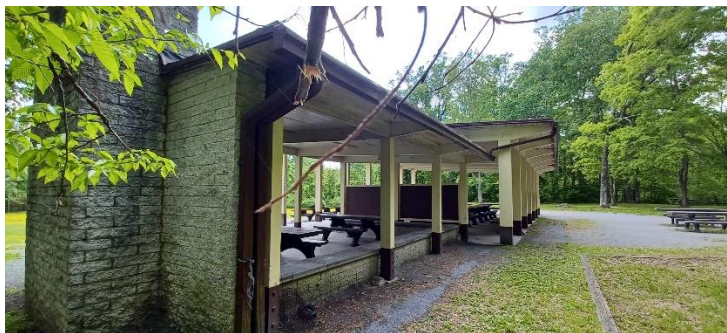
The Pavilion roof was inaccessible to inspection. Its metal gutters and downspouts appear to be in good condition. There is very little wood trim, however trim around the wooden panels located on the north and east walls is in good condition.

Carderock Pavilion gutters and downspouts on northeast corner.

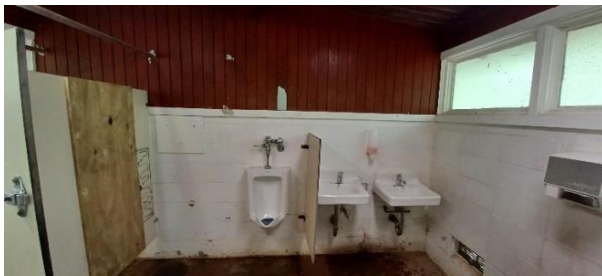
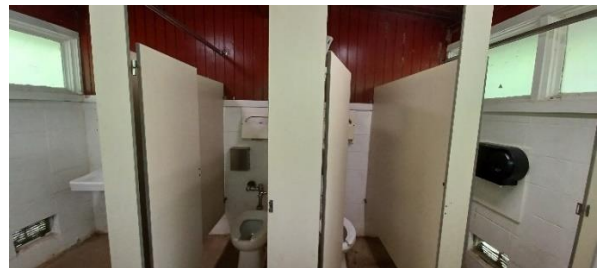
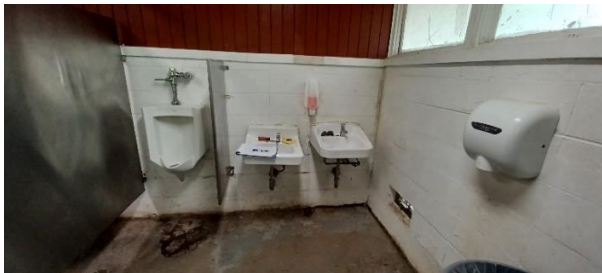
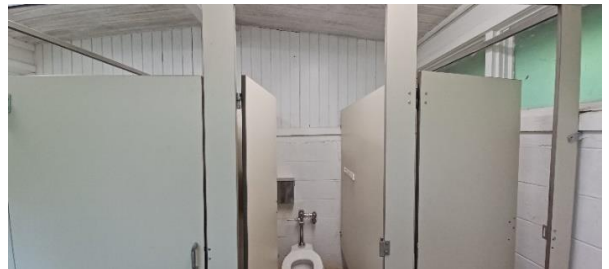
Both Comfort Stations at Carderock have a centrally located utility closet. The closet's two interior partition walls divide the closet from the men's and women's restrooms. All four of these partition walls are in good condition.

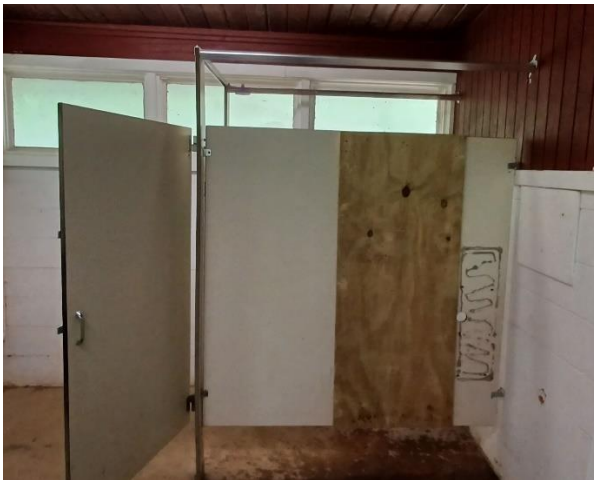
The East Comfort Station men's room has a laminated dividing wall that defines the toilet stalls. Repeated vandalism has degraded the wall. It is recommended it be replaced with metal lined walls similar to those found in the men's room in the West Comfort Station.

East Comfort Station, men's room stall walls.

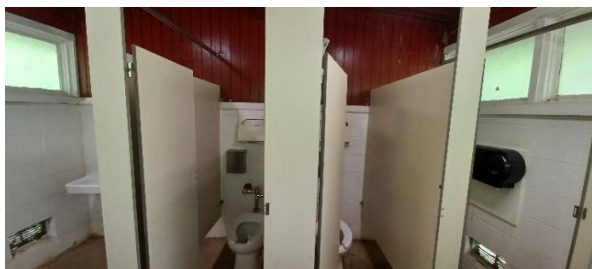
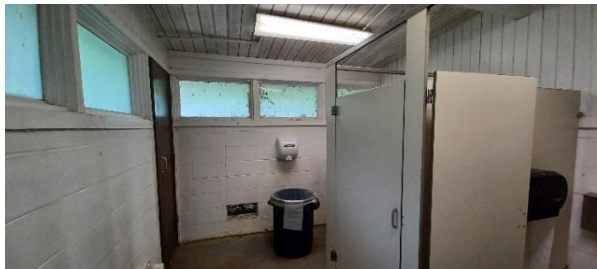
Both the East and West Comfort Station women's rooms have laminated dividing walls that define the toilet stalls. They are all in good condition and require no maintenance at this time.

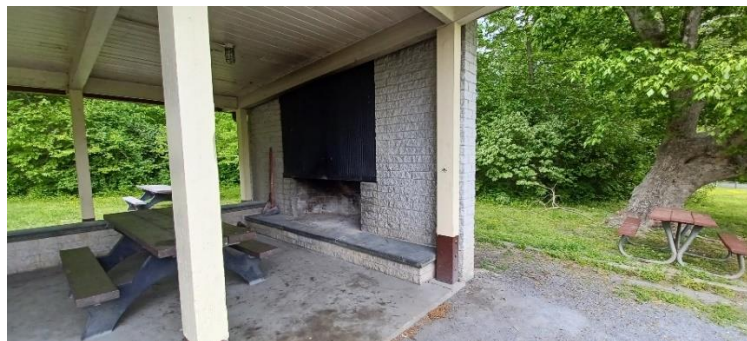
The Pavilion has an open-air construction, and only the inside and outside of the few wood panels and posts are painted. The paint on the columns supporting the roof is in good condition. The wooden screening panels are in need of paint.

Pavilion support posts.

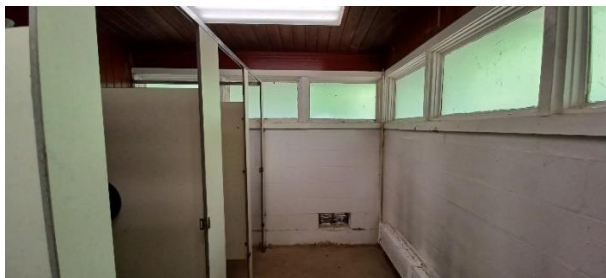
The East and West Comfort Stations women's rooms wall paint is in need of cleaning, but otherwise is in good condition.

East Comfort Station – women's room.

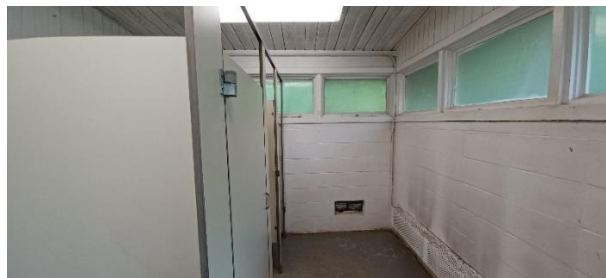
West Comfort Station – women's room.

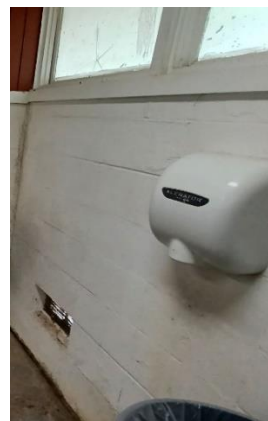
West Comfort Station Men's room wall.

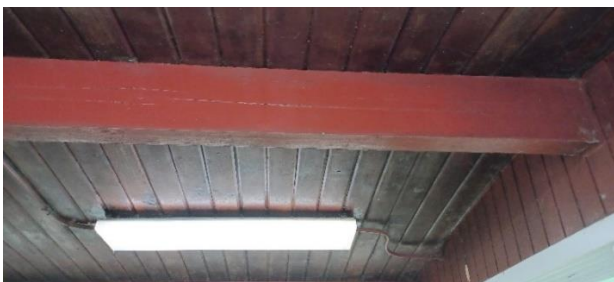
East Comfort Station, men’s room ceiling stain & paint in good condition.

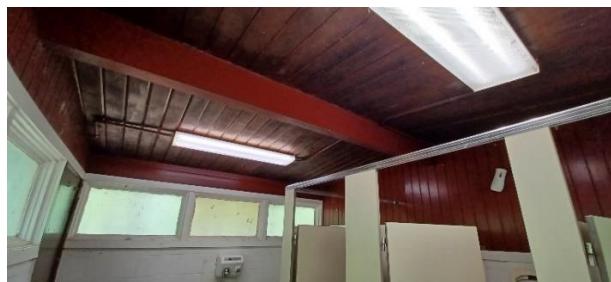
East Comfort Station, women’s room, ceiling stain and paint in good condition.

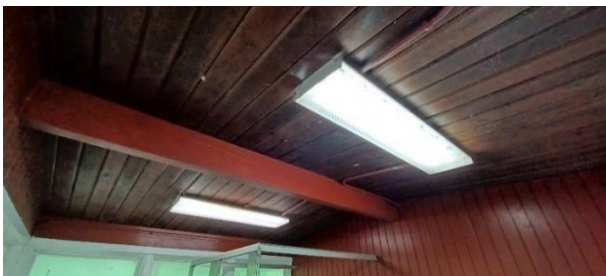
West Comfort Station, men’s room, ceiling stain & paint in good condition.

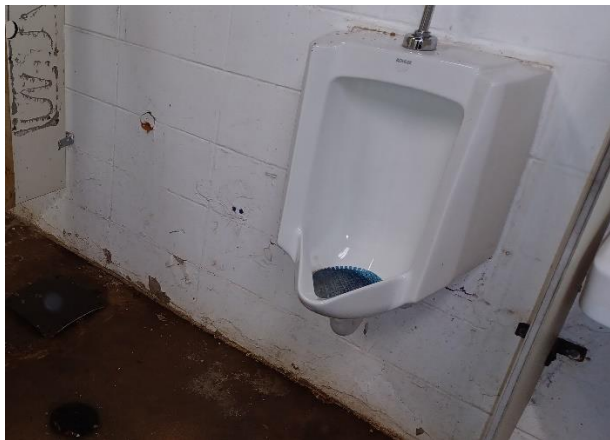
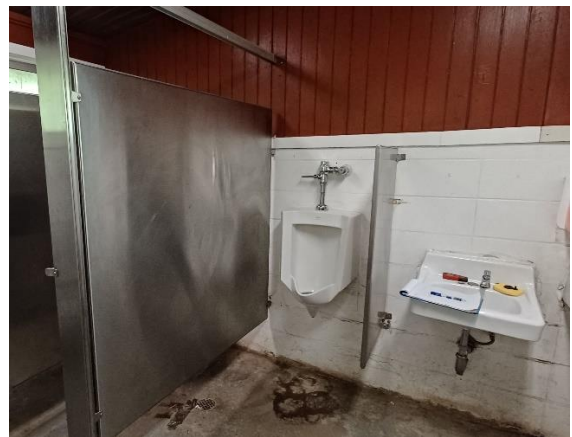
The East Comfort Station's men's room has one urinal, which is in good condition. The West Comfort Station has two urinals that are in good condition.

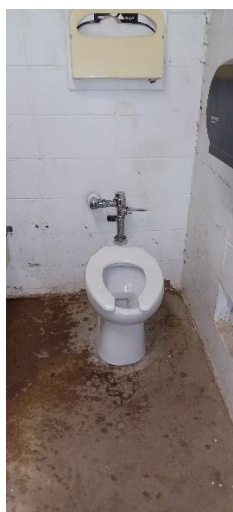
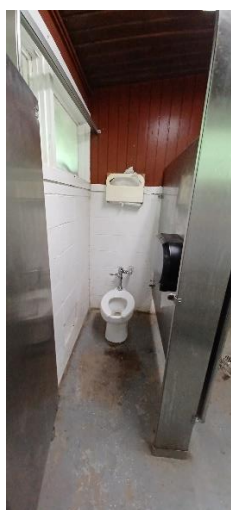
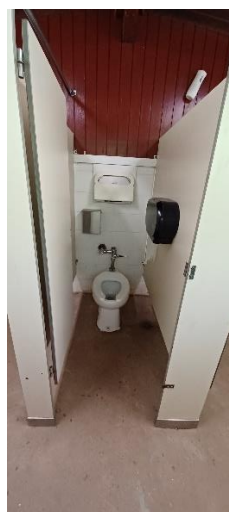
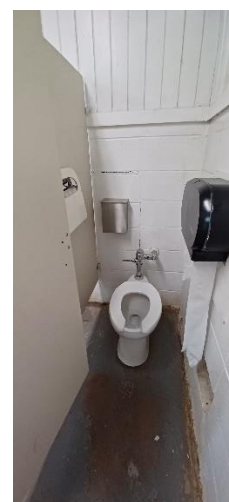
The East Comfort Station men's room has only one toilet, with the other men's room having two. Both women's rooms have three toilets. All are in good condition.

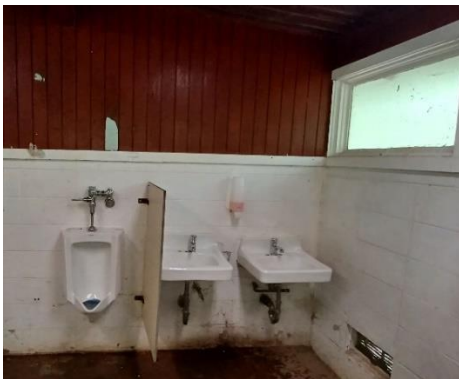
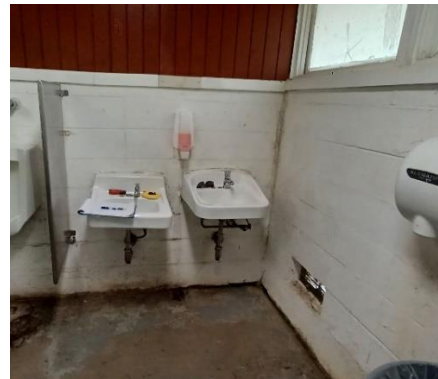
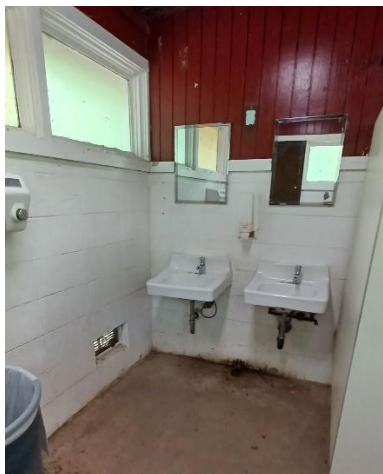
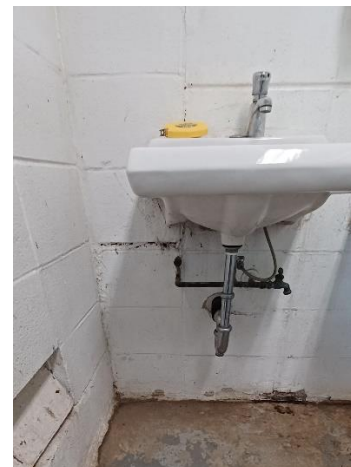
| Category | Element | Sub-Element | Individual Element | Location | Condition Assessment | Category |
|---|---|---|---|---|---|---|
| Three of the four bathrooms at Carderock have two sinks/lavatories. All of the sinks are functioning and are in good condition. | | | | | | |

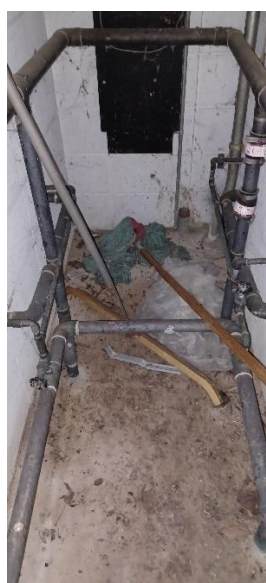
Both the East and West Comfort Stations have a utility closet located between each bathroom. Within those closets is all of the mechanical and plumbing. Although only a cursory inspection was accomplished, all plumbing and sewer appeared in good condition.

East Comfort Station, Closet showing plumbing and waste pipes.

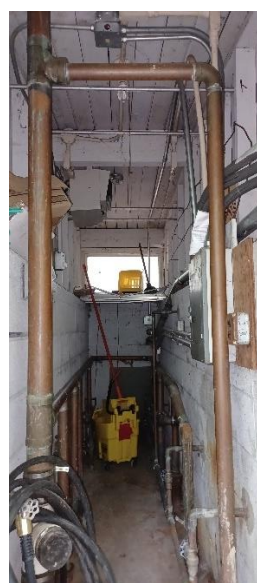
West Comfort Station, Closet showing plumbing and waste pipes.

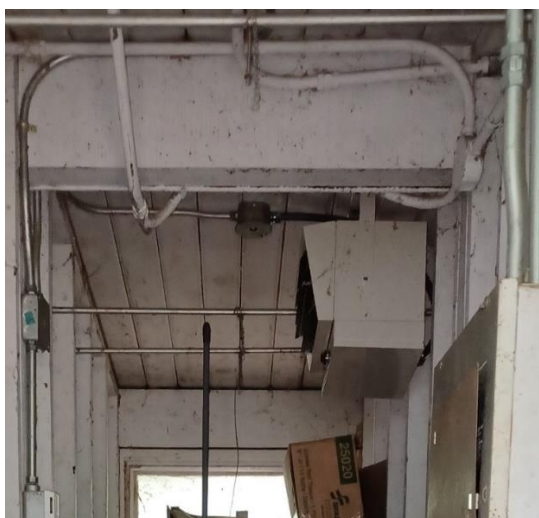
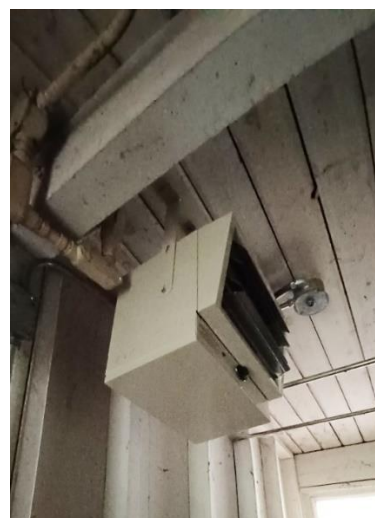
Both Comfort Stations have a heater installed inside the mechanical closet. This keeps water pipes warm during freezing weather. These units were inaccessible to inspect.

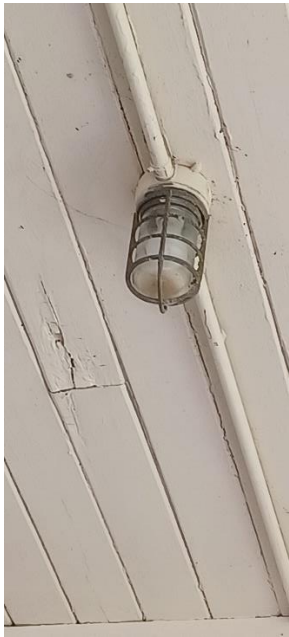
| Category | Element | Sub-Element | Individual Element | Location | Condition Assessment | Category |
|---|---|---|---|---|---|---|
| A group of wire-caged lights are mounted to the ceiling of the Pavilion. Although, close inspection was not possible, they appear to be in good condition. | | | | | | |

Carderock Pavilion lighting.

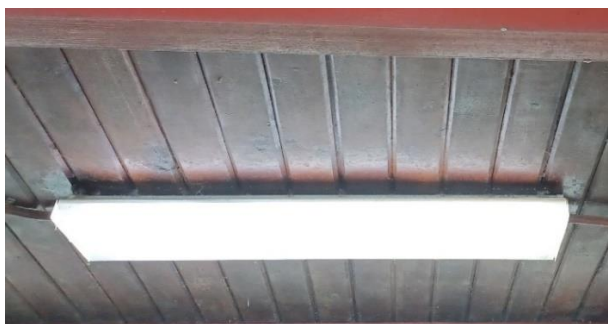
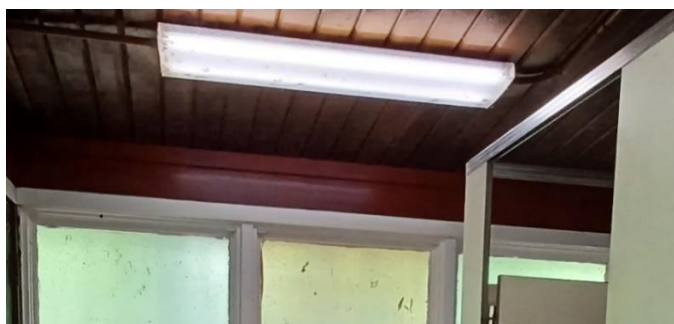
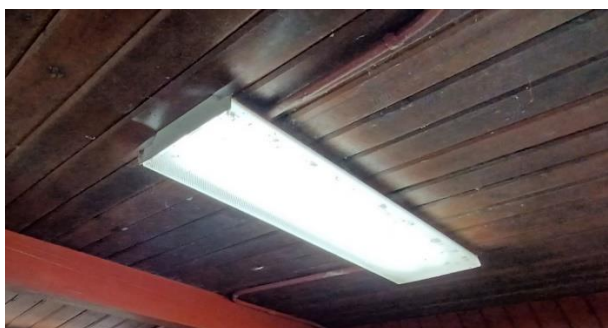
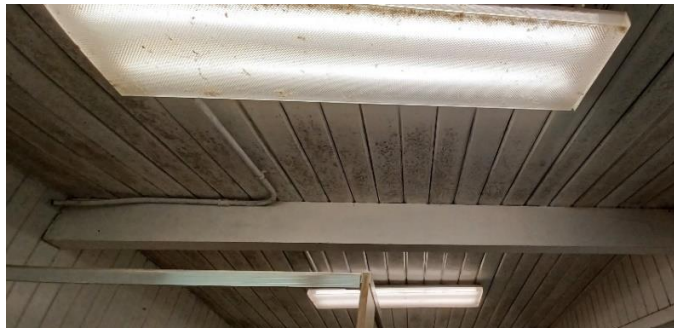
| Category | Element | Sub-Element | Individual Element | Location | Condition Assessment | Category |
|---|---|---|---|---|---|---|
| Both Comfort Station restrooms contain two, flush-mount, fluorescent light fixtures. All are in good condition. | | | | | | |
