THE "ARCHER COTTAGE"  
COLONIAL NATIONAL HISTORICAL PARK  
YORKTOWN, VIRGINIA

AN ARCHITECTURAL SURVEY REPORT

Prepared June 2, 1958

GEORGE F. BENNETT, ARCHITECT  
WILLIAMSBURG

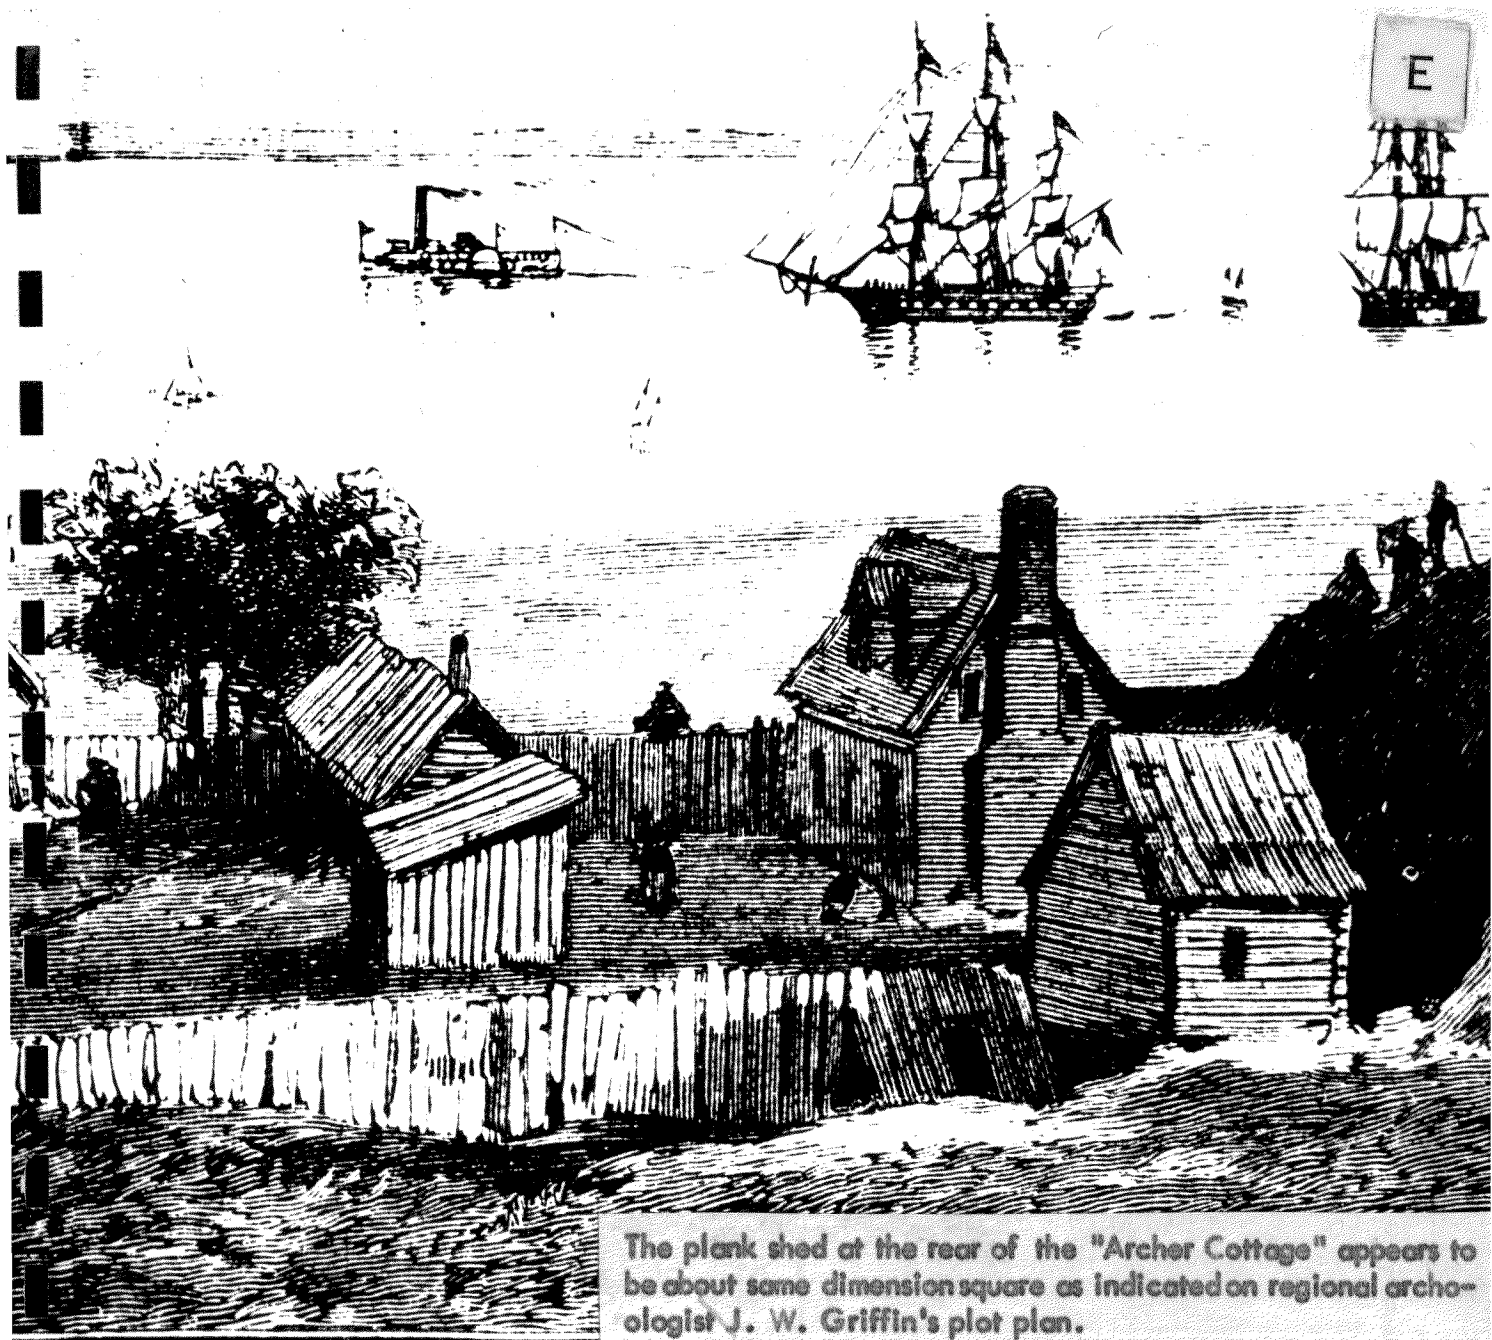
VIEW FROM "YORKTOWN HEIGHTS"  
by J. O. Davidson from Harper's Weekly, p. 908, 1881

The door at left of chimney in photograph does not show in the Davidson drawing.

The plank shed at the rear of the "Archer Cottage" appears to be about same dimension square as indicated on regional archaeologist J. W. Griffin's plot plan.

Notice the three sheds appear in the 1881 sketch and in the circa 1900 photograph opposite.

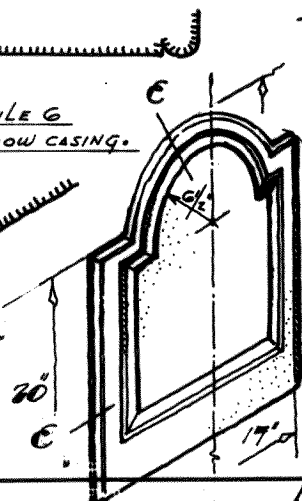
CAST IRON FIRE BACK

The fireplace opening would be about 20" wide x 30" high as indicated by brick fragments and workings. The cast iron fire back shown on sheet 3 of the measured drawings was found in this fireplace, not fastened to wall but buried 5" deep and 3" from back of opening.

MUCH OLDER THAN 2ND FLOOR  
FIRE PLACE WHERE FOUND.
