HISTORIC STRUCTURES REPORT - PART I 403/D-9A

BUILDING NO. 16, FRAME BARN

EDISON NATIONAL HISTORIC SITE

HISTORIC STRUCTURES REPORT  
PART I  
ARCHITECTURAL DATA SECTION  
ON THE  
BARN AT GLENMONT  
Edison National Historic Site

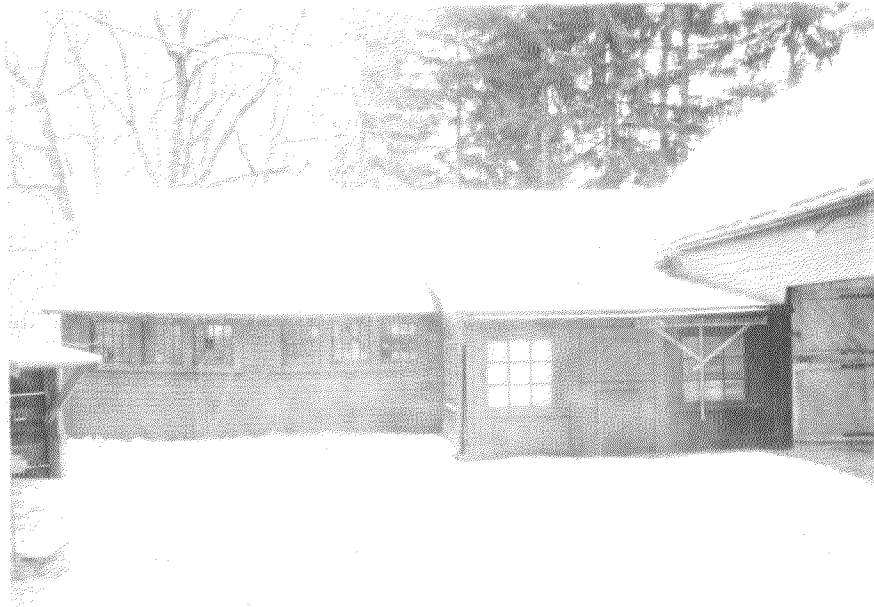
EXHIBIT 2

Photograph of west side of present  
Frame Barn, Building No. 16, showing  
addition in the "L" inside corner,  
made about one year prior to Edison's  
death in 1931. Wagon shed is at  
right rear. Taken December 8, 1964.  
Negative No. O-1448.

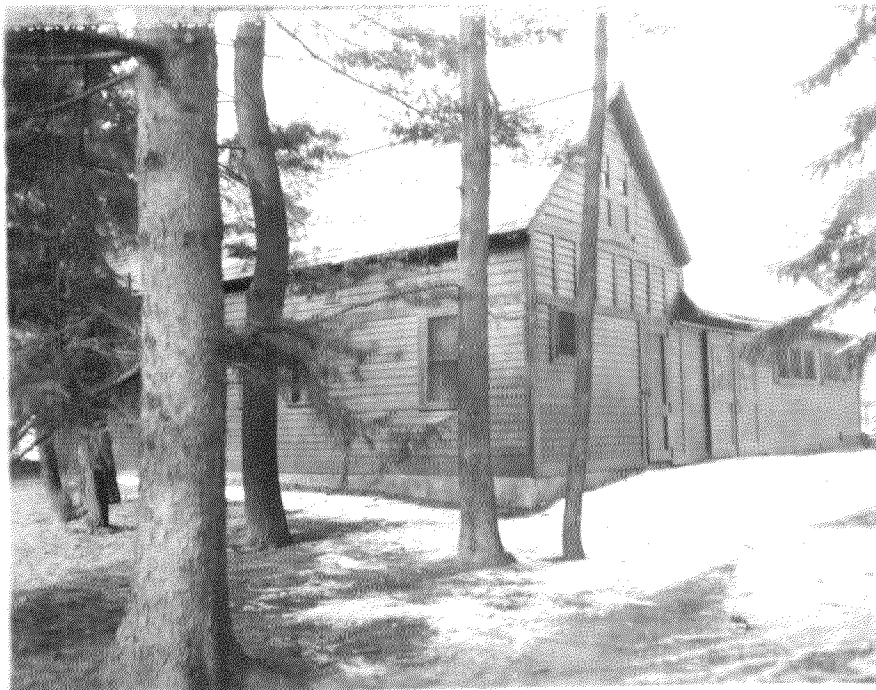
EXHIBIT 3

Photograph of southeast corner of  
present Frame Barn, Building No. 16.  
Taken December 8, 1964. Negative  
No. O-1447.

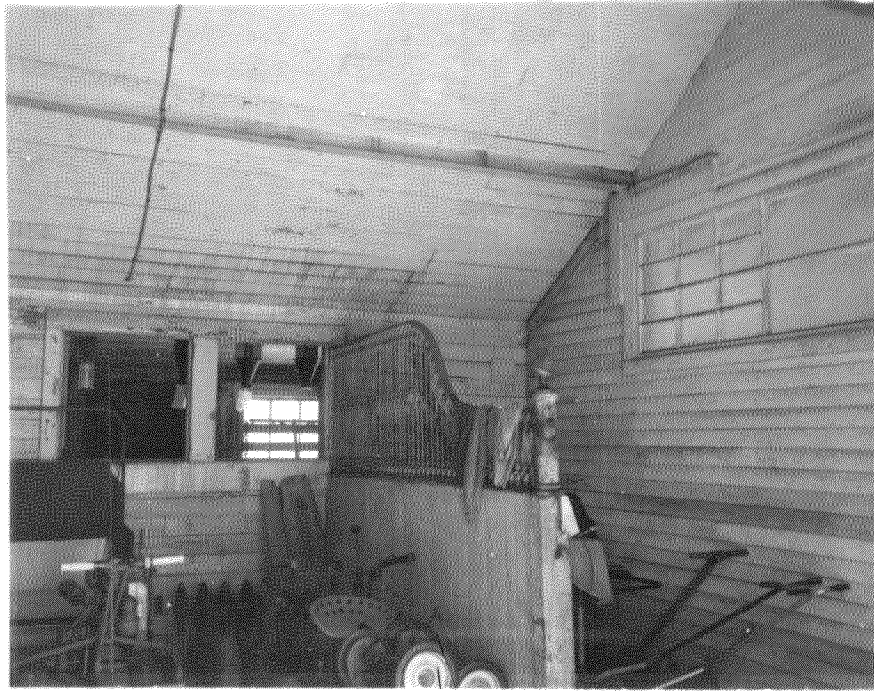
EXHIBIT 4

Photograph of present Frame Barn,  
Building No. 16, interior, showing  
horse stall. Taken December 8,  
1964. Negative No. O-1451.

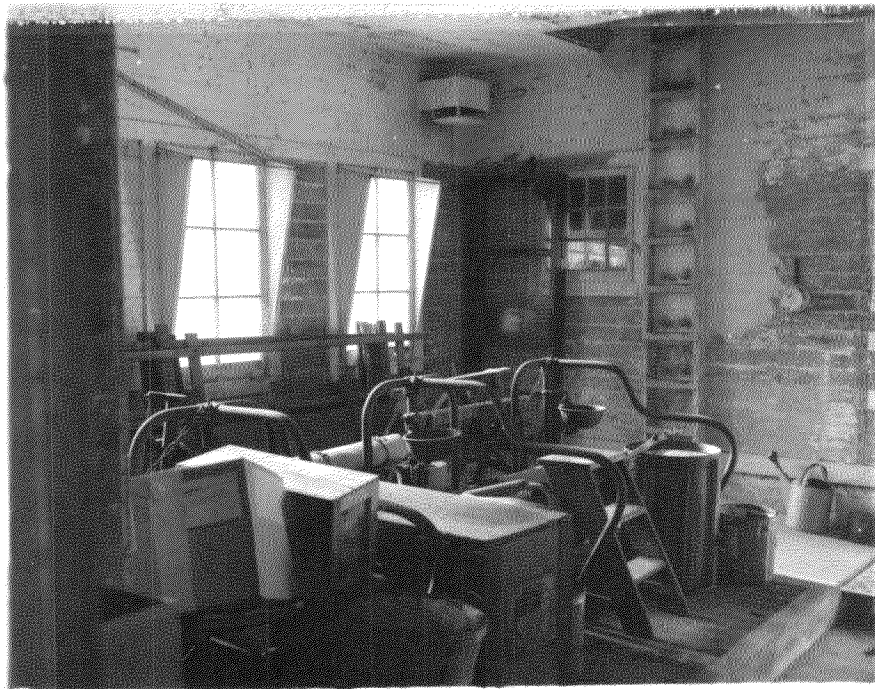
EXHIBIT 5

Photograph of present Frame Barn,  
Building No. 16, interior, showing  
cow stables. Taken December 8,  
1964. Negative No. O-1449.

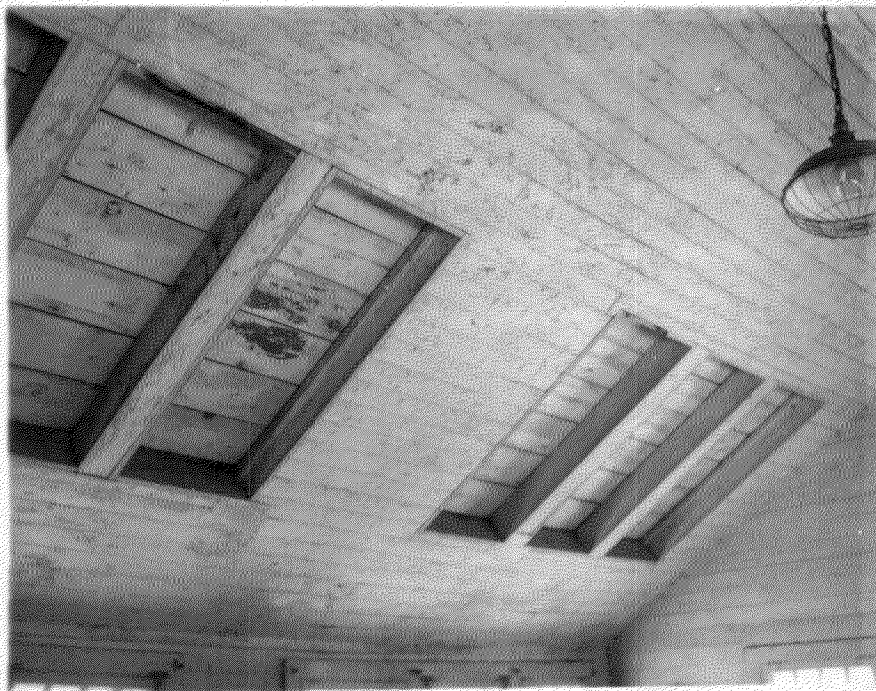
EXHIBIT 6

Photograph of present Frame Barn,  
Building No. 16, interior, showing  
portion of ceiling of chicken house.
