HISTORIC STRUCTURES REPORT

GARDENER'S COTTAGE & POTTING SHED, BLDG. #11  
GREENHOUSE, BLDG. #14

EDISON NATIONAL HISTORIC SITE

HISTORIC STRUCTURES REPORT - PART I  
GREENHOUSE, BUILDING NO. 14, AND  
GARDENER'S COTTAGE AND POTTING SHED, BUILDING NO. 11

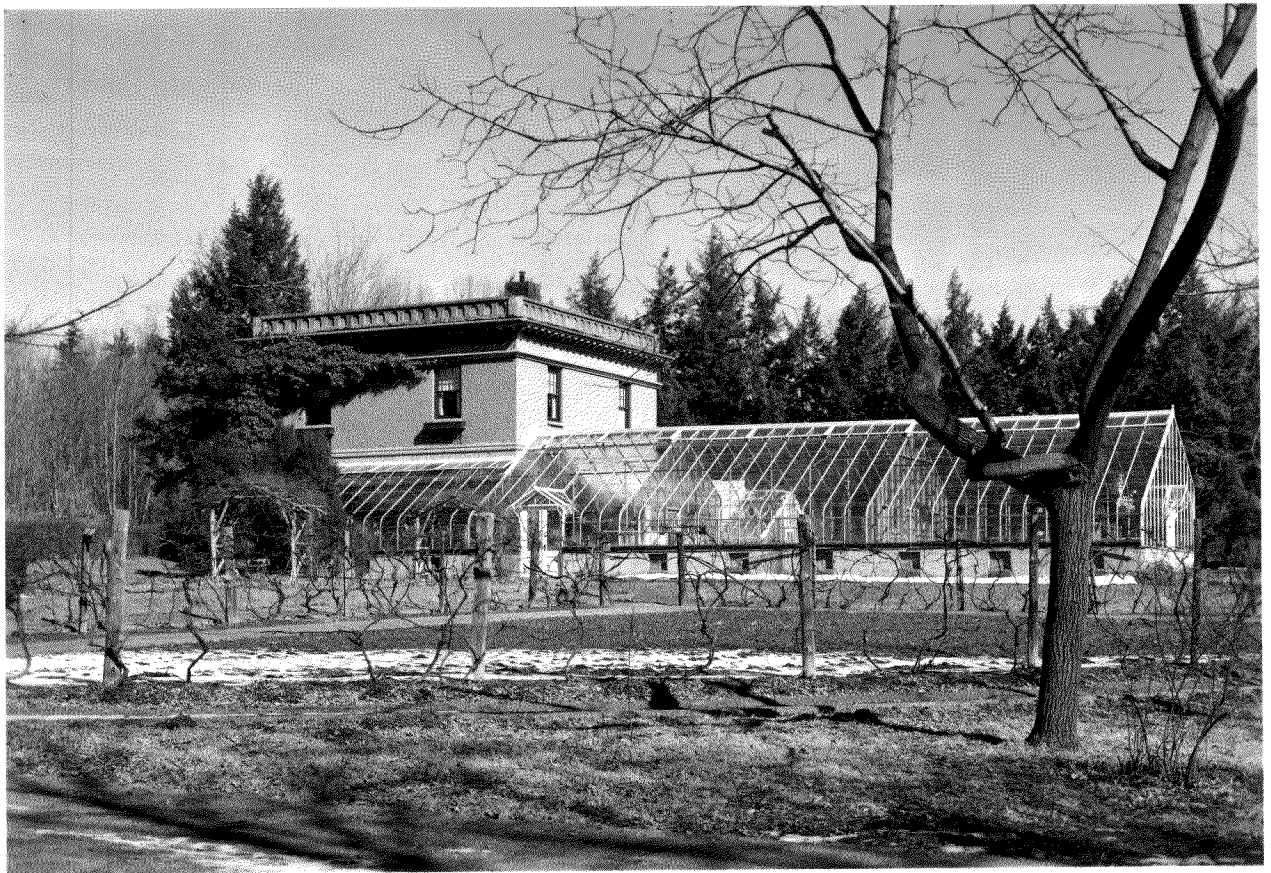
ILLUSTRATION NO. 2

The southwest corner of the Gardeners Cottage and Greenhouse. This photograph illustrates the concrete cornice and arcaded parapet in detail. The entrance to the workroom on the first floor is on the west wall at the left.

1. Repairs to the spalled concrete especially on the cornice, parapet and coping.
2. Repairs to window frames and replacement of several rotted window sash on the second floor.
3. Repairs to chimney - recommend the insertion of flue liners and fitting the opening around the liner with a waterproof cap.
4. Providing venting to space between second floor ceiling and roof slab.
