# **Review of Potential Rockfall Hazards at El Morro National Monument, New Mexico**

**William L. Ellis**

***Administrative Report***

***December 2000***

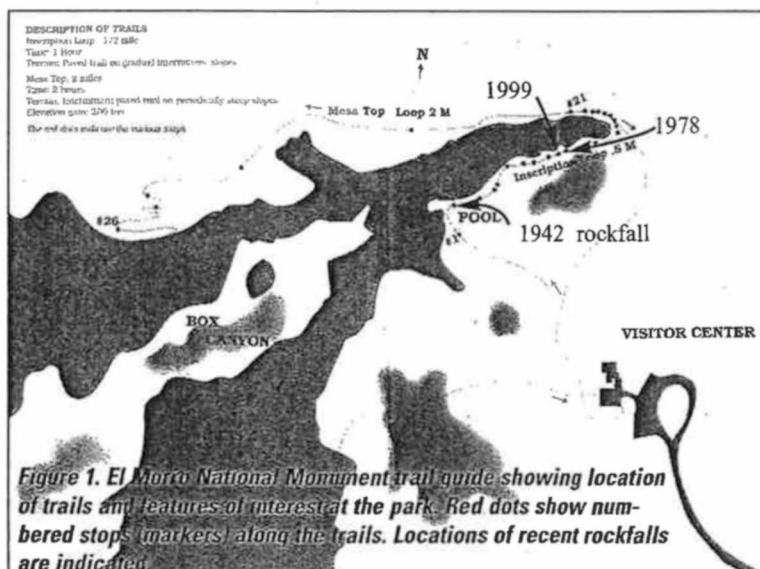
Figure 1. El Morro National Monument trail guide showing location of trails and features of interest at the park. Red dots show numbered stops (markers) along the trails. Locations of recent rockfalls are indicated.
