HISTORIC STRUCTURES REPORT

FORT HANCOCK QUARTERMASTER STRUCTURES, 1900-1918

SANDY HOOK UNIT, GATEWAY NATIONAL RECREATION AREA

April 1979

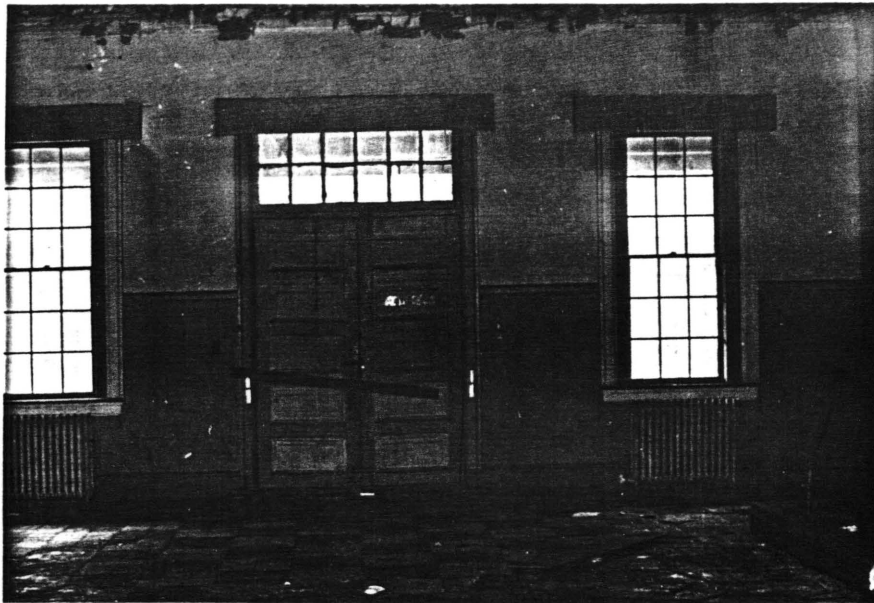
FH 9/78 B4 4

Building 58, Mess Hall, interior.

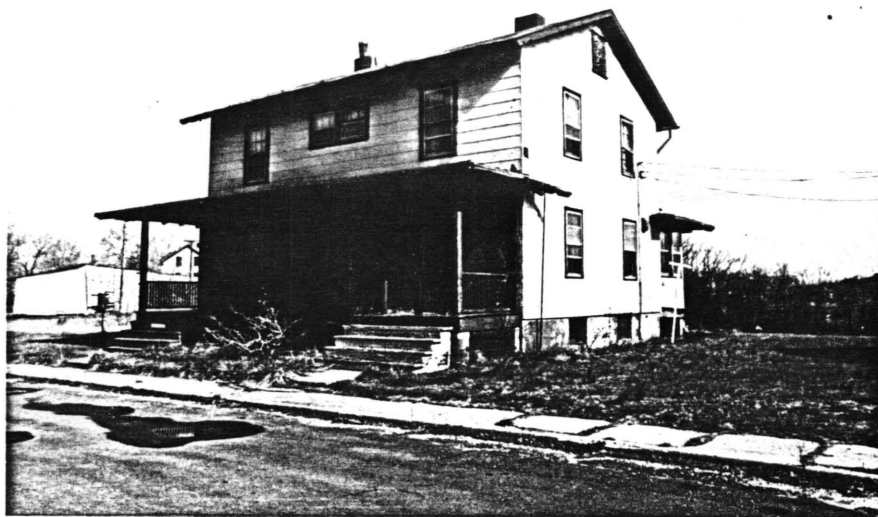
the main structure is now asphalt shingle, while the porches retain their standing seam metal coverings. This metal is rusting through in places. A portion of the front porch roof on the south side has been more severely damaged by wind or vandalism. The only gutter on the building is across the front porch, and this lacks downspouts. Both chimneys have been parged for waterproofing. The south chimney has been tarred as well. Windows are weathering due to lack of paint. Shutter pins remain on window frames. Aluminum storm/screen units cover all openings, but many are damaged. Wood trim around the entire structure is losing paint and cracking. Some trim has come loose and needs refastening.

Building 75, Duplex N.C.O. Quarters, southwest view. Asbestos shingles hide earlier clapboard walls. Army logs describe the building as stucco, so this may be the third wall material. 4/79 FH2

1. Replace porch roofs with new metal roofing.
2. Repair cracked parging on both chimneys.

3. Repair deteriorated window sash. Provide wood storm units and wood screens to replace existing aluminum units.
4. Repair missing or damaged trim. Properly prepare and paint all exterior woodwork.
5. If budget permits, strip asbestos siding and repair underlying wood siding. Repaint in original colors.
6. Rehabilitate existing plumbing, heating, and electrical systems.
7. Provide new kitchen cabinets, sink and disposal.
8. Rehabilitate room finishes.
