# MESS HALL BUILDING #58 FORT HANCOCK, NEW JERSEY

## Historic Structure Report

March 2011

JOHN MILNER ASSOCIATES, INC.

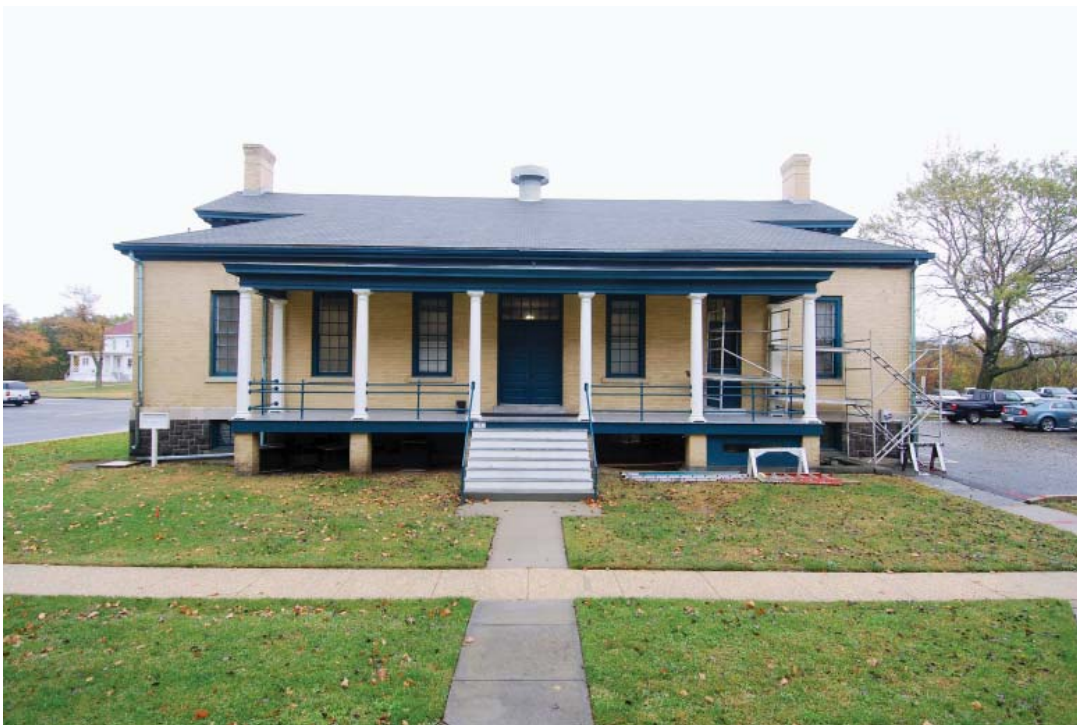
Photo 19. West elevation (JMA, October 2009)

a basement door placed in the sixth bay. The masonry materials at the west elevation wall are original but have been completely repointed. The basement windows appear to be original. The first floor wood windows are replacements except for the northernmost window, which is believed to be the only original window remaining on the first floor. The exterior window sash and frames, doors and door frames, and cornices were originally painted with a dark, olive-colored paint. The exact hue is difficult to discern in the paint samples, which exhibited several different colors of weathered olive paint (see Appendix I: Paint Analysis).

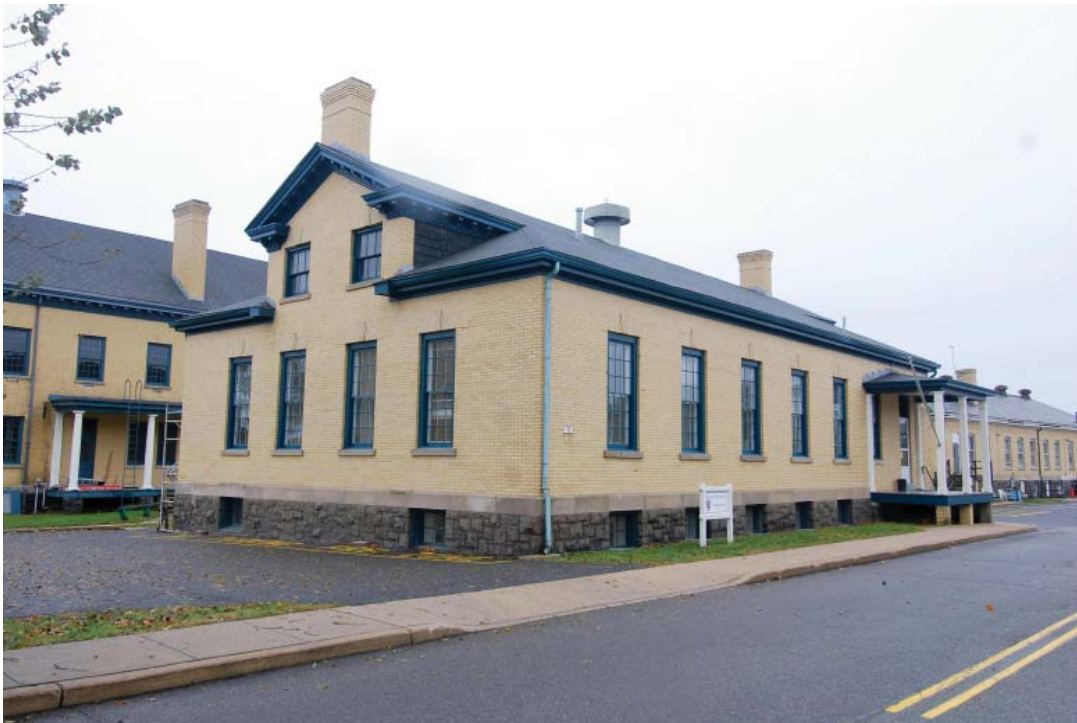
Photo 21. View of Building #58 looking northwest (JMA, October 2009)

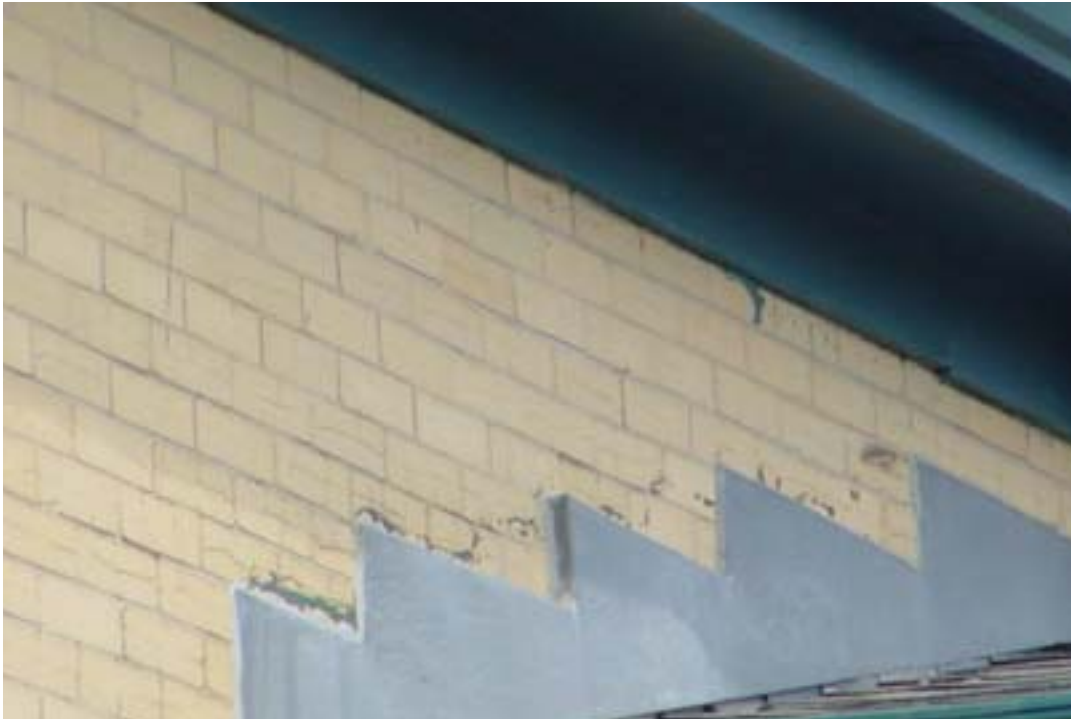
Photo 27. Detail of stepped terne-coated flashing at the east porch roof (JMA, August 2010)

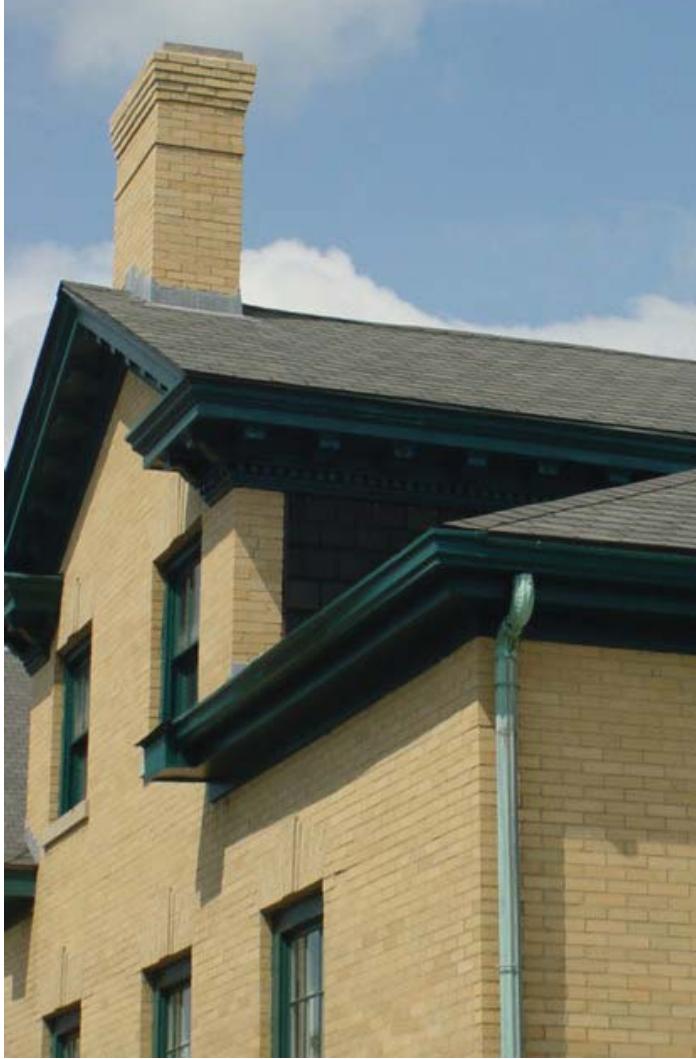
The roof cornice at the dormer ends is decorated with dentils, which appear to be the original metal cornice. The lower edges of the main roof have a plain cornice with a molded, metal box gutter mounted at the fascia (see photo 28). The original metal cornice with dentils located at the edges of the main roof was removed in 1958 and has since had a series of fascia mounted gutters. The current molded roof gutter at the main roof is drained by 4-inch and 6-inch round copper downspouts located at the four corners of the building.

Photo 28. Detail of southeast roof with the historic metal cornice at the dormer and simpler replacement metal box gutter at the lower roof (JMA, August 2010)

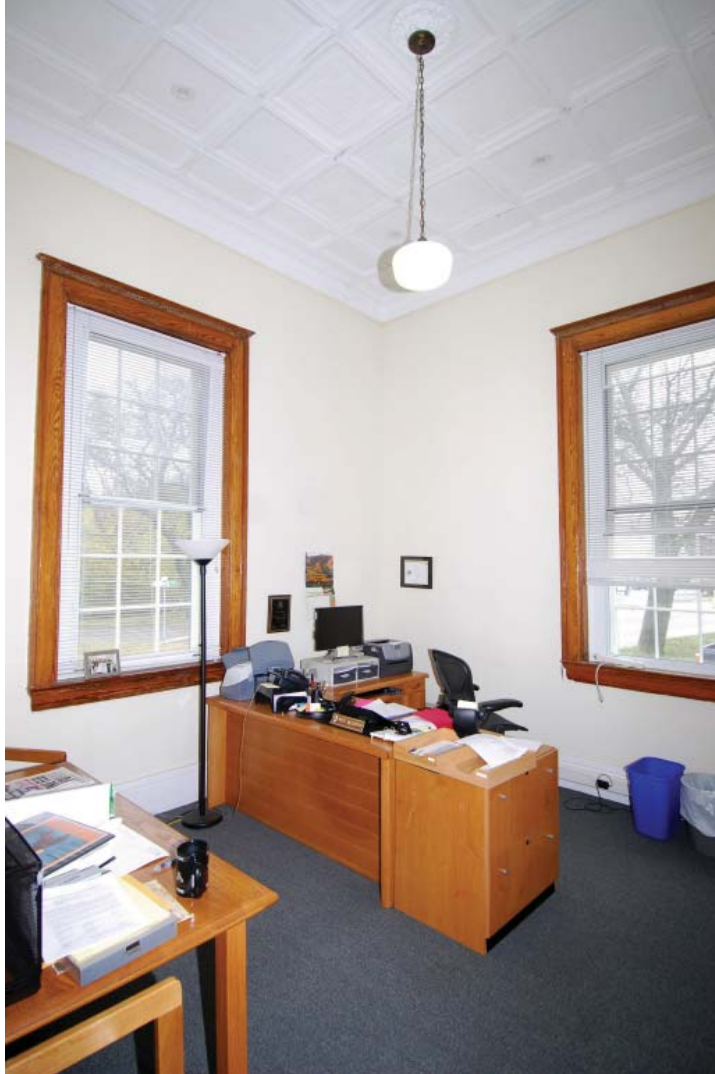
| First Floor: Historic Cook's Room (Office 108) | | | |
|---|---|---|---|
| Walls | Original plaster covered with gypsum board veneer | Water damage above the east window | 1904, gypsum board veneer from 2001 renovation |

Photo 32. Historic Cook's Room (Office 108) looking southeast  
(JMA, October 2009)

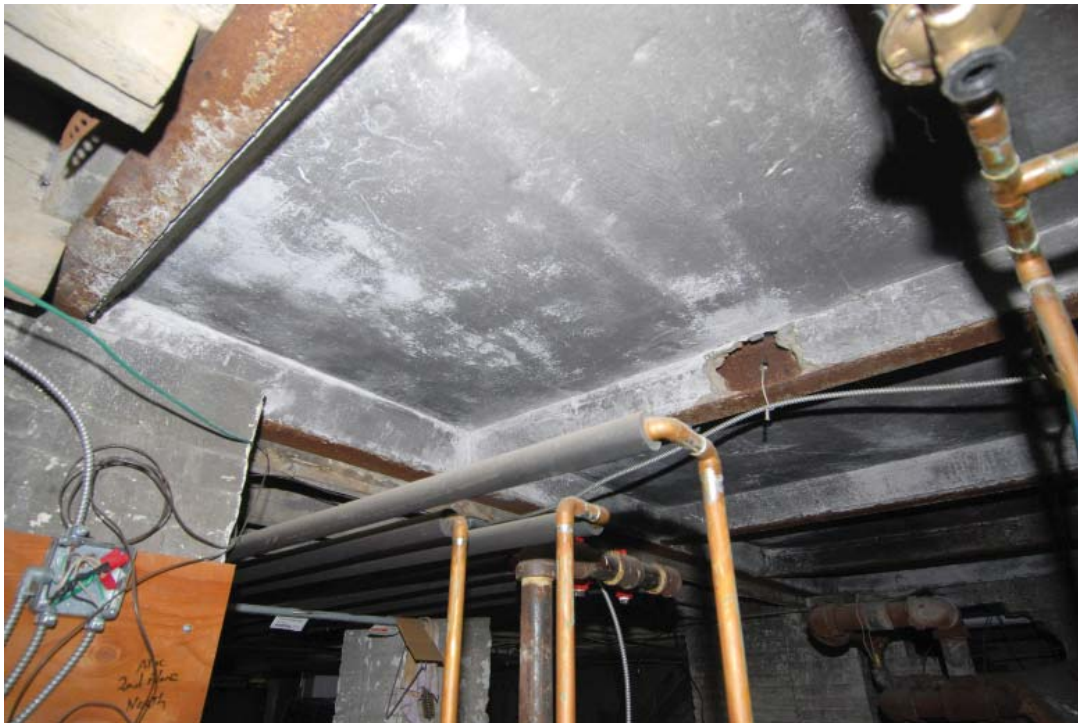
The Boiler Room 001 and Coal Bin 010 remain in their original locations. They are currently unfinished rooms used for equipment and storage. The floor is exposed concrete with square control joints 3-feet square. The walls are exposed brick at the north and east and exposed bead board walls to the west or modern partition walls to the south. Ceilings are the exposed first floor structure, including the 12 x 12 summer beam running the full length of the building (see photos 47 and 48). At the north end of the Boiler Room ceiling is cement parging on metal lath between steel framing members that support the kitchen hearth above (approximately 7'-0" x 15'-0") (see photo 49). Portions of the Boiler Room ceiling also show evidence of plaster and wood lath and the summer beam had evidence of early layers of whitewash. Windows along the north wall, 011B and 011C, are original awning style wood windows. The north window 001A is a 6-pane window, that appears to be an upper sash from a double hung wood window and is not an original awning type window. The Boiler Room houses current HVAC systems as well as old equipment that is no longer in use, including an unused boiler and oil tank (see photo 50).

Photo 48. Boiler Room looking northeast. Note oil tank no longer in use (JMA, October 2009).

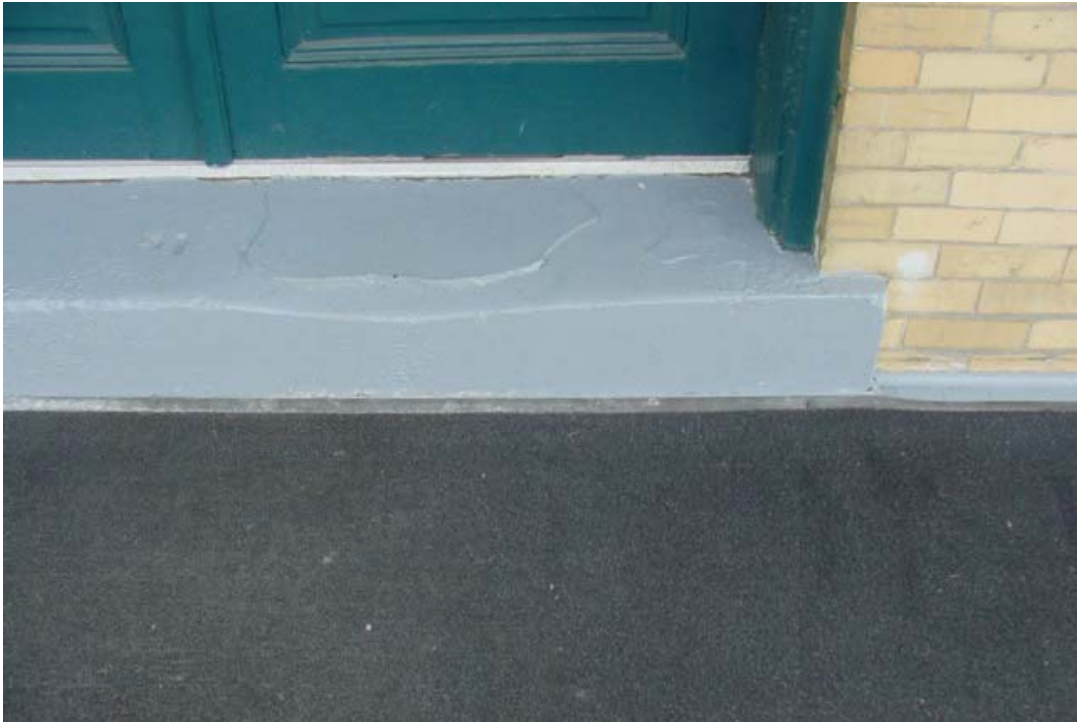
At the west elevation, there is minor cracking at the stucco at the ground line at the southwest corner. The main double door sill has been recently painted gray. A worn section of stone has been filled recently with a cement patch (14"x24"x1") (see photo 62). The southern single door sill at the west elevation has a small area of wear that has been patched with cement; there is evidence of a past coating. This stone sill also has a crack through the unit (approximately 6 linear inches) (see photo 63). The wear at the stone sills bear testimony to the passing of many men and women over the past one hundred years; patching this wear is an appropriate repair.

Photo 62. Detail of the main west entrance door sill. Note the cement patch at center and recent gray paint. (JMA, August 2010)

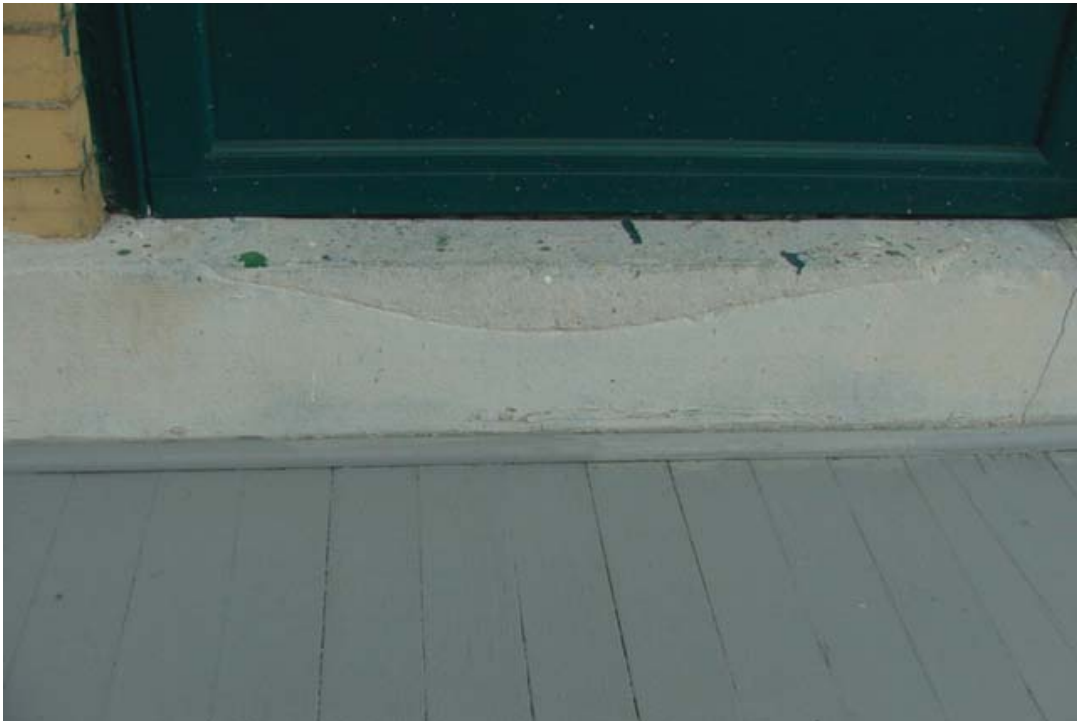
Photo 63. Detail of the door sill at the southern entry at the west façade. Note the large concrete patch and evidence of a past gray coating. (JMA, August 2010)

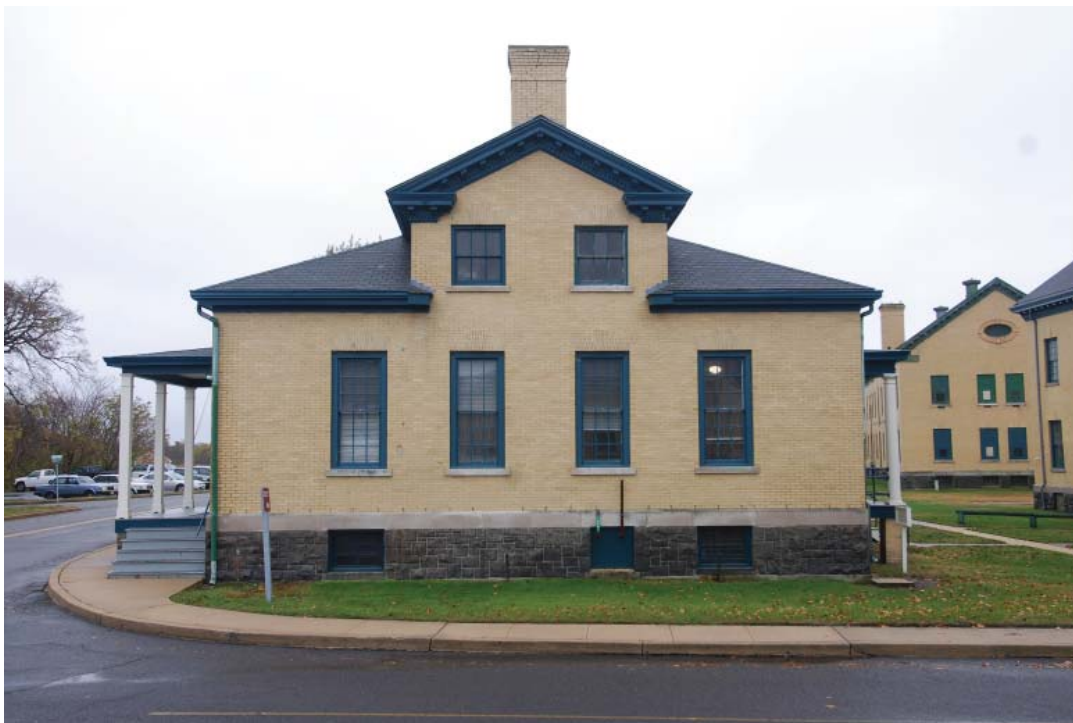
The basement awning type wood windows appear to be original, except for window 001A (see photos 70 and 71). They are generally in good condition with a few exceptions. All of the basement windows except those at the north elevation have been fitted with fixed exterior storm sash. North basement window 001A appears to be an upper sash from a double hung wood window and not an original basement window. Window 001A has loss of wood, failure of glazing putty, and failure of perimeter mortar. North basement window 009B has failing paint, corroding iron bars, and failure of perimeter mortar. At west basement window 009A, there is minor paint failure at the iron bars and wood windows and failure of the perimeter mortar.

Photo 70. North elevation of Building #58. Note the three-over-three attic windows, nine-over-nine first floor windows, and variety of basement windows and grates. Basement window 001A appears to be a six-over-six top sash from a double hung wood window. (JMA, October 2009)

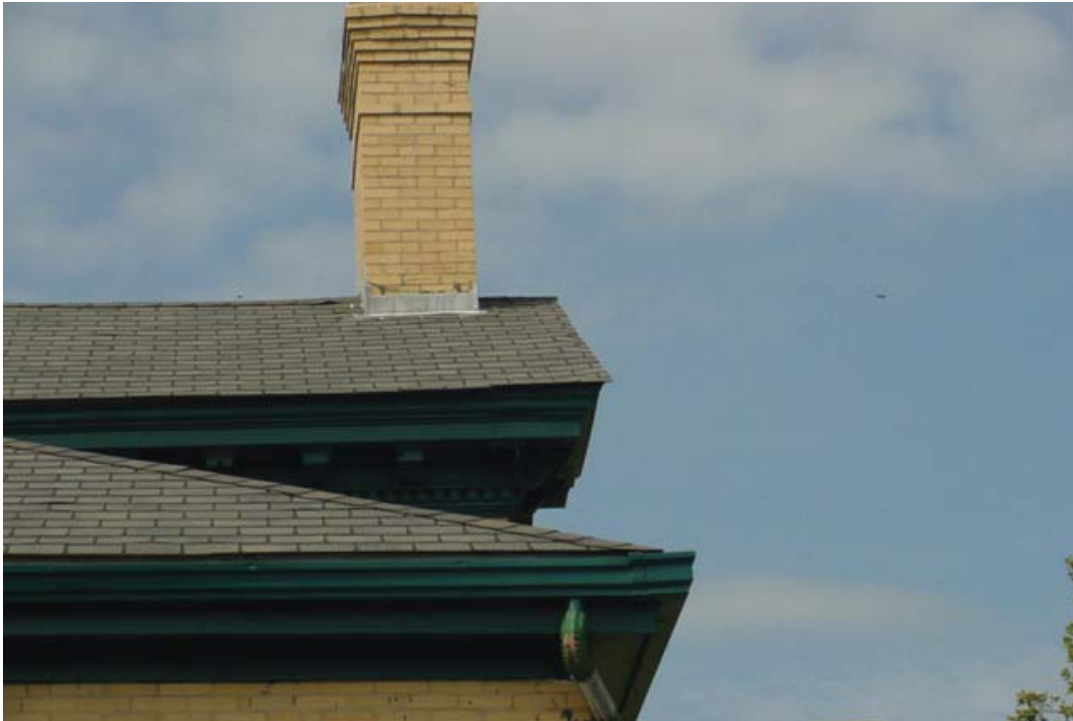
The main building and roof cornices are missing the historic dentil details, which remain at the north and south dormer cornices (see photo 75). The non-historic fascia-mounted, molded metal gutters and copper downspouts are in good condition (see photo 76). The original cornice had a built-in box gutter set within a formed, metal cornice. Site drainage remains problematic and rainwater is not effectively drained at the building foundation.

Photo 75. The dormers at Building #58 retain the original dentils at the cornice. The lower roof edge has a fascia mounted molded metal gutter. (JMA, August 2010)

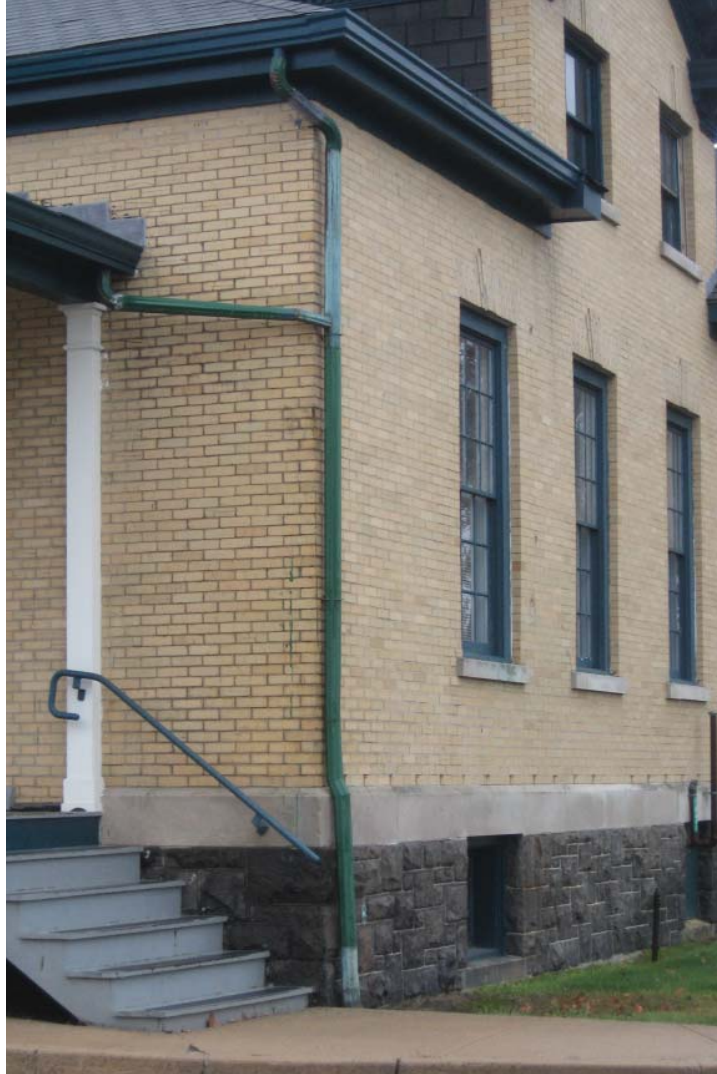
Photo 76. Northeast corner of Building #58. Note the perimeter box gutters at the main roof and east porch roof, the copper downspouts, and the outlet at grade. (JMA, October 2009)

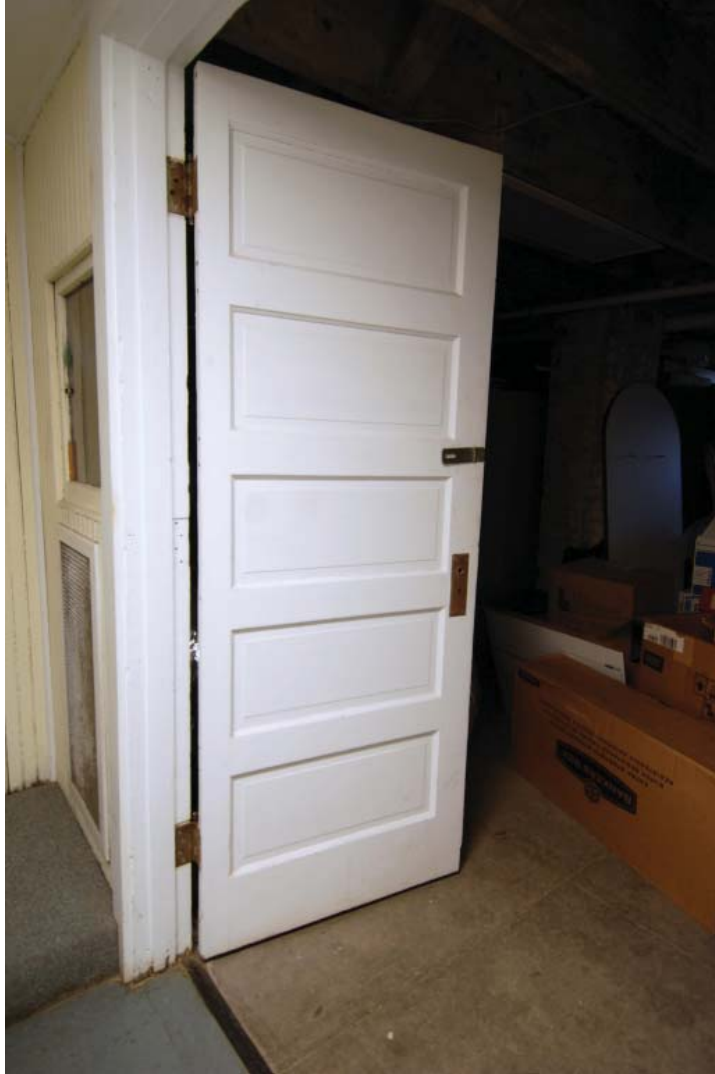
Some original architectural elements remain at the north end of the corridor near the stair to the first floor. The original wood bead board molding remains at the east side. The double doors to the Boiler Room are not original, but appear to be salvaged doors from the appropriate period (see photo 80). The glazed wood door to Office 008 also appears to be a salvaged door, but was not originally in this location.

Photo 80. One leaf of the double doors to the Boiler Room. These doors may be historic but are not in their original location. (JMA, October 2009)

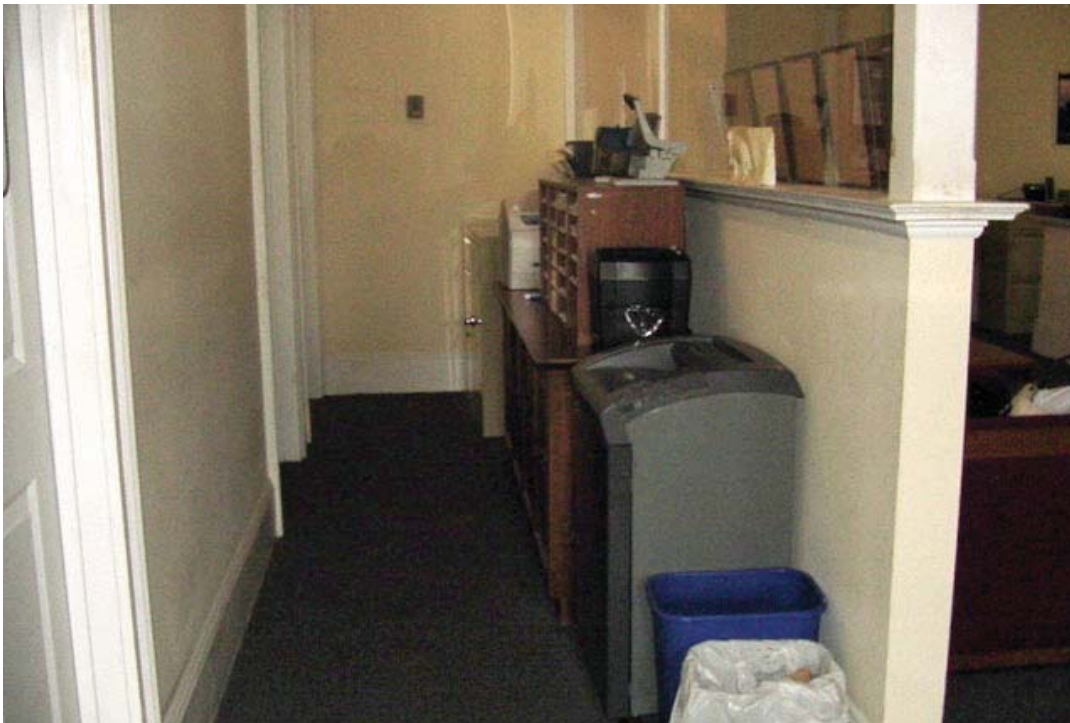
Photo 88. View of the corridor created by the partial height partition in the historic mess hall space. Note the cabinets and equipment which have narrowed the passage (JMA, August 2010).

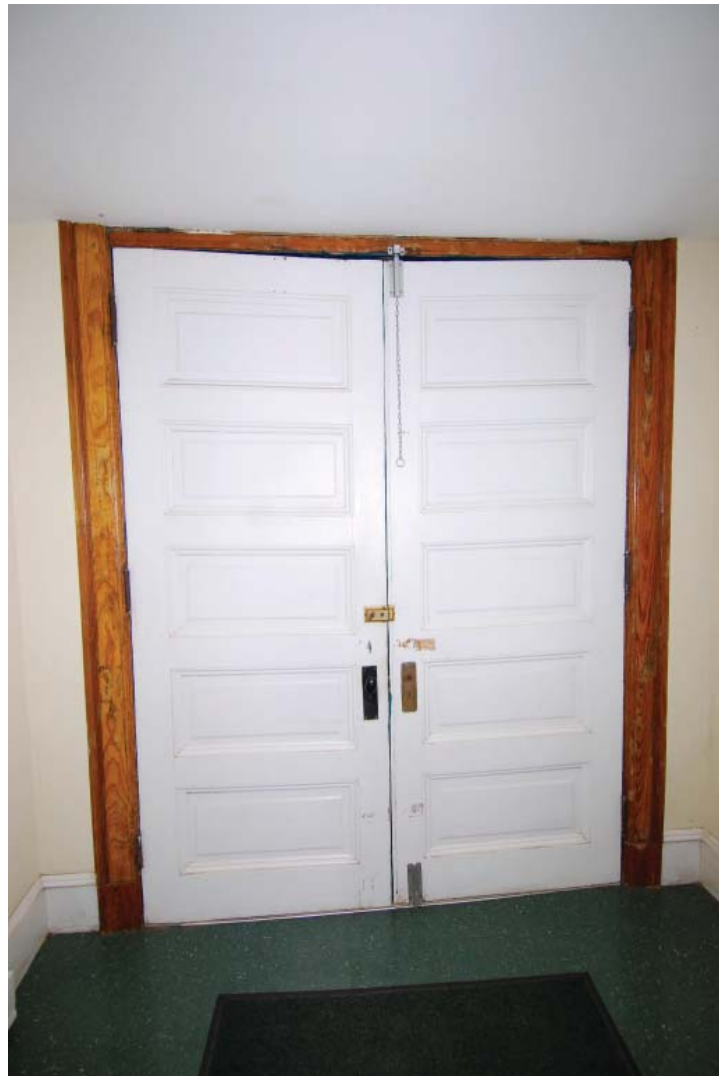
According to ADAAG Section 4.13.17 and CABO ANSI Figure B4.13.7, the layout of both sets of doors at the entrance to the mess hall create an inaccessible condition. The referenced accessibility guidelines state that doors in series shall swing either in the same direction or away from the space between the doors (see ADAAG Figure 26). Our survey findings indicate that because the historic main doors of the mess hall (114-2) swing inward and the existing door into the main interior space (114-1) swings outward, the space between these doors does not meet the minimum required space. The minimum space between 2 hinged or pivoted doors in a series shall be 48” plus the width of any door swinging into the space. According to the New Jersey Rehabilitation Subcode, historic doors used for egress purposes may swing inward. As exit access doors, it would be appropriate for both doors (114-1) and (114-2) to swing outward toward the exterior. However, if the operation of the first set were changed to achieve this, consideration will need to be given as to how this impacts an accessible entry into the building through the main, west porch entrance. The new door operation may interfere with proposed ramp and lift systems; see Sheet ALT#1 for schematic level accessibility alternatives A and C. A different strategy for providing the required clearance between the doors

Photo 89. Existing historic double in swing doors with original hardware at main west entrance (114-2). In order to make these accessible, the doors will need to be activated by a push button mounted to the side (JMA, October 2009).

The existing, in-swing, historic double doors (114-2) have the original hardware. In order to make these accessible, the doors will need to be activated by a push-button mounted to the side (see photo 89). The single leaf door from the Foyer (114-1) is appropriately sized and has ADA compliant hardware (see photo 90). The width of the single leaf doors providing entry from both the east porch (101-1) and the west porch (111-1) meet ADA requirements, but both retain their original historic hardware, which is non-compliant (see photos 91 and 92).

2. A different strategy for providing the required clearance between doors 114-2 and 114-1 that respects the current operation of these doors would entail relocating the partition separating the foyer Room 114 from the Lobby/Reception space further toward the interior of the main space.

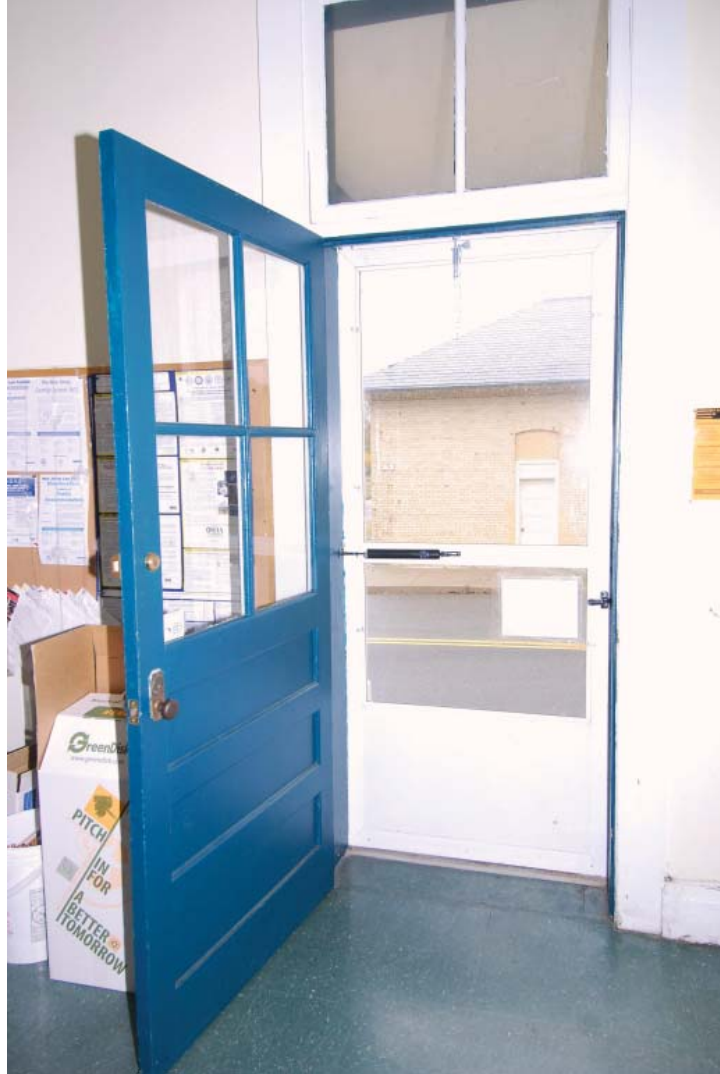
Photo 91. Entrance door from east porch has ADA compliant width but retains original hardware (JMA, October 2009).

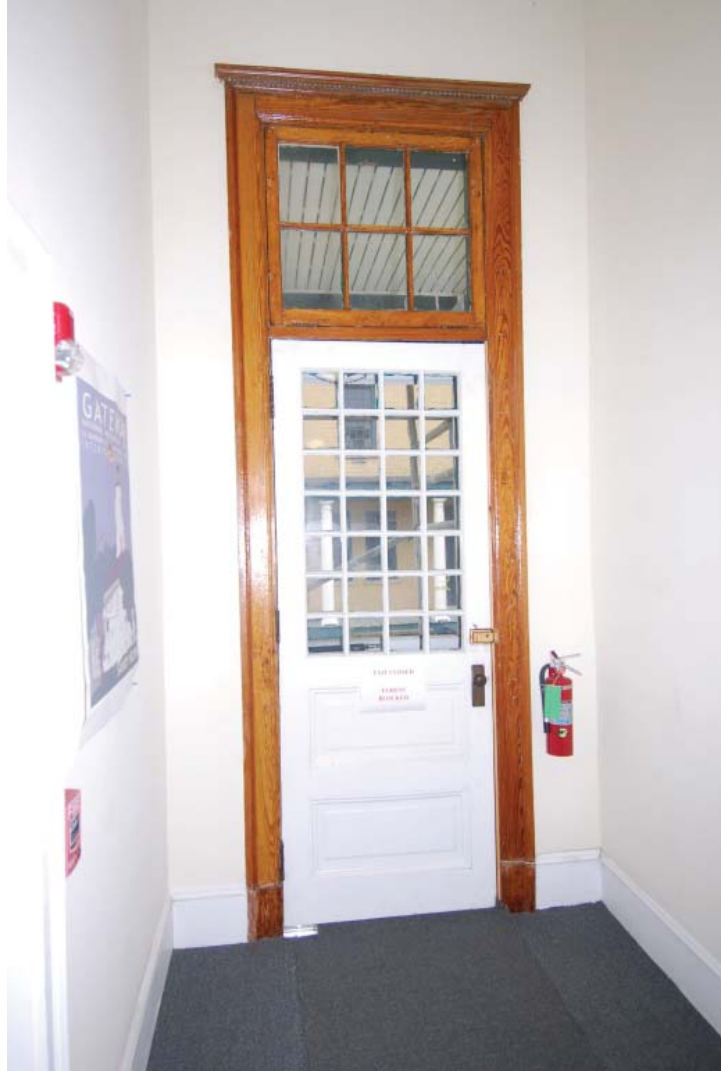
Photo 92. The single leaf entrance door from the west porch has ADA compliant width but retains original hardware (JMA, October 2009).

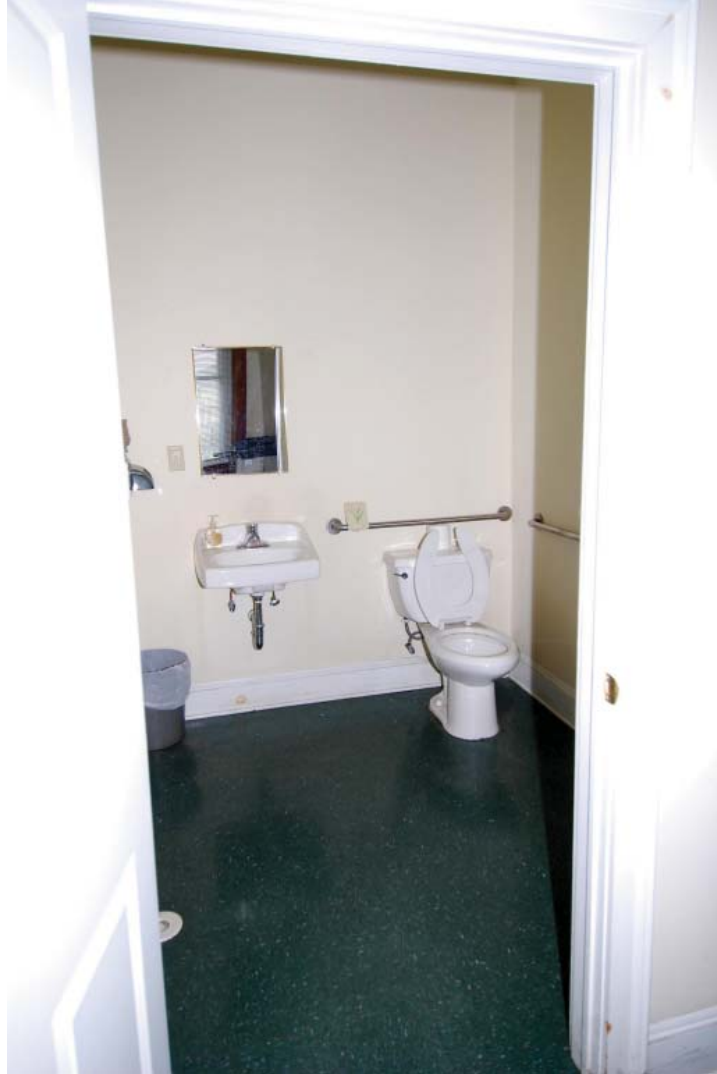
Photo 94. View of western ADA compliant toilet. These bathrooms show inconsistent efforts to address accessibility needs on the interior (JMA, October 2009).

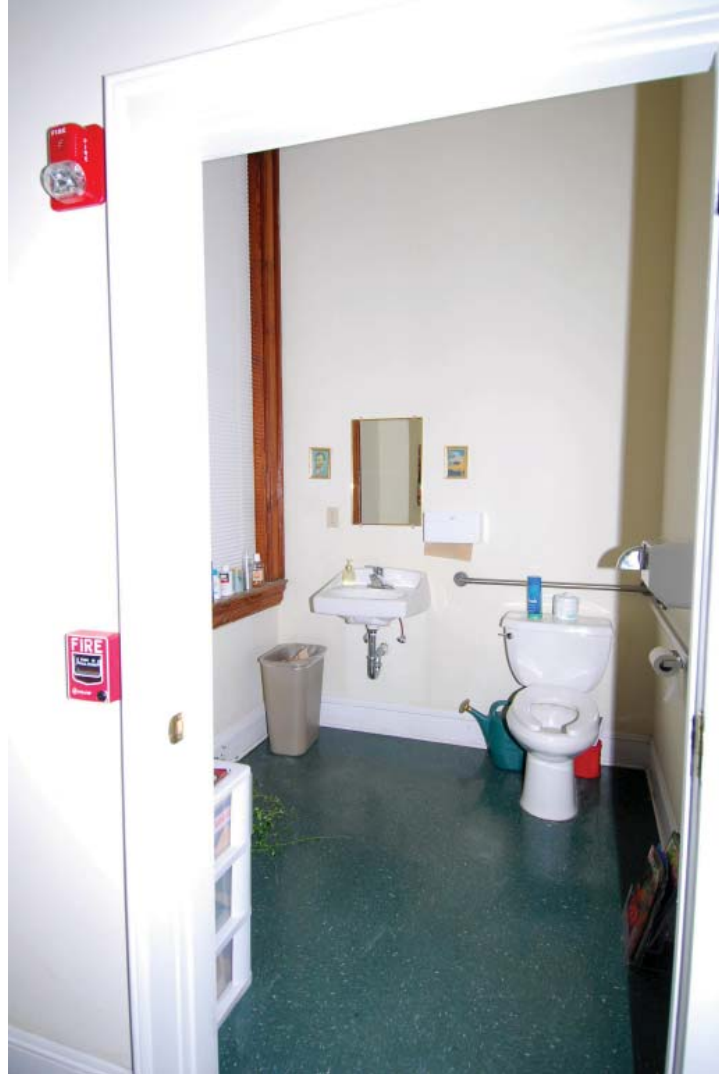
Photo 95. View of eastern ADA compliant toilet. These bathrooms show inconsistent efforts to address accessibility needs on the interior (JMA, October 2009).

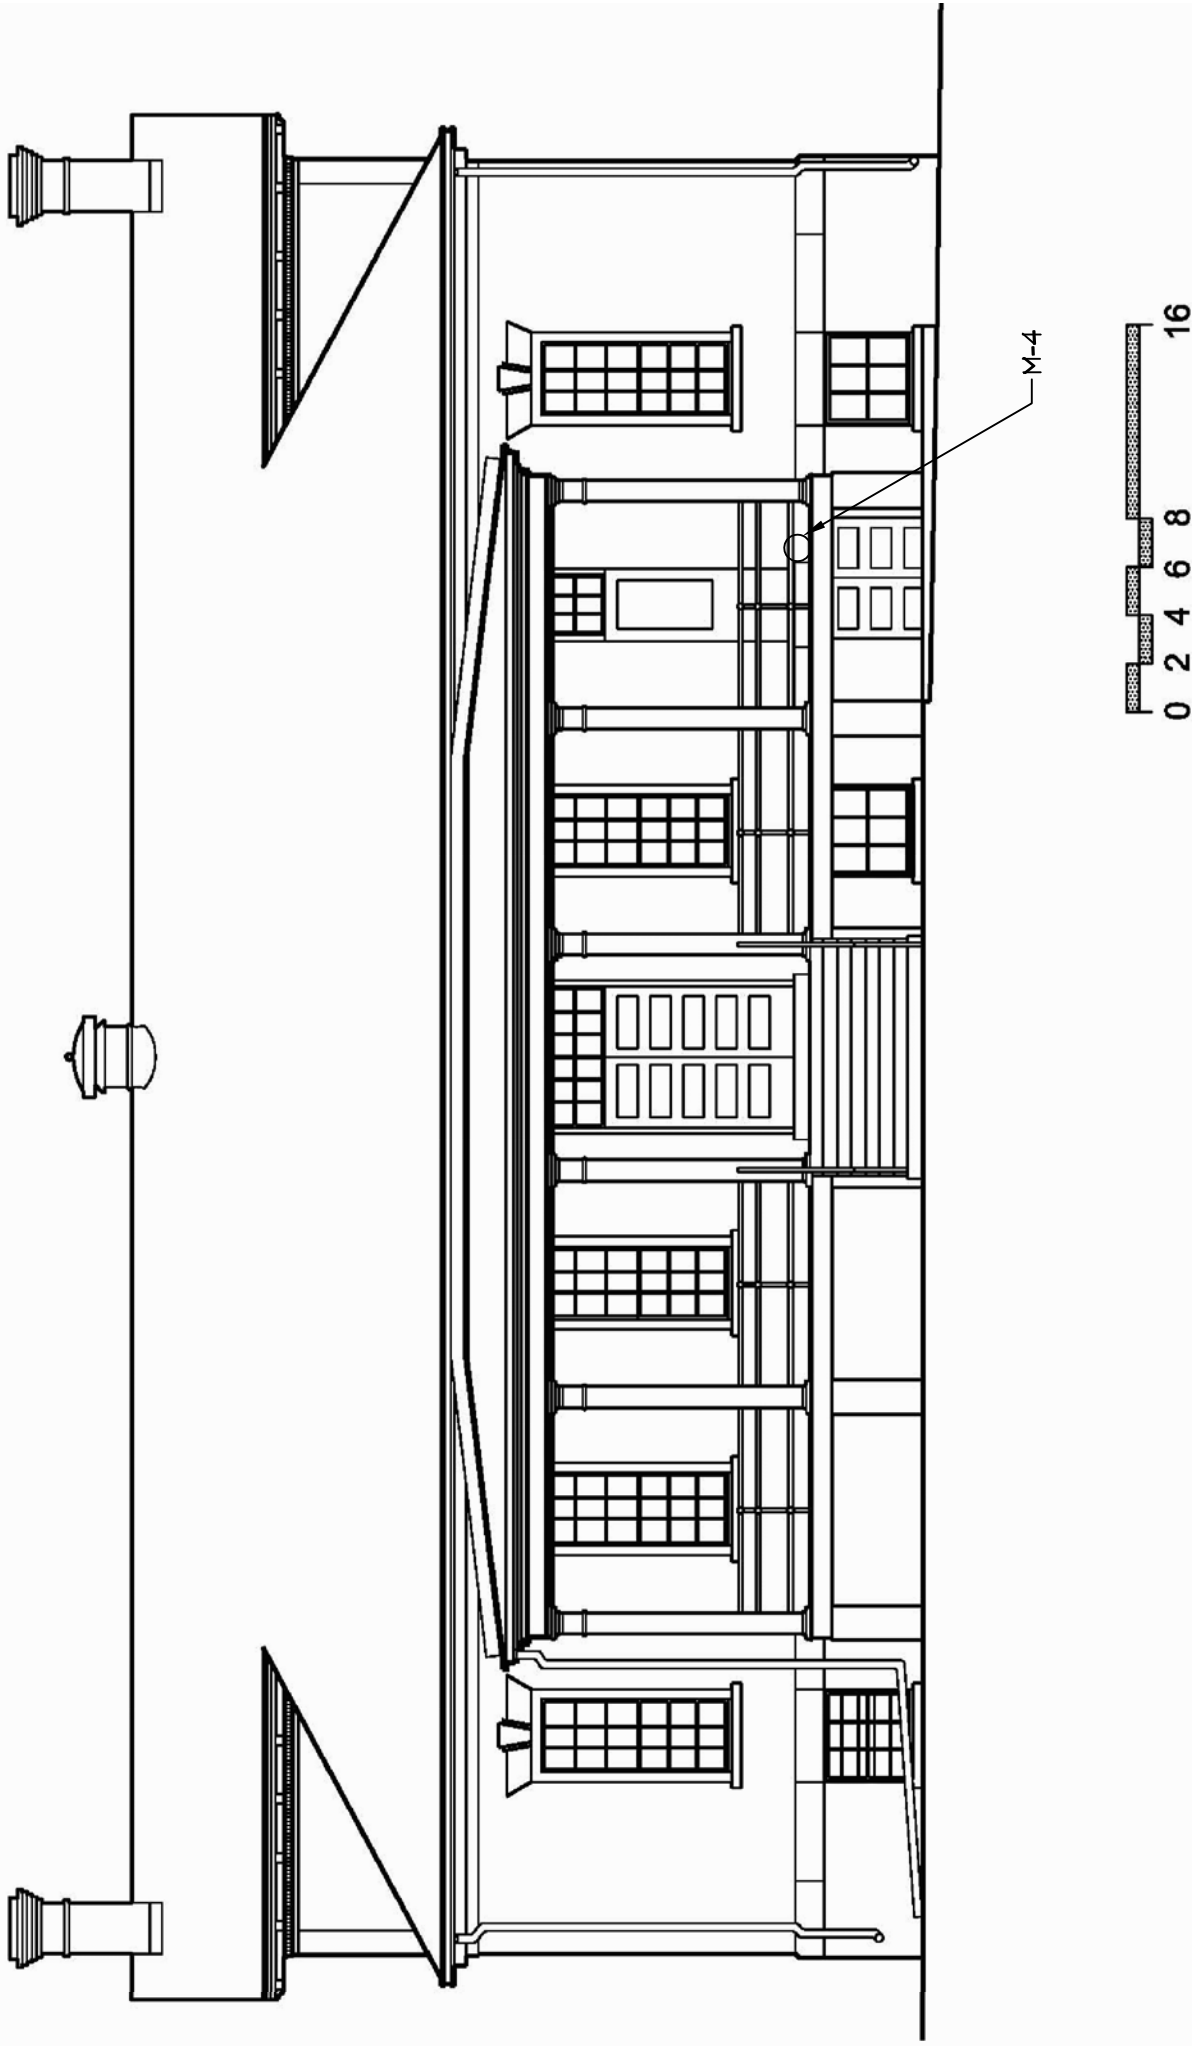
Mess Hall #58 - West Elevation

- M-1 Building #58, south elevation, foundation masonry, current repointing mortar
- M-2 Building #58, south elevation, foundation masonry, earlier pointing mortar
- M-3 Building #58, north elevation, brick masonry, repointing mortar smear coat over earlier pointing mortar
- M-4 Building #58, west elevation, brick masonry, earlier pointing mortar
- M-5 Building #57, north elevation, west end, brick masonry, earlier pointing mortar

It is recommended that Building #58 be repointed with an ASTM C270 Type O mortar (1 cement: 2 lime: 9 sand) to match the existing historic mortar in color and texture.<sup>3</sup> A Type O mortar should be softer than the buff brick, limestone, and diabase masonry. However, without data on the physical properties of the masonry, it is not possible to provide a replication mix of known physical compatibility. As the porosity of the brick, limestone, and diabase masonry will vary considerably, it will be important to carefully monitor the curing time to ensure that the mortar does not dry too quickly.
