FORT TOMPKINS  
GATEWAY NATIONAL RECREATION AREA

*Historic Structures Report*

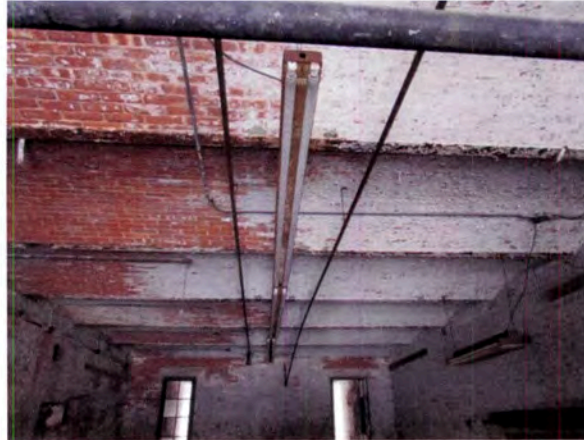
The ceilings in the main sections of the first floor consist of shallow brick vaults with exposed steel beams. This ceiling type is present in Rooms 101-110, 113-122, 127-136, and 139-149. There are remnants of paint on the arched ceilings.

*Figure 33: Typical arched, brick ceilings with exposed steel joists.*

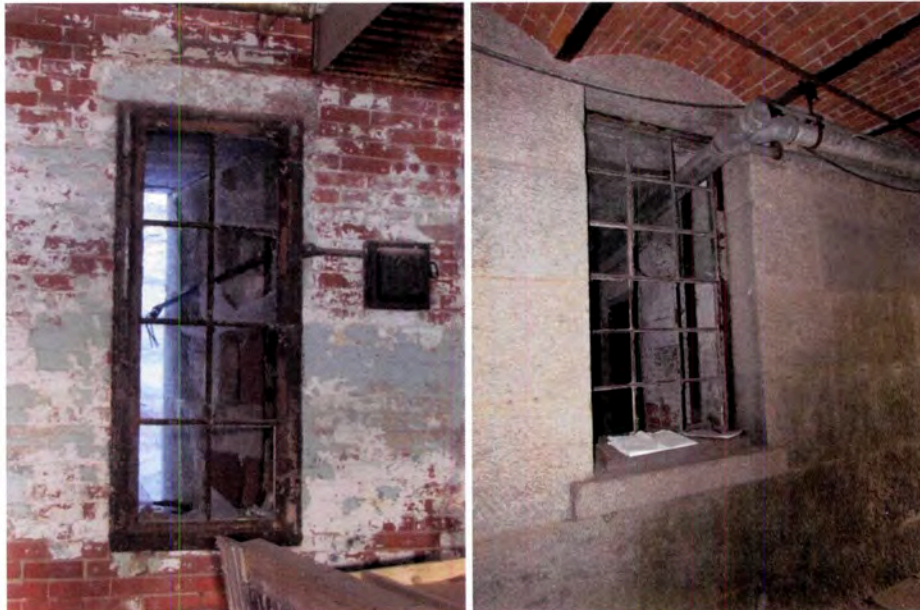
Most of the rooms on the first floor contain eight-light steel casement windows with steel frames and stone lintels. Every room in these sections has this type of window except Rooms 103, 107 and 131. Some of the casement windows have been modified but retain the original frame. The rooms also have nine-over-nine single-hung steel windows.

*Figure 34: Typical eight-light steel casement windows (left) and nine-over-nine single-hung steel window (right).*

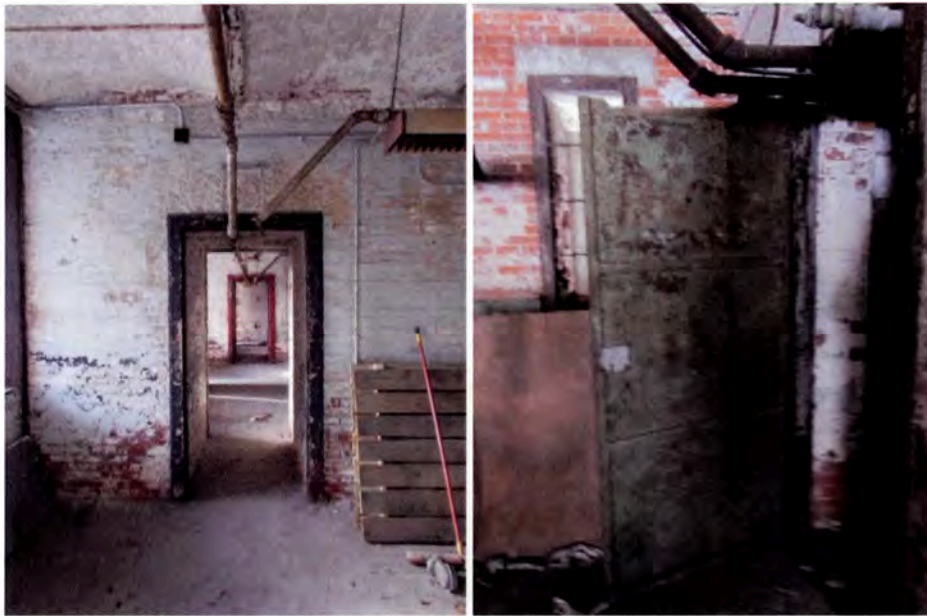
*Figure 35: Typical cased metal opening on first floor (left) and thin metal paneled door (right).*

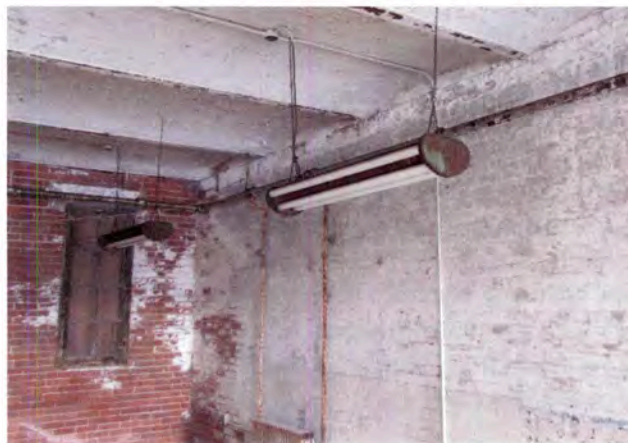
*Figure 36: Typical suspended fluorescent lights.*

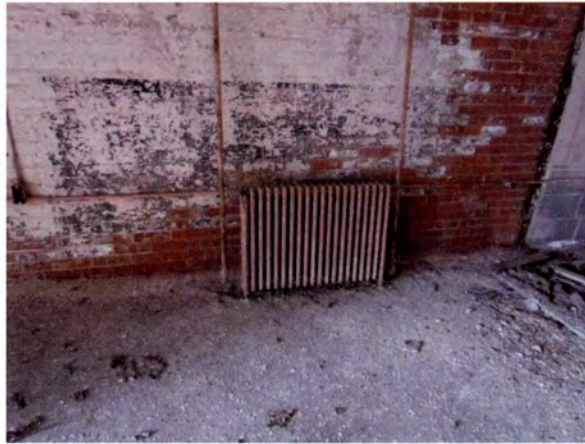
*Figure 37: Typical radiator and pipes on first floor.*

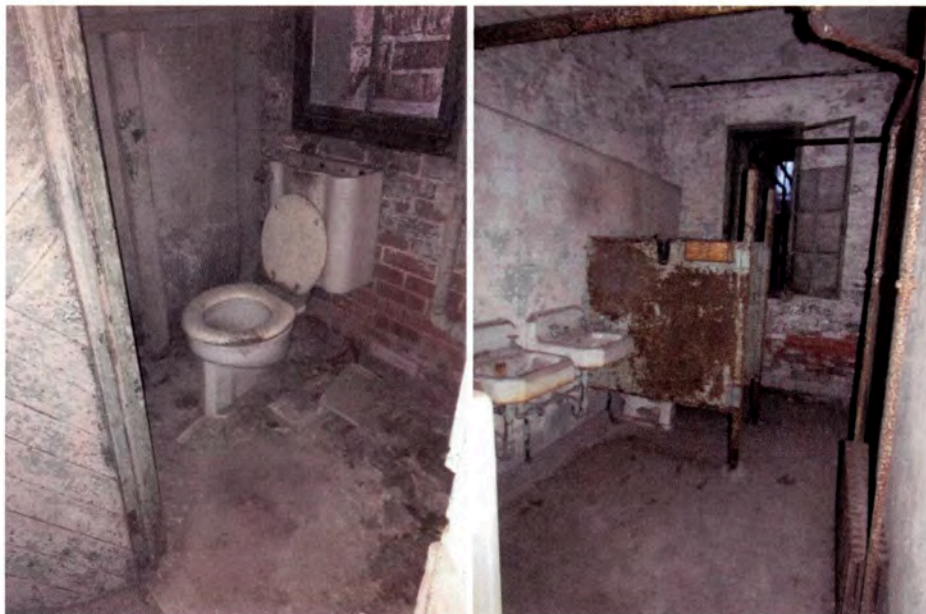
*Figure 38: Plumbing fixtures in Room 122 (note wood door herringbone pattern) (left) and lavatories and metal partitions in larger restroom on first floor (right).*

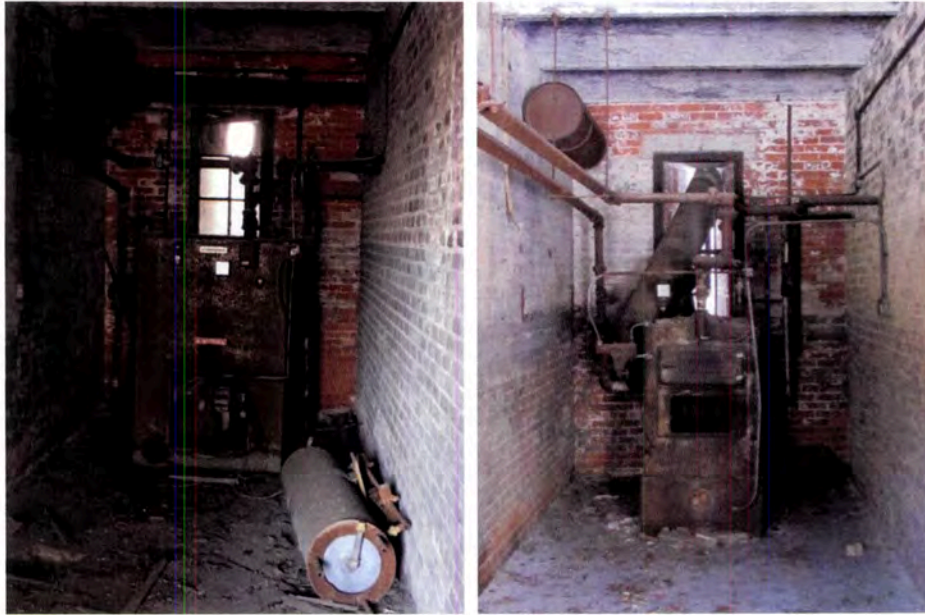
Figure 39: Boilers in Rooms 119 and 143.

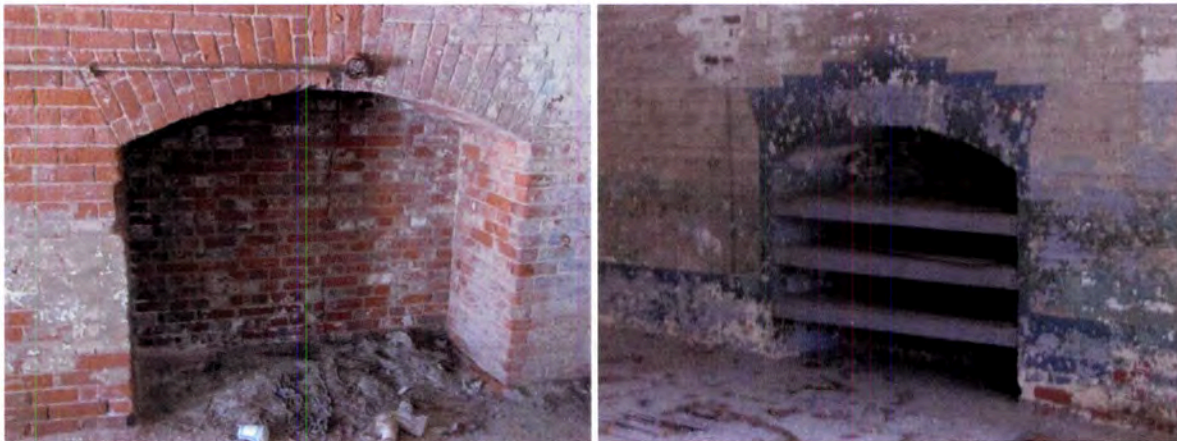
Most of the rooms on the first floor have fireplaces. The brick segmental-arched fireplaces are approximately 20 inches deep and four feet high. The rooms that do not have fireplaces are 103, 104, 107, 110, 120 and 143. Room 132 was not accessible, but there is likely a fireplace in the room as there is one drawn on the original floor plans. The fireplaces in Rooms 102 and 118 have been modified; steel diamond plate has been added around the fireplace in Room 102 and three wooden shelves were installed in the fireplace in Room 118.

Figure 40: Typical fireplace on first floor (left) and fireplace with wooden shelves in Room 102 (right).

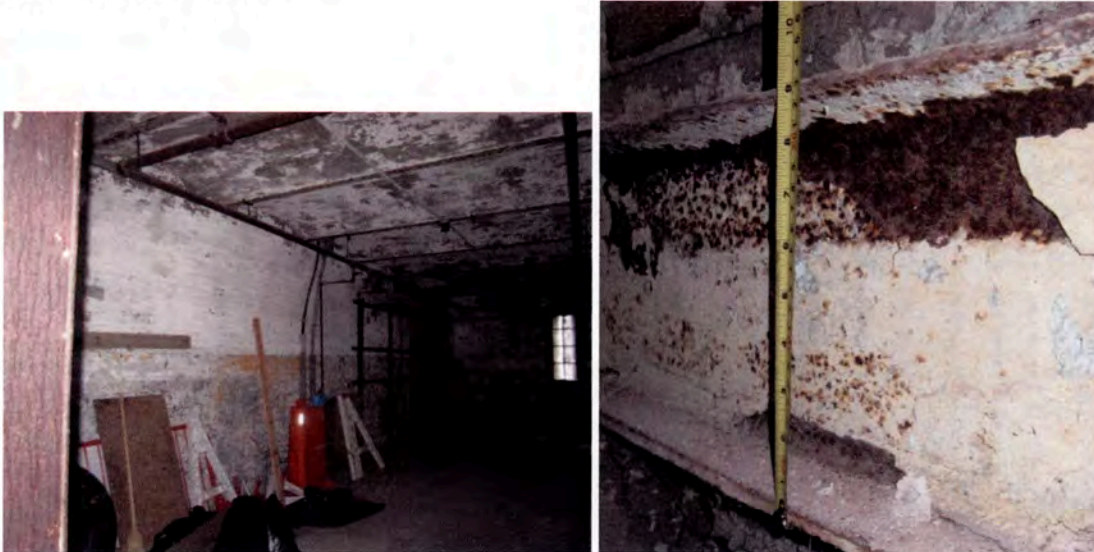
Typical wall construction consists of multi-wythe brick construction. Foundations for the walls were not visible at any of the locations. The upper level framing (ceiling of lower level) consists of steel I shapes clear spanning the room from brick wall to brick wall. Based on field dimensions of the beam at an exposed section in Room 226, the beams are approximately 9" deep with a 3.75" flange width, and a ¼" flange thickness (See Figure \_\_\_\_). Between the steel beams, brick arches span to create the structure for the upper floor. A steel support post was noted at approximately mid-span of the steel beams in Room 102. Other additional non-load bearing partition walls are located throughout the floor plan, but do not appear to be structural.

*Figure 41: Overview of typical first floor room (left) and detail of typical beam (right).*

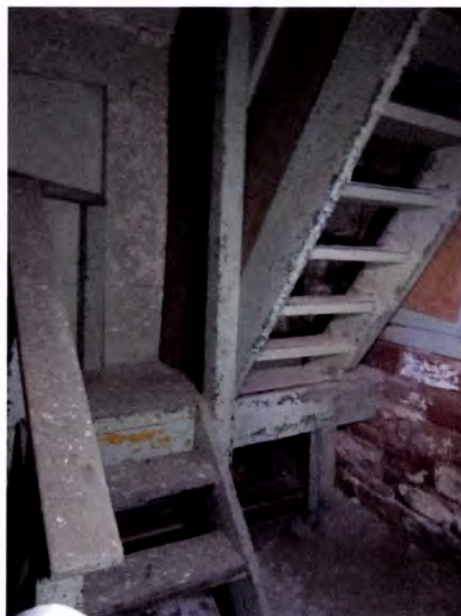
Interior stair cases, all of wooden construction, are also located on the first floor, extending up to the second floor. These stairs are located in rooms 102, 126, and 131. See Figure \_\_\_\_ below for a typical stair.

*Figure 42: Wooden staircase in Room 126.*

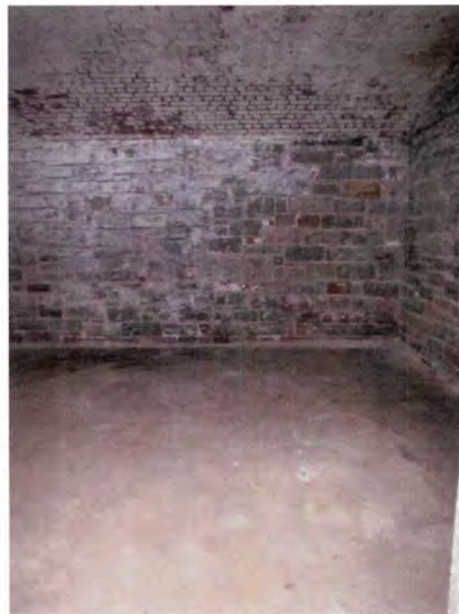
Figure 43: Typical concrete floor in corner of first floor.

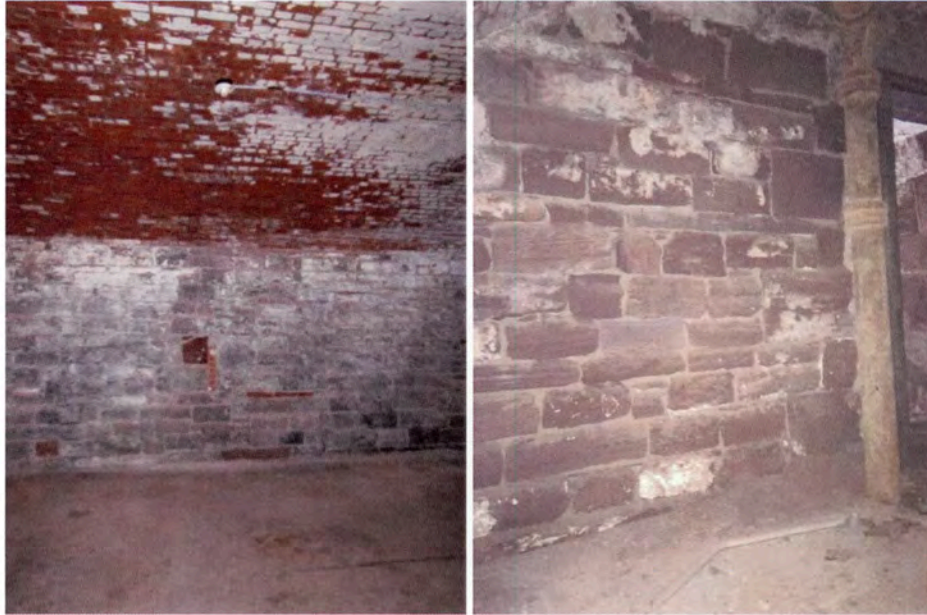
The walls in the corners are primarily granite, similar to the exterior stone. In Rooms 111, 124, 125 and 137, the granite has some areas of sandstone infill. In Rooms 112, 113A, 136A and 138, the granite walls have sandstone and brick infill, with a wood partition wall in one of the arches in Room 138. Finally, the granite walls in Rooms 123 and 126 are infilled with CMU.

*Figure 44: Granite walls (left) and sandstone walls (right) in corner sections of the first floor.*

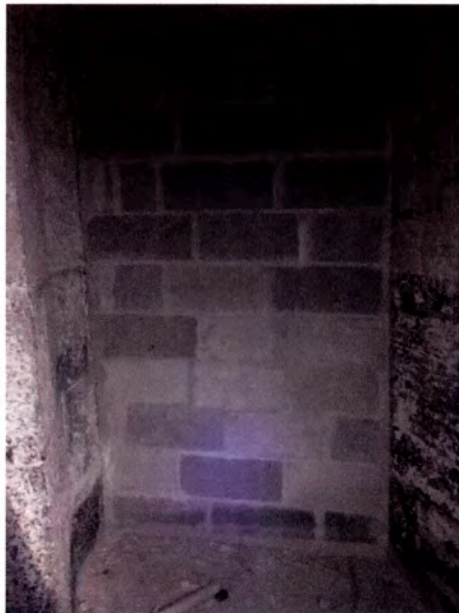
*Figure 45: CMU infill in first floor corners.*

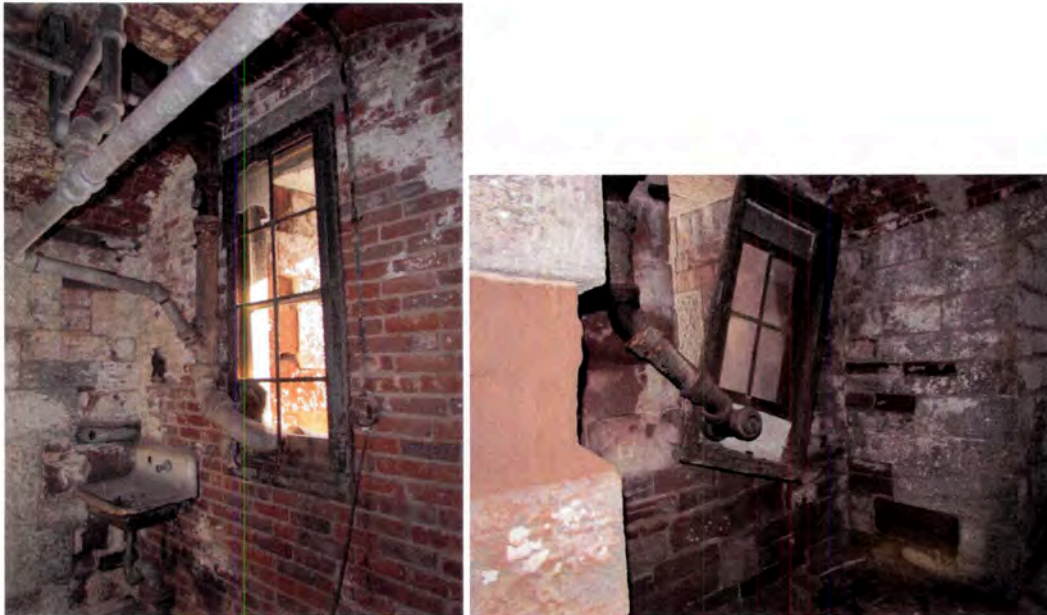
The primary window type in the corners of the first floor is granite embrasures. These are present in Rooms 111, 124, 125, 126 and 137. There are eight-light steel casement windows in Rooms 113A, 123, and 136A, similar to the windows in the main areas of the first floor. In Room 136A, the metal frame has a modified, four-light sash with metal panels above and below. Two windows in Room 136A are missing and one of the windows in Room 126 is boarded up.

*Figure 46: Typical eight-light steel casement window (left) and four-light sash in modified metal frame (right).*

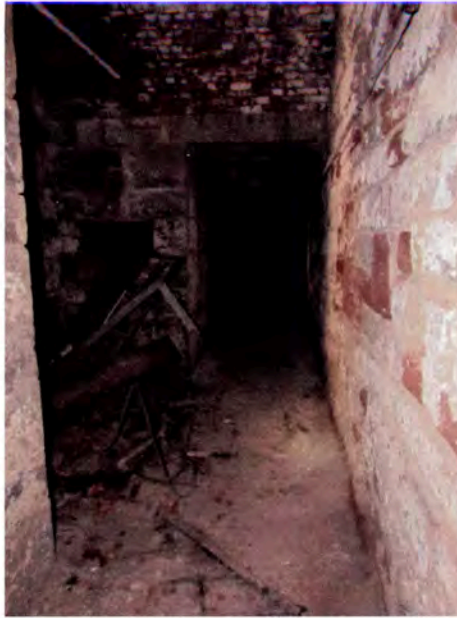
*Figure 47: Typical granite doorway in corner section of first floor.*

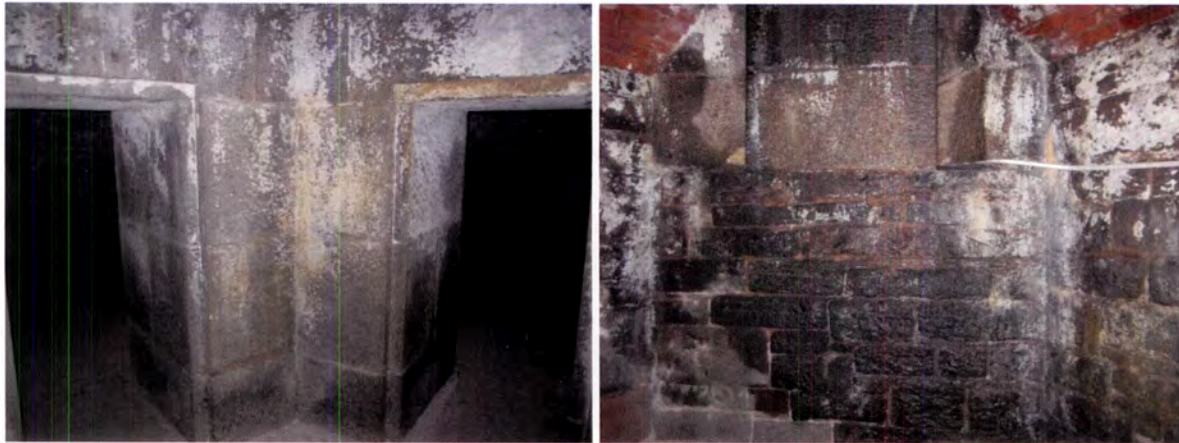
Floors for the corner sections of the fort are all concrete. Although it is believed that the floors are slab on grade, the slab in Room 112 appear to move when load was applied, potentially indicating that the slab was not on grade. Walls for these rooms were constructed using granite masonry with some sandstone mixed in (See Figure \_\_). Stone size for these walls varies (See Figure \_\_) and is not consistent

*Figure 48: Granite walls in Room 112.*

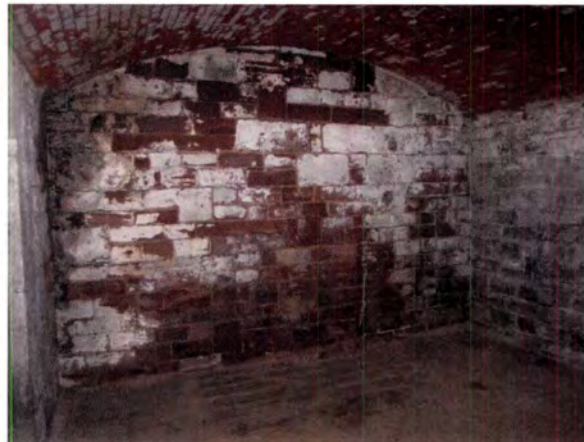
across the walls. Ceiling construction consists of high arching brick masonry, clear spanning from wall to wall with no interior supports (See typical ceiling in room 112).

*Figure 49: Brick arched ceiling in Room 112.*

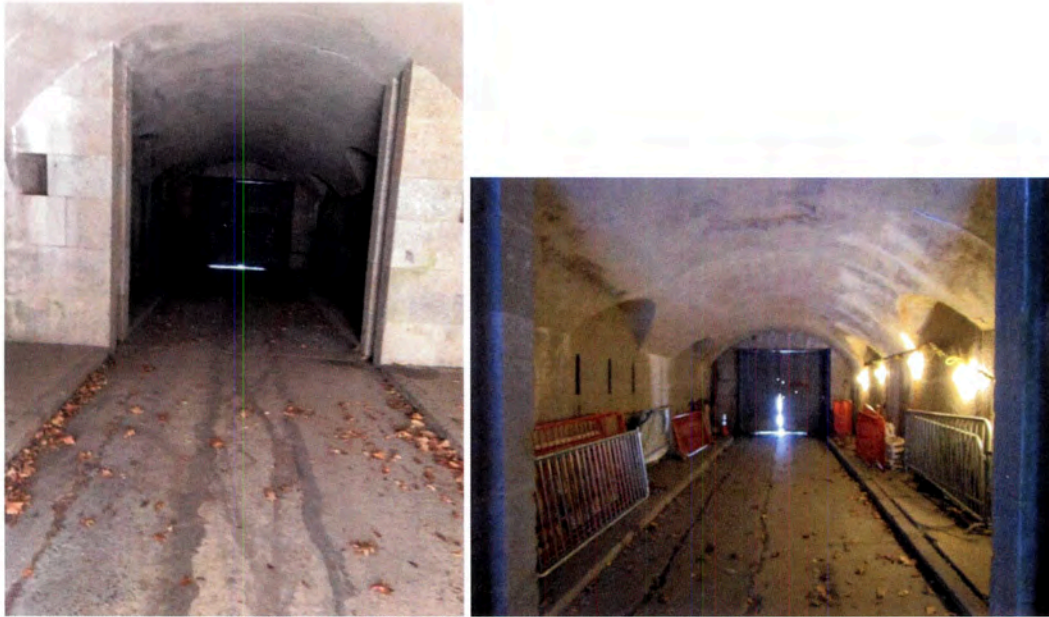
*Figure 50: North sally port (left) and south sally port (right).*

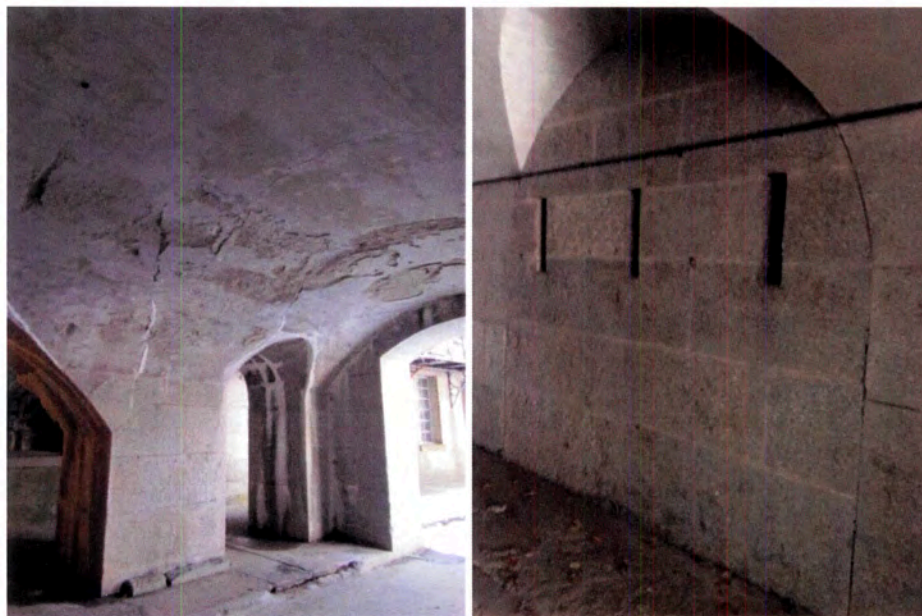
*Figure 51: Ceiling in south sally port (left) and typical embrasures found in both sally ports (right).*

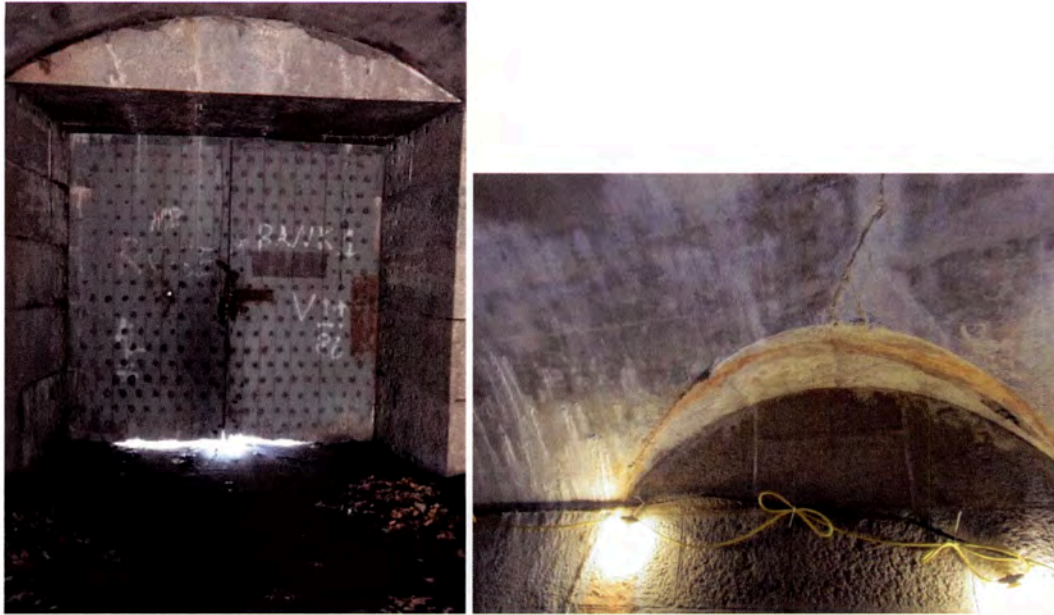
Figure 52: Doors in north sally port (left) and temporary lights in south sally port (right).

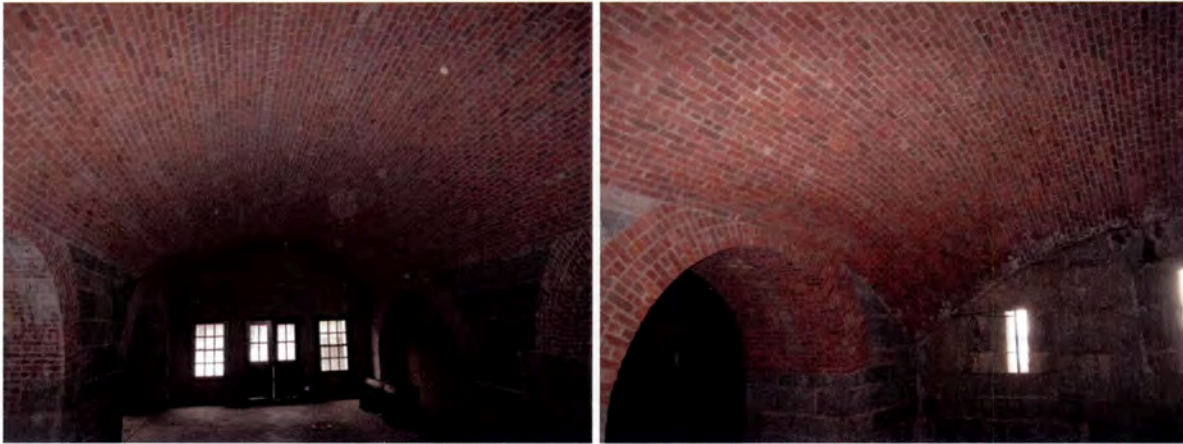
Typical wall construction on the exterior casement elevation (east) consists of granite stone masonry, consistent with the exterior of the fort. Interior walls separating the casemates consist of granite stone masonry, with multi-wythe brick-arched masonry openings (See Figure \_\_\_\_). Openings, likely for a chimney flue, were noted in the front arch between casemates G and H (See Figure \_\_\_\_). These appear to have been built with the original construction of the arches. Similar openings were also noted in the arches between Casemates A and B. Some of the interior walls are infilled with concrete masonry unit between these arched openings, however they do not appear to be structural.

*Figure 54: Typical walls, ceilings and masonry openings in East Casemates.*

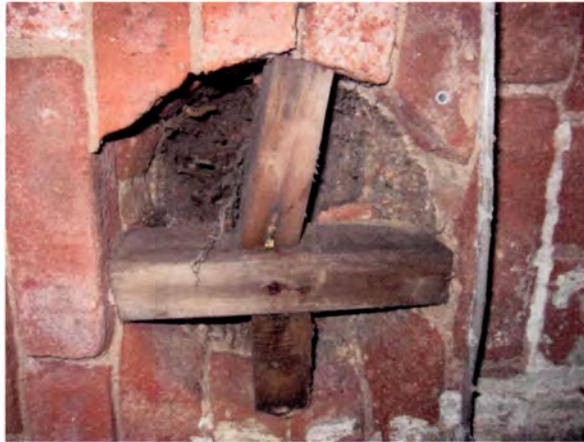
*Figure 55: Hole in arched opening.*

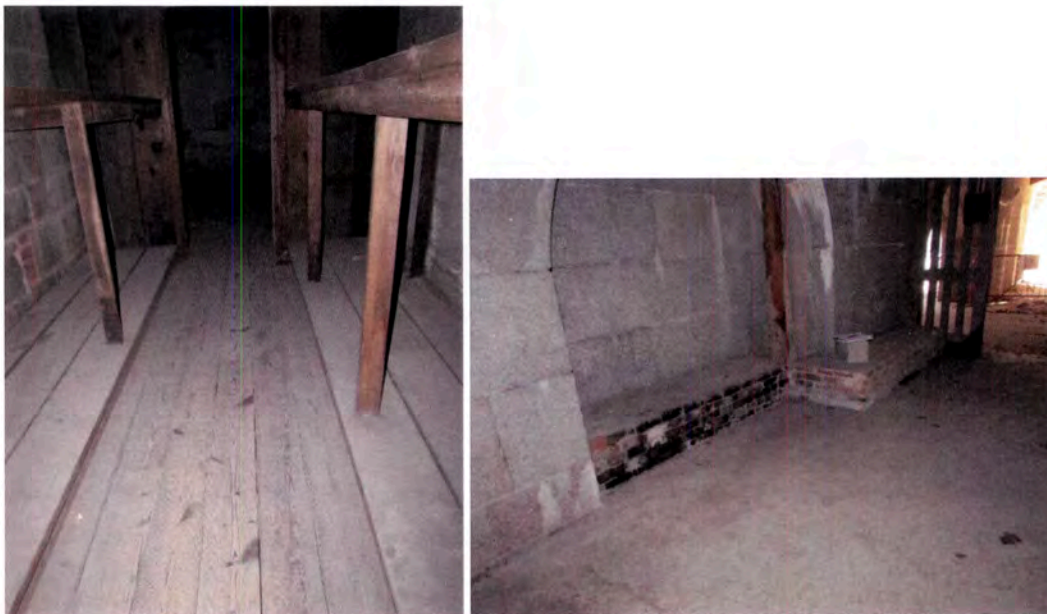
Figure 56: Wood board floors in Room 149 (left) and concrete floor in Room 150 (right).

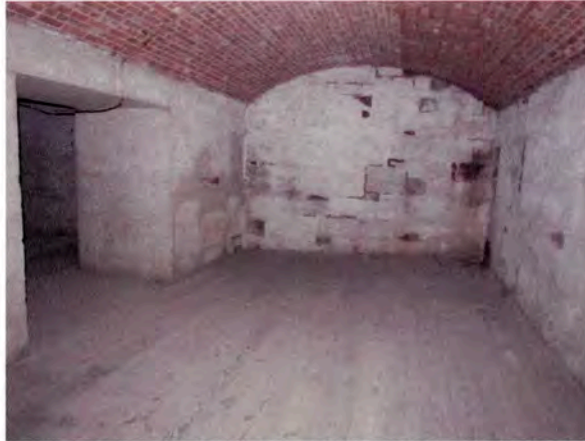
*Figure 57: Granite and sandstone walls in Room 149.*

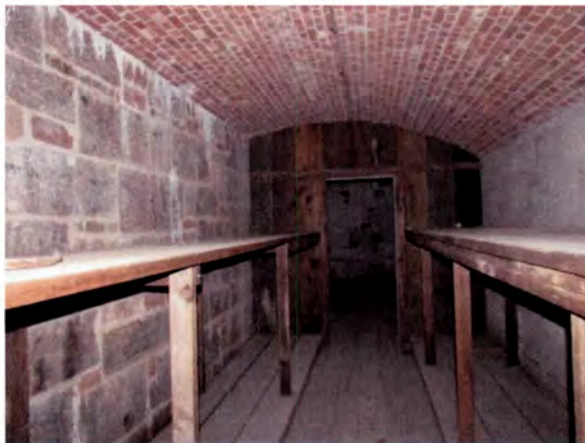
*Figure 58: Brick barrel vault ceilings in Room 149.*

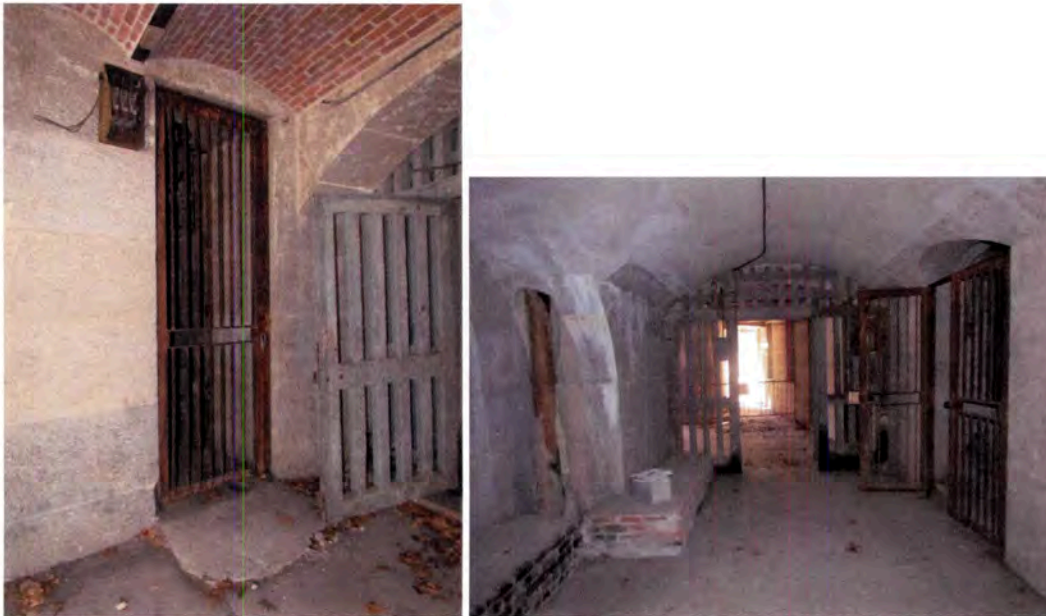
*Figure 59: Metal security gate (locked) to Room 147 (left) and open timber lattice frame and door in Room 150 (right).*

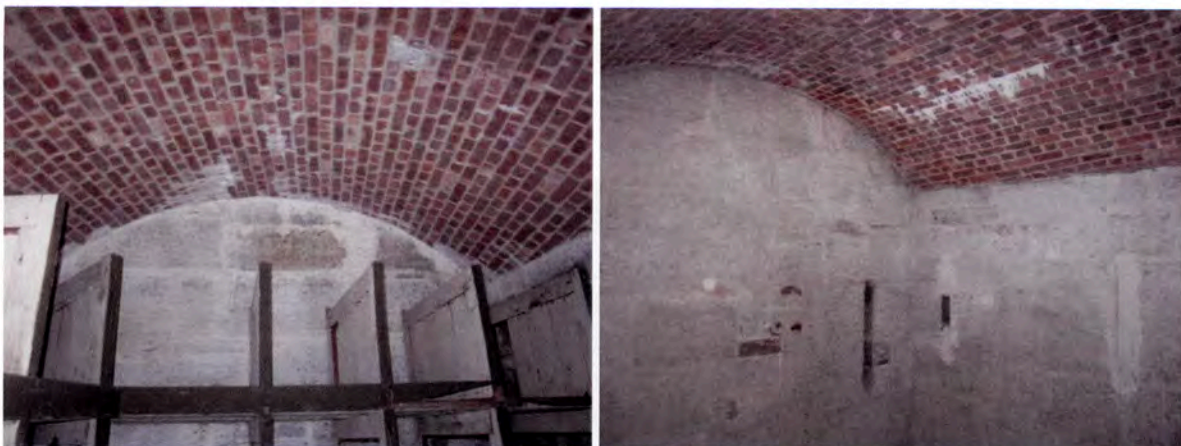
For rooms 154 to 156, and rooms 148, 149, and 150, the walls are constructed using granite stone masonry similar to the exterior walls of the fort. The ceilings in these rooms are constructed using brick arches clear spanning across the rooms.

Figure 60: Granite walls and brick arched ceilings.

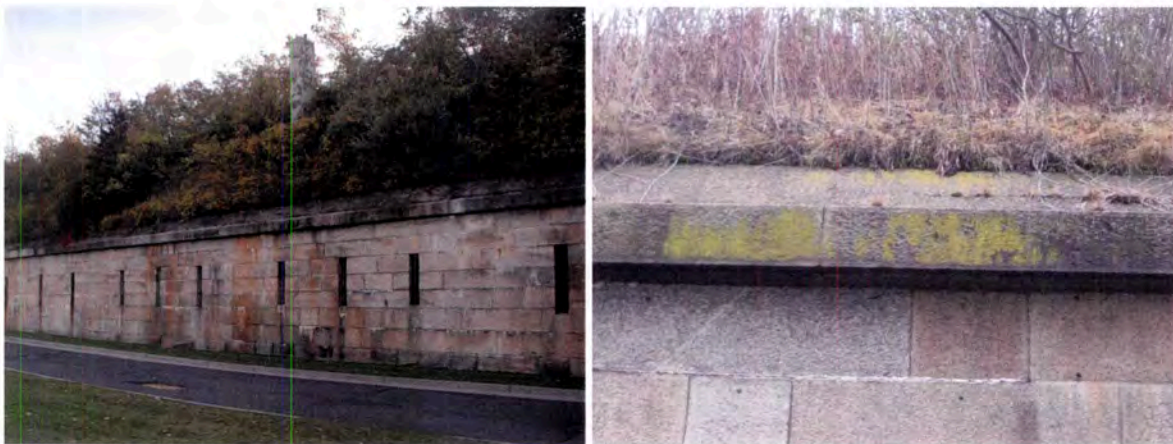
There is significant efflorescence and rust staining on the east elevation. There is also biological growth, some within the pointing. The staining appears to be concentrated in the center of the elevation, and below most of the masonry openings. The coping is exhibiting biological staining and growth as well, generally along the entire elevation. Some of the concrete has minor spalls, particularly at the north and south ends of the elevation. The amount of repointing required on the east elevation varies; the north and south ends generally require approximately 50%, and the center of the elevation varies from approximately 40-70%.

*Figure 2: Severe stains on the smooth-face granite (left) and biological staining on the coping (right) of the east elevation.*

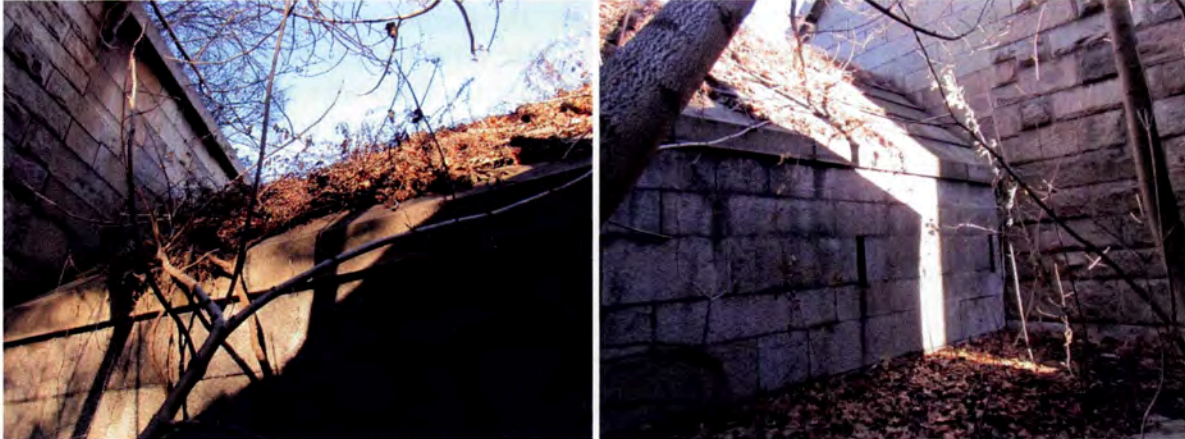
The small section between the fort and the counterscarp is exhibiting minor stains and biological growth. There is significant vegetation on the roof of the structure, and the elevation generally required 20% repointing.

*Figure 6: Vegetation on roof (left) and minor stains on small section between counterscarp and fort.*

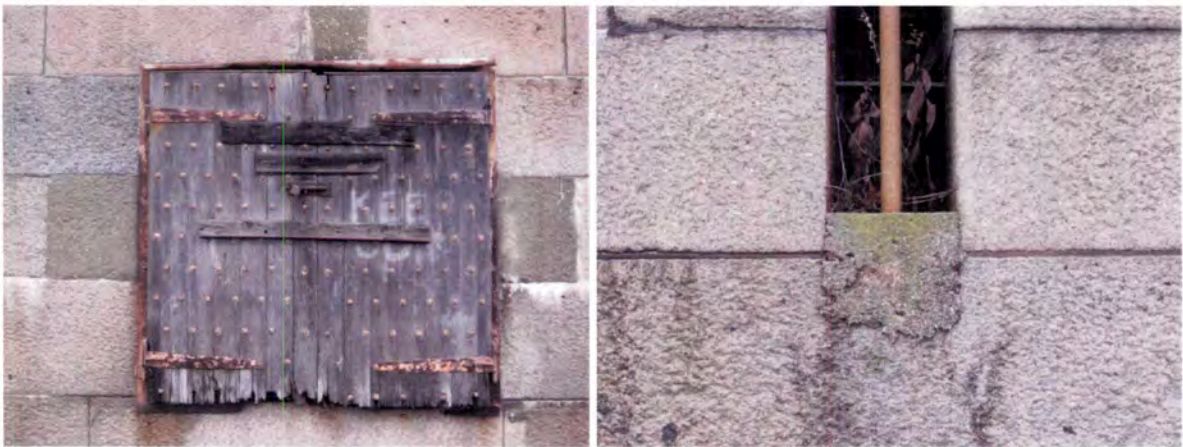
The windows on the exterior of the fort are generally in fair condition. The embrasures are in fair condition. Many have been infilled with concrete at the bottom, and some have been infilled completely. The infilled sections are in poor condition. The concrete appears to be deteriorating, and some that are infilled completely are cracked and crumbling. Many of the embrasures have been infilled with metal pipes, screens and wires. The metal is rusting, and creating stains on the granite walls. Some of the windows have been infilled with debris, including piles of bricks or trash. The masonry opening on the east elevation is in poor condition with deteriorating wood, a rusted frame that is broken on the bottom, rusted strap hinges, and rusted bolts. The wood is warped and no longer fits the shape of the opening.

*Figure 8: The masonry opening and wood panel on the east elevation is in poor condition (left). Many embrasures have been modified with concrete at the bottom to accommodate the metal bar.*

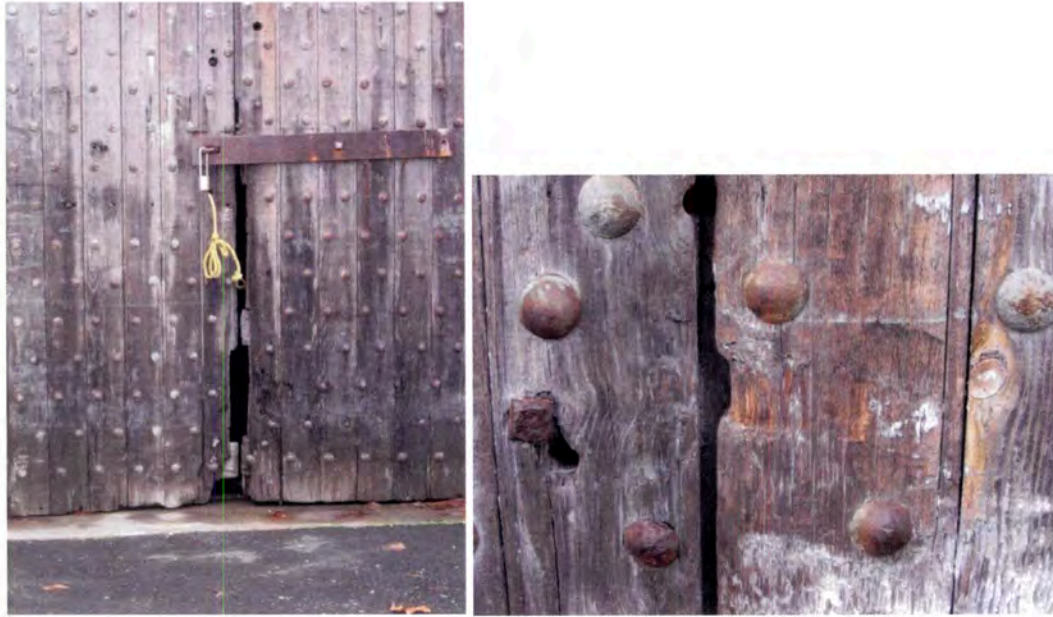
The doors on the east elevation are in poor condition. The north doors have splitting, rotting and deteriorating wood at the bottom of each door. The hardware is missing and the bolts throughout the doors are rusted. The south doors are also in poor condition; both doors are deteriorating, and the wood is rotting, creating a substantial gap where the doors meet. The strap lock is extant in the center of the doors, however it is rusting, and a modern padlock has been added. The bolts are also extant, and exhibiting rust. The paint has been stripped, and there are water stains on each door.

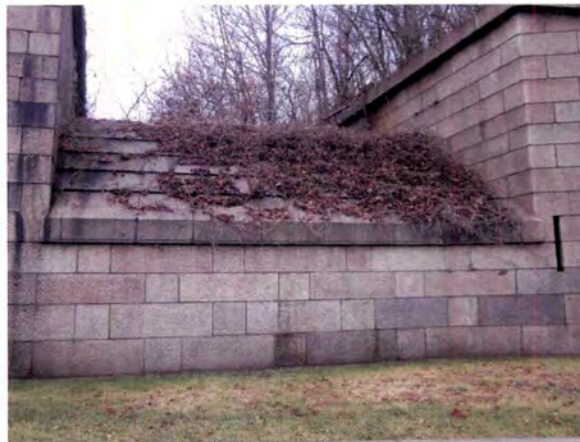
*Figure 11:*

The majority of the roof is inaccessible, therefore a thorough assessment was not possible. One section of roof that was visible was the low portion of the fort on the north side of the east elevation. This section was not intended to be vegetative, however, there is a large amount of vegetation present. This could be affecting the stones at this location, and causing further issues with water penetration.

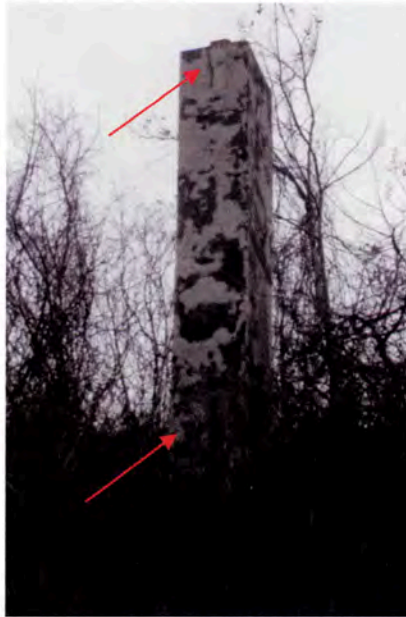
The chimneys on each of the elevations exhibit different conditions. The stuccoed CMU chimney on the east façade is in fair condition. The stucco is deteriorating, and there is a small area at the bottom of the east side of the chimney that appears to be spalling. There is also a small crack at the top of the structure.

*Figure 12: Small crack at the top of the east chimney and an area of patching at the bottom.*

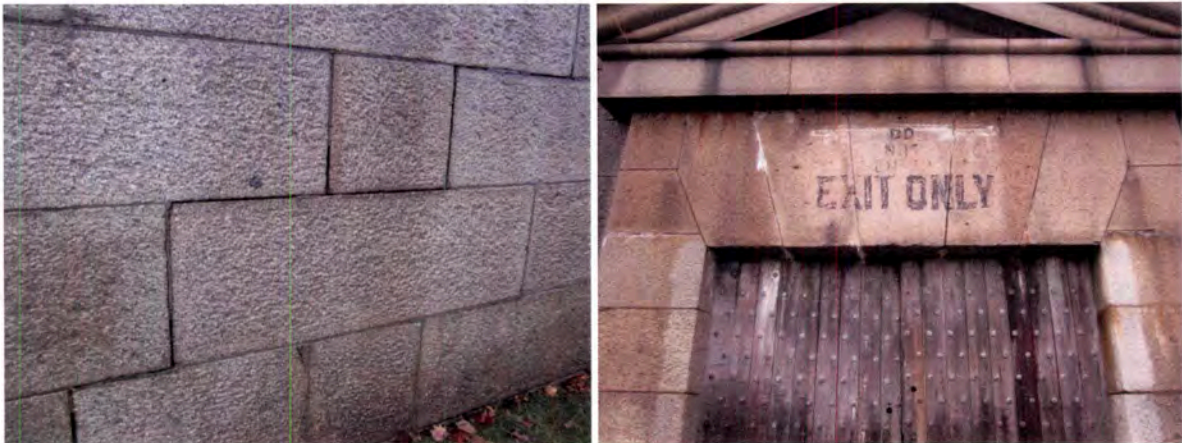
The exterior walls of the fort are generally in good condition. Minor cracking in the stone was visible in various locations (noted below), and efflorescence was also noted at various locations on the exterior of the fort. On the southeast corner of the fort, a diagonal crack was noted at the base of the wall (See Figure \_\_\_\_). Also, there is mortar missing at the flat arch above the southern door on the east elevation (See Figure \_\_\_\_). Efflorescence was also noted at various locations on the east elevation (See Figure \_\_\_\_). The stuccoed CMU chimney on the east elevation is in fair condition. There is significant spalling just above the roof (See Figure \_\_\_\_). The chimney does not appear to be in danger of imminent collapse based on observation from the ground. The chimney was not accessible from the roof, so a detailed assessment was not possible.

Figure 14: Diagonal crack in granite (left) and flat arch on east elevation (right).

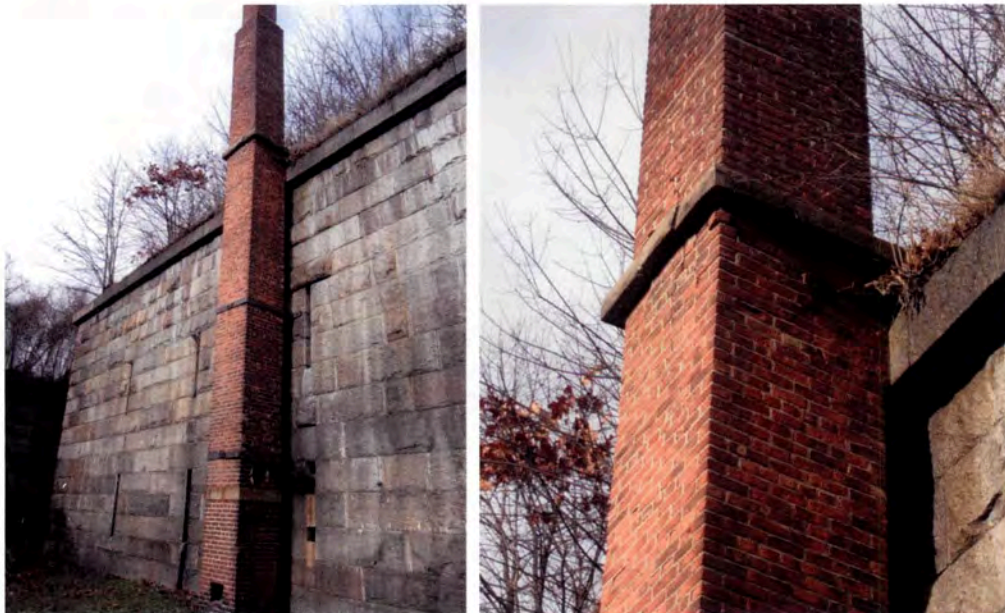
On the south elevation of the fort, the stone is in similar condition as the east elevation. Some minor cracking in the stone was noted around the windows (See Figure \_\_\_\_). The chimney on the east side of the south elevation is in fair condition, with cracks at the base (See Figure \_\_\_\_). The chimney on the west side of the south elevation is in poor condition. Metal straps intended to laterally brace the

chimney to the stone structure have failed at multiple locations. The brick masonry has also hinged at the roof level, and is in danger of imminent collapse.

*Figure 17: Overview and detail of west chimney on south elevation.*

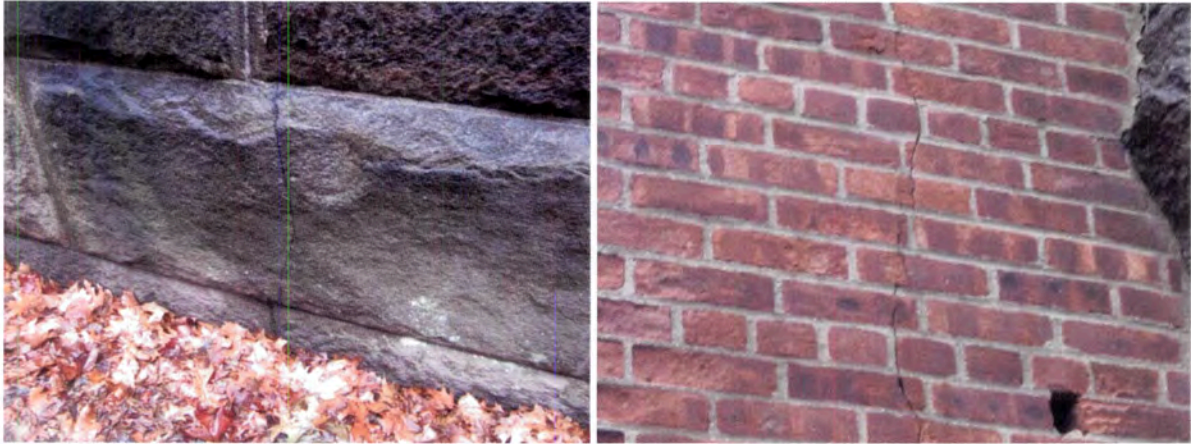
The west and north elevations of the structure are in similar condition as the south and east elevations with minor cracks noted on the north elevation (See Figure \_\_). The chimneys on these elevations are also in fair condition, with minor cracks throughout (See Figure \_\_).

*Figure 18: Crack at base of wall on north elevation (left) and crack in chimney on west elevation (right).*

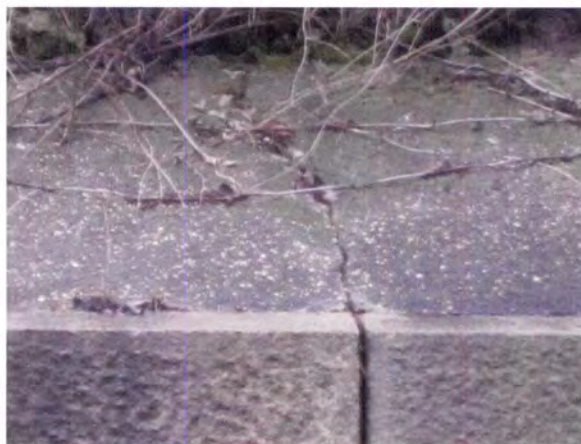
The roof of the fort is mostly inaccessible, and a thorough assessment of the roof was not conducted. Heavy vegetation is present throughout the entire roof. On the east elevation, cracking in the concrete roof was noted just above the top of the wall (see Figure \_\_).

*Figure 19: Crack in concrete below level of vegetation.*

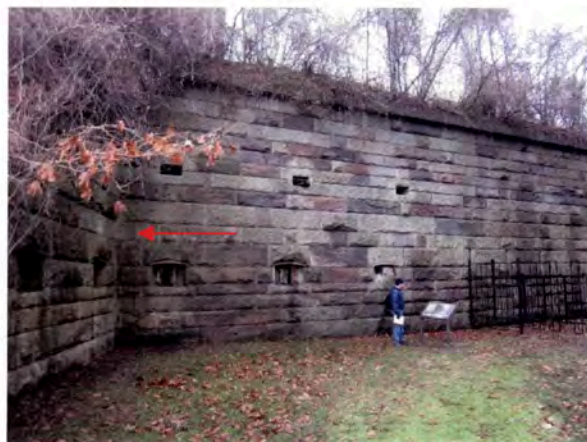
The north elevation is in fair condition. There is biological growth on the entire surface of the elevation. The elevation requires approximately 75% repointing. The coping on the north wall requires 100% repointing. There is also a significant amount of vegetation at the coping.

*Figure 20: Overview of rough-hewn granite walls of the Counterscarp (arrow is pointing to north elevation).*

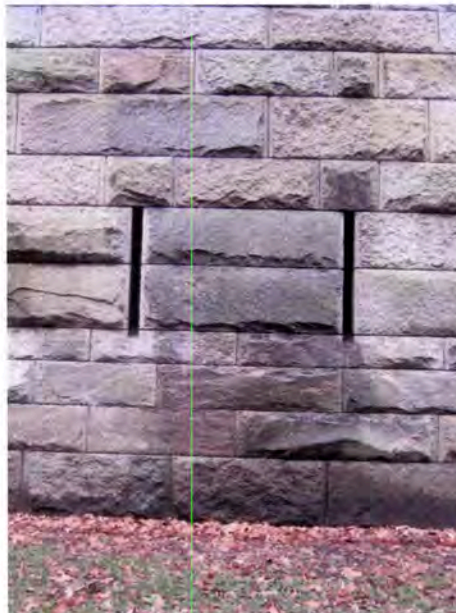
On the north end, there is moisture near ground level and under some of the masonry openings. This condition occurs for approximately 30% of the section. There is one spall under the third embrasure and one on the south side of the 11<sup>th</sup> embrasure (counting from the right). There are approximately nine minor cracks, and similarly to the south end, they are mostly near the masonry openings. There is a fair amount of vegetation along the coping on this entire section.

*Figure 21: Water damage near ground level of the west elevation.*

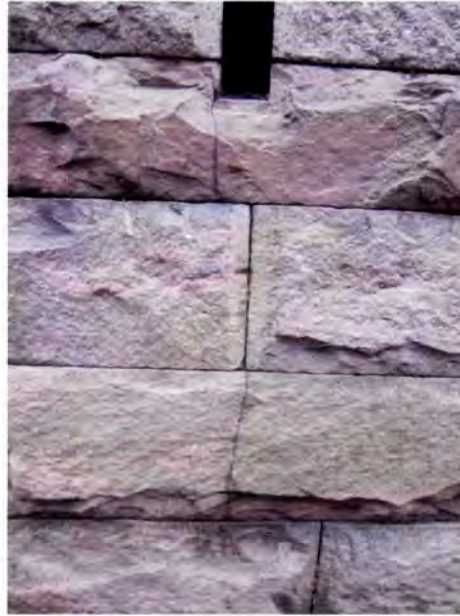
At the south end, there are two metal brackets between the first and second embrasures, conduit to the left of the first embrasure, and a pipe below the second embrasure (counting from left). There is a hairline crack near the third embrasure and a hole between the fifth and sixth embrasures. There are approximately five small holes in the center of this section, as well as two minor cracks near the masonry openings. There is a minimal staining on the lower middle window at the north end of this section.

*Figure 22: Crack in granite wall below masonry opening on west elevation.*

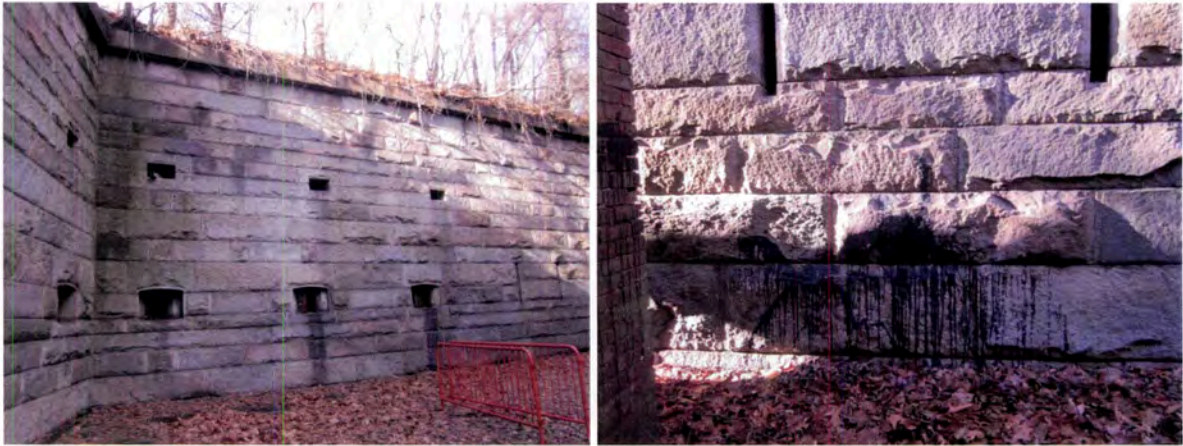
The granite walls on the south elevation is in fair condition. The east end of the south elevation appears to be in better condition than the west end. There is significant moisture and biological staining at the west end of the south elevation, particularly on the upper portion of the west end. There is moisture and staining below the windows on the west end, as well as biological growth in the pointing. Along the coping of the south elevation, there are areas of moisture and biological growth and staining, just below the vegetative roof. The biological growth and staining continues east on the elevation, however the conditions aren't as poor as the west side.

On the west end, there are approximately five small holes in the granite, on the west side of the first embrasure in this section. This appears to be the only section where the holes are present, however there are several locations with graffiti and paint stains are present. One location is approximately in the center of the elevation, and there are four other locations on the east end. There is a small spall in the granite under one of the windows, located about half way between the middle and east side of the south elevation, and a metal, rusted bracket with electrical wires is attached under one of the embrasures on the east end. Similarly to the east elevation, there are quarry marks in the stone throughout the entire elevation.

Figure 23: Staining under masonry openings (left) and paint stains (right) on south elevation.
