FORT TOMPKINS  
GATEWAY NATIONAL RECREATION AREA

*Historic Structures Report*

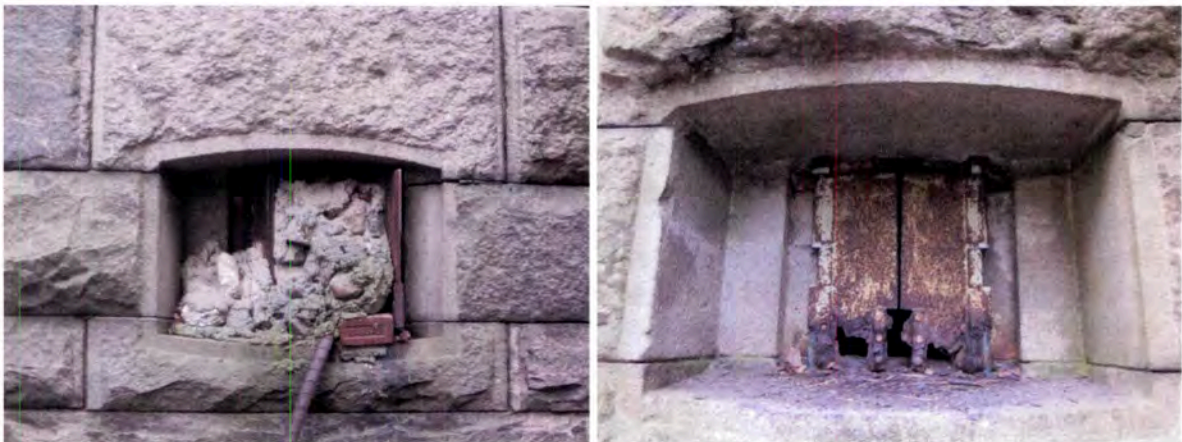
The counterscarp windows are generally in good condition. The embrasures are in good condition; only one embrasure, on the north end of the east elevation, has been modified and has a single brick placed at the bottom of the opening. While the half-arched openings are in good condition, the shutters installed within them are in poor condition. They are deteriorating, and extremely rusted. Many are fixed and no longer operable. Other openings have been infilled with cement, bricks and pipes. The shutters remain in place and are fixed with the infill surrounding them. On the west end of the south elevation, there appears to be a piece of wood protruding from one of the upper level windows.

Figure 24: Infilled window (left) and rusted metal shutters (right) of Counterscarp.

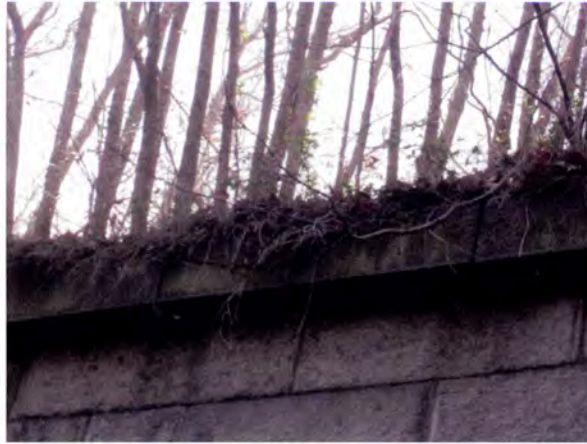
The condition of the roof is unknown as it was not accessible. It appears to be overgrown with vegetation, likely causing problems for the roof structure.

*Figure 25: Vegetative roof and biological staining on coping of counterscarp.*

The exterior of the counterscarp is in similar condition to the fort exterior. The stone is in good condition with minor cracking. There is heavy vegetation on the roof, similar to the fort. Access to the roof was not available so a thorough assessment was not conducted.

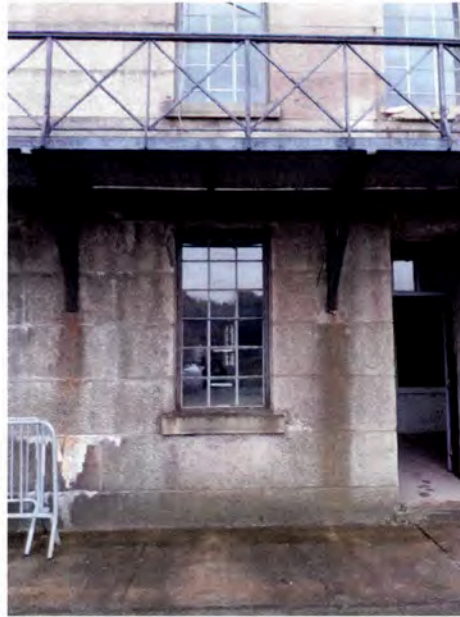
The north, south and west elevations of the Parade Ground are in fair condition. There are significant rust stains at every knee brace supporting the gallery between the first and second floors. There are also rust stains around the window sills, particularly on the second floor, and some of the metal window frames are exhibiting rust as well. The doors are generally in good condition with some paint deterioration and minor rust at the jambs. Each elevation is also exhibiting efflorescence throughout and biological staining throughout.

*Figure 26: Typical biological staining and efflorescence on granite walls of Parade Ground.*

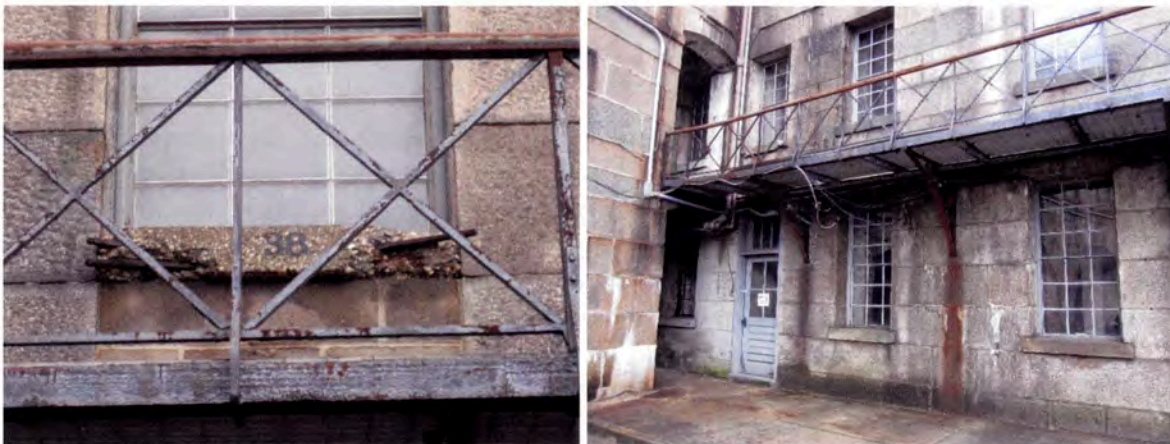
On the south elevation, four of the doorways on the second floor are infilled with windows and concrete masonry unit (CMU) below. Each infilled area is in poor condition; the cement sills are deteriorating, exposing the metal rebar. There is conduit running the length of the elevation with metal anchors causing moderate rust stains. There small holes and abandoned hardware on the south elevation, biological staining near the ground and vegetation in the southwest corner. Conduit with metal anchors causing rust stains.

On the west elevation, six of the doorways are infilled with window and CMU. Their conditions are similar to those on the south elevation. The west elevation is exhibiting efflorescence, rust stains from conduit running the length of the elevation, and paint stains. There are small patches, holes and spalls throughout. The conditions of the north elevation are similar to the others. There is active water on this elevation. Some of the window sills are spalling. The conduit and anchors are rusted, causing the stains on the granite walls.

*Figure 27: Modified door opening with deteriorating sill and exposed rebar on second story (left) and rust stains on granite walls of Parade Ground (right).*

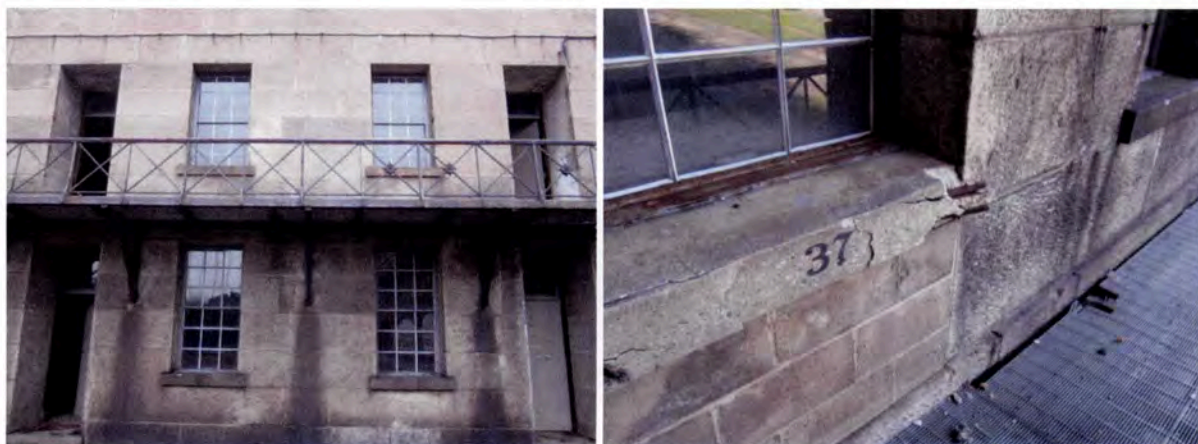
Figure 30: Caption to be included.

The stone on the inside of the fort is in good condition based on observations from ground level. Staining due to rust from the attached walkway is consistent throughout the entire interior elevation of the fort (See Figure \_\_). On the south face, concrete spalling was noted underneath one of the window sills, exposing the reinforcement in the concrete (See Figure \_\_). Minor efflorescence of the walls was also noted on the interior of the parade grounds.

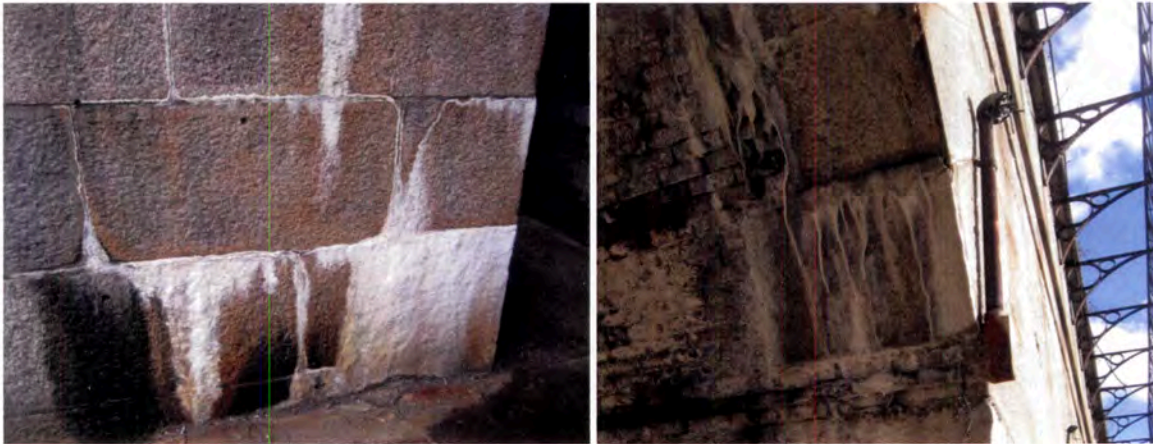
The stone on the east elevation of the interior parade ground is in good condition, similar to the other elevations. Efflorescence was noted at various locations (See Figure \_\_). Efflorescence was also noted on the stone arches that span in front of the casemates on both the brick masonry and

the exterior stone masonry (See Figure \_\_\_\_). An active water leak was visible directly in front of casemate "C". Deterioration was also noted in the pointing and extends into the mortar beds of the brick portions of the arches (See Figure \_\_\_\_).

Figure 31: Efflorescence on wall (left) and on stone and brick arch (right).

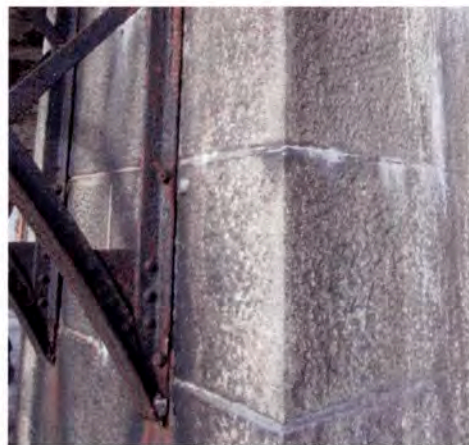
The upper gallery was inaccessible during the condition assessment and observations were limited to visual observations from the ground. In general, the upper gallery is in poor condition. The knee brace brackets for the gallery are heavily corroded and the walking surface of the upper gallery is missing or has been removed. The guardrail on the upper gallery also appears to be heavily corroded. The stairs and guard rails on the south side that lead up to the upper gallery are heavily corroded, similar to the upper gallery. No stair treads were present for the south stair and the base has been fenced off due to its deteriorating condition. The knee brace brackets supporting the intermediate landing for the south stair are shown in Figure \_\_\_\_\_. These brackets are slightly different than those found on the gallery on the west side of the fort. The brackets are showing signs of corrosion, but do not appear to be separating from the stone walls. The stair on the north side is missing. Evidence of connections that have been removed on the east stone wall are still present, as well as an upper landing.

Figure 34: Framing for landing at south stair on east elevation.

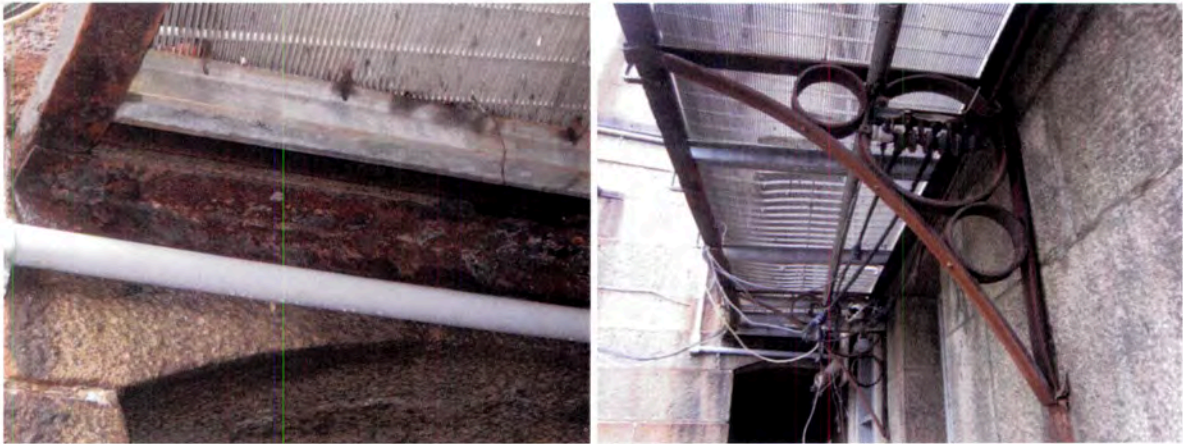
The gallery extending around the second level on the north, south and west elevations of the parade ground is in poor condition. The steel for the gallery, in general, is exhibiting heavy corrosion in areas (See Figures \_\_). The primary concern for the gallery is the connections between the gallery and the stone wall. No details were obtained showing exactly how the knee brace brackets are connected to the wall, however it appears that this connection appears to be failing. Section loss was noted at the base of the brackets (See Figure \_\_). Also, spalling in the stone was noted in around the connections at various locations, possibly due to rust jacking at the base (See Figure \_\_). It appears that some of the brackets are beginning to tilt, and separate from the wall.

Figure 35: Corrosion of Gallery members.

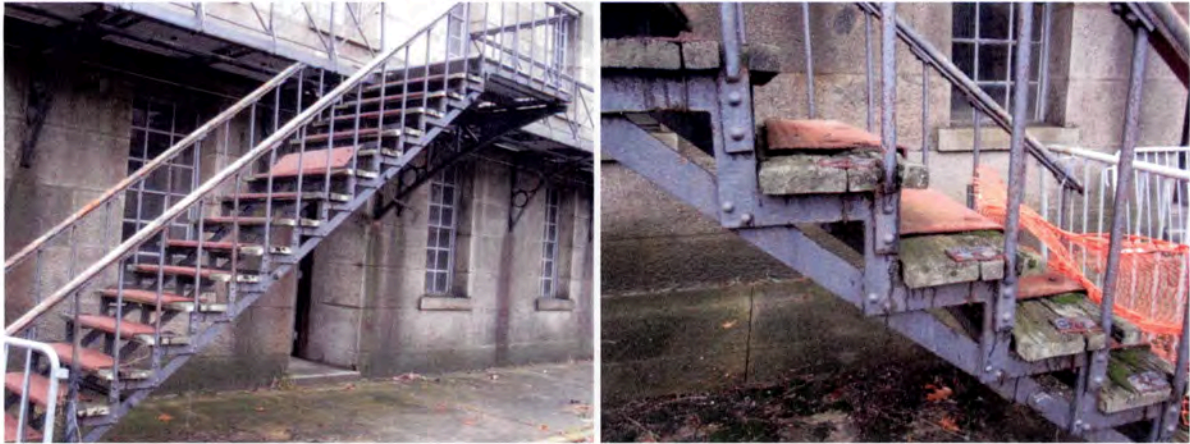
Figure 37: Caption to be included.

The stairs for the upper gallery are in fair condition. Slight corrosion was noted on the railings and the stringers (See Figure \_\_\_\_). The wooden steps that span between the stringers are starting to show signs of deterioration and have split in some locations. Also the diamond plate treads that are attached to the wooden steps are heavily corroded and are no longer attached to the stairs in some places (See Figure \_\_\_\_). The knee brace brackets that support the upper landing for the stairs are also heavily corroded at the connections, similar as the gallery described above.

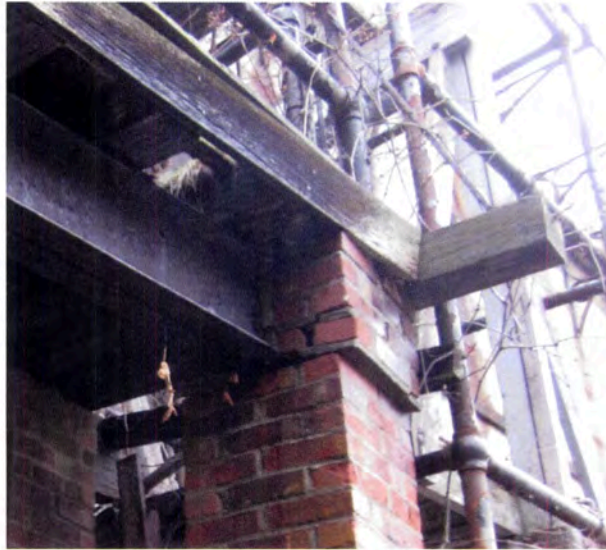
The hoist structure on the north side of the east elevation is in poor condition and it appears to have partially collapsed. The steel framing forming the hoist structure is heavily corroded, but does not show evidence of section loss (See Figure \_\_\_\_). The platform connecting the hoist structure to the upper walkway on the north elevation is in poor condition. The steel beams are heavily corroded, and are exhibiting heavy section loss (See Figure \_\_\_\_). The wood framing that spans between the steel beams is also showing signs of deterioration. The brick pillars supporting the steel beams are heavily cracked at the top around the steel beam bearings, likely due to rust jacking caused by the corrosion on the steel beams (See Figure \_\_\_\_).

*Figure 39: Cracked pillar at beam landing.*

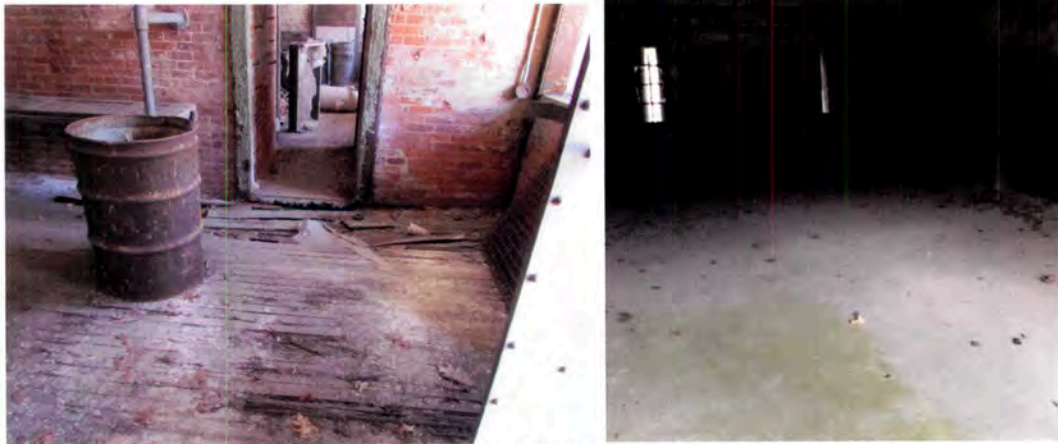
The wood floors in these sections of the first floor are in poor condition. Large sections are missing, and the boards are deteriorating, splitting, warping, rotting, or buckling. There are some areas with water damage, and there is a large amount of debris throughout, especially where the wood is missing. In these areas, the subfloor is exposed, and is also beginning to deteriorate. In many rooms, particle board has been applied on top of the boards, however the plywood is sagging or deteriorating in some areas as well. In some rooms, it appears that concrete has been added where the wood flooring is in poor condition.

The concrete floors on the first floor are generally in fair condition with some areas of water and biological staining. There are minor cracks, spalls and patches in the concrete floors. There is minor efflorescence, and dirt and debris collecting in these areas. Some of the concrete floors have been modified with sections cut out for systems or drains.

*Figure 40: Deteriorating wood floors (left) and concrete floor (right) on first floor.*

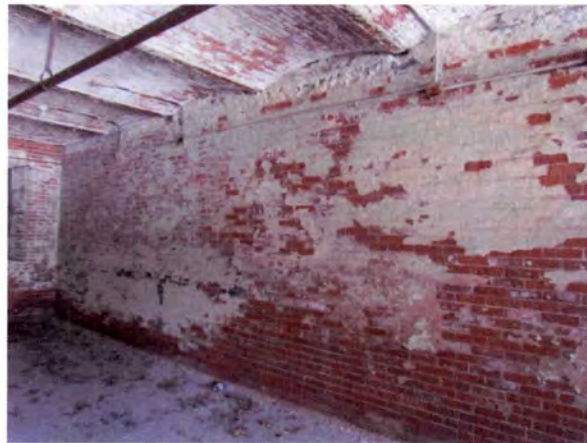
The conditions of the walls on the first floor vary from fair to poor. The brick walls are in fair condition, with minor spalling, cracking and missing pointing. There are areas with several layers of paint, and other areas where the paint is peeling and deteriorated. There is extensive water damage and biological growth in some areas and active water in others. Some of the bricks are uneven or broken, likely from water damage, and there are some rust stains throughout. There are some holes throughout the brick, likely from hardware that has been removed.

*Figure 42: Typical conditions of first floor brick walls.*

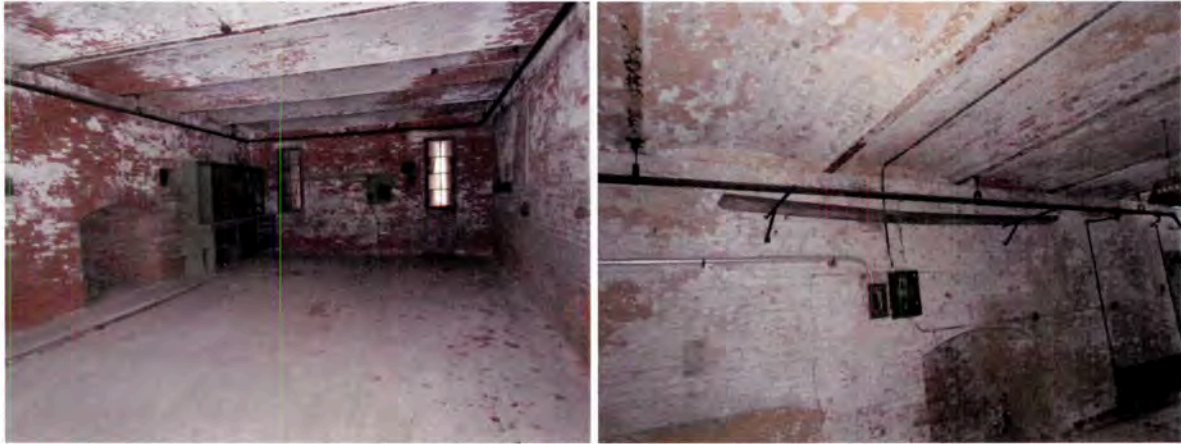
The brick ceilings in these sections are generally in fair condition. There are some remnants of parging throughout that is deteriorating in some places. Some of the ceilings are exhibiting spalling bricks, efflorescence from water infiltration, and some surface damage from paint or parging removal. In some rooms, there appears to be a black coating over the brick and under the paint, and there are patches and anchors or hangers throughout. All of the exposed steel joists are exhibiting rust, and there are mounting plates located in the center of the steel joists in Room 147.

Figure 43: Typical ceiling conditions of first floor.

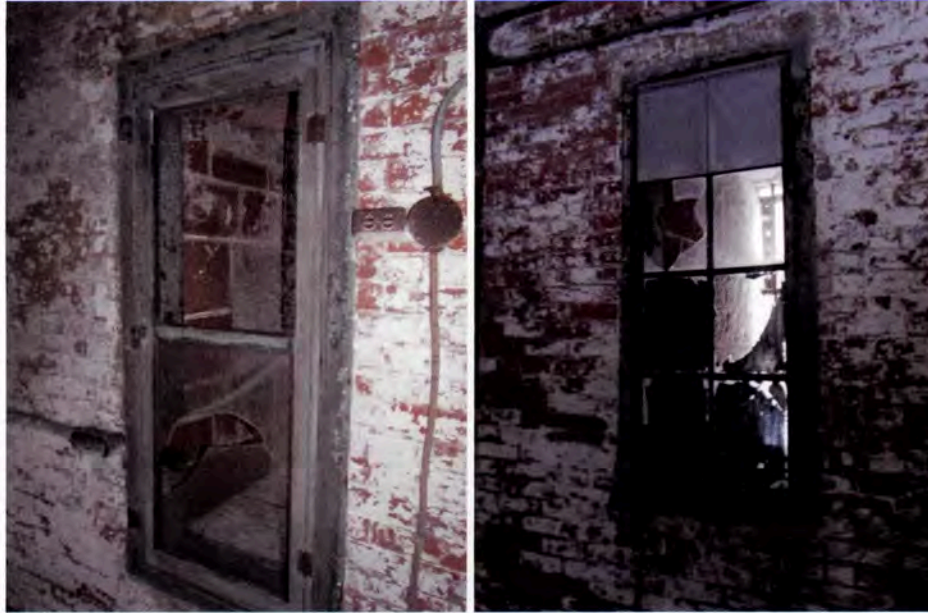
The windows are generally in poor condition. Most of the eight-light steel casement windows have missing or broken lights. All of the steel casement windows are exhibiting peeling or deteriorated paint, and rusted frames and hardware. In Rooms 104 and 105, the lights have been replaced with security glass. One of the sash has been cut in Room 106, and is missing in 134, and plexiglass has been installed in both. The lights in Room 116 have also been replaced with plexiglass. The windows have been removed in Room 110. In Room 105, the bottom two lights have been removed and infilled with cement 105. Several of the lights are painted in Rooms 113, 116, 144 and 145.

In Room 108, all of the lights have been removed and infilled with plywood and pipes. The sash in Rooms 116 and 118 have been replaced with wood sash and a wood frame. A wood screen has been added in Room 118, and is in poor condition, and two storm windows have been added in Room 130, both lights missing or broken. The sash in Room 129 is broken; one casement is missing in 139 (with deteriorated sill extant); one casement frame is broken in 139; and the casement in 146 is broken and displaced. In Rooms 119, 143 and 146, the top lights of the casement windows have been modified for systems; Rooms 114, 127, 128 and 129 are boarded up or infilled with plywood; and an exhaust fan (and plywood has replaced the middle sash in 144/145. There is a large amount of debris in the opening in Room 128. There are metal bars in the windows of Rooms 129 and 130 that are in poor condition. The single-hung, exterior steel window is in poor condition; there are no lights in the bottom sash and the top right light has been removed for a pipe.

Figure 44: Wood framed window with wood storm panel (left) and typical eight-light steel casement window (right).

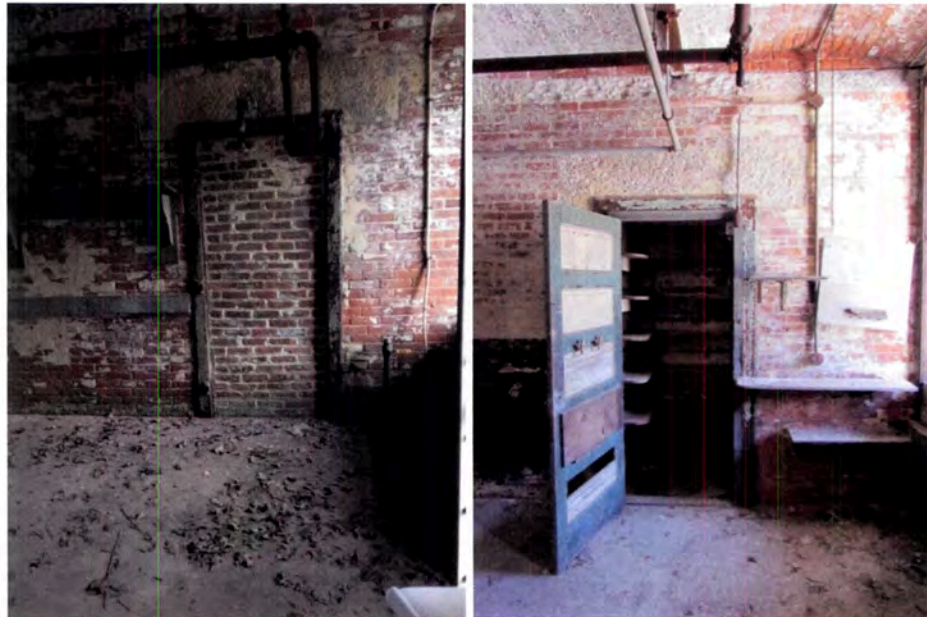
The doors are infilled with CMU in Rooms 139 and 143, with brick in Room 131, and with plywood in Rooms 133 and 135. Several of the doors are blocked; in Room 102 the door is blocked by a stair, and in Room 103 it is blocked with a steel and plaster panel. The metal doors are generally in poor condition. The conditions of the added partition doors also vary. Some of the plaster and metal partitions are in good condition, including in Room 106, and others are missing doors and the frames have peeling paint and exposed nails.

*Figure 45: Brick infill in metal cased opening (left) and five-paneled closet door (right).*

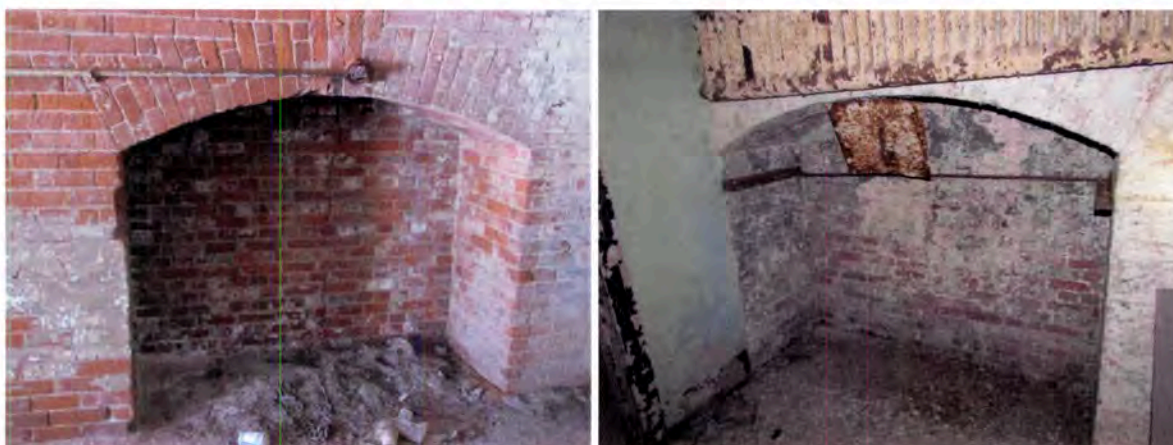
The fireplaces on the first floor are generally in fair condition. Some of the fireplaces have been modified with pipes and steel lintels. Diamond plate was installed on the fireplace in Room 102, and is very rusted, and wooden shelves were installed in Room 118, and are in good condition. There are cracks in the back wall of most of the fireplaces, some severe, and some of the fireplaces have multiple cracks. Some of the bricks in the arches are cracked or spalling, and many have patches or missing pointing. Many of the flue/vents have been modified with electrical boxes.

*Figure 48: Brick fireplace with crack at back wall (left) and modified fireplace (right).*

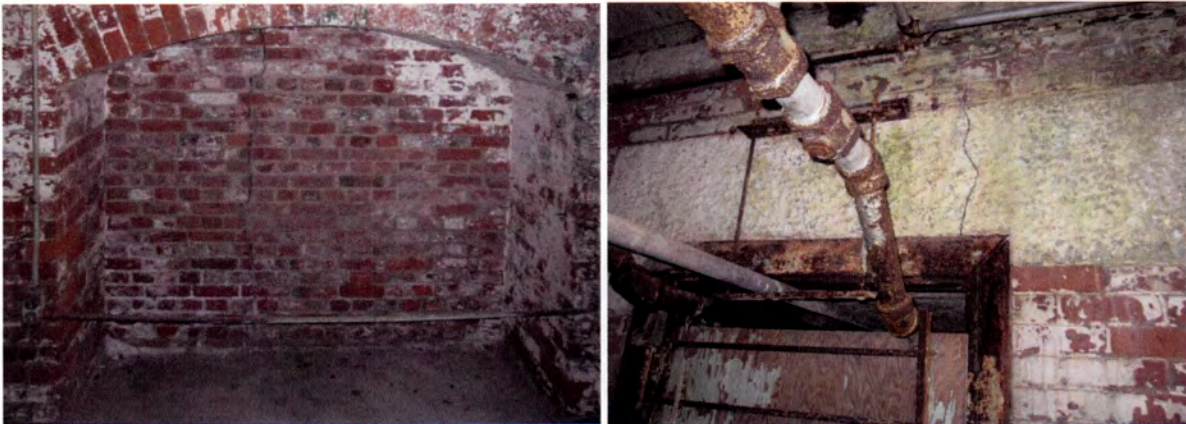
Figure 49: Caption to be included.

The single post that is located in Room 102 is in fair condition, with minor corrosion. (It is unknown why the post is located in this room and not in others). The conditions of the roof beams vary from fair to poor with corrosion present on the beams throughout the structure. The amount of corrosion varies from room to room. Major corrosion with section loss was noted on beams in Rooms 102, 107, 111, 113, 127, 128, 134, 140, and 142 (See Figure \_\_ below). The extent of the corrosion on these beams is not clear as they are mostly encased in brick. Further investigation is recommended to determine the extent of the corrosion and to see if it extends up into the web of the member and into the upper flange. The steel brick arch support on the rear wall, which appears to be an angle or ledge beam, is showing signs of heavy corrosion in Rooms 127, 128, 134, and 140 (See Figure \_\_). The brick arches that span between the beams are generally in good condition with the exception of Room 102, where there is a longitudinal crack running parallel with the steel beams. The crack spans almost the entire width of the room, and may indicate that the beam supporting the arch has been

compromised and that the beam has deflected. Further investigation is required to determine the cause of the crack.

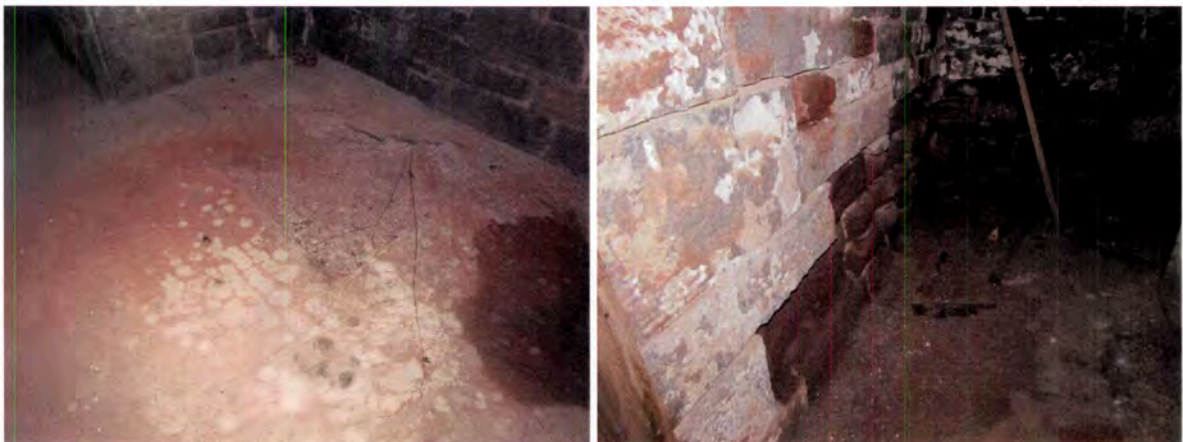
The concrete floors in the corner sections vary from poor to fair condition. There is major water damage in some areas, as well as large cracks, active water and vegetation. In fact, the damage is so poor in Room 112, assessment was carried out from Room 111, as there was major water damage and dangerous conditions. There is also a fair amount of dirt and debris collecting in these corner sections. The brick floors in the corners are in poor condition with cracks, spalling and missing pointing.

*Figure 52: Typical floor conditions of corner sections with water damage and vegetation.*

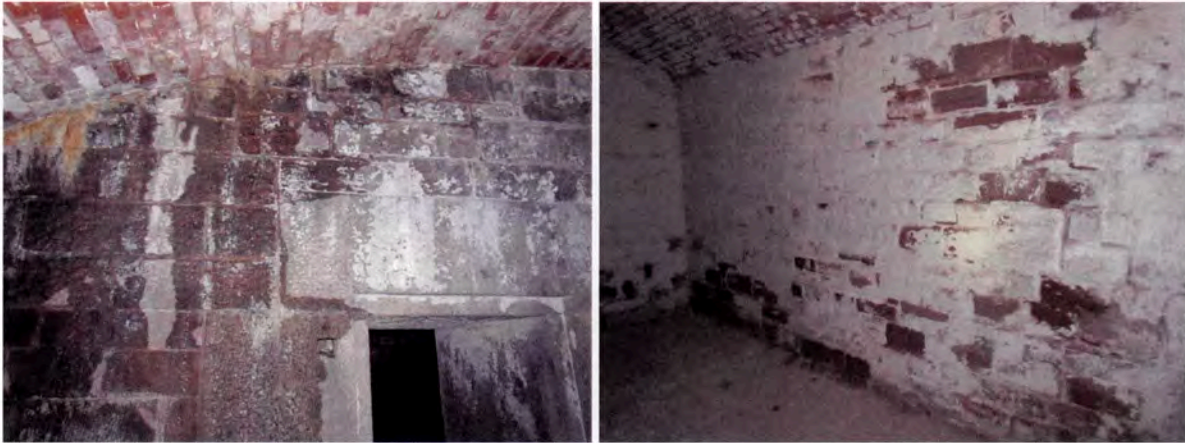
The granite walls in the corner sections of the first floor are generally in poor condition. While the granite itself is in good condition, with some peeling paint, areas of sandstone and brick infill are in poor condition. There is active water, efflorescence, and some areas where the pointing is missing 100%. The sandstone is extremely deteriorated, that there are mounds of dust collecting on the ground. Some of the brick is spalling and there are many layers of paint throughout these corner sections.

*Figure 53: Deteriorating wall conditions of the corners including water damage (left) and fading whitewash (right).*

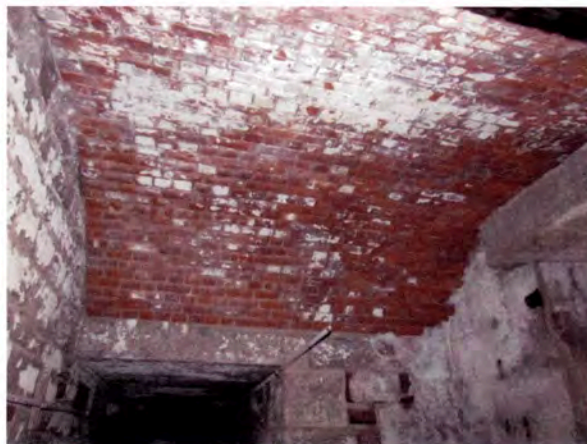
The ceilings in the corner sections are in poor condition. Some of the brick-arched ceilings have heavy parging, and all are missing pointing; approximately 50% of the ceiling in Room 123 will need repointing and Rooms 111, 112, 113A, 124, 125, 136A, 137 and 138 will need 100% repointing. There are pipes and holes in the arch in Room 113A, and the ceilings in Rooms 124 and 125 are spalling and have missing bricks in some areas.

*Figure 54: Typical brick arched ceiling in corner sections.*

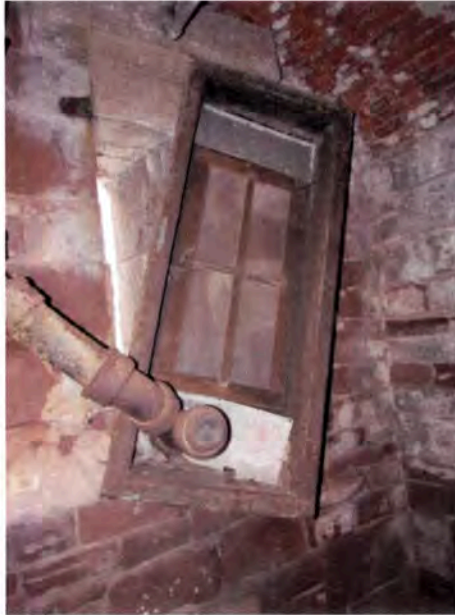
The conditions of the windows in the corner sections vary from poor to good. The steel casement windows are in poor condition, all exhibiting severe rust and missing or broken lights. There are 24 broken lights in Room 113A, five in Room 123, and eight missing in Room 136A. Seven lights are infilled with plywood in Room 113A, and the entire window in Room 126 is boarded up with plywood. In Room 136A, both windows are displaced, and one the metal-framed, four-light window, with metal panels on the top and bottom, has a large pipe installed in the bottom panel. The granite embrasures in Rooms 111, 124, 125, 126, 137 and 138 are in good condition.

*Figure 55: Modified window in corner section of first floor.*

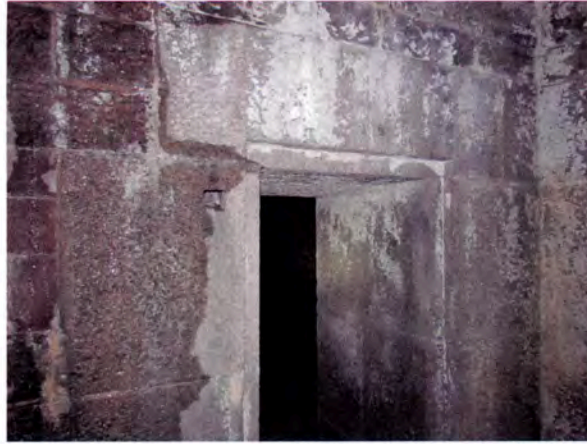
Most of the door openings in the corners are granite doorways similar to the walls. The granite is in good condition, with some water damage in adjacent areas. The wood-paneled door in Room 123 is in fair condition, and is splitting in some places. The paint is peeling and the hardware is rusted. The thick, flush metal door in the corner of Room 125 has been modified to accommodate electrical systems, and is in poor condition; the door and door hardware are rusted. The metal cased opening in Room 126 is in poor condition with severe rusted throughout.

Figure 56: Typical granite doorways in corners of first floor.

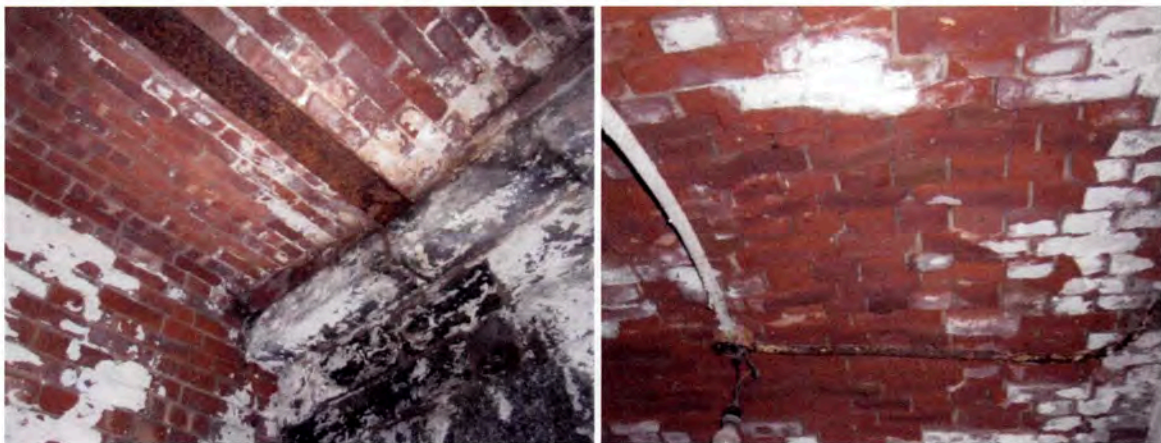
The concrete floors in the corners were in good condition with minor cracking throughout, with the exception of Room 112. When pressure was applied to the floor in Room 112, the floor appears to give, emitting a crunching sound. Further investigation is needed to determine why the floor is deflecting, what is underneath, and how it is supported. In Room 111, there is an active water leak in the roof structure. Also, the steel beam near the entrance to the room is heavily corroded and is exhibiting section loss (See Figure \_\_\_\_). The arched ceiling in Rooms 124 and 137 are exhibiting loss of brick and heavy erosion of the mortar joints (See Figure \_\_\_\_). The arched ceilings in Rooms 123, 125, 137, and 136A are showing signs of erosion in the pointing, extending into the mortar beds.

Figure 57: Rusted beam at entrance to Room 111 (left) and brick loss in Room 124 (right).

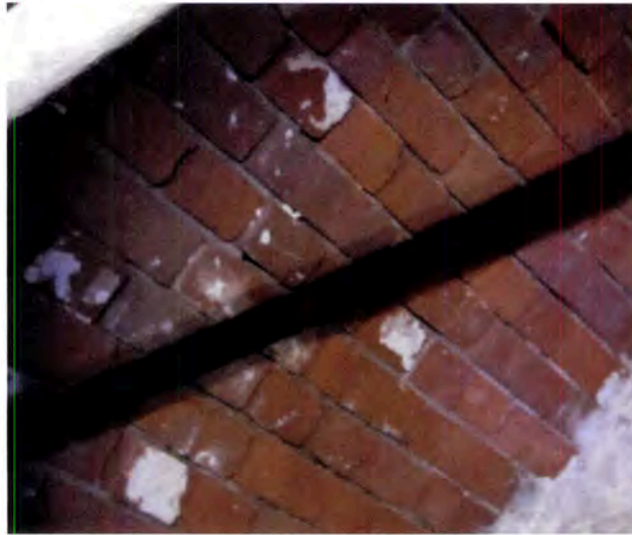
Figure 58: Brick arch with missing pointing in room 136A.

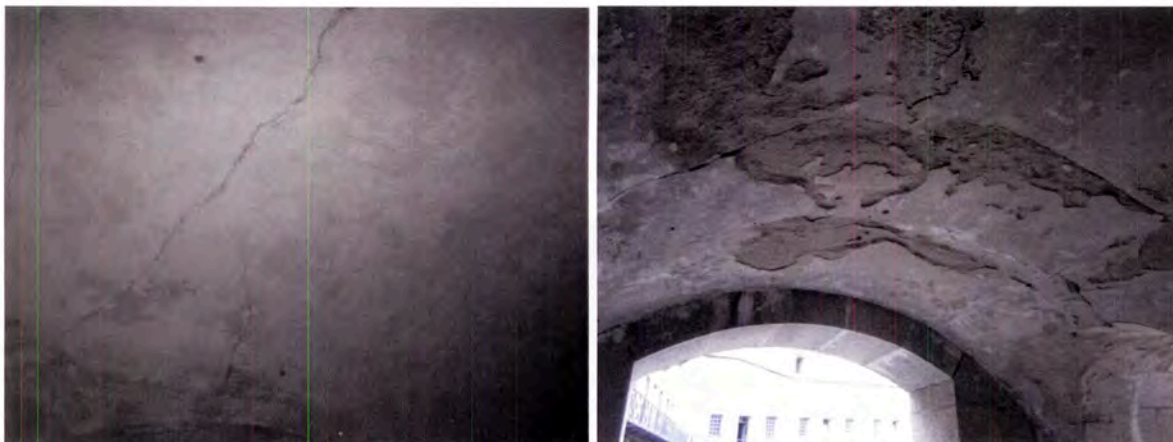
The floors in the sally ports are in fair condition with some minor cracking throughout. The stone walls are in good condition. The concrete barrel is in fair condition with cracks running both perpendicular and parallel to the arches and the concrete is spalling at the north sally port (Room 151).

Figure 60: Crack in concrete roof (left) and concrete spalling (right).

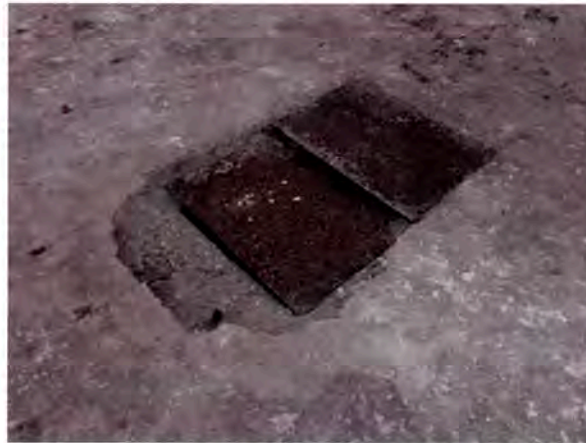
The concrete floors in the east casemates are generally in good condition, but display a wide variety of conditions from one casemate to the next. These conditions range from modern concrete installed in the recent past with minor cracking and chipping in Casemate A to concrete floor with minor spalling and partition scarring in Casemate F. Other casemate floors exhibit large spalls and abandoned plumbing penetrations (Casemate E). Some casemates are full of sand or debris making assessment of the floor condition difficult (Casemates G and O, respectively). In many of the concrete floors, a hole or hatch has been put in the floor to provide access to the flooded basement space below. These openings vary in condition from good, with tight metal frame and hatch, to poor with

concrete damage at the hole and a missing frame and hatch. Some of the holes have been patched with concrete. The plywood floor of the stage in Casemate H is in relatively good condition.

*Figure 61: Hatch in floor with damage to concrete, missing frame and rusted hatch.*

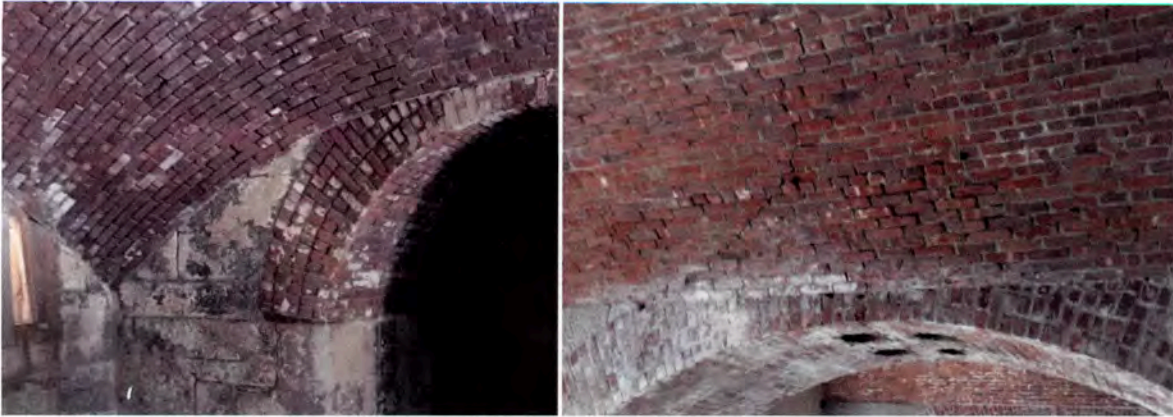
The bricks at the vault ceilings are generally in good condition except for a series of conditions that occur relatively consistently. The mortar joints at the east end of the casemate ceilings are significantly deteriorated, likely due to the amount of water infiltration occurring in these areas. In some locations, the mortar is missing to a depth of over 1 inch. Bricks in this area are often somewhat deteriorated as well. The other area of consistent deterioration is at the large arches that occur at the west ends of the casemates. Similar mortar, and occasionally brick, deterioration is often present with cracking visible as well. This cracking largely follows joint lines, but does cut through individual bricks in some instances.

*Figure 63: Brick and mortar deterioration at casemate ceilings.*

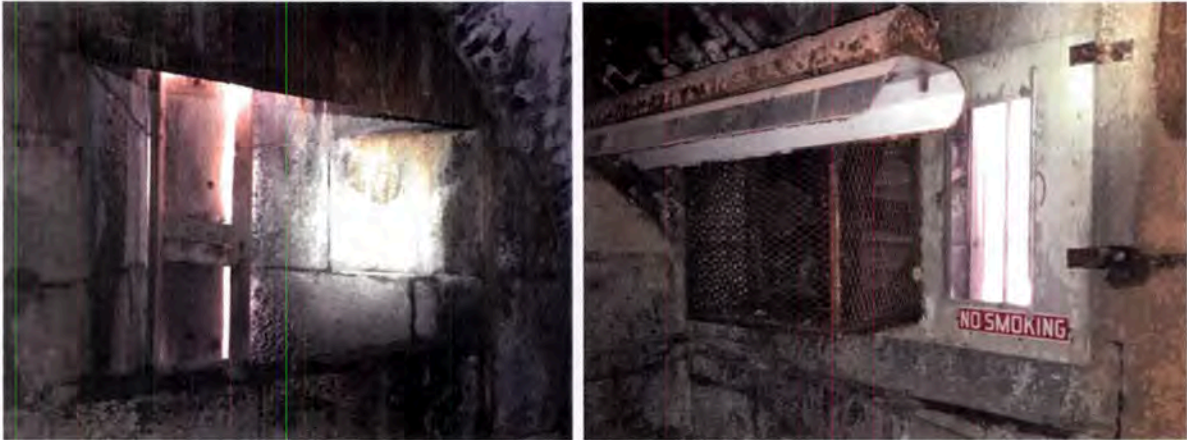
While the above conditions are typical at the east end of the casemates, there are unique examples that are in slightly better condition. Some of the embrasures have been fitted to receive mechanical equipment or covered with plywood and, while in somewhat better condition, are still only in fair to poor condition. Other openings have been fitted with plywood to prevent intrusion or vandalism and are in good condition.

Figure 66: Modern plywood infill at embrasure (left) and older plywood infill fitted with mechanical equipment at Casemate O (right).

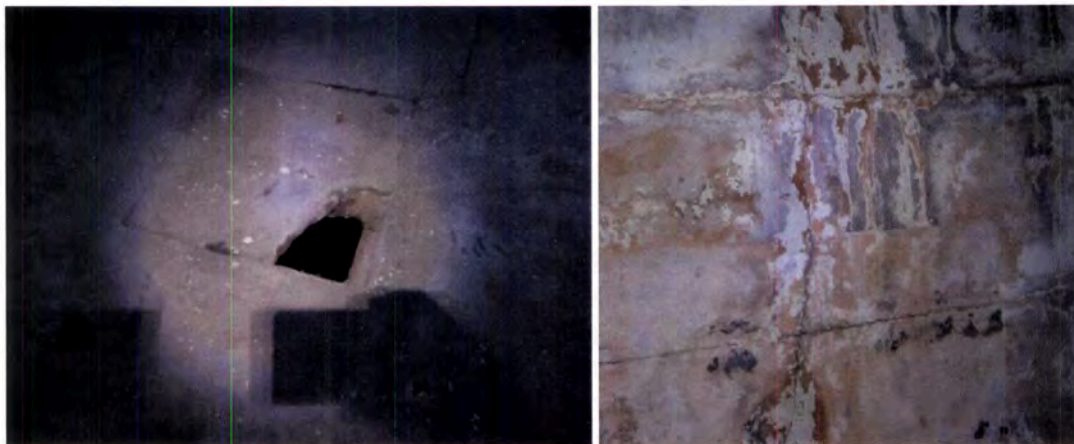
An assessment was not made in Casemates I and J as they were not accessible. In general, the casemates on the east side are in good condition. The concrete floors are in good condition, with only minor cracking noted. There is a hole in the floor towards the east wall in casemates F and N that was likely used as an access panel to the lower level (See Figure \_\_). There is a crack in the east wall of casemate M, and cracking in the CMU wall of the existing men's bathroom outside of casemate E.

Figure 69: Hole in floor in Casemate N (left) and crack in east wall of M (right).

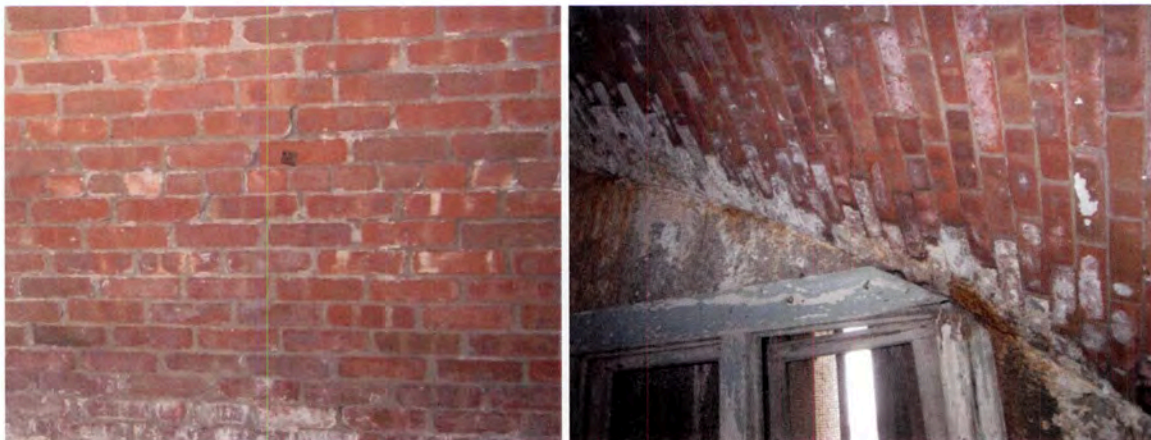
The concrete arches in the casemates vary from fair to good condition. There is minor cracking in the main barrel arch in Casemates A, B, E, H, L and P (rear arch) (See Figure \_\_). Further cracking may be present in the arches, however they were not visible due to the coatings on the barrels. Water intrusion from the roof was detected along the east wall of casemates C, D, E, H and M, (See Figure \_\_). Also, the pointing in the barrel arch has eroded on the east side, between the last opening and the east wall, in casemates A, F, G, and H.

Figure 70: Crack in masonry barrel arch (left) and water intrusion on east wall (right).

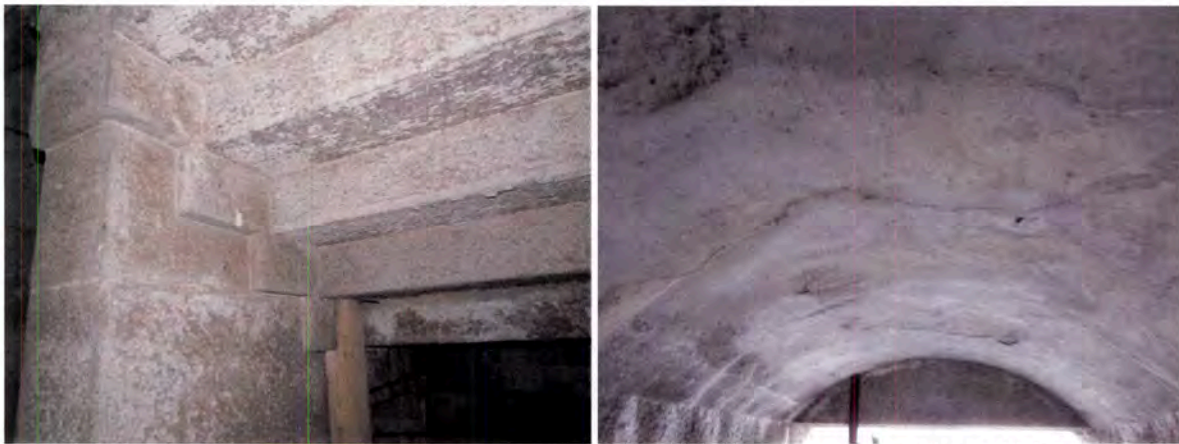
The main staircase structure is in good condition. The stone walls floors appear to be in good condition. There is a non-original wooden post on the northern staircase (See Figure \_\_\_\_). Though unclear whether the post is load bearing, it is in good condition. There are minor cracks in the roof-level barrel arch in the staircases (See Figure \_\_\_\_).

*Figure 71: Wood post in north stair (left) and crack in roof structure on south stair (right).*

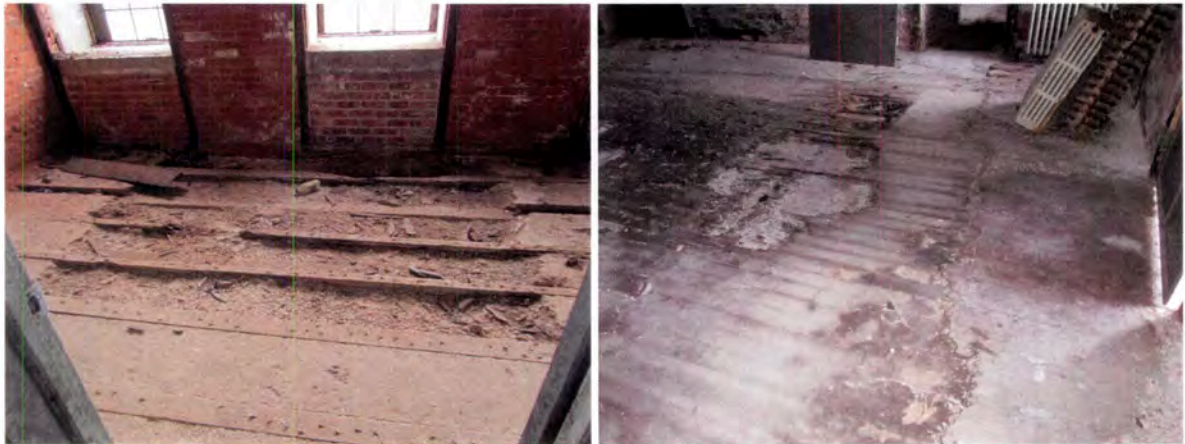
Most of the floors on the second floor are wood, and are generally in poor condition, with the exception of Room 201 where the wood floor is in good condition. Sections of the wood flooring are removed, or not sound. The boards are warping or splitting, the paint is fading or missing completely, and there is water damage and biological growth in several of the rooms. Plywood is installed on top of the wood floors in several locations, and is also deteriorating. In some of the rooms, the wood is completely removed, exposing the joists and nailers that are also damaged.

*Figure 72: Typical floor conditions on the second floor.*

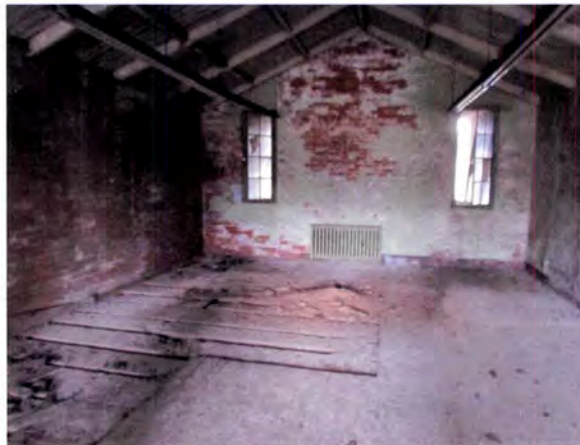
The composite sheet flooring in several of the rooms is also in poor condition as it is warping, bulging, and deteriorating. The brick floors appear to be in fair condition, however this is a large amount of debris obscuring the floor. There is a large amount of dirt and debris throughout the entire second floor. The concrete floor in Room 202 is in good condition.

*Figure 73: Deteriorating wood and plywood floor coverings on second floor.*

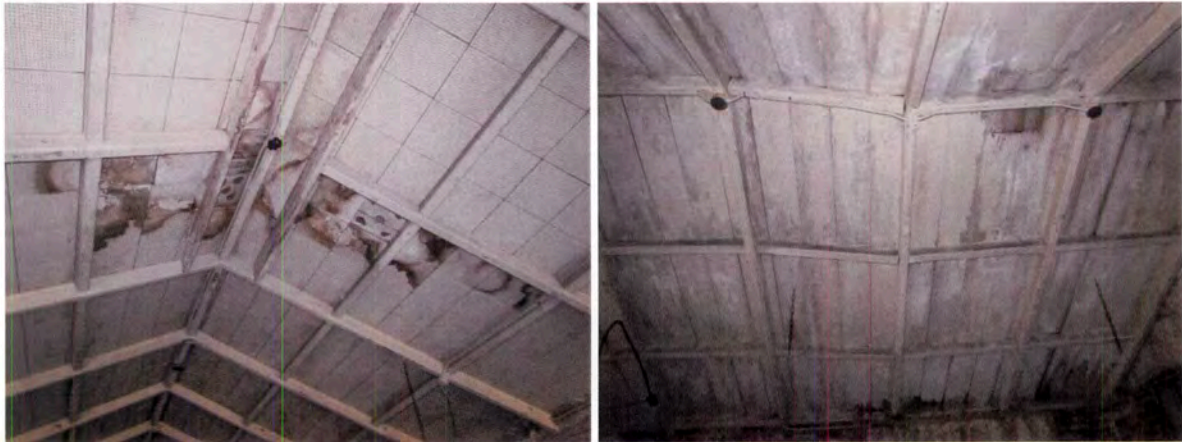
Some of the ceilings have been modified with acoustical or fiberglass tile. Some have been replaced completely, and some have section of tile with the bead board. All of tiled ceilings are in poor condition; sections are missing or sagging, and there is significant water damage throughout. The plywood and batten ceiling in Room 201 is also in poor condition with significant water damage, holes, and deteriorating paint. The brick arched ceiling in Room 232 is in fair condition with some water damage.

*Figure 76: Water damage in acoustical ceiling tile (left) and sagging bead board and exposed wood rafters (right).*

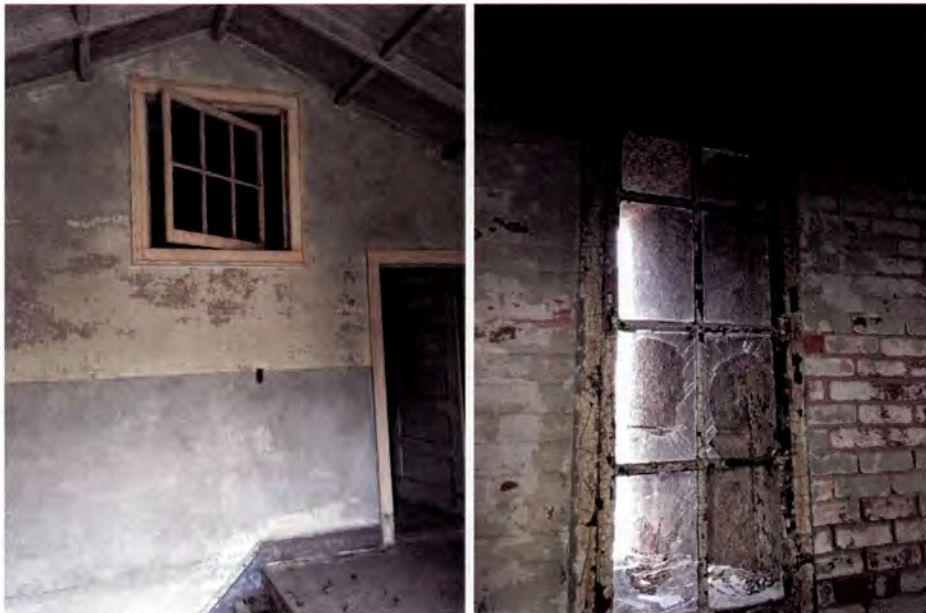
The windows on the second floor are generally in poor condition. The eight-light steel casement windows have broken or missing lights. Some windows have broken or missing glass in every single

The three six-light pivot casement windows in Room 218 are in fair condition with three broken lights and a large amount of peeling paint. The six-light pivot casement windows in Room 222/222A are in good condition with fading paint.

*Figure 78: Pivot casement window (left) and typical eight-light steel casement window (right).*
