FORT TOMPKINS  
GATEWAY NATIONAL RECREATION AREA

*Historic Structures Report*

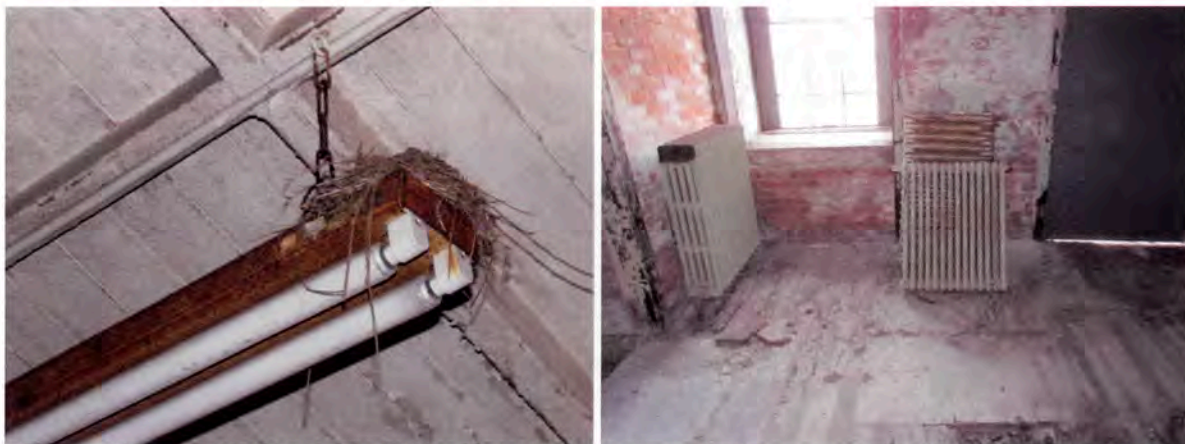
Most rooms have at least one radiator, some have two or three. The radiators are no longer in use, some are disconnected and all are extremely rusted. There is a cast iron waste vent in Room 206 that is in poor condition.

*Figure 80: Rusty suspended fluorescent light fixture with bird nest (left) and typical conditions of radiators (right).*

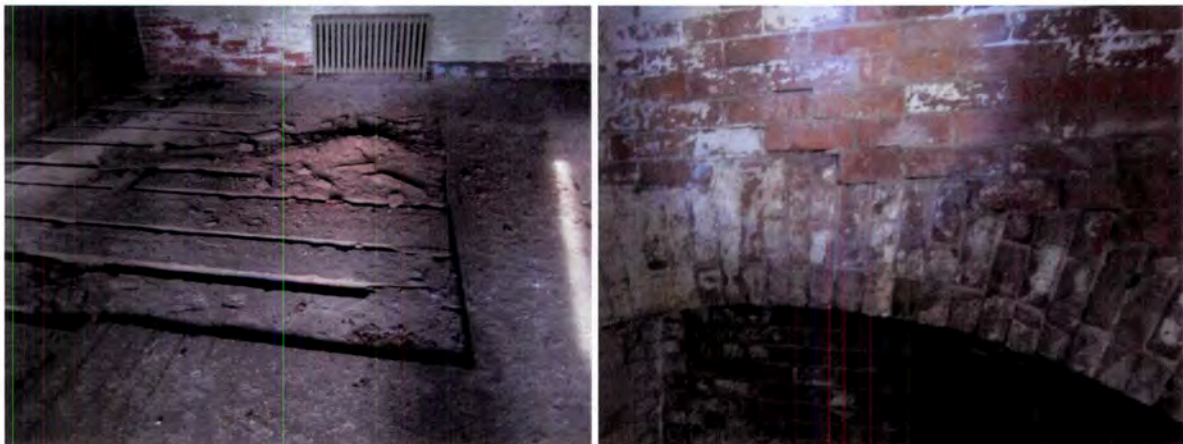
The walls of the upper floors are in fair condition, with some missing pointing in Rooms 213, 220, and 223. There are cracks in the brick walls separating fire places, similar to the first floor (See Figure \_\_\_\_). The door jamb between Rooms 202 and 203 is broken, with missing bricks (See Figure \_\_\_\_). Two interior brick walls are out of plumb: the wall between Rooms 223 and 224, and the wall between Rooms 229 and 230(See Figure \_\_\_\_). There are also holes in the mortar in the wall between Rooms 229 and 230, extending back into the wall. It is unknown why the walls are bowing; further investigation is required to determine the reason for the out-of-plumb walls, and to determine if any major structural issues are present given the extent of the condition. Finally, there is a large amount of pointing grout missing, and it is unclear how much load from the roof is being supported by the wall. Currently the roof structure does not appear to be in distress.

Figure 81: Deteriorated floor (left) and crack above fire place (right).

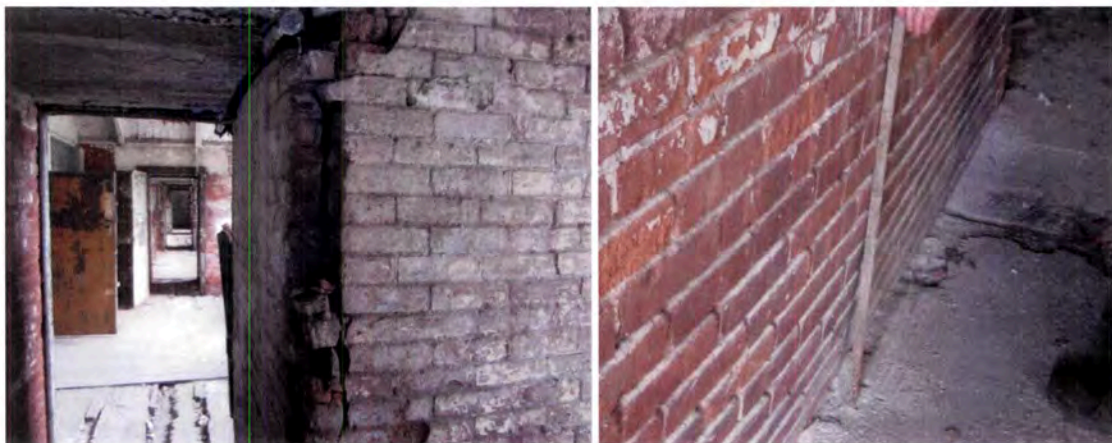
Figure 82: Broken door jamb (left) and bowing wall (right).

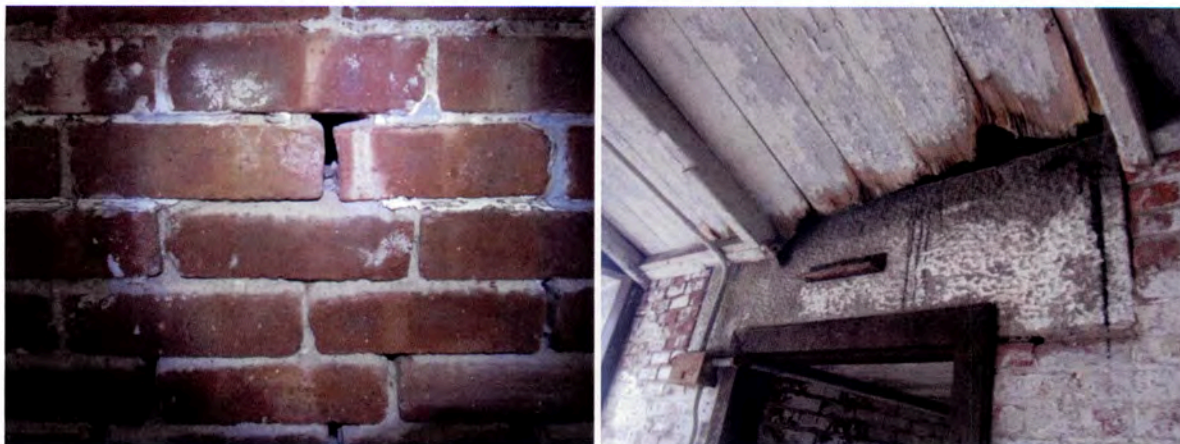
*Figure 83: Missing mortar in bowing wall (left) and failed roof purlin bearing (right).*

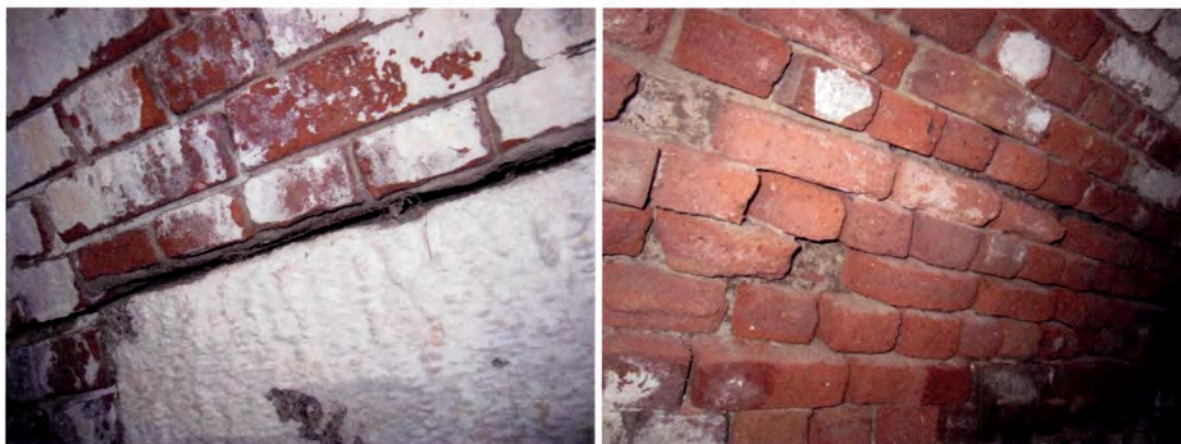
There are cracks in the arched brick roof structures in Rooms 237 and 238, as well as missing mortar and deteriorated brick in the ceiling in Room 238 (See figures \_\_ and \_\_). The stone walls and arched brick ceilings in Rooms 239 and 240 appear to be in good condition, with minor cracking in the concrete floors. There is also some efflorescence on the ceilings of these rooms and a large longitudinal crack in the ceiling in Room 235 (See Figure \_\_). The roof structure in Rooms 233 and 234 appear to be in good condition, with some efflorescence in the ceiling. Finally, there is a crack in the rear wall of Room 233.

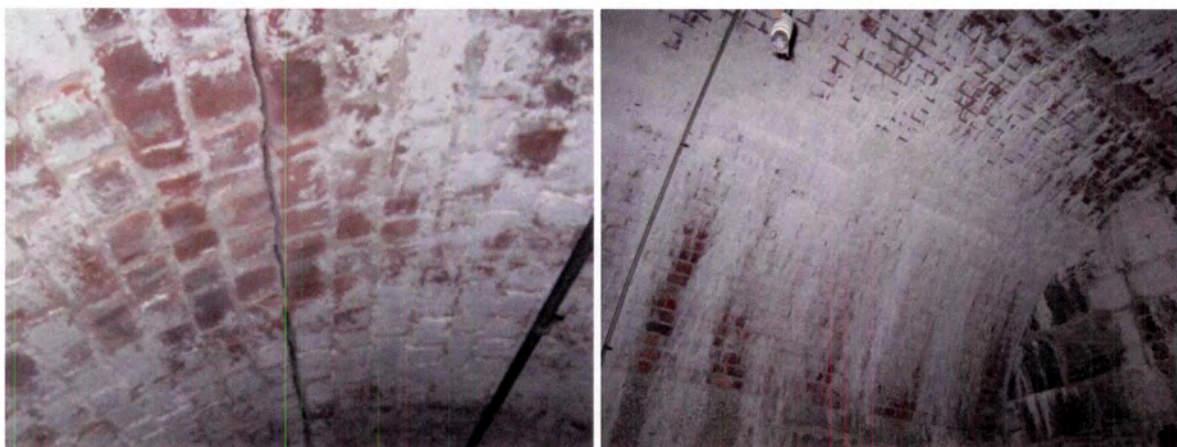
*Figure 85: Crack in roof of Room 235 (left) and efflorescence in Room 233 (right).*

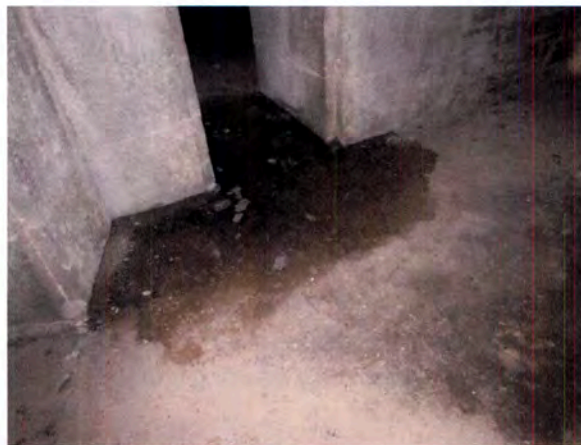
The conditions of the floors in the second floor corners vary from poor to fair. There is debris obscuring some of the concrete floors, however they appear to be in fair condition with some cracking and some standing water. The brick and ceramic tile is also obscured, and their condition aren't clear, however the ceramic tile appears to be in fair condition. Finally, the composite sheet flooring is in poor condition; it is deteriorating, cracking and sections are missing.

*Figure 87: Water damage on concrete floor in corner section.*

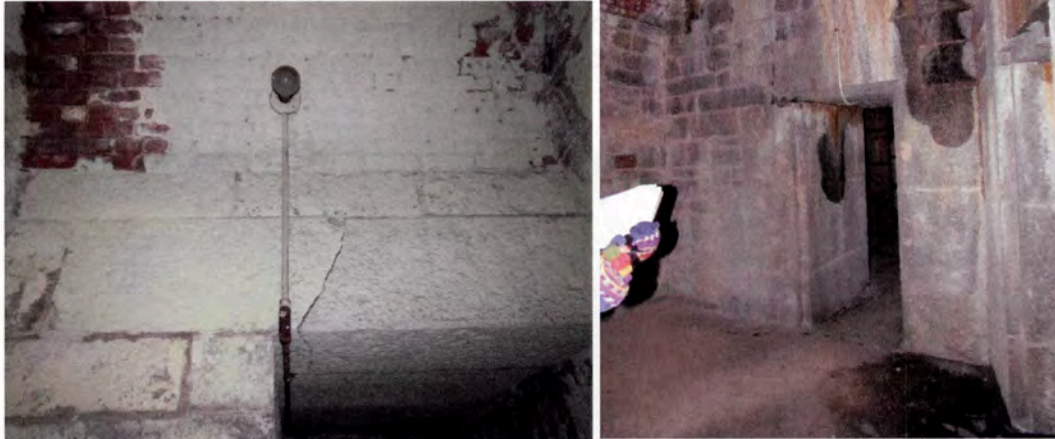
The condition of the walls vary from poor to good. Section of the granite walls are in fair condition, while others are in poor condition exhibiting efflorescence, missing pointing, and severe water damage (in the northwest corner of the fort). In one area, there is an active leak, with severe water damage and rust that carries through the granite wall to the room on other side. There is at least one crack in the granite, and some deteriorating mortar in these areas.

*Figure 88: Crack in granite and deteriorating paint (left) and severe water damage on granite walls (right).*

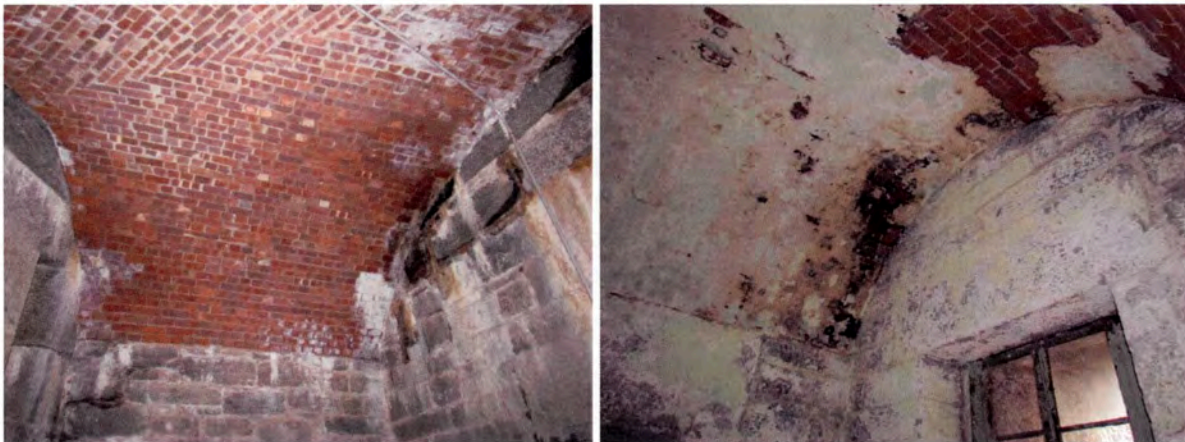
The ceilings in the second floor corners are generally in poor condition. The brick arched ceilings (some with parging) are generally in poor condition with water damage, active leaks, mold and biological growth. Approximately 50% of the pointing is missing in these areas, the paint is peeling and there is efflorescence throughout. The plaster ceilings are also in poor condition with cracks and peeling paint throughout.

*Figure 89: Typical brick ceilings in corners with evidence of water damage.*

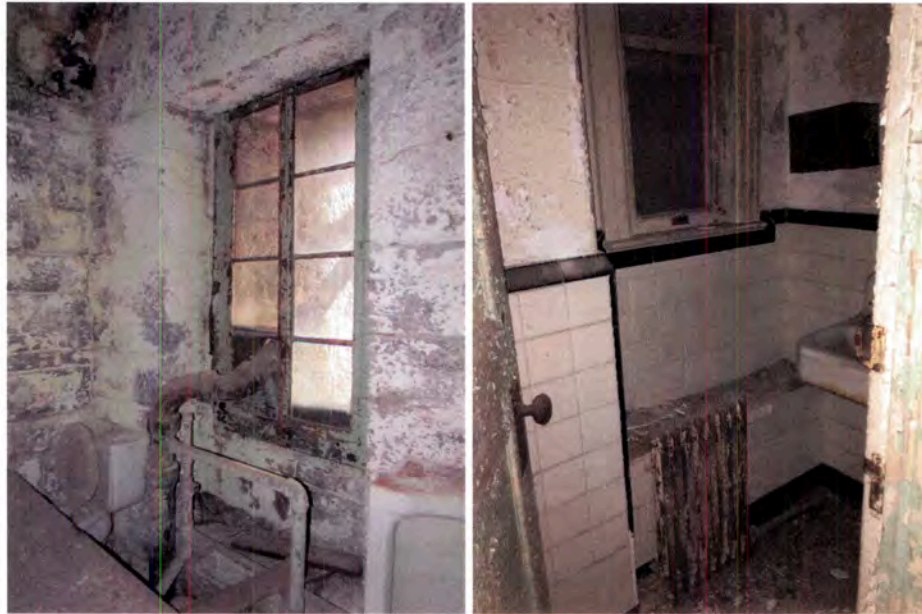
The steel French casement windows are in poor condition. There are three sets, each with three lights, and twelve of the lights are broken. One of the lights has been modified with plywood and a waste pipe is installed. The steel frames are rusted and the paint is deteriorated and peeling throughout. The single-light, double-hung window is in fair condition with peeling paint on both sash. The embrasures in the corner sections are in good condition; two have been infilled with brick on the exterior of the opening.

*Figure 90: Modified French casement window (left) and one-over-one double-hung window (right).*

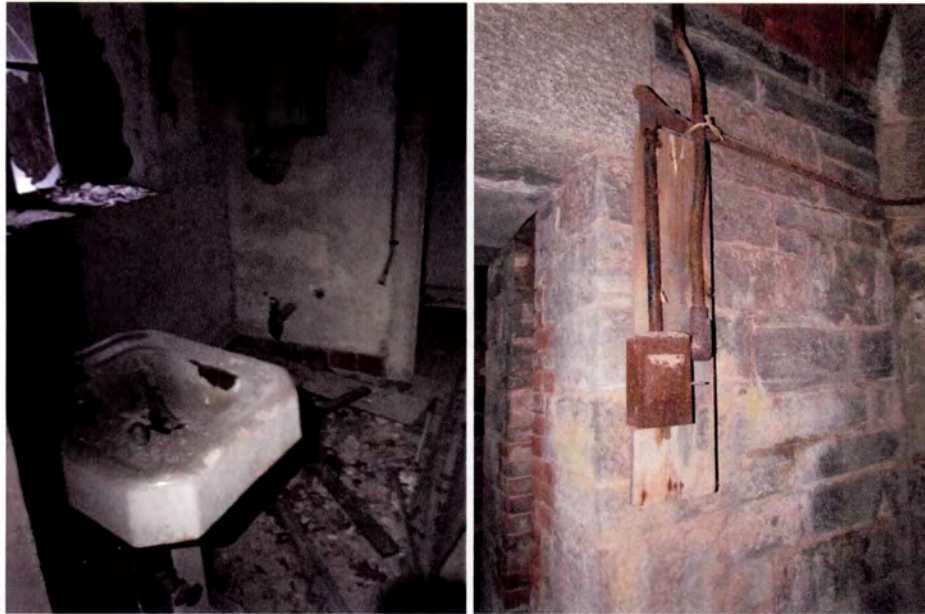
The systems in the corner sections are generally in poor condition. The conduit and electrical boxes, are extremely rusted and the junction boxes are rusted, missing fixtures and detaching from the walls. The light fixtures, including suspended fluorescent lights and wall mounted sconces are rusted and missing fixtures. The plumbing fixtures including lavatories, water closet and urinals are rusted, dated and dirty, and the radiators and floor drains are also rusted.

*Figure 92: Typical plumbing and electrical systems.*

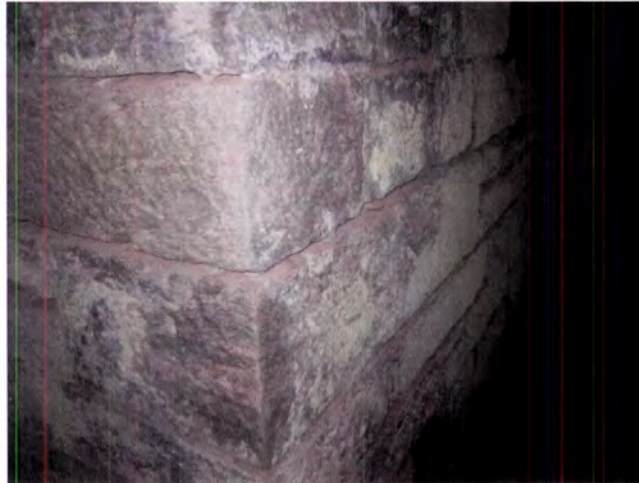
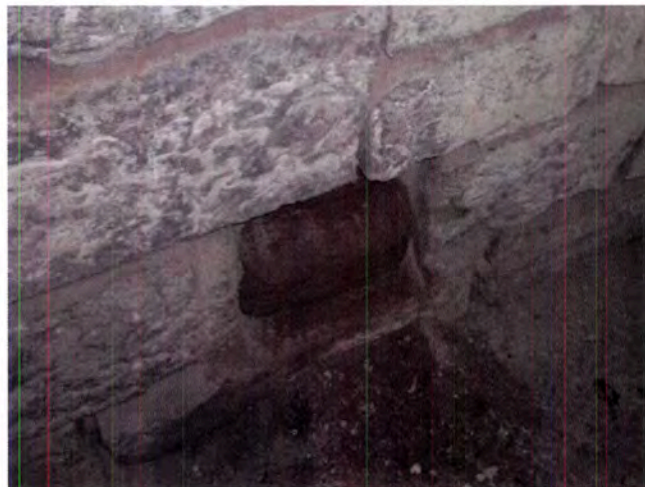
Rooms 206B, 206C, 217, and 217A were not accessible at the time of the assessment due to the condition of the upper walkway. The walls in the corners are in good condition with some minor repointing needed in Room 216 along the west wall and in Room 227A (See figure \_\_\_\_). There are areas of sandstone infill, showing signs of deterioration (See Figure \_\_\_\_). A leak in the roof was visible in Room 226B; the roof structure needs to be repointing in Rooms 206A, 226B, and 227A.

*Figure 93: Pointing missing in wall (above) and deteriorating sandstone (below).*

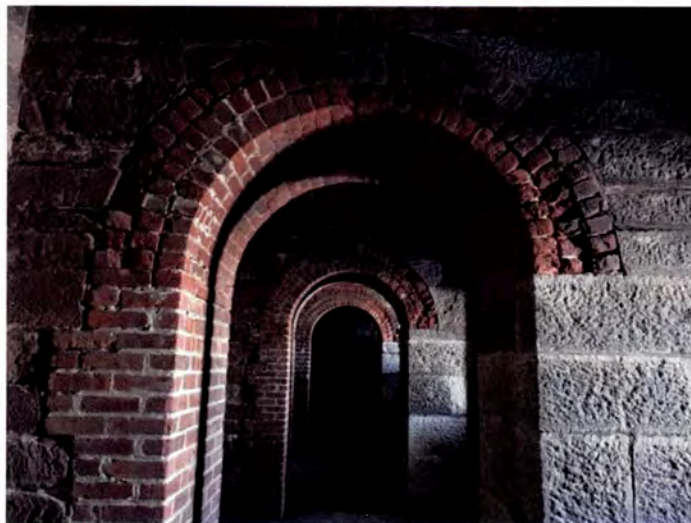
The bricks at the vault ceilings are generally in better condition than many of those found at the walls, but the mortar is frequently worse. Outsized areas of mortar joints have experienced large degrees of mortar loss. Efflorescence is significantly more pronounced at the ceilings.

*Figure 96: Brick and mortar deterioration at the northeast "tail" of the counterscarp.*

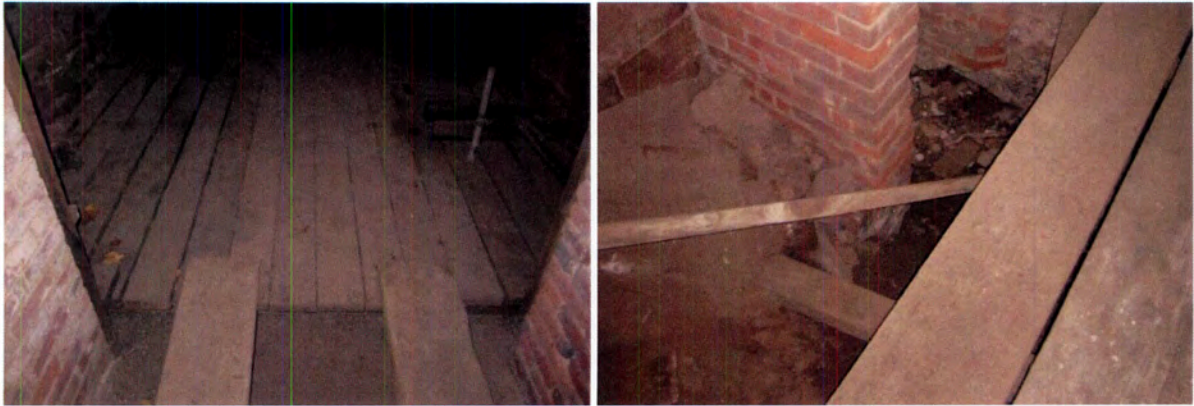
In general, the counterscarp is in good condition and the dirt floor is mostly consistent. The wooden platform in C144 is in fair condition, showing some signs of deterioration (See Figure\_\_). In C145, the soil has been removed, with two wooden boards extending over the excavation (See Figure \_\_). The boards deflect heavily when weight is added, and they are not designed to take pedestrian loads.

*Figure 99: Wooden platform (left) and excavation of Counterscarp (right).*

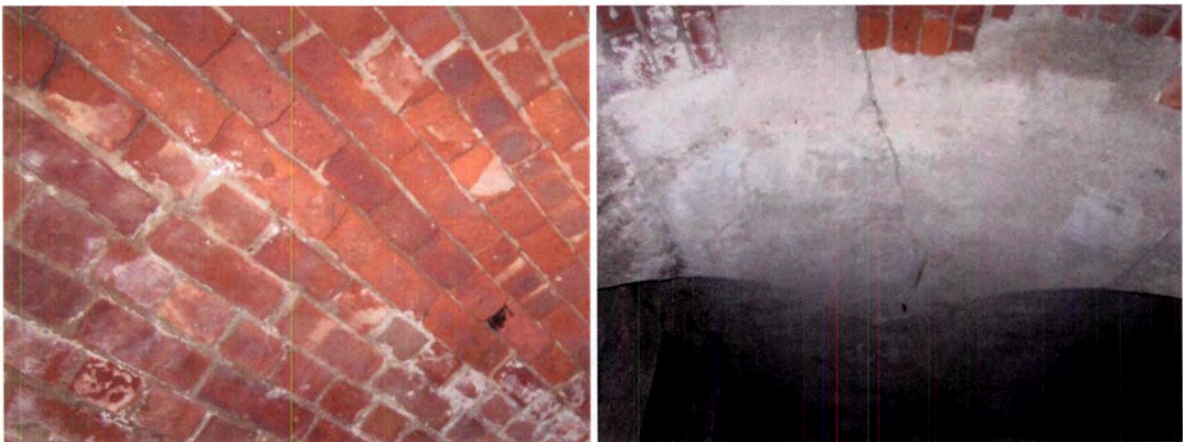
In the entrance to the counterscarp (Room 158), there are signs of erosion in the brick, pointing and mortar bed (See Figure \_\_). There is a longitudinal crack on the south side, running parallel with the barrel roof (See Figure\_\_).

*Figure 101: Erosion to brick / mortar (left) and crack in barrel (right).*

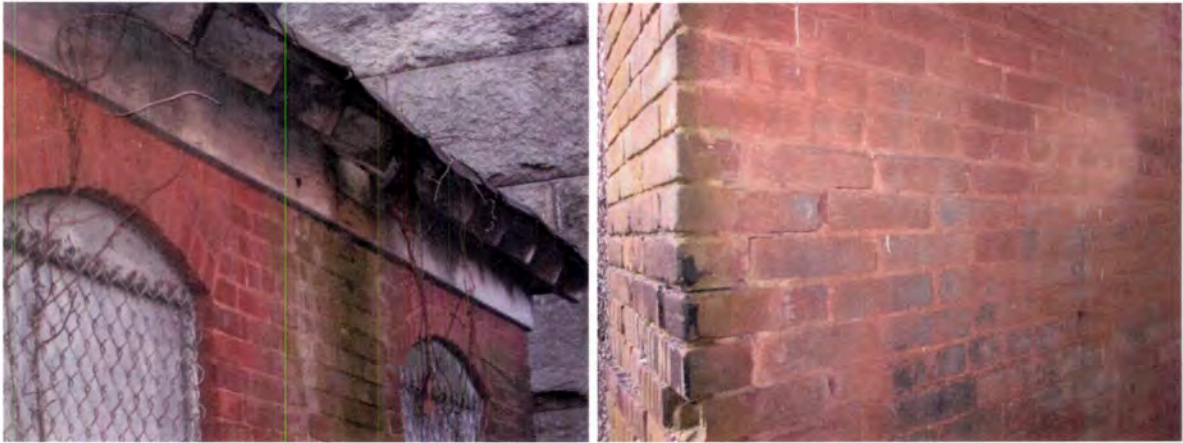
Building 138 is generally in poor condition. The exterior brick walls are in fair condition with some cracking, staining, missing bricks (east elevation), and deteriorating or missing pointing throughout. There is a crack in the stone foundation on the east elevation, and there is abandoned hardware, holes in the brick, a pipe (sealed with cement) protruding from west elevation. Other conditions include efflorescence stains, graffiti and mastic material throughout the structure, and piece of wood attached to the bottom west corner of the north elevation.

The roof of Building 138 is in poor condition. There are two large holes: one on the east elevation near the fascia, and one on the west elevation, with several missing shingles. The rafter tails and fascia are in fair condition with areas of fading and peeling paint, vegetation, and biological growth, and there are pipes and wires protruding from the fascia. The chimney is also in fair condition with cracks and missing pointing, and vegetation atop the structure. The copper brackets on the north side of the chimney are rusting and partially detaching.

*Figure 102: Stains on masonry below damaged roof and fascia (left) and stepped crack in masonry (right).*

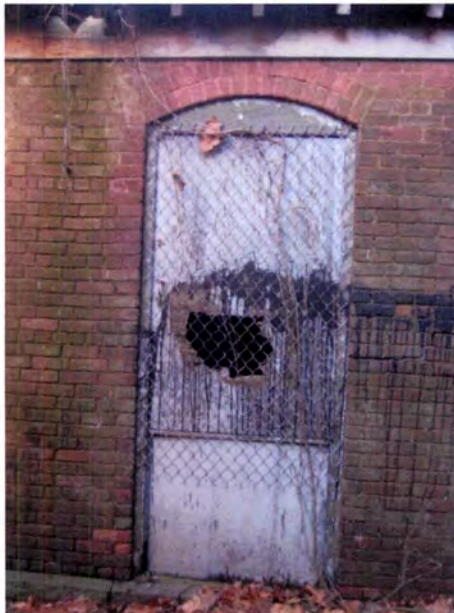
hardware is rusted. The door on the north side is infilled with plywood and chain link, and there is a large hole in the center of the door (this door has been partially infilled on interior for a window).

*Figure 103: Large hole in plywood infill and paint stains on masonry of north elevation.*

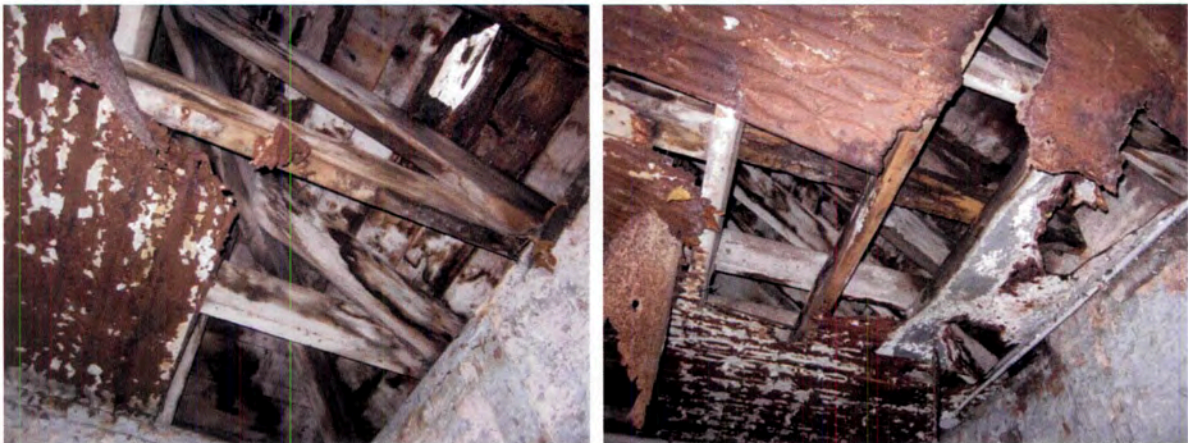
The exterior brick walls for Building 138 are in fair condition with minor cracks throughout. There are interior and exterior diagonal cracks in the northeast corner (See Figure \_\_\_\_). The structure does not appear to be in distress, however the crack should be monitored as it could be caused by a foundation settlement issue, and it is possible there are other structural issues. The roof is in poor condition; there are multiple holes in the roof, allowing moisture to penetrate, and in some areas the roof trusses are showing signs of deterioration and will likely need to be replaced (See Figure \_\_\_\_). The ceiling under the trusses is also heavily corroded and missing in some areas (See Figure \_\_\_\_).

*Figure 106: Holes and deteriorated wood in roof of Building 138.*

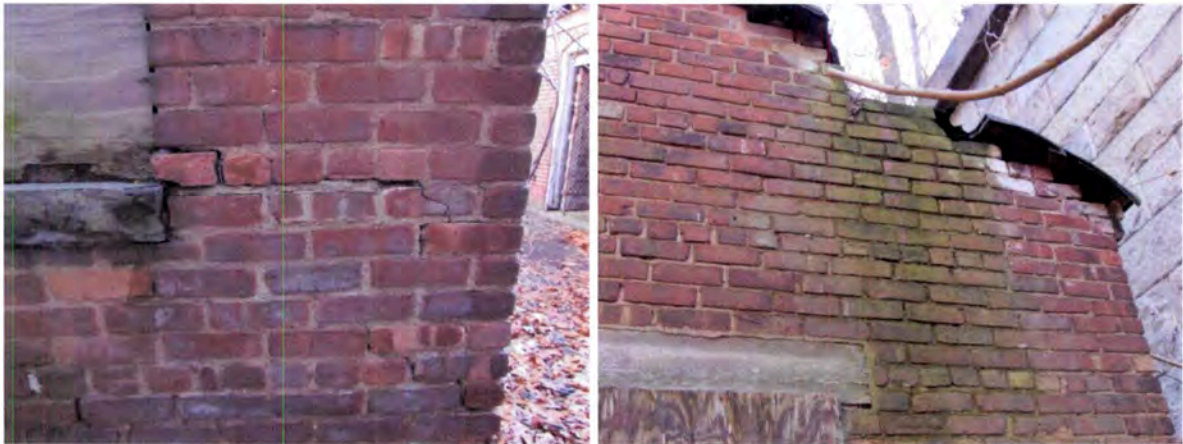
Building 139 is generally in poor condition. The condition of the bricks walls vary from poor to fair. On the west elevation, there are cracks next to and under the windows, and there is minor spalling and broken bricks in the corners of the structure. On the south elevation, some of the bricks are spalling near the door jambs and to the west of the window, and there are several minor cracks with broken bricks. There is moderate biological growth on the south elevation and severe biological growth on the east elevation, especially near the foundation and where the roof is missing. There are cracks and minor spalling throughout, as well as peeling paint. The north elevation is exhibiting mild efflorescence and brick spalling, and there are three cracks around the windows with a loose brick at one of the window jambs. The pointing on the structure is generally in fair condition, likely requiring 20% repointing throughout, however the pointing on the east elevation is in poor condition and will likely require at least 70% repointing. It is evident that some previous repairs and spot pointing on the exterior walls occurred at one time.

The wood elements on Building 139 are in poor condition. On the west elevation, the cornice and rakeboard are deteriorated, especially in northwest corner. There is severe vegetation on the fascia board, the paint is deteriorated, the ends are rotting on the north elevation, and it is partially missing on the east elevation. The roof is in poor condition, with large sections of shingles and rafters missing.

*Figure 107: Stepped crack in masonry (left) and missing section of roof causing deteriorating conditions on the masonry (right).*

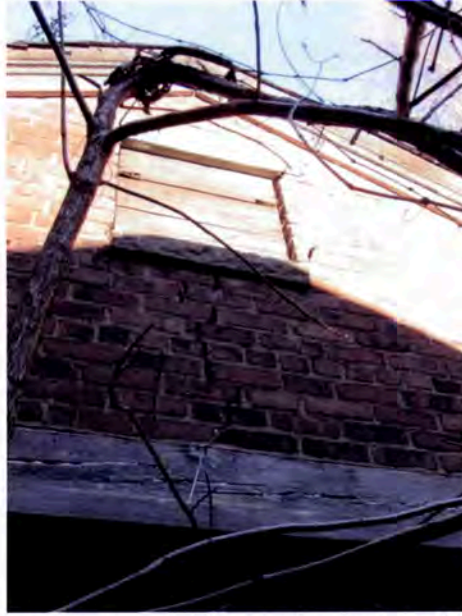
*Figure 108: Large masonry crack between fenestrations of Building 139.*

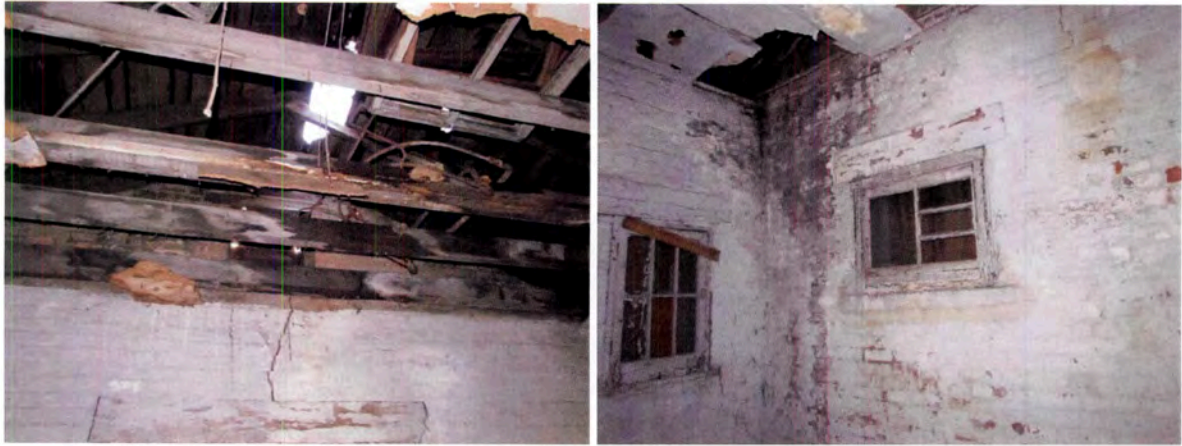
*Figure 109: Hole in roof and deteriorating wood rafters (left) and overview of the interior of Building 139.*

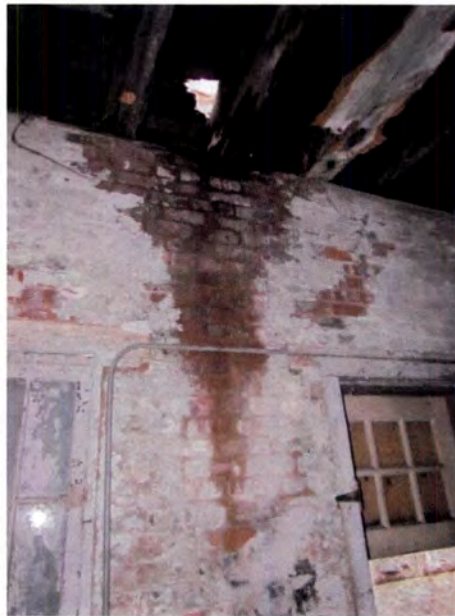
*Figure 110: Hole in roof and water stains on brick interior wall.*

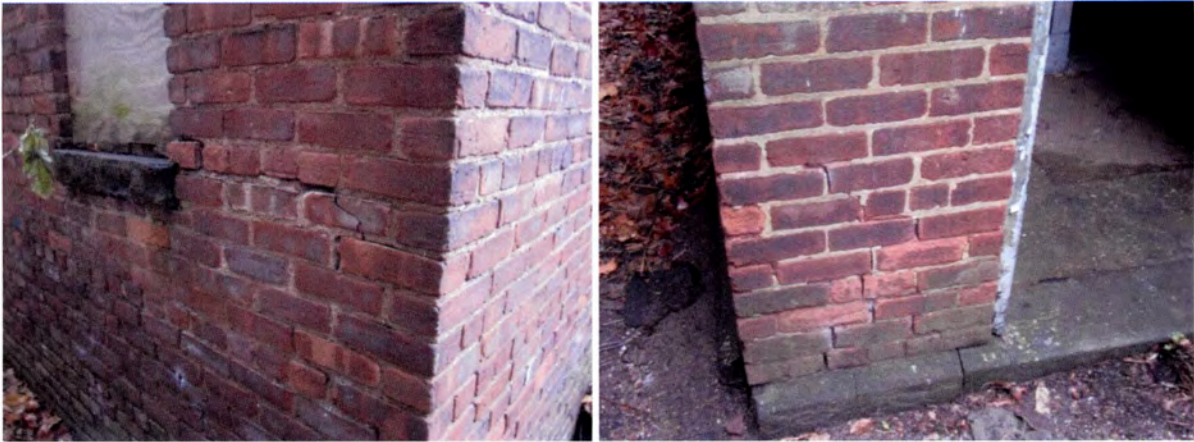
The condition of Building 139 is similar to Building 138. The exterior brick walls are in fair condition, with minor cracking in the northeast and northwest corners, which do not appear to be major structural concerns (See Figure \_\_). There are multiple holes in the roof, leading to areas of deterioration on the trusses (See Figure \_\_).

*Figure 111: Cracks in masonry in northeast corner (left) and northwest corner (right) of Building 139.*

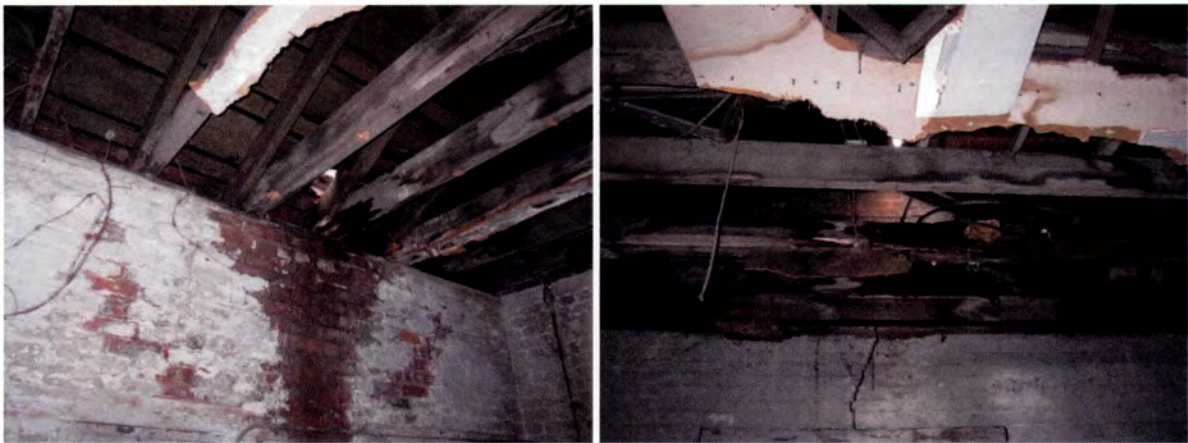
*Figure 112: Deteriorating wood trusses in Building 139.*
