# Glacier Bay Lodge Complex Historic District

## *Historic Structure Report*

Glacier Bay National Park and Preserve, Alaska

2018

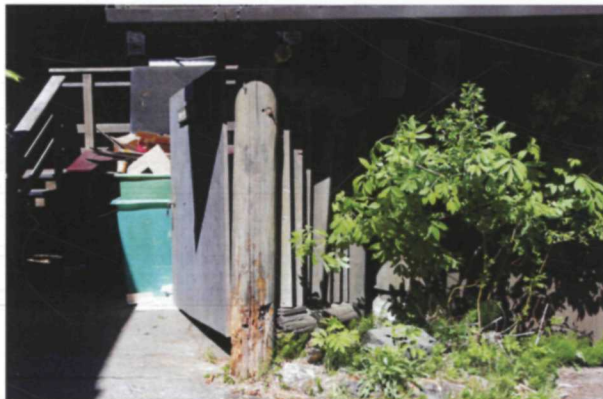
Vegetation, including grasses and shrubs, is growing at the base of the south elevation of the addition (Figure 145). This vegetation is supporting the retention of moisture in the wood building materials, and is responsible for the presence of green mold on the addition and structural damage to the post in the southwest corner (Figure 146).

Figure 145. Vegetation against building, May 2017.

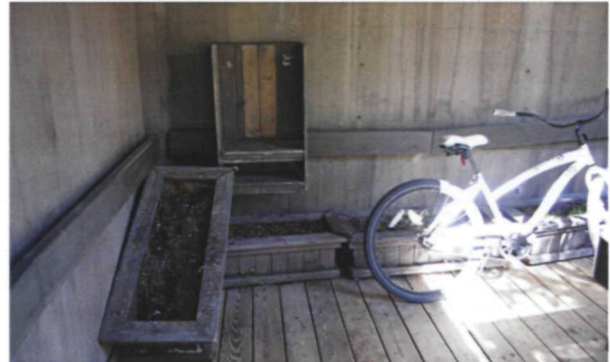
on the ramp, against the building, creating a habitat for moisture retention (Figure 147). Although there is no significant damage at this point in time, continued storage in this location will lead to moisture damage. Similarly, the area west of the 1984 addition is heavily used by the concessions kitchen staff. There are many concession items and related utilities affixed and/or resting against the wall.

Figure 147. Flower boxes stored against lodge, May 2017.

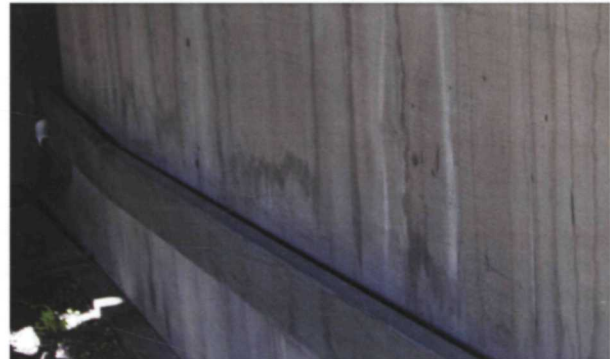
that pre-dates the 1984 modifications to the building runs continuously on the south elevation; this was caused by regular friction with benches that were lined up against this elevation in the 1970s (Figures 148 & 149).

Figure 148. Mark across south elevation, May 2017.

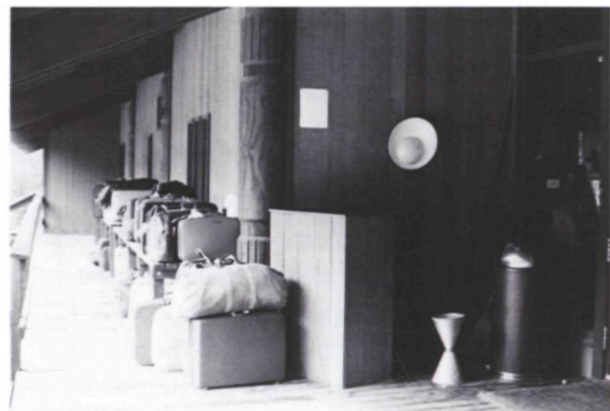
Figure 149. Enclosed wall left of luggage, photographed by Judy Ayers, circa 1976 (GLBA Archives, Box GLBA 00491, Folder 17, Photo GLBA 6012).

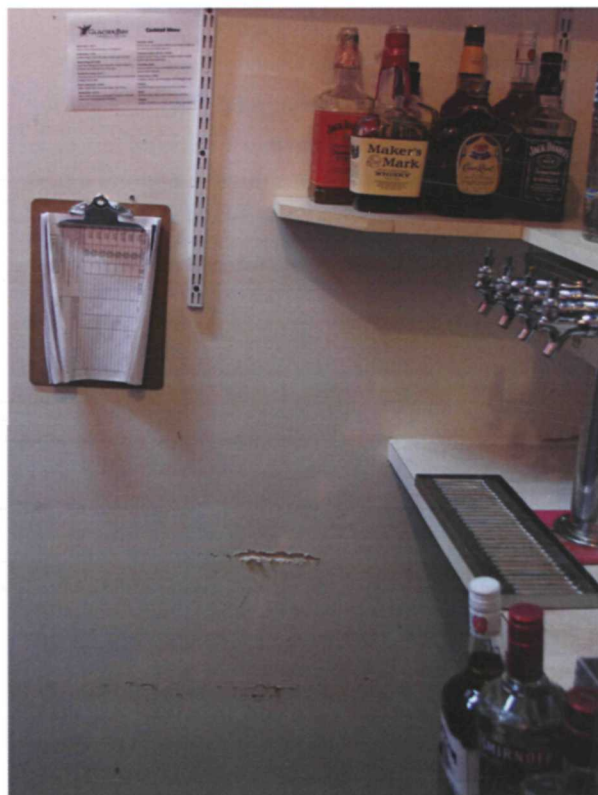
The private dining room, adjacent offices, service area, and kitchen are high traffic areas, and as a result, there are scratches, markings, remnants from a spilled liquid, and in some instances, material loss (Figures 151 & 152).

Figure 151. Cut in gypsum board in office wall, May 2017.

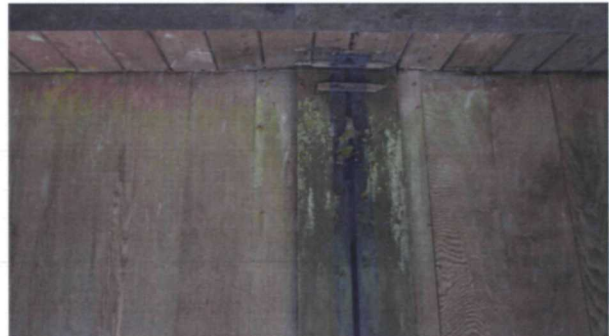
On the rear of several cabins, metal screens are used for bat abatement between paired battens. On the south elevation of Cabin 51-52/U3, the carcass of a bat is stuck in the netting, and a biological substance surrounds the area (Figure 160). At the time of this assessment, there was no evidence of bats inside the buildings.

Figure 160. Metal screen for bat abatement with biological substance, March 2017.

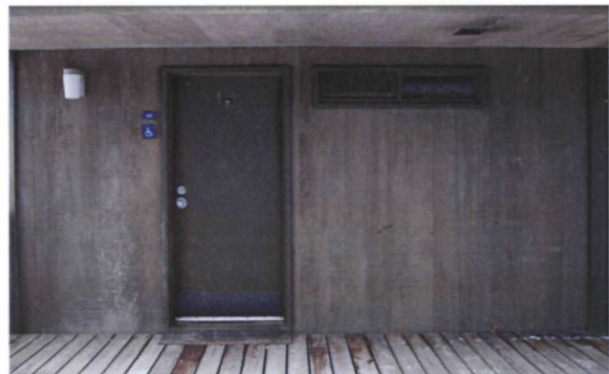
A burst pipe beneath the boardwalks between Cabin 55-56 and Cabin 53-54 resulted in the backsplash of mud over south elevation of Unit 54 and the north elevation of Unit 55 (Figure 161).

Figure 161. Mud backsplash on cabin, March 2017 wall cut

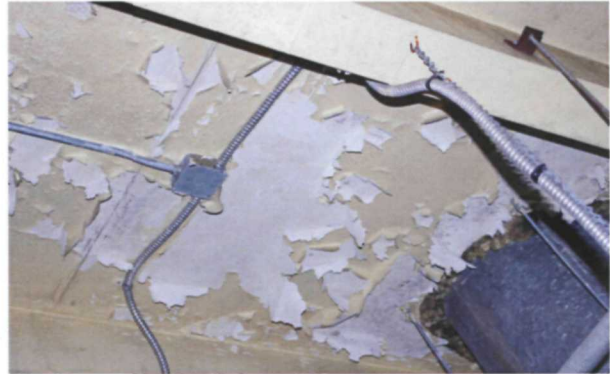
Due to a high concentration of moisture with limited ventilation in the utility rooms, black mold covers all surfaces of the interior (Figure 165). Utility panel are rusted. Paint is severely chipping and/or cracking and likely contains lead (Figure 166). It is recommended that a certified lead abatement specialist test these rooms.

*Figure 166. Paint peeling on utility room ceiling, March 2017.*

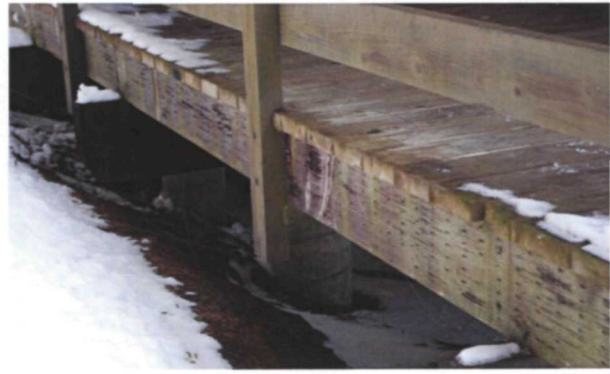
Several areas of the boardwalks have been recently replaced. Those areas that have not been replaced are in fair condition. The decking surrounding the lodge building has been affected by cellar rot. Much of the decking and boardwalks throughout the district are covered in mold (Figure 167).

*Figure 167. Mold on boardwalk, March 2017.*

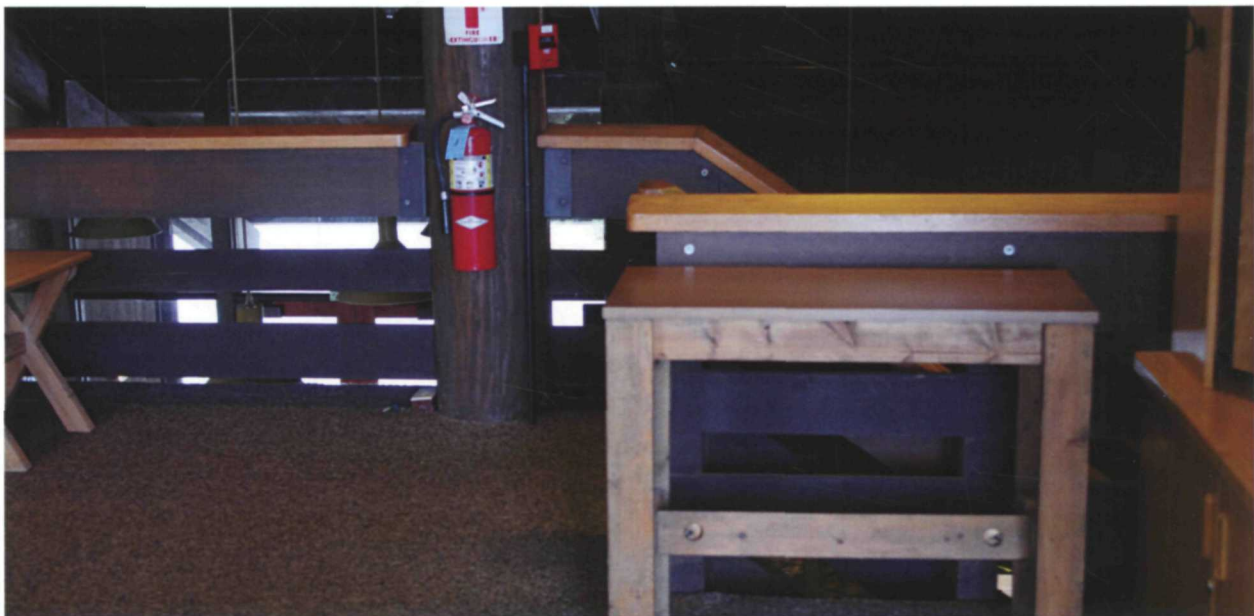
Figure 168. Railing on southeast corner of mezzanine room, May 2017.

- Restore second floor mezzanine room to the 1970-1975 period (see Figure 33)
  - Remove non-historic partition wall, which measures 32'-7" x 15' across the south end of the main mezzanine room
  - Remove the non-historic 17' x 32'-7" southwest corner of the main mezzanine room
  - Install railing along south end of restored mezzanine room to match existing railing on southeast corner of room (see Figure 168)

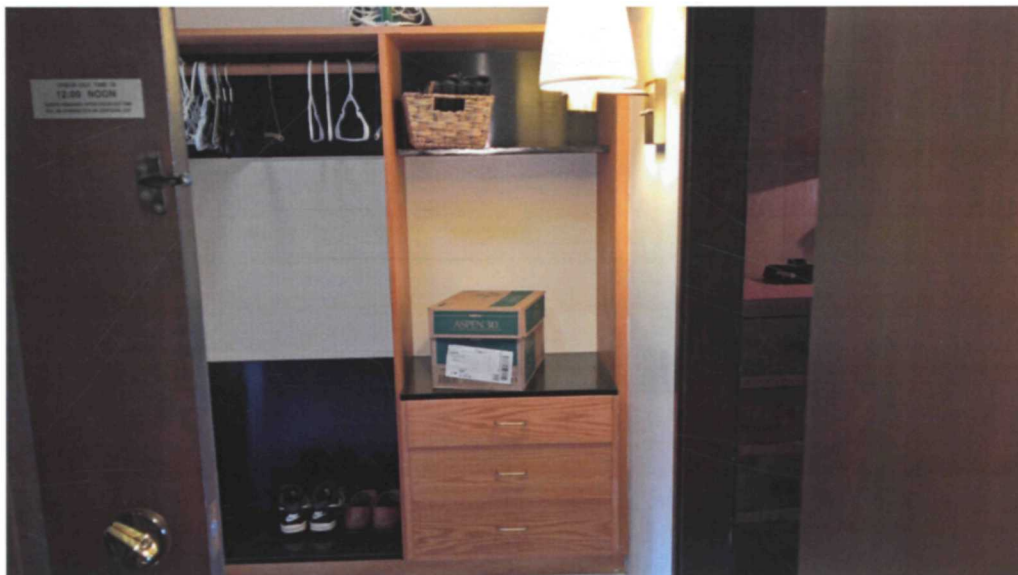
Figure 4. Phase I Built in case work

- Furniture (*Figure 4*)
  - There is a built in casework unit with three drawers, shelves and coat rack. The casework is not moveable. The area below the casework originally intended for shoes has been filled in with a wood filler and rubber base.

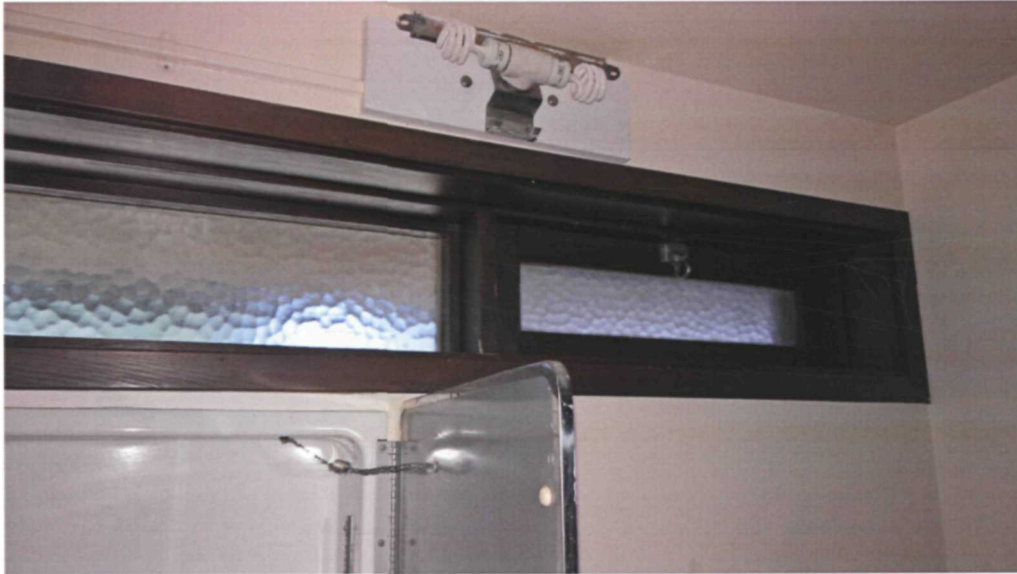
Figure 11. Phase I custom window

- The receptacles are not ground fault circuit interrupter (GFCI) which is not compliant with the 2009 international building code (IBC).
    - Light fixtures above the lavatory do not have a cover and bare bulbs were observed. The original cover was not discovered on the trip. *(Figure 11)*

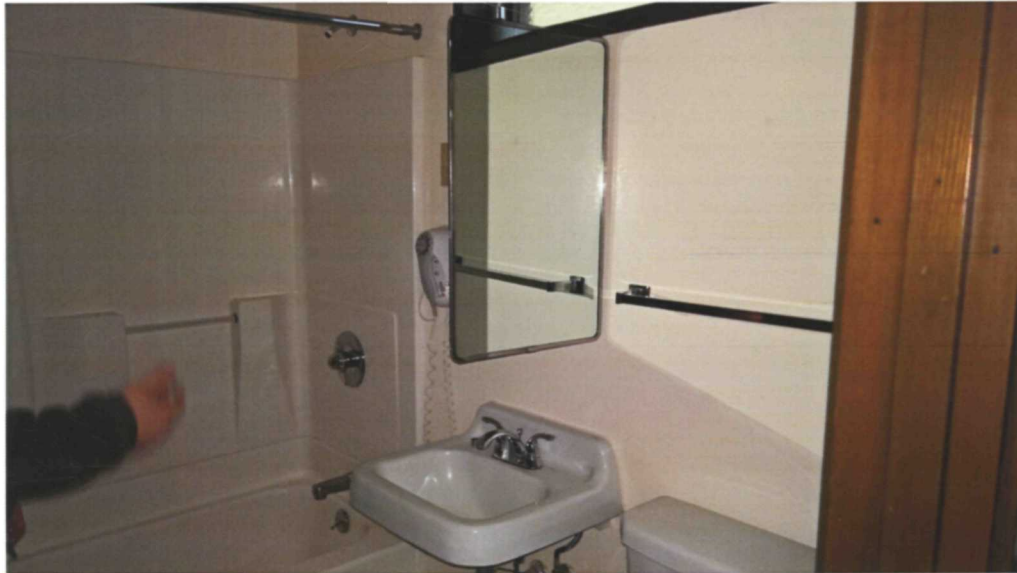
Figure 12. Phase I lavatory with medicine cabinet

- The toilet is a conventional 5 gallon toilet and not the low water usage preferred today for less water consumption.
    - There is a wall hung lavatory with medicine cabinet above for storage. *(Figure 12)*

- Bathroom Accessories
    - A medicine cabinet with swinging mirror door, glass shelves, toothbrush holder for four, and a slot for dispensing razors. *(Figure 12)*

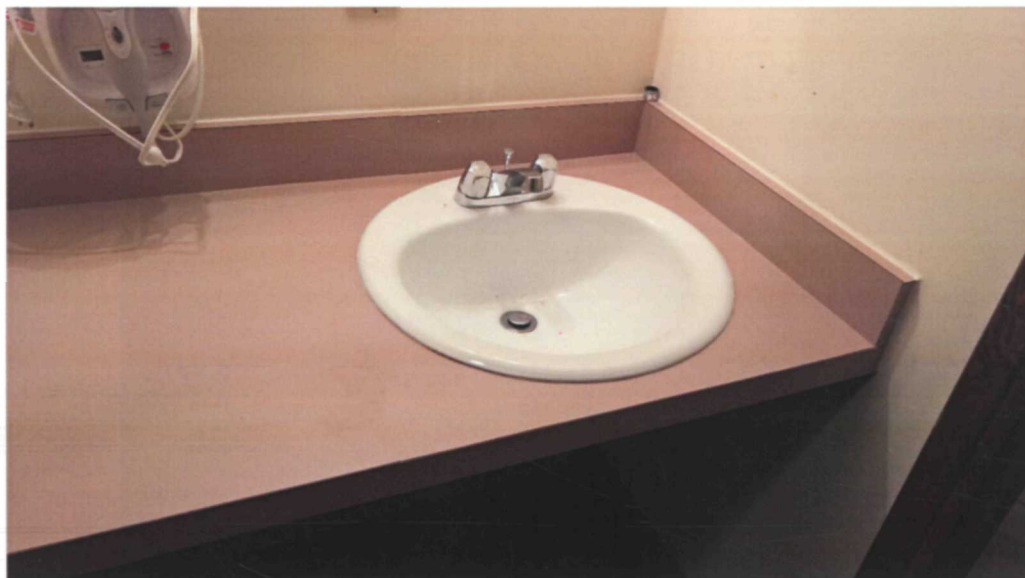
Figure 13. Phase II original sink

- The sink is a top mounted bowl in plastic laminate counter with a back splash on all three sides. The original was a deep pink as evidenced by the type of installation on site with square edges that were filed in place. The replacements are a lighter pink utilizing a premanufactured post formed laminated counter with an integral backsplash. Square backsplashes were added to the sides. *(Figures 13, 14 & 15)*

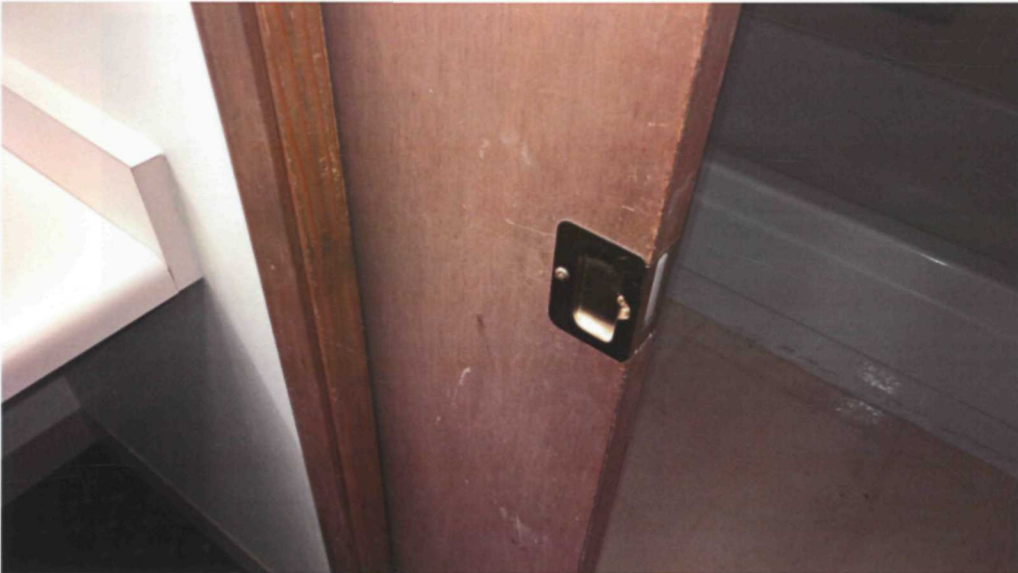
Figure 20. Phase II Pocket door

- Doors and Windows
    - There is a dark stained pocket door with pull hardware. It is not compliant with the Architectural Barriers Act (ABA). *(Figure 20)*

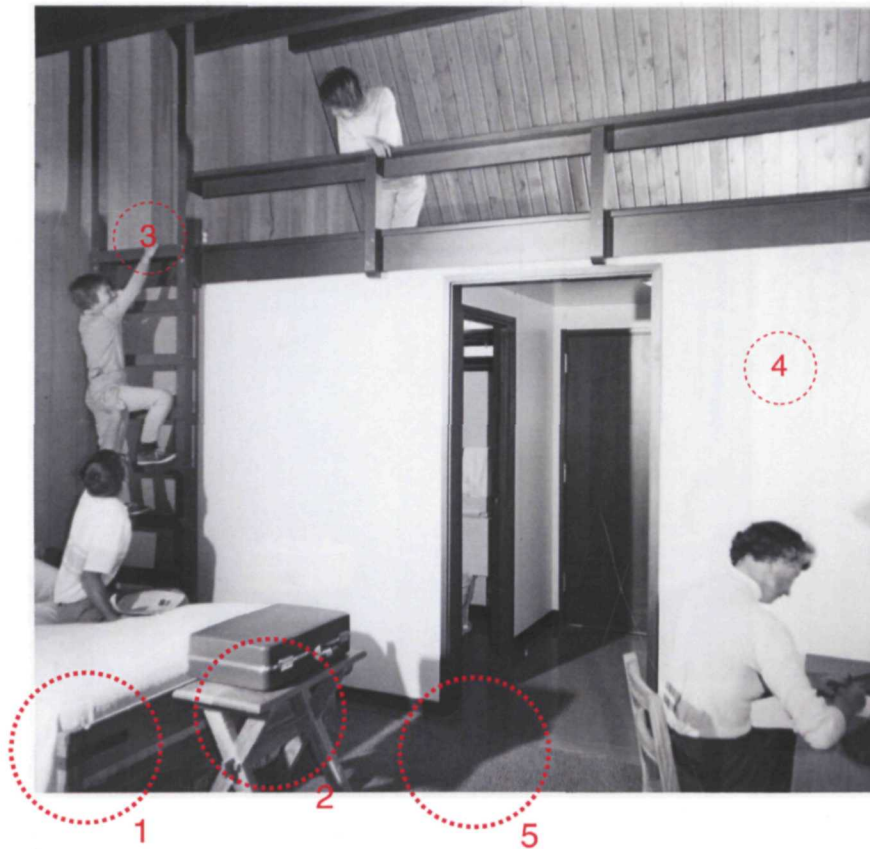
This historic photo is of the interior of the original 1966 Phase 1 cabins, and illustrates a number of furniture items and features that could be restored to the Phase 1 cabins.

Contemporary photos show these original bed frames are still present in a number of cabins. The original bedspread appears to be a solid white down comforter or blanket. See page 3, Historic Furniture.

- 1 Two (2) original bed frames 1966 era. Locate existing beds from current inventory, and use for restoration of the 1966 Phase 1 cabins, or replace in-kind using original specifications. See following pages.

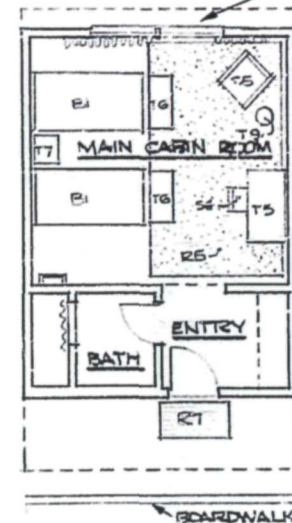
DRAPERY & TRACK  
TYPICAL ALL CABIN  
WINDOWS

Original drawings and this photo indicate the main room of the cabins were finished with hard wood floors and covered with area rugs.

Original drapery and textiles to be retained and used in '66 Phase 1 cabins whenever possible. Re-place in kind using original specifications.

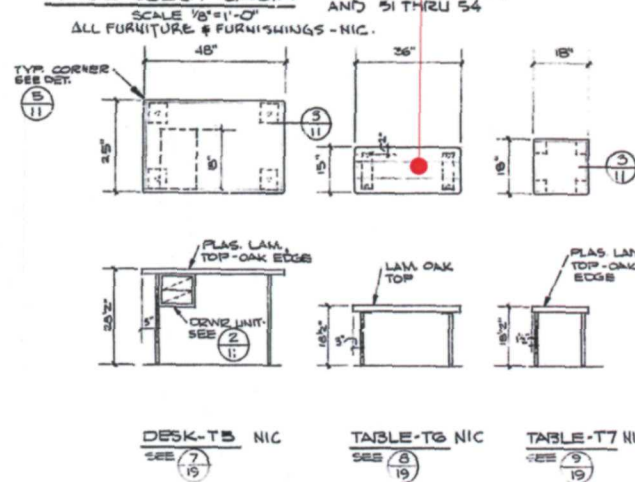
The original '65 construction drawings include details of construction and materials for custom furniture. The furniture was not included in the contract "NIC" so it is assumed it was procured separately under another contract.

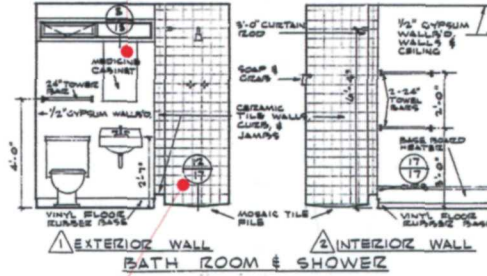
8

Some cabins still have the original mirrored medicine cabinet, featuring adjustable shelves, tooth brush holder and a razor blade slot into the wall.

The 1966 Design Documents indicate that the same ceramic tile finish, "Hermosa" on the walls and "Mosaic" on the floors was used in all baths. The Main Lodge restrooms still retain these finishes. Materials should be match to the existing tile.
