Higdon Cabin

Elkmont Historic District
Great Smoky Mountains National Park

Historic Structure Report

August 2015

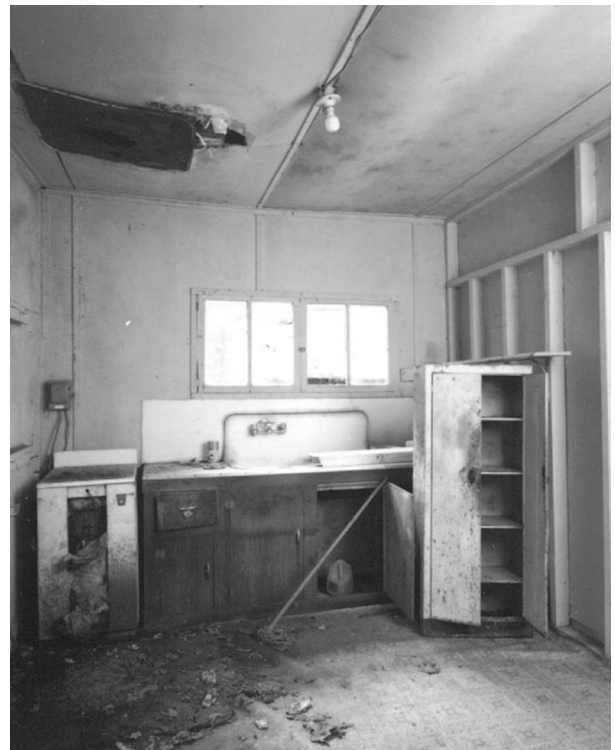
Figure 30. View looking south in Room 106 in 2000. (Historic American Buildings Survey)

Other Features: Open shelving, similar to that on the east wall of Rooms 104A and Room 105 is installed on the east wall behind the door to Room 107. The damaged water heater visible in the southeast corner of the room in Figure 30 is no longer present.

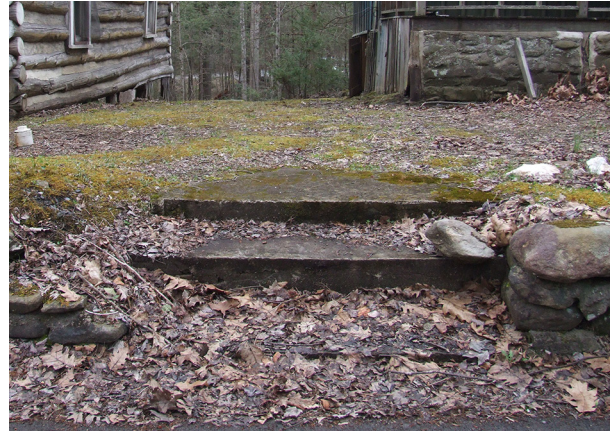
Figure 37. View of concrete steps at north end of front yard.

The concrete steps at the rear remain in excellent condition, but the others suffer from some surface erosion. At the steps from the road to the front walkway, the lowest step has shifted and is badly cracked, as is the front walk itself.

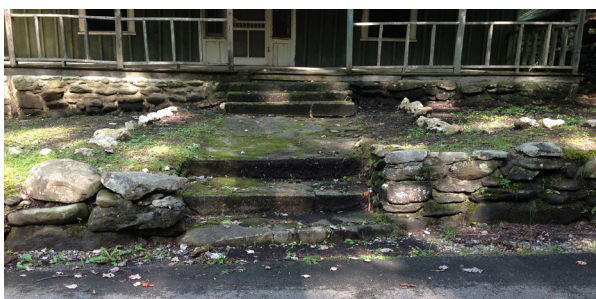
Figure 36. View of concrete steps and walkway from the road to the front porch.

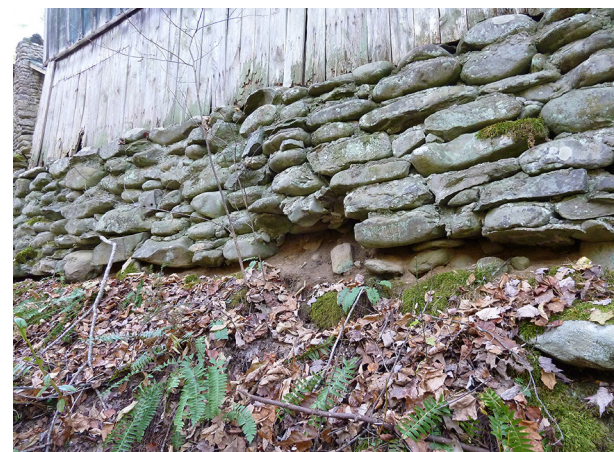
Figure 39. View of retaining wall at rear of cabin where erosion is threatening its stability.

including poor drainage around the perimeter of the cabin. Ground erosion has undermined the stone wall supporting the east end of the cabin and precipitated a significant structural crack in the concrete block foundation under the south side of Room 106. Unlike some of

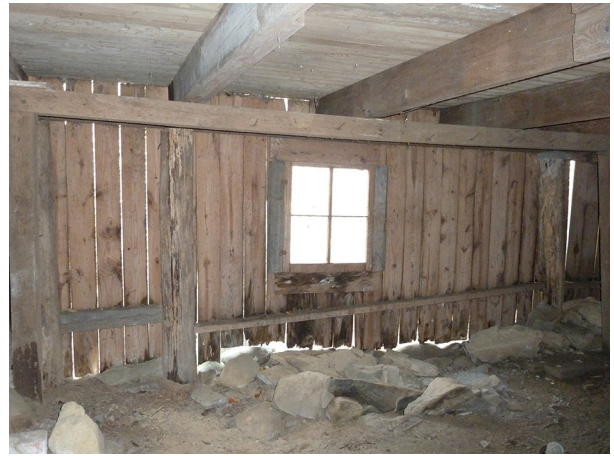
On the south side of the cabin, poor drainage also keeps the low concrete-block foundation damp for extended periods, precipitating rot in the wooden wall plates with which it is in continuous contact. Areas of continued dampness in the crawl space and the many points of wood-to-ground contact are conditions conducive to termite infestation. Some of the makeshift posts, particularly under Room 107, are not stable.

Figure 54. View looking southeast under Room 107.

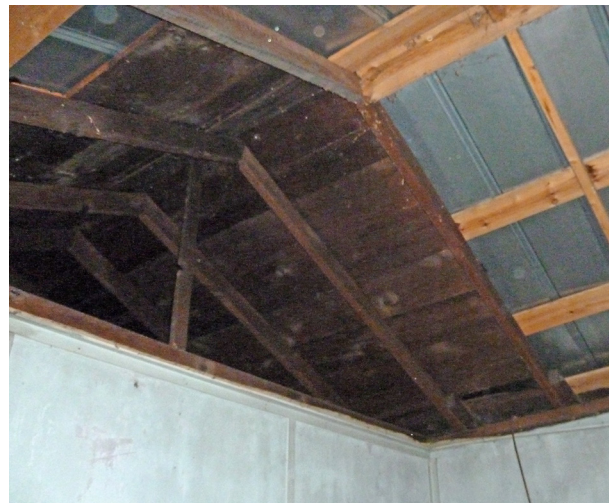
Figure 55. View of roof framing, decking, and roofing over Room 105. The 2" by 4" upright left of center is not typical.

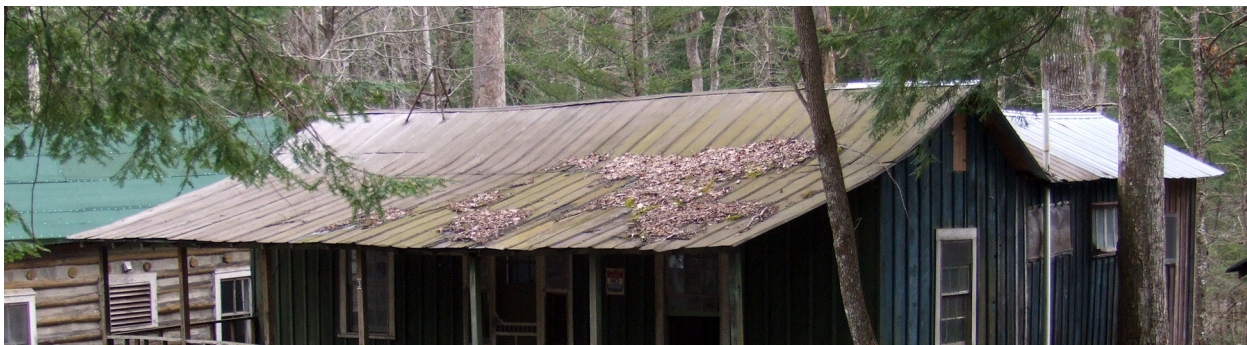
The cabin does not have gutters and rainwater runoff from the roof remains uncontrolled, which has led to ground erosion all around the cabin. At the northeast corner of Room 107, a falling tree limb or other impact has damaged the roofing. There may still be roof leaks around the chimney and at the junction of the shed roofs and the gable roofs.

Figure 58. View looking northeast at roofing on Higdon Cabin.

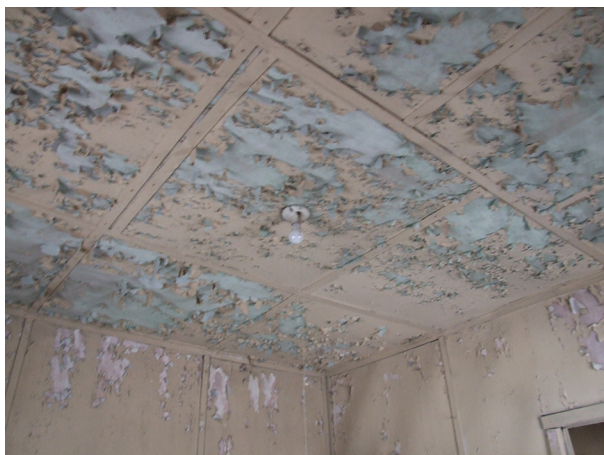
Figure 72. View of ceiling in Room 101.

The same material is used for the ceilings. Walls and ceilings are now covered with a four-ply, 3/16"-thick fiberboard installed in 4' by 8' sheets with 1/4" by 1 1/2" battens covering the seams. All of the fiberboard has been painted, and much of it has been water damaged.

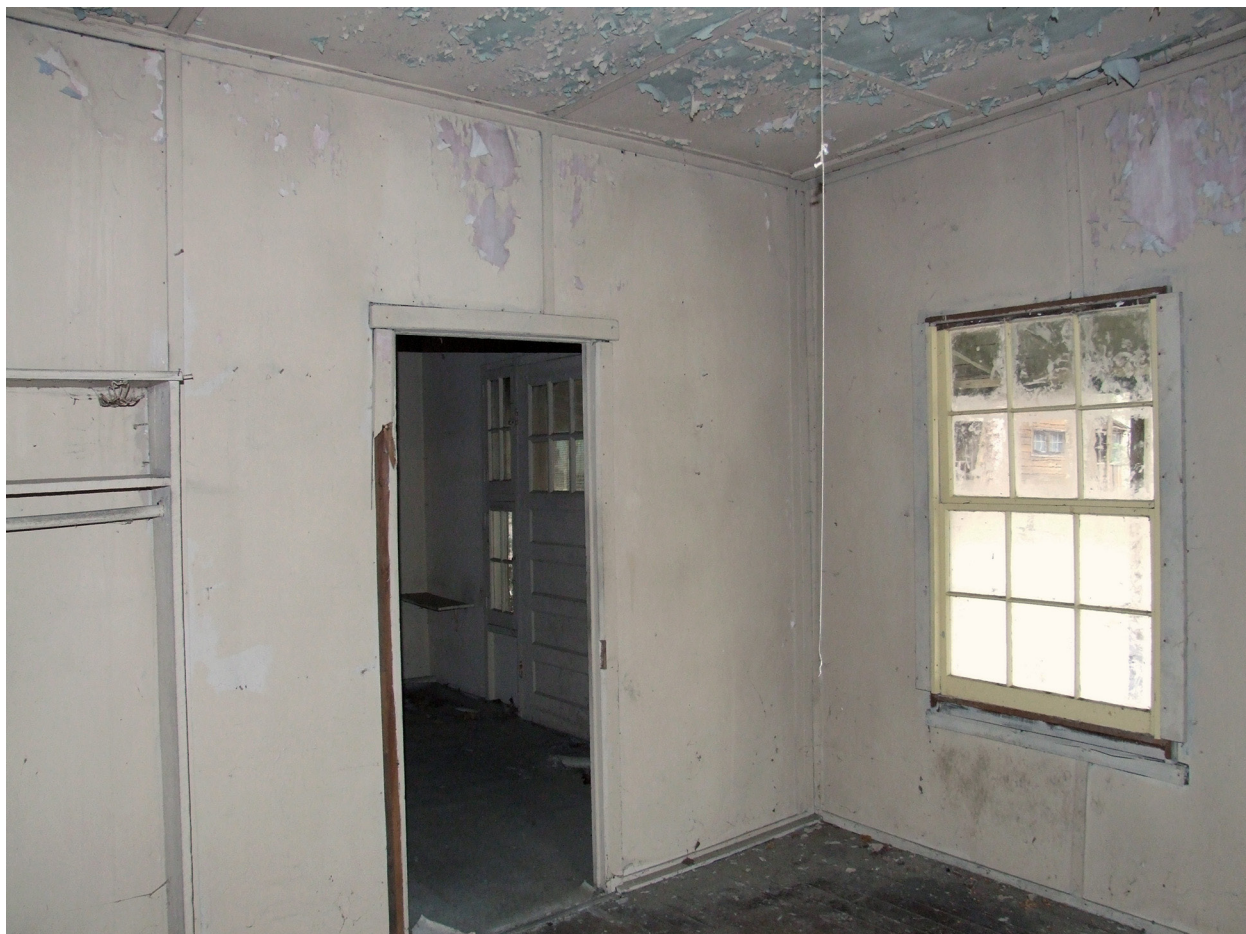
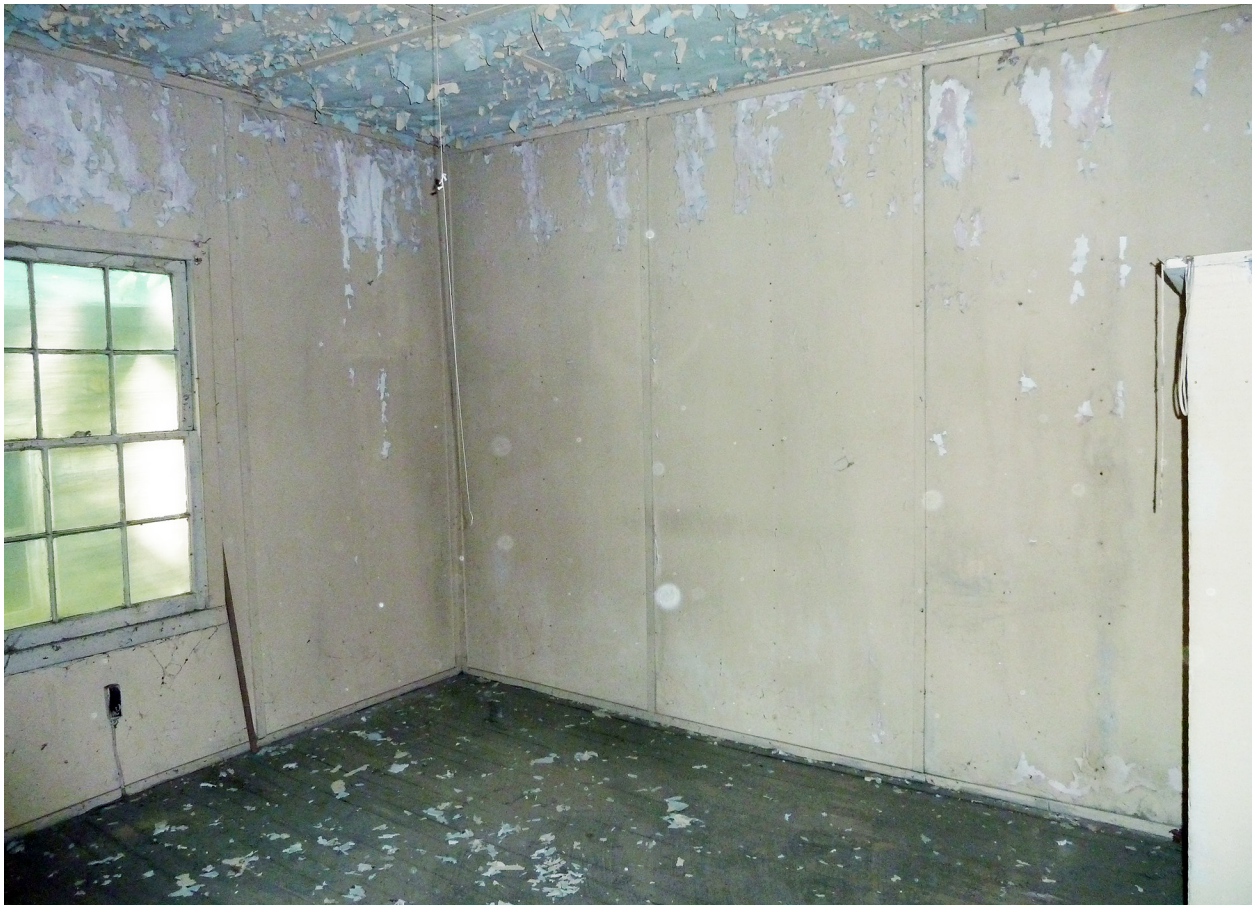
Figure 73. View looking southwest in Room 101.

Figure 74. View looking northeast in Room 101.

Walls and ceilings have been painted on at least two occasions, but the paint is now in ruinous condition.

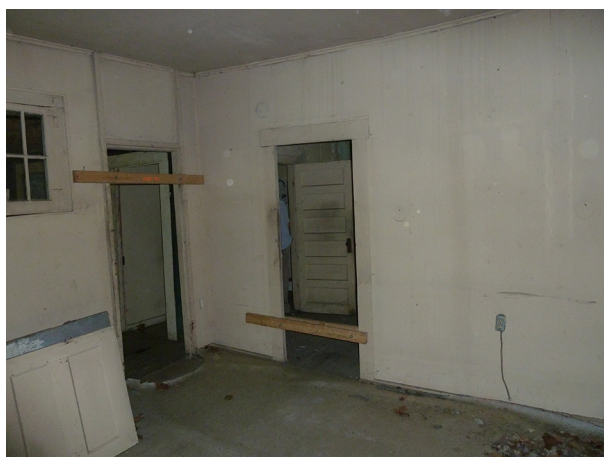
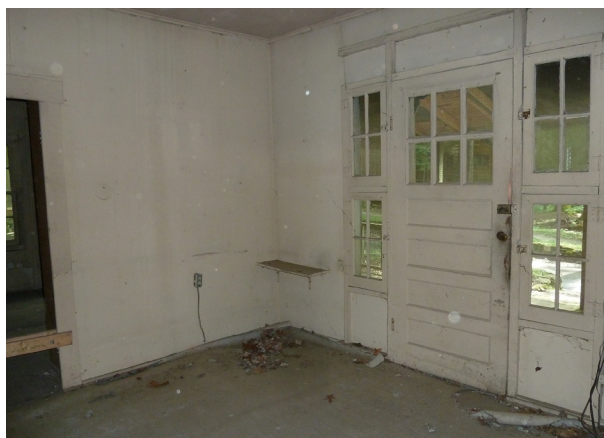
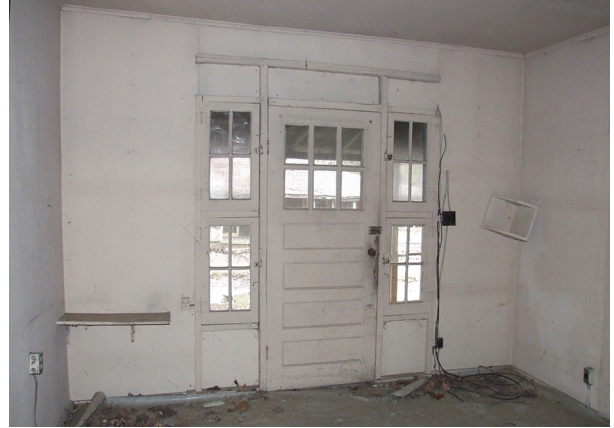
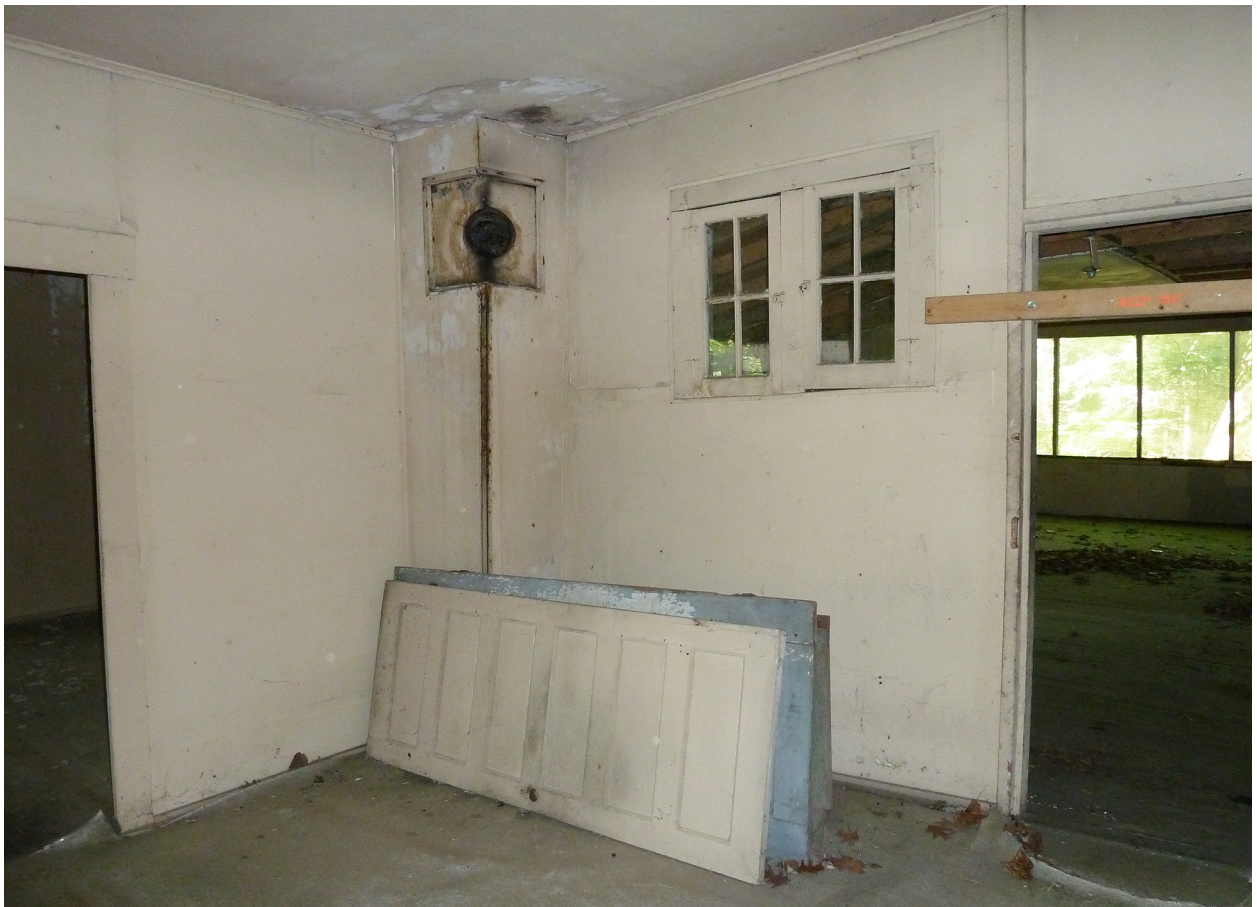
Figure 76. View looking southeast in Room 102.

Figure 77. View of west wall of Room 102.

Chimney: Built into the northeast corner of the room is a small brick chimney, 16" by 16" in plan, built as a flue for a wood- or coal-fired stove. Inexplicably, it was built directly on the wood flooring in that corner with no foundation below. The chimney rises about

a foot above the roof. There has been serious structural damage in that corner of the room, perhaps more so because of water penetration around the chimney than the actual weight of the chimney itself.

Figure 79. View of west wall of Room 102.

Figure 78. View looking northeast in Room 102.

Walls and ceiling have been painted on at least two occasions but the paint is now in ruinous condition.

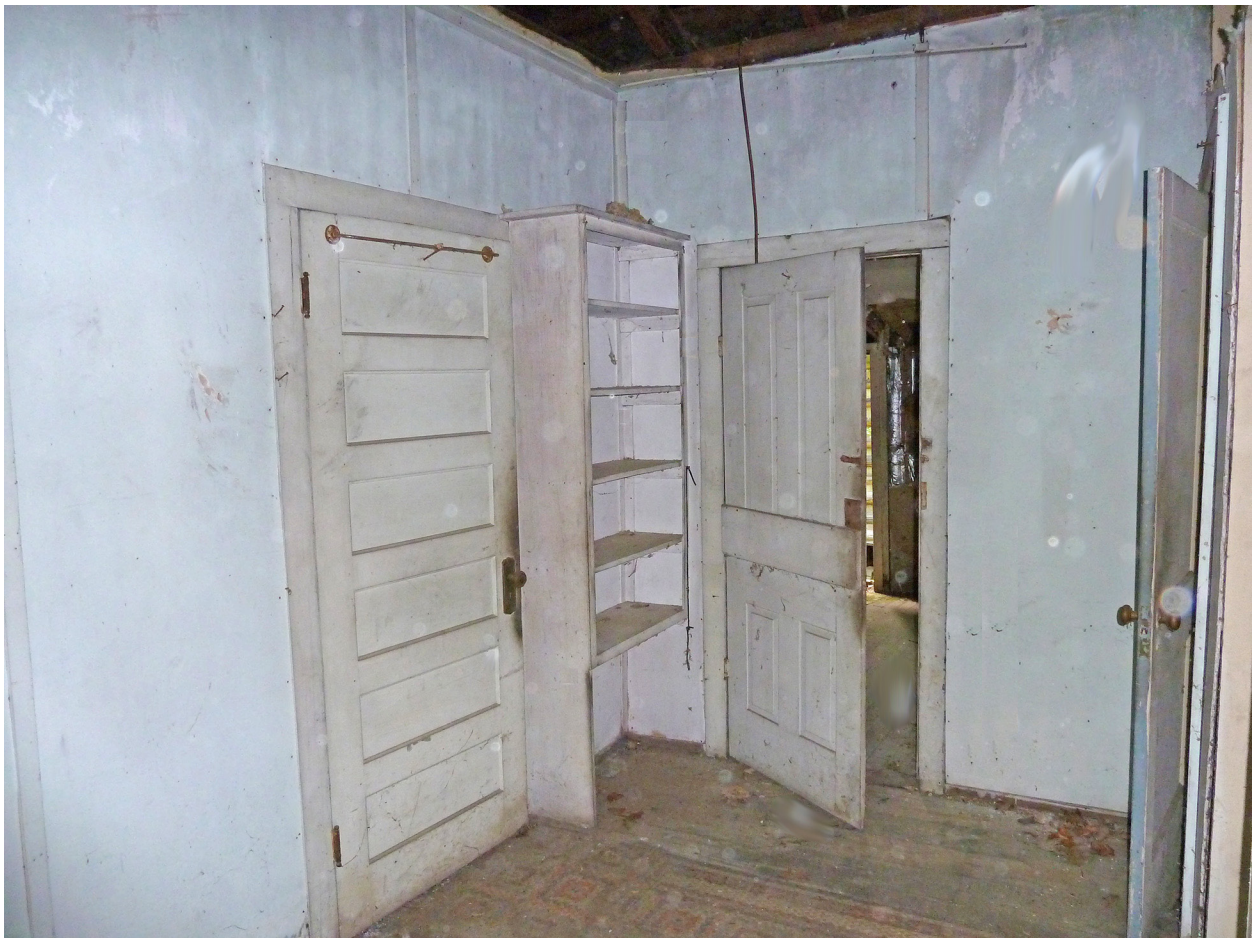
Walls: The north, south, and west walls are typical vertical plank walls. The east wall is a conventional stud wall. All walls were originally covered with ½" drywall, but that is now missing from the east wall.

Ceiling: The ceiling appears to have been at 9', but no longer exists. Joists were removed in conjunction with the repairs in 2008,

Figure 91. View looking northwest in Room 105.

but remnants of the original drywall remain around the perimeter of the room.

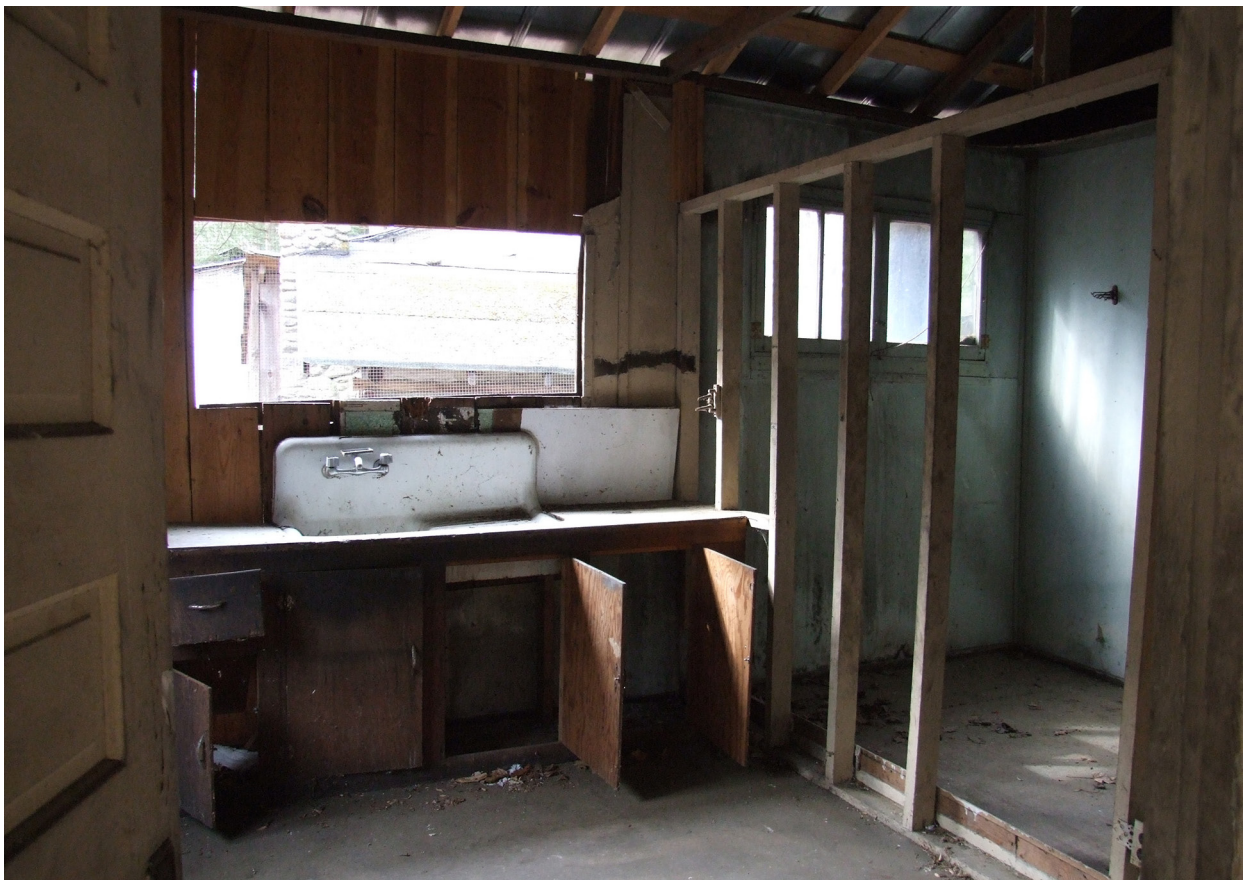
Walls: The north, south, and east walls are typical vertical plank walls. The west wall is a conventional stud wall. The south wall was

Figure 94. View looking southwest in Room 106 with Room 105 visible through the stud wall at right.

almost completely rebuilt during the course of the recent repairs.

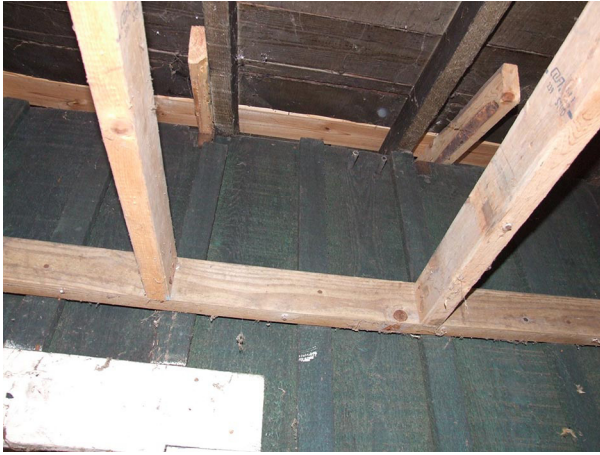
Ceiling: The ceiling was built with two slopes in an apparent effort to avoid covering the existing windows on the west. The ceiling height is around 7'-2" above the floor on the south, around 6'-10" in front of the windows, and only 5'-8" on the north wall. The ceiling was finished with drywall, but much of that was removed during the course of recent roof repairs.

Figure 98. View of framing of ceiling and roof in Room 107. Visible at the top are the dark wood of the original porch rafters and decking and the lighter wood of the rafters and decking from the recent roof repairs. In the foreground are the ceiling joists installed in the late twentieth century.

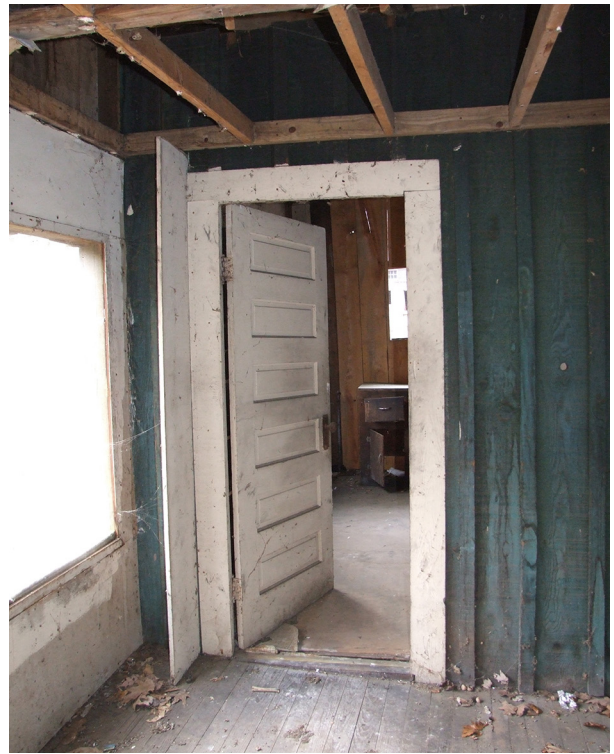
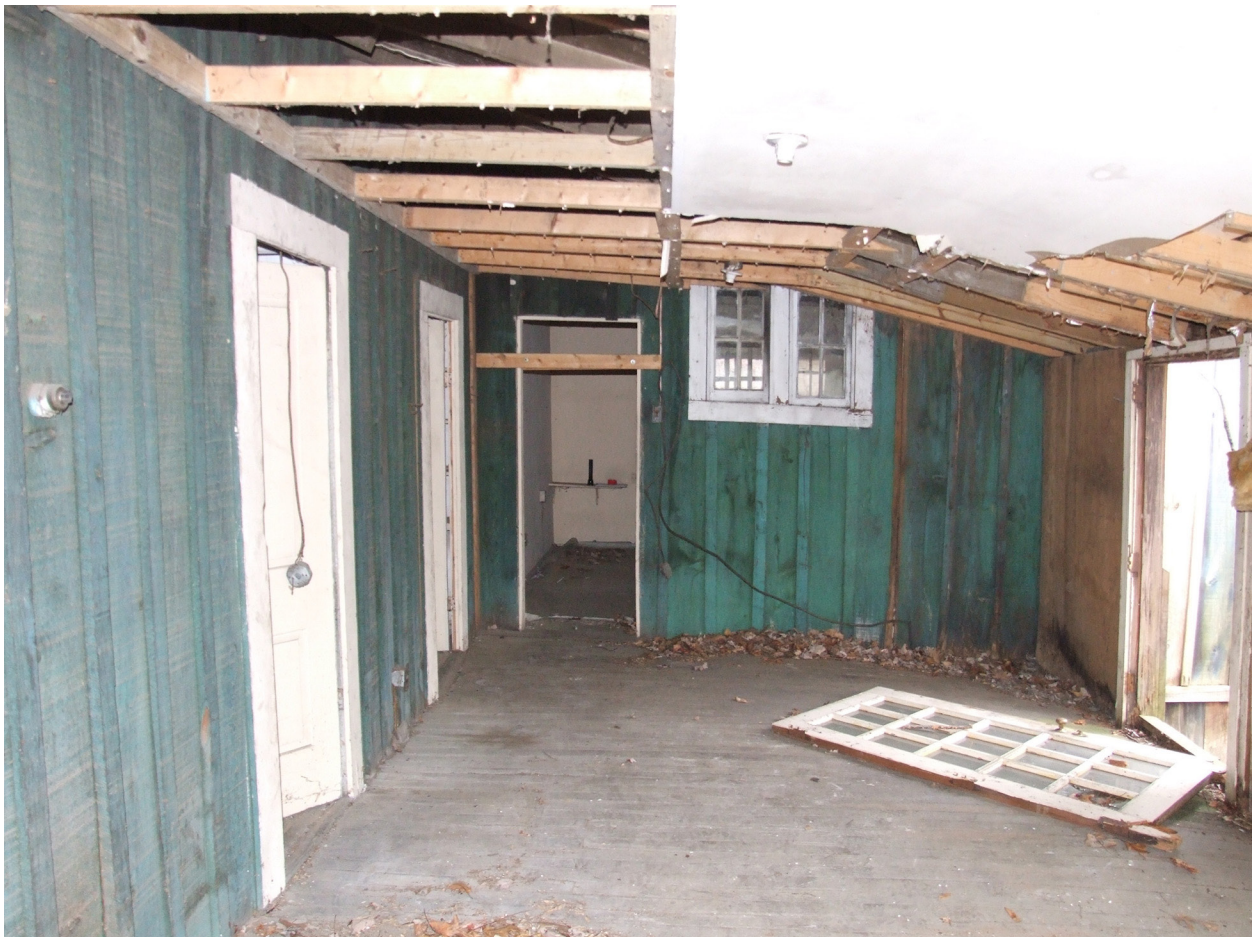
The interior of the Higdon Cabin is in fair to poor condition, with debris throughout. Some doors are out of their frames and others are missing knobs and other hardware. Rooms 101-104 remain much as the Higdon left them, except for removal of part of the ceiling in Room 103. Flooring in the bathrooms is deteriorated. Painted finishes are in poor

Figure 101. View looking south from Room 107 into Room 106.

Figure 100. View looking west in Room 107.

condition throughout the cabin. The enclosure of the back porch has compromised the historic character of the cabin as have the incomplete repairs to the front porch and to the south side of Room 106.

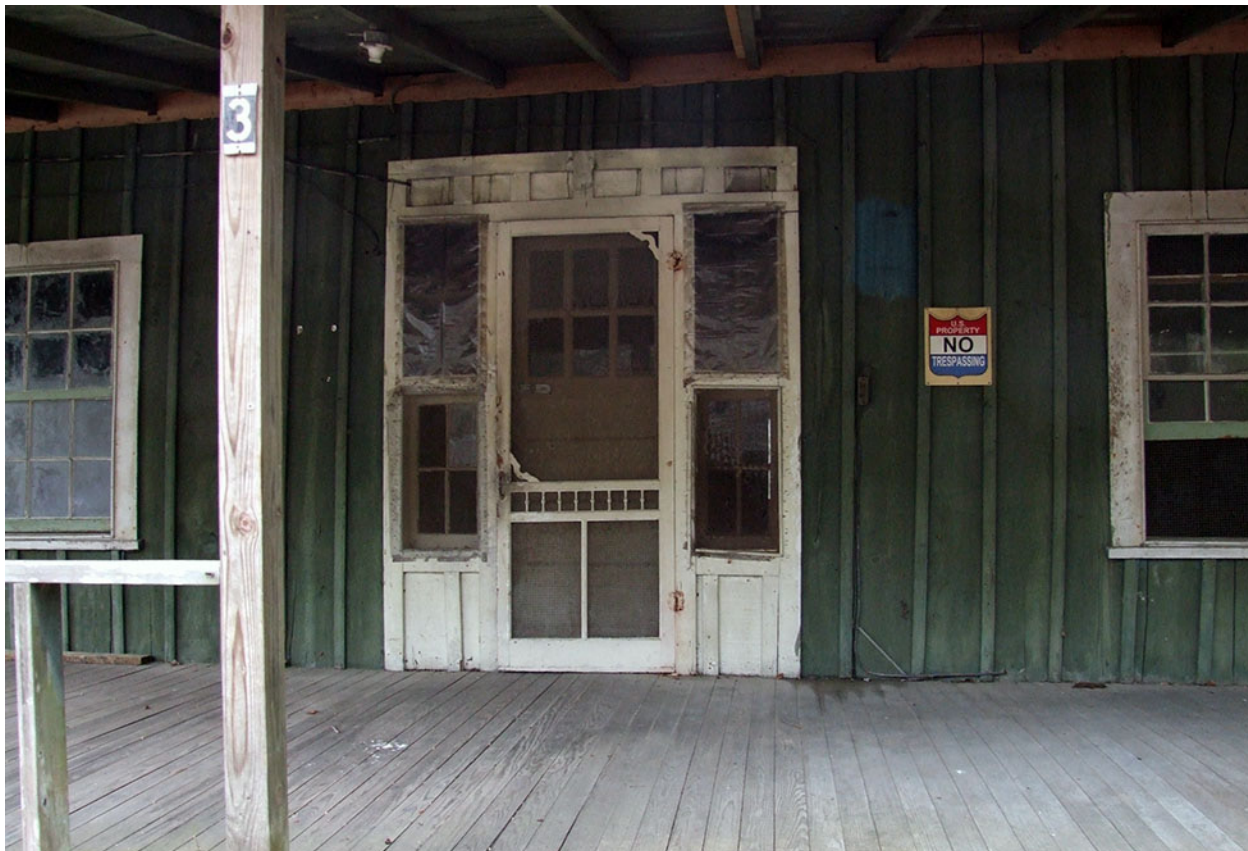
Figure 110. View of front entrance to Higdon Cabin in 2015.

The front porch posts and railings were replaced in kind in 2007, using nominally 4" by 4" posts and 2" by 4" rails and vertical pickets, matching those seen in 1993 photographs. A historic photograph may be located that would document a different arrangement, but considering the simplicity of the cabin's historic finishes and the sorts of posts and railings documented in other cabins at Elkmont, the present design and materials are entirely appropriate.

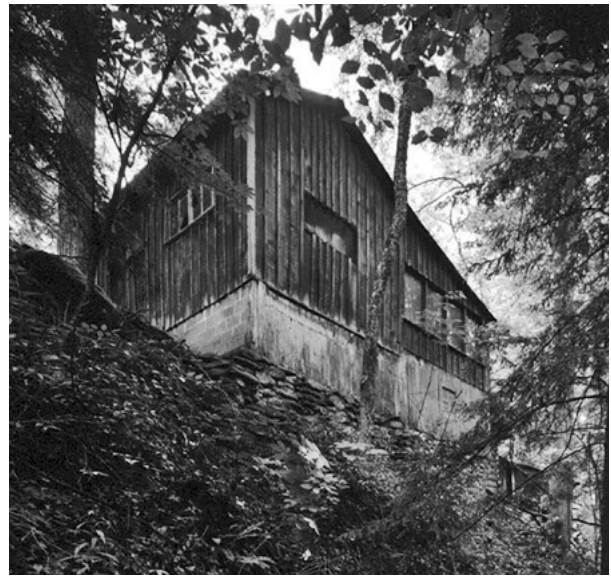
The most significant component of exterior restoration would be removal of the late-twentieth-century walls that enclose the back porch (now Room 107) and reconstruction of a screened back-porch enclosure and back steps. With an orientation to the north and

Figure 111. View of rear of Higdon Cabin in 2001. (Historic American Buildings Survey)

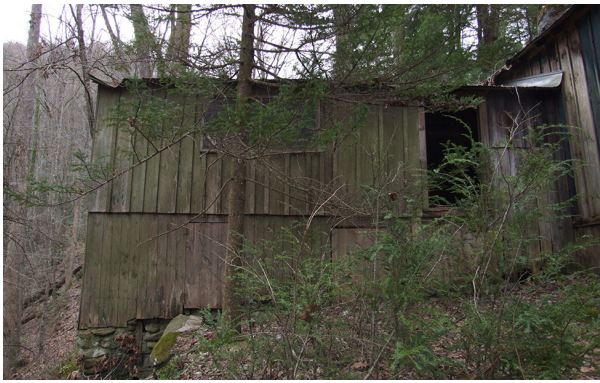
Figure 114. View looking south of the north side of the wing at the rear of the cabin, 2014.

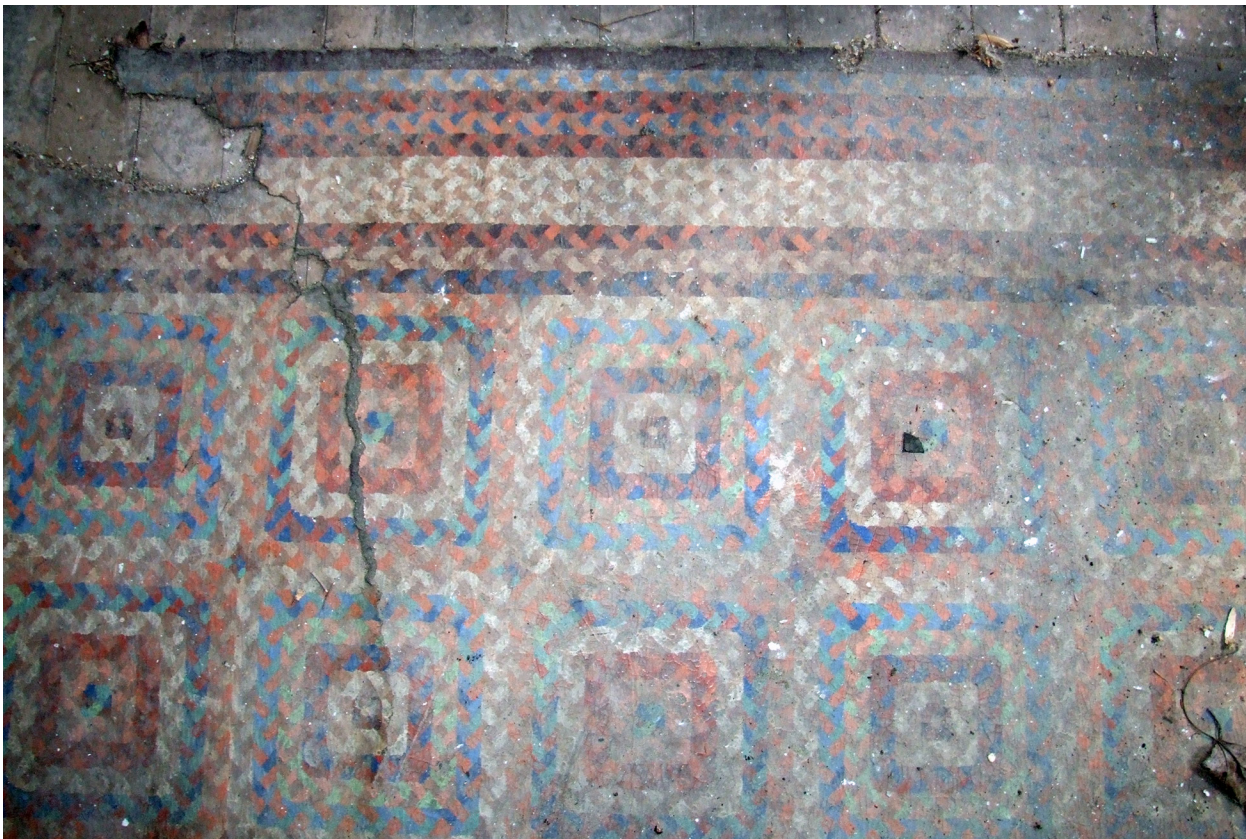
Figure 115. View of linoleum in Room 105.

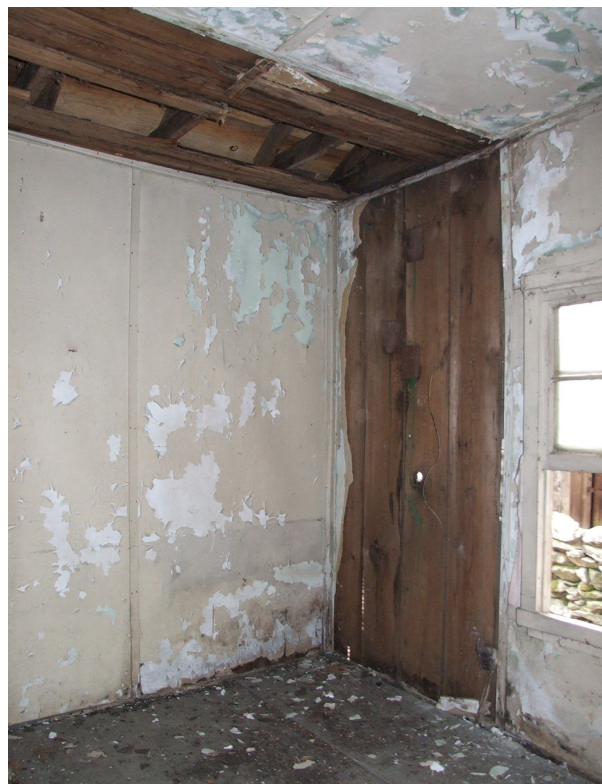
Figure 117. View of southeast corner of Room 103, showing the structural materials in the cabin.

The damaged runs of double-beaded tongue-and-groove boards along the east side of Room 103 should be replaced, while leaving

a “window” in the walls and ceiling around the southeast corner in order to expose some of the tongue-and-groove boards, which the Higdon's used throughout the house, and to allow better exhibit of the house's unusual wood frame.

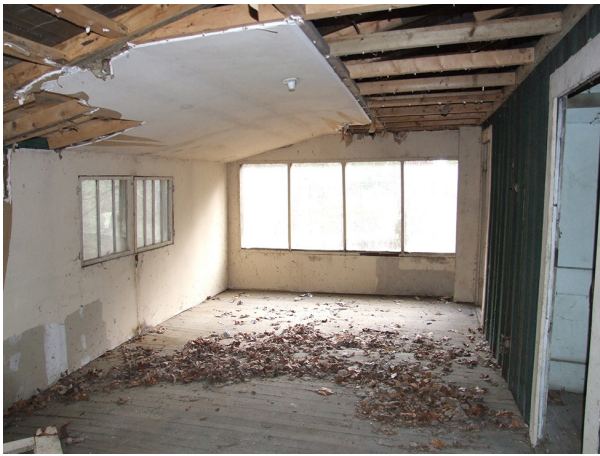
Figure 118. View east in Room 107, which was created by enclosing the back porch in the late twentieth century.

- dismantle east and west walls of what is now Room 107 in order to recreate the back porch;

- follow material evidence that is exposed during demolition to recreate screened enclosure of those walls.

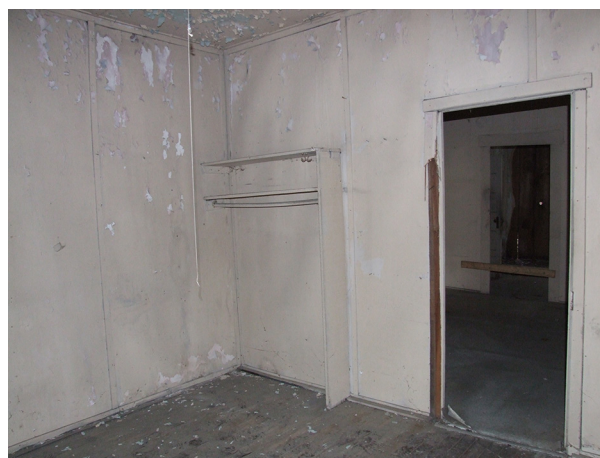
Figure 119. View looking southeast in Room 101.
