HISTORIC STRUCTURE REPORT

SUGARLANDS HEADQUARTERS

Final Report December 2019

GREAT SMOKY MOUNTAINS NATIONAL PARK

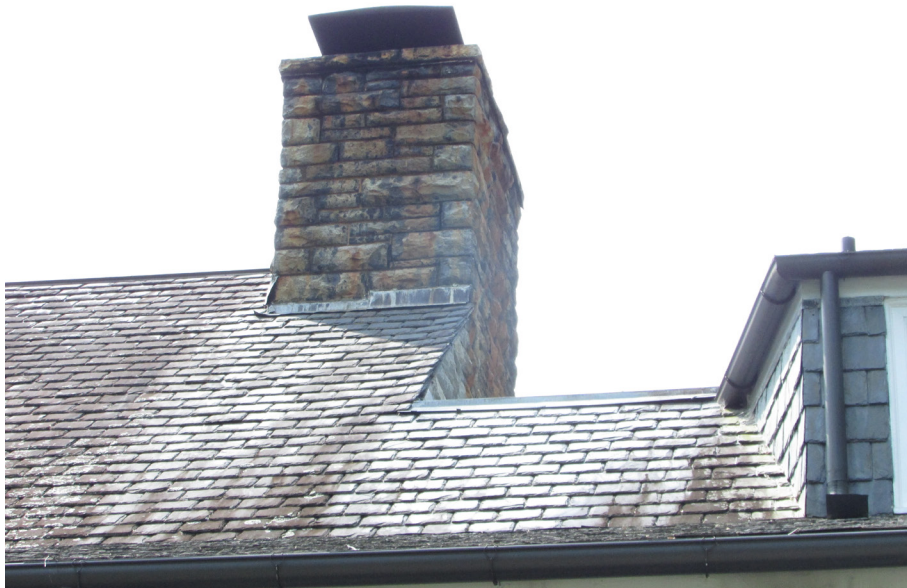
Figure 4-8. North elevation roof detail showing chimney and side of one dormer (source: Quinn Evans 2019)

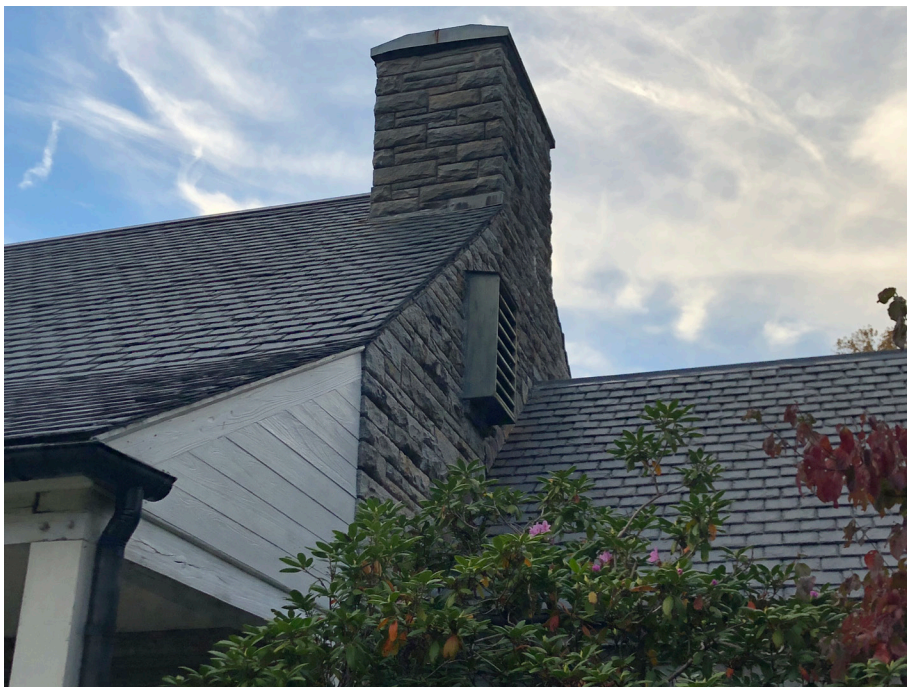
The building's main roof is Virginia Buckingham Slate, attached via wood nailers. According to historic photos and construction details, the nailers are laid over a layer of asphalt roofing paper, over a one-inch layer of indeterminate rigid insulation, on top of a "nailable" concrete deck. Overall the roof is in poor

Figure 4-9. East chimney and roof intersection (source: Quinn Evans 2019)

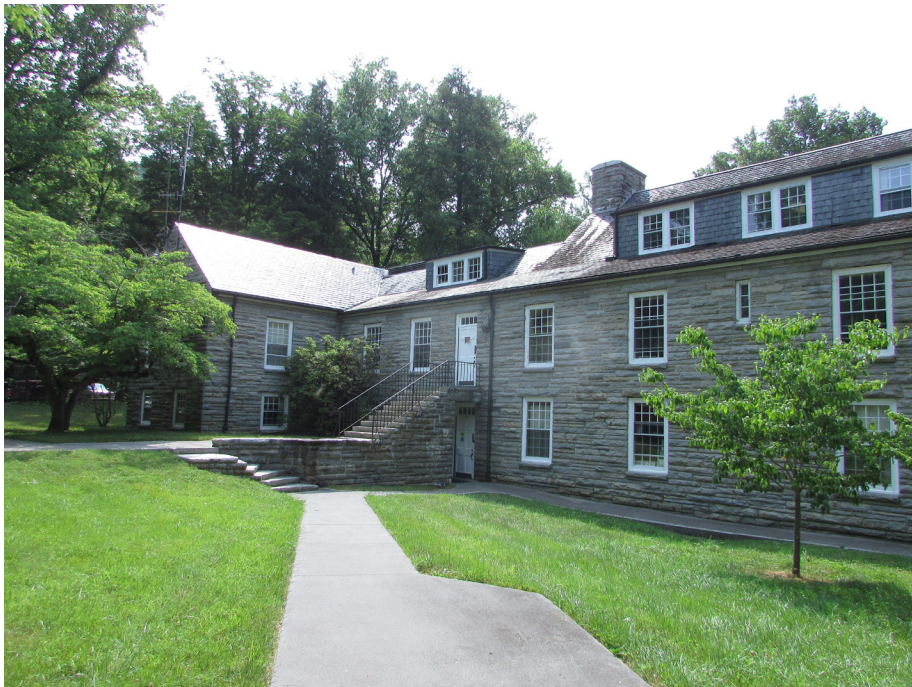
Overall the sandstone elevation is in fair to good condition with some areas of discoloration from rust and biological growth. Some cracking and disintegration of the mortar along the bottom edge of the wall was observed.

Figure 4-15. North elevation, east side (source: Quinn Evans 2019)

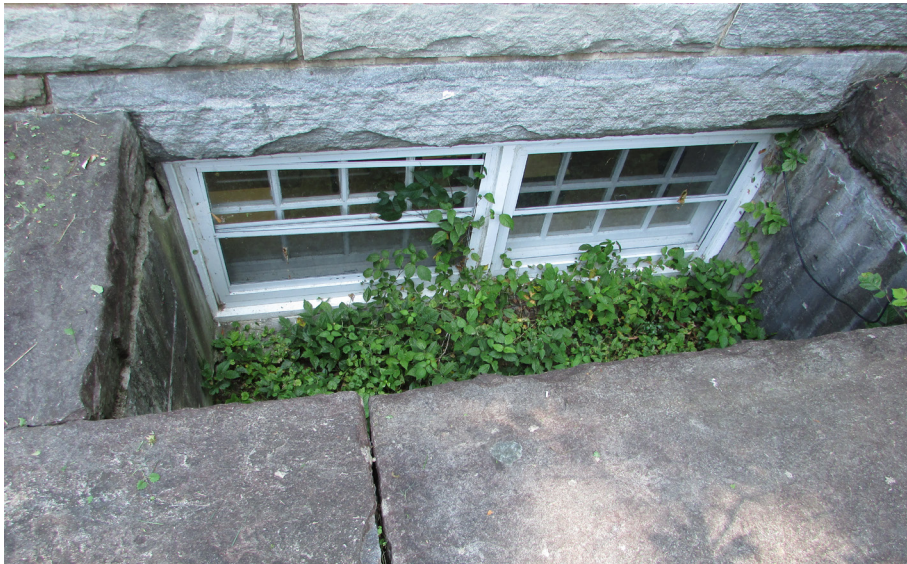
Figure 4-21. Typical basement window/light well, south elevation (source: Quinn Evans 2019)

In general, the basement level windows are in fair condition. One of the storm windows in each of the wings have failed and the mullions show signs of water damage. The louvers and remaining windows are in good condition.

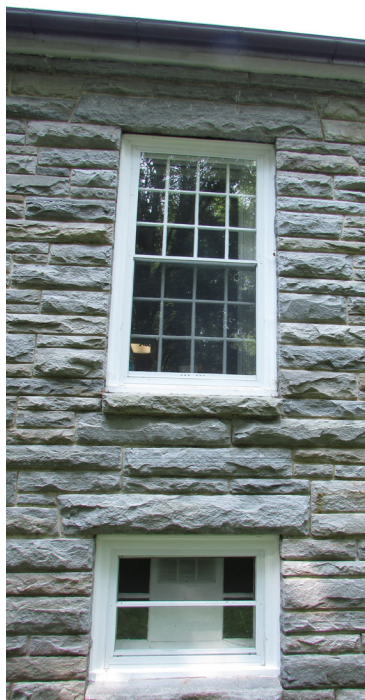
Figure 4-25. East elevation window bay, showing basement window with ducting (source: Quinn Evans 2019)

At the basement level, from south to north, there are two wood eight-lite casement windows. Two more similar sized masonry openings north of those are mostly filled with duct supply and return vents but use stippled glass to fill the rest of the opening and allow light in (figure 4-25). The last two windows north of those are larger wood eight-over-eight double-hung units (figure 4-26). The window in the fifth bay does not have a storm window so that pipes from a small air handling unit can enter the building through one of the lites. All of the window lintels on this level are aligned. At the main floor level, all of windows are twelve-over-twelve double-hung units and have storm sash.

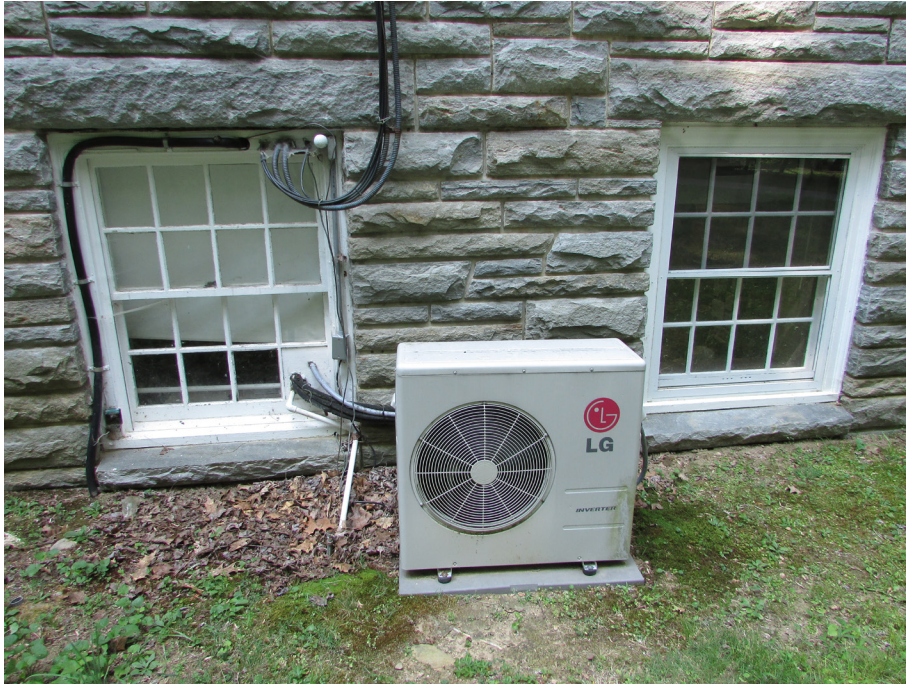
The exterior of the main level windows were not observable up close from the ground, but in general appear to be in good condition except for some instances of dried sealant. Most of the windows on the basement level are dirty, but are in fair to good condition except for the window in the fifth bay which has been

Figure 4-26. Northernmost basement windows on east elevation (source: Quinn Evans 2019)

exposed to the elements. That window has damaged glazing and the wood sill has some water damage.

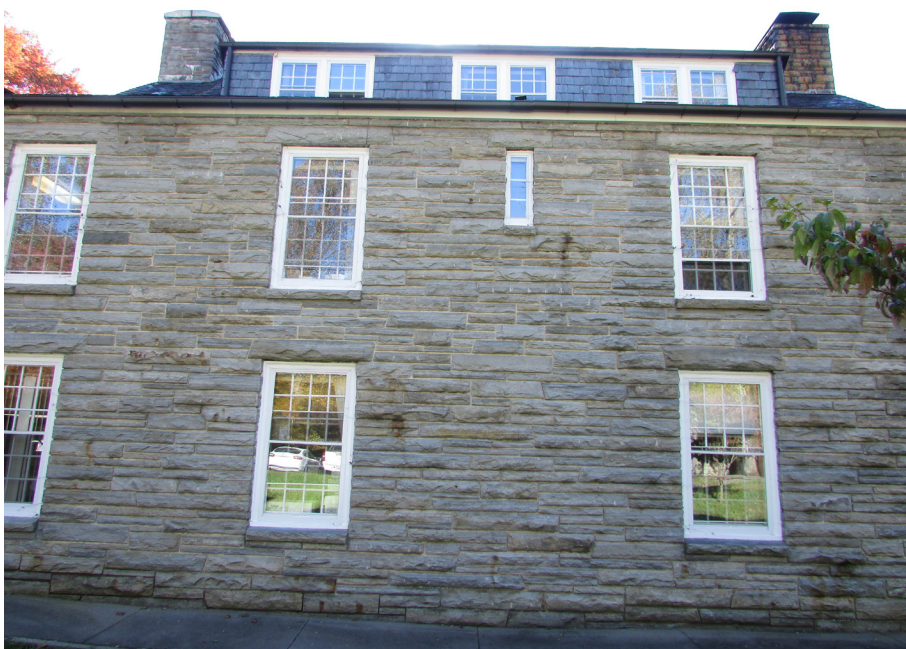
Figure 4-27. North elevation typical windows (source: Quinn Evans 2018)

In general, all of the windows appeared to be in good condition with no obvious evidence of water damage.

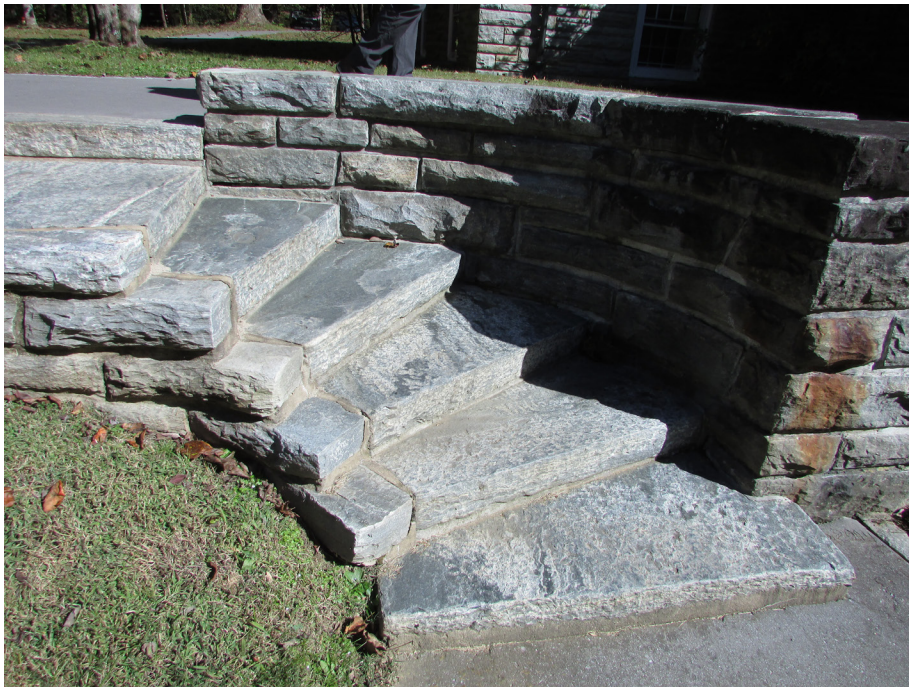
Figure 4-31. Curved retaining wall and steps, north elevation (source: Quinn Evans 2018)

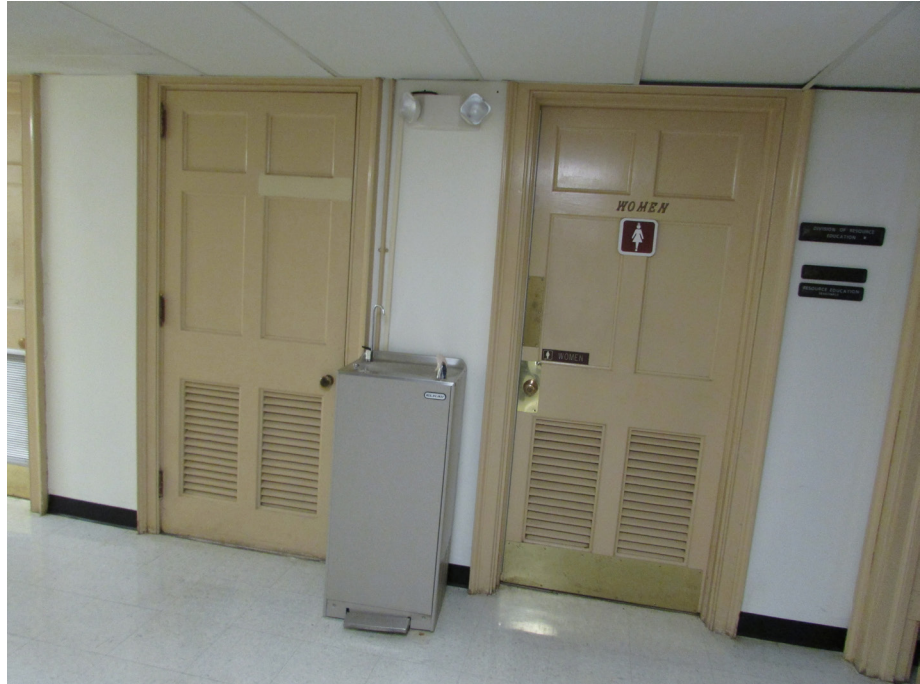
Figure 4-35. Typical six-panel doors, west wing, lower level (source: Quinn Evans 2019)

All of the doors in the west wing are the original solid wood six-panels with decorative trim and are in good condition (figure 4-35). All of the doors anywhere else in the lower level are typically hollow wood with simple wood trim and are in good condition, but of poor quality. Metals doors allow the hallways and coal room to be enclosed and are in good condition despite some chipped paint. A louvered door leads into the mechanical room and is also in good condition.

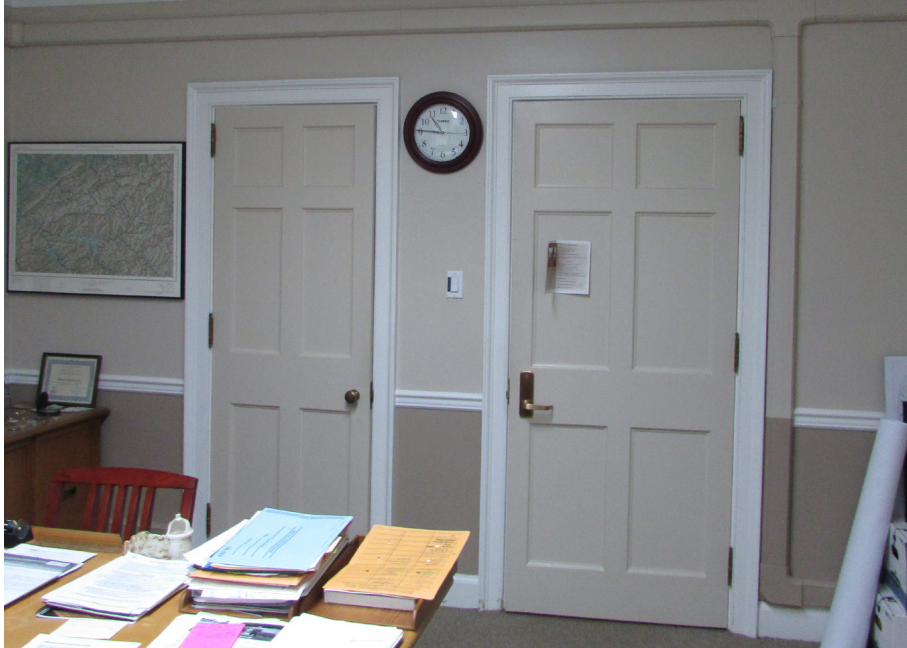
All doors throughout the floor are solid wood six panels with decorative trim and are in good condition (figure 4-37). Some of the closet doors have original hardware, but most doors have new hardware.

Figure 4-37. Typical six-panel corridor and closet doors, main level (source: Quinn Evans 2019)

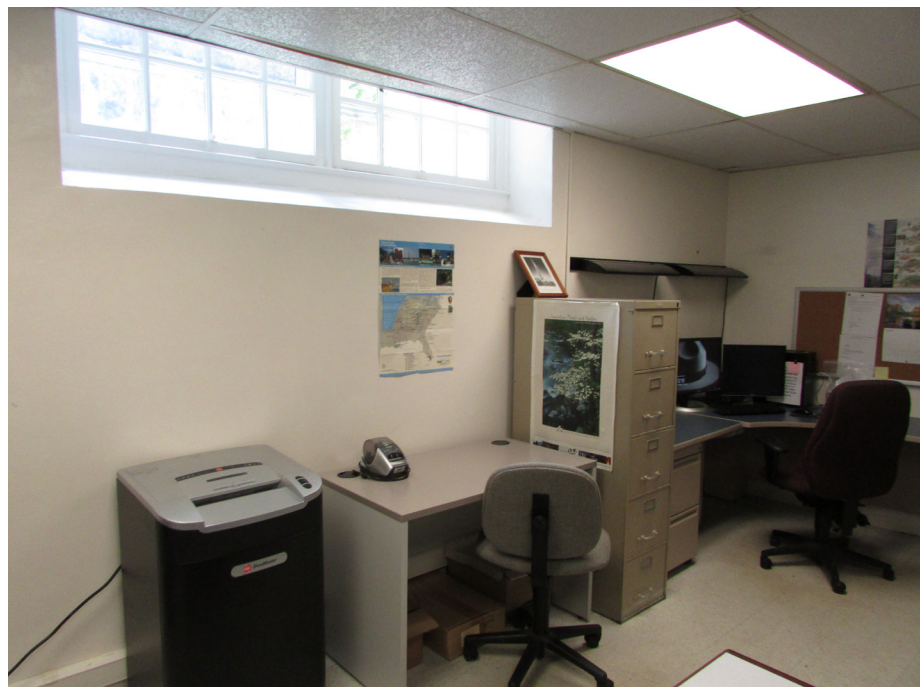
In general, all of the walls in the east wing are original to the building and are made of gypsum block with a plaster board covering and are in good condition. The restrooms have Tennessee pink marble panels along the walls and stall partitions and are in fair condition, but holes remain from changes made over the years (figure 4-39). All of the walls in the center and west wing of the lower level are wood framed with wood panel boards that appear to be in good condition; however, staff have noted mold growth behind the panels. The ceilings throughout the lower level are dropped 2'x2' or 2'x4' ACT and are in poor to fair condition as some have been replaced. The window lintels were constructed to stop just below the floor slab above, but the ceiling hangs roughly two feet below the slab which required a bulk head to be installed at the inside face of the wall at each window.

Figure 4-38. Basement, typical condition showing flat walls, dropped ceilings, and bulkhead over windows (source: Quinn Evans 2019)

The lighting fixtures are fluorescent tubes inlaid in the dropped ceiling and are in fair to good condition (figure 4-38).

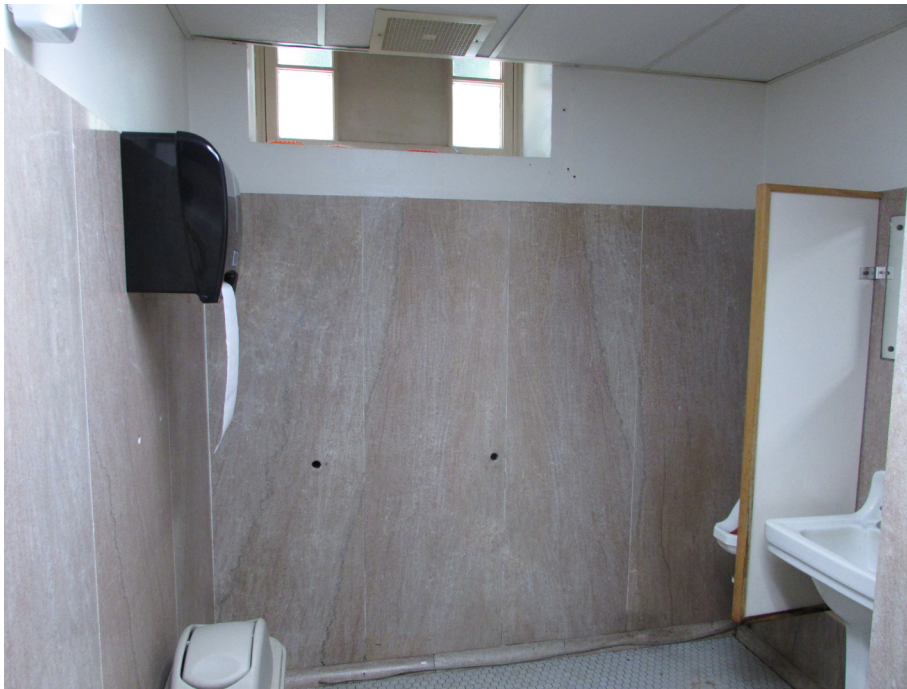
Figure 4-39. Basement restroom, typical conditions (source: Quinn Evans 2019)

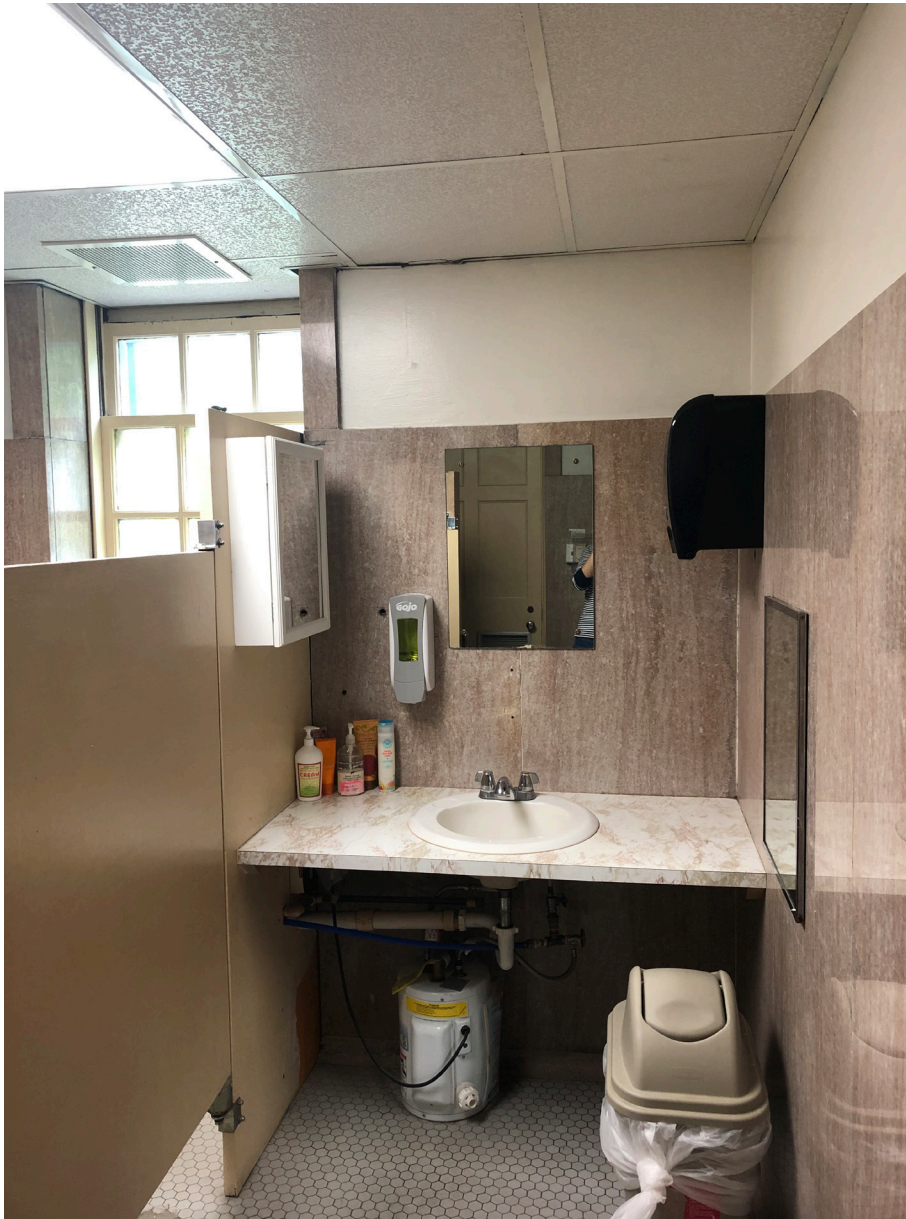
Figure 4-47. Main level, typical restroom (source: Quinn Evans 2019)

condition with some holes remaining from previous renovations (figure 4-47). The ceilings in the east and west wings are dropped gypsum board in fair condition except for in a few rooms where water damage has caused the plaster to bubble and crack, and the lights are ceiling mounted fluorescent strip lights.

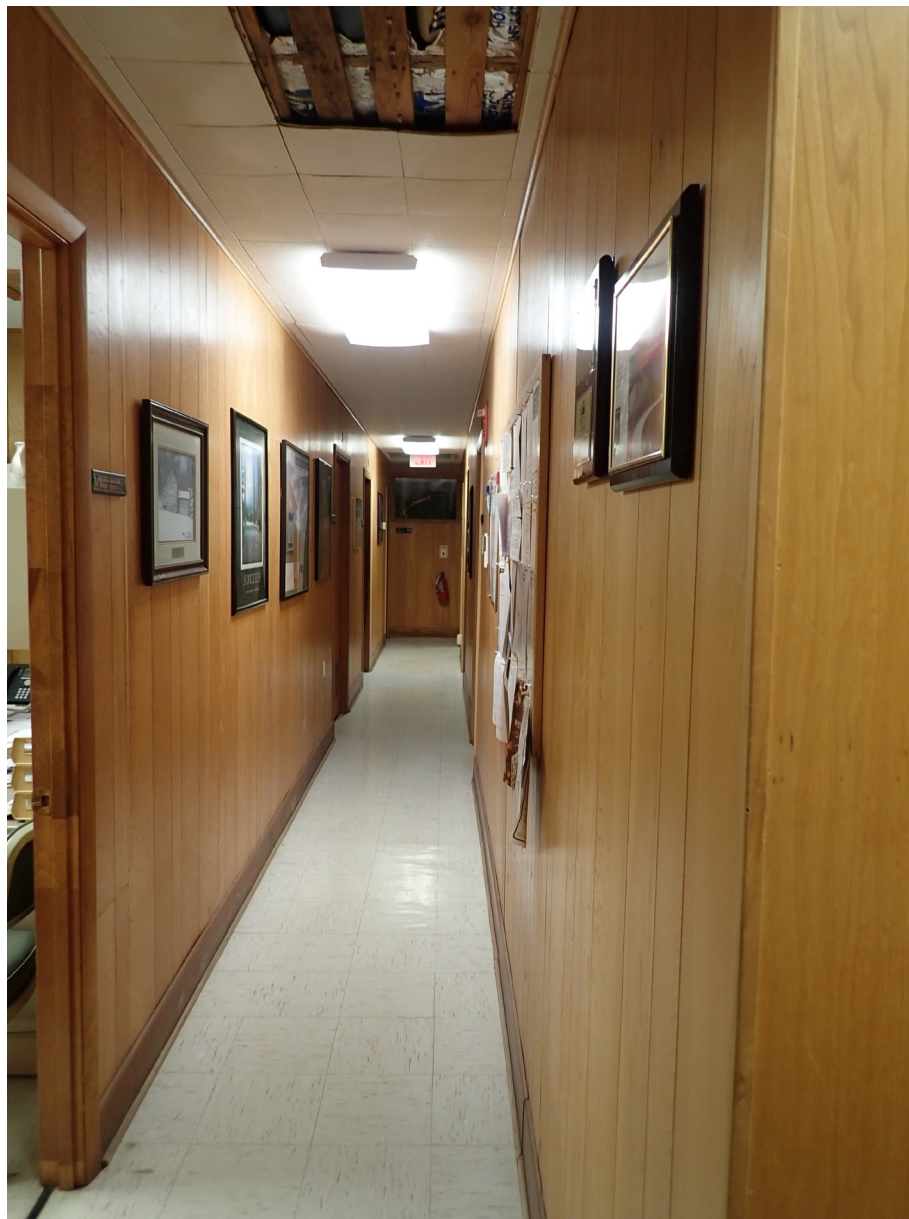
In general, all of the walls appear to be wood stud with plywood panels and are in good condition (figures 4-48 to 4-50). Most of the offices and the hallway have dropped 2x4 ACT tile ceilings in poor to fair condition and vary between the spaces. The east and west wings have exposed ceilings where the concrete roof slab can be seen and show some cracking in a few areas.

Figure 4-48. Upper level corridor (source: Quinn Evans 2019)

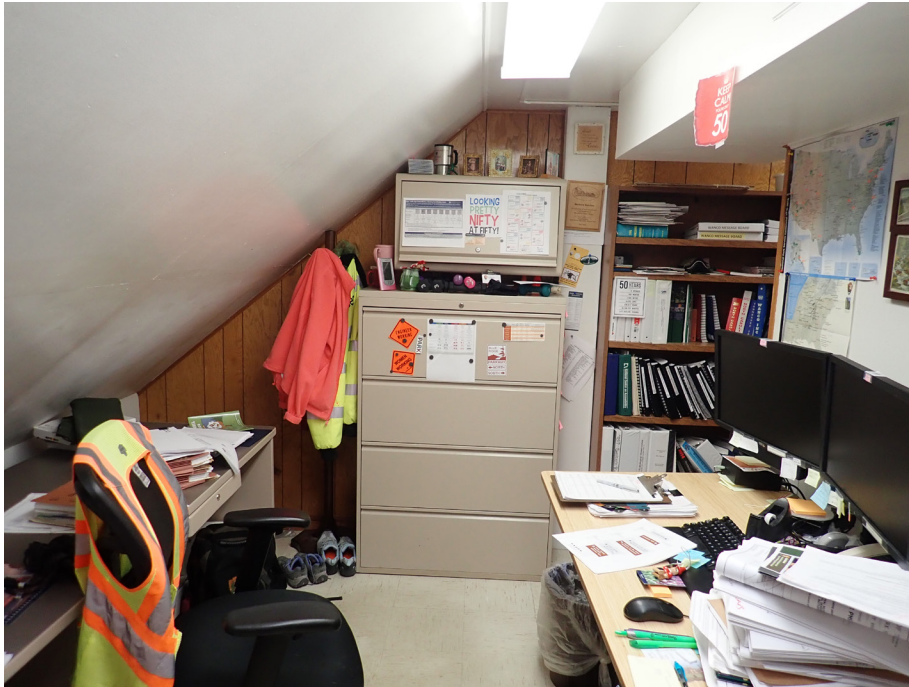
Figure 4-49. Upper level, typical office with slanted roof (source: Quinn Evans 2019)

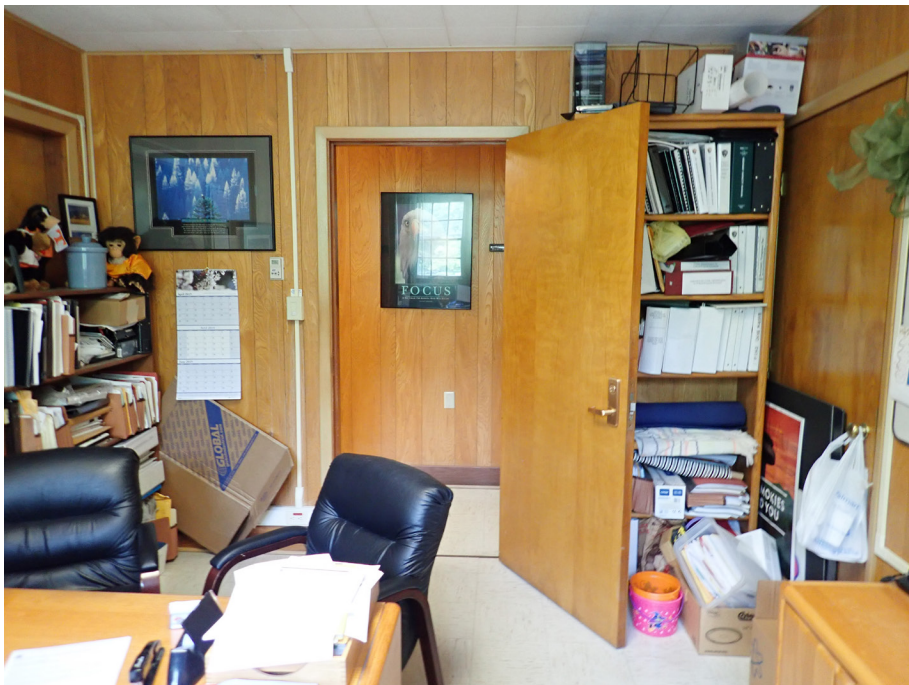
Figure 4-50. Upper level, typical office (source: Quinn Evans 2019)

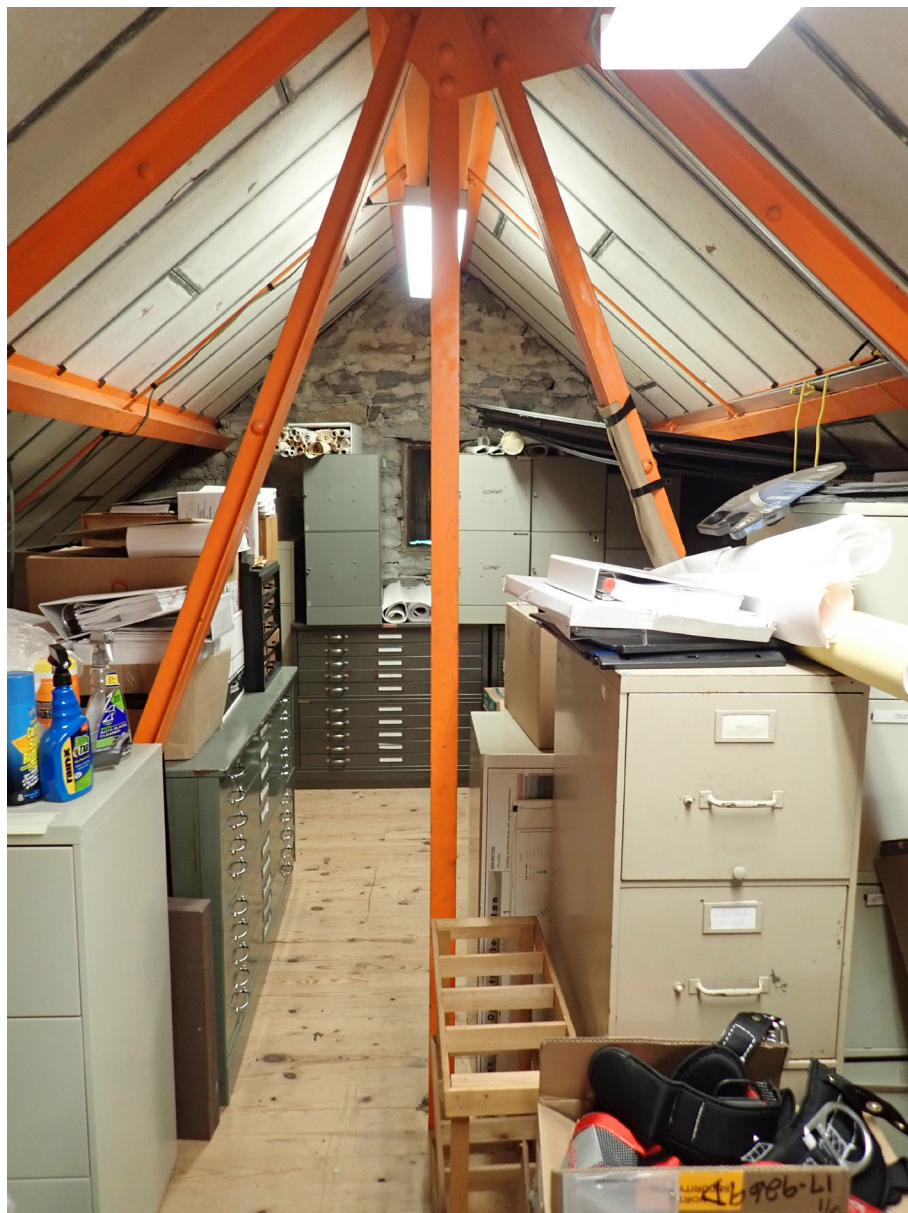
All of the flooring in the office areas of the upper level is vinyl tile and is generally in fair condition. The storage spaces within the east and west wings are exposed plywood (figure 4-51).

**Figure 4-51. Upper level,
unfinished attic storage area**
(source: Quinn Evans 2019)

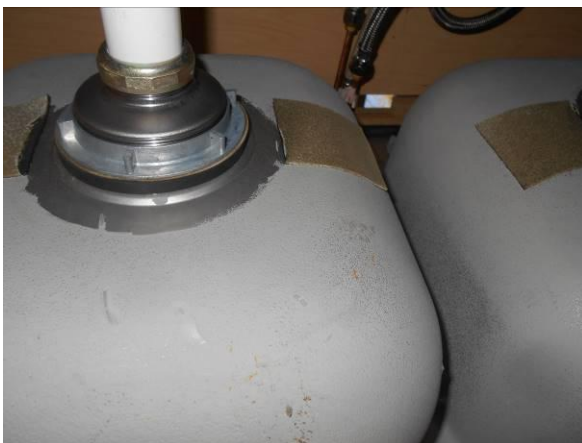
Photo #23 View of the grey sink undercoating in the basement.

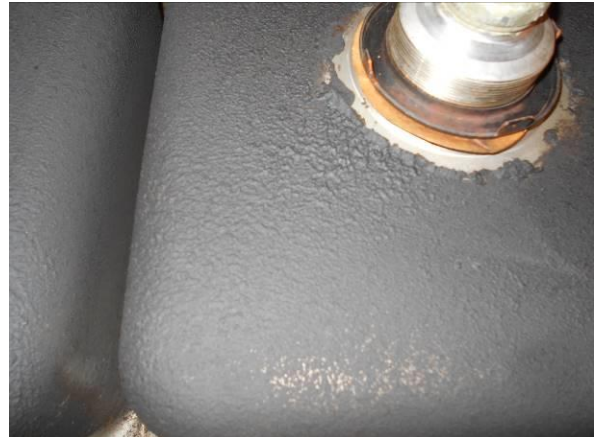
Photo #32 View of the asbestos black sink undercoating on the 2nd level of the building.

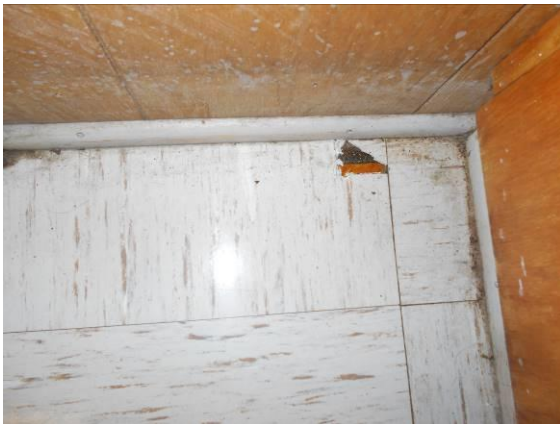
Photo #33 View of the asbestos bottom floor tile in the basement of the building.

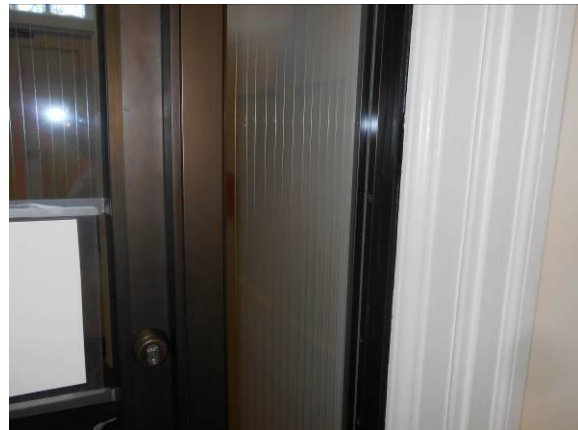
Photo #34 View of the asbestos caulking around the exit doors of the building.

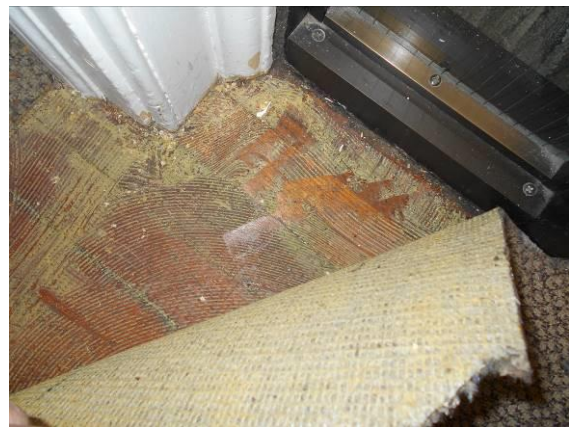
Photo #36 View of the carpet glue over hardwoods in the interior of the building.

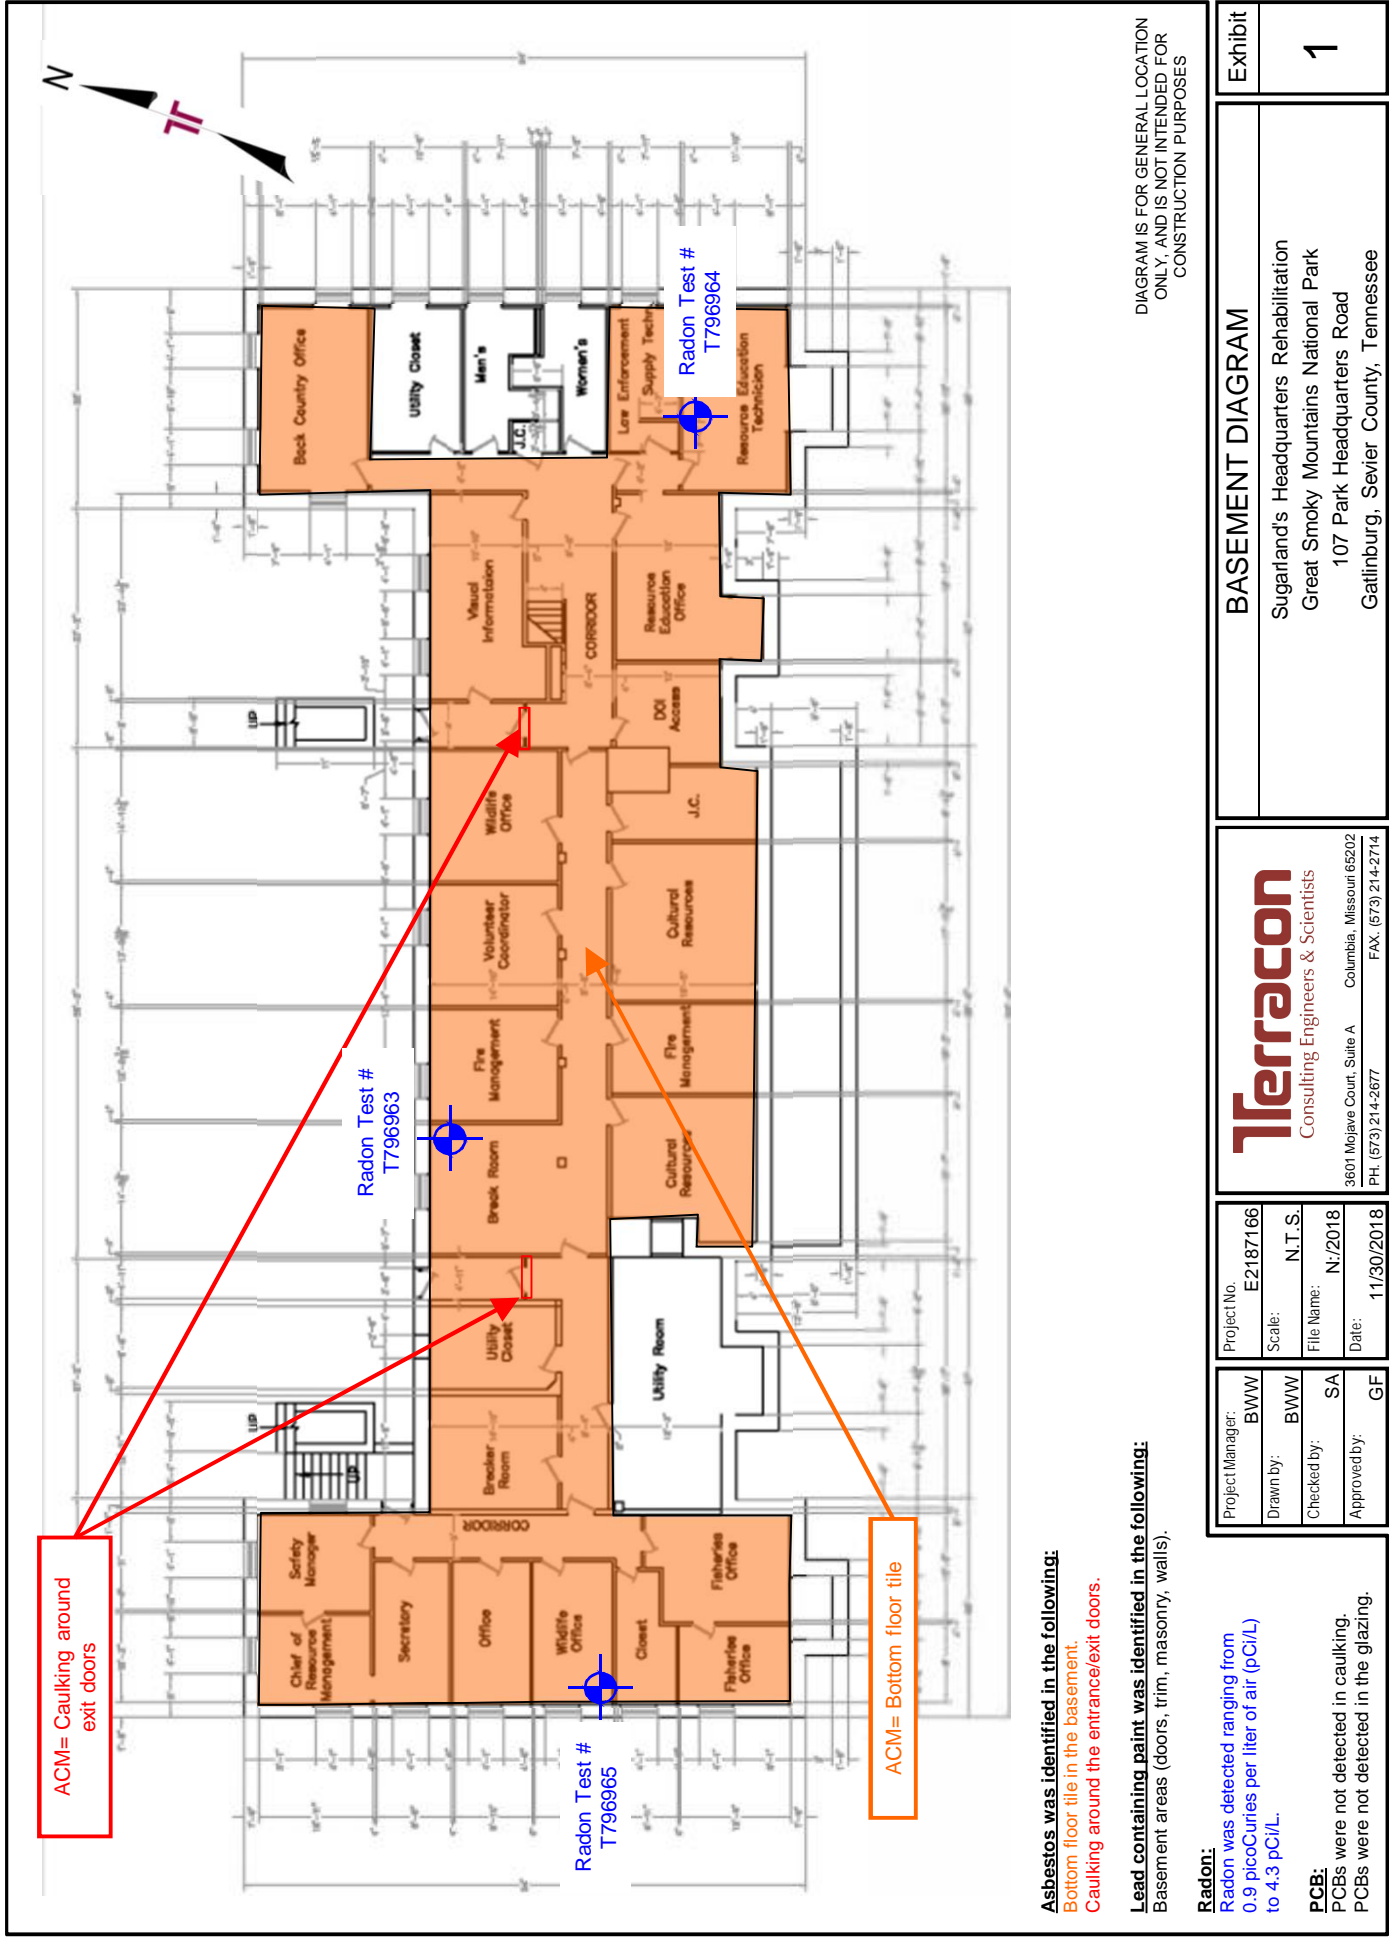
Asbestos was identified in the following:
Bottom floor tile in the basement.
Caulking around the entrance/exit doors.

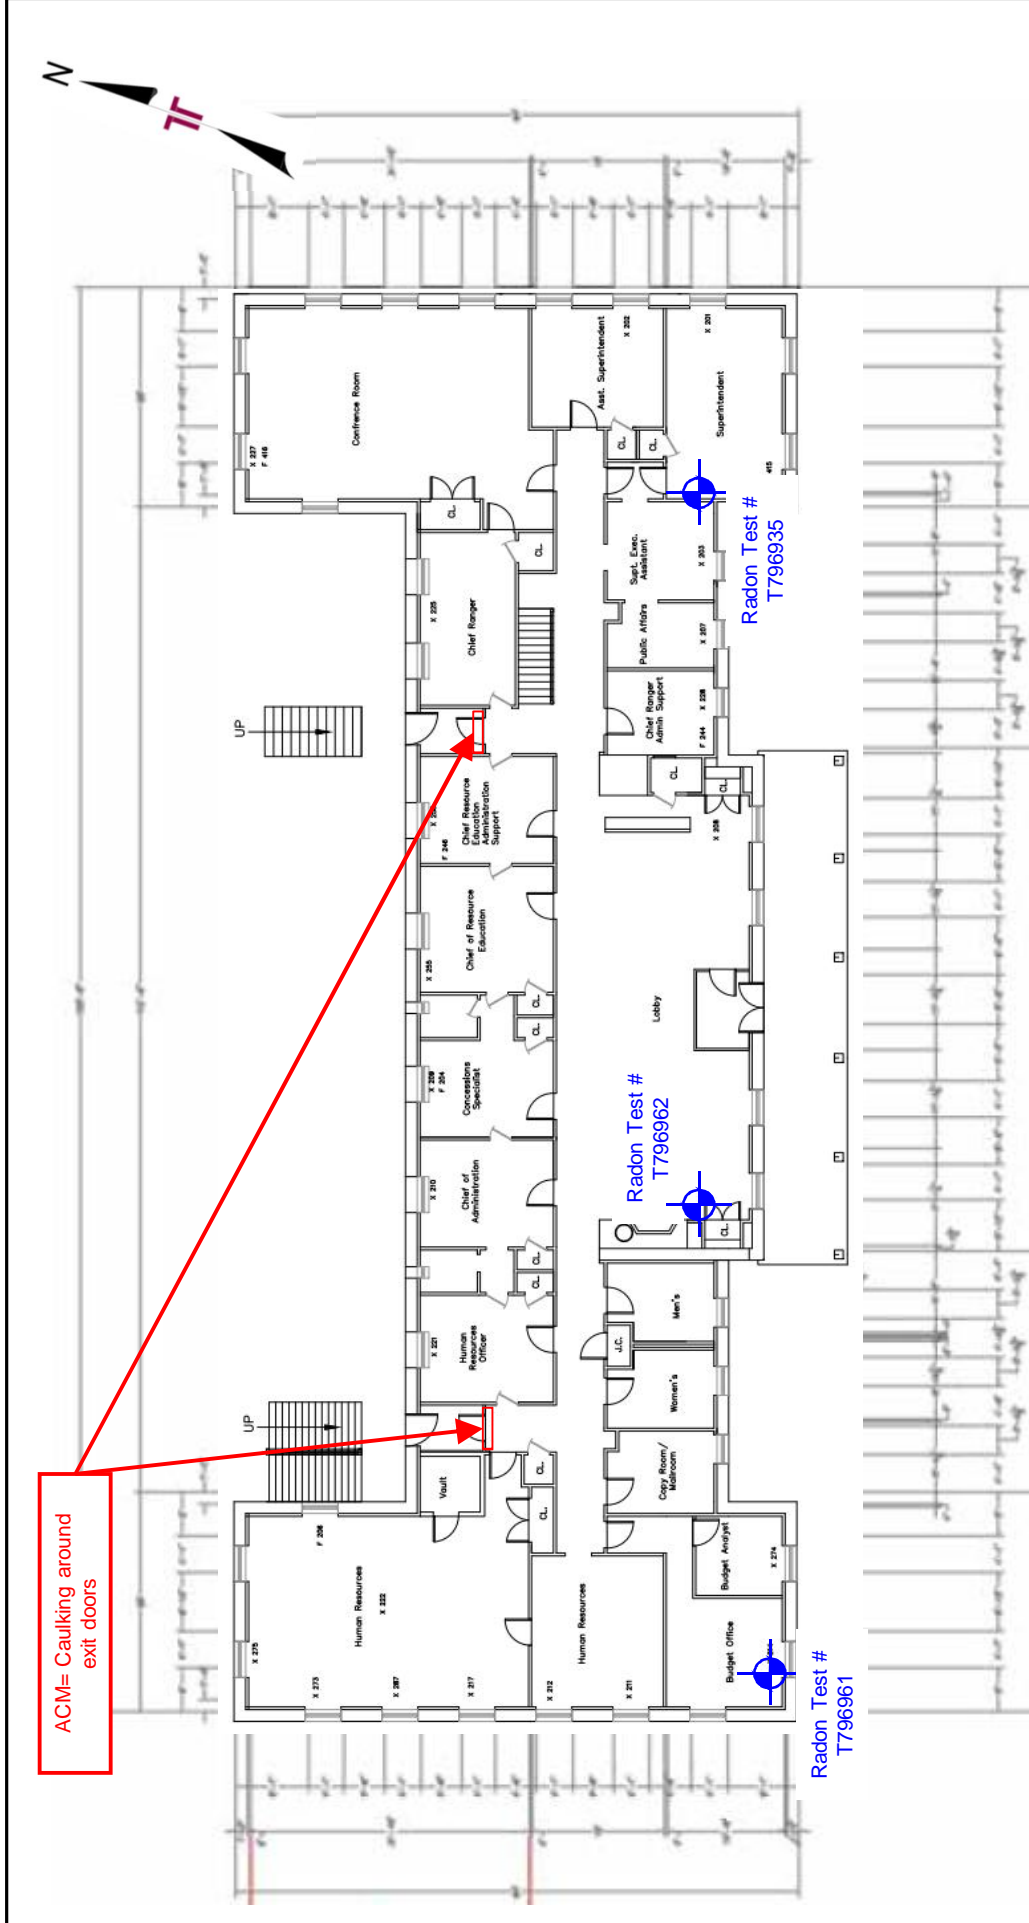
Asbestos was identified in the following:
Caulking around the entrance/exit doors.

Lead containing paint was identified in the following:
1st Floor areas (doors, trim, walls).

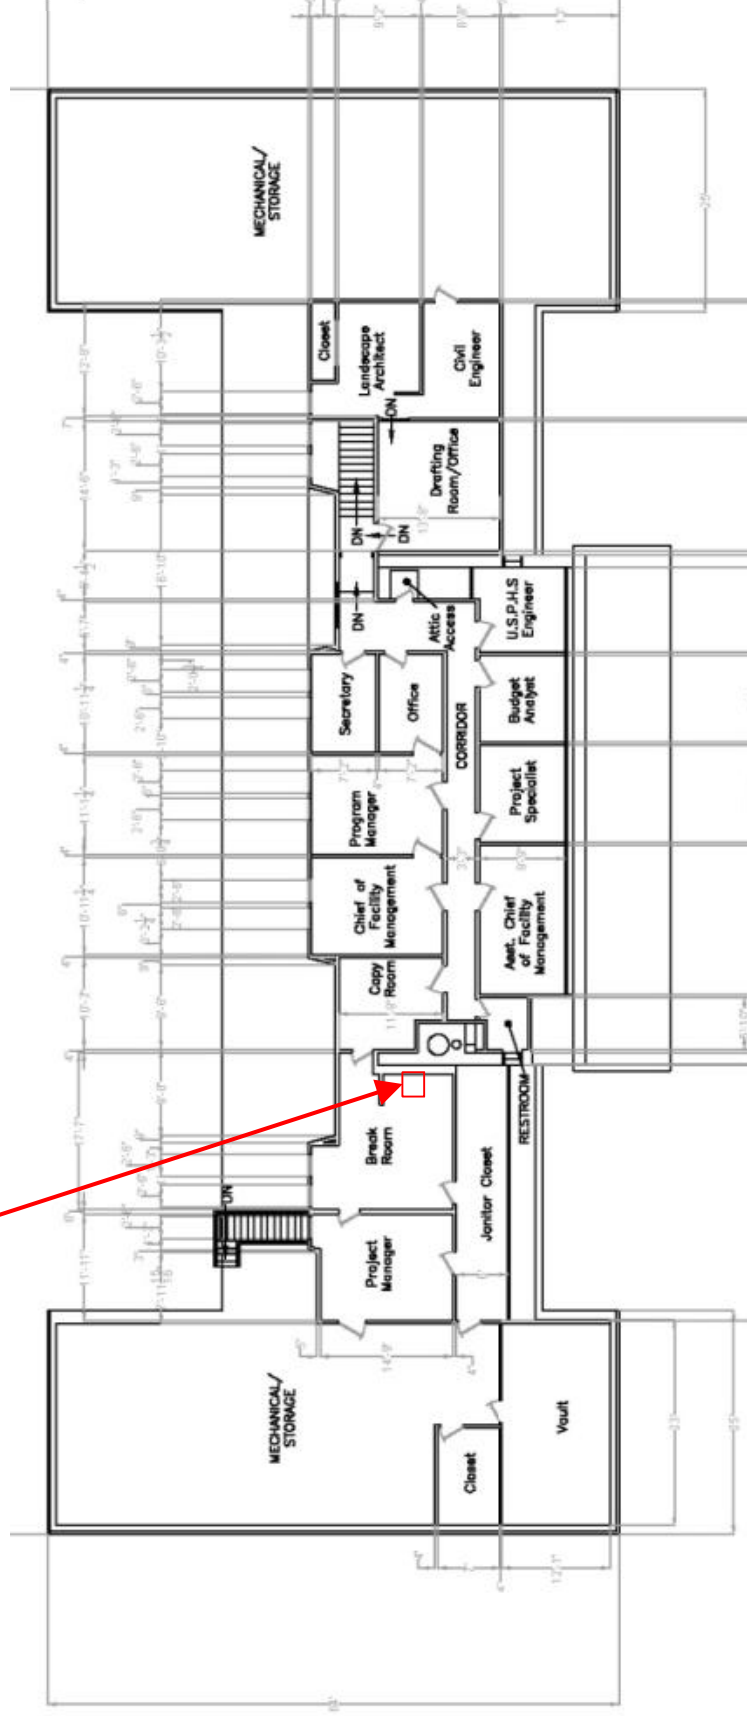
ACM= Sink Undercoating

Asbestos was identified in the following:
Sink undercoating in the breakroom 2nd Floor.

Lead containing paint was identified in the following:
Lead containing paint was not detected on the 2nd Floor.
