**HARPERS FERRY**  
**BLDG. 3-NICHOLS/WILLIAMS BUILDING**

HARPERS FERRY  
HISTORIC STRUCTURE REPORT  
ARCHITECTURAL DATA SECTION  
NICHOLS/WILLIAMS BUILDING  
BUILDING 3

July 1981

Prepared by  
Thomas E. Fields  
and  
Susan L. Shufelt

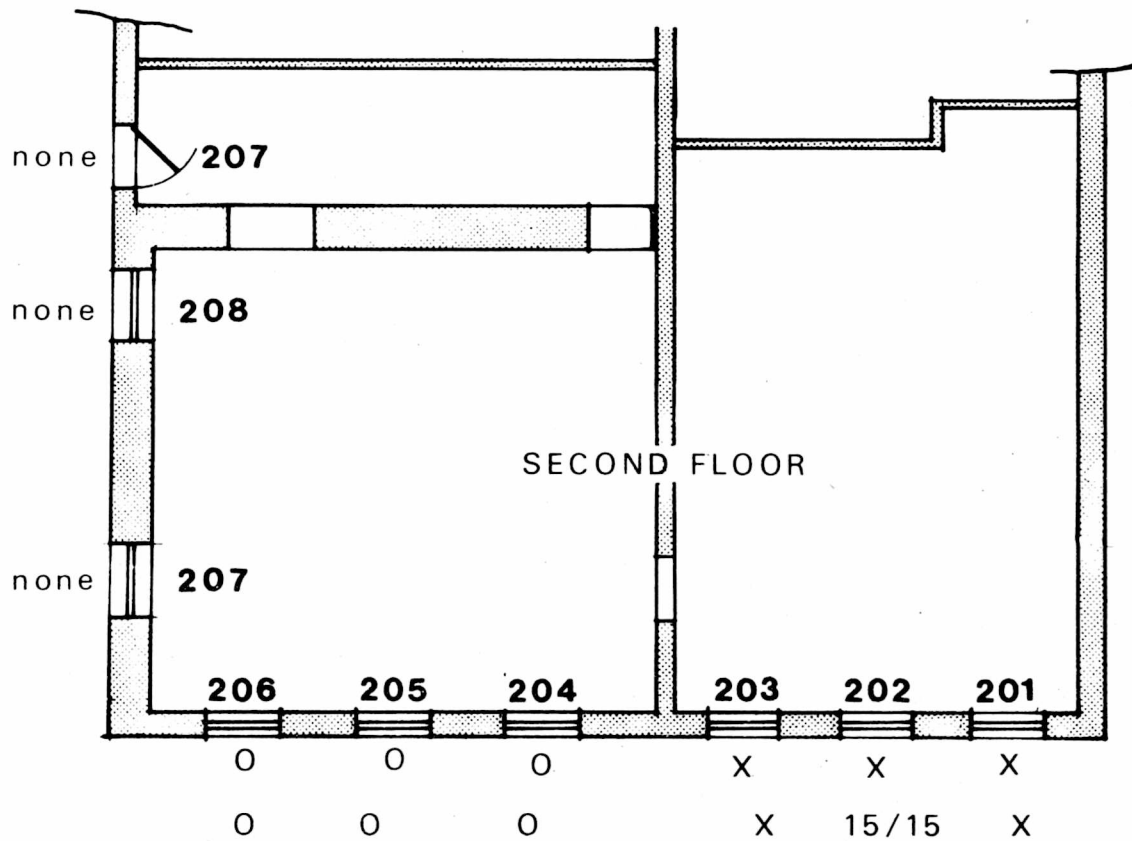
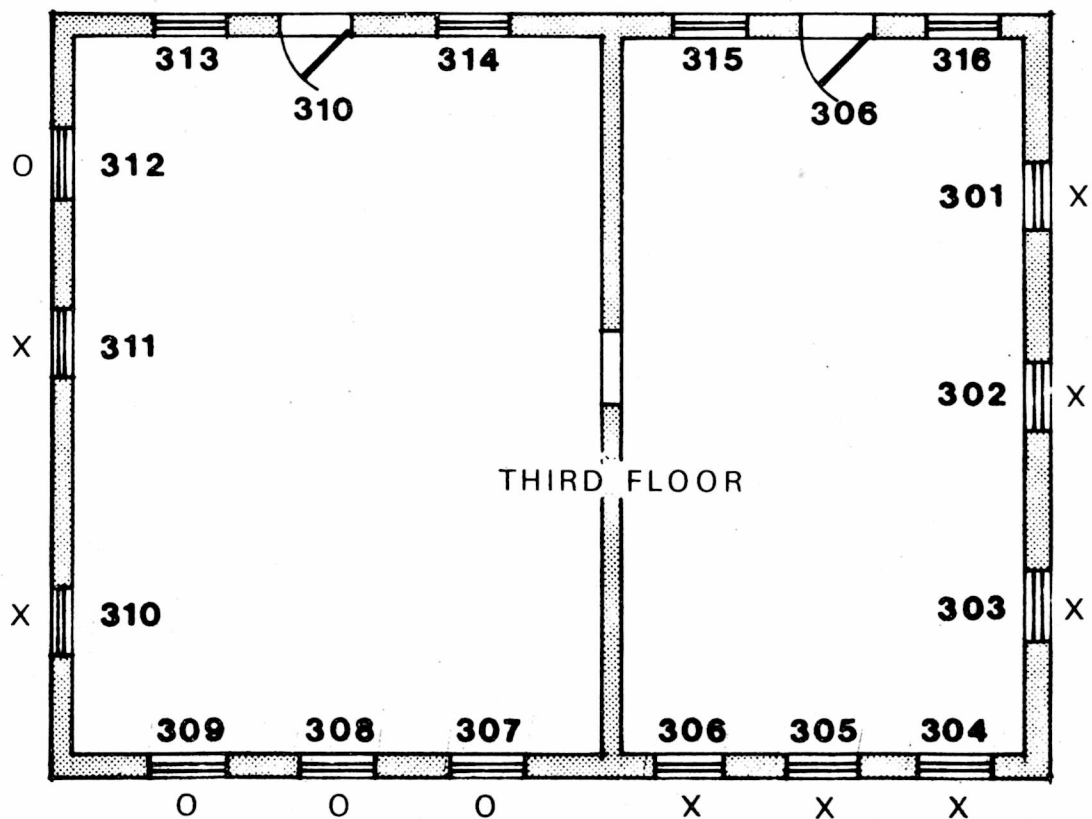
FIGURE No. 7  
SEGMENTAL ARCH  
BRICK PATTERNS

The windows on the east (W 207, 208, and 310-312) and west (W 301-303) elevations and the doors (D 306 and 310) on the south elevation also follow this pattern, but there are exceptions. Windows 310 and 311 on the east elevation repeat the pattern of 15 bricks over 14 bricks found on the west elevation.

The arch over door 306 has 15 bricks over 15 bricks, and windows 208 and 209, located in the parged stone wall, have no brick arches (see figure 7).

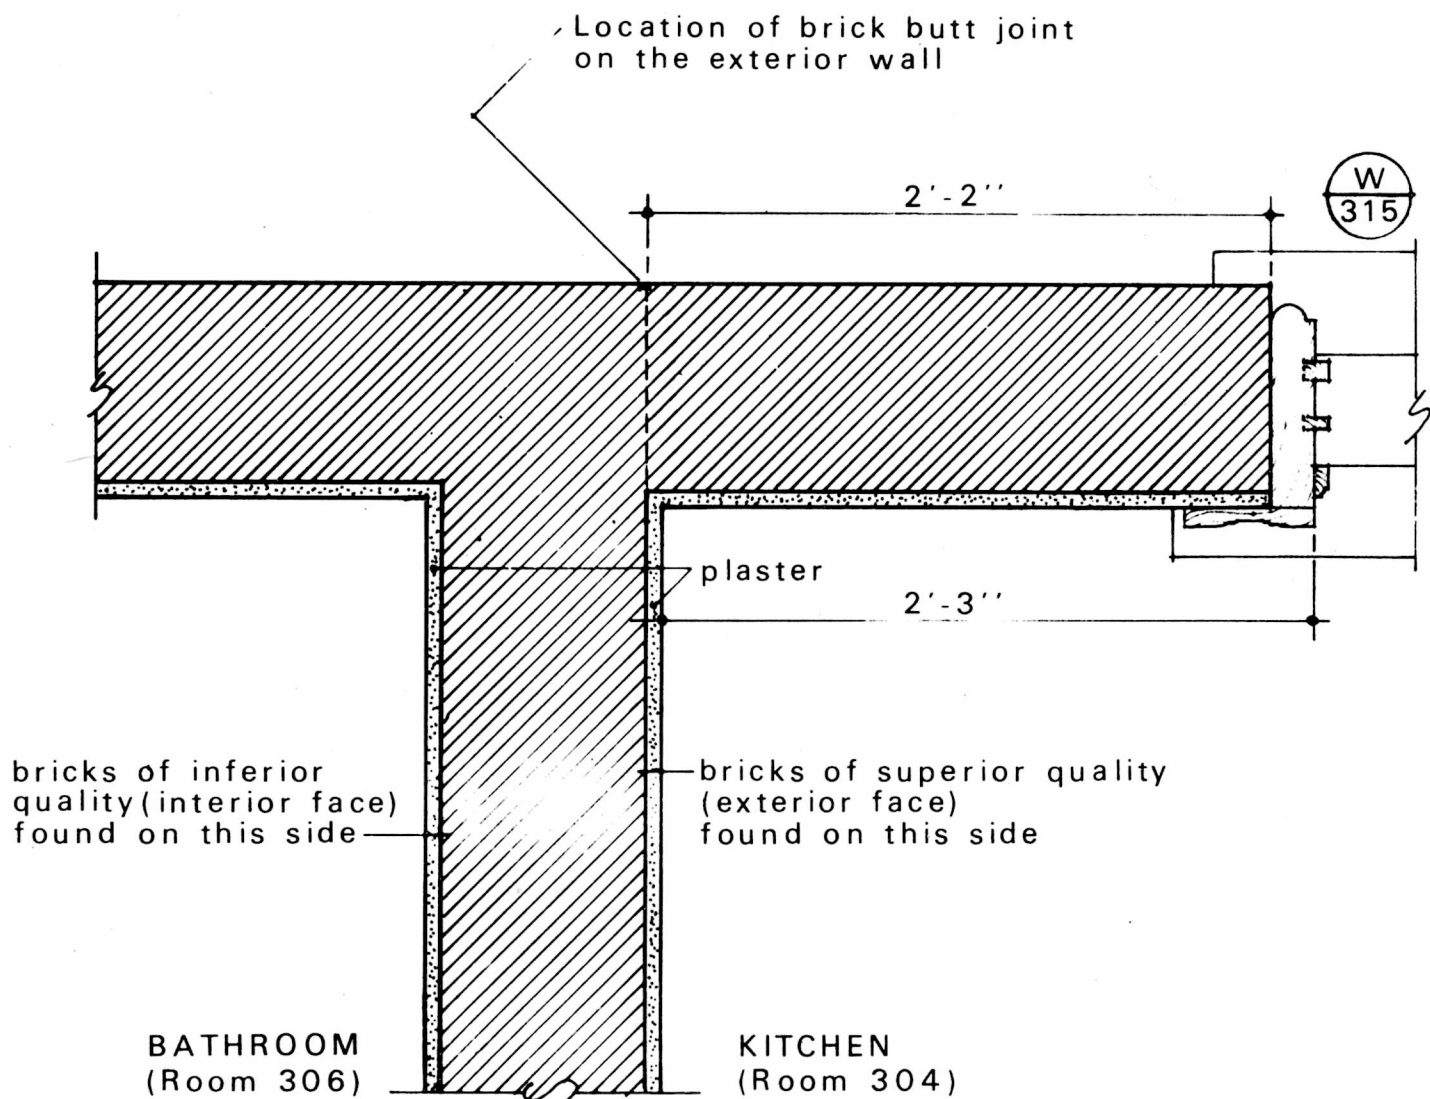
**FIGURE No. 8**  
**LOCATION OF**  
**BRICK BUTT JOINT**  
**IN RELATIONSHIP TO**  
**INTERIOR BRICK WALL**

(7) The interior brick wall which divides Building 3 into two sections continues up through the ceiling of the third floor to the roof. This is consistent with the theory that this wall, at one time, was an exterior wall for the eastern section of Building 3.

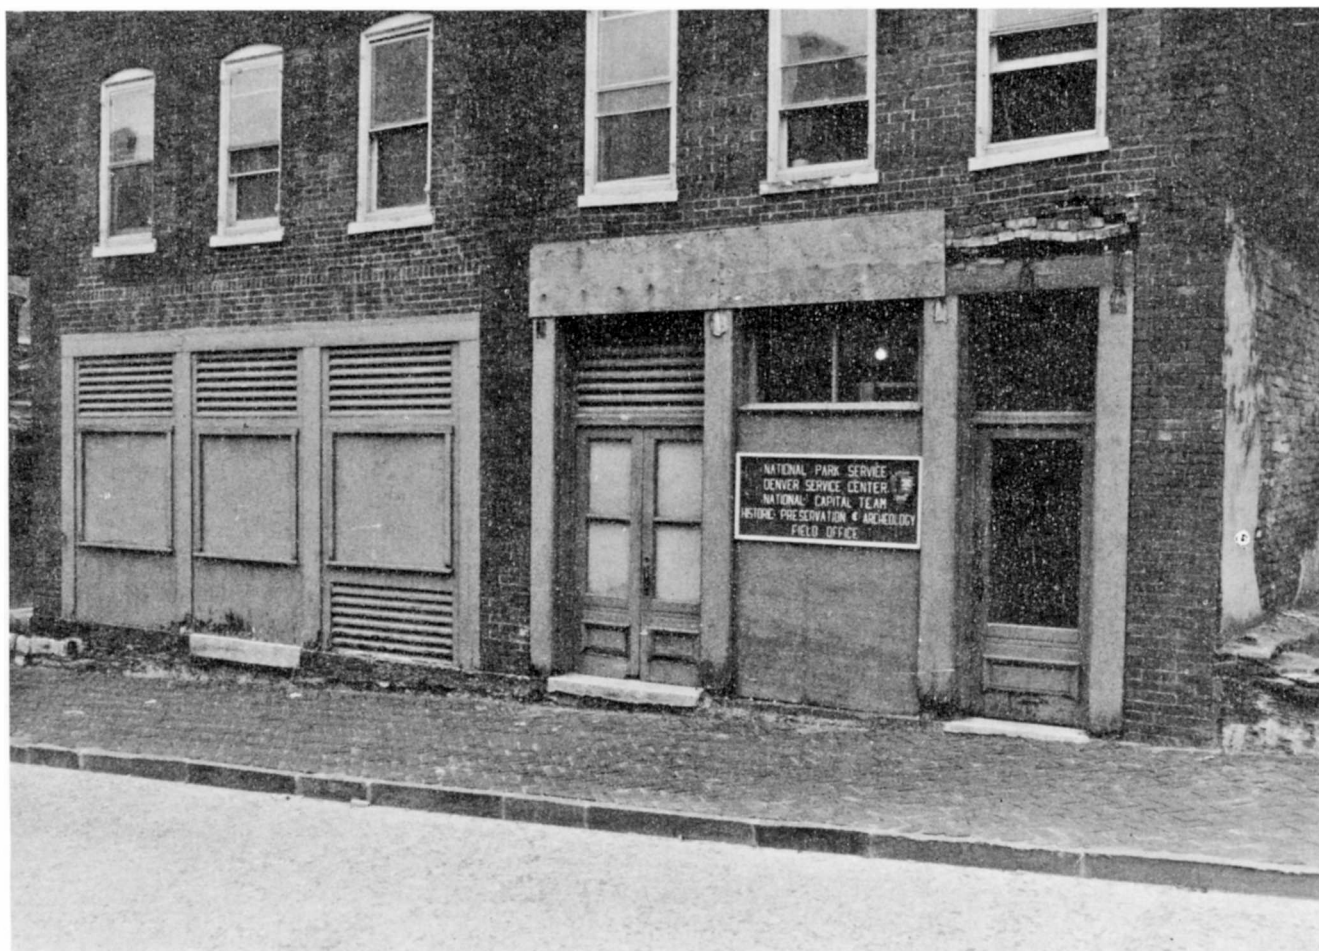
PHOTOGRAPH 2 (1980)  
Storefront Doors

Nearly all the original windows and window frames which existed on the first floor of Building 3 have been removed. These windows include one splayed window opening in the east stone wall of the "back room" (room 104) which is covered with pieces of wood and insulation, and three sections of windows along the front or north elevation which either contain vents or have been covered with plywood. Only two small panes of glass remain on what was originally the storefront (see photograph 2).

Two of the original three storefront doors remain. The sill on the eastern side of the storefront marks the location of the third door.

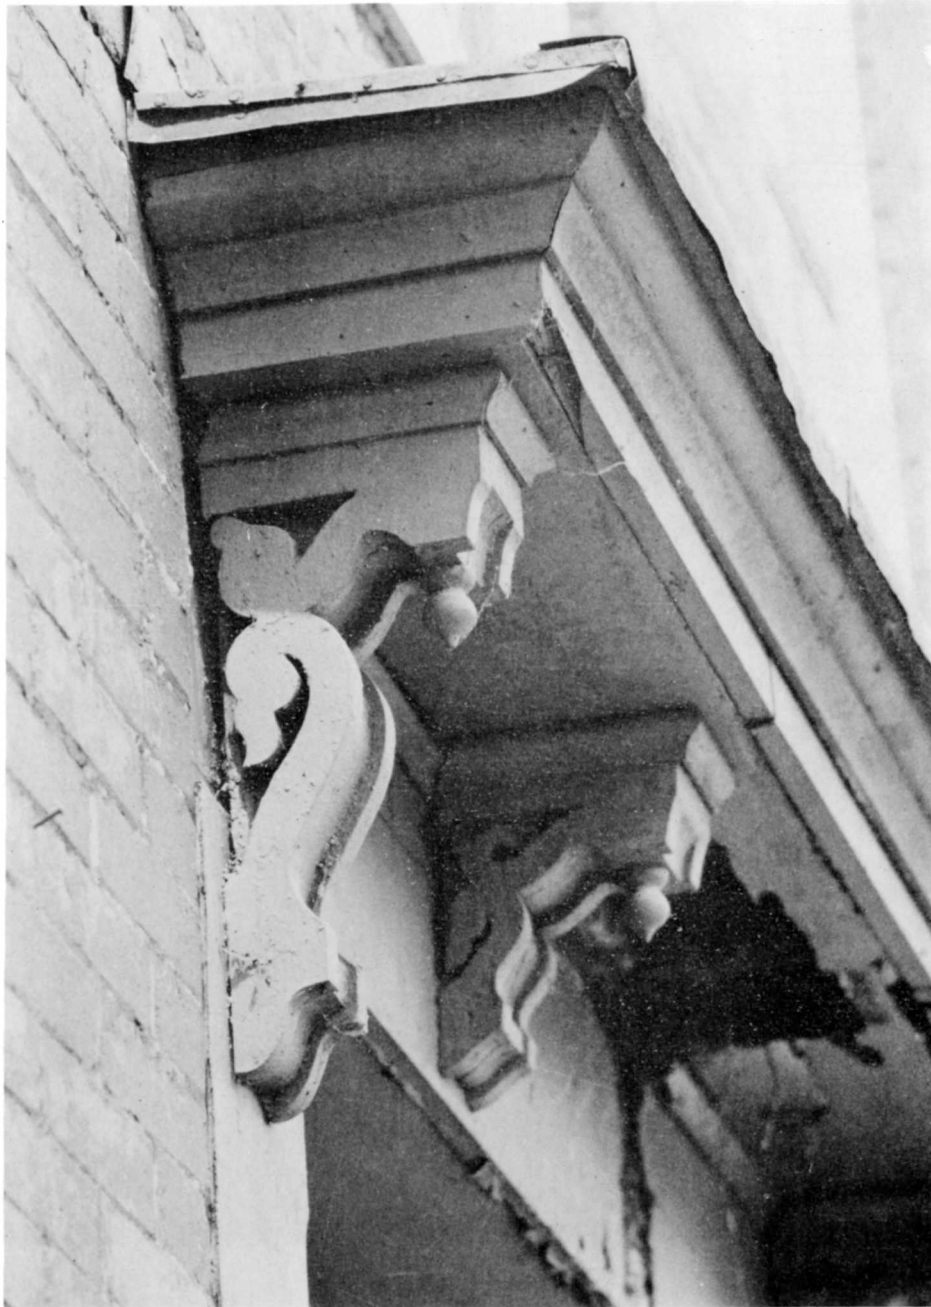
PHOTOGRAPH 6 (1977)  
Boxed Cornice over Storefront

The boxed cornice, which is no longer on the building, had two types of brackets which differed in size and design.

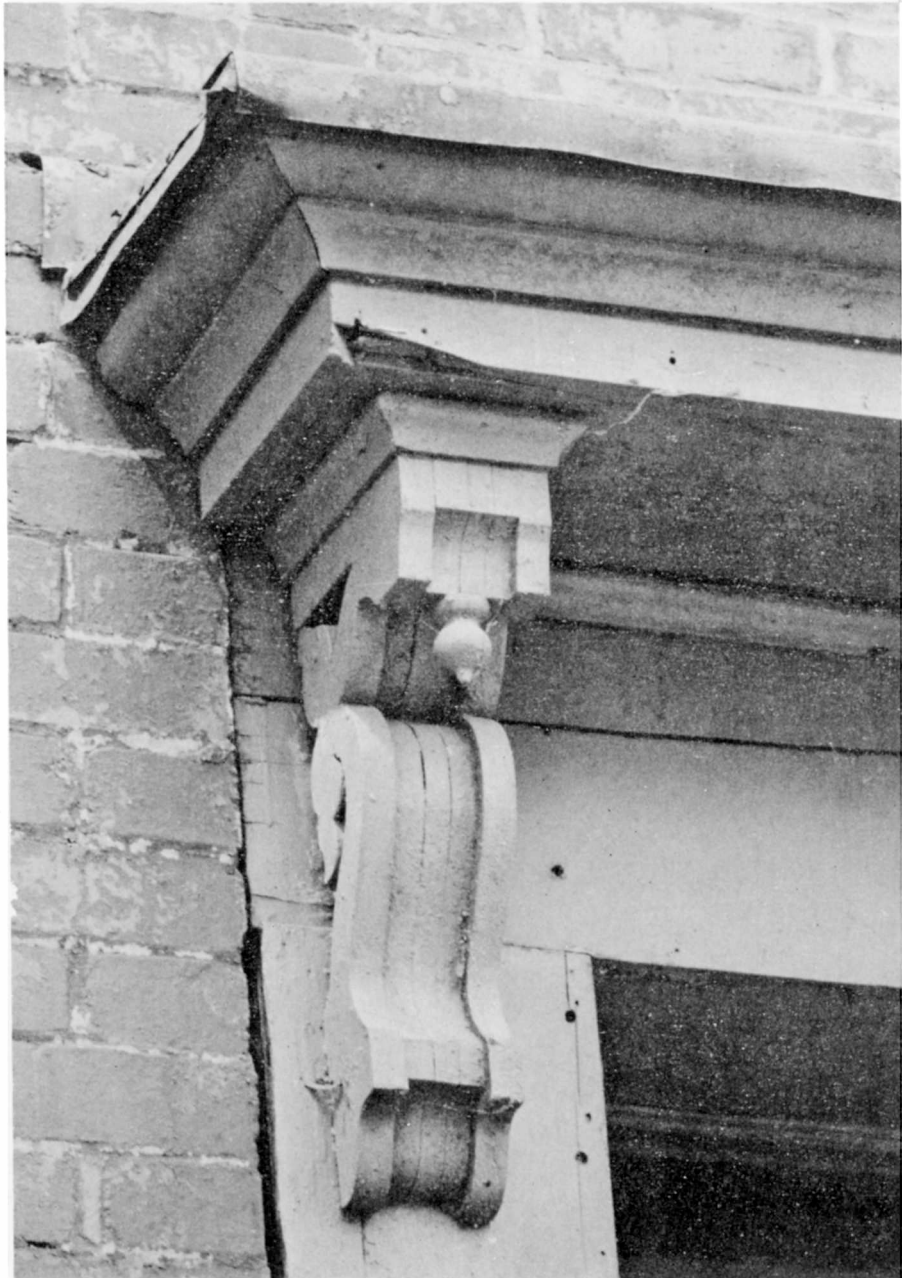
PHOTOGRAPH 7 (1977)  
Boxed Cornice over Storefront

The brackets supporting the cornice were each composed of several pieces of wood.

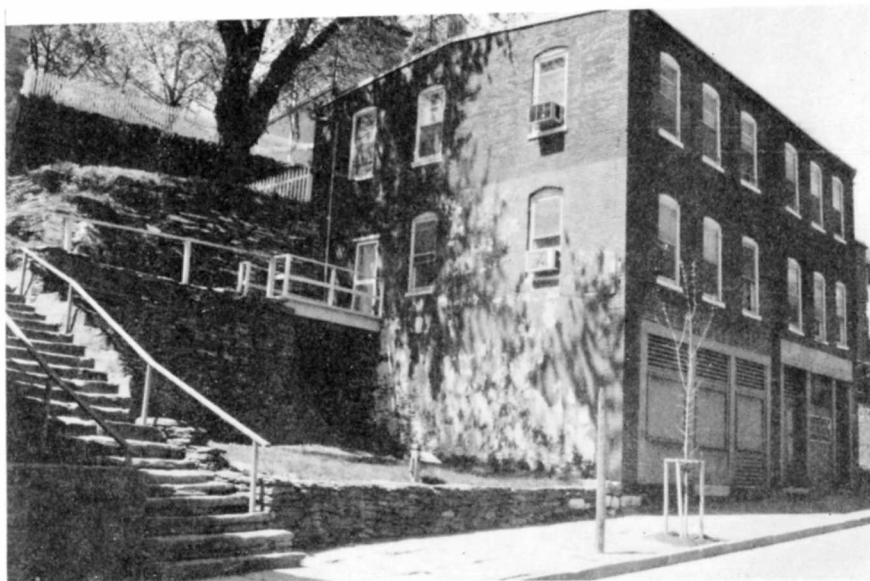
PHOTOGRAPH 8 (1980)  
East Elevation

There is one exterior door (D 207) on the second floor (see photograph 8); it is located on the east elevation near the rear of the building, close to the cliff. This entrance is connected by a wooden bridge to a ledge in the cliff. The door is a four-panel wood door which is boarded shut.

The east wall was built in stages. A stone wall, constructed between 1849 and 1876 by Samuel Williams forms the front (or north) 22 ft. of the first and second stories. The rear 6 ft. of this wall and all of the third floor were added later. This addition is stone at the first level and brick at the second and third levels.

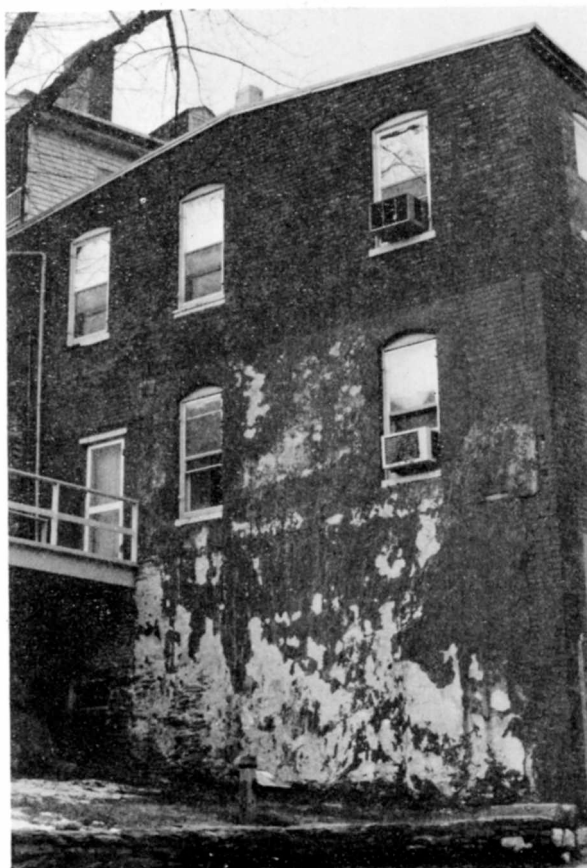
PHOTOGRAPH 9 (1980)  
East Elevation

The west wall is constructed of brick, and is approximately 1 foot, 1½ inches thick. The east wall was constructed in stages. About the front 22 feet of the east wall consist of a 1-foot, 9 3/4-inch mortared stone wall for the first and second levels; this stone wall is a survival of the earlier stone building which was built on this site between 1849 and 1876. Approximately 6 feet of the rear of the east wall was added to this old stone wall; the 1-foot, 6-inch thick addition was stone at the first-floor level and brick at the second level (see photographs 9 and 10). The third floor of the east wall is built of brick and is approximately 8 inches thick.

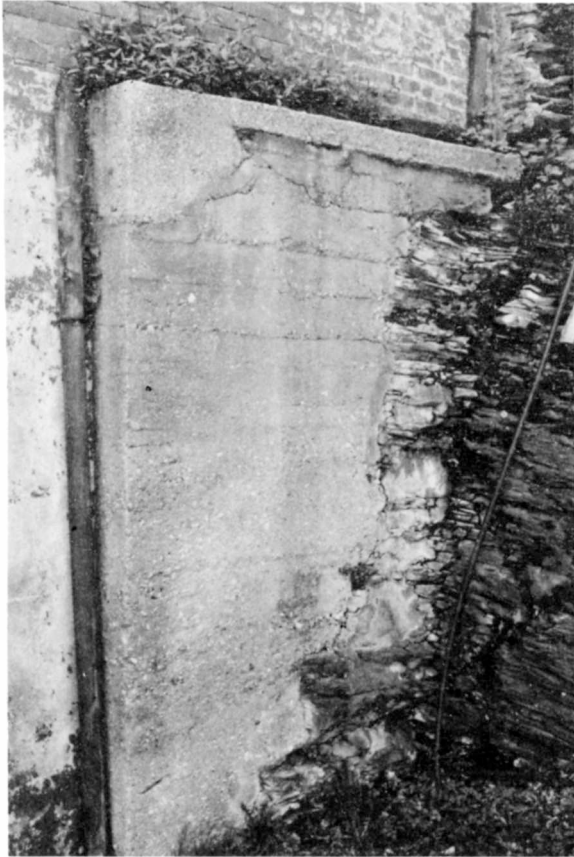
PHOTOGRAPH 13 (1980)  
West Elevation

All the remaining exterior walls are brick. The first-floor level of the west brick wall was covered with parging; however, recently this parging fell off. The rear quarter of this first-floor level west brick wall is covered by another wall, made of concrete 8½ inches thick (see photographs 12 and 13). It is unclear whether this concrete wall was an attempt to repair the brick west wall or to reinforce the cliff wall. The brick walls on the north and south sides are topped by a dentil-patterned cornice (see photograph 16).

Since these pictures were taken,  
the parging on the west wall at  
the first story has fallen off.

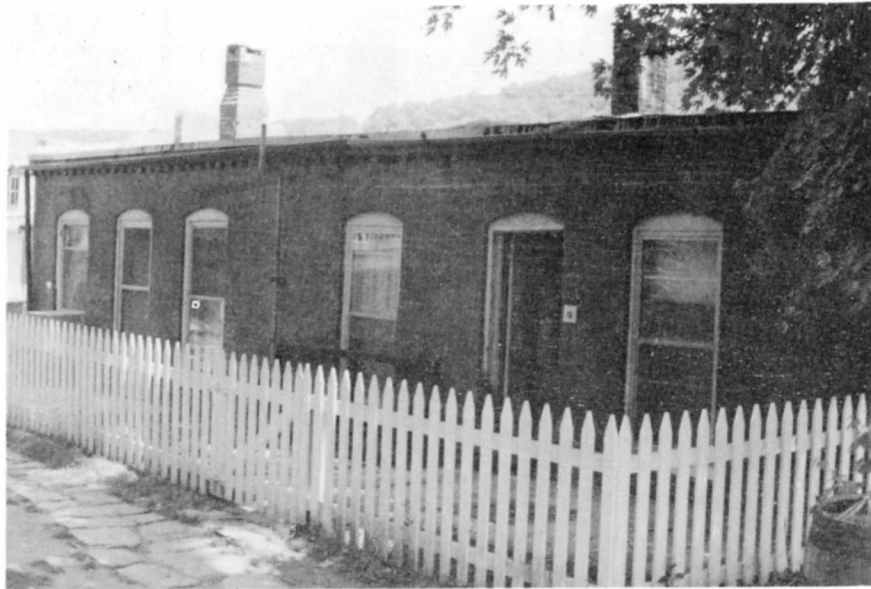
PHOTOGRAPH 14 (1980)  
South Elevation

(4) On the front and rear elevations, the window spacing on the eastern section differs from that on the western section (see photographs 1 and 14).

On the third floor, there are two entrances on the south elevation opening on to the top of the cliff (see photograph 14). Both doors (D 306 and 310) are four-panel wood doors with aluminum storm doors. These two doors are the only doors on which the segmental brick arches found over the windows are repeated. The door on the western side (D 306) of the south elevation has a bull-nose frame, while the door on the eastern side has a square frame.

Note that the window spacing on the western portion of the building is different from that on the eastern side. The stone walk in the foreground is part of the public walkway that passes behind Building 3.

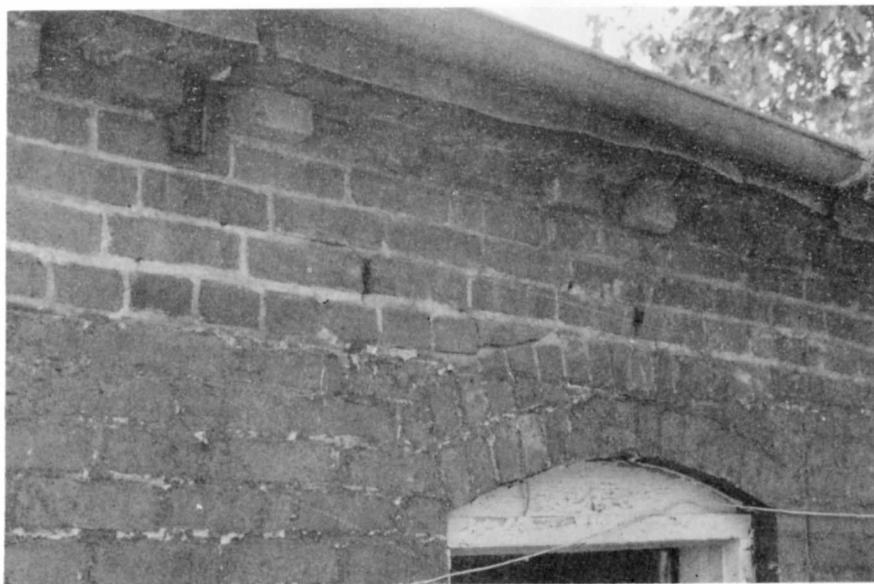
PHOTOGRAPH 15 (1980)  
South Elevation

Note the ghost line and wood nailers in the brick wall. They indicate the location of a porch that was formerly attached to the south elevation.

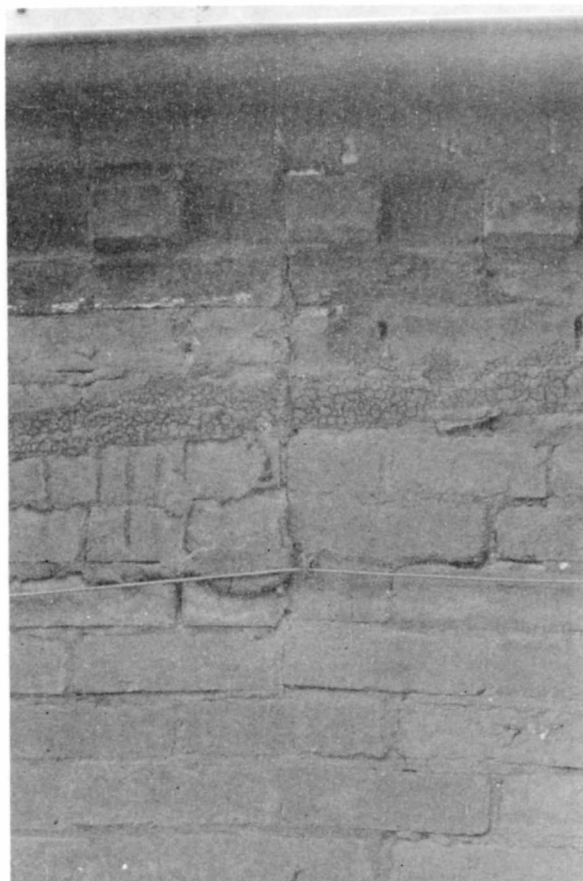
PHOTOGRAPH 16 (1980)  
South Elevation Near Roof Line

These pictures show evidence of a butt joint, indicating where a corner might have existed before the western portion of Building 3 was added to the eastern section.

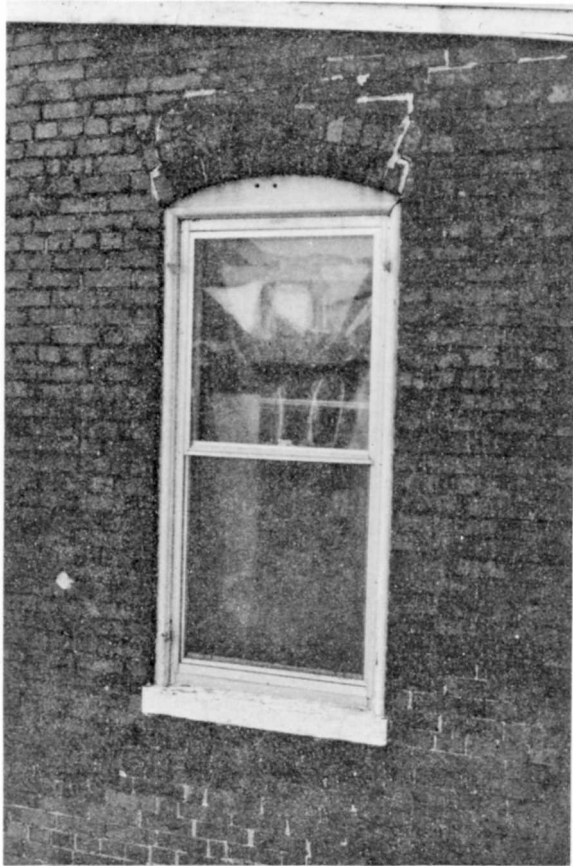
PHOTOGRAPH 18 (1980)  
Window 301

This window is typical of the second-  
and third-floor windows.

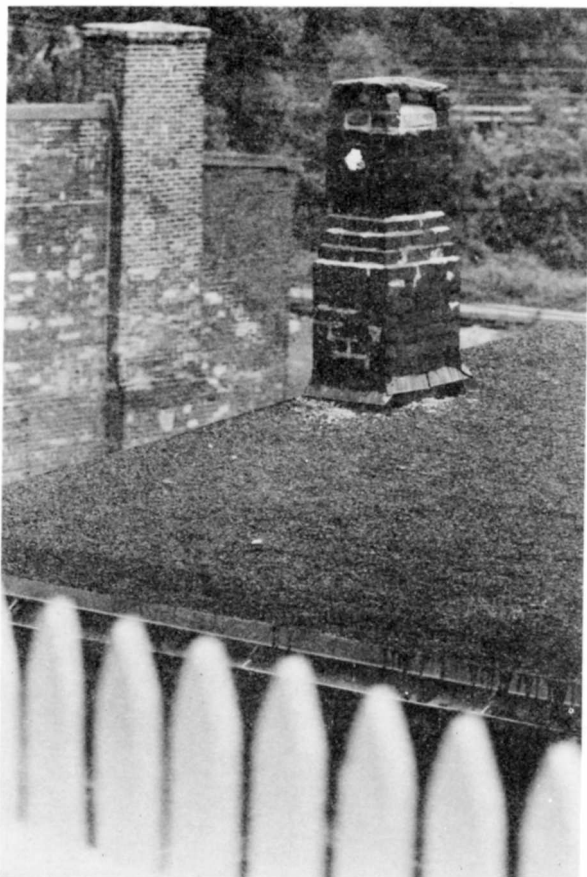
PHOTOGRAPH 20 (1977)

Chimney No. 1

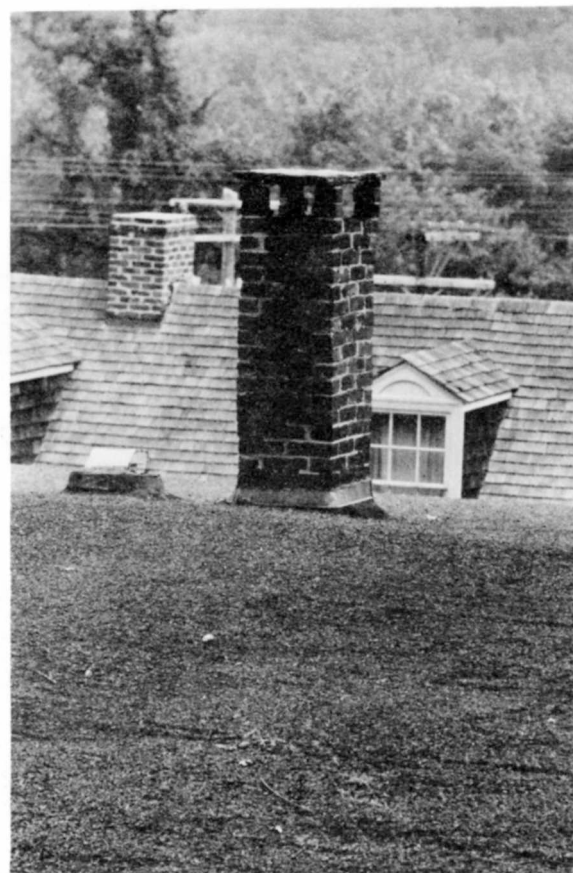
PHOTOGRAPH 21 (1977)

The other chimney located in the middle of the roof extends straight up above the roof for 17 courses. The next two courses consist of two bricks at each corner. Topping the chimney is a 2-inch thick piece of Harpers Ferry shale (see photograph 21).

Chimney No. 2

Only two of the original five chimneys remain.

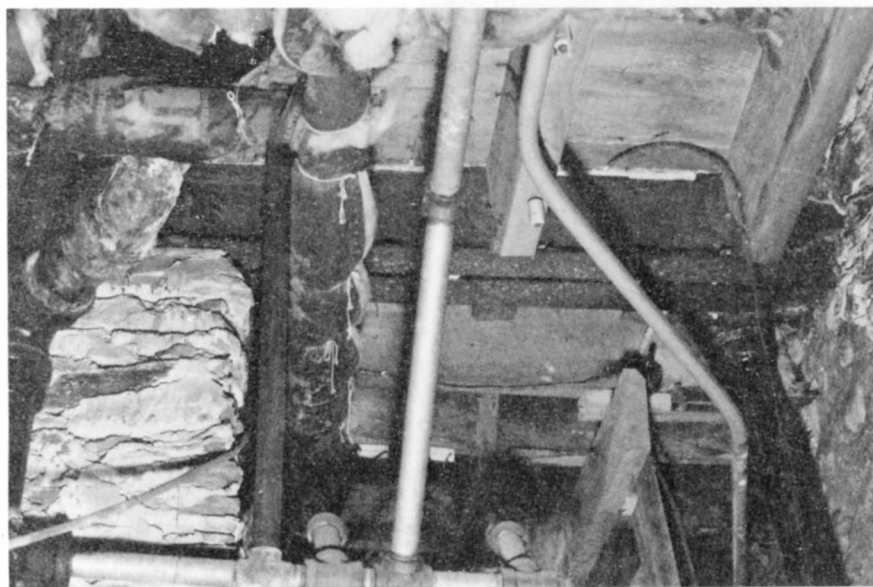
PHOTOGRAPH 24 (1980)  
Room 104, Steel Beams Supported by Stone Wall and  
Rock Cliff

The interior brick wall which exists on the second and third floors, at one time extended down to the first floor. The cavity in the stone wall, visible in PHOTOGRAPH 22, indicates where the brick wall and rock cliff met on the first-floor level. When the interior brick wall was removed from the first floor, two steel I beams were added to support the brick wall above. The interior stone wall between rooms 102 and 104 was extended six to eight inches to help support these beams.

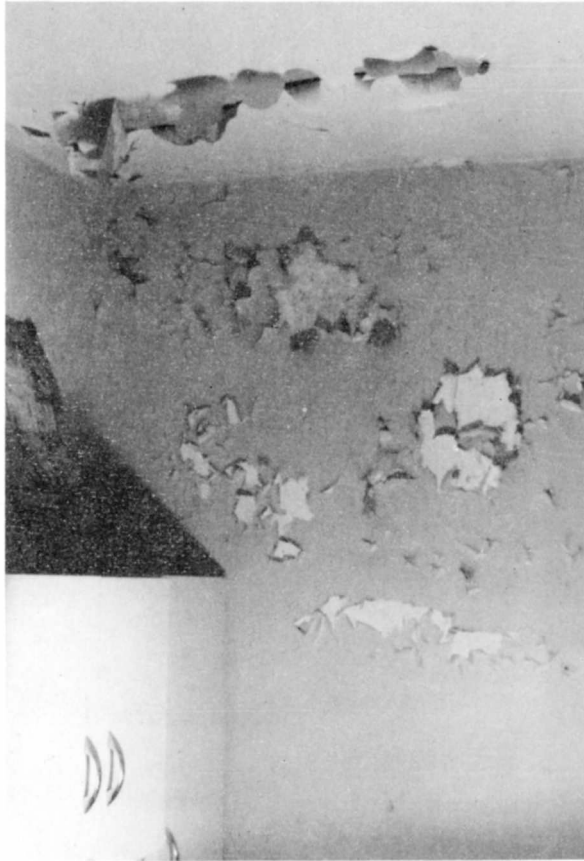
PHOTOGRAPH 28 (1980)  
Room 204, Southeast Corner

The plumbing system in Building 3, which was probably added after the 1896-1907 construction period, is in operating condition. There are, however, problems in the system: the drain under the sink in the second-floor bathroom (room 204) does not work, and water stains on the ceiling in room 207 and peeling paint in room 204 (see photograph 28) indicate that there have been leaks in the plumbing of the bathroom (room 306) above.

These photographs show evidence of water problems. PHOTOGRAPH 28 shows possible interior plumbing problems. PHOTOGRAPH 29 shows evidence of rising damp due to poor drainage outside the south exterior wall.

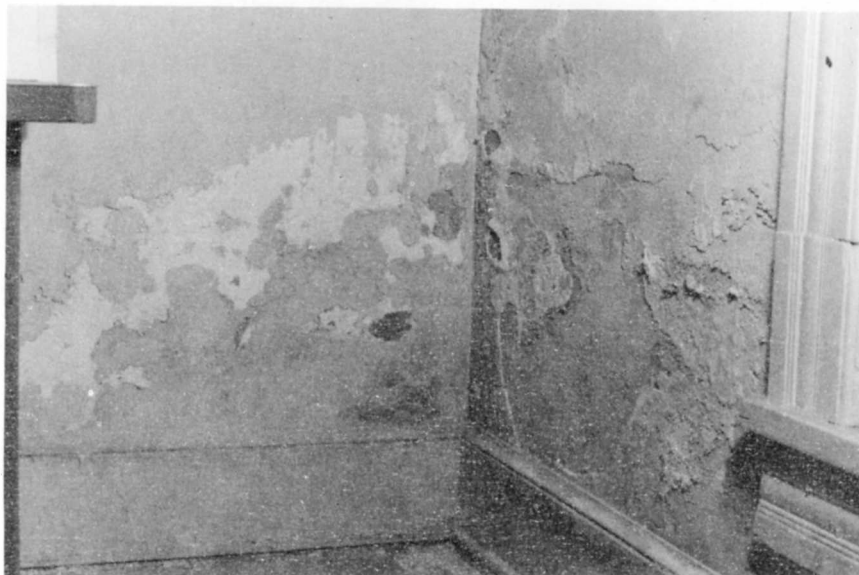
PHOTOGRAPH 29 (1980)  
Room 307, Southeast Corner

The concrete slab situated behind Building 3 causes additional water problems. This slab directs water toward the building's third floor--which is about level with the top of the cliff--rather than away from the building. Evidence of this problem can be seen on the walls of the southeastern corner of room 307 where the plaster has been damaged (see photograph 29).

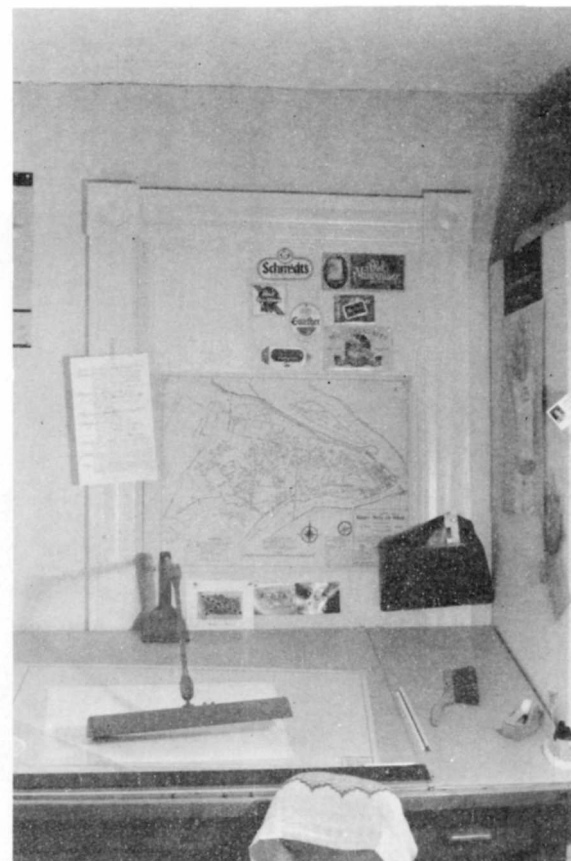
PHOTOGRAPH 31 (1980)  
Room 303, East Wall

This opening in the interior brick wall was probably a window before the western section of Building 3 was constructed.

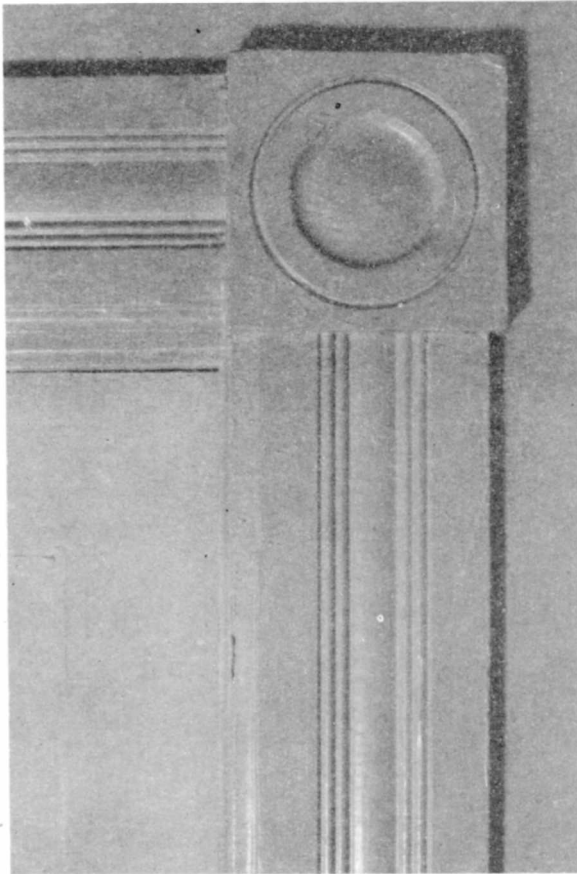
There are several types of architraves and corner blocks found on the windows and doors of Building 3. There appears to be a definite pattern in the distribution of these architraves and corner blocks: among the door (D 101-103, 107, 201, 203, 204, 209, 302, 305, 306 and 308-314) and window openings (W 201-206, 301-310, and 312-316), which appear to be original, type 3 architrave and type 1 corner block tend to be found in the eastern section of the building, while type 1 architrave and type 4 corner block tend to be found in the western section of the building (see photographs 32 and 33 and the charts on pages 41 and 42).

PHOTOGRAPH 32 (1980)  
Type 4 Corner Block  
Type 1 Architrave

This trim is found on the original windows and doors in the western section of Building 3

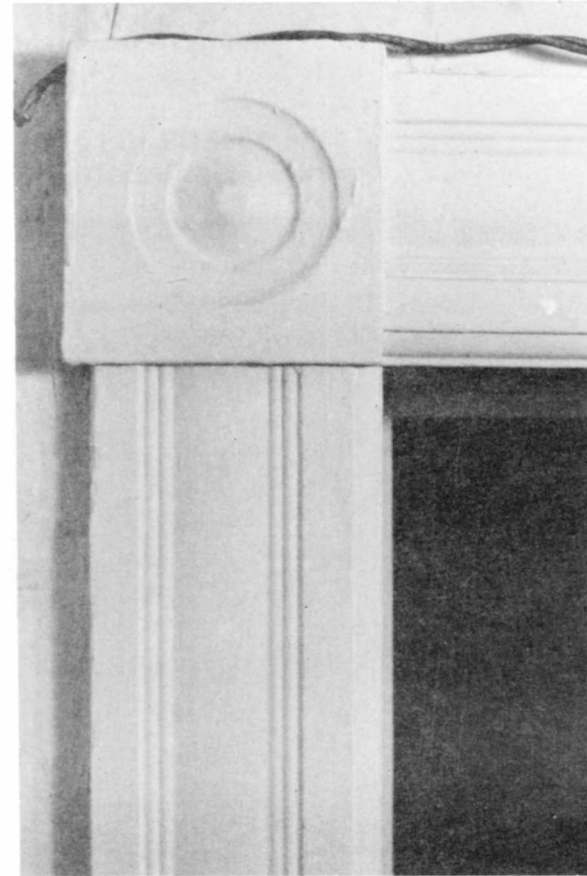
PHOTOGRAPH 33 (1980)  
Type 1 Corner Block  
Type 3 Architrave

This trim is found on the original windows and doors in the eastern section of Building 3.

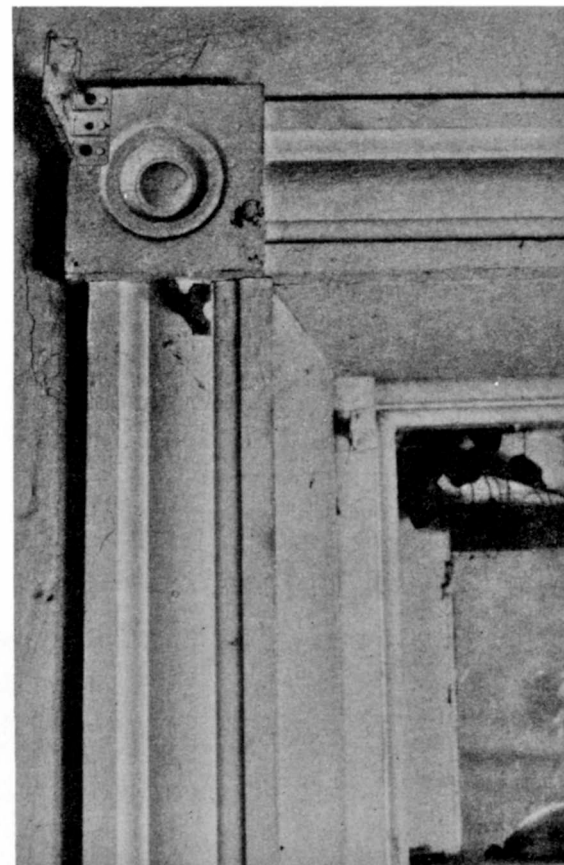
PHOTOGRAPH 36 (1980)

Type 2 Corner Block

Type 2 Architrave

This type of trim is found around windows 207 and 208. These windows are not original; they were added sometime after 1917.

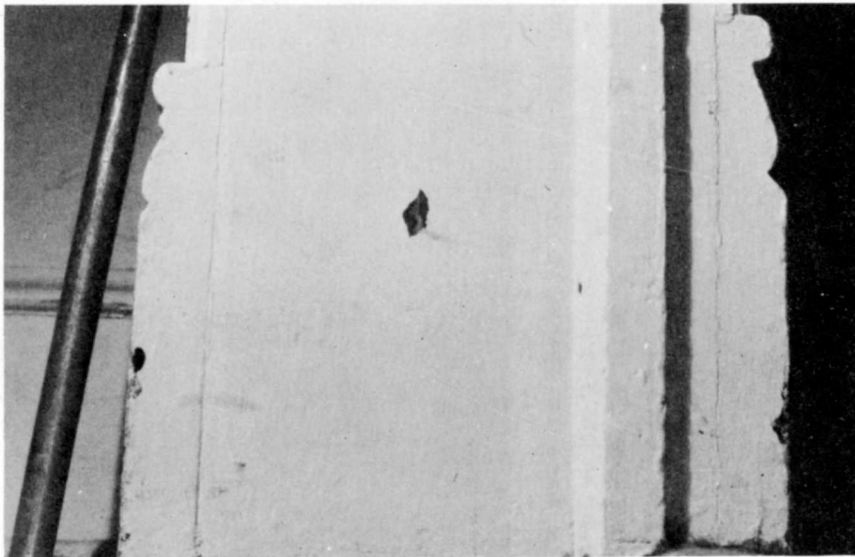
PHOTOGRAPH 38 (1980)

There are two types of plinths found on the original door openings (see photograph 38). Both types can be found in the western or newer section, but only type 1 can be found in the eastern or older section.

Plinth Profiles

These plinth profiles represent the two types of plinths  
found in Building 3.

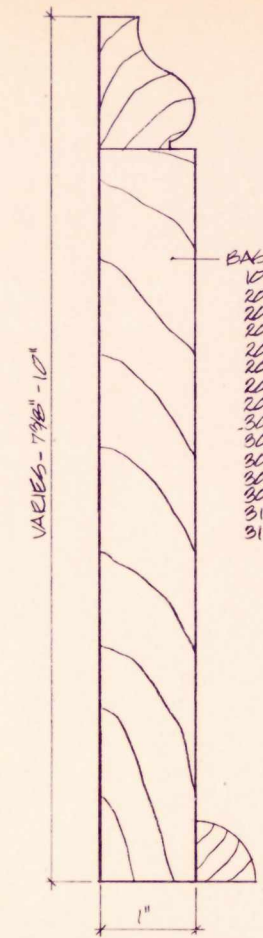
**5  
19** **BASE**  
FS.

BASE FOUND IN ROOMS -  
201 (EAST WALL)  
202  
203 (SOUTH & EAST WALLS)  
204 (NORTH & WEST WALLS)  
205 (EAST WALL)  
206 (EAST & SOUTH WALLS)  
209 (EAST WALL)  
301 (NORTH, SOUTH & WEST WALLS)  
302  
303  
304 (NORTH, SOUTH & WEST WALLS)  
305-310  
312 (NORTH, SOUTH & WEST WALLS)  
313 (NORTH, EAST & WEST WALLS)

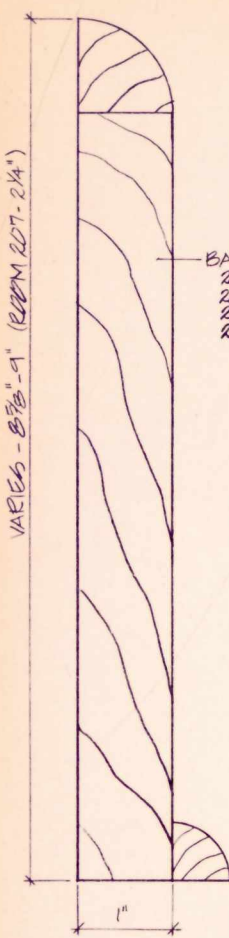
**6  
19** **BASE**  
FS.

BASE FOUND IN ROOMS -  
204 (SOUTH WALL)  
205 (NORTH & SOUTH WALLS)  
207  
209 (SOUTH WALL)

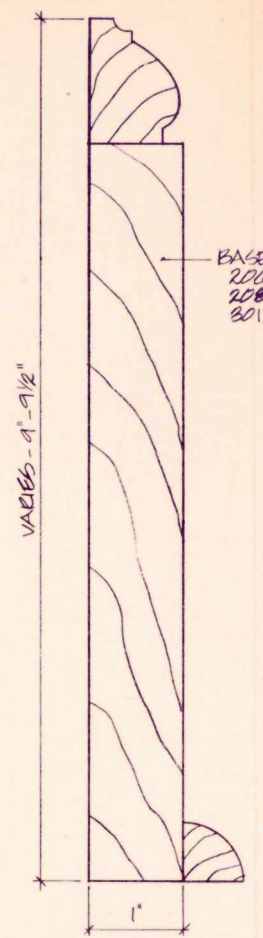
**7  
19** **BASE**  
FS.

BASE FOUND IN ROOMS -  
206 (NORTH & WEST WALLS)  
208 (WEST WALL)  
301 (EAST WALL)

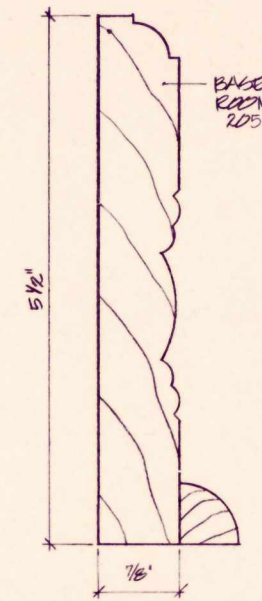
**8  
19** **BASE**  
FS.

BASE FOUND IN  
ROOM -  
205 (WEST WALL)
