historic structures report  
building 38

HARPERS FERRY  
TEARNEY BUILDING

Historic Structure Report  
Building 38/ Tearney Building  
Harpers Ferry National Historical Park  
Jefferson County, West Virginia

Prepared by  
Susan L. Shufelt

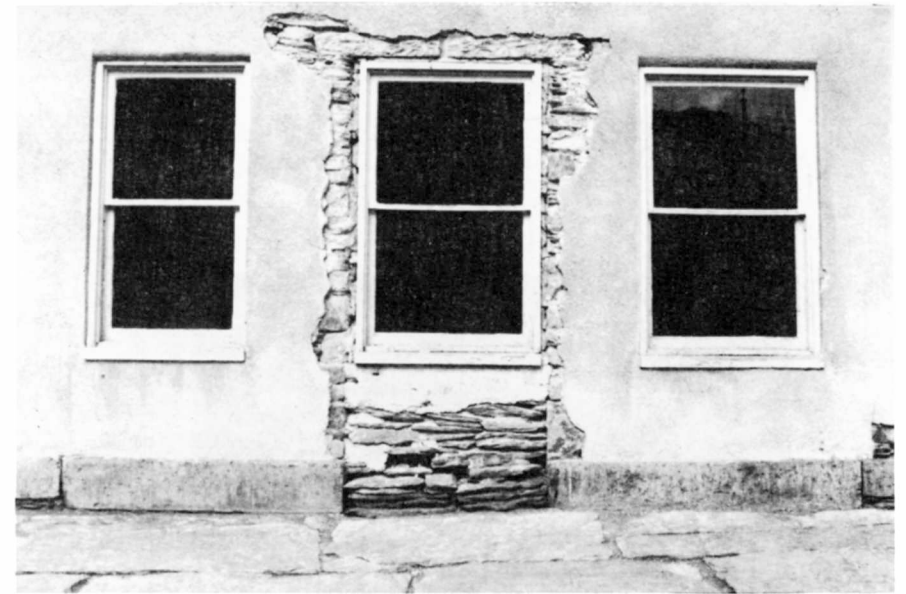
PHOTOGRAPH 15 (1981)  
Windows 101, 102, and 103

The stone infill around window 102 and the break in the water table stones are some of the evidence indicating that window 102 was originally an alley entrance. Note also that window 101 is narrower than windows 102 and 103.

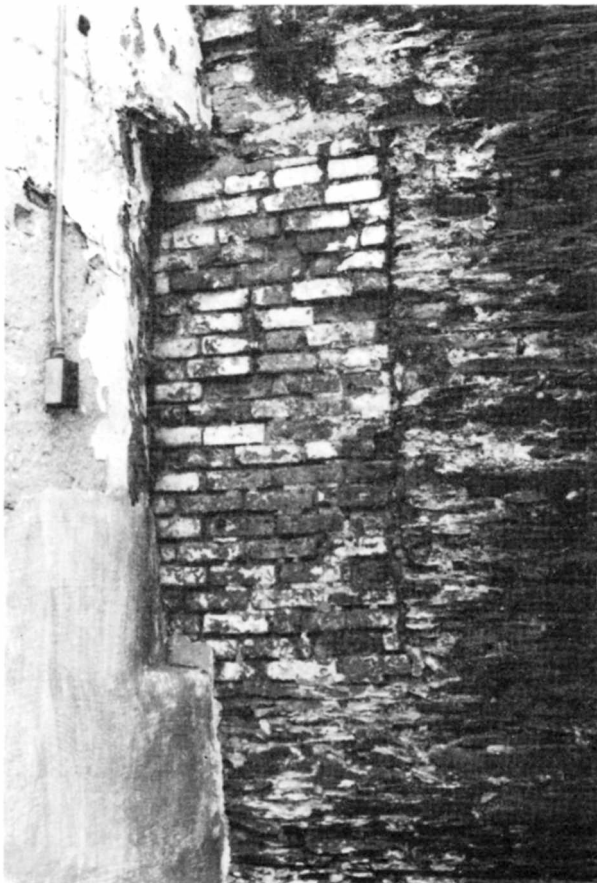
PHOTOGRAPH 24 (1980)  
Building 40's Bricked-Up  
Window

The rear or west wall of Building 38 was distorted to accommodate a window in Building 40's side wall.

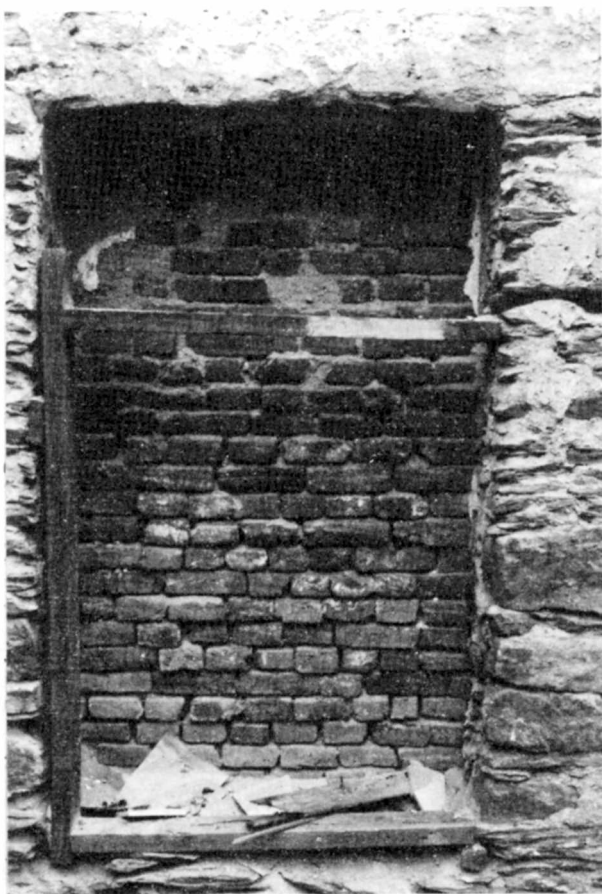
PHOTOGRAPH 26 (1980)  
Window 105

The openings on the first-floor rear elevation also contradict a symmetrical pattern (see figure 3). But again, changes are evident. There is a brick patch at the extreme north end of the rear stone wall (see photograph 26). The size and shape of this patch (referred to in the drawings and figure 3 as window 105) indicate that this area of the rear wall once contained a window. The location of the patch indicates that this window was situated directly under window 210.

Window 105 is bricked-up.

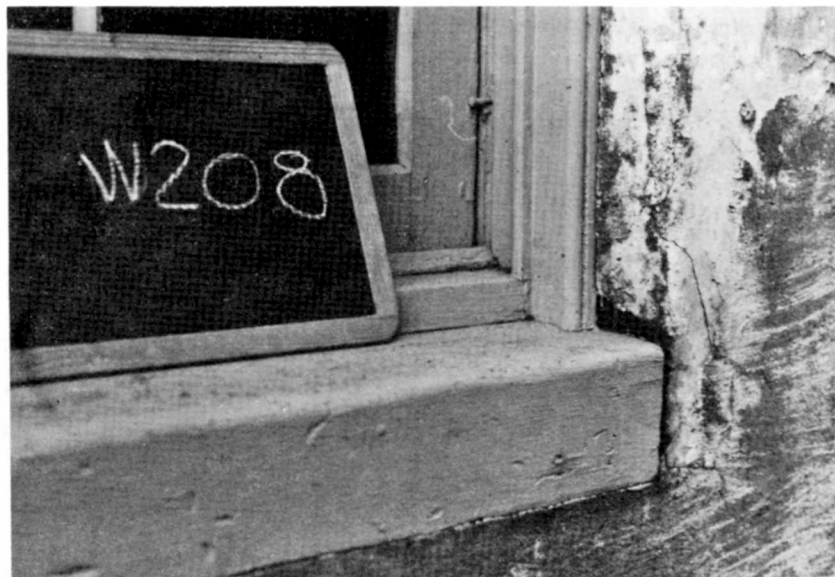
PHOTOGRAPH 28 (1977)  
Window 208

In addition, all of these unmodified windows (windows 201-206, 209, 301-310) have sills but no subsills. By contrast, the windows around which modifications have occurred (windows 101-104 and 207, 208 and 210) all have both sills and subsills (compare photographs 28 and 29). Thus, originally all of the window frames probably had sills, but no subsills.

All of the upper floor rear and first-floor front windows have beaded frames.

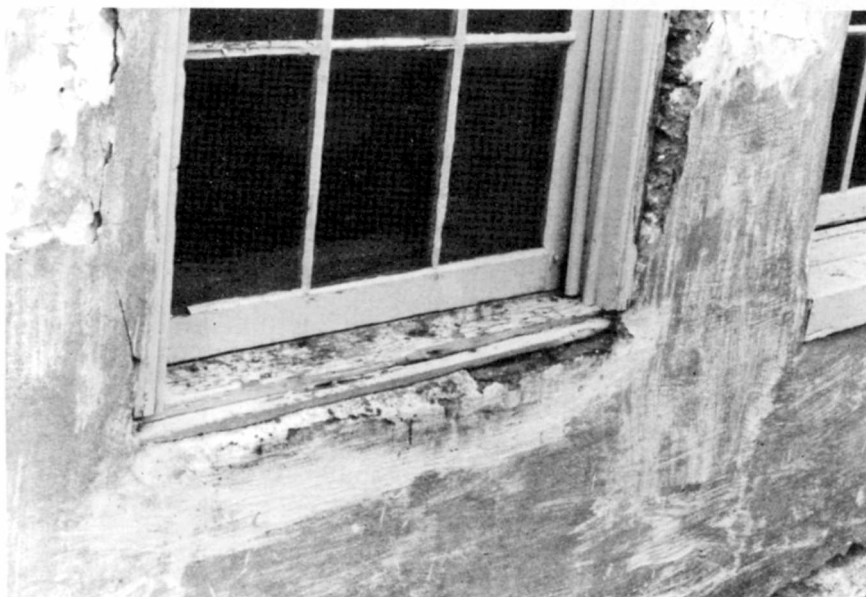
PHOTOGRAPH 29 (1981)  
Window 209

Unlike the other second-floor rear windows, window 209 has no subsill.

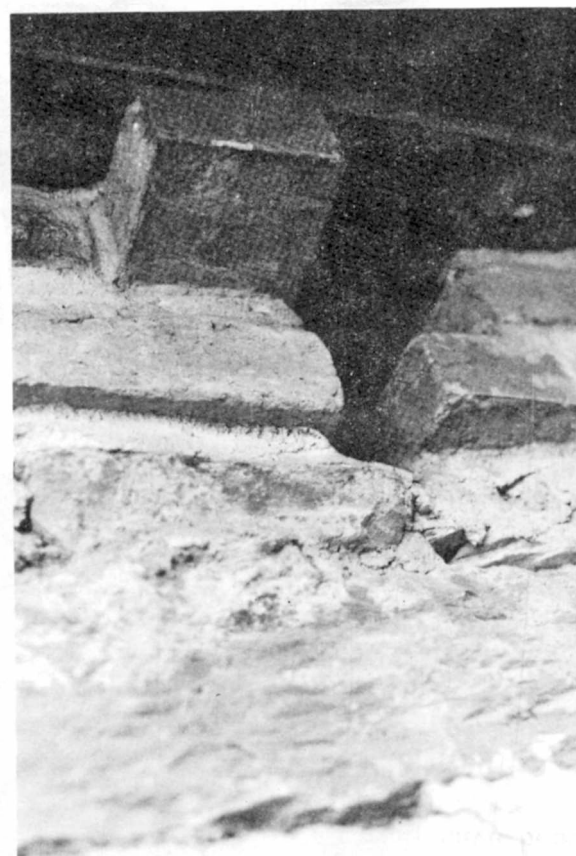
PHOTOGRAPH 32 (1977)  
Rear Cornice

Joist pockets (see photographs 30 and 32) along the rear roof line, as well as the porch roof visible in photograph 4, indicate that the porch had a roof which continued along the entire length of building 38. According to photograph 4, the slope of the porch roof varied. The center section was almost flat, while the slope of the end sections matched that of the main roof of the building. The flat center section might indicate a projection in the porch structure, perhaps where the stairs and/or walkway to the cliff were located. A study of photograph 4 also indicates that the porch roof material might have been corrugated metal. However, not enough detail can be seen in the photograph to make a definite determination. It should be cautioned that the few clues revealed in photograph 4 regarding the porch might reflect modifications rather than original design, since this photograph was not taken until at least 1877.

Note the joist pockets visible in this photograph and Photograph 30.

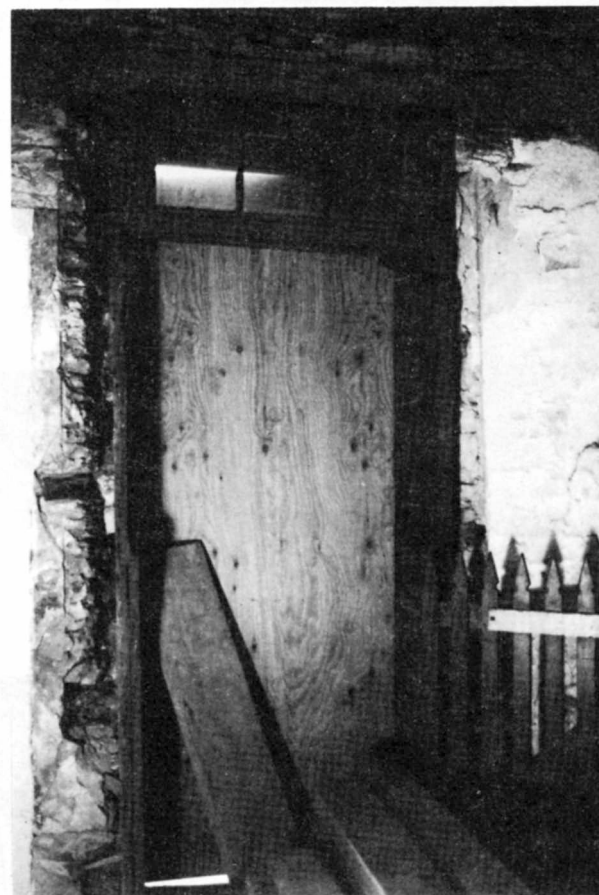
PHOTOGRAPH 34 (1981)  
Door 101

This opening was originally a window. Removal of some plaster and the brick alley wall revealed that the upper portion of the masonry opening is splayed. Note the void where the sill probably rested.

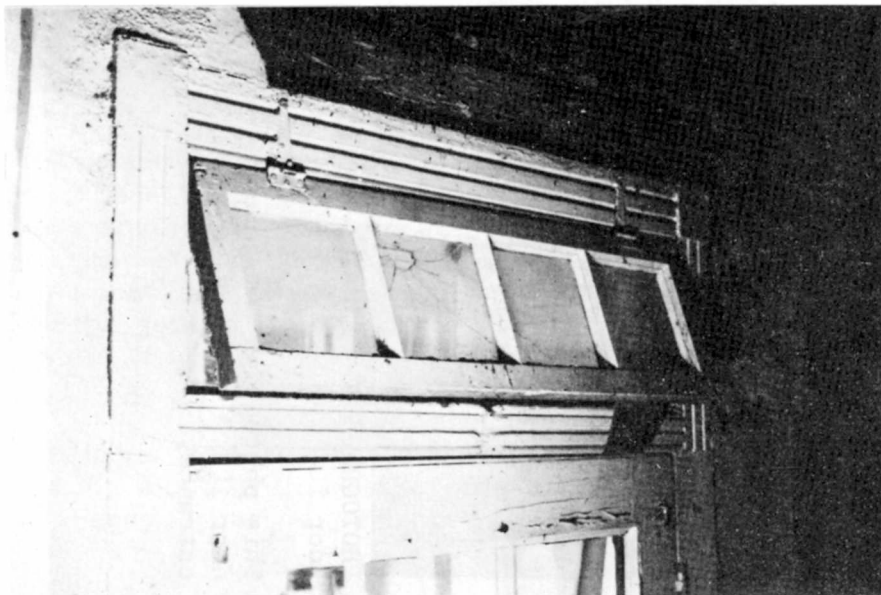
PHOTOGRAPH 36 (1981)  
Transom above Door 102

Door 102 and the interior trim around it are not original. The paneled frame, transom, and interior trim around the transom, however, probably do date back to 1844.

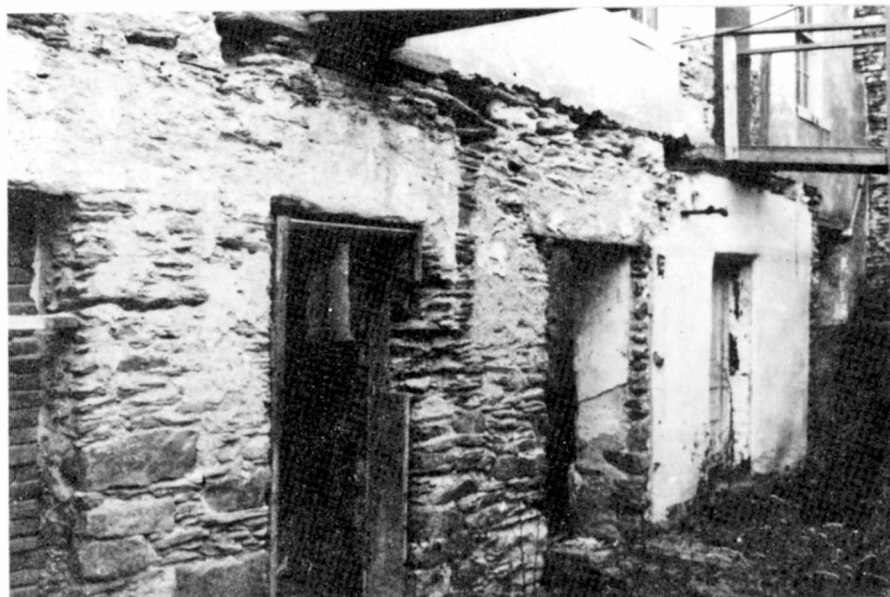
PHOTOGRAPH 39 (1980)  
Rear or West Elevation, First Floor

Door 104, at the extreme south end of the rear elevation, is different from the other first-floor rear openings (see figure 3 and photographs 39-41). Looking at the rear elevation, stone lintels are visible above doors 106 and 107 and above window 105 (the lintel above door 105 is concealed by stucco). In contrast, a wood lintel is visible above door 104. Also, the top of the opening for door 104 is much higher than the tops of the other rear first-floor openings (which all line up evenly). And, finally, this opening is the only first-floor opening (besides door 106 which originally provided access to the center alley) not lined up directly under a second-floor opening. On the interior side of the rear wall, just to the north of door 104 and directly under window 207, is a large piece of wood (3 1/2 inches by 7 inches--see photograph 43). The bottom of this wood lines up with the tops of window 105 and doors 105, 106, and 107. This coincidence suggests that this wood might have at one time functioned as a lintel over an opening. Similar wood lintels are visible on the interior side of the rear wall over window 105 and door 107 (the lintels over doors 105 and 106 are concealed by plaster). Thus, the evidence indicates that door 104 was not an original part of building 38; instead, there was a window directly under window 207 (see figure 4). This window was removed during the 1860s when the center alley was removed, and the function of the alley--to provide access to the backyard--was transferred from the center of the building to what was then a new alley at the southern end. This new alley required a rear door which lined up with the front alley entrance--that is, lined up with door 201.

Note that the doorway at the far right is taller than the other first-floor openings.

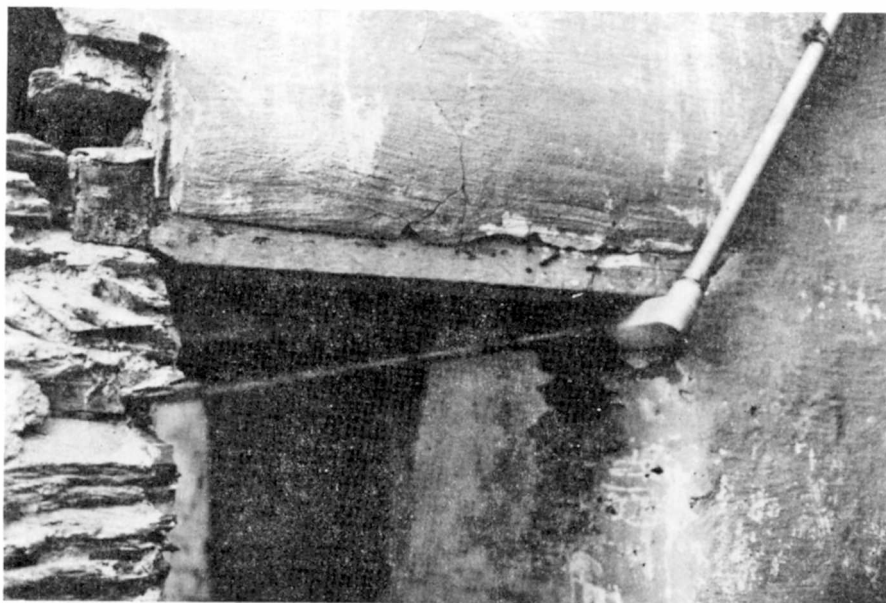
PHOTOGRAPH 41 (1980)  
Wood Lintel, Door 104 (Exterior View)

On the exterior side of the rear wall, stone lintels are visible above all the openings where the stucco has been removed except one: door 104 has a wood lintel.

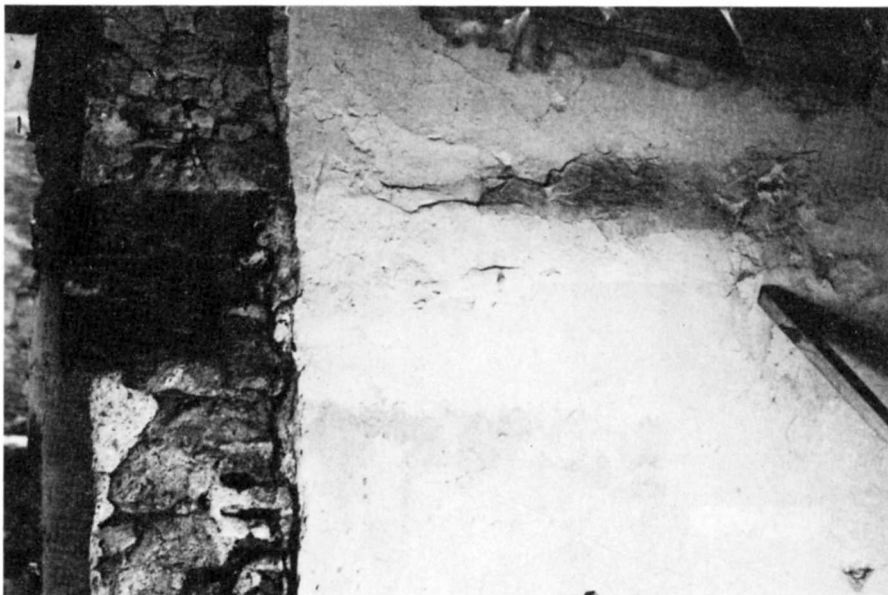
PHOTOGRAPH 43 (1981)  
Wood Lintel above Nonextant Window

This window was removed when door 106—one of the alley entrances for the relocated alley—was added. Door 106 is partially visible on the left side of this photograph.

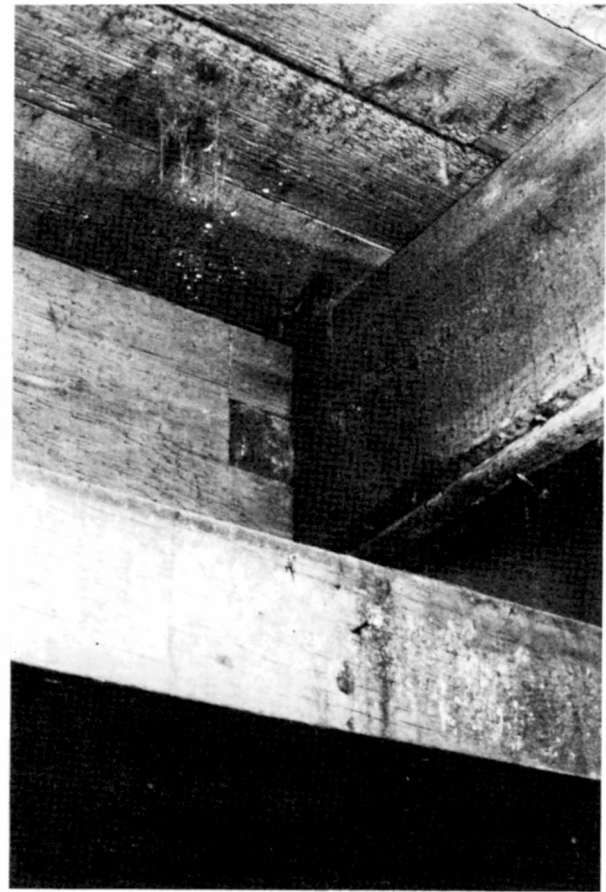
PHOTOGRAPH 49 (1981)  
Mortise-and-Tenon Joint between Second  
Floor Joists and Center Girder

The 5 1/2-inch by 11 1/8-inch wood girder support is visible under the girder and joists. The one-inch-thick random width tongue-and-groove flooring can be seen above.

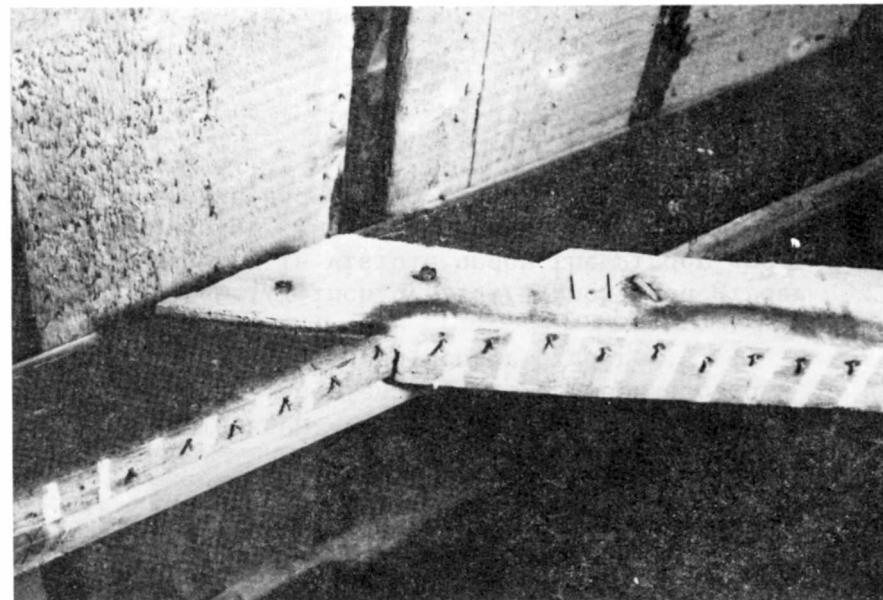
PHOTOGRAPH 52 (1981)  
Rafter and Collar Beam Connection

Note the ghosts of wood lath on the original rafter and collar beam. Next to the original rafter is a new rafter with no ghosts.

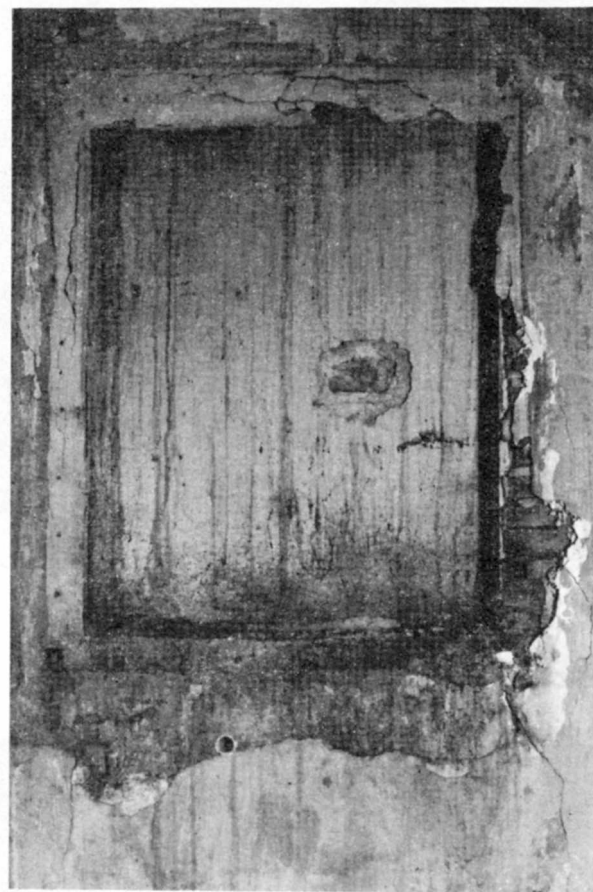
PHOTOGRAPH 54 (1981)  
South Wall, Room 302

The wood plate visible in Photograph 54 at one time (before the construction of Building 38) supported Building 40's rafters. A brick cornice was probably located beneath this plate at Building 40's eaves. When Building 38 was constructed, this wall was made taller, forming a gable for Building 38. Windows were installed in this gable. When Building 40 was enlarged, the windows were bricked-up.

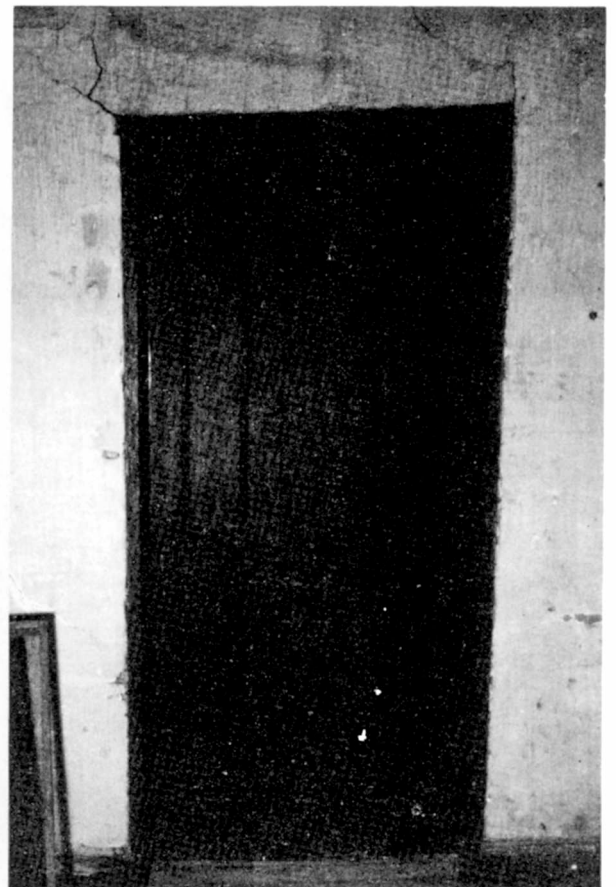
PHOTOGRAPH 57 (1981)  
Door 210

The interior of building 38 has one four-panel door: door 210 (see photograph 57). As has been discussed, this opening is probably not original. This door's counterpart on the south side of building 38 (door 205)--also probably not original--does, however, match the other typical six-panel doors. But hinge marks on the frame (and not on the door) indicate that this door is not the first door to occupy this opening. Perhaps when door openings 205 and 210 were added, doors were salvaged from another building. Then, sometime later, door 205 was replaced by a door taken from one of the other door openings in building 38, which is now missing its door or from a first-floor doorway that has been eliminated. Also, doors 205 and 210 might have been added at different times. Not only do their sizes differ (door 210 is only 2 feet, 5 inches wide by 6 feet, 4 inches tall), but the jamb and head details for each vary (see drawings, sheets 17 and 18).

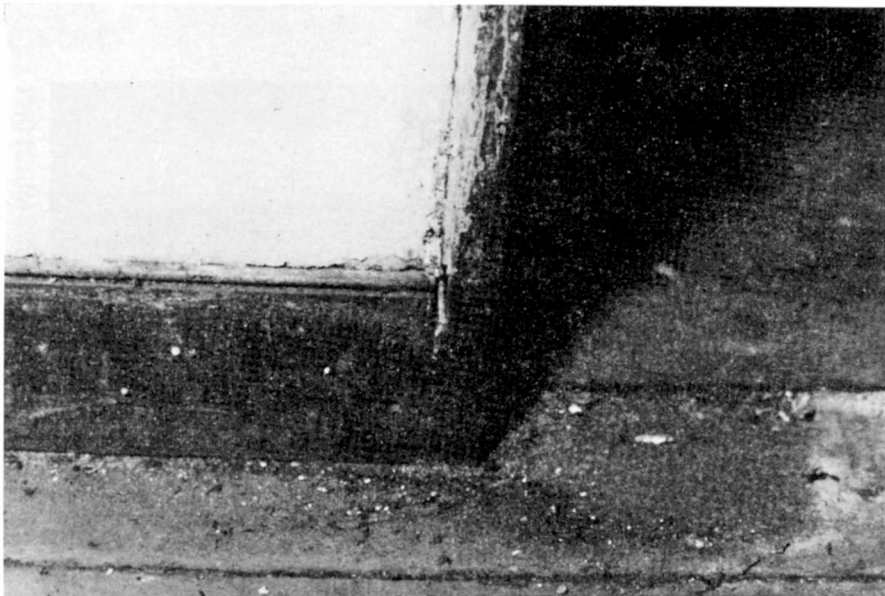
PHOTOGRAPH 65 (1981)  
North Wall, Room 201

The width of the plinths varies from 4 1/2 inches to 4 3/4 inches; and the height varies from 5 1/4 inches to 8 3/4 inches. Two plinths exist on each side of the partition separating rooms 201 and 205 (see photograph 65). There is, however, no door.

This wall is the only one covered with drywall.  
Note the two plinths along the base.

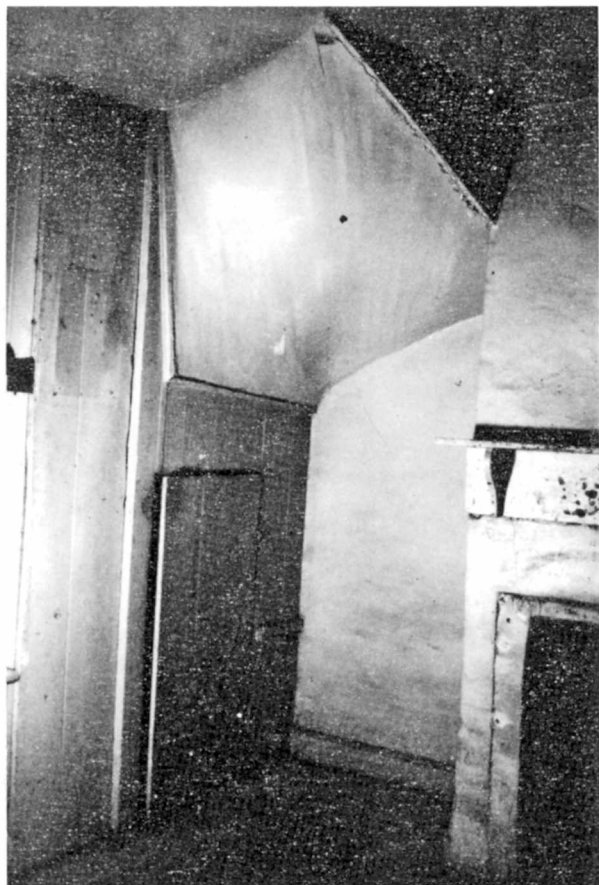
PHOTOGRAPH 67 (1977)  
Railing at South Stairs

There are no handrails on either of the stairways, although there is a guard rail at the top of the north stairs (see drawings, sheet 11). This rail is not well constructed or in good condition. Photograph 67 indicates that a guard rail existed on the south wall not long ago.

This railing no longer exists.

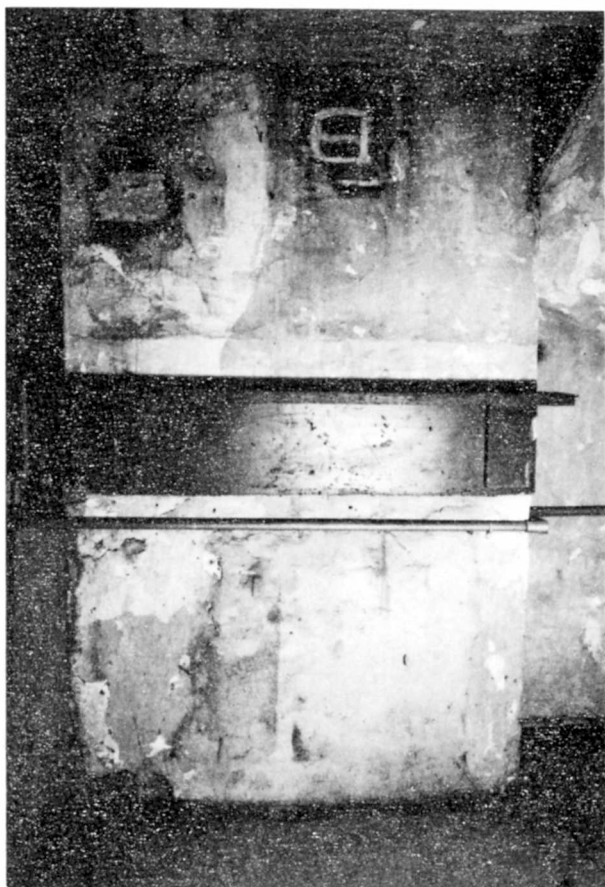
PHOTOGRAPH 70 (1981)  
Door 212 at North Stairs

The six-panel door, which varies somewhat in size from those described above, is door 212 (see photograph 70). This door is the same width as the other doors, but is shorter--it is only 6 feet tall. This door was made shorter to allow it to sit on the third tread of the north stairs. (Its counterpart on the south side of the building sits on the second tread and, therefore, can be taller and matches the height of the typical six-panel doors).

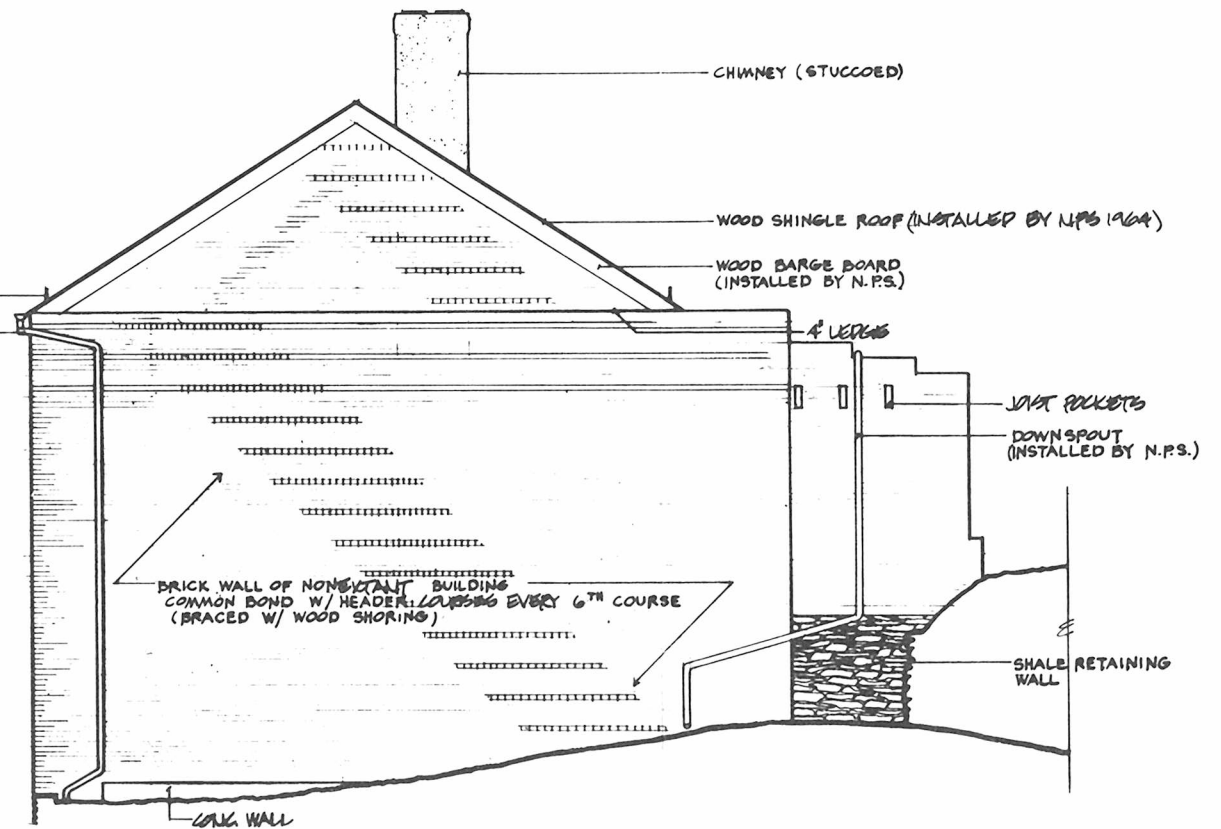
**NORTH ELEVATION**  
SCALE: 1/4" = 1'-0"

Several unusual details and/or problems developed as a result of this arrangement. First and most critical, when the contiguous building in lot 51 was removed, the soft brick on the north side of the shared wall (-intended for interior climatic conditions only), became subjected to exterior weathering effects. As can be expected, the structural integrity of this wall began to deteriorate (and continues to do so) to the point that it has deflected away from the rest of Bldg. 38. Approximately a two-inch gap now exists between this and the intersecting walls at the roof line. This has occurred in spite of an attempt to tie the brick wall to the stone walls with tie rods. Also, several cracks in the brick work have formed where its monolithical movement is restrained.

The cause of the movement of the north wall stems from the fact that the exposed brick were not prepared and the mortar joints not detailed to shed water. Moisture is therefore readily absorbed by the brick and, when this occurs in conjunction with freezing temperatures, the brick will spall and disintegrate. The deterioration of the exterior side of the wall has resulted in an imbalance between the bearing properties of the inside and outside brick, causing the movement of this wall. One area of particular concern occurs at the base of the wall, at mid length, where 10 to 20 square feet of brick work has deteriorated or been removed to a depth of at least four inches. This failure is presently covered by a sheet of plywood and located between the two timber shoring supports located in the vacant lot 51.

SNOW BOARD  
GUTTER & DOWNSPOUT  
STEPPED BRICK CORNICE  
REMAINING BRICK WALL OF NONHISTORIC BUILDING ON LOT 51 (SUPPORTED BY WOOD SHORING)  
OPENINGS ENLARGED FOR NONHISTORIC WINDOWS

Because of problems inherent in the simultaneously preserving and interpreting this wall, the dubious value of preserving the historic brick work on the second and third stories, and the less obtrusive, more structurally sound final product achieved, the restoration approach is the method recommended for dealing with the north wall.

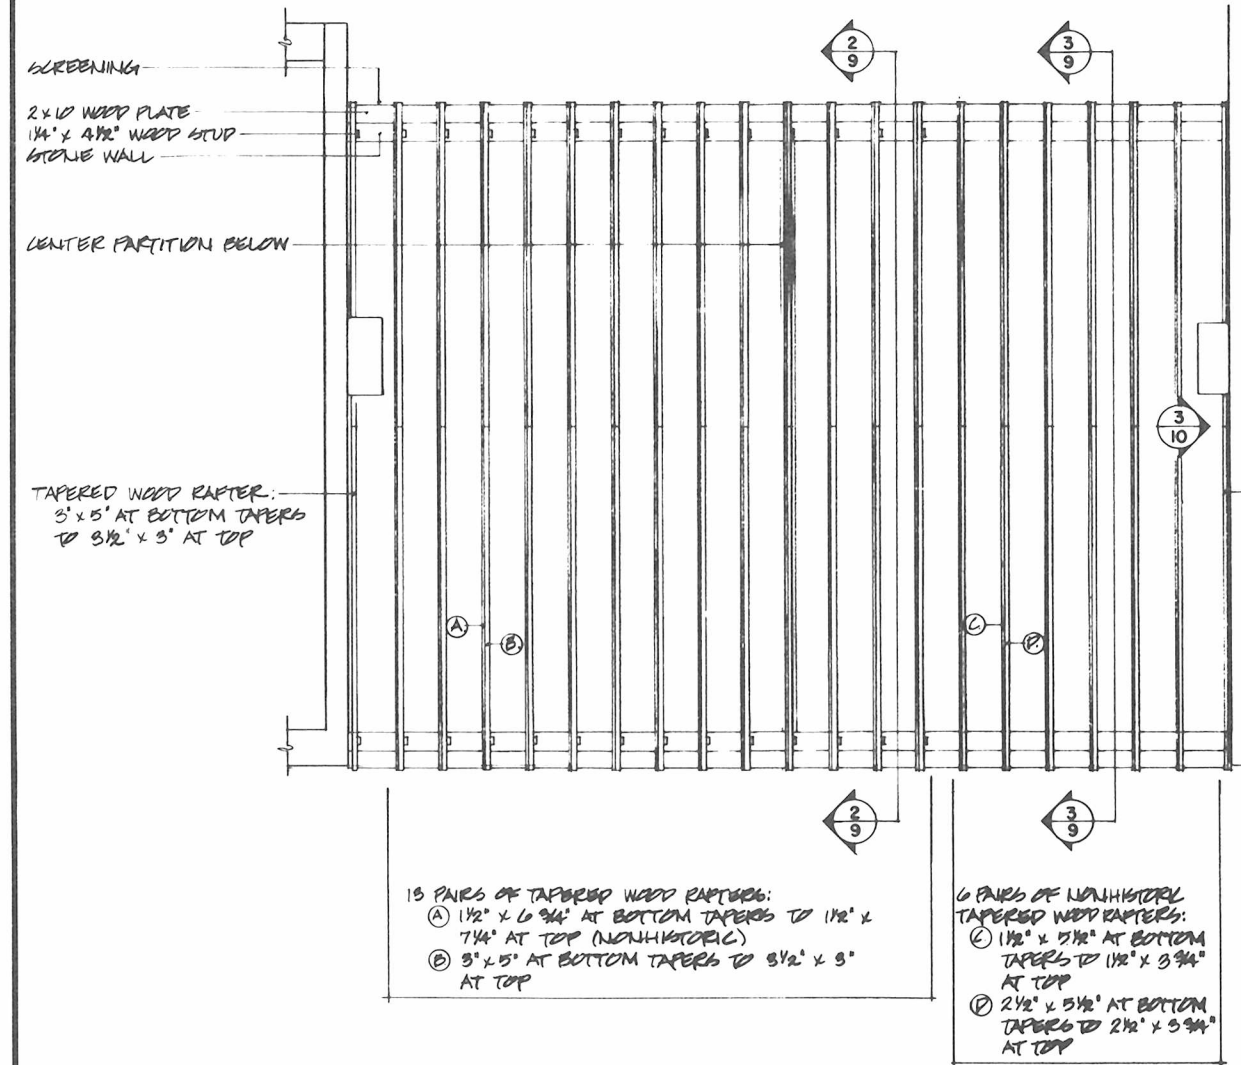
**1**  
**9** **ROOF FRAMING PLAN**  
SCALE: 1/4" = 1'-0"

The roof on Bldg. 38 was repaired in 1964 as a temporary stabilization measure in response to damage incurred from a fire on the third floor and the considerable period of neglect which followed. The historic framing members which survived the incident with only superficial damage and which continue to perform the structural function for which they were installed are located primarily on the south side of the building. Other more seriously damaged members also remain on the north half of the building although they no longer support any roof loads. Depending on how severely they were affected, the roof trusses were either replaced or simply reinforced with new wood rafters, collar beams and other bracing members. Also, wood shingles were selected to replace the damaged metal, "standing-seam" roof.
