THE PHILIP COONS BUILDING  
SOMETIMES CALLED THE MASONIC HALL BUILDING  
(Building #44)

Harpers Ferry National Monument

Architectural Data Section

October 1962

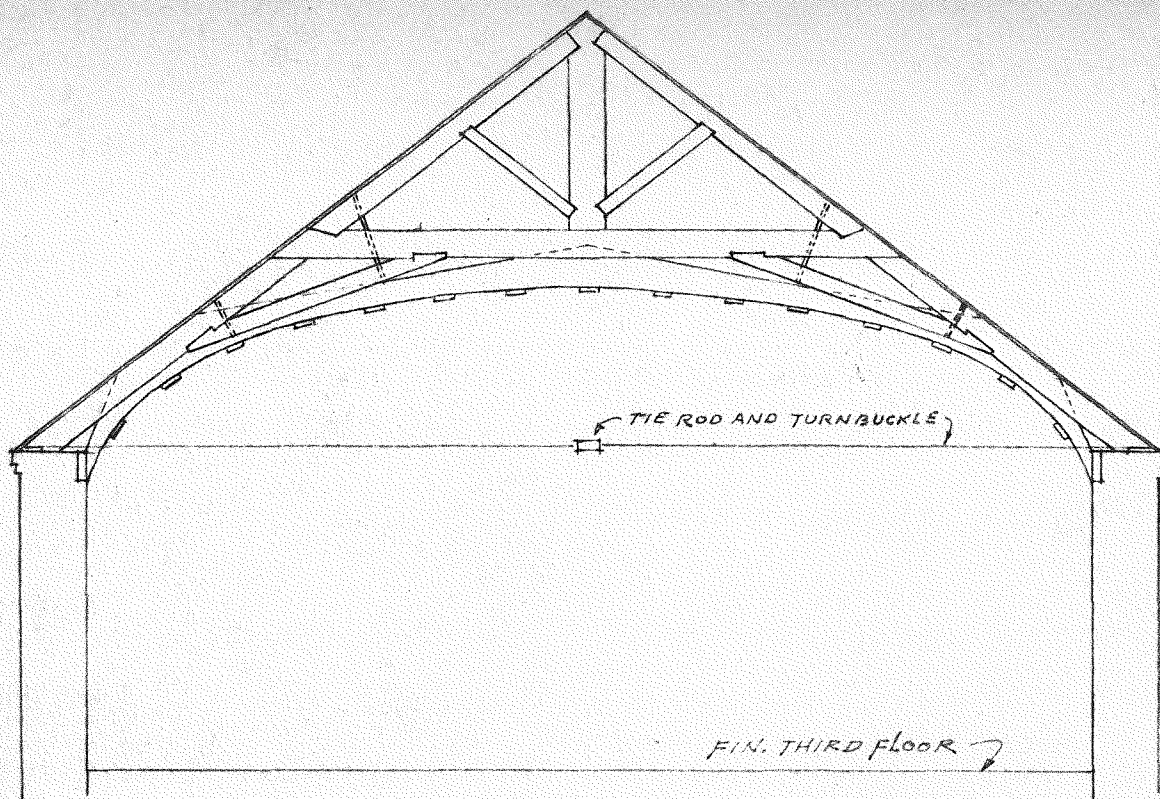
SECTION SHOWING ROOF TRUSS  
- 5 THUS WITH PAIRED RAFTERS IN BETWEEN -

The ceiling plaster was removed by the Service in 1956 when the roof structure was stabilized. The joints of the king post trusses are bolted together and it was found necessary to tighten these connections to bring the top chords into their proper position and prevent further sagging. The two tie rods, one of which appears in the photograph, were installed in 1892.

Some construction features are similar to those found in the neighboring structures to either side of the subject building. However, the roof construction is different to that found in any of the Harpers Ferry buildings and the details of the kick plates and their components supporting the trusses are unique to those observed anywhere else.

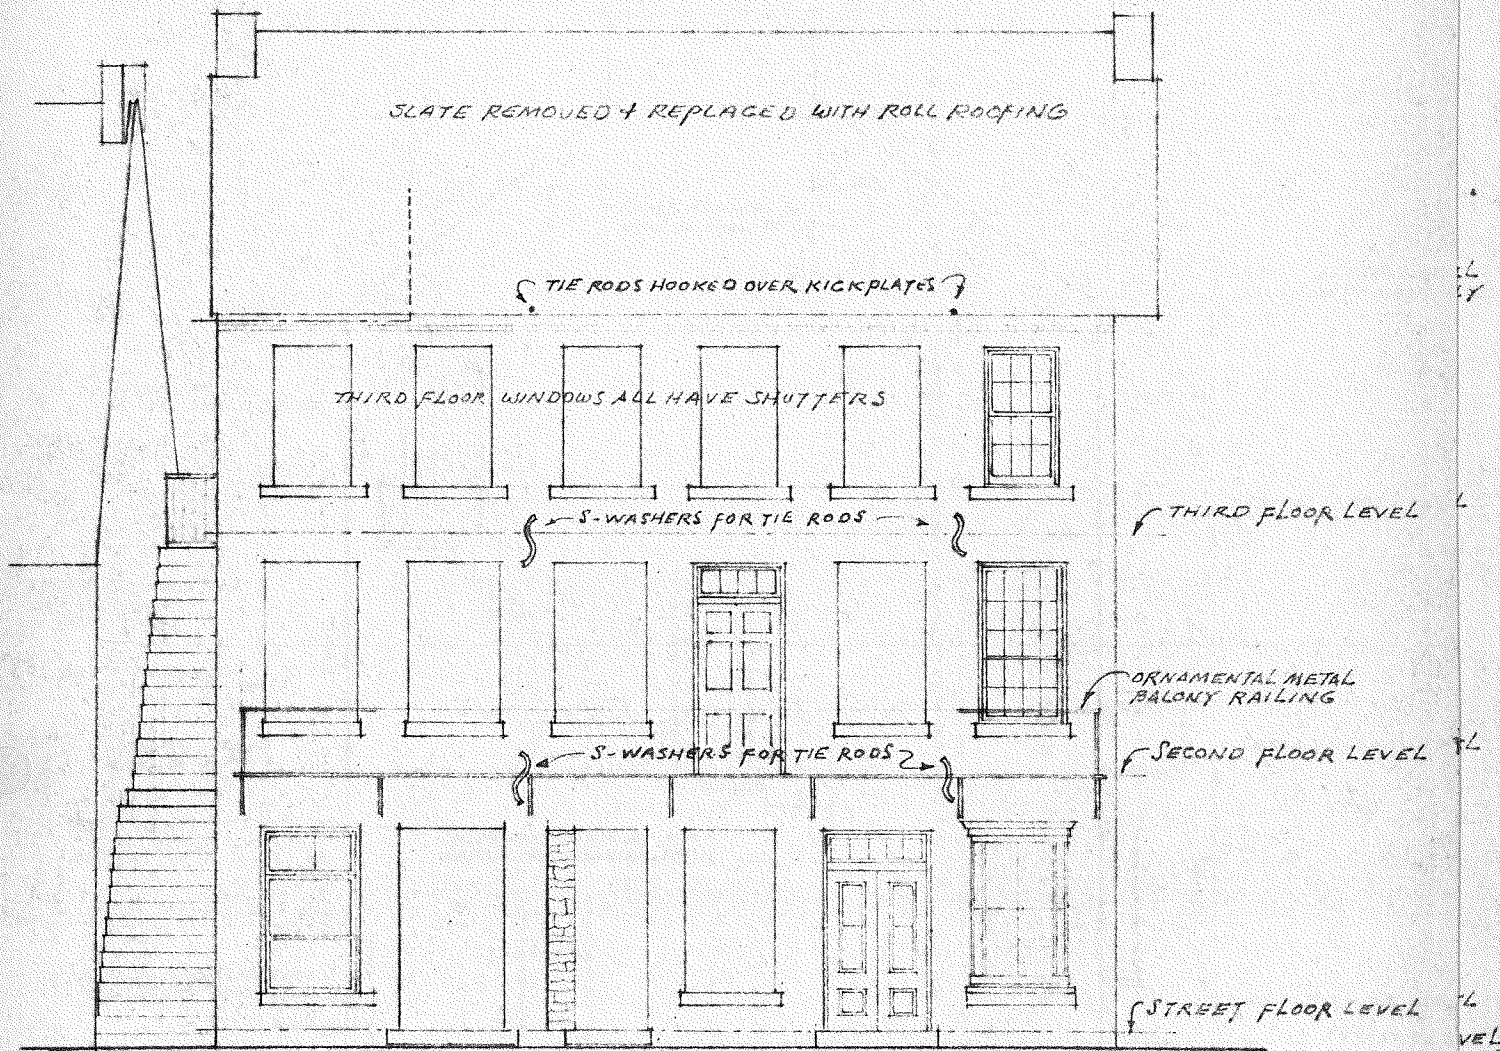
SHENANDOAH STREET ELEVATION

Further research is required to establish whether the existing balcony railing on the Shenandoah Street elevation was in use during the 1859-65 period. Several of the exterior doors will need additional study to determine if they are replacements or originals. It would be desirable to establish the period appearance and furnishing of the Masonic Hall on the third floor. The Historian's Data Section suggests the possibility of a cooperative agreement with the Masonic Lodge to furnish the Lodge Room.
