HOT SPRINGS NATIONAL PARK

Cultural Landscape Report and Environmental Assessment

January 2010

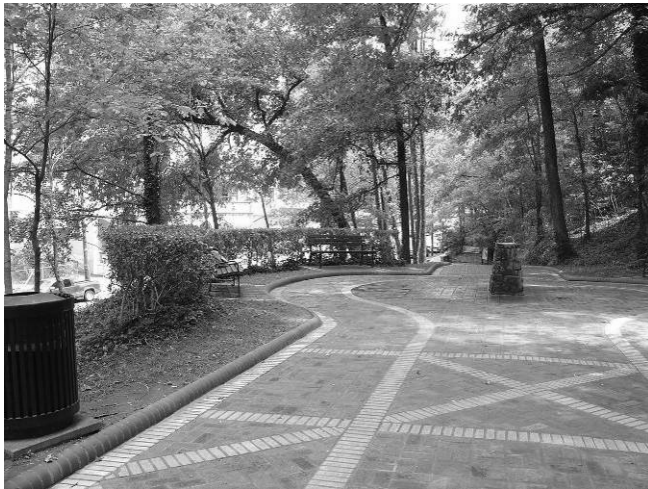
On the western side of the Grand Promenade, brick plaza #4 is enclosed by dense vegetation. The center of the plaza has a planting area with sparse grass and weeds, and a pine tree that is in fair condition. The tree has suckers at its base and appears to have been damaged by a trimmer. North of this area the Grand Promenade has a pleasant shaded character. The western side slopes down away from the promenade and is fairly open lawn. There are deciduous trees of varying age, form and size, spaced somewhat regularly in fifteen to twenty foot intervals throughout the area. These include redbud, flowering dogwood, white oak, and sycamore. The majority of these plants appear to be in good condition however the redbud appear to be declining and one exceptional white oak (near the curved retaining wall) has been damaged and needs to be pruned. Toward the northern end of the promenade there are large dense patches of English ivy. Woody plants within the ivy patches are in fair to poor condition as the ivy is growing up their trunks and the trees (mainly red oak) appear to be declining. A cedar is in fair condition but may be declining due to too much shade. These areas also include tree stumps, weeds, seedlings and some suckering shrubs. A four foot by four foot holly hedge outlines the western side of brick plaza #5. The hollies are very leggy and sparse.

Figure 3- 18: Holly hedge at brick plaza #5 (QEA, DSC01973, June 2005)

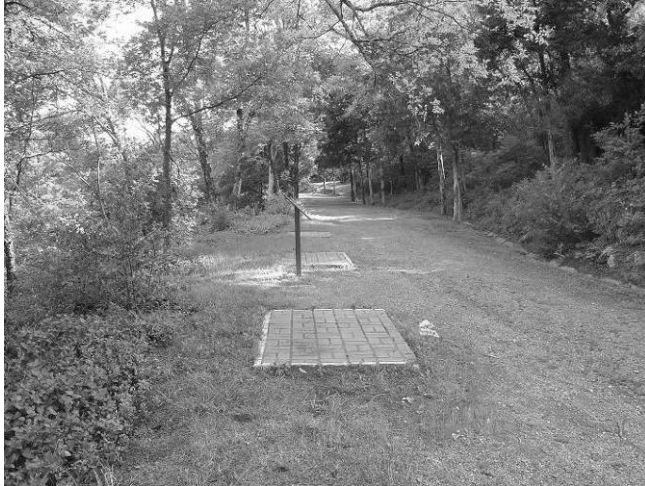
The Old Carriage Road is a gravel route that extends from an iron gate at the Rehabilitation Center to the north and intersects with Hot Springs Mountain Road (see figure 3- 25). Along the western edge of the road there are a total of eleven brick bench pads. A deteriorated concrete gutter runs parallel to the eastern side of the road. There is vegetation growing through the gravel in some portions of the road.

Figure 3- 25: Old Carriage Road (QEA, June 2005)

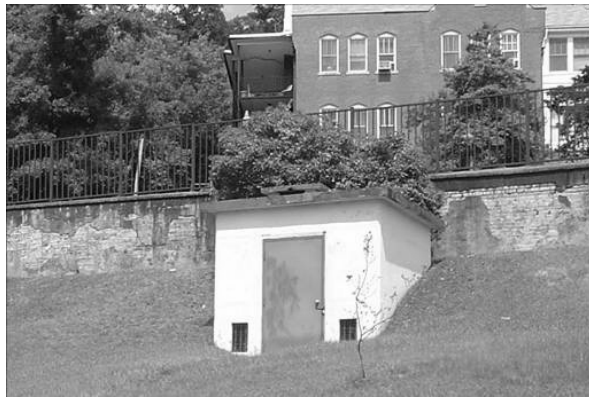
<i>Buildings</i>	<i>Figure Number</i>	<i>Description</i>	<i>Condition</i>
Utility Building	3-37	Approximately 8'x6' concrete structure built into slope near stone wall on east boundary of Grand Promenade near the Rehabilitation Center. This building covers the old Army-Navy Spring/Well. It is on property that belongs to the Rehabilitation Center, but could be obtained by the park in the future. Constructed c. 1985-86 to cover the spring/well that was formerly accessed from the basement of Building 8 (constructed 1901). Portions of Building 8's east and west walls are still extant.	Fair The spring is seeping through the floor of the building and leaking out.

Figure 3-37: Small Utility Building (QEA, June 3, 2005, DSC01823)

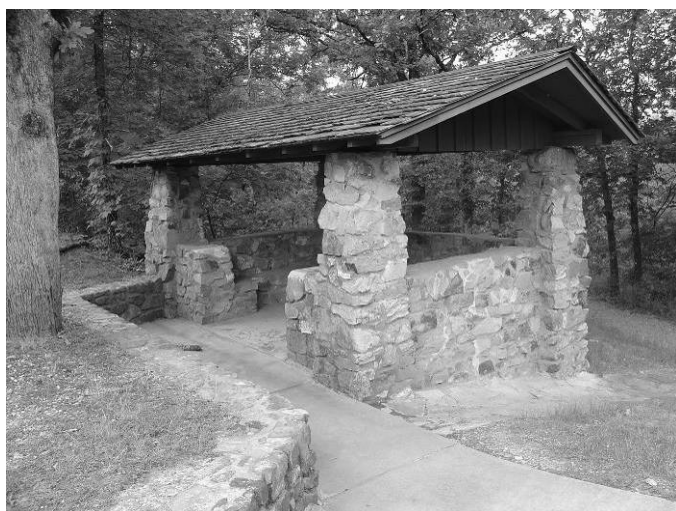
<i>Buildings</i>	<i>Figure Number</i>	<i>Description</i>	<i>Condition</i>
Comfort Station at picnic area	3-41	One story painted concrete block building with asphalt shingle gable roof has bathrooms for men and women.	Good
Pagoda Pavilion	3-42	Painted concrete pavilion with ornamental hip, clay tile roof.	Good
Gulpha Gorge Trail Shelter	3-43	Sandstone shelter with built-in sandstone seats and asphalt shingle gable roof.	Fair Previous mortar repair impacting structure.
Hot Springs Mountain Tower	3-44, 3-45	Steel tower with elevator and observation deck.	Good
Stone Utility building at Hot Springs Mountain Tower	N/A	Sandstone building.	Fair
Trail Shelter	3-46	Sandstone shelter with built-in sandstone seats and asphalt shingle gable roof; at the intersection of Floral and Honeysuckle trails.	Fair Graffiti and mortar impacts.

Figure 3- 43: Gulpha Gorge Trail Shelter (QEA, 6/3/05, Hot Mtn Rd, DSC02131)

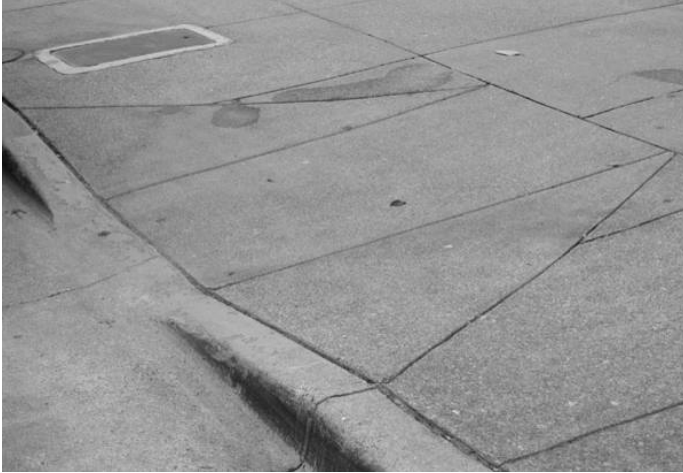
<i>Landscape Feature</i>	<i>Figure Number</i>	<i>Description</i>	<i>Condition</i>
Parking Lot/Service Drive	3-48, 3-49	Broom-finished concrete service drive and five space parking lot, accessed from Reserve Street and located behind building; attached sidewalk with red brick in basket weave pattern; mortared limestone retaining wall ranging in height from twelve inches to four feet.	Good
Basement Stairs at Park Administration Building	3-50	Concrete steps on northeast (back) side of the building, descending to the basement, concrete retaining walls on both sides. One side of wall has a red tile cap and tube steel handrail. Wrought iron guardrail on the other side	Good Some minor cracking and settling.
Concrete Walk at Reserve Street	3-51, 3-52, 3-53,	Twelve foot wide concrete broom-finished walk from entrance of Grand Promenade to corner of Central Avenue and Reserve Street on south side of Park Administration Building. Four feet wide red brick paving in a basket weave pattern is adjacent to curb. Two temporary "No Parking" signs; ADA concrete curb ramps; five parking meters. Portions of the curb, walk and ramp were built in 1989.	Fair Some cracking and displacement

Figure 3- 53: Concrete Curb Ramp at Reserve Street (MBD, 060705-59)

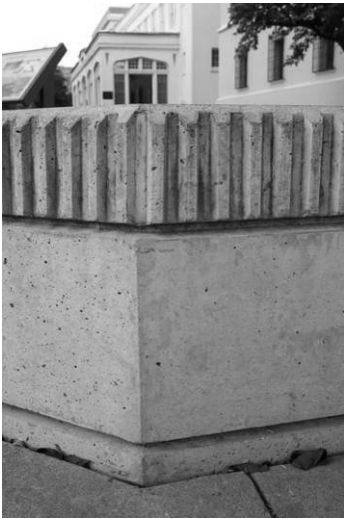
Concrete Retaining Wall	3-54, 3-55	Fluted concrete retaining wall (twenty-four inches tall) built in 1989 is on south and southwest sides of Administration Building. Bottom 16" is smooth finished and top 8" is fluted. Monument sign "Hot Springs National Park, United States Department of Interior National Park Service" faces the intersection. Sign has fluted concrete base and columns, and is wood with white letters and NPS logo.	Good Wall: Some minor chipping and cracking

Figure 3- 54: Fluted Concrete Wall (MBD, 060705-71)

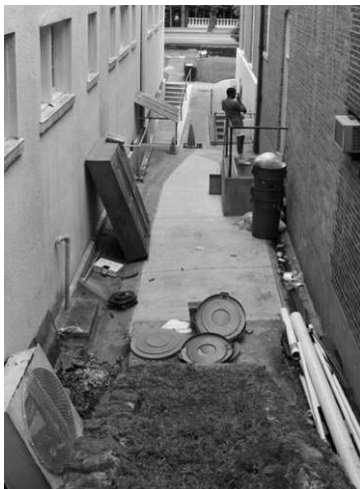
Figure 3- 68: Concrete Walk between Lamar and Buckstaff Bathhouses (MBD, 060705-99)

Concrete Walk between Lamar and Buckstaff Bathhouses	3-68	Broom-finished concrete walk.	Good Some minor cracking Trash and debris
Turf Stone Ramp between Lamar and Buckstaff Bathhouses	3-69	Mortared limestone ramp with turf in the center. Ramp begins at the end of the broom-finished concrete walk and extends over a rock outcrop one third of the way up the mortared stone retaining wall #1.	Good

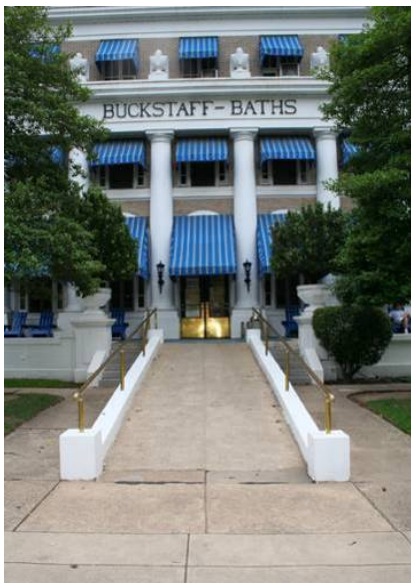
Figure 3- 73: Buckstaff Bathhouse Entrance (MBD, 060705-107)

Buckstaff Bathhouse Entrance	3-73	Concrete broom-finished ADA ramp centered on building entrance and extends to the linear walk with two sets of limestone stairs on each side, and concrete cheek walls painted white with brass handrails on top.	Good
Perimeter Concrete Walks	3-74, 3-75	1) Broom-finished concrete walk begins at the linear walk and wraps around south side of building to the stairs on side of building. 2) Broom-finished concrete walk begins at the linear walk and wraps around north side of building to basement stairs at back of building.	Fair Some cracking and heaving

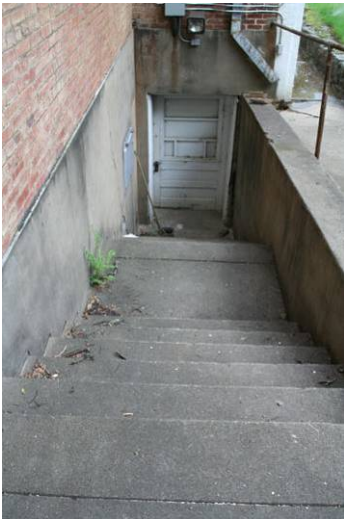
Figure 3- 76: Basement Stairs at Buckstaff Bathhouse (MBD, 060705-116)

Basement Stairs	3-76	Broom-finished concrete steps on northeast corner of building with concrete retaining wall and steel pipe guardrail on north side of steps.	Fair Deterioration of the concrete
Remnant Concrete Piers behind Buckstaff Bathhouse	3-77, 3-78	Concrete pier remnants from a cooling tank built in the early 1900's. Also there is a remnant base from the original entrance two south exedra wall dating to 1894.	Fair Deterioration of the concrete
Retaining Wall #2 between Buckstaff and Ozark Bathhouses	3-79	Mortared stone retaining wall with limestone capstone retains the hillside between the back of the bathhouses. Height is approximately five to eight feet. Mortared stones are rectangular and square shaped in red and pink tones.	Fair
Ozark Bathhouse Entrance	3-80, 3-81	Four broom-finished concrete steps and walk centered on building entrance with eighteen inch concrete cheek wall on each side, painted white with black steel tube handrail. ADA ramp extends to the northern side, along the front façade.	Good

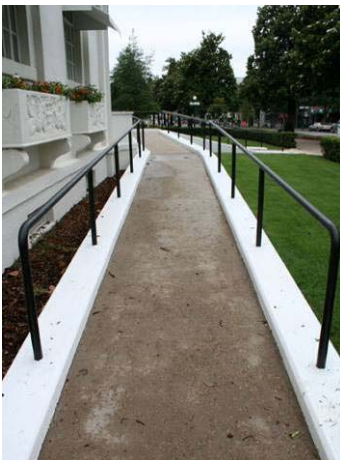
Figure 3- 81: Concrete Ramps at the Ozark Bathhouse Front Entrance (MBD, 060705-131)

North side of Ozark Bathhouse	3-81, 3-82	Holly hedge lines broom-finished concrete walk that extends on north side to set of sixteen broom-finished concrete steps that access basement. Concrete retaining wall and black steel pipe guardrail on north side, and black steel pipe handrail. A concrete ramp was installed in 2006.	Poor Deterioration of concrete steps Failing concrete retaining wall
Concrete Walk to Men's Comfort Station	3-83	Broom-finished concrete walk lined by holly hedge on one side connects to linear walk.	Good
Quapaw Bathhouse Entrance	3-84	Central set of four concrete steps with concrete cheek walls painted white and black steel tube handrails centered on building entrance. Two curved concrete ramps flank the steps on both sides with concrete walls, painted white.	Good
Basement Stairs at Quapaw Bathhouse	3-85, 3-86	1) Concrete walk connects the linear walk to Men's Comfort Station and basement stairs on south side of building. Twelve broom finished concrete steps with steel pipe handrail, concrete retaining wall	Fair Cracking and failure of both retaining walls

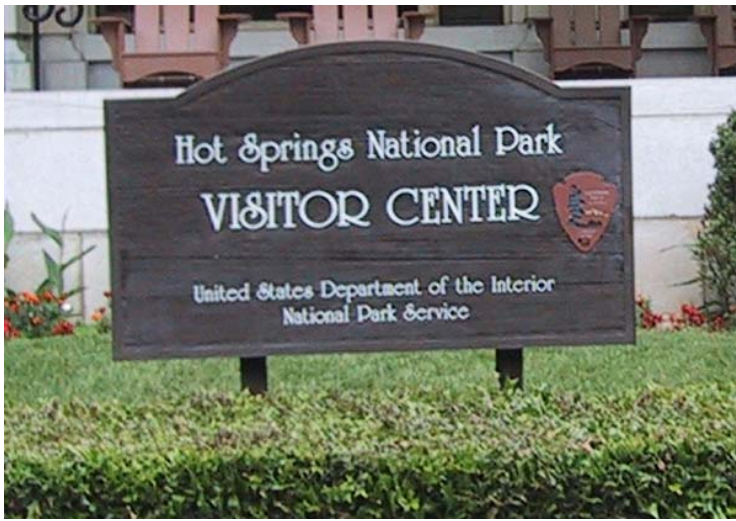
Figure 3- 92: Visitor Center Sign (MBD, 060905-8)

Visitor Center Sign in front of Fordyce Bathhouse	3-92	Dark brown wood sign on wood posts with the words <i>"Hot Springs National Park Visitors Center, United States Department of Interior, National Park Service"</i> with white letters and NPS logo, faces Central Avenue.	Good
Basement Stairs At Fordyce Bathhouse	3-93	Broom finished concrete steps lead to basement on building's North side, concrete retaining wall with stone capstone and black steel pipe guardrail on top.	Fair Failure of mortar on the capstone and cracks in the retaining wall Deterioration of concrete steps
Display Spring	3-94, 3-95	Display Spring is carved out of the tufa wall behind the Maurice Bathhouse. Situated adjacent to the Formal Entrance, Display Spring is an enclosed terrace with two distinct areas, the spring with a large cave-like opening, a smaller stone opening, and stone channel and the adjacent semi- circular seating area. Rustic stone walls define both openings. Both openings once had doors that were removed circa 1931-1932. The area's characteristic hot springs erupt from both openings, and spill into a series of rustic stone basins and stone channels. A sloping concrete walk with two steps leads to the tufa wall opening. The seating area is a basketweave brick terrace that is edged with an exposed aggregate concrete band that was added in 1989. The concrete band also edges the lower portion of the spring. Heavy vegetation, a mix of introduced and invasive species, cover the hillside and surround the spring. On the bathhouse edge are a few low deciduous shrubs and a few small trees including an Arborvitae. Associated features include three wood benches, interpretive sign and metal trash receptacle.	Fair/Good

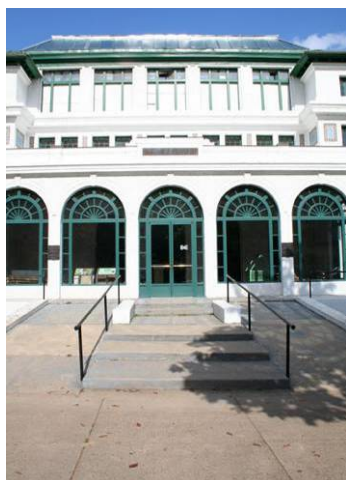
Figure 3- 96: Maurice Bathhouse Entrance (MBD, 060705-18)

Maurice Bathhouse Entrance	3-96, 3-97	<p>Set of three long steps and two shorter broom- finished concrete steps centered on the building entrance. The top two shorter steps are flanked by concrete cheek walls. Steel handrail extends the full length of steps. Central steps flanked by two concrete ramps with cheek walls that extend from the linear walk to building. Ramps do not have handrails.</p> <p>Concrete ADA ramp with black tube steel handrail extends to the north along the front building façade.</p>	<p>Good /Fair</p> <p>Cracking and heaving of concrete ramps and steps</p>
Maurice Historic Spring	3-98, 3-99, 3-100, 3-101, 3-102	<p>Situated within the hillside behind the Maurice Bath House, Maurice Historic Spring is carved out of a tufa wall. It consists of mortared limestone retaining wall (approximately 15 feet tall) with limestone cap; set of eleven limestone steps; an irregularly shaped terrace of scored concrete and a low limestone wall with a limestone cap. Associated features: four foot tall steel picket fence; tubular steel hand rail, painted black.</p> <p>Tunnel Spring No. 27 located under tufa rock outcrop enclosed with steel picket gate, painted black; wood bench; security light with one round globe fixture; steel handrail, fountain set within the limestone wall.</p> <p>The Dripping Spring No. 29, set into the mortared limestone retaining wall, is new distribution system water and drips narrowly into a limestone bowl. Spring is not operational.</p> <p>The jug fountain, located south of the Maurice Historic Spring, was originally fed by Maurice Spring but is now distribution water. Its concrete pedestal (circa 1981-82) is a reproduction of the original, possibly limestone, pedestal.</p>	<p>Good/Fair</p>

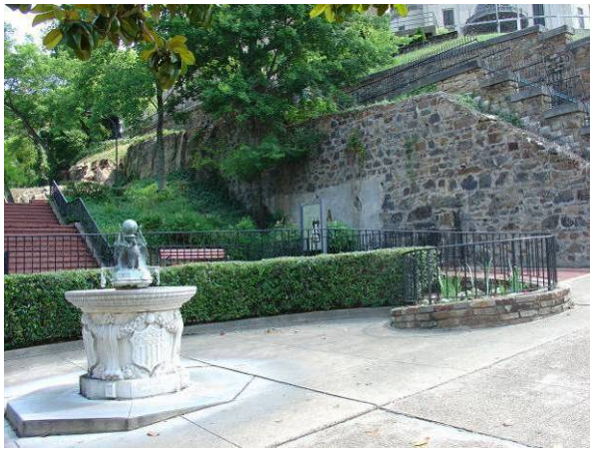
Figure 3- 123: Noble Fountain, Entrance Stone Wall with Fence, Curved Stone Wall with Fence at Reserve Street pedestrian access to the Grand Promenade and Hot Springs Mountain (QEA, June 3, 2005, DSC01721)

<i>Feature</i>	<i>Figure Number</i>	<i>Description</i>	<i>Condition</i>
Reserve Street Entrance	3-123, 3-124	<ul style="list-style-type: none"> Noble Fountain: Located at the Reserve Street entrance to the Grand Promenade. The Noble Fountain was completed in 1895. It was moved from its original location in 1945, and sited at its present location in 1957. Curved Stone Wall with fence: Mortared stone wall topped with iron fence with finials. Located along the western edge of the stairway leading to the Grand Promenade. Brick Pavement and Stairway: Bordered by the Entrance Stone Wall and Curved Stone Wall with the iron fence, this red brick entry is bordered by blonde brick. It extends north through a series of two brick stairways and iron fence railing, up to a brick landing. Interpretive Sign: Metal sign at the entrance to the Grand Promenade attached to the Entrance Stone Wall. 	Good
Lower Stone Retaining Wall with fence at Rehabilitation Center	3-123	Mortared stone retaining wall topped with iron fence with decorative finials. Located along the western edge of the Rehabilitation Center property and the eastern edge of the Grand Promenade. The wall is situated atop a steep slope and visible from the southern portion of the Grand Promenade. This wall extends from Reserve Street to the concrete steps that are just south of the small utility building. The wall is the property of the Rehabilitation Center.	Fair Needs mortar repair and some stone repair.

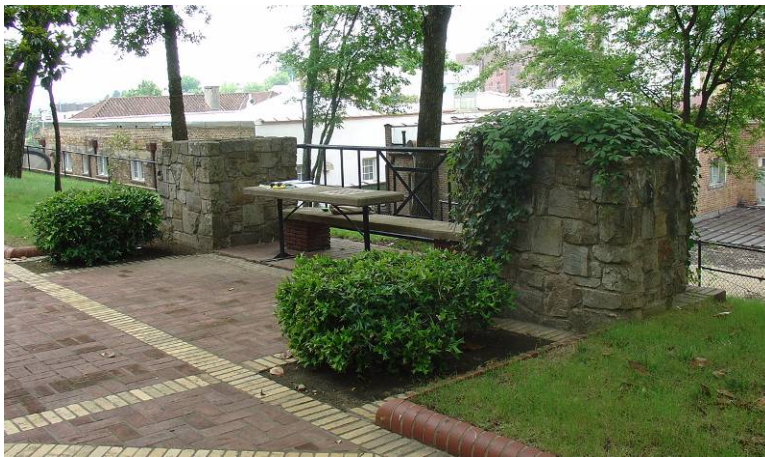
Figure 3- 126: Brick Seating Area #1 (west side of Grand Promenade); the black chain link fence can be seen in the background. (QEA, 2 June 2005, DSC01792)

Fence	3-126	4' high, black chain link fence Extends along the top of the slope between Bathhouse Row and the Grand Promenade.	Good
Brick Seating Area #1	3-126	12'x9' seating area with red brick paving and yellow brick edge. Includes large concrete benches and concrete tables with tile checker boards, with stone planters at both ends and small shrubs (holly). A mortared stone retaining wall is located at the eastern side of the seating area. Located on the east side of the Grand Promenade.	Fair Planters have weeds and some cracked brick.
Brick Seating Area #2	3-127	12'x9' seating area with red brick paving and yellow brick edge. Includes large concrete benches and concrete tables with tile checker boards, stone planters at both ends and small shrubs (holly). The planters may be remnants of a historic structure. Located on the west side of the Grand Promenade.	Good
Upper Stone Retaining Wall with fence at Rehabilitation Center	3-127	Mortared stone retaining wall topped with iron fence with decorative finials. Located along the western edge of the Rehabilitation Center property and the eastern edge of the Grand Promenade. The wall is situated atop a steep slope and visible from the southern portion of the Grand Promenade. This wall extends from Reserve Street to the steps that are just south of the small utility building. The wall is the property of the Rehabilitation Center.	Fair, needs some mortar repair.

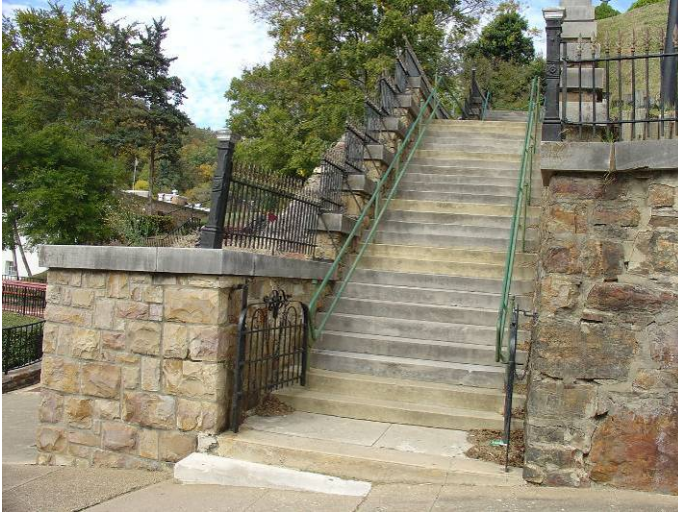
Figure 3- 128: Stairs from Reserve Street to Rehabilitation Center (QEA, Nov 2005)

Stairs from Reserve Street to Rehabilitation Center	3-128	Concrete stairs with metal railings and stone retaining walls topped with ornamental metal fence. Property of the Rehabilitation Center.	Concrete stairs and metal railings good condition. Stone retaining walls and ornamental fences need some mortar repair.
Stairs to Rehabilitation Center and Brick Utility Structure	3-129	Located to the south of the small utility building illustrated in figure 3- 26. The stairs' brick structure is the property of the Rehabilitation Center.	Good

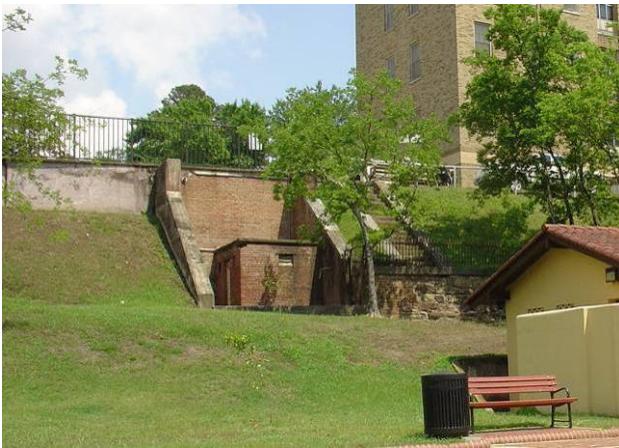
Figure 3- 129: Steps, Retaining Walls, and Brick Utility Structure at Rehabilitation Center (QEA, 2 June 2005, DSC01813)

Stone/Concrete Retaining Wall	3-129, 3-131	This wall is mortared stone with a stone cap at the northern end and has a stucco surface (structure unknown) for the southern portion of the wall. A portion of it may be the remnants of a former building foundation. The stone portions may be reused blocks from the old springhouse that once enclosed the Eisele Spring (which still steams there, near the bottom of the gutter); some blocks may be in their original portions. The stucco-surfaced brick wall was a portion of the west wall of Building 8 (built 1901, demolished 1985). The blocks belong to the park, but the wall is located on Rehabilitation Center property.	Good
Brick bench pads	3-131	3'9"x6'10" redbrick basket weave with running bond blonde brick border, pad for benches (several pads do not have benches). The pads border the eastern and western edges of the Grand Promenade. Nineteen pads are on the western edge, eighteen pads are on the eastern edge. One larger pad is on the southeastern edge of the curved portion of the promenade immediately south of the Formal Entrance. Four additional pads with benches encircle Brick Plaza #5.	Fair to Good Some of the pads have been damaged or have deteriorating bricks or mortar.

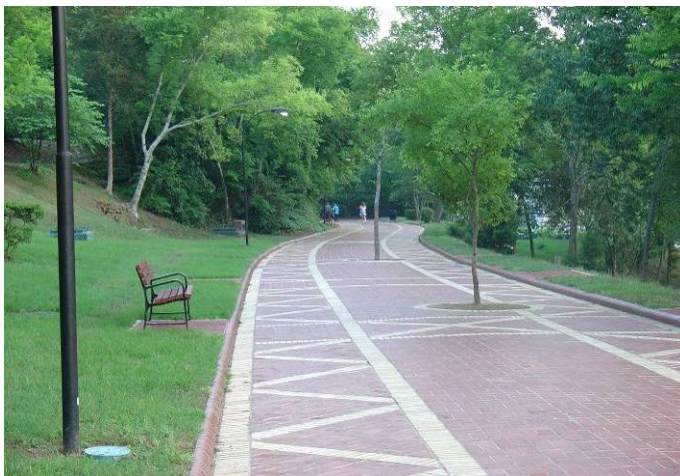
Figure 3- 136: Tree Planting Areas (QEA, June 2005,DSC01872)

Tree planting areas	3-136	Two circular tree planting areas are situated in the Grand Promenade Decorative Paving (between the Superior Bathhouse and the Pump Building). They each contain a small Chinese Elm. The trees are in fair to poor condition.	Fair Dirt with weeds and fair to poor trees.
Brick Plaza #2	3-137	Red brick pavement with planting area along the western side of the Grand Promenade above the park Service Area. The plaza serves as an overlook and as the beginning/end point for the Lower Tufa Terrace Trail. A 30" high stone wall surrounds the plaza on the south and west sides. A small maple tree is situated in the planting area with an iron fence surrounding it. A hedge extends around the northwest and western sides of the stone wall, and three hollies are situated near the south side of the plaza.	Good
Brick Plaza #3	3-138	Red brick pavement situated adjacent to the northwestern side of the Grand Promenade; a stone wall with an iron fence provides an edge on the northeast, northwest, and southwest sides. Overlooks the Hot Water Cascade.	Good

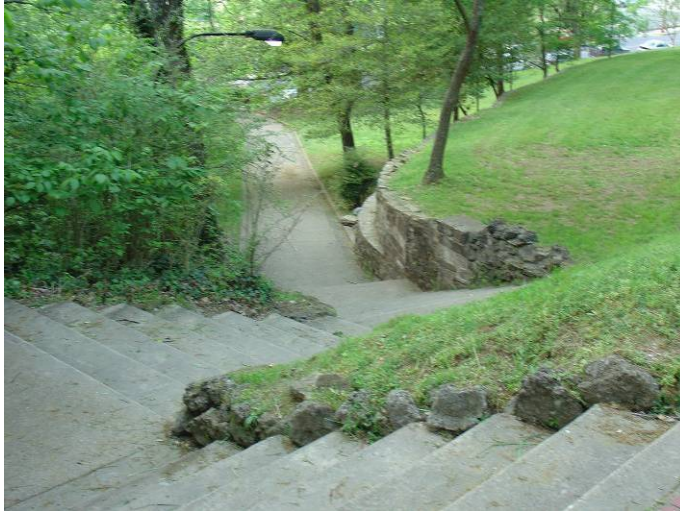
Figure 3- 143: Concrete Steps (QEA, April 2005)

Tufa outcrop	3-142	Short wall of exposed tufa along the eastern side of the Grand Promenade north of the Hot Water Cascade Display Spring.	Good
Tufa sign	3-142	Small metal sign.	Good
Concrete Steps	3-143	Lead down from Grand Promenade to sidewalk that continues to Fountain Street. The stairs are concrete with brick and stone retaining walls.	Fair Need some mortar repair.
Brick Plaza #5	3-144	Circular plaza with drinking fountain in center.	Good
Simple Red Brick Pavement	3-145	Running bond red brick pavement with yellow brick edge band.	Good

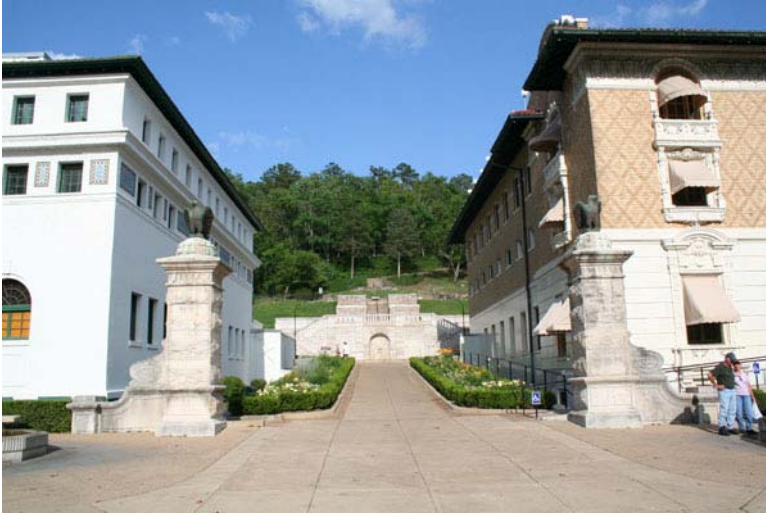
<i>Landscape Feature</i>	<i>Figure Number</i>	<i>Description</i>	<i>Condition</i>
1. Entry/Gateway at Central Avenue			
Entry Columns	3-146, 3-148, 3-149	Two original columns, completed in 1895, define the entry/gateway. The columns, similar in height, style and construction, are arranged equidistant from the central axis of the Formal Entrance. Both are constructed of limestone blocks set on a granite base with a bronze eagle on the top. Each column has a base, middle and top on which the bronze eagle sits. The eagles show the signature of Edward Kemeys. Attached to the outer side of each column is a low carved limestone wall. The column on the north is inscribed with <i>HOKE SMITH, SECRETARY OF THE INTERIOR, 1893-1896, U.S. HOT SPRINGS RESERVATION and E.A. Hitchcock, 1898-1907.</i> The column to the south is inscribed with <i>JOHN W. NOBLE, SECRETARY OF THE INTERIOR, 1889-1893, U.S. HOT SPRINGS RESERVATION and David R. Francis, 1896-1897.</i>	Good In need of cleaning. Base of each column, particularly the eastern side requires repair. Overspray from fountains may be causing the damage to limestone walls.

Figure 3- 146: Formal Entrance (Stevens Balustrade) (MBD, 060805-8)

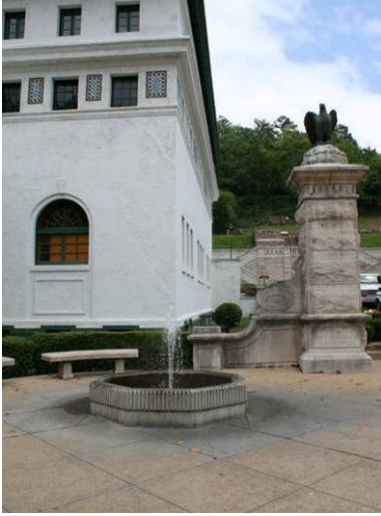
Exedra Fountains and Plaza	3-150, 3-151	Scored concrete plaza, arranged as a half-circle, with two round, fluted pre-cast concrete basins with central jets (circa 1988) define the entry/gateway to the Formal Entrance.	Fair Water damage from the fountain jets is damaging basins and

Figure 3- 150: North Exedra Fountain (MBD, 060705-11)

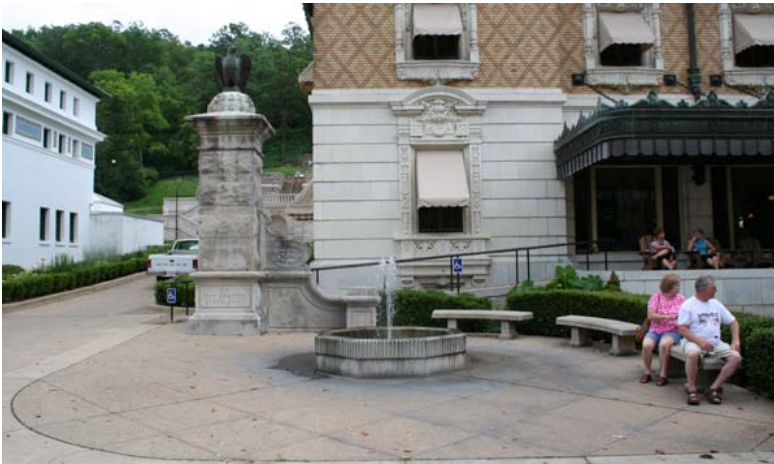
Figure 3- 151: South Exedra Fountain (MBD, 060705-13)

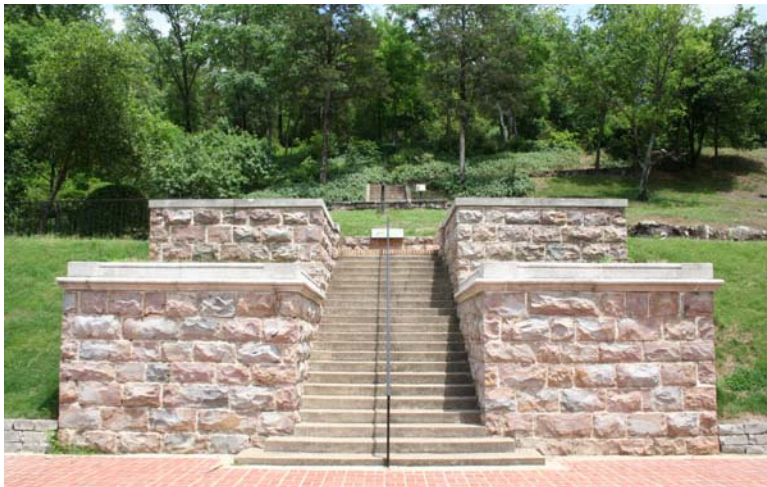
Upper Staircase	3-154	<p>Central staircase extends from terrace to the Grand Promenade. Built of concrete, it consists of 22 steps, flanked on both sides by rough cut stone walls that create two planters. A center steel handrail extends for the length of the steps.</p>	<p>Fair Stone walls have newer mortar repairs of a lower quality than</p>

Figure 3- 154: Upper Steps (MBD, 060705-43)

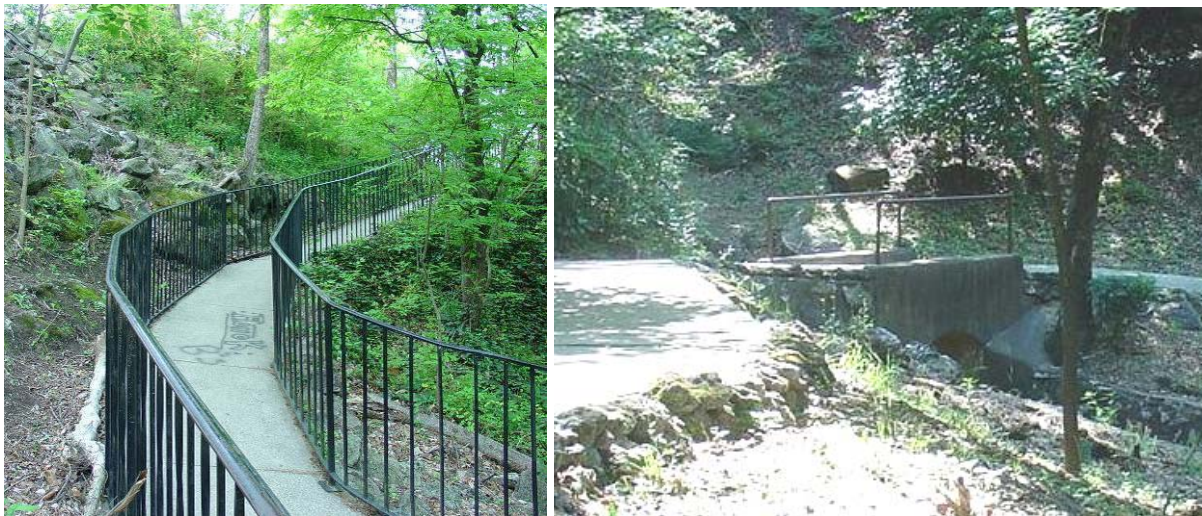
Lower Tufa Terrace Trail	3-156	Steep and curvilinear trail winds between the Brick Plaza #2 and Arlington Lawn. The trail includes three sets of steps and two Thermal Water Cascade overlooks.	Fair Graffiti and irregular slopes along route.
Brick Seating Area #3	3-139	Rectangular brick paved area on the west side of the Grand Promenade across from the Hot Water Cascade Display Spring. Black iron railing.	Fair Retaining wall is in need of repair.
Tufa Cascade Pool/Hot Water Display Spring	3-140	Tufa outcrop with exposed spring. Surrounded by black wrought iron fence.	Good
Thermal Water Cascade	3-158, 3-159	Large tufa outcrop that extends from the western side of the Grand Promenade to the pools at Arlington Lawn. Spring water cascades down the steep tufa outcrop.	Fair Invasive plants are impacting surrounding vegetation.
Brick Plaza #4	3-141	Same shape as Plaza #4 with planting area and tree in center.	Fair Planting area has weeds and wall needs repair.

Figure 3- 156: Left: Lower Tufa Terrace Trail and Right: Upper Tufa Terrace Trail and Footbridge (QEA, April 2005, DSC01352 and DSC02239)

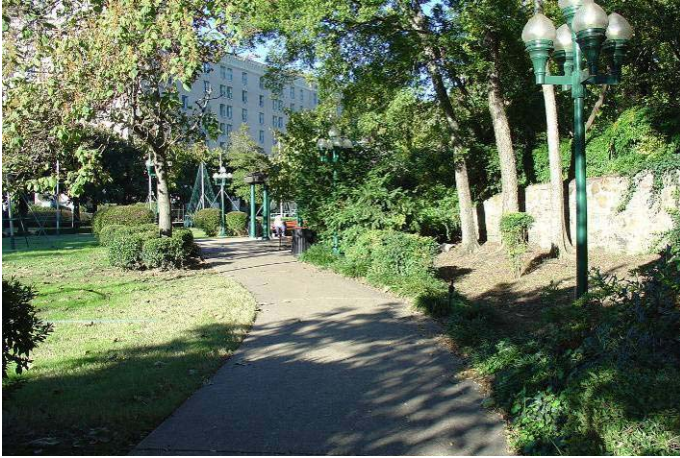
<i>Feature</i>	<i>Figure Number</i>	<i>Description</i>	<i>Condition</i>
Stone Wall South of Tufa Terrace Trail	3-157	This linear stone wall is situated to the southwest of the Tufa Terrace Trail and is covered with English ivy.	Fair Needs some mortar repair and ivy is impacting.
Thermal Water Cascade	3-158, 3-159	Constructed ca. 1982, a man-made naturalistic Tufa rock outcropping with thermal water cascade; it originates to the west of the Grand Promenade. The thermal water flows down to the geometric thermal pool.	Good
Desoto Rock	3-159	A large block of Tufa rock situated to the west of the thermal pool area. A bronze plaque is mounted to the rock.	Good
5-Globe Light Fixtures	3-157	Located along Fountain Street and Central Avenue sidewalks; also along the walkways within the Arlington Lawn area. The globe light fixtures along Fountain Street are much older than the ones along the Lawn sidewalks.	Good

Figure 3- 157: Sidewalk, Light, plants, and stone wall south of Tufa Terrace Trail (QEA, DSC04461)

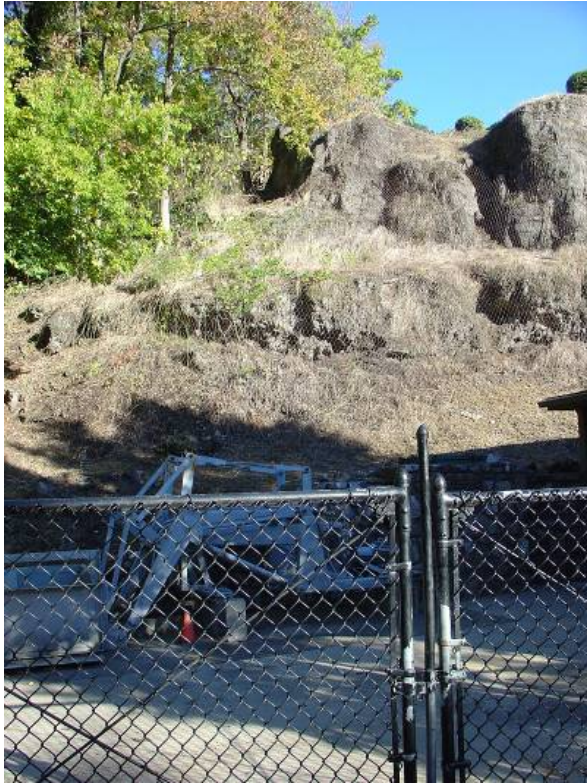
Chain mesh over rock outcrop	3-160	A rock outcrop between the Brick Plaza #2 and the Service Area is unstable. A chain mesh lies over the rocks to stabilize the surface.	Fair Condition should be monitored.
Stone Rubble Retaining Wall at Arlington Lawn	3-161	+/- 48" Stone Retaining wall Located between the two exposed aggregate sidewalks with entrances on Fountain Street. The height varies but is approximately 48" tall. Ivy plants cover a large portion of the wall.	Fair Vegetation impacts
72" Stone Retaining Wall	3-162	Rough-cut mortared stone wall extending from the Grand Promenade area, bordering in a curved-shape towards the Fountain Street entrance, adjacent to the Concrete Walk. It cuts through the lawn on the Fountain Street side.	Fair Needs mortar repair and cap repairs
36" Stone Retaining Wall	3-163	Located directly below the 72" Stone Retaining Wall.	Fair Needs mortar and cap repairs

Figure 3- 160: Chain Mesh stabilizing slope, service area fence and Trash Loader (QEA, Nov. 2005, DSC04456)

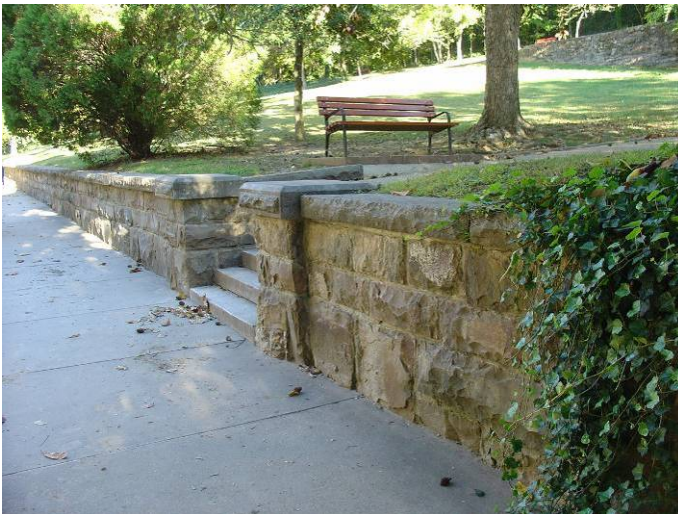
Stone Retaining Walls at Fountain Street Sidewalk	3-163	<ul style="list-style-type: none"> • 44" Mortared Stone Wall: Starting at the east side of the concrete walk along the Fountain Street sidewalk boundary, the wall extends 70' to the east. • 48" Mortared Stone Wall: Continuing from the 44" wall due east along the Fountain Street sidewalk boundary, the wall has numerous cracked stones where tuck pointed. The wall extends 100'. • 32" Mortared Stone Wall: Continuing from the 48" wall due east along the Fountain Street sidewalk boundary, the stone wall has a 19-20" cap width and extends 100'. • 30" Mortared Stone Wall: The stone wall has a 19" cap and continues after a 9' gap from the 32" wall and extends 87'. Some areas of the wall are in poor condition and need tuck pointing and mortar. • 34" Mortared Stone Wall: The stone wall has a 14" cap width and ends at the Grand Promenade Entrance on Fountain Street. 	Fair/Good Mostly in good condition, some portions are damaged and need replacement of stone and/or mortar repairs.

Figure 3- 163: Stone Retaining Wall at Fountain Street Sidewalk (QEA, Nov. 2005, DSC04483)

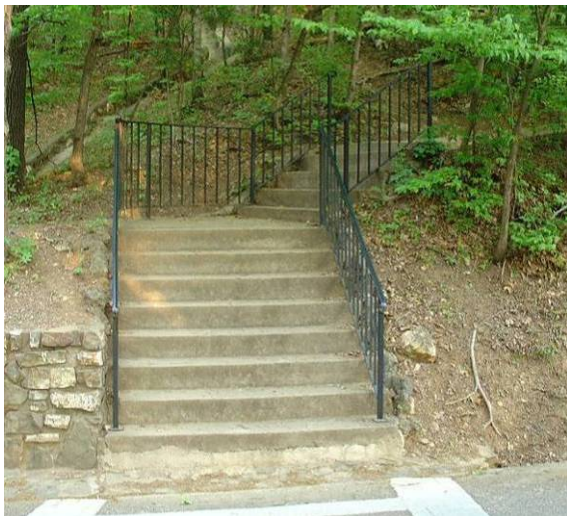
Concrete Steps and Iron Railing	3-177, 3-178	Two sets of concrete stairways connected by a painted crosswalk across Hot Springs Mountain Road. The upper stairway leads toward Peak Trail; the lower stairway continues west toward Arlington Lawn.	Good
Mortared Stone Wall and Arched Culvert	3-180, 3-181	Located adjacent to Lower Stairway; mortared stone with stone coping, with arched culvert; brick structure (inlet or manhole) with concrete coping; stone gutter.	Good to poor some mortar repairs needed.
Mortared Stone Gutter with Concrete Extension	3-184	Typical treatment for curved areas along Hot Springs Mountain Road.	Good to poor some mortar repairs needed.
Concrete Pedestrian Bridge	3-189	Access to Promenade and Arlington Lawn from Hot Springs Mountain Road.	Good
Mortared Stone Slope and Stone Culvert	3-190, 3-191	East of Hot Springs Mountain Road, near the Fountain Street Entrance; arched stone culvert with stone coping adjoining a mortared stone slope.	Good to poor some mortar repairs needed.

Figure 3- 177: Upper Stairway: Concrete steps and Iron Railing east of Hot Springs Mountain Road (QEA, April 2005, DSC01507)

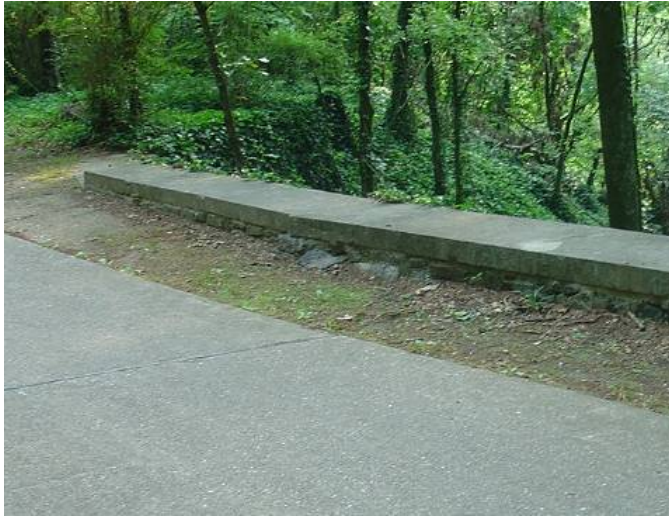
Figure 3- 192: Stone Retaining Wall with English Ivy, view to southwest (QEA, June 3, 2005, DSC02052)

Stone Retaining Wall with English Ivy	3-192, 3-193	West of Hot Springs Mountain Road and due east of Brick Plaza #5, mortared stone retaining wall with stone coping	Fair to Good
Stone Wall with Drainage	3-194, 3-195	East of Hot Springs Mountain Road, recessed mortared stone wall with inlet pipe not visible from road, east of Promenade Brick Plaza #5; adjoining mortared stone culvert with cut notch over outlet pipe.	Fair Poor mortar repairs
Mortared Stone Gutter	3-198	2' mortared stone gutter bisecting the parking area and Hot Spring Mountain Road	Good
Stone Water Fountain	3-197	Stone fountain, ashlar, random pattern; wider at base, located at the Picnic Area near the Overlook Tower.	Good
Accessible Water Fountain	3-199	The cold-water drinking fountain, exposed aggregate concrete set on a concrete pad, universally accessible, at the picnic area, with concrete walk access to Hot Springs Mountain Road.	Good

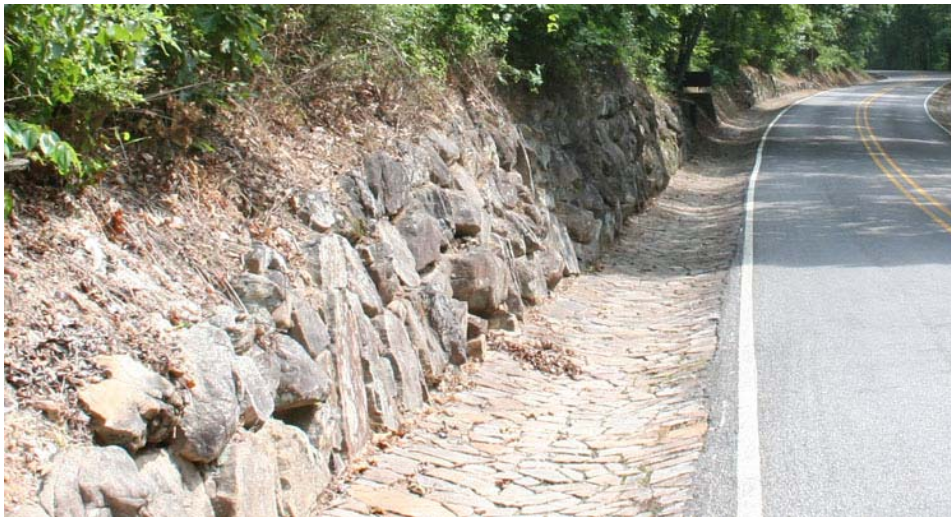
Figure 3- 210: Stone Retaining Wall at Road (MBD, 060805-0600)

Stone Retaining Wall at Road	3-210	Stacked stone retaining wall retains the slope along straight and curved portions of West Mountain Drive and West Mountain Summit Drive. Walls are located on both inside and outside curves. Height of wall varies two to five feet, and length of the wall varies to respond to the hillside.	Good Fair some wall failure
Mortared Stone Gutter at Road	3-211	Mortared stone gutter along curved and straight portions of roads. Gutters vary in width from eighteen to twenty-four inches and terminate into inlets. Gutter depth is shallow on moderate slopes and deep on steep slopes.	Good Some sections have mortar failure
Mortared Stone Shoulder/Gutter at Road	3-212	Mortared stone shoulder with an attached stone gutter located along curved and straight portions of roads. Width of the shoulder varies from six to eight feet with the attached gutter approximately two to three feet wide.	Good/Fair Some cracking and displacement

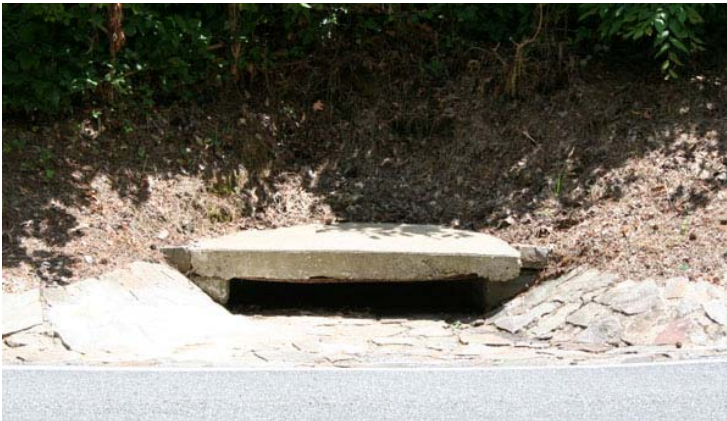
Figure 3- 214: Concrete Inlet (MBD, 060805-0382)

Concrete Inlet	3-214	Water flows from mortared stone gutters into concrete inlets in select locations along roads.	Fair Deterioration of concrete
Wood Guardrail	3-215	Wood posts with wood rail approximately twenty-four inches tall. Located on curves along roads.	Good
West Mountain Overlook #1	3-216, 3-217, 3-218	Located along West Mountain Summit Drive at a curved section of road where thick forested vegetation opens to views of the city of Hot Springs. Overlook consists of pull-off lane for parking, mortared stone curb, broom- finished concrete walk adjacent to mortared stone curb, twenty-four inch tall mortared stone retaining wall adjacent to concrete walk, bear-proof trash receptacle.	Good
West Mountain Overlook #2	3-219, 3-220, 3-221, 3-222	Located on West Mountain Summit Drive. Overlook consists of ten space asphalt parking area; cleared vegetation for views of city of Hot Springs; stone shelter (see buildings/structures), mortared stone curb, broom-finished concrete walk, mortared stone retaining wall (appears to have two different types of stone) with black wrought iron guardrail, two mortared stone planters (one with a tree, one without tree), two wood picnic tables, bear proof trash receptacle; mortared stone steps to shelter; and trail access to Canyon Trail and West Mountain Trail.	Overall: Good Stone Planters: Fair Some deterioration of mortar Stone Steps: Poor Deterioration of mortar and settling

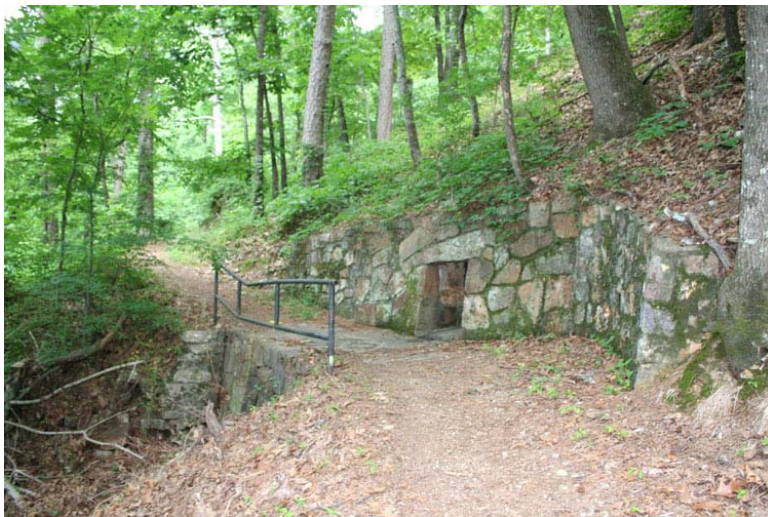
Figure 3- 231: Mortared Stone Bridge/Culvert at Oak Trail (MBD, 060905-0596)

Mortared Stone Bridge Culvert on Oak Trail	3-231	Mortared stone bridge culvert in two locations on Oak Trail. Trail has stone surface and steel handrail. Stone culvert is part of mortared stone wall that retains uphill slope and is covered in lichen. The wall may have been constructed in the 1930s.	Fair/ Good Deterioration of mortar and poor condition of handrail
Mortared Stone Spillway on Oak Trail	3-232	Mortared stone spillway connects to culvert under the bridge culvert. Spillway is a two foot wide mortared stone channel with vertical mortared stone walls on each side varying in height from two to four feet. Spillway daylights at the bottom of West Mountain on the northeast side of the mountain. Probably constructed in the 1930s.	Good

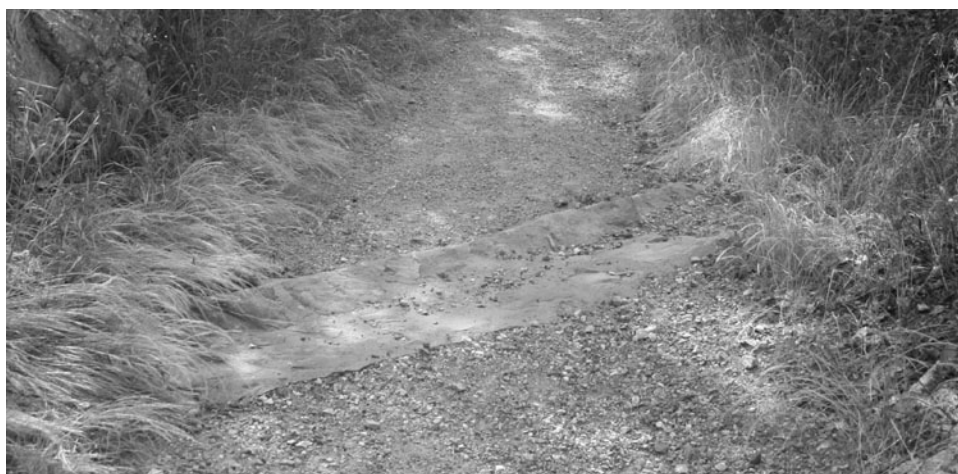
Figure 3- 233: Mortared Stone Gutter on Trails (MBD, 061005-0783)

Mortared stone gutter on Trails	3-233	Mortared stone gutters direct water across the trails. Stone gutters extend the width of the trail and are approximately eighteen inches wide.	Fair Due to deterioration of the mortar and displacement of the stones
Stone Water Bars on Trails	3-234	Stone water bars are located intermittently along trails to alleviate erosion and direct water. Stone is buried and protrudes between two to five inches above trail grade.	Good Some are covered in debris. Stones are slightly displaced
Mortared Stone Steps on Oak Trail	3-235	Mortared stone steps on uphill side of crosswalk for Oak Trail at West Mountain Summit Drive.	Good
Mortared Stone Steps on Mountain Top Trail	3-229	Mortared stone steps at Prospect Avenue	Fair Poor mortar repairs
Trail Signs	3-236	Single panel steel signs mounted on steel posts, usually at the beginning of trail, and intersections of two or more trails.	Good

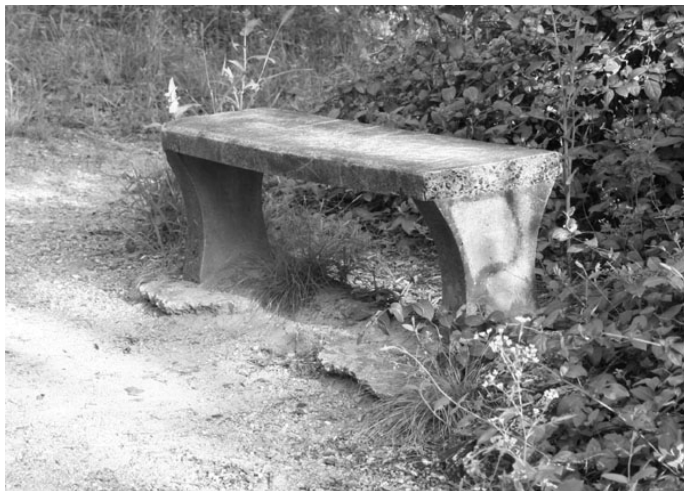
Figure 3- 237: Concrete Bench (MBD, 061005- 0786)

Concrete Bench	3-237	Concrete benches four feet in length; provide resting places along trails in select locations on West Mountain.	Fair Wash out and exposure of concrete footings and deterioration at edges of bench
Concrete gutter on Trail	3-238	Concrete gutters direct water across the trail surface. Concrete gutters extend the width of the trail and are approximately eighteen inches wide.	Fair Some cracking, displaced, and deteriorating concrete
Painted Pedestrian Crosswalk	3-239	Pavement striping at trail crossings on West Mountain Drive, three locations.	Good

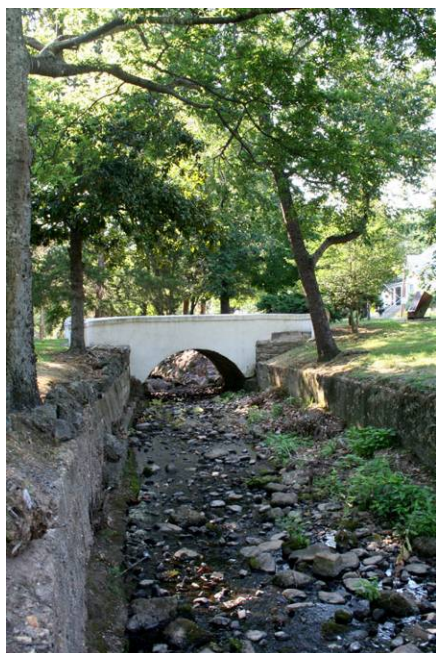
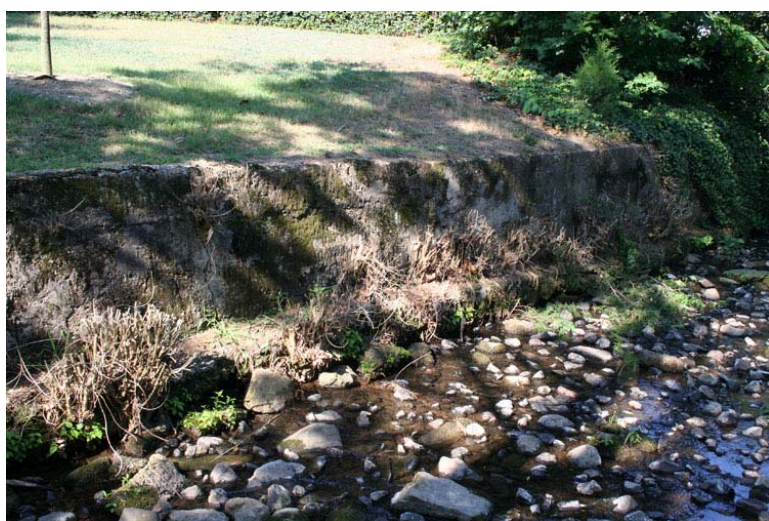
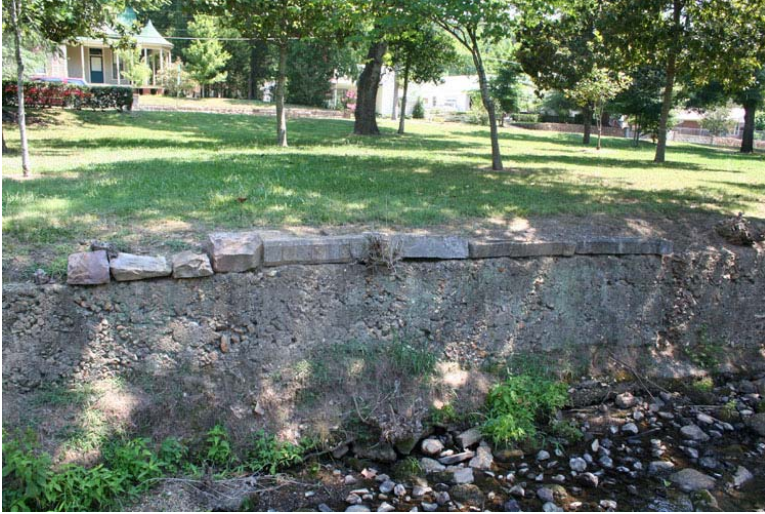
<i>Landscape Feature</i>	<i>Figure Number</i>	<i>Description</i>	<i>Condition</i>
Channel Section One	3-240, 3-241, 3-242	Original concrete retaining wall (1897) defines both sides of Whittington Creek. Height of the wall varies, on average it is approximately five (5) feet. Remnants of stone and concrete cap occur on portions of the wall.	Fair to Poor-creek bottom eroding, undermining the wall, concrete cracking, chipping and failing.
Channel Section Two	3-243, 3-244	Sloped boulder retaining wall (early 1940s) defines both sides of Whittington Creek. Wall is large boulders that taper down the slope to the creek bottom. Height of the wall varies, on average it is approximately 5'-6'.	Good - some undermining on creek bottom.
Channel Section Three	3-245, 3-246	Sloped boulder retaining wall (early 1940s) defines the north side of Whittington Creek. Original concrete retaining wall (1897) defines the south side of Whittington Creek.	Good to Fair - creek bottom eroding, undermining and causing deterioration of concrete wall.
