HOT SPRINGS NATIONAL PARK

Cultural Landscape Report and Environmental Assessment

January 2010

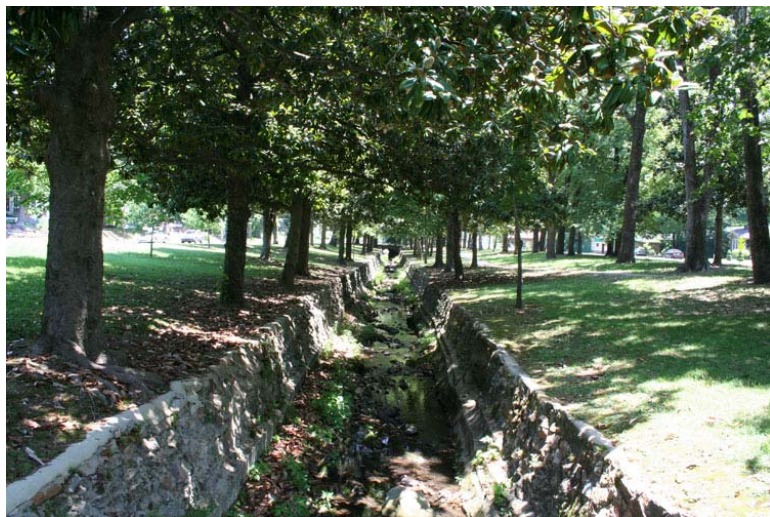
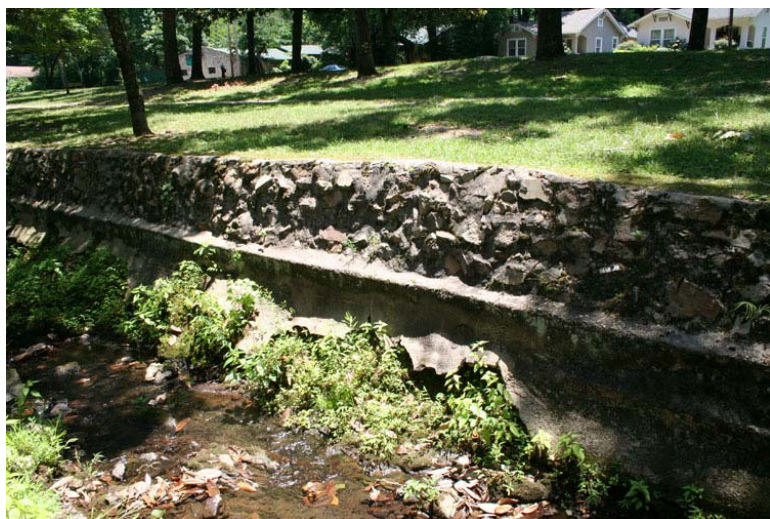
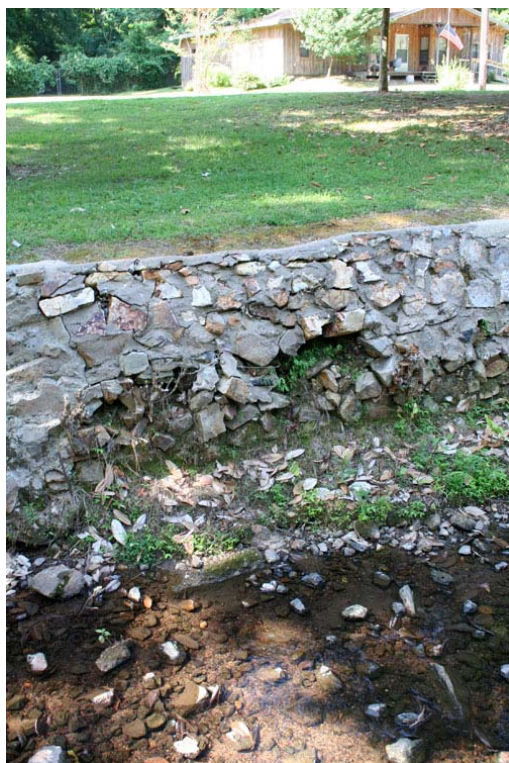
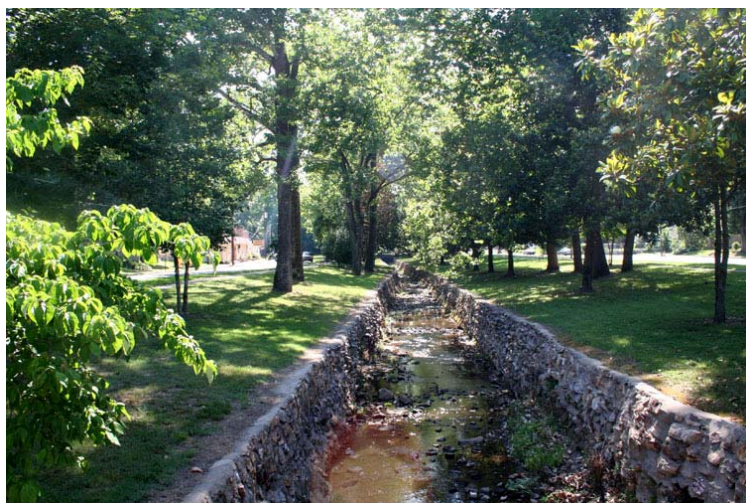
Channel Section Four	3-247, 3-248, 3-249, 3-250	Concrete and stone retaining wall (early 1900s) defines both sides of Whittington Creek. Stone veneer is of random sizes and shapes.	Fair to Poor-sections of wall are in fair condition, needing stabilization. Other sections are severely deteriorated, falling into the creek and in need of immediate repair. Large portions of channel bottom are eroding, exposing the bottom of

retaining wall. Repairs are not consistent with the materials and craftsmanship of the original wall. Additional repairs were made in 2006 and are inconsistent with the original craftsmanship.
Concrete Bridge #1	3-251, 3-252, 3-253	Monolithic concrete structure with a stucco finish (1910), painted white with bridge abutments of mortared stone and concrete and arched opening for Whittington Creek. Provides trail access across Whittington Creek.	Good – some minor cracking of the concrete and grout of the abutment.
Concrete Bridge #2	3-254, 3-255, 3-256	Monolithic concrete structure with a stucco finish (1910) painted white with bridge abutments of mortared stone and concrete with an arched opening for Whittington Creek. Provides trail access across Whittington Creek.	Good – minor cracking of the concrete structure and grout of the abutment.
Concrete Bridge #3	3-257, 3-258, 3-259	Monolithic concrete structure with a stucco finish (1910) painted white with bridge abutments of mortared stone and concrete with an arched opening for Whittington Creek. Provides trail access across Whittington Creek.	Good – minor cracking of the concrete and grout of the abutment.

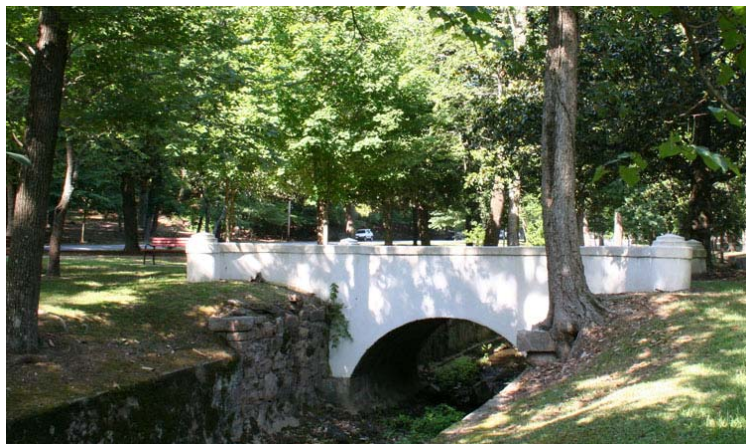
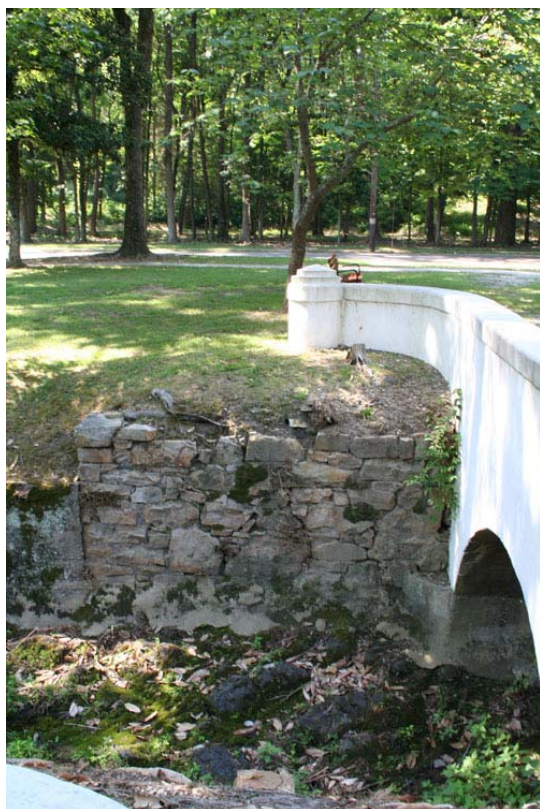
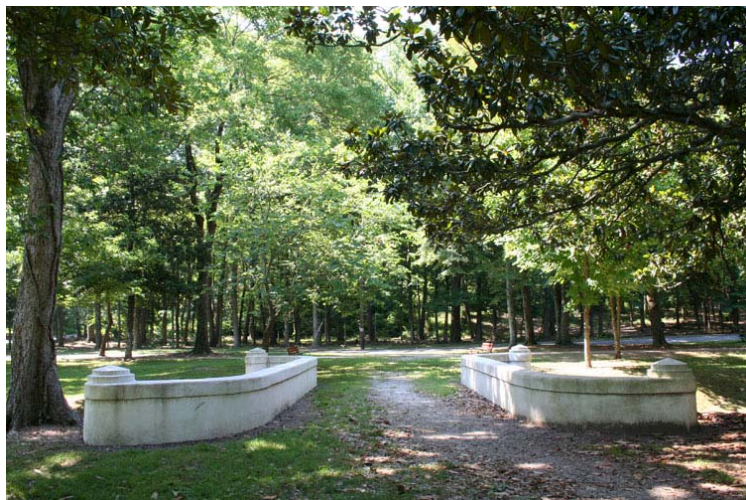
Concrete Bridge #4	3-260, 3-261, 3-262	Monolithic concrete structure with a stucco finish (1910) painted white with bridge abutments of mortared stone and concrete with an arched opening for Whittington Creek. Provides trail access across Whittington Creek.	Good – minor cracking of the concrete and grout of the abutment.

Figure 3- 260: Concrete Bridge # 4 (MBD, 062806-3865)

Figure 3- 261: Concrete Bridge # 4 (MBD, 062806-3870)

Figure 3- 262: Concrete Bridge # 4 (MBD, 062806-3872)

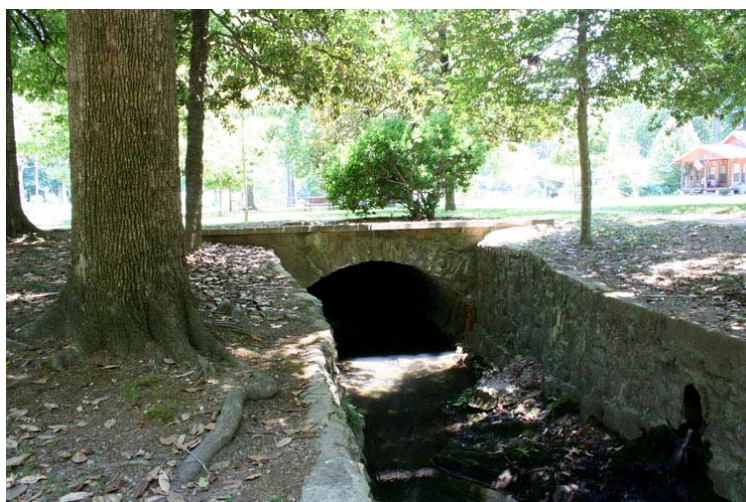
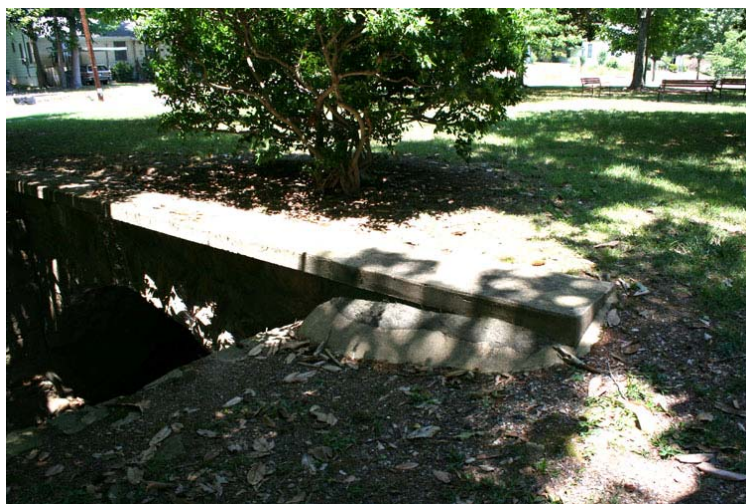
Stone Arch Culvert	3-263, 3-264	Original stone culvert, with concrete capstone, stacked rubble stone façade and cut keystone arch, spans Whittington Creek.	Good – some previous repairs are not consistent with the materials and craftsmanship of the original wall/capstone.
Steel Culvert at road connection to West Mountain Road	3-265	Steel culvert under road to West Mountain spans Whittington Creek. Installed in mid 1900s with road construction. Stacked, mortared stone set on top of steel.	Good – structural stability should be reviewed by structural engineer.
Stone Arch Culvert at Myrtle Street	3-266	Original stone culvert, stacked rubble stone façade, cut keystone arch, concrete capstone and steel knuckle railing. On the east side of Myrtle Street at road.	Good – structural stability should be reviewed by structural engineer.
Stone Arch Culvert – at East end of Park	3-267	Original stone culvert, stacked rubble stone façade, cut keystone arch. At the east end of the park.	Good – some cracking of mortar Structural stability should be reviewed by structural engineer.

Figure 3- 263: Stone Arch Culvert (MBD, 062906-3949)

Figure 3- 264: Stone Arch Culvert (MBD, 062906-3976)

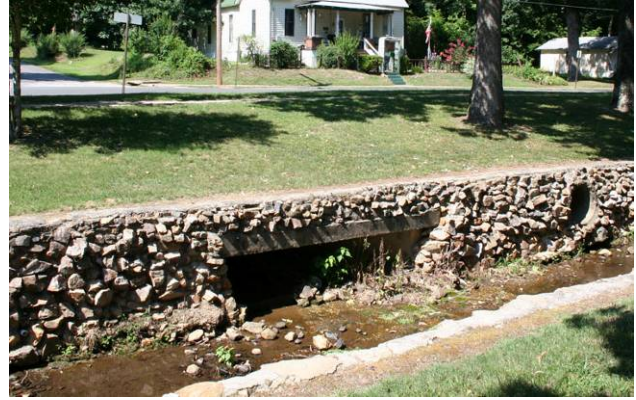
Stone/Concrete Outfall	3-268, 3-269	Several concrete/stone outfalls convey storm-water from adjacent neighborhoods into Whittington Creek. Inlet sizes vary along the channel.	Good to Fair- Some are in good condition, others are in fair condition due to poor repairs.
Corrugated Pipe Outfall	3-270	Corrugated PVC pipe outfall conveys stormwater from adjacent neighborhoods into Whittington Creek.	Fair – Eroding wall and channel below.

Figure 3- 268, Figure 3- 269: Stone/Concrete Outfall (MBD, 062906-3973, 3983)

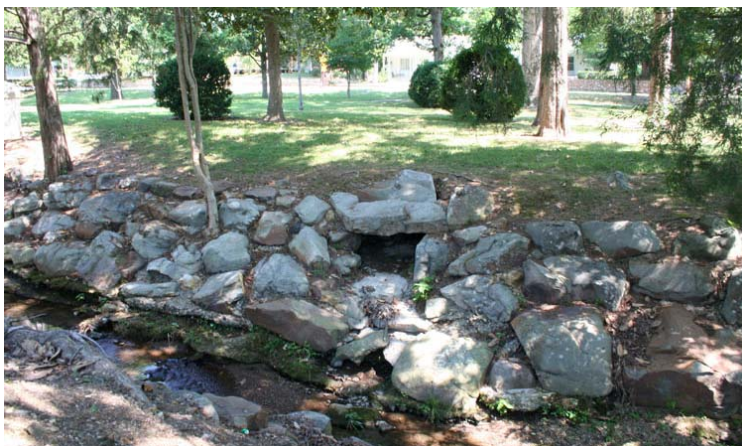
Boulder Outfall	3-271	Boulder outfall set in boulder wall conveys stormwater into Whittington Creek from adjacent neighborhoods.	Good – some cleaning and vegetation. Removal needed
Steel Pipe Outfall	3-272	Steel pipe outfall set in stone and concrete channel retaining wall conveys stormwater from adjacent neighborhoods to Whittington Creek. Stone and concrete surround the steel pipe.	Fair – Repairs around the pipe are poor and not consistent with the materials and craftsmanship of original wall.
Concrete Outfall	3-273, 3-274, 3-275	Concrete outfall conveys stormwater from adjacent neighborhoods into Whittington Creek. Outfalls vary in size and occur along the wall.	Good to Fair – cracking and deterioration on some.
Soft Surface Trail	3-276, 3-277	Crushed granite trail surface, width varies from (3) three to (6) six feet wide, six (6) feet is average. Loop trail around the park with access to the other side of the park at bridge crossings.	Fair – needs a consistent width and edge treatment. In need of routine maintenance of trimming and vegetation removal at edges.

Figure 3- 271 Boulder Outfall (MBD, 062806-3787)

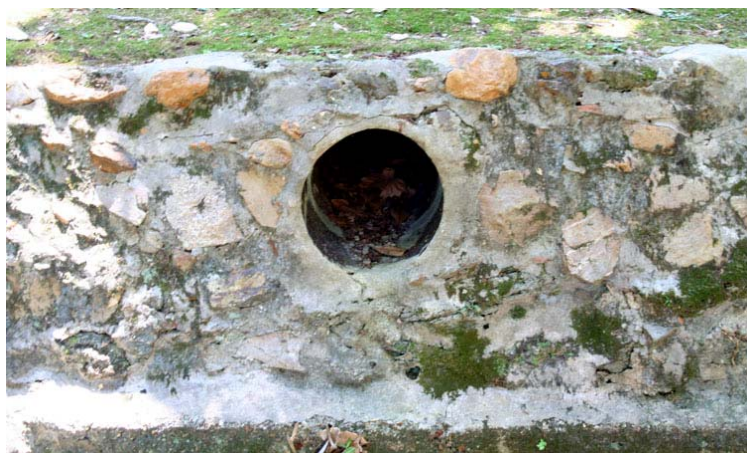
Figure 3- 272: Steel Pipe Outfall (MBD, 062906-3935)

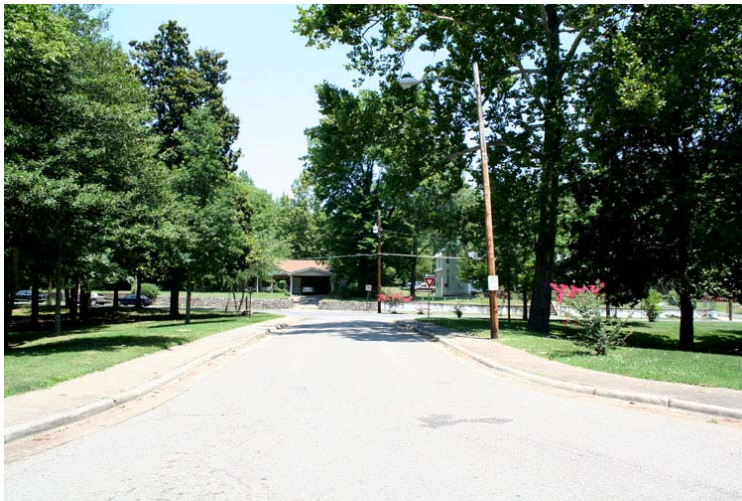
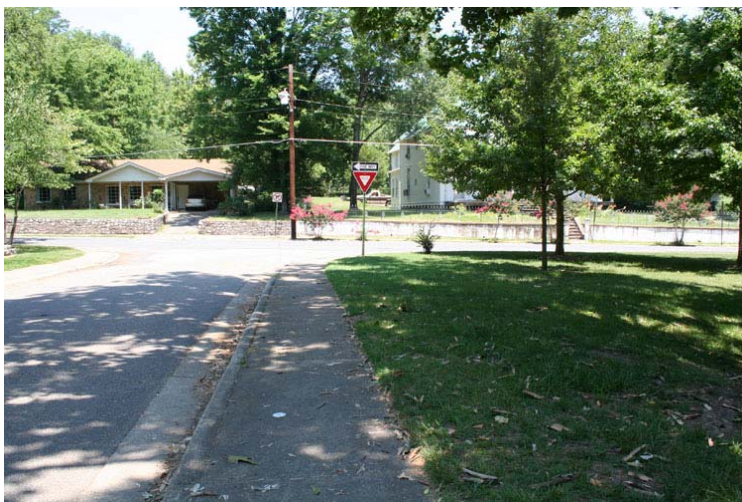
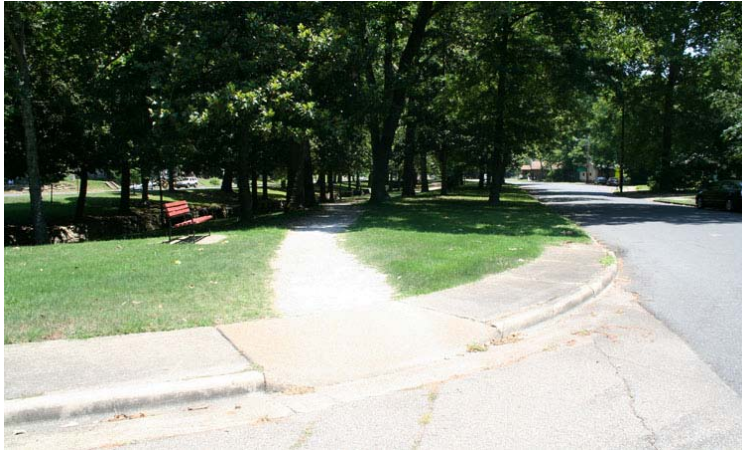
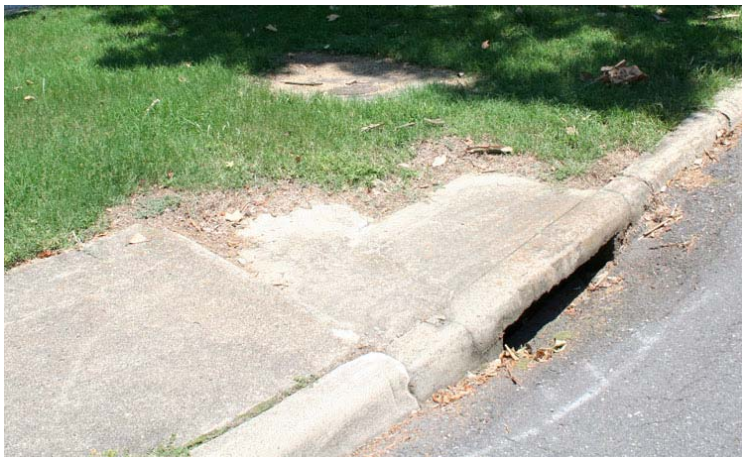
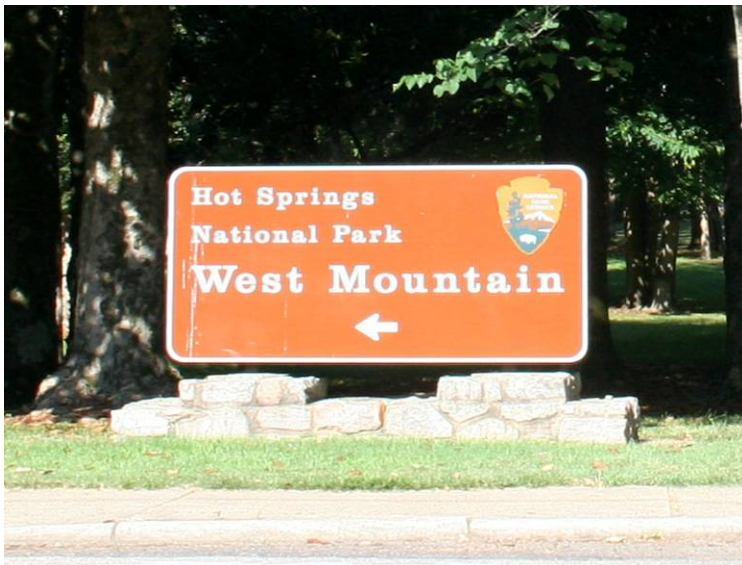
West Mountain Road connection	3-278 3-279, 3-280, 3-281, 3-282	Connection from north-side of park to south-side and West Mountain. Associated features: concrete curb inlet for stormwater, attached four (4) foot wide concrete walk on both sides of road with accessible curb ramps on all corners connecting to the soft surface trail.	Good – Some cracking of the curb and concrete walk.
West Mountain Directional Sign	3-283	Directional wood sign “ <i>Hot Springs National Park West Mountain</i> ,” set on mortared, stacked stone base. Sign directs visitors to vehicular connection through the park to West Mountain	Good - Sign in need of repainting, minor cracking of mortar.

Figure 3- 278: West Mountain Road connection (MBD, 062906-3918)

Figure 3- 279: Concrete Walk (MBD, 062906-3915)

Figure 3- 280: Concrete Walk (MBD, 062906-3917)

Figure 3- 281: Concrete Curb Inlet (MBD, 062906-3919)

Figure 3- 282: West Mountain Directional Sign (MBD, 062906-3854)

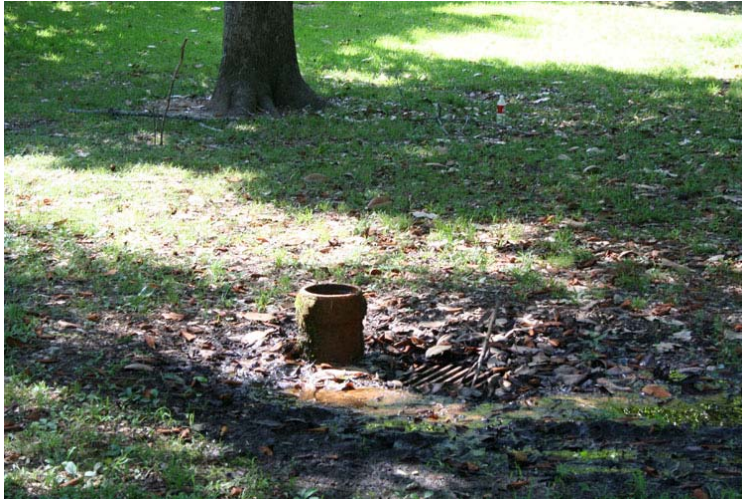
Well	3-283	Steel well and steel grate over inlet and well head cover. Water is bubbling out of the well cover	Fair – Water source is unknown. Overflow has created a wet soggy area.
Driveway Curb Cut	3-284, 3-285	Original 1897 curb cut for the original carriage road. Curb cut does not connect to any existing site features in the park	Good
Concrete Curb Inlet	3-286	Concrete curb inlet with manhole for storm water located adjacent to the concrete curb cut.	Fair – some deterioration, patching of concrete is poor.
Myrtle Street Road Connection	3-287	Road provides north-south vehicular access through Whittington Park, but does not directly connect with adjacent streets. Road is asphalt paving with concrete curb and gutter.	Good
Hot Springs National Park – Whittington Park Sign	3-288	Park sign “ <i>Hot Springs National Park, Whittington Park</i> ” standard NPS sign with brown background and white letters installed on a stone and mortar base with a stone and mortar column with the NPS logo affixed to it	Good – some cracking of the mortar.

Figure 3- 283: Well (MBD, 062906-3876)

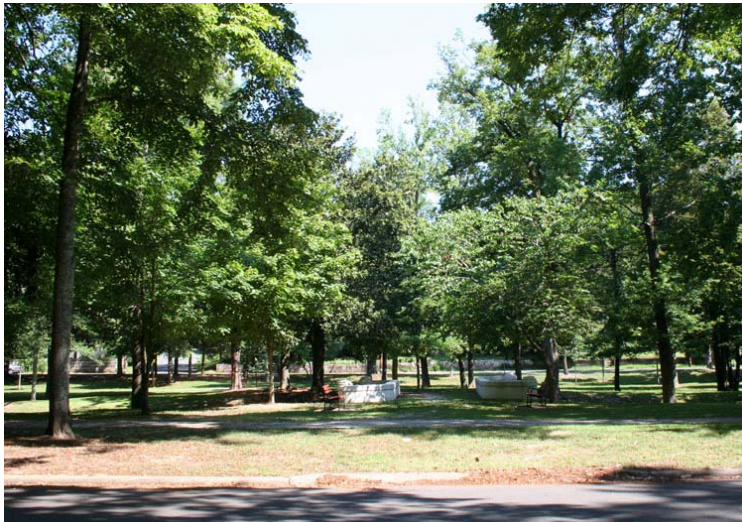
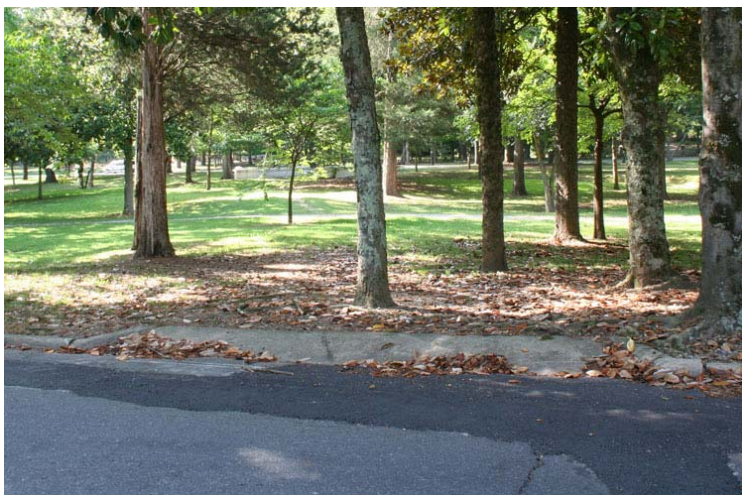
Figure 3- 284: Driveway Curb Cut - South (MBD, 062906-3880)

Figure 3- 285: Driveway Curb Cut - North (MBD, 062906-4034)
