# Hot Springs National Park Buckstaff Bathhouse Historic Structure Report

**June 30, 2026**

# Historic Structure Report

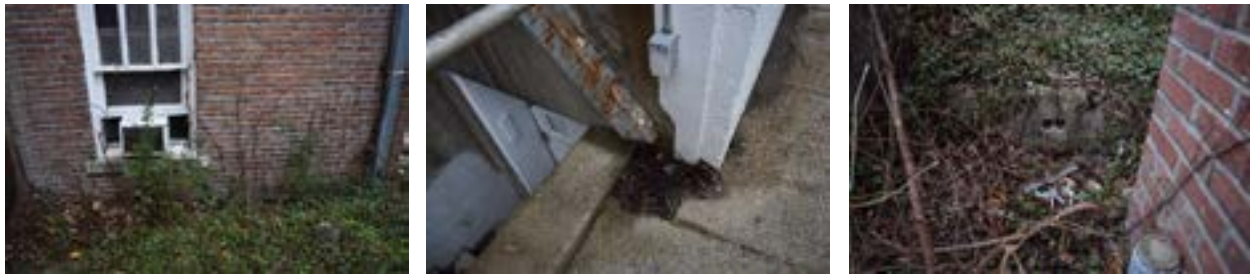
Overall, the site is in good condition, with many historic landscape features intact. There is evidence of ongoing drainage problems at the site over the years, worsened by the tight spaces between the bathhouses and Buckstaff's proximity to the retaining wall on its east side. In these areas, there are some inlets that provide access to the stormwater system below. The concrete is graded into shallow swales in some areas on the south side of the building to facilitate this flow. Degraded concrete and accumulated debris indicate ongoing drainage issues (Figure 1.D.2).

**Figure 1.D.2.** Areas with drainage concerns typically have debris buildup and degraded concrete. The proximity of the building to the retaining wall east of the bathhouse makes facilitating positive drainage difficult (WLA Studio, 2025).

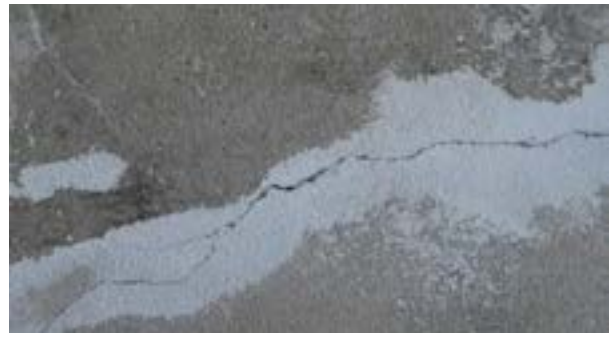
- Cracks are visible in the perimeter basement walls (Figure 1.D.14). Improper repairs have been made to some of these cracks (Figure 1.D.15).
- A crack occurs in an interior load bearing concrete wall on the south side of the crawlspace. It occurs directly beneath a girder which bears into this wall (Figure 1.D.16). The widest part of the crack was measured to be 1/8 inch. It should be monitored periodically to see if it widens (Figure 1.D.17).

**Figure 1.D.15.** A cementitious material was buttered over some of the cracks on the exterior face of this wall.

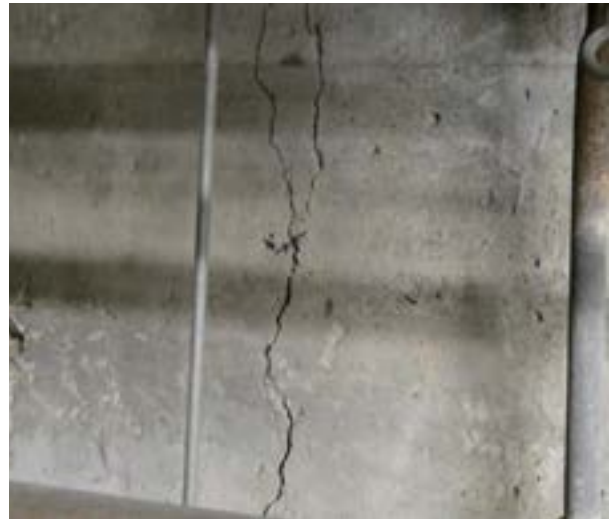
**Figure 1.D.16.** Crack in an interior concrete wall in the crawlspace, which is load bearing. This occurs under a girder connection.

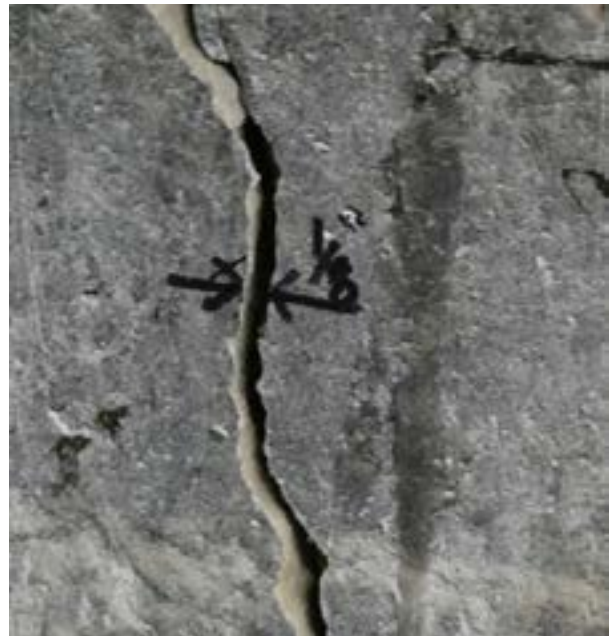
**Figure 1.D.17.** The widest portion of the crack was measured to be 1/8 inch.

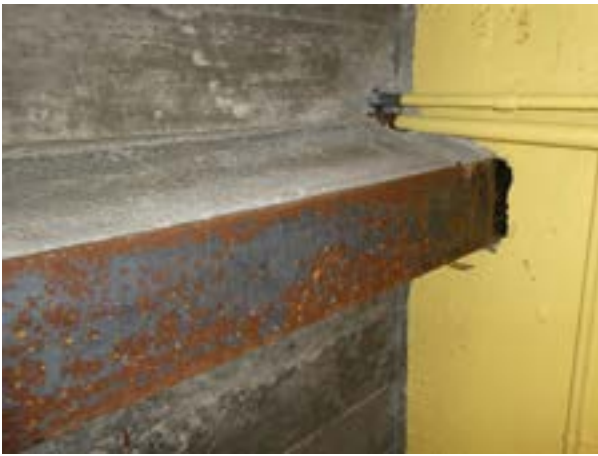
- evidence of any significant deterioration or distress in any of the supported floors where they were visible. Minor corrosion was visible on the bottom flange of some of the steel beams (**Figure 1.D.23 & Figure 1.D.24**).

**Figure 1.D.23.** Slight corrosion on the bottom flange of a steel beam in the basement.

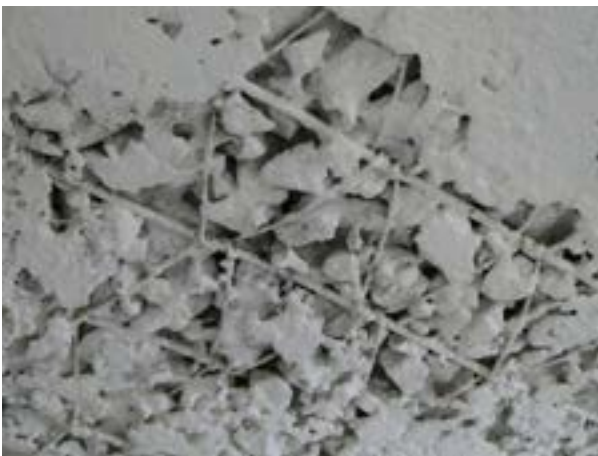
- The slab reinforcement was laid directly on the wood forms. This caused the steel to be exposed in a few locations (**Figure 1.D.25**).
  - Concrete had fallen from the bottom of the 1<sup>st</sup> floor slab in one location exposing the wire reinforcement and allowing it to begin to rust (**Figure 1.D.26**).

**Figure 1.D.25.** Slab reinforcement visible in the basement where honeycombing occurred during construction.

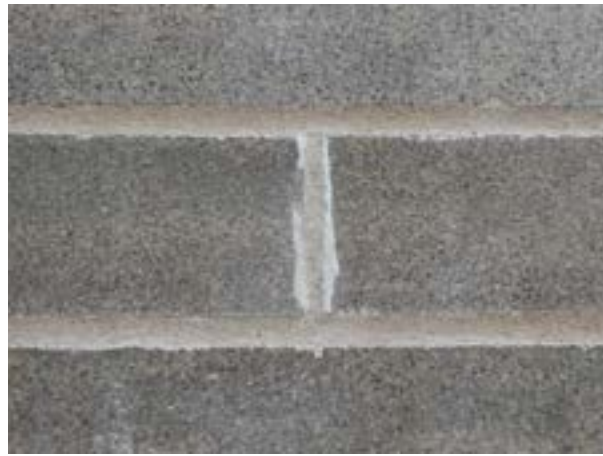
- All of the mortar joints in the blonde ironspot brick have been cut out and repointed. This is reported to have occurred in 2023 and the joints are generally in good condition. There is evidence of a lighter colored cementitious material on the sides of several of the joints. This material is adhered to the faces of the brick. It is probably the remnant of an even more previous repair effort where the mortar joints were “masked and grouted” (**Figure 1.D.32 & Figure 1.D.33**). This method of mortar joint repair was popular in the 1970s but is rarely seen today.

**Figure 1.D.32.** All of the mortar joints have been cut out and repointed. In general, they are in good condition but there is evidence of a lighter colored cementitious material on portions of the brick. This is probably a remnant of a previous repair effort where the mortar joints were "masked and grouted."

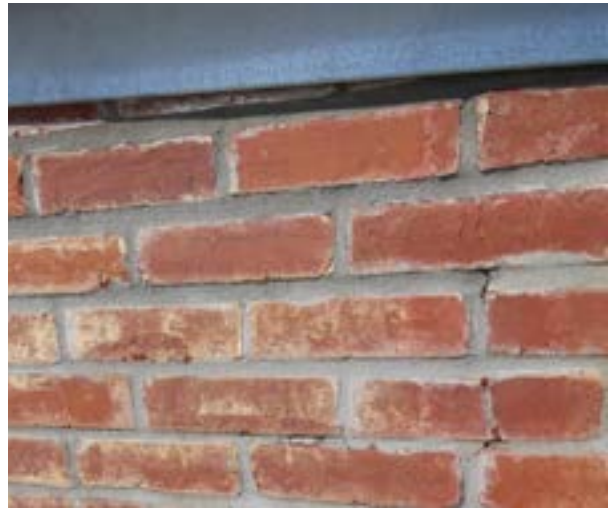
- The one exception to the overall good condition of the mortar joints throughout the building was in the sides of the elevator hoist which protrudes above the roof (**Figure 1.D.41**).

**Figure 1.D.41.** The mortar joints in the top of the elevator hoist are in poorer condition.

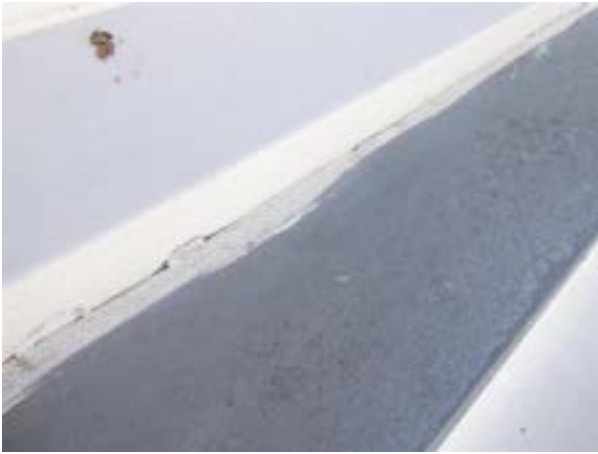
**Figure 1.D.43.** Sealant joints are often beginning to debond.

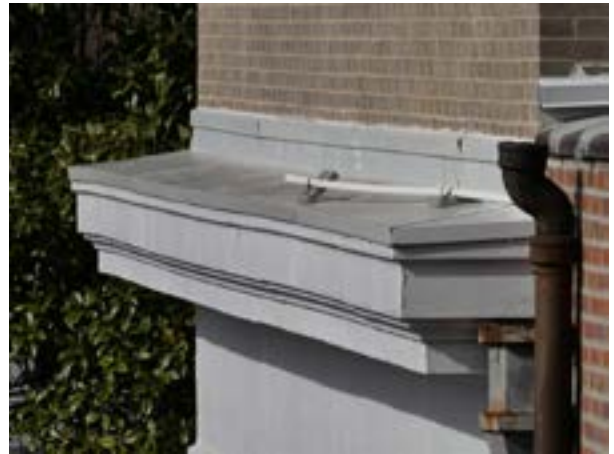
- Sheet metal has been installed on top of both of the stone cornices (**Figure 1.D.47**). The date of this installation is believed to be 2009/10. We are working with the local National Parks folks to better understand the timing of these repairs and the damage to the interior plaster. We suspect the sheet metal was installed to address damage to the plaster.

- The seams in the sheet metal are screwed together. There was evidence of gaps in some of these seams. There were also gaps between the counterflashing used to tie the vertical leg of the flashing back to the brick and in the sealant joint between the sheet metal and the brick. All of these conditions could allow wind driven rain to circumvent the sheet metal cap (**Figure 1.D.48**, **Figure 1.D.49** & **Figure 1.D.50**).

**Figure 1.D.47.** Sheet metal has been installed on top of the stone cornice of both the main and upper roof levels.

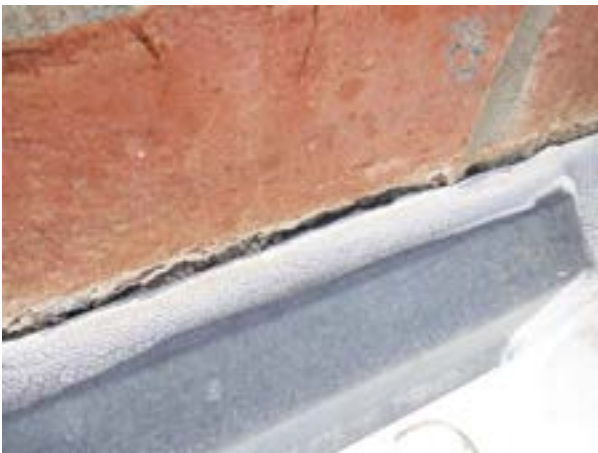
**Figure 1.D.45.** The sealant joint at this interface has typically failed.

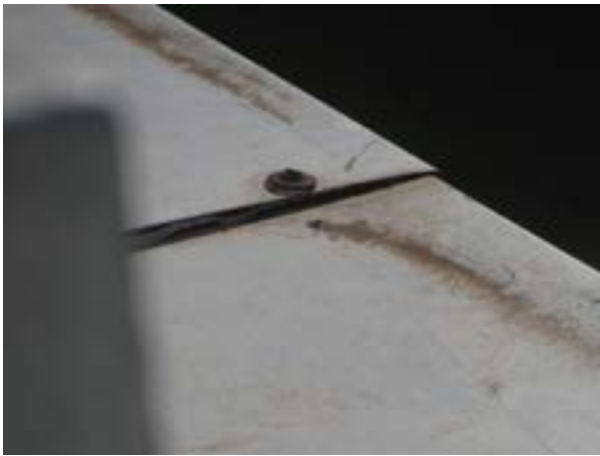
**Figure 1.D.49.** Gaps in this lap may allow wind driven rain to infiltrate under the metal.

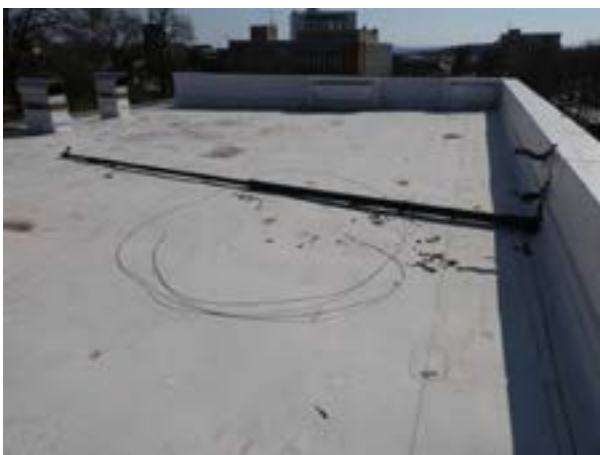
**Figure 1.D.51.** The flagpole has fallen onto the upper roof.

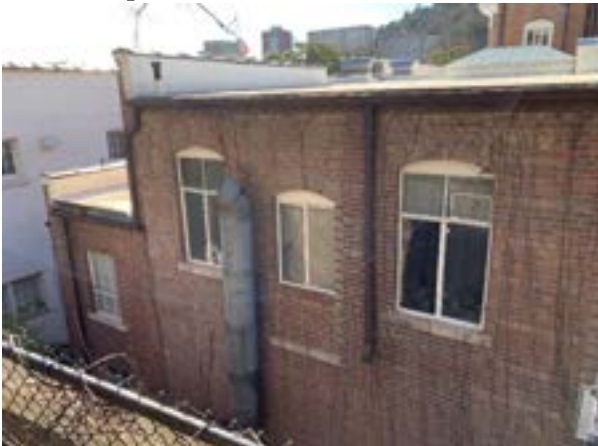
- Wood windows are in good condition overall. Some windows exhibit wear around hardware. Galvanized metal windows are in good condition overall but have a heavy accumulation of paint. Steel sash windows are in fair to good condition, with corrosion evident on many interior surfaces. (Figure 1.D.53-55)

**Figure 1.D.53.** Some of the multiple types of steel sash windows at the rear wings.

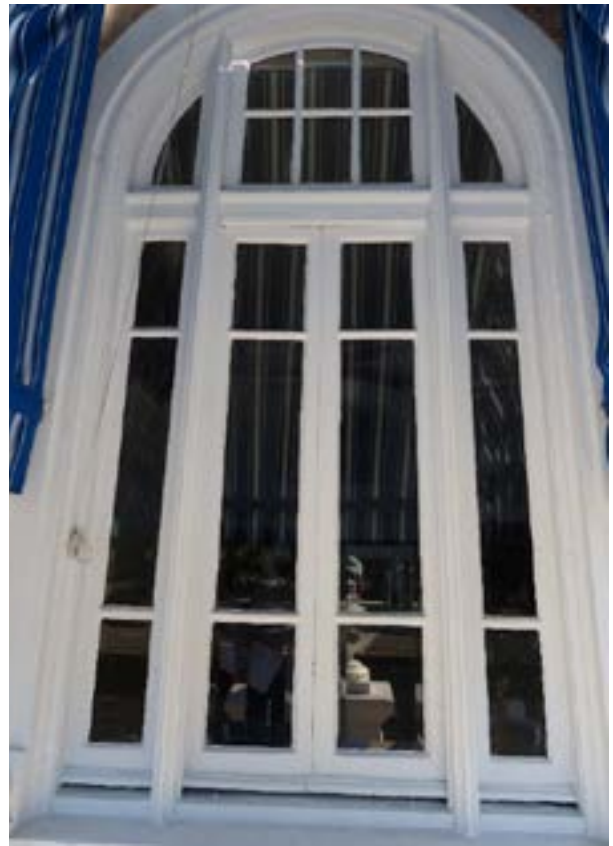
**Figure 1.D.54.** Typical wood windows at west façade.

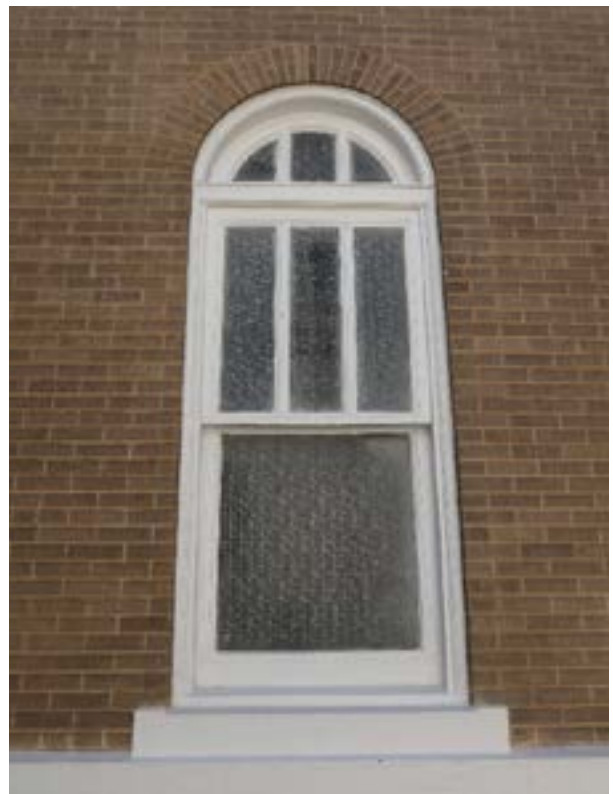
**Figure 1.D.55.** Typical metal window at side and rear walls.

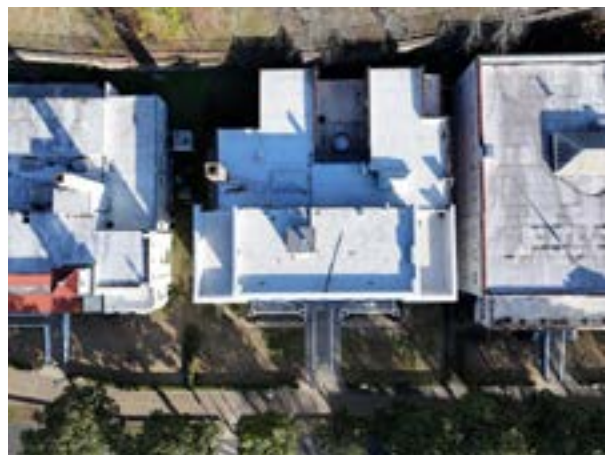
- The majority of the flat roofs are covered with a white roof membrane which is believed to be a TPO system that was installed in 2009-10. The details for this installation call for vapor retarder to be applied onto the base concrete deck. This was covered with 1½ inches of rigid insulation – no mention or evidence of this being tapered with the roof membrane then adhered to the insulation (Figure 1.D.57, Figure 1.D.58, Figure 1.D.59 & Figure 1.D.60).
- The roof membrane generally appears to be in good condition and there are no known reported leaks at this time.
- The roof over the elevator hoist appears to be an original flat lock terne metal roof. Terne metal was a precursor to galvanized

**Figure 1.D.58.** All of the major sections of roof are covered with a TPO membrane.

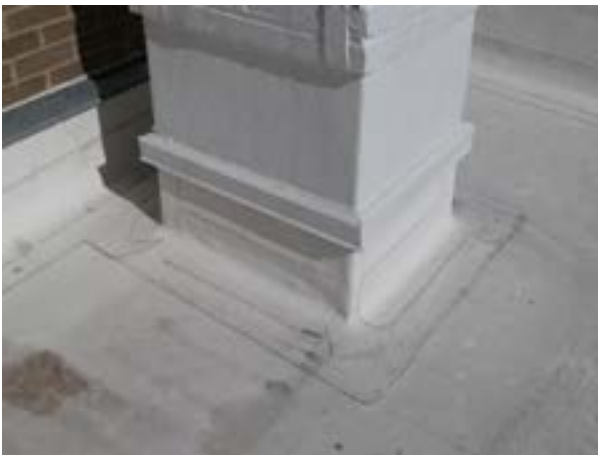
**Figure 1.D.60.** Typical flashings around the base of mechanical exhaust units.

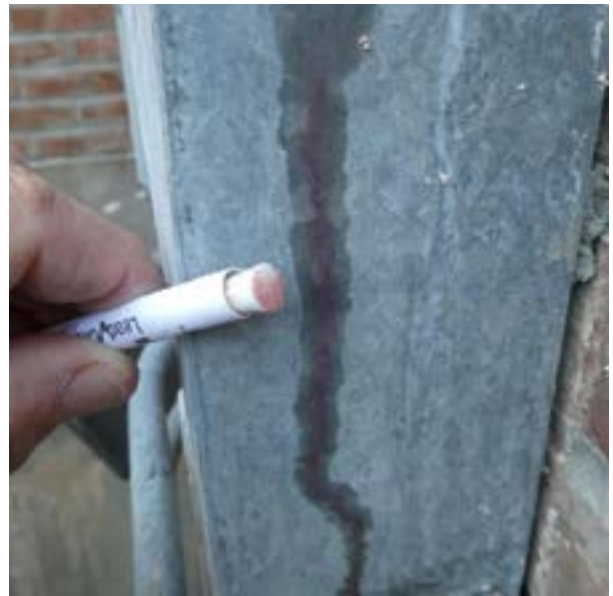
- A few of what appear to be the original collector head and downspouts still exist in the back of the building. Field swab tests reveal they are also fabricated from terne metal (Figure 1.D.62 & Figure 1.D.63).
- Newer aluminum gutters and downspouts have been installed throughout much of the building. The roofs are pitched to drain water to the east or back side of the building. Several of these newer aluminum downspouts are in disrepair (Figure 1.D.64).

**Figure 1.D.63.** The red color reveals the base steel is coated with lead.

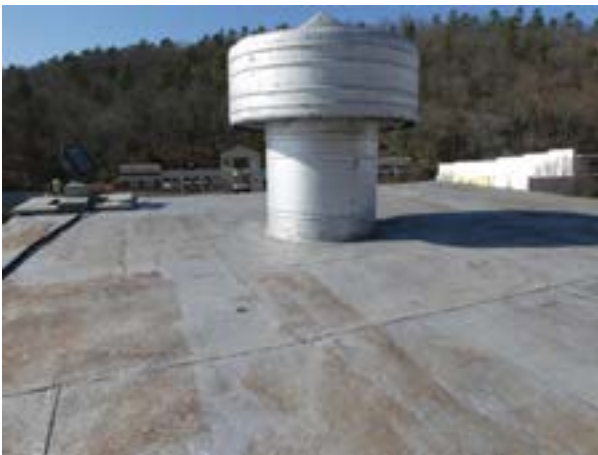
steel. The base steel is coated with a corrosion resistant alloy of lead and tin. While there is evidence of a loss of the terne metal and corrosion of the base sheet steel, the roof remains functional (Figure 1.D.61).

**Figure 1.D.61.** The roof of the elevator hoist is made of flat-lock terne metal.

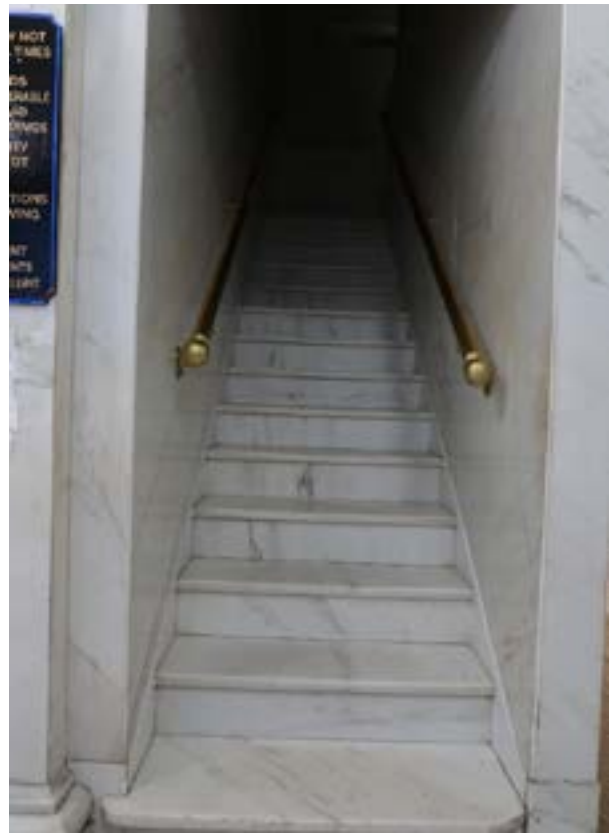
- Marble stair components at the main stair (S1) are in good condition overall. Treads show some wear, as expected for their age. Sealant between components is inconsistent in appearance and is in fair to poor condition. (Figure 1.D.65)
- Metal stair components in the men's dressing rooms and back stair (S2) are in good condition overall. Finishes of the back stair (a non-public space) exhibit significant wear.
- Existing stair handrails are original and do not comply with current requirements.

**Figure 1.D.65.** Marble and brass components at front stair (S1).

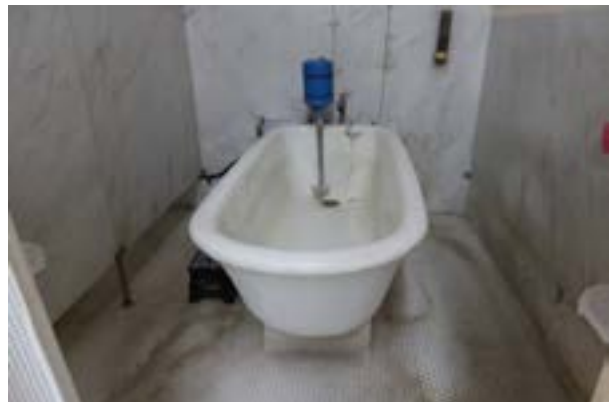
**Figure 1.D.73.** Mosaic tile floor in men's bath hall (106) showing typical mineral accumulation around plumbing fixtures.

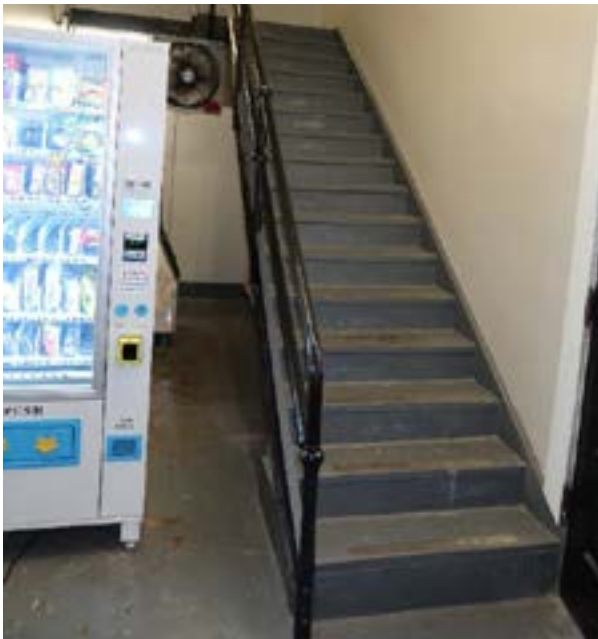
**Figure 1.D.74.** Painted concrete floor are only present in non-public areas, including the back staircase (S2).

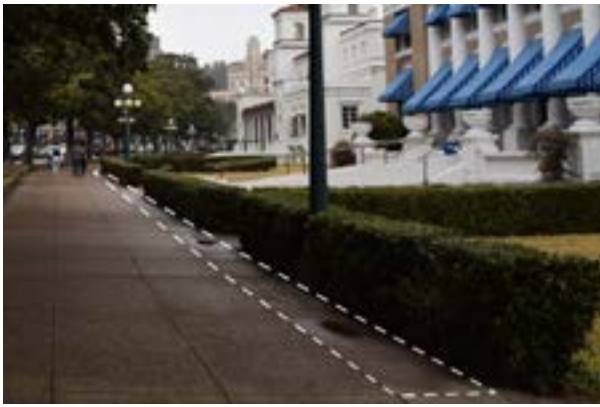
**Figure 1.D.89.** The east edge of the sidewalk is paved to facilitate drainage to three brass strip drains. While there is some ponding present, the system works to drain water from the concrete walk to a subsurface drainage system (WLA Studio, 2025).

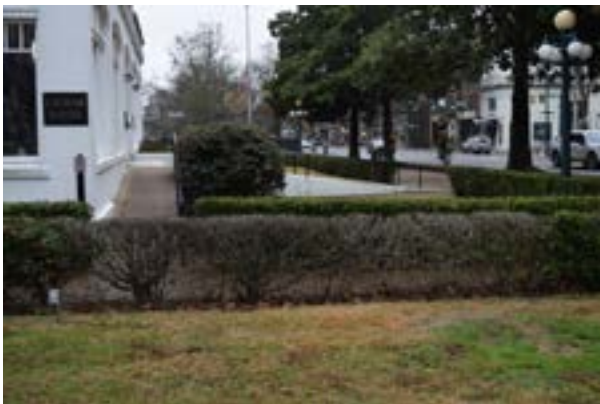
**Figure 1.D.91.** Blighted section of the holly hedge along the southern border of the front lawn area. View to south (WLA Studio, 2025).

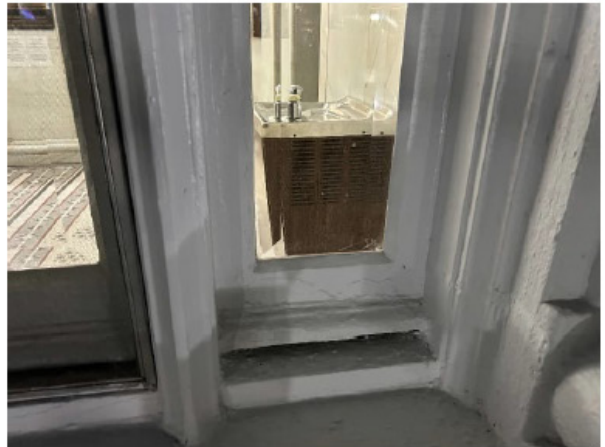
Photo 4 ACM Exterior caulking around windows and doors HA-9.

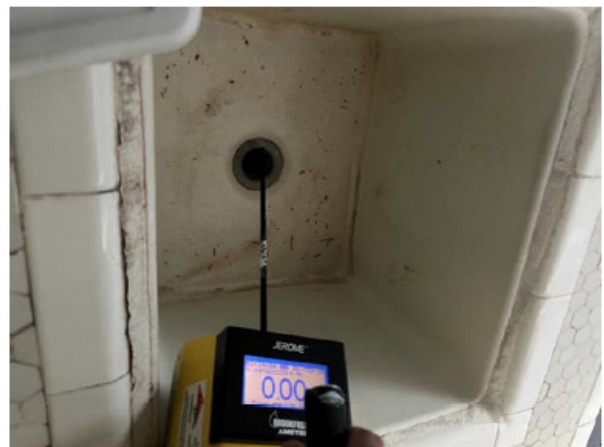
Photo 12 Screening drains near identified rooms.

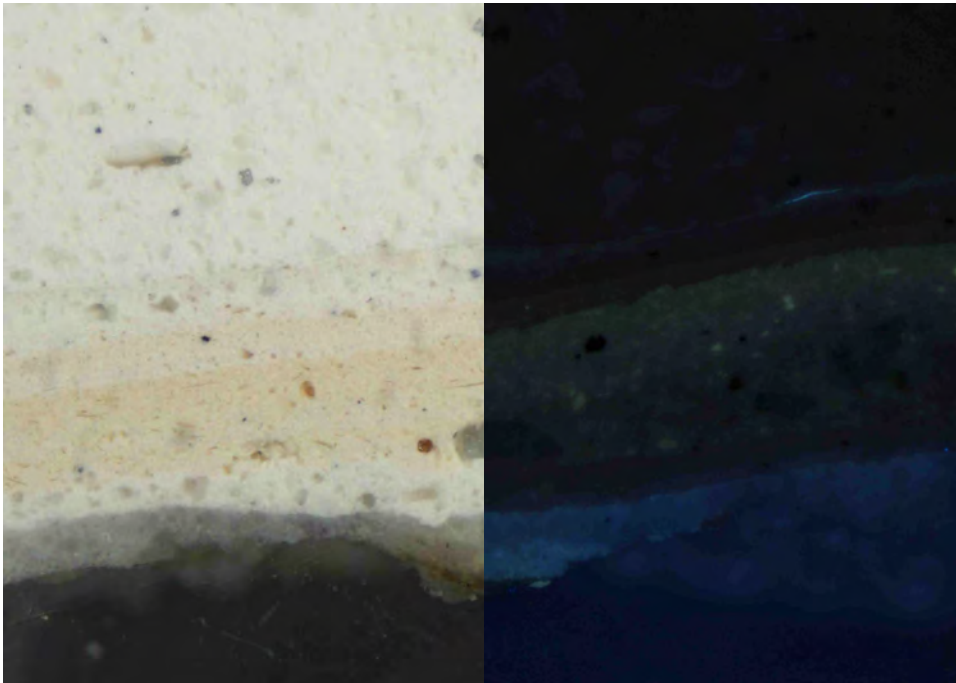
All of the samples from the stucco appear to contain only a few layers of non-historic paint, likely latex paint based on their lack of autofluorescence under ultraviolet light. The current HSR documents that the exterior was sandblasted in 1965. If the stucco had historic paint layers, they were likely lost during this process. However, the appearance of the stucco can be inferred from other evidence. Based on the c. 1912 historic photographs, the stucco had a light color value, indicating that it was either unpainted originally (as the color of the stucco is yellowish white) or it was painted a light color (Figure 5 – Figure 7). The earliest existing, likely original, finish on the exterior woodwork was identified as a pale grayish yellow sand paint with sand inclusions creating a rough textured paint likely intended to mimic stucco. This evidence suggests that the stucco was likely unpainted and the woodwork was painted to match it, although BCA was unable to confirm this since all of the stucco's early paint finishes appear to have been removed from the exterior.

Figure 8. A representative stucco sample removed from a pilaster base shows that all layers are likely latex paint, and no historic layers are present. BB.EXT. 2, visible light (L), ultraviolet light (R), 40x magnification.

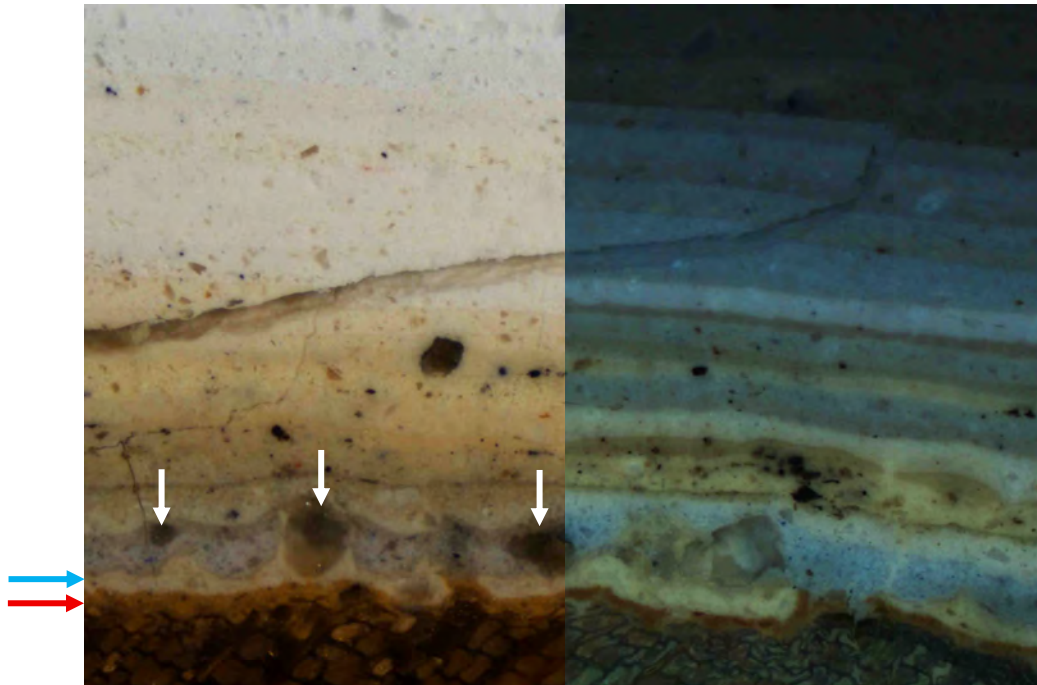
Figure 9. A sample from a wood window sash on the first-floor façade showing a brownish orange, likely a preparatory layer (red arrow), and the original pale grayish yellow sand paint (blue arrow) found on most other exterior wood elements. Note the sand grains indicated by white arrows. BB.EXT. 6, visible light (L), ultraviolet light (R), 40x magnification.

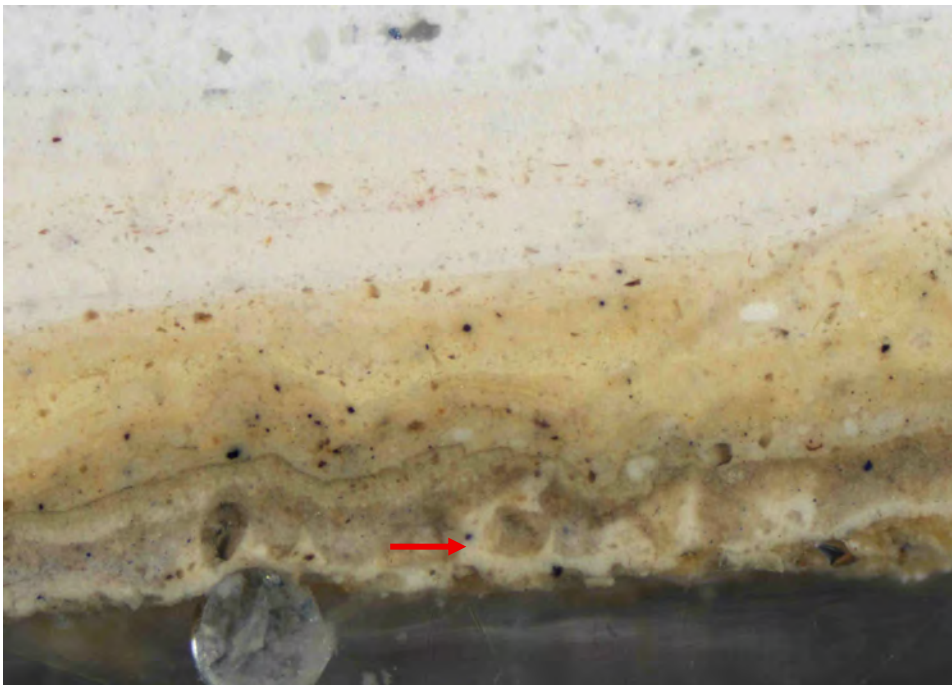
Figure 10. A representative woodwork sample from window trim on the first-floor façade showing the typical original pale grayish yellow sand paint (red arrow). See Sample Stratigraphy Sheets for the substrate and primer. BB.EXT. 1, visible light, 40x magnification.

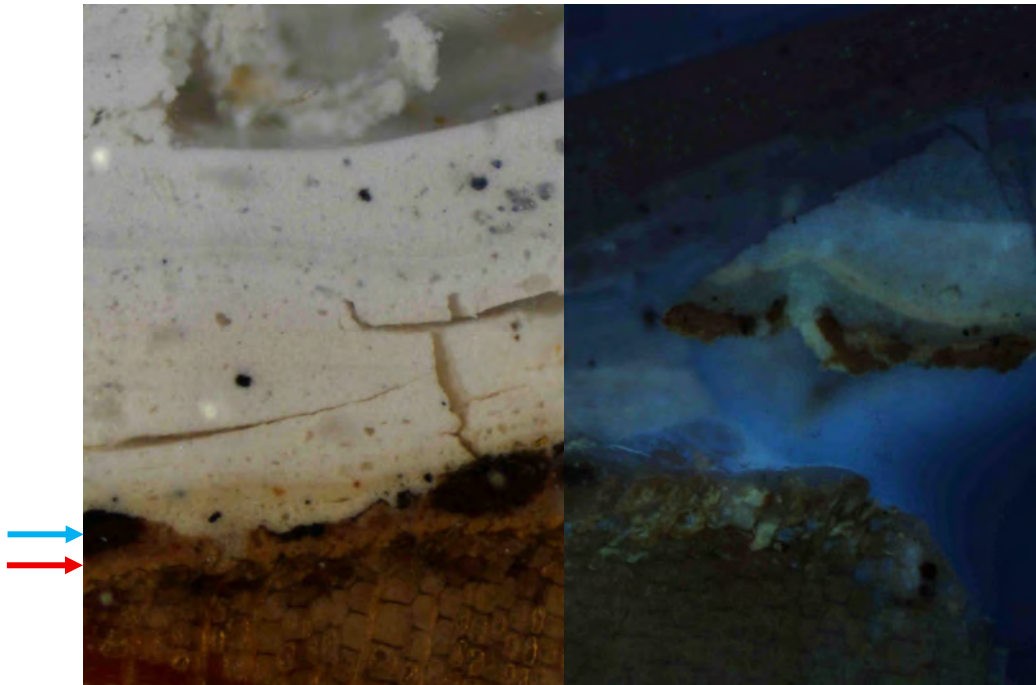
The front doors and the fanlight were finished with a dark natural wood color. BB.EXT.22 from the fanlight sash suggests the original finish is a brownish orange paint topped with a transparent coating, creating an overall appearance in glossy very dark purplish brown. Although the front doors only contain the current black paint, the historic photograph in Figure 5 captured them in a dark color value, possibly finished the same way as the fanlight sash.

Figure 11. The sample from the fanlight sash suggests that the original finish is a brownish orange paint/stain (red arrow) topped with a transparent coating (blue arrow), creating an overall appearance of glossy very dark purplish brown. BB.EXT. 22, visible light (L), ultraviolet light (R), 40x magnification.

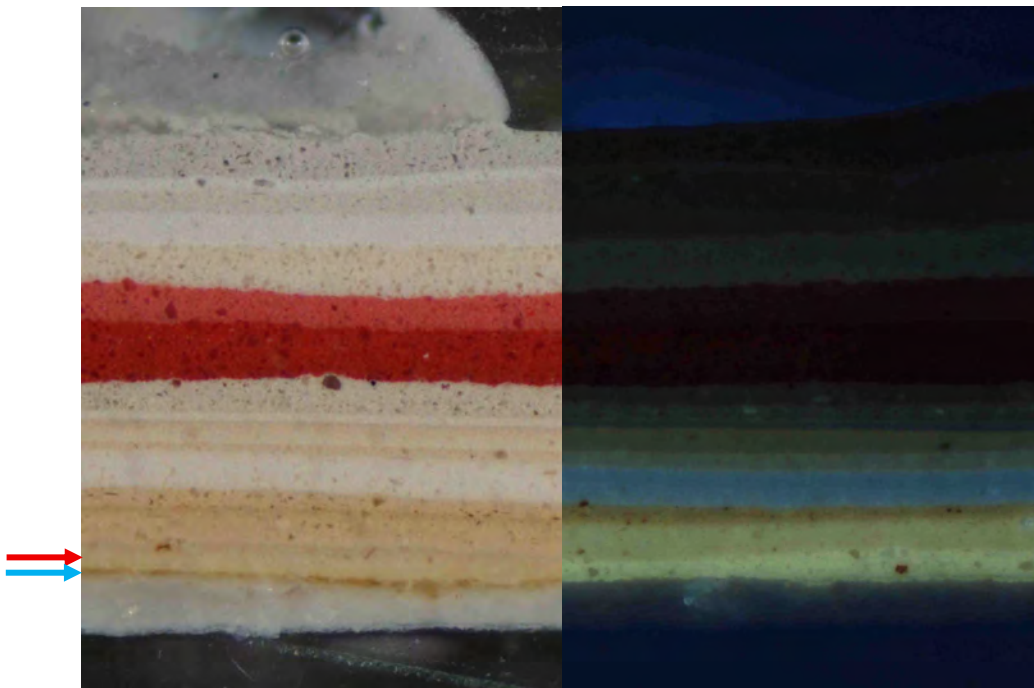
Figure 15. A representative plaster sample removed from the plaster ceiling of the Lobby showing the sealer (blue arrow) and the original pale grayish yellow finish (red arrow) with bright yellow autofluorescence. BB.100.2 (IF Lobby), visible light (L), ultraviolet light (R), 40x magnification.

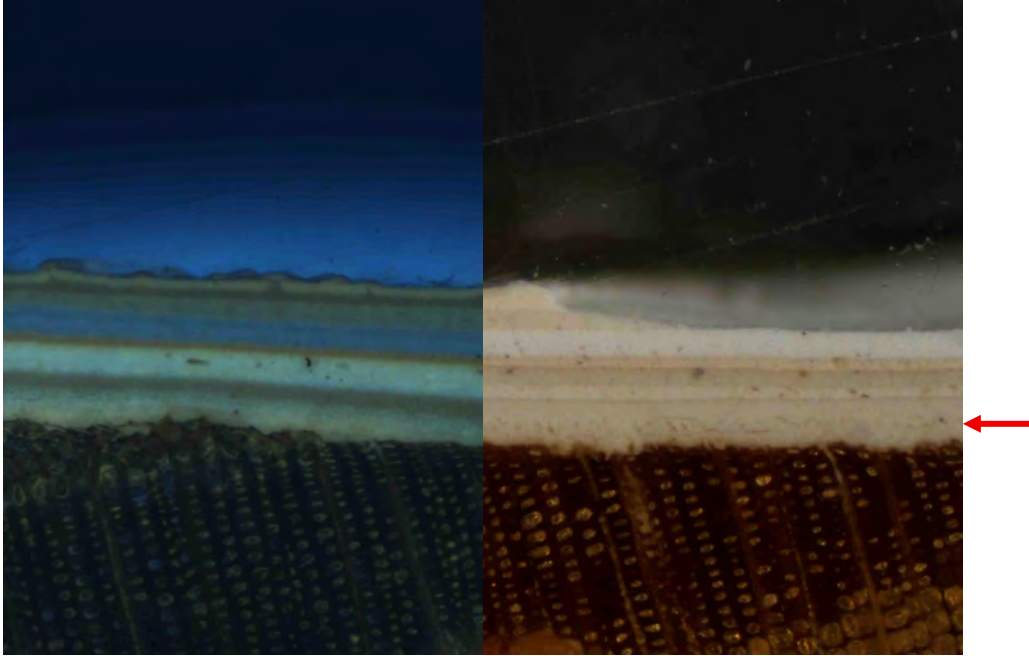
Figure 16. Most of the woodwork that is currently painted white in the building has always been painted white or other pale neutral colors, as shown in this sample removed from the front door surround. The original finish here is a grayish yellowish white (arrow). BB.100.8 (1F Lobby), ultraviolet light (L), visible light (R), 40x magnification.

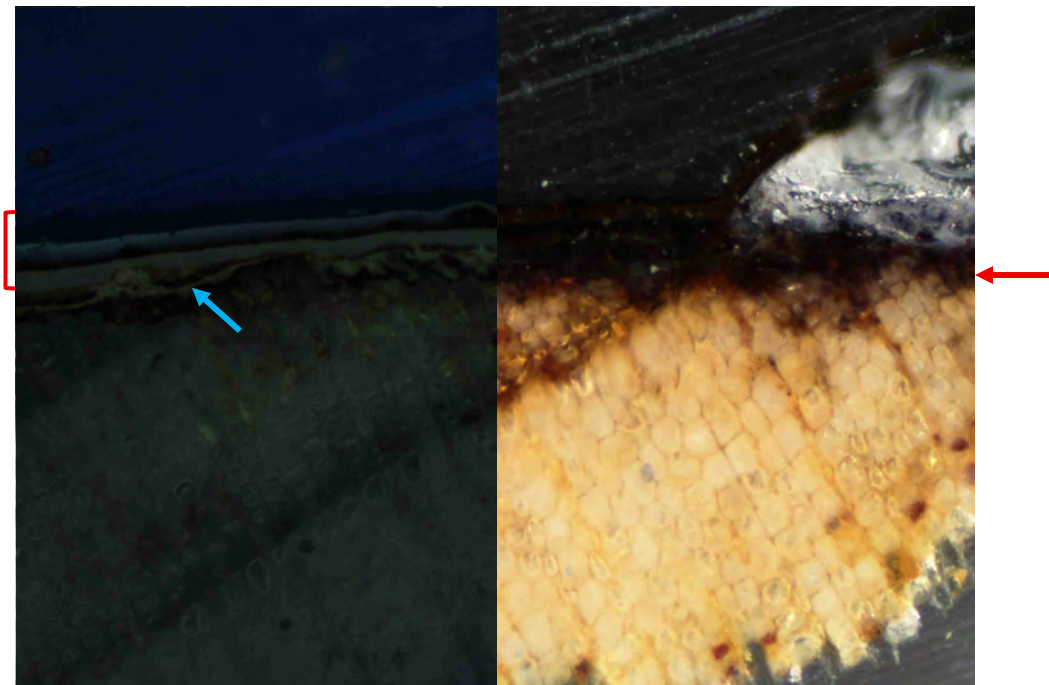
Figure 17. Most of the naturally finished woodwork in the building was originally stained (red arrow) with a pigmented transparent topcoat (blue arrow), followed by two to three refinishing campaigns (bracket), as seen in this sample removed from the wood fanlight. BB.100.9 (1F Lobby), ultraviolet light (L), visible light (R), 40x magnification.

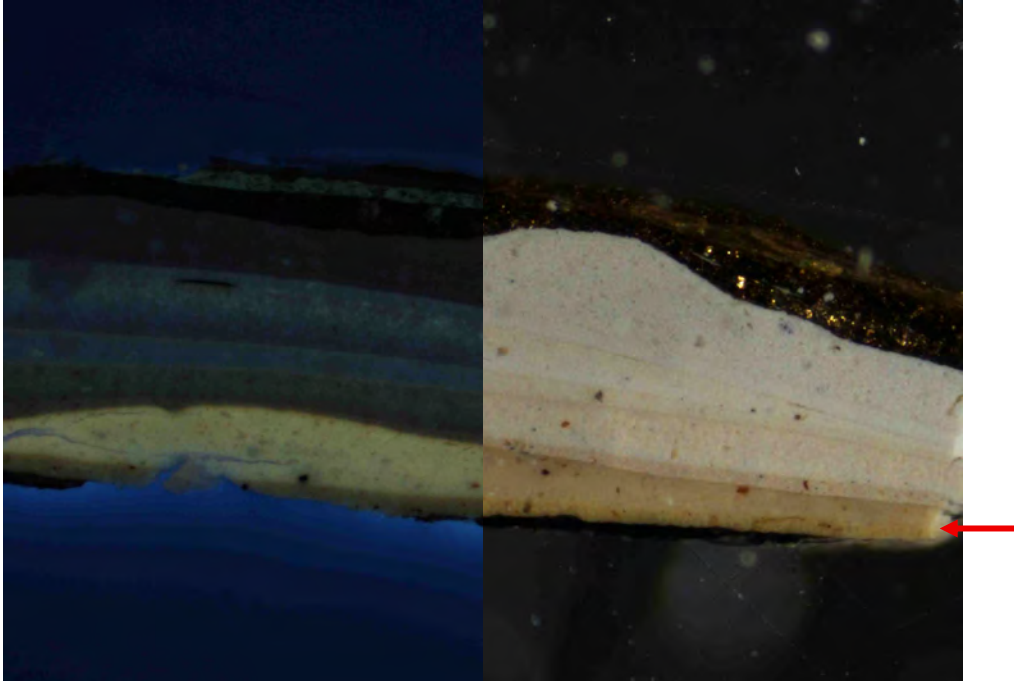
Figure 18. The metal grille in the elevator was originally painted with grayish orangish yellow (arrow). It was only painted gold in the most recent paint scheme. BB.E2 (elevator), ultraviolet light (L), visible light (R), 40x magnification.

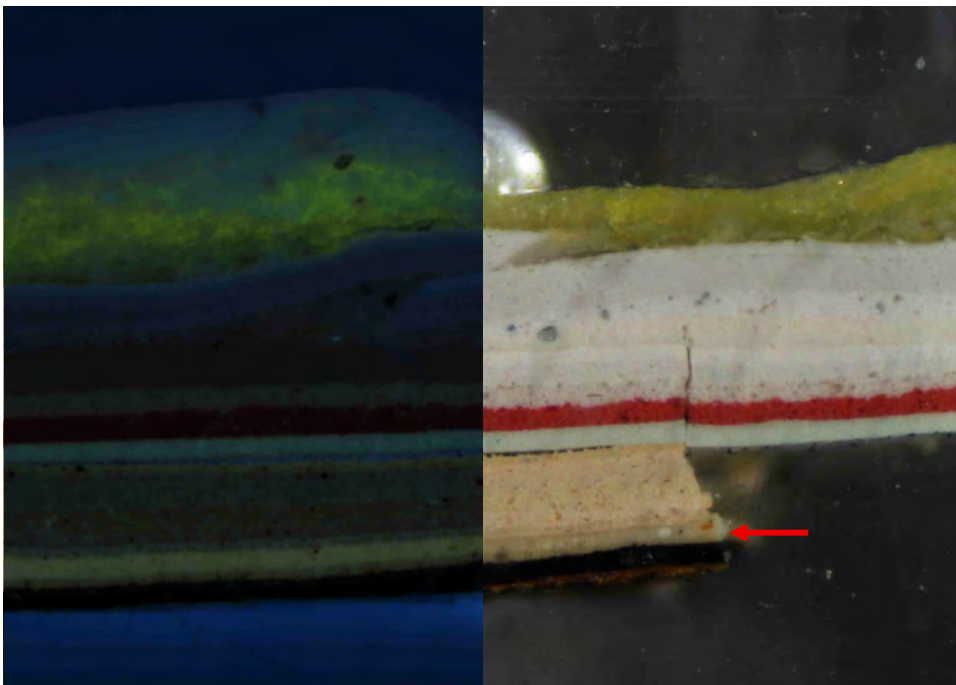
Figure 19. The elevator walls, including the metal seams, and the ceiling were originally painted with the same grayish orangish yellow (arrow) as the metal grille, as seen in this cross-section of the wall sample. BB.E5 (elevator), ultraviolet light (L), visible light (R), 40x magnification.

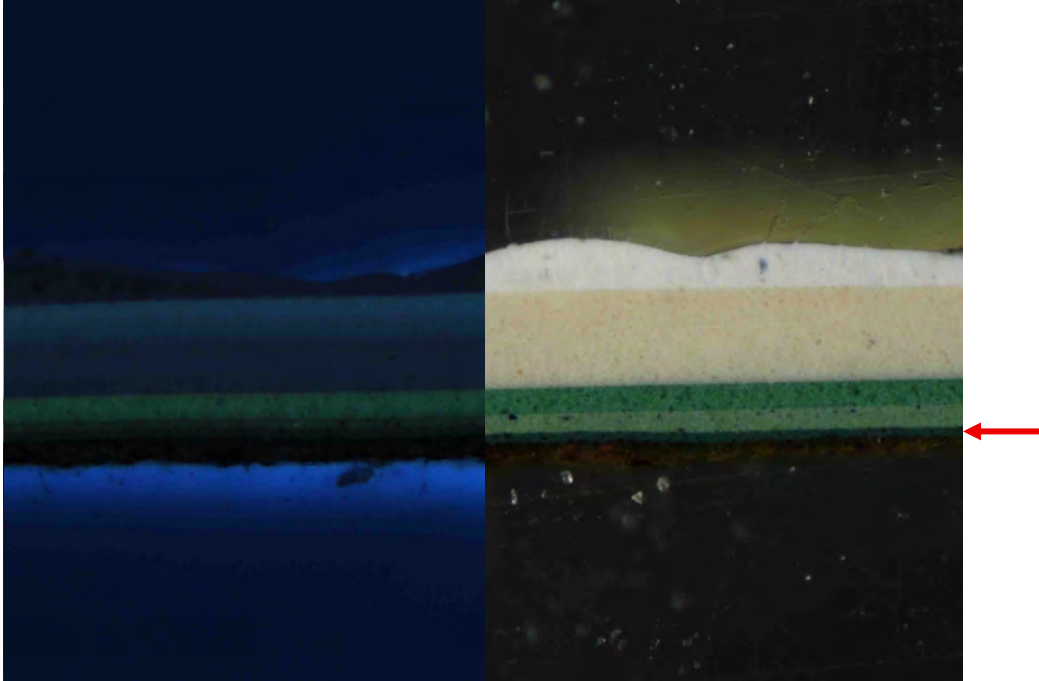
Figure 20. The earliest existing finish on the face of the bottom shelf is a very dark yellowish green (arrow). However, all the paint layers appear to be latex paint, suggesting they are not historic. *BB.101.1 (Lobby Office), ultraviolet light (L), visible light (R), 40x magnification.*

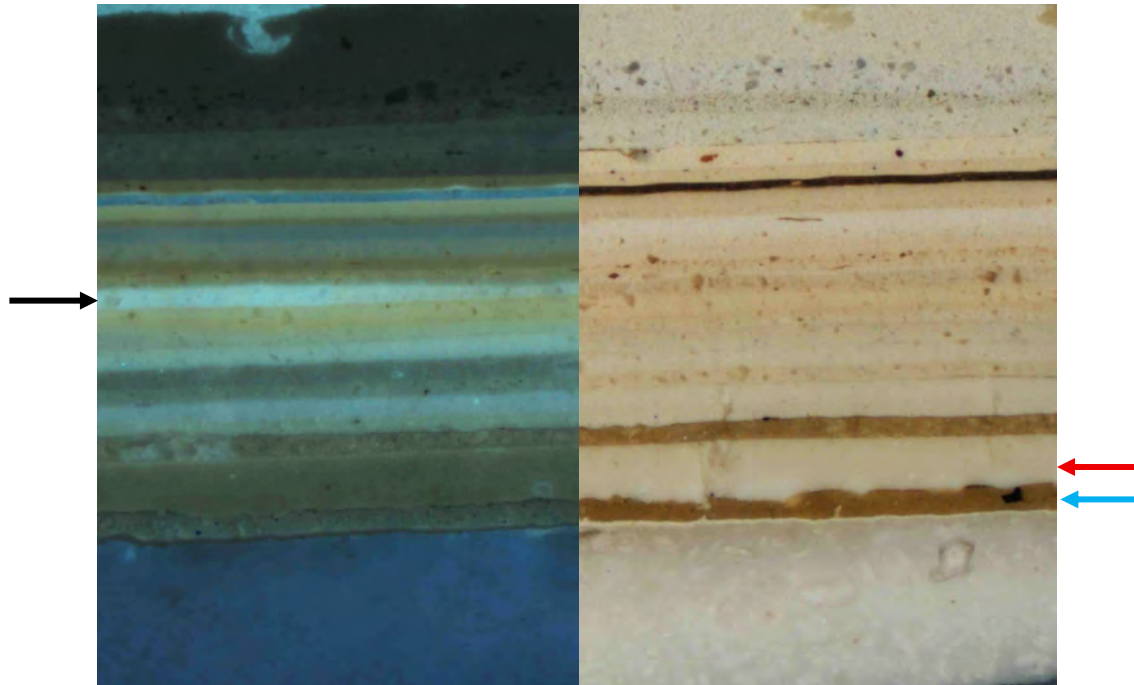
Cross-section analysis shows that the plaster walls of the Men's Dressing Room were originally painted pale yellow on top of multiple primer or preparatory layers. This is unusual compared to plaster samples in other rooms, which typically consist of a translucent sealer and one finish layer. The earliest existing finish on the beam and ceiling samples matches approximately the 12<sup>th</sup> layer on the wall sample, suggesting that the ceiling samples are missing earliest paint layers. However, the paint evidence from other rooms suggests that the walls, ceiling, and ceiling beams were generally painted in the same color, which may also be the case in the Men's Dressing Room.

Figure 23. The plaster walls were originally painted in pale yellow (red arrow) on top of a dark grayish yellow (blue arrow) preparatory layer. The earliest existing and subsequent layers on the ceiling (see Figure 24) line up with approximately the 12<sup>th</sup> layer (black arrow) on this sample. BB.102.4 (Men's Dressing Room), ultraviolet light (L), visible light (R), 40x magnification

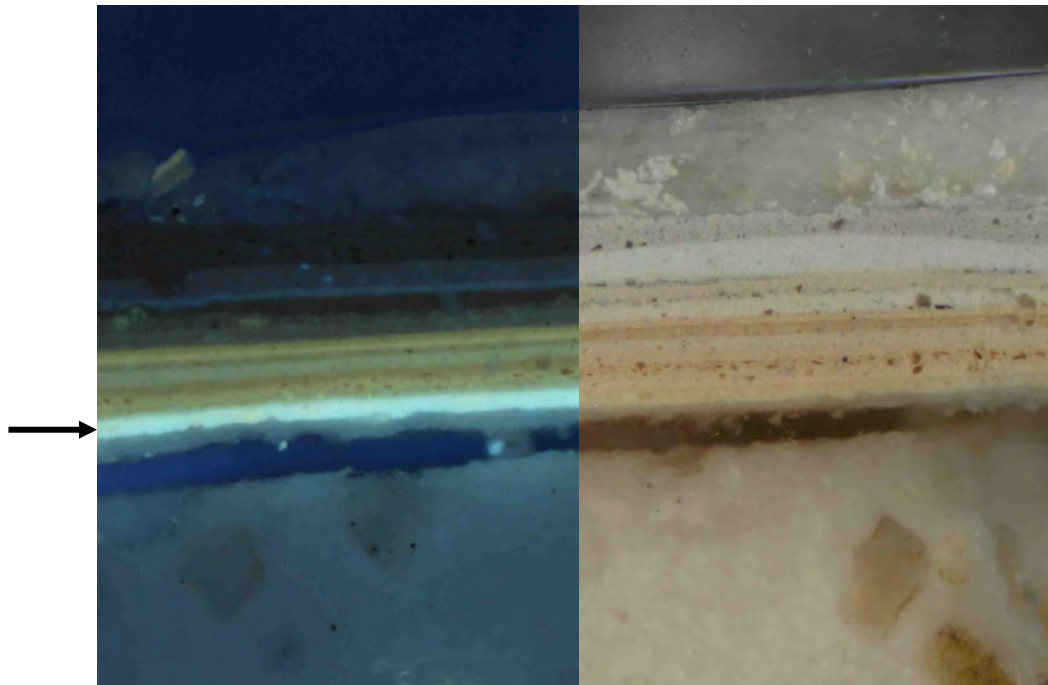
Figure 24. The ceiling sample is missing the earliest layers found on the wall sample (see Figure 23). The earliest existing paint layer on the ceiling (black arrow) match with approximately the 12<sup>th</sup> and later layers on the wall. BB.102.9 (Men's Dressing Room), ultraviolet light (L), visible light (R), 40x magnification

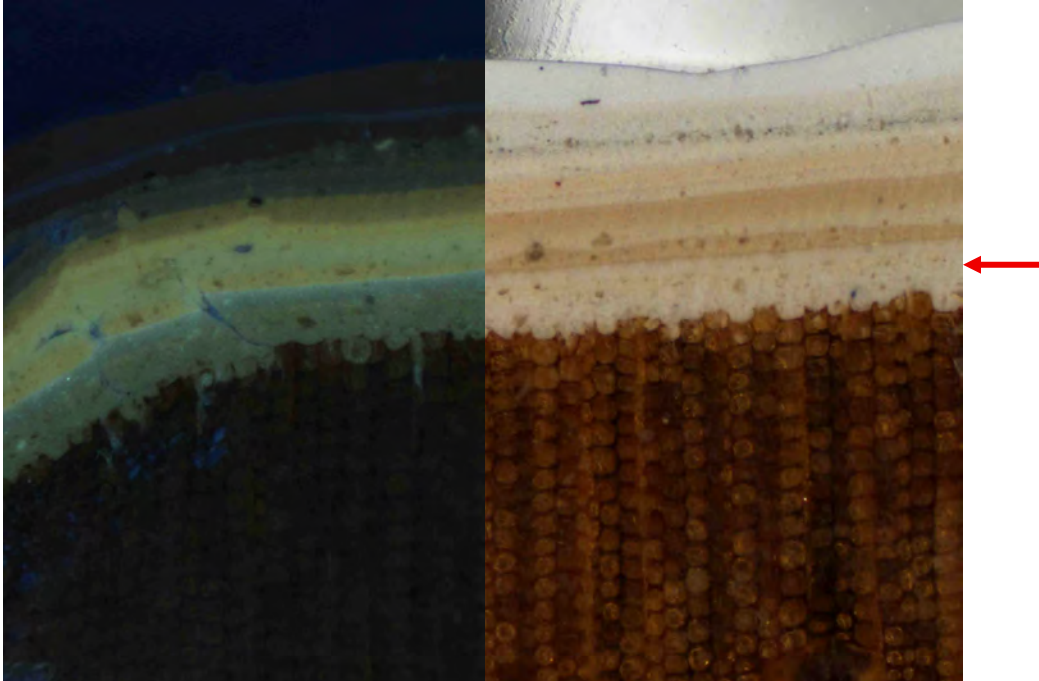
Field investigation and laboratory analysis found that the Greek key molding on the sides of the balcony floor, the metal support beam, and the wood deck all share the same original finish in brownish white and similar subsequent layers in light yellows or light yellow oranges, suggesting that these features have the same installation date. According to RATIO, the 1911 shop drawings indicated that the balcony floors were glass. If that is the case, then the current balcony structure is a replacement. However, the multiple layers of paint on these elements suggest that they likely date to early 20<sup>th</sup> century. The balcony structure in the c. 1916 photograph appears to match the current one and was painted in a very light color, likely white (Figure 21).

Figure 25. The wood deck at the underside of the balcony is painted the same original brownish white (red arrow) as the metal Greek key molding (see Figure 26) and the metal balcony support beam. BB.102.5 (Men's Dressing Room), ultraviolet light (L), visible light (R), 40x magnification

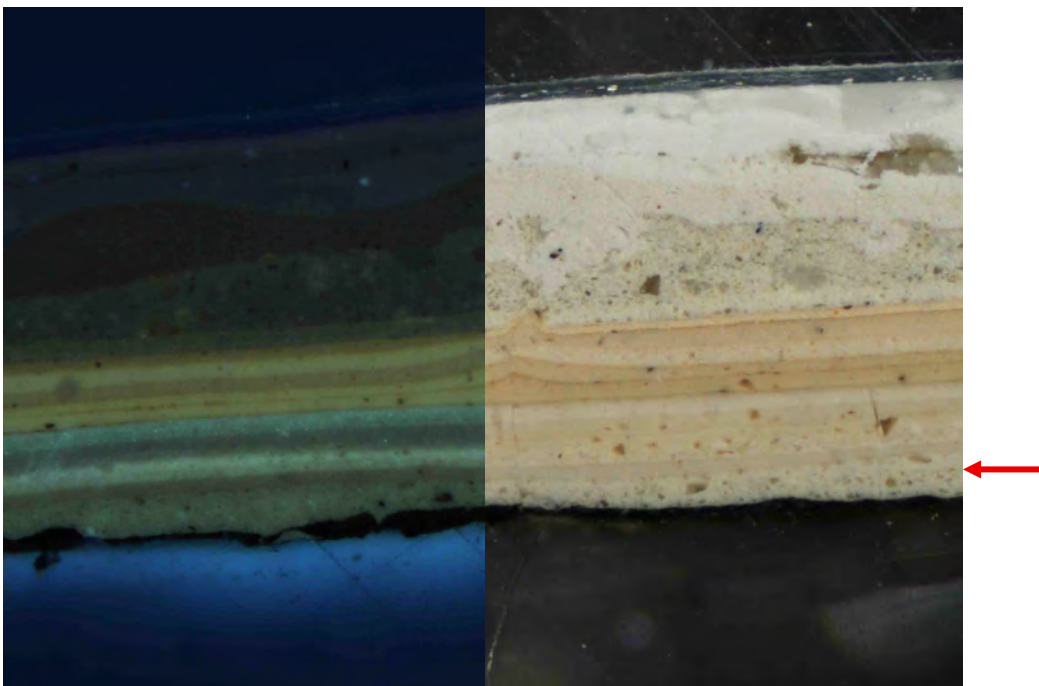
Figure 26. The Greek key molding is painted with the same original brownish white (red arrow) as the wood deck at the underside of the balcony (see Figure 25) and the metal balcony support beam. BB.102.3 (Men's Dressing Room), ultraviolet light (L), visible light (R), 40x magnification.
