# Hot Springs National Park Buckstaff Bathhouse Historic Structure Report

**June 30, 2026**

# Historic Structure Report

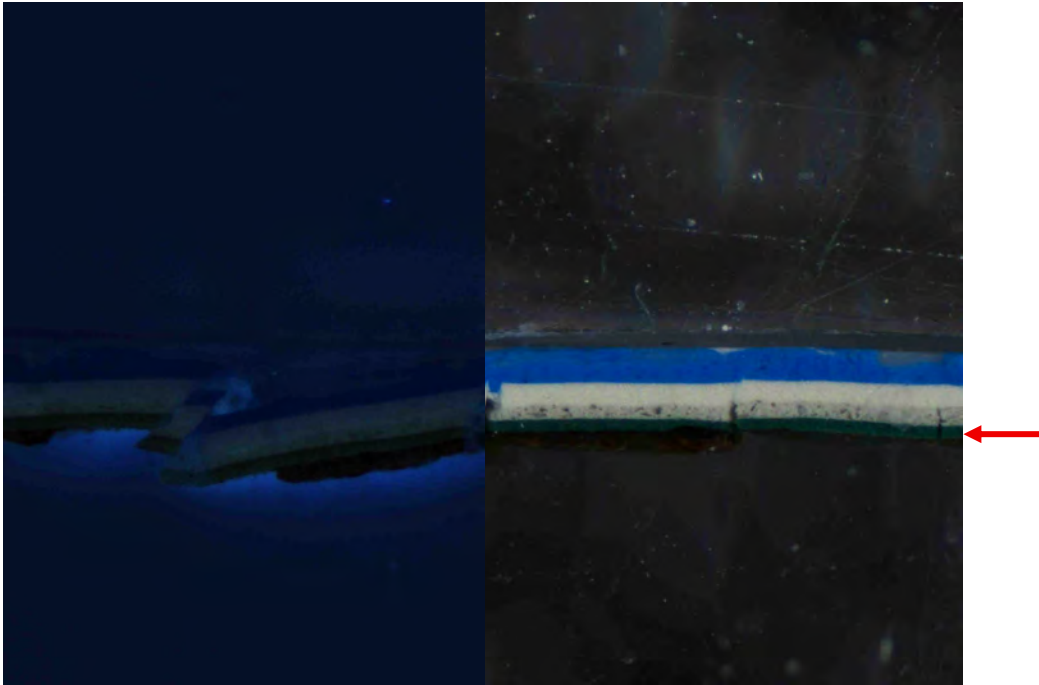
The four paint samples from the metal lockers contain two to five layers, including the dark brown primer. All layers show the typical visual characteristics of latex paint, suggesting either that the lockers were installed after the mid-twentieth century or that the lockers are original and have had their historic layers removed during preparation for repainting. Three of the locker samples (BB.102.1, 102.6, 102.7) share the same dark green earliest existing finish, with subsequent layers in pale grayish blue, white, and the current vivid blue. The same dark green is the only finish layer on the interior of the balcony level lockers. The dark green is similar to the very dark yellowish green found on the counter in the Office (Room 101), although not an exact match.

Figure 27. The earliest existing finish on all the locker samples is a dark green (arrow). However, all the layers appear to be latex paint, suggesting they are not historic. *BB.102.1 (Men's Dressing Room), ultraviolet light (L), visible light (R), 40x magnification.*

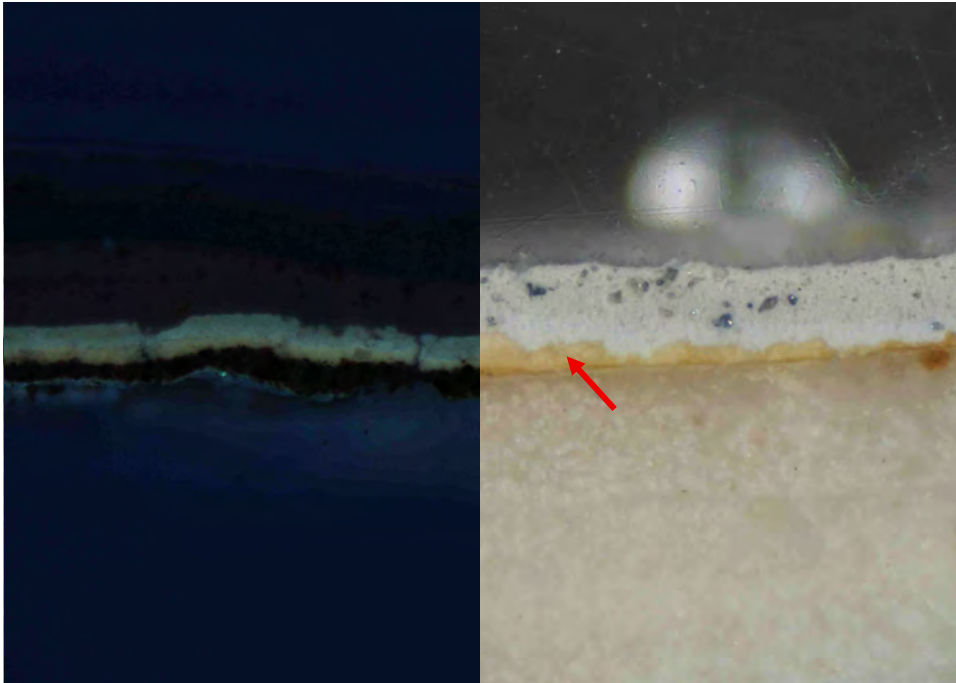
Much of the ceiling in the Bath Hall is displaying signs of deterioration. BCA performed field investigation at multiple ceiling and beam locations and analyzed three samples. Out of the three, only Sample BB.106.1 potentially retains the original finish, a pale grayish yellow, the same color as the original plaster finish in Rooms 100 and 200. However, this sample only contains two paint layers that appear to be historic paint. In comparison, BB.106.3, removed from the column capital, has approximately 12 layers that appear to be historic. This suggests that Sample BB.106.1 is likely missing many historic paint layers. The 1912 historic photograph shows that the skylight ceiling was in a relatively light color value, potentially the pale grayish yellow identified by BCA (Figure 28).

Figure 30. This is the only ceiling sample containing the potentially original finish in pale grayish yellow (arrow). It appears that some historic paint layers may be lost, considering how few layers remain on this sample compared to the metal panel sample in Figure 32. BB.106.1 (Men's Bath Hall), ultraviolet light (L), visible light (R), 40x magnification.

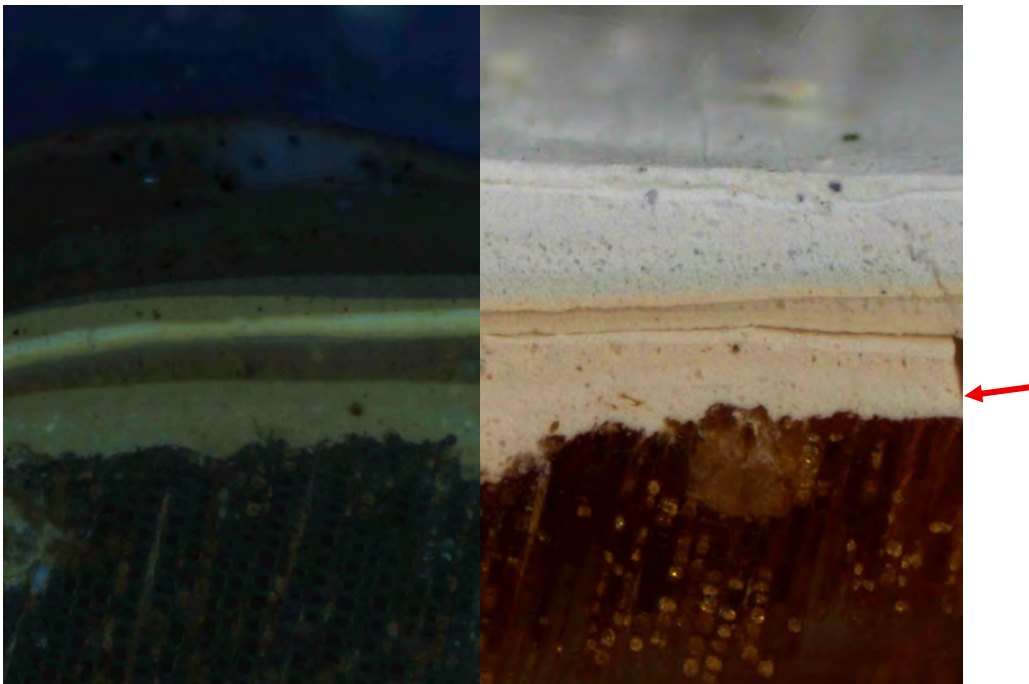
Figure 31. The earliest existing finish on the 1940s partition cornice is a light orange yellow (arrow) that matches the seventh layer on the paneled capital sample (see Figure 32). BB.106.8 (Men's Bath Hall), ultraviolet light (L), visible light (R), 40x magnification

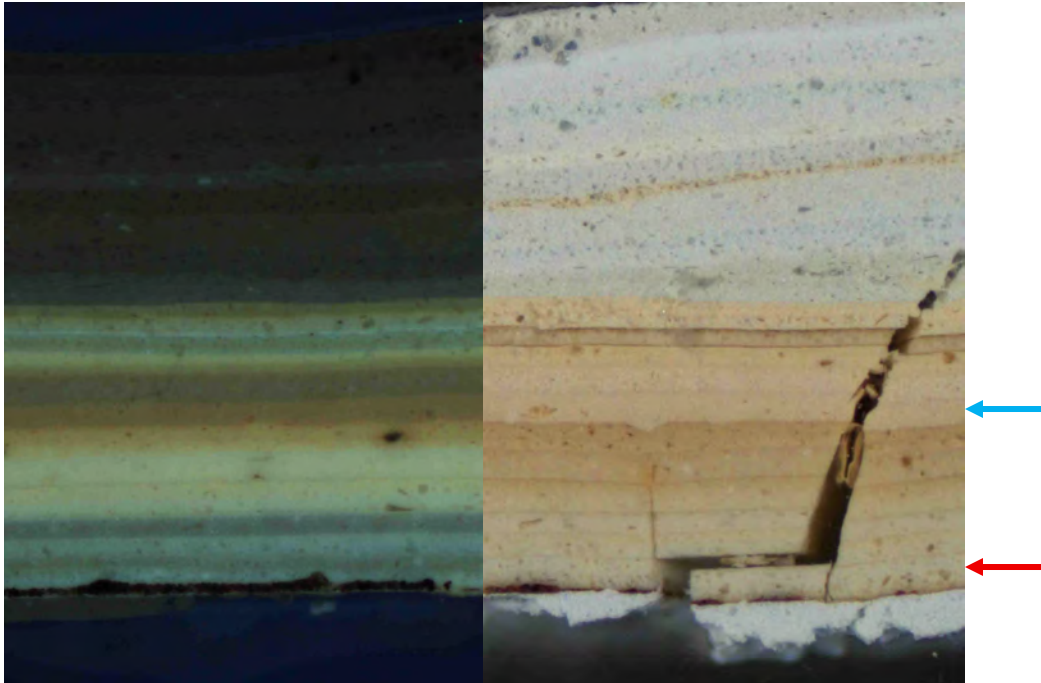
The two column capital samples share the same original brownish white finish and largely the same subsequent layers. The bulk sample examination of the molding around the center panel suggests it shares the same layers as well. The brownish white is also identified as the original finish on the balcony elements in Men's Dressing Room. The findings are consistent with the 1912 historic photograph that captures the column capitals in a monochromatic light color (Figure 28). After the original finish, the capital was painted in a series of light yellows and light orange yellows, followed by pale greens and blues, then light grays and whites. As discussed above, the 1940 light orange yellow on the partition cornice matches the seventh layer on the capital samples, therefore dating the seventh layer to 1940. This finding suggests that the paint scheme on the column capital changed from light orange yellows to pale green around the 1960s or '70s.

Figure 32. A representative sample of the metalwork originally painted brownish white (arrow), removed from the paneled capital center. The blue arrow indicates the light orange yellow that likely matches the earliest existing layer on the partition cornice. BB.106.3 (Men's Bath Hall), ultraviolet light (L), visible light (R), 40x magnification.

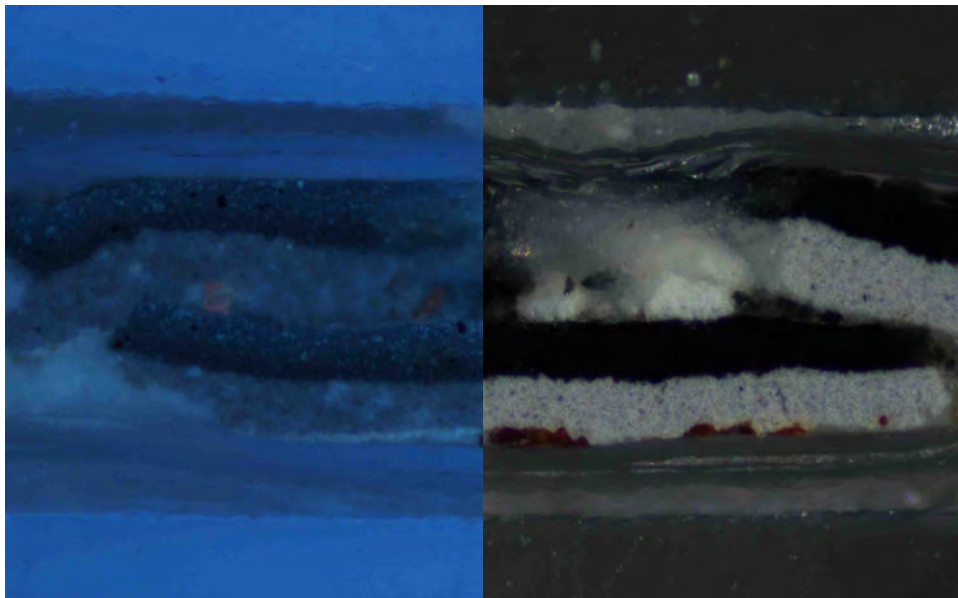
The metal grille sample appears to contain only more recent presumably latex paint layers, first a moderate gray on a dark brown primer, then the current black. Either the grille is a later replacement, or the earlier paint layers have been lost or removed.

Figure 33. All paint layers on the metal grille sample appear to be latex, suggesting they are not historic. BB.106.9 (Men's Bath Hall), ultraviolet light (L), visible light (R), 40x magnification

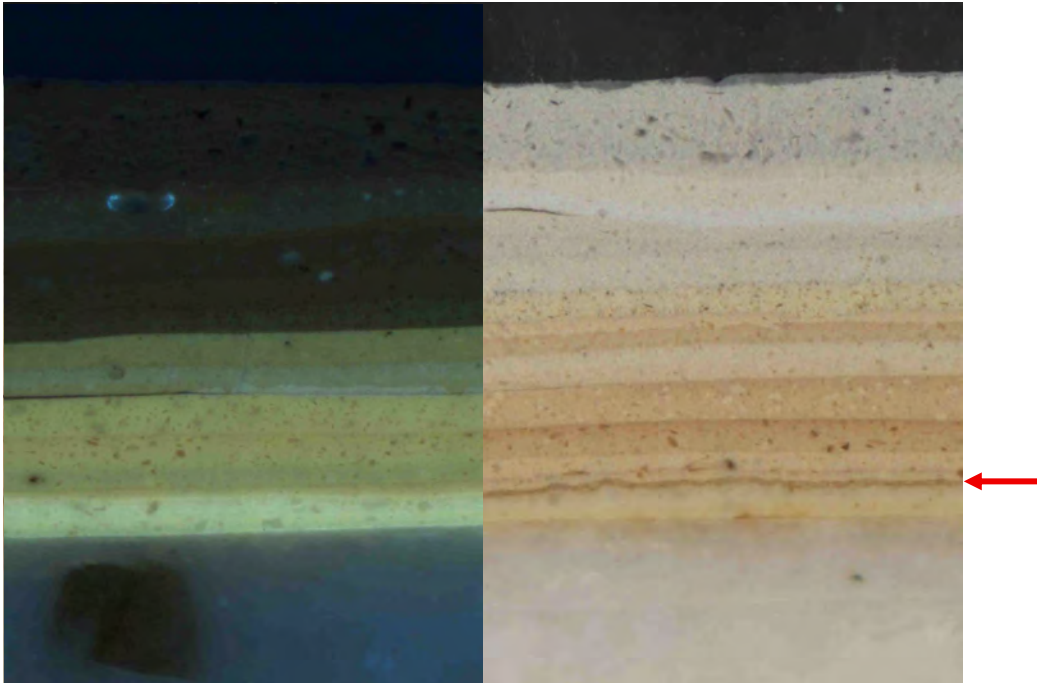
Figure 37. The plaster walls and ceiling were originally painted in brownish yellow (arrow), as seen in this wall sample. BB.109.3 (Men's Cooling Room), ultraviolet light (L), visible light (R), 40x magnification.

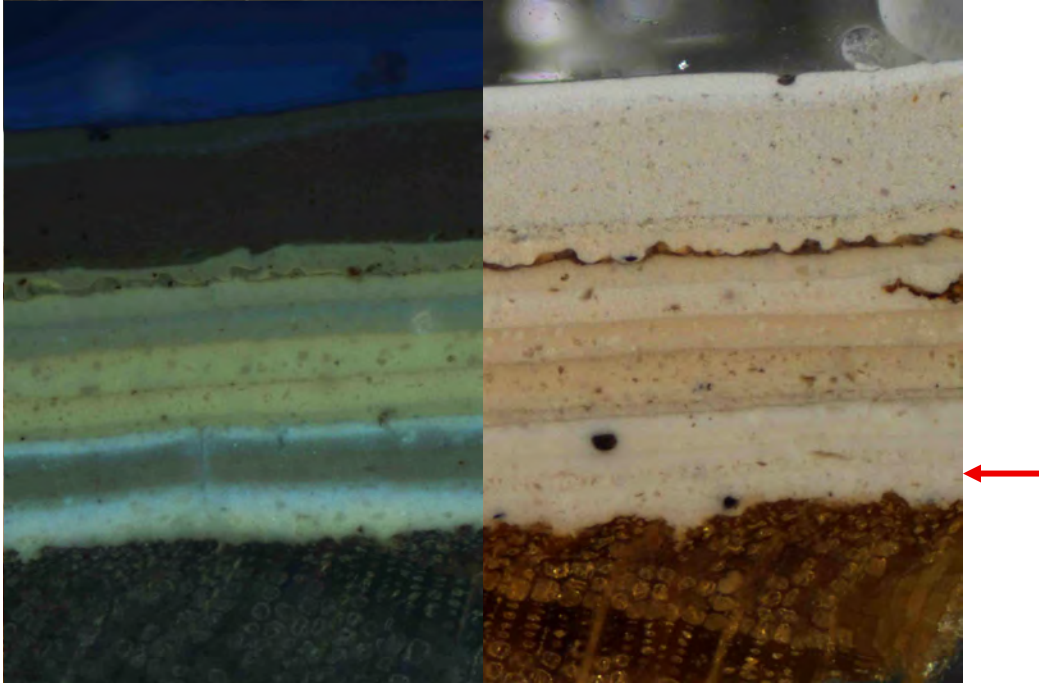
Figure 38. The wood window sill was originally painted in the same grayish yellowish white as the first-floor Lobby door surround (see Figure 16). BB.109.1 (Men's Cooling Room), ultraviolet light (L), visible light (R), 40x magnification.

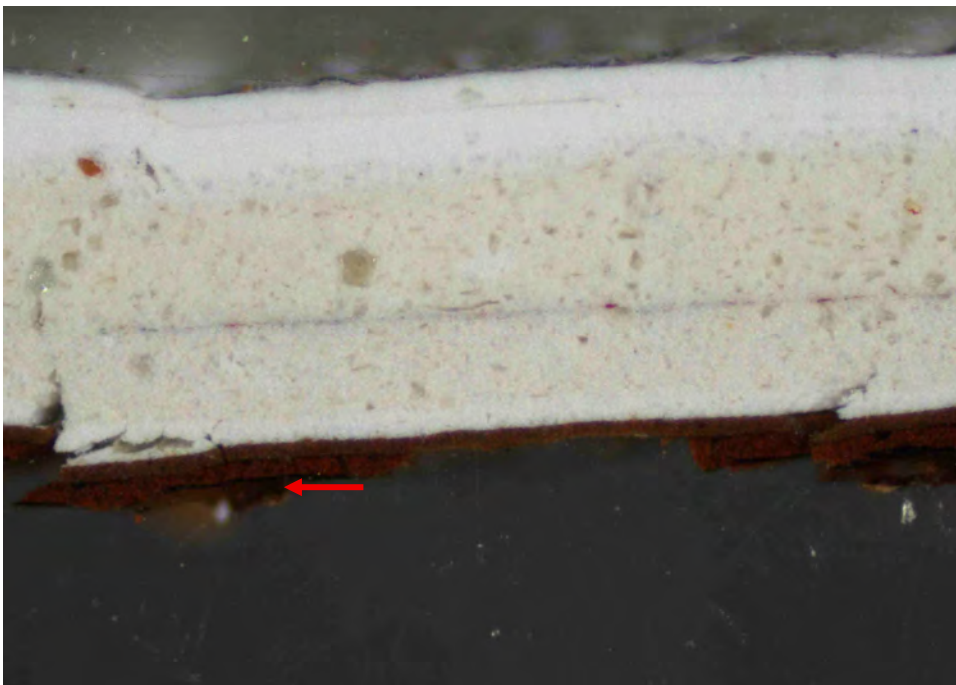
The samples suggest that the metal windows, like the wood windows, were painted in a dual white and dark brown scheme originally. The window trim and mullions were painted in the same grayish yellow white as the wood windows. The double-hung window sash and transom sash were painted in a dark grayish reddish brown, likely intended to match the stained wood window sash. The findings are corroborated by a historic photograph, although from a different room on the second floor, capturing a double hung window with dark sash and light colored frame/trim (Figure 36).

Figure 39. The metal windows were finished in a dual white and brown color scheme like the wood windows. The metal window transom, pictured, was originally painted in dark grayish reddish brown (arrow), likely intended to match the naturally finished wood window sash. BB.109.8 (Men's Cooling Room), visible light, 40x magnification.

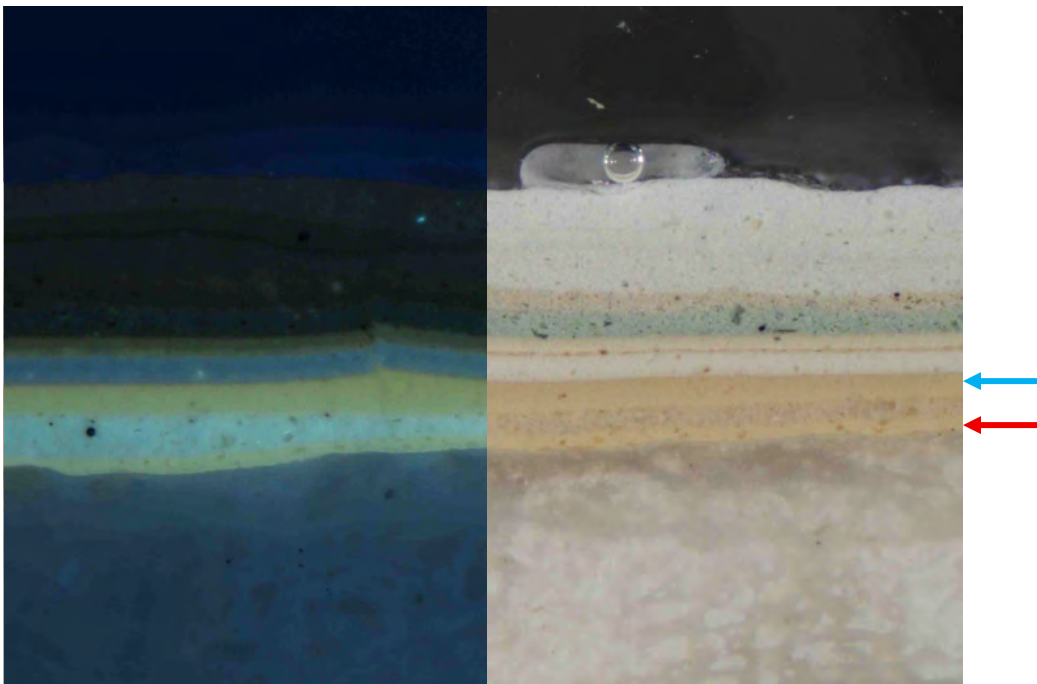
Figure 41. A representative plaster sample removed from the pilaster capital showing the original pale grayish yellow finish (red arrow). The third layer (blue arrow) appears to match the earliest existing finish on the wall partition sample in Figure 42. BB.200.1 (2F Lobby), ultraviolet light (L), visible light (R), 40x magnification.

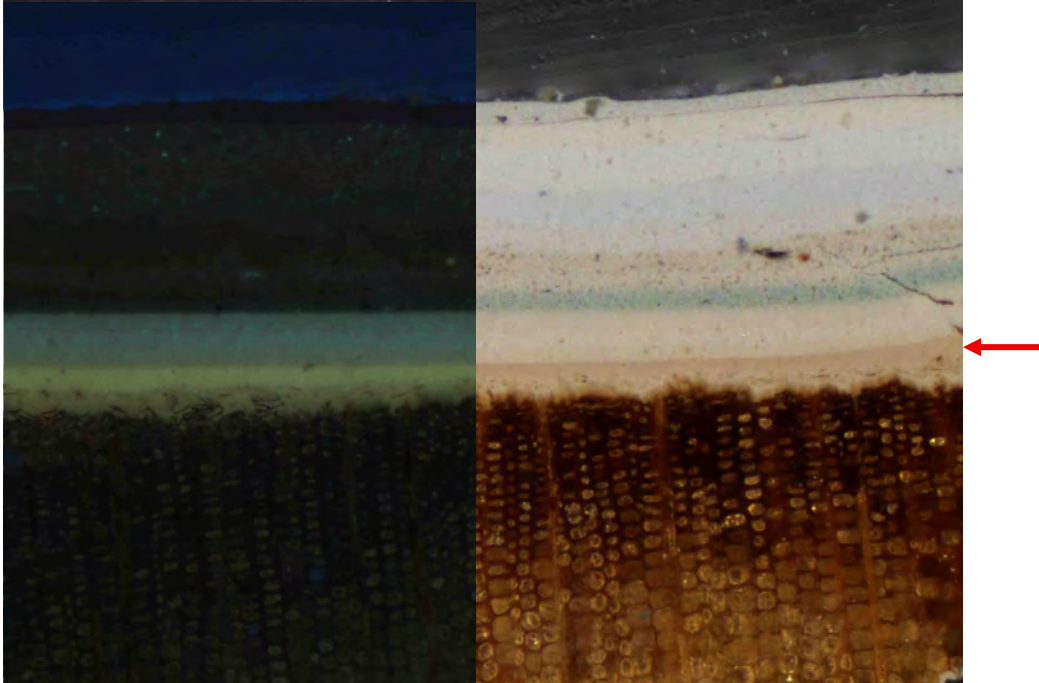
Figure 42. The partition sample contains two fewer layers than the plaster wall sample, suggesting that the partition was installed early. The earliest existing finish on the partition is a moderate orange yellow (arrow) that appears to match the third layer on the plaster (see Figure 41). BB.200.13 (2F Lobby), ultraviolet light (L), visible light (R), 40x magnification.

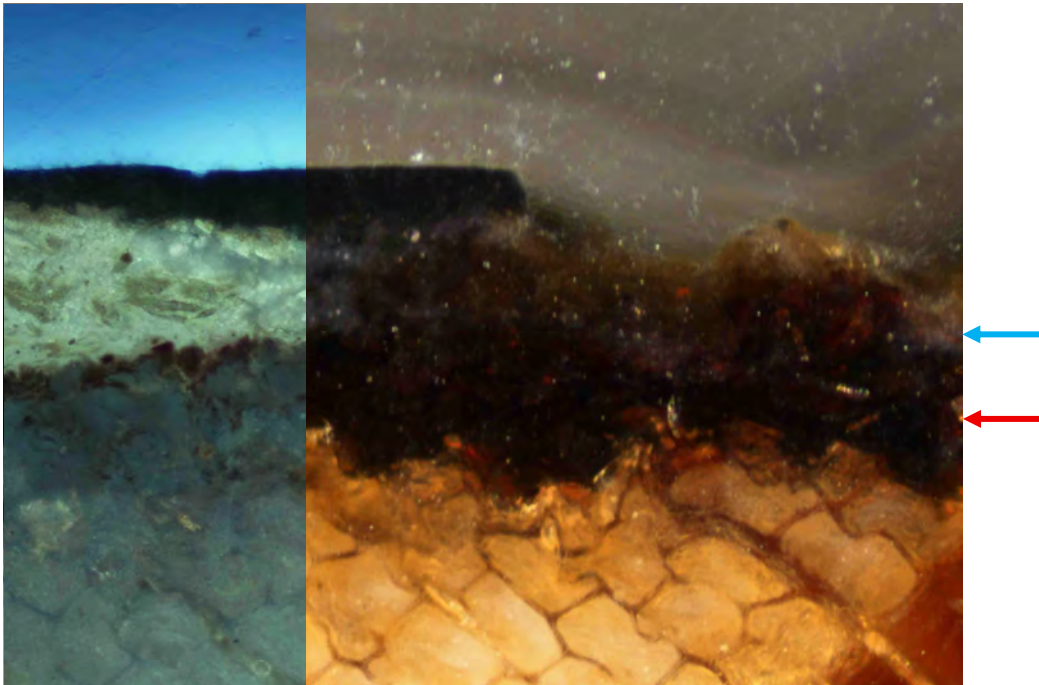
Figure 43. The wood window sash was originally stained in grayish reddish brown (red arrow) and topped with a transparent coating (blue arrow). BB.200.10 (2F Lobby), ultraviolet light (L), visible light (R), 100x magnification.

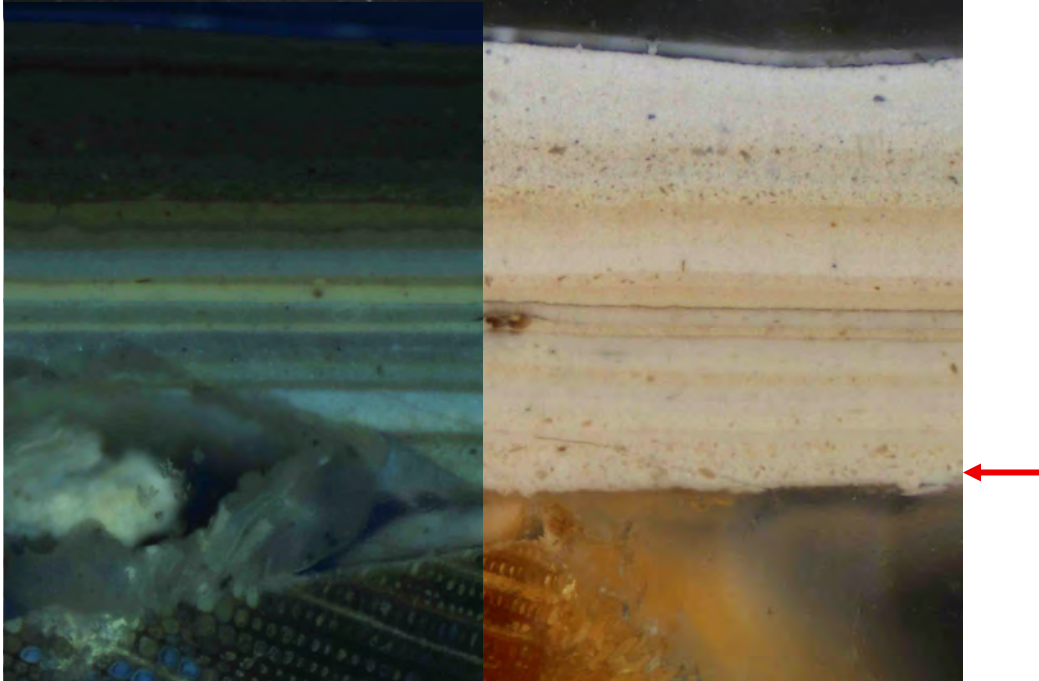
Figure 44. The door frame was originally painted in the same grayish yellowish white (arrow) identified in other rooms. BB.200.14 (2F Lobby), ultraviolet light (L), visible light (R), 40x magnification.

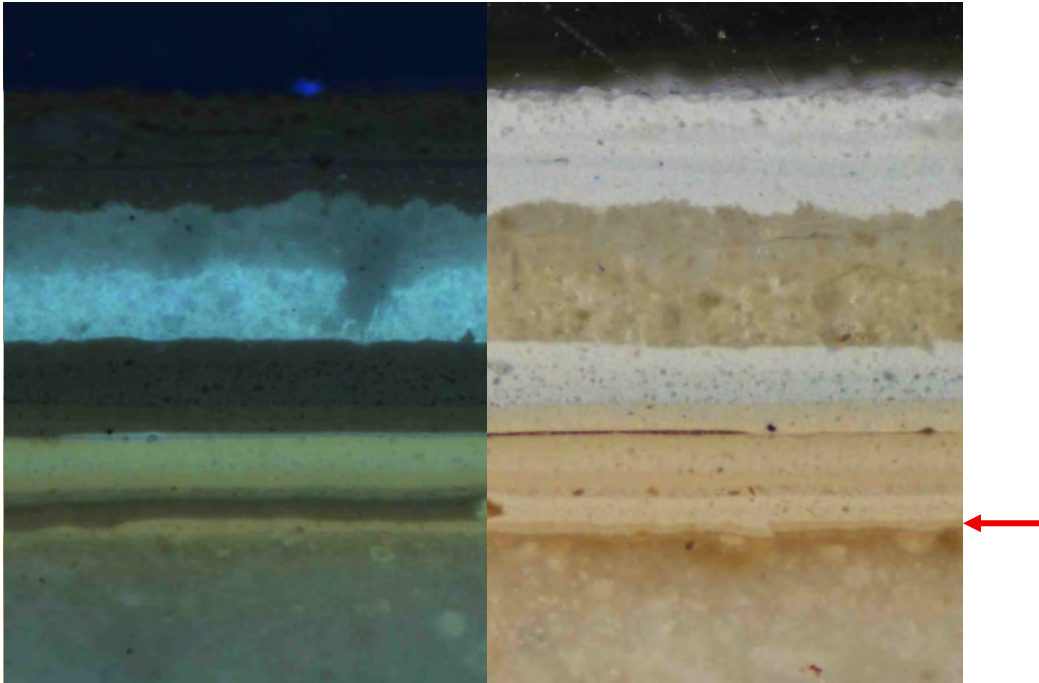
BCA's analysis suggests the plaster ceiling was originally painted in grayish yellow, a slightly different color from the original plaster finish found in the lobbies and Men's Bath Hall. The plaster beam sample is missing the earliest three paint layers, but it was likely painted in the same color as the ceiling as they were in other rooms. The grayish yellow is consistent with the moderately light color value of the ceiling captured in the 1912 historic photograph (Figure 45). The ceiling and beam were painted with a few more light yellows or light orange yellows after the original finish, then pale blues and whites. The earliest paint layer on the 1967 plaster wall is an off-white that comes after the pale blue on the plaster ceiling sample, therefore placing the pale blue as a 1950s-1960s layer.

Figure 49. The plaster ceiling in Room 212 was originally painted grayish yellow (arrow). BB.212.5 (Women's Bath Hall), ultraviolet light (L), visible light (R), 40x magnification.

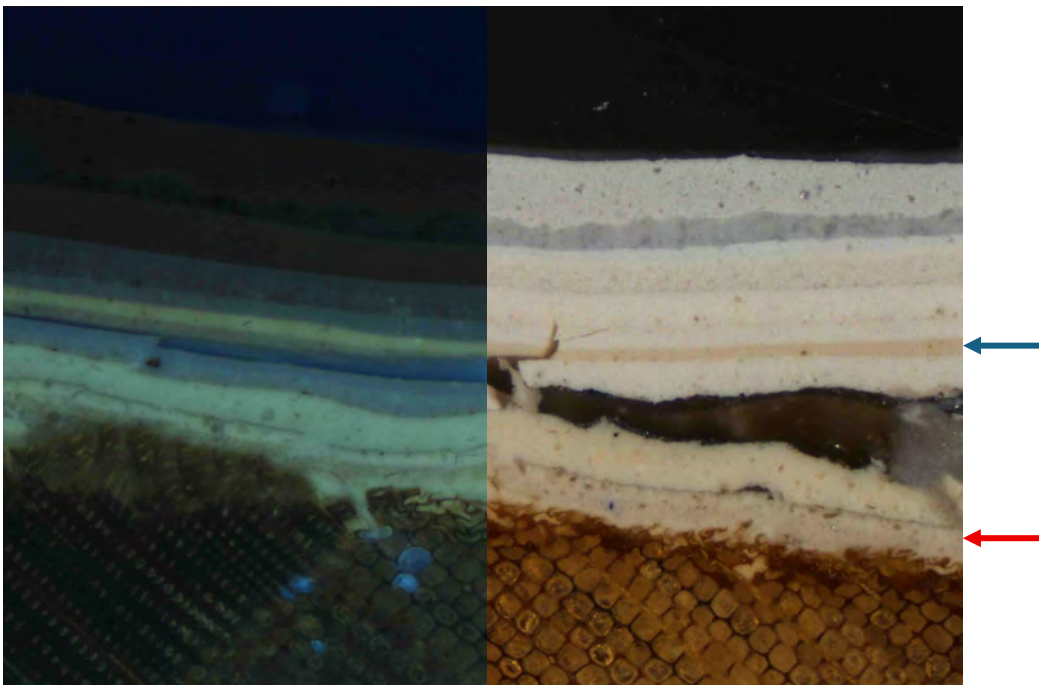
According to the current HSR, the interior sash of the metal windows in this room were installed after the original construction. The earliest existing paint layer found on the sash is a pale grayish yellow, a slightly different color from the grayish yellowish white layer observed on other woodwork in the building. The pale orange yellow (fifth layer) on the sash sample appears to be the same color both in visible and under ultraviolet light as the eighth layer of architectural features dated to the original construction, such as the window mullion in Room 200. This suggests the sash may date to the 1920s or 30s.

Figure 50. The interior wood sash to the metal window was installed sometime after the construction. It shows a different original finish in pale grayish yellow (red arrow) compared to the grayish yellowish white on original woodwork (see Figure 52). Also note the fifth layer (blue arrow) is the same color as the eighth layer of a 1912 window mullion in Room 200 (see Figure 51). This dates the installation date of the sash to 1920s or 30s. BB.212.2 (Women's Bath Hall), ultraviolet light (L), visible light (R), 40x magnification.

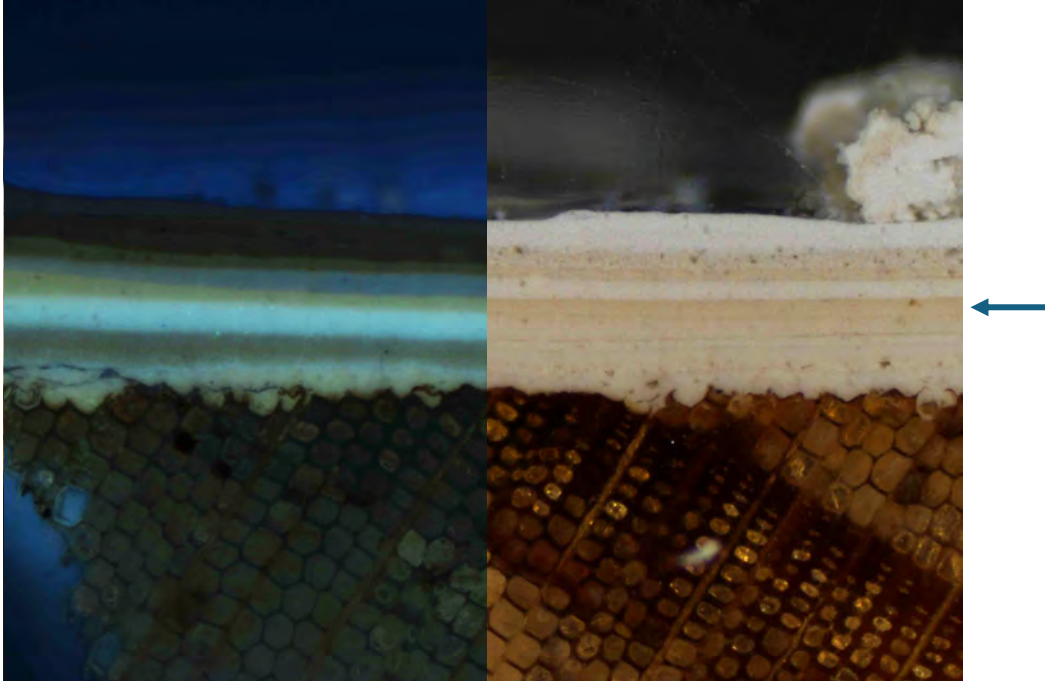
Figure 51. A window mullion dated to 1912 with a pale orange yellow eighth layer (blue arrow) that is likely the same as the fifth layer on the Room 212 sash sample (Figure 50). BB.200.9 (Second Floor Lobby), ultraviolet light (L), visible light (R), 40x magnification.

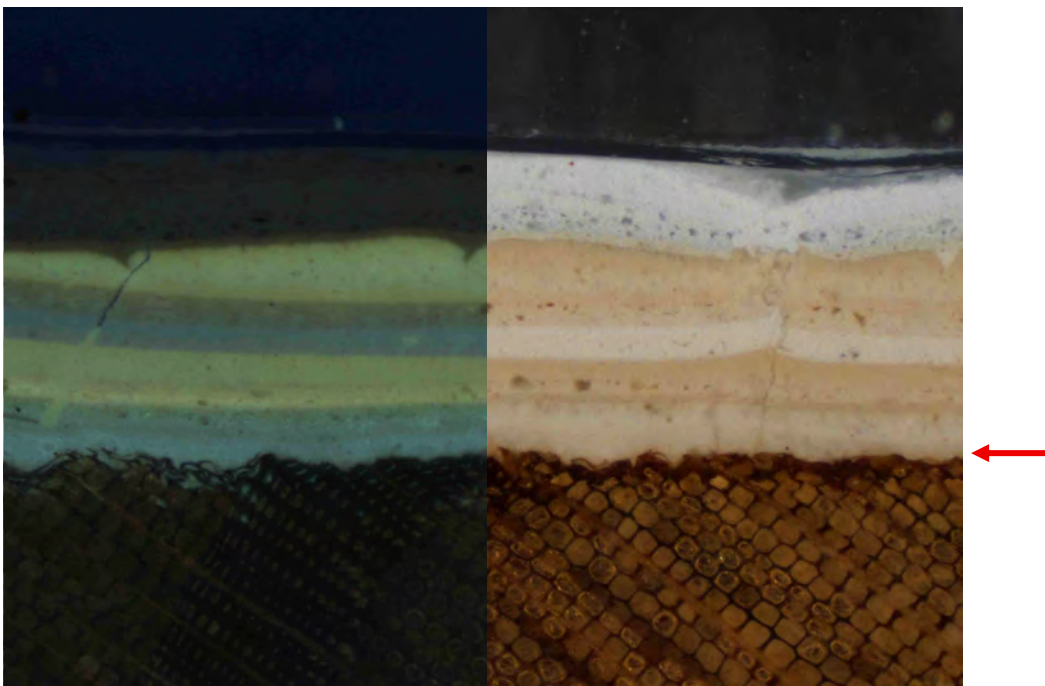
Figure 52. The wood skylight elements were originally painted in grayish yellowish white (arrow). BB.212.6 (Women's Bath Hall), ultraviolet light (L), visible light (R), 40x magnification.

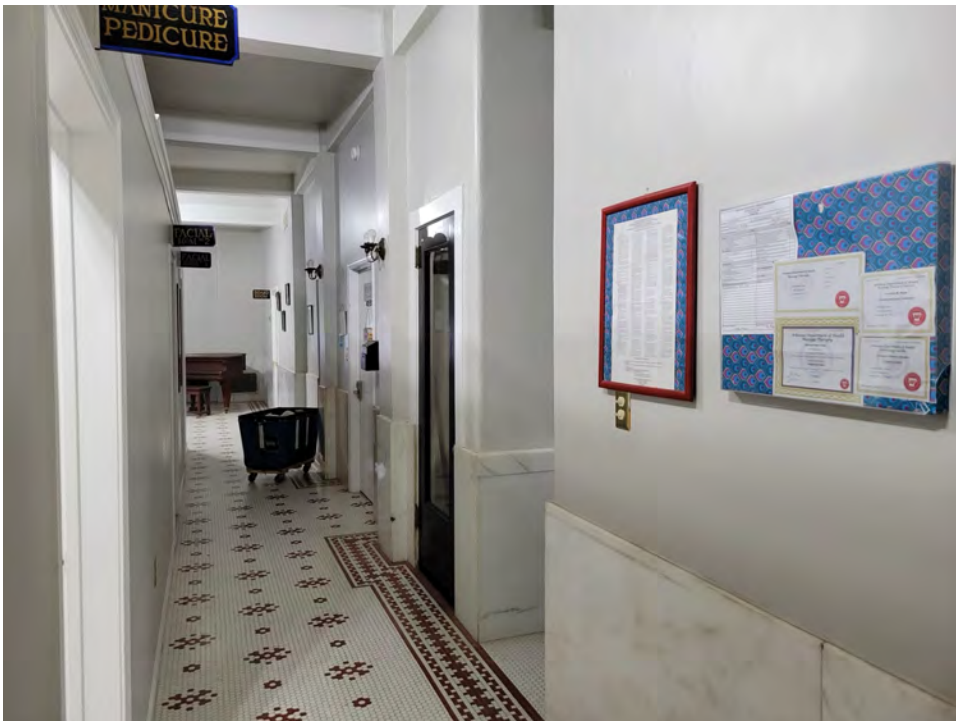
Figure 54. Image of third floor Hall and Manicure/Pedicure Room in 2025, view looking northeast.

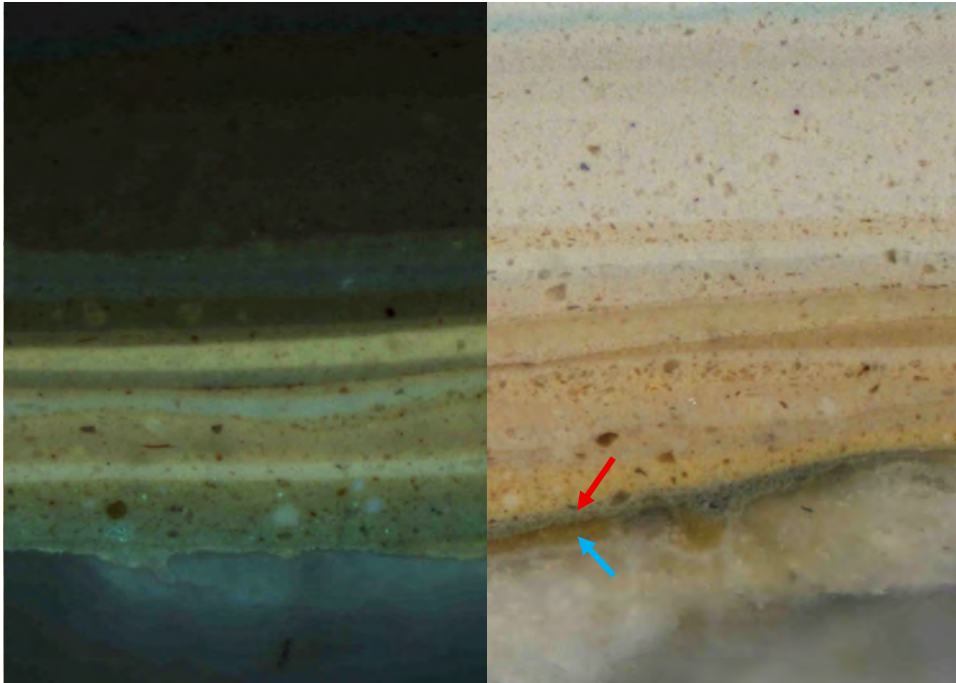
All the plaster elements share the same original finish in grayish yellow green on top of a light olive preparatory layer. The 1912 historic photograph captures the walls, ceiling, and ceiling beams in a relatively light color, which may be grayish yellow green (Figure 53). In the historic photograph, the walls, the side and the face of the ceiling beam have different color values. This is likely due to highlight and shadow, BCA found that these elements were painted in the same grayish yellow green. The subsequent layers on walls and ceiling elements diverge at times, although both were painted in vivid yellow for the second campaign. Then, the walls were painted strong orange yellow while the ceiling elements either remained yellow or were painted pale orange yellow. Following this, the wall colors were painted in neutral orange yellows before they were painted with many layers of pale greens or light greenish blues. The ceiling elements remained in light neutral colors after the vivid yellow.

Figure 55. The plaster was originally painted in grayish yellow green (red arrow) on a light olive preparatory layer (blue arrow), as seen in this representative sample removed from the plaster. BB.300.8 (3F Hall), ultraviolet light (L), visible light (R), 40x magnification.

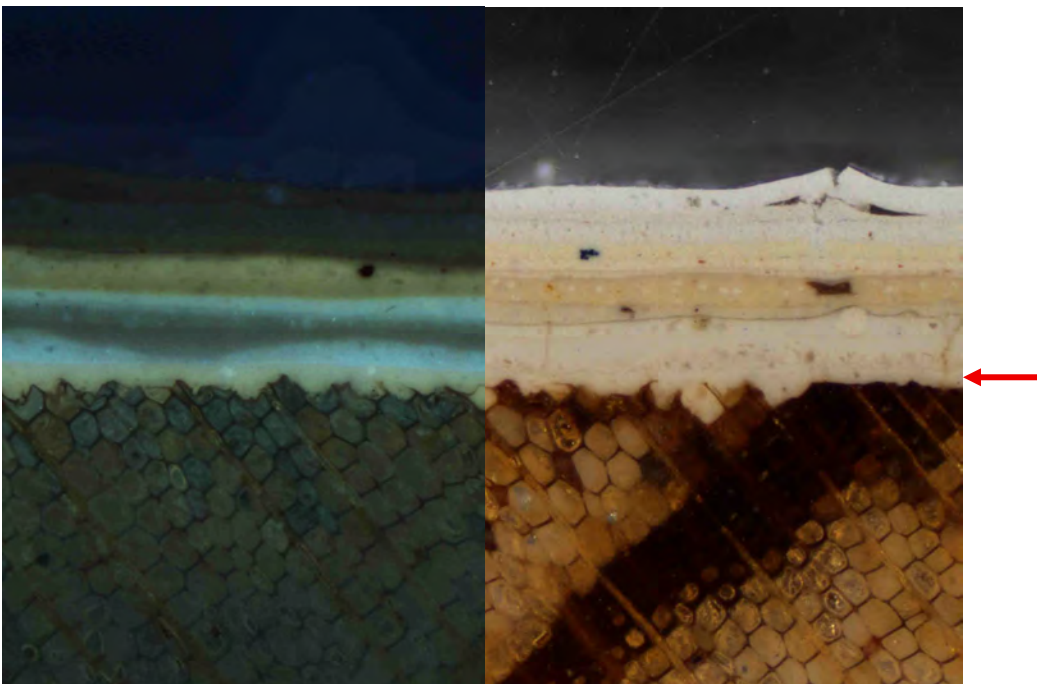
All of the woodwork samples except the door stile share the same original finish in grayish yellowish white. The window trim was painted in a few light blue greens more recently to match the walls; all other woodwork has subsequent layers in light yellows and off-whites. The original finish on the door appears to be a grayish reddish brown stain with a glossy transparent coating. The original finish is similar to its current appearance, but redder. The door has been refinished twice in similar finishes. No historic paint layers were found on the window sash during BCA's field investigation.

Figure 56. A representative woodwork sample removed from the window frame showing the original finish in grayish yellowish white (arrow). BB.300.1 (3F Hall), ultraviolet light (L), visible light (R), 40x magnification.

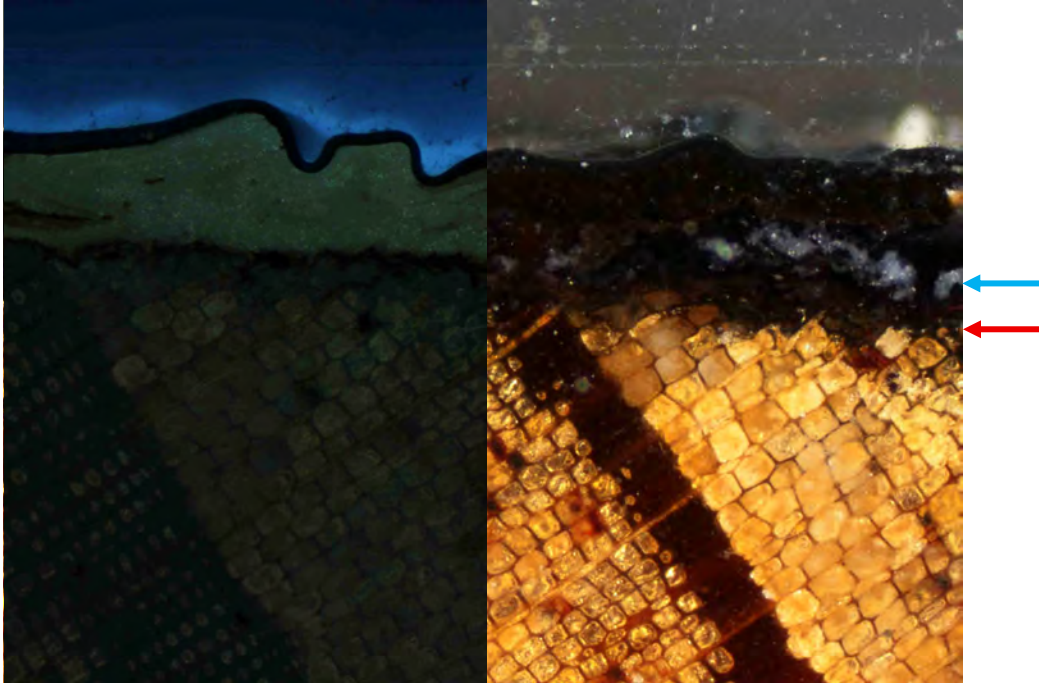
Figure 57. Like naturally finished woodwork in other rooms, the door stile was originally finished with a grayish reddish brown stain (red arrow) topped with a transparent coating (blue arrow). *BB.300.5, ultraviolet light (L), visible light (R), 40x magnification.*

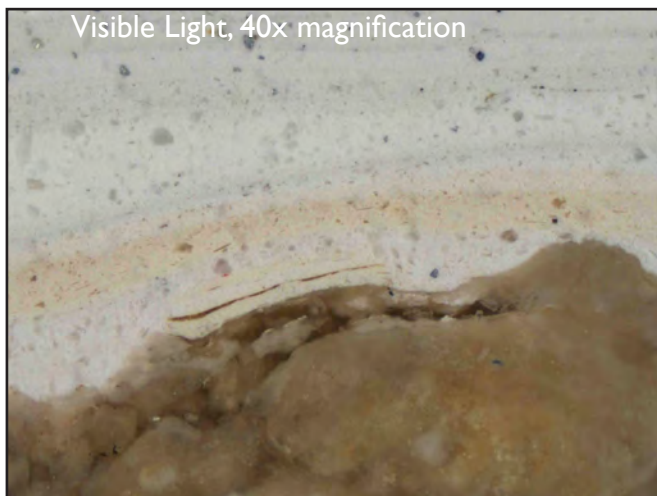
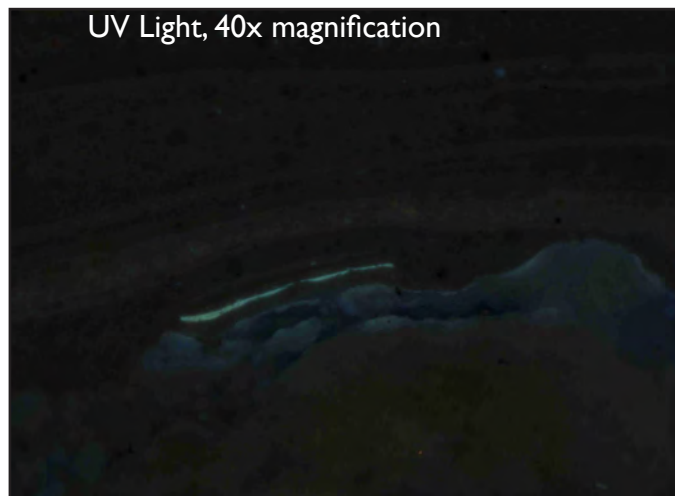
| <b>SAMPLE #:</b> BB. EXT.4 | <b>ROOM:</b> Exterior |

| <b>DESCRIPTION:</b><br>West elevation planter | |

| LAYER | REFLECTED LIGHT COLOR | NOTES |
|---|---|---|
| Substrate | stucco | Possibly lost historic paint layers due to 1965 sandblasting. |

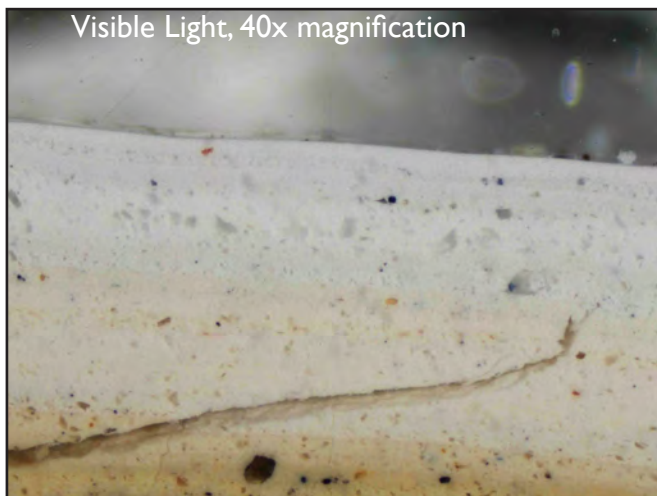
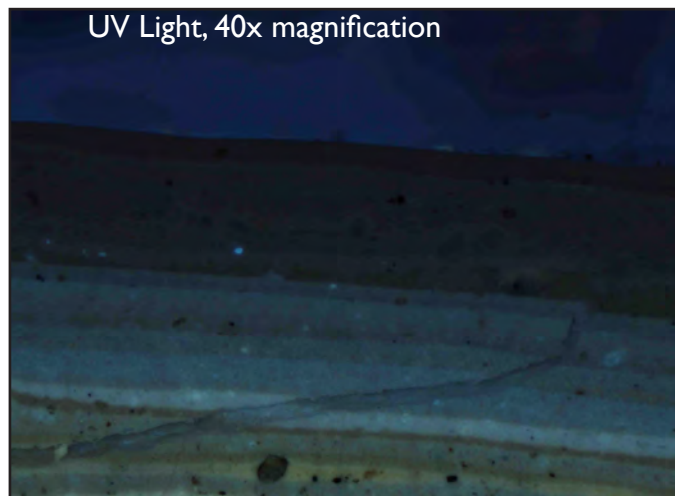
West elevation window sash, more recent layer.

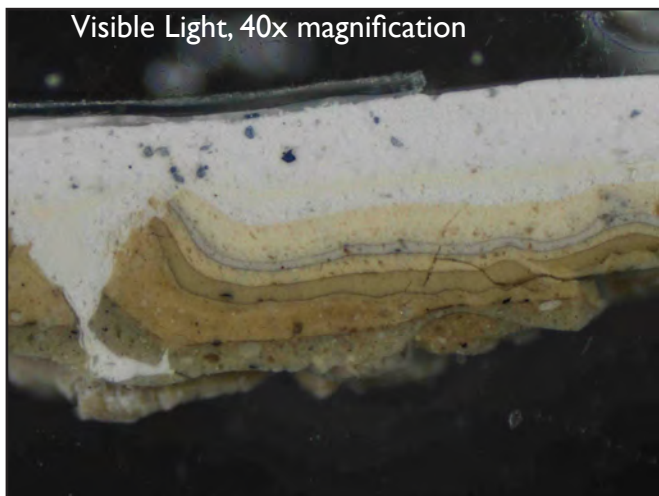
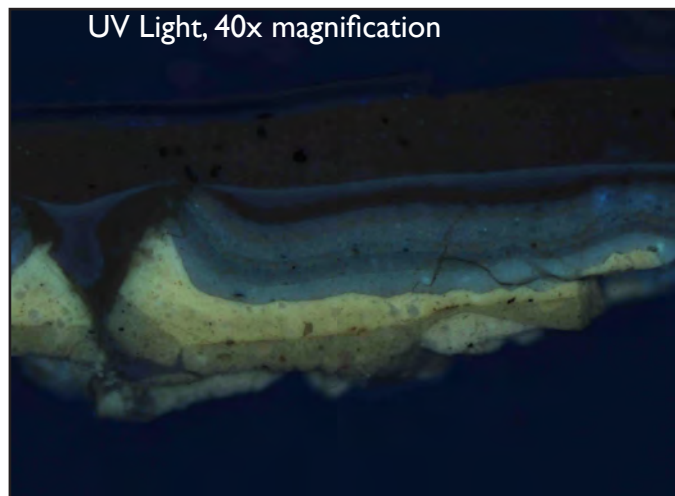
| <b>SAMPLE #:</b> BB. EXT.10 | <b>ROOM:</b> Exterior |

| <b>DESCRIPTION:</b><br>East elevation roof, window lintel | |

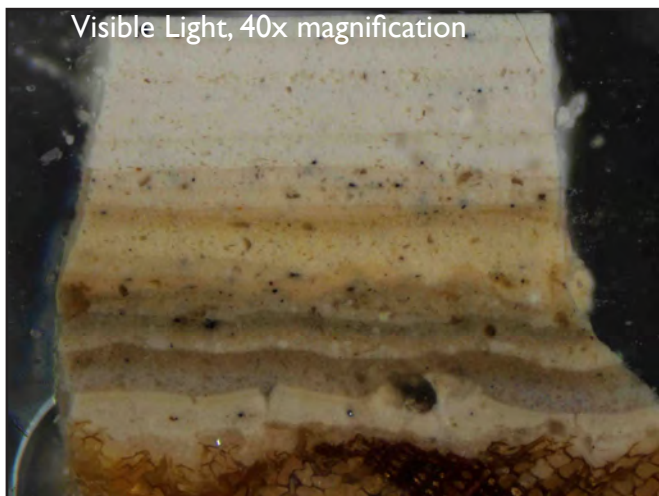
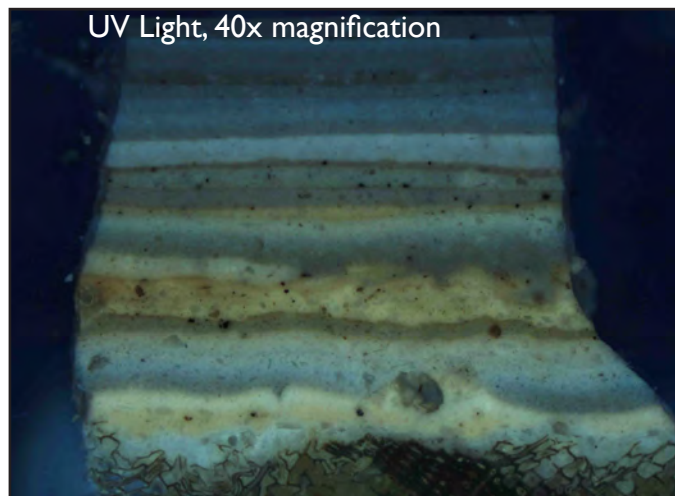
| <b>SAMPLE #:</b> BB. EXT.18 | <b>ROOM:</b> Exterior |

| <b>DESCRIPTION:</b><br>North elevation, third floor, window frame | |

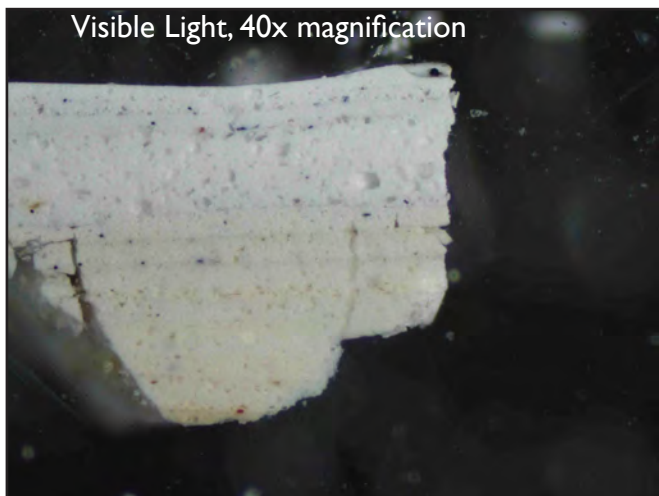
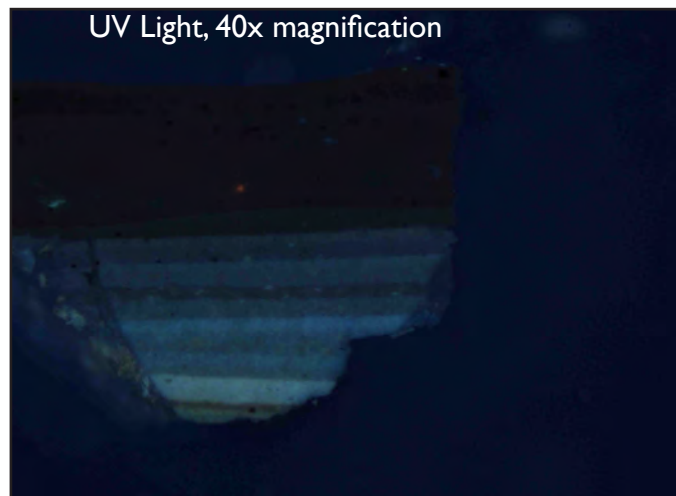
**SAMPLE #:** BB. EXT.18

North elevation, third floor, window frame

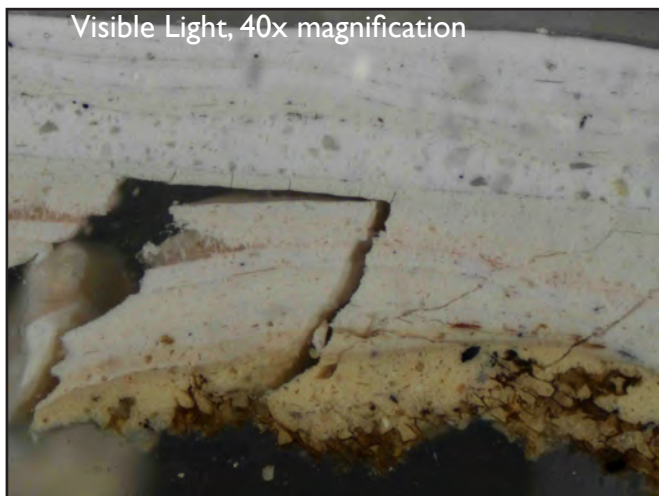
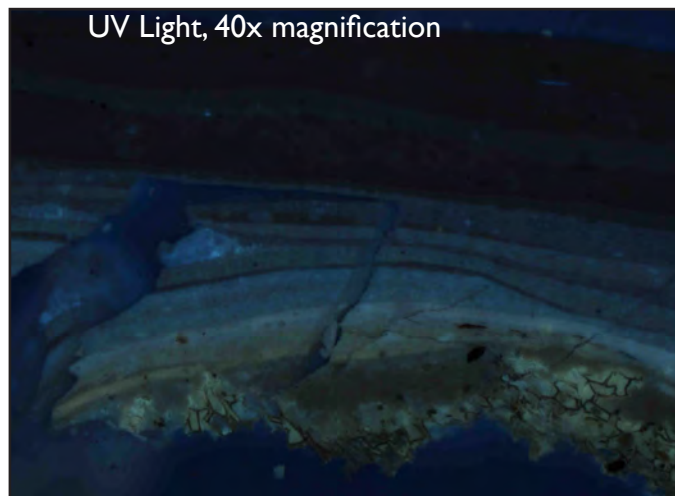
| <b>SAMPLE #:</b> BB. EXT.19 | <b>ROOM:</b> Exterior |

| <b>DESCRIPTION:</b><br>West elevation, front door trim | |

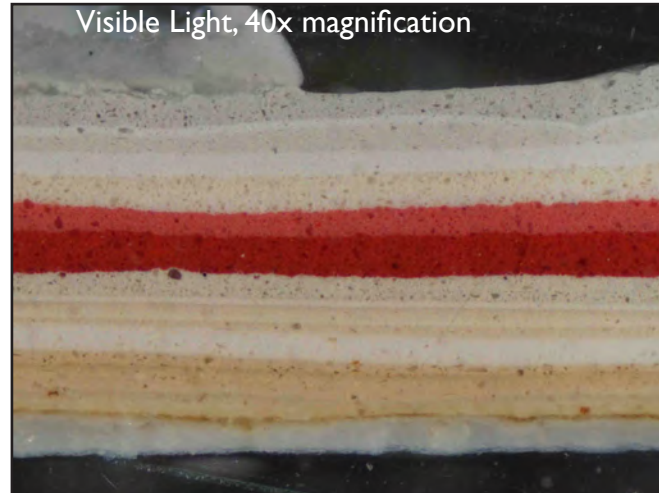
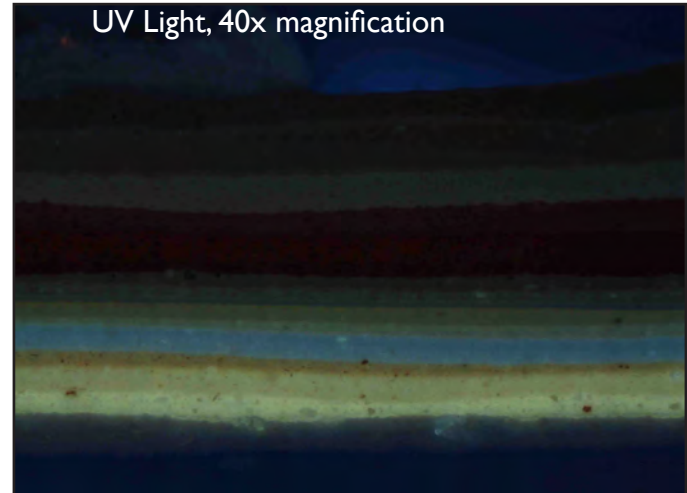
| <b>SAMPLE #:</b> BB. 100.2 | <b>ROOM:</b> 100 |

| <b>DESCRIPTION:</b><br>Ceiling field | |

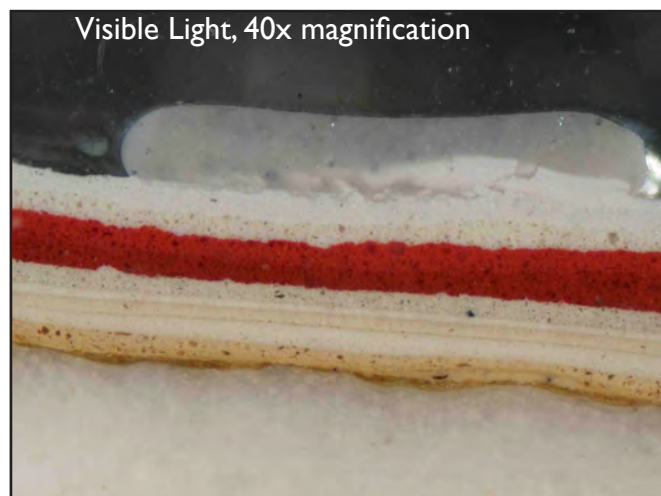
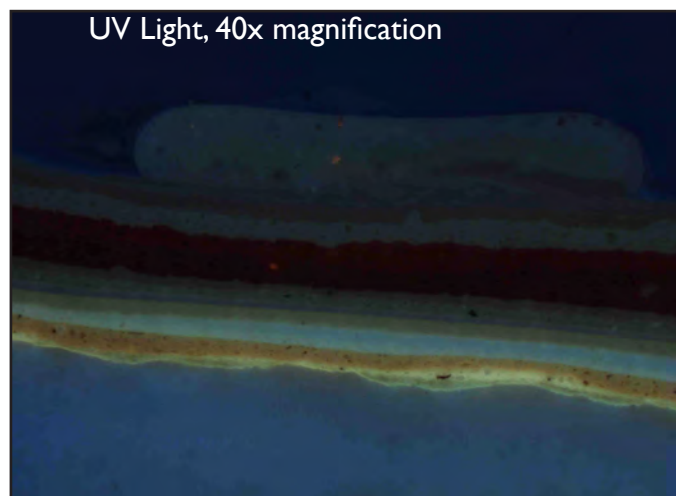
**SAMPLE #:** BB. 100.3A

Cornice molding
