# Hot Springs National Park Buckstaff Bathhouse Historic Structure Report

**June 30, 2026**

# Historic Structure Report

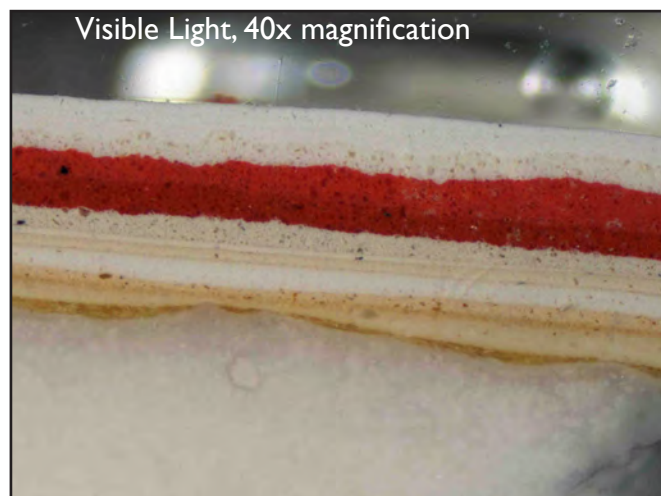
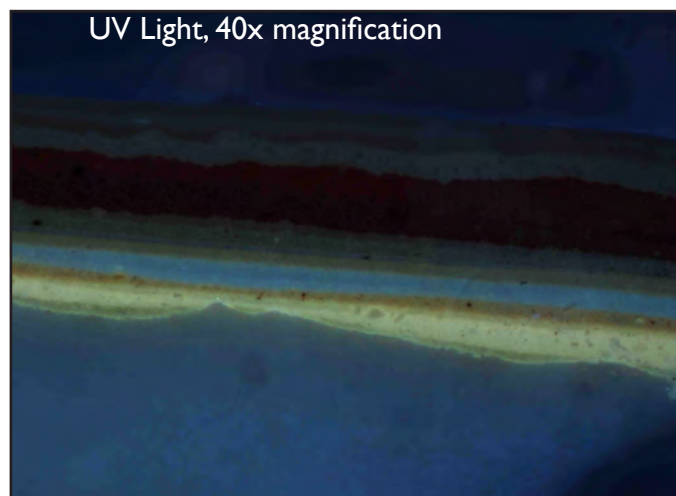
**SAMPLE #:** BB. 100.3B

Cornice molding

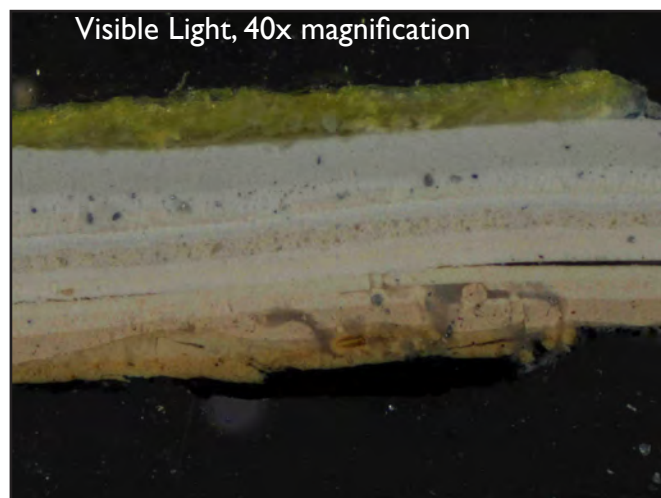
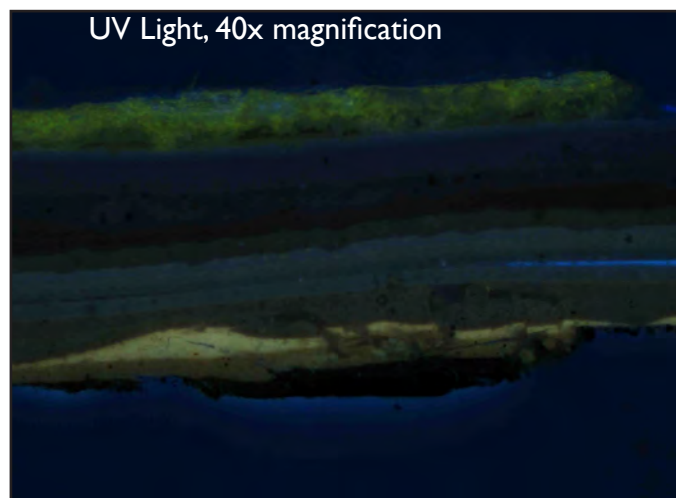
| <b>SAMPLE #:</b> BB. E3 | <b>ROOM:</b> 100 |

| <b>DESCRIPTION:</b><br>Elevator ceiling | |

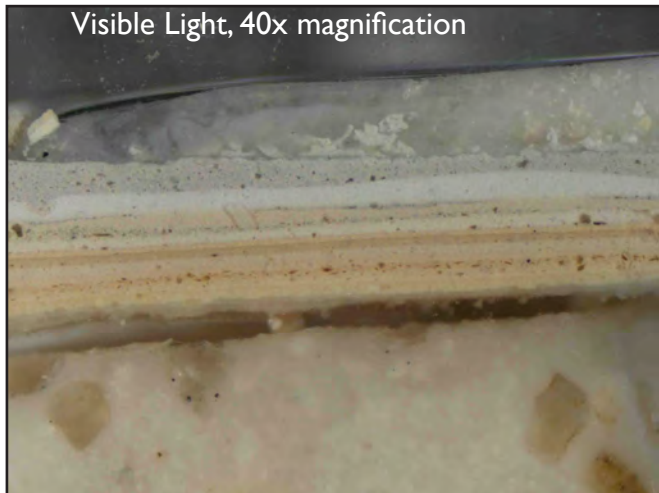
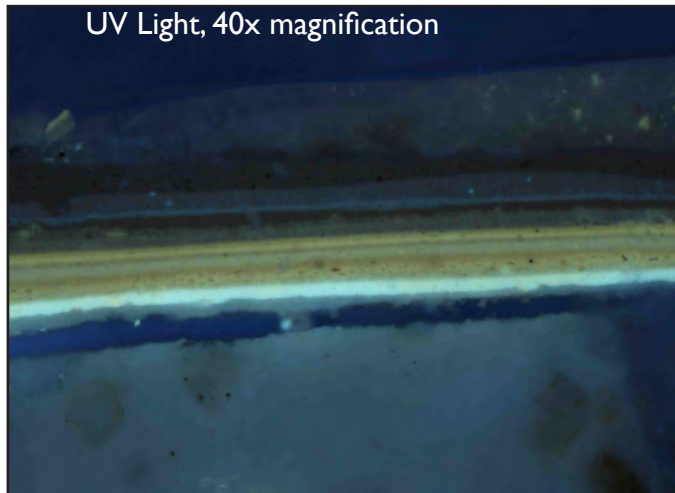
Ceiling beam

| LAYER | REFLECTED LIGHT COLOR | NOTES |
|---|---|---|
| 1 | pale yellow | Earliest existing but not original. Missing historic paint layers present on 102.4. |

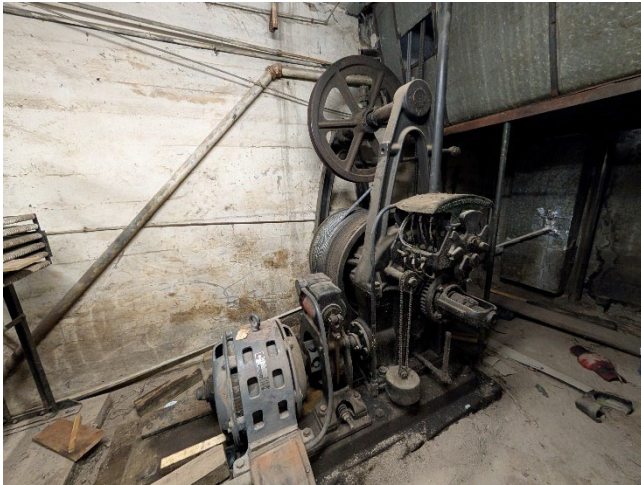
1.

Otis basement-set winding drum machine

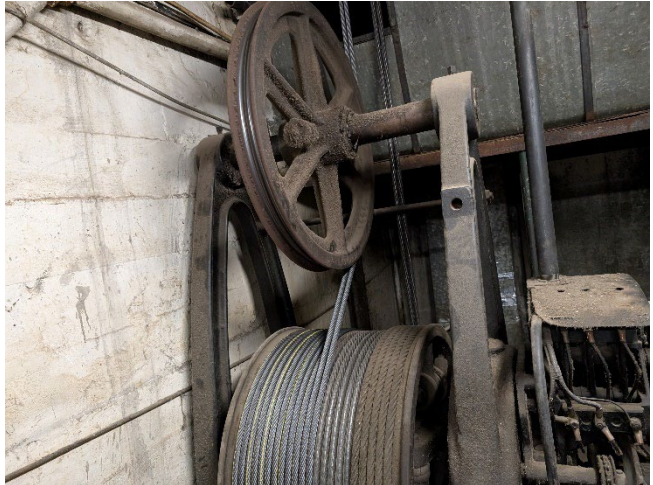
2.

Otis basement-set winding drum machine

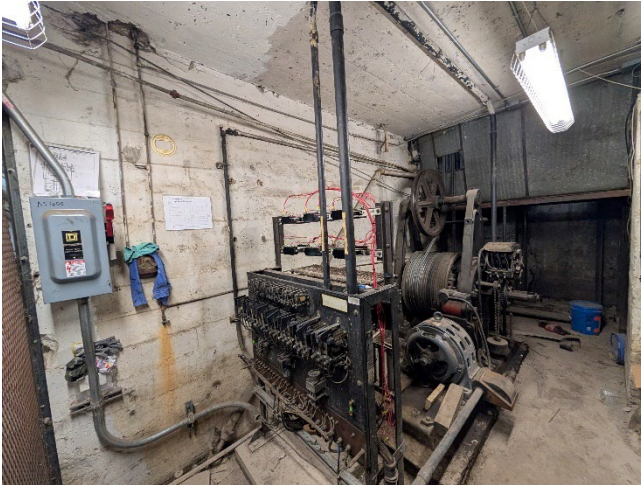
3.

Elevator machine room

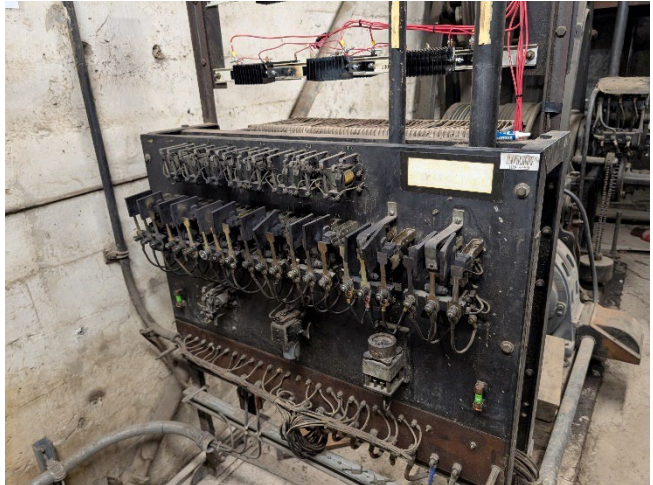
4.

Elevator relay logic controller components

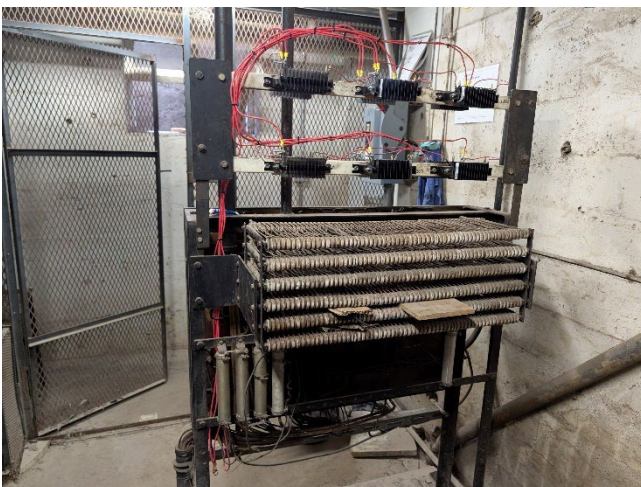
5.

Elevator relay logic controller components

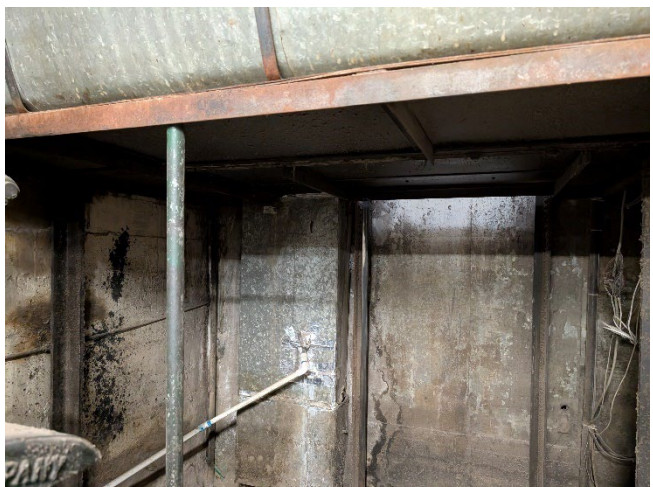
6.

Space below Elevator Pit

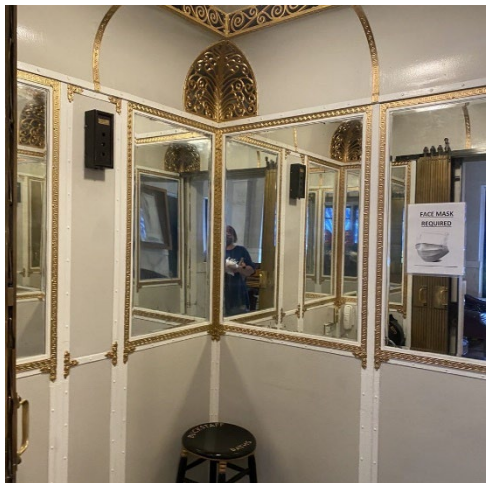
1.

Elevator Cab

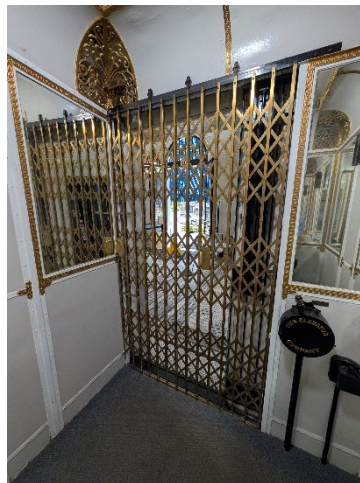
2.

Elevator Cab- Front

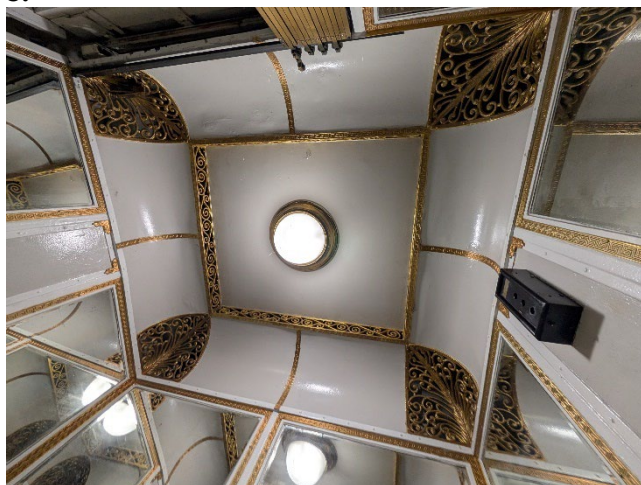
3.

Elevator Cab Ceiling

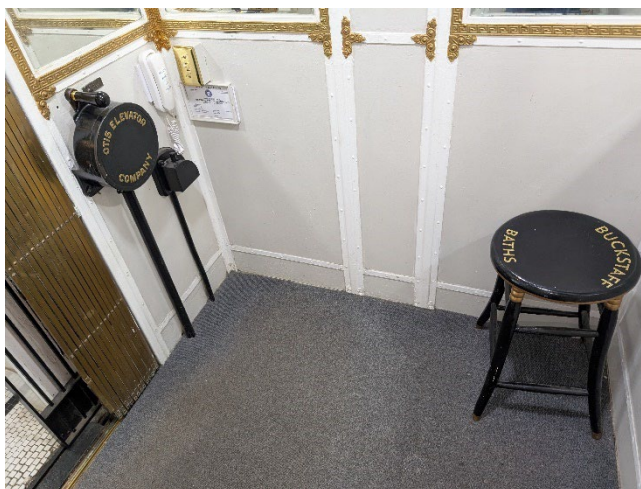
5.

Elevator Cab

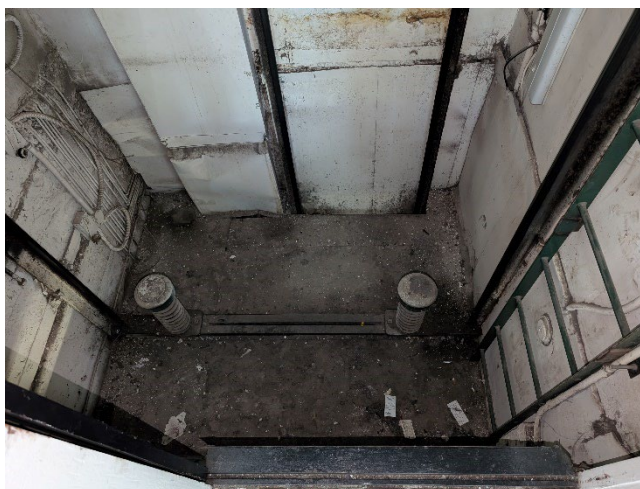
6.

Elevator Pit

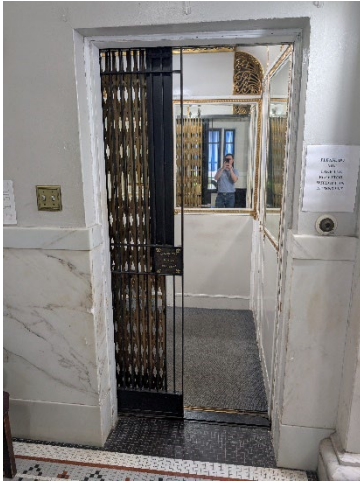
1.

Floor 1 Hoistway Entrance

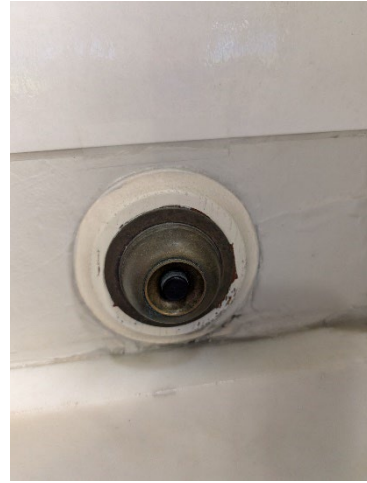
2.

Elevator Push Button

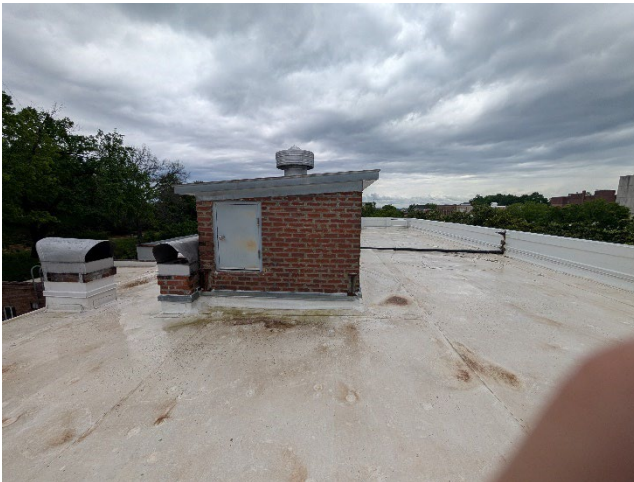
3.

Top of Hoistway Access

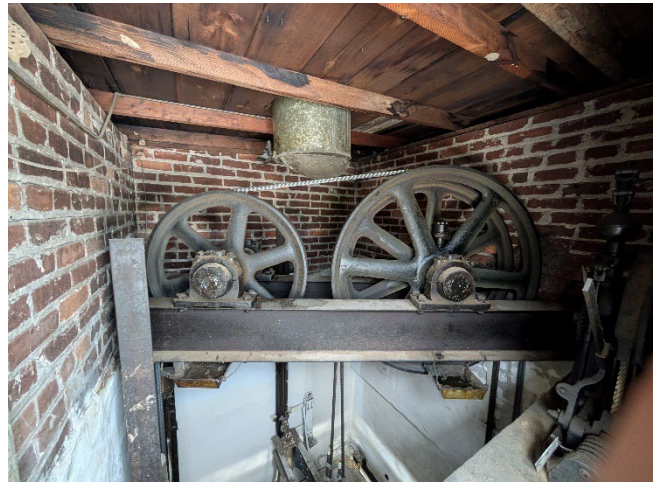
4.

Top of Hoistway Sheaves

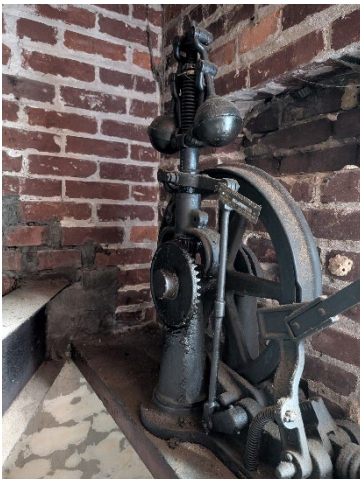
5.

Otis Flyball Governor

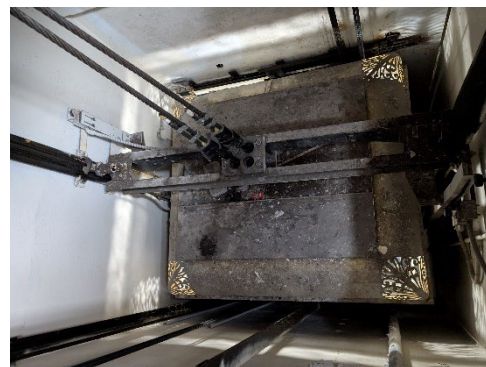
6.

Top of Elevator Car
