The purpose of this document is to document the evolution of the structure, assess existing conditions and features, evaluate alternative treatments, and recommend treatments responding to objectives identified by park management for the rehabilitation of the House of Tomorrow. The House of Tomorrow was constructed for the 1933 Century of Progress Exposition. This report will offer alternative treatments for key issues while proposing treatments that will preserve the structure for the use and enjoyment of future generations.

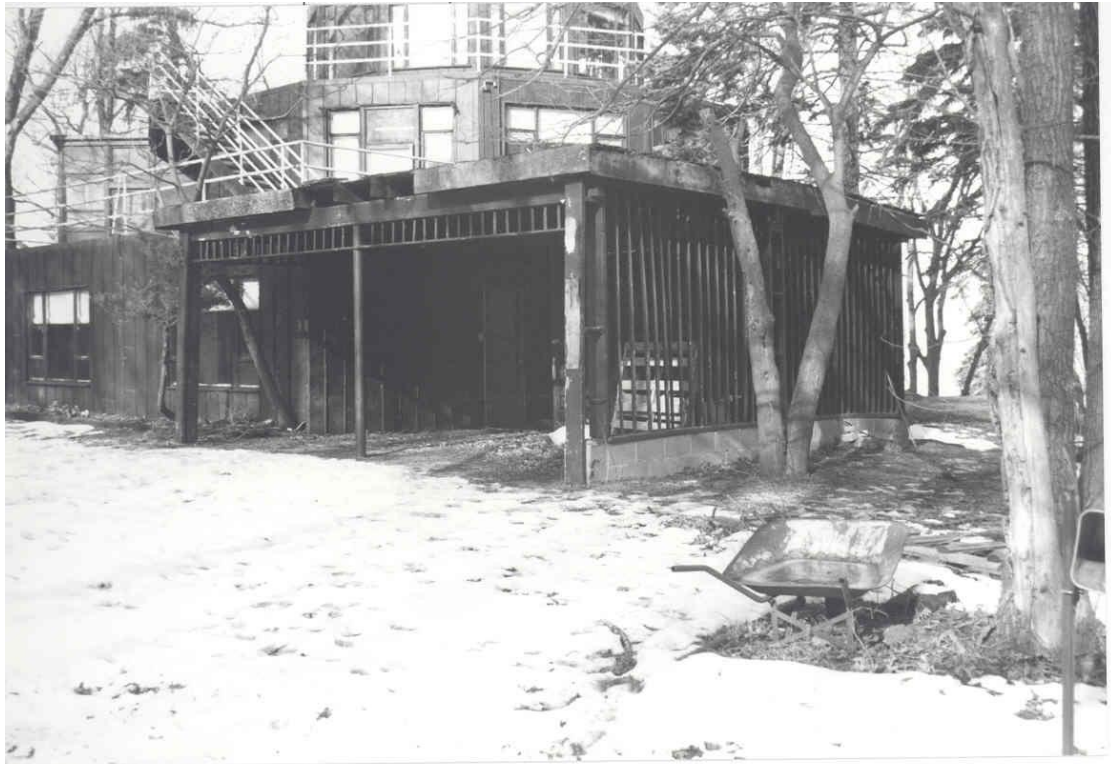
View 4 – Southeast Perspective – Original Hangar Area

The following numbered photographs, referenced in the sketch floor plan below, were chosen to represent the overall existing conditions of the building. All numbered photographs are located in Appendix D, Exhibit F.

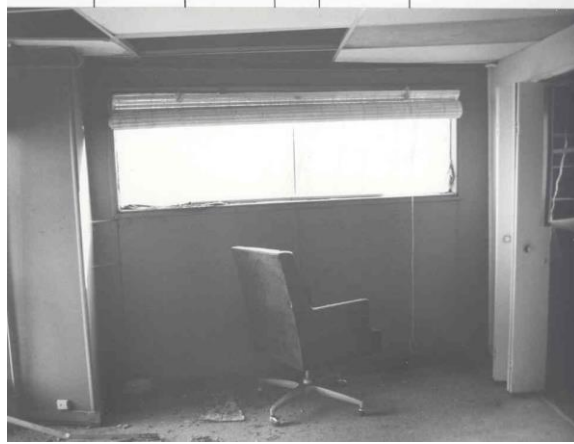
*Type* - Single-paned Steel Frame Rectangular Fixed Window (two lights) – Horizontal Orientation

*Locations* - Mechanical Room, Bedroom/Workshop

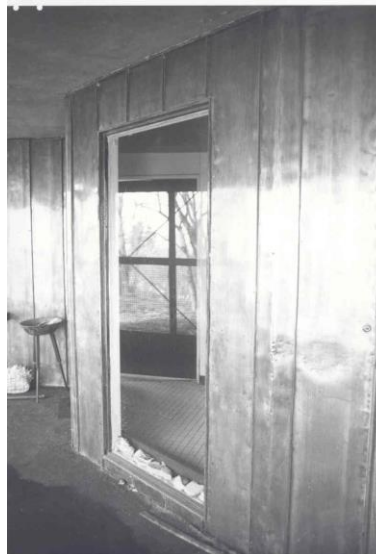
*Type* - Single-paned Steel Frame Rectangular Fixed Window (one light) – Vertical Orientation

*Location* - Entry

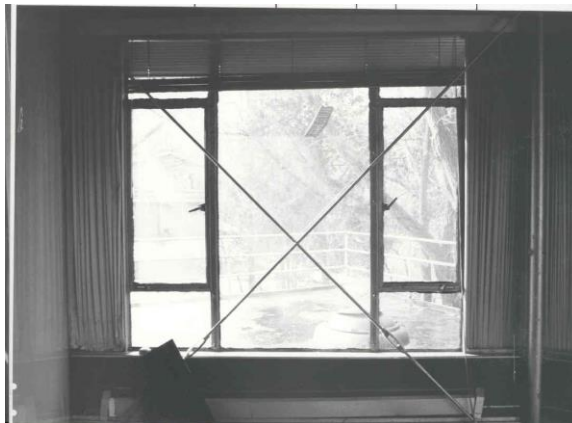
*Type* - Single-paned Steel Frame Three-part Window – Central section fixed, outer sections casements with a small fixed light above and below the casement

*Locations* – Second and Third Floor - all rooms
