# PATTERSON-MCDERMOTT CABIN

KLONDIKE GOLD RUSH  
NATIONAL HISTORICAL PARK  
SKAGWAY, ALASKA

## HISTORIC STRUCTURE REPORT

2018

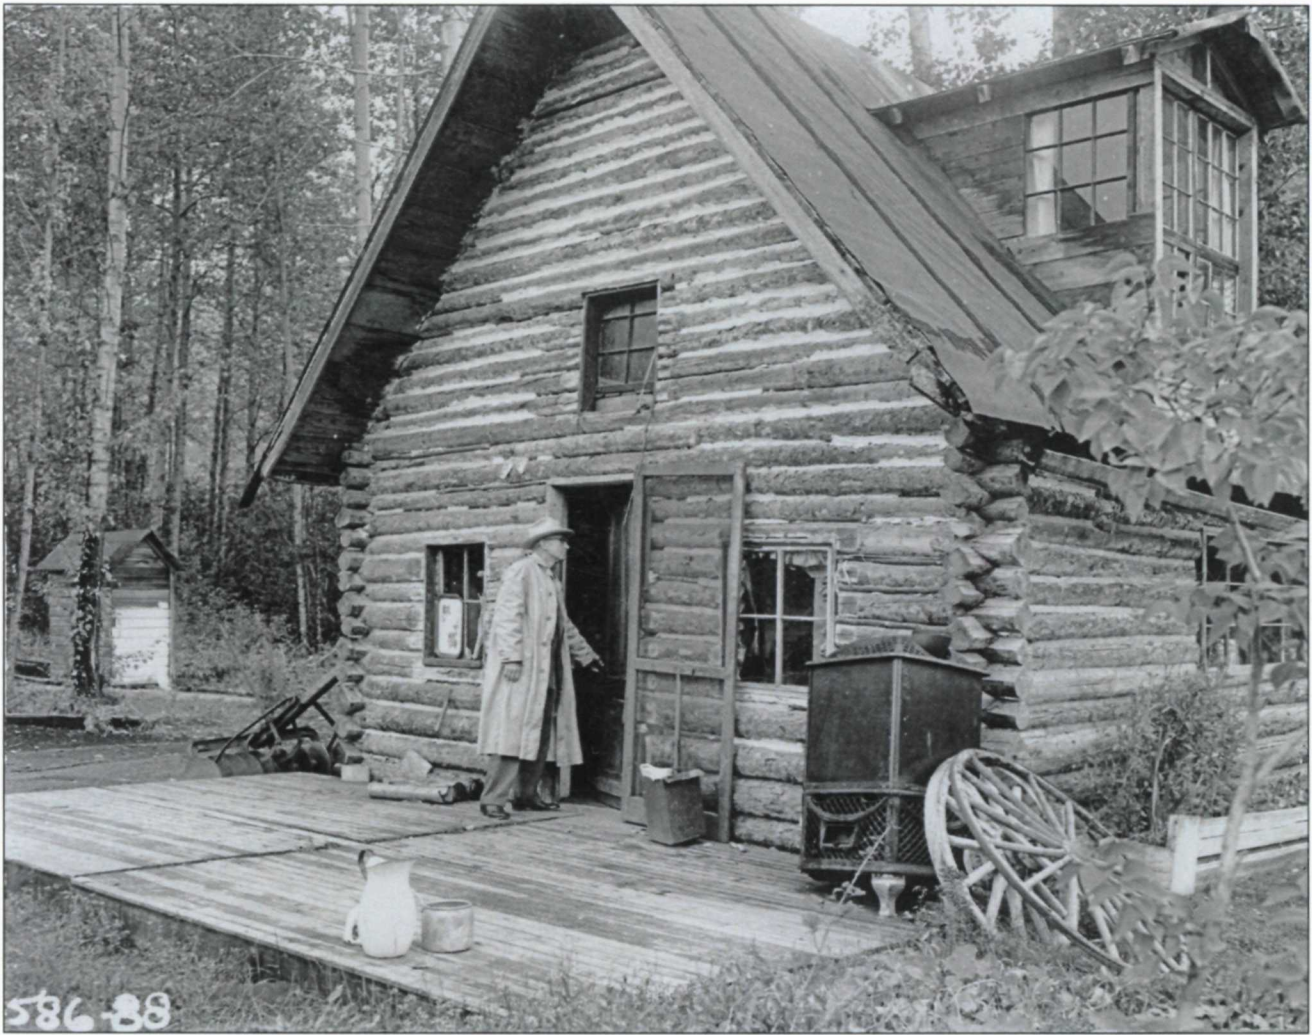
**Figure 21.**  
Patterson Cabin, north and  
west elevations (586-88),  
photographed by Hunter  
Gruening, September 1952  
(NPS, KLGO, Steve Hites  
Collection).

- Ensure doorway is compliant with the ADA and ABA.
  - Construct a replica four-panel wood sash door and screen door, per historical photographs dating to 1952 (Figures 21 & 24).

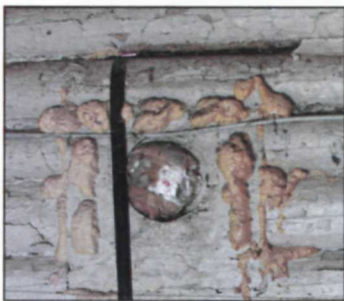
**Figure 22.**  
Interior portion of wall thimble,  
remnant from Patterson era  
stovepipe, photographed by  
Kathleen Wackrow, NPS, April  
2016 (NPS, AKRO, Historic  
Architecture, Patterson Cabin  
Digital Files).

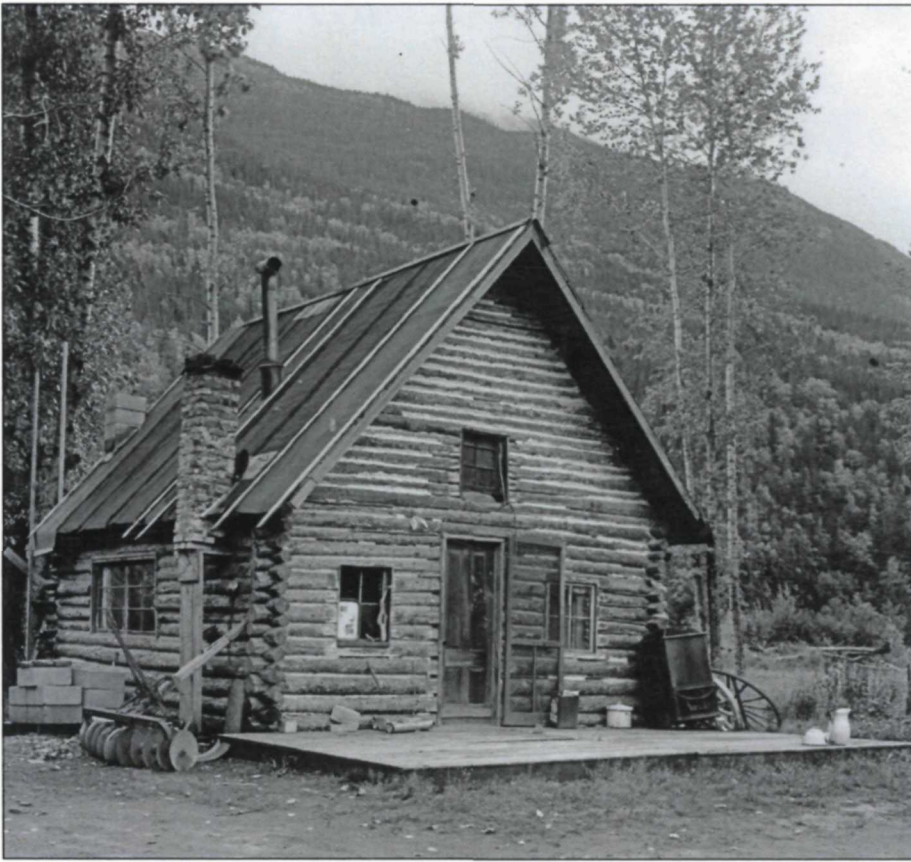
**Figure 24.** Patterson Cabin, north and east elevations (586-87), photographed by Hunter Gruening, September 1952 (NPS, KLGO, Steve Hites Collection).

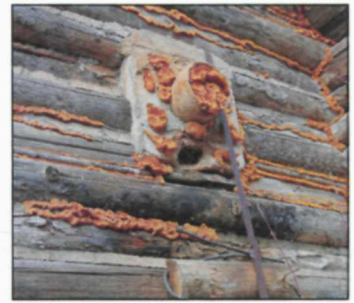
**Figure 23.** Exterior portion of wall thimble, remnant from Patterson era stovepipe, photographed by Kathleen Kathleen Wackrow, NPS, April 2016 (NPS, AKRO, Historic Architecture, Patterson Cabin Digital Files).

The south elevation contains several areas with spray foam and Portland cement in the log joints (Figure 64). On the east end of the elevation, there is an 8" diameter concrete thimble associated with a Patterson-period wood burning stove and chimney. The thimble marks where the stove pipe penetrated the log wall and entered a concrete block chimney (no longer extant). Historical photographs, taken in 1971 by Theodore R. Merrell and in 1952 by Hunter Gruening, reveal the chimney configuration during the Patterson period (Figures 26 & 29).

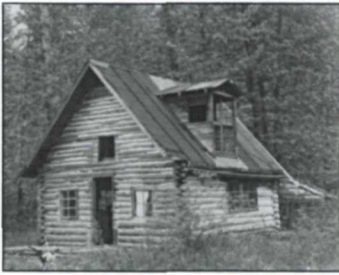
**Figure 27.**

In June of 1962, approximately 6-7 years after the Pattersons left the cabin in Dyea for California, Carl Mulvihill, a long-time Skagway resident, photographed the building (Figure 27). At this time, the building had broken windows above the door and in the dormer.

Patterson Cabin, north and west elevations, photographed by Carl Mulvihill, June 1962 (NPS, KLGO, Carl Mulvihill Collection).

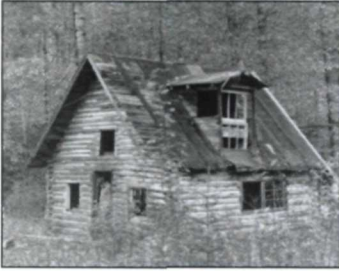
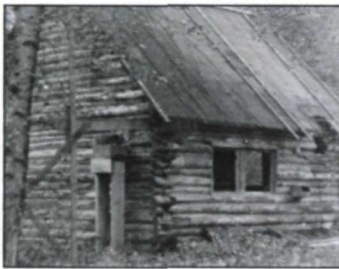
In the fall of 1971, three scientists traveled from Juneau to Dyea to evaluate the effects the proposed Yukon-Taiya hydroelectric project would have on the environment, particularly fisheries. Initially proposed in the 1950s, this project intended to use water from the Yukon River's headwater lakes in Canada to create electricity for an Alcoa, Inc. aluminum smelter near Skagway, Alaska—routing the water through tunnels through the Chilkoot Pass. U.S. Fish and Wildlife Service employee Theodore R. Merrell was joined by two biologists, Dale Evans and Mel Monson, from the Auke Bay Laboratory out of Juneau, Alaska. Merrell brought his Speed Graphic 4x5 camera to document the area, and photographed the building, which was unused at the time.<sup>57</sup> Merrell photographed all sides of the building, revealing a missing chimney and many broken windows (Figures 28 & 29).

Patterson Cabin, north and west elevations (DV-43-5530), photographed by Theodore R. Merrell, 1971 (NPS, KLGO, Theodore R. Merrell Collection).

Patterson Cabin, south and east elevations (DV-29-5460), photographed by Theodore R. Merrell, 1971 (NPS, KLGO, Theodore R. Merrell Collection).

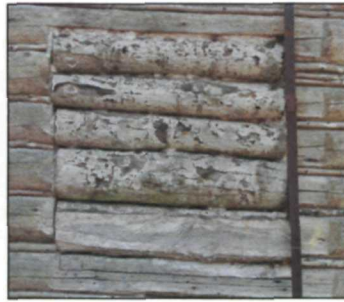
During their tenure, the Pattersons used a ladder inside to access the second story. The McDermotts filled-in the window on the first floor of the north elevation (Figures 32 & 22), and subsequently replaced the Pattersons' ladder with a wood staircase (Figures 13 & 34). A single railing flanking the staircase opening to the south was acquired by Alf Kalvick, Lorna's father, and installed by the McDermotts for safety purposes. Above the staircase, they installed fiberglass insulation sheathed with gypsum wall board.

**Figure 33.** Former first-floor window (to the west), filled-in by McDermotts, north elevation, photographed by Kathleen Wackrow, NPS, April 2016 (NPS, AKRO, Historic Architecture, Patterson Cabin Digital Files).

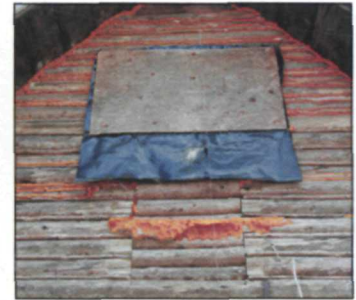
The McDermotts also filled-in the existing rectangular window just above the door on the north elevation (Figures 32 & 35). This window was aligned with the foot of the second floor. The McDermotts, who determined that it was impractical to have a window at their feet, removed the six-paned wood window and filled-in the window opening with cottonwood logs. The McDermotts cut a new, larger window opening in the gable peak, and installed a single-paned awning window.

**Figure 35.** Former second-floor window, filled-in by McDermotts, north elevation, photographed by Kathleen Wackrow, NPS, April 2016 (NPS, AKRO, Historic Architecture, Patterson Cabin Digital Files).

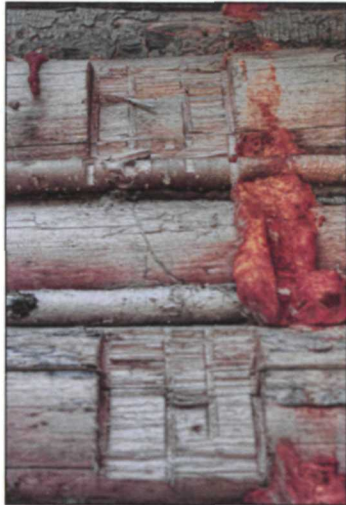
The first floor walls of the north elevation contain peeled logs, while approximately 50% of the logs comprising the gable peak are barked (Figure 56). Two vertical strips of square-shaped hewn cut-outs in the log walls are present between the first floor windows and the log crowns (Figures 57 & 58). These are the only remnants of a shed-roofed kitchen addition, added by the McDermotts at an unknown date between 1977 and 1983.

**Figure 58.**  
Remnants of former shed roofed  
kitchen addition, north elevation,  
photographed by Kathleen  
Wackrow, NPS, April 2016 (NPS,  
AKRO, Historic Architecture,  
Patterson Cabin Digital Files).

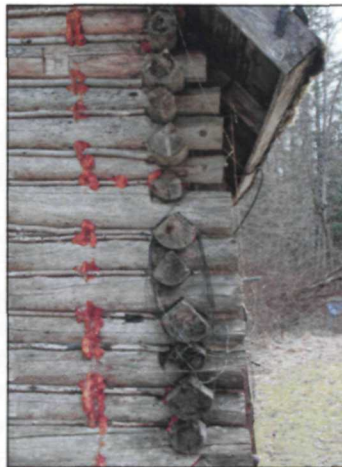
**Figure 59.**  
Utility wire, north elevation,  
photographed by Kathleen  
Wackrow, NPS, April 2016 (NPS,  
AKRO, Historic Architecture,  
Patterson Cabin Digital Files).

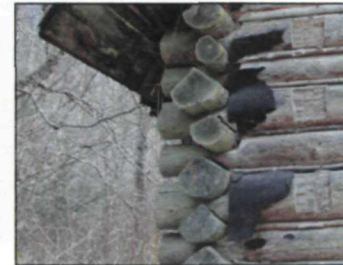
**Figure 57.**  
Remnants of former shed roofed  
kitchen addition, north elevation,  
photographed by Kathleen  
Wackrow, NPS, April 2016 (NPS,  
AKRO, Historic Architecture,  
Patterson Cabin Digital Files).

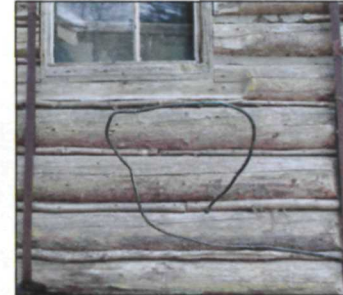
There is also a copper propane pipe on the east portion of the north elevation, below the eastern-most first floor window (Figure 60). An electrical wire has penetrated through the log walls, just west of the in-filled window above the door (Figure 55).

**Figure 60.**  
Copper Propane Pipe, north  
elevation, photographed by  
Kathleen Wackrow, NPS, April  
2016 (NPS, AKRO, Historic  
Architecture, Patterson Cabin  
Digital Files).

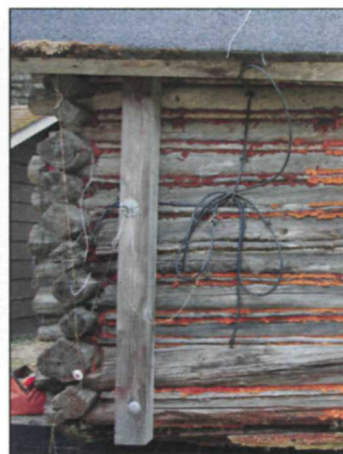
At the northern-most end of the elevation, there are wires that were associated with John McDermott's CB antenna (Figure 63). The northwest corner of the shed roof of the dormer is pierced with a hole that once held the mast for the CB radio antenna.

**Figure 63.**  
Radio wires, west elevation, photographed by Kathleen Wackrow, NPS, April 2016 (NPS, AKRO, Historic Architecture, Patterson Cabin Digital Files).

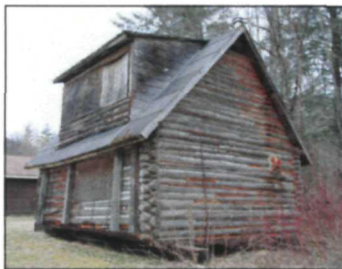
**Figure 64.**  
South elevation, photographed by Kathleen Wackrow, NPS, April 2016 (NPS, AKRO, Historic Architecture, Patterson Cabin Digital Files).

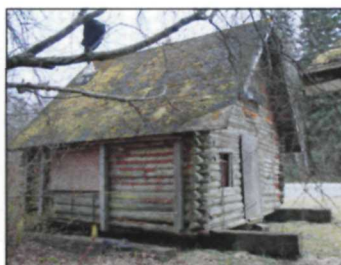
The east elevation is a mirror image of the west elevation, without the dormer (Figure 65). The elevation has one window opening, located south of center. It is a large, horizontally oriented, rectangular window opening covered in a sheet of plywood. In 2002, a triple window, comprised of three six-pane wood sash windows, was removed from this opening, in preparation for the

**Figure 65.**  
East elevation, photographed by Kathleen Wackrow, NPS, April 2016 (NPS, AKRO, Historic Architecture, Patterson Cabin Digital Files).

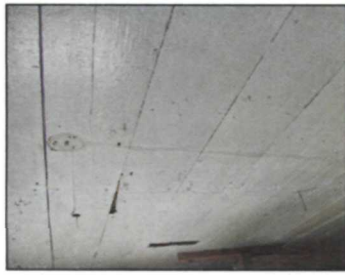
**Figure 75.**

In the center of the ceiling, a rectangular-shaped cut-out is evidence of damage caused by theft of the well point, a remnant of the Patterson period

First floor ceiling and well point remnant, photographed by Kathleen Wackrow, NPS, April 2016 (NPS, AKRO, Historic Architecture, Patterson Cabin Digital Files).

(Figure 76). An individual entered the house, created a pulley system in the ceiling to lift up the well point from a well (no longer extant). The pulley system likely damaged the ceiling, and the McDermotts cut the hole out of the ceiling to remediate the damage.

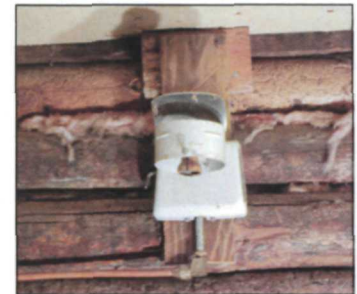
In the gable peak of the north wall of the second floor, there is the remnant of a propane light fixture, associated with the McDermott period of occupation (Figure 83).

**Figure 83.** Propane lamp, second floor (attic), photographed by Kathleen Wackrow, NPS, April 2016 (NPS, AKRO, Historic Architecture, Patterson Cabin Digital Files).

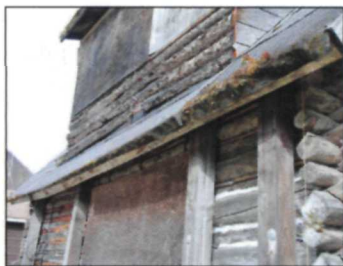
**Figure 89.** Biological growth, west elevation, photographed by Kathleen Wackrow, NPS, April 2016 (NPS, AKRO, Historic Architecture, Patterson Cabin Digital Files).

The fascia and the logs on the west elevation have black mold and heavy biological growth (Figure 89). A RYOBI Pinless Moisture Meter (Model E49MM01) indicated that the logs on this elevation are overly dry, with approximately 1% moisture content in some areas. The roof, at the north edge of the dormer, has a significant amount of biological growth (Figure 90).

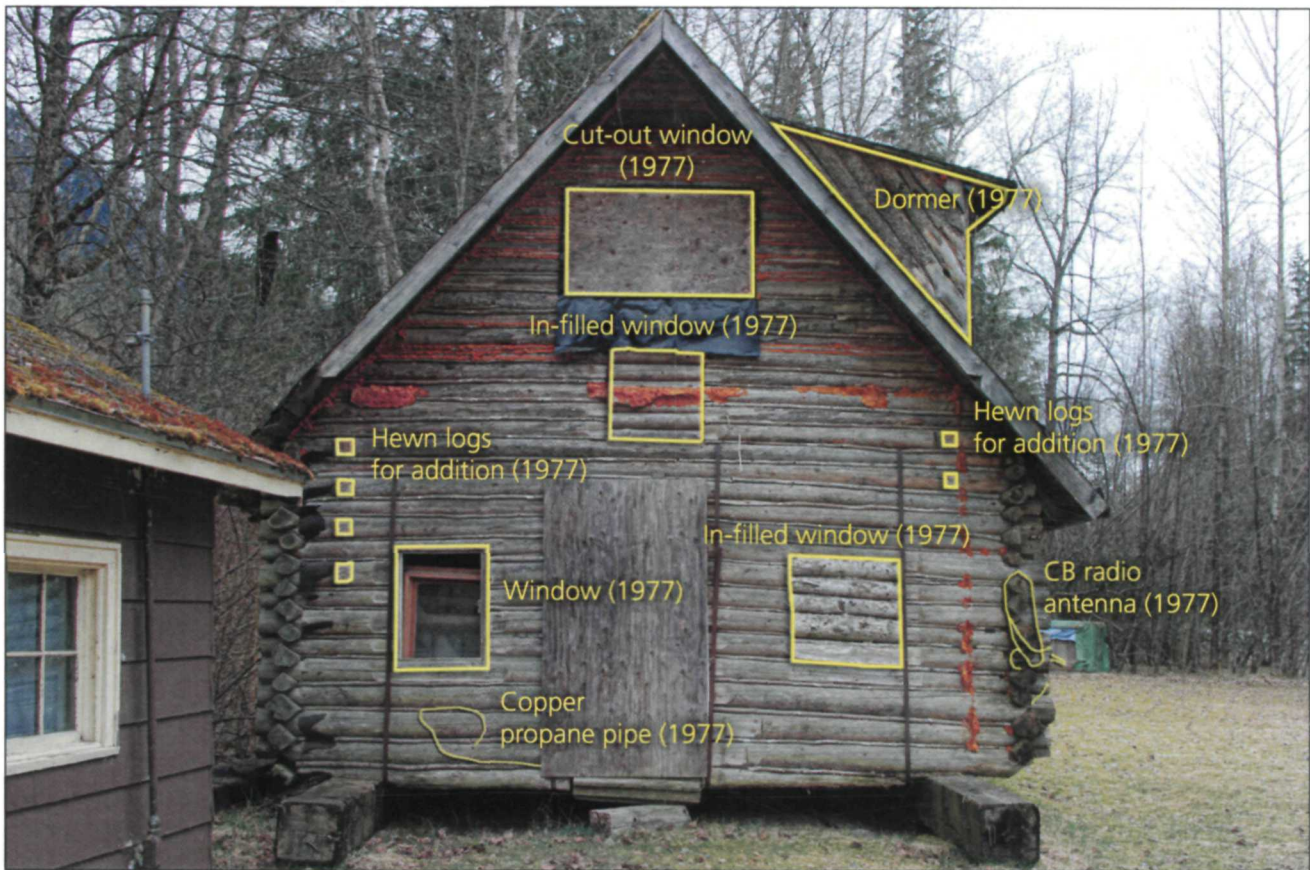
McDermott Era Modifications, North Elevation.

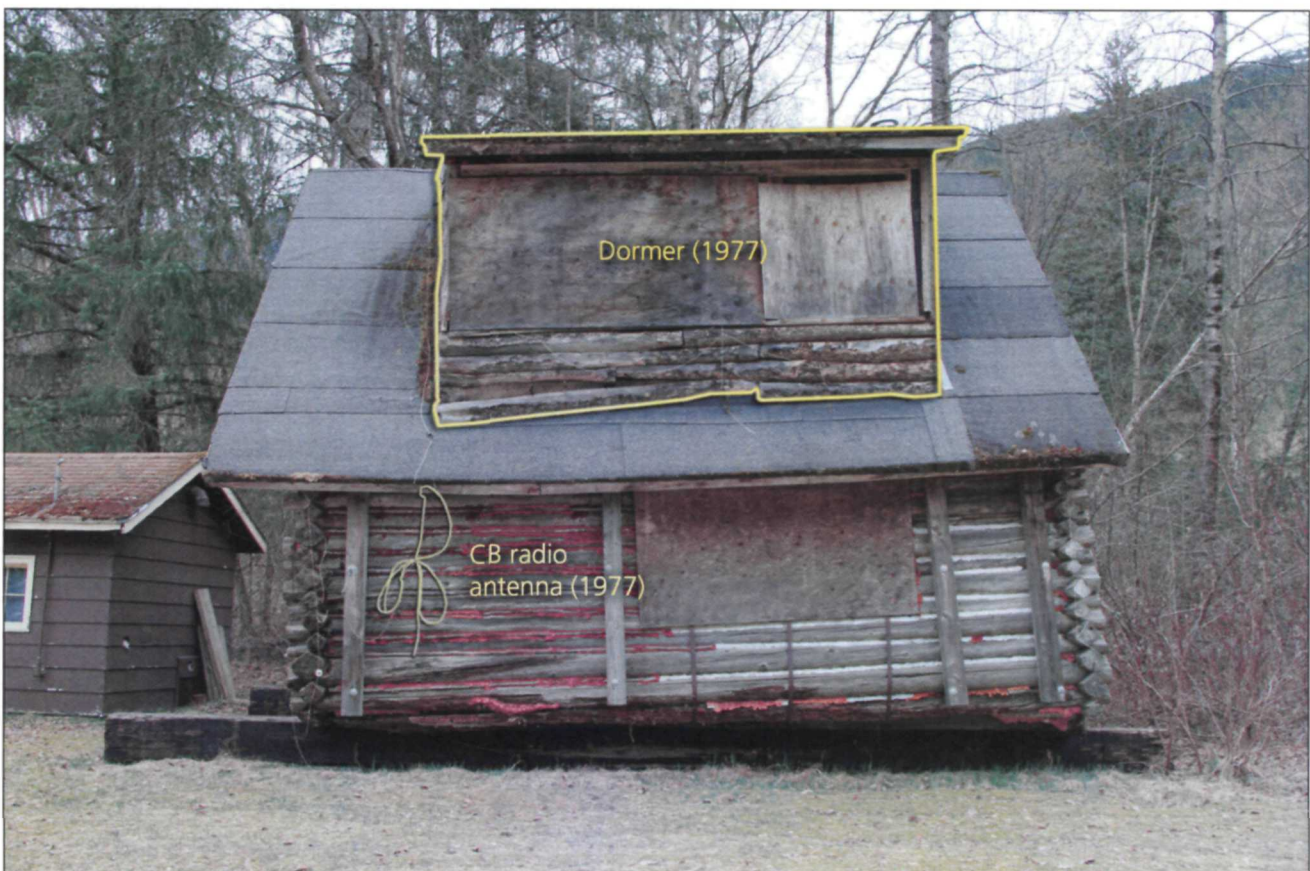
McDermott Era Modifications, West Elevation.

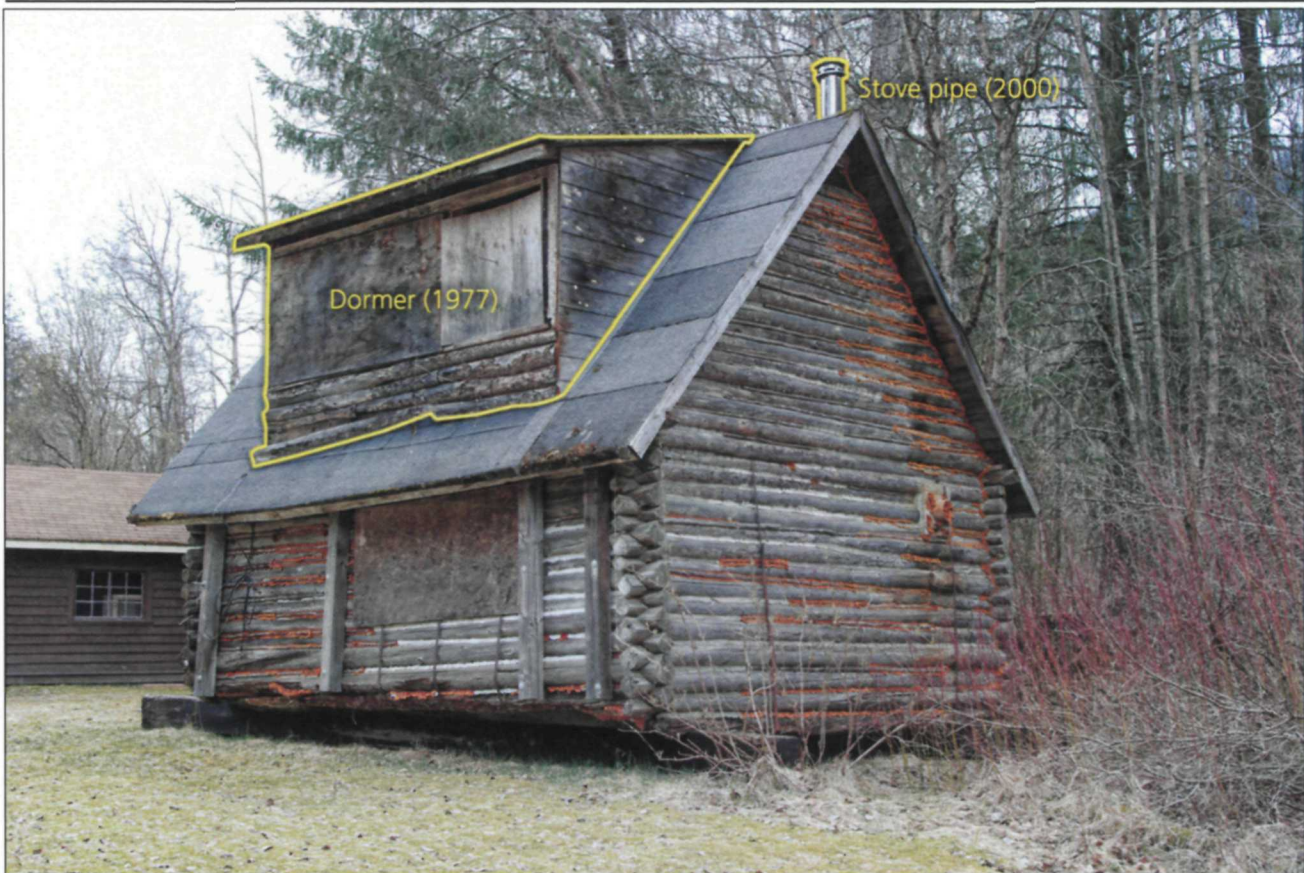
McDermott Era Modifications, West and South Elevations.

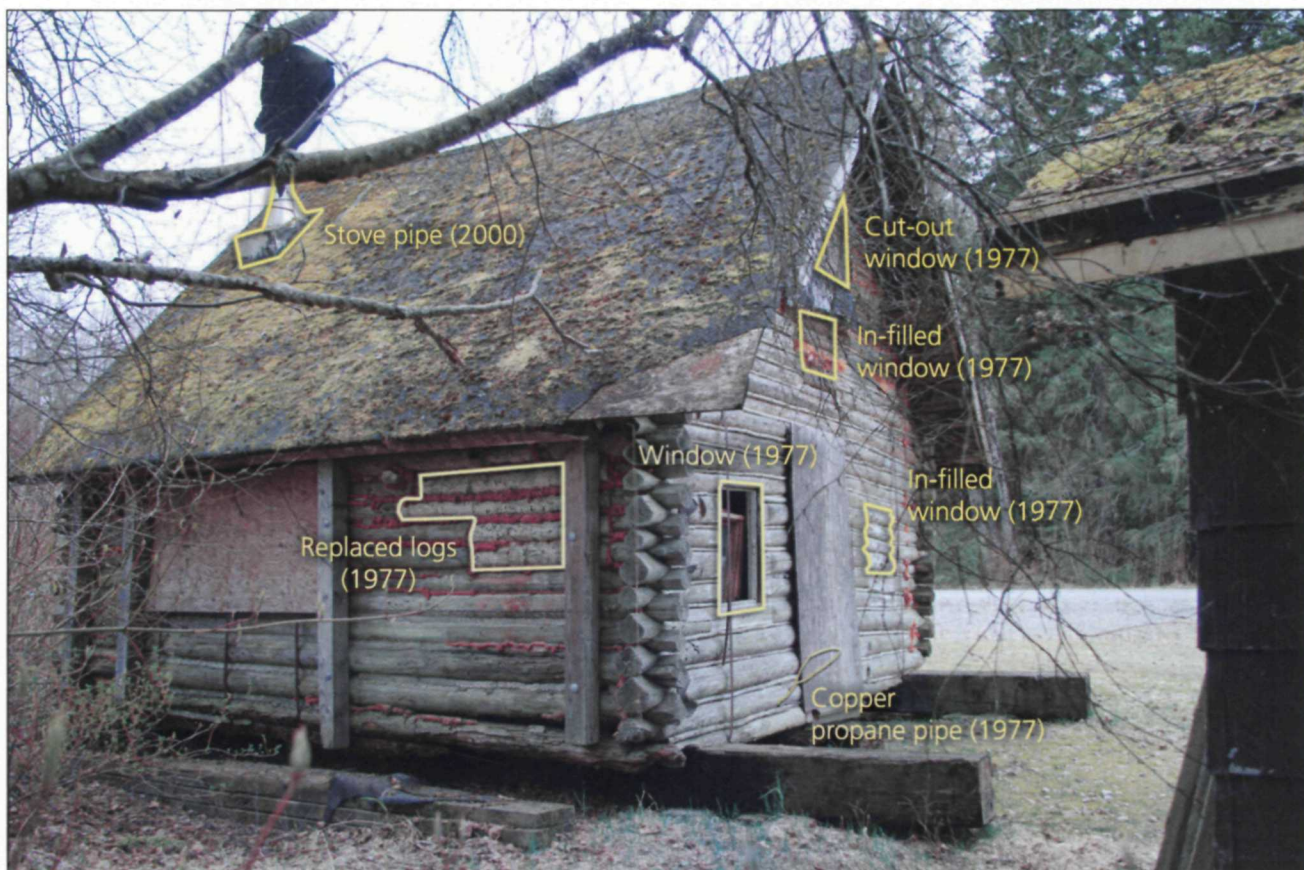
McDermott Era Modifications, East and North Elevations.

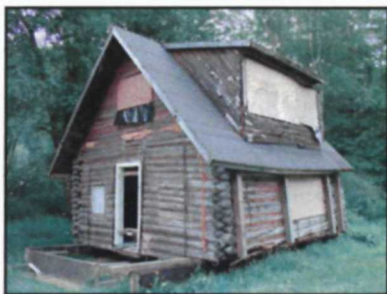
Overview NW

Building has been moved from its original location and is now temporarily mothballed. Plans are to move it to the Dyea Townsite. Recommendations in this plan are based on preserving cabin as a historic structure for interpretative purposes.

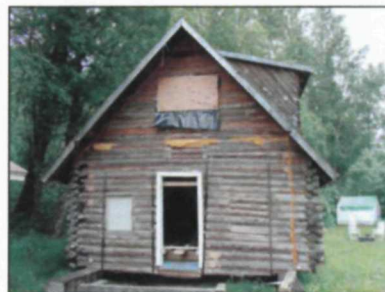
North Elevation

Many changes have been made to the structure, especially in the last 35 years. East and west windows have been made wider, a window cut into the gable end, and dormers included. Some windows and chimney openings have been infilled or modified. It is not possible to return all of the changes back to the building's original or earlier appearance.

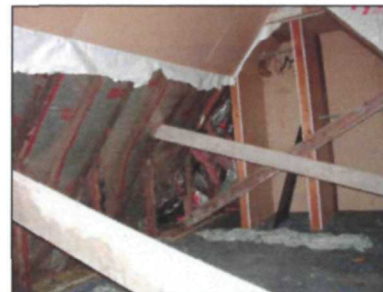
**Existing**

Roof structure and appearance of 2nd level has undergone much change and visible alteration. Upper level cannot be occupied.

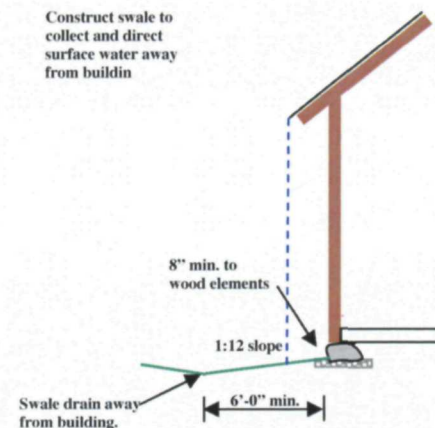
Trees at current temporary location are impacting building. Trim back tree branches within 25' of building.

Keep vegetation cut to ground within 15' of building.

Construct swale to collect and direct surface water away from building
