Lincoln Home National Historic Site  
Springfield, Illinois

## Historic Structure Report

May 19, 2023

Prepared by: Seven Generations Architecture + Engineering

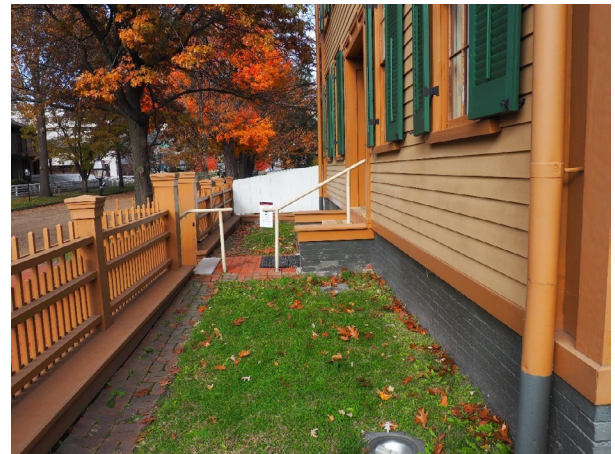
The south and west fences are 7'-0" tall. The fence on the north side of the site is 4'-0". At the time of the site visit there was a 1'-4" wide brick lined gutter on the inside of the brick retaining wall in the front yard. [Figure C.9.] This gutter turned west to extend across a portion of the north elevation, where it widened to 3'-6". The NPS removed the gutter between the time of the site visit and the completion of the final report as part of a wall repair project. Small scale features at the site include ground mounted metal spot light fixtures in the front yard and a wayside, two nonfunctioning hand pumps, and a trash receptacle in the rear yard. All downspouts from the house are routed underground. There has been extensive archeology performed at the Lincoln Home site. Most of the area under the barn, privy, and wood shed buildings has been previously excavated. The area under the south porch has also been documented by archeology. Archeology has identified the locations of a former cistern and well in the rear yard. A 1987 archeological study also reveals a location of a possible outbuilding east of the house.<sup>137</sup> This report identifies the yard midsection as an area of high archeological potential.<sup>138</sup>

**Figure C.9.** View facing north of the brick gutter that lines the inside of the brick retaining wall in the front yard. The gutter widens and extends across the most of the north elevation of the building. Ground mounted metal spot light fixtures are in the grass along the façade of the building. Source: WLA Studio, 2021.

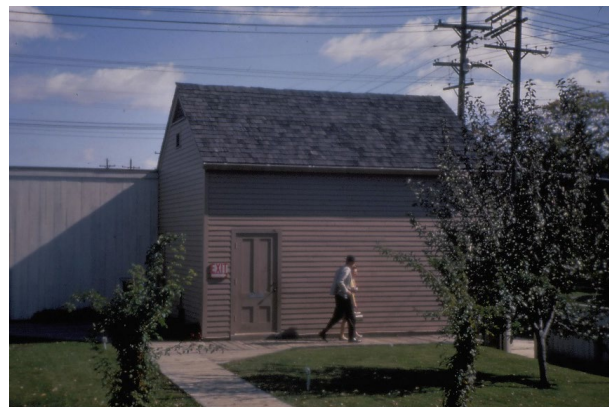
**Figure C.15.** Inaccurate reconstruction of barn and woodshed (1964), facing east, ca.1965. Source: LIHO Photo ID: B7F1P170

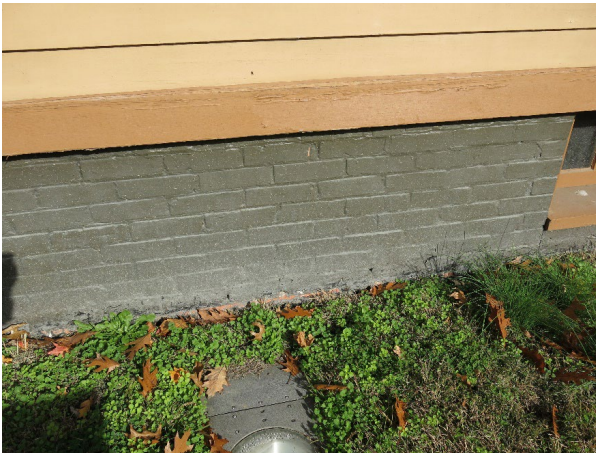
The Lincoln Home rests on a brick foundation that is exposed above grade. Most of this foundation dates from the construction of the house between 1839 and 1856, with partial reconstruction of part of the foundation along the north elevation in 1954 and 1987-1988. The brick is currently painted following evidence from past historic finish analysis.

**Figure C.25.** Detail of typical section of painted brick foundation. Source: RATIO Architects.

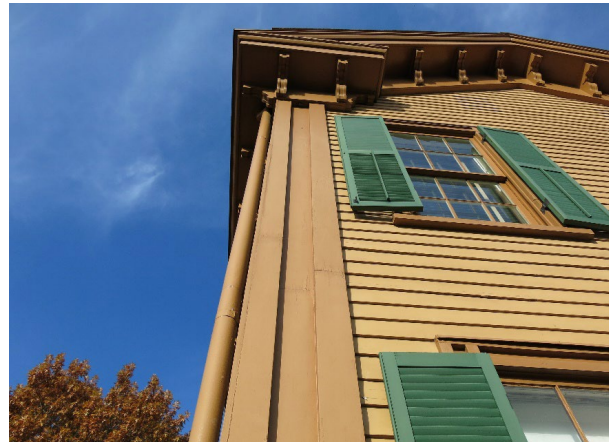
- Deterioration and failure along top of wood water table, particularly on the south elevation

**Figure C.26.** Detail of wood trim and siding at southwest corner of south elevation. Note the horizontal breaks in the boards forming the pilaster at center; these mark the top of the pilaster from 1839 until the second floor was raised in 1855. Source: RATIO Architects.

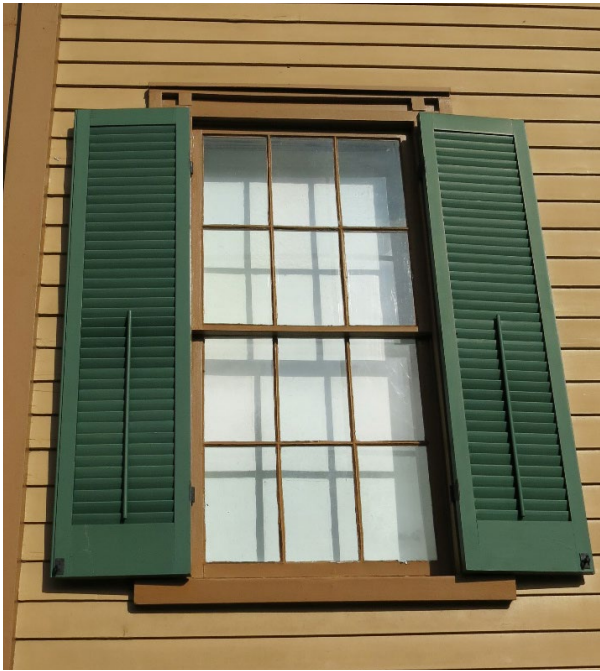
**Figure C.28.** Typical six-over-six window with paneled casing and louvered shutters. Source: RATIO Architects.

The windows are in good condition overall. The following issues were evident at the time of the site visit in November 2021:

- Limited failure of glazing putty and paint
- Limited paint failure below flashing at top of casing of window of room 105
- Paint failure on some exterior windowsills

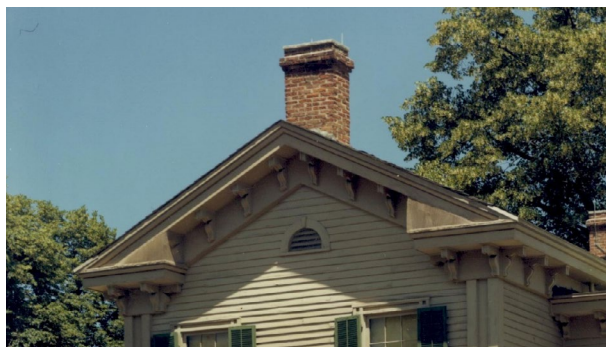
**Figure C.32.** Detail of ca.1977-1987 photograph of south elevation showing louvered attic vent added in the 1920s. No such vents were present during the period of significance. Note also the bird screens concealing the cornice returns. Source: LIHO Photo ID: B2F4P3.

Sometime between 1922 and 1927, louvered attic vents with horizontal sills, semicircular arched tops, and simulated keystones were added to the north and south gables of the west wing. The 1987-1988 restoration removed these vents, replacing them with inconspicuous ventilation openings created by routing the back of the weatherboard siding.

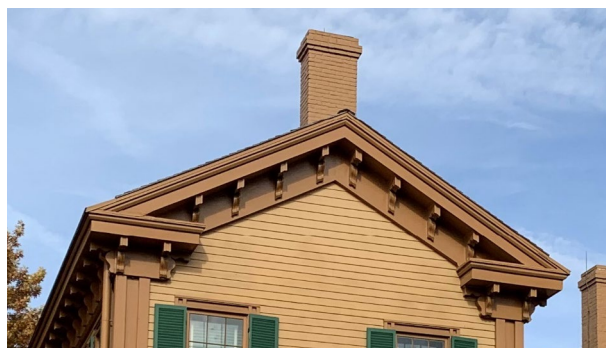
**Figure C.33.** Detail of south gable as restored in 1987-1988 with inconspicuous attic vents, November 2021. Source: RATIO Architects.

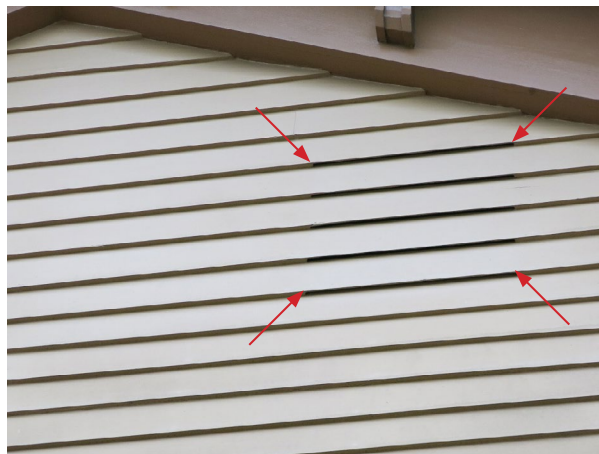
**Figure C.34.** Exterior detail of east concealed attic vent in south elevation, typical of the four vents installed during the 1987-1988 restoration, November 2021. These vents are effectively invisible to visitors. Source: RATIO Architects.

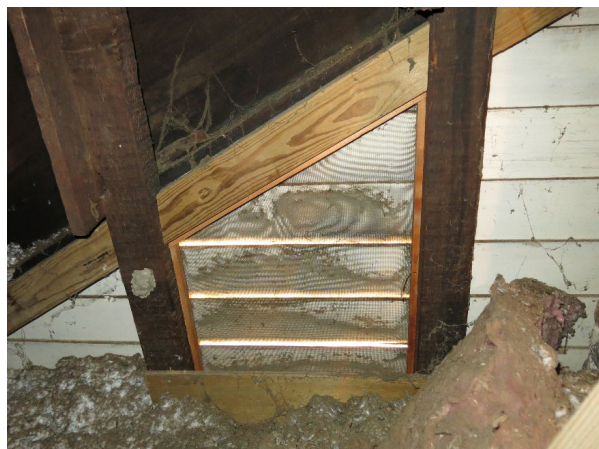
**Figure C.35.** Detail of interior of same vent showing insect screen, November 2021. Source: RATIO Architects.

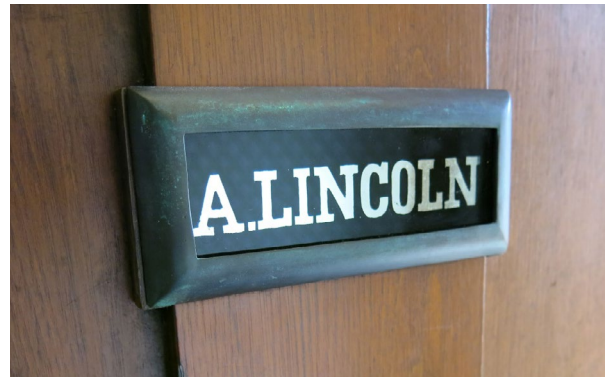
**Figure C.39.** Front door nameplate, November 2021. Source: RATIO Architects.

Krupka reports that the 1938 replica nameplate was then "in deteriorated condition." The replica was reinstalled on the front door at the completion of the 1987-1988 restoration. The following

In 1938, a glass and brass nameplate was placed on the front door of the Lincoln Home to replicate the original installed by Abraham Lincoln in the 1850s. The original was placed in storage at what is now the Abraham Lincoln Presidential Museum, the replica stayed on the front door since 1938. The door, which was not the original, has been replaced several times with the nameplate always attached in the center of the door. At some point, the nameplate, which is reverse silver leaf and paint on glass, was losing the paint so three straps of packing tape were applied directly on the paint to keep it attached. Some thin cardboard strips were also installed between the glass and the door, presumably to help keep the glass in the frame better. The nameplate is now badly in need of conservation. Some of the paint has irreversibly attached itself to the packing tape and the silver leaf is tarnished almost to the point that the silver and black paint all look the same. There is adhesive failure between the leaf and the black paint and some paint loss throughout. The glass has scattered scratches and the surface has a layer of grime.<sup>150</sup>

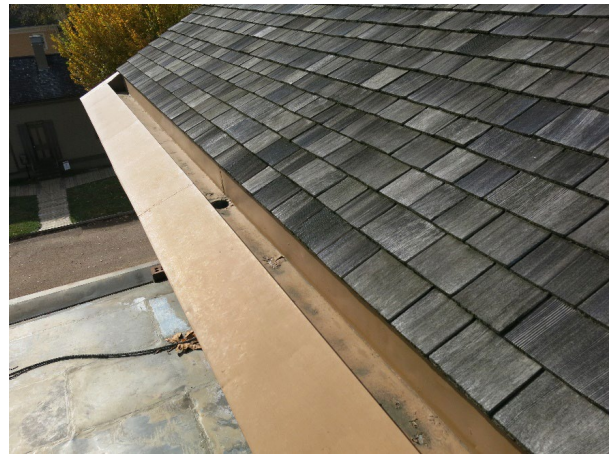
**Figure C.44.** Detail of west wing gutter, facing southwest, November 2021. Source: RATIO Architects.

The west wing roof features built-in gutters deeply recessed into the eaves at the west façade and east elevation. These gutters were framed with wood and lined with painted sheet metal. They retain the configuration documented in photographs taken between 1860 and 1865. The only difference from the conditions shown in those period photographs is that wood shingles do not continue down the slopes of the roof at the north and south ends of the gutter; this area is now clad in sheet metal, a modification that is largely invisible and is more resistant to leaks.

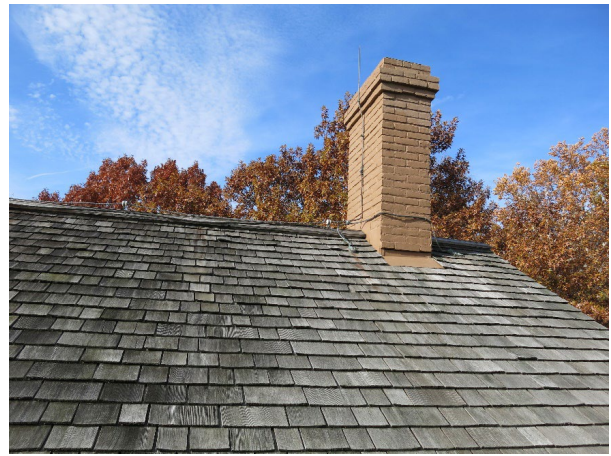
**Figure C.49.** Detail of lightning protection at north chimney of west wing, facing west-northwest, November 2021. Source: RATIO Architects.

The lightning protection system was replaced during the 1987-1988 restoration. At the west wing, this installation is similar in appearance to that present in 1860-1861. The concern noted by Krupka was addressed by passing the grounding wires through holes in the roof rather than wrapping them around the cornice. A 2019 condition assessment notes that five-gallon

buckets were in place within the attic, below each grounding wire penetration, but no water was present in either bucket at the time of inspection.<sup>193</sup> These conditions were also observed during the site visit in November 2021. The grounding wire on the north elevation runs down the face of the siding as shown in the 1860 photograph. At the east wing, lightning rods are provided at both chimneys and at the northeast and southeast corners of the roof. Grounding wires for this wing are connected to those of the west wing via penetrations through the east wall of the west wing and the east face of the west wing roof.

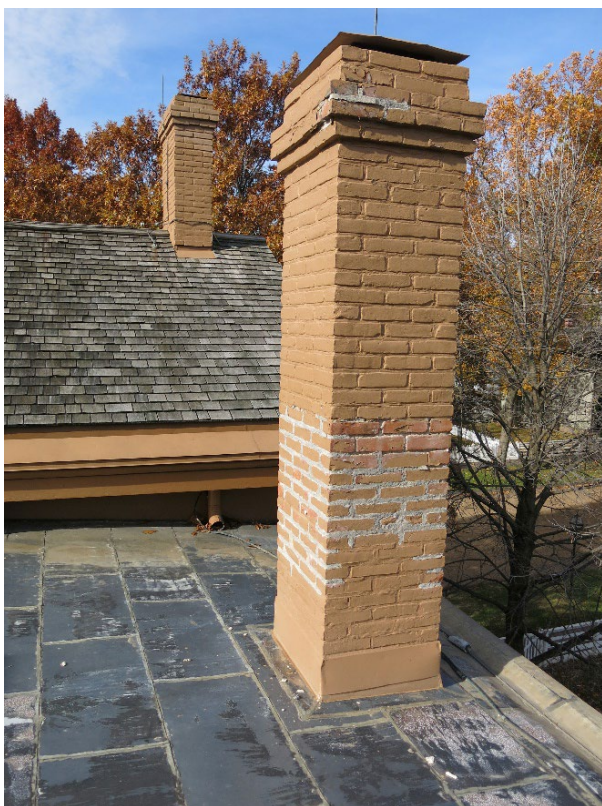
The chimneys appear to be in good condition overall. Sloppy repointing on the north chimney of the east wing was never painted and many of these joints have experienced failure. Active mortar loss and paint failure were observed on the necking at the southeast corner of this chimney and at areas near the past sloppy repointing. The south chimney of the east wing exhibits limited paint failure and brick spalling above and below the necking.

**Figure C.50.** North chimneys of east (foreground) and west wing, facing northwest, November 2021. Source: RATIO Architects.

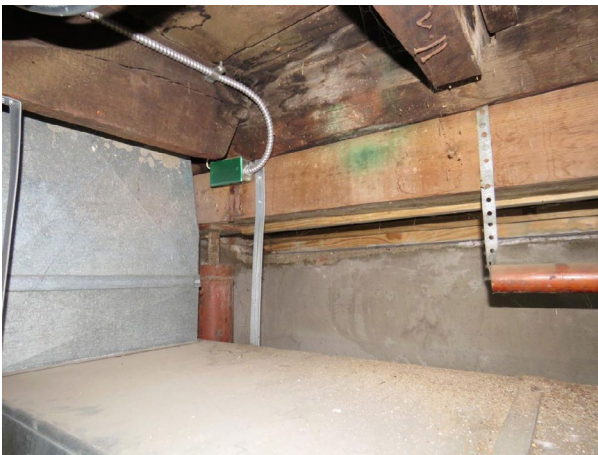
**Figure C.61.** View of an existing post and beam left from the 1954-1955 restoration. This post and beam can be seen from the basement, near the west entry. Source: Lawson Elser.

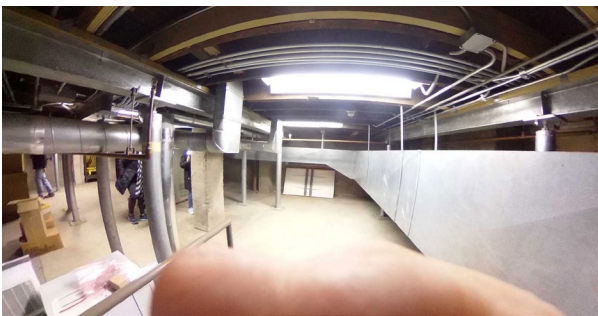
**Figure C.62.** View of the galvanized steel beams and posts supporting floor joists under the first floor. This view is looking west, under the north side of the basement. Source: Lawson Elser

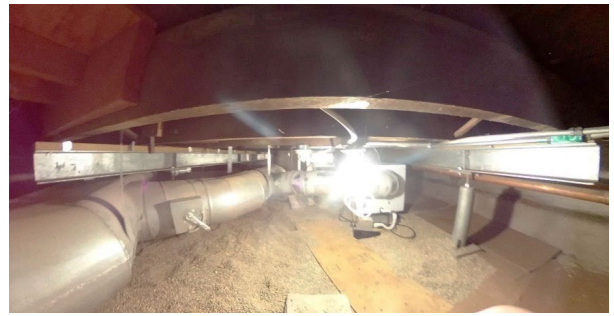
**Figure C.63.** View of the galvanized steel beams and posts supporting floor joists under the first floor. This view is looking east, under the south crawlspace. Source: Lawson Elser.

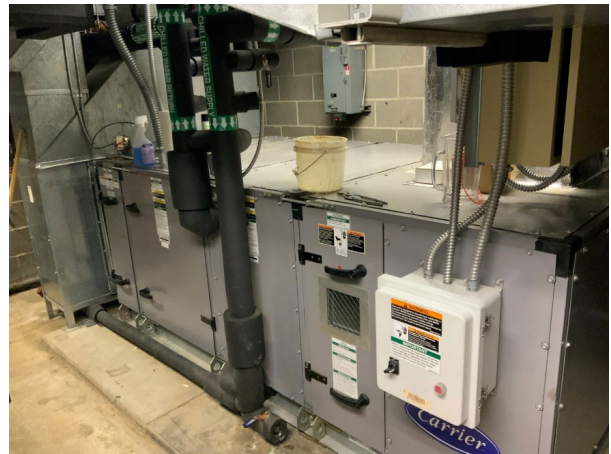
LIHO staff is concerned with the noise that is produced by the existing HVAC system; the chiller unit is loud and could disturb the visitor's experience. These intrusive noise conditions were noted by the design team during the site visit in November 2021. The Existing Conditions Report prepared by Melotte Morse Leonatti Parker Ltd. in

**Figure C.69.** Modular air handling unit installed in 2014. Source: H. F. Lenz

2019 notes that NPS's long-term goal for the LIHO campus includes a central geothermal loop under the sidewalks. Connecting the Lincoln Home to the campus geothermal loop would eliminate the need for any outdoor equipment (and the resultant noise). The indoor air handling unit would either be replaced with a modular water source heat pump unit or a water-to-water heat pump installed in the basement level to provide chilled/hot water to the air handling unit.

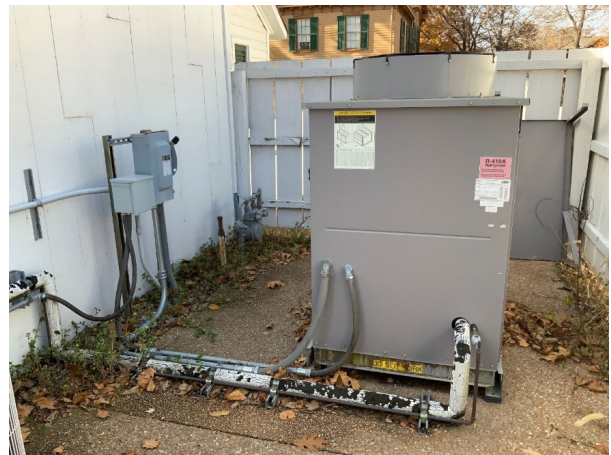
**Figure C.70.** Air-cooled chiller located in fenced in area adjacent to the barn. Source: H. F. Lenz

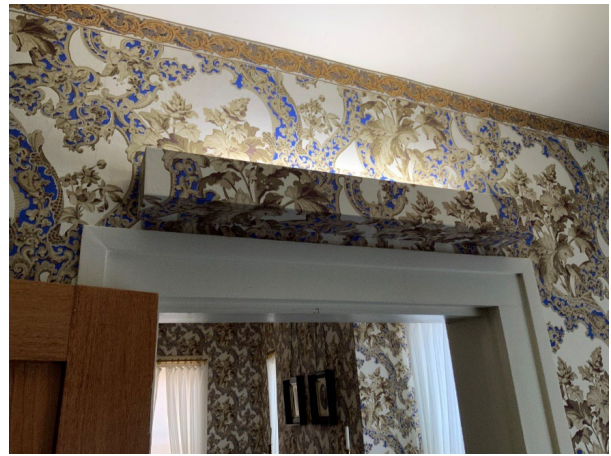
**Figure C.77.** Typical lighting installation for second floor bedrooms. Source: HF Lenz

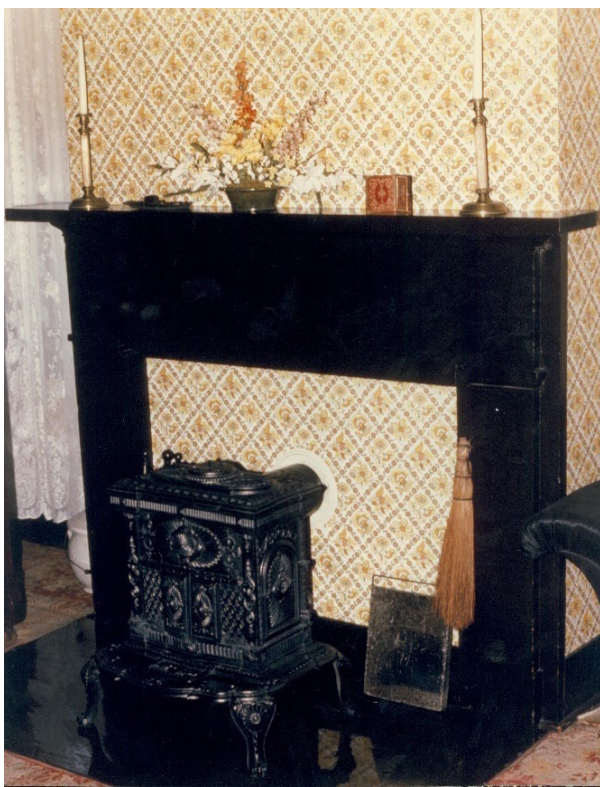
Wallpapers installed during the 1960s and 1970s tended to be unsuitable for the period of interpretation. Many of these were contemporary papers intended for “Early American” interiors and bore no resemblance to papers the Lincolns would have had. Bearss reported that, during his 1972 site visit, he found that “Boxes of wallpaper ordered from Katzenback & Warren, Thomas Strahan Co., and Valentyn Bing were stored in the southwest corner [of the basement]. As these

**Figure C.90.** Wallpapers installed in the 1960s and 1970s, including this contemporary “Early American” style wallpaper in room 208, bore no resemblance to papers the Lincolns would have had. Source: LIHO Photo ID: B7F17P2.

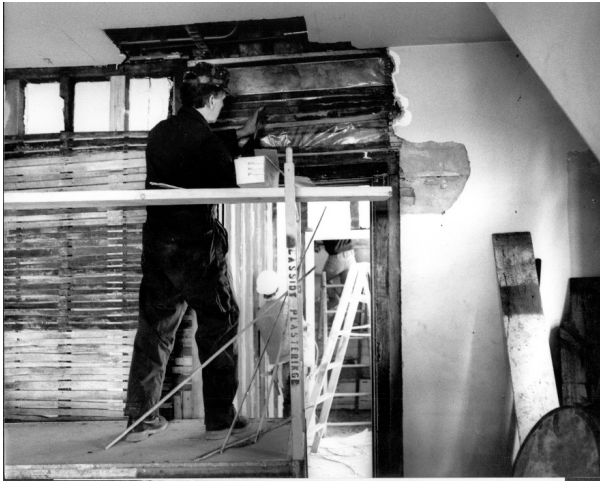
**Figure C.137.** View north in Kitchen, 1987-1988. Note riven lath exposed at wall to left of door. The second stud from left shows a rabbet for a half-lapped floor joist at the original ceiling height prior to the raising of the ceiling in 1856. Source: LIHO Photo No. B4F26P10.

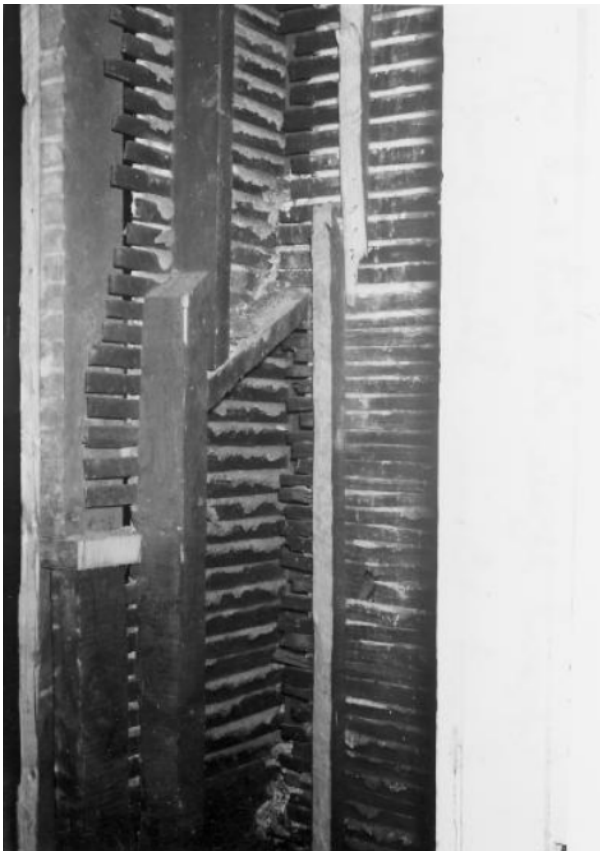
**Figure C.172.** View of back side of lath of north wall of room 208 (left) and east wall of room 200 (right), looking through cavity from northwest corner of room 207, photograph by James T. Hickey, June 1954. The angled board at left marks the slope of the ceiling from 1839 to 1855. Surviving riven (split) lath from 1839 is visible on the lower part of the wall at right, with sawn lath from 1855 elsewhere. Source: Courtesy of the Abraham Lincoln Presidential Library & Museum..

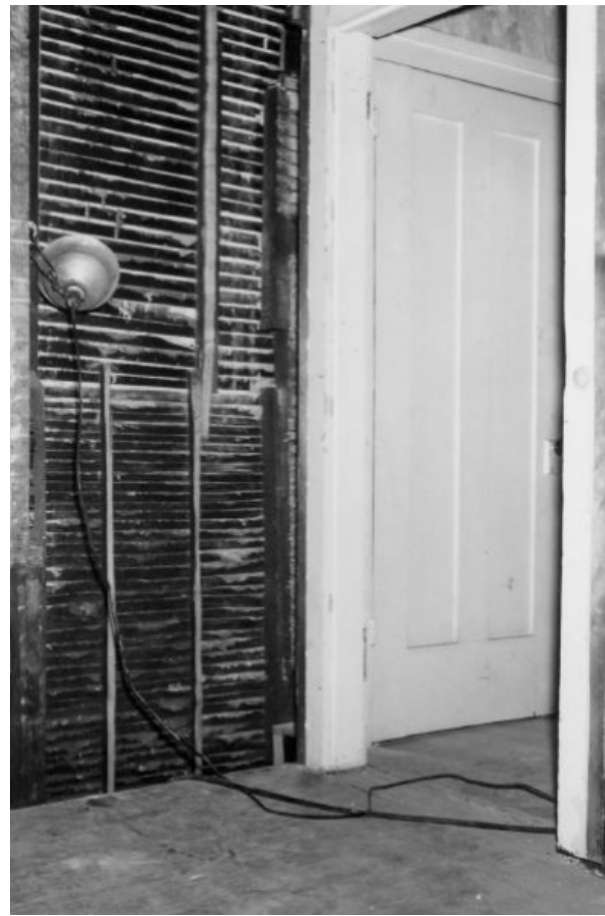
**Figure C.173.** View of back side of lath of east wall of room 200, looking through cavity from northwest corner of room 207, photograph by James T. Hickey, June 1954. Surviving riven (split) lath from 1839 is visible on the lower part of the wall, with sawn lath from 1855 above. Source: Courtesy of the Abraham Lincoln Presidential Library & Museum.

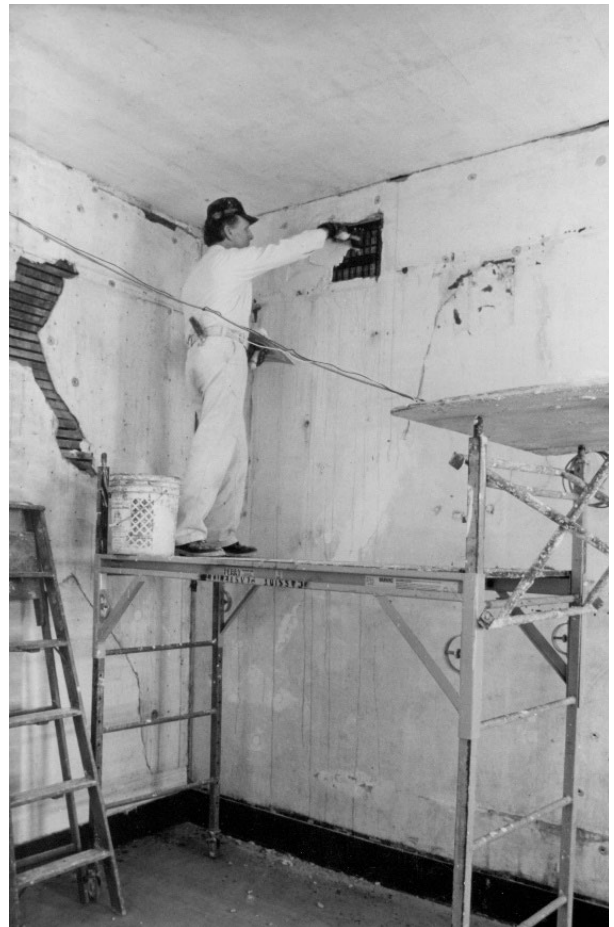
**Figure C.186.** Plaster repair at south wall of room 201, facing southeast, 1987-1988. Source: LIHO Photo ID: B3F13P24.

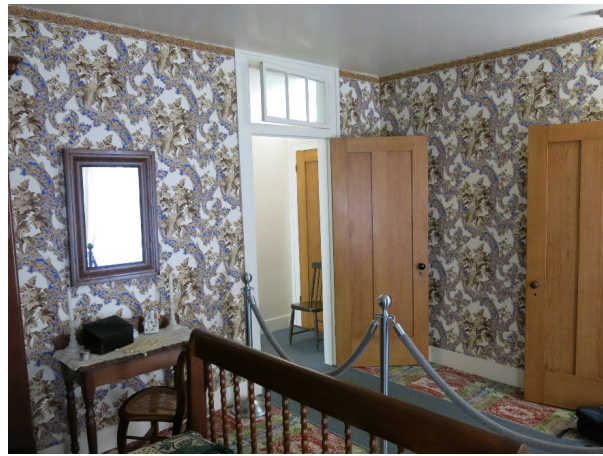
**Figure C.203.** View southwest in room 202, November 2021. Transom will not close because the sash has warped. Source: RATIO Architects.

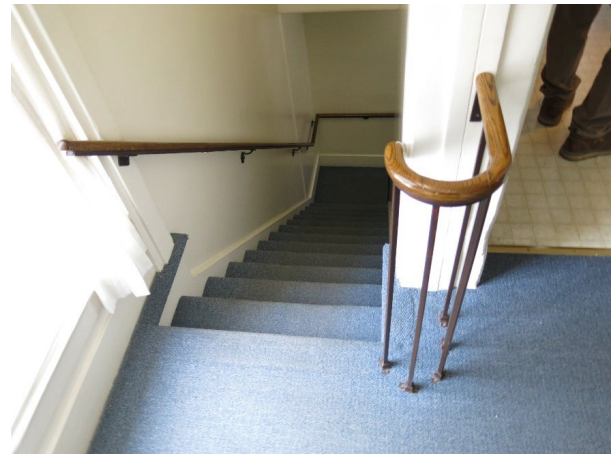
This new kitchen staircase solved the Lincolns' immediate problem, albeit awkwardly. Its original (57°) slope was even steeper than that of the stairlet... Rebuilt by the State of Illinois in 1954, the finished soffit of this less steep replacement staircase now passes in front of the upper corner of the existing east kitchen window, a situation that did not exist during Lincoln's lifetime.<sup>198</sup>

**Figure C.216.** Back staircase as modified in 1954, encroaching into room 204, November 2021. Source: RATIO Architects.

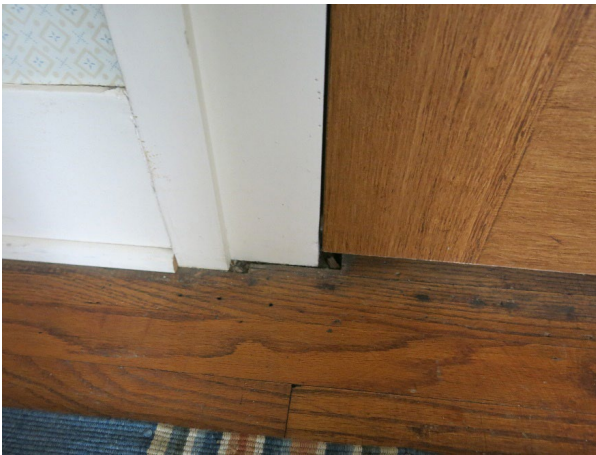
**Figure C.231.** Misalignment between closet door as reconstructed in 1987-1988 restoration and pre-1954 oak flooring with outline of opening infilled in 1954, facing east, November 2021. Source: RATIO Architects.

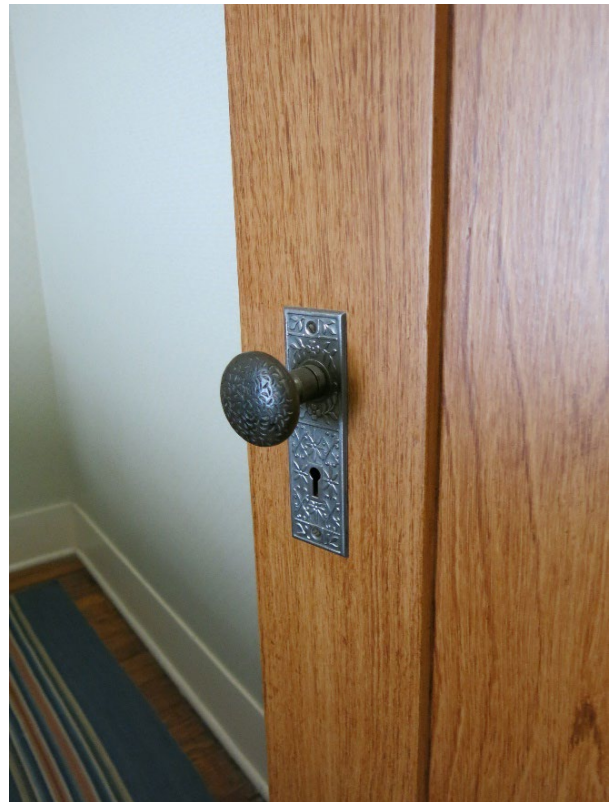
**Figure C.232.** Detail of knob and escutcheon of between rooms 204 and 207, November 2021. This hardware dates from ca.1880-1905 and is inappropriate for the period of interpretation. However, it is not clearly visible. Source: RATIO Architects.

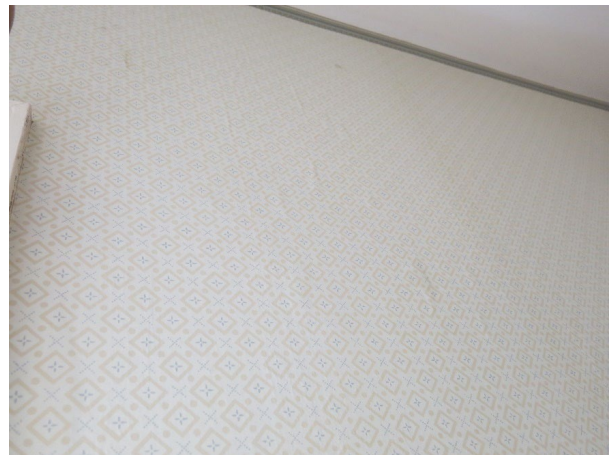
Lattice,” a reproduction of a ca.1860 American sidewall paper found in the Grevenberg House (1851) in Franklin, Louisiana, reproduced by Mt. Diablo Handprints of Benicia, California in a custom colorway of blue and tan on a cream ground. The top half of the same border used for the Parlors was used in this room. This was “Locust Grove Border” (No. 81228), an English paper dated to ca.1850-1860 and reproduced by Scalamanré of New York from that hung in the drawing room of Samuel F. B. Morse’s “Locust Grove” (1851, Alexander Jackson Davis) in Poughkeepsie, New York.<sup>222</sup> The sidewall paper exhibits some bubbling and discoloration.

**Figure C.233.** Detail of wallpaper at south wall, facing southwest, showing bubbling and discoloration, November 2021. Source: RATIO Architects.

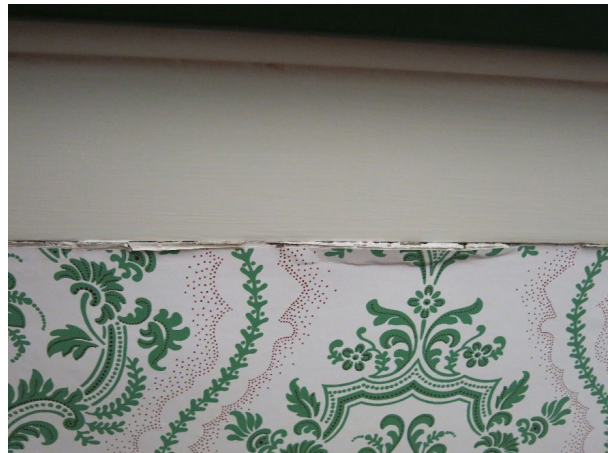
**Figure C.255.** Detail of plaster and wallpaper displacement below stool of north window of west wall of room 208, November 2021. Source: RATIO Architects.

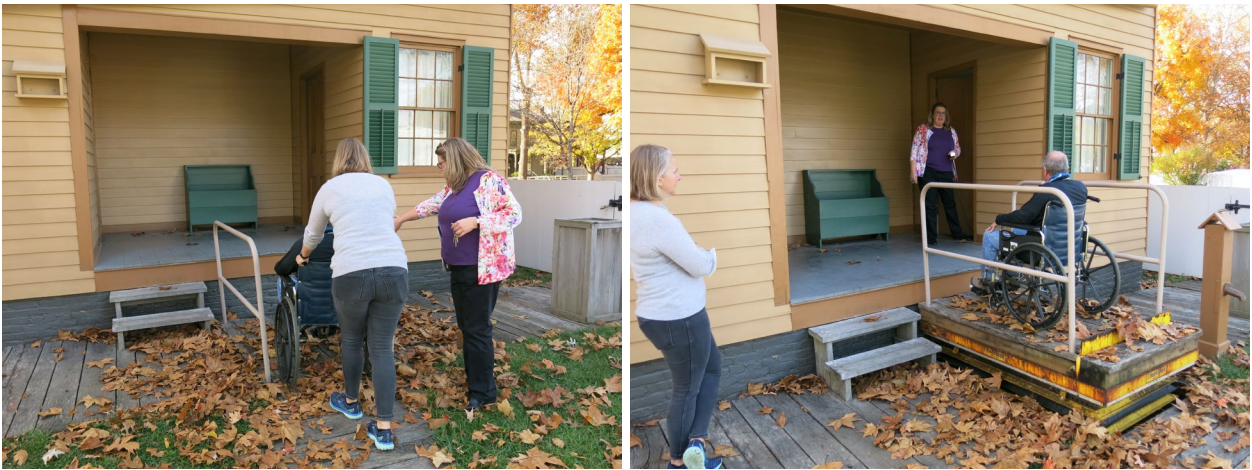
**Figure AD.3.** Route taken by visitors who use a wheelchair: approach to disappearing platform lift (left), lift rising to East Porch, operated by park staff using controls in Pantry (room 103) (right). Source: RATIO Architects.

pass through the back yard to the disappearing platform lift. This lift, replaced in-kind since the initial installation in 1989, disappears into the wood boardwalk and its side rails are removed and hung on the fence of the north side yard when not in use, making it effectively invisible. Controls for the lift are located within the Pantry (room 103) and are accessed and operated by LIHO staff. The lift's cover is not watertight, and its operation is sometimes prevented by accumulation of ice in cold weather.

**Recommendation #4:** When raised, the lift is not flush with the porch. The service company should adjust the height that the lift can achieve or the planks on the lift should be replaced to ensure the change in level between the lift platform and porch is not greater than ¼".

**Recommendation #5:** Consider replacing the wooden planks on the lift with a different surface material that requires less maintenance and is more stable, firm, and slip resistant.

**Recommendation #6:** Investigate the feasibility of reconfiguring the operating mechanisms for the lift so that it can be independently operated as required by the standards.<sup>442</sup>

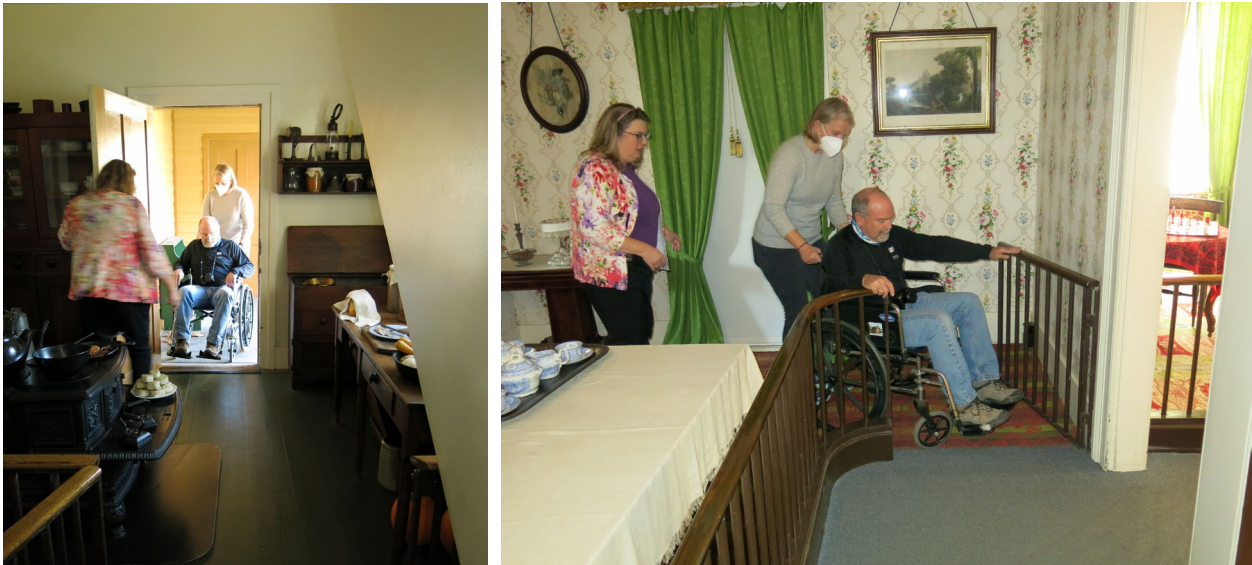
**Figures AD.4.** Route taken by visitors who use a wheelchair: entrance to non-public portion of Kitchen (room 105) from East Porch (left), passing through non-public portion of Dining Room (room 107) (right). Source: RATIO Architects.

must pass through the non-public portion of the period room, entering the public space at the south end through a gate in the visitor railing. This visitor must then pass through a gate in the door between the Kitchen and Dining Room and through another between the period room portion of the Dining Room and the visitor path to the northwest.

The existing first-floor visitor walkways, defined in the 1950s with limited alterations in the 1960s, include several tight corners that are difficult to navigate even with the park's narrow wheelchairs. These include the gate in the Dining Room and all door openings.

**Recommendation #2:** The current latch mechanism for the railing gates inside the Lincoln Home should be replaced as needed for any staff members who have a disability that affects their ability to open and close it.

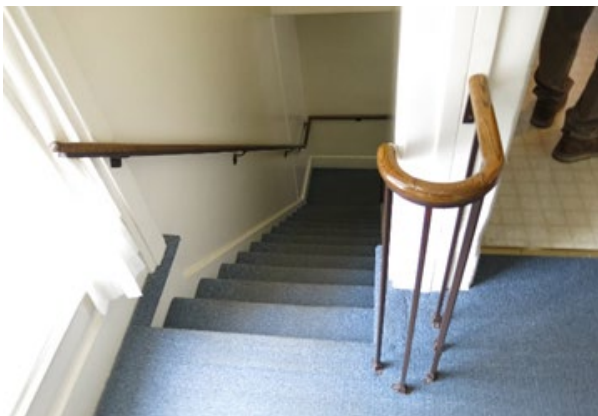
**Figure AD.6.** The existing visitor path passes down the back staircase (rebuilt in 1954 in a non-historic configuration intended to better serve museum visitors). Note how the extended run of the stair projects through the plane of the corridor wall and into the Upstairs Back Hall. Source: RATIO Architects.

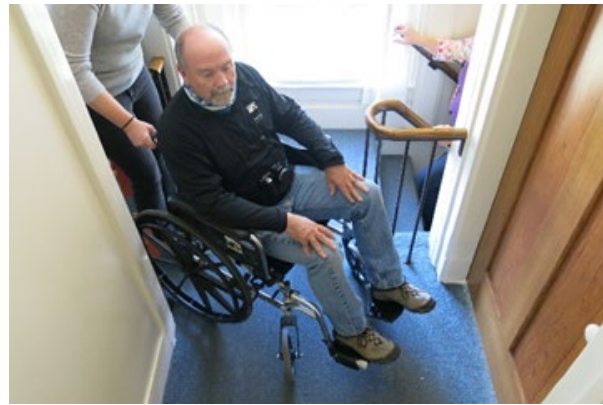
**Figure AD.7.** The second floor is not currently accessible to wheelchair users. The HSR team carried one of the park's narrow wheelchairs to the second floor to evaluate the ability to maneuver a chair if a lift is provided in the future. The Upstairs Back Hall (room 204) is particularly difficult to navigate. Note the encroachment of the non-historic stair extension into the clear floor space of the hall. Source: RATIO Architects.

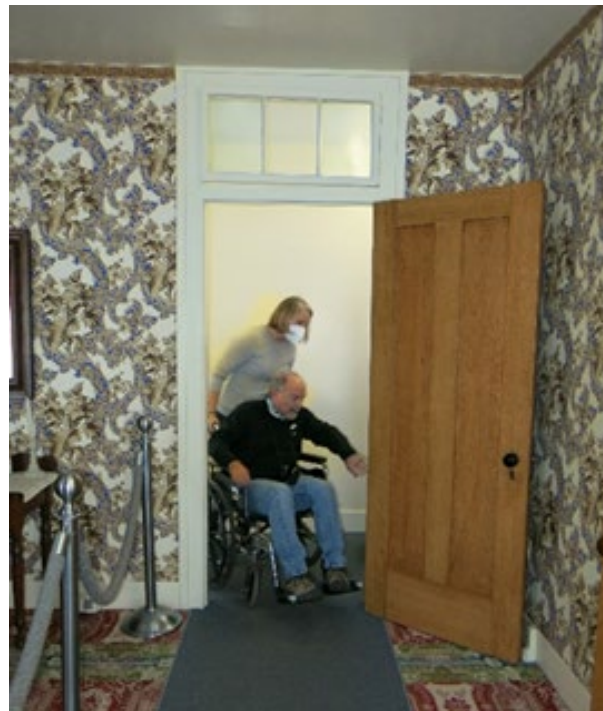
**Figure AD.8.** The turn from the Upstairs Back Hall (room 204) to Mary's bedroom (room 202) is challenging to navigate, even in the park's narrow wheelchair. Source: RATIO Architects.

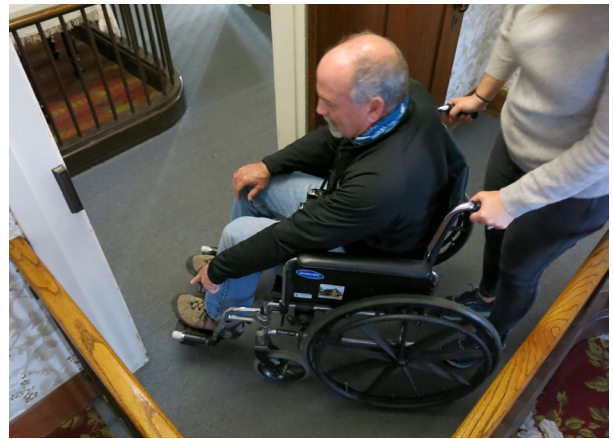
**Figure AD.11.** Many of the turns are constrained by the existing visitor control railings and woodwork shows evidence of repeated strikes from wheelchairs. Source: RATIO Architects.

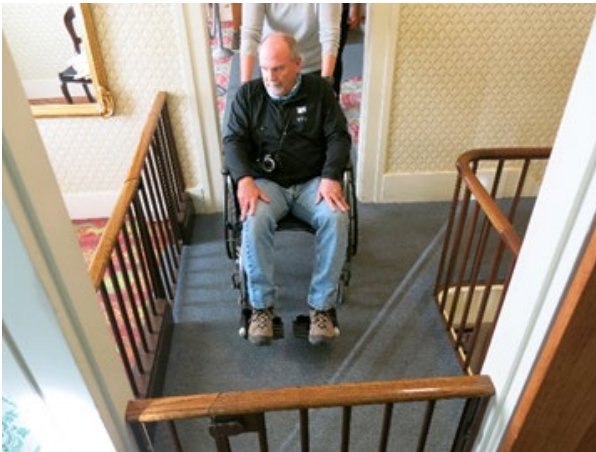
**Figure AD.10.** If a lift is provided in the future, the Upstairs Front Hall (room 200) would likely be a dead-end requiring visitors who use wheelchairs to retrace their path. Source: RATIO Architects.

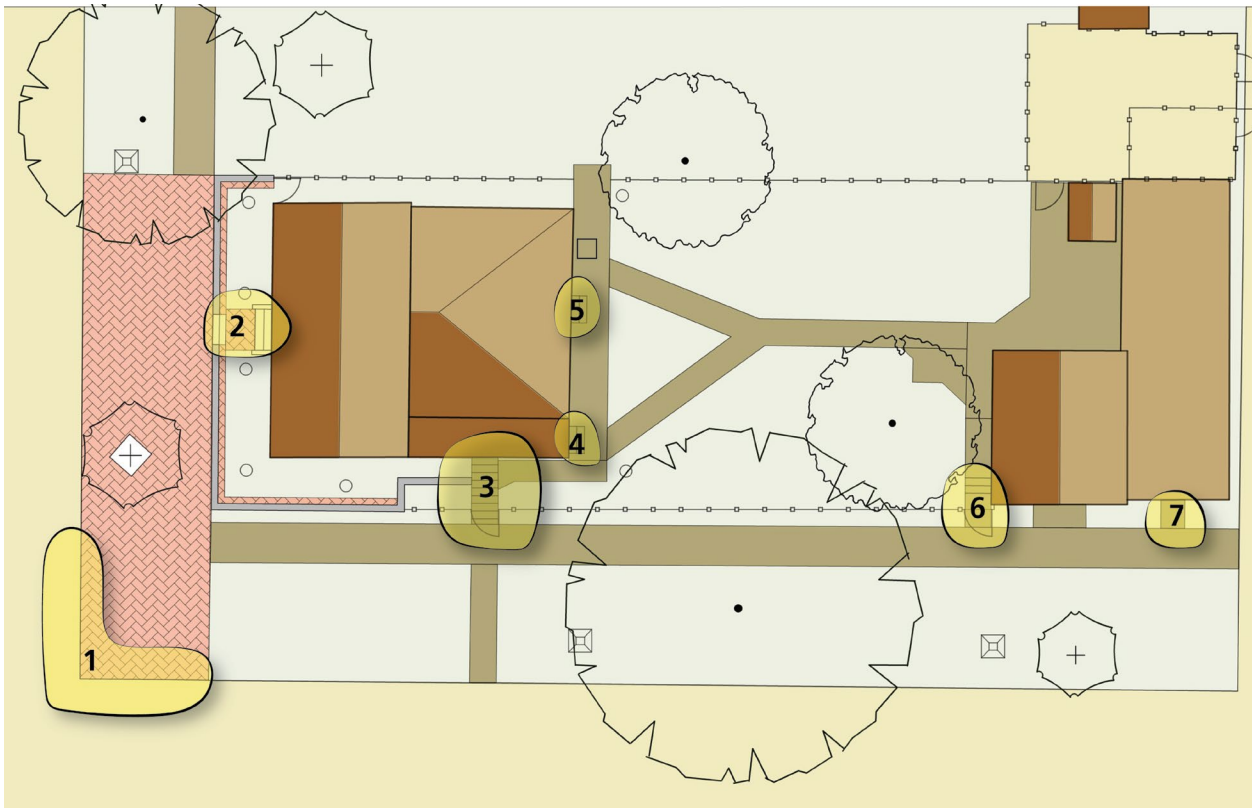
**Figure AD 22.** The location of site barriers to visitor access into the Lincoln Home. Source: WLA Studio.

1. Raised Curb, SW corner of site to street
2. Front Steps to House (9 steps)
3. South Side Steps to Porch (8 steps)
4. Rear Steps to South Porch (2 Steps)
5. Rear Steps to East Porch (2 Steps)
6. Side Gate Steps to Rear Yard (3 Steps)
7. Raised Threshold into Woodshed

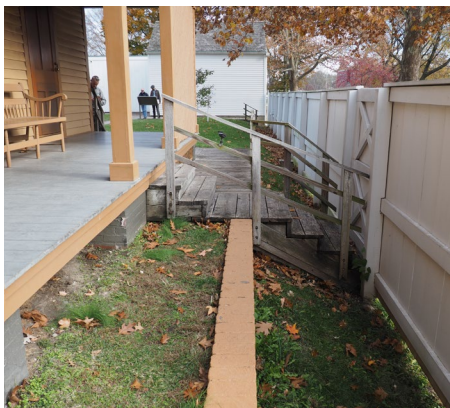
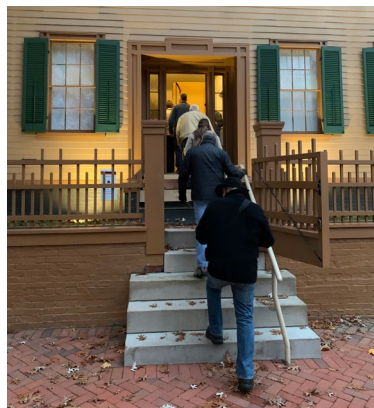
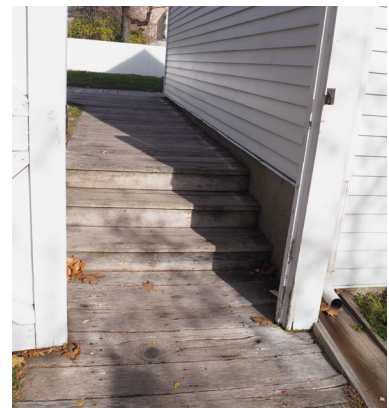
**Figure AD.23.** Barriers to universal access at the Lincoln Home including the front steps and steps to the porch and rear yard. Source: WLA Studio.
