HISTORIC STRUCTURES REPORT  
ARCHITECTURAL DATA, PART I

REHABILITATION AND RESTORATION  
OF THE  
DOGAN HOUSE

MANASSAS NATIONAL BATTLEFIELD PARK  
Virginia

April 1960

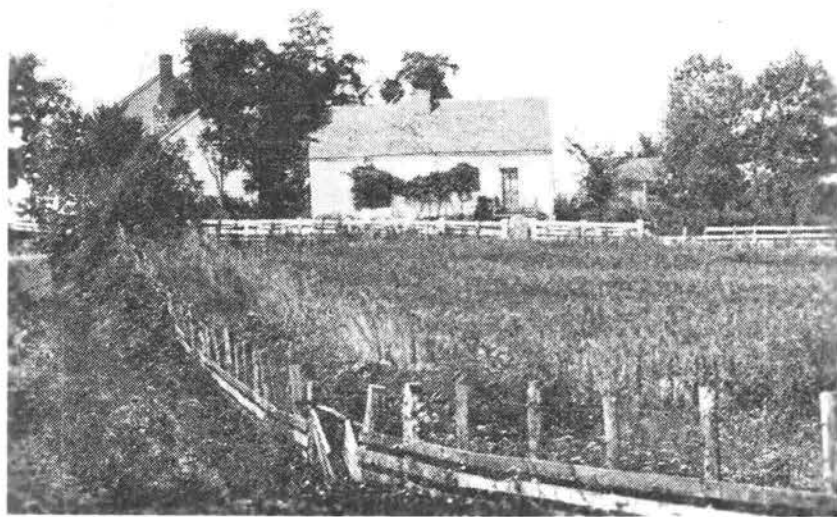
ILLUSTRATION NO. 3      SOUTH EAST VIEW

This view from the south-east shows the relationship between the W. H. Dogan House and the crossing of the Warrenton Pike (U.S. No. 29-211) and the Groveton-Sudley Road (Va. No. 622). This house is the last remaining structure at Groveton dating back to the Civil War.

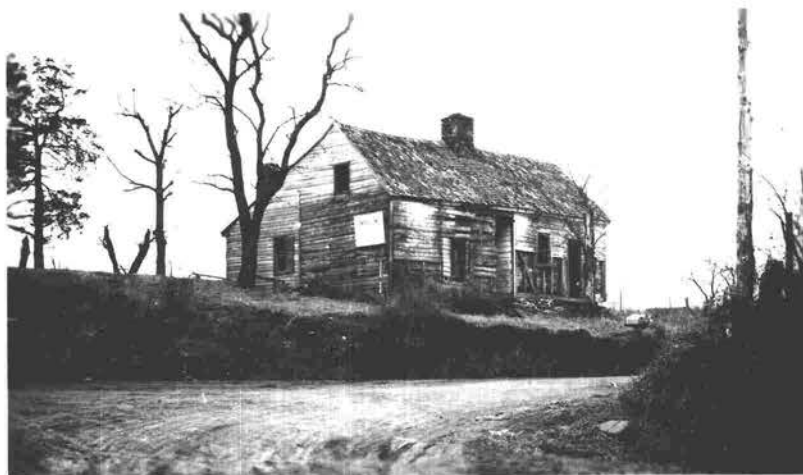
ILLUSTRATION NO. 4    VIEW FROM SOUTH EAST

Sign indicates early interest of community  
in the Dogan House as a building of historical importance.  
It reads "Groveton, Old Dogan House, shelled during Second  
Battle." Very little participation in its preservation  
occurred until 1947, when the house and 4914 square feet of  
land was purchased from W. H. Dogan by the Prince William  
County Chamber of Commerce and a subsequent stabilization  
occurred.

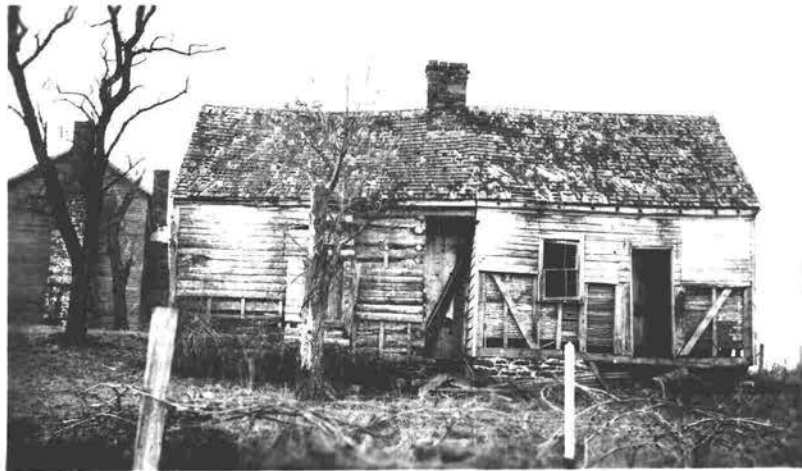
ILLUSTRATION NO. 6 VIEW FROM NORTH WEST

View of 1881-1882 addition to the west side  
of the Ogden House. Prior to demolition of addition.

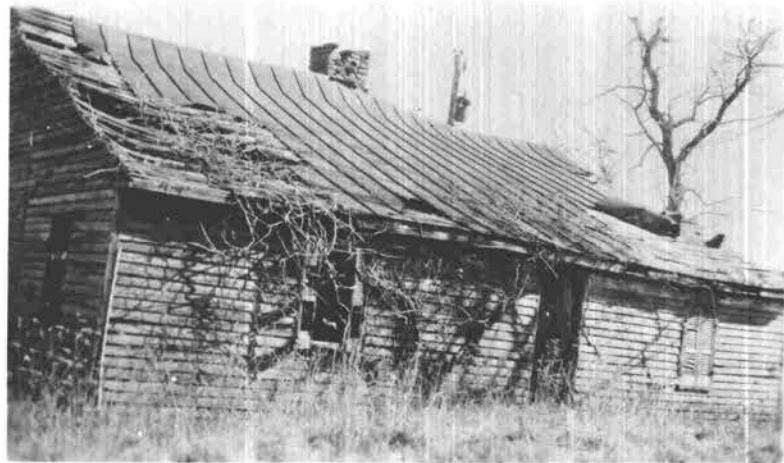
ILLUSTRATION NO. 7    NORTH ELEVATION

View of the 1881-1882 addition to the west  
(right) shortly before its demolition. Most of the  
exterior wood work dates back to 1881-1882.

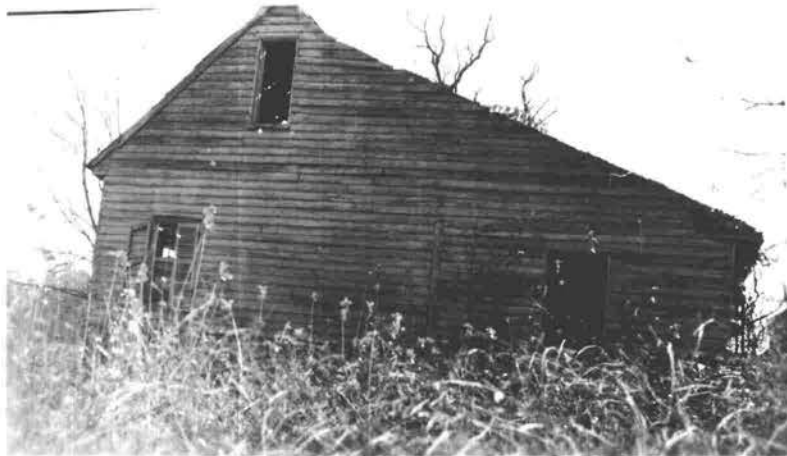
ILLUSTRATION NO. 8     NORTH WEST VIEW

This photograph shows the demolition of later addition to the Jogan House. Work was accomplished in 1948 by Mr. Raymond H. Cross, carpenter, under the supervision of the Prince William County Chamber of Commerce. Note door and window frame covered over by lath and plaster.

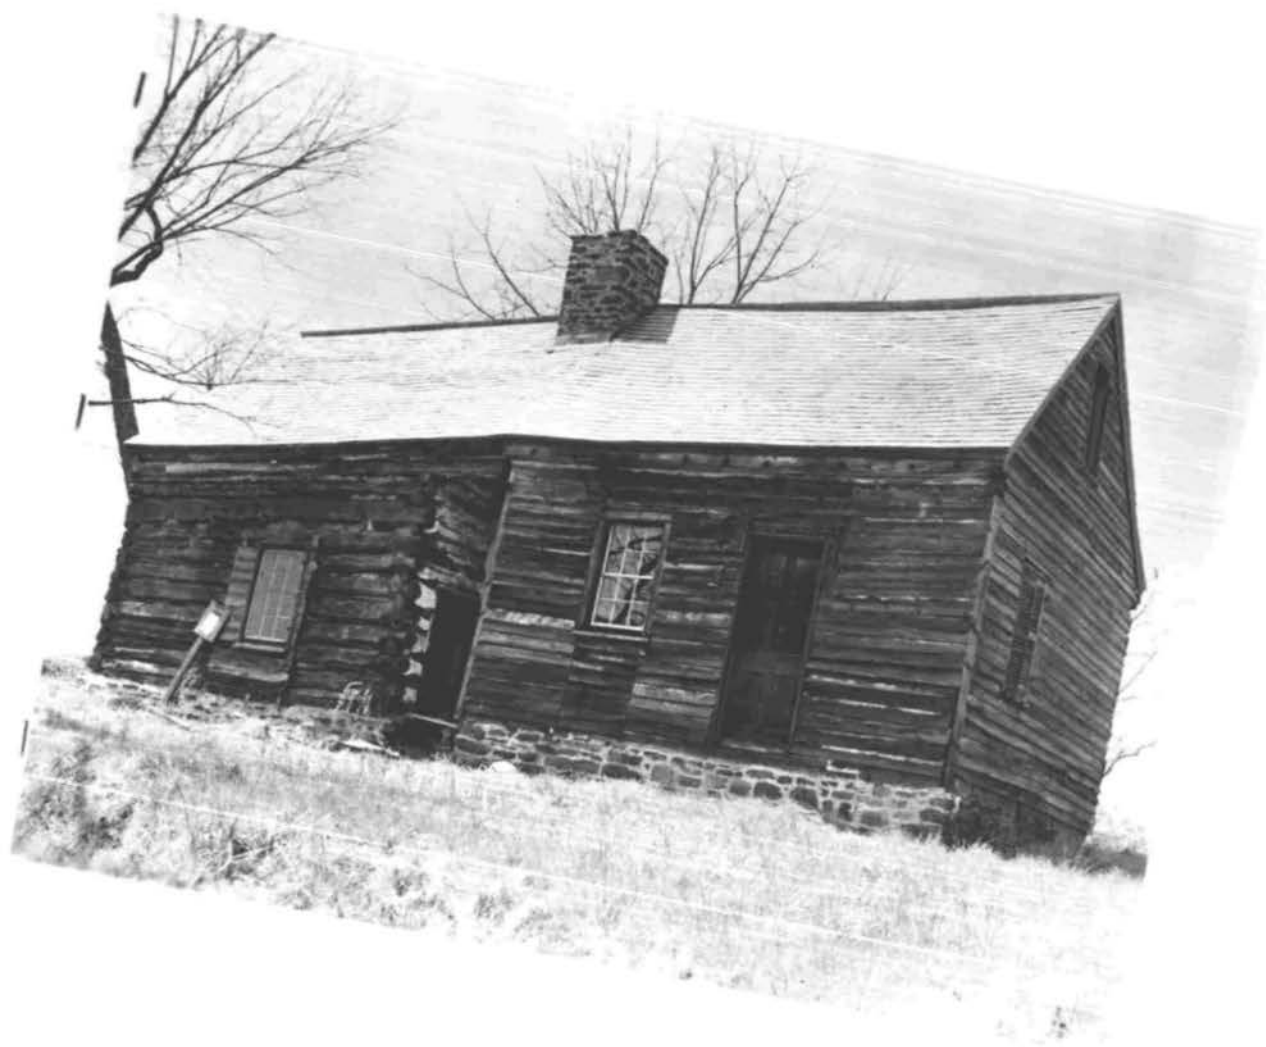
ILLUSTRATION NO. 12      VIEW FROM NORTH EAST

The log structure seems to have suffered more abuse than its frame counterpart. Due to the deterioration of the lower logs in the south wall, the log building has settled approximately two feet, and as a result, this section of the house has separated from the frame addition. Photo Illustration No. 15 shows the physical break in the roof at the juncture of the two buildings.

Latest photograph of the Dogan House taken from the Croveton-Sudley Road in 1959. The straight break in roof to the right of the chimney represents the junction of the early log structure and the frame portion.

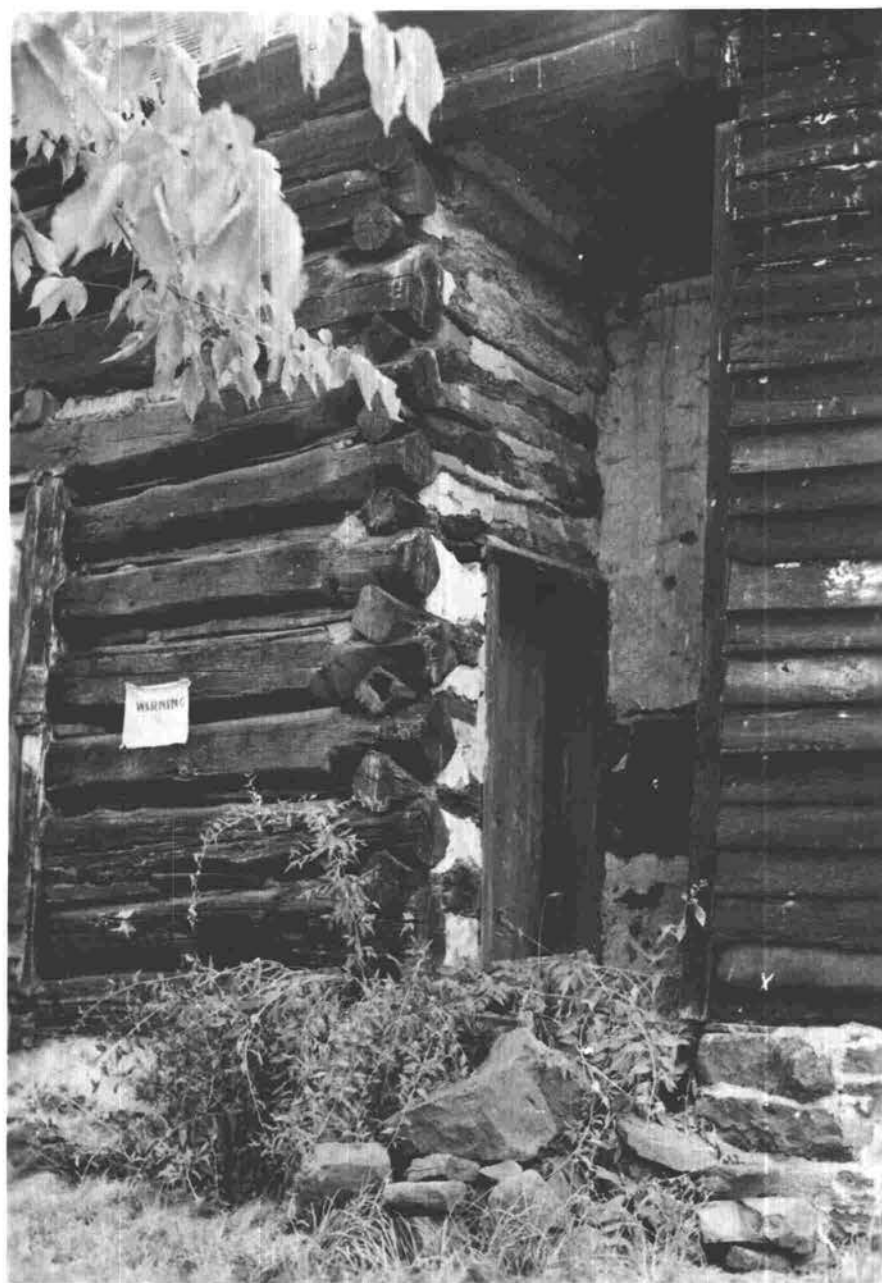
ILLUSTRATION NO. 14 EAST WINDOW, LOG STRUCTURE

This view shows an alteration to an early door opening on the east side of the original log structure. The door frame is still intact and this view shows the logs butting up against the door frame. Later alterations changed the doorway to a window opening as shown.

Windows: Rebuild all window frames according to original found in east wall of frame addition. All windows require new sash with "old" glass.

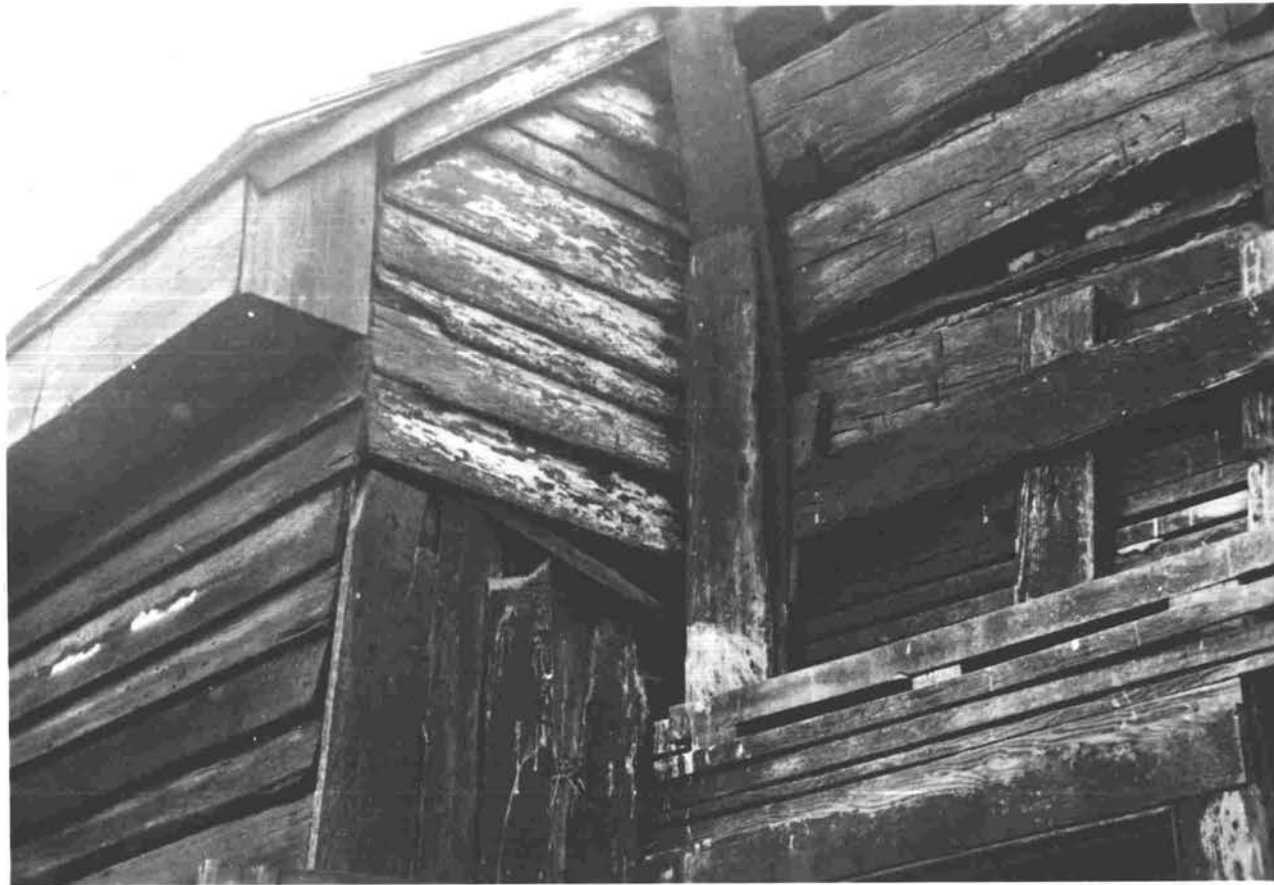
ILLUSTRATION NO. 19    VIEW FROM SOUTH WEST

The rapid deterioration of the basic log structure can be seen clearly in this photograph. The corner nearest the camera has already lost three logs in height. Notice changes in log construction from 1st to 2nd floor.

Frame: Straighten and level existing building; replace all rotted members in log structure and frame addition.

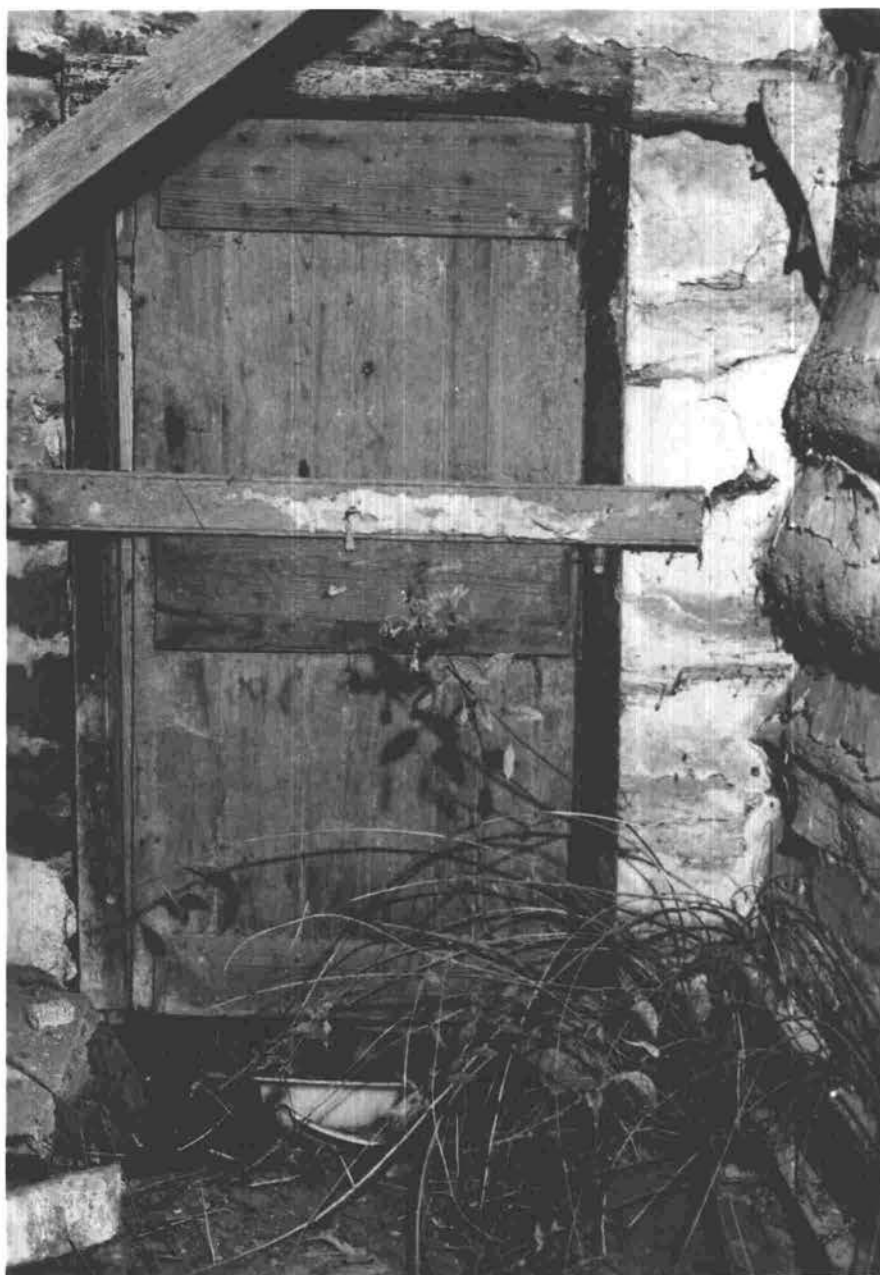
ILLUSTRATION NO. 31 DOOR INTO 1st FLOOR, LOG PORTION

This view is looking into the small entrance hall on the west side of the chimney. It provides access into both 1st floor rooms as well as to the outside. Ceiling beams and boards can be seen overhead. National Park Service shoring in foreground.

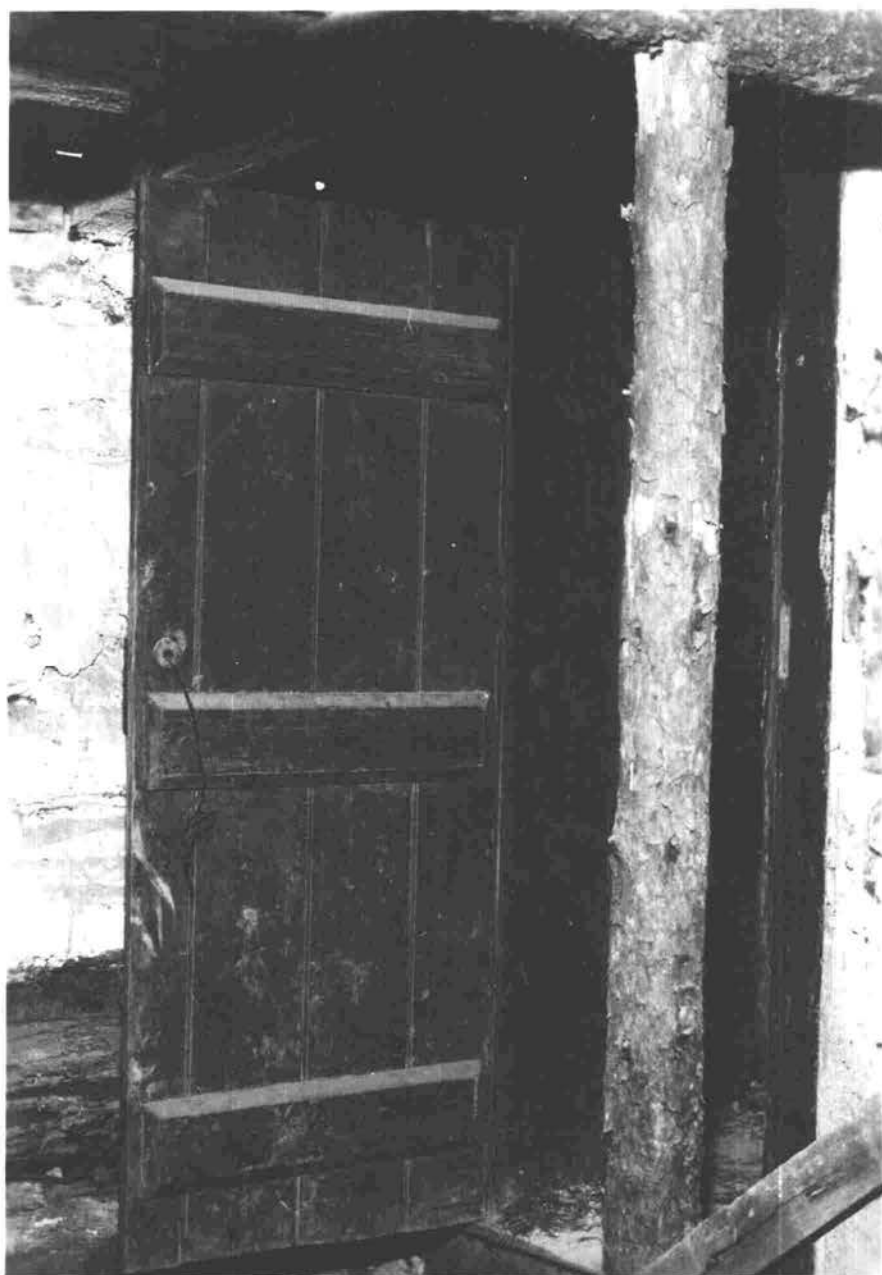
ILLUSTRATION NO. 32      STAIRWAY REMAINS

Very little of the interior trim that remains can be reused. Some baseboards exists in place on both floors of the log structure that might be used again. On the first floor, all the original floors, floor joist, baseboards, chairrails, mantels and window sash are missing. Portion of the 2nd floor have been replaced in the log section but by and large, the floor boards are un-useable. Floor joists on the 2nd floor appear to be in poor condition in both rooms. Only the three top risers remain on the stairway and the

board and batten door at the foot of the stairs. All board and batten doors are in good condition and can be used again.

This view shows the last remnants of the "dog-leg" stairway located in the south-east corner of the log building. The stairway was once enclosed and the board and batten door at the foot of the stairway is visible to the entrance left.
