## HISTORIC STRUCTURES REPORT

## ARCHITECTURAL DATA, PART II

## REHABILITATION AND RESTORATION

## DOGAN HOUSE

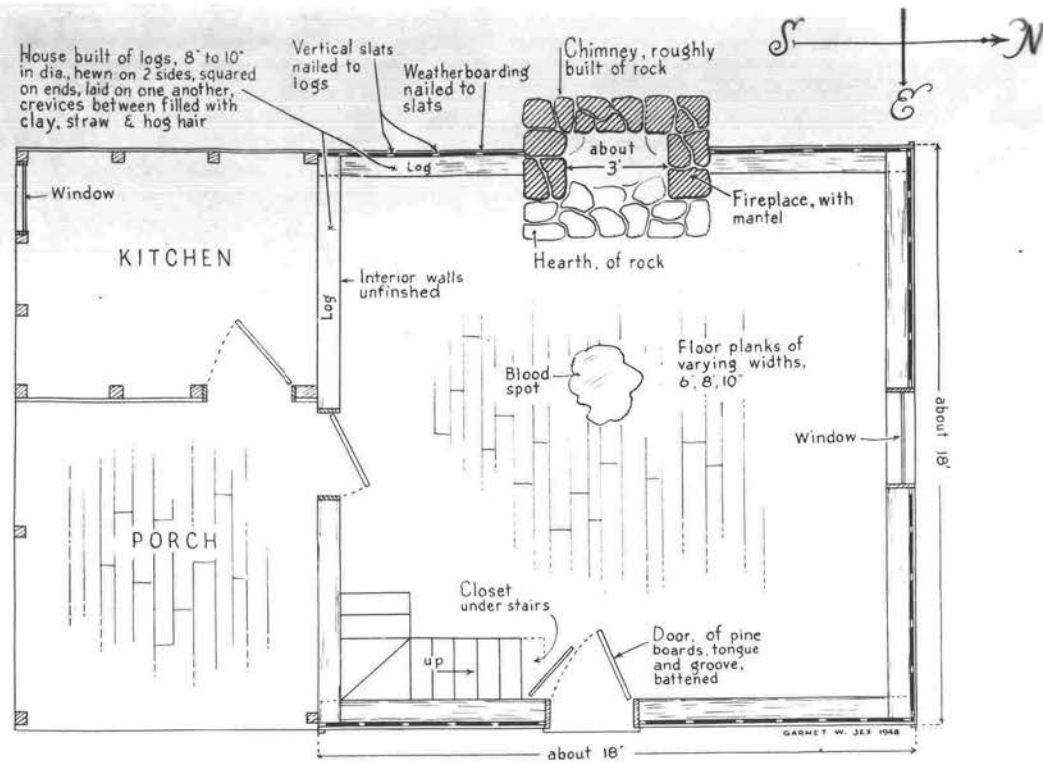
ILLUSTRATION NO. 7

First floor plan of Robinson House. Notice the similarity of features with the log portion of the Dogan House.

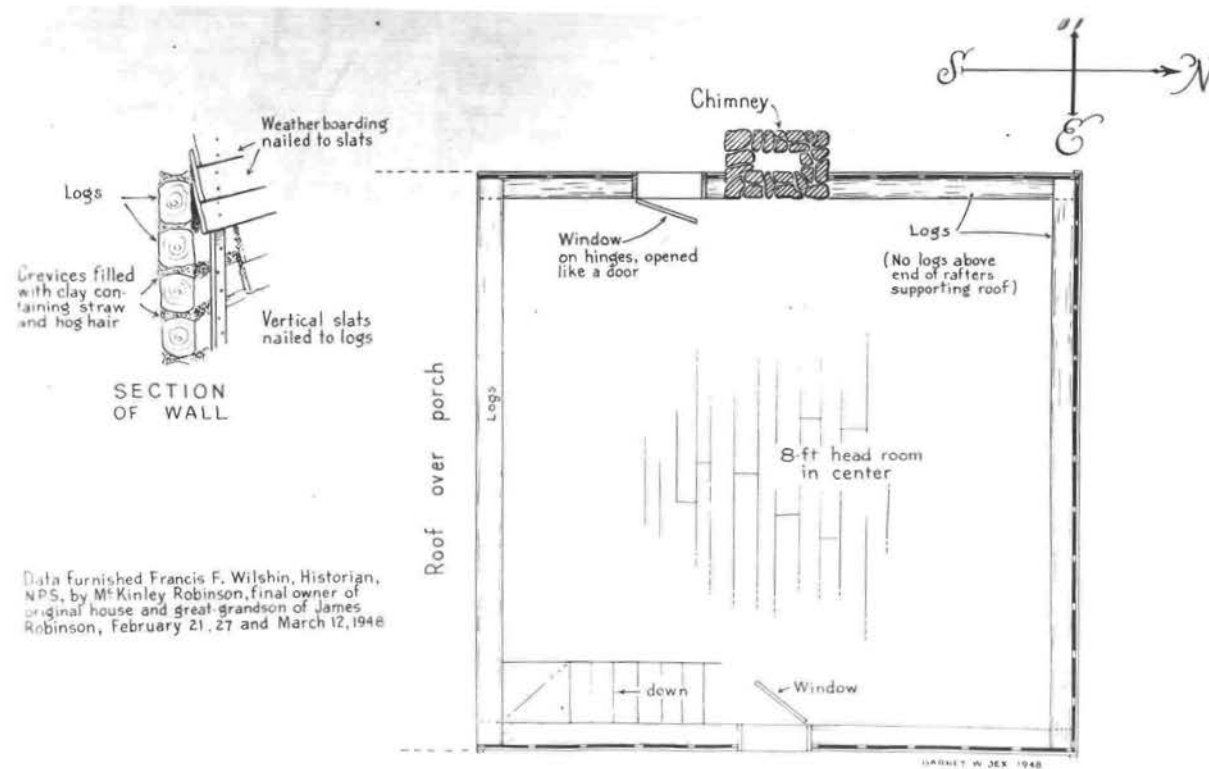
ROBINSON HOUSE  
PLAN OF SECOND FLOOR

Second floor plan of Robinson House. Sketch to left illustrates construction of log wall. In the Dogan House, the spaces between logs were chinked with rocks, brick and wooden poles, and covered with a lime mortar.
