# Medgar and Myrlie Evers Home National Monument Historic Structure Report - Appendices

## CONDITION ASSESSMENT

### MEDGAR AND MYRLIE EVERS HOME NATIONAL MONUMENT

SEPTEMBER 2021

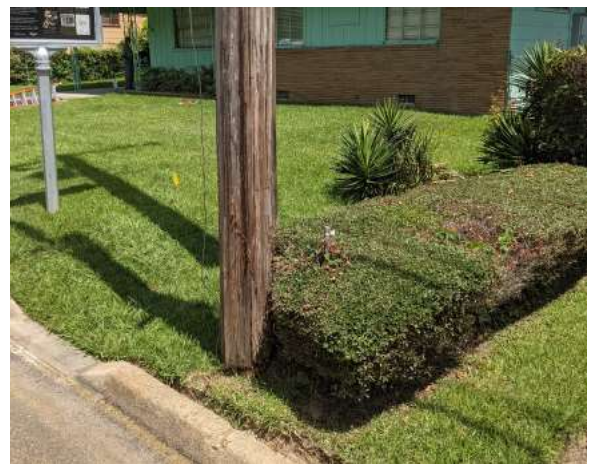
At the southwest property line there is what appears to be a partial hedge made up of Helleri Holly (*Ilex crenata* 'Helleri'). These shrubs may very well be original to the property. Through conversations with family members it is believed that hedges were once planted around the periphery of the site, and holly was mentioned as one of the plant types. (See image below.)

Figure 16. Possible historic hedge.

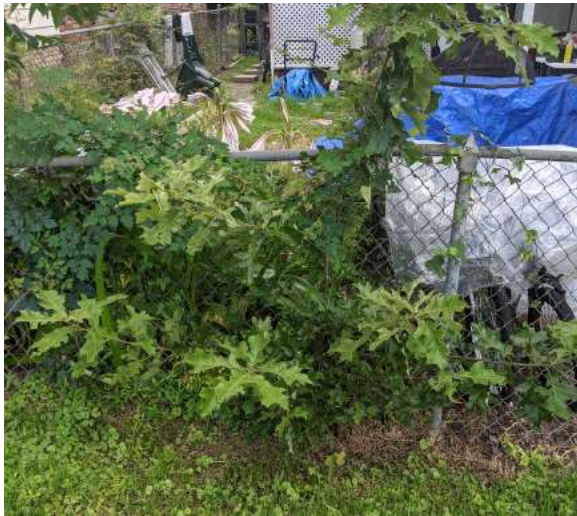
Fencing is currently installed on three sides of the property, the west, north and east property lines. There is also a section of fence on both sides of the house connecting to the property line fence, which encloses the back yard. A section of fence and a gate are currently installed under the carport, that allow access to the rear yard. The segment of fence with a gate contains a dog decoration has been identified as a gift from Medgar to Myrlie. A chain link fence was installed at some point during the period of significance, when the family owned a dog. The current fence type is typical chain link, and the height varies from 3'-6" to 5'-6" tall. The screening plantings along the property line make it difficult to evaluate the full section of fencing, but what is visible shows rust and bent framing. The fence sections that abut the structure also have large gaps at the corners. The fence is not considered a security fence. (See images below.)

Figure 17. Overgrown existing fence.

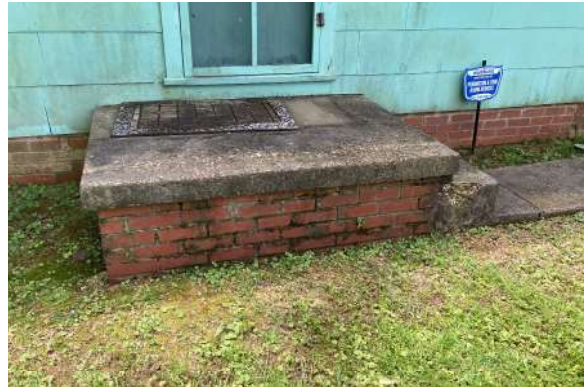
**Stairs:** The stairs at the rear entrance are concrete, sitting on red brick foundation and are discolored and worn. There are significant chips in the concrete and a major crack underneath the concrete landing/stoop. Dirt and biological growth can be seen on the concrete, bricks and mortar. The stairs in the carport are a similar concrete and brick configuration; the concrete shows an expected level of wear but is well intact. Some staining from a cleaner or mortar can be seen on the brick.

Figure 22. Existing rear stoop.

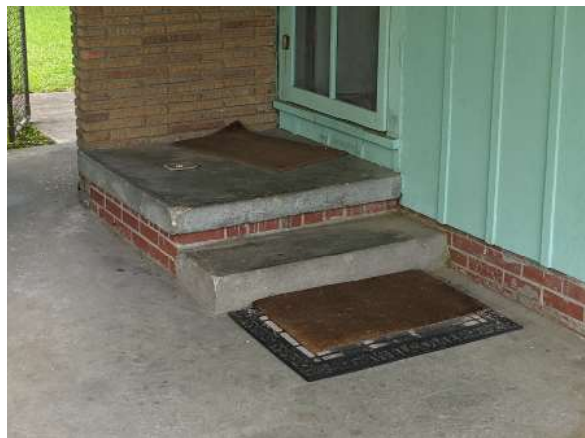
Figure 24. Carport stairs

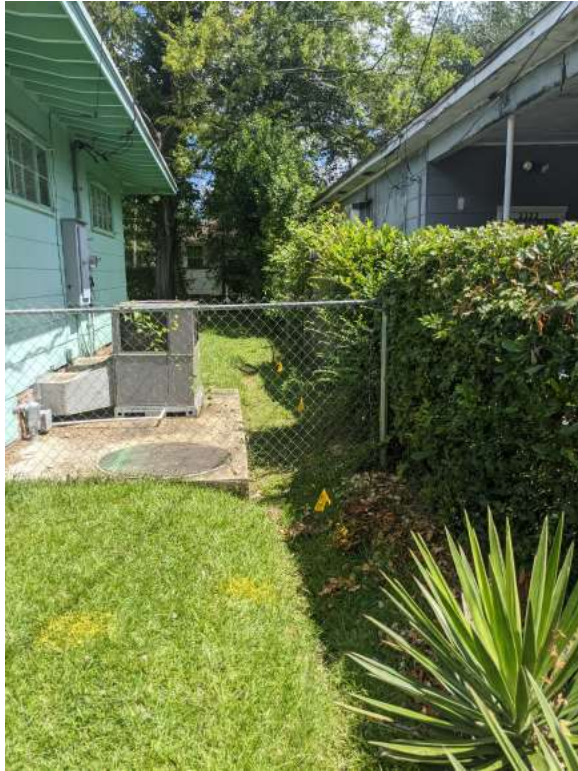
This swale appears to be working as designed, although a few of the plants (Yucca) along the property line have fallen over and are blocking part of the swale.

Figure 27. Swale drainage with yucca in bottom right of image.

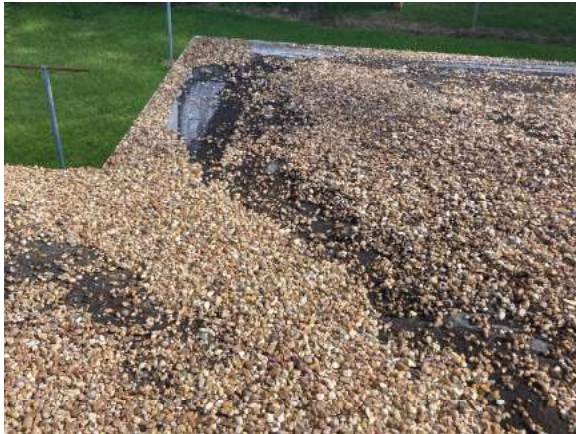
Ballast on the roof has shifted over time and has exposed roofing material below; there appears to be no gravel stop, or the height of the gravel stop is

not adequate to prohibit materials from washing off in many areas.

Figure 34. Shifted ballast in valley and edge of roof.

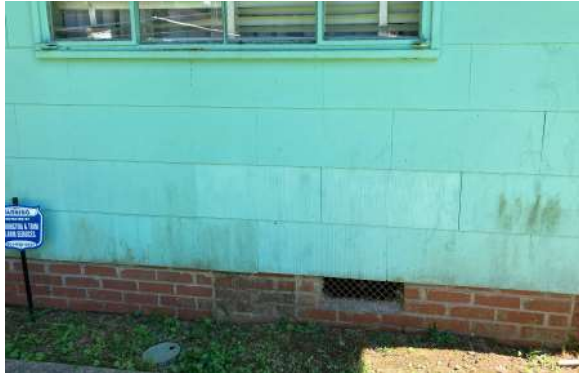
Figure 38. Dirt and discoloration on siding.

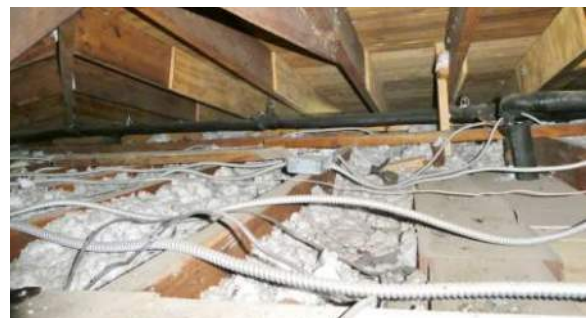
A junction box in the attic was noted to be open, exposing wires.

Figure 47. MC Cable and open junction box in attic.

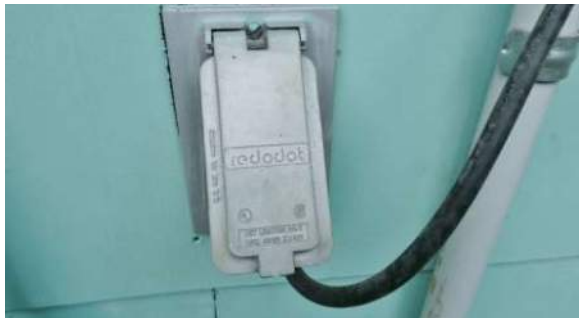
For the exterior Rain Bird irrigation controller, the cord is plugged into a weatherproof receptacle not rated for while-in-use.

Figure 49. Weatherproof receptacle, when closed.

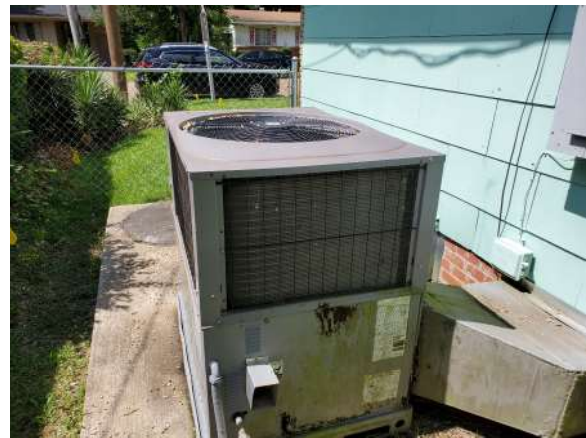
The 3-ton air conditioning unit is 6 years old manufactured in 2013 by Carrier and appears to be working properly. The outdoor ductwork is weatherproofed and connects to insulated ductwork in the crawl space. The connection to the indoor ductwork and other branch connections were observed to be leaking a significant amount of cold air into the crawlspace. The crawlspace is reported to be uncomfortably cool. Much of the insulated ductwork is wet and dripping on to the concrete floor of the crawlspace. This is contributing to the water in the space as well as causing other metallic items to sweat. See images in Structural Report, Appendix D.

Figure 50. Carrier air unit.

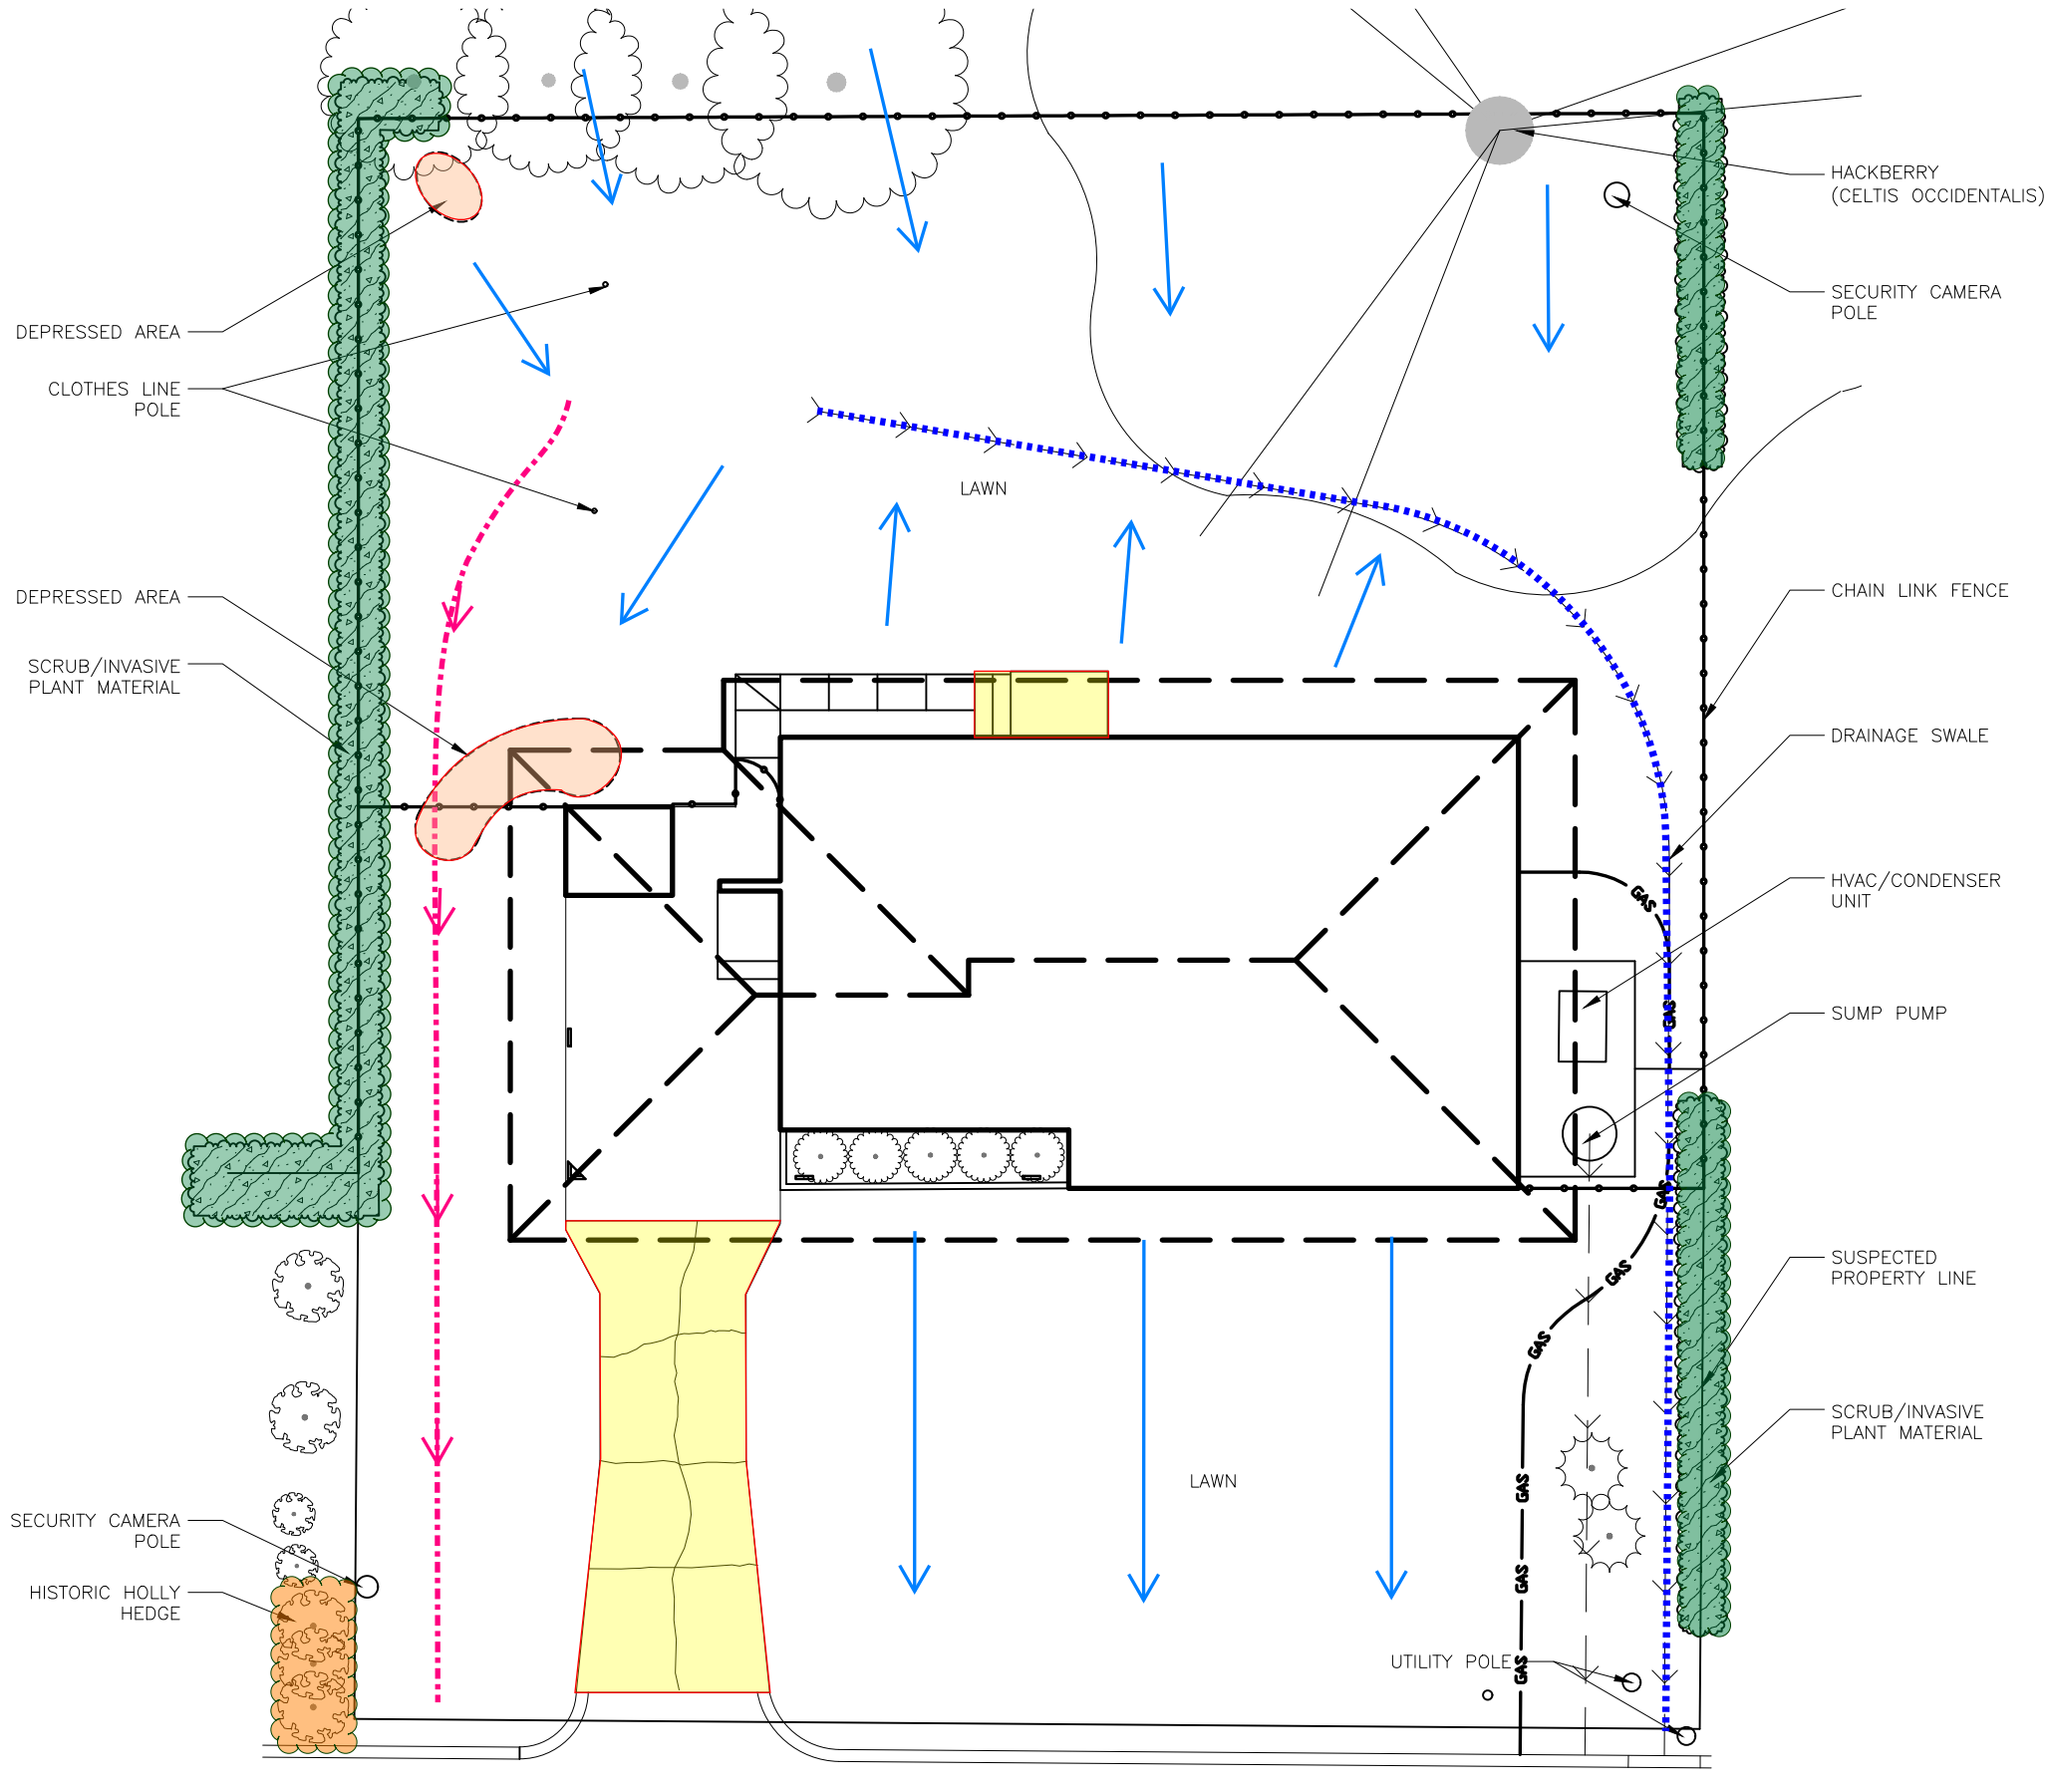
1 SITE PLAN  
L1.0

- DEPRESSED AREA/SINK HOLE
- FENCELINE SHRUB MATERIAL
- HISTORIC HOLLY
- OBSERVED SITE DRAINAGE PATTERN
- EXISTING SWALE- ENHANCE WITH NEW FRENCH DRAIN
- PROPOSED NEW SWALE/FRENCH DRAIN
- DETERIORATING HARDSCAPE

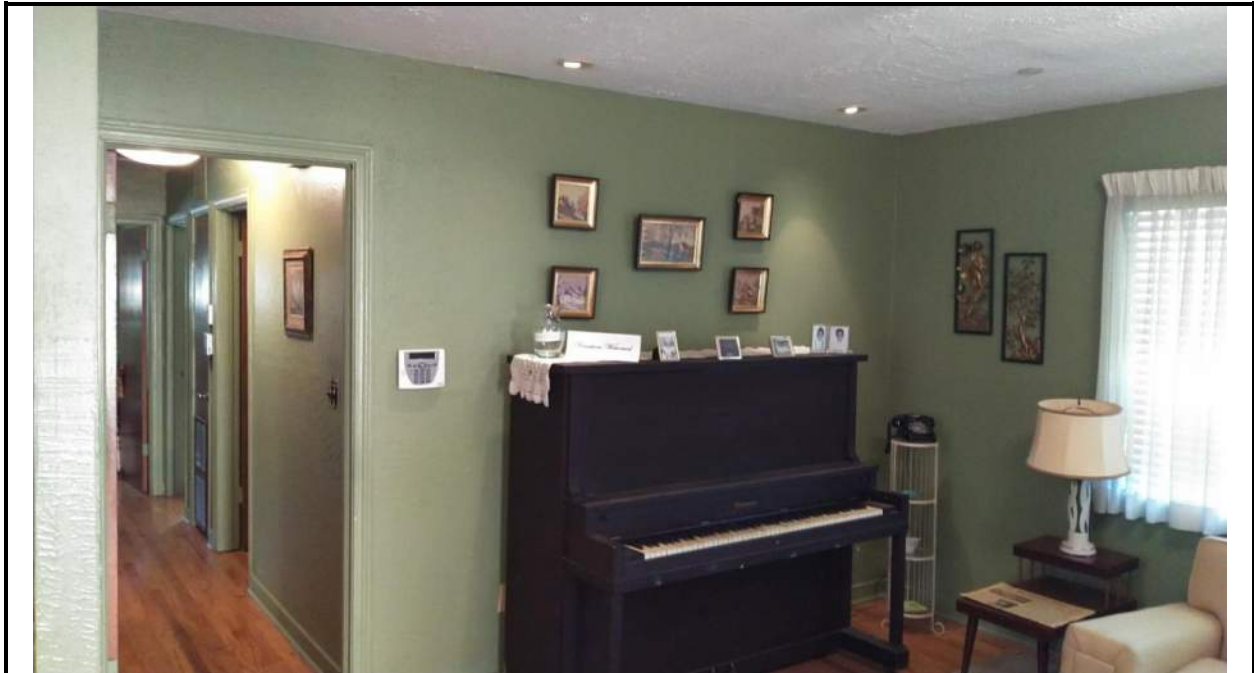
**Photo 1:** Drywall System (PSI HSM 01 and B&A HSM 5)

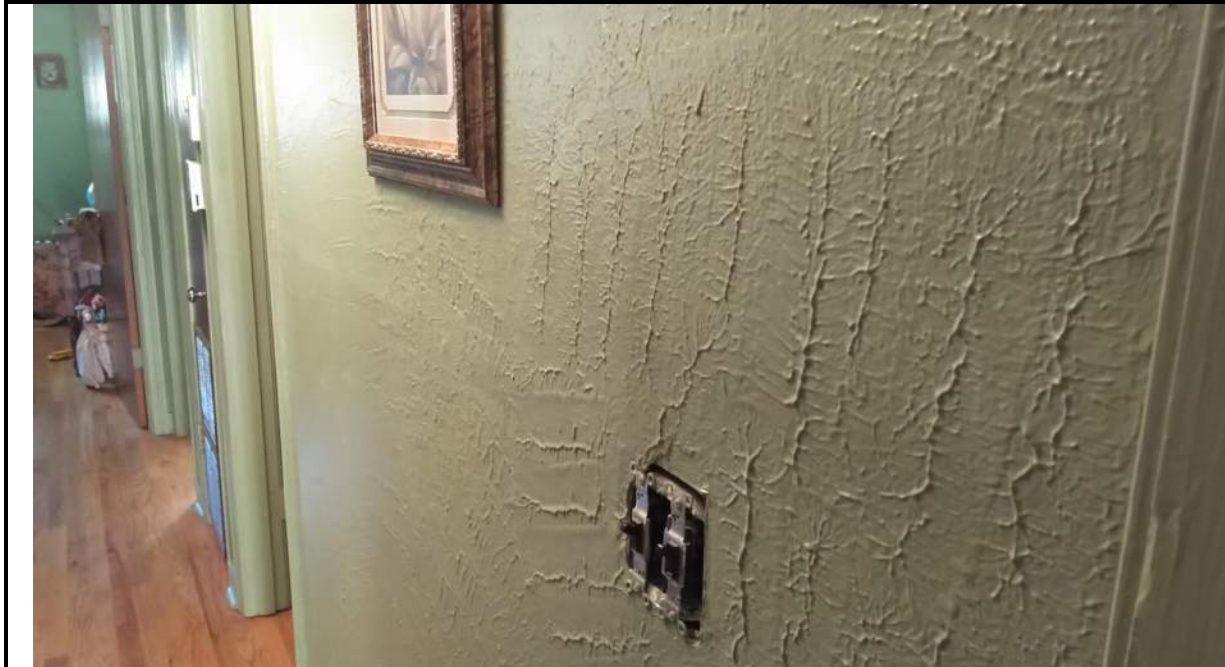
**Photo 2:** Wall Texture (PSI HSM 02 and B&A HSM 8)

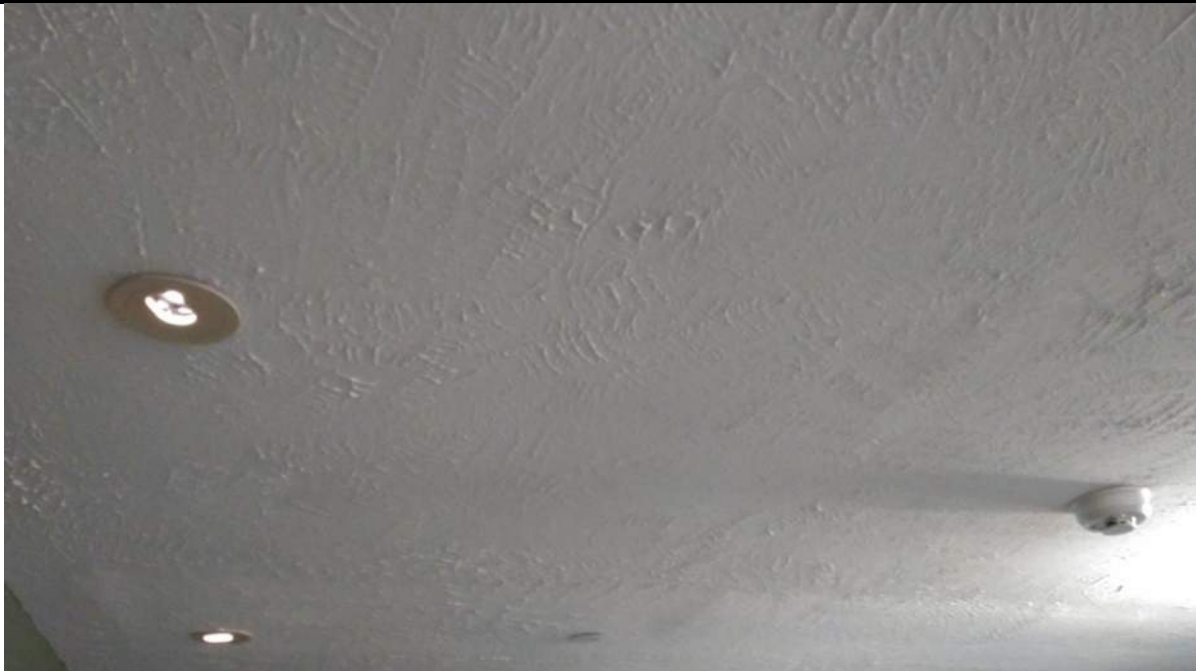
**Photo 3:** Ceiling Texture (PSI HSM 03 and B&A HSM 8)

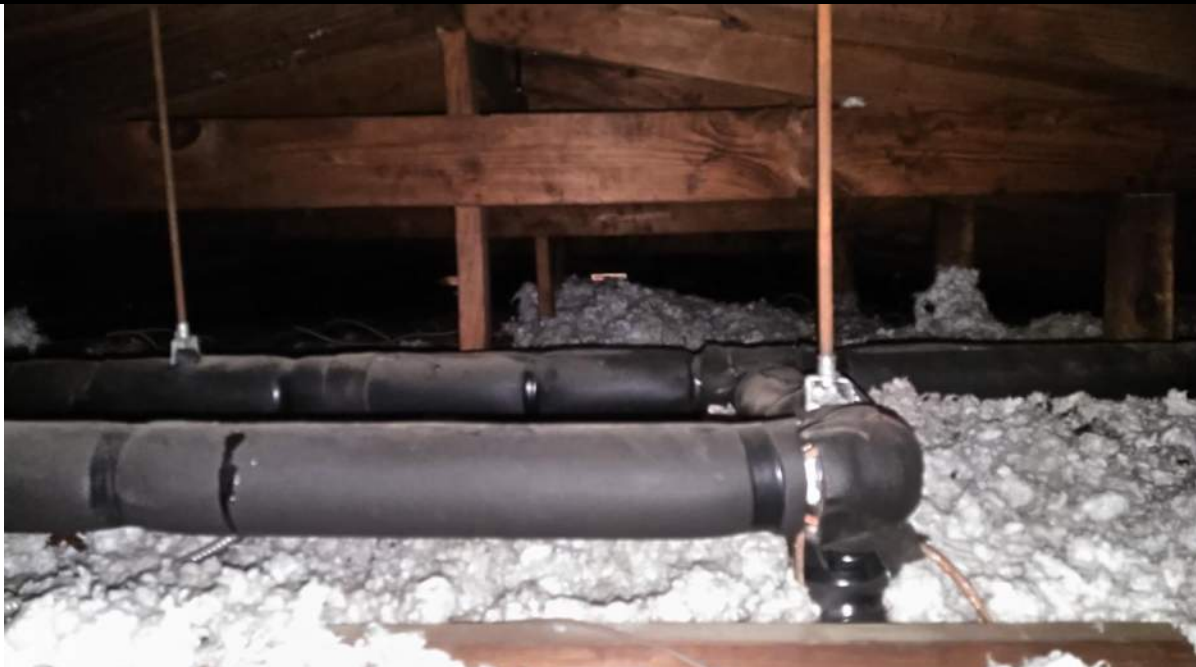
**Photo 4:** Attic Insulation (PSI HSM 04)

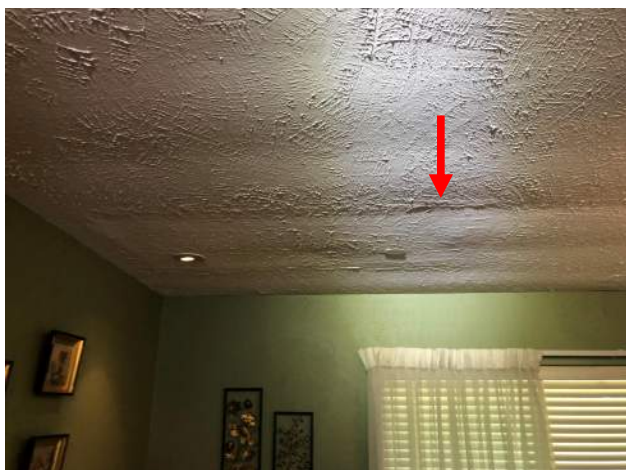
**Photo 1** – Ridges in ceiling at attachment to furring strips.

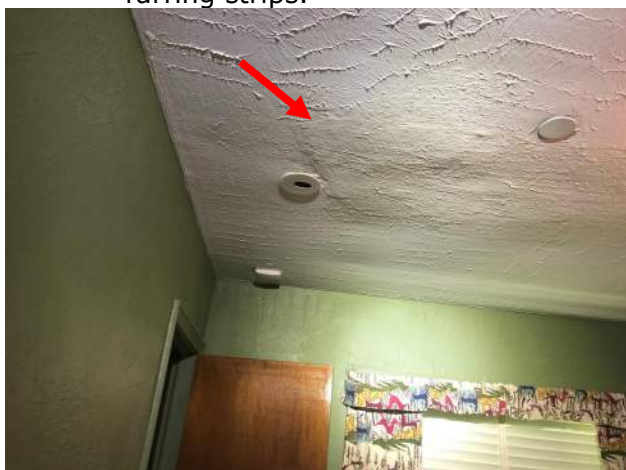
**Photo 2** – Patches in ceiling for installation of sprinklers and recessed lights.

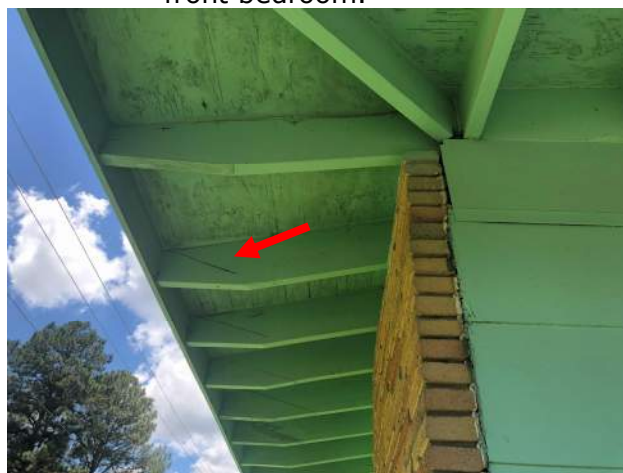
**Photo 6** – Typical repair of rafter tails.

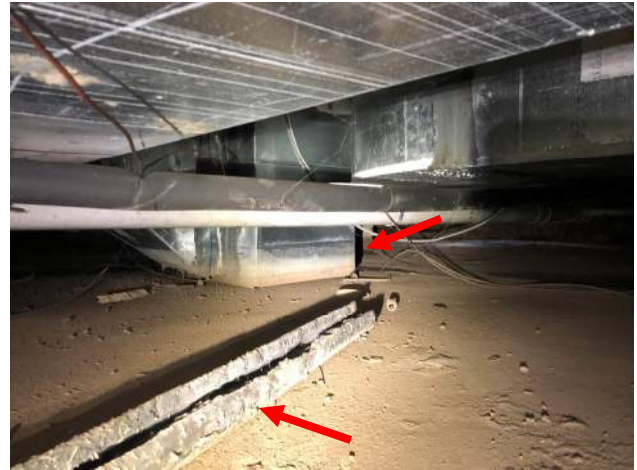
**Photo 10** – Typical crawlspace. Dirt and debris. Water marks on ductwork.

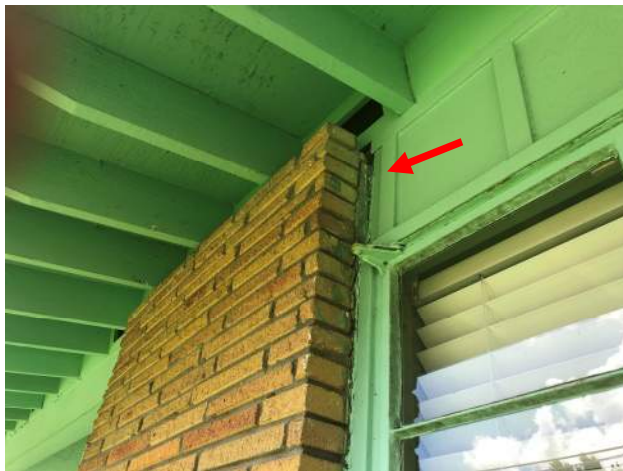
**Photo 8** – Brick veneer at front of house. Slight gap.

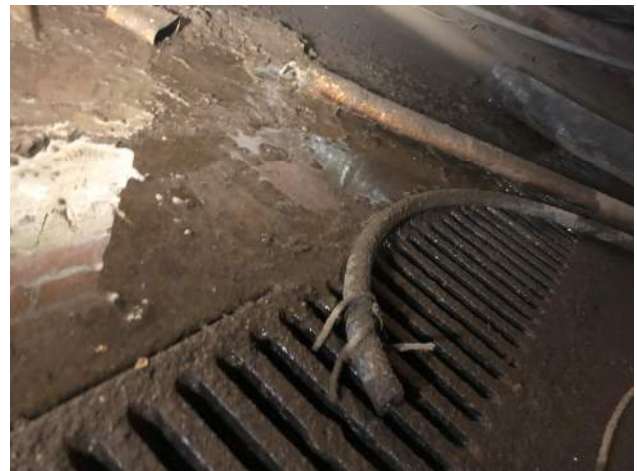
**Photo 11** – Condensate lines draining in crawlspace.

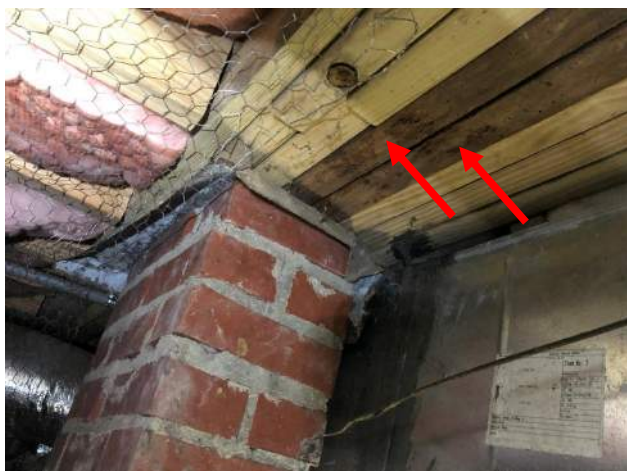
**Photo 13** – Foundation pier and reinforced center beam.

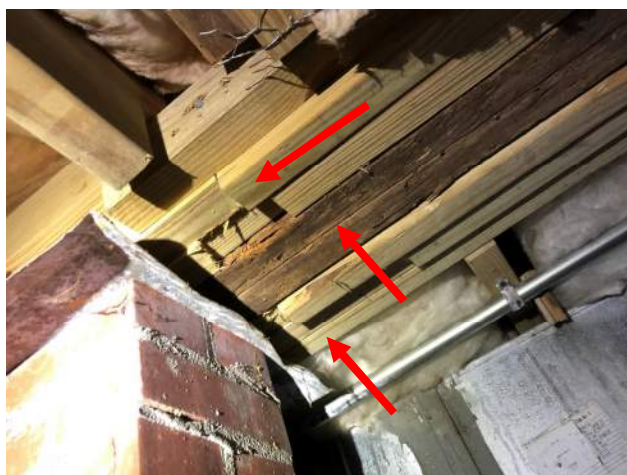
**Photo 14** – Fit up of reinforced beam.

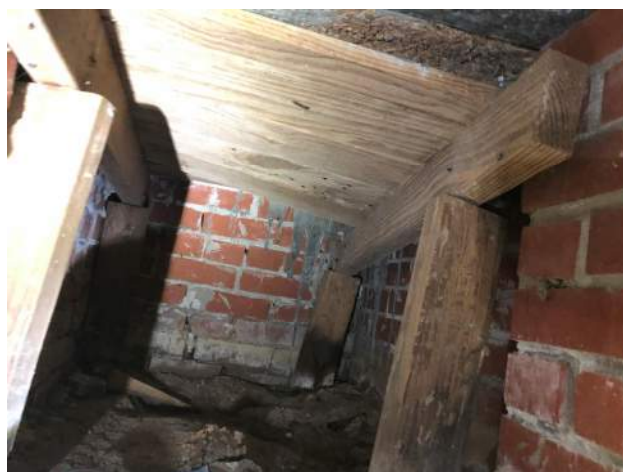
**Photo 18** – Formwork left in place.

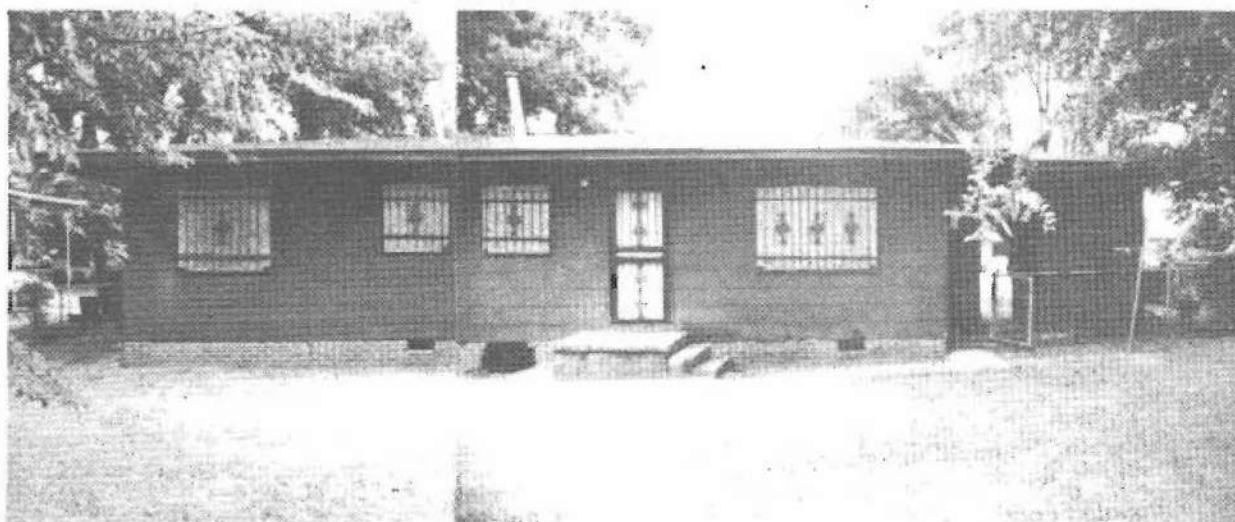
Figure 7. 1994 photograph of the rear (north) elevation of the house with decorative burglar bars which were more recent additions.

North elevation: There are 5-6 broken pieces of siding along the foundation edge and 1 near the door.

North elevation: The concrete and brick stoop has suffered minor cracking and spalling probably associated with the water that collects in the crawlspace and outside of the foundation wall. There are two porcelain light fixtures, one attached to the exterior wall surface east of the door and one attached to the bottom of a rafter tail on the northeast corner.

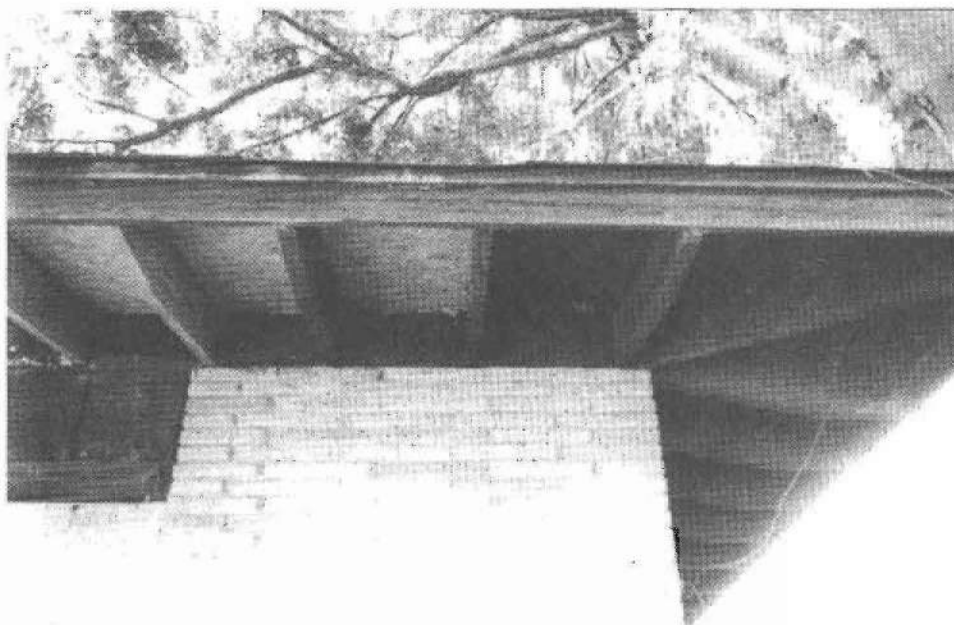
**Figure 9.** Original exposed rafters along the deep overhang and Roman bricks found on the front (south) elevation are evident in this 1994 photograph.

The shingle roof has suffered damage as indicated by the areas of water damage on the interior, but it has been repaired by the owner, Tougaloo College. The structure of the roof, which consists of 2 x 8 joists and rafters 16" on center, is still intact and in good condition. The soffits, exposed rafter tails and fascia have some damage on the south and east faces which will require minimal repair, but most of the eaves have suffered only the deterioration of paint. Two rafter tails have recently been replaced.

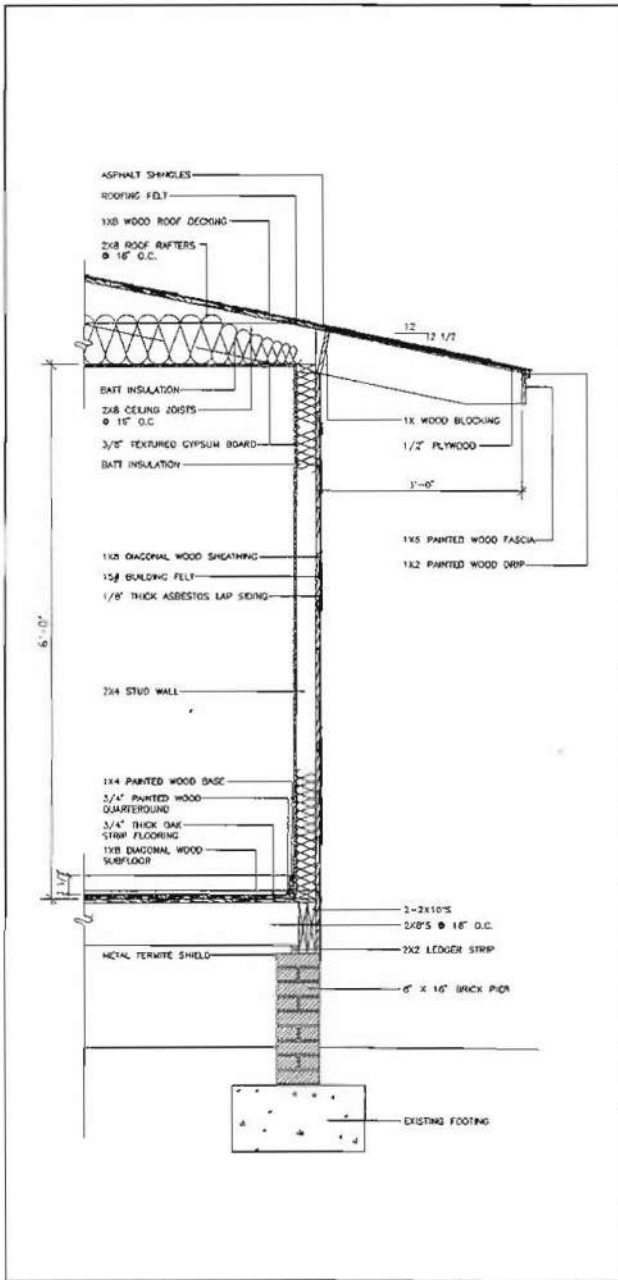
The typical wall section (see Figure 11) has 11 1/2" asbestos lap siding on the exterior with metal trim at the corners. The metal corner trim is painted, but 1963 photos indicate that it was unpainted. Behind the siding is building felt and 1 x 8 diagonal sheathing. 2 x 4 studs support the wall, and 3/8" textured gypsum forms a surface for the interior. Some pieces of asbestos siding have been replaced as the original ones have broken. The pieces that are not original to the house can be identified by a more pronounced and wider vertical pattern on the surface.

Figure 11. Measured drawing of typical wall section showing asbestos siding and exposed rafter tails.

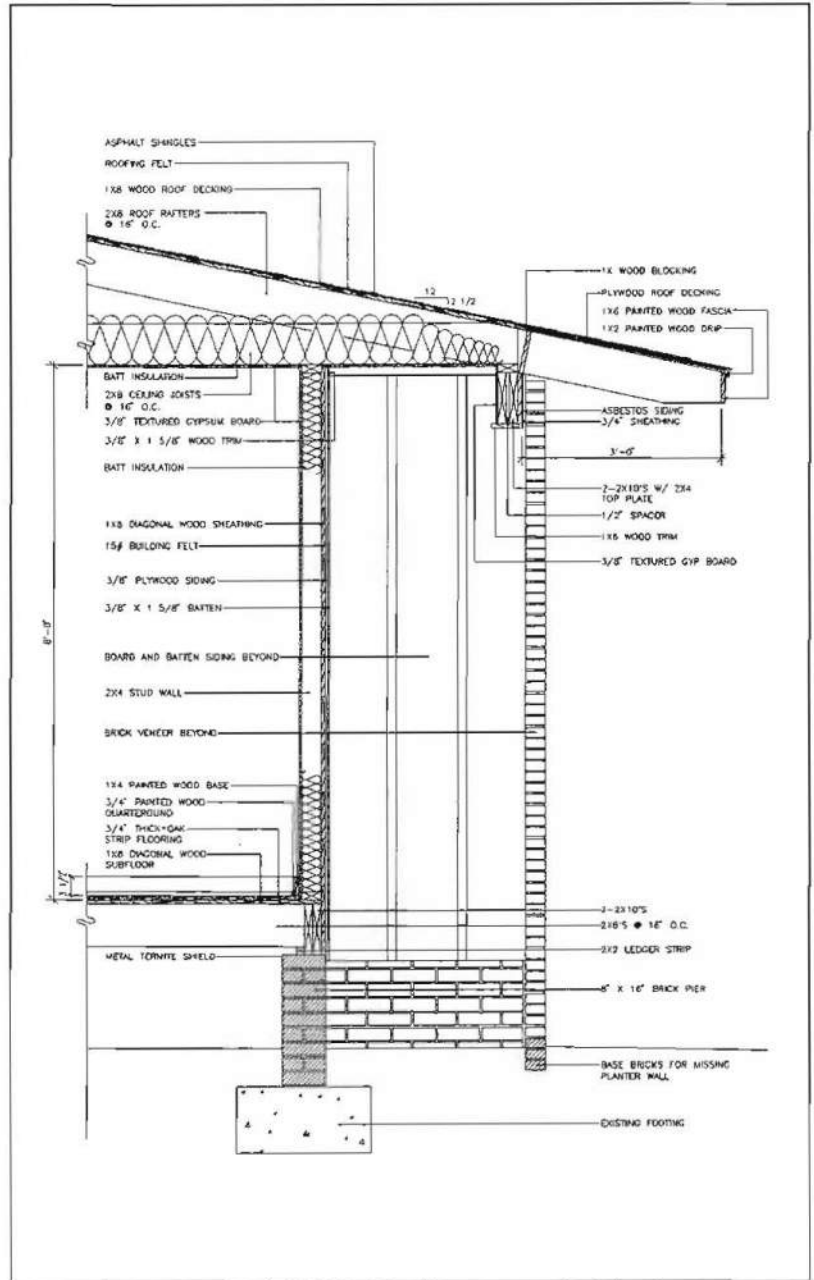
Some areas of the south and west faces have board and batten siding. In that wall section (see Figure 12) the asbestos siding is replaced with 3/8" plywood as board and 1 5/8" wood battens.

Figure 12. Measured drawing of wall section showing the optional wood board and batten siding and Roman brick chosen by the Evers and used on the front (south) elevation.

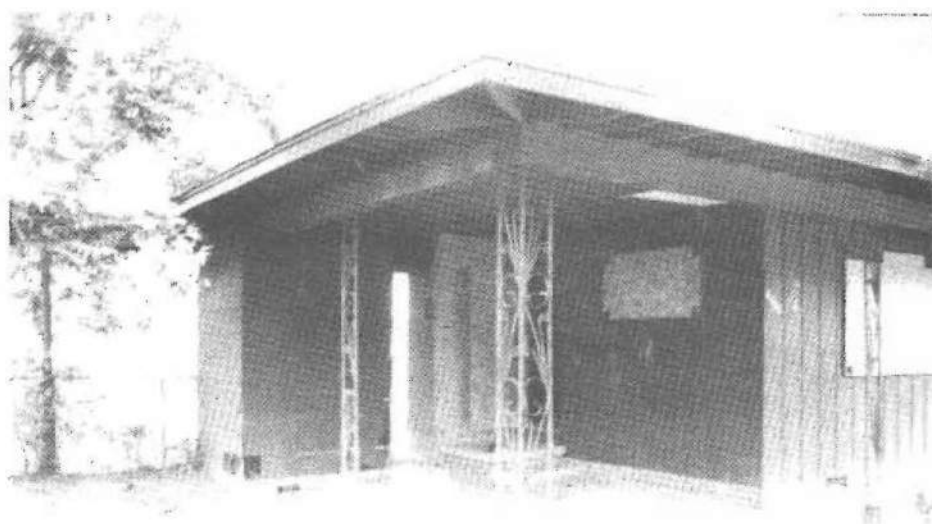
Four decorative wrought iron columns support the carport roof and a portion of the overhang of the south facade. Except for the deteriorated bases, all are in good condition. Beneath the current dark green coat of paint is a light green (chips collected).

Figure 15. 1994 view of the carport. Note the original decorative, wrought iron posts supporting the roof. Note also the dark paint that replaced the original light green paint on the storage closet door and the board and batten siding.

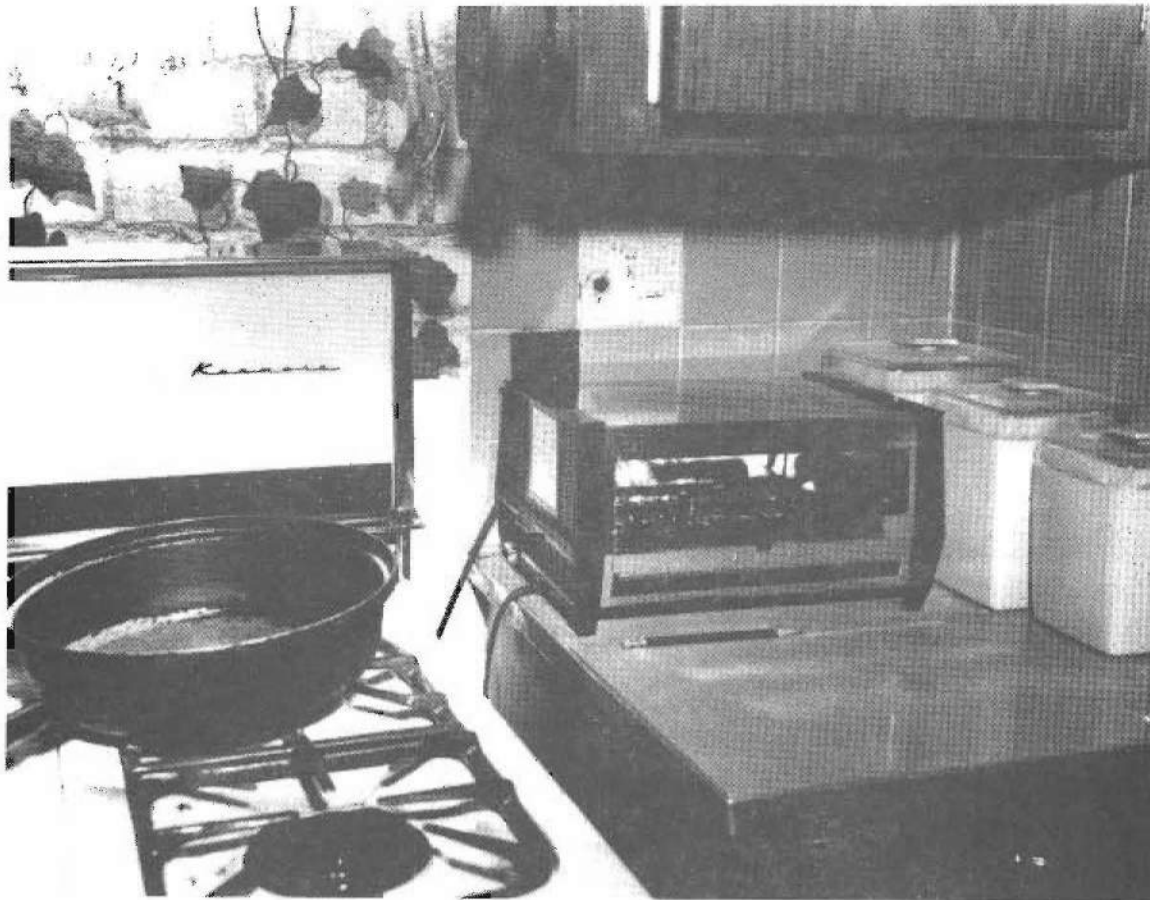
**Figure 23.** District Attorney's Office photograph taken the night of the assassination. The bullet dislodged or shattered a piece of tile on this kitchen wall, and the tile has never been replaced. The stove and other appliances shown are no longer in the house, and the wallpaper shown behind the stove no longer exists. All of the outlet and switch plates were originally brown like the one shown. They have since been painted.

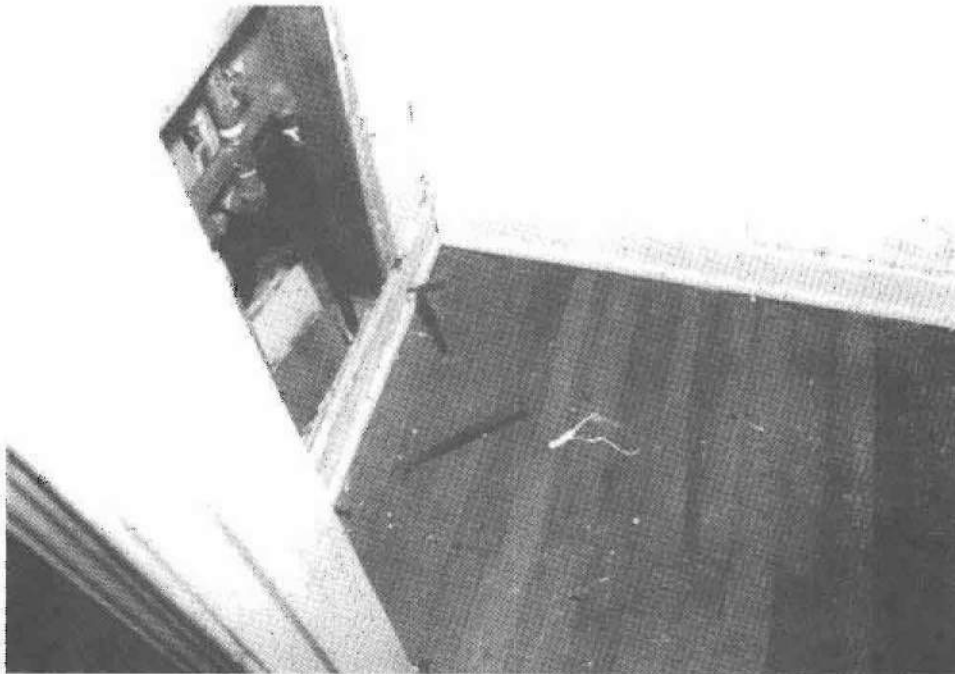
This closet provides access to the bath tub plumbing which is exposed in the south wall. The ceiling is heavily damaged, and the walls are heavily stained with mildew. One shelf and a metal clothes rod run the length of the closet.

**Figure 26.** Photograph taken in 1994 of the bathtub plumbing access located in the closet of Bedroom 1.

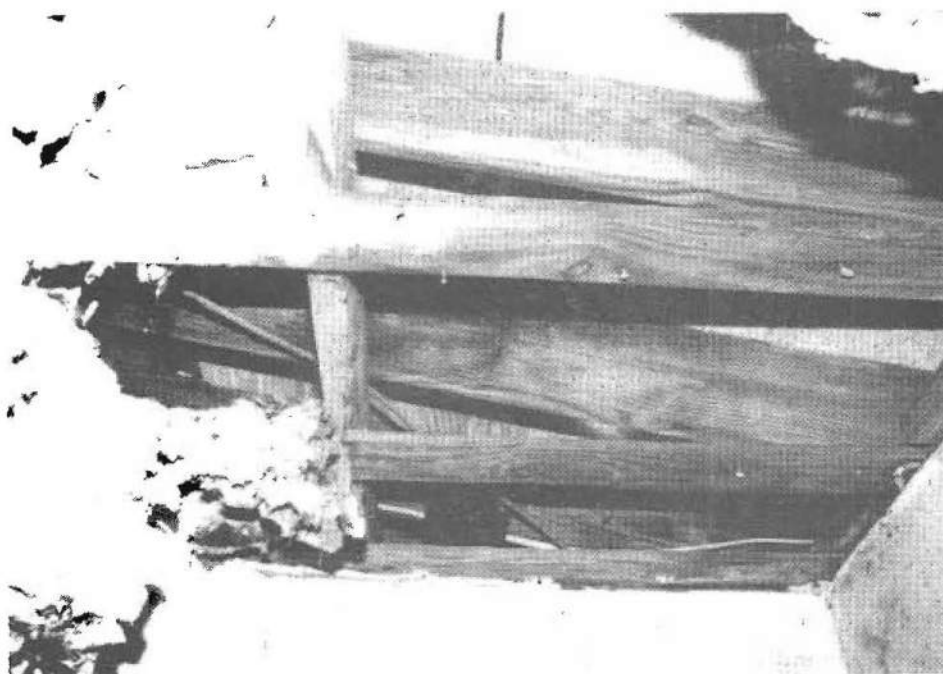
**Figure 28.** The fallen and deteriorated ceiling allows a view of the attic space above Bedroom 2 in this 1994 photograph. Areas of patched roof decking visible in the photograph have halted the leaks that caused the water damage.

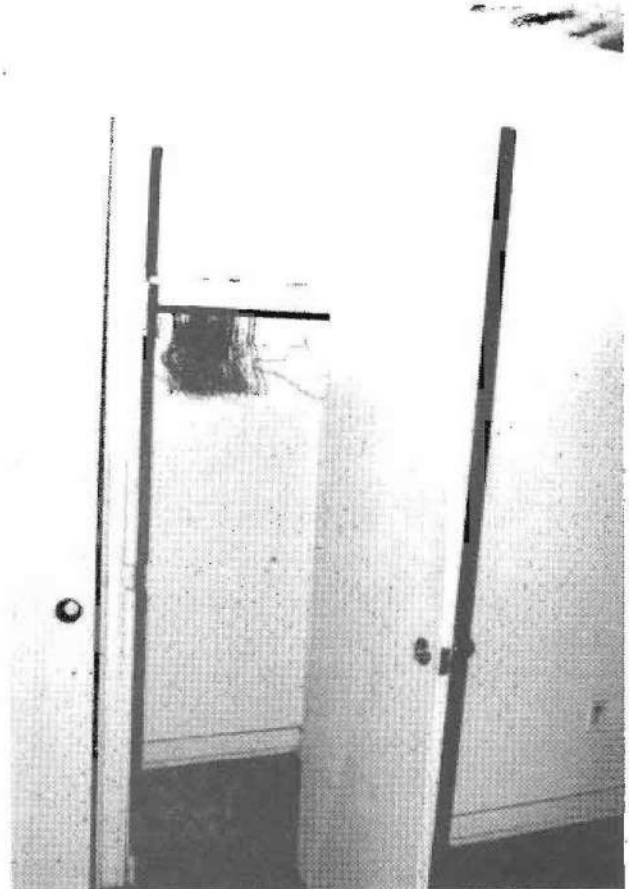
When the heater was installed, space was taken from the closet in this bedroom. The rear wall of the heater closet extends past the door jamb and into the bedroom closet considerably reducing its original size. The closet contains one painted 3/4" thick wood shelf and one metal clothes rod.

Figure 30. This photograph shows the back wall of the mechanical closet that extends into the closet opening in Bedroom 3. The mechanical closet encloses area that was once a part of the bedroom closet.

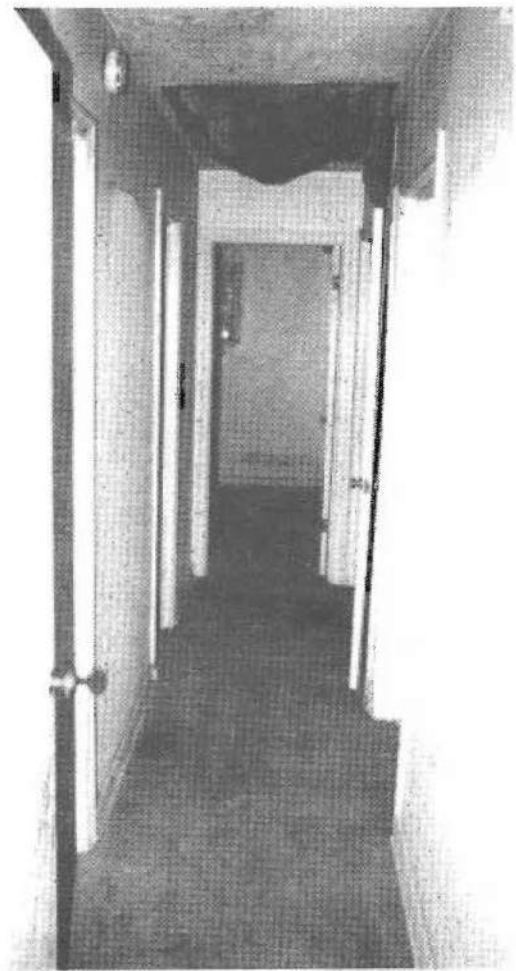
**Figure 33.** In this 1994 photograph, a blanket patches the opening that once held an attic fan.

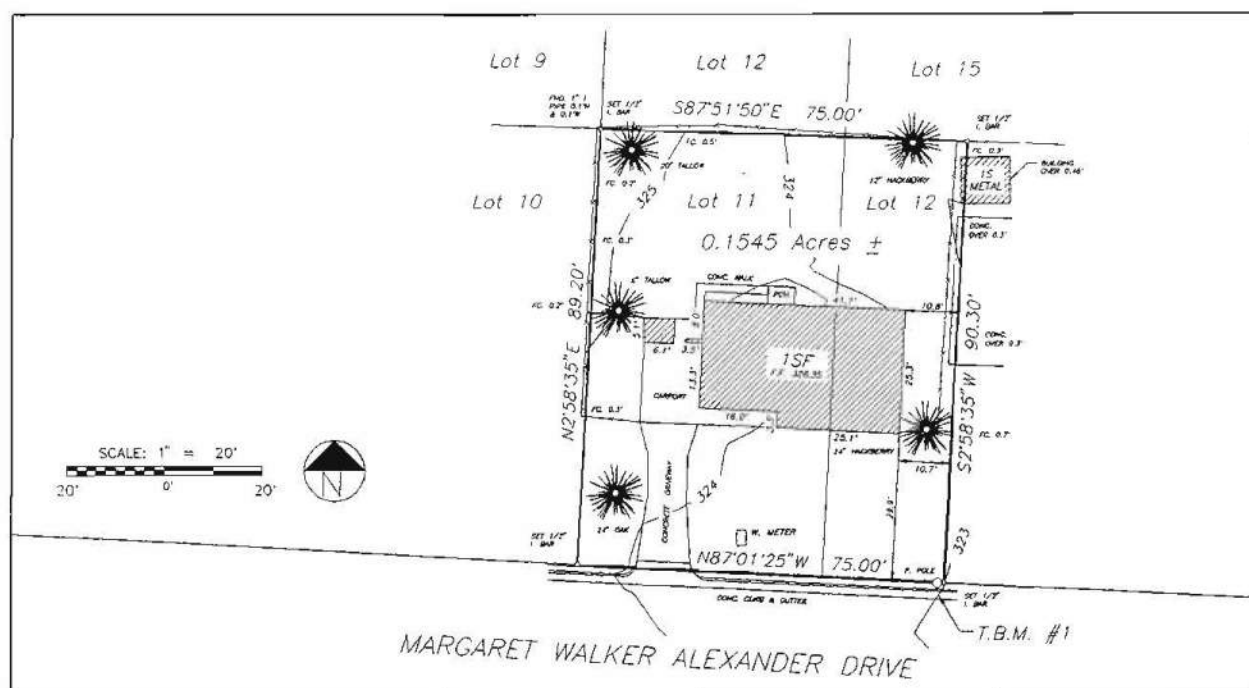
Site drainage is poor, and water accumulates in the crawl space under the house. A system of French drains will be necessary to prevent future water related problems once the renovation/restoration work is complete. A catch basin and drain line may be required to divert water away from and around the house, if French drains alone are insufficient.

Figure 34. Site plan of the Evers homesite from a 1995 survey done by Case & Associates, Inc.
