# Medgar and Myrlie Evers Home National Monument Historic Structure Report - Appendices

## CONDITION ASSESSMENT

### MEDGAR AND MYRLIE EVERS HOME NATIONAL MONUMENT

SEPTEMBER 2021

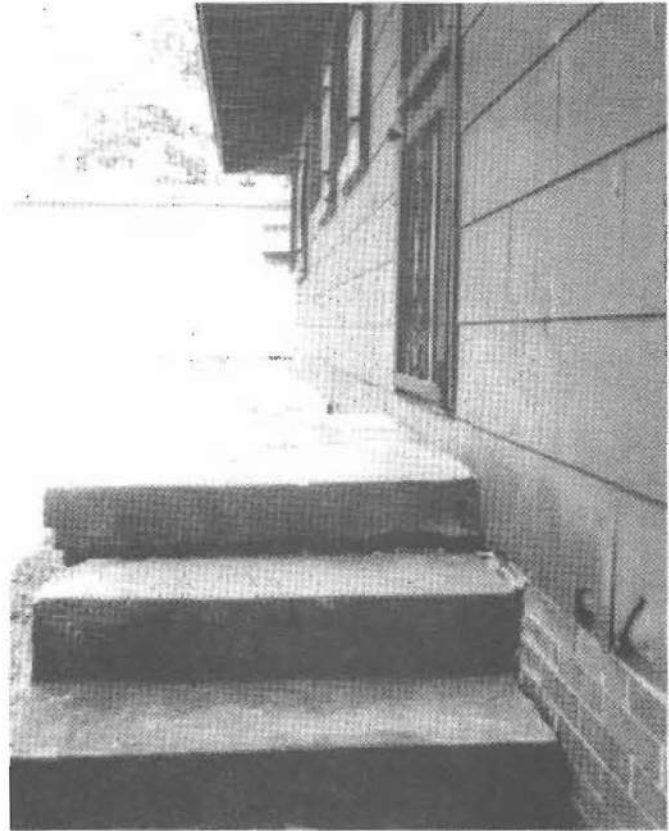
Figure 35. 1994 photograph of the stoop on the north side of the house.

The Americans with Disabilities Act and the Standard Building Code requirements for accessibility to the main level of the house can best be achieved by construction of a ramp. However, the location of a ramp is limited to the rear door of the house that opens into the kitchen or the main door of the house that opens from the carport into the living/dining area. The rear door is too narrow to be an accessible entrance, and the kitchen will not permit adequate maneuvering space for wheelchairs. A suitable ramp at the main door would encroach upon the space of the carport and appear totally incongruous. In addition, none of the doors inside are wide enough for wheelchairs making the entire house inaccessible. The size and layout of the house were dictated by the need for efficiency and economy, so even minimal changes to the fabric of the house would be significant. It would not be feasible to make the changes necessary to provide mandated accessibility to persons with disabilities and still preserve the fabric of the house. Section 4.1.7 of *ADA Rules and Regulations* gives some discretion to the State Historic Preservation Officer regarding the compliance of historic buildings. An opinion should be requested from the SHPO before the preservation plan is adopted.
