## **HISTORIC STRUCTURE REPORT**

### **GOWING-CLARK HOUSE (Daniel Taylor House)**

**Minuteman National Historical Park  
Concord, Massachusetts**

**February 2000**

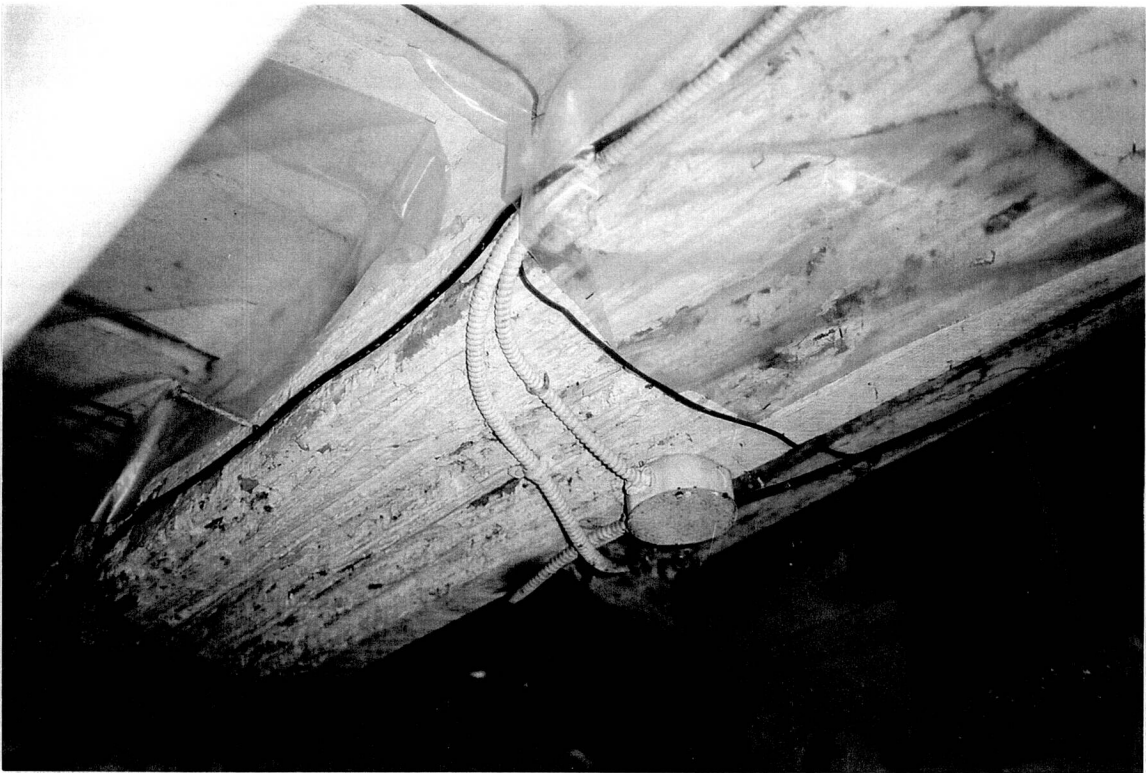
**Figure 18.** Gowing-Clark House – Ell Cellar, Reused Timber as North/South Girt (2000).

- In the ell cellar, the north/south girt that marks where the ell begins to extend east of the east wall of the main house is a massive beam measuring at least 1 foot in cross section (**fig. 18**). This beam was original to the construction to ell-cellar area, but is considerably oversized for its use and also has empty pockets. In addition, although the girt is extremely deteriorated a portion of a bead has survived on one edge. The size of the girt plus the presence of a decorative bead indicates that this girt was once a major carrying beam, probably a summer, from an earlier house that had been exposed and decorated.

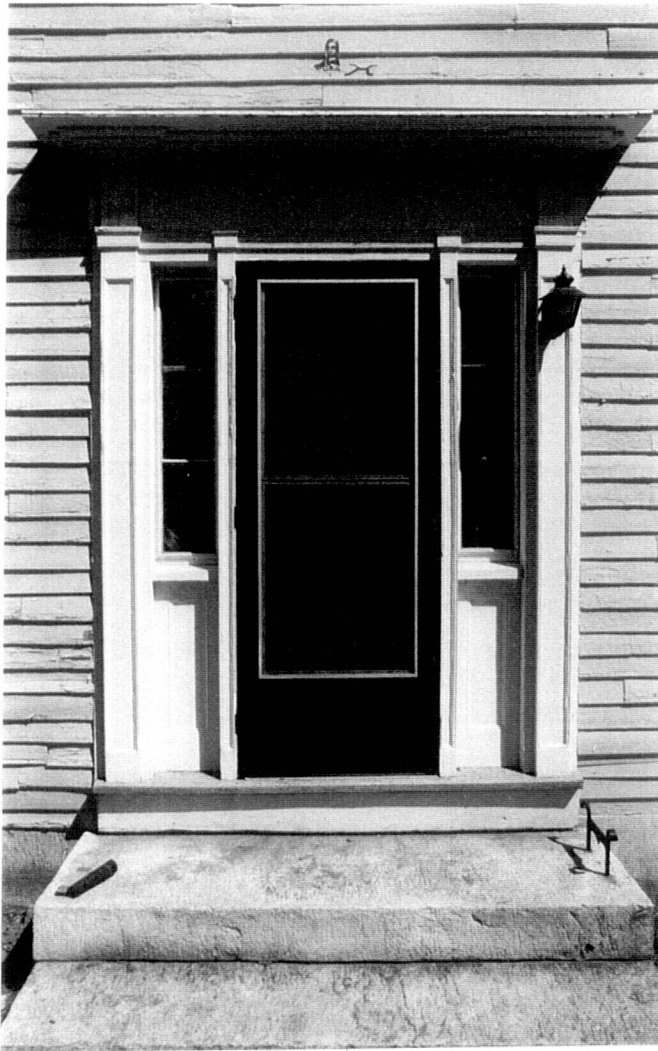
The main entrance on the south façade of the main house, with its doorway flanked by half-sidelights and topped by a simple architrave, is a federal style that was most commonly used in the late eighteenth and early nineteenth centuries (see **fig. 43**). It was this feature, along with the massing and proportions of the structure, that triggered the speculation that the main house may have been built around 1805 to 1810. However, only wire nails could be seen in the surround and

**Figure 43.** Gowing-Clark House – Main House South Façade, Doorway D101 (1999).

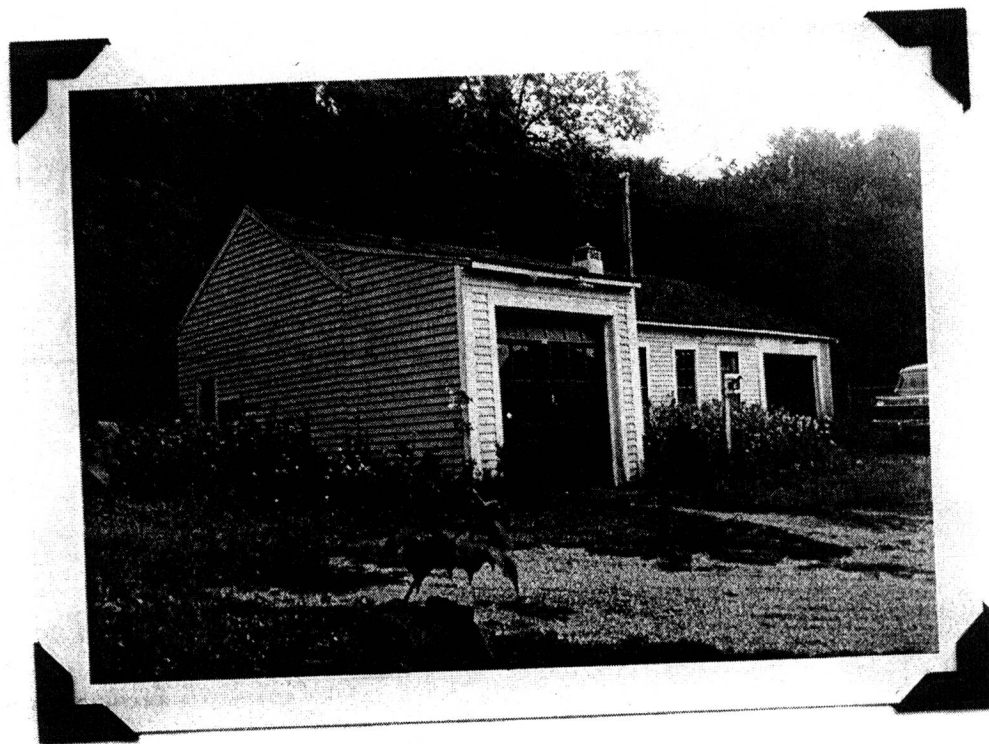
SHED-GARAGE

The Garage and Storage building originally part of the razed barn is a shed type structure with pitched roof, of wood frame construction on one layer concrete block foundation, outside walls are covered with clapboard, roof without gutters is covered with composition shingles. Inside divided into three parts, single car garage at each end with storage area in the middle; rough frame, floors in the garage areas are concrete, in the middle section it appears that the floor was originally concrete but now larger part is dirt flooring; an addition in rear of this part of 2.6 x 9 feet has been added to make room for a car, as the depth of 15.9 feet

was not sufficient. This building is in a poor condition with rafters spreading, showing a decided sway in the ridge; it appears that a heavy snow storm may level this building. 7

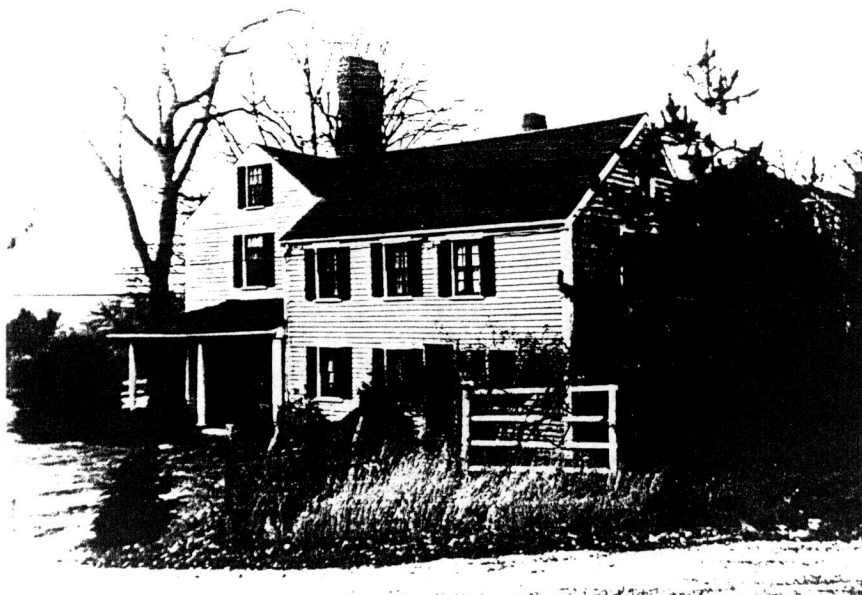
Northeasterly View of Ell

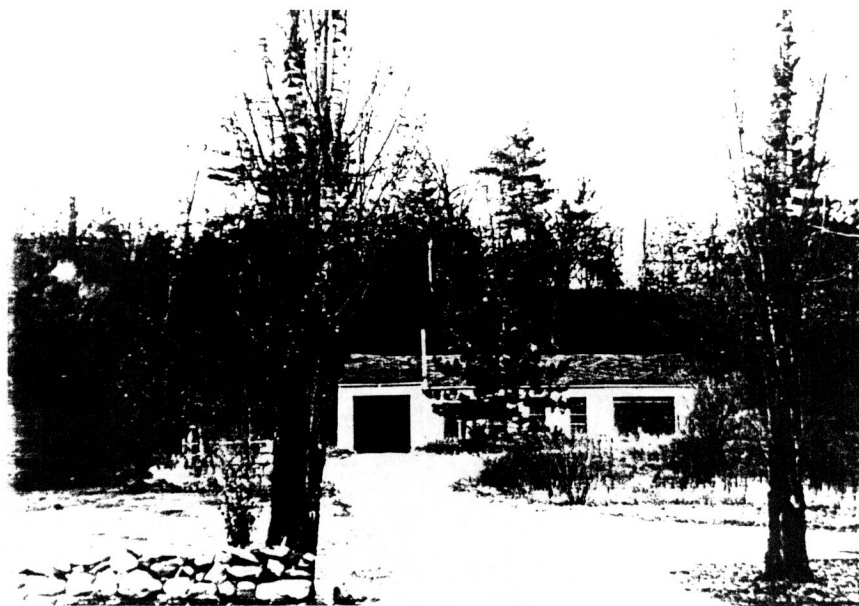
Driveway and Shed
