**HISTORIC STRUCTURES REPORT**

**BUILDING NUMBER LEX-3**

**THE JACOB WHITTEMORE HOUSE**

**Prepared by  
Russell V. Keune  
Architect  
January, 1963**

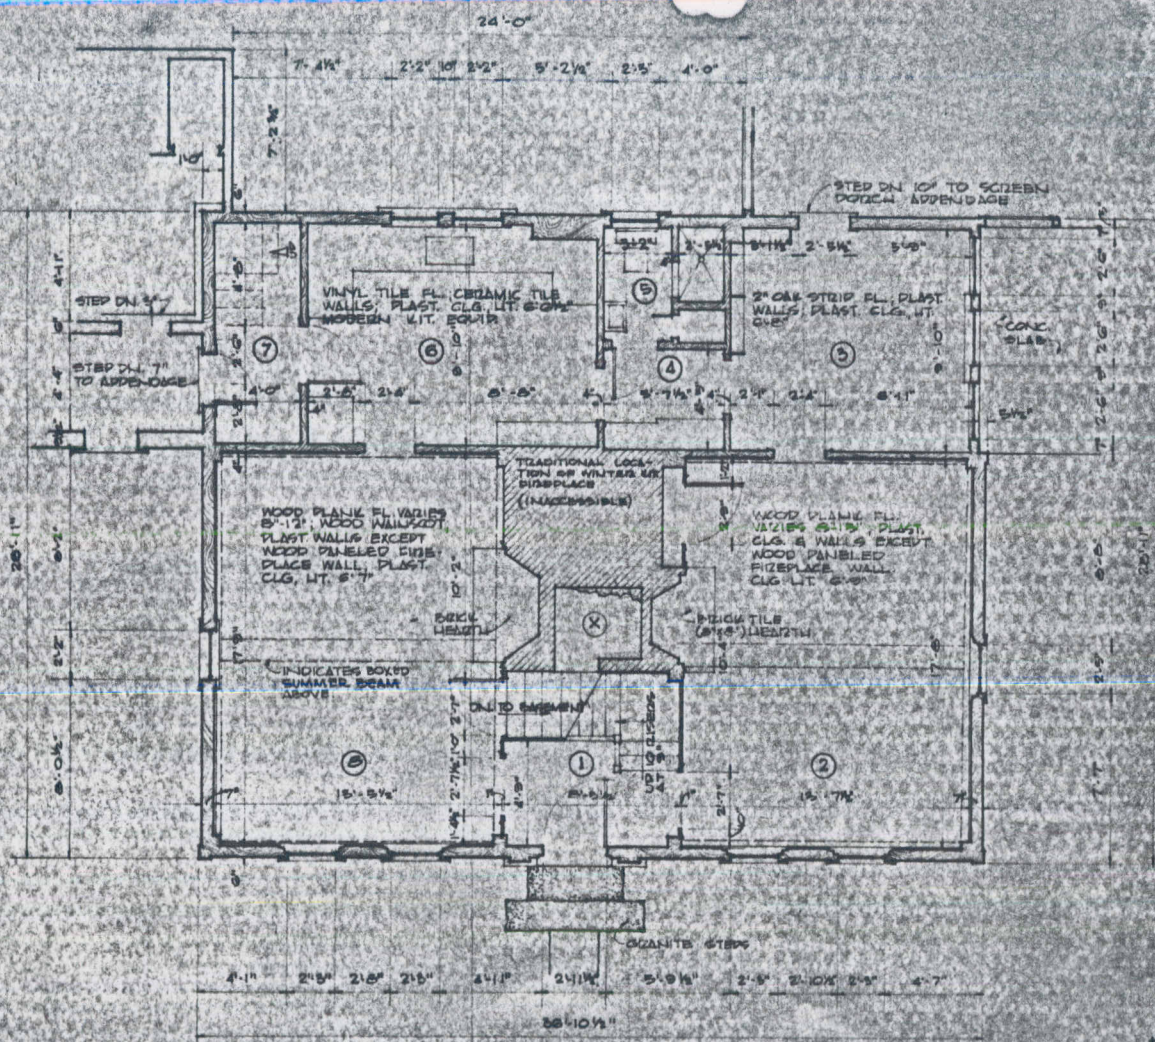
NOTE:

A 1915 PHOTOGRAPH SHOWS AN APPENDAGE ON THE EAST CORNER OF THE HOUSE, PROBABLY USED AS A SUMMER KITCHEN.

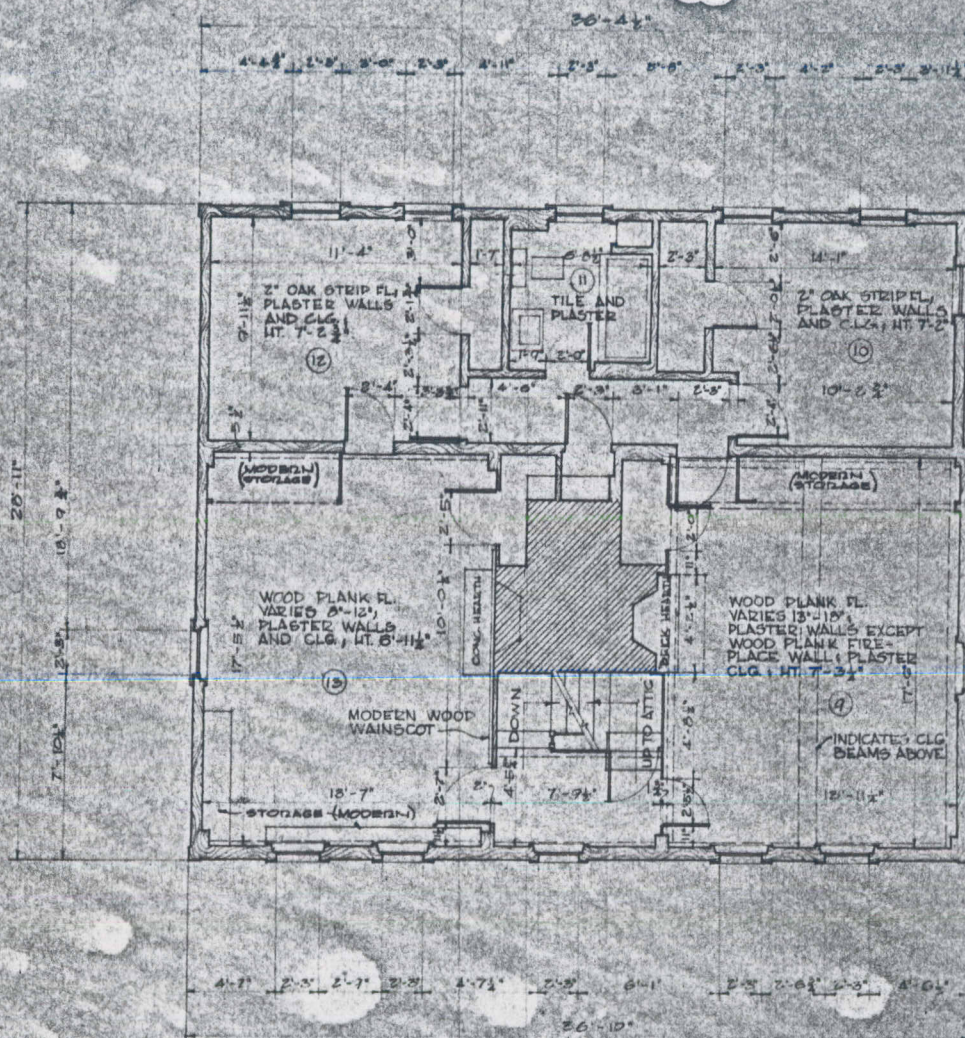
**NOTE:**

- CONC. HEARTH IN RM (10) INDICATES CLOSED FIREPLACE.
- ROOMS (13) (11) (12) APPEAR TO BE RECENT WORK. IN OTHER HOUSES OF THE AREA SIMILAR TO THIS STRUCTURE, THIS SPACE WAS USED AS A LARGE SLEEPING LOFT HEATED BY A SINGLE FIREPLACE IN THE CENTRAL CHIMNEY. (SEE THE BROOKS-STURM HOUSE, LINCOLN, MASS.)

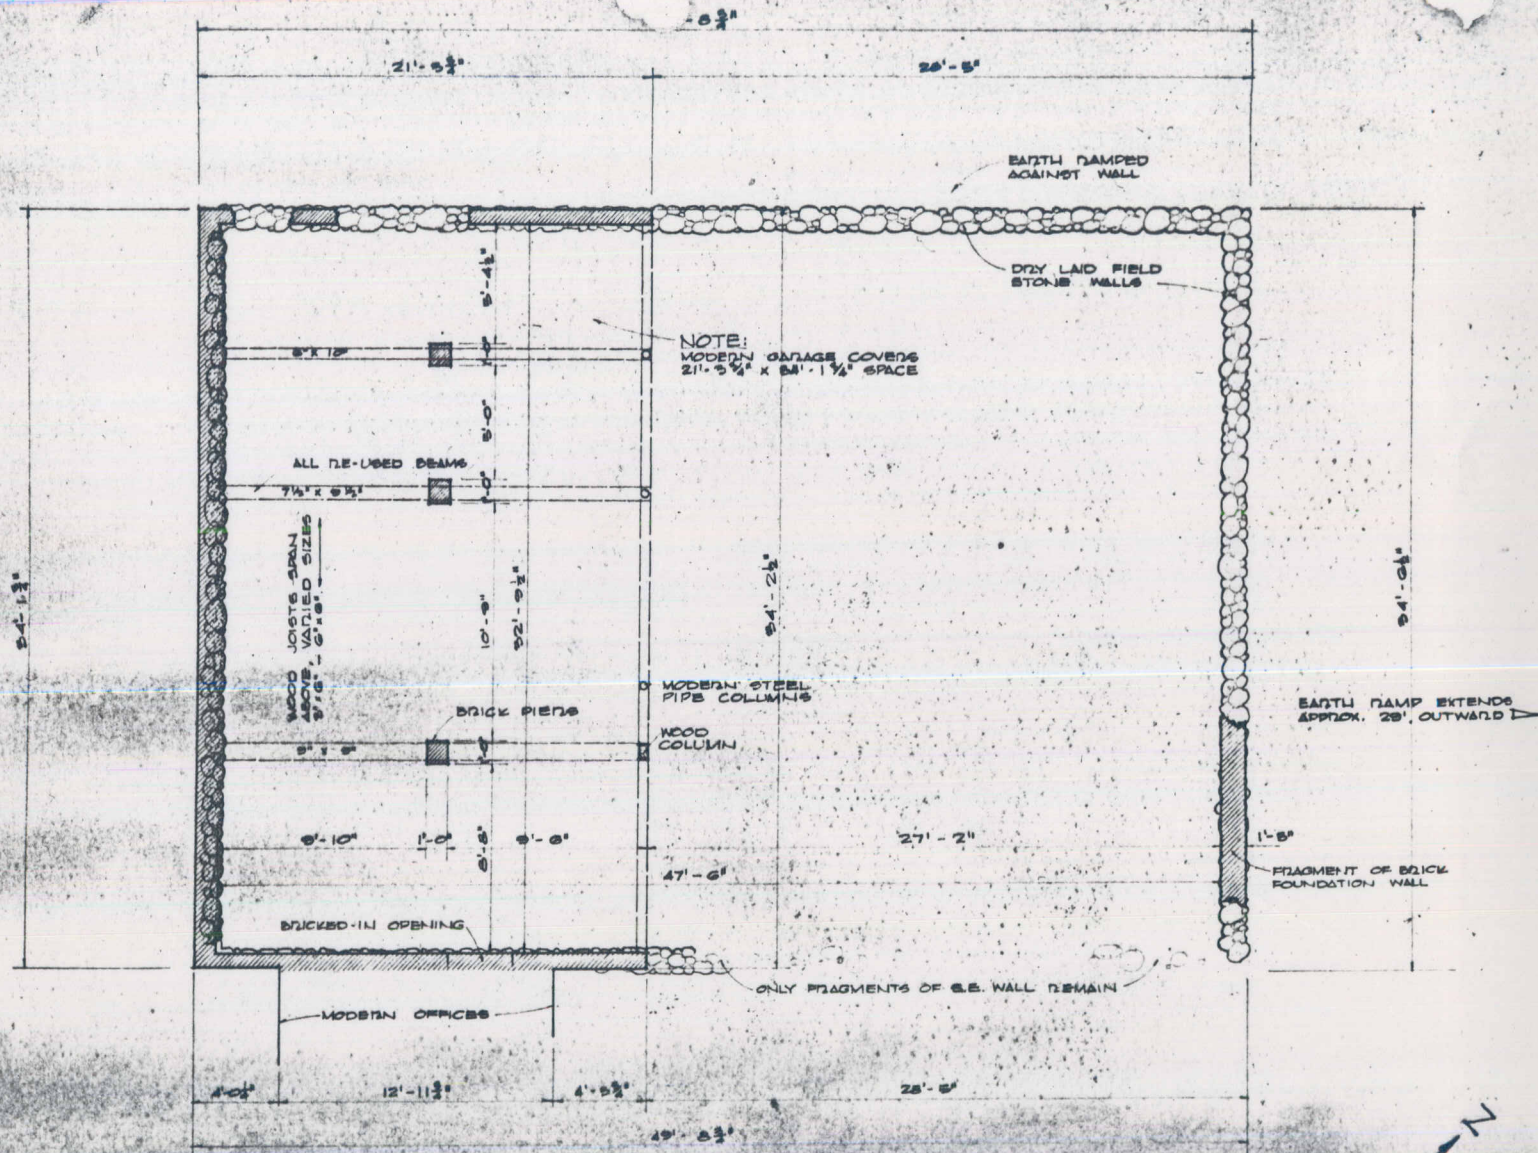
**BAZIN FOUNDATION**  
SCALE  $\frac{1}{4}'' = 1'-0''$

The extent, size or specific types of outbuildings in existence in 1775 is unknown at this time. To the north of the house, beneath the present garage, are the remains of a rectangular shaped foundation of an earlier building. Below grade the walls are constructed of field stone laid up dry in a random pattern; above grade, where remaining, the foundations are constructed of brick laid up in common bond. The walls are in a varying degree of collapse. What appears as an earth ramp leads off the east end of the foundation.
