COMPLETION REPORT  
RESTORATION OF THE HARTWELL TAVERN  
Minute Man National Historical Park  
Concord, Massachusetts

May 1983

National Park Service - North Atlantic Region  
North Atlantic Historic Preservation Center

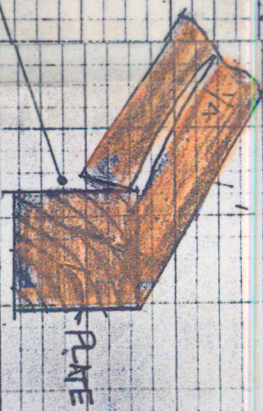
TYPICAL RAFTER END

ALL RAFTER ENDS AT PLATE RAFTERS SOUND BUT CRACKED BY SINKS  
 -SPLICE IN PLATE RAFTERS DUE TO SETTLEMENT

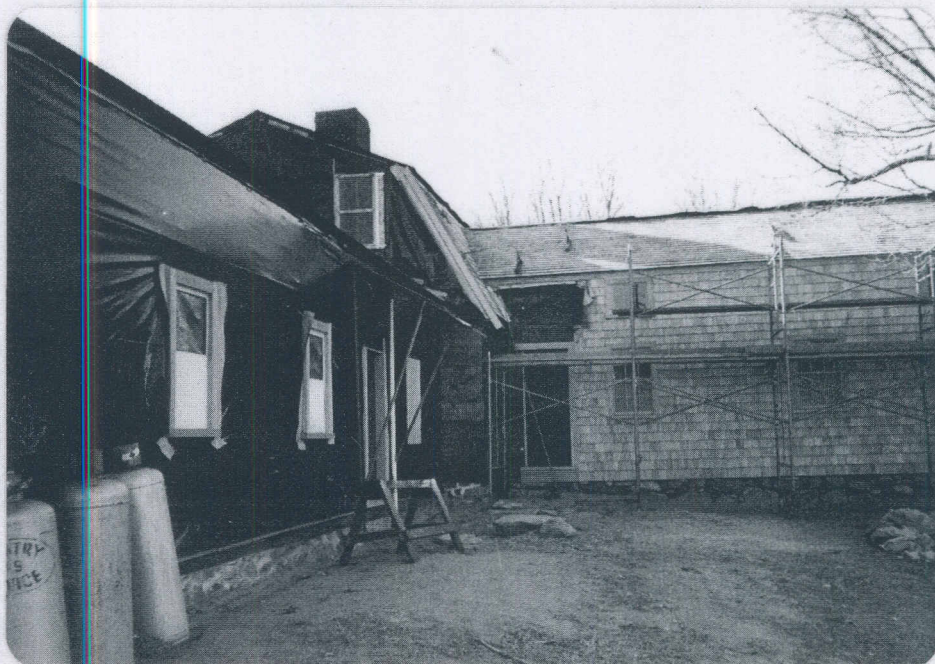
By early winter of 1981, the roofs had been shingled, exterior window and door frames installed and work on the shed addition nearly completed. View at rear of Hartwell Tavern.

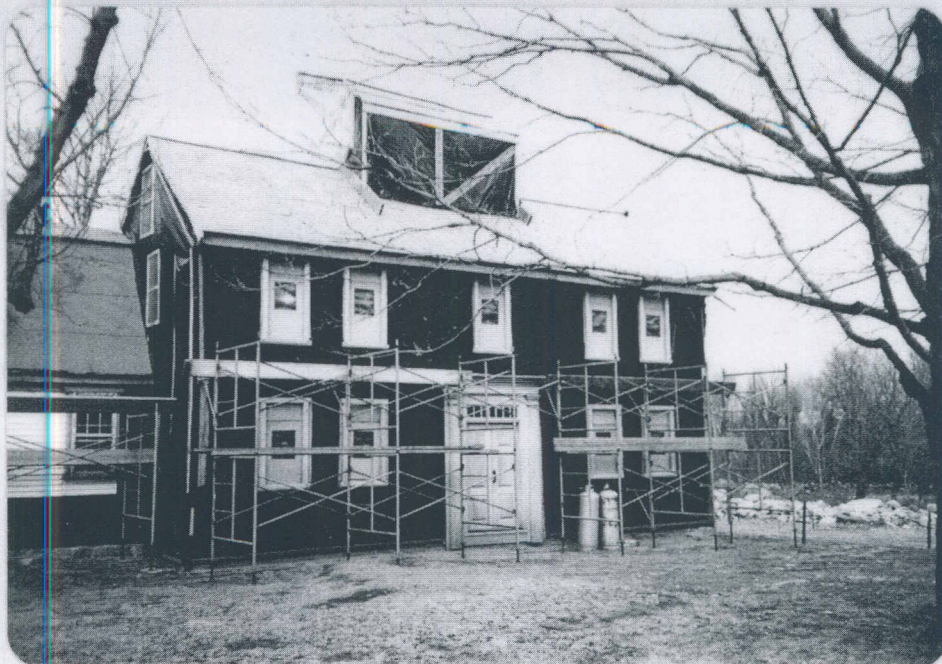
South wall of the Hartwell Tavern after the reproduction (1733) window frames and fronticepiece for the central doorway had been installed. The temporary tent structure seen on the roof provided protection to the brick mason while the central chimney was being built.

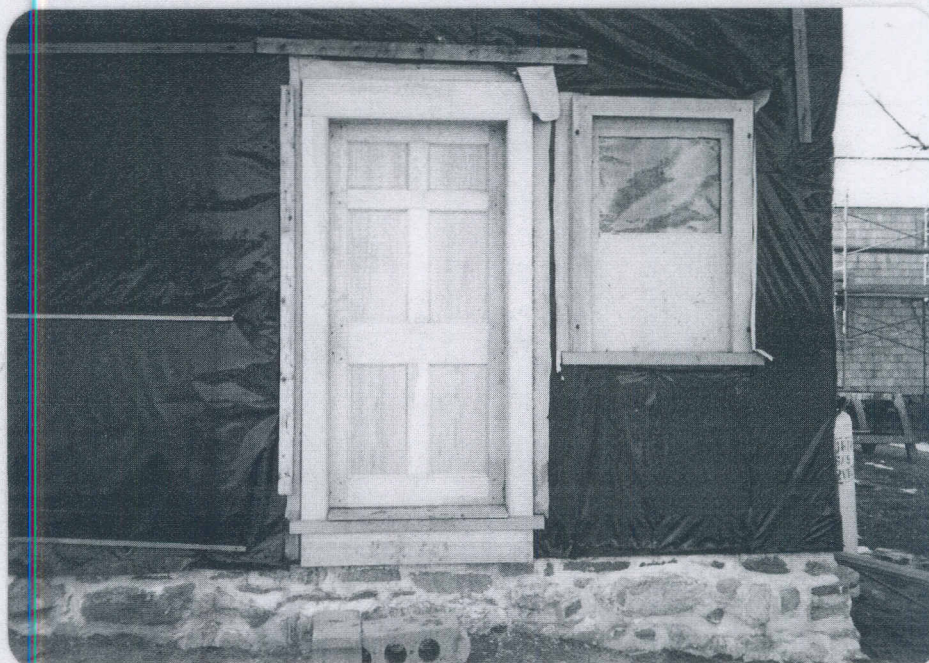
East wall of the kitchen lean-to showing the recently installed door frame and door along with a new adjoining window frame. These members represent one of several architectural styles in use during the first half of the 19th century.

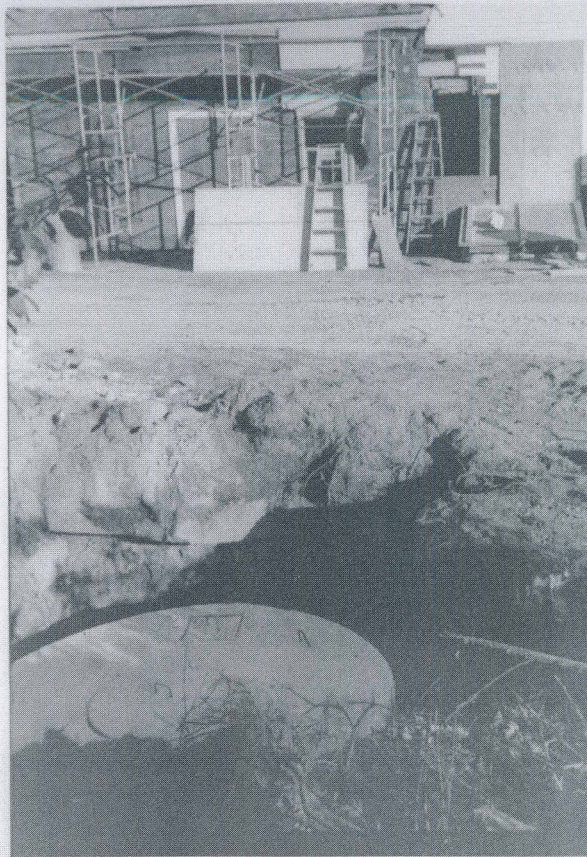
Location of the concrete leaching pit on the west side of the gambrel addition.

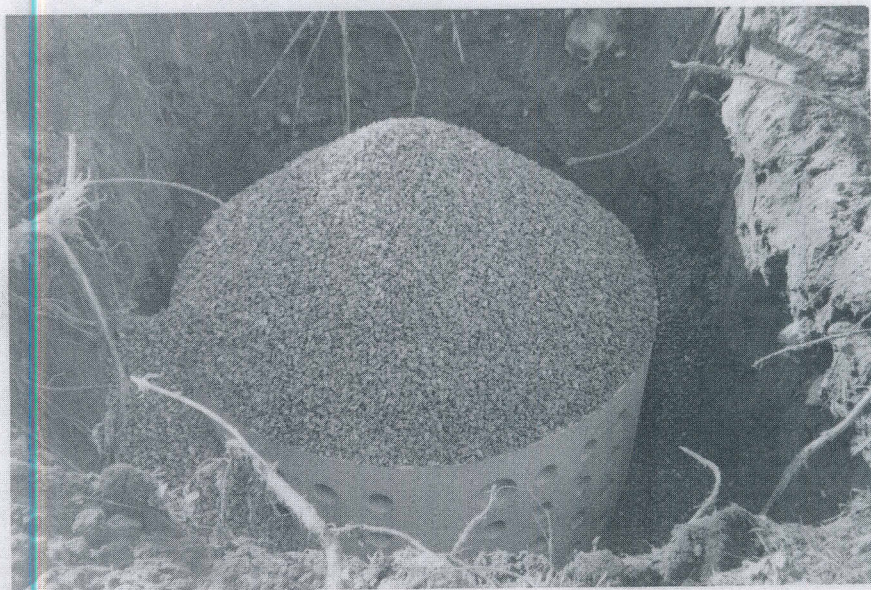
Concrete leaching pit with reinforced concrete top, being covered with gravel. A second leaching pit was placed on the east side of the Tavern as well.

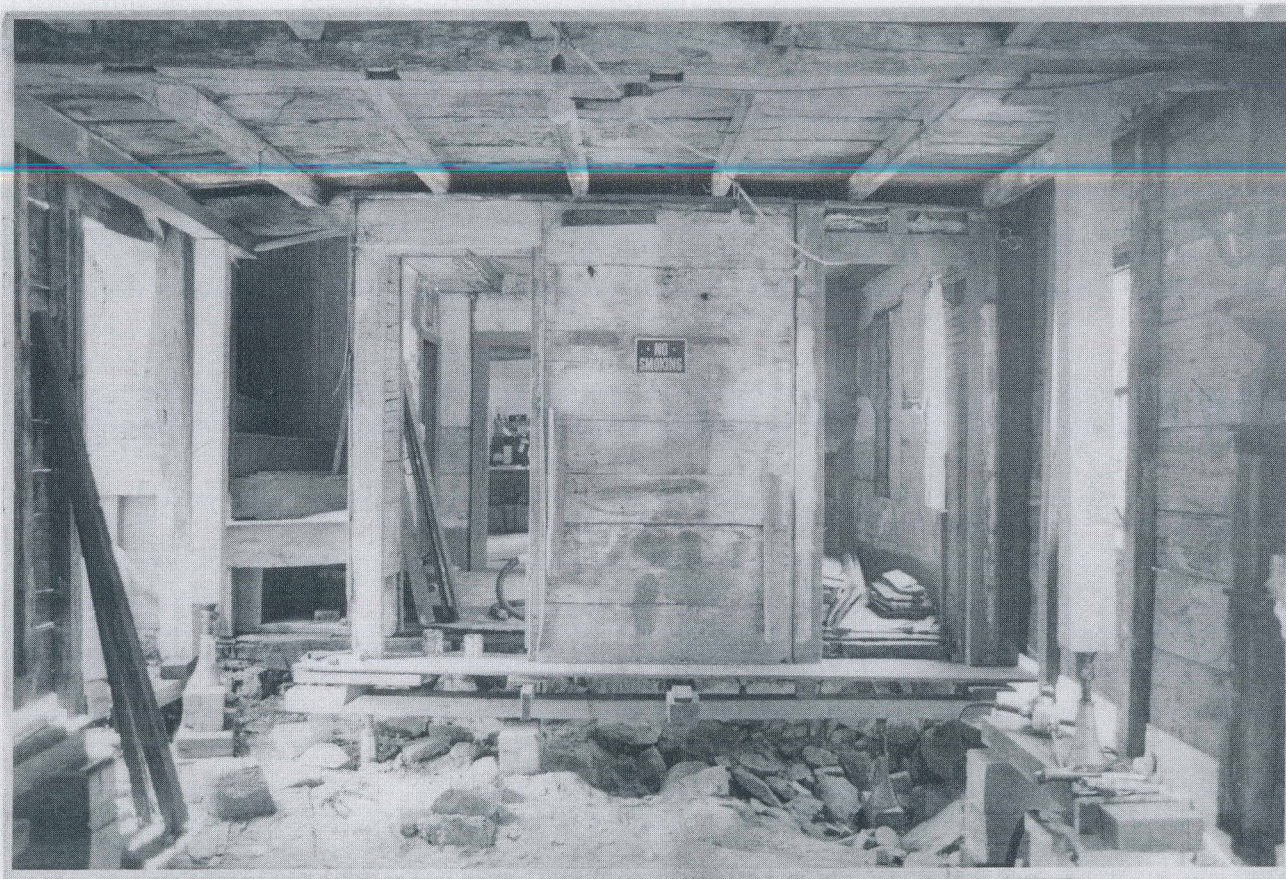
Interior view of the shed during rehabilitation work on the floors and stairway. View looking south with gambrel addition beyond.

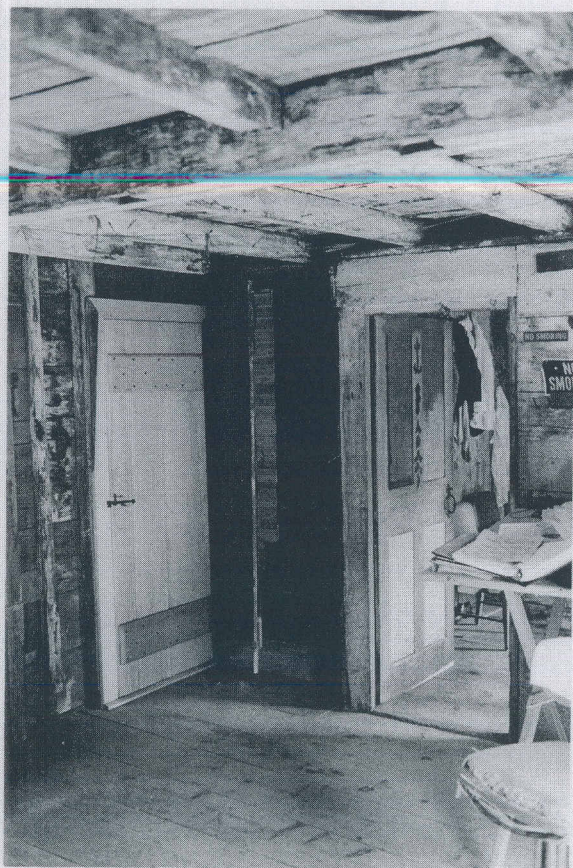
Shed addition of c. 1830 after rehabilitation work on interior was completed in 1982.

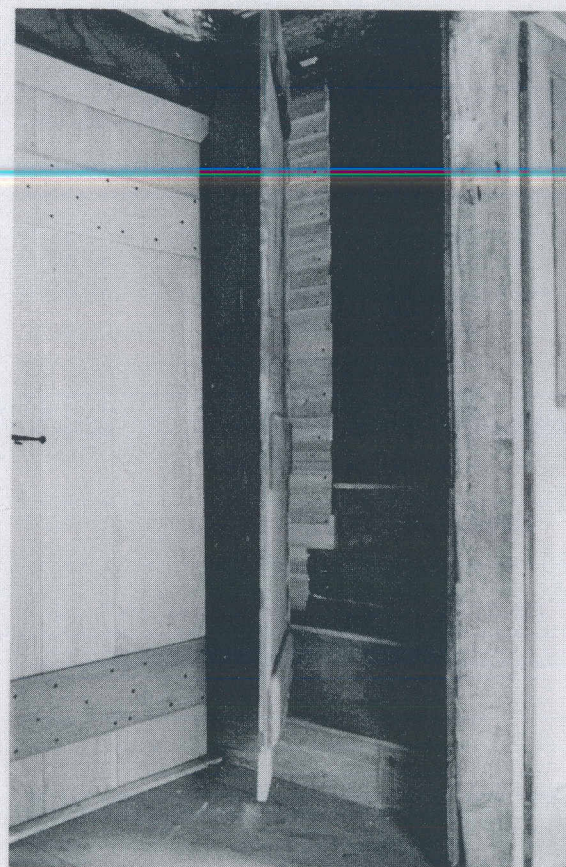
Shed addition of c. 1830 showing new exterior door and rehabilitated stairway to gambrel chamber.

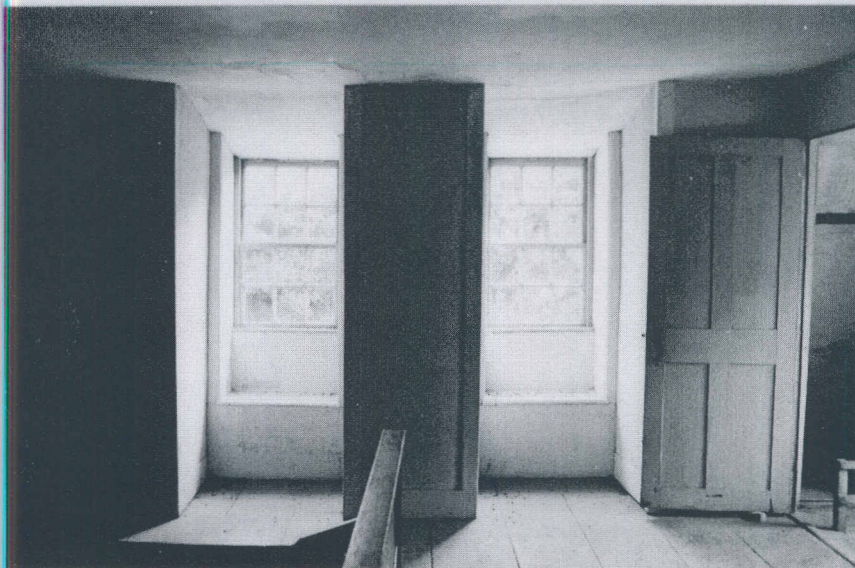
Chamber in gambrel addition of c. 1783, looking at south wall with new window sash and stops. Remaining parts of the room are original in this view.

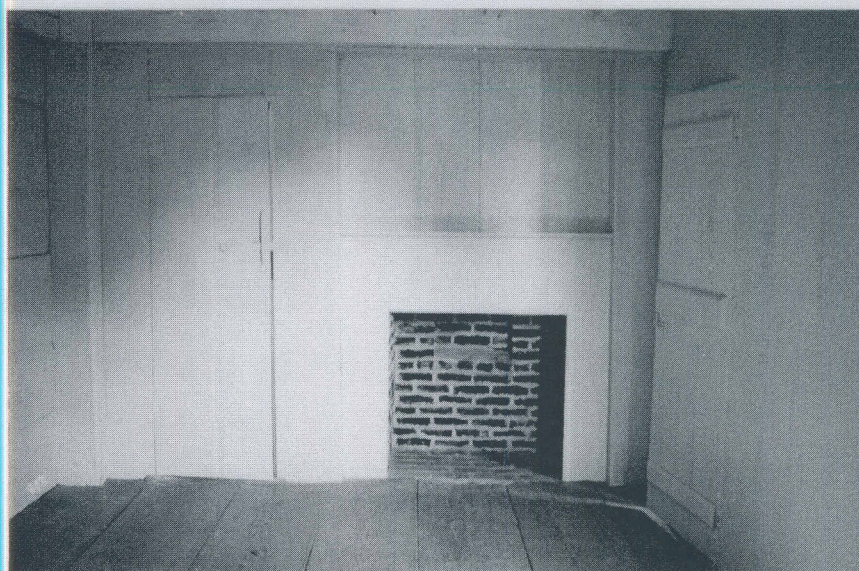
North room of divided West Chamber, 1733, looking at restored fireplace surround including mantel shelf, jamb and head boards and feathered edge molded boards above mantel shelf.

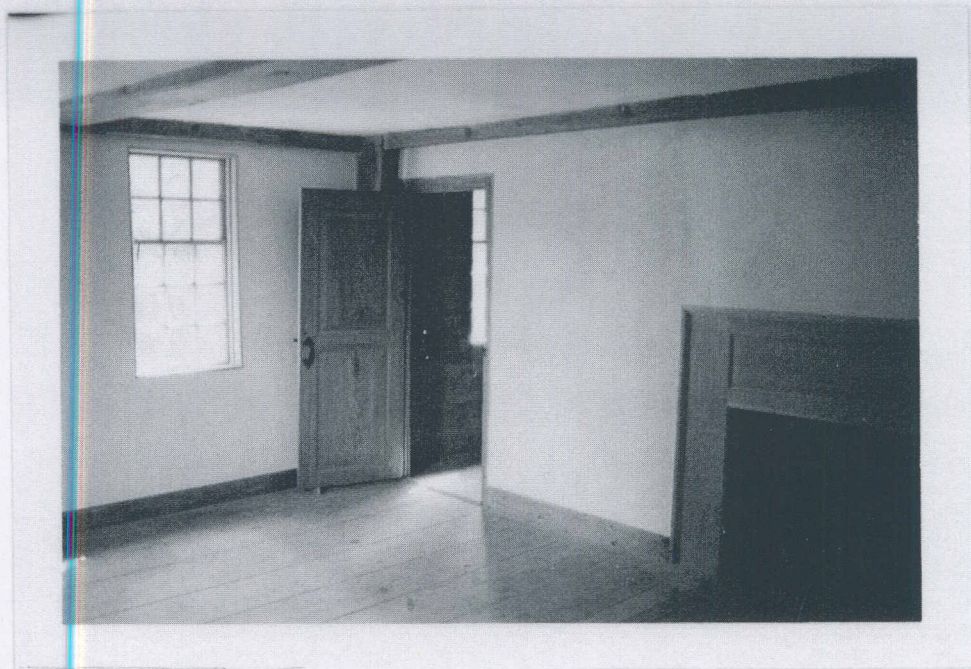
Southwest corner of the East Chamber with an original two paneled door and thumb latch. Mantelpiece is a reconstruction.

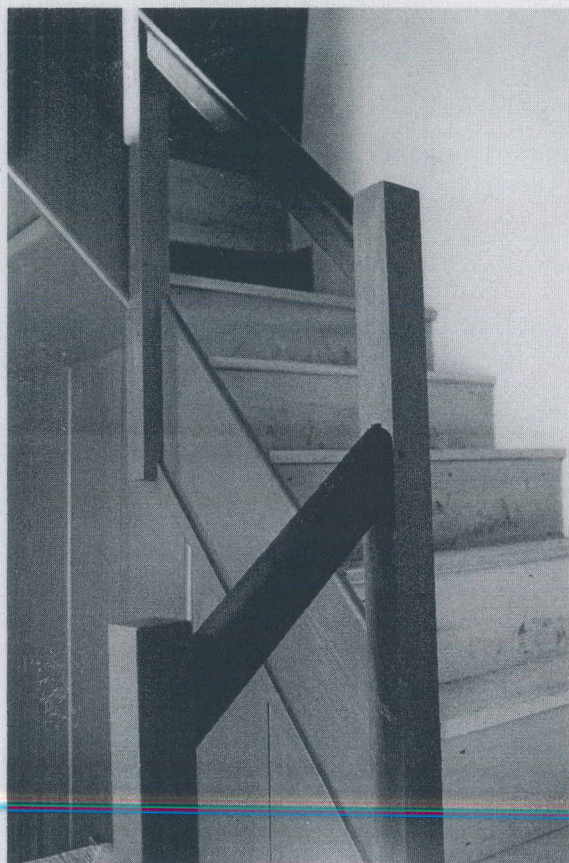
Reconstructed stairway on first floor, 1733. All pieces are new except the handrails which are original.

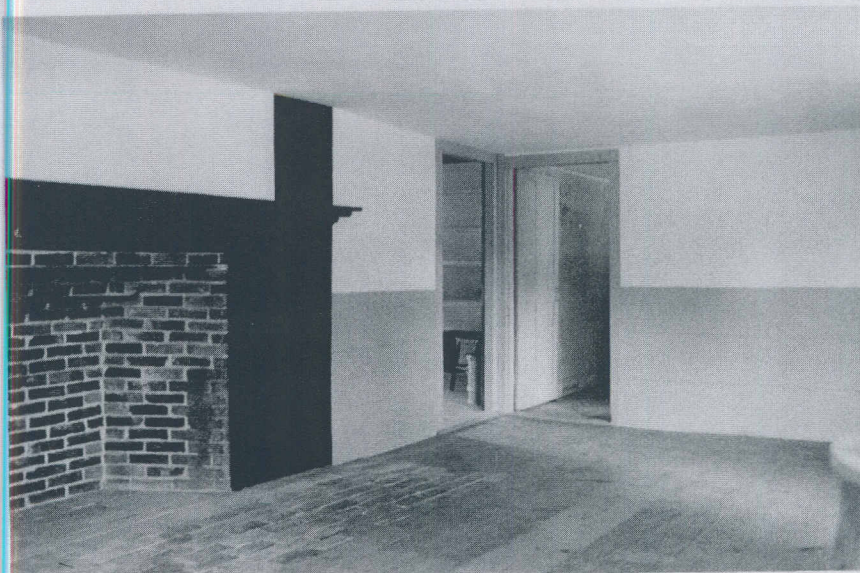
Kitchen in lean-to built about 1830. Fireplace was reconstructed in 1982. Plaster walls and ceiling and floor boards were installed in 1982. Mantel is original to c. 1830.

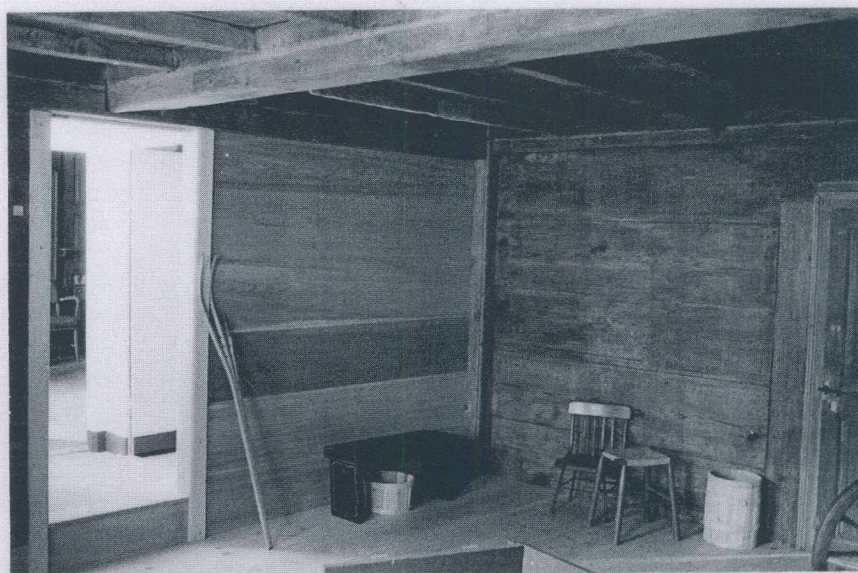
West Parlor, 1733 house, after restoration of wall boards on west wall in 1982. Doorway to Kitchen lean-to, dating from c. 1830 was left intact.

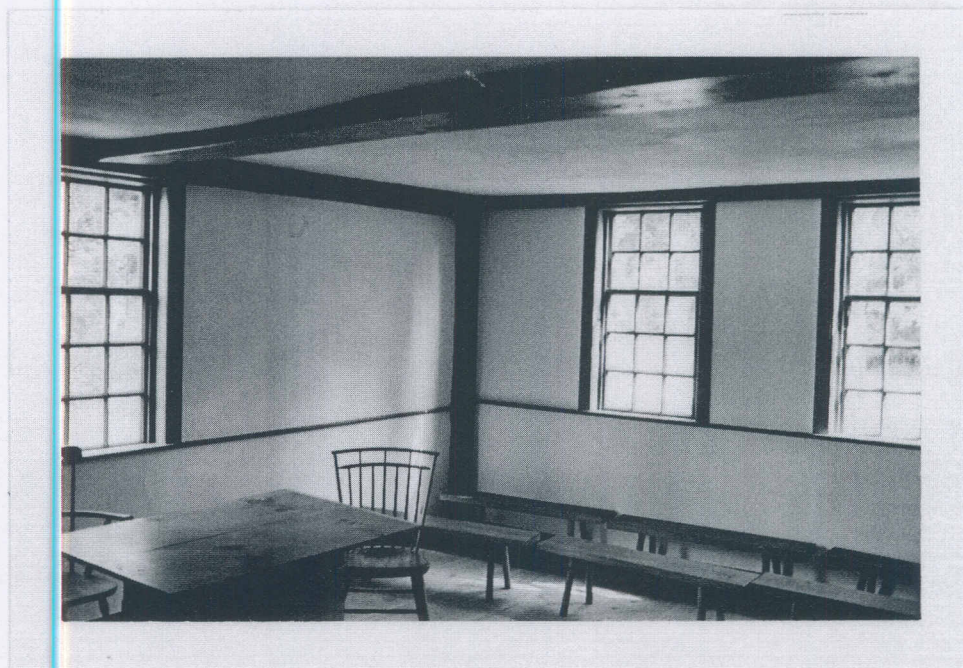
East Parlor, showing reconstructed window frames and sash representing the 1733 period of construction. Plaster walls and ceiling are original.

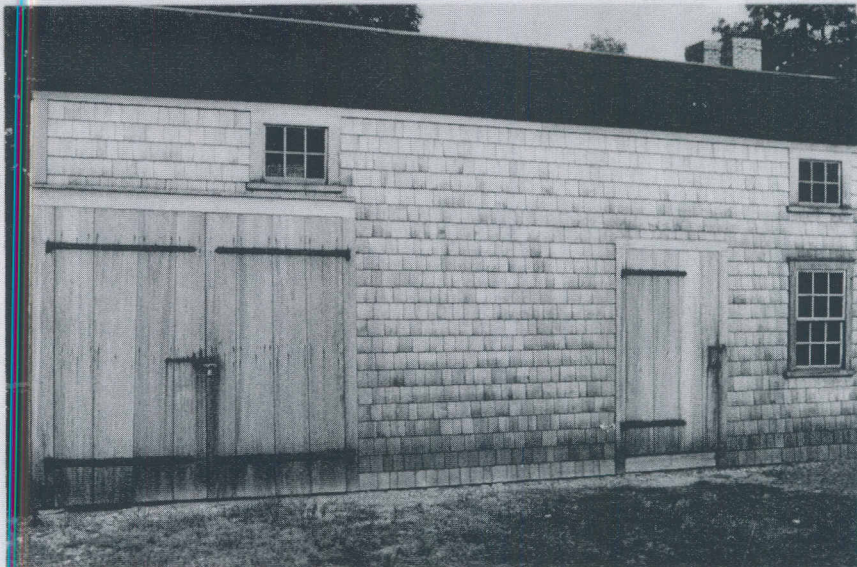
West wall of shed after restoration to the c. 1865 period was completed.

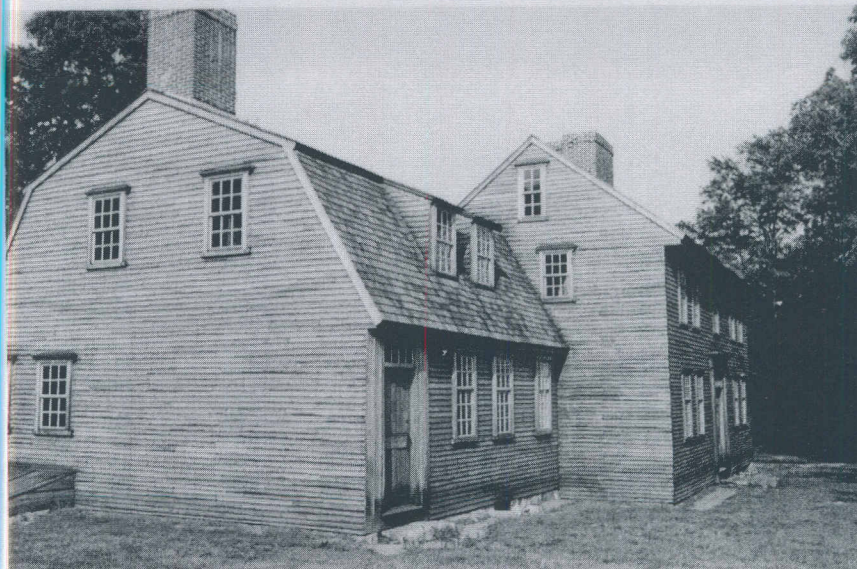
View of Hartwell Tavern looking northeast at restored exterior completed in 1981-82. Window frames and doorway in south wall of c. 1783 gambrel addition are original.

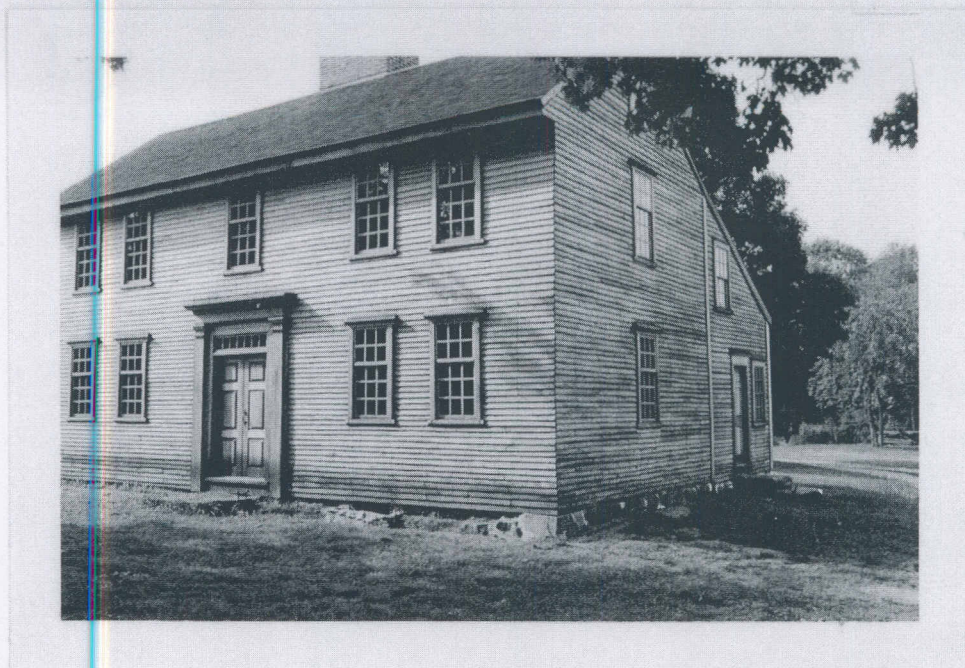
Exterior view of 1733 house as restored in 1981-82.  
All woodwork replaced was reproduced from white pine.

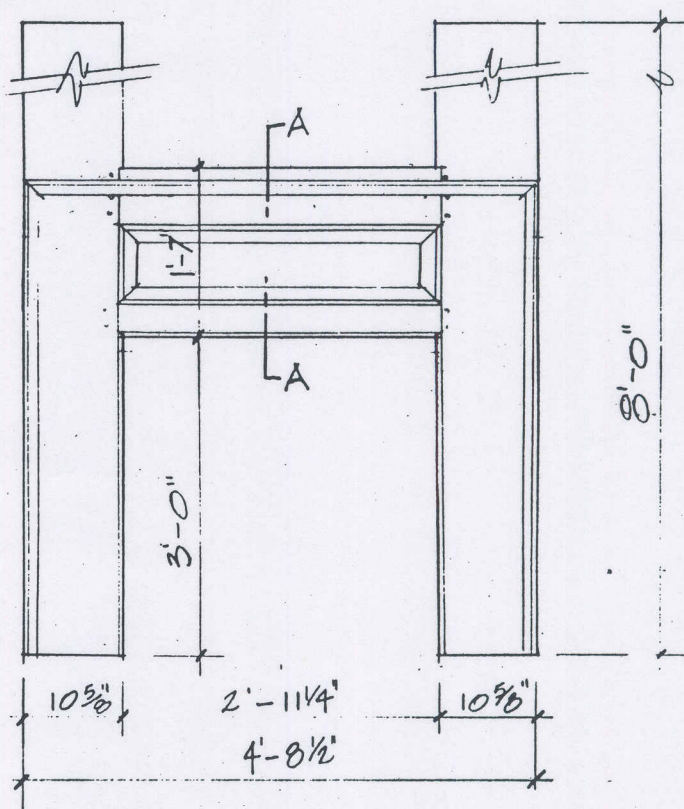
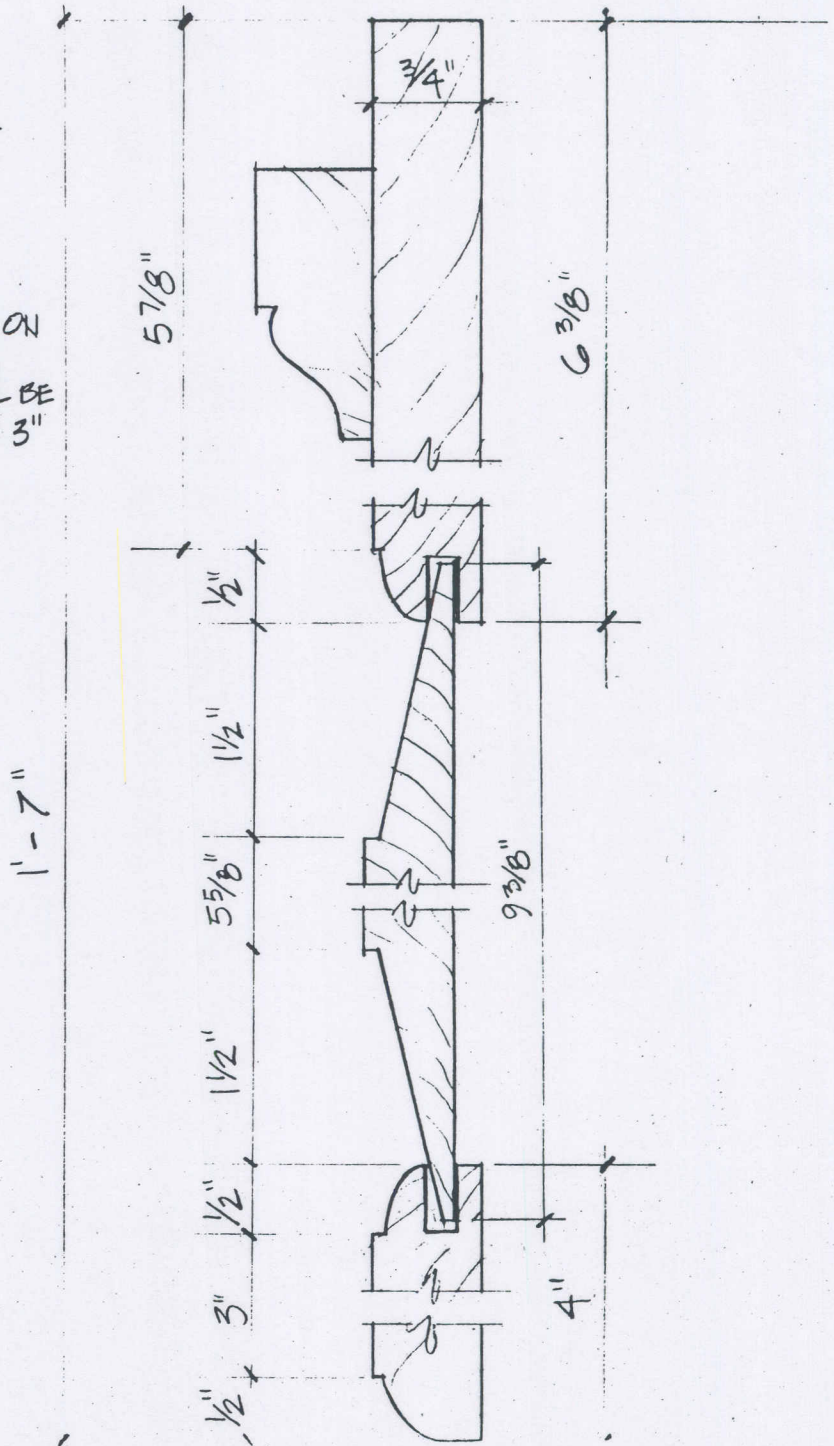
SHEET 1 OF 3

ITEM 1 ON SCHEDULE, SHEET 26, CONSISTING OF 5 1 x 6s  
JOINED TOGETHER SHU, HAVE DIMENSIONS CHANGED AS  
SHOWN BELOW:

REVISION OF EAST  
CHAMBER CHIMNEY  
BREAST.

ON DETAIL (B) JOINT ON  
ORIGINAL SHEET 26,  
BOTTOM TENON SHALL BE  
CHANGED FROM 4" TO 3"  
& TOP TENON FROM  
6 5/8" TO 5 7/8".

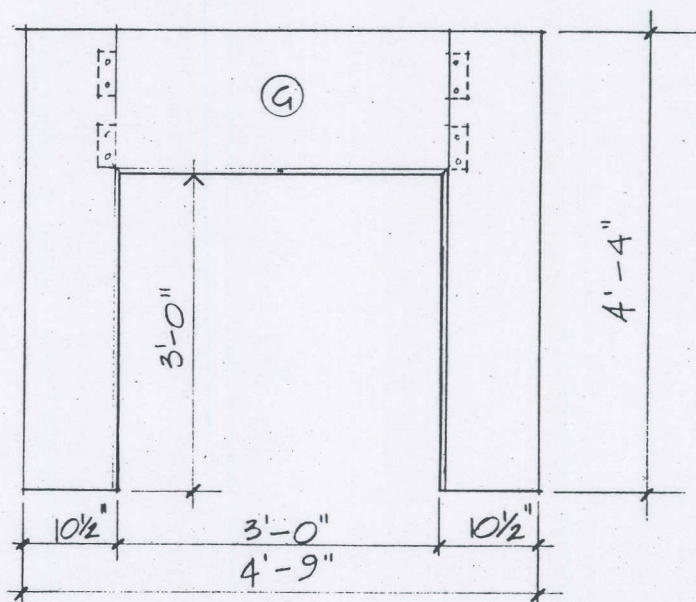
SHEET 3 OF 3

ITEM "G" CONSISTING OF THREE  
BOARDS SHALL HAVE DIMENSIONS  
CHANGED AS SHOWN BELOW.  
MOULDED EDGES & MORTICE & TENON  
JOINTS SHALL REMAIN AS SHOWN ON  
ORIGINAL DRAWING.
