National Park Service  
Cultural Landscapes Inventory  
2004

Camp Muir  
Mount Rainier National Park

**CULTURAL LANDSCAPES INVENTORY (CLI) PROGRAM**  
*2010 Condition Assessment Update for:*

**Camp Muir**  
**Mount Rainier National Park**

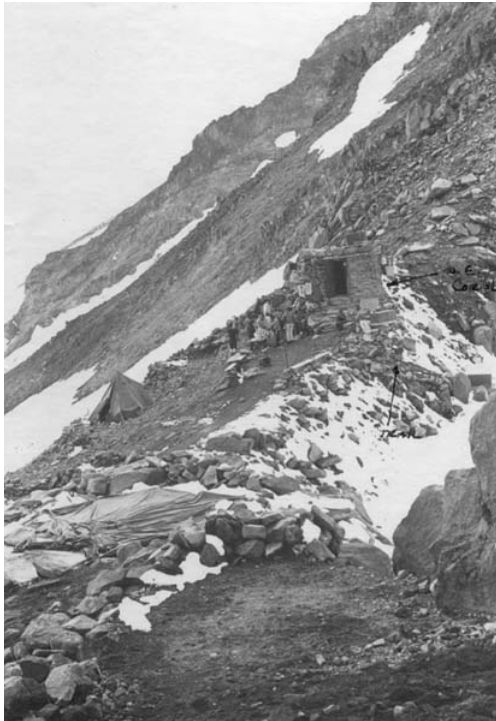
Degradation, a combination of natural and human caused erosion, has reduced the elevation of the ridge significantly. A topographic survey completed in September 2000 indicated that the elevation of the area from the entrance door of the Guide Shelter had dropped roughly 15 feet since 1919. In a historic photo from 1919, the topography appears level at the entrance door to the Guide Shelter, but at present it is necessary to climb an extensive buildup of stone steps to reach the entrance door. Most of the surface substrate loss occurred after the 1970s, as can be seen by comparing a photograph dated 1970–1973 to a photograph of the current existing condition. The construction of the helipad in 1984 and the dramatic increase in the popularity of climbing in the 1970s have exacerbated the loss of surface substrate since the 1970s. This extensive loss of surface substrate is not typical throughout the site. The relatively level area between the helipad and the Public Shelter retains integrity, as does the level terrace south of the Public Shelter. These two areas are the only contributing landscape features of topography, i.e. the only topography that has remained relatively unchanged since the period of significance.

*Historic photograph of the narrow ridge on which Camp Muir was sited, mid-1960s. MORA Archive (twc506)*

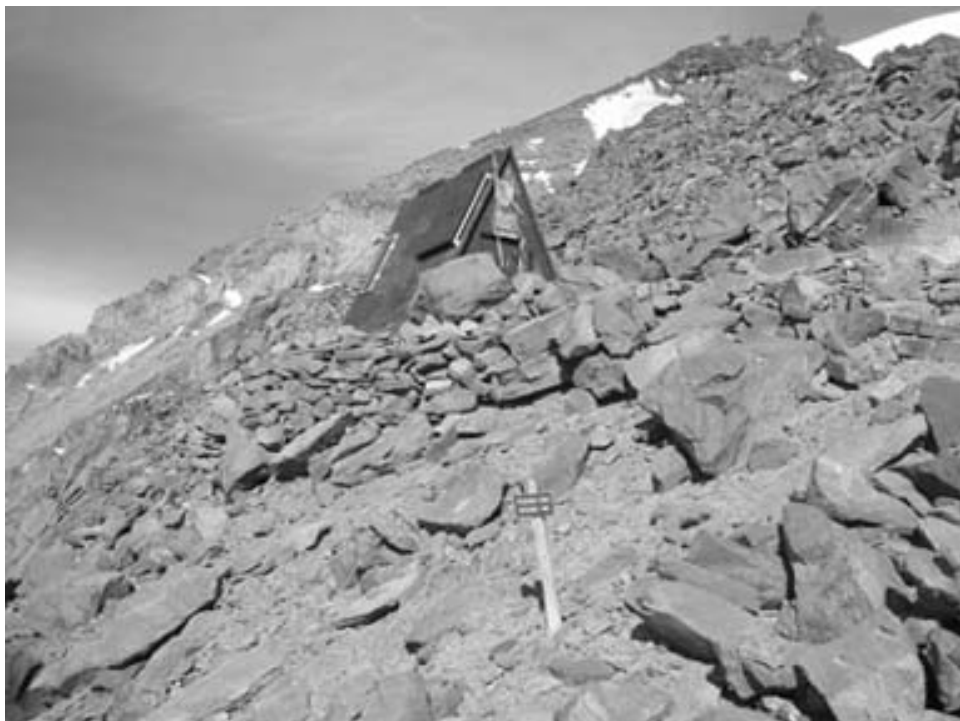
*Contemporary photograph of the Butler Shelter, 2001. Note the stone abutment below the shelter. NPS Photo*

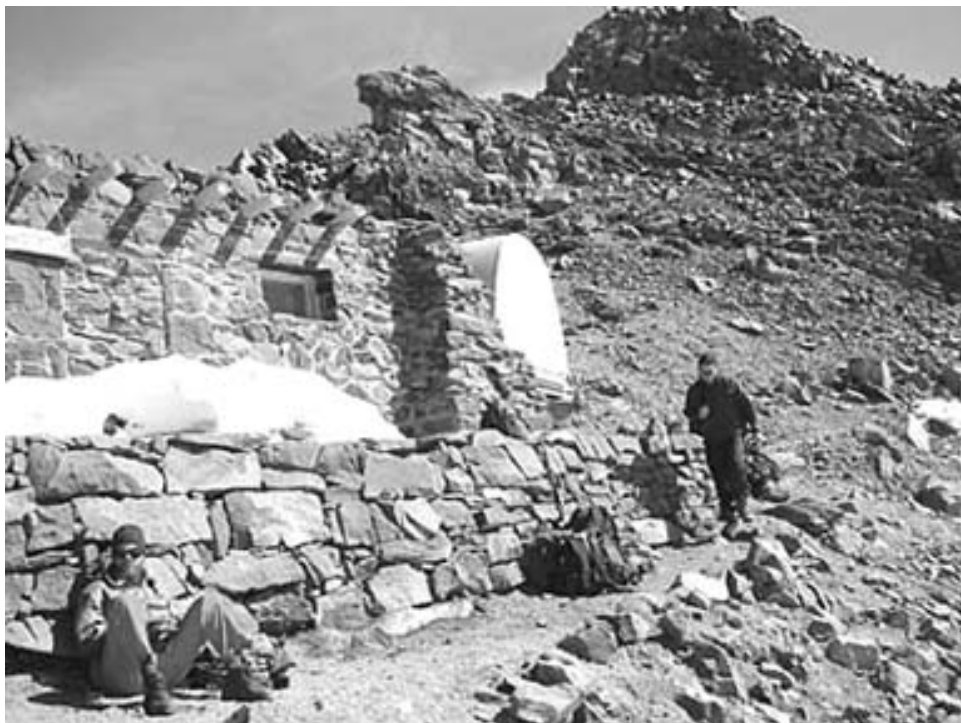
*Contemporary photograph of the Public Shelter. Note the blocked in historic door at the far left of the photograph, taken 2001. Note the exposed whole log rafter tails, a character defining feature of the Public Shelter. NPS Photo*

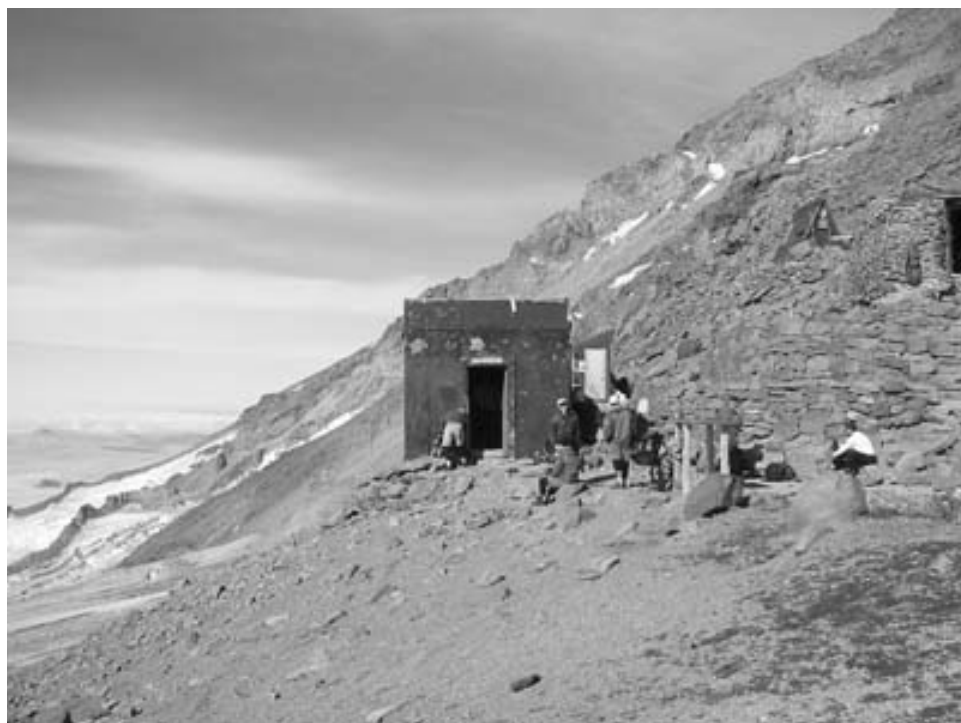
*Contemporary photograph of the Gombu Shelter, Guide Shelter, Butler Shelter, and Pit Toilet, 2001. Also note the retaining walls built on the downhill sides of the Gombu Shelter, Guide Shelter, and Butler Shelter. NPS Photo*

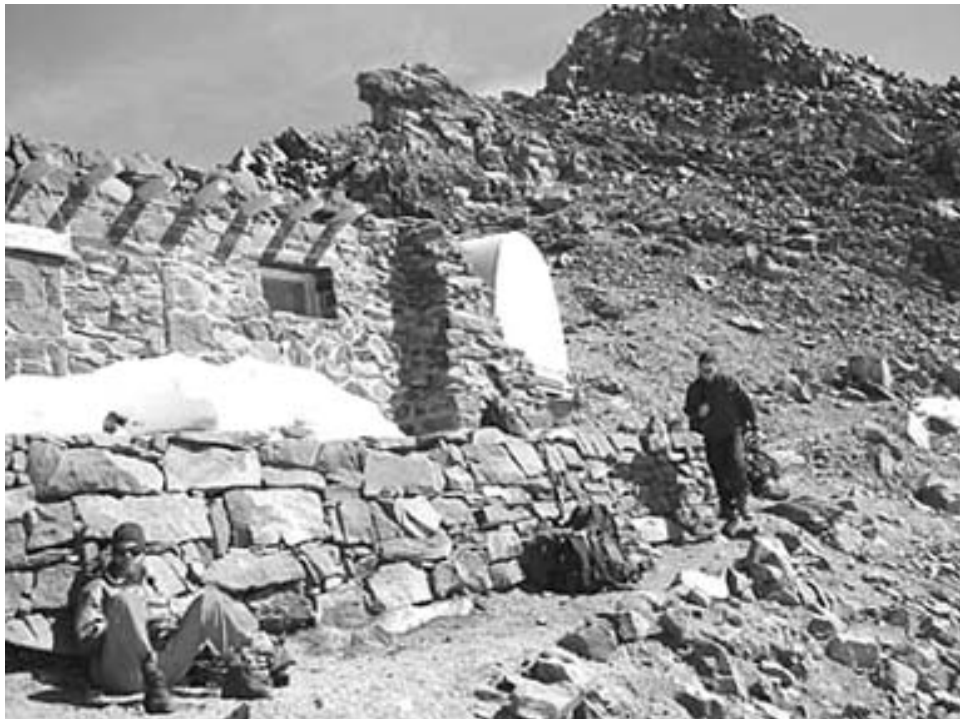
*Contemporary photograph of the Public Shelter, 2001. Note the historic sign at the far left side of photo above the blocked in historic doorway. A wood and stone bench is located under the snow drift, above the rock retaining wall.*  
NPS Photo
