# National Park Service Cultural Landscapes Inventory 2004

Ricksecker Point Mount Rainier National Park

# CULTURAL LANDSCAPES INVENTORY (CLI) PROGRAM 2010 Condition Assessment Update for:

CONDITION ASSESSMENT: FAIR

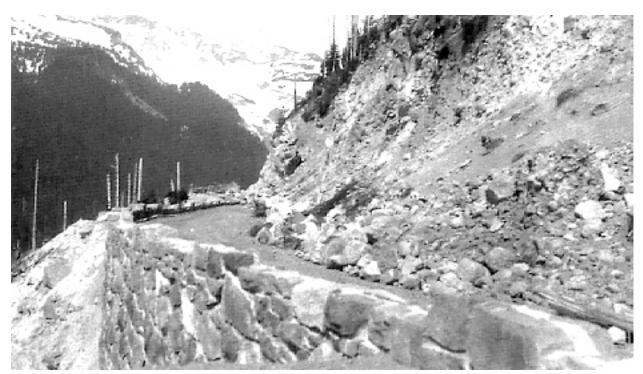
Historic photograph of a retaining wall along Ricksecker Point, looking northeast. Note the unstable appearance of the slopes above the road. (MORA photo file, neg. 4040, 1932).
