# DISTRICT OF COLUMBIA WAR MEMORIAL

Historic Structure Report  
& Cultural Landscape Assessment

National Mall & Memorial Parks  
PMIS NO. 43699

May 2006

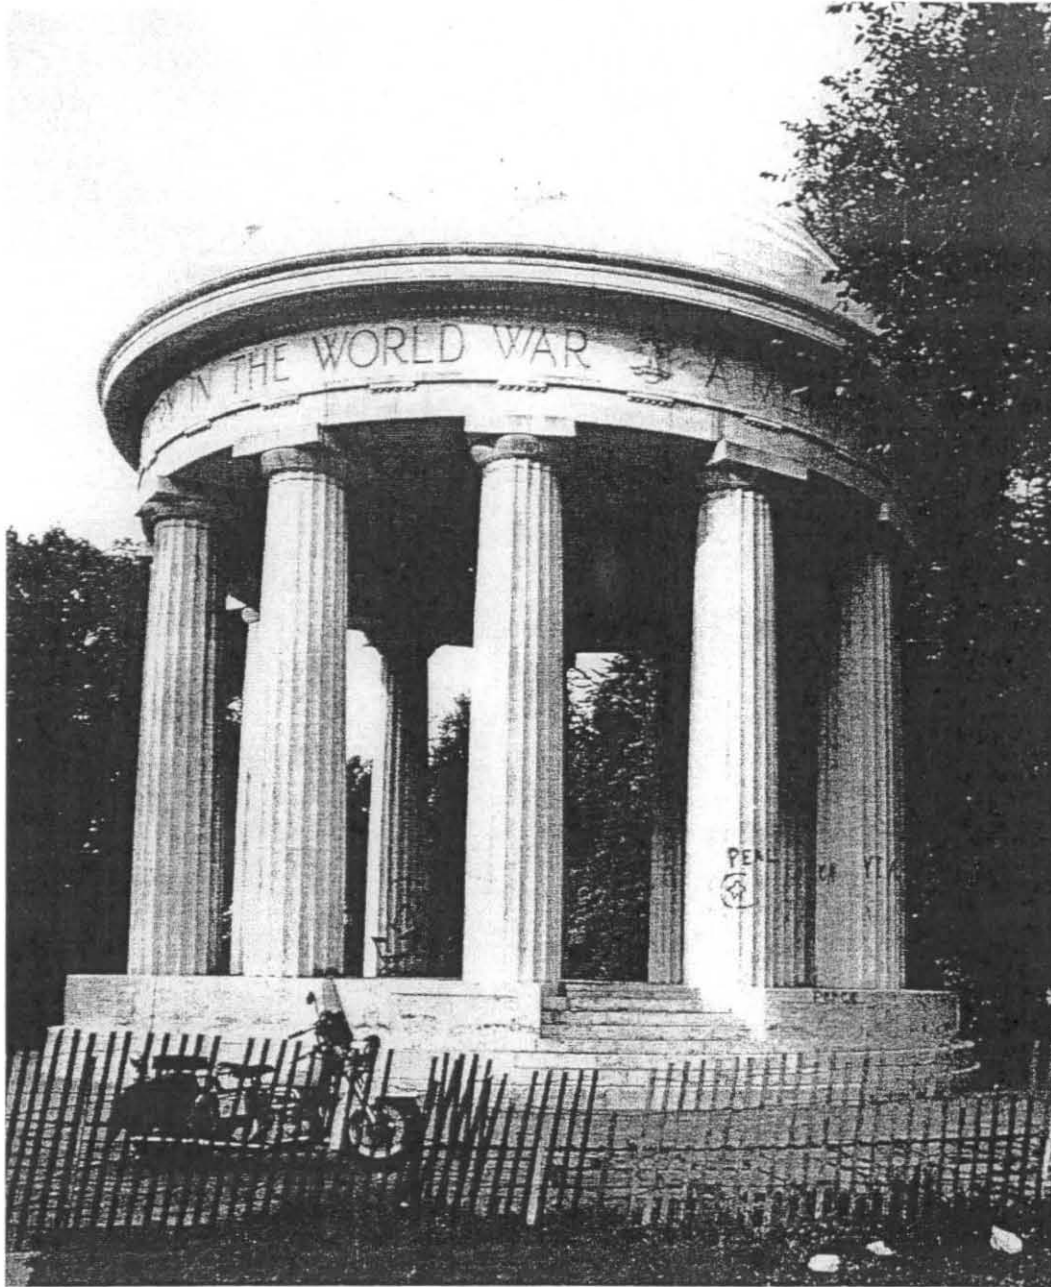
Figure 22. In 1968, vandals defaced the Memorial with graffiti. [Action Line, Evening Star, June 29, 1968]

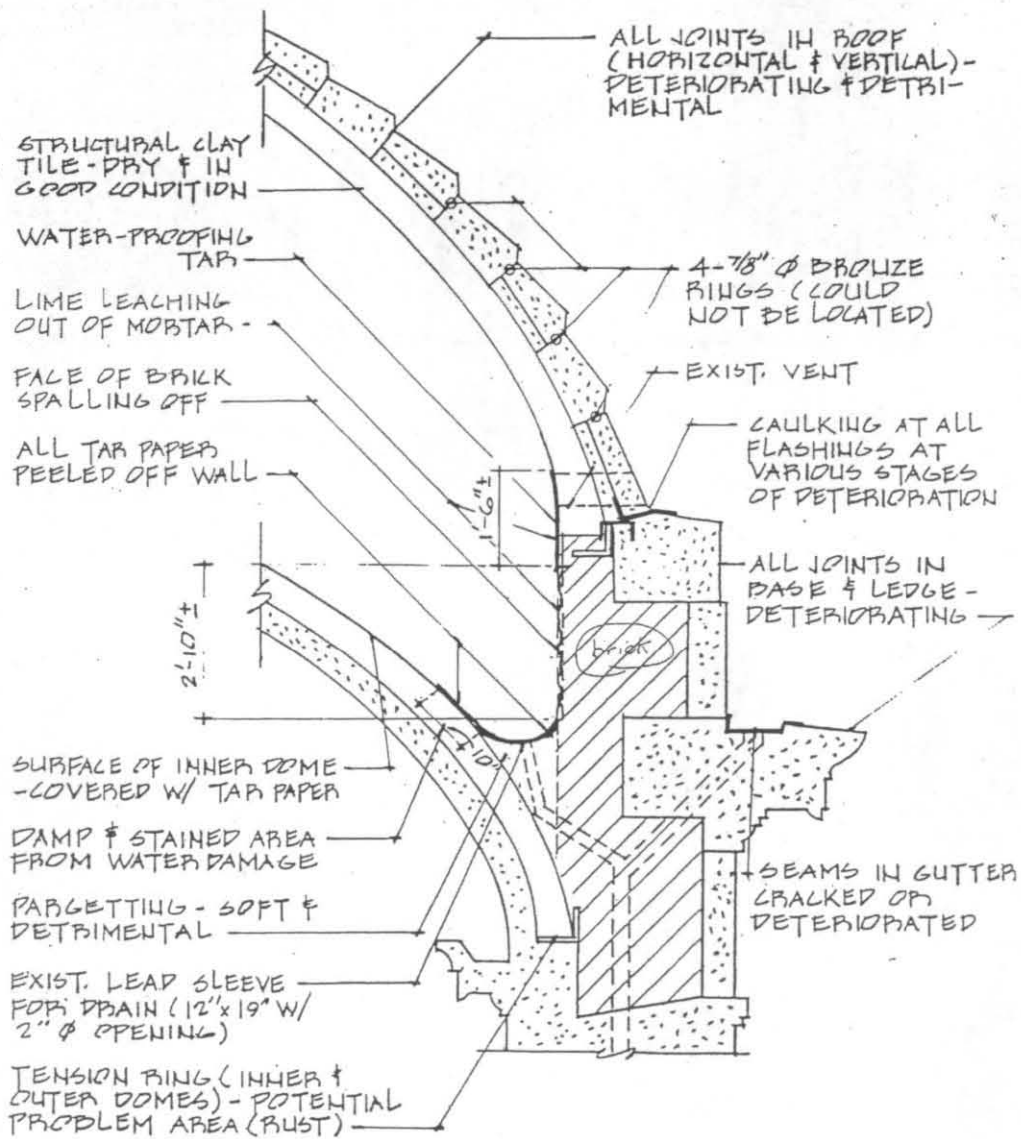
EXISTING CONDITIONS  
@ CORNICE

Figure 24. "Existing Conditions @ Cornice," included in September 28, 1984 report by Tom Fields. [District of Columbia War Memorial File, National Capital Parks-Central, courtesy of Tony Donald.]

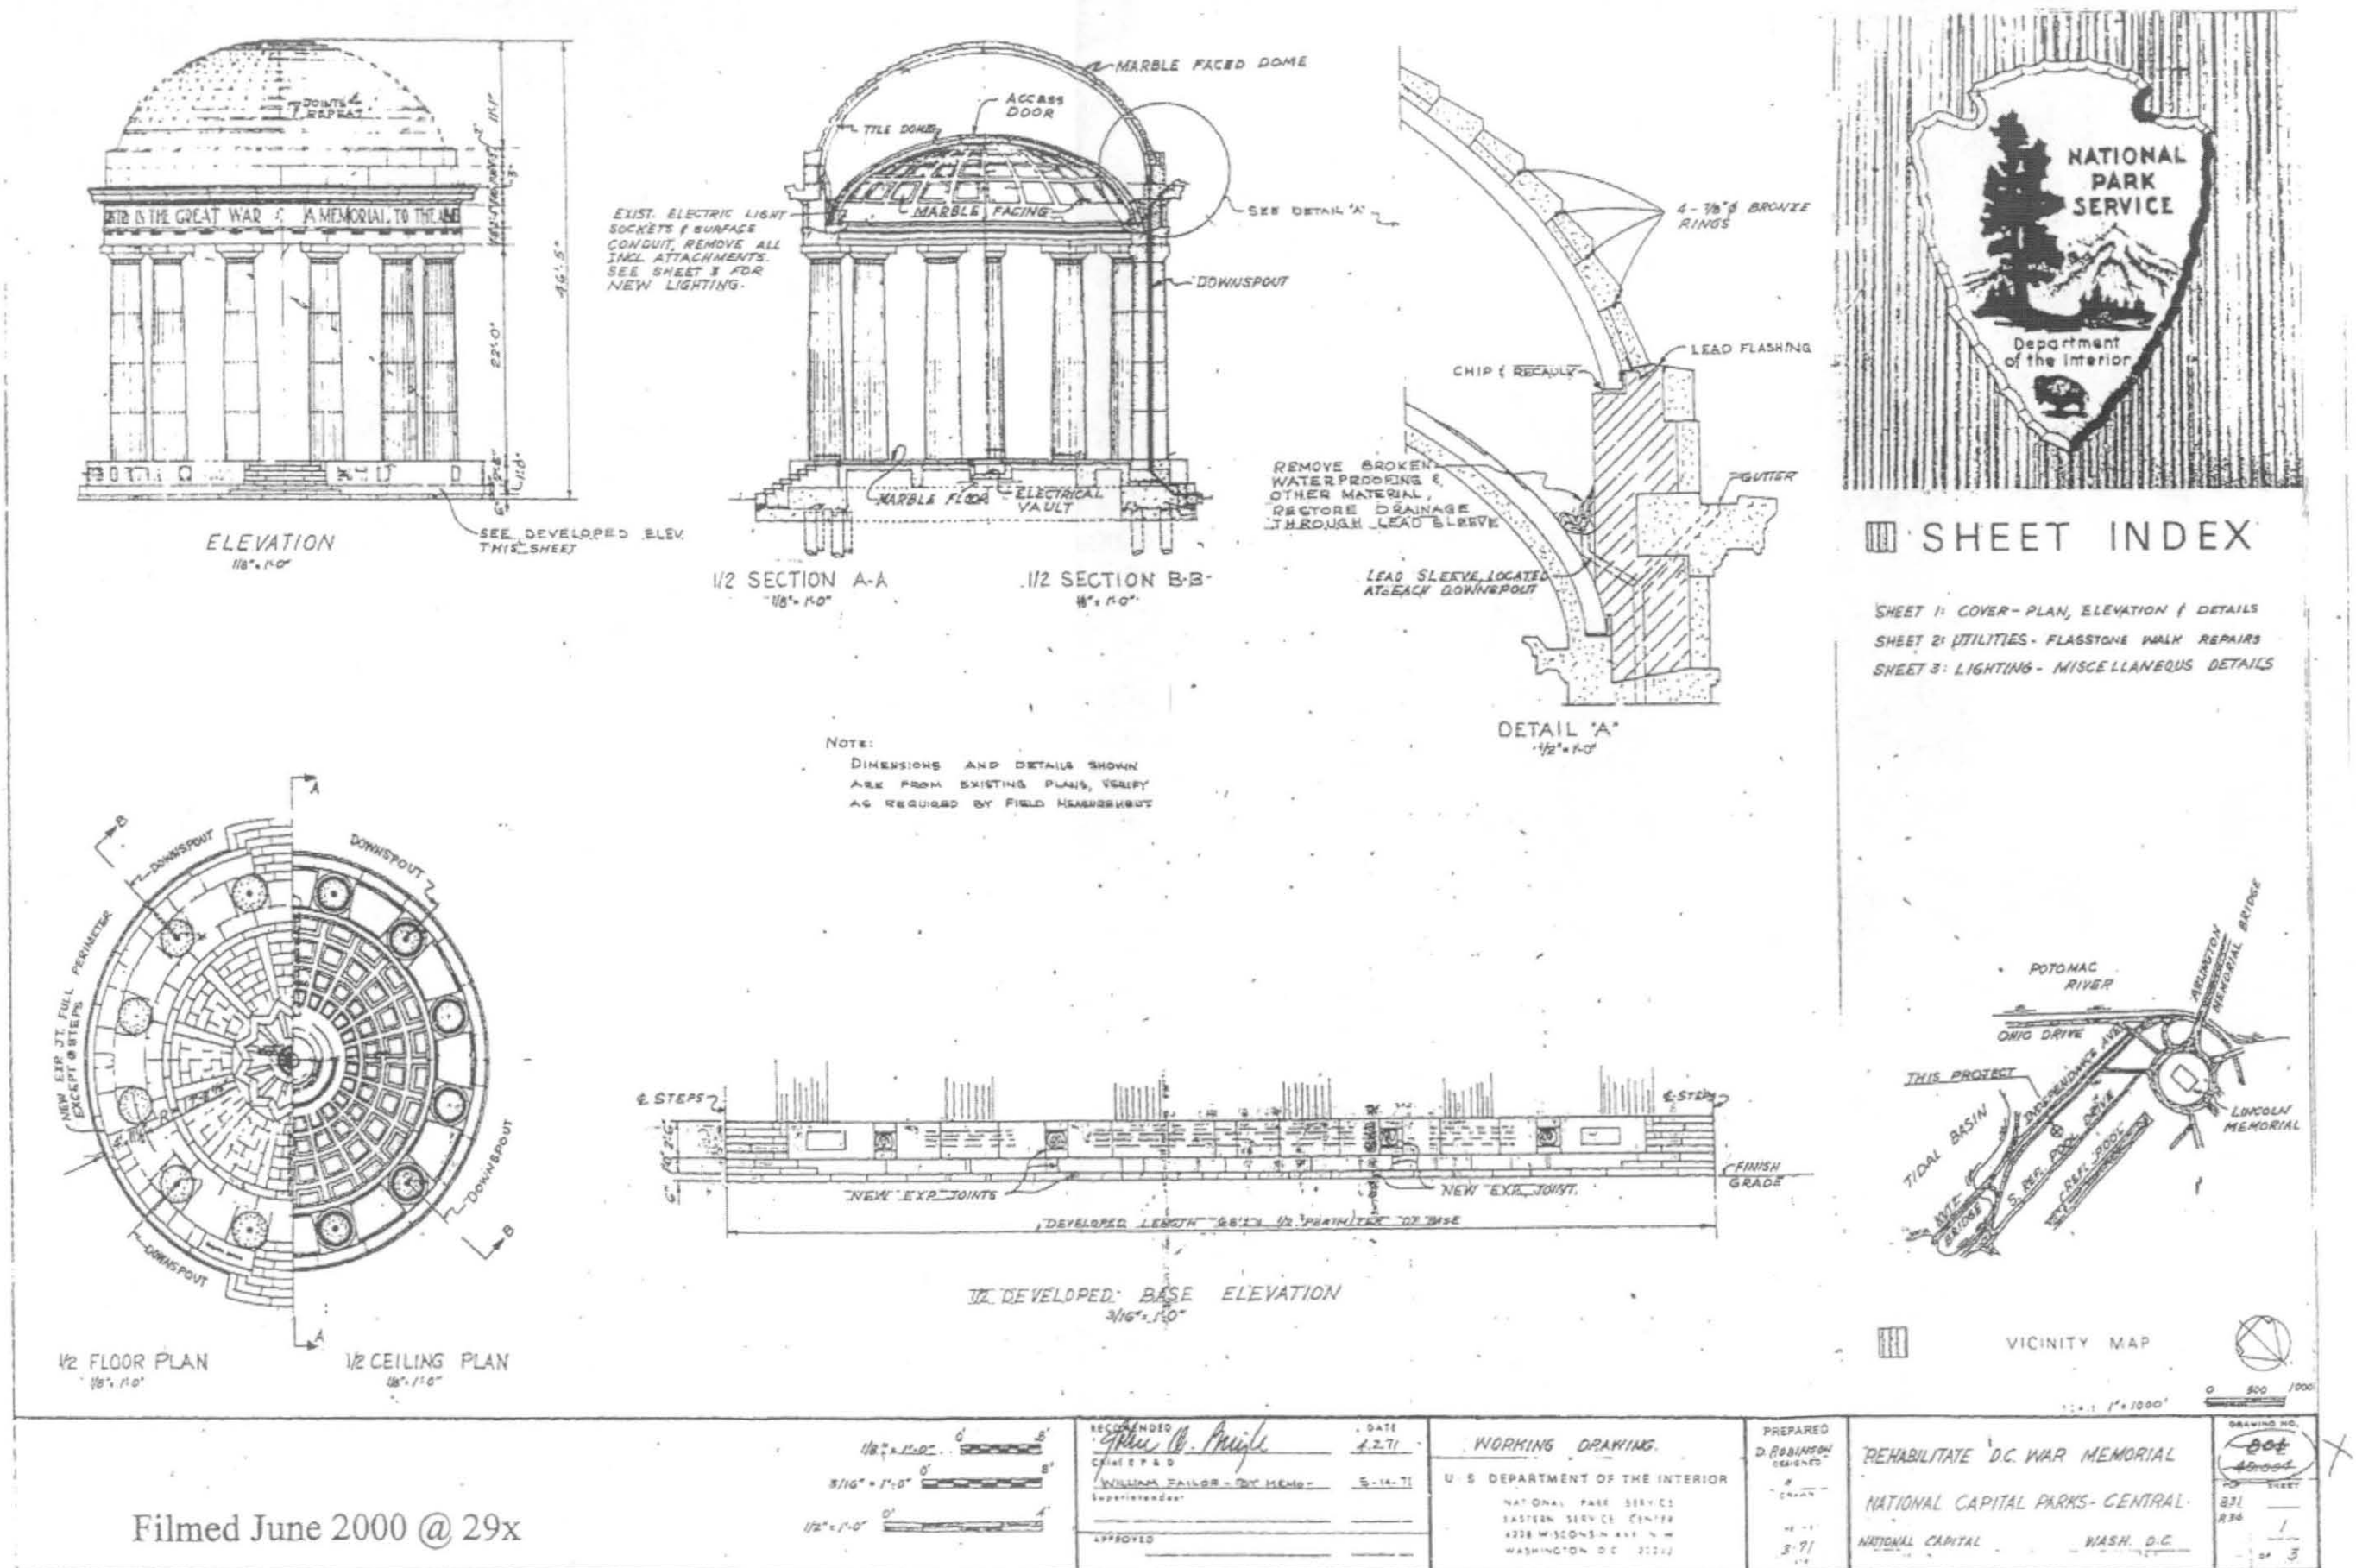
Drawings of the elevation and cornice details of the memorial were done by a D. Robinson of the National Park Service in March 1971 in preparation for repairing the drainage problem and repairing and replacing the walkways and the lighting system in the memorial (Fig. 23).<sup>166</sup>

Figure 23. "Rehabilitate D.C. War Memorial, National Capital Parks-Central," March 1971, prepared by D. Robinson, National Parks Service. [Drawing no. 801-89890. District of Columbia War Memorial File, National Capital Parks-Central, courtesy of Tony Donald.]

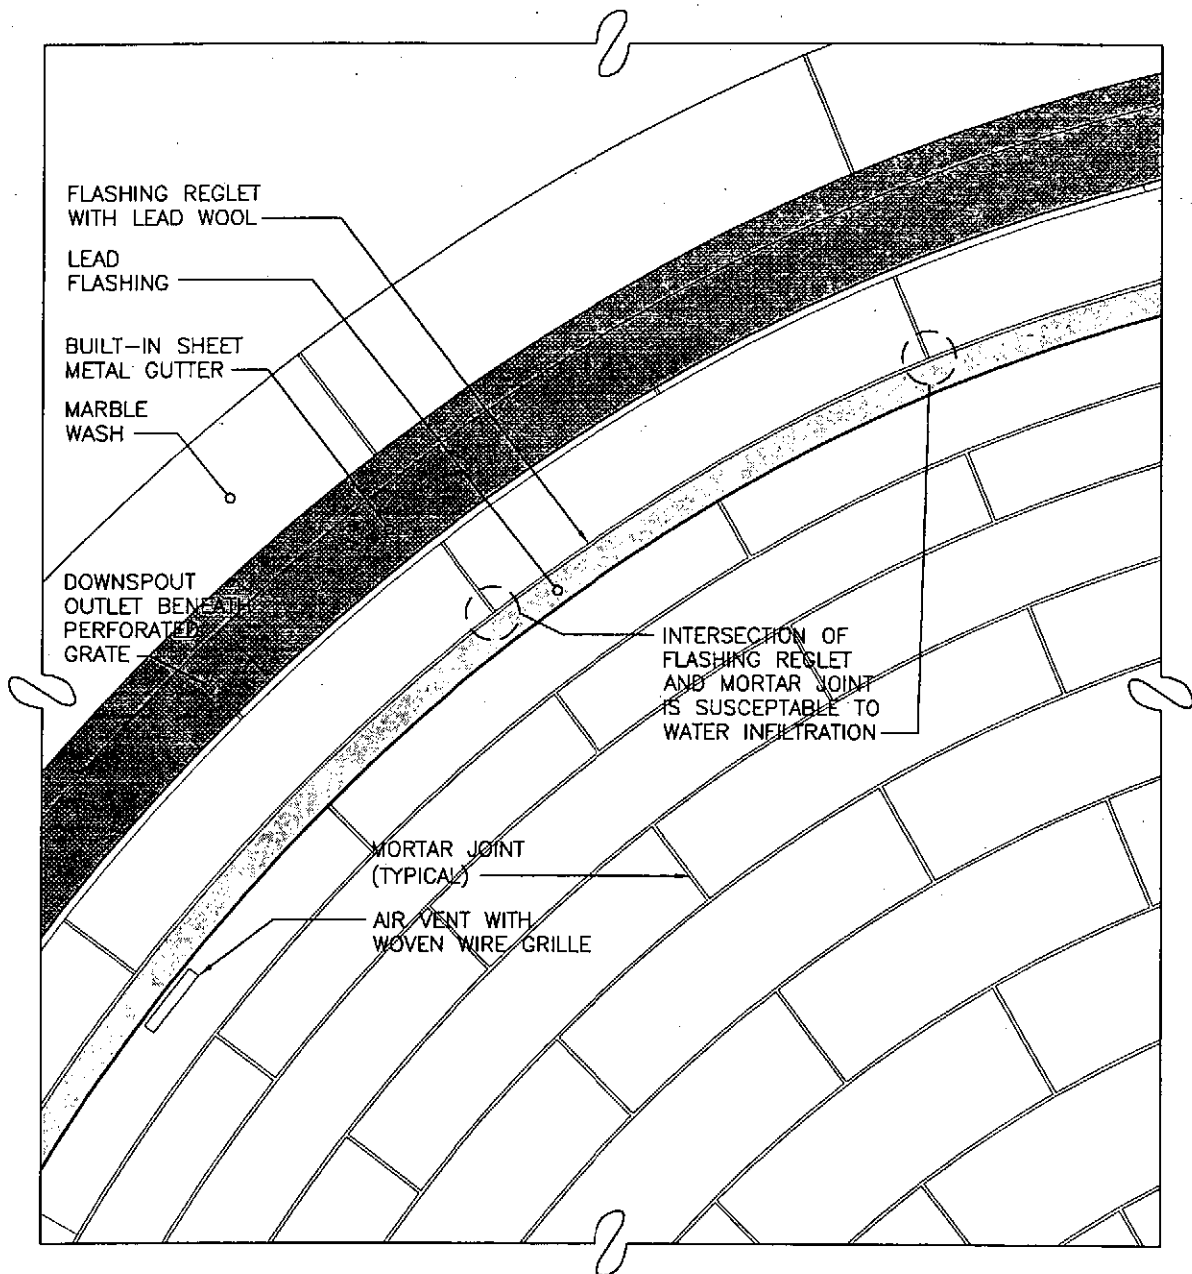
DC WAR MEMORIAL  
ROOF PLAN — REGLET LOCATION

- The woven-wire stainless steel vent grilles at the base of the outer dome are loosely fitted in the openings.
- The lead-coated copper of the replacement gutter is beyond its service life span; the lead is eroded, exposing the thin layer of tin between the lead and copper. Many of the joints in the lead-coated copper have been compromised; they have been torn and pulled apart by thermal expansion and contraction of the metal. The solder joints are cracked. The counter flashing at the back of the gutter is generally loose in the horizontal mortar joint of the marble. Moss and algae are growing in the mortar joint; and sealant, which is over-applied onto the flashing and surrounding stone and mortar, has failed.

- The pitch of the gutter is insufficient for proper drainage to the four downspout outlets. Cross seams in the copper gutter are pronounced, preventing proper drainage.

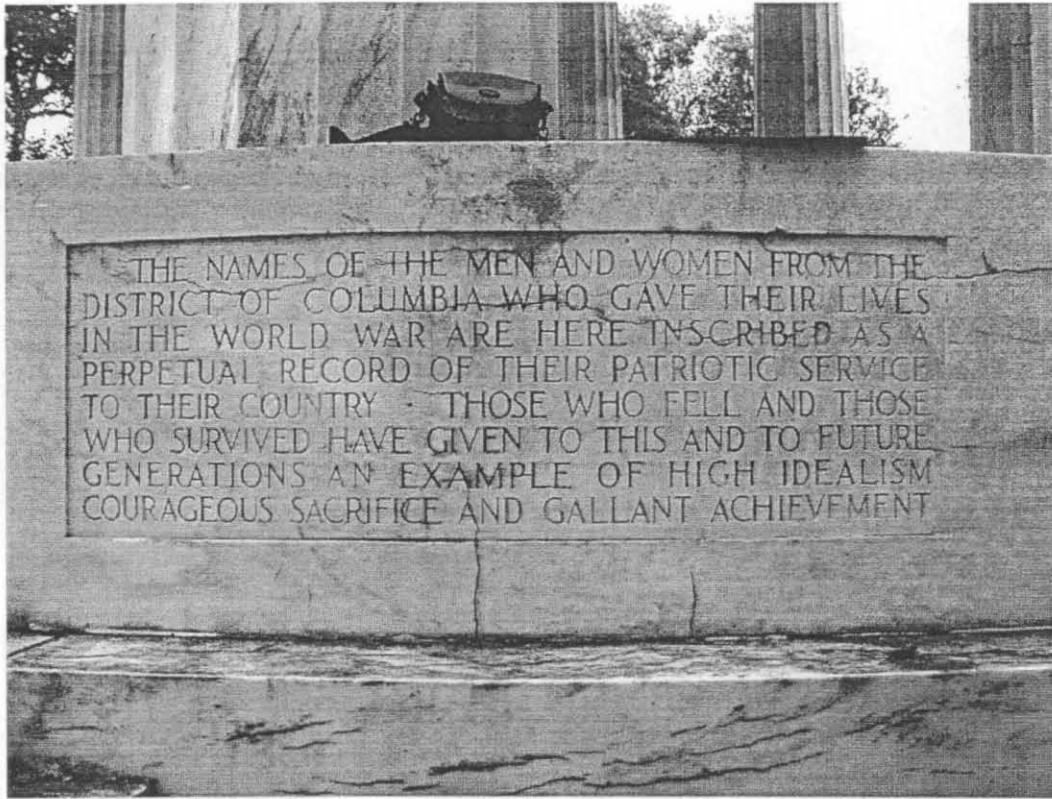
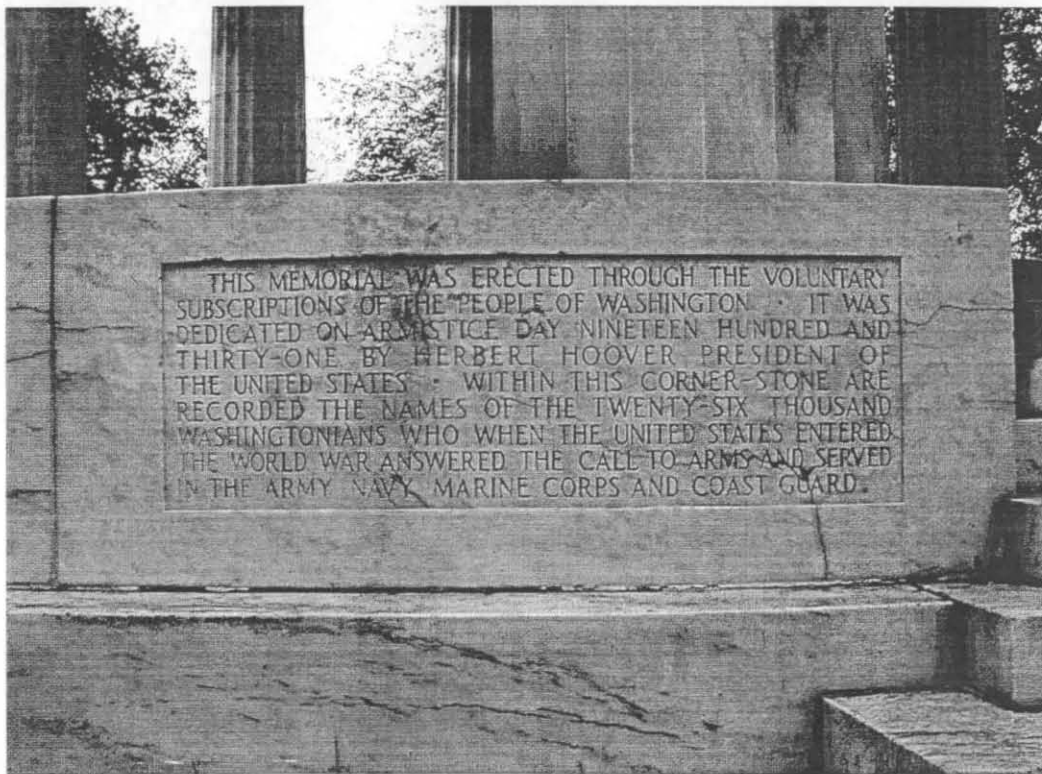
*Fissures, cracks, and natural imperfections in the carved marble panels at the base of the Memorial. [NPS, 2004]*

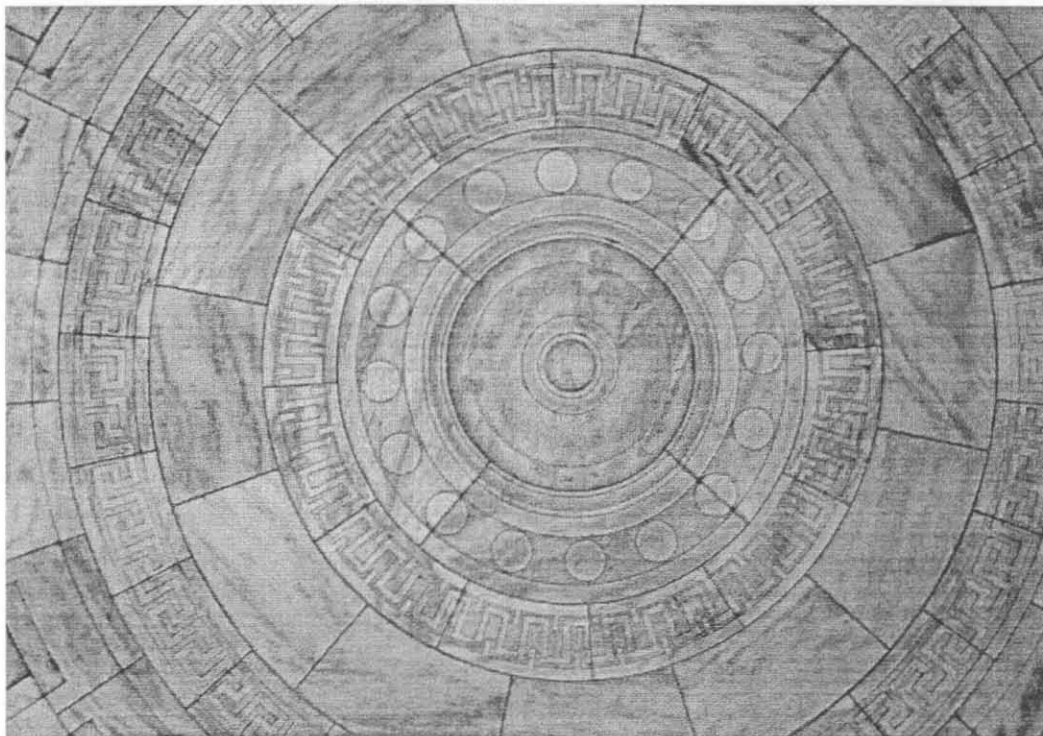
*The ceiling of the Memorial. The counterweighted attic access panel is located in the oculus of the lower dome. [JGWA, 2005]*

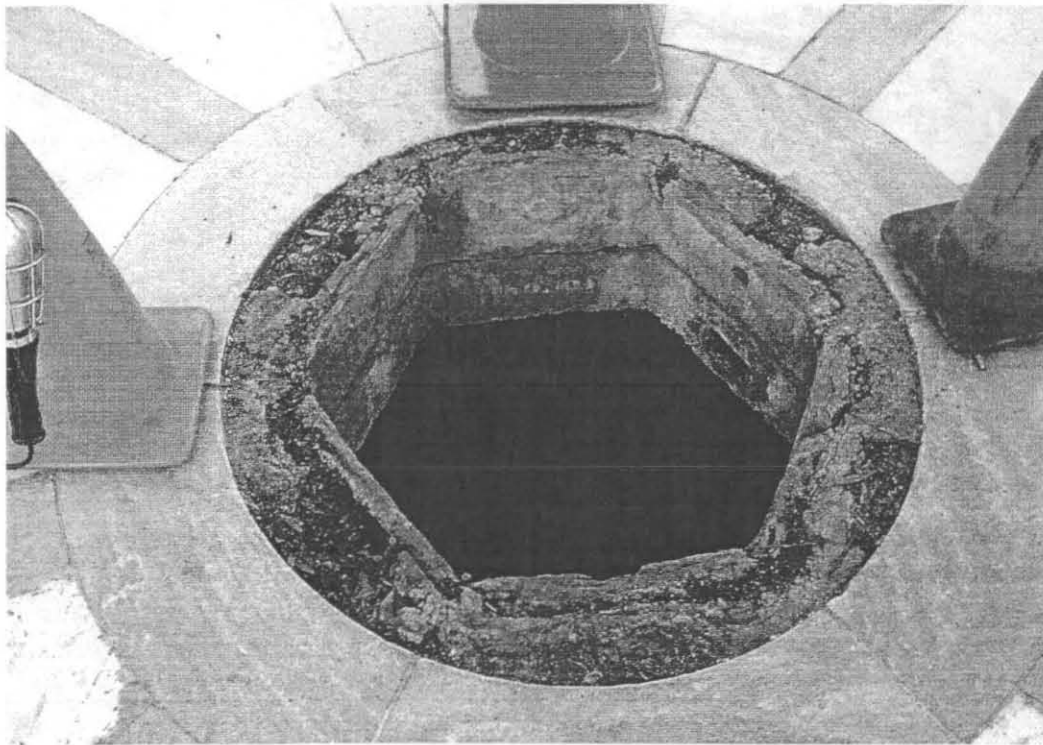
*Floor opening providing access to the electrical vault below the Memorial. [JGWA, 2005]*

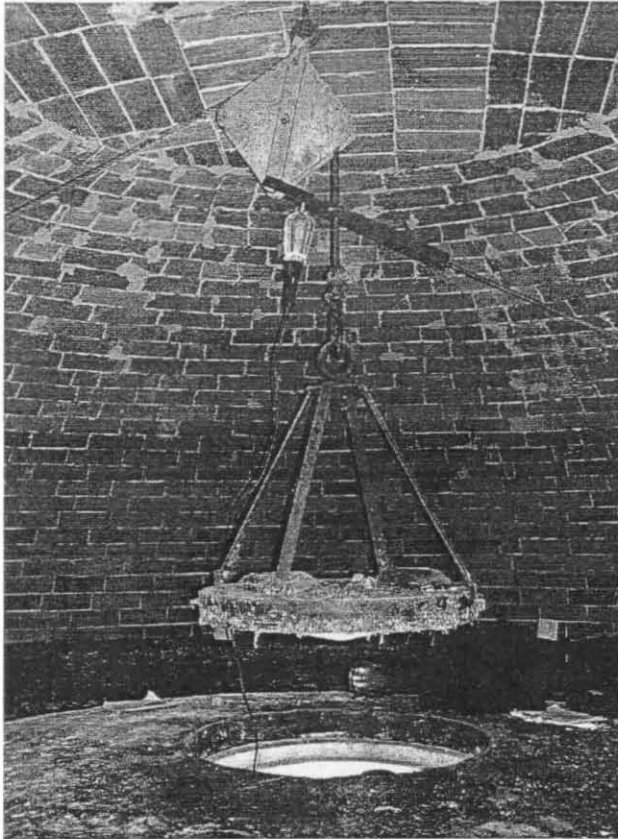
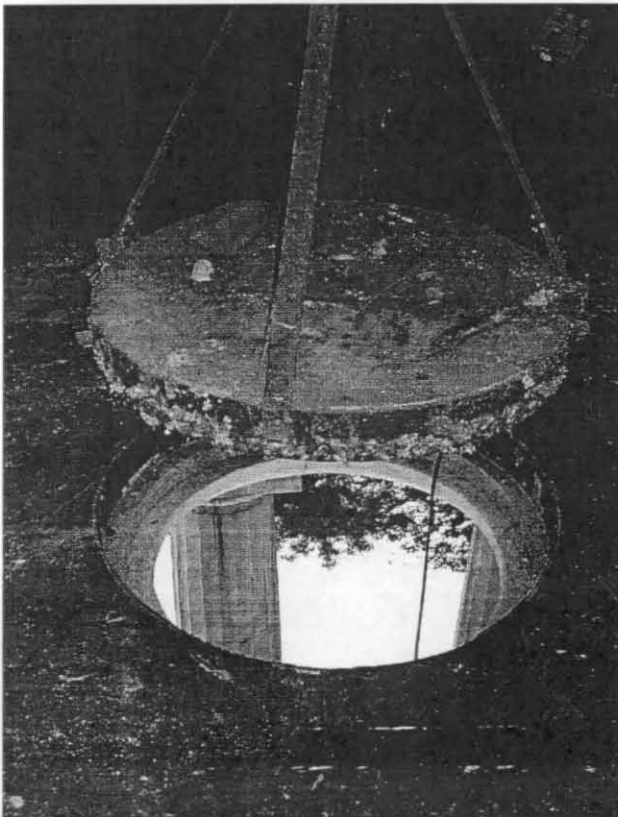
*The counterweighted marble access panel is suspended from the Guastavino tile construction of the upper dome. [JGWA, 2005]*

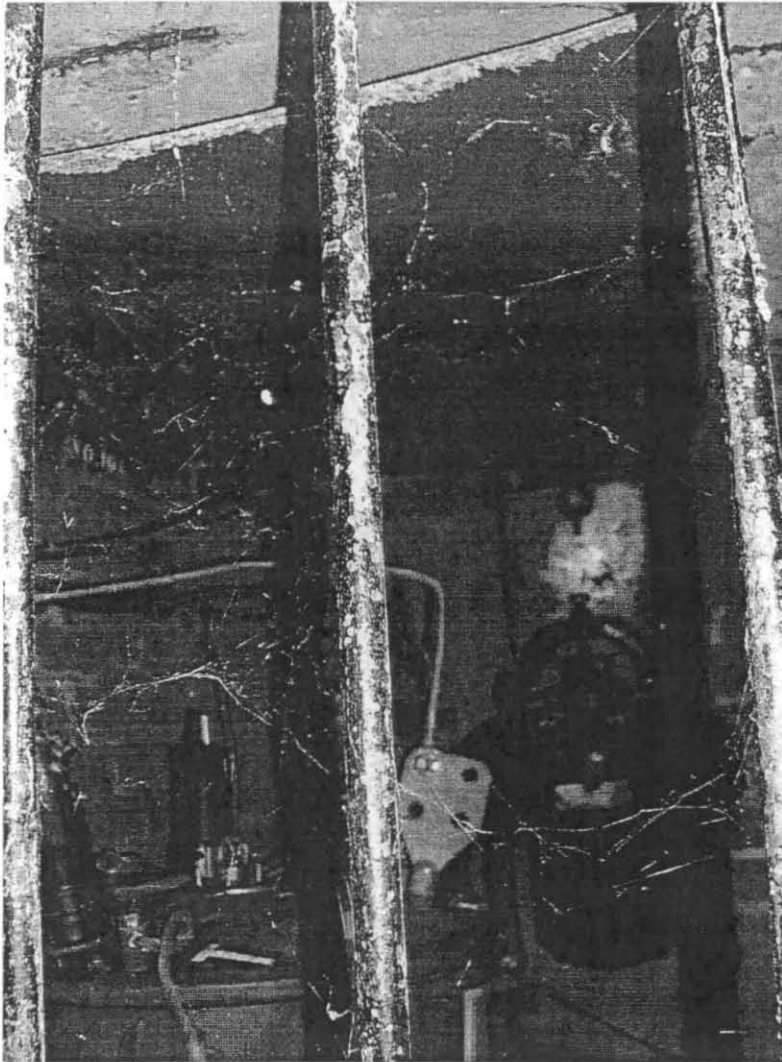
*The electrical vault beneath the Memorial, looking south into the transformer room. [JGWA, 2005]*

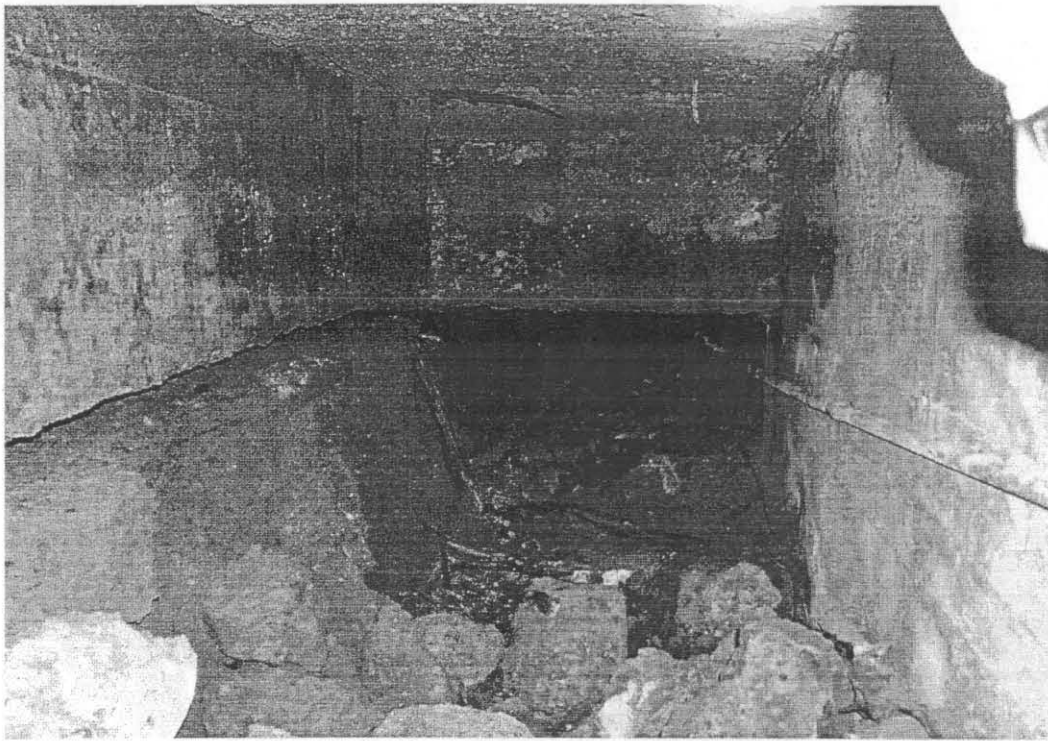
*The crawl space to the north of the electrical beneath the Memorial, looking east. It appears that this area was excavated some time after the original construction of the Memorial. [JGWA, 2005]*

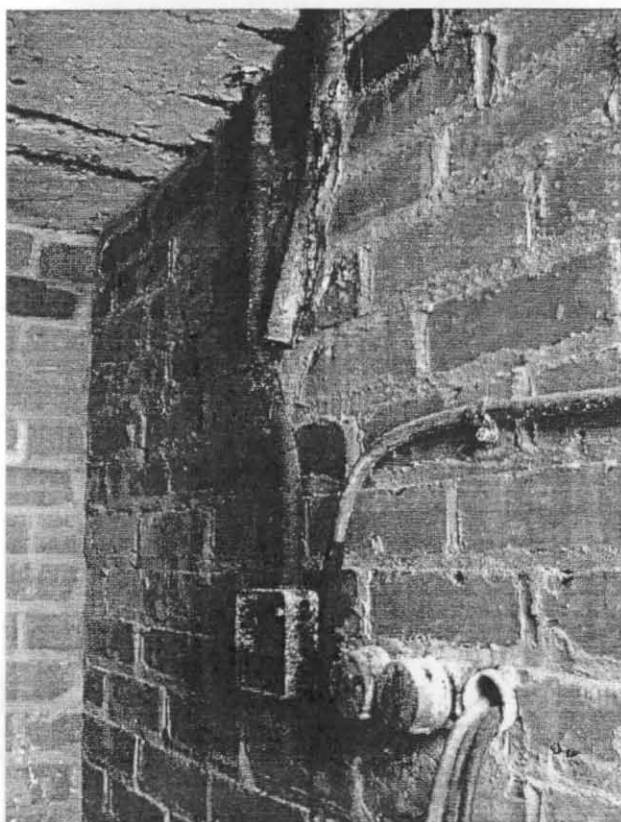
*An open electrical junction box and a panel box with exposed conductors are located in the electrical vault beneath the Memorial. These are significant electrical shock hazards. [JGWA, 2005]*

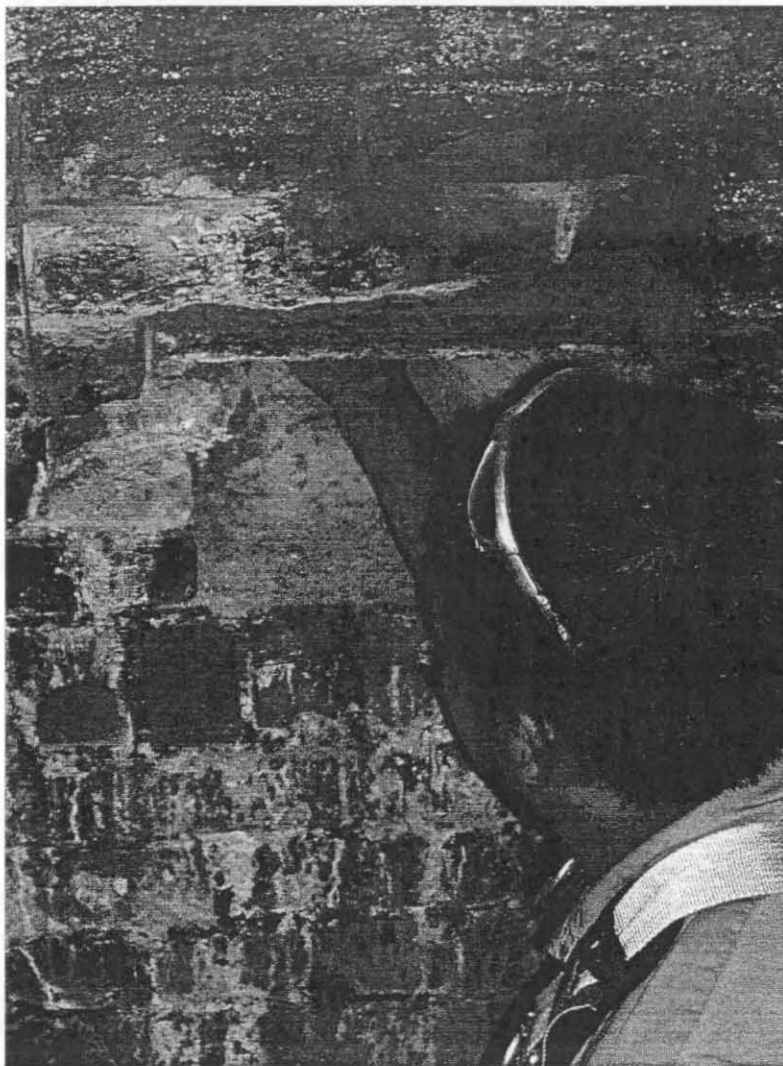
*Binh Nguyen of the National Park Service investigating the void between the steel angle tension ring and the marble construction beyond. [JGWA, 2005]*

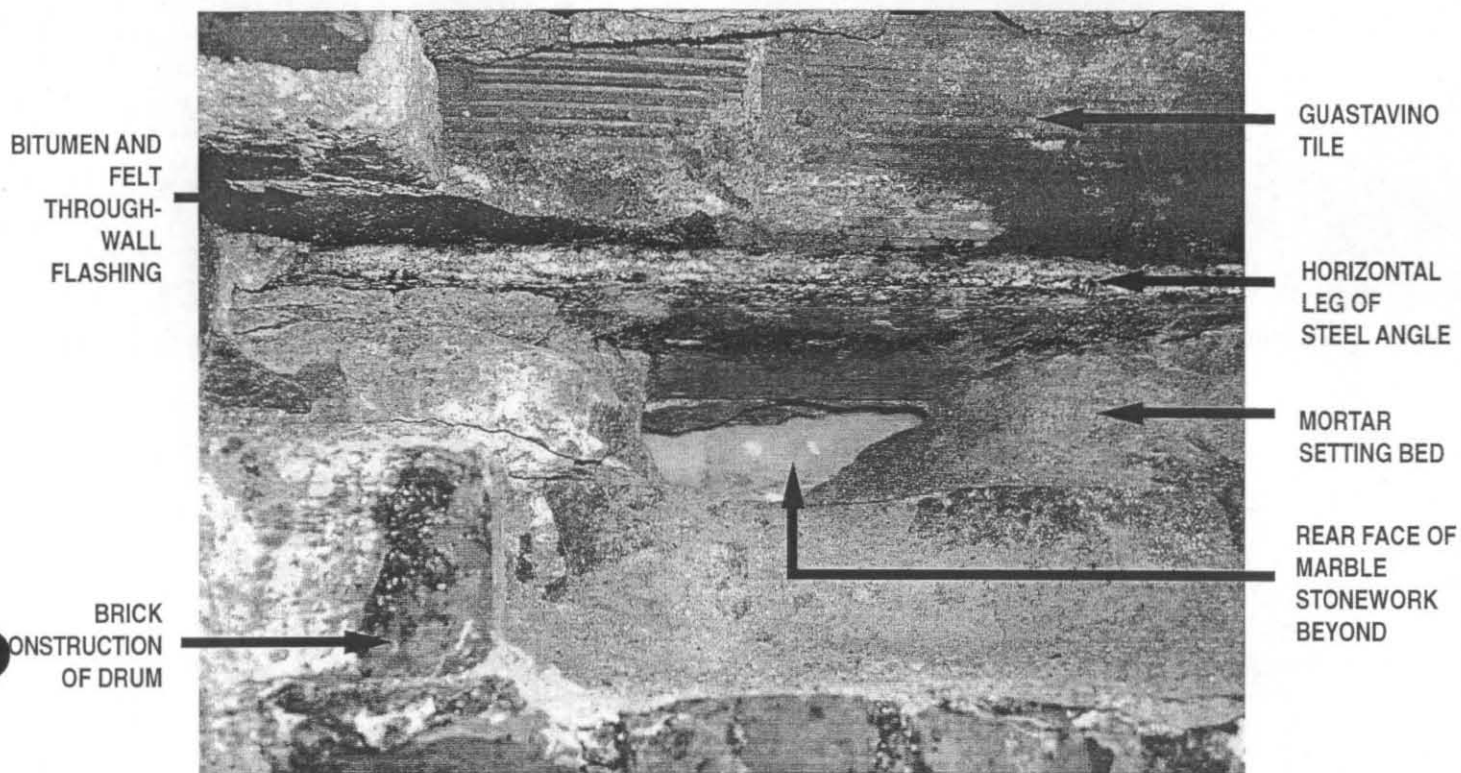
The brick was removed above and below the horizontal leg of the 6"x6"x1/2" steel angle. The terra cotta tile of the outer dome was found to be bearing on the angle, with the vertical leg of the angle restraining the tile. The displaced brickwork was the result of the brick at the upper extent of the drum sliding on a through-wall bitumen-and-felt waterproof flashing that appears to have been installed during the original construction of the memorial. The flashing or membrane appears to have been applied along the vertical surface of the brick drum, within the attic space, and turned into the wall approximately 3'-0" above the condensate drainage valley between the lower dome and the drum of the upper dome. The flashing was laid over the horizontal leg of the steel-angle tension ring, and presumably extended upward at the vertical leg of the steel angle, between the terra

*Detail view of Probe A. [JGWA, 2005]*

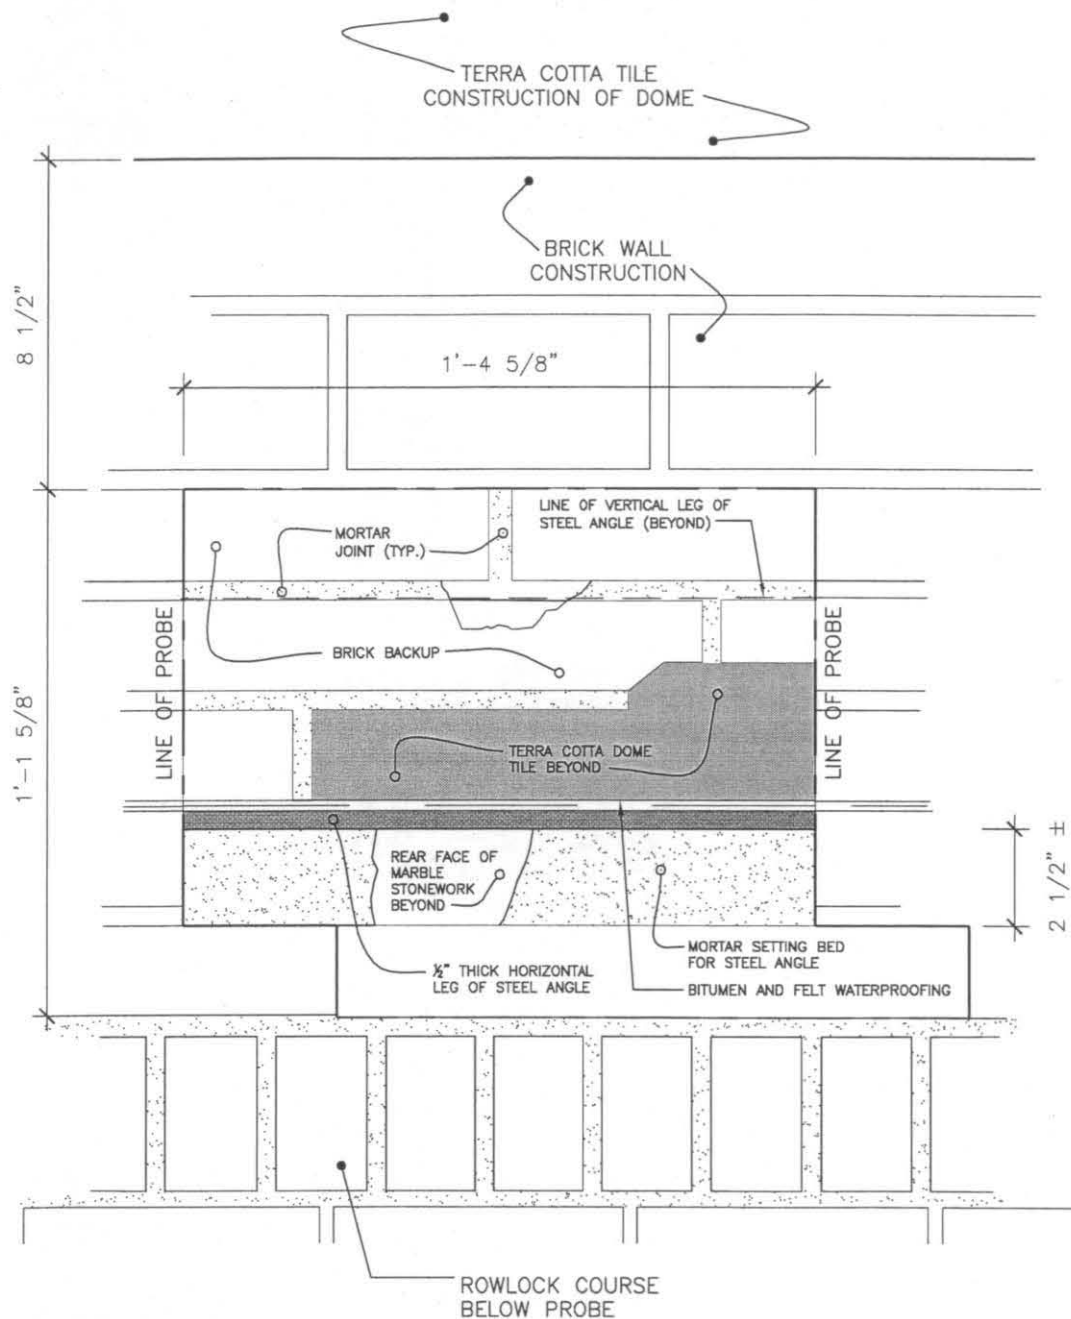
DC WAR MEMORIAL  
 PROBE A -ELEVATION  
 JUNE 22, 2005

If the through-wall flashing simply continued up the outer surface of the upper tile dome, we would expect the steel-angle tension ring to be seriously corroded as water was shed off the base of the tile dome. This was not the case. The steel was found to be in very good condition, with only a minor degree of surface rust. The membrane on the outer surface of the upper tile dome may have continued out to the lead flashing at the base of the marble dome tiles. In this way the integrity of the steel angle may have been preserved. The 3"± void between the vertical leg of the steel angle and the back face of the marble cap stone of the outer drum may have contributed to the survival of the angle (see drawings).

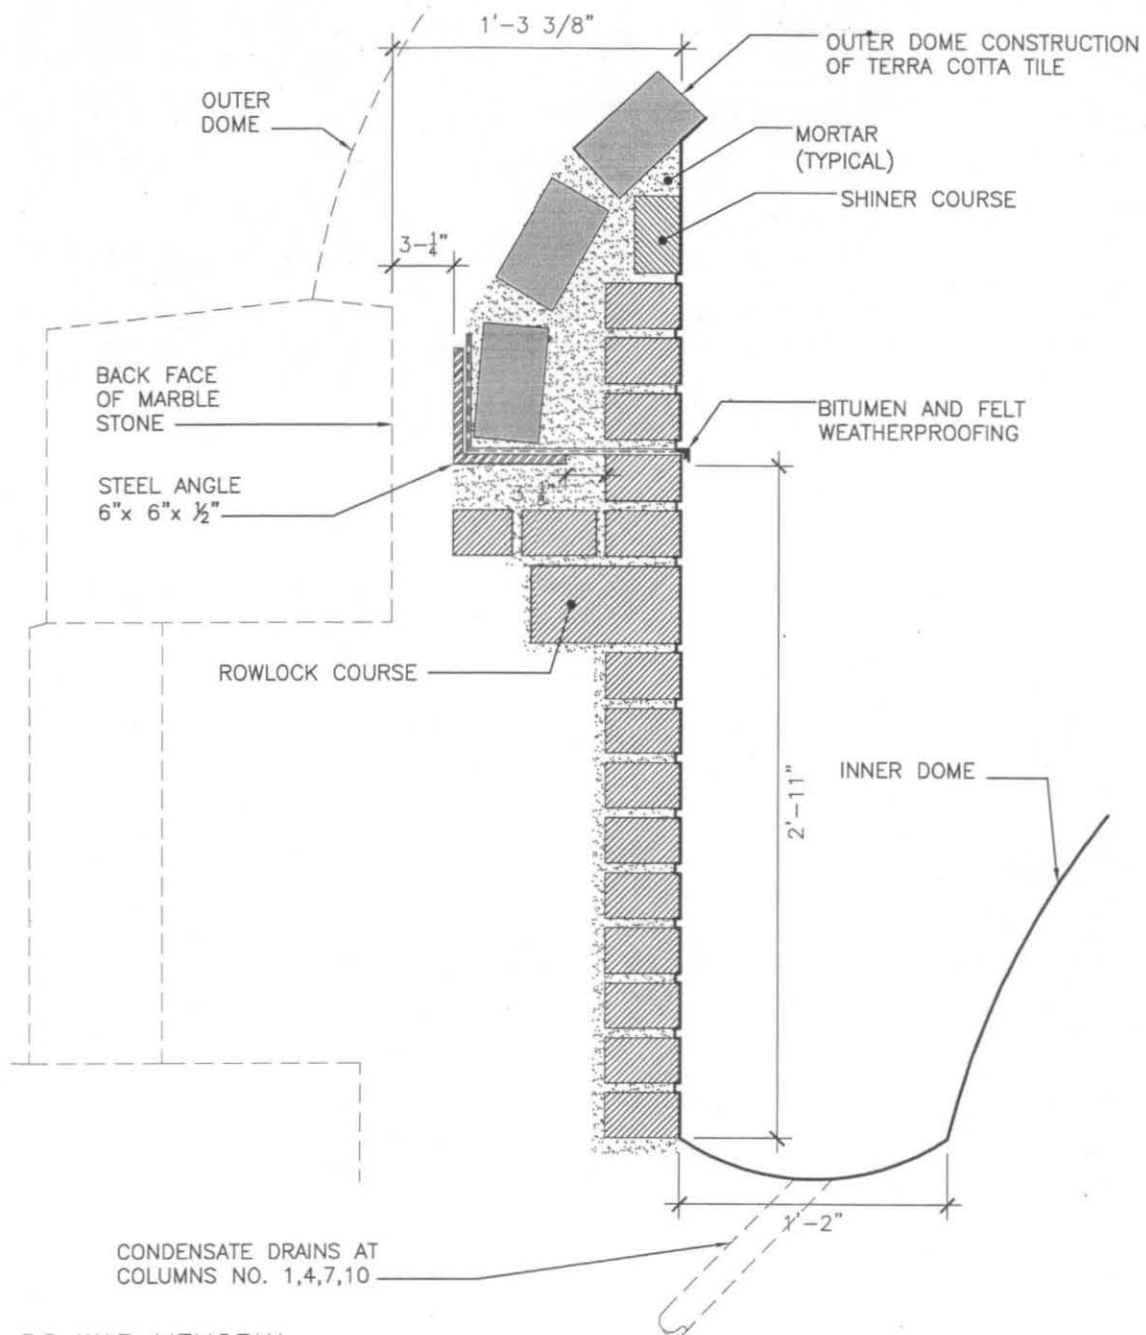
DC WAR MEMORIAL  
 PROBE A -SECTION THROUGH OUTER DOME AND DRUM  
 JUNE 22, 2005

Within the attic space the terra cotta tile of the upper dome appeared to be in excellent condition, with no staining, nor indications of failure. Therefore, it was assumed that the waterproofing membrane above the terra cotta dome must be in good condition. It was known that the mortar in the joints of the marble roofing tiles or slates was deteriorated or missing for an extended period of time. It appears that water infiltrated the open joints in the marble dome construction and was shed by the waterproof membrane above the tile dome. The water appears to have drained to the base of the outer dome, where it saturated the masonry construction of the drum; the moisture in the drum construction then appears to have undergone freeze-thaw cycling, causing brick spalling and the delamination of the waterproof membrane from the inner wall of the drum. A significant amount of efflorescence has occurred on the surface of the drum brickwork as the moisture in the drum construction has evaporated.

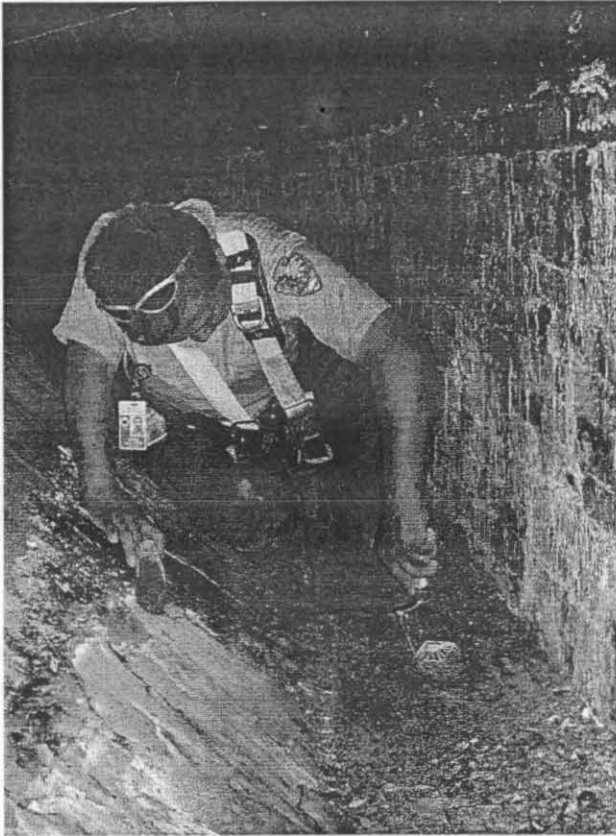
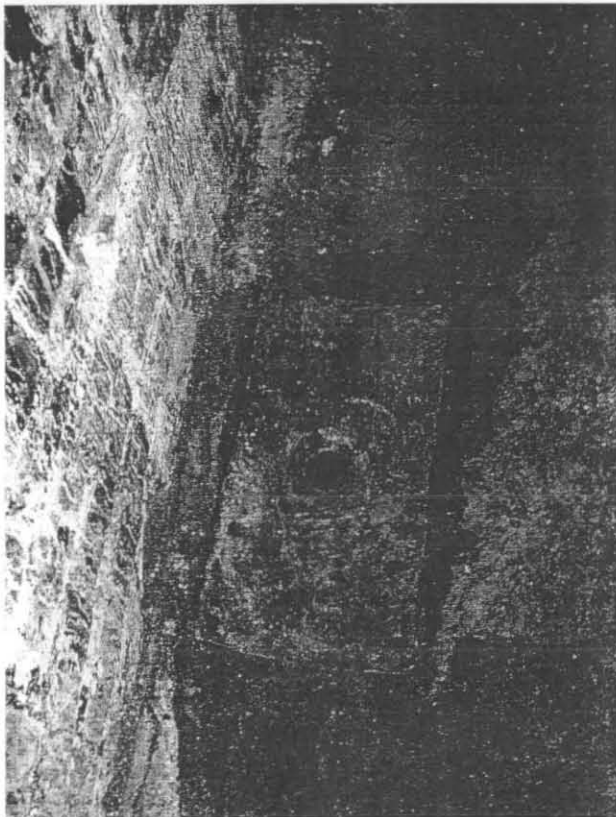
A lead flashing or pan, approximately 9-1/2" wide by 1'-6" long was exposed. There was a 2" diameter outlet located at the center of the pan. The pan was located in the shallow trough or valley at the intersection of the inner dome and the drum construction of the outer dome. The drum construction consisted of brick as a backup material for the marble entablature.

*Probe B investigated the condensate drainage outlet above column 10. The outlet and bird's nest strainer were blocked with sand and covered with bitumen-coated roofing felt.*

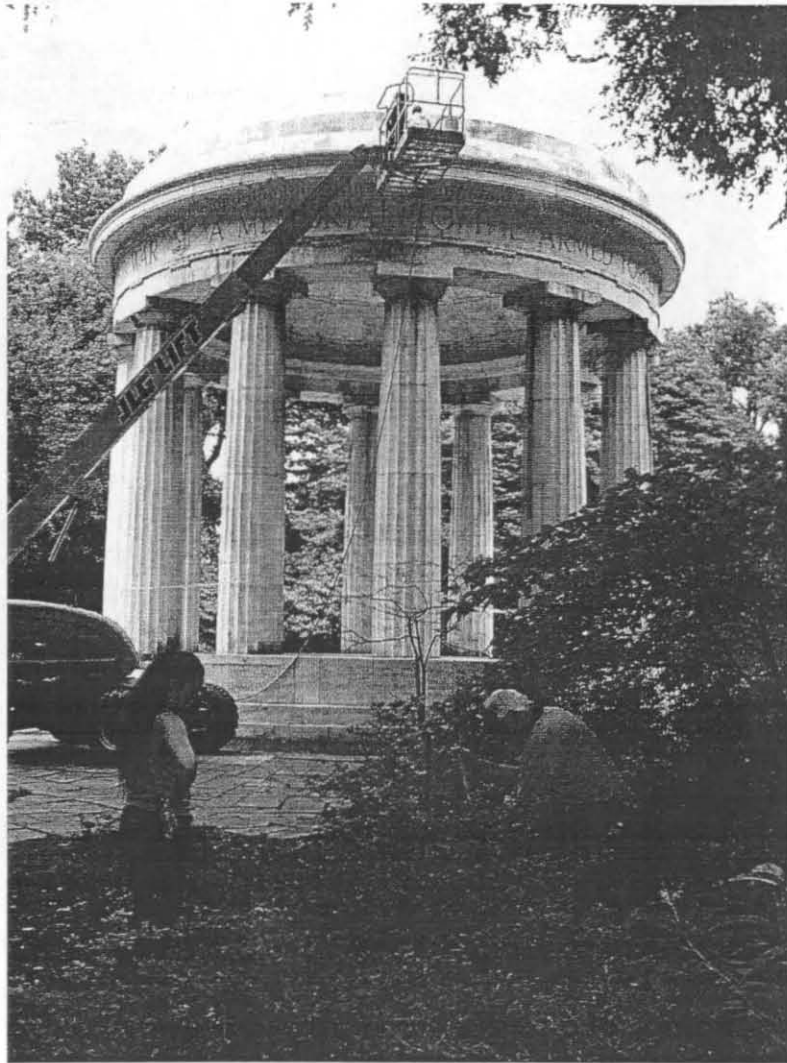
A continuously flowing water hose was inserted in the downspout outlet above Column No.1 (northwest quadrant). A capped concrete distribution box was located six to twelve inches below grade, approximately twenty yards to the northwest of the memorial. It was not possible to determine if water was flowing into the distribution box (see drawing).

*Tony Donald of the National Park Service and Nancy Rankin of John G. Waite Associates, Architects look for a site drainage structure to the northwest of the Memorial, as Binh Nguyen of the National Park Service directs water through the internal downspout at column 1. A series of water tests were conducted to determine how the Memorial's stormwater drainage system operated. [JGWA, 2005]*
