# DISTRICT OF COLUMBIA WAR MEMORIAL

Historic Structure Report  
& Cultural Landscape Assessment

National Mall & Memorial Parks  
PMIS NO. 43699

May 2006

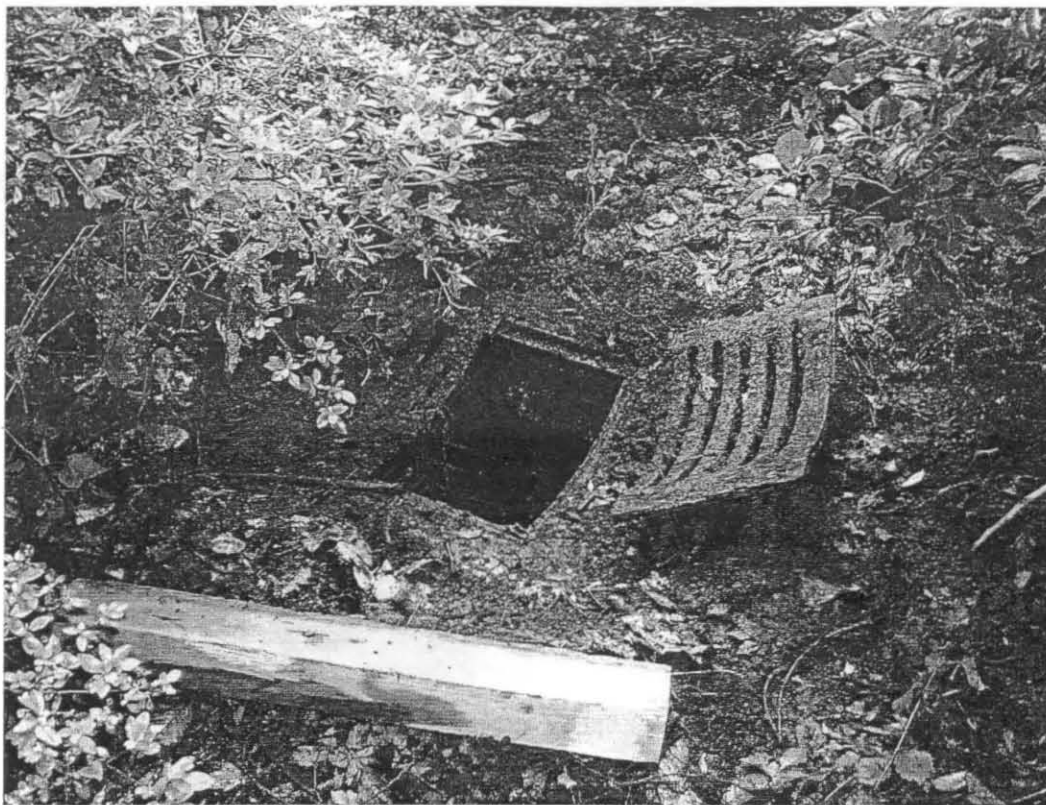
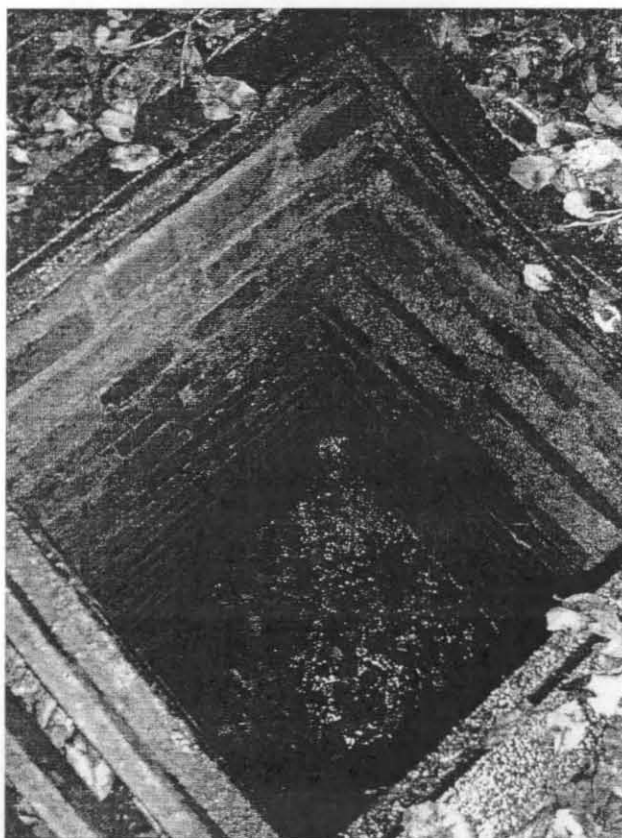
On July 15, at 12:50 p.m., in hot, humid weather (overcast with sun, 80 degrees F), a continuously flowing water hose was inserted in the downspout outlet above Column No.10 (southwest quadrant). After removing six to twelve inches of soil and mulch from the grate of the catch basin located approximately twenty yards to the southwest of the memorial, water was observed to be flowing freely through the catch basin. Water came into the catch basin on the diagonal, directly sighted from Column No.10. No moving water was observed at the catch basin located to the southeast of the memorial.

A continuously flowing water hose was inserted in the downspout outlet above Column No.7 (southeast quadrant). After removing the grate of the catch basin located approximately twenty yards to the southeast of the memorial, water was observed to be flowing freely through the catch basin. Water came into the catch basin on the diagonal, directly sighted from Column No.7. No moving water was observed at the catch basin located to the southwest of the memorial.

*Water tests demonstrated that the downspouts in columns 7 and 10 drained directly to these catch basins located to the southeast and southwest of the Memorial, respectively. [JGWA, 2005]*

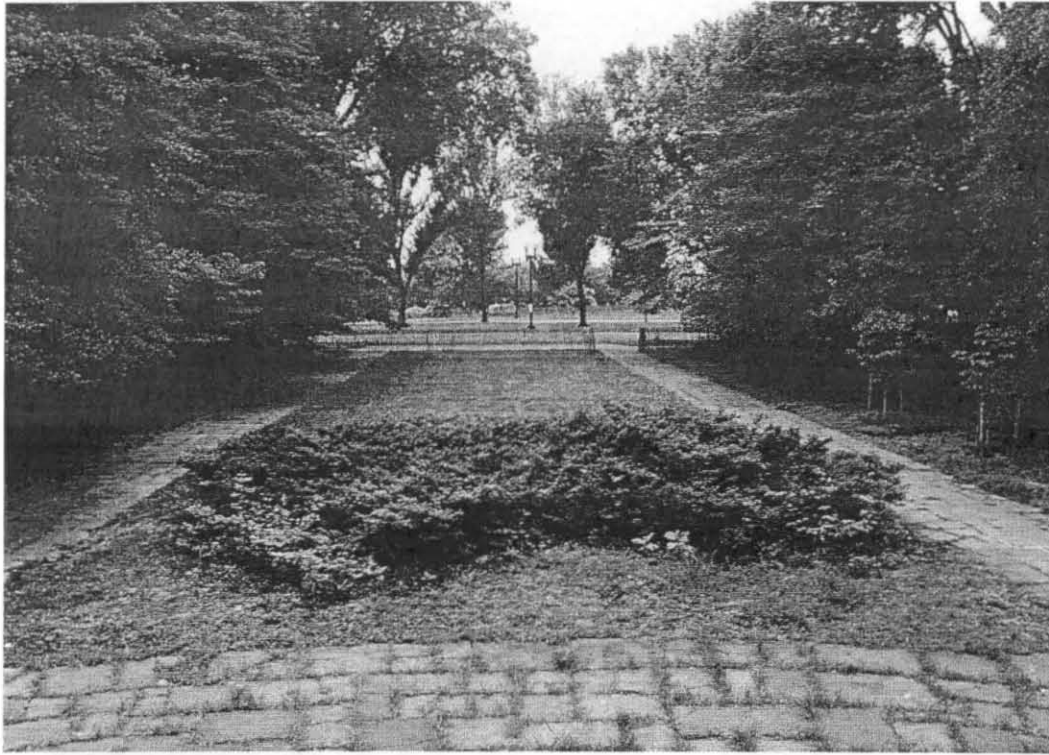
*Looking south at the flagstone walks from the Memorial. [EDC, 2005]*

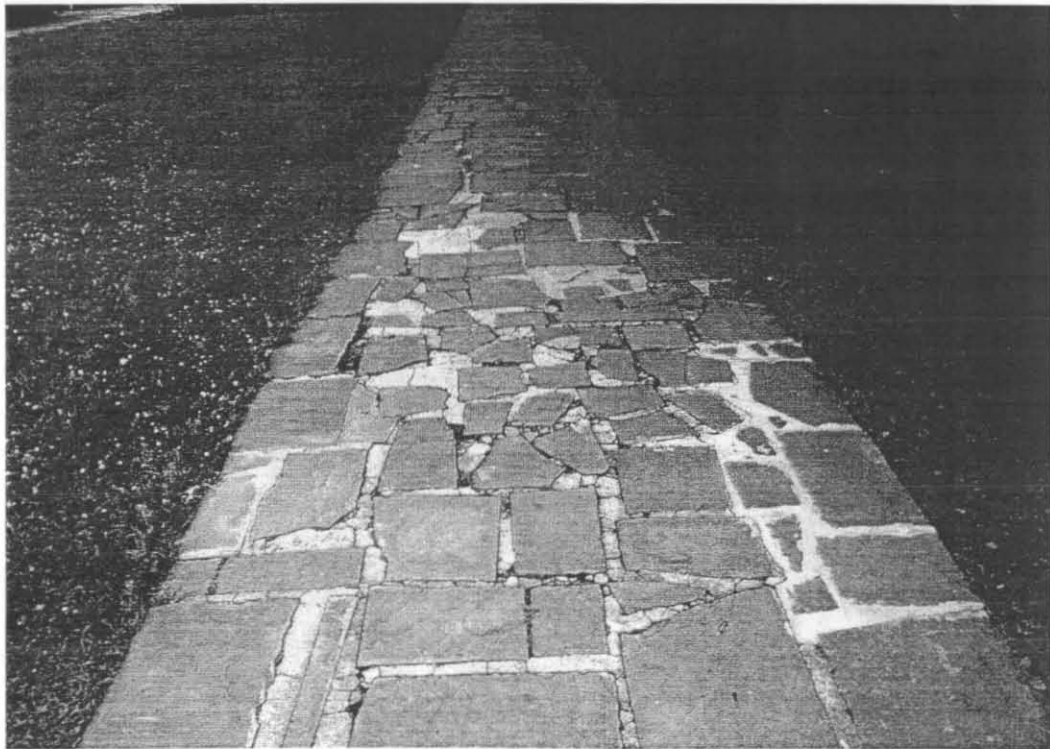
*This walk was relaid with small flagstones in a slightly different pattern than original. [EDC, 2005]*

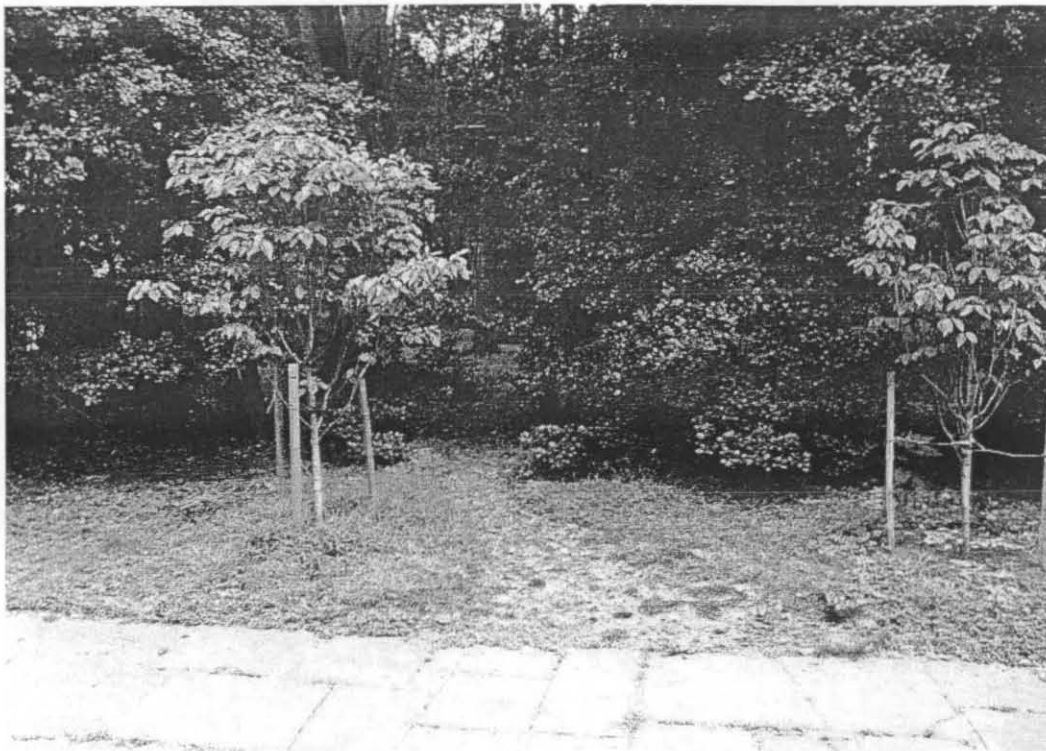
*West trail connecting the flagstone walk with the woods to the west. [EDC, 2005]*

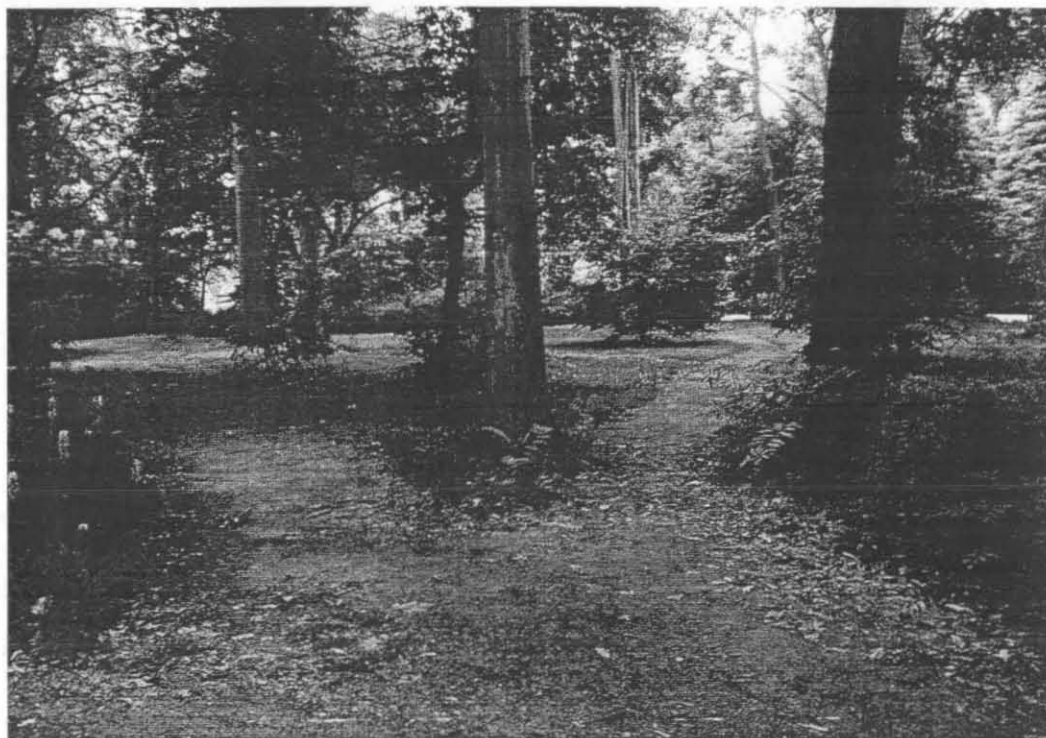
*This wear trail, in the west woods, divides and goes in two directions. [EDC, 2005]*

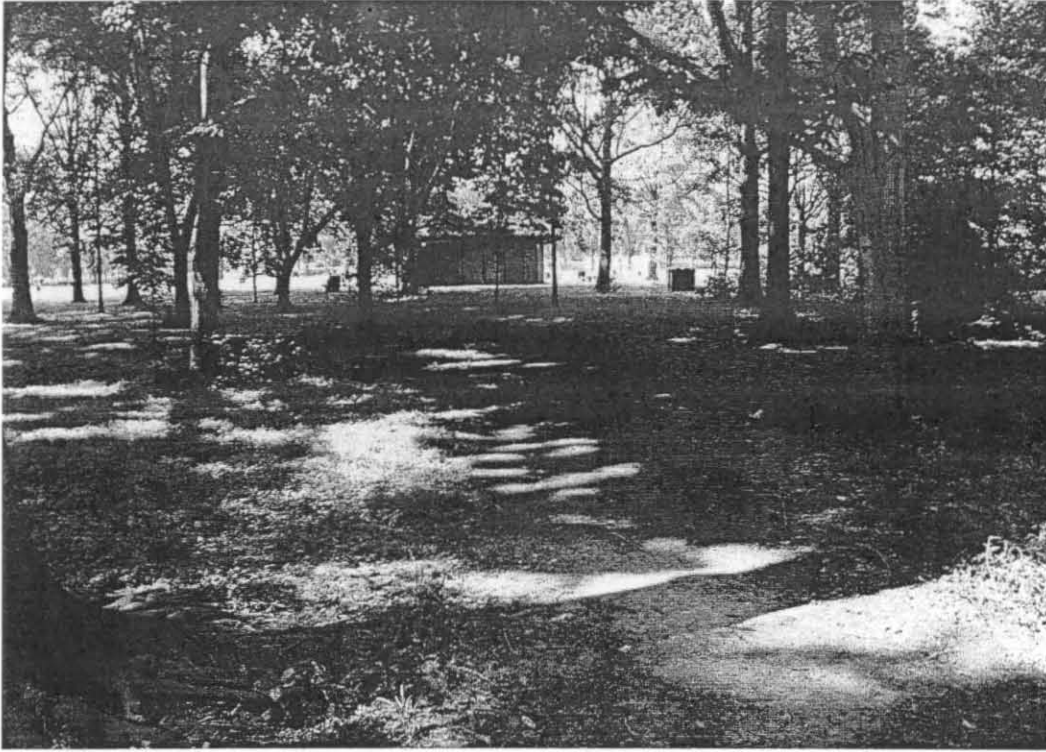
*Wear trail leading to the public restrooms. [EDC, 2005]*

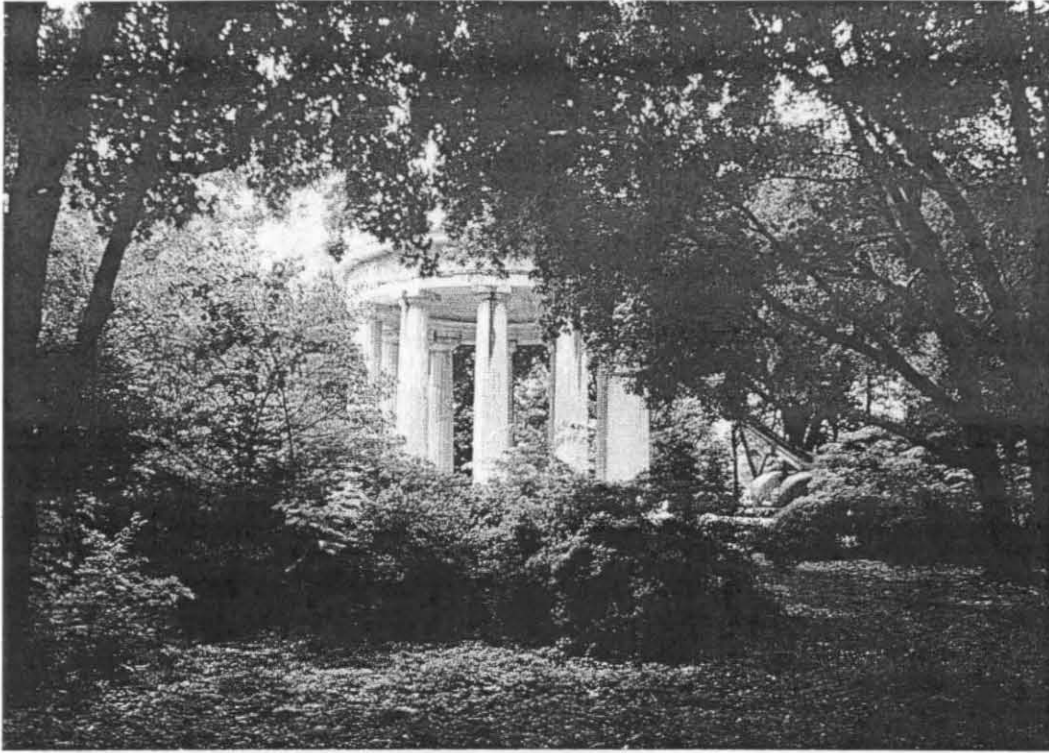
*Azaleas and low tree branches restrict views to the Memorial from the woods. [EDC, 2005]*

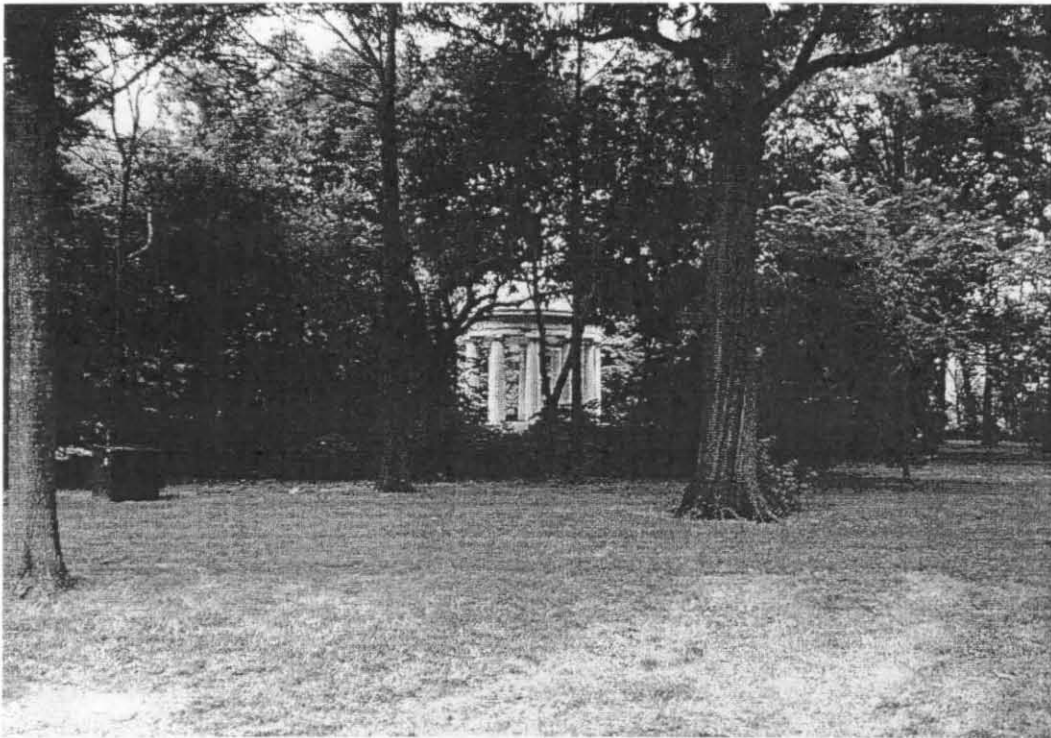
*Hollies, azaleas, and low tree branches restrict views to the Memorial from the woods. [EDC, 2005]*

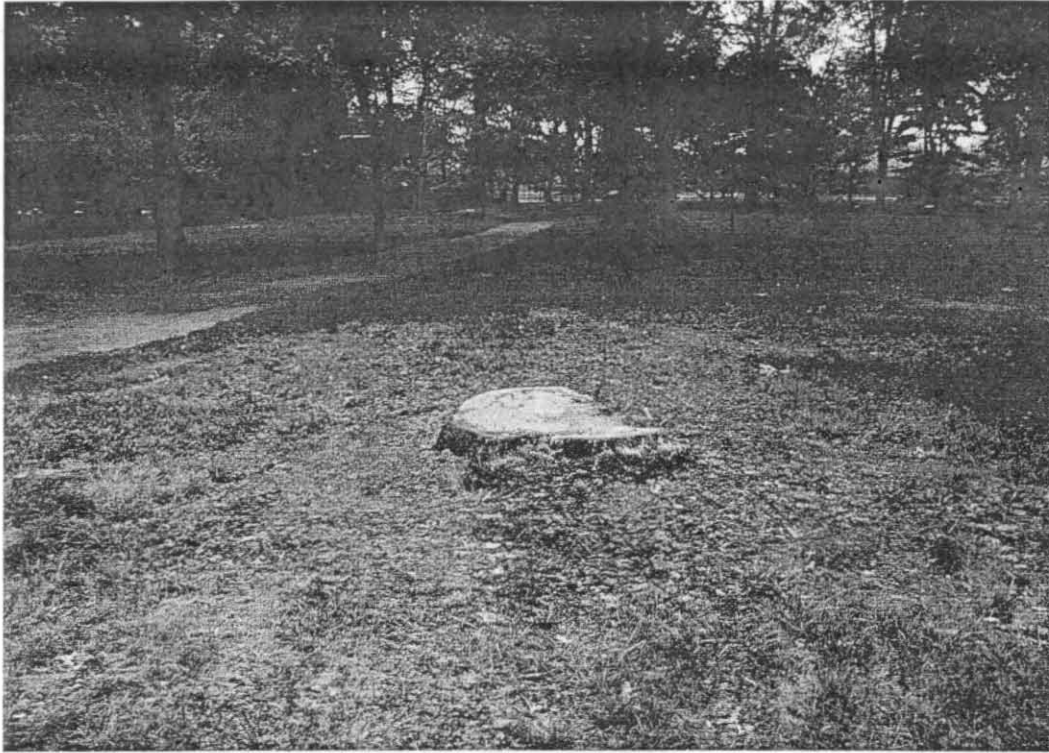
*This large stump indicates that some trees are being removed as needed. [EDC, 2005]*

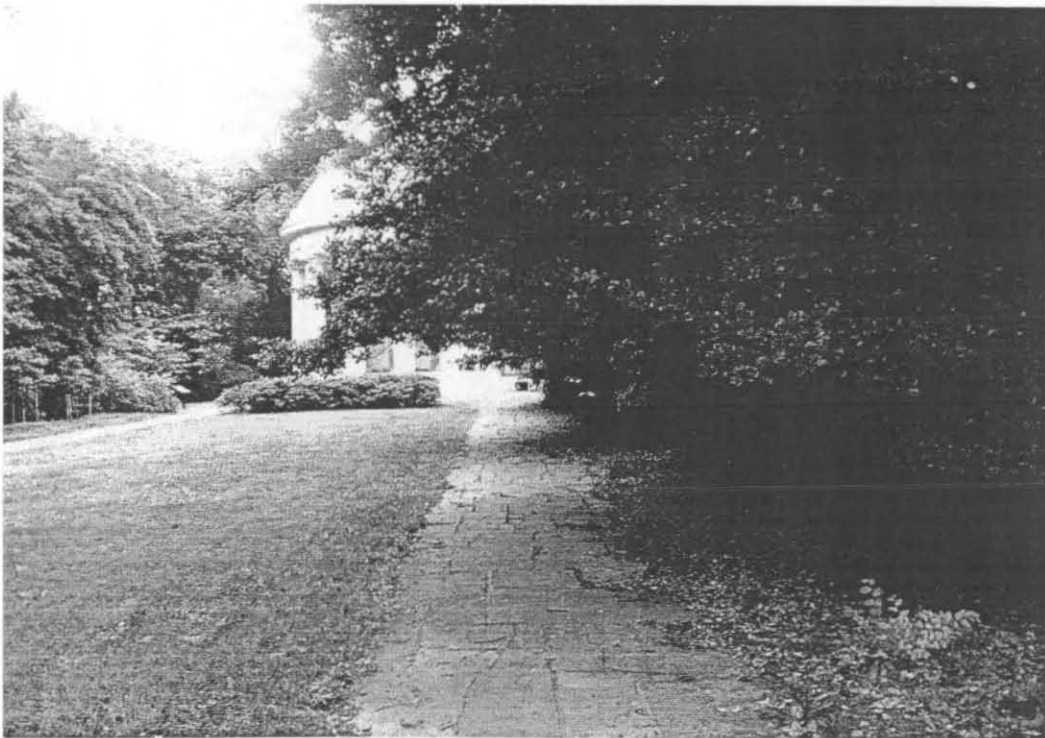
*Hollies overhang the flagstone walks south of the Memorial. [EDC, 2005]*

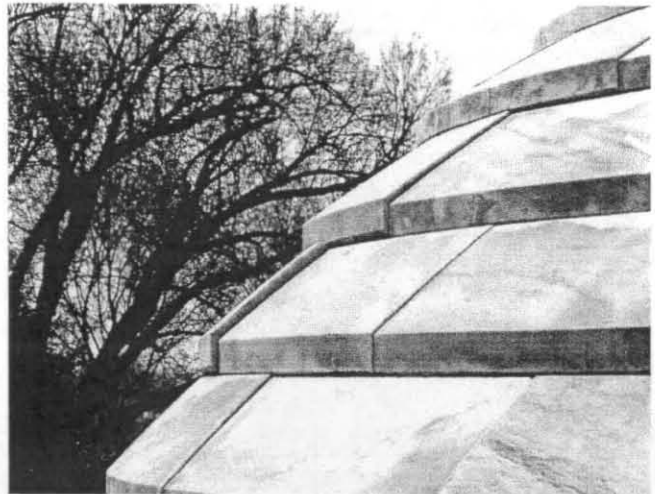
Localized movement was observed in some of the marble roof pieces (Photo 2). The Guastavino tile dome which supports the marble roof was observed from the interior attic space and appeared to be in good condition with little movement or mortar loss. It is unclear what may have caused the shifting of the roof marble, however, the long term entrapment of moisture within the setting bed or collar joint between the marble and Guastavino vault structure could certainly have induced movements in response to freeze-thaw cycling. The shifting could also be in response to minor shifting of the Guastavino dome, however, as noted above, there was no cracking or apparent displacement observed from within the attic. Another possible influence on the marble roof tiles is the presence of 4 – 7/8"

Photo 2. Displaced marble roof pieces.

diameter bronze rings which are shown on historic drawings to be set within the marble joints at the lower levels of the dome (SSK-1). Some localized disturbance related to these rings may be occurring, however no consistent pattern was observed which would indicate this as the likely cause.

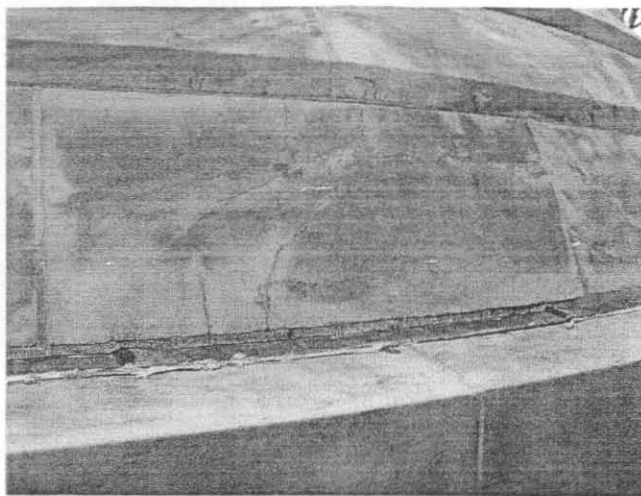
Small hairline cracks were observed in the marble roof pieces (Photo 3.) These cracks are most likely due to age and normal wear, and do not appear to affect the structural integrity of the roof.

Photo 3. Minor cracks in marble roof piece.

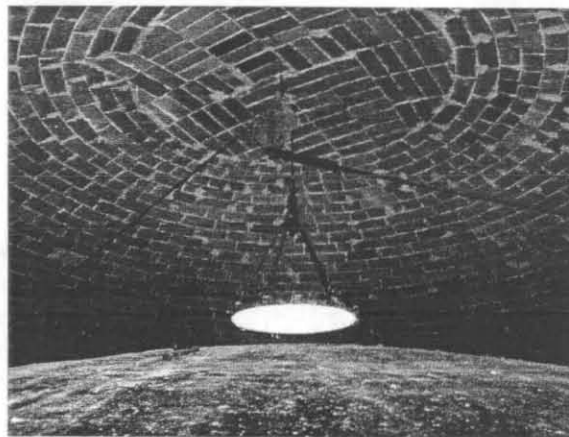
The visible surface of the outer Guastavino tile dome appeared to be in good condition (Photo 4). The inner dome surface was obscured by a bituminous surface coating. From within the attic space we could observe the general arrangement of support for the upper and lower domes on the entablature. Here, the brick backup wall of the entablature presented nearly continuous efflorescence around the perimeter, a strong indication that water has been passing through the base of the roof dome into the entablature substrate (Photo 5). Significant movement in the brick backup masonry was observed in the vicinity of the L-rings from within the attic space. A probe of the masonry (Photo 6), however, revealed the steel L-rings to have only minor surface rust (Photo 7).

Photo 4. Interior surface of outer dome and counterweighted ceiling oculus.

*Recommendation: The infiltration and potential entrapment of water should be minimized by*

addressing water penetration and general breathability of the masonry at the exterior in the vicinity of the drum. No immediate structural action is required in this area.

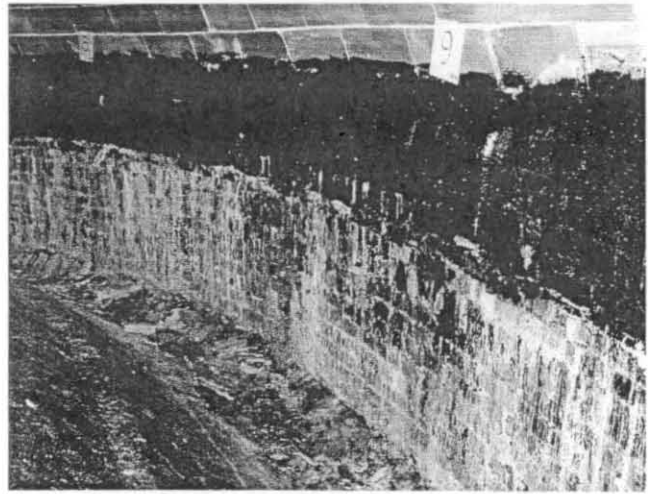
Photo 5. Interior brick backup at entablature

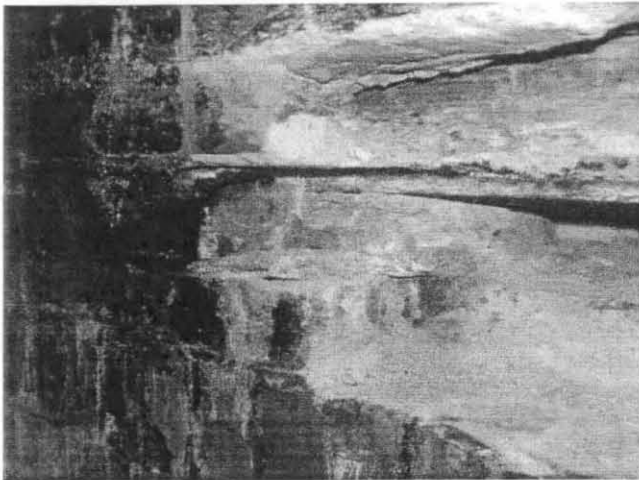
Photo 6. Probe of masonry wall at attic.

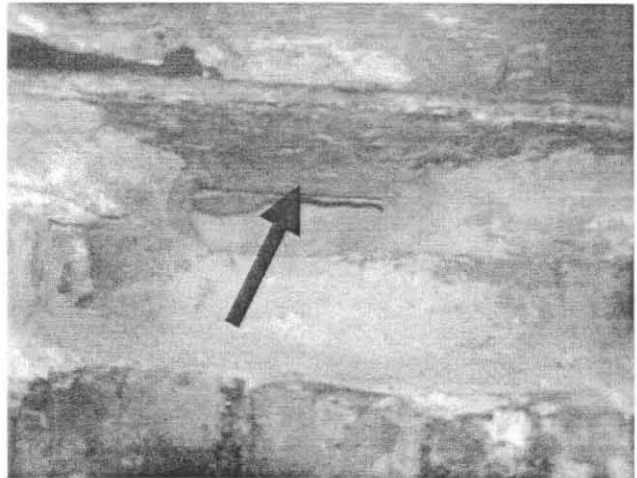
Within the interior attic space, the upper steel L-ring was observed on July 15, 2005 through a probe, and appeared to be in relatively good condition; the steel presented a nearly fully intact section with only some minor surface rust. Significant displacement was observed from within the attic space within the area of brick masonry between the underside of the Guastavino tile dome and the waterproofing layer (approximately where the brick is coated with a bituminous material. See Photo 5). The observed masonry displacement may be the result of a number of possible phenomena, given the generally loose connectivity of this upper, non-structural portion of brick masonry at the interior, backside of the drum. Possibilities may range from simple thermal cycling to the effects of freeze-thaw cycling of saturated masonry. A failure of the drainage and water-shedding systems may have resulted in long term moisture entrapment within the masonry. This extended presence of moisture may be the source of a number of problems, which could range from deteriorating ferrous masonry ties or embedded elements to basic freeze-thaw cycling. No direct evidence of deteriorating ferrous elements within the masonry was uncovered in this investigation.

Photo 7. Bottom surface of steel L-ring seen in probe.

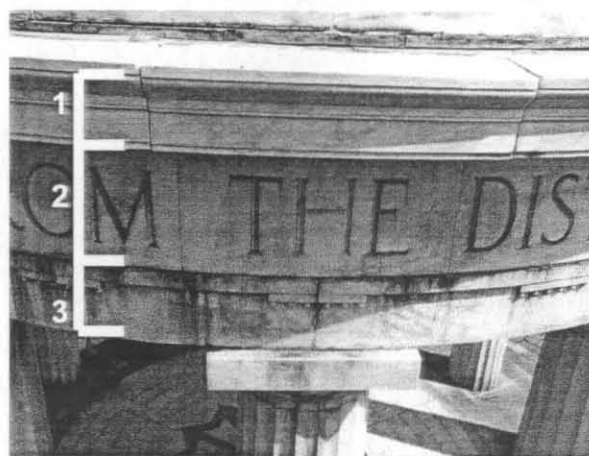
Photos 8-10 show the cracked cornice section located on the west elevation. The crack extends from the right joint to the center of the soffit (Photo 9) to the joint of the dentil unit below (Photo 10). The entire section appears to be sloping downward to the right (Photo 8), and there is significant mortar loss in the joints between adjacent marble pieces (Photo 11). Original drawings indicate that the column below this section is one of four that contain a downspout. It is probable that this downspout is not functioning properly, causing water to become trapped in the gutter and in the masonry assembly itself (Photo 12). In addition, the presence of water in the brick walls adjacent to the steel L-rings could be causing displacement of the masonry due to freeze-thaw cycles or possible ferrous metal deterioration, in turn placing stresses on the exterior marble pieces. As noted previously, no direct evidence of steel rusting was uncovered in this investigation, so our concerns are more focused on general moisture infiltration and entrapment at this time.

Photo 8. Displaced cornice element.

Recommendation: As the previously described probe investigation did not reveal ferrous metal deterioration as the source of masonry cracking and displacements, we recommend focusing on water infiltration and entrapment by implementing repairs of the cracks. Though it doesn't appear that any pieces are near falling from the building, it is prudent to provide a connection between the cracked pieces to assure long term stability. A combination of stainless steel pinning and epoxy injection are the likely means of assuring long term stability and minimizing moisture entrapment at the crack interface.

Recommendation: The entire downspout and drain system of the structure should be examined further to determine its deficiencies. These deficiencies should then be repaired in order to prevent continued water penetration of the entablature. After the drainage system is

repaired, the cracked cornice sections should be patched with an appropriate material and the joints repointed to restore stability. Localized pinning and epoxy injection are appropriate treatments to reconnect pieces where stability of one part is in question.

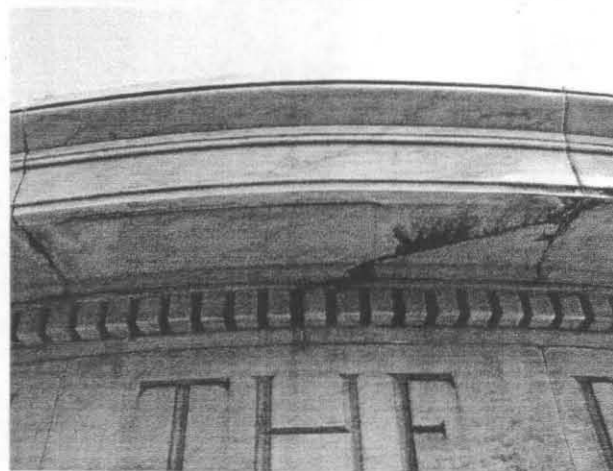
Photo 9. Crack extending from right joint to center of the cornice soffit.

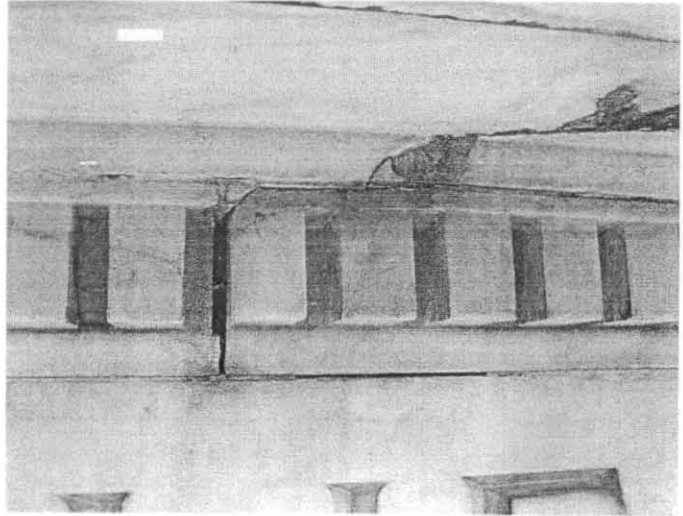
Photo 10. Close-up of crack through joint between dentil units.

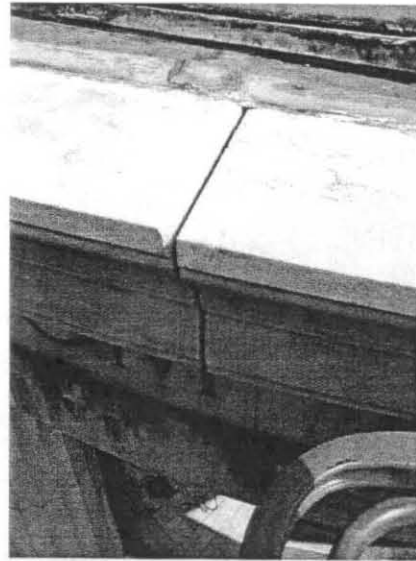
Photo 11. Mortar loss around displaced element.

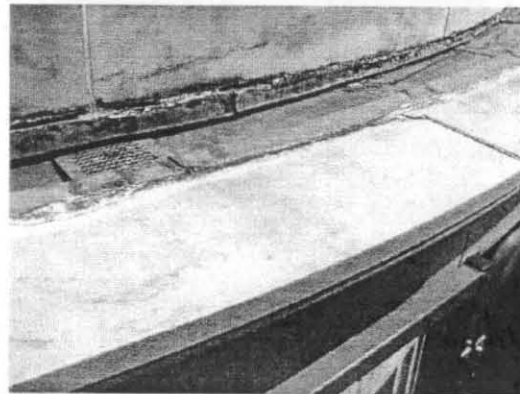
Photo 12. Top of cornice unit showing gutter.

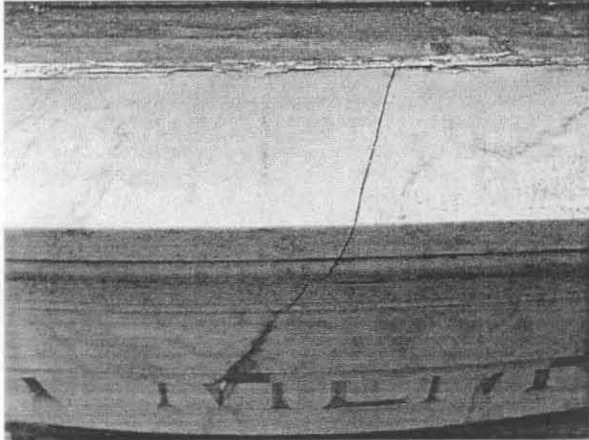
A similar condition occurs in a cornice section on the north elevation (above the word "Memorial" in the frieze.) This crack extends across the top of the section and down its face, terminating where it meets the dentil unit below (Photos 13-14). Original drawings indicate that the column below does not contain a downspout; however, malfunctioning of the drainage system and subsequent water penetration is still the likely cause of this crack.

Photo 13. Cracked cornice unit on north elevation.

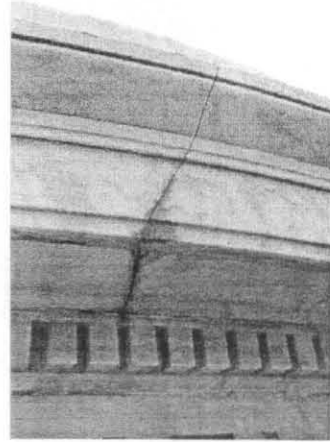
Photo 14. Extent of crack in cornice unit.

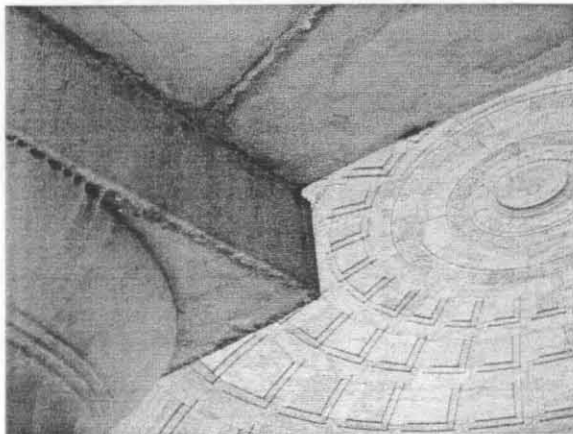
SSK-2 shows the observed locations of cracks in the soffits of the architrave between columns. Three of the architrave pieces exhibited significant cracks, while one had light cracking. Photos 15 and 16 show the cracked soffit at the north side of the structure. The cracks appear to have either a buildup of mineral deposits or a prior repair with some kind of mortar or patching material. As with the cornice, it is most likely that the drainage system is not functioning properly, causing water to soak through the entablature elements and allowing the freeze-thaw cycle to damage the stones. Furthermore, an existing section of the entablature shows a metal strap extending from the interior ceiling cornice through the architrave unit. Corrosion of this metal strap could cause significant cracking in the architrave.

Photo 15. Cracks in architrave soffit.

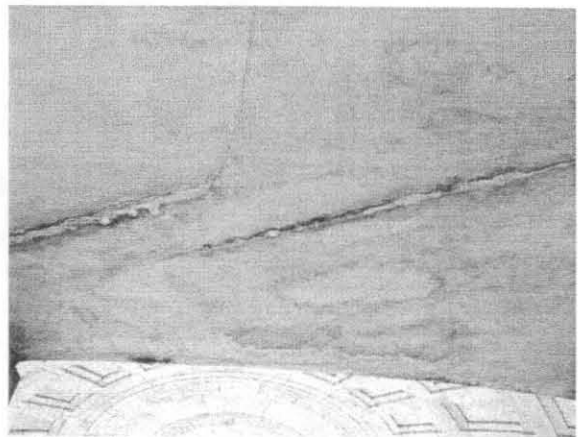
Photo 16. Close-up, cracks in architrave soffit.

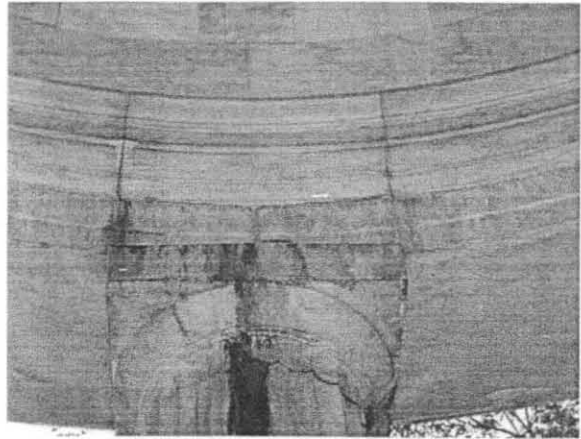
The outer surfaces of certain columns exhibited signs of mineral deposition and staining, as well as small cracks (Photo 15).

Photo 17. Column Capital with Staining

*Recommendation: No immediate action is required structurally, however consideration should be given to possible treatments to best support the longevity of the stone.*

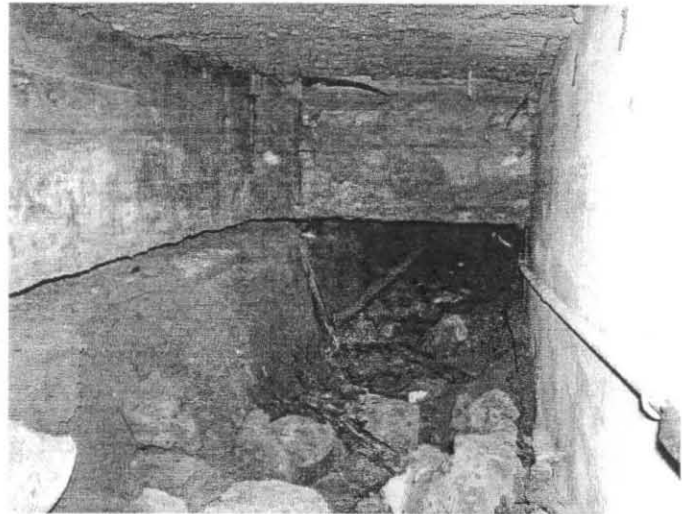
The foundation was observed through a crawlspace accessed through the manhole in the center of the memorial's floor. Based on original drawings and observed conditions, it appears as though the space beneath the foundation beams was originally filled. Removal of the fill material, however, does not affect the structural stability of the foundation, since the beams span to the outer concrete pile caps. The concrete beams appeared to be in good condition (Photo 18). In some locations, the reinforcing bars of the concrete slab were exposed, giving an appearance as if the framed slab was originally cast on earth but subsequently excavated for the vault construction (Photo 19).

Photo 18. Concrete grade beams.

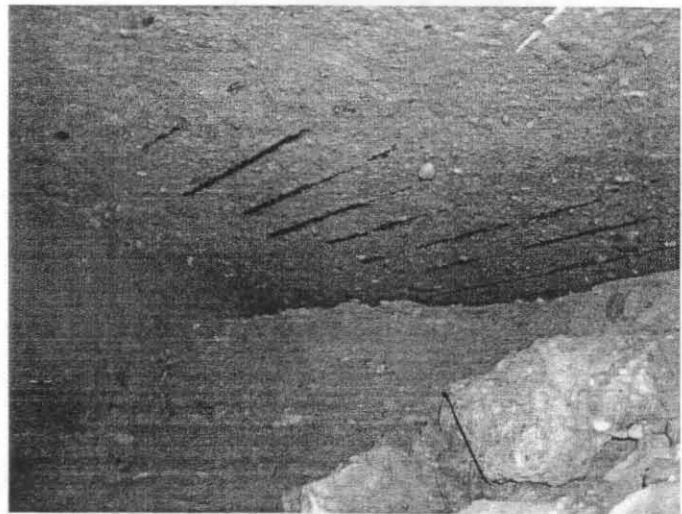
Photo 19. Underside of floor slab showing exposed reinforcing bars.

*Recommendation: Areas of exposed reinforcing should be repaired to minimize the possibility of further deterioration of the reinforcing steel. Exposed bars should be further exposed, coated with a corrosion inhibitor and bonding agent, then covered with an overhead repair mortar.*

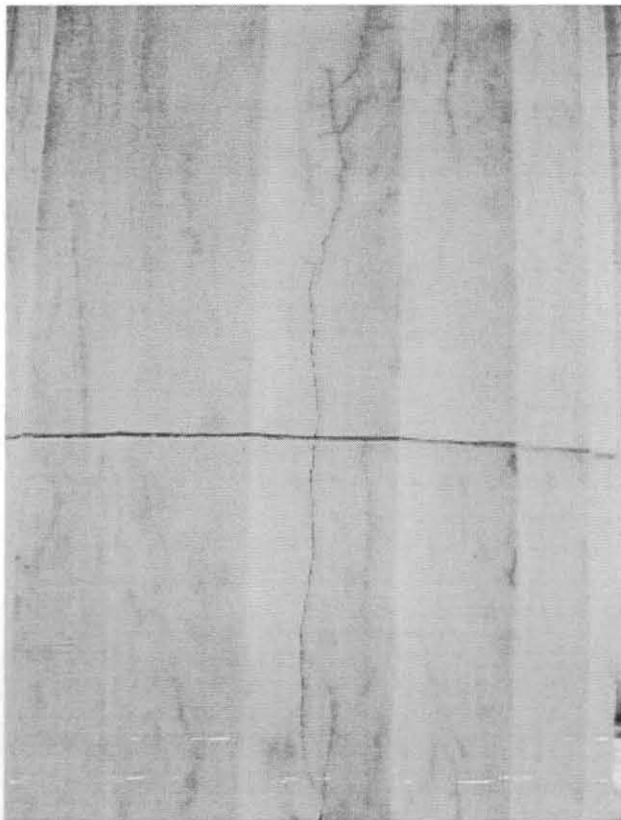
*Occasionally, vertical cracks extend through mortar joints. [MSSC, 2005]*

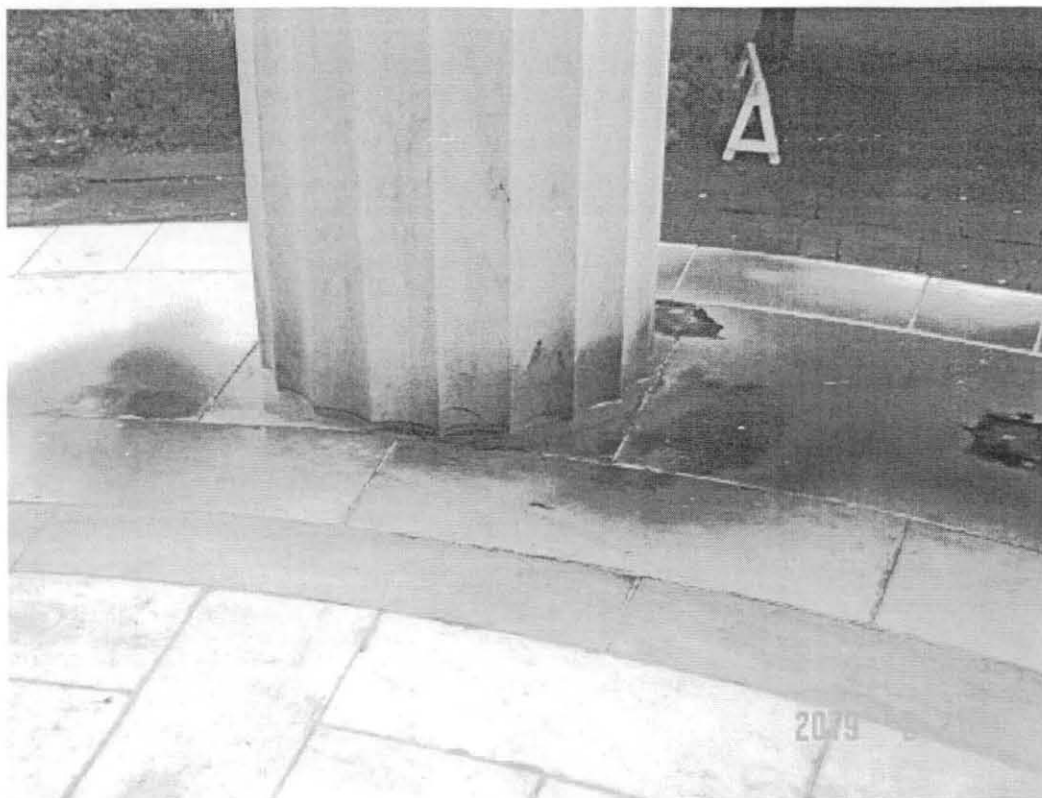
*Dark-colored soiling and water pooling on marble floor near base of column. [MSSC, 2005]*

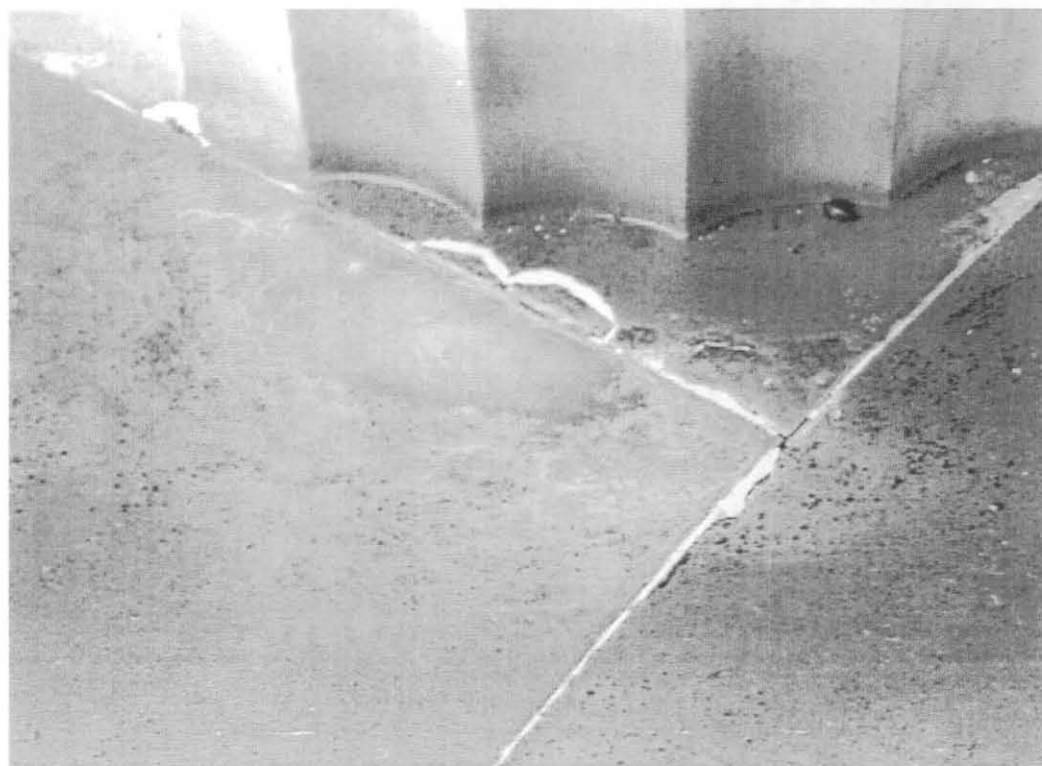
*Re-deposited calcium carbonate on marble floor. [MSSC, 2005]*
