John Gordon House  
Natchez Trace Parkway  
**Historic Structure Report**

# Historic Structure Report

April 2012

LCS#: NATR 00020

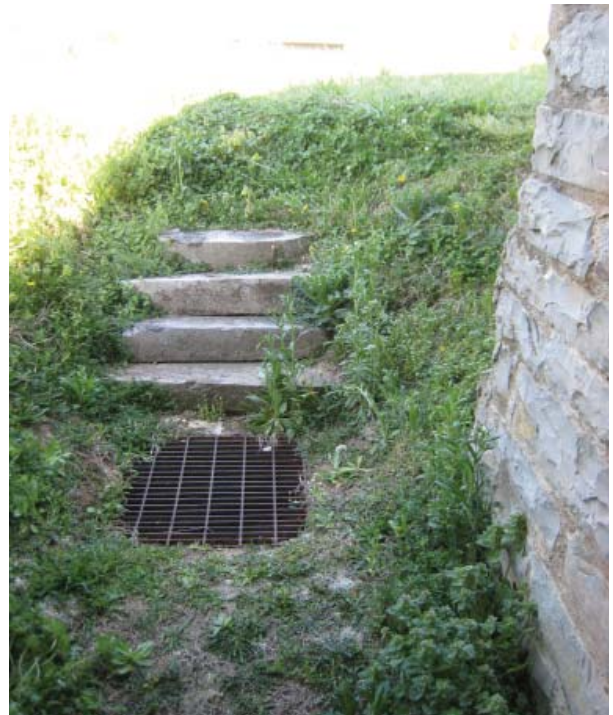
**Figure 91.** Stone steps leading from Basement. Modern catch basin is at the base of the steps.

There are no roof gutters or downspouts. The natural slope of the site, from northwest to southeast, directs rain runoff around the house and downhill. French drains were installed in 1977-78 but were reportedly inadequate for handling the runoff; the basement flooded regularly. A swale and berm were added at the steps leading to the basement in 2001 and has had more satisfactory results.

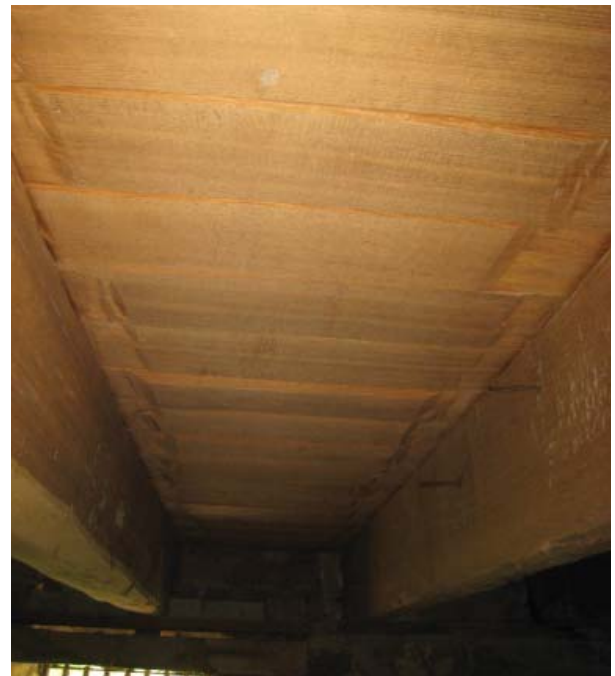
Figure 97. Hewn joists and gauged flooring.

Four of the original joists have been repaired for damage along the south section of the perimeter foundation wall. Counting west to east, joists number 4, 5, 10, and 11 have been sistered onto with modern framing to strengthen the ends as part of the 2003 repairs.

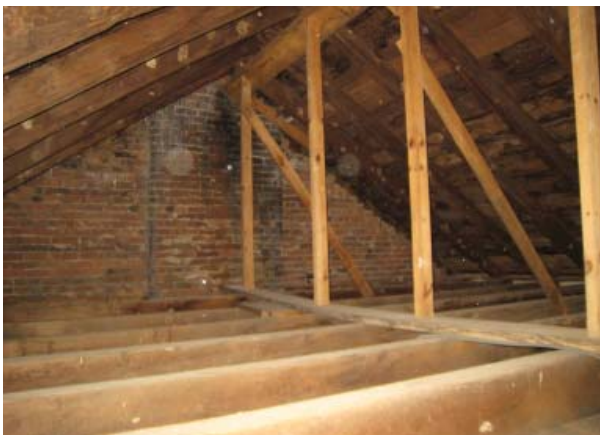
Figure 100. Supplemental support of rafters.

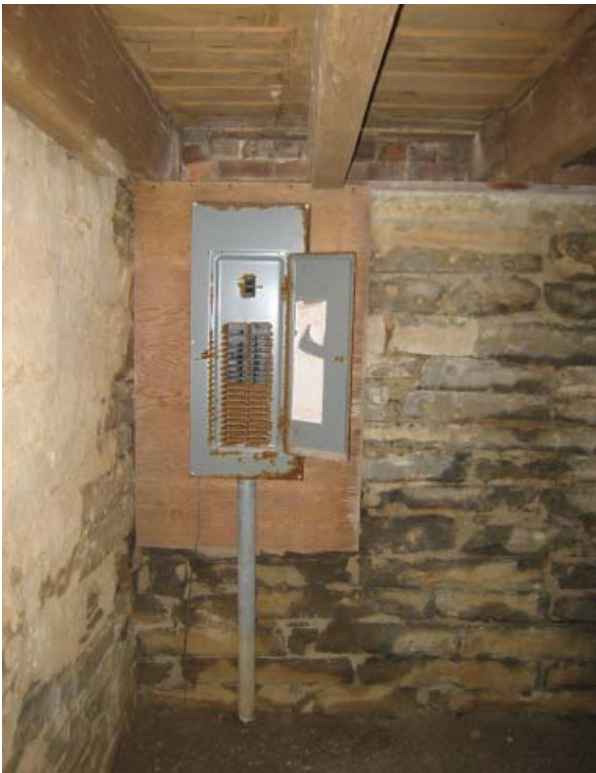
Figure 103. Electrical panel box of 1977-78 on north wall of Room 002.

Though there is no electrical power at the site at this time, there are remnants of an electrical system installed during the NPS restoration effort of 1977-78. These remnants include an unlabeled and otherwise unidentified panel box on the north wall of the East Basement room (Room 002). Associated equipment includes switches and outlets and their cover plates, junction boxes, sections of cloth-wrapped wiring, porcelain light bulb sockets at basement and stair closet, and a light fixture in Room 102 The Parlor.

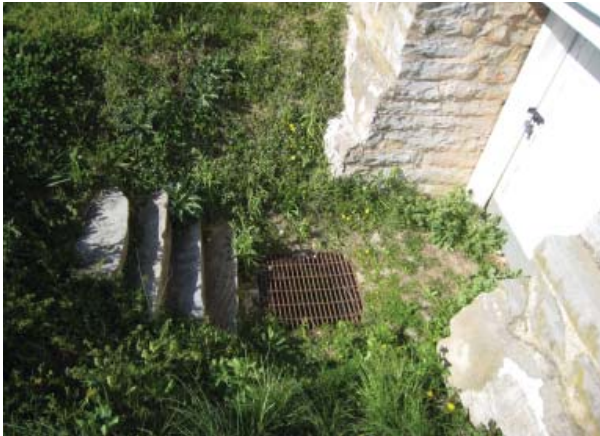
**Figure 106.** Catch basin at entrance to Basement.

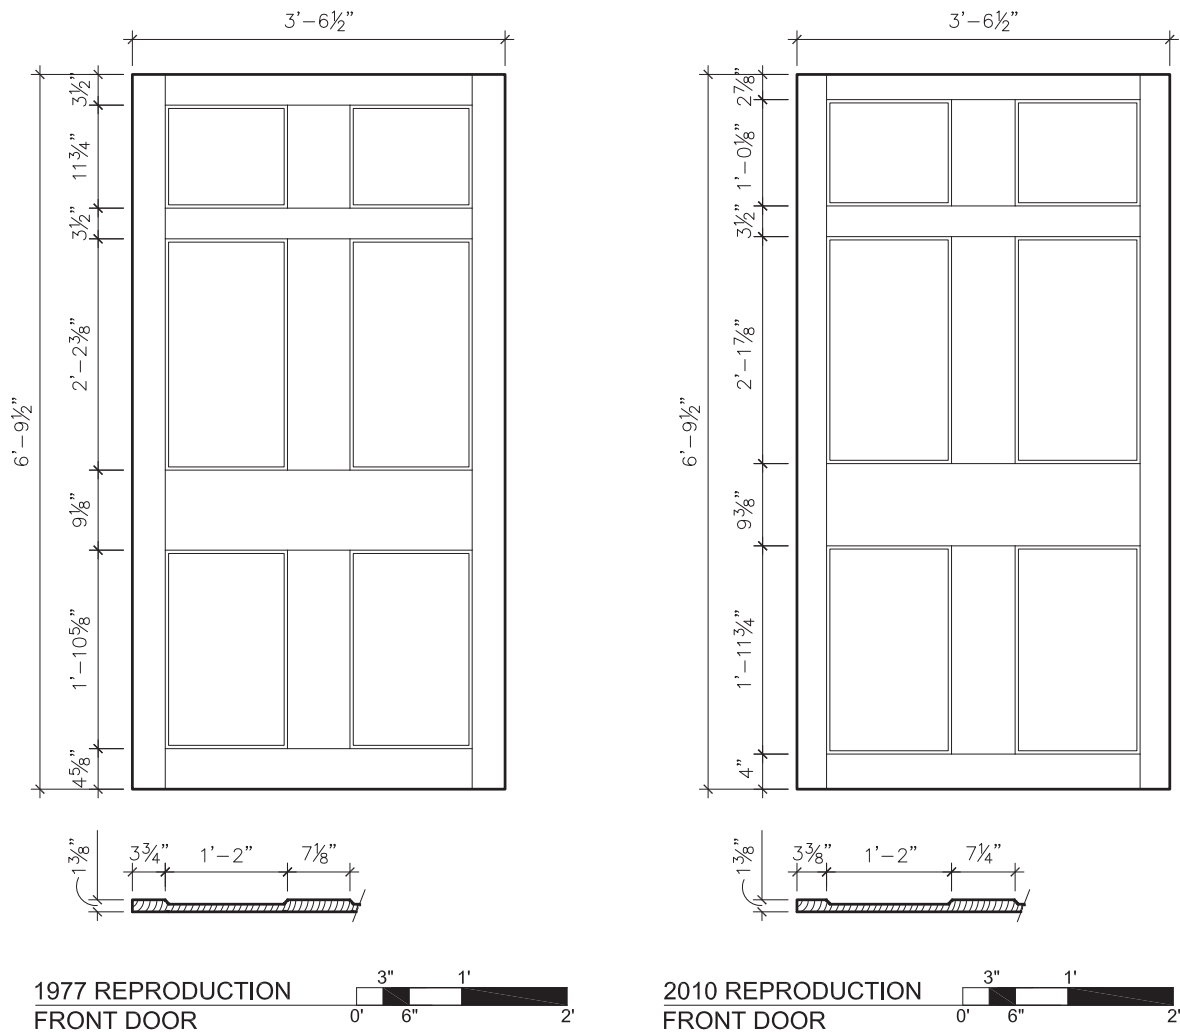
The 1977-78 replica doors overall measure 3'-6½" by 6'-9½" by 1⅜" and are in poor condition. New replacement doors have been fabricated and are awaiting installation. Unfortunately, the new doors are dissimilar in dimensions (Figure 111).

**Figure 111.** Comparison of elevations and sections of reproduction doors of two different time periods of the front entrance doorways.

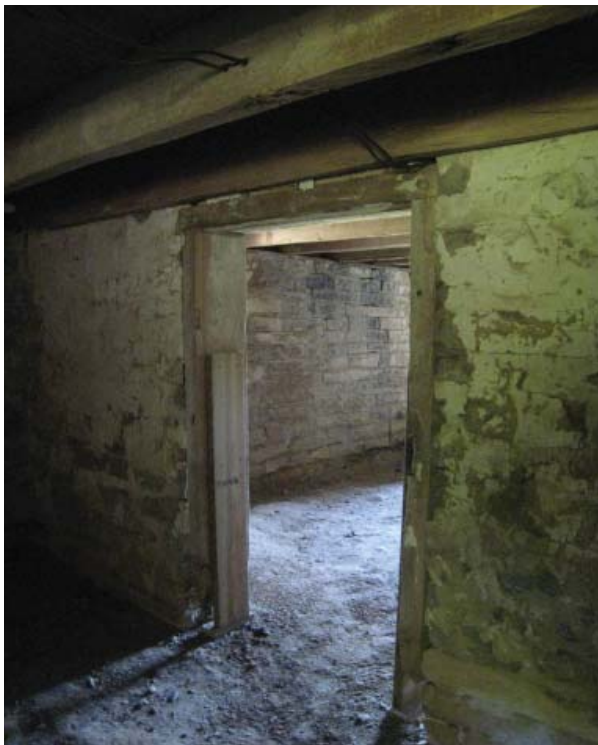
**Figure 121.** Connecting doorway as viewed from Room 002.

A second doorway is on the east wall and connects with Room 002, East Basement Room. The original jambs and lintel remain, joined with mortises and tenons at the two intersections of framing. The door, measuring 3'-6" in width by 6'-2" in height, is missing. For this location and use for ancillary activities, the door probably was made of boards and battens. Scars for two 3½" tall butt hinges on the Room 002 side of the south doorjamb indicate that the door opened into Room 002. A U-shaped wrought-iron strap on the Room 002 side of the north doorjamb indicates the door could also be secured.

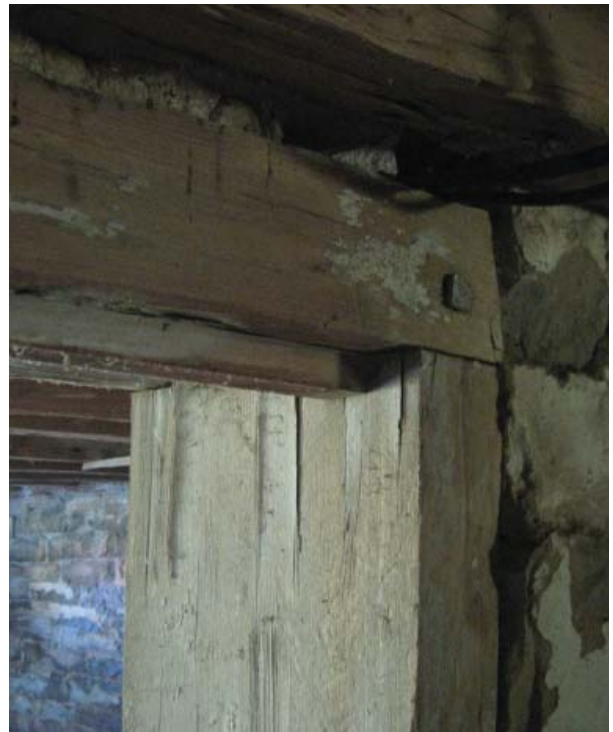
**Figure 122.** Doveled and tenon framing of interior doorway.

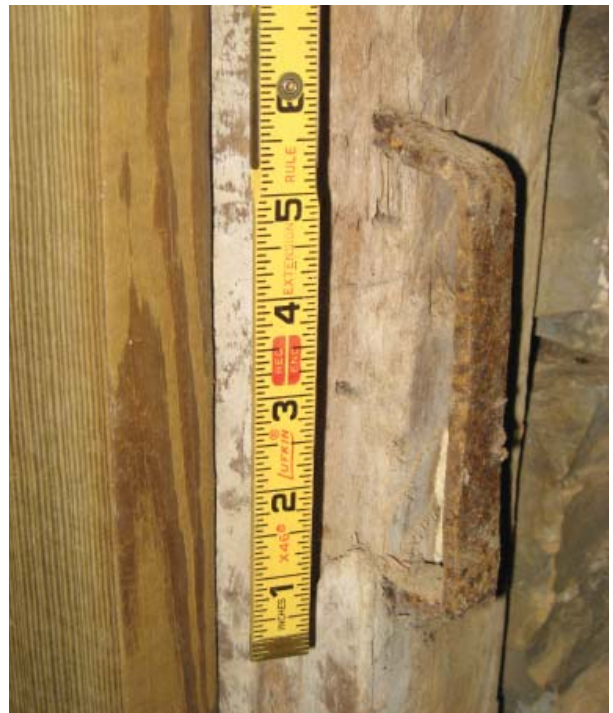
**Figure 123.** Wrought-iron staple on north jamb of doorway between Room 001 and Room 002.

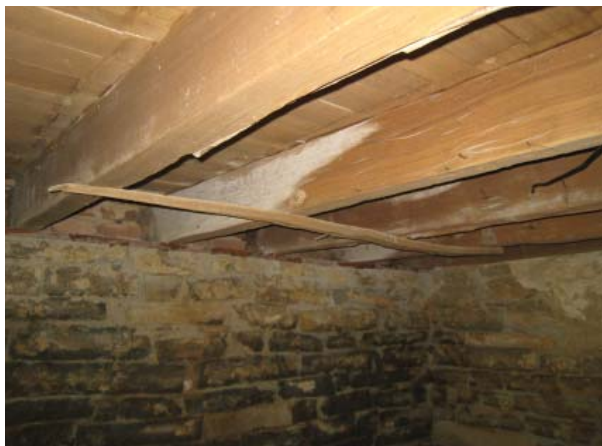
Near the north wall and parallel to it there is nailed to the bottom of joists number 5 through 8 a wooden strip several feet long, presumably to serve as a hanger for suspending objects (Figure 124).

Figure 124. Split wood hanger in Room 001.

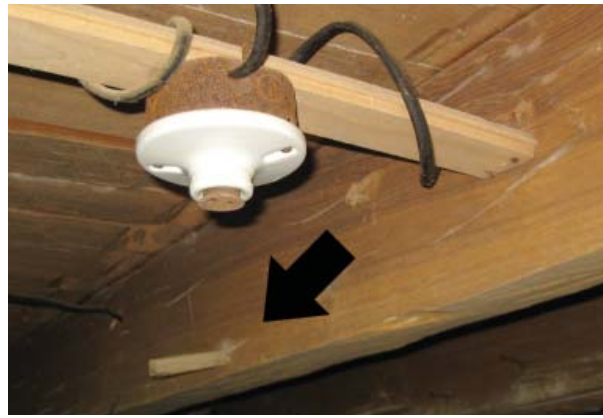
On the west side of joist number 6 at midsection is a driven dowel, presumably another hanger (Figure 125).

Figure 125. Driven dowel hanger.

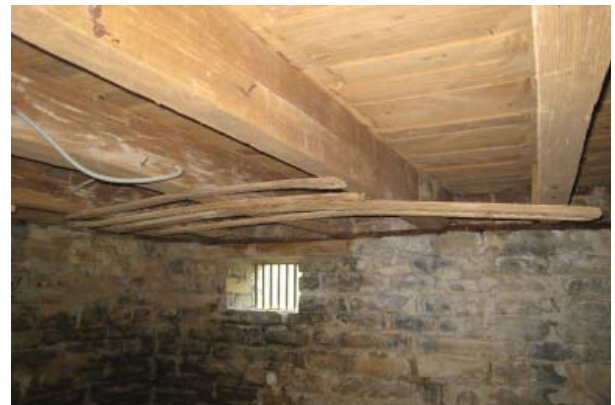
Near the south wall and parallel to it there are nailed to the bottom of joists number 12 through 14 two wooden strips. Each strip is several feet long. Presumably the strips served as hangers. Two more wooden hangers are nailed to joists number 11 through 14 (Figure 128).

**Figure 128.** Split wood hangers nailed to bottom of joists.

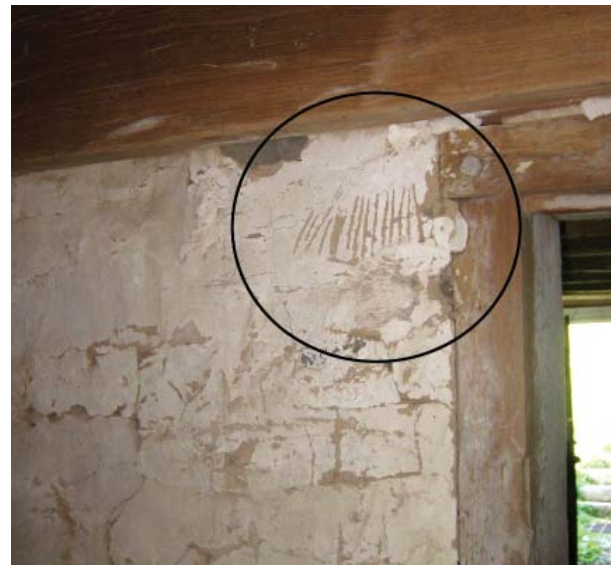
Opposite these hangers, scratched into the applied limewash of the west wall, is a series of small vertical lines about three inches in height, possibly an accounting record (Figure 129).

**Figure 129.** Graffiti scratched into limewash of west wall of Room 002.

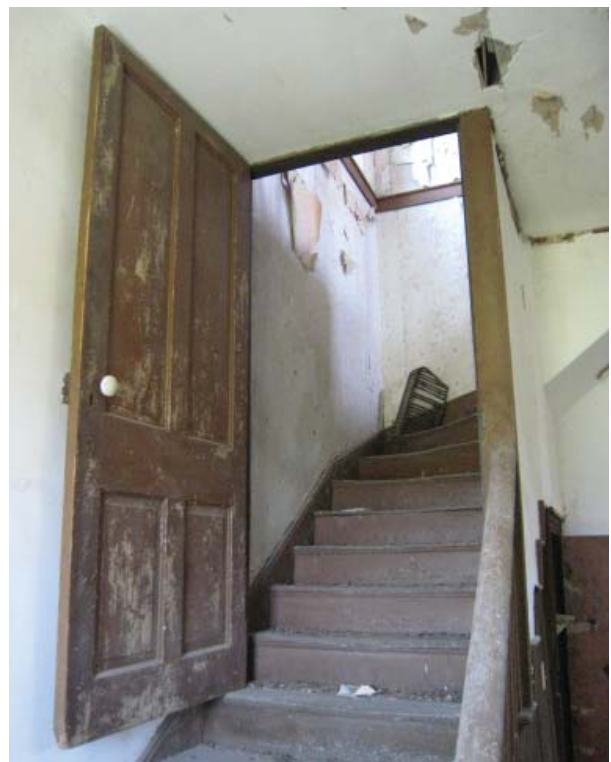
Figure 135. Early-twentieth century stairway enclosure in Room 101.

The fourth doorway appears to be part an early-twentieth century remodeling that enclosed part of the staircase. This door, a four-panel measures

1½" thick by 3'-0" wide by 6'-8" tall. Stylistically, the door stile and rail molding dates to the late-nineteenth through the early-twentieth century. (Figure 135). The doorway retains one of its original 3½" tall, five-knuckle, iron-embossed hinges (Figure 136) also stylistically from that era; the bottom hinge is a modern 3" tall, butt hinge replacement. The original iron rim lock also remains. It measures 3" tall by 4" wide and retains both of its porcelain door knobs but is missing the keep.

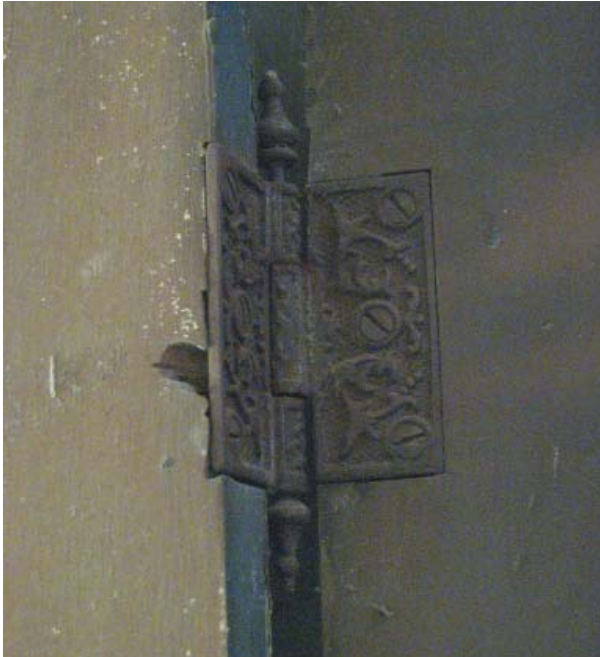
**Figure 136.** Embossed hinge of door on stairway to second floor.

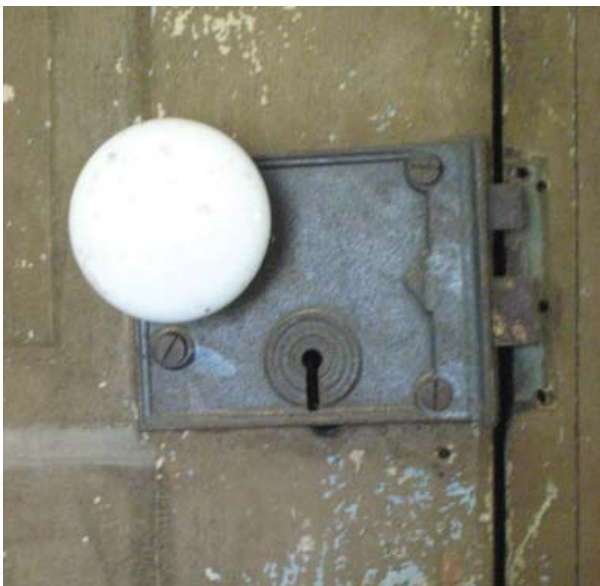
**Figure 137.** Rim lock of door on stairway to second floor.

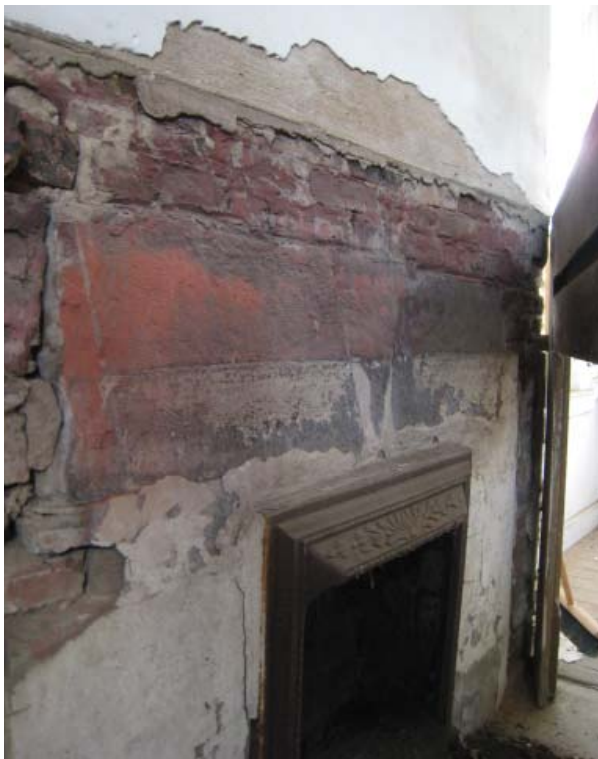
**Figure 138.** Faux-dressed stonework behind replacement mantle of Room 101.

stone hearth remains, as well as its wood lock strip notched into the flooring to hold the hearth stone in place. Comprised of a single stone, the hearth measures 1'-8½" deep by 4'-8" wide. The original wood-burning, stone firebox has been infilled with brick and plastered to enclose a small early-twentieth century, cast-metal coal grate measuring 1'-8" tall by 1'-8" wide by 9" deep. It is noteworthy that Garner compared the top coat of room plaster with the plaster enclosing the coal grate and concluded they are from the same period. The replacement mantel stylistically dates to late-nineteenth/early-twentieth century. This mantle is slightly less ornate than its comparable counterpart in the adjoining Parlor. Both mantels are made of wood, and assembled with wire nails, presumably by the same maker. This mantle measure 4'-6½" tall by 6'-4" wide at the shelf. Hidden behind the mantle architrave is decorative faux painting of dressed stonework, apparently exposed when a previous, perhaps original, mantle was in place.

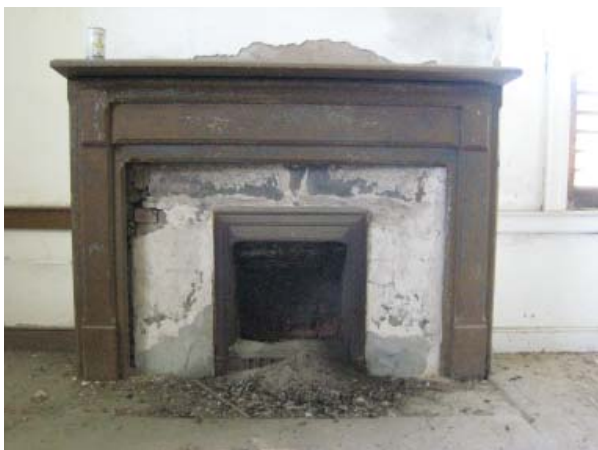
**Figure 139.** Fireplace of Room 101.

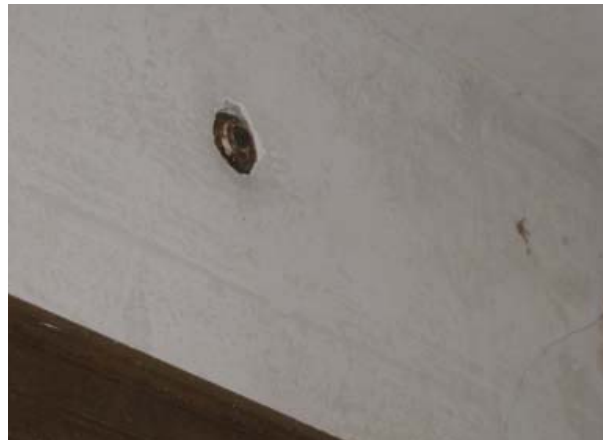
Figure 144. Bolt and nut on the upper south wall of the Hall, probably for securing the upper section of the double gallery.

On the south wall above the west window is a bolt and round nut. A matching set is above the east window of the Parlor (Room 101). These bolts probably secured the upper section of the c. 1907 double-gallery porch against the south elevation of the house (Figure 144).

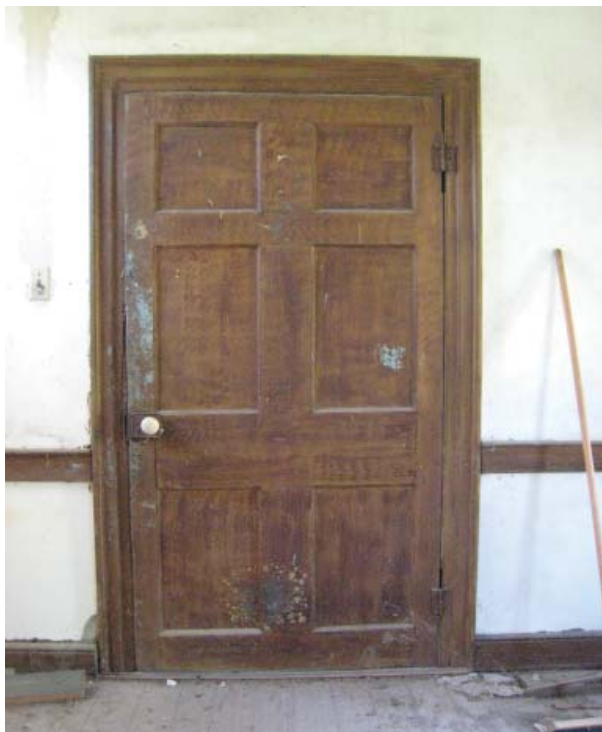
The exposed paint finish of baseboards, chair rails, door and window casings, and doors (interior door and exterior rear door) is faux-wood graining. Replacement elements from the 1977-78 restoration have a coating of only a white primer.

**Figure 147.** Faux wood graining of door to Hall (Room 101).

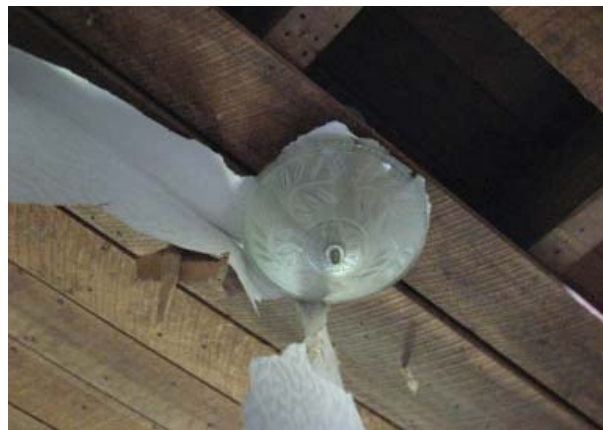
Though now disconnected, remnants of the 1977-78 electrical system remain. These items include

**Figure 148.** Ceiling light in Parlor (Room 102).

light switch, a ceiling light, outlet, and fabric-wrapped electrical wiring.

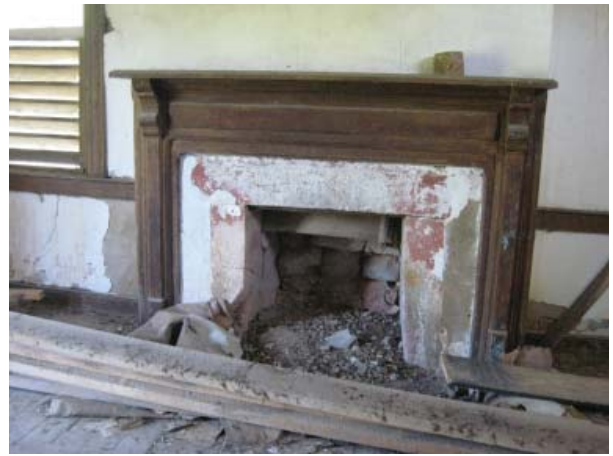
The original wood-burning, stone-lined firebox remains. The mantel is a replacement, as indicated by a burned adjacent section of original baseboard; the scorch on the baseboard does not continue onto the mantel. Stylistically dating to the late-nineteenth/early-twentieth century, it is somewhat more ornate than its comparable counterpart in the adjoining Parlor. Both mantels are made of wood, and assembled with wire nails, presumably by the same maker. This mantle and measures 4'-6½" tall by 6'-4" wide at the shelf.

**Figure 150.** Mid-to late-nineteenth century replacement mantel of Parlor (Room 102).

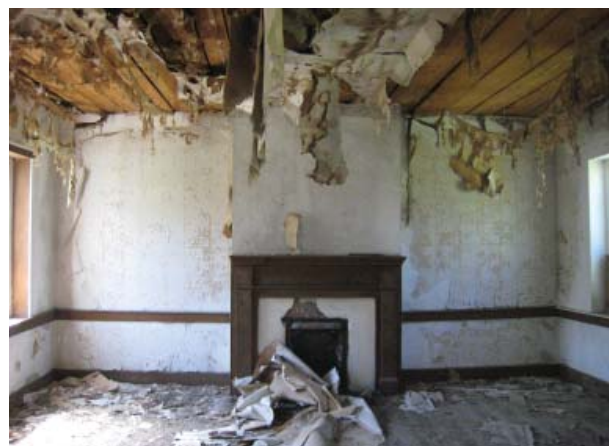
85. Gildart, *Natchez Trace*.

enclose a small, early-twentieth century, cast metal coal grate measuring 1'-8" wide by 2'-2" wide by 10" deep. The mantel is probably original and has Federal-style features. It is slightly less ornate than its comparable counterpart in the adjoining bedroom. Both mantels are made of wood, presumably by the same maker. This mantel is the smaller one, measuring 4'-6" tall by 5'-7" wide at the shelf. The shelf itself is 8½" deep.

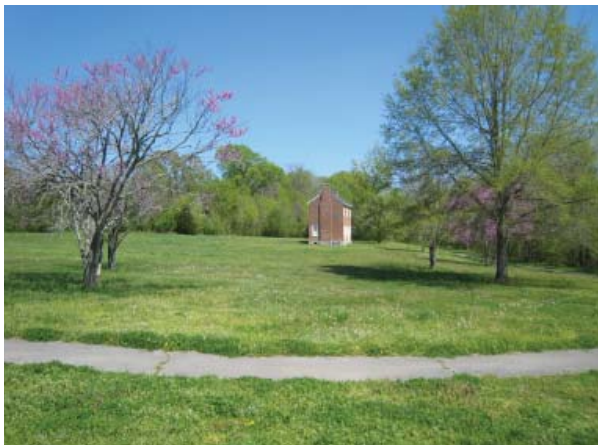
**Figure 165.** The Gordon House as viewed from the west.
