# Ridgeland Information Cabin Historic Structure Report

May 2021

## Historic Structure Report

Mills + Schnoering Architects, LLC   Princeton, New Jersey

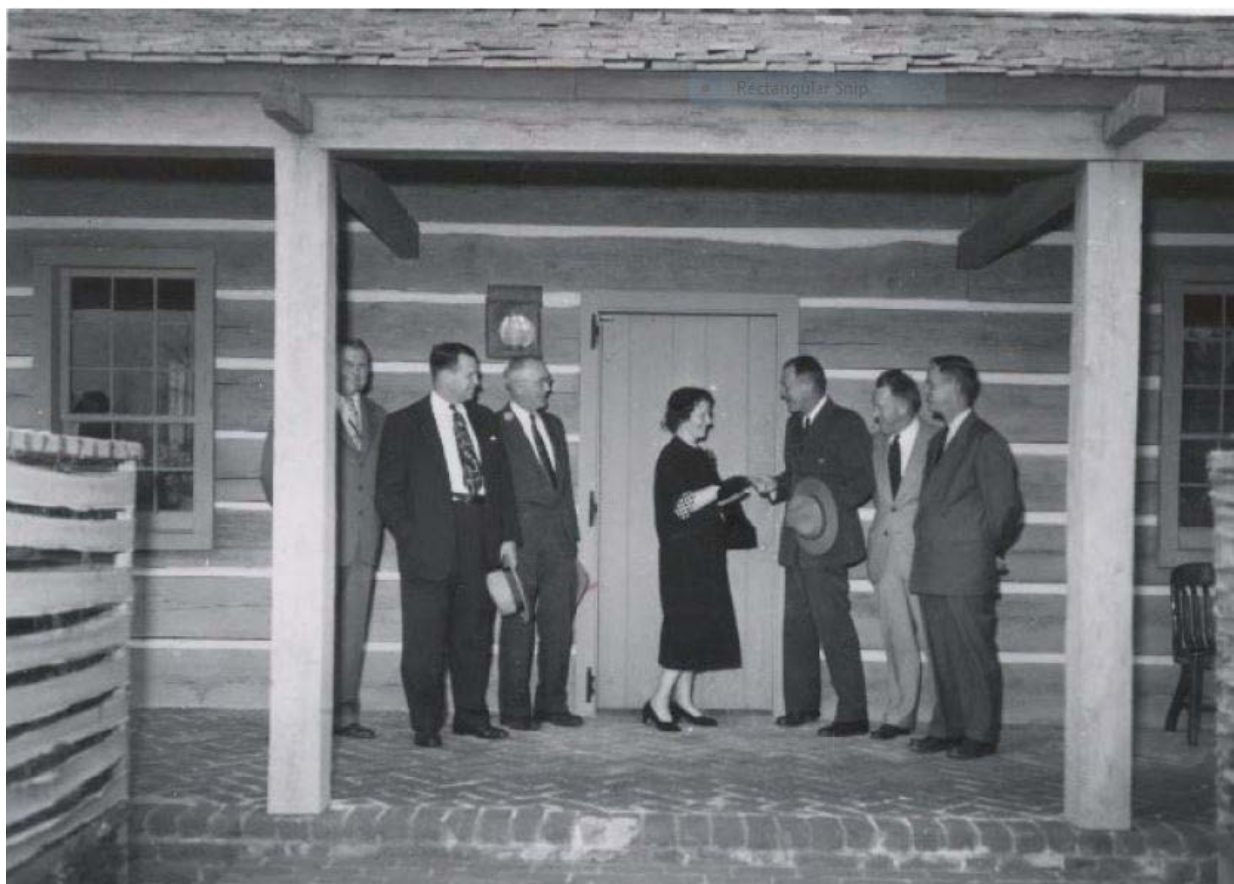
**Figure 21.** Exterior view from dedication in 1951 looking towards the south entrance to the Exhibit Room. Note contrast between color of logs and chinking. Note original lighting fixture. Wood rain trough and screen door are missing but hinges for screen door are present at the door jamb at left. Source: Interpretive Photographic Collection, Number 9266, Natchez Trace Parkway Archives, Tupelo, MS. 1951.

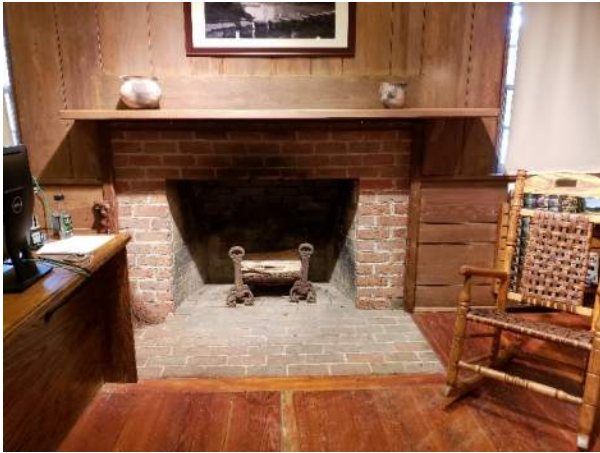
**Figure 24.** View of fireplace. The mantel shelf does not appear in earliest photograph of room.

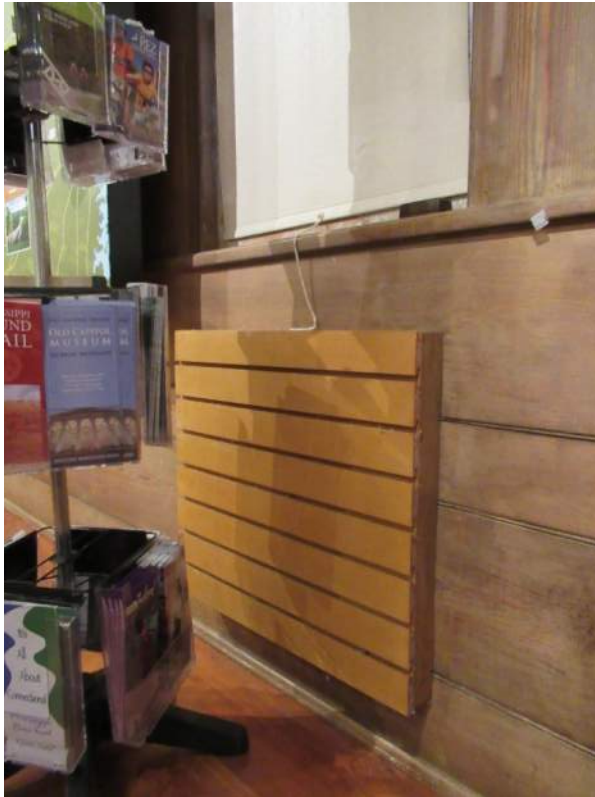
**Figure 27.** Wood covers have been placed over the original electric heaters.

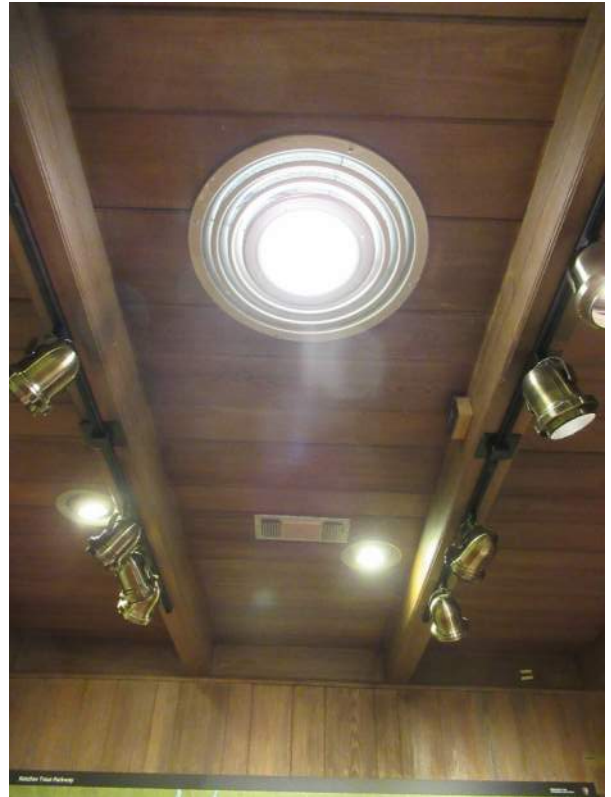
**Figure 29.** View of ceiling showing original lighting fixture and air diffuser. The brass track lighting was added at a later date.

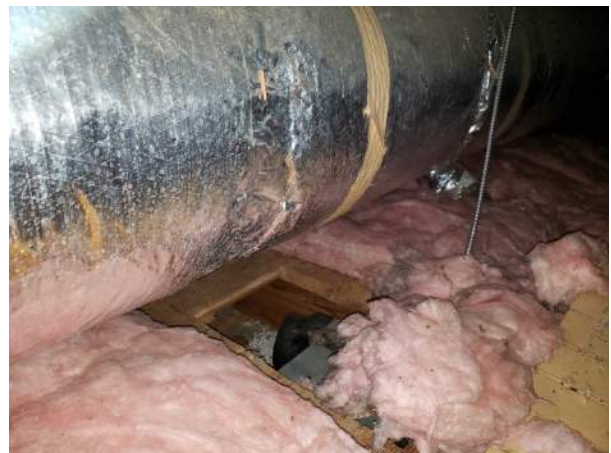
**Figure 34.** View of attic floor decking over Men's Toilet Room.

The attic space is unfinished and is open the full length of the building. The attic is accessed through an access hatch in the ceiling of the Men's Toilet Room. The attic floor framing is 2" x 8", 16" on center. The floor is 2" thick tongue and groove wood boards covered with fiberglass batt insulation (Figure 33 and 34). The gable end walls are diagonal wood board sheathing. There is a central brick chimney at each end wall and wood louvers at either side. The louvers are not original. The roof framing is exposed wood 2" x 8" s 16" on center braced with 2" x 6" boards. The roof sheathing is wood boards. The ridge beam is 3" x 10".

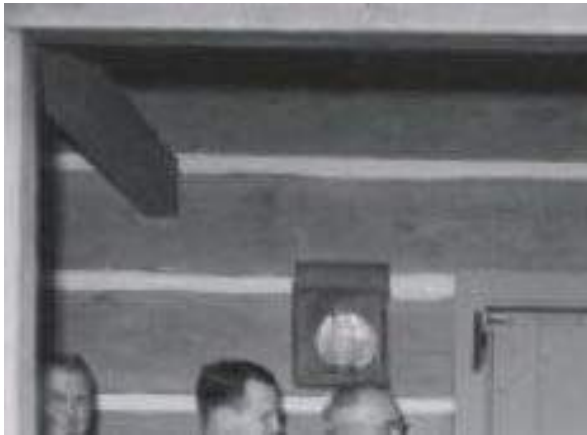
**Exterior Lighting.** The exterior wall mounted light fixtures have been replaced with modern fixtures (Figure 102) that are not in keeping with the original wall sconce seen in the photograph from the dedication in 1951 (Figure 103). These wall mounted lanterns had arched tops likely constructed of copper with an interior reflector and hurricane glass simulating a kerosene lantern (Figure 104). Some modification to the original would be appropriate as shown in the following examples (Figure 105). The fixtures would require mounting heights that comply with ADA -ABAAS or be designed so as not to project from the wall more than 4”.

**Figure 103** Detail view of original exterior light from historic image from dedication. Source: Interpretive Photographic Collection, Number 9266, Natchez Trace Parkway Archives, Tupelo, MS 1951.

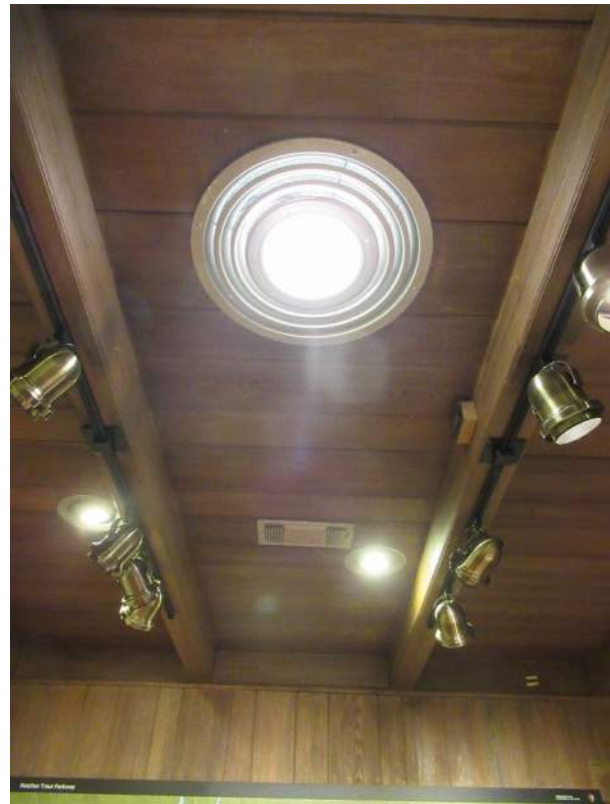
**Figure 106.** Detail of existing lighting in Exhibition Room.

**Interior Lighting.** The Exhibit Room retains three original combination air diffuser lighting fixtures that were detailed in the original plans. These fixtures are contributing and should remain, although they are modern in design. Improvements to exhibit lighting should be considered to minimize the appearance of the large track head light fixtures which are not original.

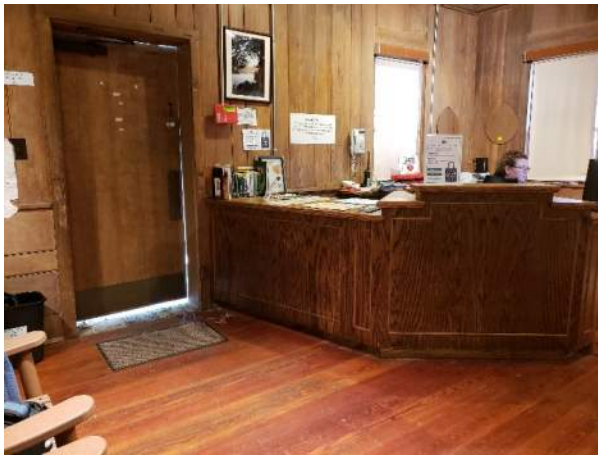
**Figure 108.** View of existing information desk.

**Cabinetry.** There is no fixed cabinetry other than an information desk. The large reception desk is located in the western end of the Exhibit Room. The desk will need to be removed to facilitate the flooring and foundation work. It likely dates to the period following the occupation by the Mississippi Craft Center and is not considered a character-defining feature and could be considered for replacement.

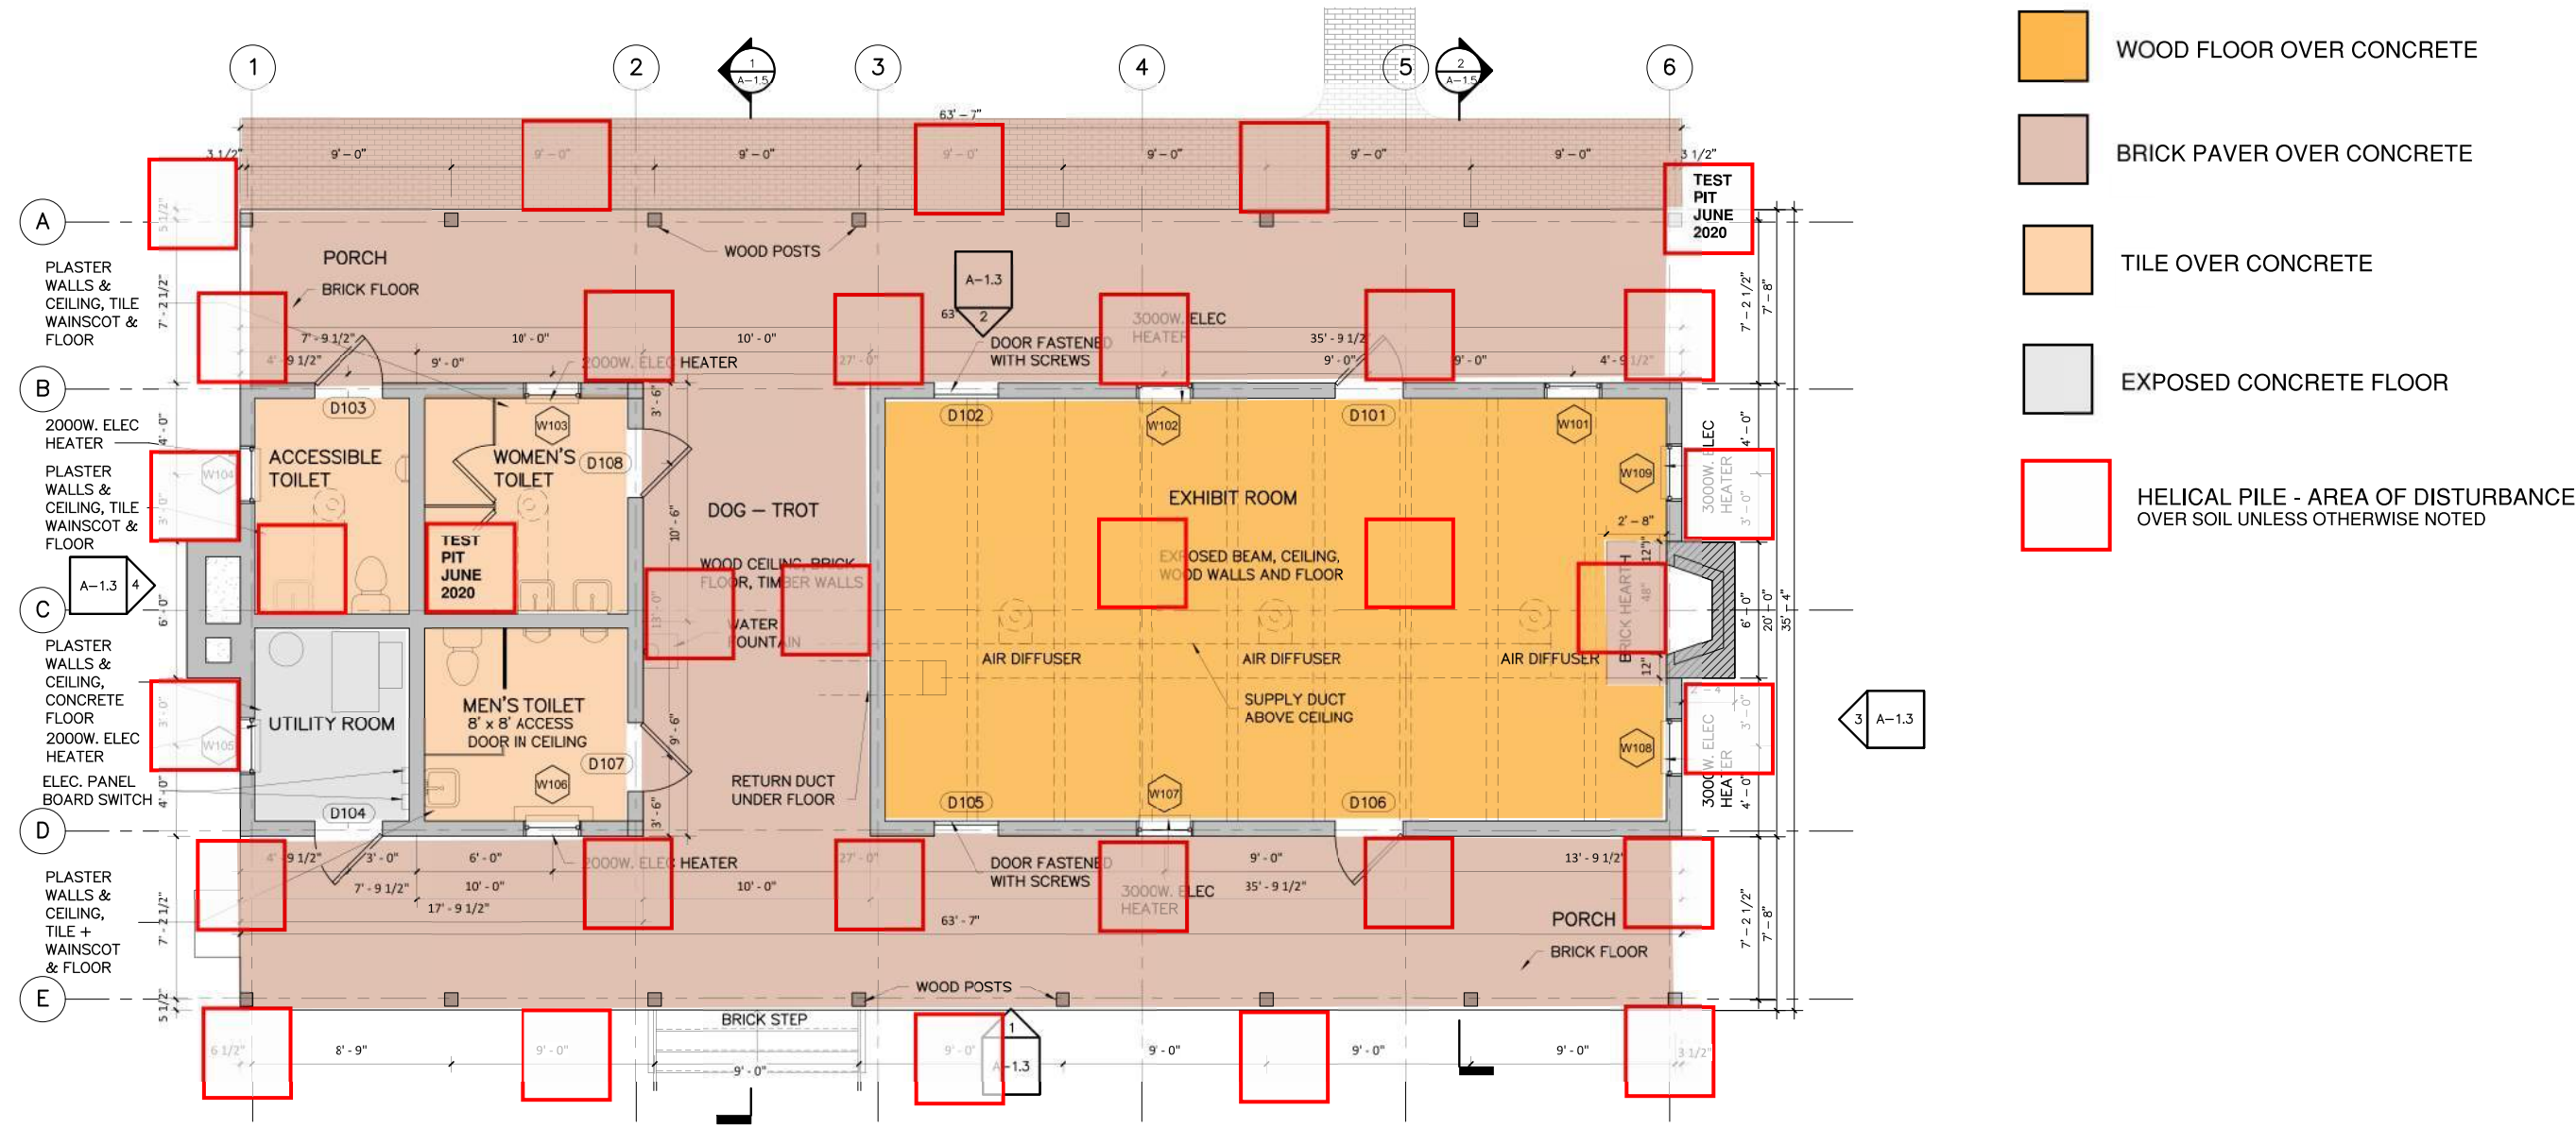
1 FLOOR PLAN  
A-1.2 SCALE (A)

CONCEPT REPAIR FLOOR PLAN WITH OVERLAY OF HELICAL PILE FLOOR AND SLAB DISTURBANCE  
DECEMBER 2020

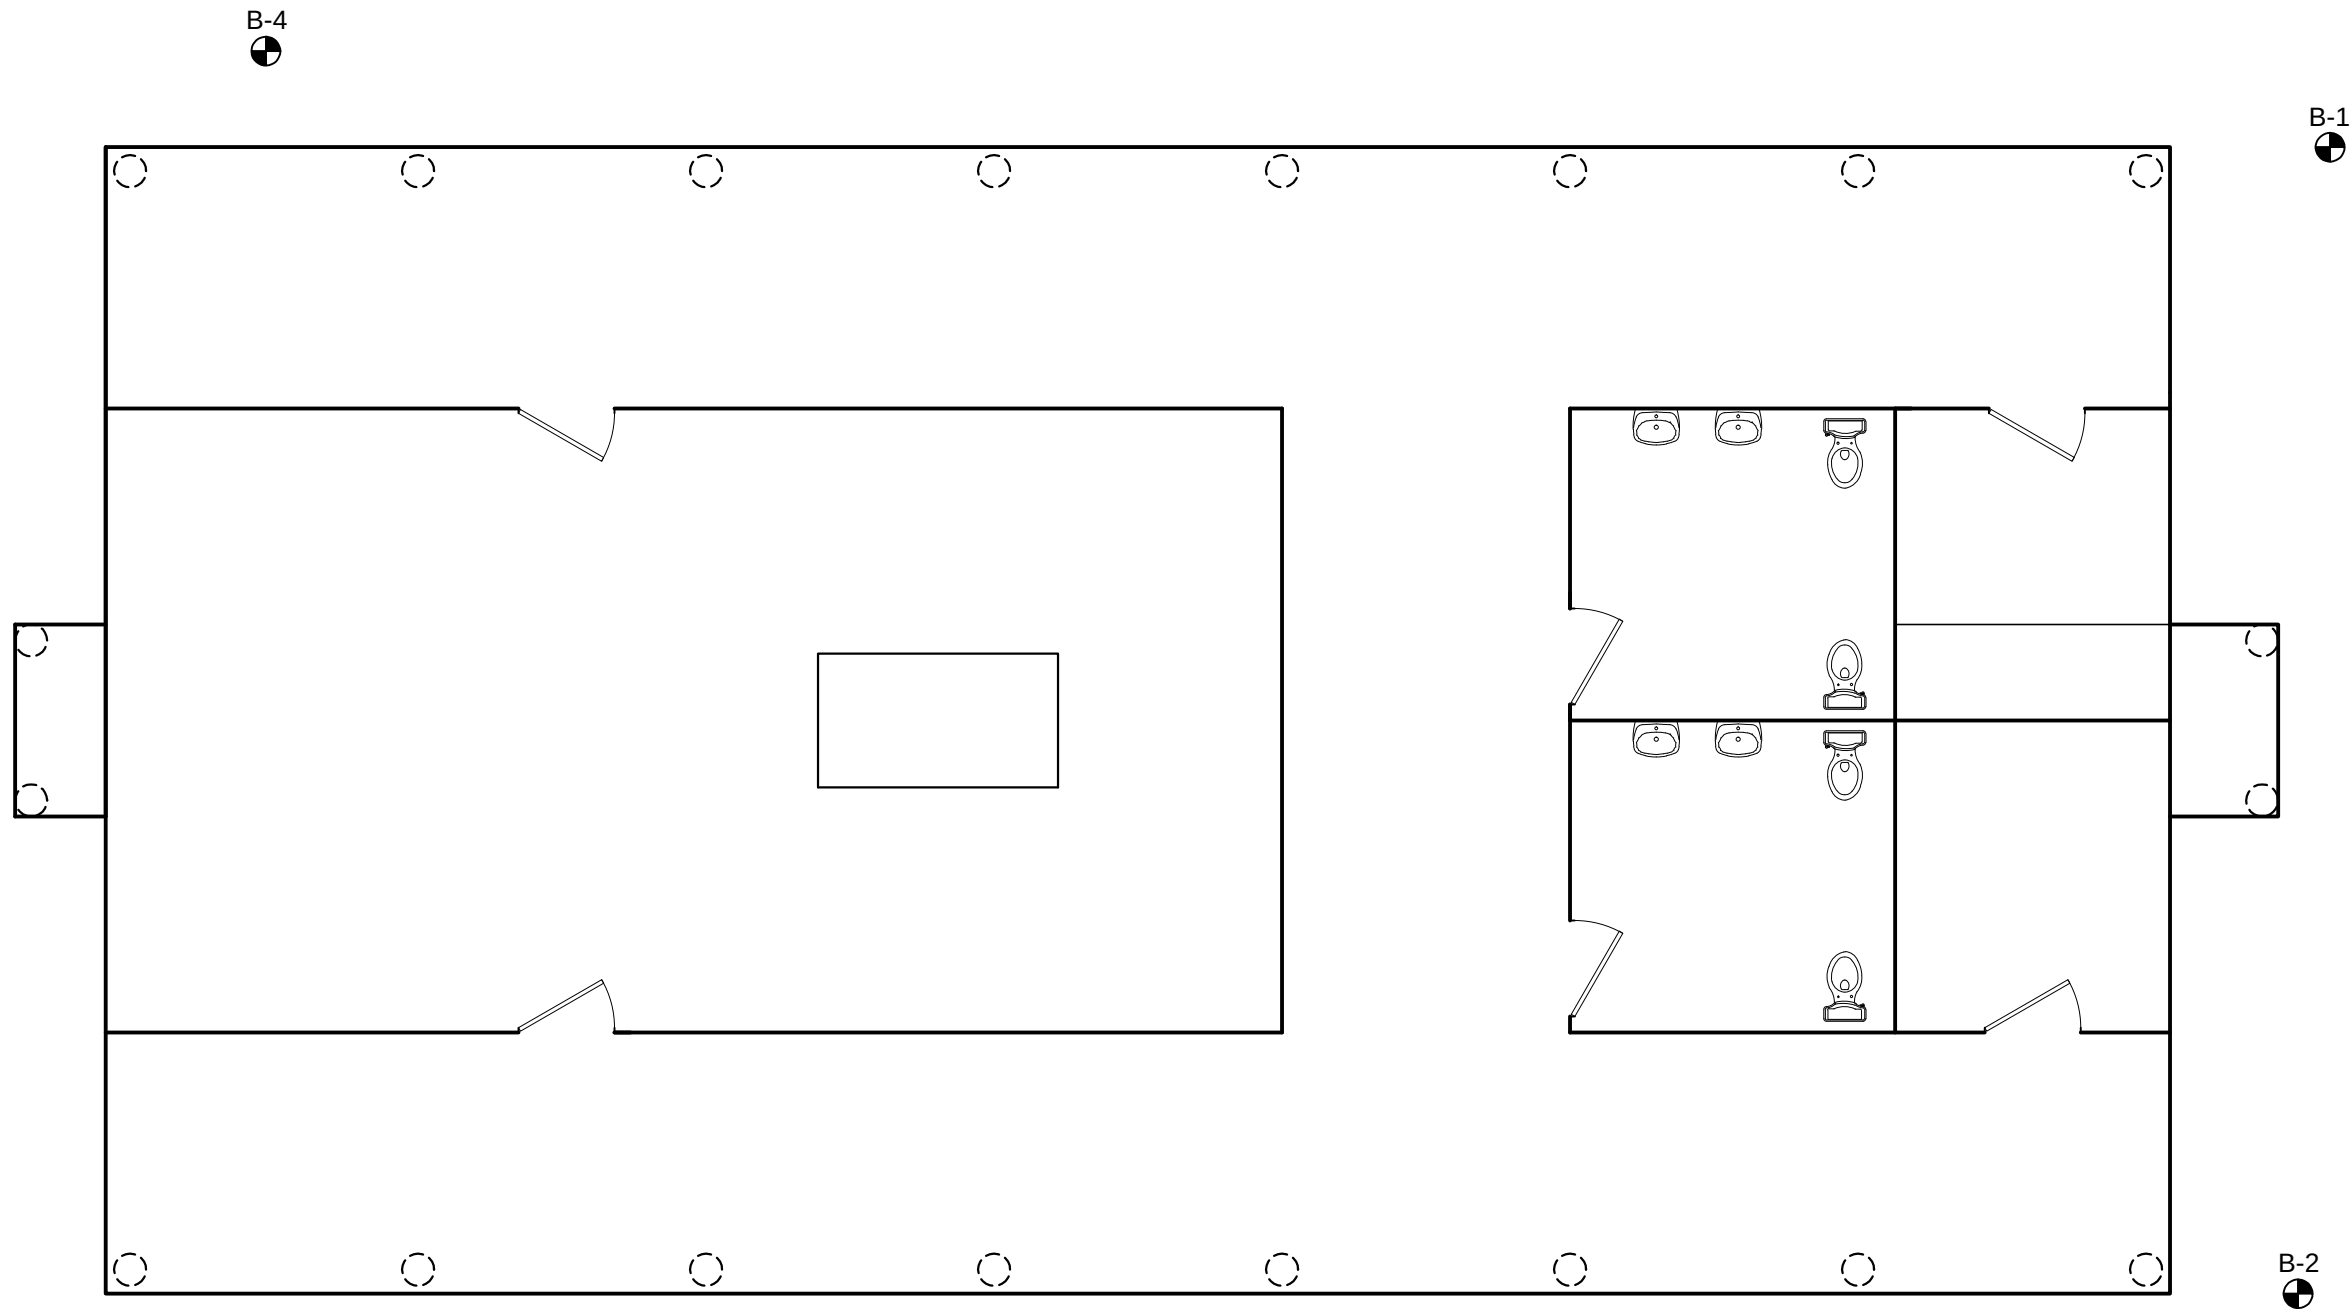
| Approximate Boring Locations | | |

Subsurface soil conditions adjacent to the building were explored by means of four borings. The approximate locations of the borings are shown on Figure 1 of this report. All soils were classified in general accordance with the Unified Soil Classification System. A synopsis of the Unified Soil Classification System is presented on Figure 2 along with symbols and terminology typically utilized on graphical soil boring logs. Graphical logs of the borings are presented on Figures 3 through 6. The graphical logs illustrate the types of soil encountered with depth below the existing surface at the individual boring locations. GPS coordinates for the boring locations as determined using a hand-held device are shown at the bottom of the graphical logs within the "Comments" section.

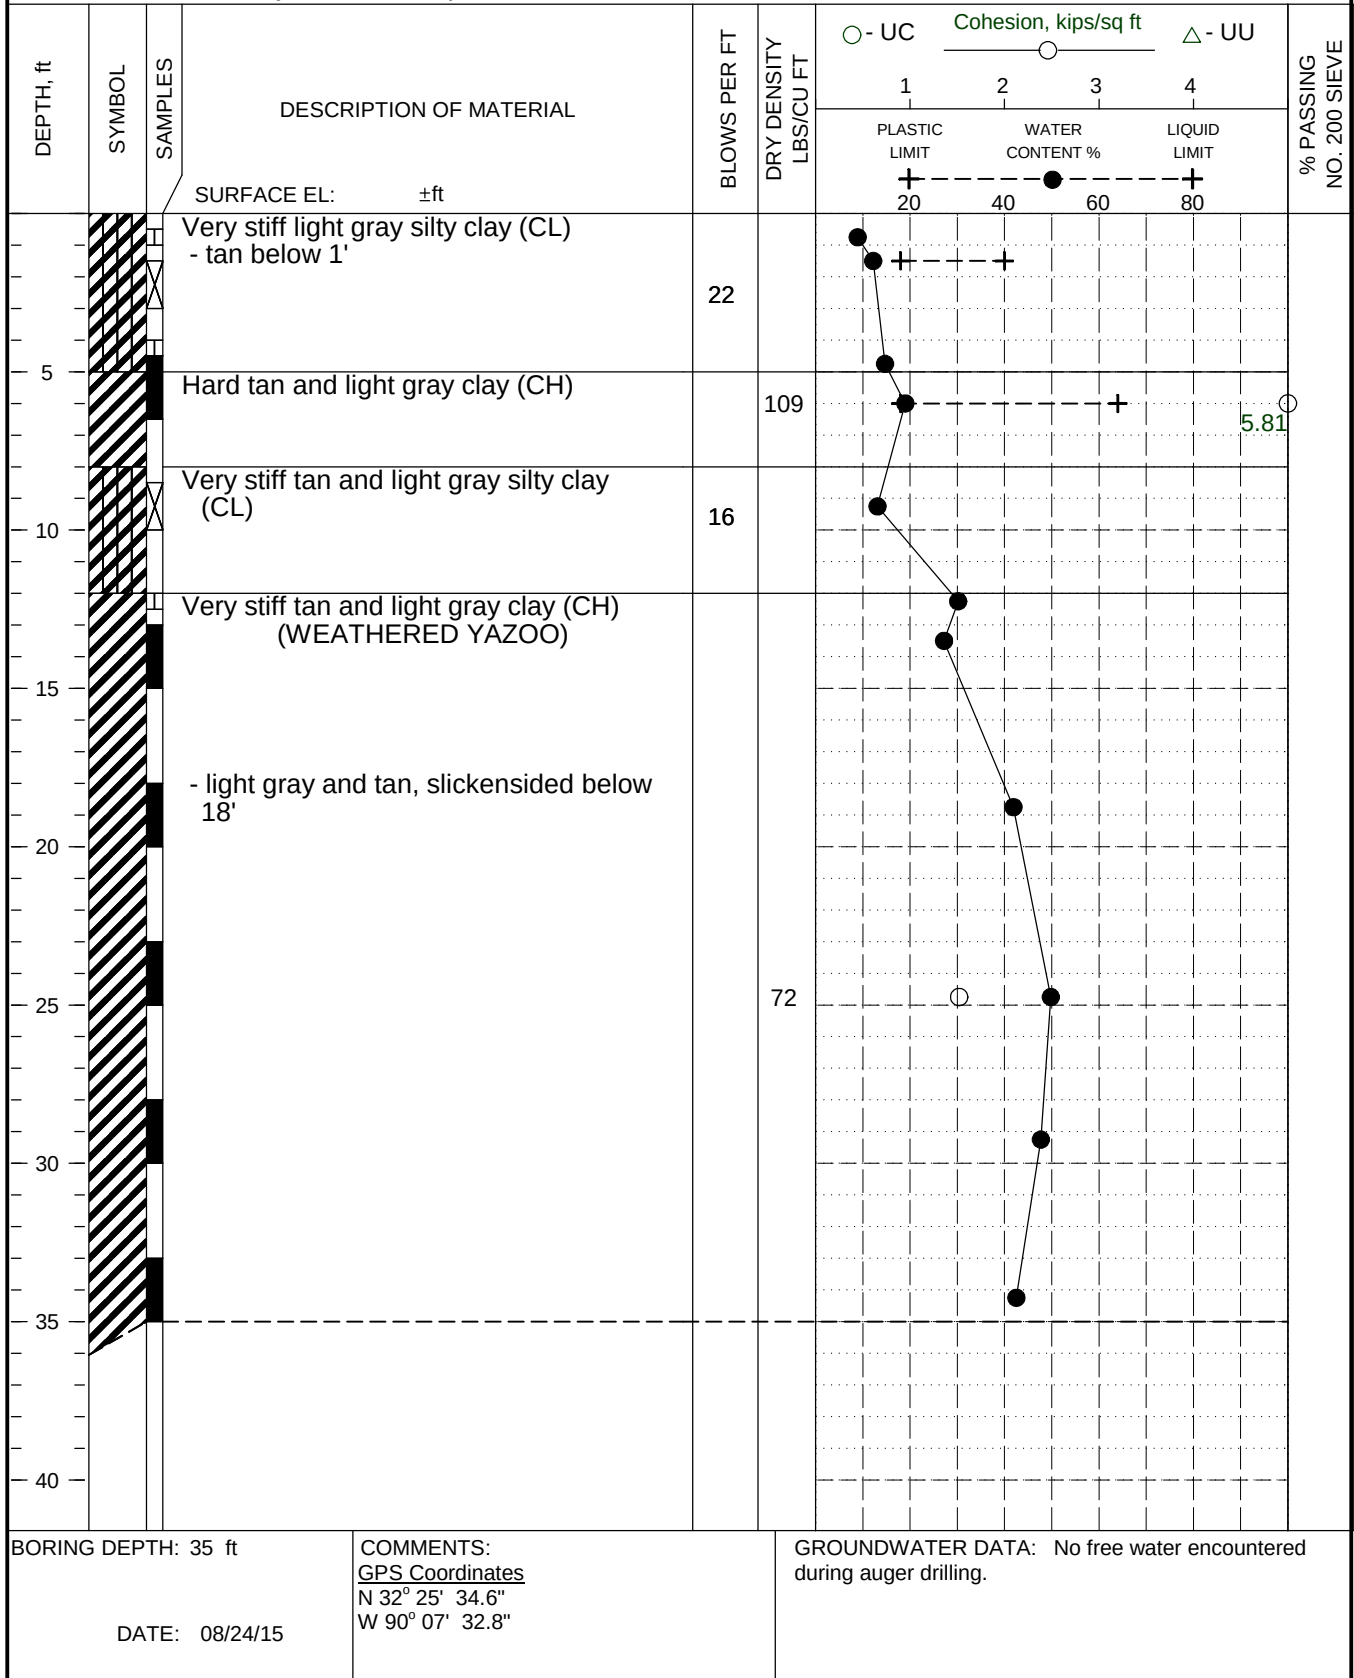
# LOG OF BORING NO. 2

The ground surface at Borings 2 and 3 was found to be underlain by silty sand (SM) fill materials to an approximate depth 1.5 ft. The silty sand (SM) fill materials are characterized as medium dense and are considered to have moderate strength and low compressibility. The silty sand (SM) fill materials have no potential for shrinking and swelling.

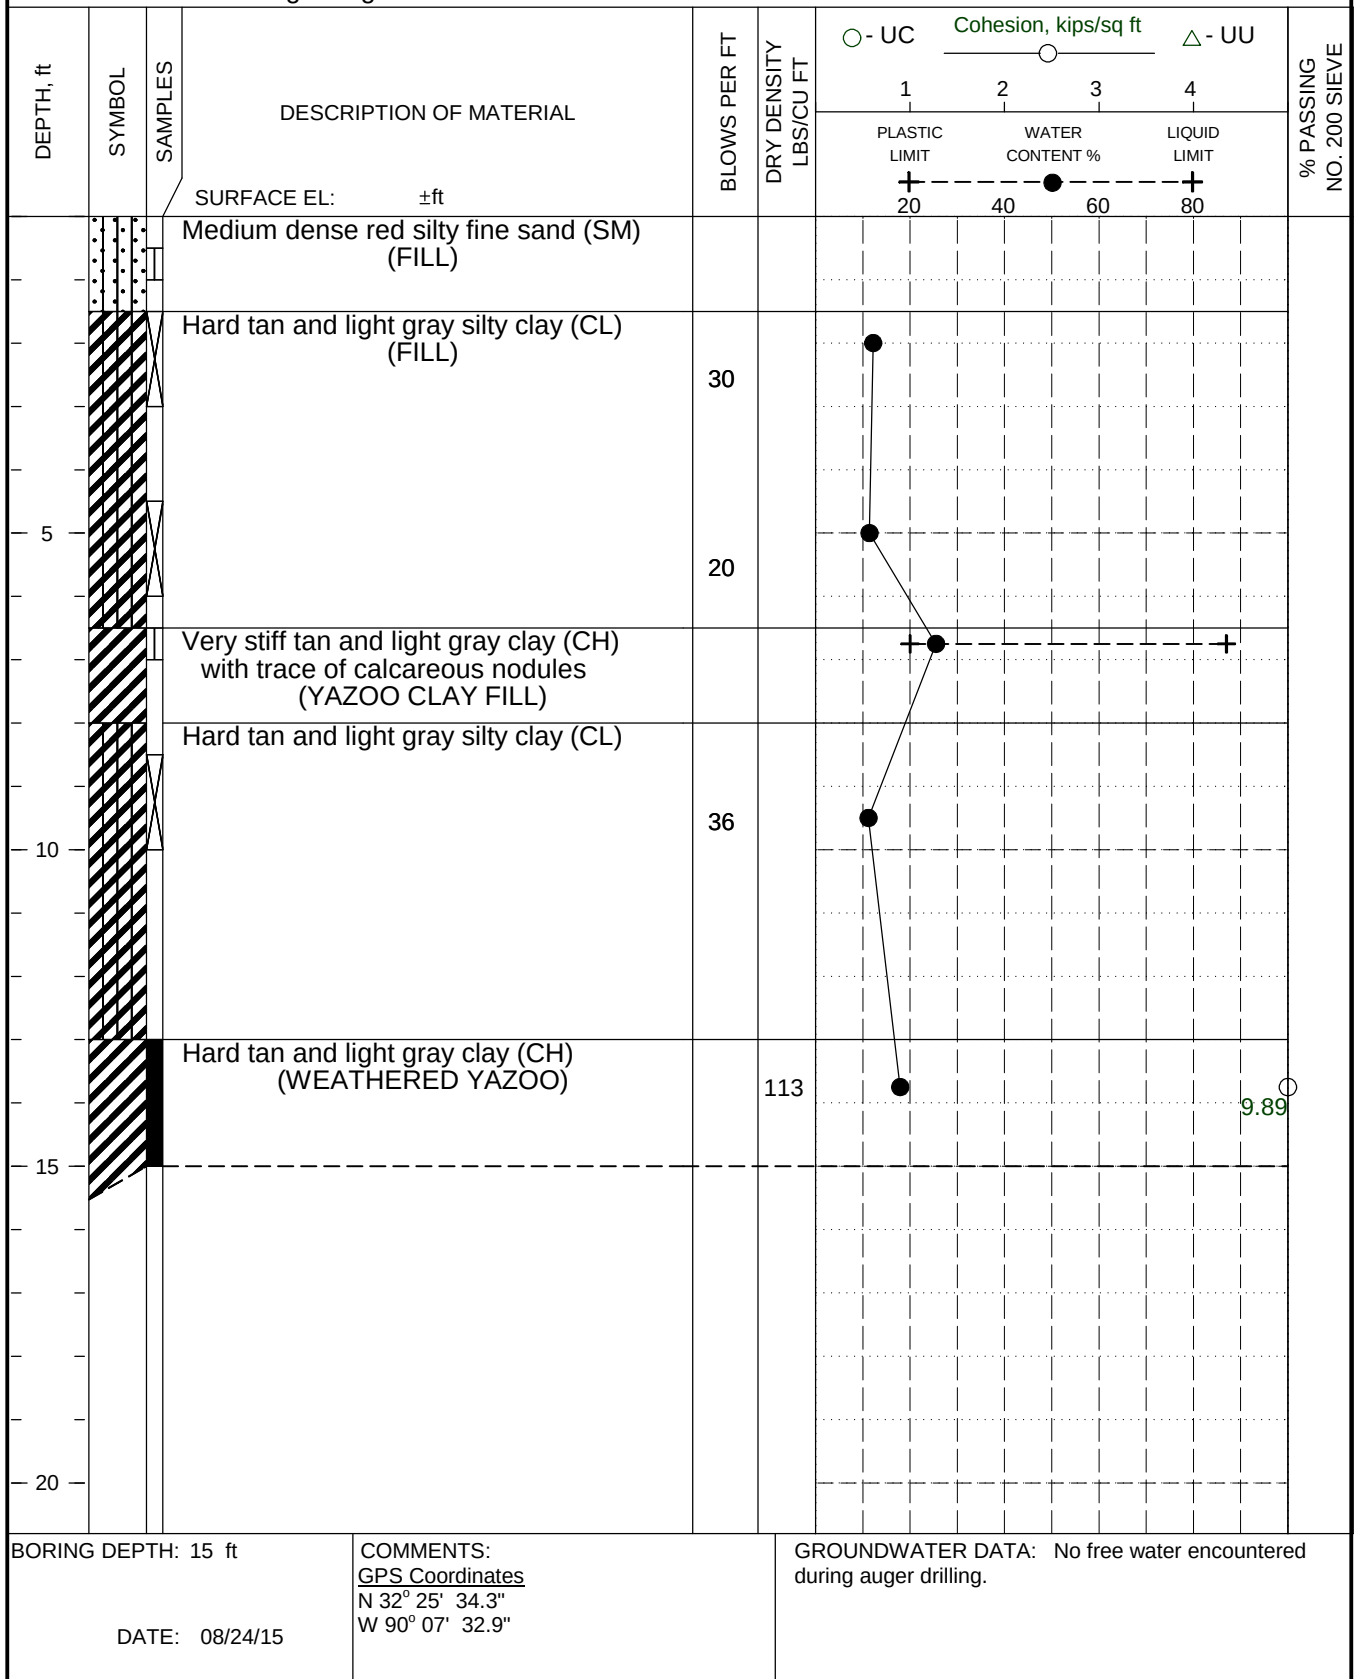
# LOG OF BORING NO. 3

Unweathered blue Yazoo clays (CH) were encountered at a depth of approximately 33 ft at Boring 3 and were found to extend to the 35-ft boring termination depth. The unweathered Yazoo clays (CH) are classified as hard with respect to consistency and are considered to have high strength and low compressibility. The unweathered Yazoo clays (CH) are highly expansive.

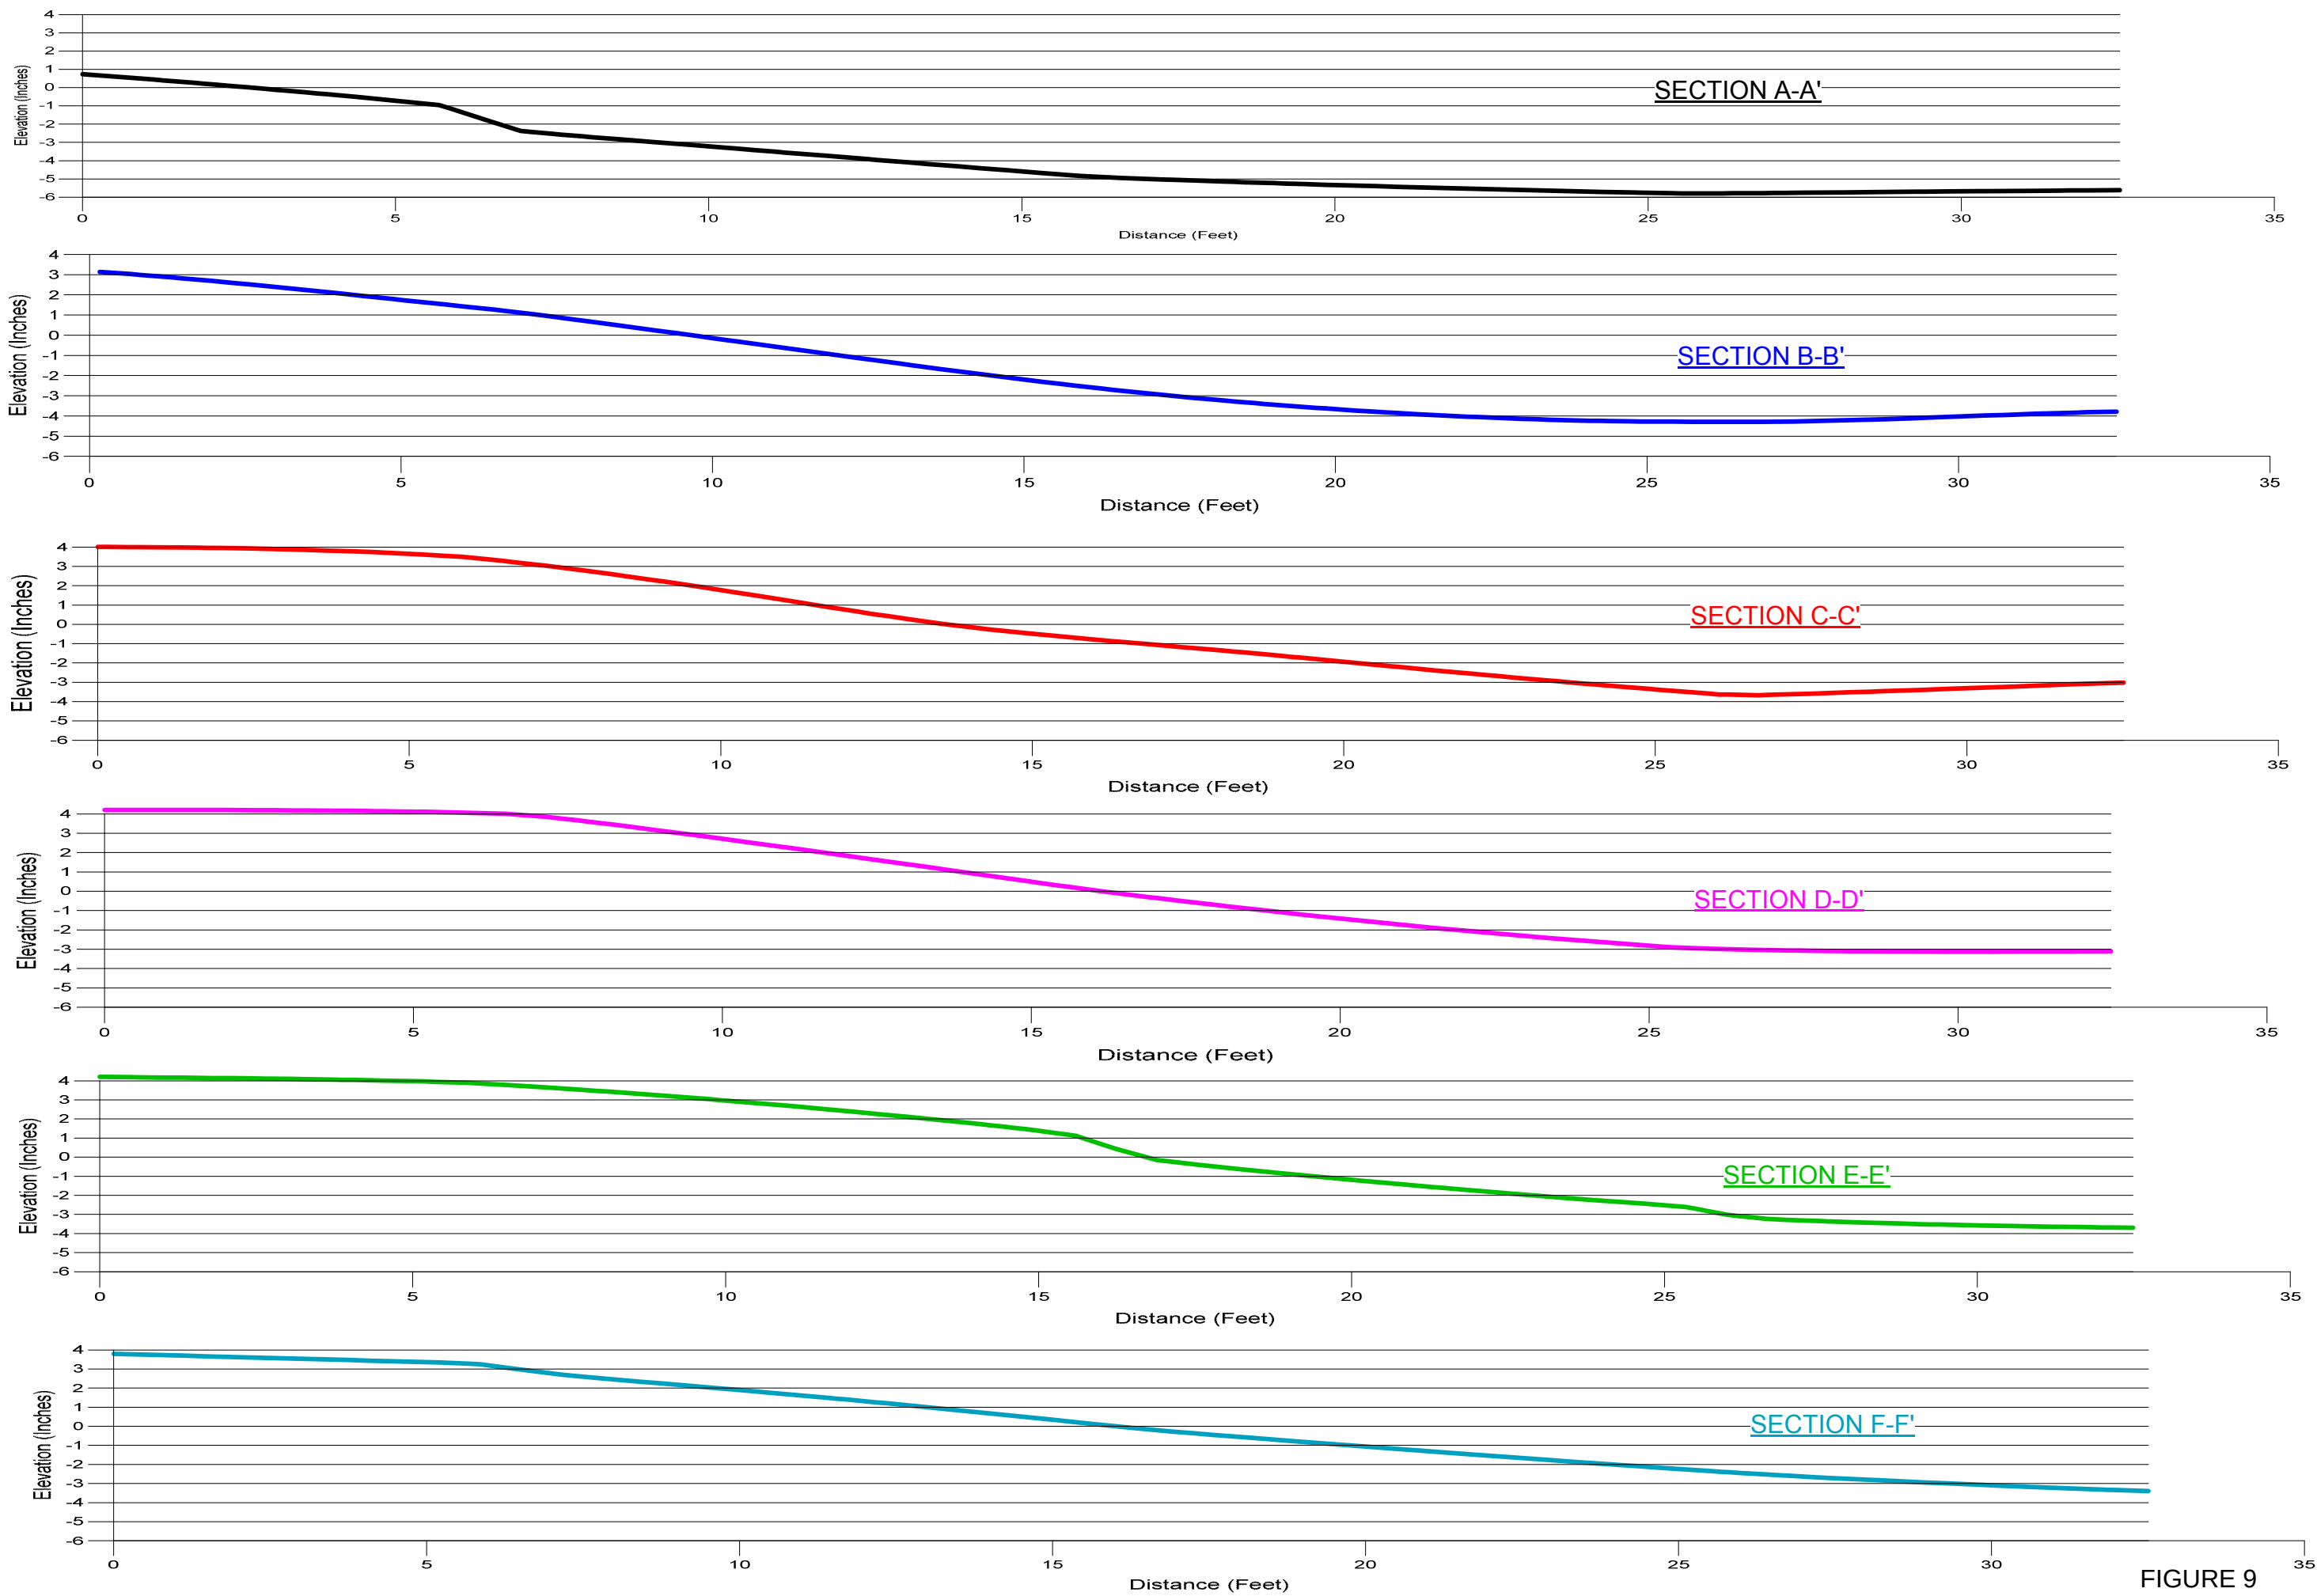
FIGURE 9

August 26, 2015 and was performed using a "ZIPLEVEL PRO-2000" gas-pressured manometer elevation measurement system. The survey basically consisted of measuring the differences in elevation on top of the slab at numerous locations throughout the Natchez Trace Visitor Center building and surrounding porch. The results of the floor level survey are presented as a two-dimensional contour plot on Figure 8. Relative spot elevations that were measured during the survey are also shown on Figure 8. All elevations are in inches and are relative to the elevation of the point labeled "Base". Cross-sections of the floor level survey are shown on Figure 9.

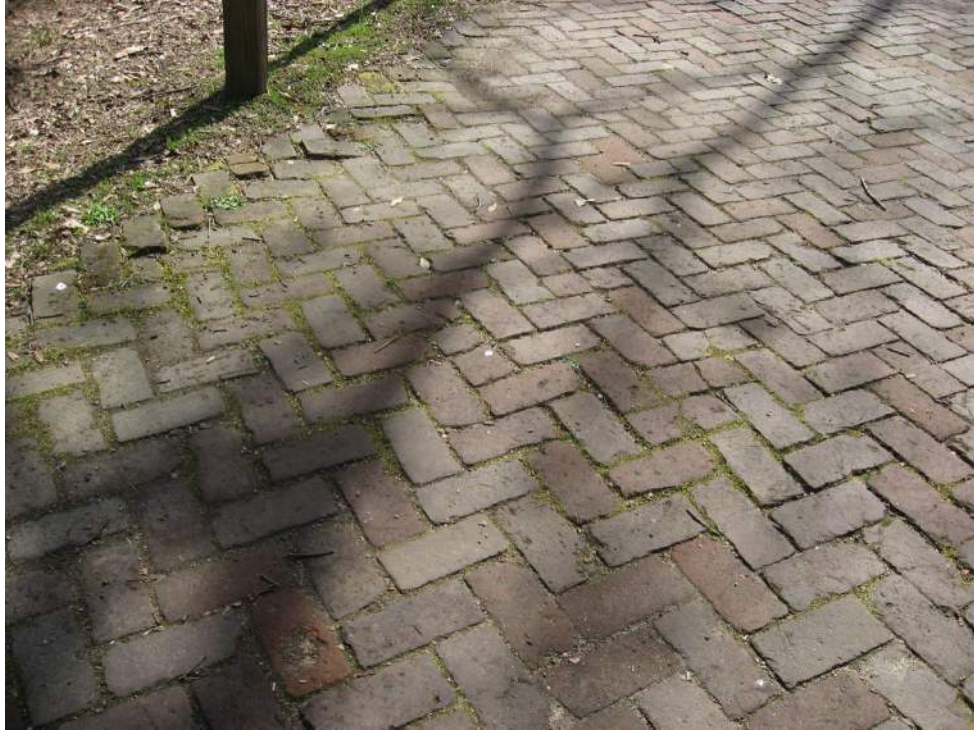
Photo 7: Brick sidewalk.

The sidewalk contributes to the building's character and to the cultural landscape. In order to provide an appropriate accessible path to the building, we propose to add a route to the existing sidewalk as shown on the schematic drawing (Enclosure 1). The area adjacent to the porch will be filled to bring the ground level back to the 1951 grade (Enclosure 2, Photograph 2). The existing brick paths will have to be removed during the fill and grading work. Except for the area where the accessible route will be placed, the paths will be rebuilt in their original locations using the original bricks depending on their condition. Salvaged bricks will be used to reconstruct steps leading to the porch on the north side as shown in Photograph 4 (Enclosure 3). Handrails along the steps will be rough-cut lumber in keeping with the building's log cabin appearance.

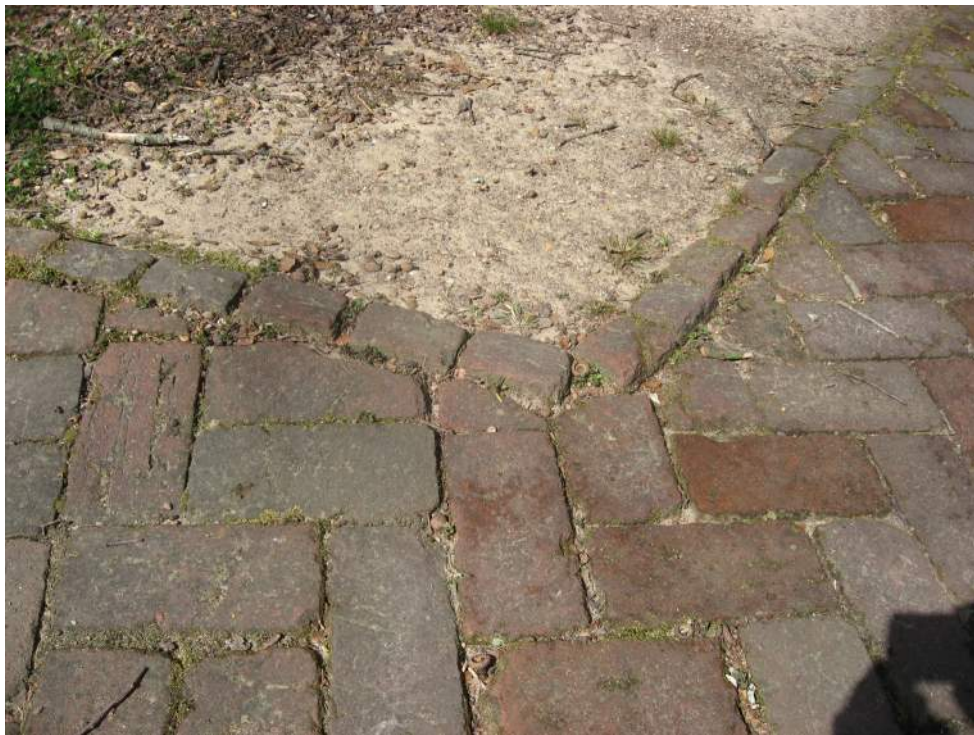
Photo 8: Brick sidewalk detail.

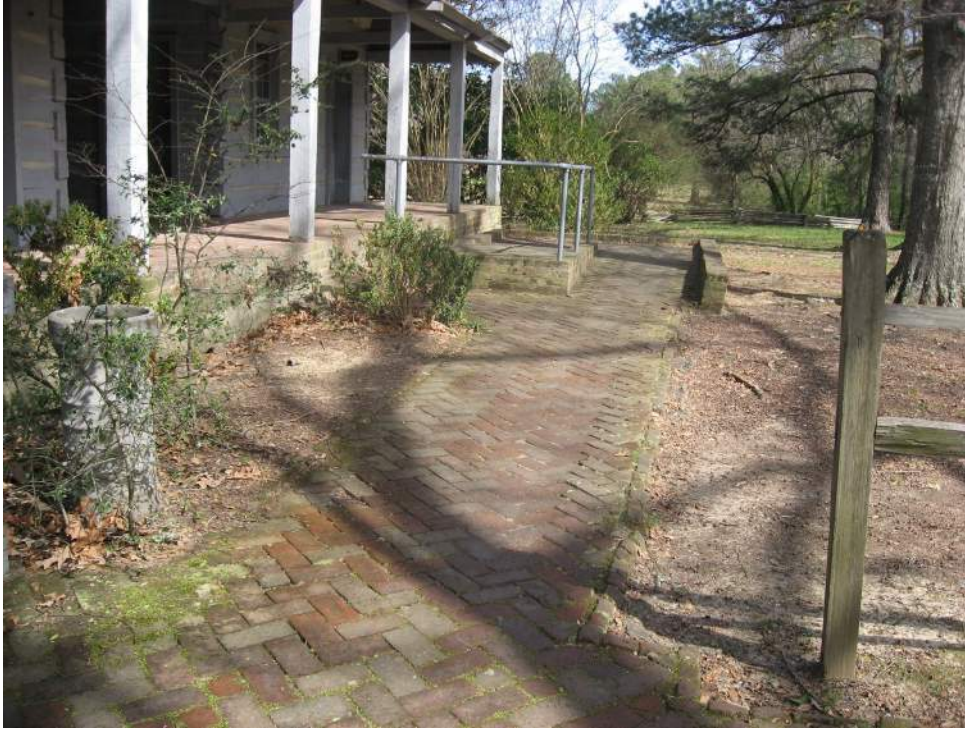
Photo 11: View of sidewalk and existing handicap entrance.

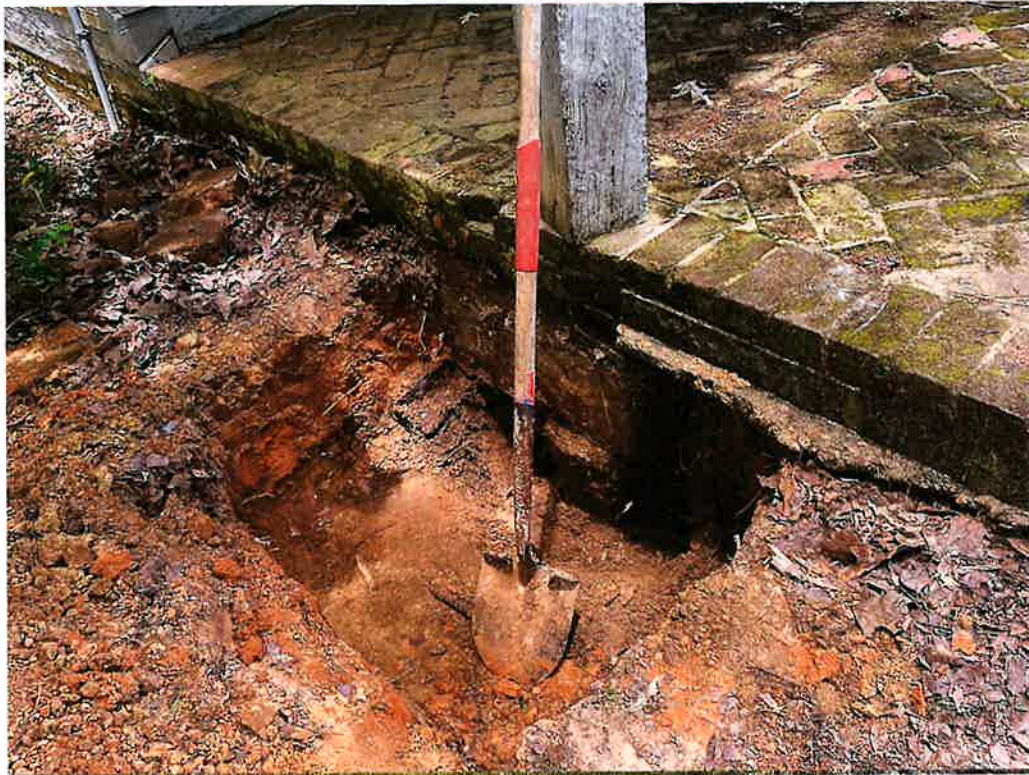
- TP#1 was excavated outside of the building adjacent to the west side at the southwest corner of the cabin. **(Photograph No. 1)**
- A significant number of roots and rootlets were observed in TP#1. **(Photograph No. 2)**
- The exposed portion of the pile is intact and appears to be in good condition. **(Photograph No. 3)**
- Top of pile was not in contact with grade beam near edge of exposed grade beam. **(Photograph Nos. 4 and 5)**
- The grade beam was cast on top of the pile. **(Photograph Nos. 6 and 7)**

**Photograph No. 1** – Test Pit#1 was excavated outside of the building adjacent to the west side at the southwest corner of the cabin.
