# Ridgeland Information Cabin Historic Structure Report

May 2021

## Historic Structure Report

Mills + Schnoering Architects, LLC   Princeton, New Jersey

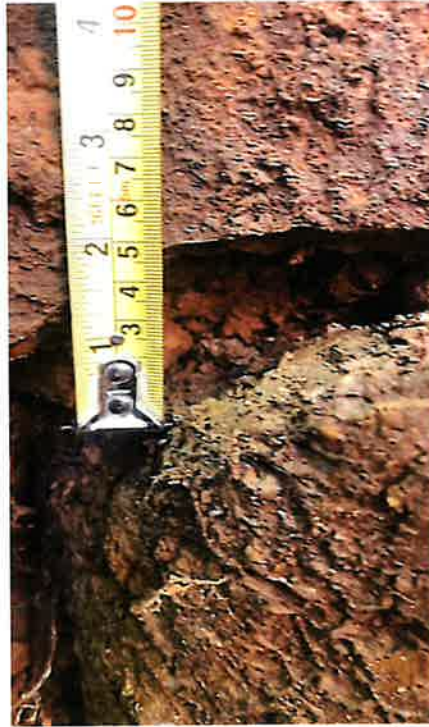
- TP#1 was excavated outside of the building adjacent to the west side at the southwest corner of the cabin. **(Photograph No. 1)**
- A significant number of roots and rootlets were observed in TP#1. **(Photograph No. 2)**
- The exposed portion of the pile is intact and appears to be in good condition. **(Photograph No. 3)**
- Top of pile was not in contact with grade beam near edge of exposed grade beam. **(Photograph Nos. 4 and 5)**
- The grade beam was cast on top of the pile. **(Photograph Nos. 6 and 7)**

**Photograph No. 5** – Top of pile was not in contact with grade beam near edge of exposed grade beam.

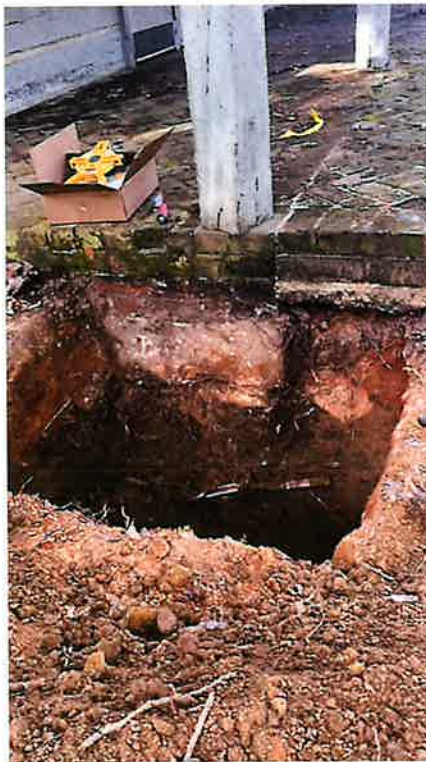
**Photograph No. 6** - Grade Beam casted on top of the pile.

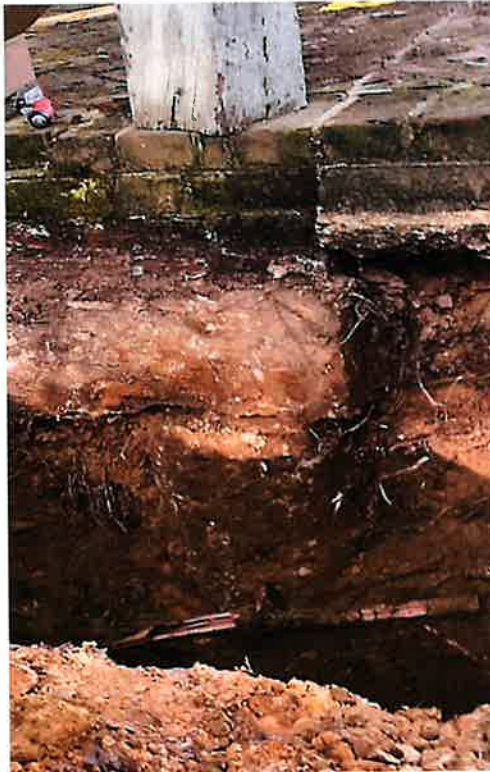
**Photograph No. 7** – Grade Beam casted on top of the auger cast pile.
