# Burdick House

NEW PHILADELPHIA NATIONAL HISTORIC SITE  
BARRY, ILLINOIS  
PMIS 343880

## Condition Assessment and Treatment Report

JUNE 2026

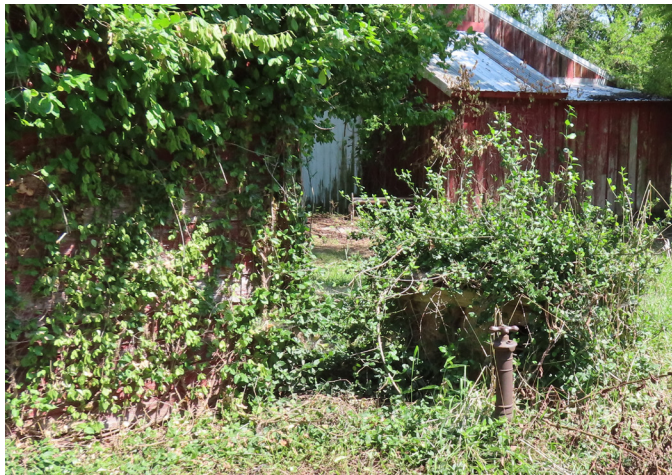
The third cistern is located northwest of the shed and is sheltered in a small gabled-roof cover that is approximately 2 feet high. There is likely a modern pump for the cistern within this cover. An older pump is visible a few feet west of the shed. (Figure 17)

Figure 17. Cistern near shed (covered in vegetation) with remnants of old metal water pump in foreground. (source:RRJ, 2025)

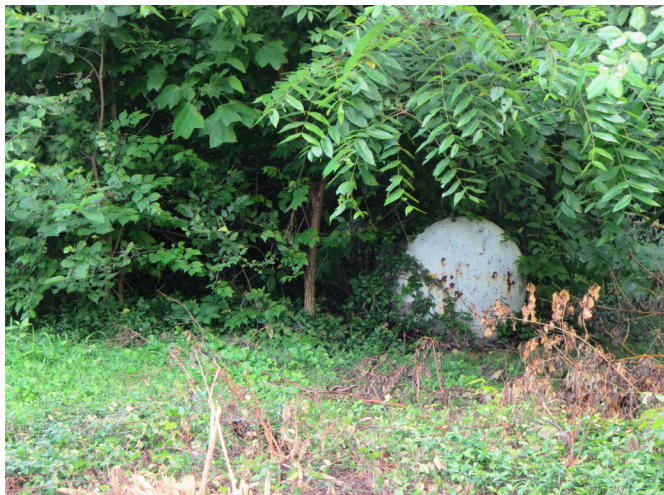
Some features within the house are fueled by an above ground propane tank that is located near the south wall of the house. (Figure 18)

Figure 18. South end of propane tank (covered in vegetation) (source: Alvine, 2025)

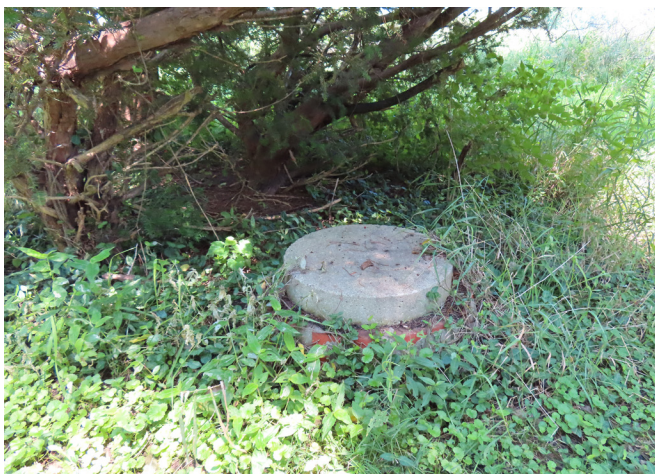
The largest cistern is adjacent to the barn along the north wall. (Figure 15) Piping connecting the cistern to the barn is present. This likely diverted rainwater from the roof of the barn to the cistern. The cistern was capped with deteriorated wood planks and was inundated with vegetation. Another cistern is located several yards from the southeast corner of the house. The base of this cistern was constructed with brick masonry and a concrete cap was present. (Figure 16)

Figure 16. Brick cistern with concrete cap located near southeast corner of the house. (source:RRJ, 2025)

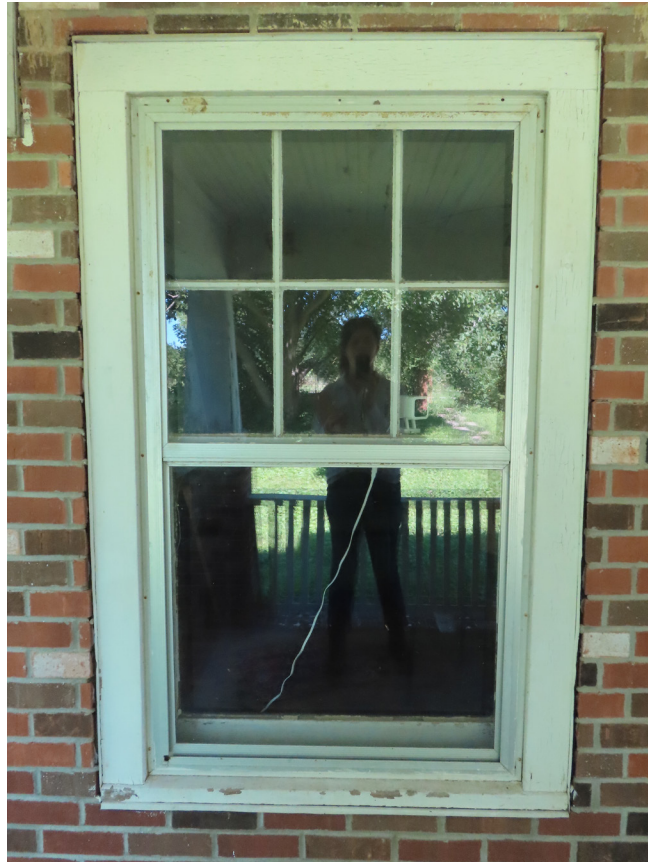
The windows are generally in good condition. The original wood sashes show little signs of wood deterioration and are operable in most locations. The exterior paint and glazing at all window locations has failed and should be replaced. Aside from a single pane at windows W101A, W102B, and W203B all window glass was intact and in good condition. Wood rot was noted at several exterior windowsills including: W101B, W102A/B, W105B, W106A/B/C, W107A, W108A, W204A, W204C, W205B.(Figure 37) These windowsills will likely need to be replaced, but all other wood window components are repairable. The aluminum storm windows are in poor to failed condition throughout the house and should be removed and/or replaced. Replacement storm windows should be sympathetic to the period and style of the house.

Figure 34. Typical 6-over-1 window unit with aluminum storm window at exterior. (source: RRJ, 2025)

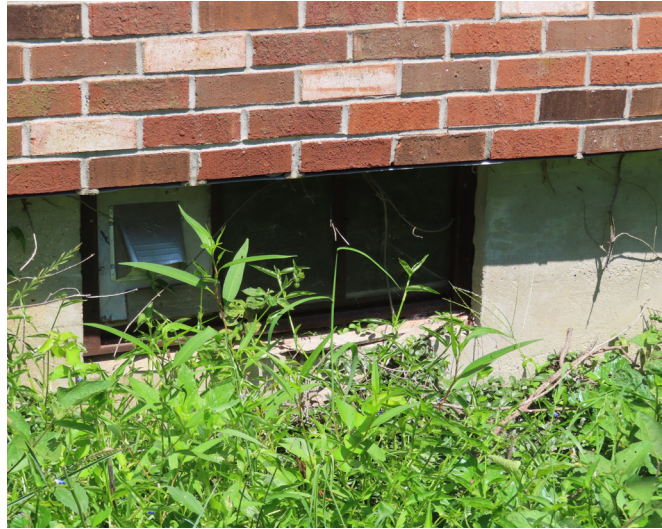
The Burdick House is generally square and has approximately 28 feet 8 inches clear distance between the interior face of the basement walls in both directions. The house has a cast-in-place concrete foundation that supports the exterior walls, first-floor fireplace, and first-floor beams and joists. The basement concrete walls were board formed with horizontal wood planking as evidenced by the planking seams. (Figure 48) The foundation wall extends inward along the north wall to support the first floor living room masonry fireplace. Four basement window openings are cast into the top of the basement walls, one on the north wall, two on the south wall, and one on the east wall. The east foundation wall height near the middle of the wall is reduced to accommodate the basement stairs. A door opening within the original east foundation wall provides access to the root cellar located under the first-floor bathroom (Room 106). The construction of this opening suggests that the doorway and root cellar were early additions to the house. First-floor beam pockets are cast into the north and south foundation walls near the center of the foundation walls. The width of the beam pockets can only accommodate a portion of the first-floor wood beam width (approximately 3 of the 4 wood beam members). The basement wall thickness measured 7¼ inches at the cast-in door opening. A wood sill plate is present at the top of the concrete foundation wall and supports the first-floor wood joists and rim boards.

Figure 48. Exterior of cast in place board formed concrete foundation wall with inset basement window and brick veneer above. (source: RRJ, 2025)

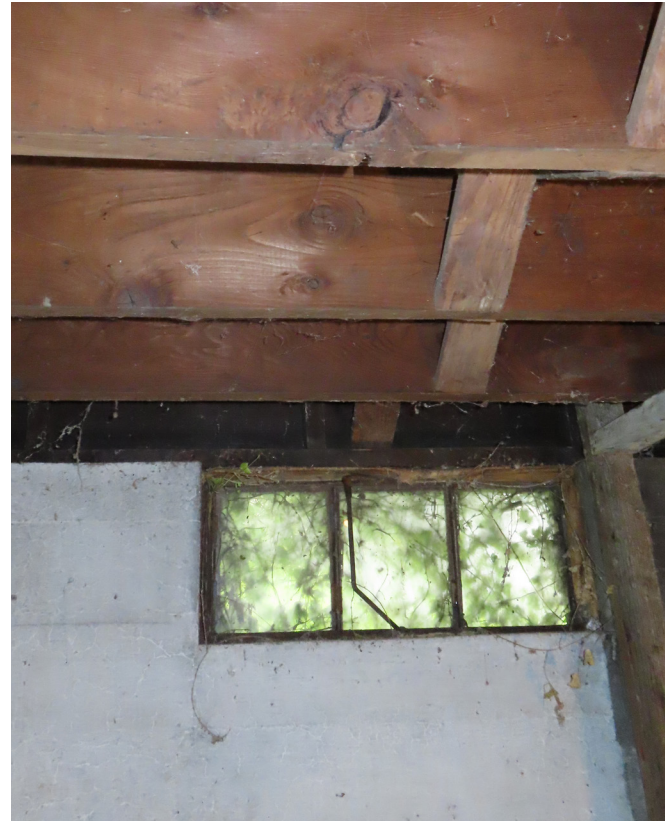
The wood columns and centerline wood beam members do not appear to exhibit signs of distress, including cracking or excessive deflection. The wood joists generally appear to be in good condition; however, isolated members exhibit distress, generally at their knots. Several joists exhibit either cracking

Figure 50. First-floor framing with diagonal bracing between joists. (source: RRJ, 2025)

immediately at or adjacent to the knots or the knots themselves are missing, creating voids within the wood joists. RRJ did not perform any openings to reveal the first floor exterior or interior wall framing. The wall thicknesses were measured, but no verification of the member sizes nor condition of the wood wall framing was performed. No apparent signs of insect infestation were observed in the exposed first-floor wood framing within the basement level.

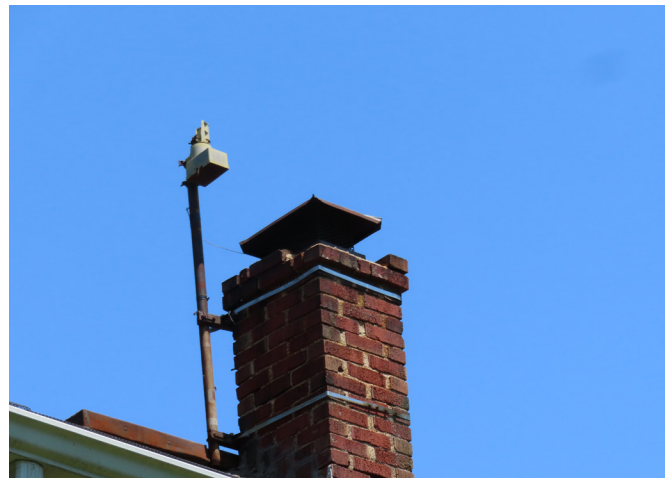
Both chimneys are generally in good condition. Mortar loss was noted at the primary chimney at isolated locations. Significant overgrowth of vegetation was noted at the primary chimney. Vegetation growth on masonry can lead to damage due to increased moisture retention and root growth that can weaken the masonry.

Figure 54. Secondary chimney at center of roof. (source:RRJ, 2025)

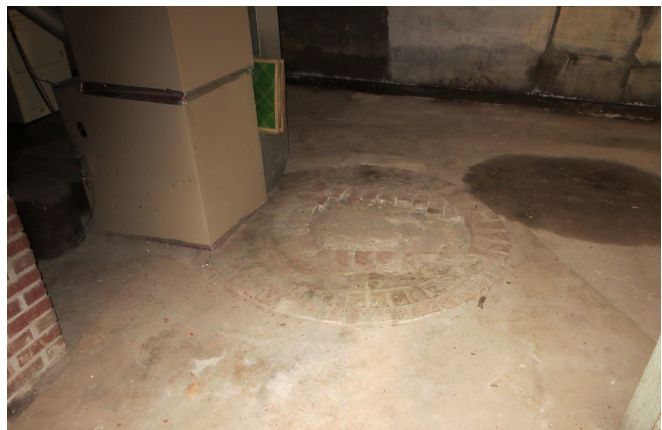
Figure 57. Basement, Looking East at Brick Cistern at Floor Behind Furnace. (source: Alvine, 2025)

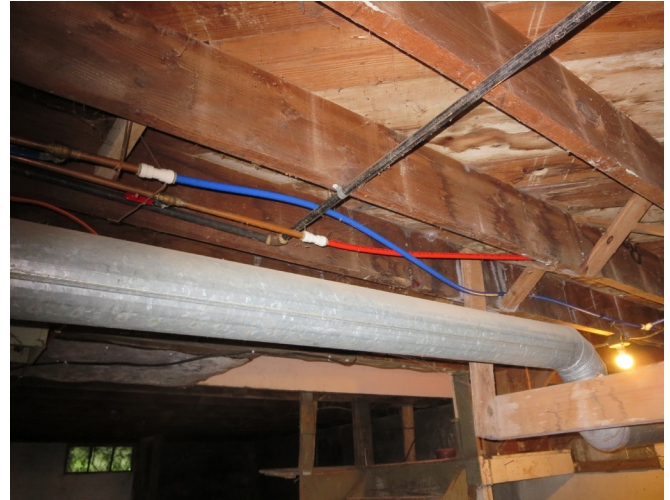
Much of the water piping in the basement appears to be rigid copper with various branch connections transitioning to PEX piping before continuing to serve the plumbing fixtures at the basement level (Figure 59 and Figure 60).

It is unknown how old the house's copper and PEX water piping is, but observations made would indicate that the piping has been present for over 20-years based on its condition. PEX piping has been in use in the United States since the early 1990s with more widespread use after the mid-2000s. The piping is in reasonably good shape, and there are no signs of water leaks.

Figure 59. Basement, Looking Northeast Towards Stairs at Copper and PEX Water Piping. (source: Alvine, 2025)

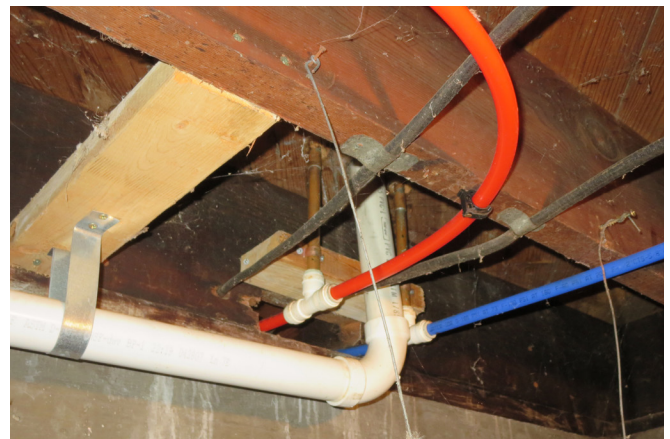
Figure 60. Basement, Looking East From Inside the Room Below the First Level Restroom. (source: Alvine, 2025)

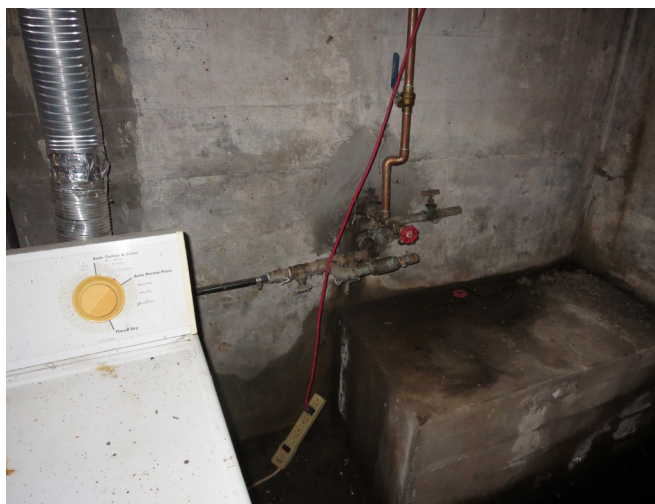
The piping present in the Basement Level of Burdick House is a mix of rigid copper with soldered joints and some cross-linked polyethylene piping (PEX) connected to it. The water service enters the house at the north wall near the northeast corner of the basement. The water service appears to be 3/4" in size. The copper piping appears to be in reasonably good shape. There is a ball valve for water service isolation (Figure 58).

Figure 58. Basement, Looking at South Wall Where Water Service Enters House. (source: Alvine, 2025)

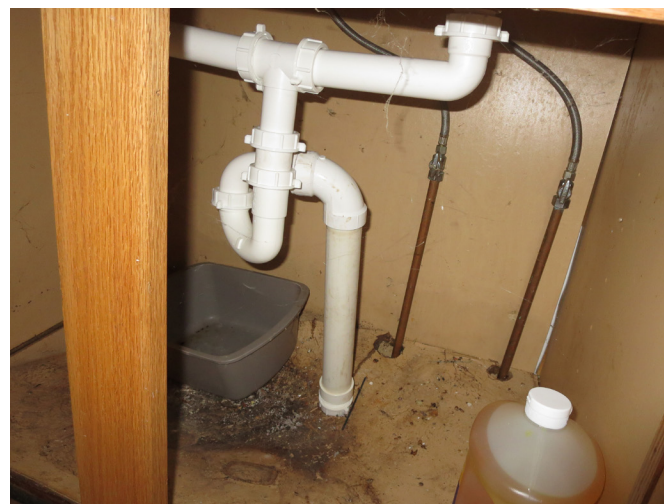
Water piping serving plumbing fixtures at the First level and Second level is rigid copper which then transitioning to flexible braided stainless steel prior to connection to the plumbing fixtures (Figure 61 and Figure 62).

Figure 61. First Level, Looking North at Piping Below the Kitchen Sink. (source: Alvine, 2025)

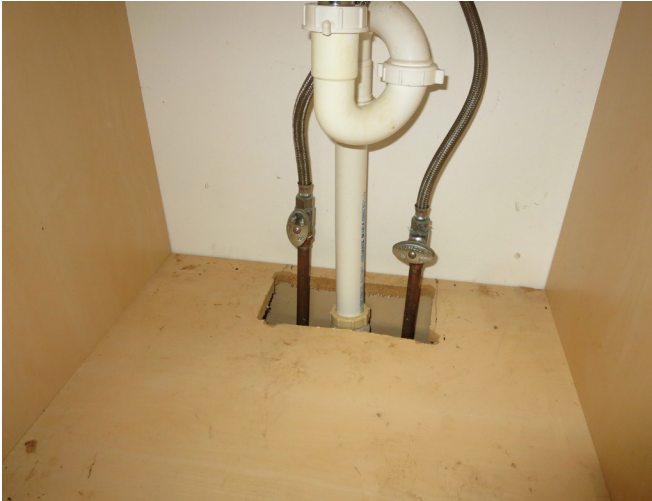
Figure 62. First Level, Looking East at Piping Below Restroom Lavatory. (source: Alvine, 2025)

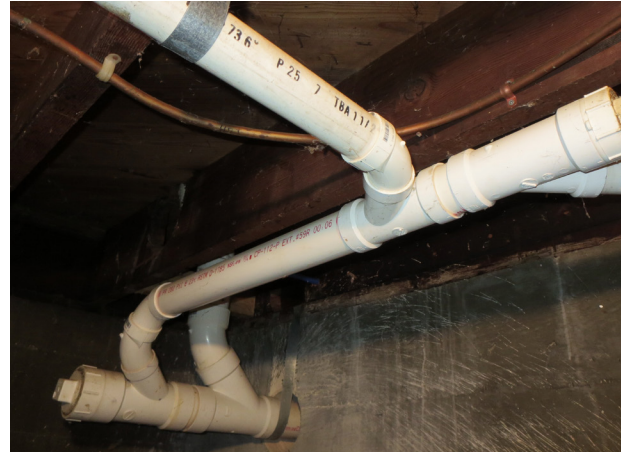
There is sanitary waste piping exiting at a higher elevation at the Basement level which appears to be four inches in size where it exits the house. This occurs at the north side of the basement near the northwest corner (Figure 66). The piping is exposed and appears in reasonably good shape with no major issues noted.

Figure 66. Basement Level, Looking Northwest at Sanitary Piping Serving First Level Restroom Where Piping Exits the House. (source: Alvine, 2025)

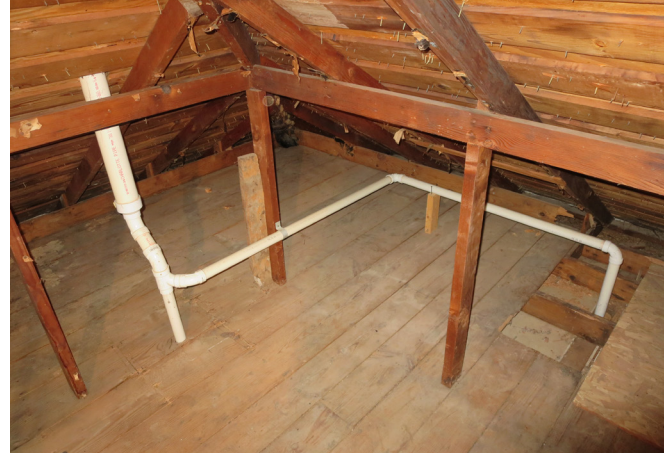
The sanitary piping system, which serves plumbing fixtures on the Second level of the house and those located at the First level, is served by PVC vent piping located in the attic. The vent piping increases in size from 1 1/2" to three inches before exiting out the roof (Figure 68). It is difficult to determine the age of this piping but is believed to be the same vintage as the PVC sanitary piping installed to serve the plumbing fixtures in the house. The vent piping appears to be in good condition.

Figure 68. Attic Level, Looking Northwest at PVC Vent Piping Serving Second Level Restroom. (source: Alvine, 2025)

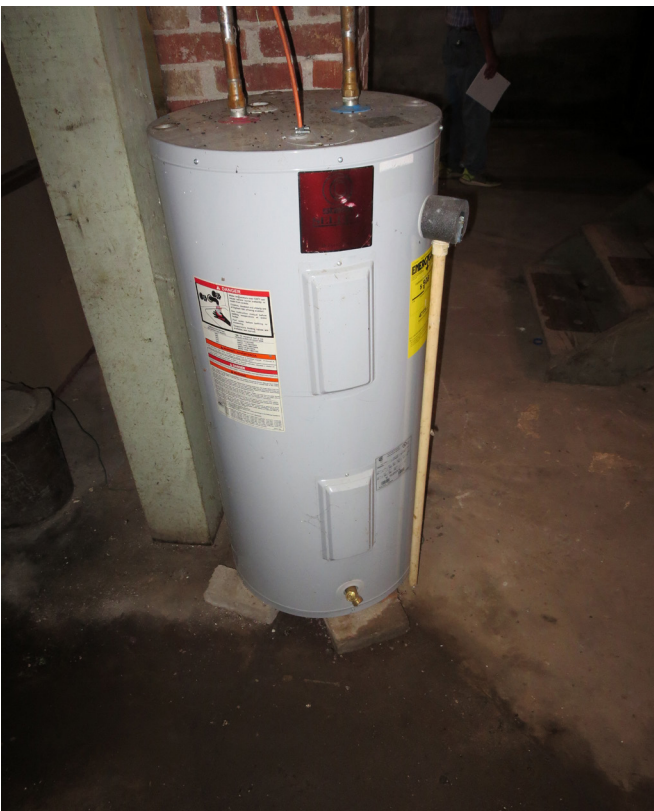
Potable hot water for the Burdick house is produced by a single, 40-gallon storage water heater located at the Basement Level of the house (Figure 69 and Figure 70). The water heater is a State, model number ES640DORS, and serial number 1111A008961. The water heater incorporates two, 3500-watt elements with non-simultaneous operation. The manufacturer date for the water heater is not listed on the water heater but based on the first four digits of the water heater's serial number, the date of manufacture is approximately 11 weeks into the year 2011. The water heater has markings stating it was installed on June 13, 2011. It is in reasonably good shape, as there is no tank leakage present. Based on this assessment, it is estimated that it could continue to serve the house for another 5-10 years before it should be considered for replacement.

Figure 69. Basement Level, Looking South at Water Heater Adjacent to Brick Chimney and Furnace. (source: Alvine, 2025)

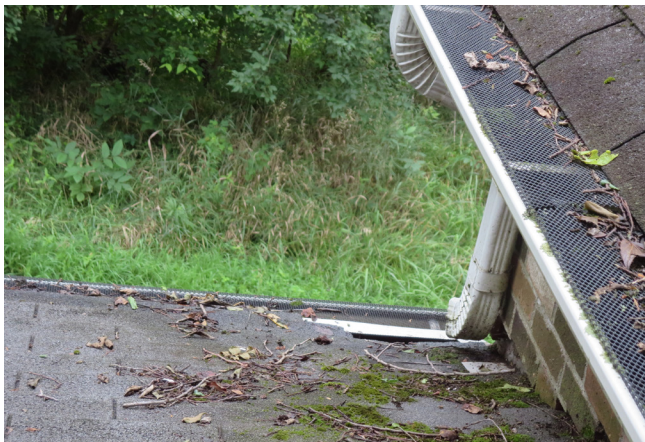
The gutters appear to incorporate gutter covers or screens to protect the gutters from getting filled up by leaves (Figure 73). It is unknown if the gutter covers are installed at every gutter location as a visual verification was not possible. The house located in an area with many trees, would require regular maintenance to keep the gutter clear of debris. It is assumed that gutter covers are present at all gutters of the house to minimize the maintenance needs.

Figure 73. Second Level, Looking West from Stairway to Attic Through Window at Gutter Screen Covers. (source: Alvine, 2025)

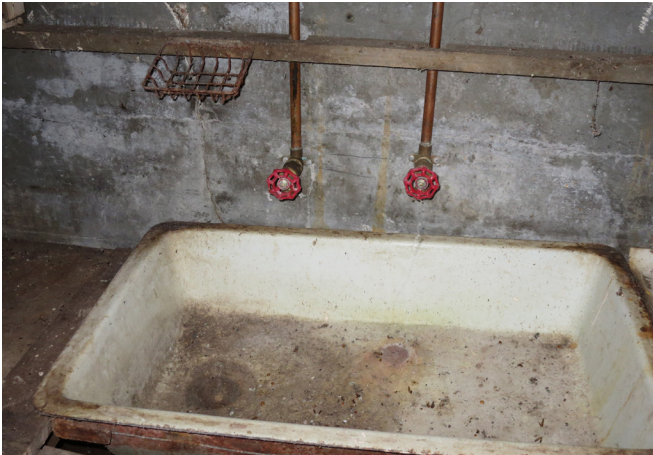
At the Basement level is a vintage-looking cast iron, which is located along the north wall. The sink is a white enamel sink with wall-mounted hose bibbs used for a faucet (Figure 74). This fixture appears to be the oldest fixture currently in the house. The drain at this sink appears to be completely plugged up, so if the sink were desired to be put into service, the drain would need to be unplugged, allowing water drainage. Other fixtures present at the basement include a floor-set, flush-tank water closet (Figure 75), and a make-shift shower stall with shower mixing valve and shower head (Figure 76). The floor drain in the basement would appear to serve the shower, as it is located immediately outside the basement restroom space.

Figure 74. Basement Level, Looking North at Sink and Hose Bibbs Used for Sink Faucet. (source: Alvine, 2025)

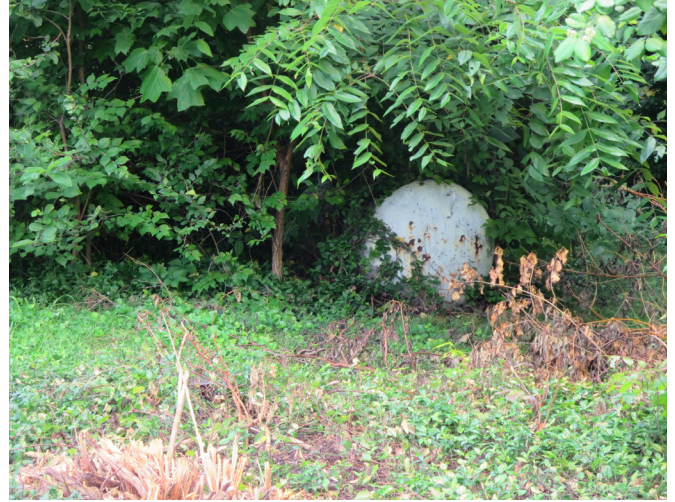
The house is currently served by a liquified propane. A steel propane storage tank resides south of the house, located in an overgrown brush area (Figure 86). A propane meter located at the south side of the house monitors propane usage (Figure 87). It was reported by NPS personnel that the propane tank currently has a leak, so propane has been shut off to the house. NPS has expressed the desire not to use any propane-fired equipment for any future heating equipment replacement. They have expressed their approval to use equipment incorporating electric heat.

Figure 86. Exterior of House, Looking West at Existing Propane Tank. (source: Alvine, 2025)

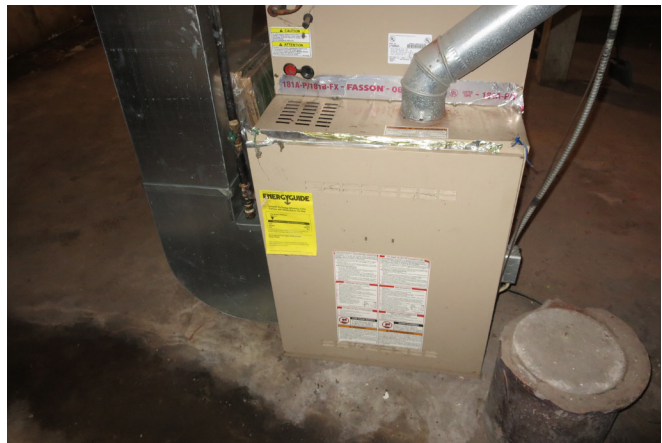
The Burdick house is currently served by a single, propane-fired, forced-air furnace located near the center of the Basement level adjacent to a brick chimney. The furnace manufactured by York, is a model FG8D15020UH11A, with serial number WFLM039525 (Figure 90 through Figure 92). The furnace propane input is 150,000 Btu with an output of 120,000 Btu, which equates to an annual fuel utilization efficiency of 80%. The furnace is fed by a single 120-volt, single-phase power circuit.

The furnace is approximately forty years old based on its serial number. The serial numbers second digit listed as “F” indicates the month of manufacture which would represent a manufacture date in June. The fourth letter indicates the year of manufacture, which would be 1982. Based on this information, this makes the furnace age at 43.5 years old. According to ASHRAE (American Society of Heating, Refrigeration and Air Conditioning Engineers), residential furnaces have expected lifespans of 30-years. Based on this information, the existing furnace has reached the end of its expected useful life. This unit would be recommended for replacement.

Figure 90. Basement Level, Looking South at Existing Propane-Fired Furnace. (source: Alvine, 2025)

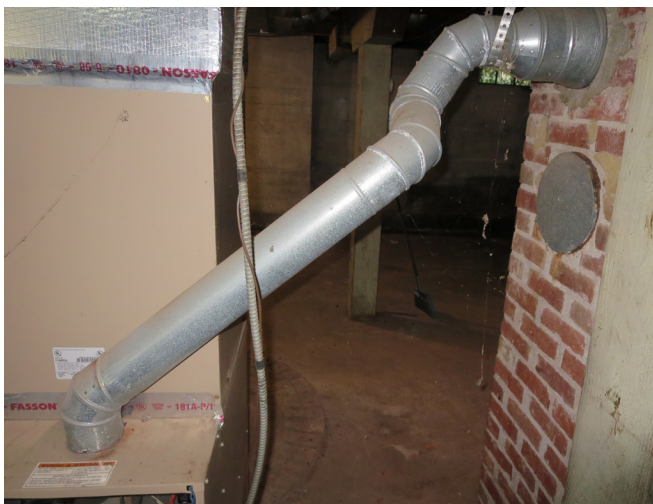
The furnace has a sheet metal flue, which is currently connected to the brick chimney that resides adjacent to the furnace and water heater. (Figure 93). This flue would need to be removed and the opening in the chimney patched air-tight if the furnace were to be replaced with an electric unit.

Figure 93. Basement Level, Looking South at Furnace Flue and Connection to Adjacent Chimney. (source: Alvine, 2025)

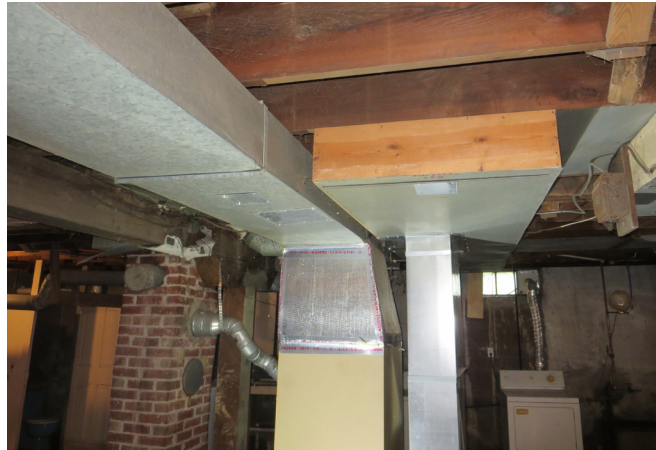
None of the supply air ductwork is insulated within the Basement level. The supply air ductwork in the house appears to be in reasonably good shape and could possibly be reused as part of any rehabilitation or renovation of the house. The floor supply air grilles and wall return air grilles could remain and be reused if desired, maintaining the age-appropriate look of the house finishes.

Figure 95. Basement Level, Looking North at Furnace Supply and Return Air Ductwork. (source: Alvine, 2025)

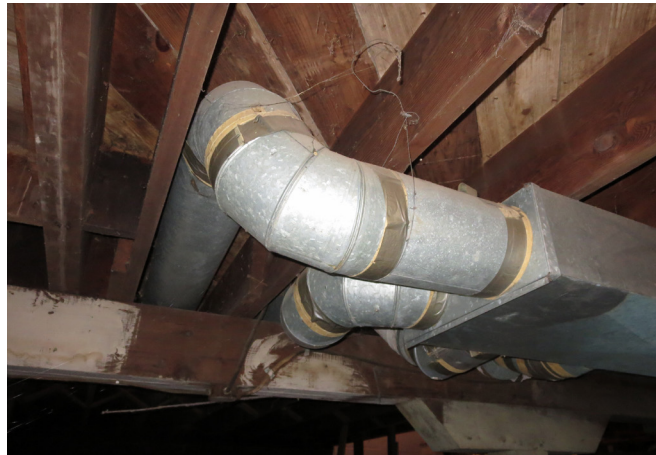
Figure 96. Basement Level, Looking Northeast at End of Supply Air Duct Main and Round Branch Ducts. (source: Alvine, 2025)

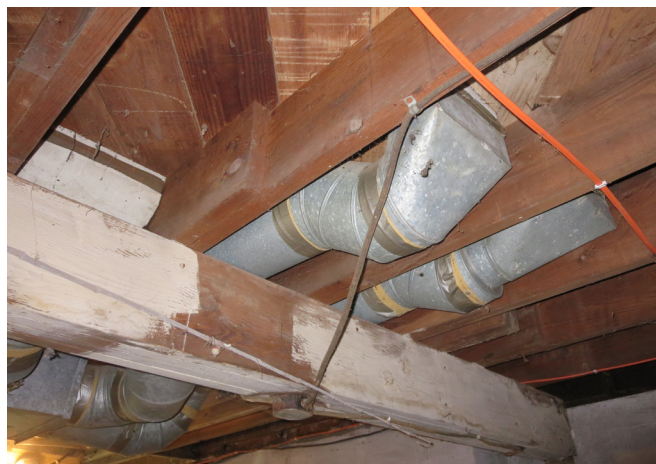
Figure 97. Basement Level, Looking Southeast at Round Branch Air Ducts Offset Up Through the First Level. (source: Alvine, 2025)

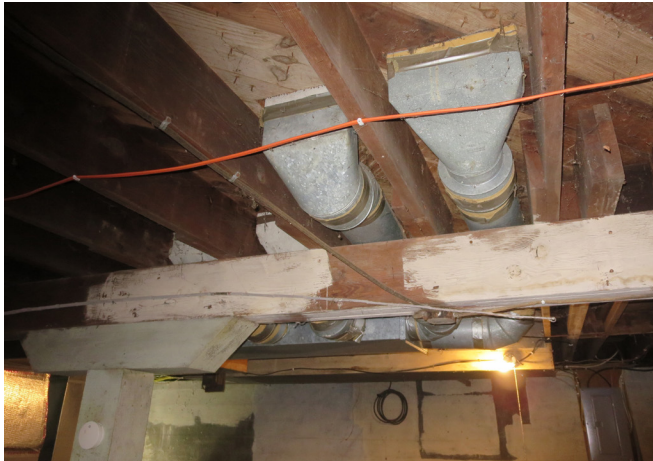
Figure 98. Basement Level, Looking East at Round Branch Air Ducts Offset Up Through the First Level. (source: Alvine, 2025)

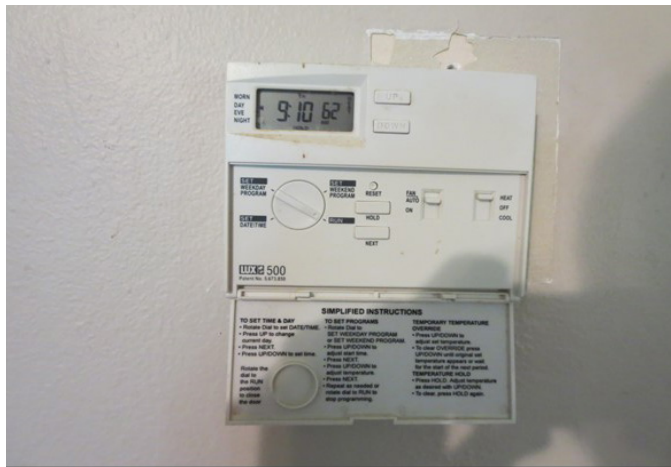
Figure 110. First Level, Looking West at the Wall Where the Furnace Control Thermostat Resides. (source: Alvine, 2025)

The thermostat appears to be operating satisfactorily and could continue to serve the house's HVAC system for the foreseeable future. Control of the HVAC system heating operation, however, will not be possible since propane is no longer flowing to the basement furnace.

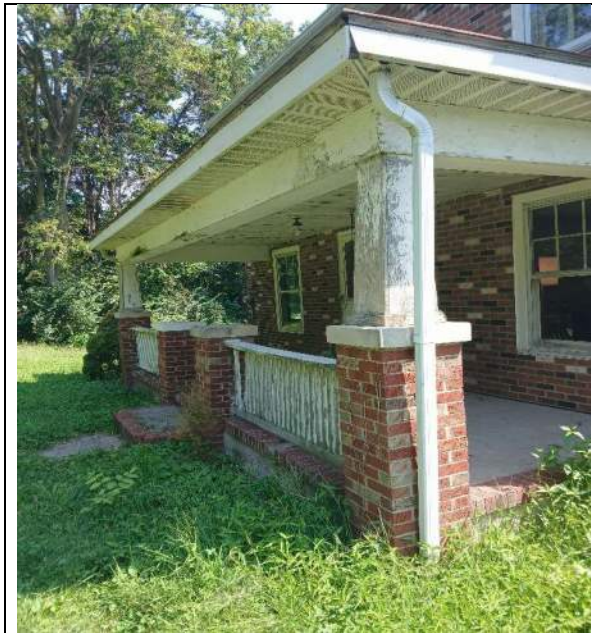
**Photograph 3:** Exterior Front Porch (ceiling, fascia, posts, bottom rail, balusters, and pillar caps all LBP).

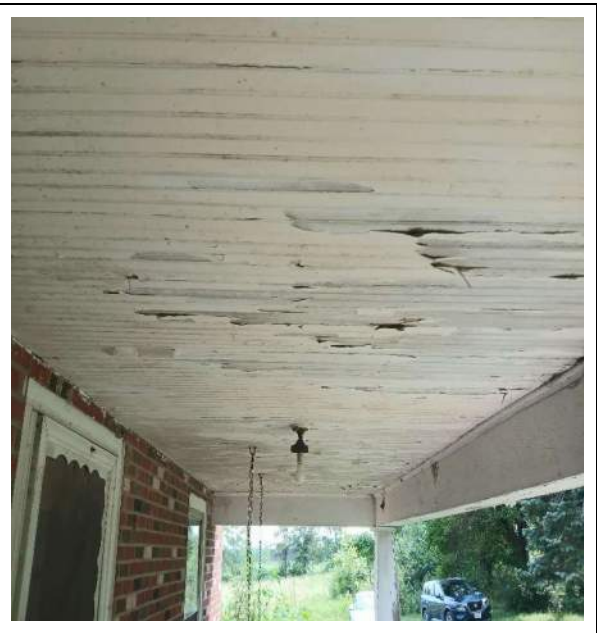
**Photograph 4:** LBP front porch ceiling and beams. LBP front door frame and windows, window frames and sill.

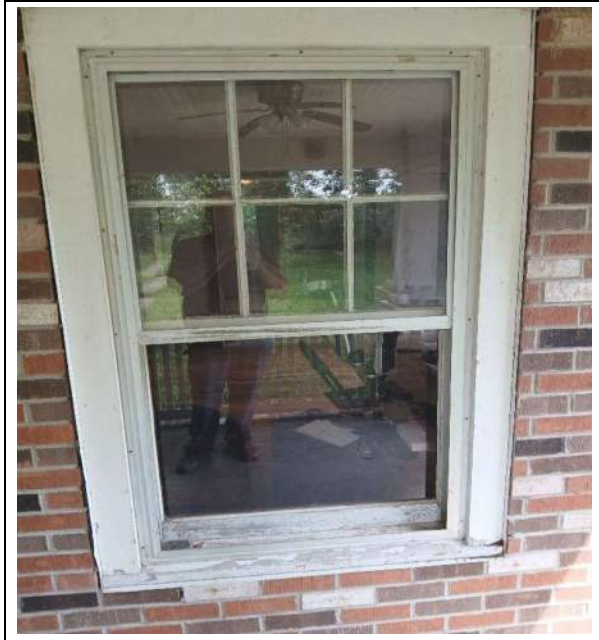
**Photograph 5:** LBP front porch window frame, window and sill.

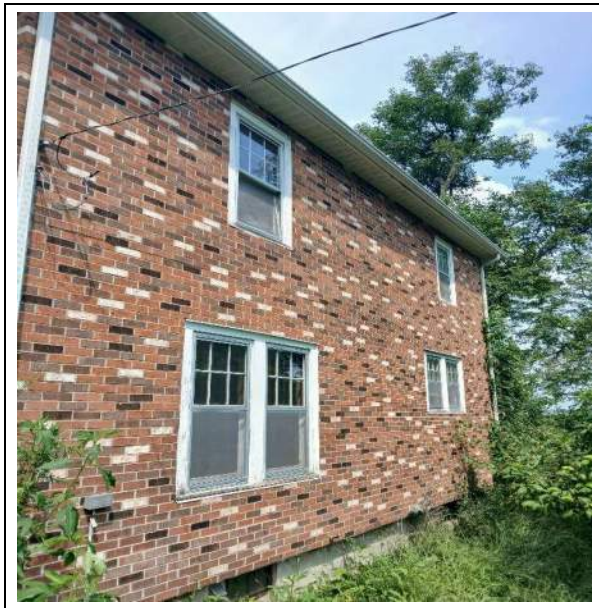
**Photograph 7:** South exterior building LBP windows (6-seven panel windows, window frames and sills).

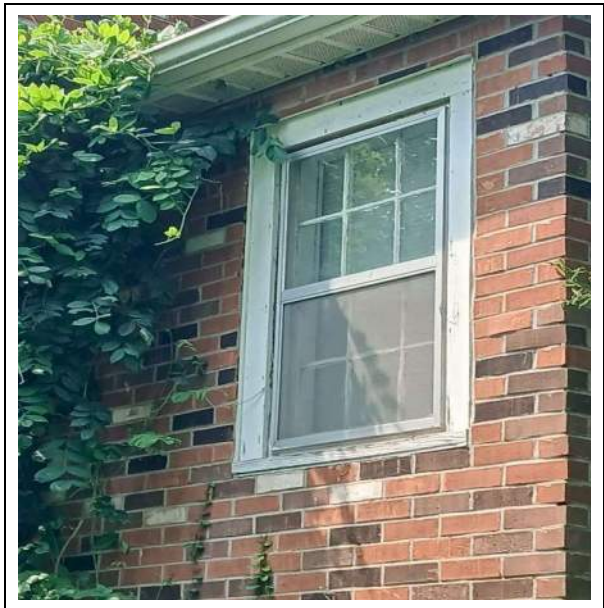
**Photograph 8:** North exterior building LBP windows (12-seven panel window, window frame and sill).

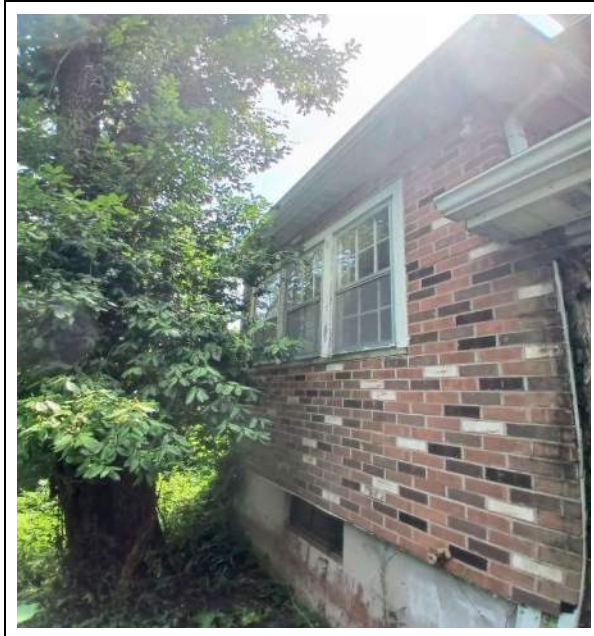
**Photograph 9:** East exterior building LBP windows (12-seven panel windows, window frames and sills).

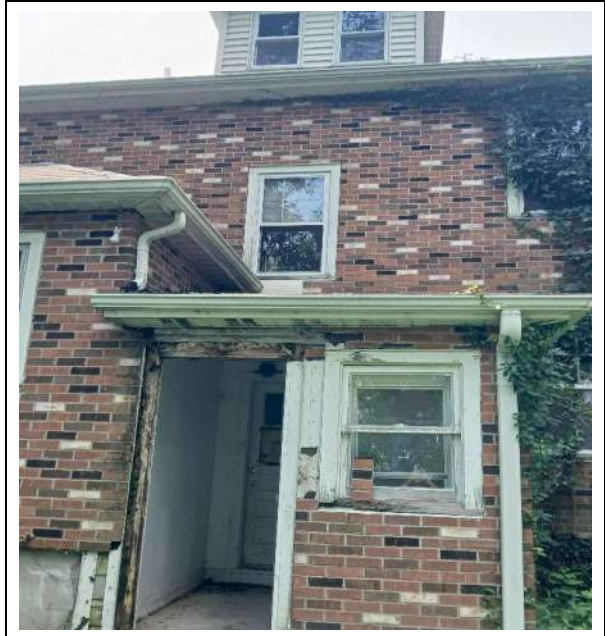
**Photograph 10:** East exterior building LBP windows (Seven panel window and two-panel windows, window frames and sills).

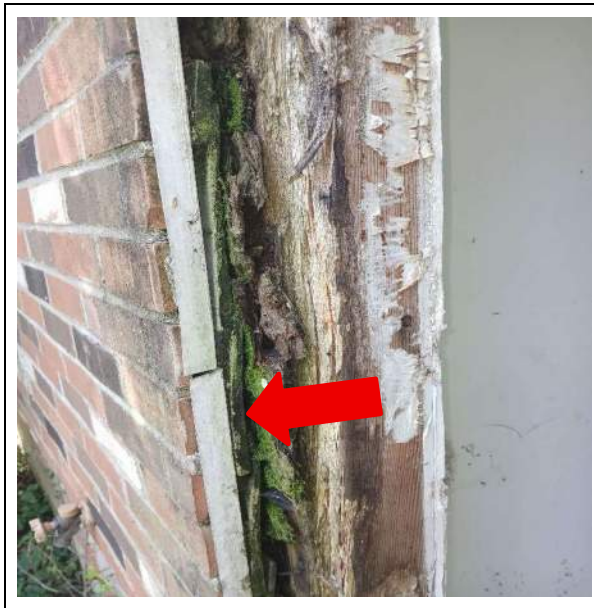
**Photograph 11:** North exterior wall (Note: LBP gray wood siding beneath fake brick veneer).

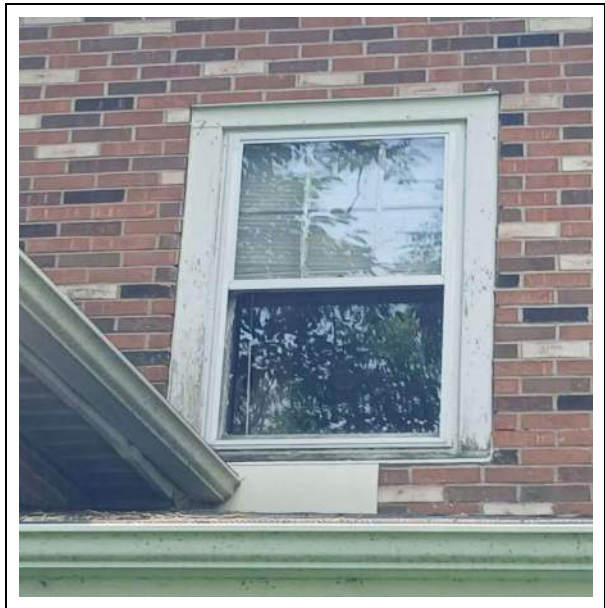
**Photograph 12:** East exterior building LBP window (Seven panel window, window frame and sill).

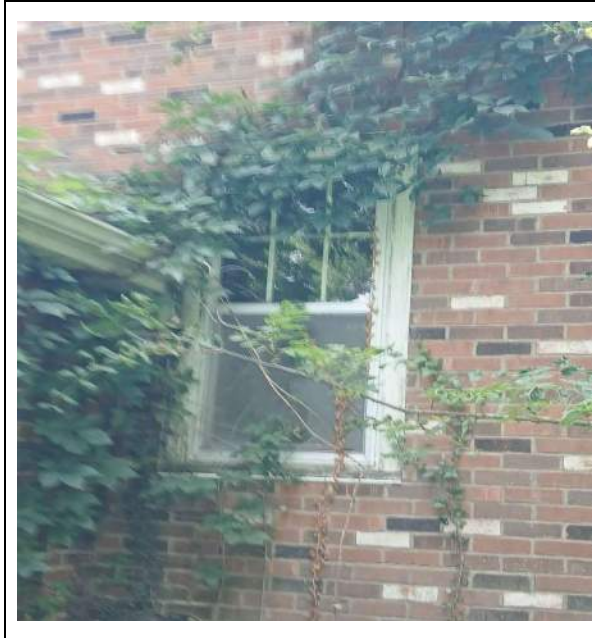
**Photograph 13:** South exterior building LBP Seven-pane window, window frame and sill.

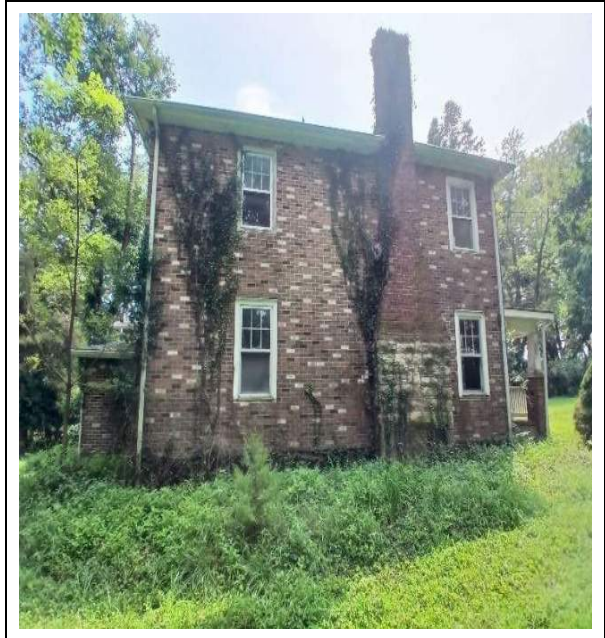
**Photograph 14:** West exterior building LBP seven-pane windows, window frames, and sills.

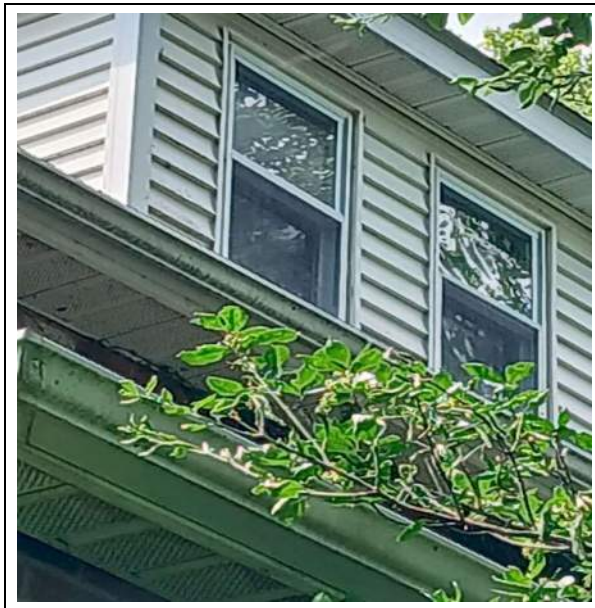
**Photograph 15:** South exterior attic windows vinyl non-LBP.

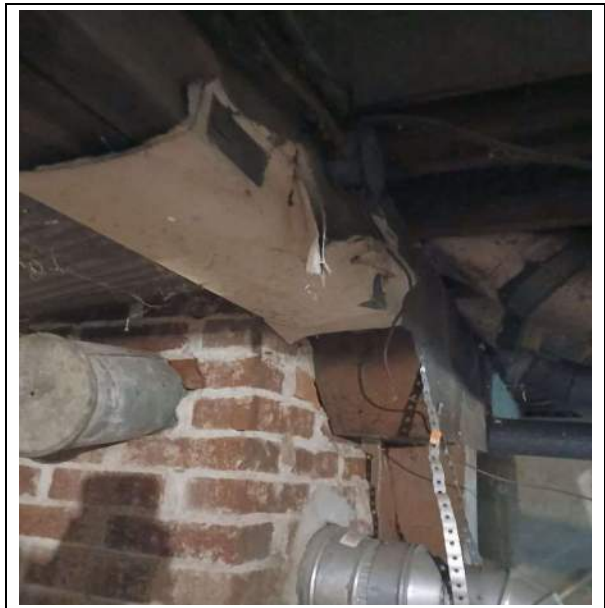
**Photograph 16:** Asbestos ductwork insulation location in basement.

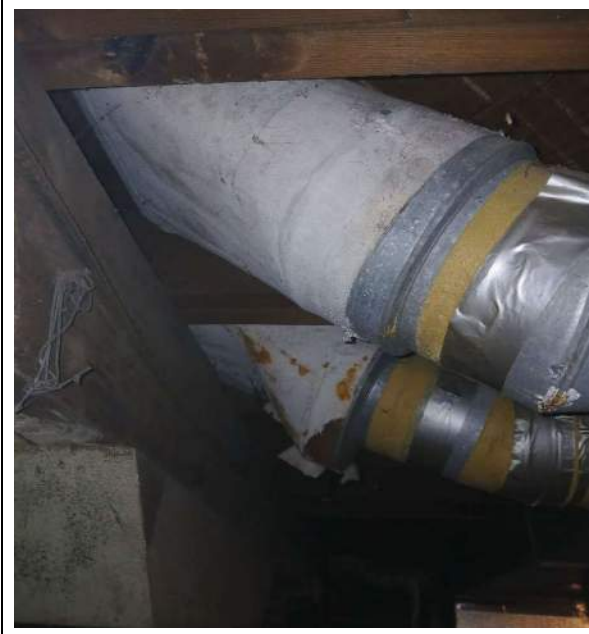
**Photograph 17:** Asbestos insulation on ductwork in basement (Note: Present behind walls on first and second floors, and wall and grates).

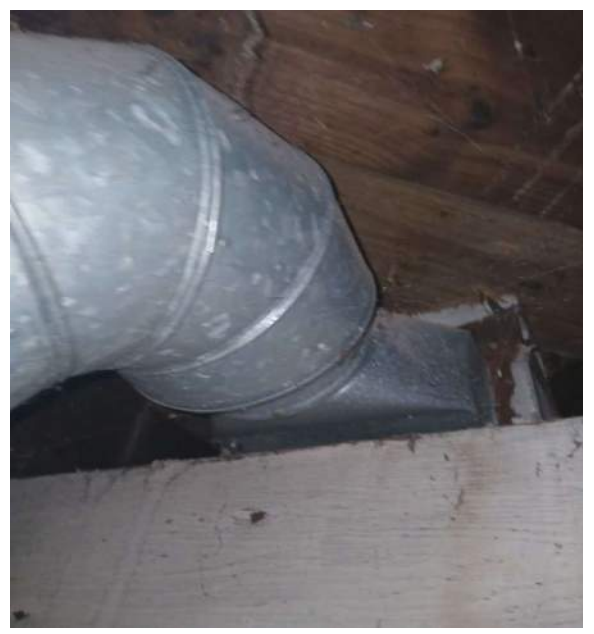
**Photograph 18:** Asbestos insulation on ductwork in basement (Note: Present behind walls on first and second floors, and wall and grates).

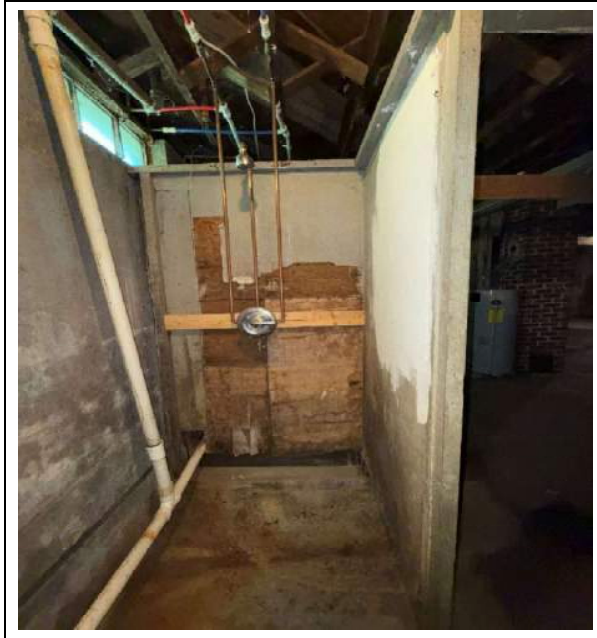
**Photograph 21:** Basement LBP shower walls.

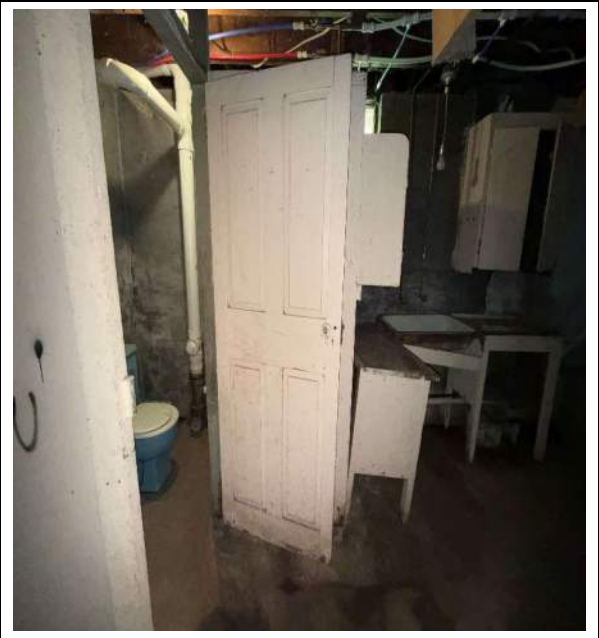
**Photograph 22:** Basement LBP bathroom door and door frame.

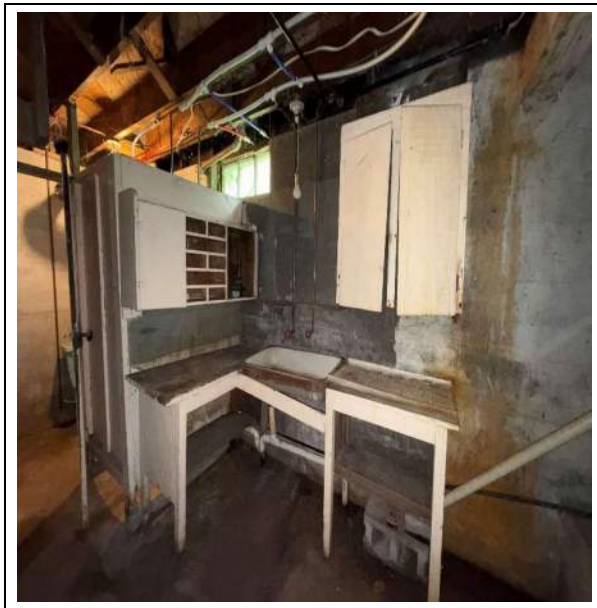
**Photograph 23:** Basement LBP cabinetry, cabinetry doors, shelving, tool bench and tool bench shelving.

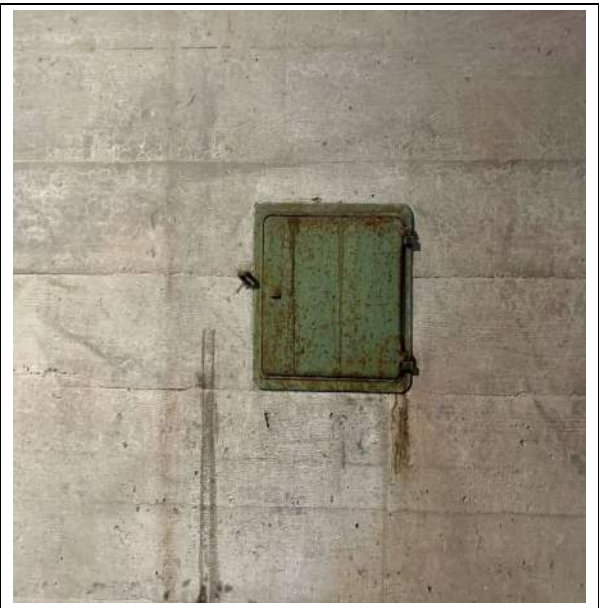
**Photograph 24:** Basement LBP coal chute door and frame

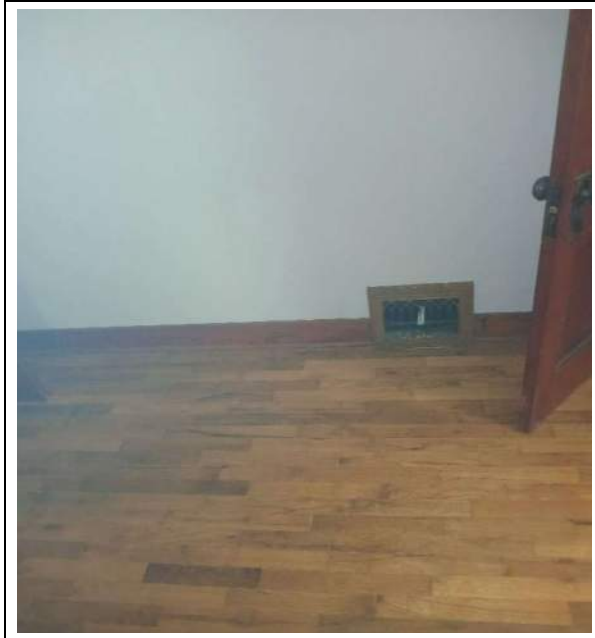
**Photograph 25:** Typical view of wall grates on first and second floor (Note; Asbestos insulation wrapped around ductwork behind wall to second floor).

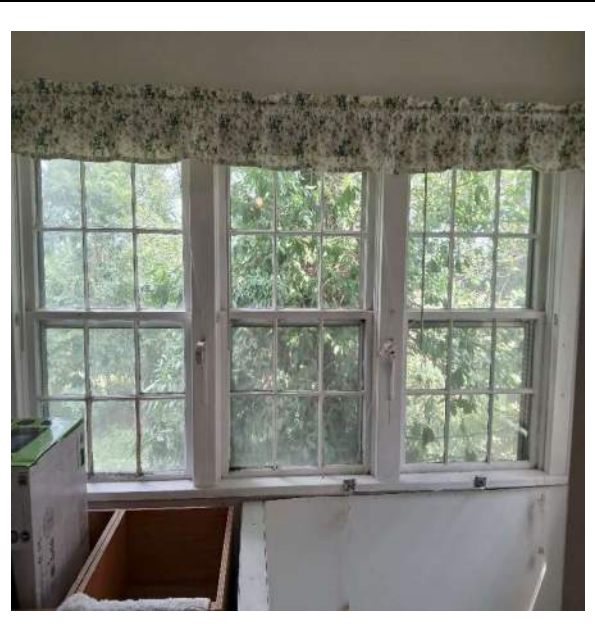
**Photograph 26:** East interior LBP window mullion, window frame and sill in first floor bath.

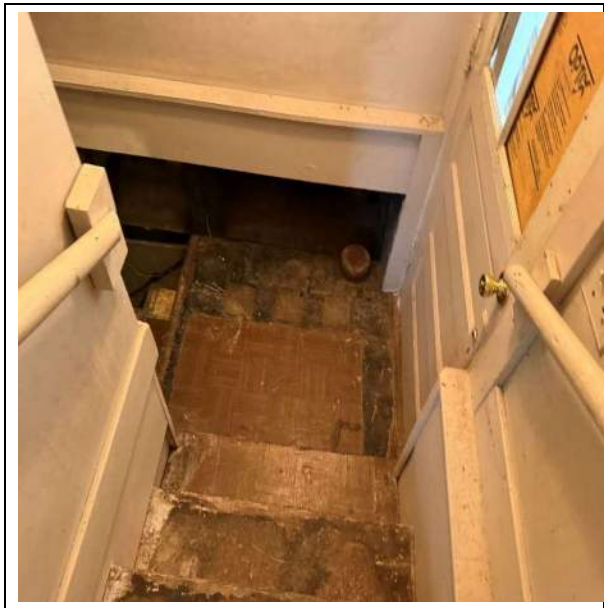
**Photograph 32:** Basement landing LBP door, door frame, baseboard, header board (Note: Asbestos floor tile beneath brown, black and brown floor tile, floor felt and yellow green floor sheeting).

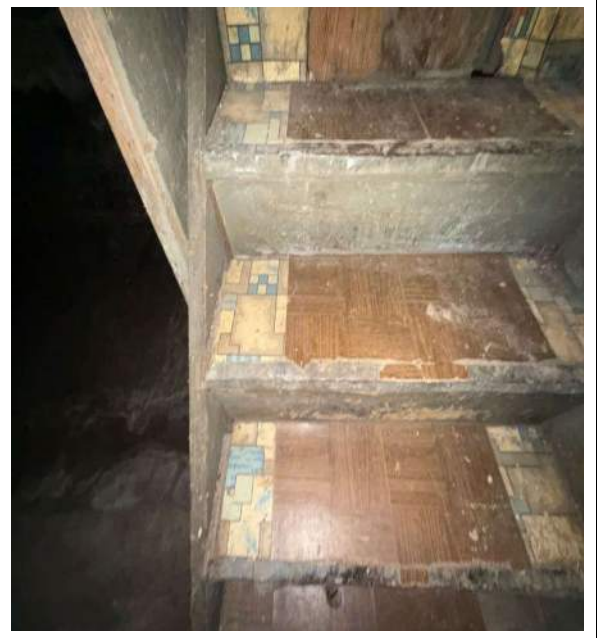
**Photograph 34:** Basement stairway asbestos beige floor tile assumed beneath brown and yellow green floor sheeting.

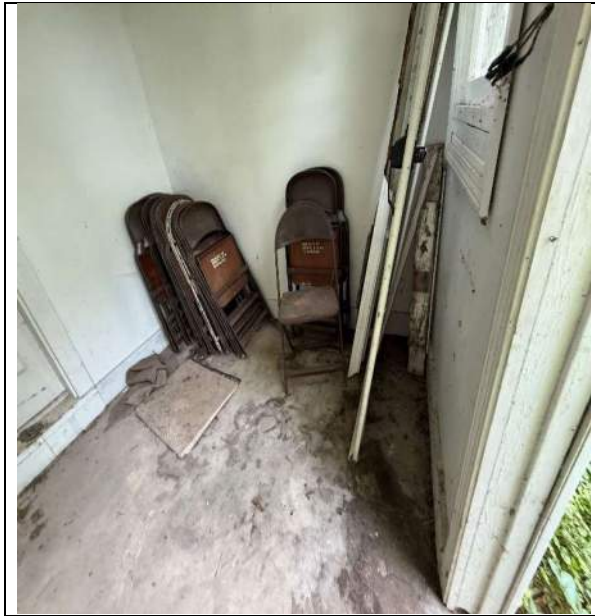
**Photograph 35:** Exterior rear porch LBP door frame.

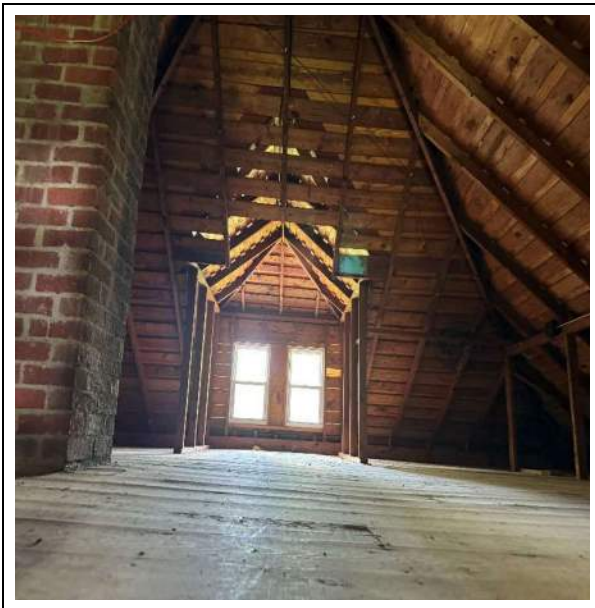
**Photograph 39:** View of attic with non-LBP vinyl windows.
