## Historic Structure Report

### Thurmond Commercial Buildings **NEW RIVER GORGE** National River • West Virginia

Historic Structure Report  
August 1992

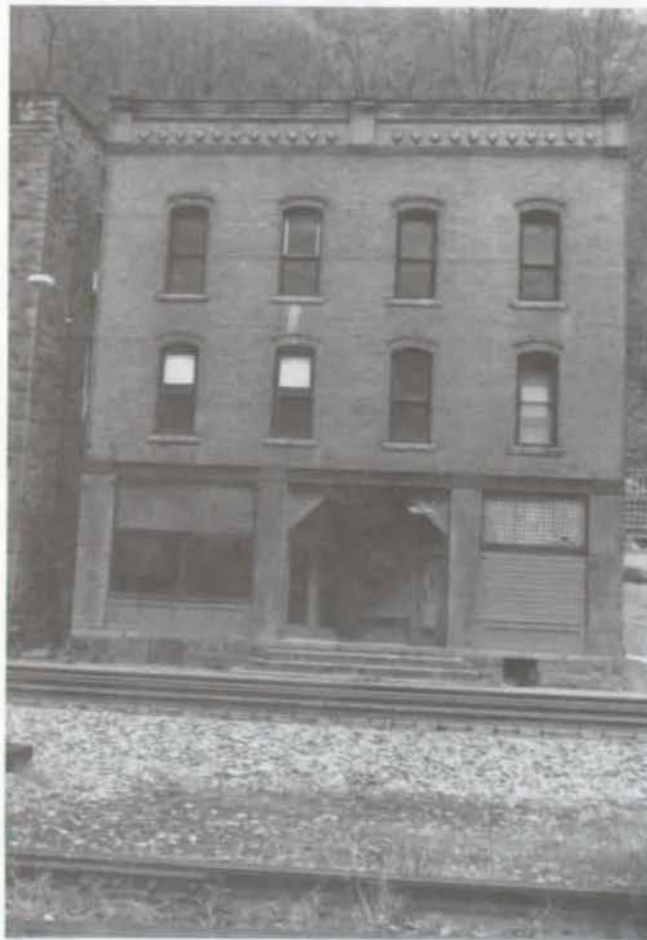
**Figure 11**  
Mankin-Cox Building, April 1991  
(NPS Photo)

The Mankin-Cox Building is a three-story brick building, constructed in 1904 (figure 11). The track, or west, elevation is faced with yellow brick and topped by an ornately corbelled parapet. The foundation is constructed of rusticated ashlar with a smooth stone water-table course level with the first floor. A door leading into the cellar area is located to the north of the main entry into the building, with a cellar window to the south. The wooden frames, door, and sash for these openings no longer exist. The fenestration pattern at the second and third floors consists of four bays of double-hung wood windows, each headed by a brick arch. Brick piers support the iron lintel across the first-floor storefront bays. Decorative rosettes are applied to the web of the beam periodically along its length, and decorative metal panels fill in between the flanges at the top of each pier.

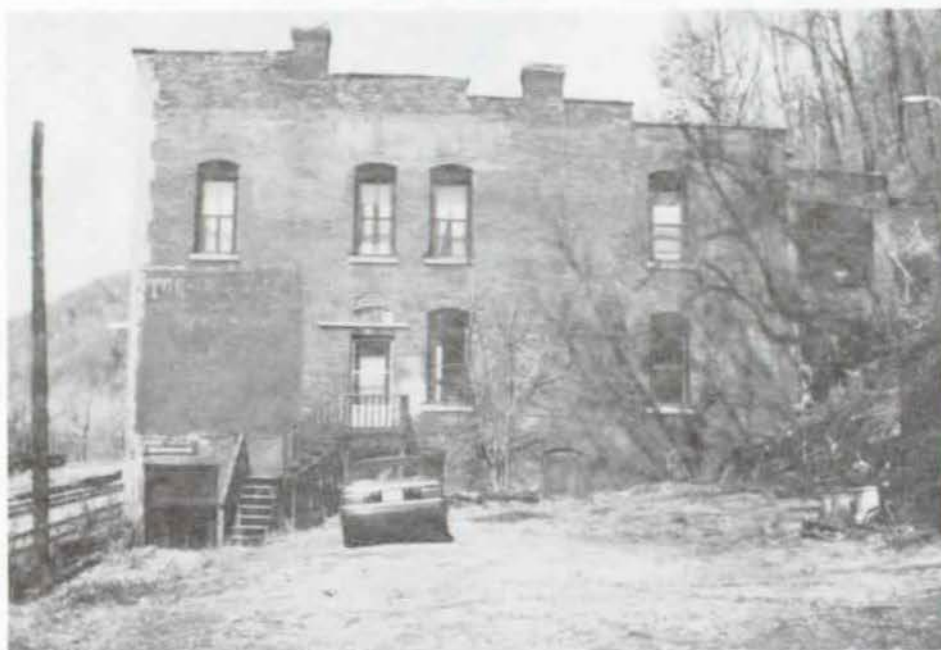
**Figure 13**  
South Elevation, Mankin-Cox Building, March 1990  
(NPS Photo)

The north, south, and east elevations are all of red brick, as is the addition to the southern rear corner of the building. The original portions of the north and south elevations are somewhat similar in composition (figure 13). Both elevations have four stepped parapet sections and two chimneys. Both elevations have three small, high windows at the first floor, three double-hung windows at the second floor, and four double-hung windows at the third floor. The third-floor windows are located directly over the second-floor windows, with the extra window to the east on the north elevation and to the west on the south elevation. Actually, the westernmost second-floor window on the south side of the building is now a door. The original window opening was modified to accommodate a door, probably for access to the second floor when the interior stair from the first floor was removed. What looks like a railing on the landing of the stair leading up to this door appears at the extreme right edge of a photograph taken about 1925 (figure 2). This stair was rebuilt late in 1990 (figure 14).

All of the original double-hung windows on the south side have been replaced with modern aluminum double-hung windows. The easternmost first-floor window on the south elevation has been completely bricked up and is now partially below grade. The eastern two first-floor windows of the north elevation were no longer used after the New River Banking and Trust Company moved into the building in 1909. These windows were completely bricked up from the inside, but the frames were left in place and only partially bricked up at the exterior. Also, when the bank moved into the building, an iron security grill was installed in front of the third window on the north elevation.

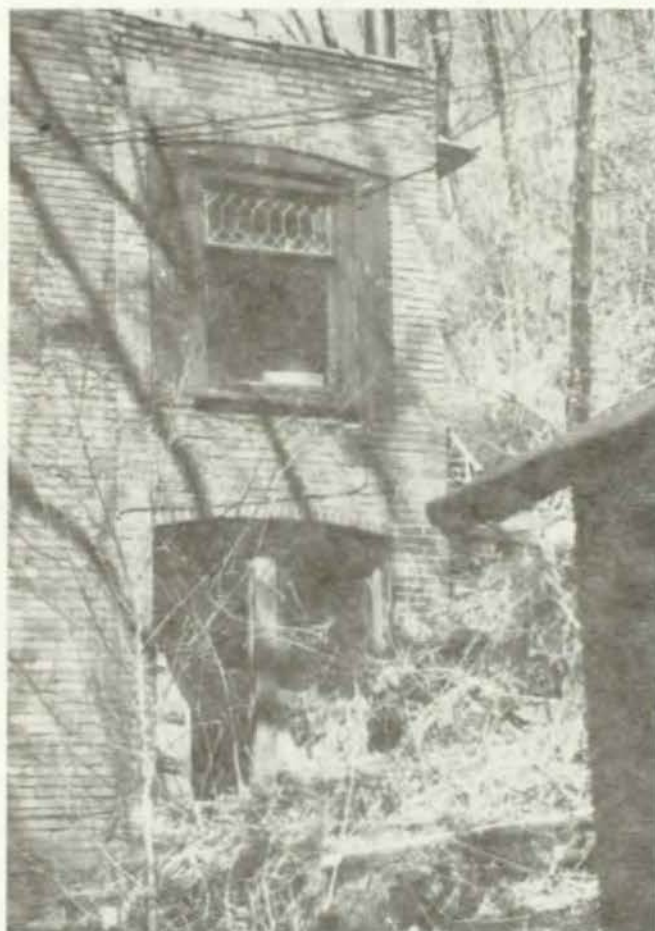
**Figure 16**  
 South Elevation of Rear Addition, Mankin-Cox  
 Building, March 1990  
 (NPS Photo)

the second and third floors of this elevation. The third-floor door is headed by a transom and a brick arch. At the northern end of the second floor, a small arched window is also visible. An original third-floor arched window opening and an original second-floor door still exist inside the addition.

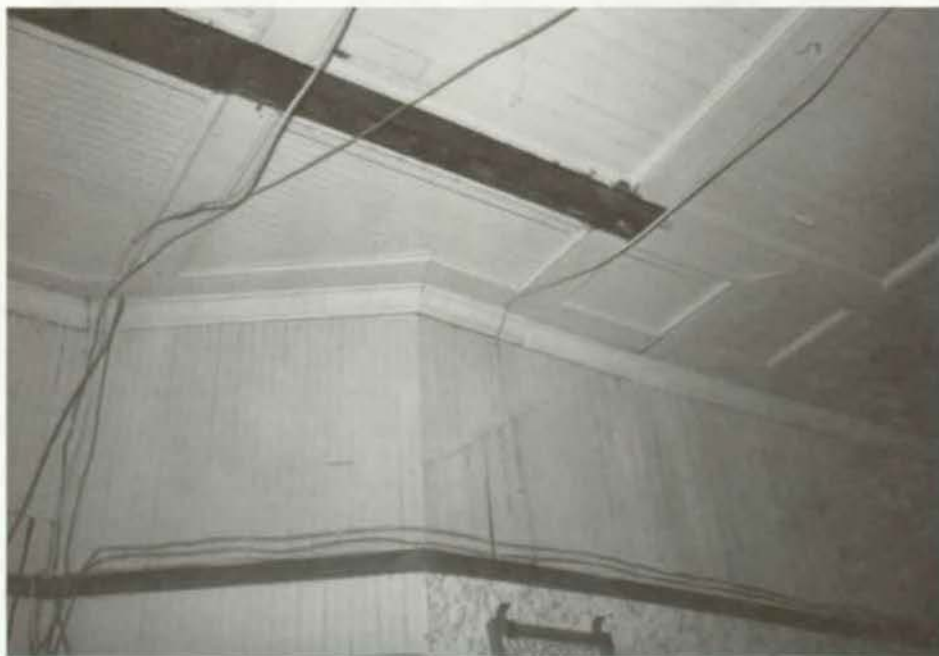
**Figure 25**  
 Ceiling at Original Stair Location, Room 102  
 Mankin-Cox Building, April 1991  
 (NPS Photo)

unfinished boards outlining the approximate extent of the stair enclosure were removed during the investigation for the this report (figure 25). (It is unknown why these boards were unfinished, but they appear to be recently installed to replace missing earlier boards.) This ceiling extends to the east wall of the building and above the toilet rooms that were added later. The condition of this hidden portion of the ceiling is unknown, but in view of the general decay found in the eastern end of the building, it may be assumed that much of the ceiling is rotten.

The north wall is finished in vertical beaded tongue-and-groove boards, painted. Most are probably original, and the patched areas at the previous stair (figure 25) and double door to room 101 locations are obvious. In the middle of the north wall was a suspended canopy, constructed of wood framing and trim (figures 26 and 27) with an acoustical tile ceiling. The canopy was removed by the park in the summer of 1990. The wall finish below this canopy is plastic laminate panels in a gold-on-white abstract pattern. Generally, the wall is in good condition, although decay appears to be setting in along the bottom, especially at the east end of the room.

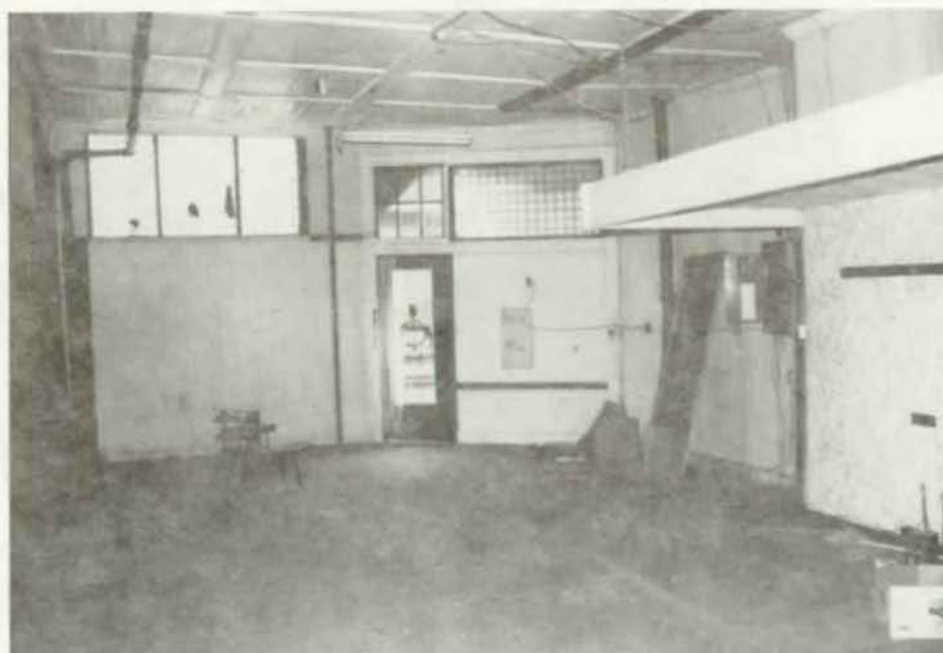
Figure 27  
West End of Room 102, Mankin-Cox Building, May 1990  
(NPS Photo)

The west wall of this room is finished in vertical beaded tongue-and-groove boards, painted yellow with black trim (figure 27). Gypsum board covers the original window opening to the north of the exterior door. While covered in tongue-and-groove boards, the wall to the south of the door had a patched area that may once have been an access to a window display.

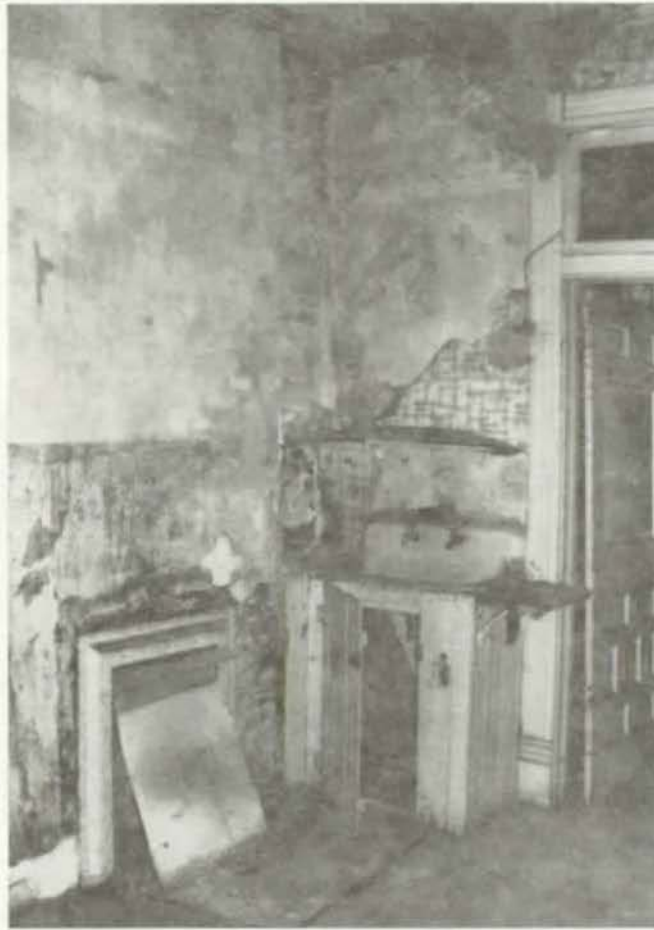
Figure 30  
Northeast Corner, Room 202, Mankin-Cox  
Building, May 1990  
(NPS Photo)

**Room 202.** This room was used as a kitchen, with sink, cabinet, and shelves located in the northeast corner (figure 30). While these do not appear to be original, they do appear to be an early addition. The tongue-and-groove flooring is in fair condition, with a wide orange brown painted border. Linoleum flooring was removed in May 1990 as part of a general building cleanup. The baseboard is in good condition, although a section of it is missing to

the west of the fireplace, and with the reduced ventilation in the sink cabinet, it is suspected the base there may be rotten. The walls and ceiling are plastered, with seven layers of wallpaper. The walls are in fair condition, although there is evidence of moisture damage in the corner around the sink, and the top several inches of the walls are cracked and loose. The wall area to the south of the door to room 203 is in particularly bad condition with large diagonal cracks and buckling, probably caused by the general settling of the building toward its center. During the winter of 1991, the park removed a section of plaster at the bottom of the wall to the south of door 203. The bottoms of the studs thus exposed are in good condition.

The ceiling has areas of loose and missing plaster along the south and east walls. The original mantle has been removed and the firebox boarded up, perhaps at the time of the sink installation. The decorative metal firebox surround and grate are still in place (figure 30). The firebox is filled with debris, including chunks of mortar from the chimney. The stone hearth has dropped to slightly below the surrounding floor surface.

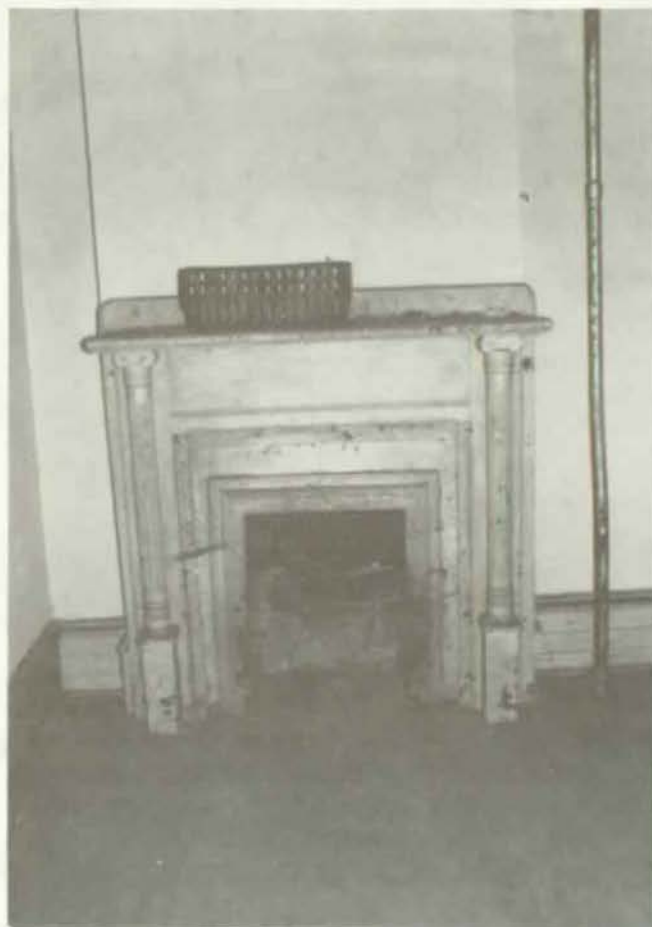
**Figure 31**  
Mantle, Room 203, Mankin-Cox Building, May  
1990  
(NPS Photo)

**Room 203.** In this room, the tongue-and-groove flooring is in fair condition and has a wide orange brown painted border. The baseboard is in good condition, with a small area of loose top molding at the west wall. The small molding returns at both sides of the fireplace are loose or missing. The walls are plastered and painted pink. All are in fair condition with some cracking and buckling caused by the building's settling. The walls were papered at one time, evidenced by the remaining scraps along the tops of the walls. The ceiling is also plastered and papered, with some loose plaster in the southeast corner. The general treatment of the room, with the wallpaper removed from the walls but not the ceiling, suggests the last owners were planning on installing a suspended acoustical tile ceiling similar to the one underway in room 205. A small square of plaster ceiling was removed in the winter of 1991 to expose the third-floor framing for the structural analysis portion of this report.

The wood mantle and decorative metal firebox surround are both in place (figure 31) and in fair condition. Several bricks in the firebox have fallen out, and the hearthstone has cracked in half and settled slightly. The metal grate exists but is not in place in the firebox.

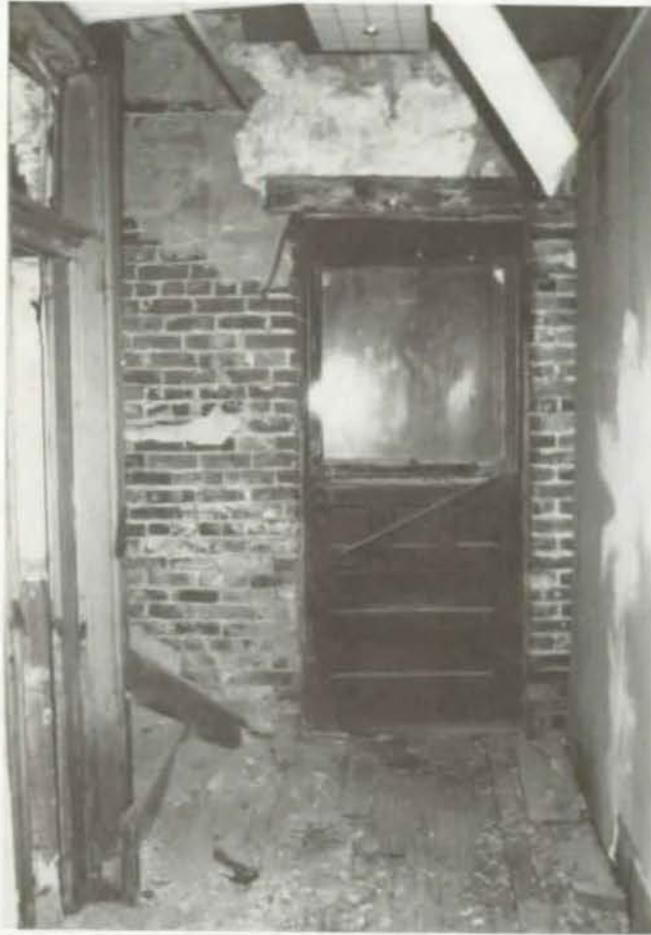
**Figure 32**  
East End of Hall 206, Mankin-Cox Building, May  
1990  
(NPS Photo)

**Room 206.** This hallway is in very poor condition at the eastern end. Paneling scraps have been applied to the ceiling in an attempt to prevent the plaster from falling further. At the east wall, nearly all of the plaster, baseboard, and door trim are gone; the door head trim and a small area of plaster above the door remain (figure 32) but are in visibly poor condition. The easternmost 10 feet or so of the south wall have been replaced with unfinished gypsum board. While it is likely that the original plaster finish was severely deteriorated, this portion of the wall may also have been redone to facilitate the installation of the modern bathtub in the adjoining bathroom. The baseboard at this stretch of wall is missing. The tongue-and-groove flooring at the east end of the hall, in a area extending west to door 202, is severely decayed. While the entire eastern end of the building is suffering from moisture-related deterioration, the deterioration of this section of flooring was exacerbated by a pile of debris that trapped moisture. The park removed the debris in May 1990.

The hall to the west of the area described above is in much better condition. While much of the original plaster ceiling is cracked, loose, or missing, the 2' x 4' suspended acoustical panel ceiling below it is intact. The tongue-and-groove flooring, covered by red linoleum at the west, is in fair condition. The baseboard at the infill for the original stairway door at the west wall is missing, and the adjacent baseboards are in only fair condition. The remainder of the baseboards are in visibly good condition, although it would not be surprising to find them deteriorated from behind. The plaster walls at the north and south, except those areas mentioned above, are in fair condition with a few areas of previously delaminated skim coat not covered by the current white paint. Turned wood corner guards protect the two corners

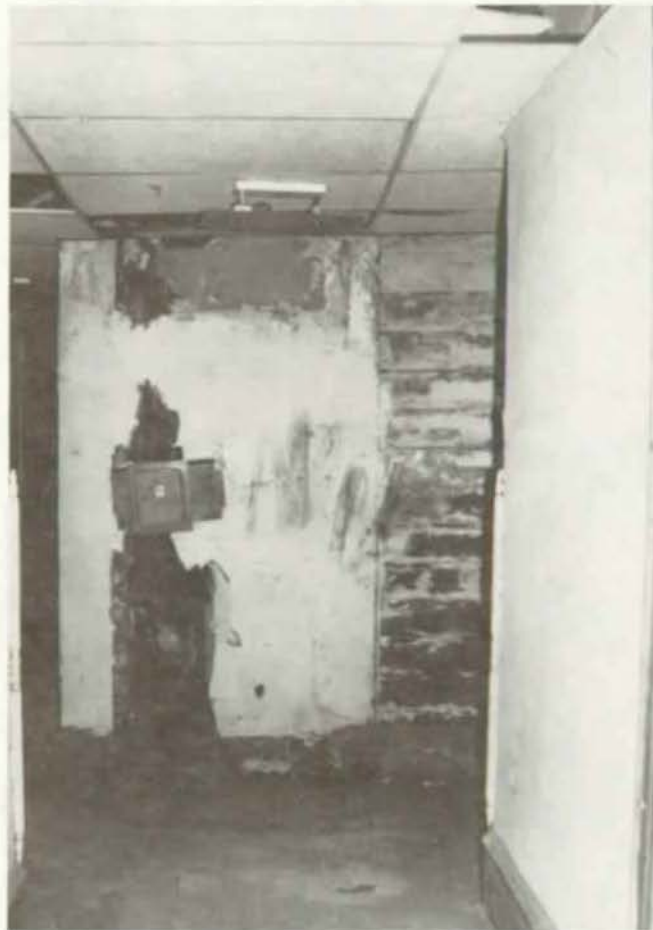
**Figure 33**  
West End of Hall 206, Mankin-Cox Building,  
May 1990  
(NPS Photo)

near doors 206 and 216. The plaster of the west wall is in fair condition, but the gypsum board door infill has large holes in it and is not all taped and painted (figure 33). The adjacent horizontal board wall is in fair condition with a great deal of peeling paint.

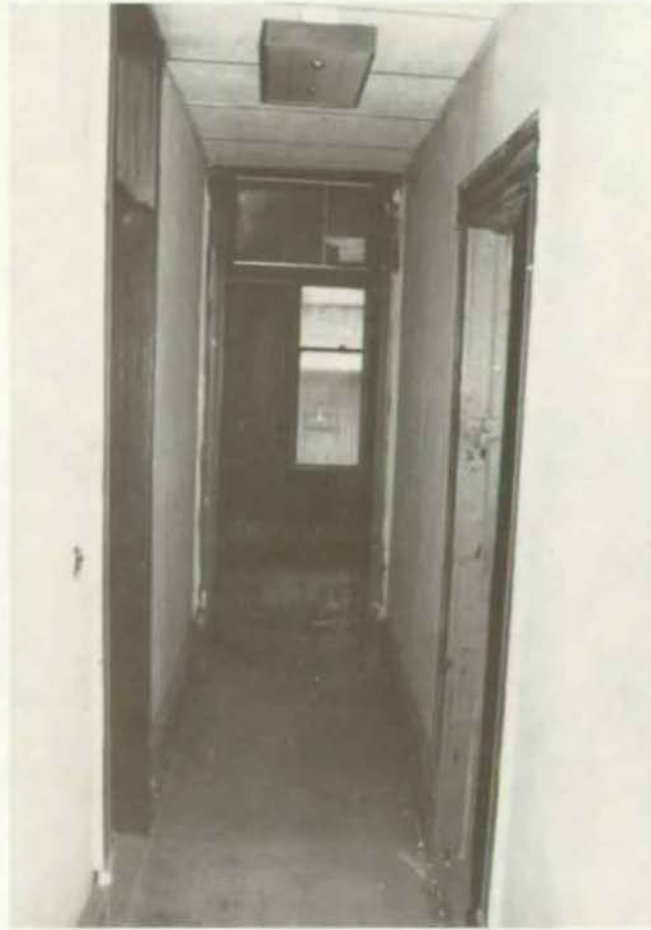
**Figure 34**  
Hall 207, Looking West, Mankin-Cox Building,  
May 1990  
(NPS Photo)

**Room 207.** This section of hall is in much better condition than the main hall, room 206 (figure 34). The tongue-and-groove flooring is completely covered with red linoleum, so its condition is unknown. The baseboard is painted salmon brown and is in good condition. The plaster walls, painted white, are also in good condition. The ceiling is finished with a 2' x 4' suspended acoustical panel ceiling in excellent condition. The condition of the plaster ceiling above is unknown. The corner guard (similar to that in figure 40) near door 209 is missing.

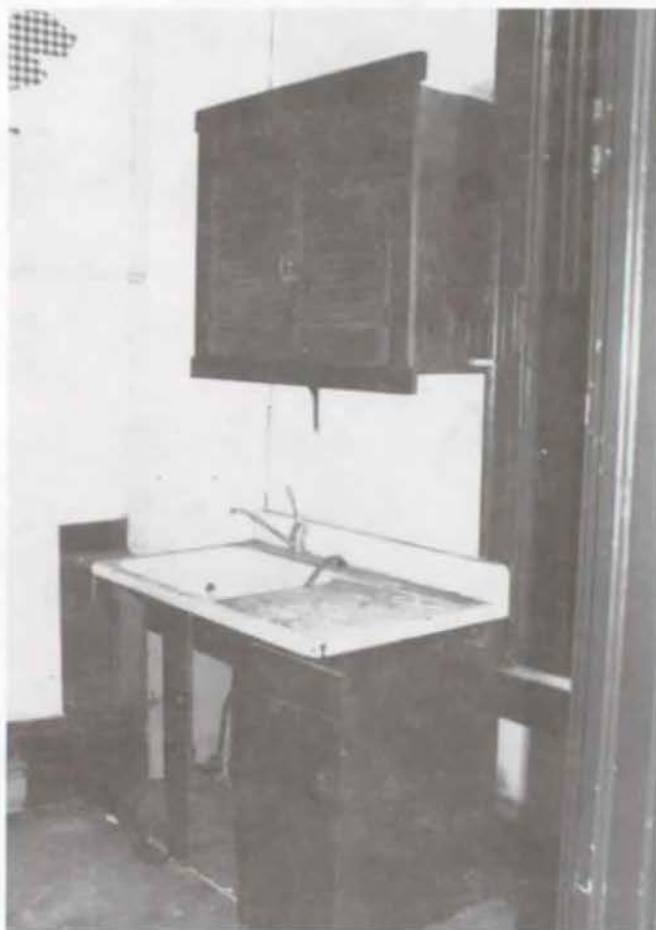
**Figure 35**  
Cabinets in Room 210, Mankin-Cox Building,  
May 1990  
(NPS Photo)

**Room 210.** This room served as a kitchen, although the stove and refrigerator were removed by the park in May 1990. The floor is covered in linoleum, so the exact condition of the tongue and groove underneath is unknown. The shoe molding of the baseboard is missing, but the baseboard is in good condition. The plaster walls are in fair condition with a gypsum board wainscot at the north, south, and east walls. Behind the present sink, the plaster at the west wall contains the ghost of a former sink. The current sink and cabinet are located along the west wall in the southwest corner of the room (figure 35). A gypsum board-covered pipe chase is located in the same corner and extends to the third floor. A wood cabinet with louvered doors, stained dark, hangs on the wall above the sink. The ceiling is a 2' x 4' acoustical panel suspended ceiling. The condition of the original plaster ceiling above is unknown.

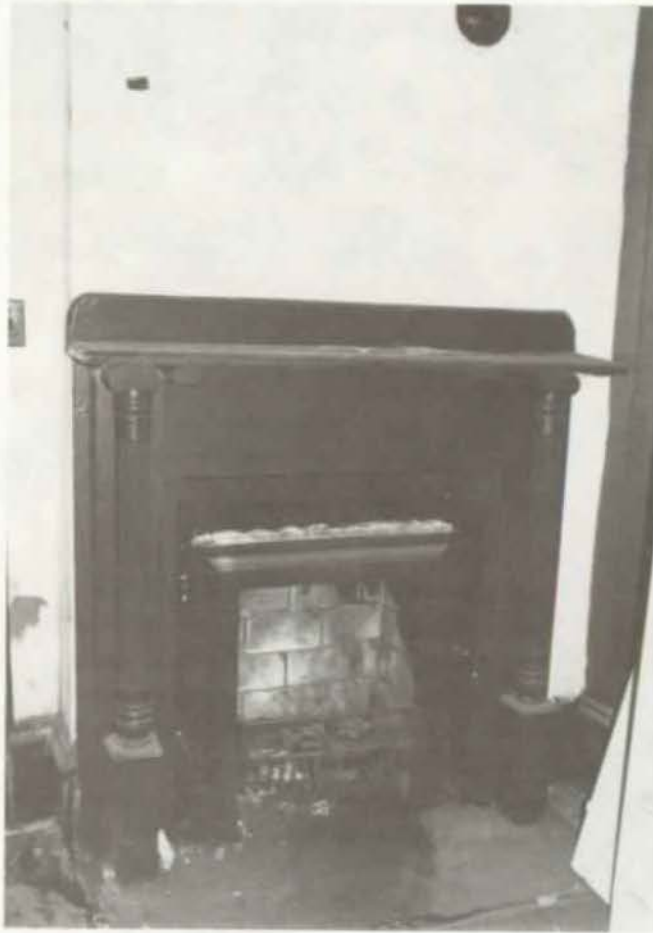
**Figure 36**  
Mantle, Room 211, Mankin-Cox Building, May  
1990  
(NPS Photo)

**Room 211.** The flooring in this room is tongue and groove, painted dark green. Carpeting was removed in May 1990. A section of baseboard is missing to the west of the mantle, and another section is loose at the east corner of the mantle. The remainder of the baseboard is fine. This room has paneled walls to the north, east, and west. The plaster at the south wall is painted white and displays a large old crack to the west of the fireplace flue. The ceiling is a 2' x 4' acoustical panel suspended ceiling. The condition of the original plaster ceiling above is unknown. The original wood mantle (figure 36) is in place, although its shelf is cracked lengthwise; the western column has shifted with the building; and various other elements are nicked and gouged. The metal grate is rusted and broken and contains bricks that have fallen from the chimney flue. Several firebox bricks are cracked and loose.

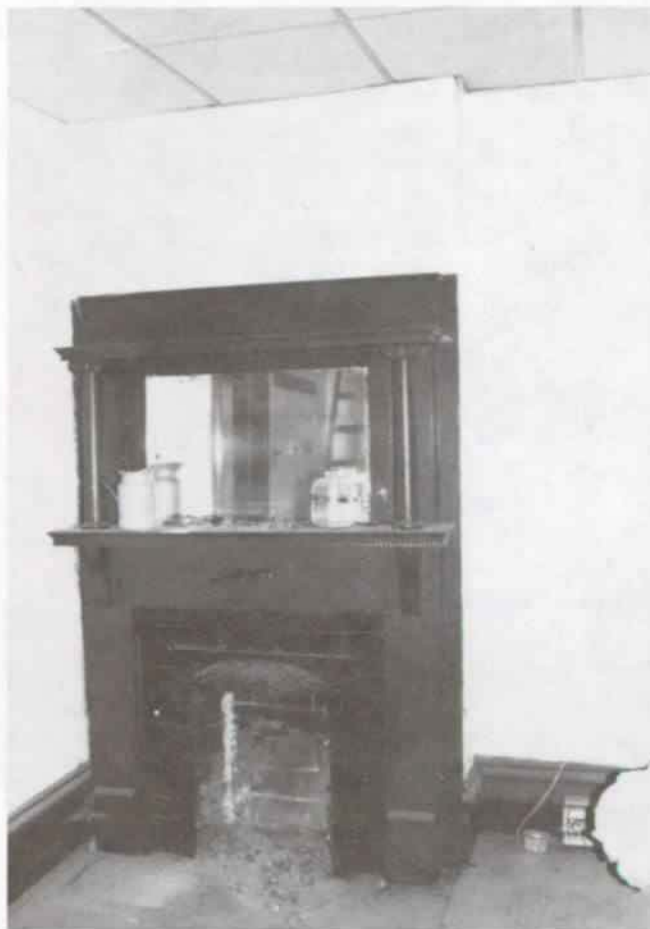
**Figure 37**  
Mantle, Room 212, Mankin-Cox Building, May  
1990  
(NPS Photo)

**Room 212.** The tongue-and-groove flooring of this room is painted dark green with a dark brown border. The floor is in fair condition and has a small, square sheet metal patch in the northwest corner. It is unknown whether the patch covers a hole and, if so, what kind. The baseboard is in generally good condition, although many of the tongue-and-groove joints are loose. The plaster walls are painted white; some areas have moisture damage, delamination, roughness, and cracking. On the east wall, a piece of board 1/8" thick evidently covers a hole

near the mantle. Several holes have been knocked in the plaster at the west wall. The ceiling is a 2' x 4' acoustical panel suspended ceiling. The condition of the original plaster ceiling above is unknown. The original mantle in this room is missing and has been replaced with another style of mantle. The current mantle (figure 37) is taller, with a mirror above the mantle shelf. The mirror is fastened in place with molding in a fashion that appears to be other than what was intended when the mantle was made. Several pieces of the mantle are cracked or otherwise broken. The decorative metal firebox surround is also of a different design than the others in the building, and a wythe of brick has been added to front of the fireplace as part of the firebox surround. Some of this brick is loose and misaligned. The hearthstone is original and is cracked.

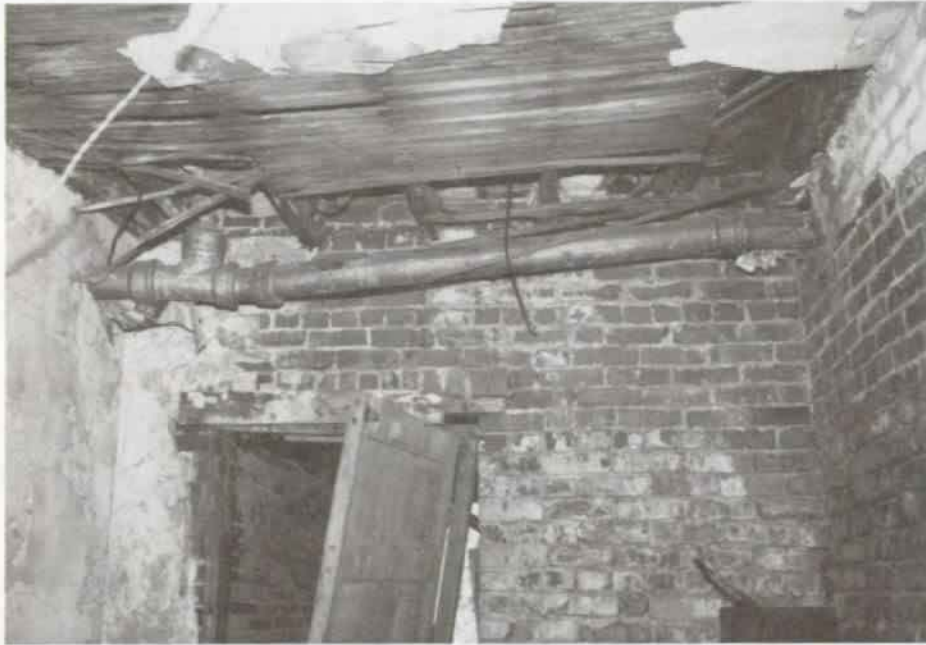
**Figure 38**  
North End of Room 217, Mankin-Cox Building, April 1991  
(NPS Photo)

**Room 217.** This room is the lower level of a two-story addition to the southeast corner of the original Mankin-Cox Building. The concrete floor is in good condition, the best of any element in the room. Most of the plaster on the walls and ceiling has disintegrated, leaving only the wood ceiling lath (figure 38). A ghost line indicates the room once had a baseboard, but it no longer exists. The doors and windows in this room were described under the exterior section above.

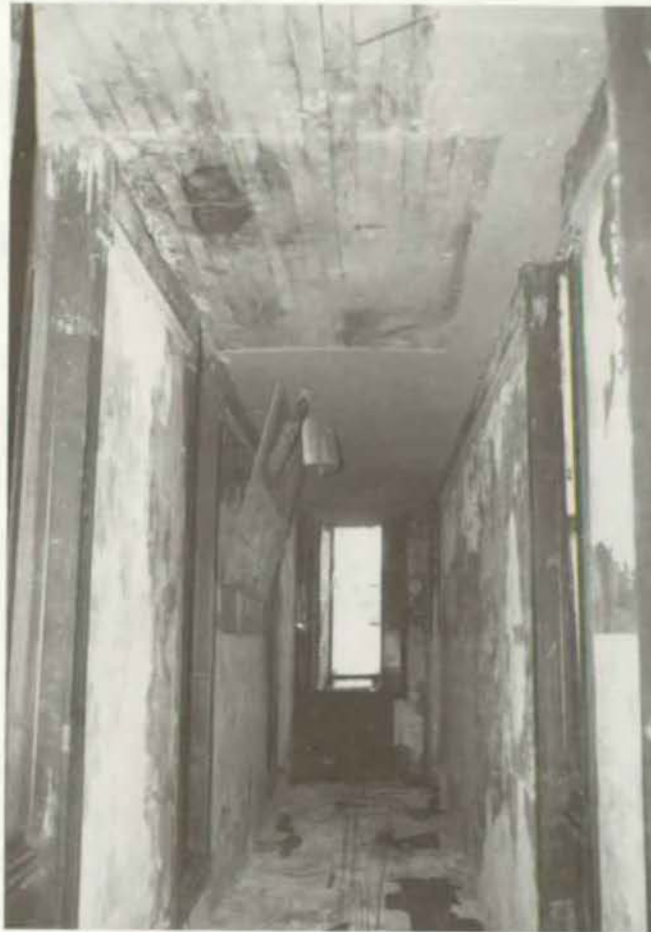
**Figure 39**  
Hall 303, Looking East, Mankin-Cox Building,  
April 1991  
(NPS Photo)

**Room 303.** The entire floor of this hallway is covered with plywood, presumably applied over the original tongue and groove because of the poor condition of the original floor. Between doors 311 and 312, this plywood flooring is very springy, as though nothing supports it. This section of plywood was removed during the winter of 1991, revealing a completely deteriorated section of flooring (figure 39). At the eastern end of the hall, the settlement of the original floor seems to be a factor in the installation of this plywood flooring. Indeed, at the intersection with hall 302, the plywood flooring is an inch or two above the level of the

original tongue and groove. The baseboard is painted a dark reddish brown, and some sections appear to be rotten at the bottom. Much of the paint has peeled.

As is typical throughout the building, the plaster at the east wall is severely deteriorated, and much of it is missing. The rest of the plaster is in fair condition, and the more cracked or otherwise deteriorated areas are at the eastern end of the hall. The walls are covered with two layers of wallpaper, painted cream, with a dark red painted wainscot. Turned wood corner guards (figure 40) protect the corners at the intersection of hall 202. The plaster ceiling is in poor condition with much plaster missing or loose. The ceiling was finished with cream paint on wallpaper, though most of the painted wallpaper has peeled.

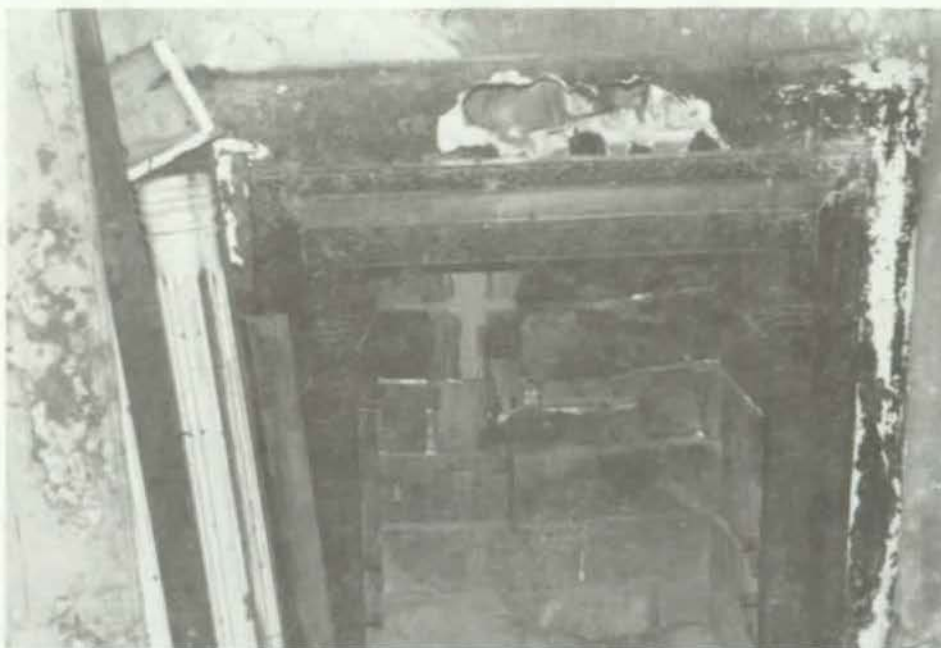
**Figure 42**  
Fireplace, Room 305, Mankin-Cox Building, May 1990  
(NPS Photo)

The mantelpiece is in pieces leaning against the wall. It appears that several pieces, including one column, are missing. The metal firebox surround is in place, but the grate is missing. The firebox bricks and bricks immediately above the firebox opening (figure 42) are cracked or missing.

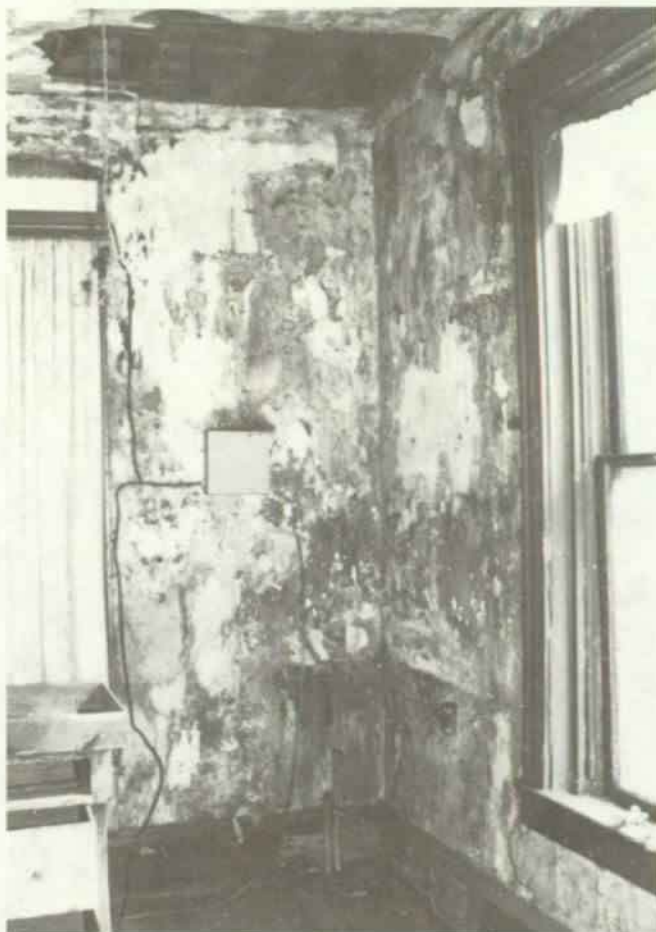
**Figure 44**  
Southwest Corner, Room 308, Mankin-Cox  
Building, May 1990  
(NPS Photo)

**Room 308.** As at room 307, the floor has pulled away from the west wall, creating a gap between the baseboard and the baseboard shoe molding. The tongue-and-groove floor is very rough with raised grain and cupping. The baseboard is painted dark brown and is patched in the northwest corner at the heating pipe in a manner similar to room 307. A small hole is in the baseboard at the center of the east wall, and there appears to be decay in the baseboard in the southwest corner, where a cabinet once sat (figure 44). The cabinet probably contained a sink as plumbing lines still exist through the floor in this corner. The rough dimensions of the cabinet can be determined by the paint line at the baseboard and a differentiation of wall color.

The plaster walls are wallpapered, although many of the seven layers of paper have peeled, especially in the southwest corner where there appears to have been a leak from the roof. The plaster ceiling is missing in this corner as well. The plaster walls are in fair condition, with areas of cracking and small areas of loose plaster concentrated in the northwest and southeast corners of the room, especially around the windows. A small area of rough and missing plaster also occurs at the area of the former cabinet. A large crack in the plaster has occurred in the northwest corner, where the interior wall has pulled away from the exterior wall as the building settled. The ceiling is wallpapered and, in addition to the missing area, has cracked and loose plaster. At the east wall, a ghost suggests that a wall cabinet, mirror, or other large object once hung here.

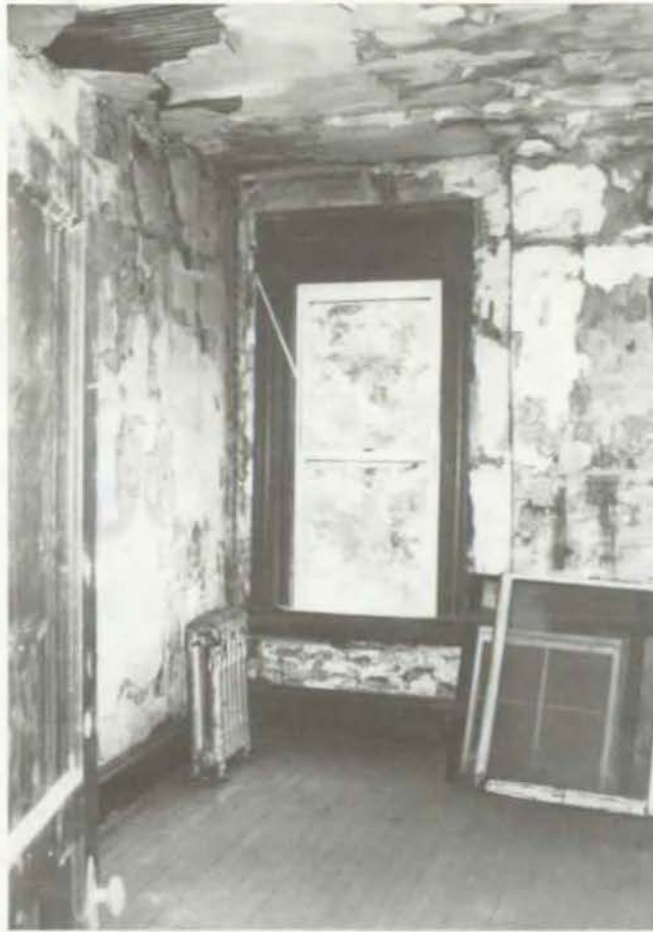
**Room 309.** The tongue-and-groove floor of this room is rough with some cupped areas. The baseboard is dark brown and has areas of loose top molding. Electrical boxes are located in the baseboard at the east and west. The plaster walls are covered with approximately 10 layers of wallpaper. Cracks and some delamination of the plaster's skim coat occur at the eastern portion of the north wall and at the top of the east wall. Cracks occur at the doors and window, caused by the building's movement. Very significant cracks occur in the southeast and southwest corners where the interior walls have pulled away from the exterior ones. Most of the plaster ceiling is loose or missing. The original mantle in this room has been removed and the room's wallpaper extended down to the original metal firebox surround, which still remains. The firebox is boarded, but the grate appears to be in situ, filled with debris, including bricks and mortar from the chimney. The original radiator, one of the two remaining in the building, is in place in the southeast corner (figure 45).

**Figure 45**  
Southeast Corner, Room 309, Mankin-Cox  
Building, May 1990  
(NPS Photo)

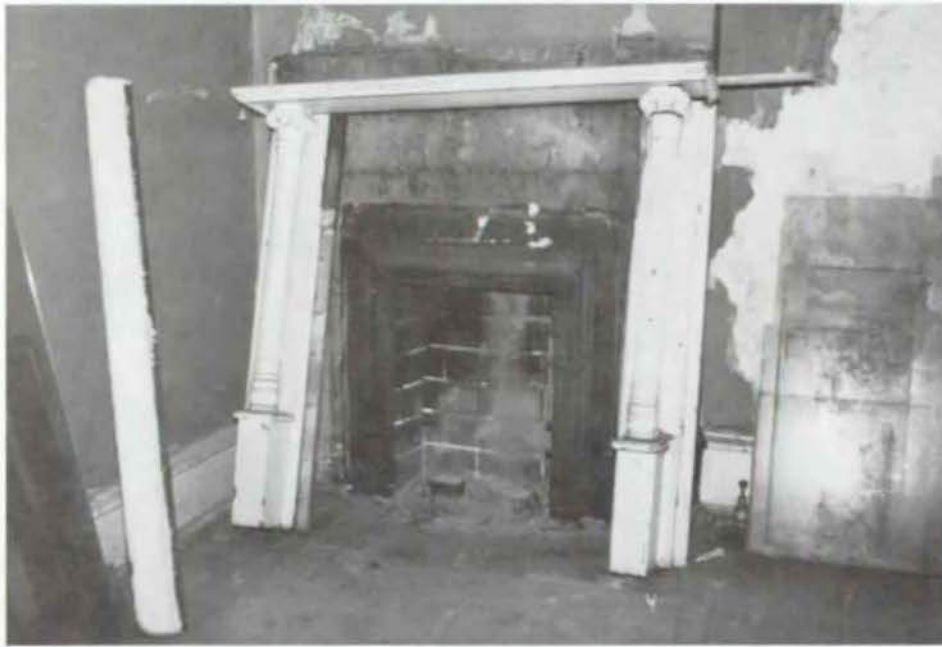
The ceiling is in poor condition, with much loose plaster. The original wood mantle (figure 46) is not attached to the wall but is leaning against it at the proper location. Several pieces of the mantle are broken. The original metal firebox surround is in place, but the grate is missing.

**Figure 46**  
Mantle, Room 310, Mankin-Cox Building, April 1991  
(NPS Photo)

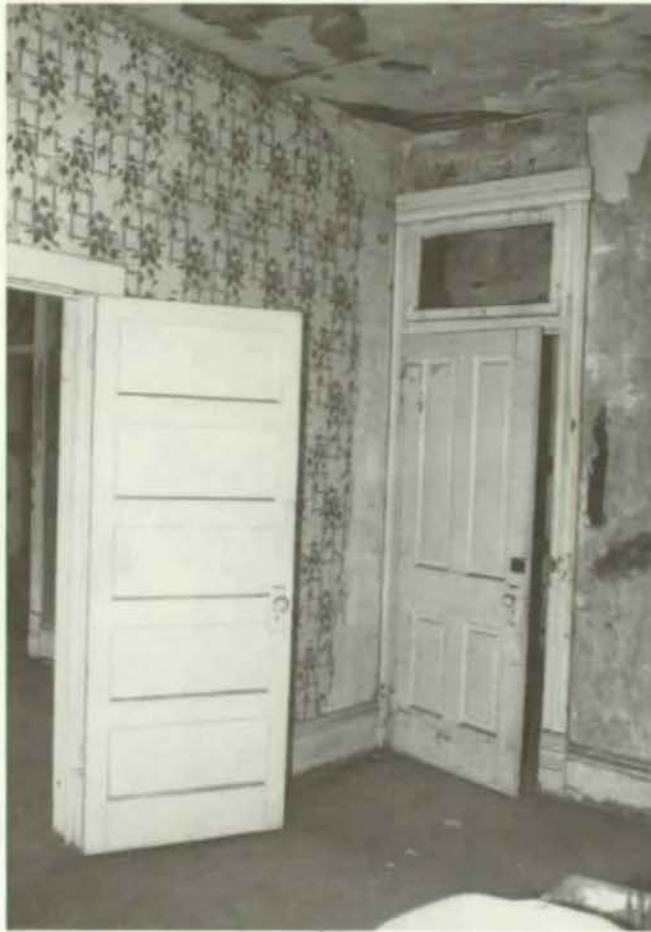
**Room 311.** This room appears to have been used as a kitchen (figures 47 and 48), based on the presence of a sink, kitchen-like wallpaper, and linoleum on the floor. All of the linoleum has been removed, exposing the original tongue-and-groove floor. The baseboard is painted white, although the paint is peeling, especially in the northeast corner. The plaster walls are papered with approximately eight layers of wallpaper. This paper is intact at the west, south, and southern half of the east walls but is peeling at the remainder of the space. The plaster is loose at the top half of the north wall and has moisture damage at the north half of the east wall and at the sink. The interior walls have separated from the exterior walls. The ceiling is wallpapered, with many areas of loose and missing plaster.

**Figure 47**  
Northwest Corner, Room 311, Mankin-Cox  
Building, April 1991  
(NPS Photo)

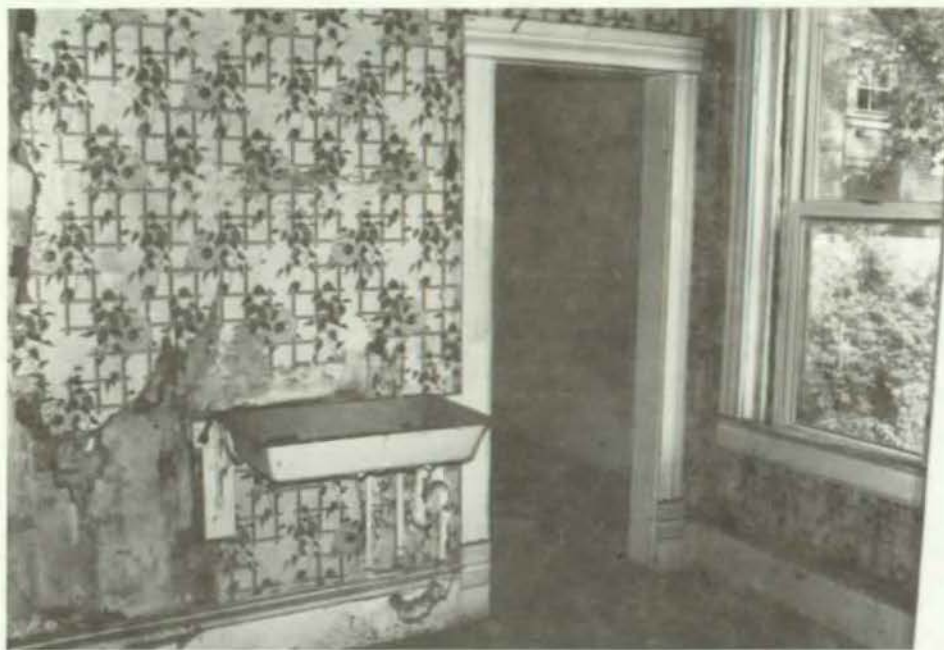
**Figure 48**  
Southeast Corner, Room 311, Mankin-Cox Building, May 1990  
(NPS Photo)

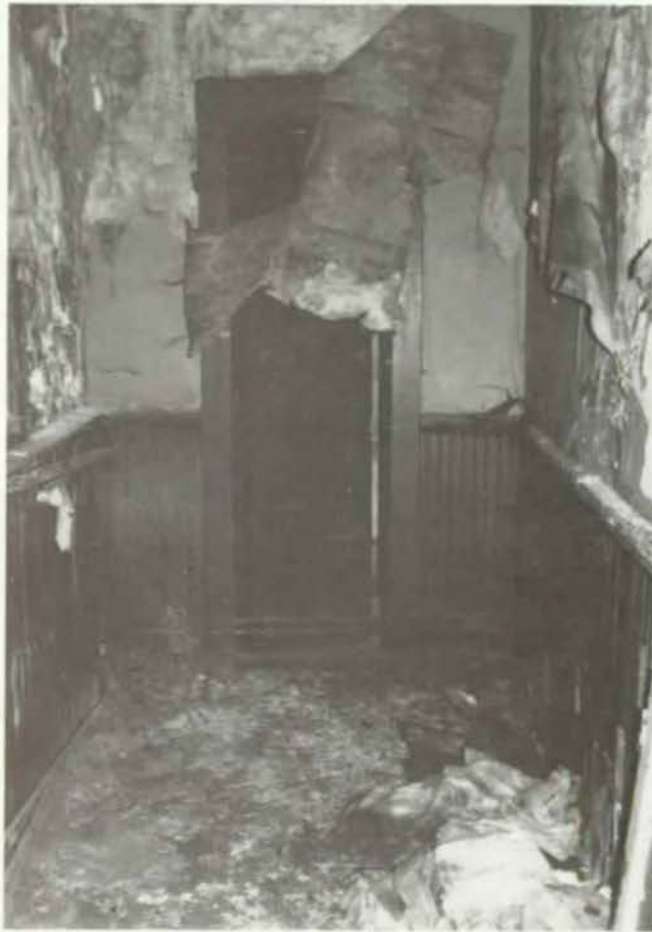
**Room 312.** This bathroom is in poor condition. Much of the tongue-and-groove flooring is rotten and has caved in, especially in front of door 316 (figure 49). Vertical beaded tongue-and-groove wainscoting, painted dark brown, is on all four walls. It is largely rotten, especially from the bottom up, and has some buckled areas. The plaster above the wainscot is papered with wallpaper, painted aqua. Most of this wallpaper is peeling. At the north and east walls, the plaster itself has severely deteriorated. At the south and west walls, it is much less deteriorated, but there are still areas of moisture damage and delamination of the skim coat. Vertical beaded tongue-and-groove boards create a chase around a cast-iron soil stack at the north wall. This chase is falling apart. Most of the plaster ceiling is missing. The remaining portions are covered with wallpaper, painted aqua, and are in poor condition. All of the bath fixtures are missing.

**Figure 49**  
South End of Room 312, Mankin-Cox Building,  
May 1990  
(NPS Photo)

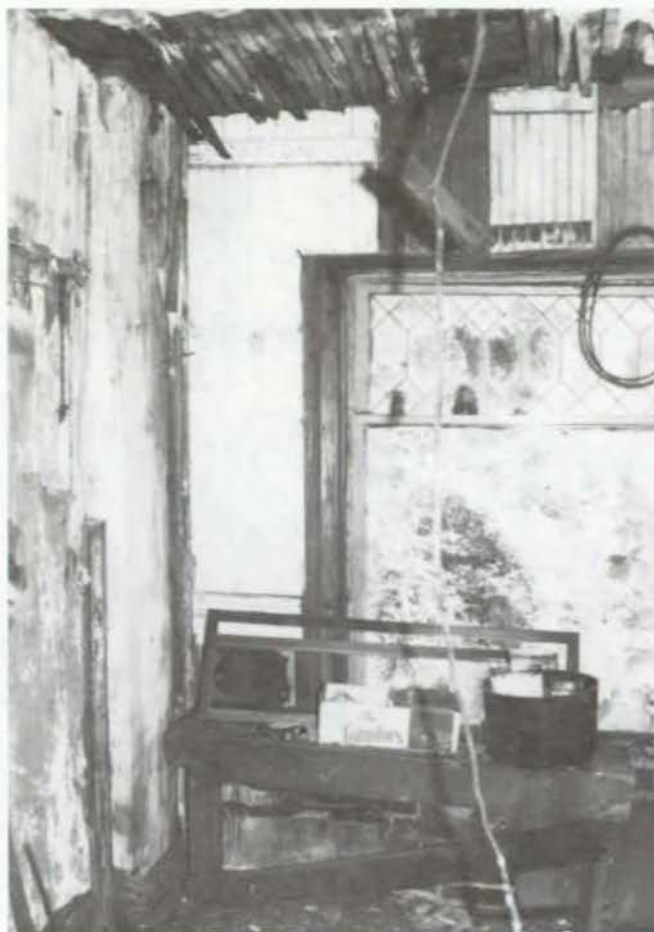
All of the walls are or were of plaster except the south wall of room 314, which was finished with various groupings of vertical beaded tongue and groove painted different colors (figure 50). The plaster walls in room 314 are papered and painted colonial blue. These walls are in good to fair condition except the east wall, which is cracked and shows signs of water damage, especially at the top. An original window opening in the west wall has been boarded over (figure 51). In room 315 the plaster walls are in poor condition. The plaster is mostly missing at the north and west walls, and is cracked and loose at the east wall. Much of the plaster at the ceilings of both rooms is gone. Remnants of wallpaper are found on the ceiling of room 314.

**Figure 50**  
Southeast Corner, Room 314, Mankin-Cox  
Building, May 1990  
(NPS Photo)

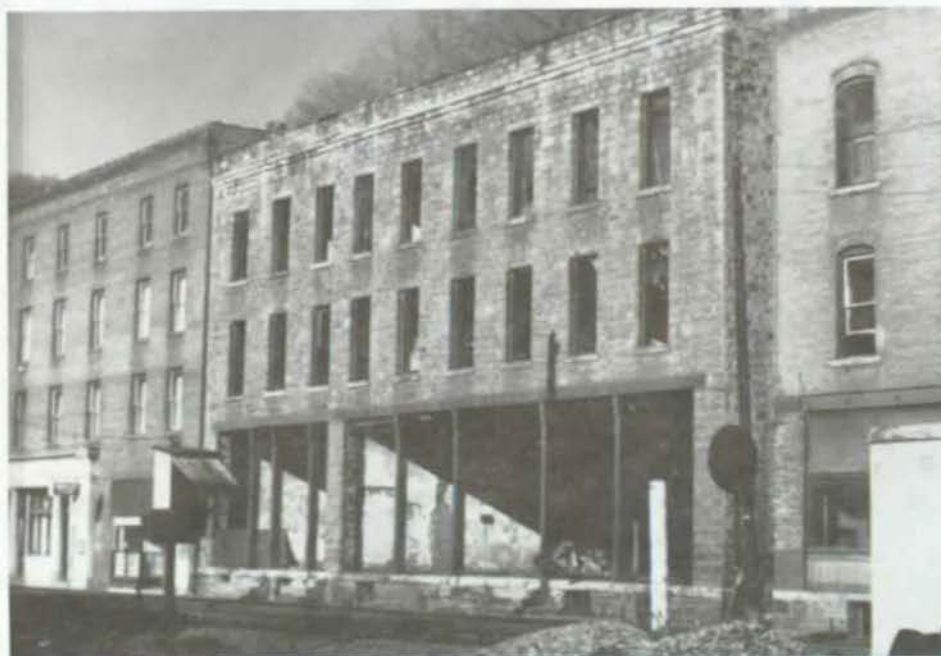
The current storefronts and upper windows at the west elevation are not historic. Because of the humid climate and neglect, little was left of these elements by 1975 (figure 53). The current storefront at the northern end of the building was constructed in 1975 or shortly thereafter. The storefronts and upper windows at the southern end of the building were part of movie sets constructed for "Matewan," which was filmed in Thurmond in 1985. A wooden platform running the full length of the building was also built for the movie but was removed in July 1990.

**Figure 53**  
Goodman-Kincaid Building, November 1975  
(NPS Photo)

In general, little original fabric remains in the interior of the Goodman-Kincaid Building, only scattered remnants of plaster and window frames. In the 1960s, the southern two-thirds of the building collapsed. The northern third of the building remained standing but was apparently in severe disrepair. Photographs from 1975 (figure 53) indicate the extent of the neglect from which the building was suffering.

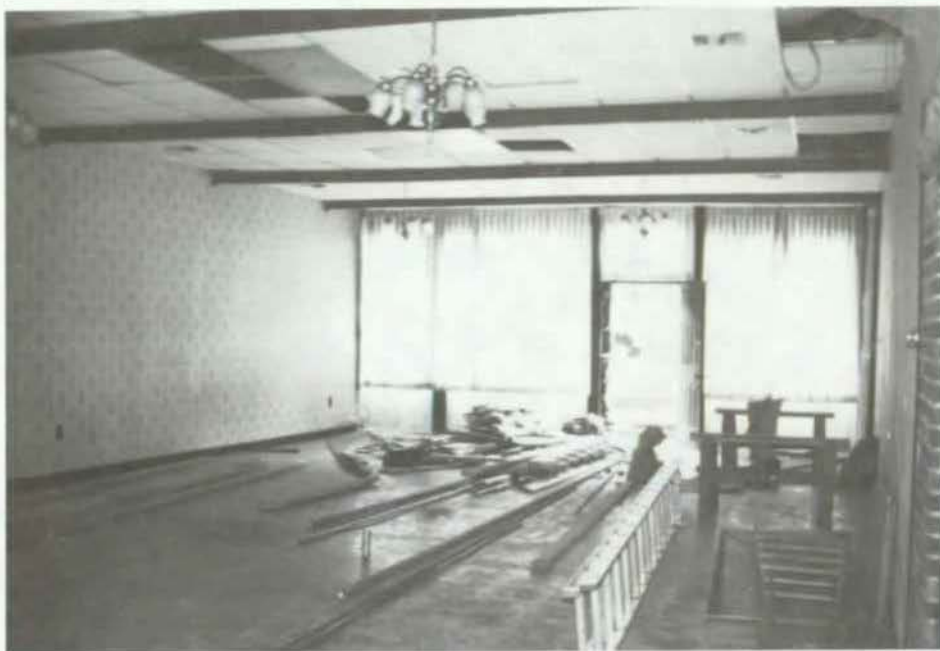
**Room 101.** This room served as a dining room for the Banker's Club (figures 57 and 58). The floor is finished with 12" x 12" linoleum tile with a black 4" vinyl base. Both floor and base are in good to fair condition. A section of tile in the middle of the floor was removed in the winter of 1991 to reveal the change in subfloor materials from concrete to plywood.

**Figure 57**  
West End of Room 101, Goodman-Kincaid Building, August 1990  
(NPS Photo)
