## Historic Structure Report

### Thurmond Commercial Buildings **NEW RIVER GORGE** National River • West Virginia

Historic Structure Report  
August 1992

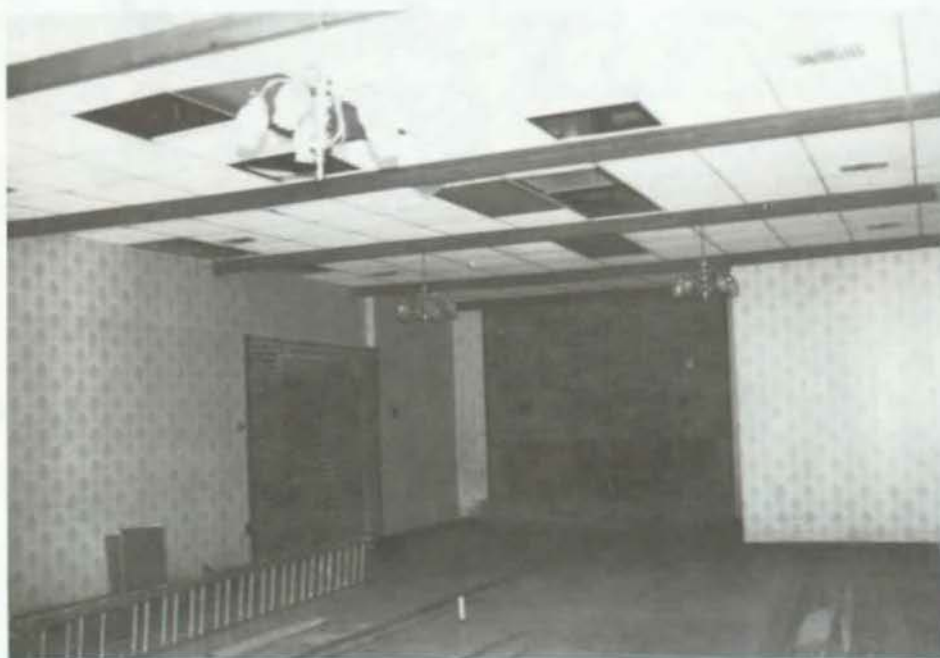
**Figure 58**  
East End of Room 101, Goodman-Kincaid Building, August 1990  
(NPS Photo)

A brick fireplace located at the far eastern wall of this room (figure 58) was probably constructed when the space was remodeled to its current configuration. The actual firebox is flanked on both sides by niches for wood storage, and, like the adjacent frame walls, the brick fireplace facade stops just above the level of a suspended ceiling. The back of the firebox is formed by the original stone wall, while the backs of the wood storage niches are brick. The fireplace is tied into an original flue in the east stone wall. The entire fireplace sits on a raised brick hearth.

A ramped passageway at the north wall joins the former Banker's Club kitchen in the National Bank of Thurmond. The walls of the passageway are constructed of brick, with the brick returning for a few feet either side of the opening along the northern wall of room 101 (figure 58). The ceiling of the passageway, as well as the ramped floor, are of poured concrete. A stone lintel heads the passage opening at room 102; it may be a sill stone from one of the blocked-up windows.

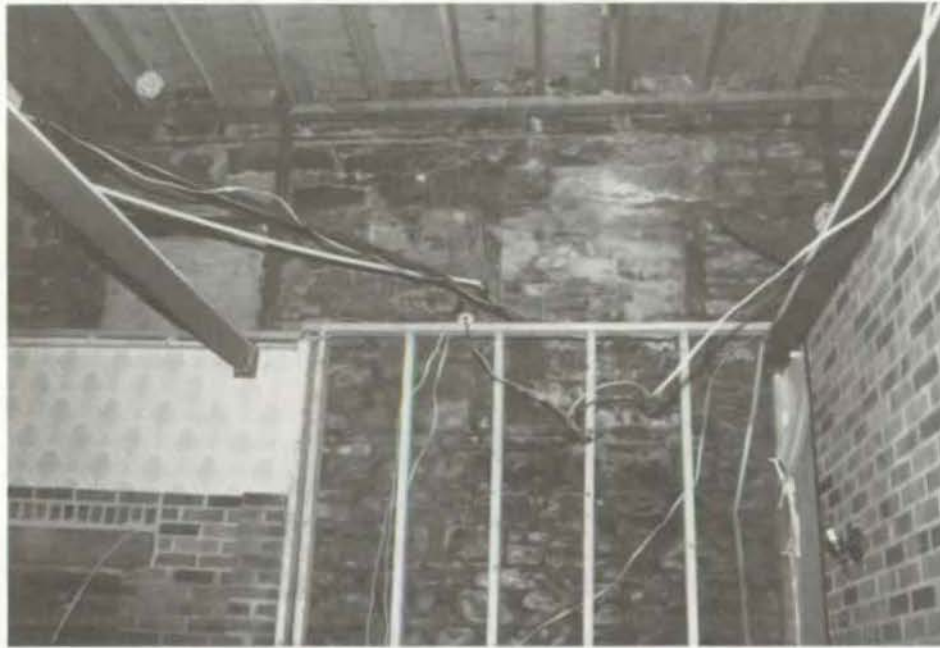
At the eastern end of the north wall, two original window openings are visible (figure 59). These openings are now below ground and were probably closed and backfilled against when the National Bank of Thurmond was constructed. Figure 6 also indicates a partition wall

**Figure 59**  
Original Windows in Room 101, Goodman-Kincaid Building, April  
1991  
(NPS Photo)

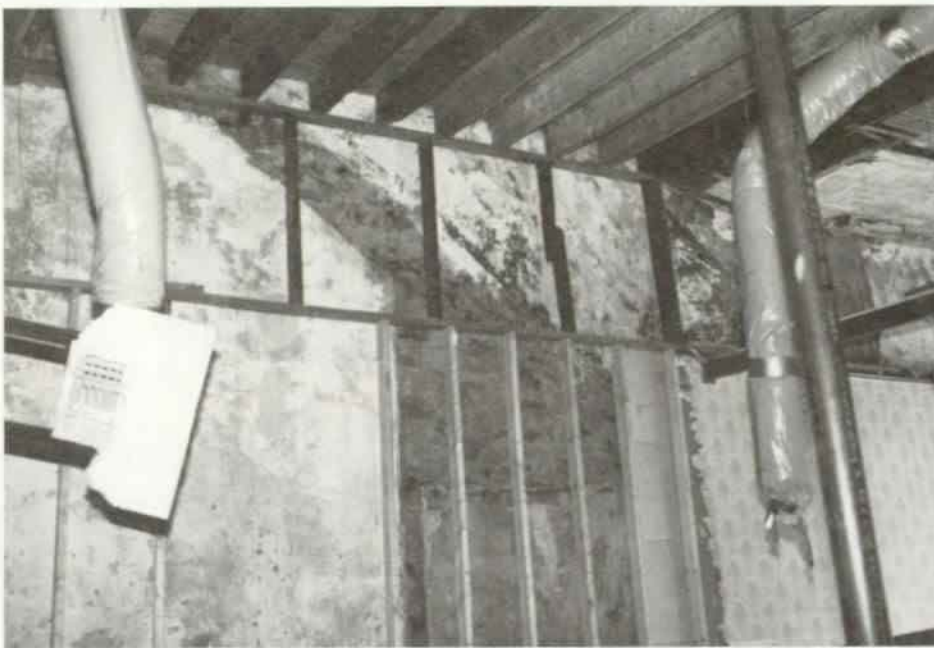
dividing the cafe dining room in the western half of the space from a back room to the east. It is unclear from the picture exactly where this wall was located. Large areas of drywall, framing, insulation, and vapor barrier were removed from the north and south walls during the winter of 1991. This removal revealed the end of the original plaster at the north wall and located the original partition wall. It also revealed the ghost of the original stair along the south wall (figure 60).

**Figure 60**  
South Wall, Room 101, Goodman-Kincaid Building, April 1991  
(NPS Photo)

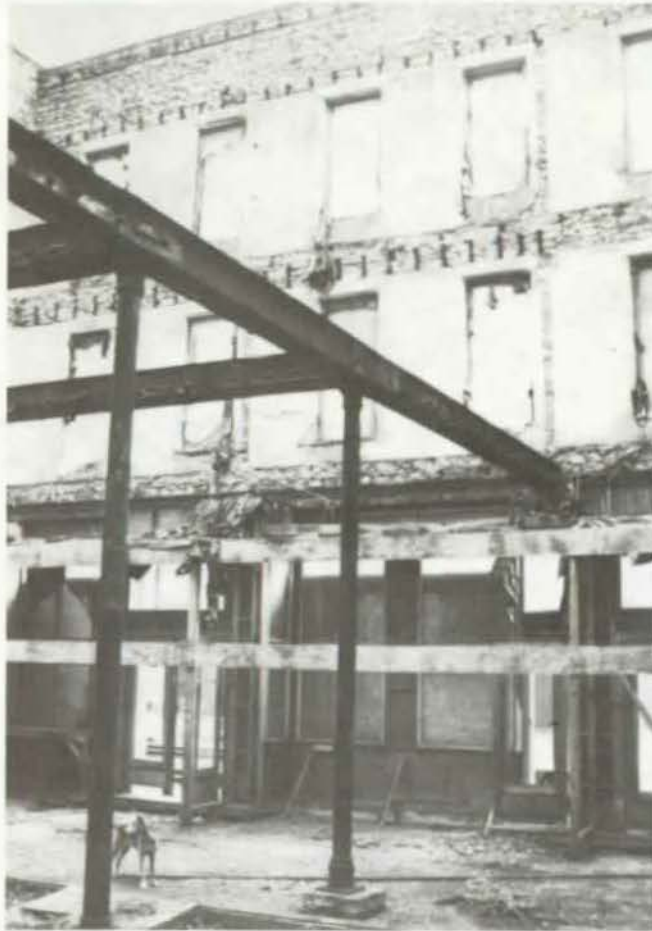
**Room 102.** This "room" comprises approximately two-thirds of the building, all the space that collapsed in the 1960s, and is now open to the sky (figures 61 and 62). Enough plaster remains on the stone walls so that the locations of partition walls at the second and third walls can still be seen. The plywood floor at the western portion of the space, over the basement, was installed for the filming of "Matewan." The remainder of the "floor" is dirt. Wild raspberry bushes were growing in this eastern portion of the space, but they were removed in July 1990. A couple of trees were also growing in the northern and eastern walls at the second floor level. One tree in the east wall was approximately 12" in diameter before the trees were cut back in July 1990. At the first-floor level, four steel columns and three steel beams of the second-floor framing system remain in place, though severely rusted. As stated above, all of the windows and storefronts at the west wall were constructed for the filming of "Matewan."

**Figure 61**  
West Wall, Room 102, Goodman-Kincaid  
Building, August 1990  
(NPS Photo)

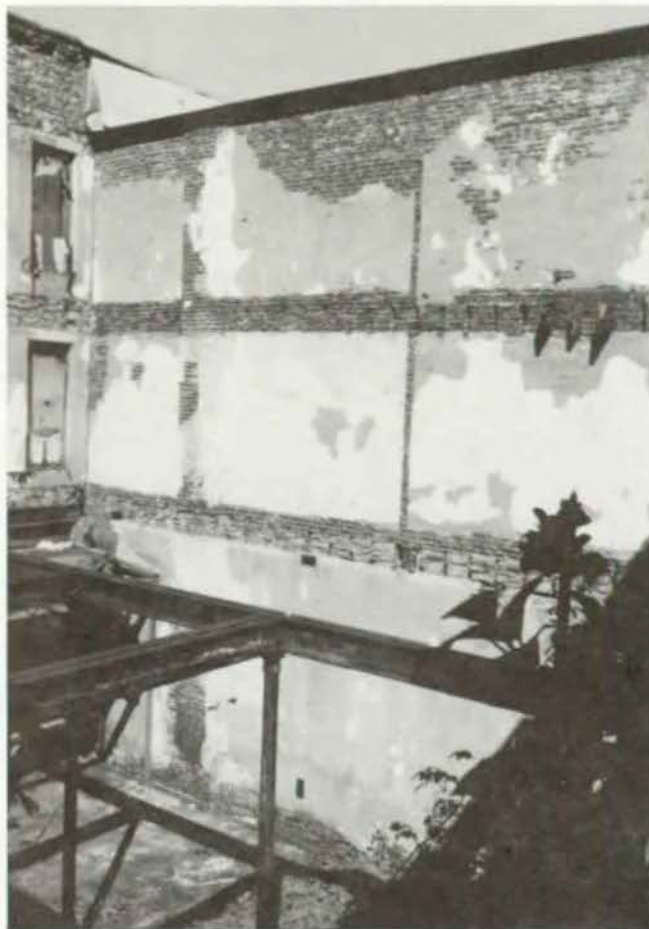
**Figure 62**  
South Wall, Room 102, Goodman-Kincaid  
Building, April 1991  
(NPS Photo)

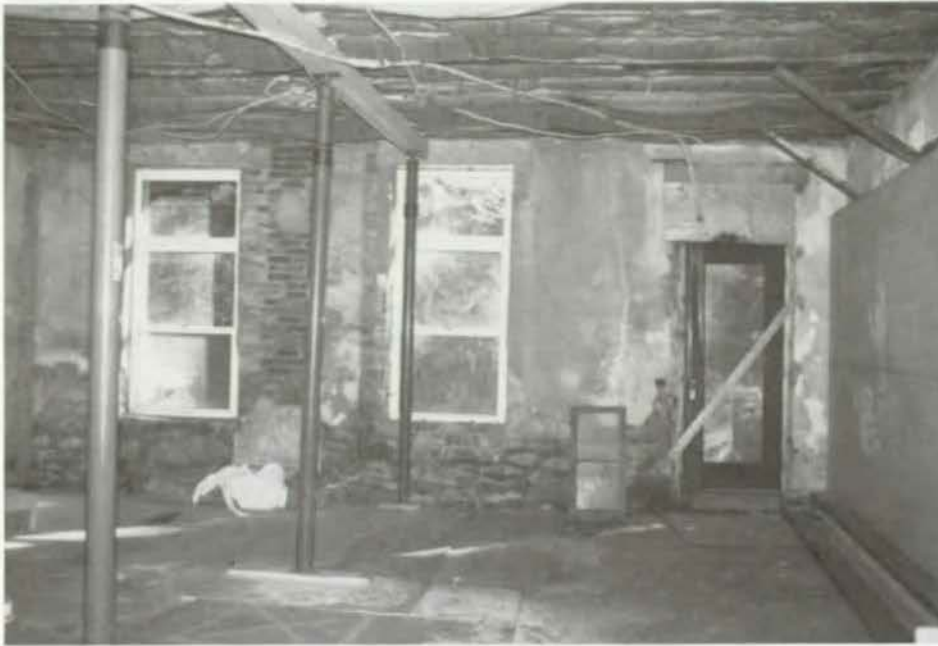
**Room 202.** This space is currently unfinished and unused. The floor is of plywood, and there is no baseboard (figure 63). Several areas of the floor are particularly springy, such as at the bottom of the stairs to the third floor and to the west of the door into the laundry room.

**Figure 63**  
 East End of Room 202, Goodman-Kincaid Building, April 1991  
 (NPS Photo)

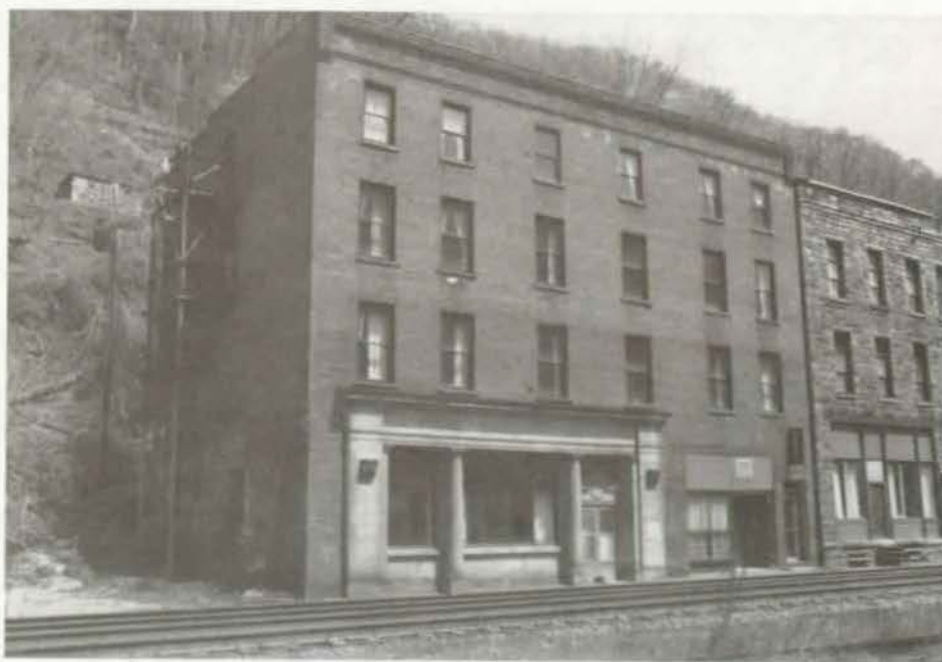
The track or west elevation (figure 68) of the building has an irregularly spaced six-bay fenestration pattern on the second, third, and fourth floors. The first floor is divided into two bays. The southern bay consists of a storefront, much of which may be original, and a modern metal door set into the original second-floor access doorway at the far south end of the building. This southern storefront consists of recessed double doors, with a small display window to the south and a large display window to the north of the doors. The masonry opening above the windows is currently infilled with masonite panels, but remains of horizontal wood siding over prism glass panels can be seen from the interior. The prism glass is probably original, but this cannot be confirmed from historic photographs because an awning was deployed at this storefront. The original storefront at the north end of the building is documented in only one photograph from 1920 (figure 4). This original storefront had a central recessed entry with large display windows to either side. In the photograph it is unclear what the area above the windows and door is made of, though it appears solid. It probably is an area of prism glass, as remains of prism glass can still be found behind the masonite panels above the southern storefront. This original storefront was replaced with the current neoclassical limestone facade in 1923 (figure 67). This facade is formed by rectangular end pilasters, a dentiled and carved frieze, and two semi-Doric columns dividing the storefront into three bays. The double-width center bay and the northern bay contain large fixed-pane windows, each topped by a square sash with eight muntins radiating outward

**Figure 68**  
West and North Elevations, National Bank of Thurmond, April 1991  
(NPS Photo)

The top of the west elevation consists of a corbelled parapet. Two courses below the very top of the wall, the corbelling extends outward a full brick width and is topped with a mortar wash. This mortar wash is in fair condition and is not adequately protecting the bricks. Several of the bricks have cracked, and moisture is entering the cracks and freezing, causing the face of the bricks to spall off.

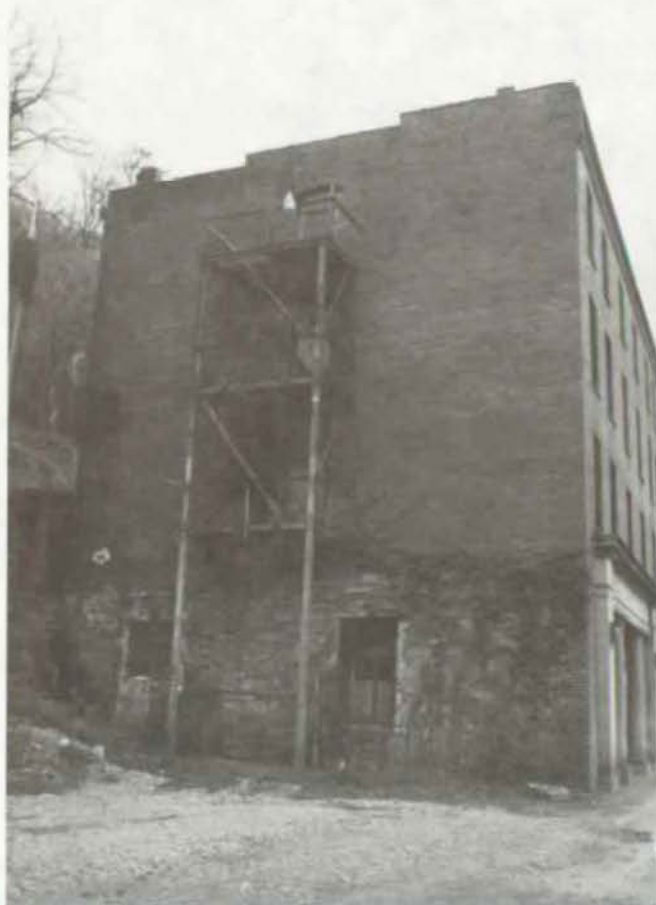
The north elevation (figure 69) of the building is very plain. At the second, third, and fourth floors, a single window is centered in the middle of the wall. These windows are metal with emergency exit doors. All three windows appear to be nonoriginal installations into original openings. The heads of the third and fourth are arched, while the second-floor window is spanned by a steel lintel. Two windows, both with iron security grills, are located at the first floor. The window to the east is a later sash installed in a larger, original masonry opening.

**Figure 69**  
North Elevation, National Bank of Thurmond,  
April 1991  
(NPS Photo)

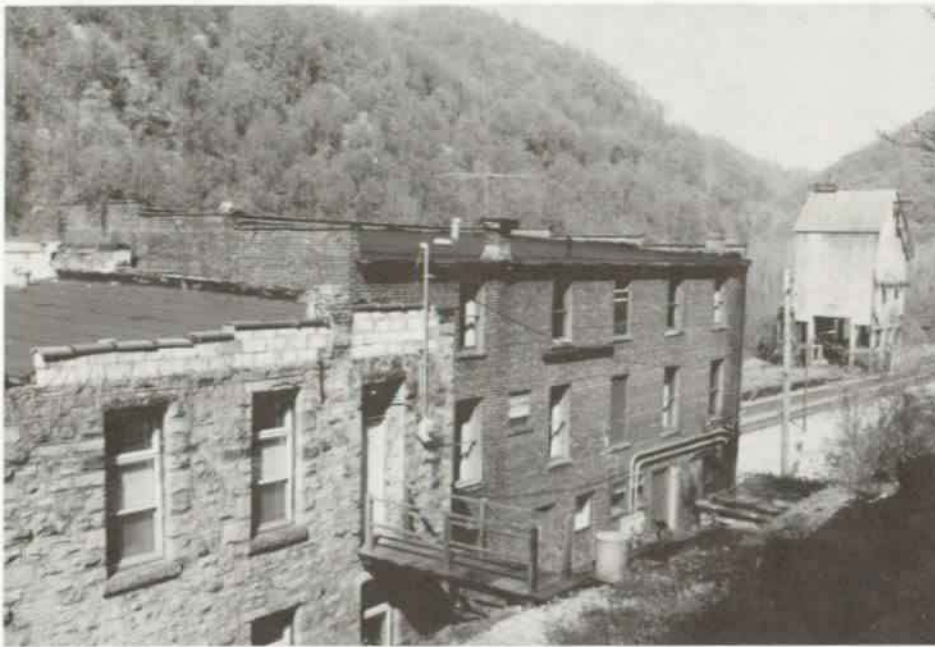
The east elevation (figure 70) is brick on the top three floors. The first floor is stone and is below grade on this side of the structure. At the far south end of the building are two original window openings at the landings of the interior stairs. The upper window is the original one-over-one double hung typical of the building, while the lower opening has been converted to a very short door. This door fits within the original, unmodified opening with room for a small fixed pane of glass above it. The door was evidently installed as an emergency exit, and it opens onto a deteriorating wooden bridge to grade. There are five double-hung windows on each of the third and fourth floors. An additional small, high window toward the southern end of the third floor is boarded over. Six double-hung windows are found at the second floor, with the two northernmost windows grouped together under a single brick arch. The remaining windows in this elevation are headed by steel lintels. Two small, high windows are located in the central portion of the second floor. Their tops are covered with masonite and have a bathroom vent at each masonite panel. On each floor, the third double-hung window from the north is boarded over to accommodate interior bathroom functions. The fourth-floor window is not completely boarded over and has a small window at the very top of the opening. A number of large electrical panels and meters are located at this elevation, with large conduits running between them. At the top of the east wall, roof-joist ends extend beyond the wall and are exposed to view. Wood blocking between the joists is located in the same plane as the masonry wall and is also exposed to view.

**Figure 70**  
East Elevation, National Bank of Thurmond, April 1991  
(NPS Photo)

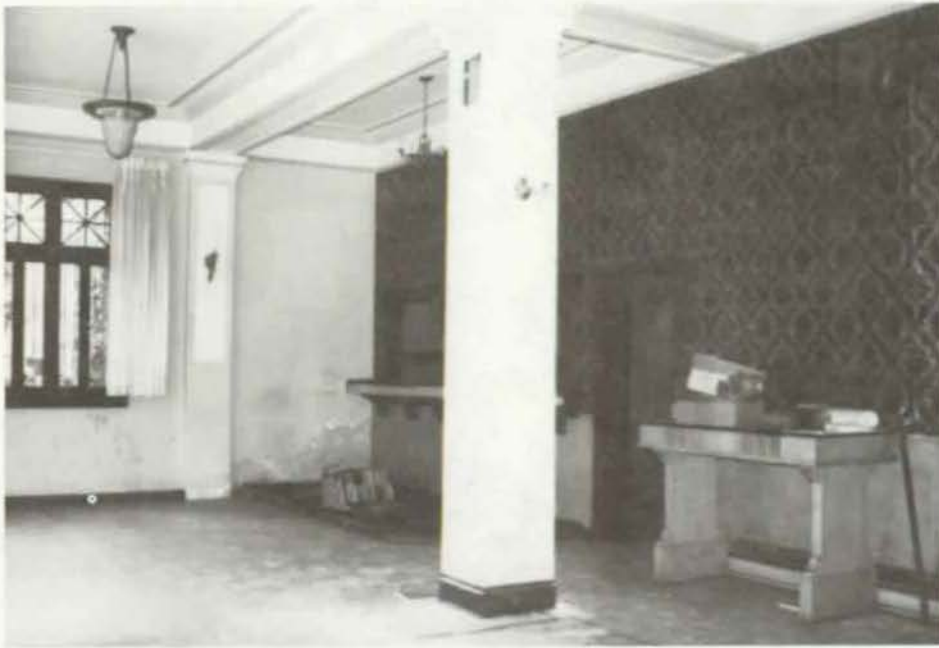
The marble check-writing stand now sits along the east wall (figure 71), just to the south of door 109. At some point, the tellers' area was moved from the banking hall to rooms 103 and 104. To accommodate this move, the existing tellers' windows were cut into the east wall of room 101. When the space was later converted for the Banker's Club, a padded edge was added to the counter at the tellers' windows, and a raised wooden platform covered in black shag carpeting was installed on the floor in front of the tellers' windows. The Banker's Club used this counter as a bar.

**Figure 71**  
Northeast Corner, Room 101, National Bank of Thurmond, August  
1990  
(NPS Photo)

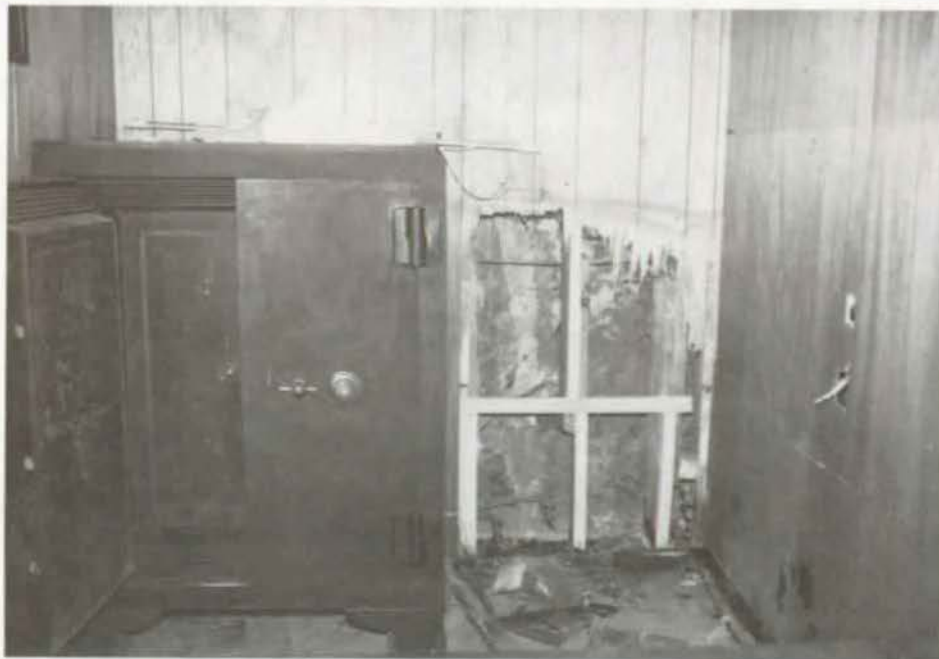
**Room 103.** Used as a teller's cage and office during the latter part of the National Bank of Thurmond's tenancy in the building, this room still contains a large safe from those days (figure 73). The safe is on wheels but is too large to be moved easily or to fit through doorways. The floor of the room is finished in 12" square linoleum tile. Much of the floor is stained, and some areas are scratched or gouged. There is no baseboard except for 4" vinyl cove at the south wall and about a third of the east wall. The walls are paneled, with water stains and possible decay along the bottom, especially at the north wall. In the southeast corner of the room, a section of paneling was removed during the winter of 1991 to expose the condition of the eastern stone wall, which is parged and in good condition.

**Figure 73**  
East End of Room 103, National Bank of Thurmond, April 1991  
(NPS Photo)

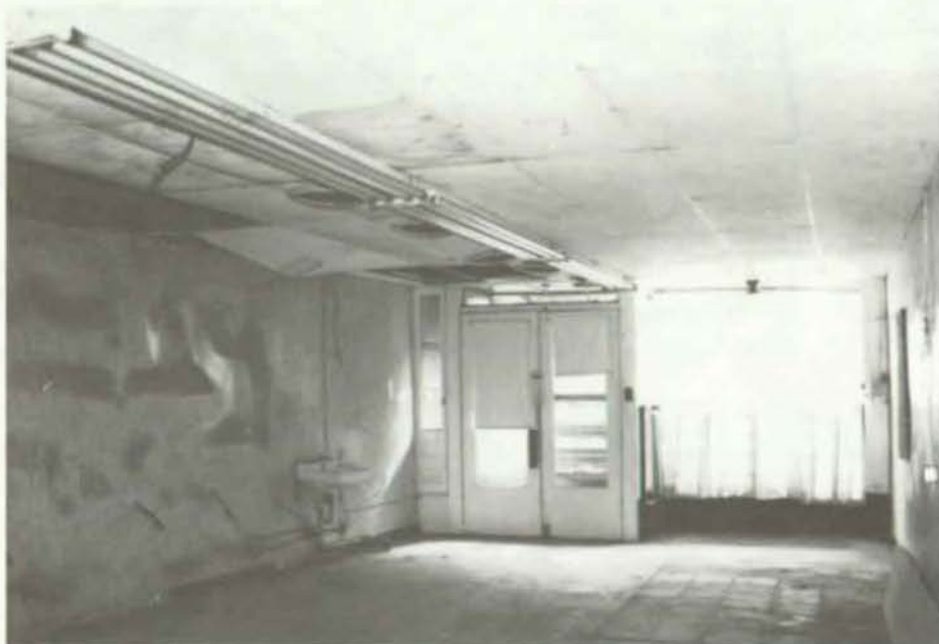
**Room 111.** This room served as the kitchen for the Banker's Club, and two sinks and some cabinets on the south wall remain (figure 74). The floor is of 1" white hexagonal tile with a blue Greek key border design in 3/4"-square tile around the perimeter of the room. Along the north wall, the border pattern turns into the room, outlining the location of an original counter from the days when this space had a mercantile function (figure 75). The border placement also suggests that a counter may have been located at the west window and perhaps used as a display surface. The tile is generally in good condition, although in a few areas tile is stained or missing. The floor at the display window and original counter is concrete. At the original counter, the floor is covered with 12"-square linoleum tile that is

**Figure 74**  
West End of Room 111, National Bank of Thurmond, August 1990  
(NPS Photo)

loose, warped, and generally in poor condition. Four-inch vinyl cove molding serves as a base but much is loose, missing, or in poor condition.

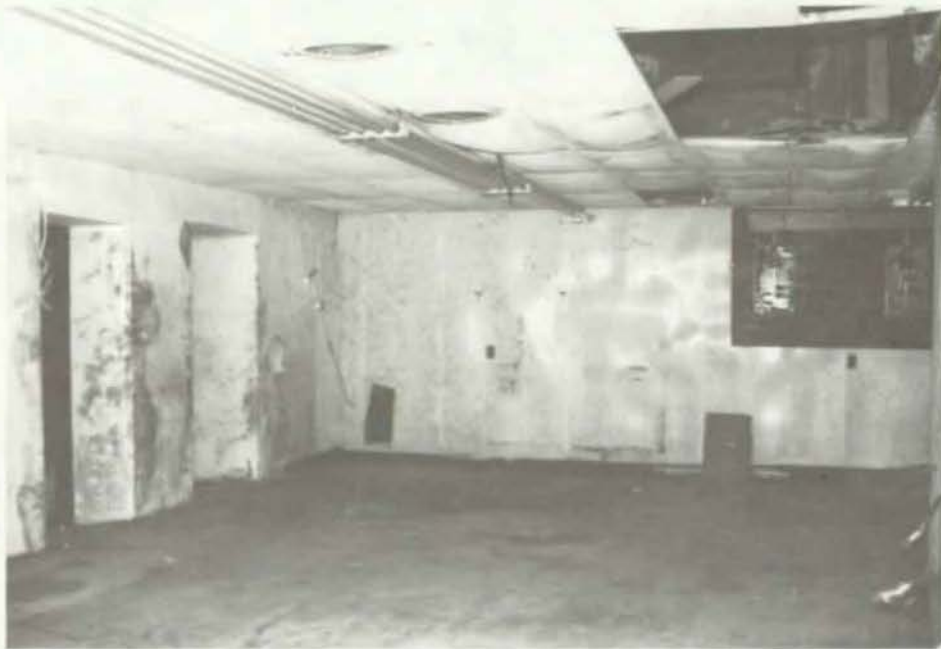
The north wall is finished in plaster. The plaster is rough in areas, with moisture damage along the bottom of the wall and significant amounts of mold growing on the eastern third of the wall (figure 76). The south and east walls are finished with plastic laminate on wood framing installed over the original wall surfaces. The laminate is white with a gold abstract pattern, is bucked from moisture, and has some areas of mold growth. In two areas where the studs behind the laminate can be seen, the bottoms of the studs are decayed. In the winter of 1991 some laminate was removed from the east wall. The studs were in poor condition, but the stone wall was in good condition. The west wall is formed by the entry doors and display windows (figure 74).

**Figure 76**  
East End of Room 111, National Bank of Thurmond, August 1990  
(NPS Photo)

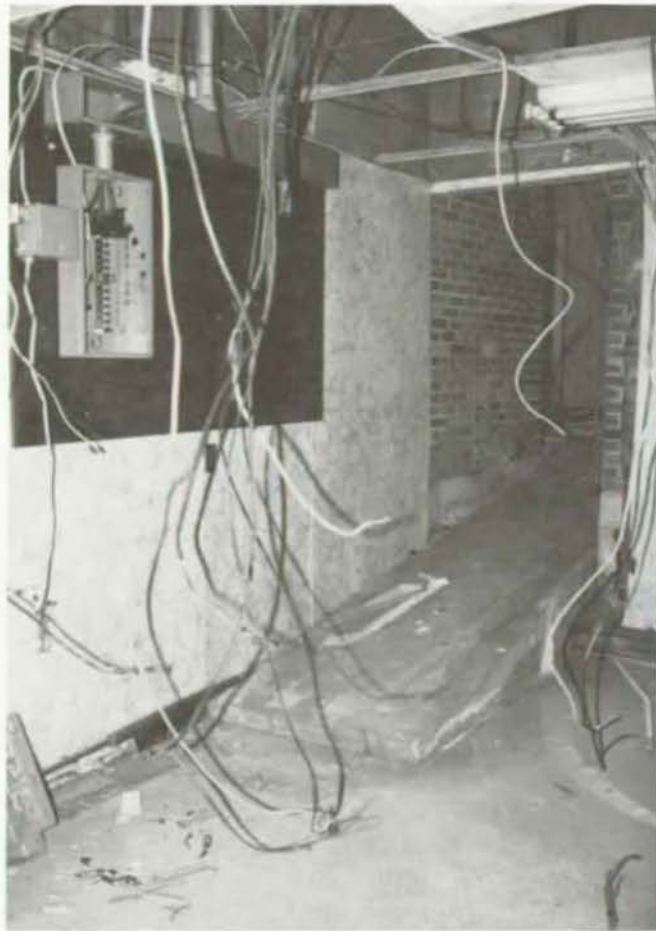
A concrete ramp up into the Goodman-Kincaid Building extends into the southeast corner of the room (figure 77). It was added after 1975, when the first floor of the Goodman-Kincaid Building was renovated for an additional Banker's Club dining room.

**Figure 77**  
Southeast Corner, Room 111, National Bank of  
Thurmond, April 1991  
(NPS Photo)

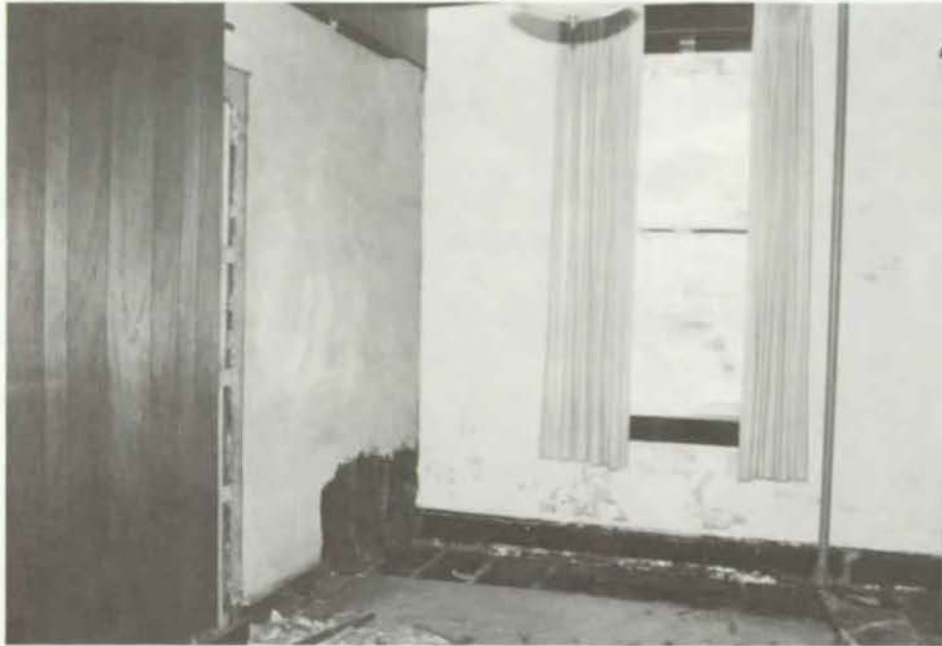
**Figure 80**

During the destructive investigation that took place in the winter of 1991, the carpet and flooring were removed from the east end of room 212 to expose the floor framing. Lath, plaster, and paneling at the bottoms of the interior walls in the northeast and southeast corners of the room were also removed. The studs thus exposed are in good condition. Removing the paneling also exposed the ghost of an original door opening on the north wall (figure 80).

Northeast Corner, Room 212, National Bank of Thurmond, April 1991  
(NPS Photo)

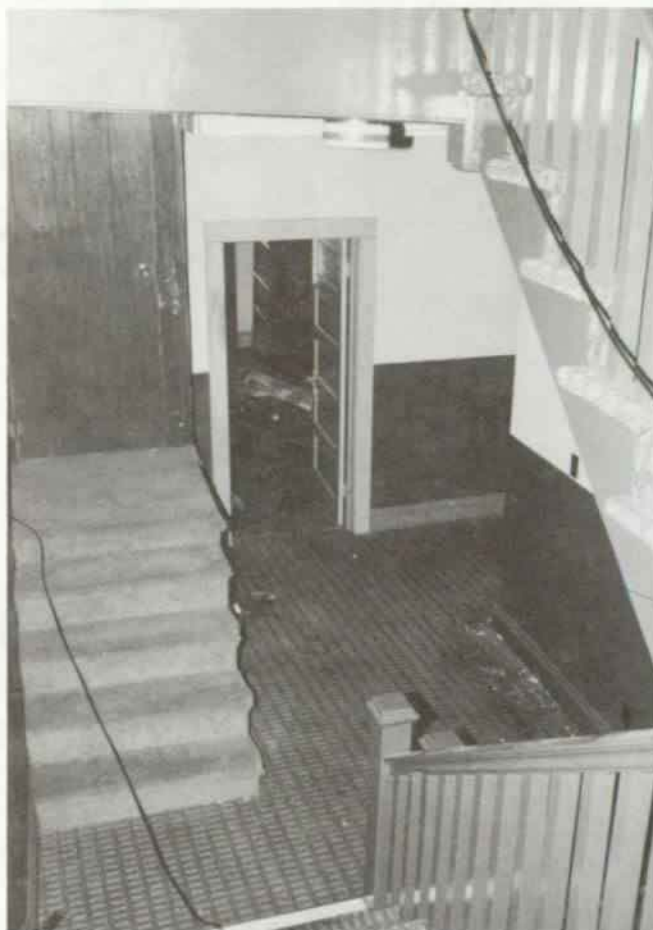
**Room 307.** Like that at the second floor, this hallway has plastered walls, painted white with a brown wainscot. However, the plaster here is textured in a brush-stroke pattern, not in a swirl pattern. It is not clear whether this texture is in the plaster or the paint. The vertical crack in the north wall of the building continues adjacent to the north window, and some other minor cracking occurs at the west wall. The plaster above door 310 is in poor condition. The floor is carpeted, and the baseboard is the typical wooden baseboard. The baseboard at the north wall is damaged. The ceiling at the main part of the hall is of 2' x 4' suspended acoustical panels, while the ceiling near the stairway is of plaster, painted white. At the south end of the hall is a set of steps and a platform that accesses a door into the third floor of the Goodman-Kincaid Building (figure 82). The steps and platform are carpeted, and a small closet is constructed on the west end of the platform. The closet exterior is of unfinished gypsum board. The platform is enclosed underneath with a set of cabinet doors, creating a storage area.

**Figure 82**  
South End of Hall 307, National Bank of  
Thurmond, April 1990  
(NPS Photo)

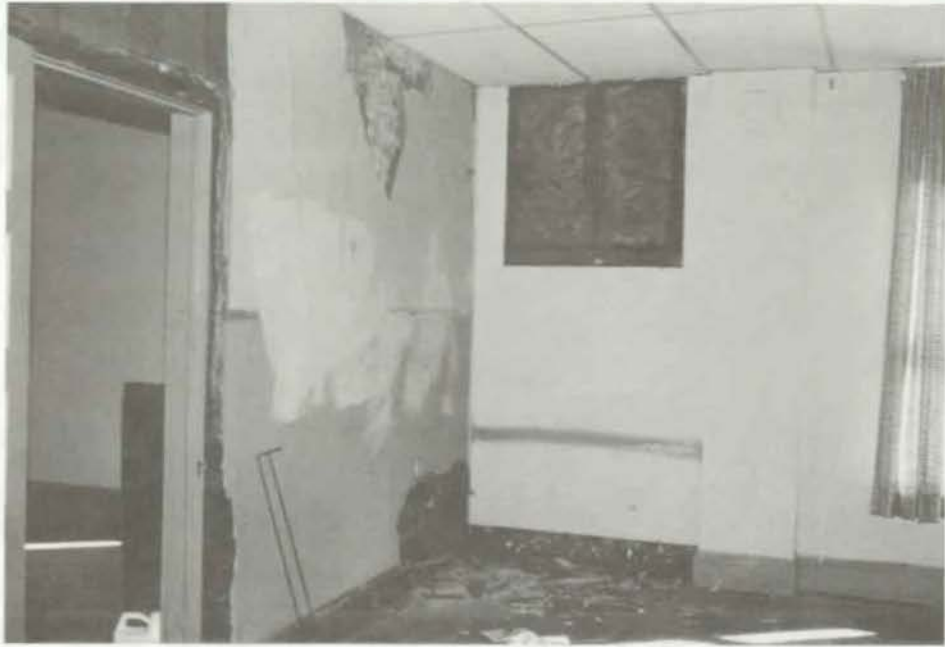
**Figure 83**  
Northeast Corner, Room 308, National Bank of Thurmond, April 1991  
(NPS Photo)

**Room 308.** During the winter of 1991, all carpeting was removed in this room. In the northeast corner, the flooring was removed to expose the floor framing, and lath and plaster were removed from the bottom of the interior wall to expose the wall framing. The studs were found to be in good condition. The wood panel covering the small window in the northeast corner was also removed (figure 83).

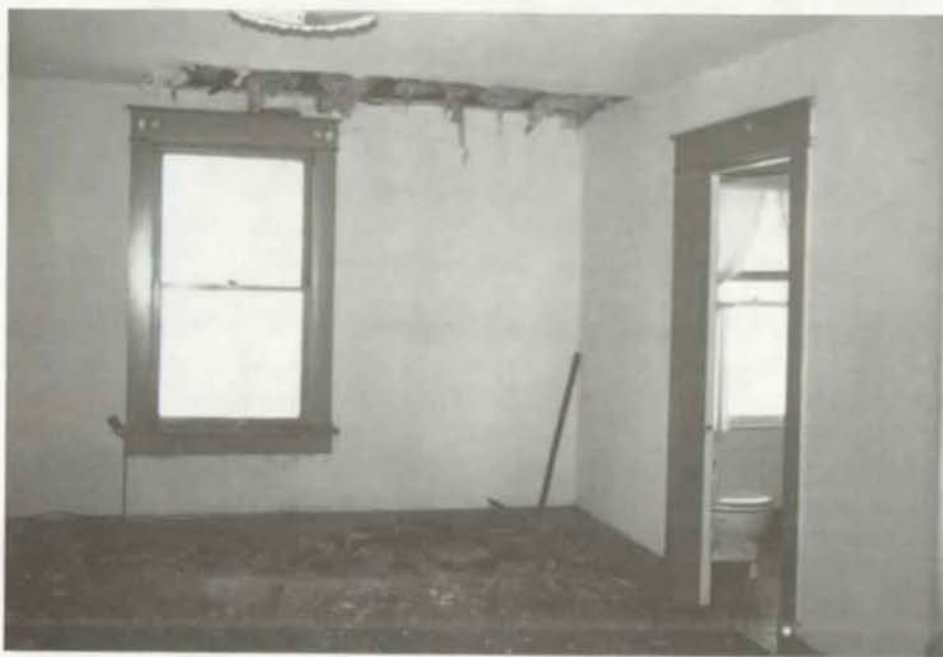
**Figure 85**  
Northwest Corner, Room 404, National Bank of Thurmond, April 1991  
(NPS Photo)

**Room 404.** This is perhaps the one hotel room that most closely retains its original finishes and character. The only changes that seem to have been made are the installation of carpeting, the painting of the woodwork, and the replacement of the original plaster ceiling with gypsum board. During the winter of 1991, a portion of the ceiling in the northwest corner of the room was removed to expose the ceiling joists (figure 85).

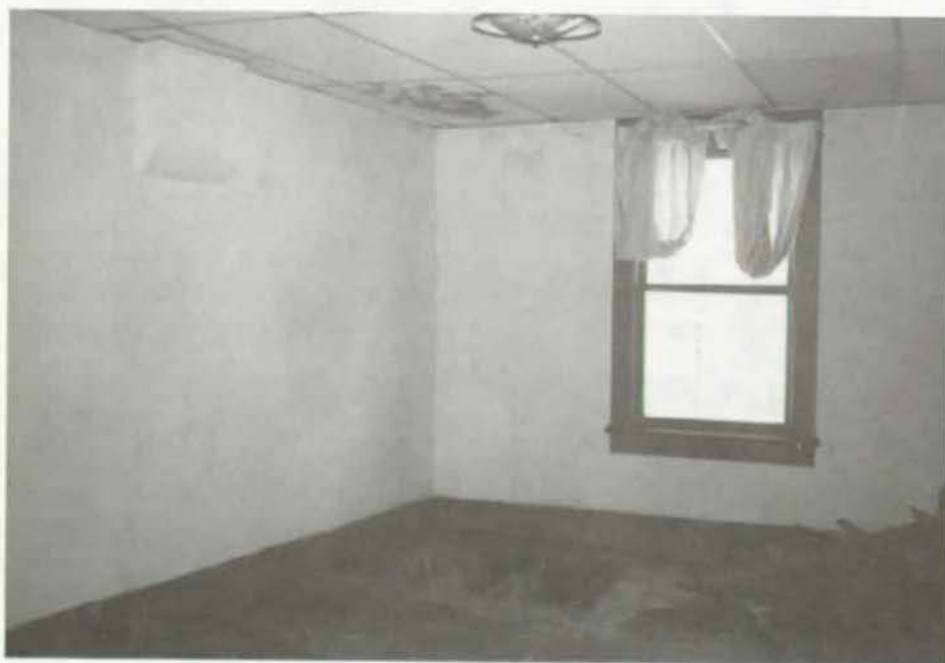
**Figure 86**  
Southwest Corner, Room 407, National Bank of Thurmond, April 1991  
(NPS Photo)

**Room 407.** The basic finishes of this room are described above. There is a 3' section of different baseboard to the south of door 408. Also, the floor slopes downward noticeably from the southeast corner toward the northwest. In the winter of 1991, a section of carpeting and flooring in the northwest corner of the room was removed to expose the floor framing (figure 86).

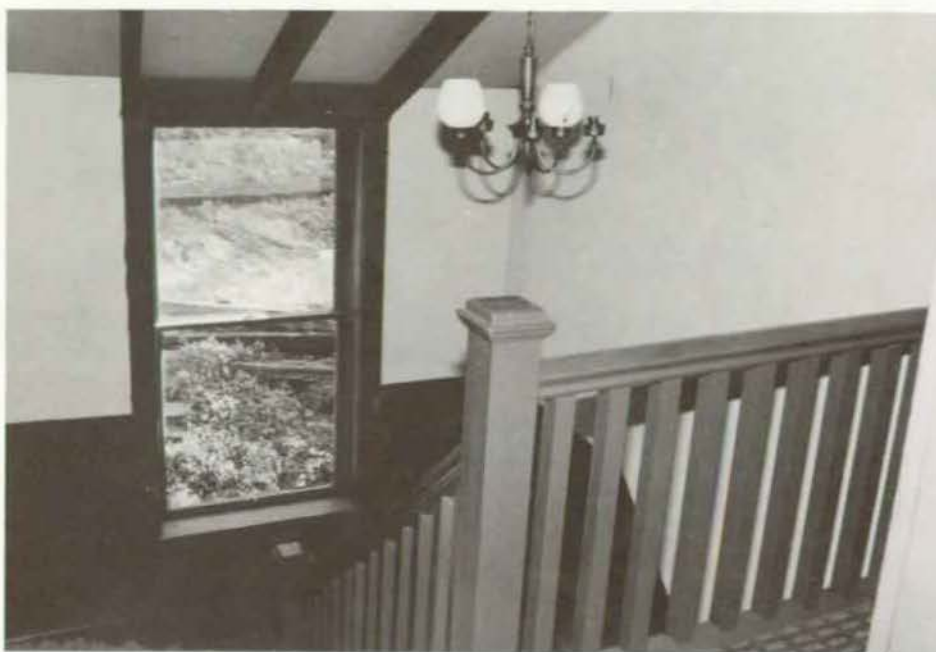
**Figure 88**  
Stair 410, National Bank of Thurmond, April 1991  
(NPS Photo)

**Room 410.** Much of this space is finished like the lower flights of stairs. The floor is carpeted, and the north, south, and east walls are plastered with a painted wainscot. The west wall is paneled, and at least the door portion of the wall was installed to comply with fire codes. The ceiling is finished with unfinished gypsum board between unfinished 3 x 6 beams, creating something of a Tudor look (figure 88). The flat ceiling at the upper landing is composed of 2 x 4 acoustical panels. The original plaster ceiling was undoubtedly flat.

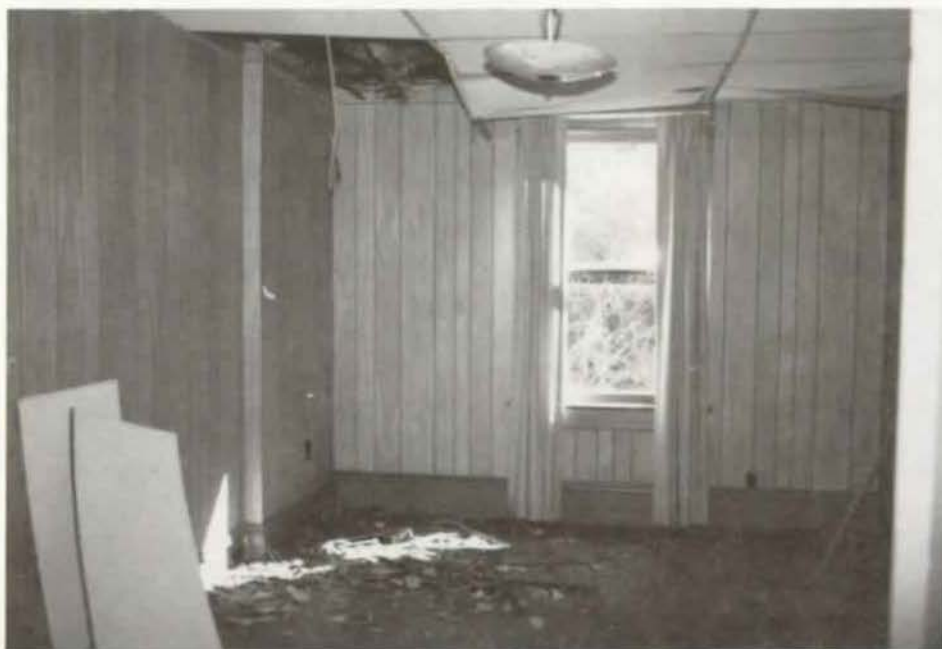
**Figure 89**

plain board covers the gap between the bottom of the higher base and the floor. All of the paneling in room 418 is light in color, quite unlike the paneling found throughout the rest of the building (figure 89).

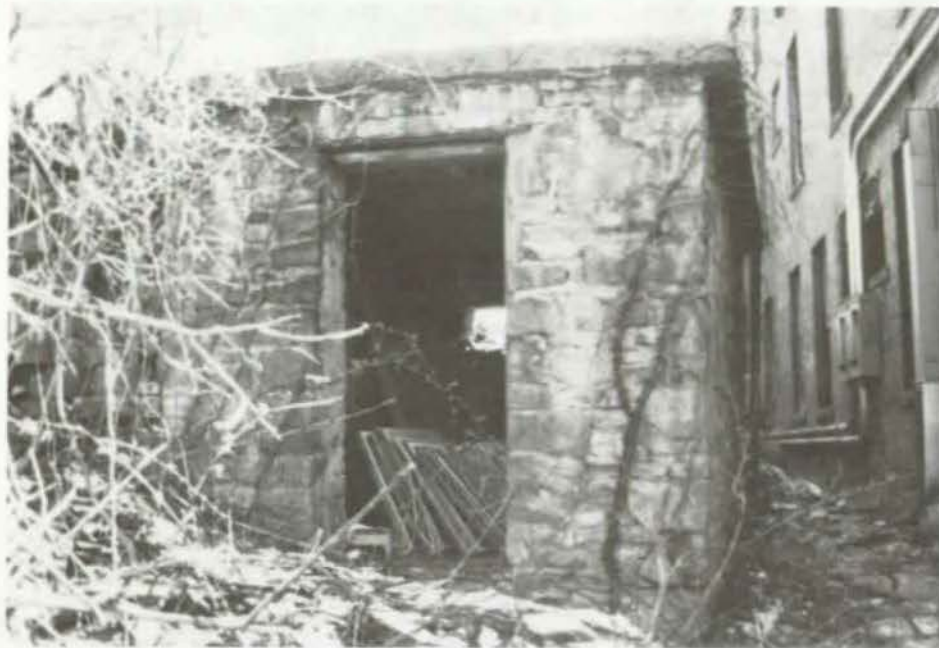
**Figure 90**  
North Elevation, Stone Structure, March 1990  
(NPS Photo)

This one-room structure is constructed of split fieldstone with a sloping concrete roof and located to the east of the northeast corner of the National Bank of Thurmond (figure 90). A single door is located in the center of the north wall, and two small windows are located in the south wall. The roof slopes downward to the south and is cracked in numerous places. Moss and other vegetation are growing on the roof, and vines cover much of the building.

The stone walls are in fair condition; only a few areas need repointing. There is a large crack connecting the window heads and wrapping around the southwest corner. This crack has been caused by the original iron lintels at the window heads rusting severely and jacking up the stones. Only the ends of the lintels embedded in the stone walls remain. The portion of the lintels spanning the openings are no longer there.

No use has been identified for this structure. The stonework inside and out should be repointed as necessary. A new wood door and windows, including frames, should be installed to match the historic ones. New metal lintels should be installed to replace rusted and missing ones. Cracks in the masonry walls should be repaired. The debris and stored material should be removed from the interior in order to perform the restoration work and determine the condition of the floor slab. Vines and other vegetation should be removed from the walls and roof.

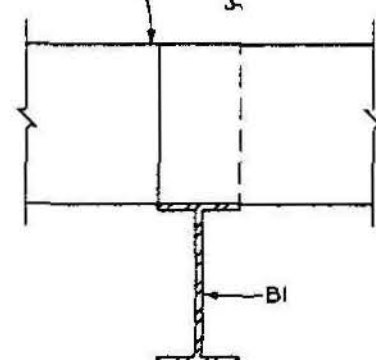
FLOOR JOIST BEARING (A)  
SCALE (B)

FRAMING IN POOR CONDITION  
DUE TO WATER DAMAGE

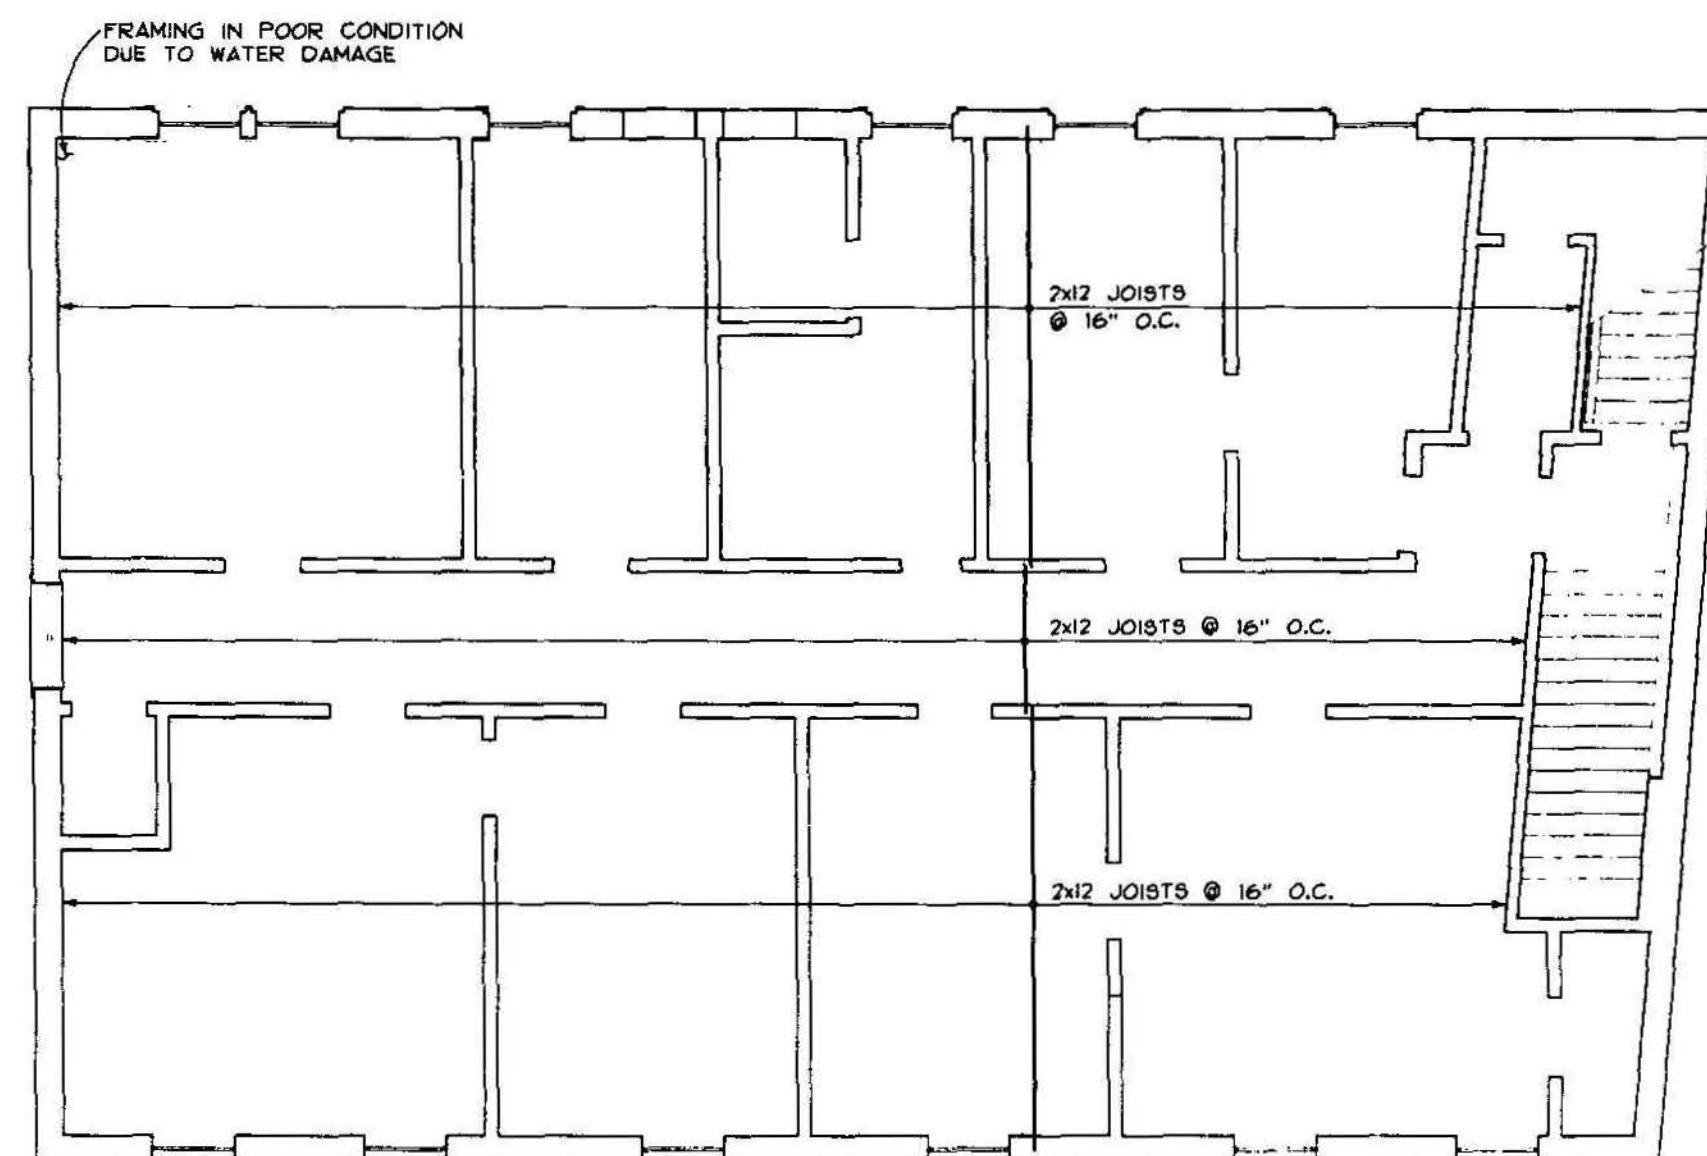
THIRD FLOOR FRAMING PLAN (1)  
S11

JOIST POCKETS DAMP,  
BEARING DETERIORATED

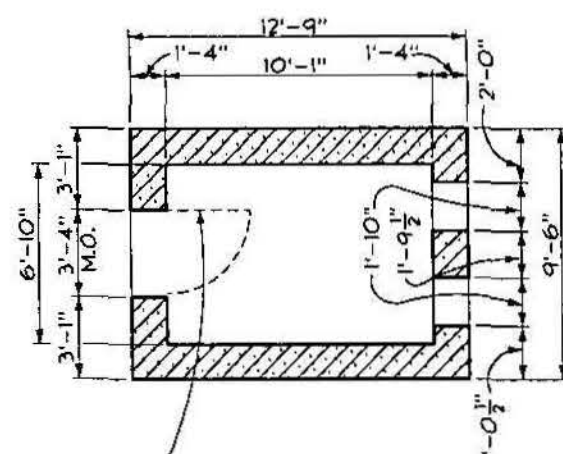
THERE IS A 5 PANEL DOOR (POOR CONDITION) SIMILAR TO BANK TYPE A DOOR STORED IN THE JAIL, ASSUMED TO BE THIS DOOR.
