## Historic Structure Report

### Thurmond Commercial Buildings **NEW RIVER GORGE** National River • West Virginia

Historic Structure Report  
August 1992

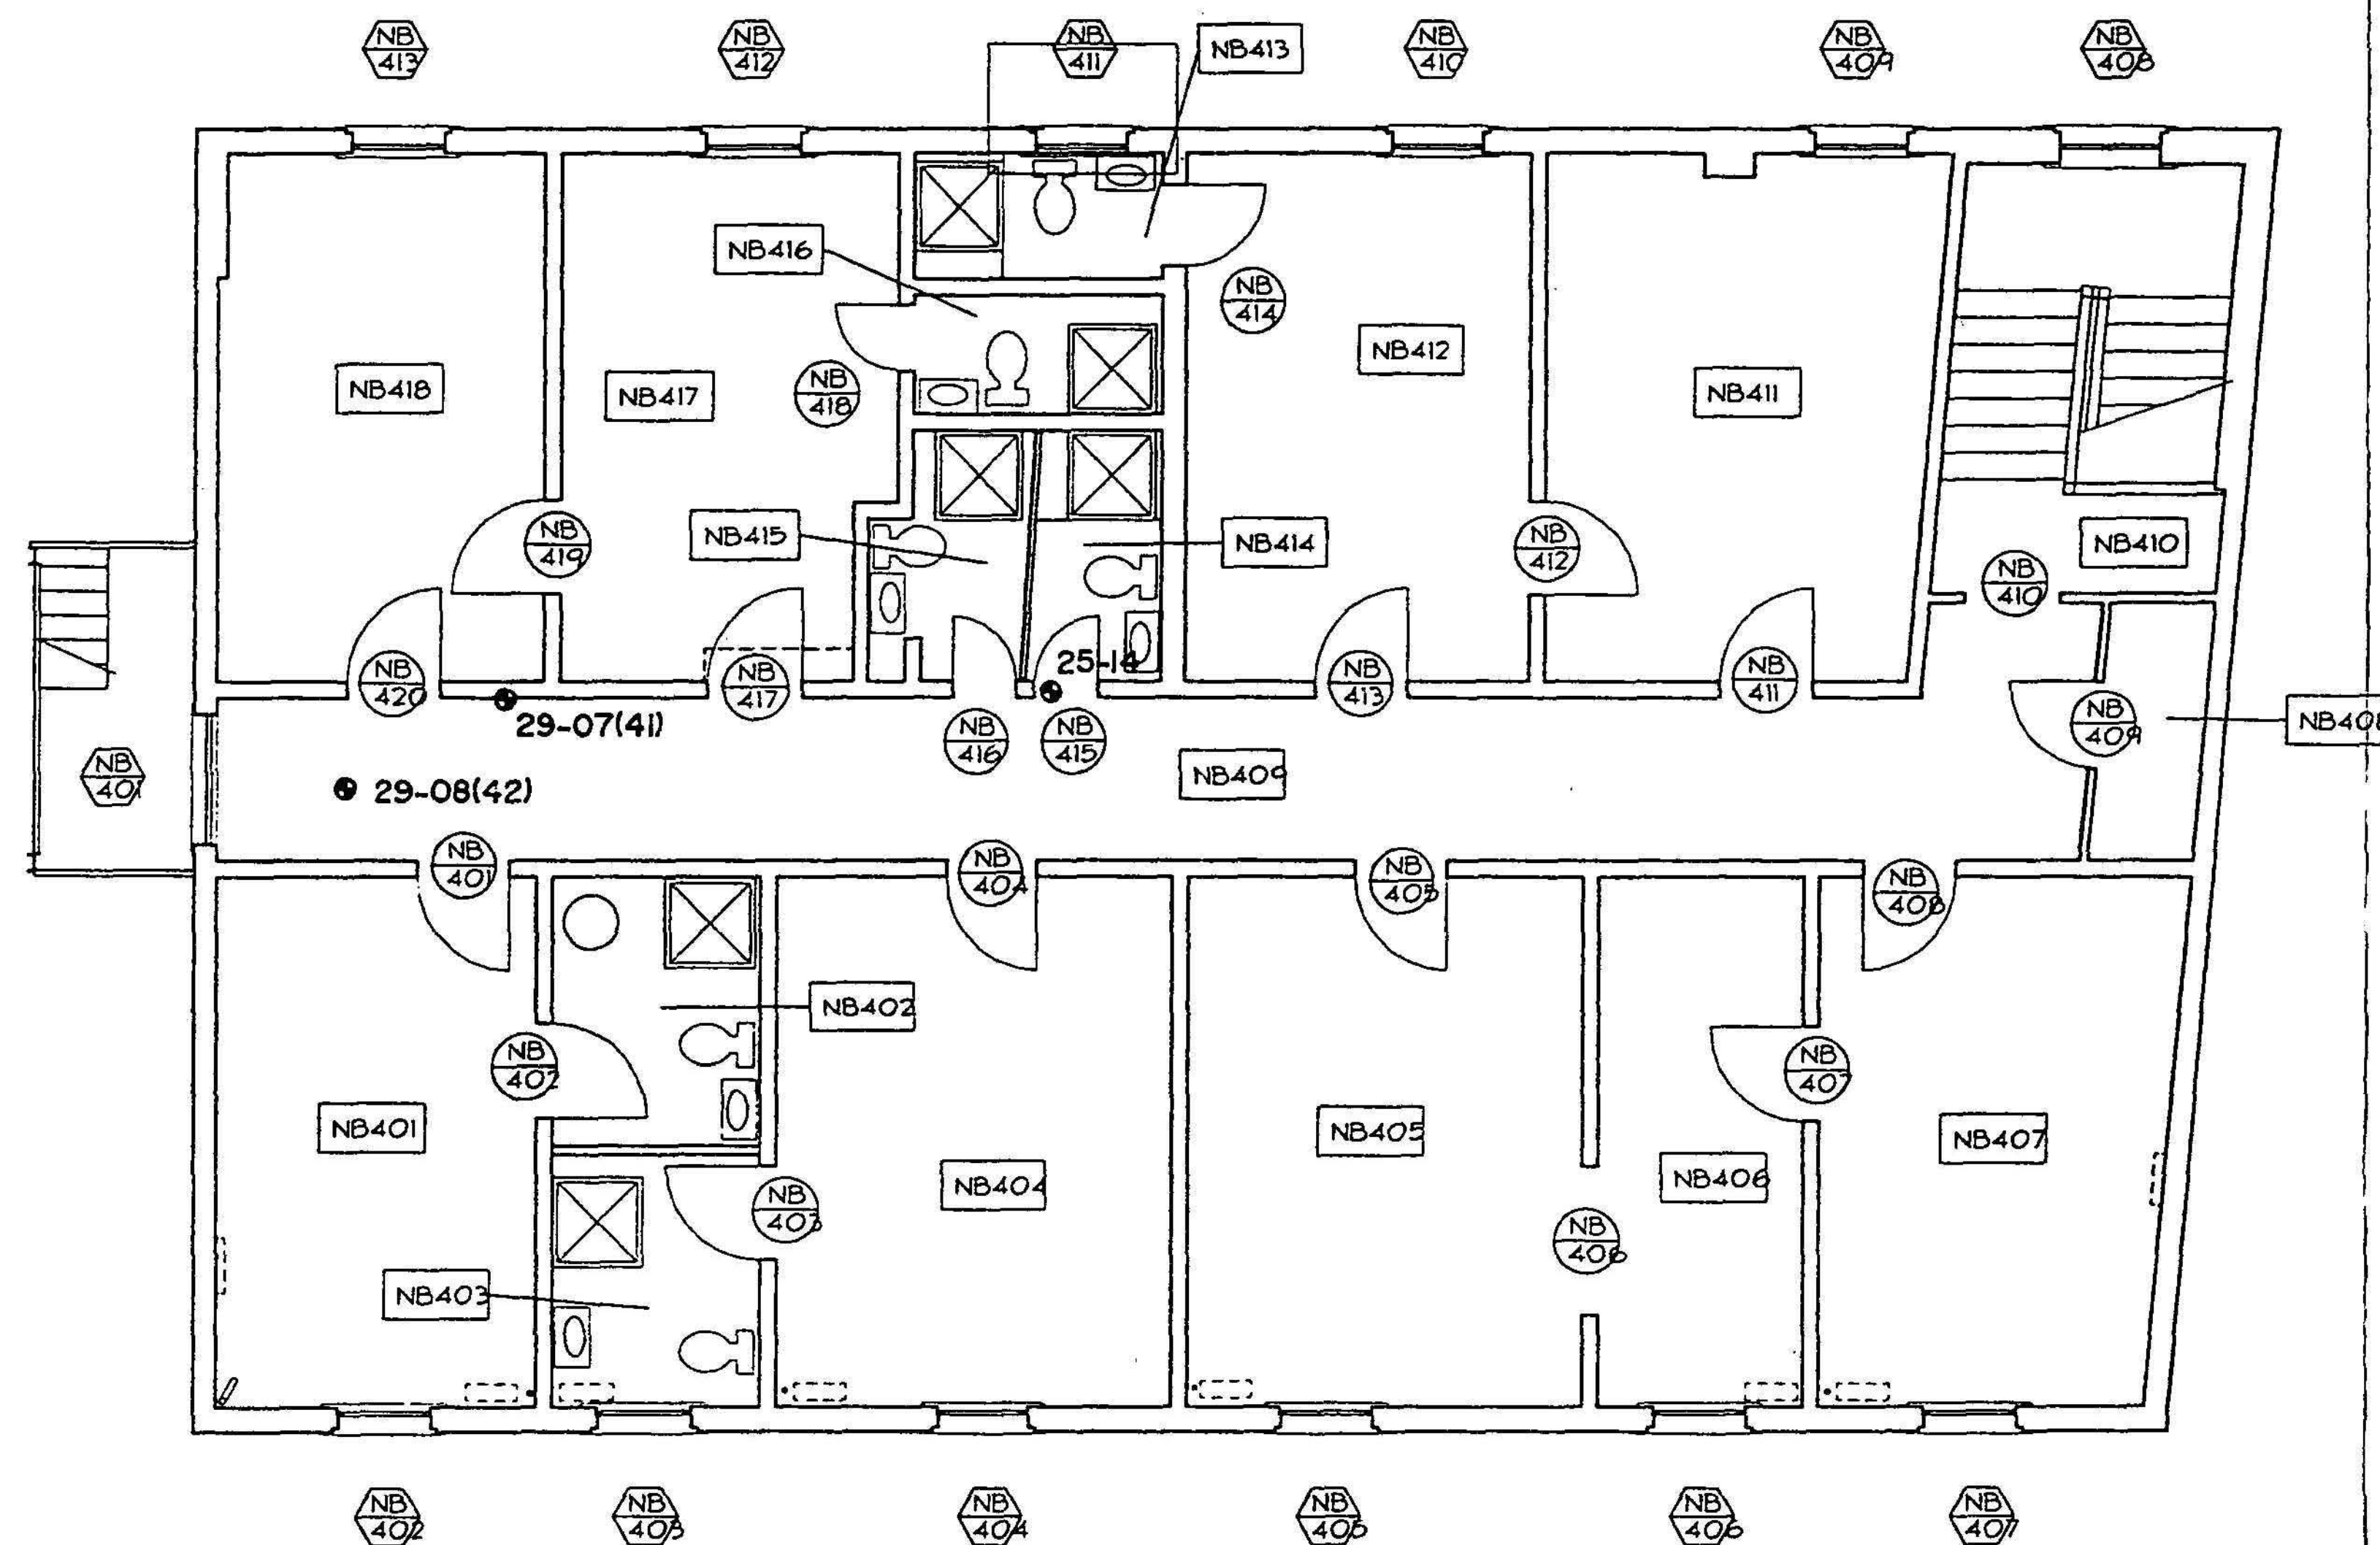
Figure 4  
LEGEND  
● Sample Point

# FOURTH FLOOR PLAN - EXISTING CONDITIONS

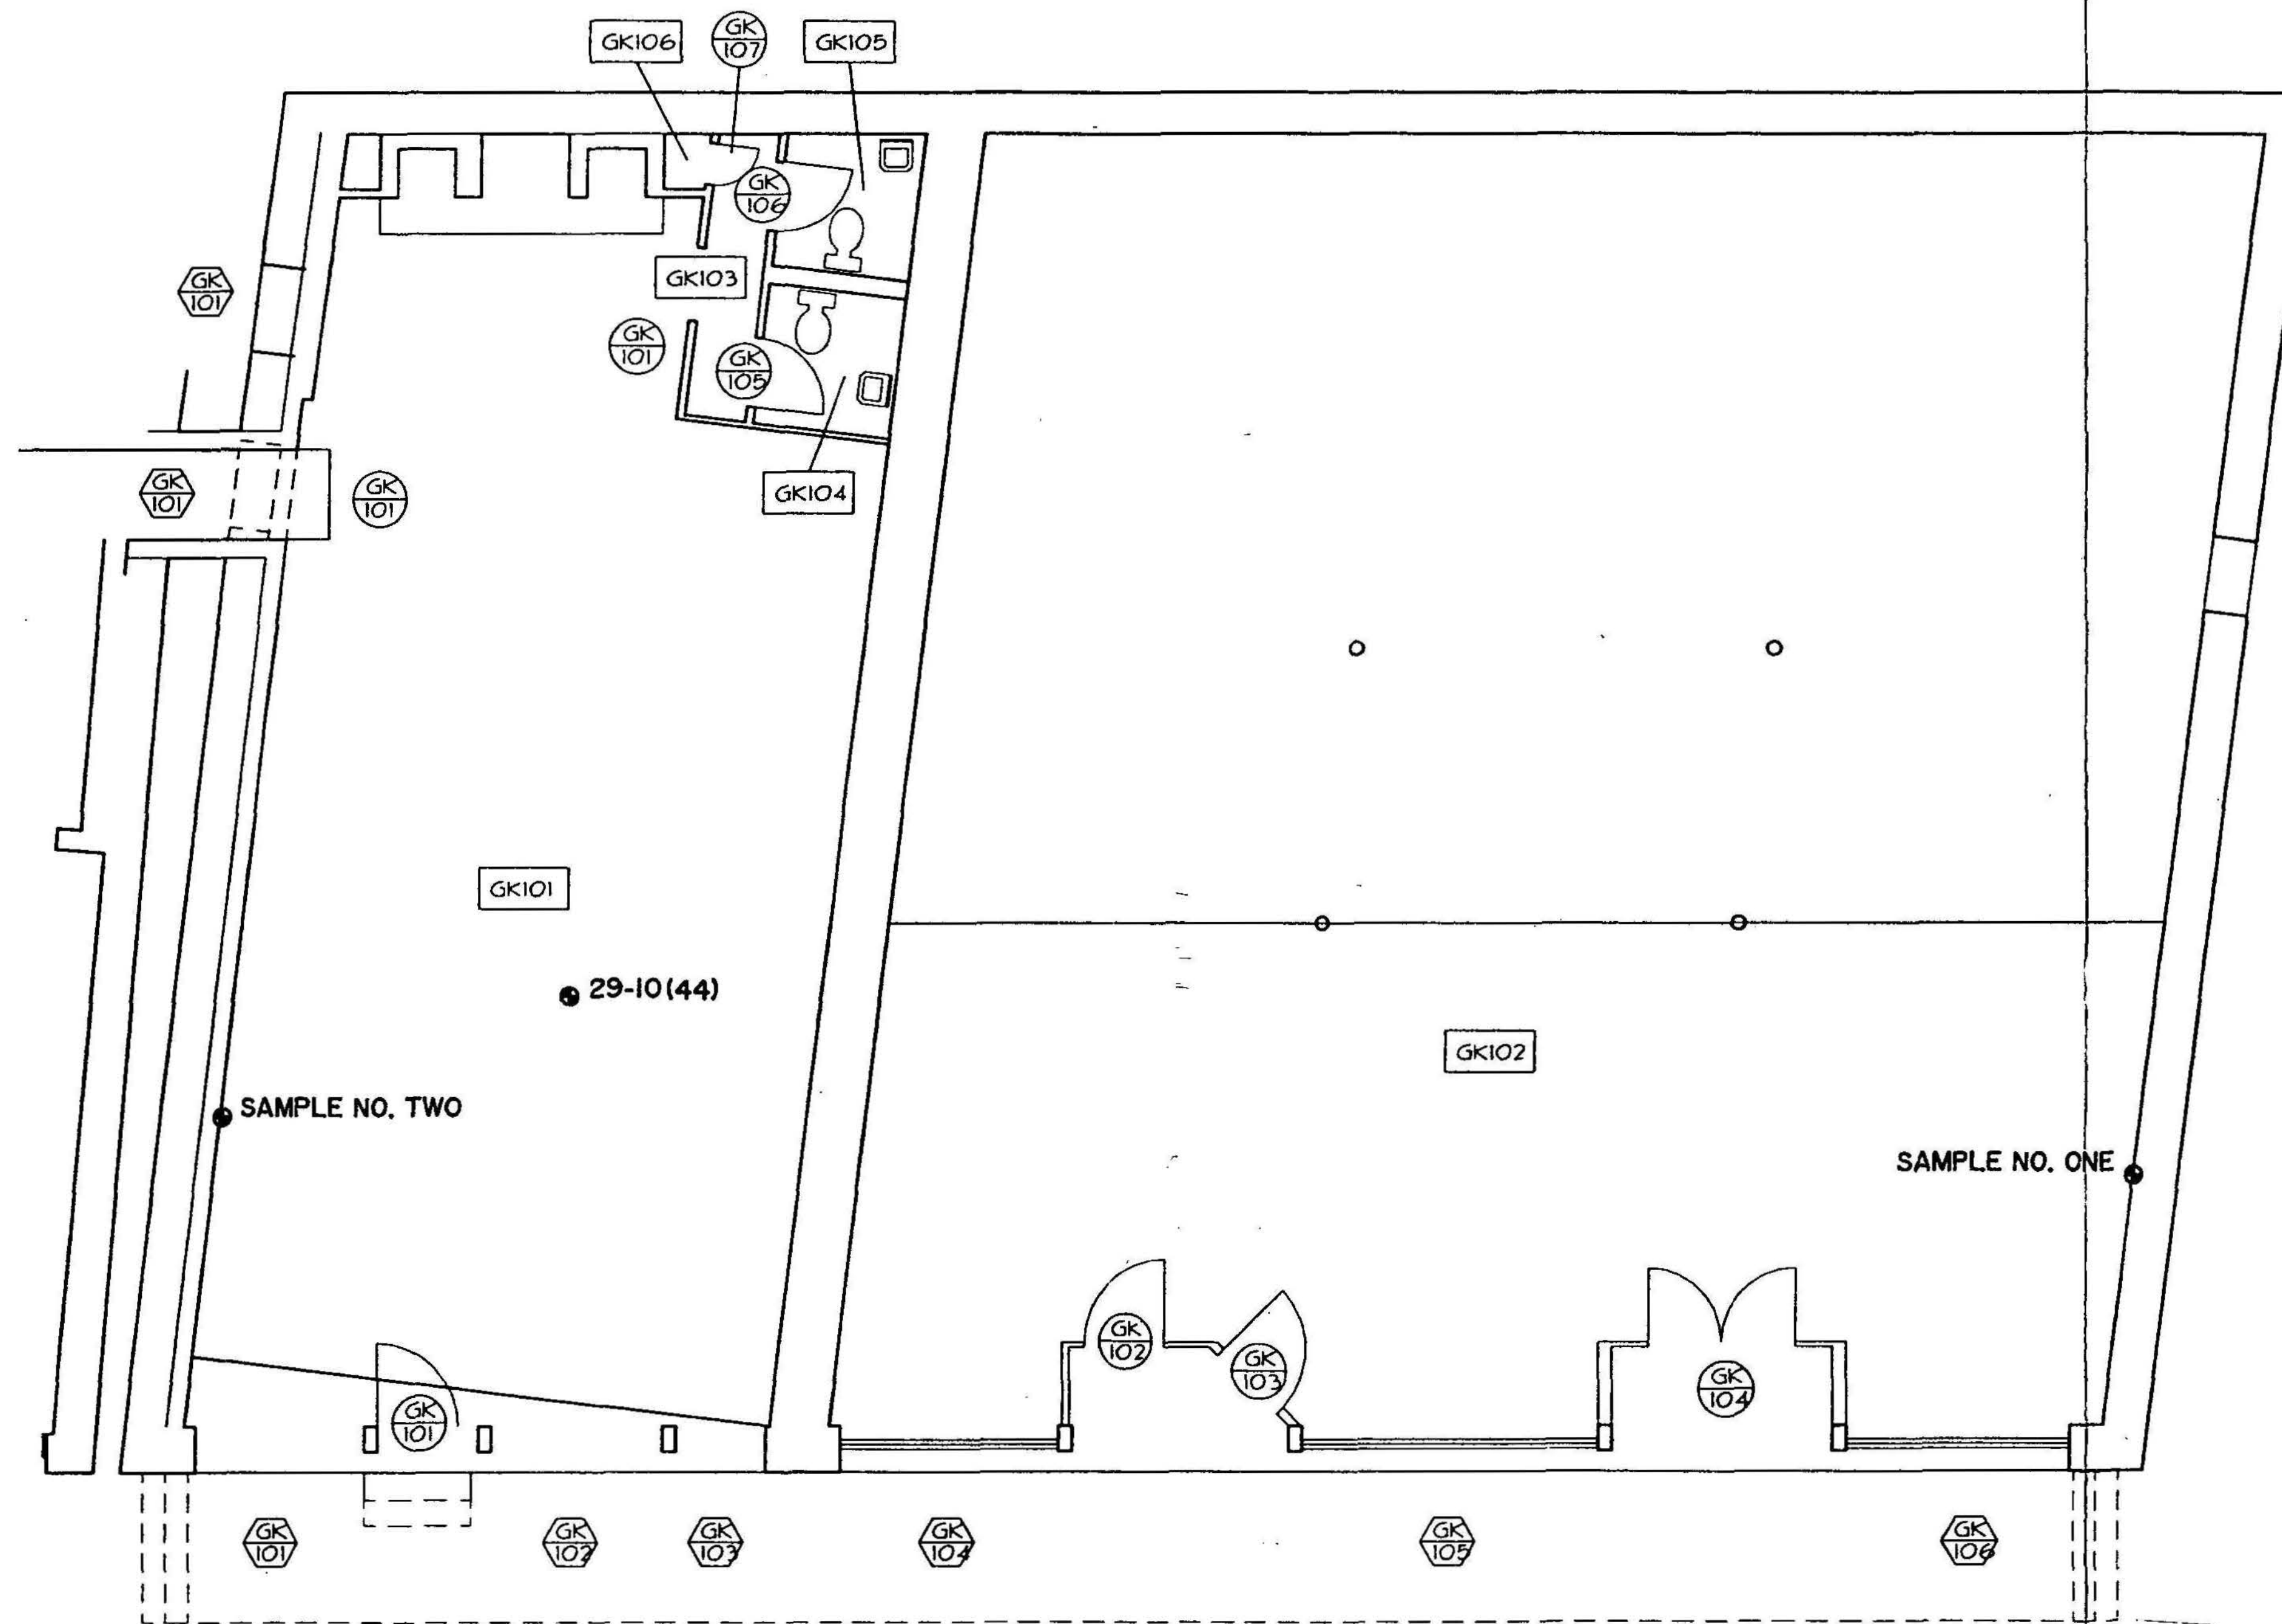
Figure 8  
 LEGEND  
 ● Sample Point

FIRST FLOOR PLAN - EXISTING CONDITIONS

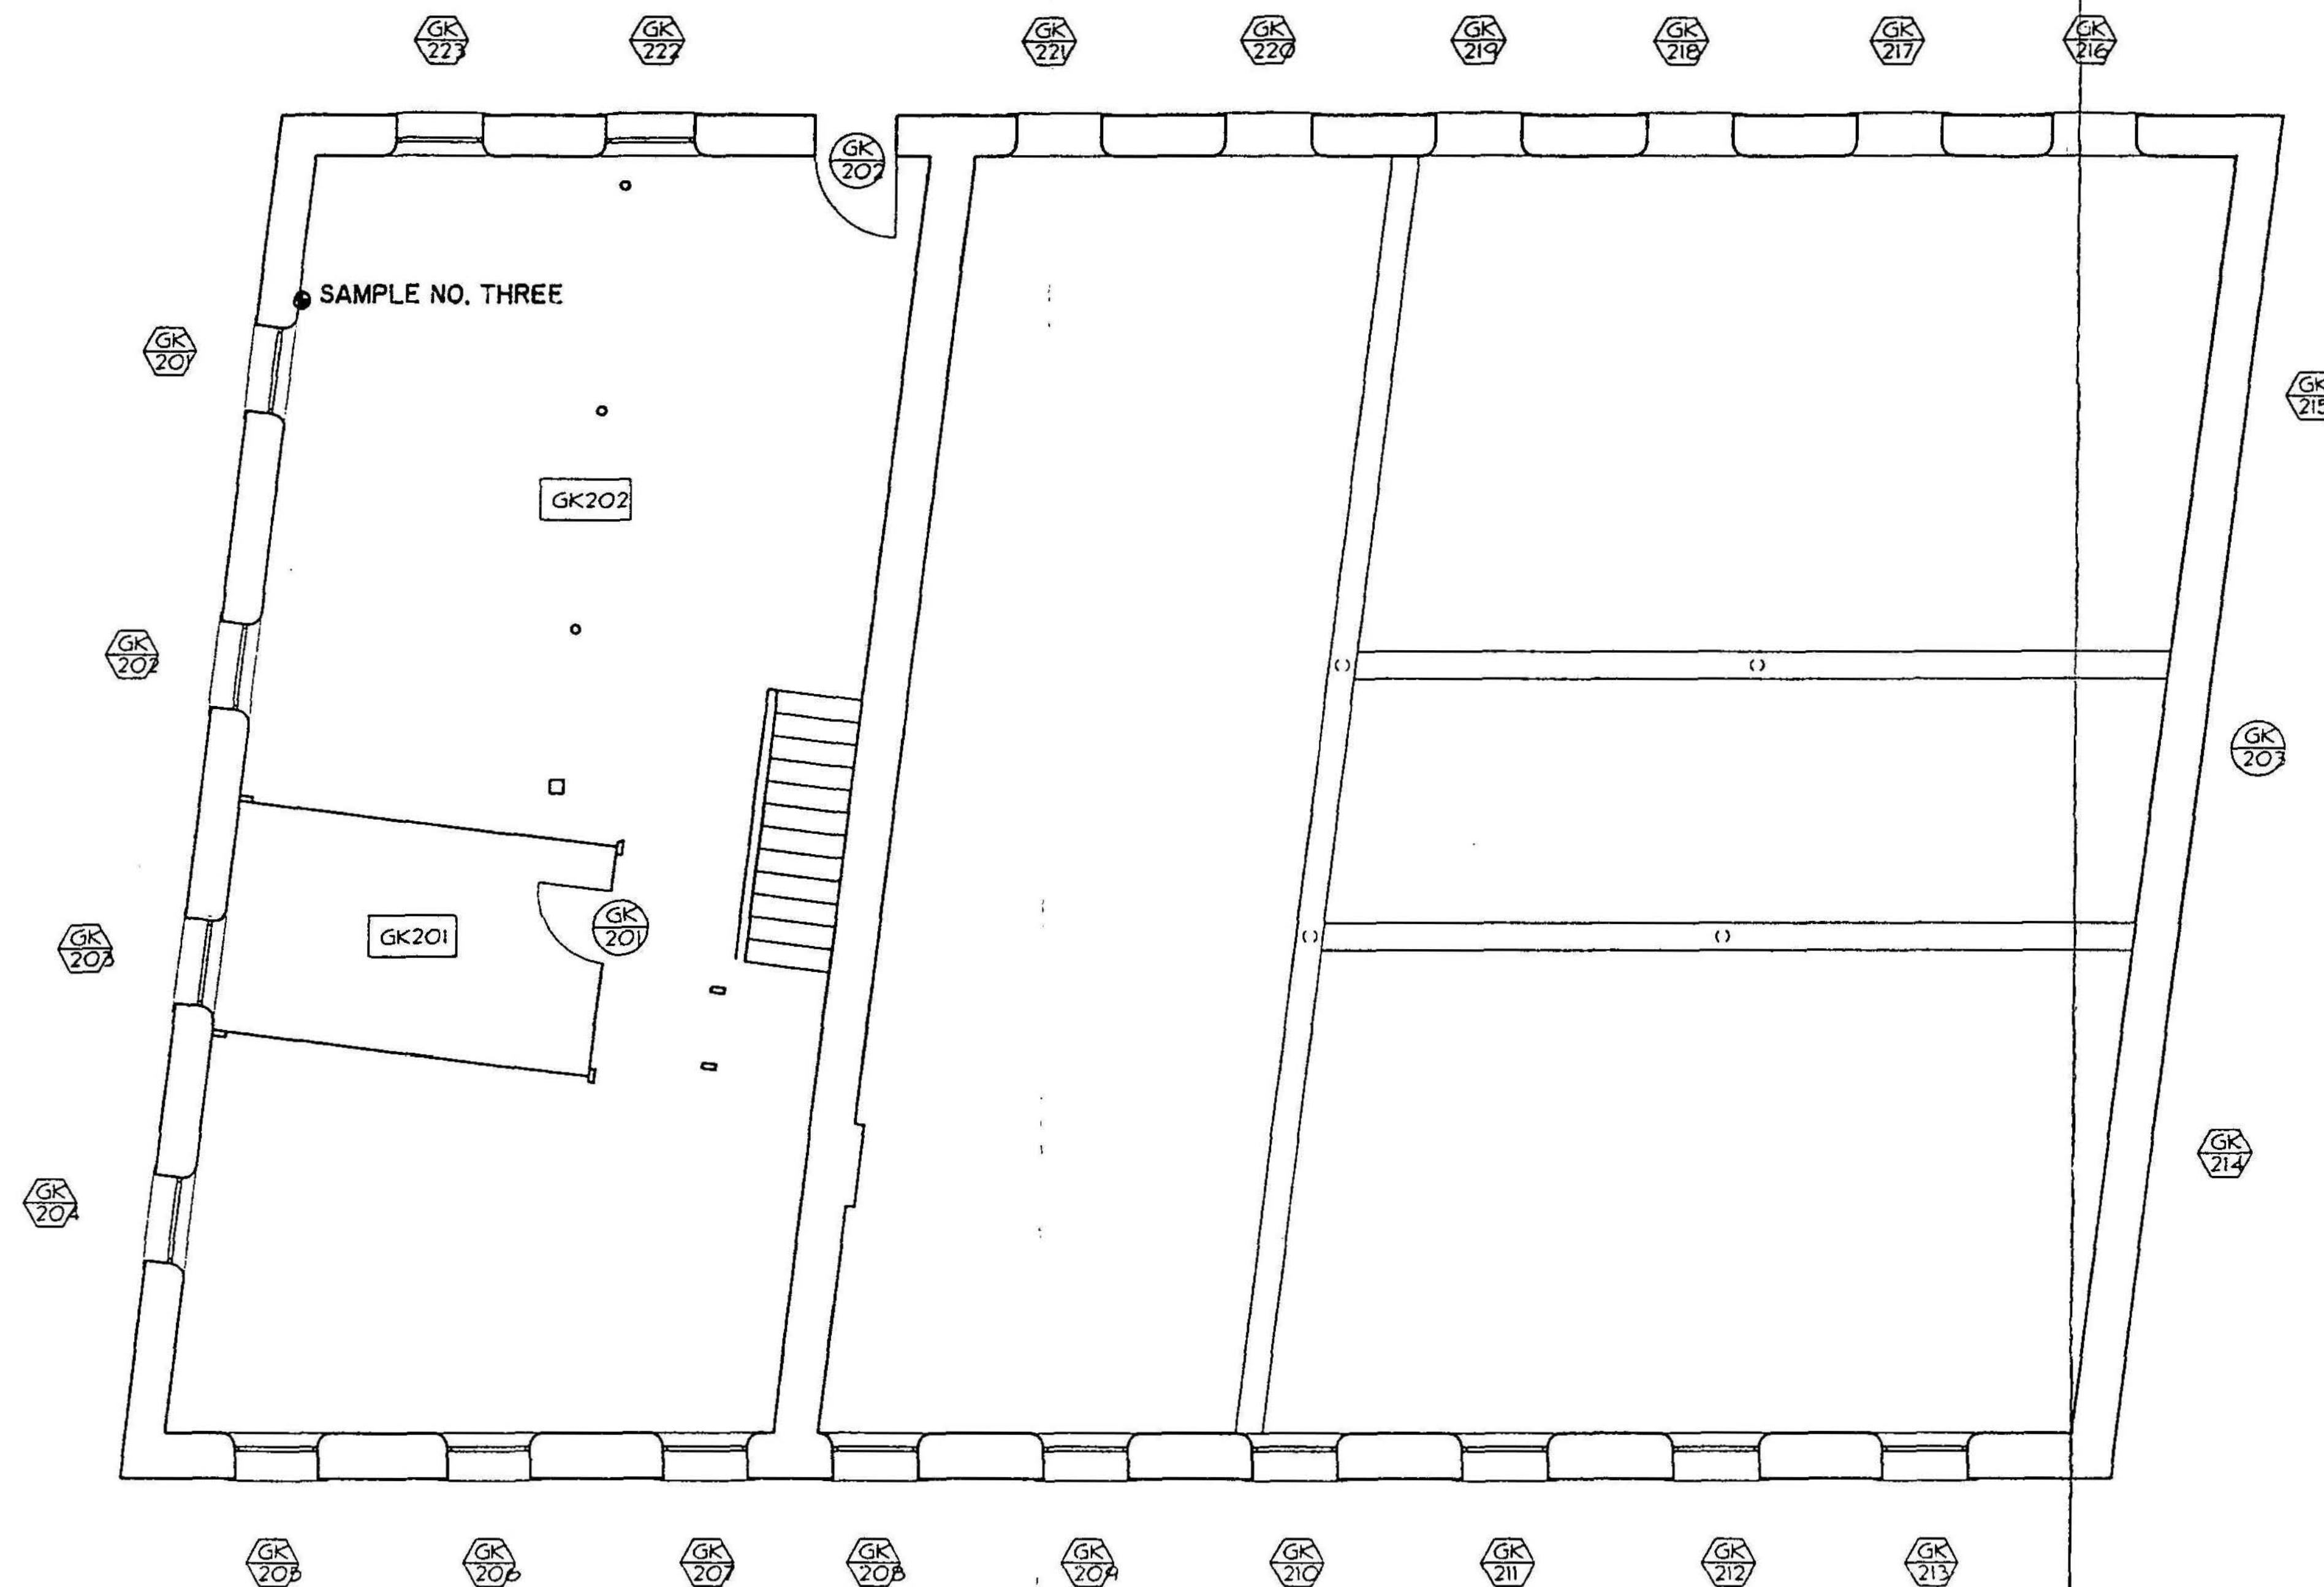
FIGURE 9

SECOND FLOOR PLAN - EXISTING CONDITIONS
