Ocmulgee National Monument  
Dunlap House  
Historic Structure Report

March 2011

2011  
Historic Structure Report  
Dunlap House  
Ocmulgee National Monument

This Historic Structure Report was compiled in direct response to an arson fire at the house on February 8, 2011. Its main objective was to help ensure that the historic fabric of the house is protected as repairs are made and the house rehabilitated for continued residential use.

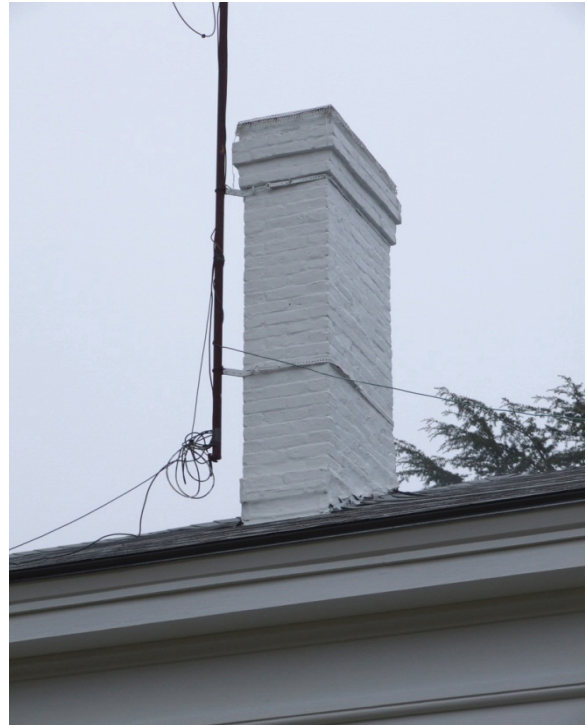
**Figure 5.** View of west chimney and part of attached television antenna.

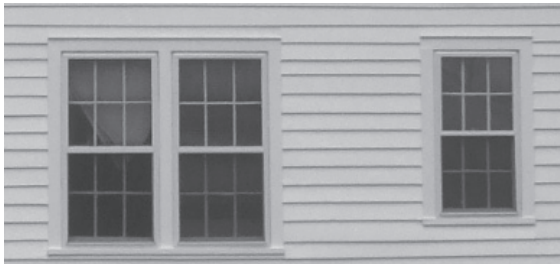
**Figure 10.** View of window openings created in 1952, all of which included a drip cap not present on the original window openings.

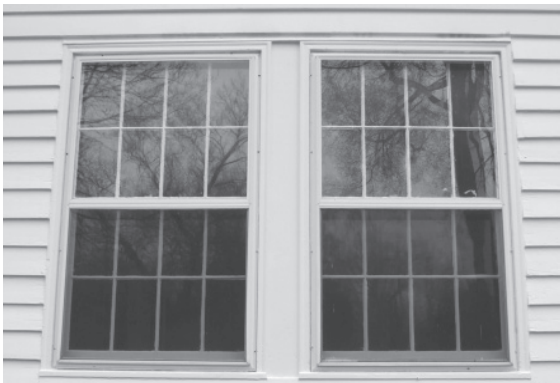
**Figure 11.** View of window opening at south end of Room 107, created in the last quarter of the twentieth century.

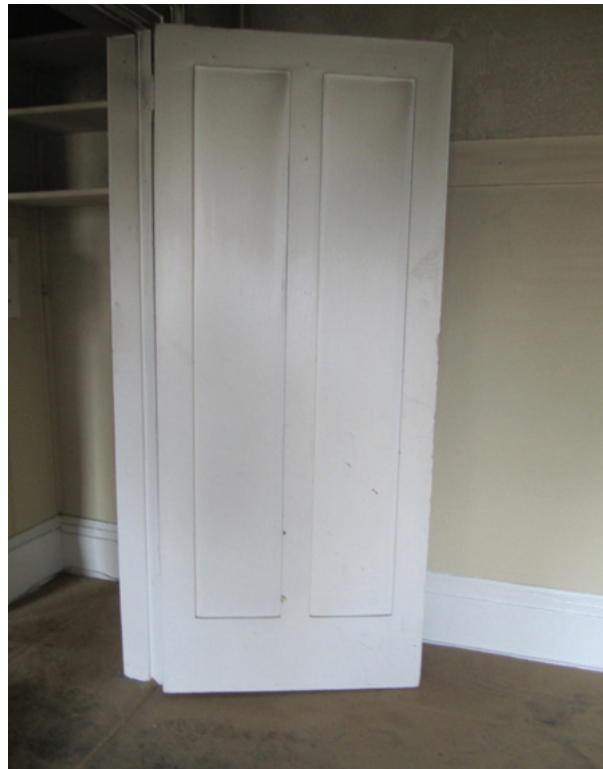
**Figure 20.** View of one of the two, two-panel doors in Bedroom #2, probably the only nineteenth century doors left in the house.

The only two nineteenth-century doors remaining in the house appear to be the closet doors in Bedroom #2 (102). With two vertical panels, these would have been considered very old-fashioned in the 1850s. Neither the 1936 nor the 1952 plans call explicitly for replacement of doors, but the 1952 plans call for new doors in nearly every opening in the house. Most of the original openings that were not altered do not show doors at all, including the openings with the present two-panel doors in Bedroom #2 (102), but it is not clear if doors were not present or simply not shown on the plan. The plans also give no indication that the present four-panel doors replicated the original door design, but it is likely that they did. It would not be surprising to have had four-panel doors at the openings off the center hall, and probably the front and back doors as well, while having two-panel doors at the closets.

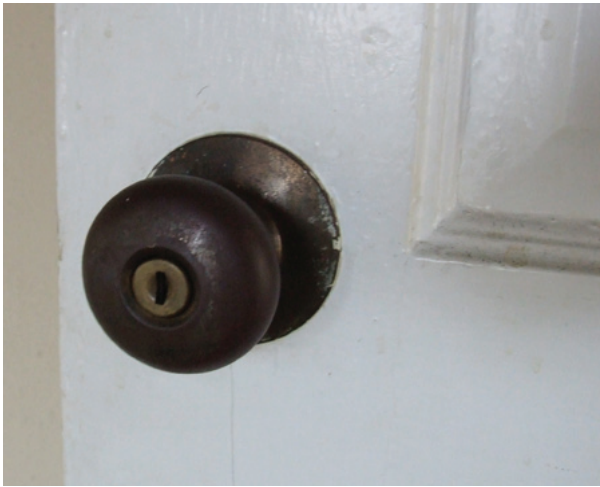
No nineteenth century hardware has been observed in the house. All of the window lifts, hinges, and locksets date to the twentieth century, most to the early 1950s. All are brass-plated.

**Figure 23.** View of a typical lockset from the 1950s.
