National Park Service  
Cultural Landscapes Inventory  
2003

Park Headquarters  
Olympic National Park

CULTURAL LANDSCAPES INVENTORY (CLI) PROGRAM  
*2010 Condition Assessment Update for:*

**Park Headquarters**  
**Olympic National Park**

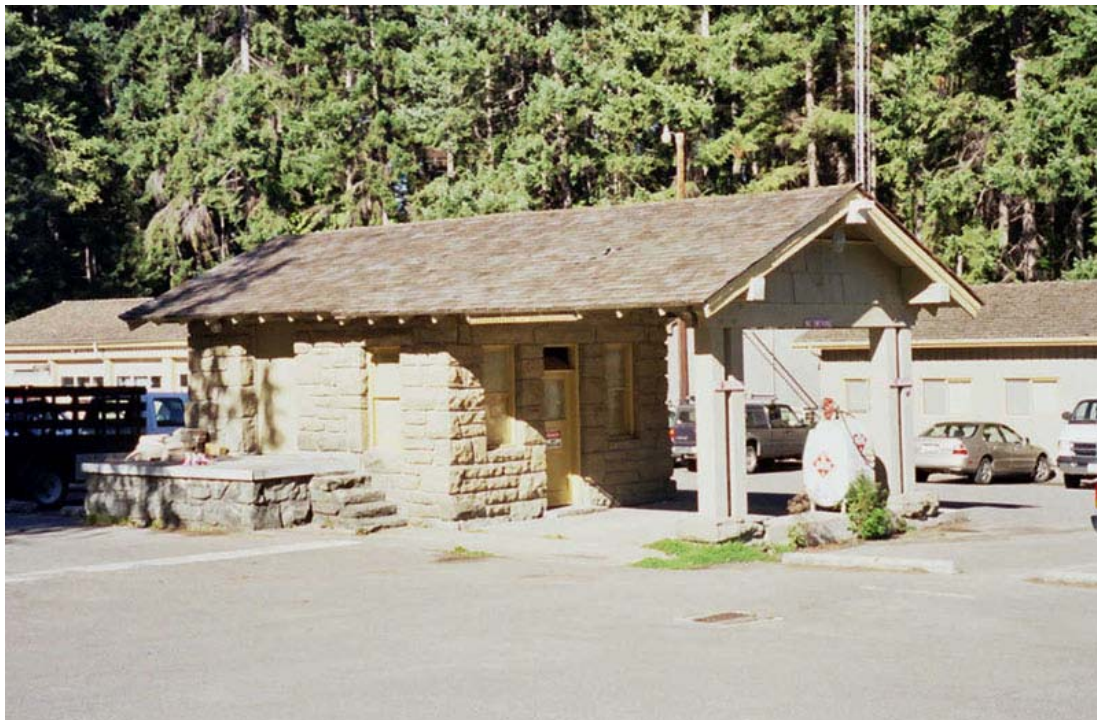
*When the CLI was completed in 2006, the Gas & Oil house required some stabilization measures that have since been completed. However, the Transformer/pump house is still in need of some stabilization measures such as replacement of a broken window on the north façade.*

*Contemporary photograph of the historic Gas & Oil house completed in 1941, looking northwest. (CCSO, 2002)*

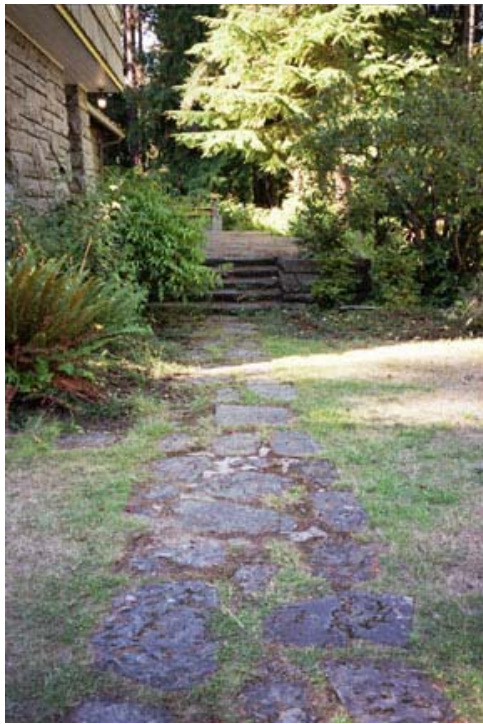
*Since 2003 much of the historic pedestrian circulation has been stabilized and reconstructed. However, the historic flagstone pathway between the Administration building and the Superintendent's Residence needs stabilization. The mortar between the flagstones is missing and/or deteriorating due to weathering and growth of forest vegetation. The flagstone walkways around the Superintendent's Residence are also in need of stabilization due to growth of lawn vegetation in between the flagstones. The flagstone patio on the north side of the Superintendent's Residence was partially covered with a thin layer of concrete in order to smooth the surface for ADA accessibility. However, much of this concrete is separating from the underlying flagstones. Vegetation should be removed, flagstones reset, and mortar repaired to prevent further deterioration of the walkways.*

*Contemporary photograph showing a historic flagstone path and terrace at the Superintendent's residence. (CCSO, 2002)*

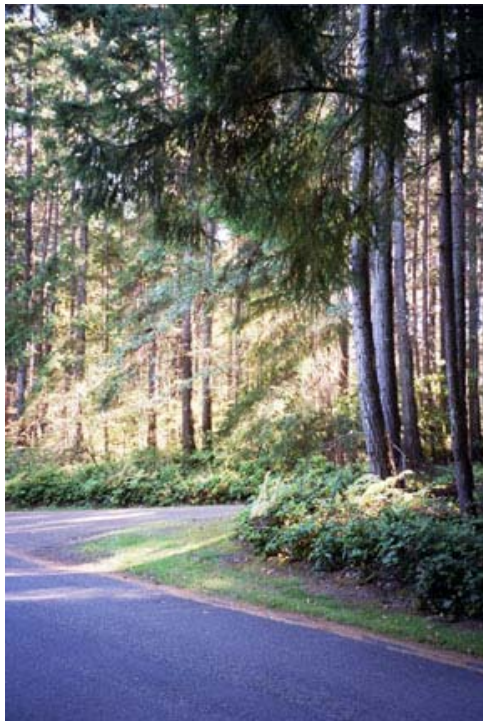
*Contemporary photograph showing the historic second growth forest with a layered edge edect. (CCSO, 2002)*

Continue pruning and thinning planting beds and second growth forest as recommended

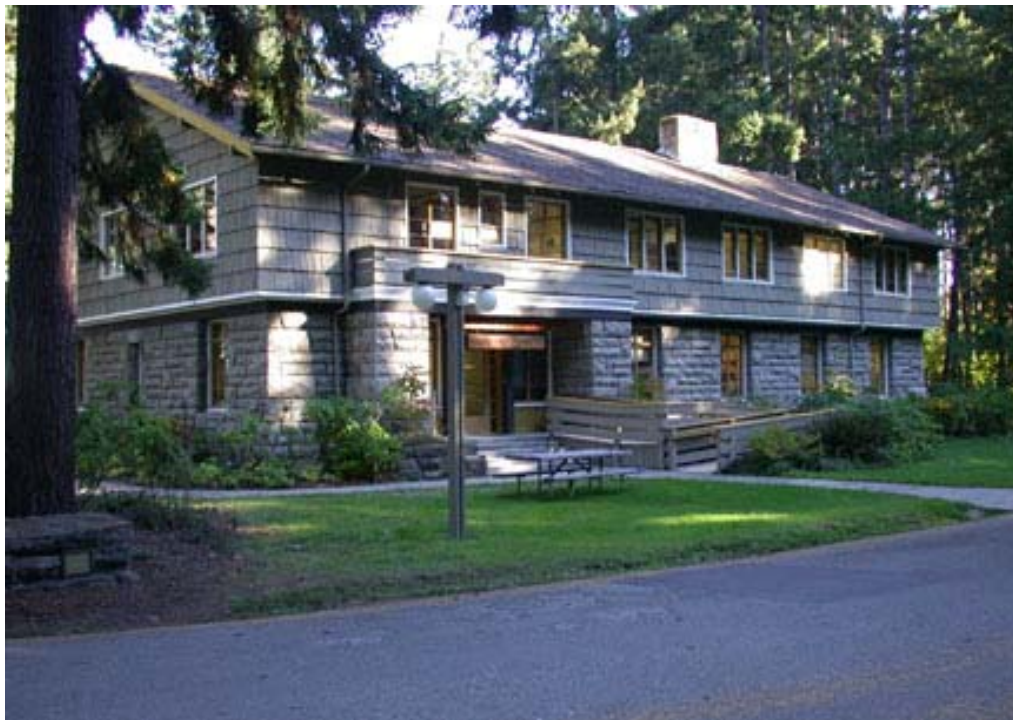
*Contemporary photograph showing historic plant beds located along the west and south sides of the Administration building. The ADA ramp and plantings in front of the ramp are contemporary additions. (CCSO, 2002)*

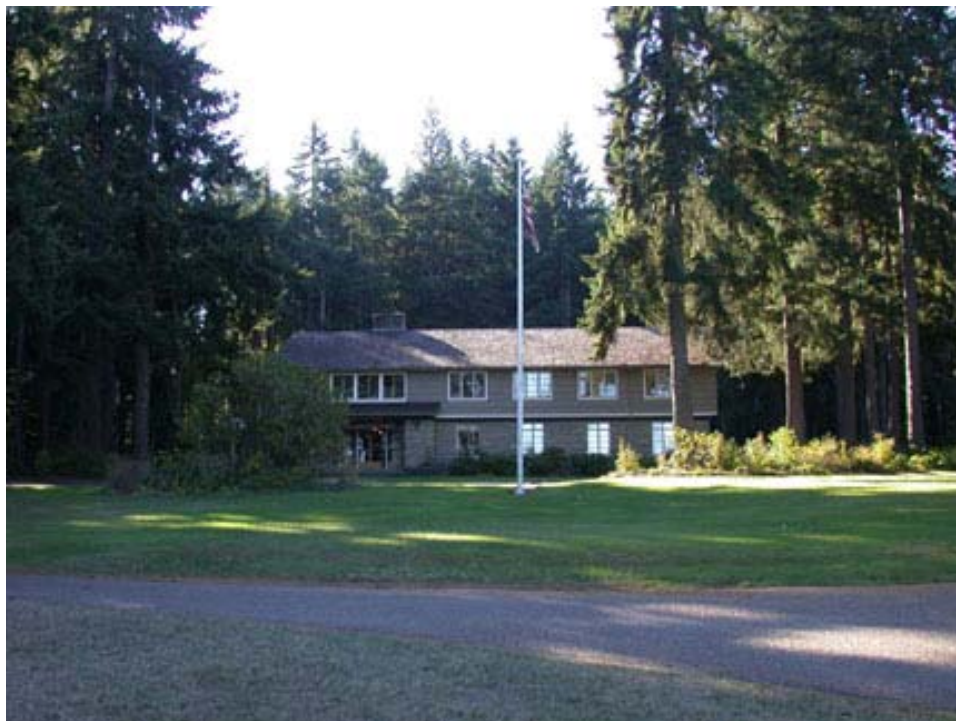
*Contemporary photograph showing the historic lawn on the north side of the Administration building with clusters of trees. (CCSO, 2002)*

Improve lawn as recommended by the Vegetation Management Plan.
