# PARASHANT NATIONAL MONUMENT

## Historic Preservation Report

*Condition Assessment and Preservation Recommendations –  
Grand Gulch Mine and Pine Well Ranch*

SEPTEMBER 30, 2003

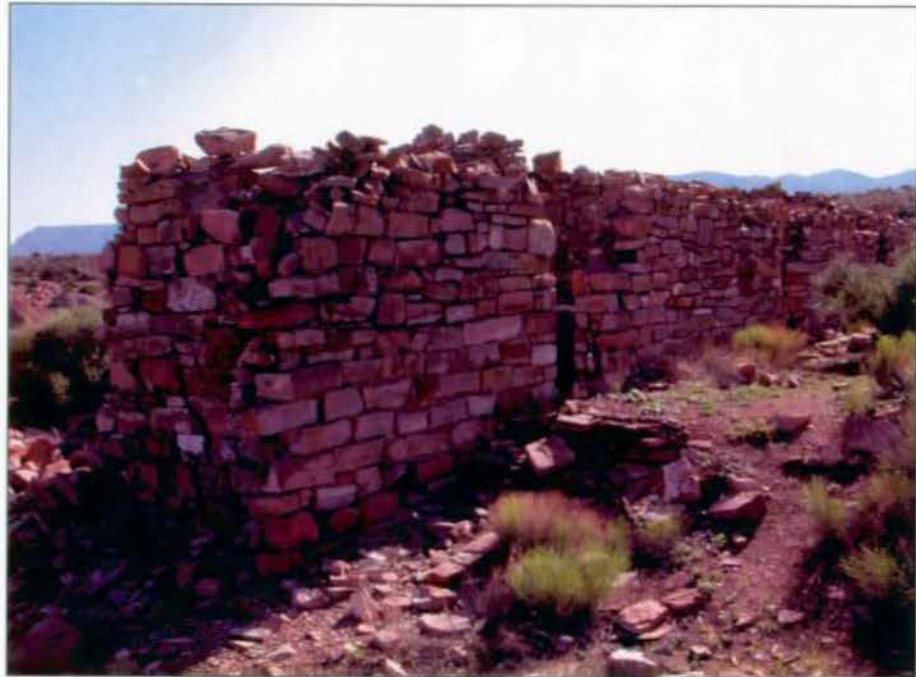
View from southwest. Note south wall extending out past corner.

The west end of the south wall appears to extend out to the west, beyond the obvious corner, but it is not obvious what purpose this served – there may have been another room at one time.

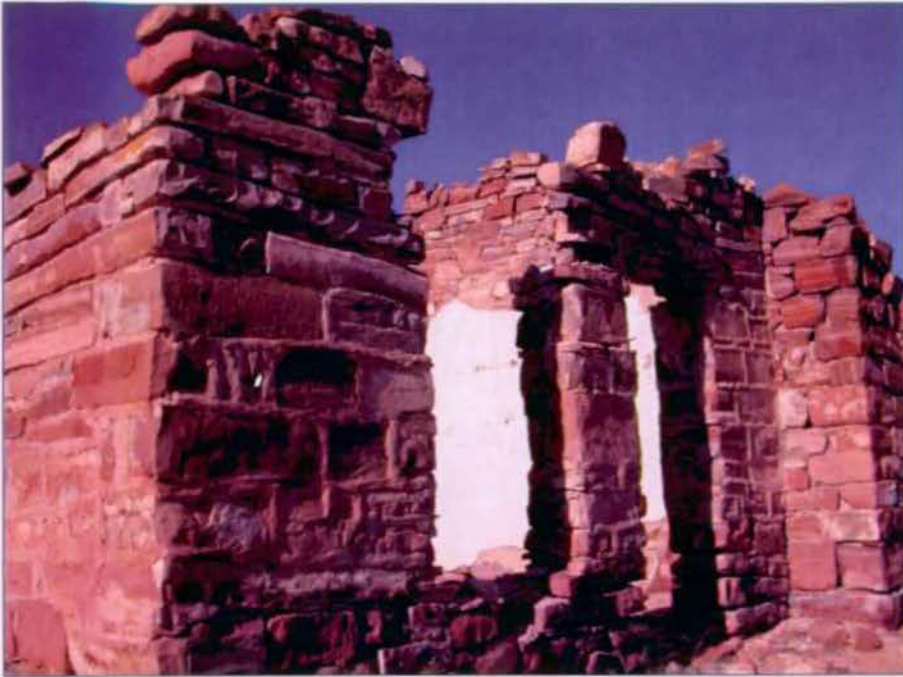
Close-up of north wall of addition. Note mortar joints.

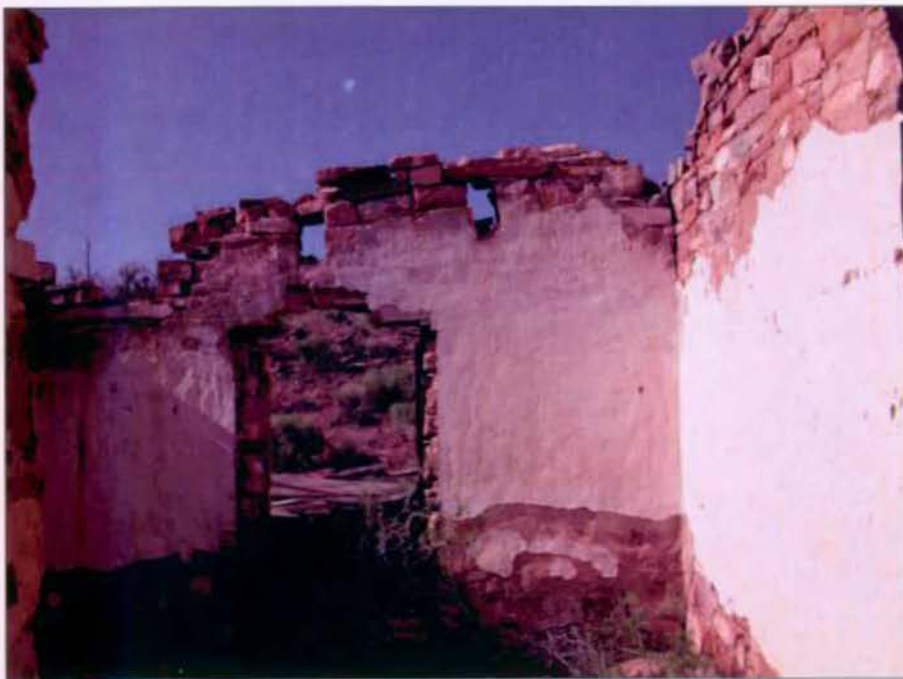
Interior of addition. Note plaster on walls, and beam pockets in south wall.

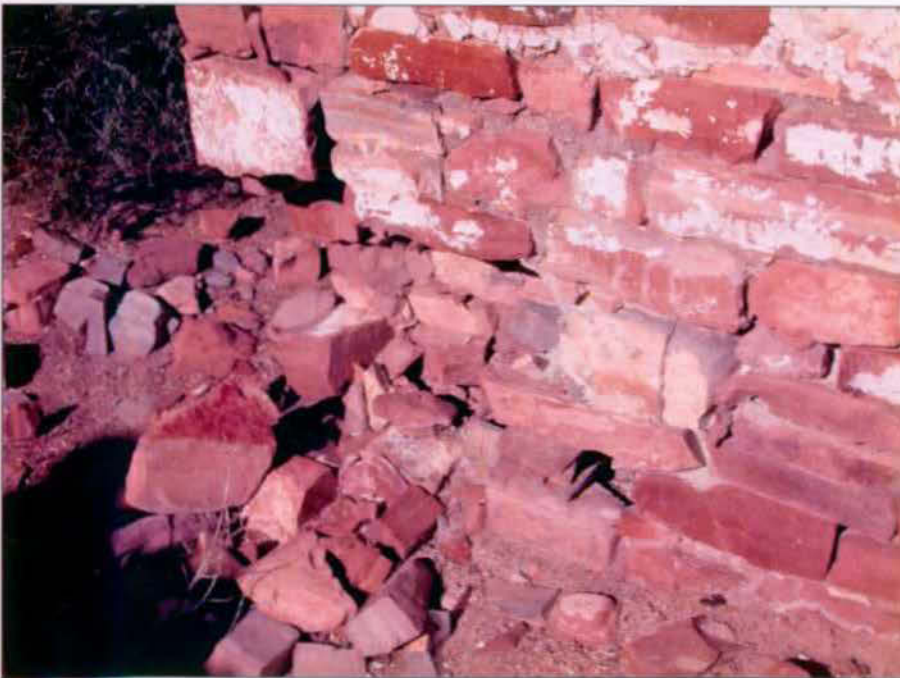
Detail at collapse of base of wall below arched opening.

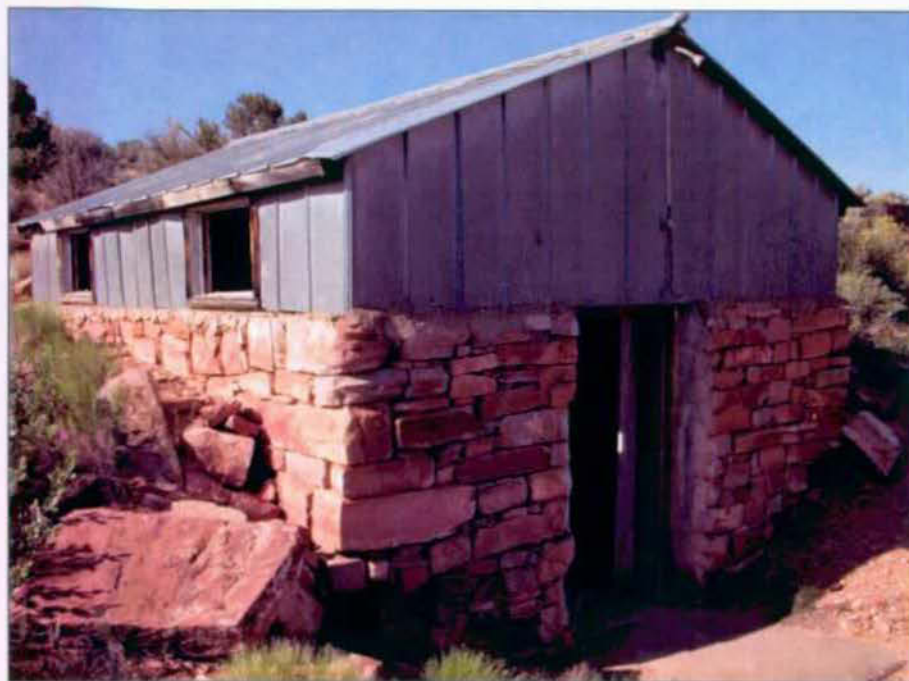
View from northeast. Note metal clad addition on top of stone walls.

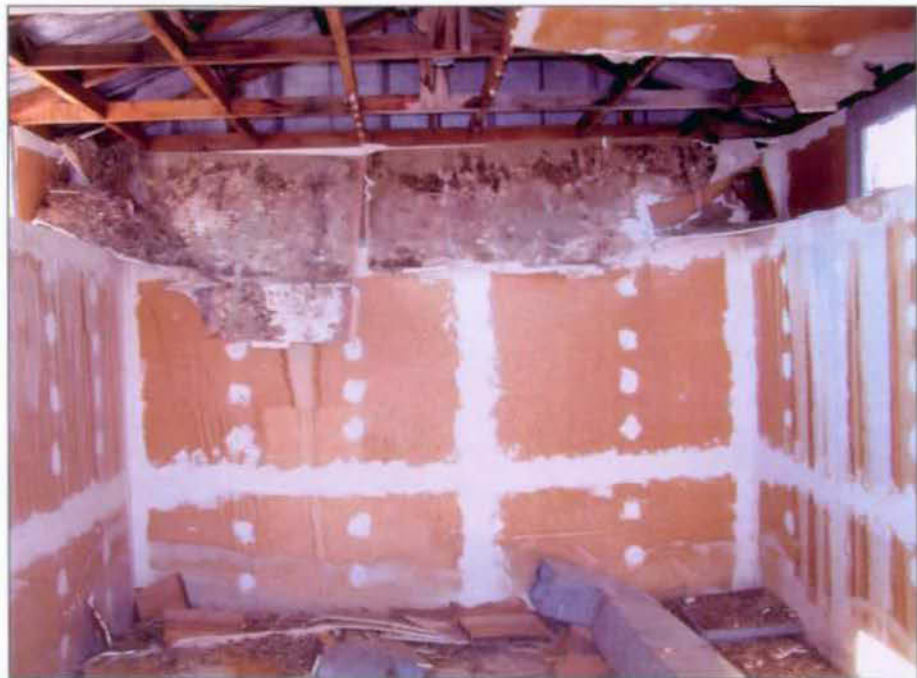
Detail of interior. Note gypsum board walls on furring, and trussed/framed roof structure.

Finally, the interior of the building should be cleaned up. This would include removal of loose or severely deteriorated gypsum board from the ceiling and walls, as well as removal of all trash, debris, rodent nests, and rodent droppings. (Precautions should be taken during this work to avoid exposure to Hantavirus).

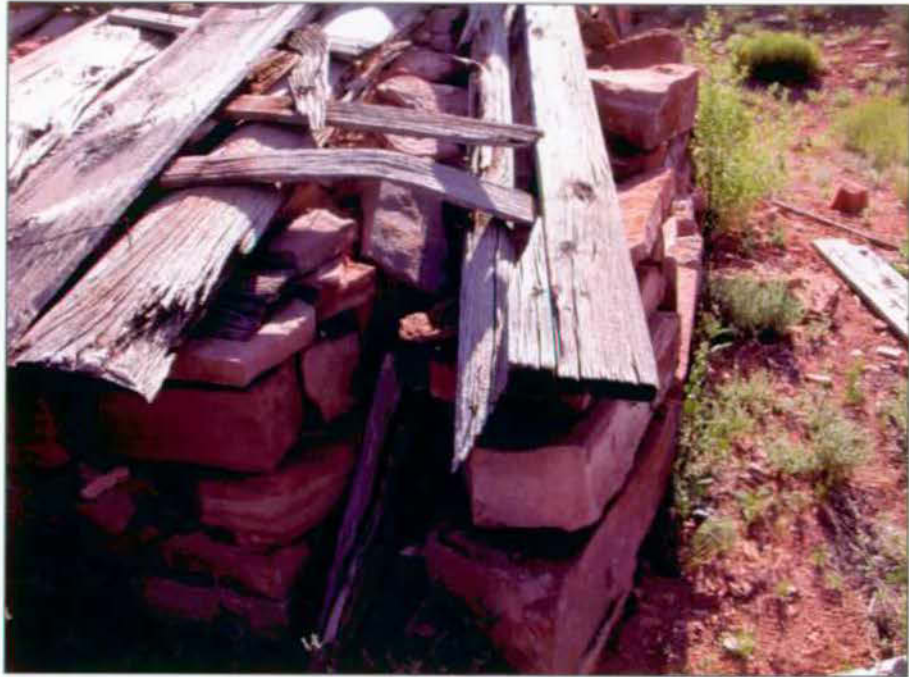
Detail of southwest corner. Note corner separation, collapsed roof structure, and "orrilas" in roof below.

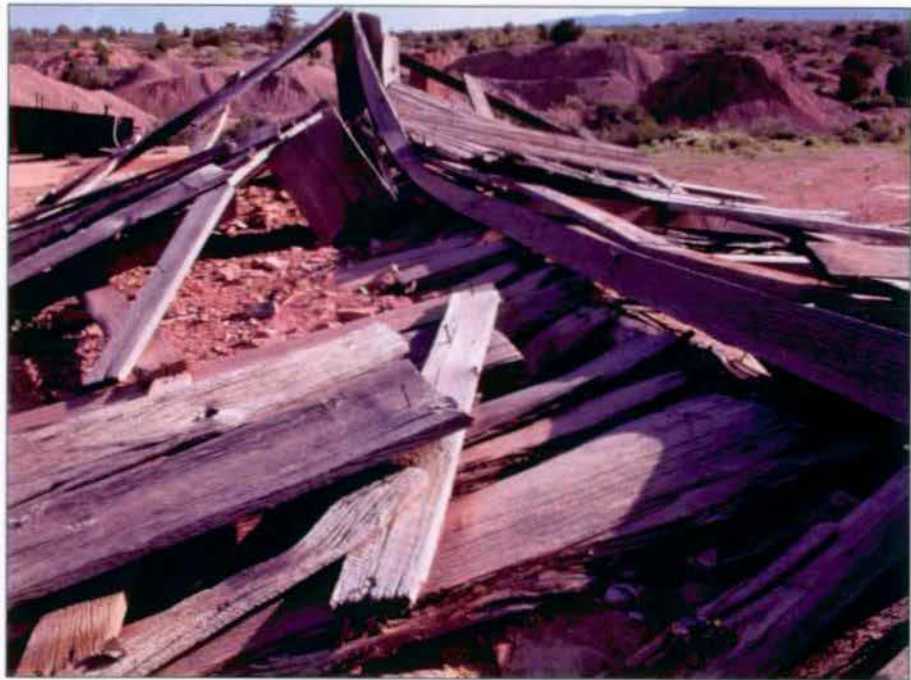
Detail of roof. Note original roof under collapsed secondary roof and earth covering.

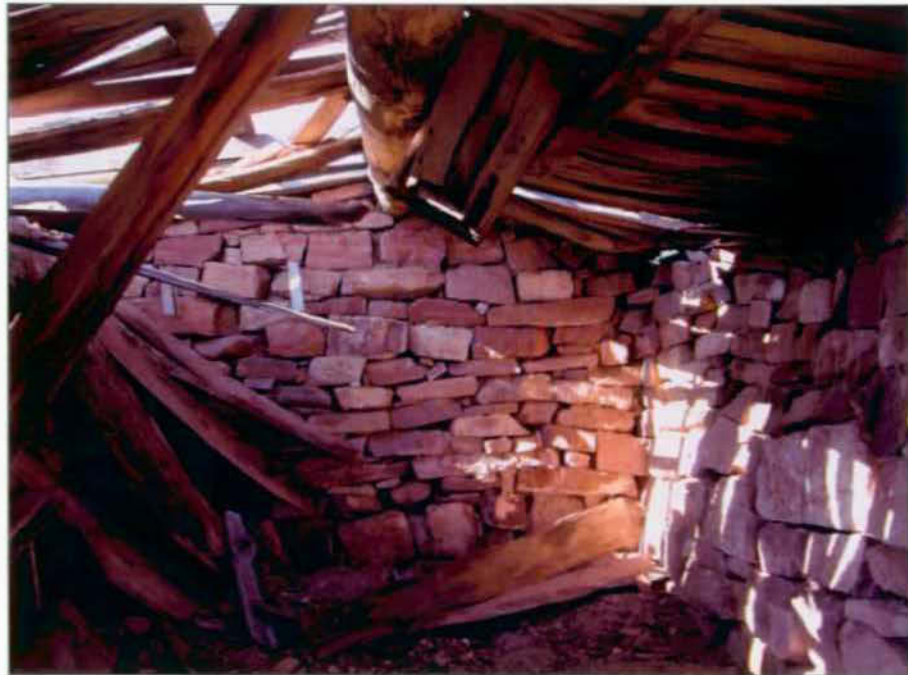
Detail of interior. Note collapsing roof and walls.

Finally, the interior of the building should be cleaned up. (Precautions should be taken during this work to avoid exposure to Hantavirus).

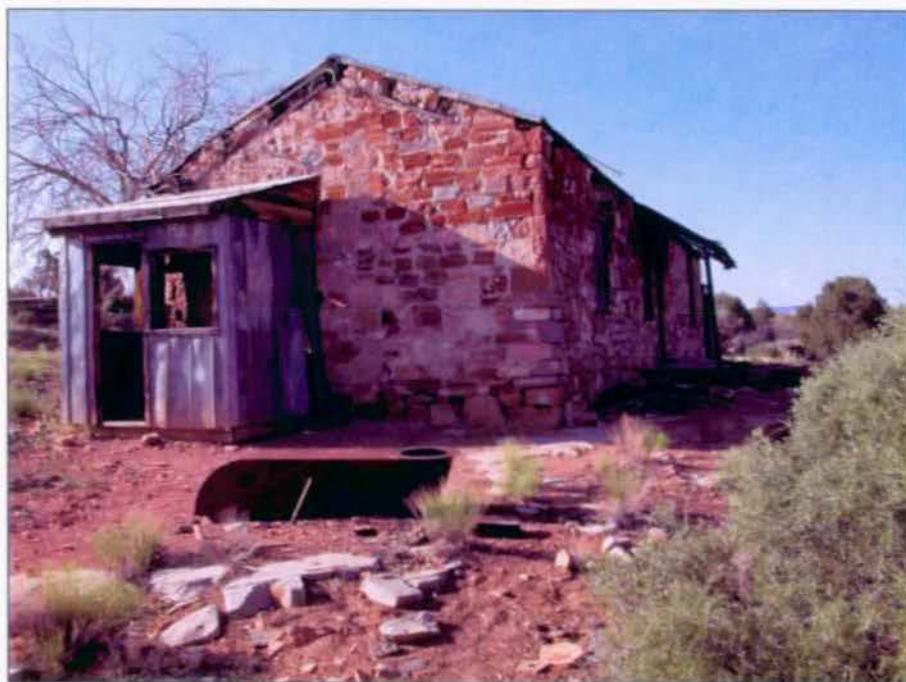
View from Northwest.

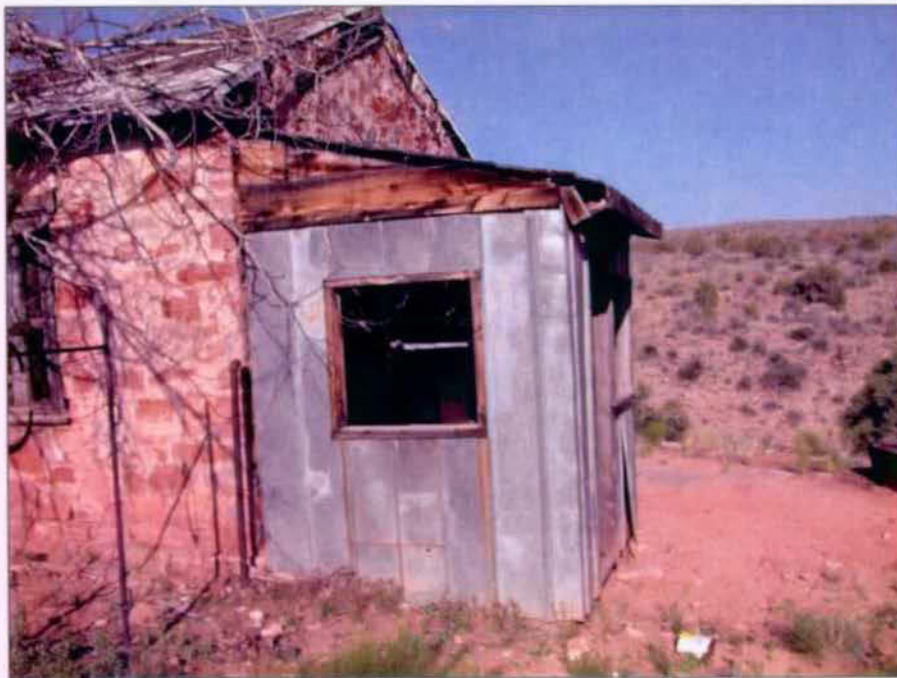
Detail of addition on north.

If stabilization of the additions is undertaken, work should include repair or replacement of the metal roofing and siding, as well as the framing. If necessary, the structures should be pushed back into square, and all structural connections should be securely fastened.

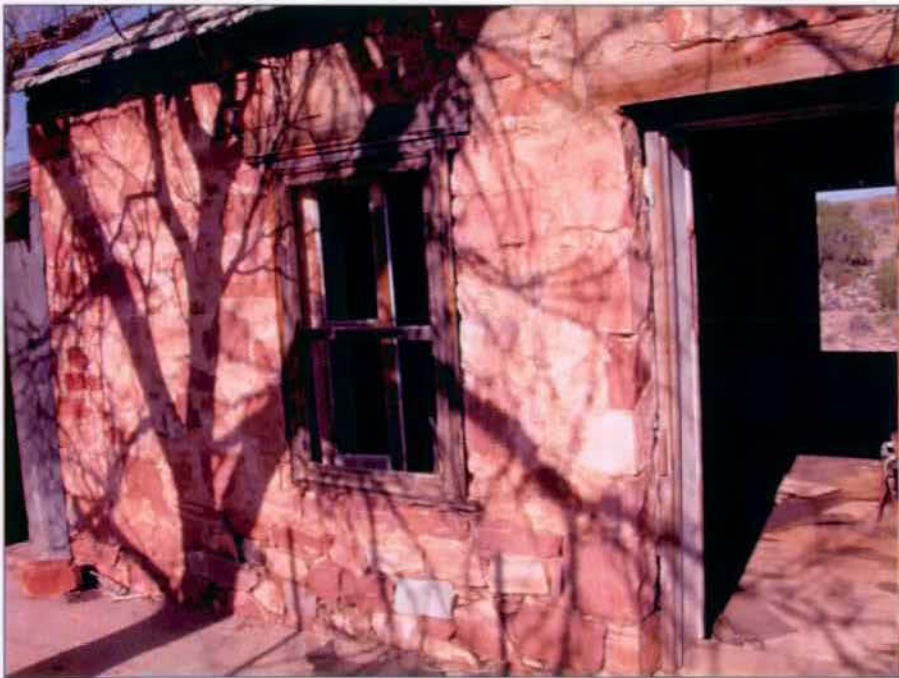
Detail of window in east wall. Note eroded and re-pointed mortar joints.

Once the roof is stabilized, work can focus on the stone walls. Areas which have sluffed off or collapsed should be rebuilt. In addition, the walls should be examined for loose stones, and those areas repaired. Then, the mortar joints should be re-pointed. All of this work should be done using earthen mortar, amended with an acrylic polymer admixture.

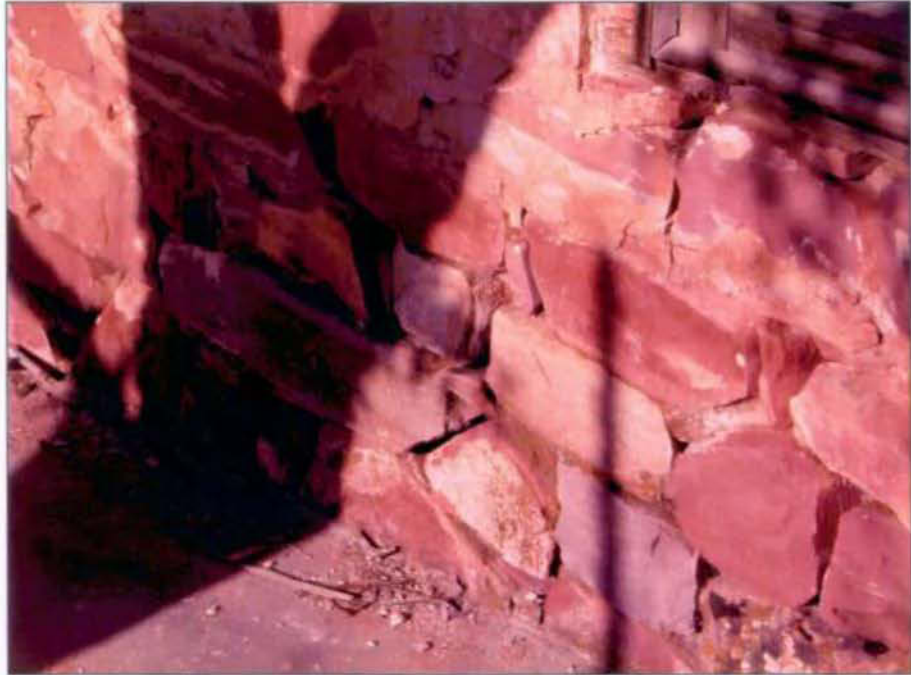
Detail of east wall. Note eroded mortar joints.

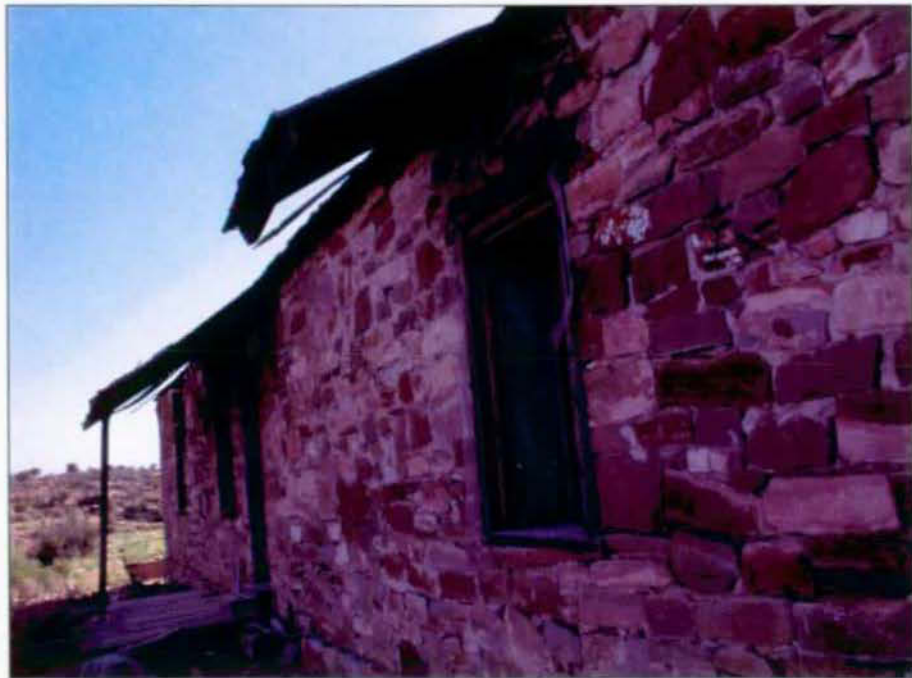
View of west wall. Note unsupported roof over window, and partially collapsed roof over porch.

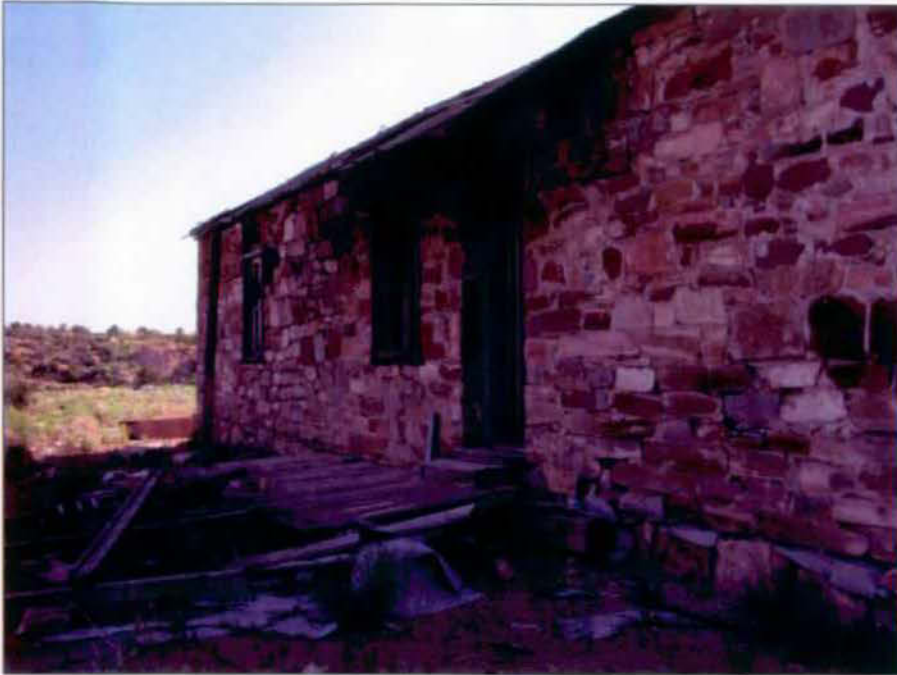
Detail of west wall and partially collapsed roof and porch floor.

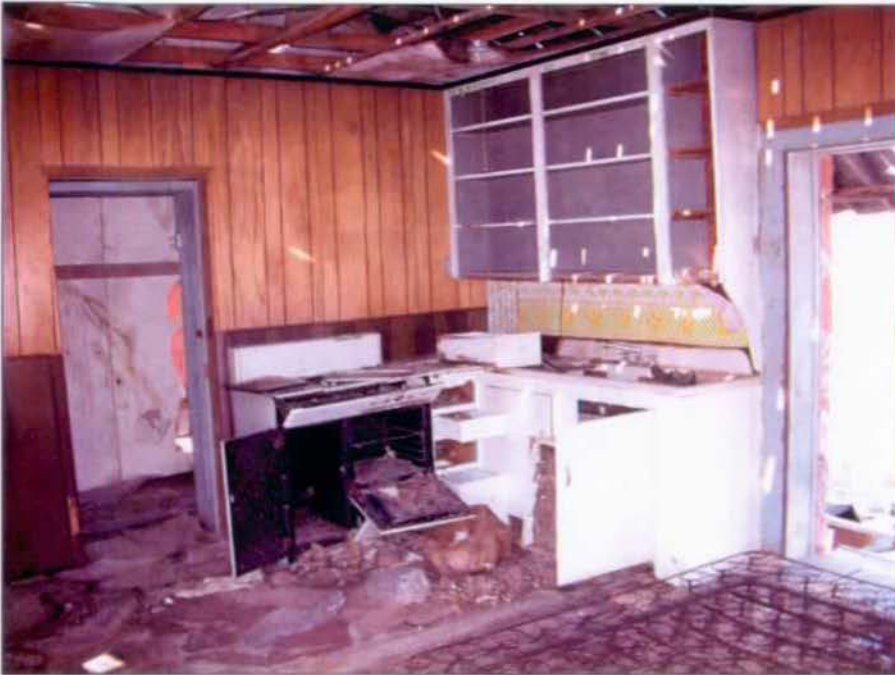
Interior of center room (room 2) looking southwest

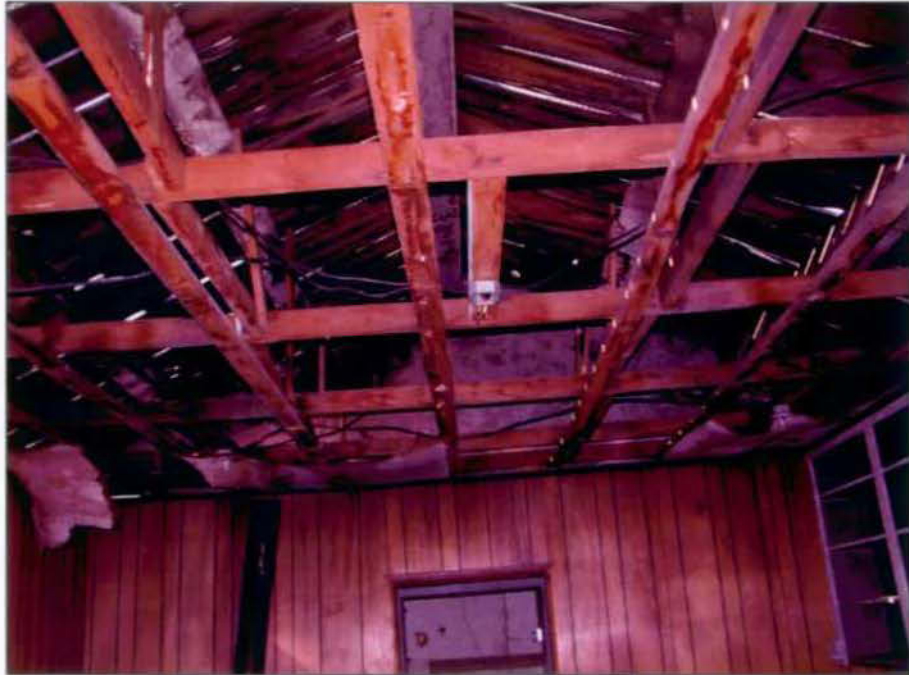
Detail of center room (room 2) roof/ceiling structure, looking south.

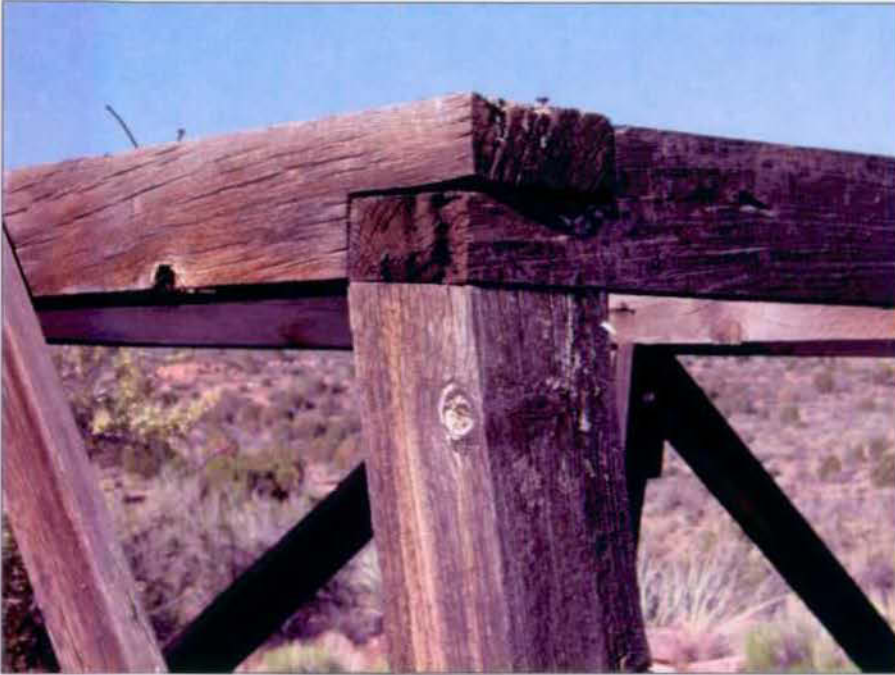
Detail of connection at top. Note nailed lap joints.

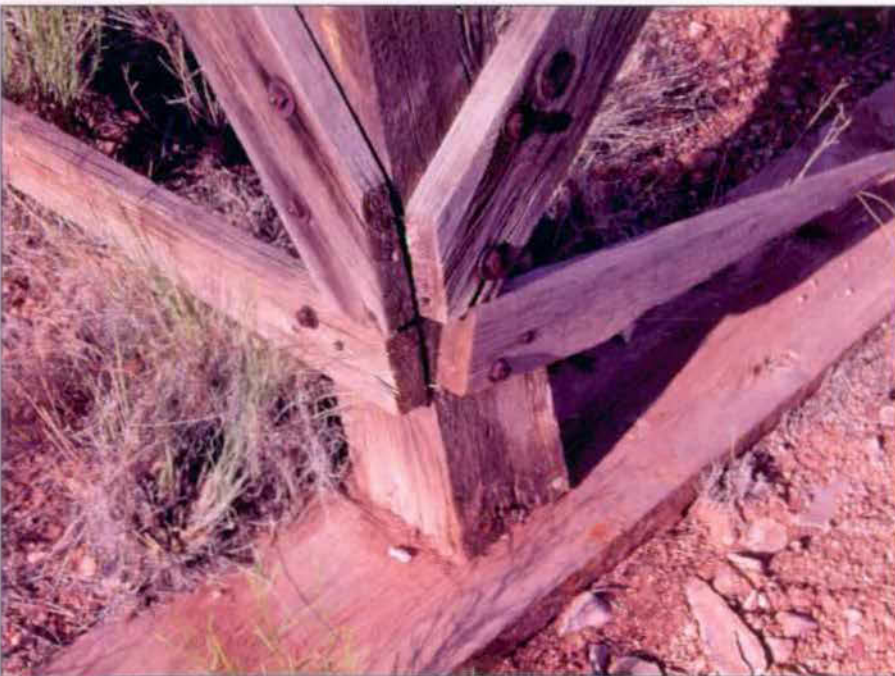
Detail of connection at bottom. Note bolted joints, and posts sitting on 2x12 plate.

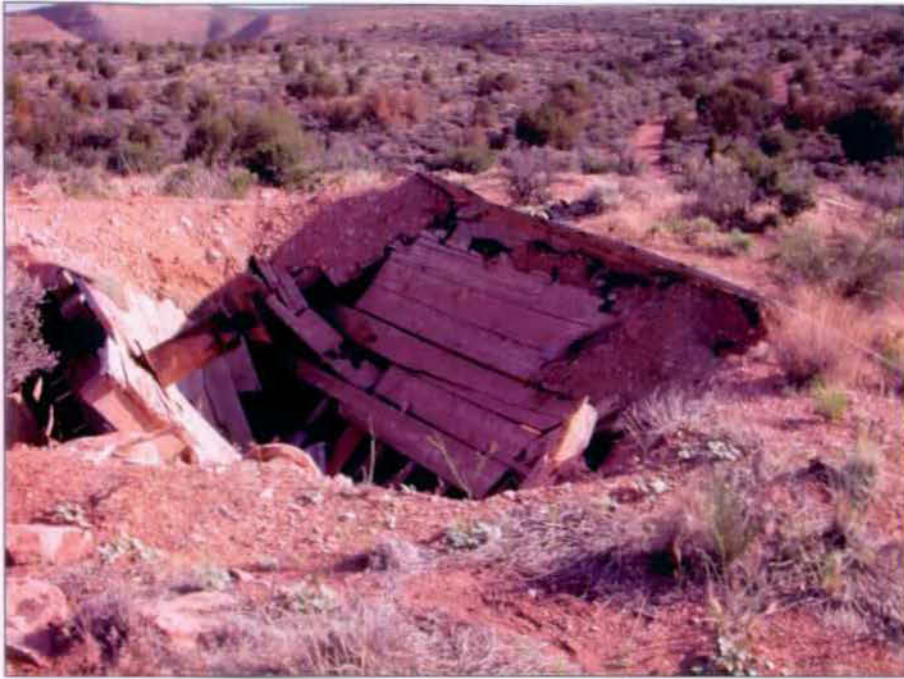
View from southeast. Note collapsed roof

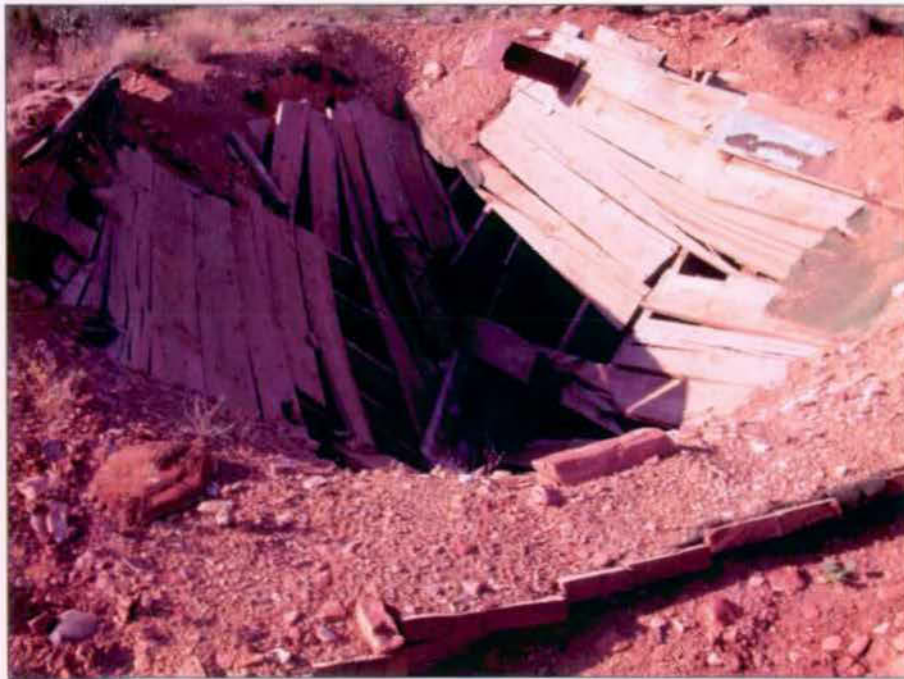
View from northwest. Note collapsed roof.

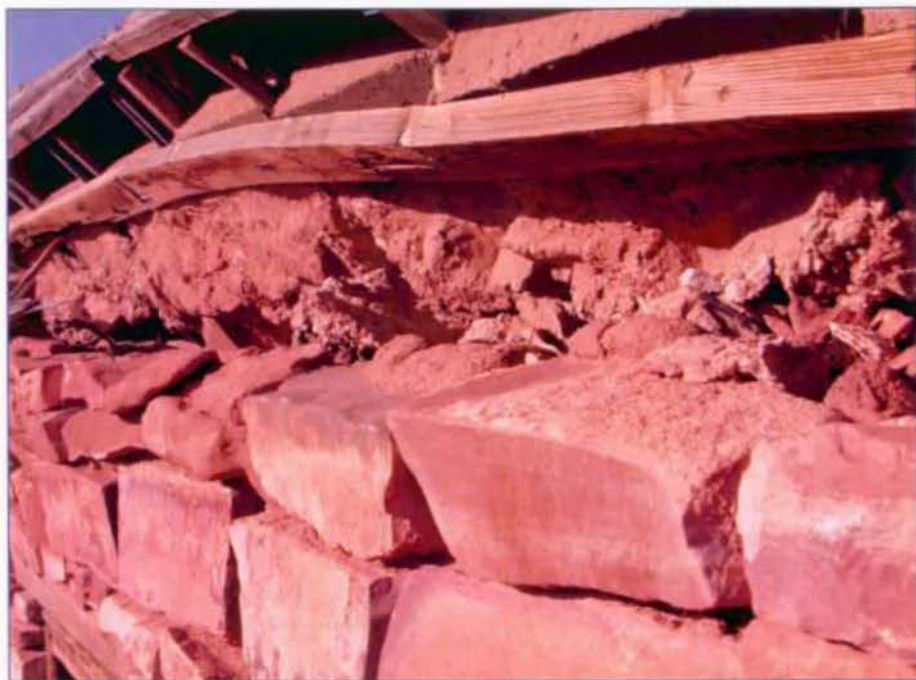
Detail of east wall. Note how roof collapse has rotated framing and associated construction up off of top of wall.

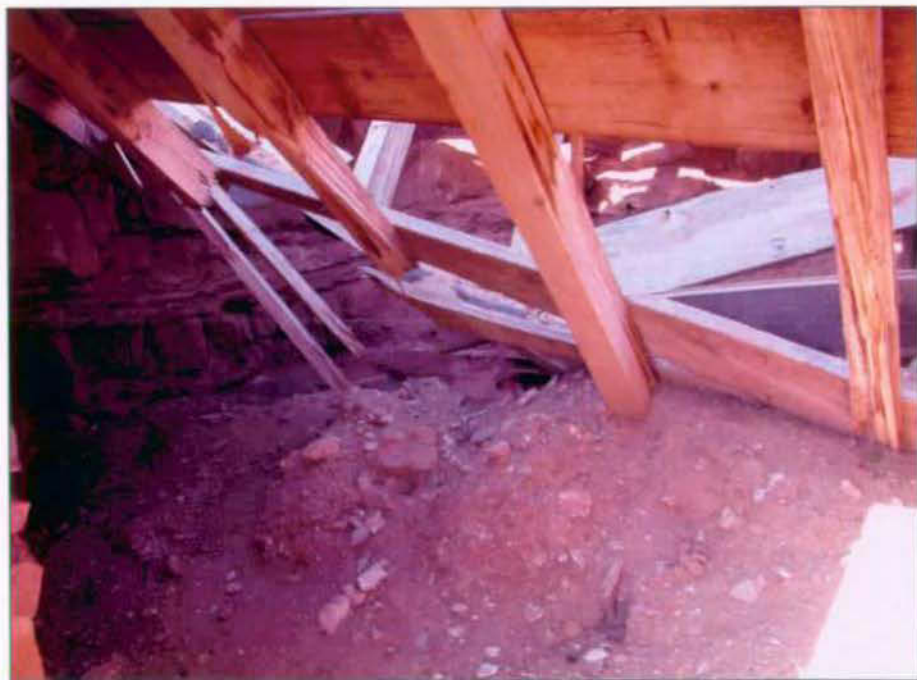
View if interior. Note collapsed roof and sediment on floor.

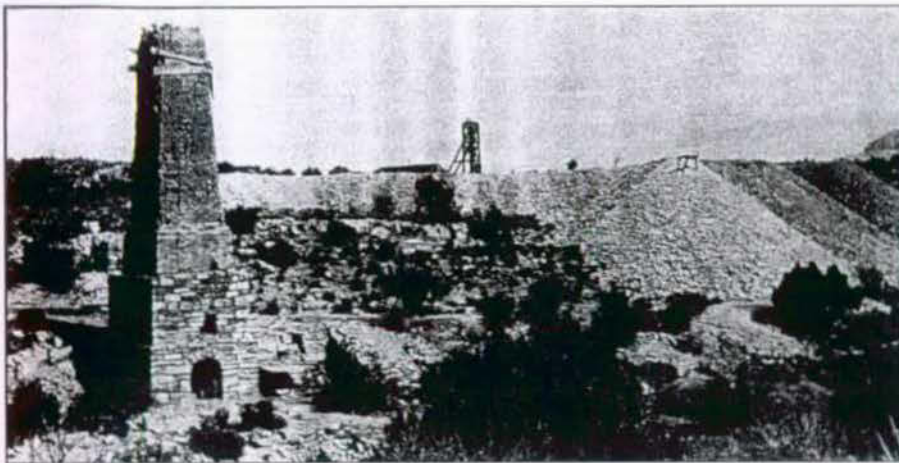
View from southwest, circa 1904. Note holes in masonry above arch and in adobe above stone base, and visible step in adobe chimney.

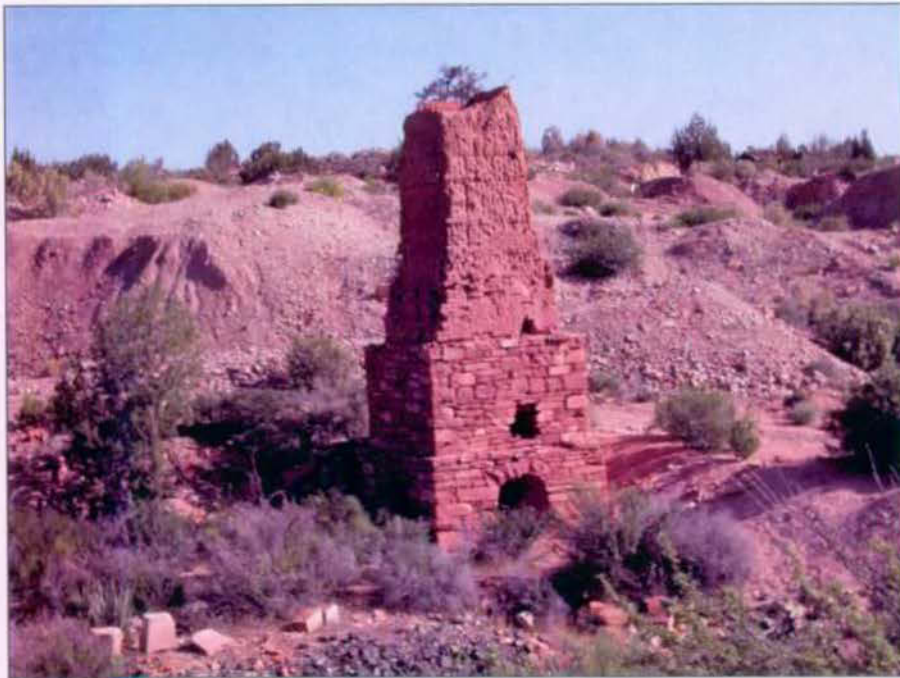
View from southwest. Note holes in masonry above arch and in adobe above stone base, and erosion of step in adobe chimney.

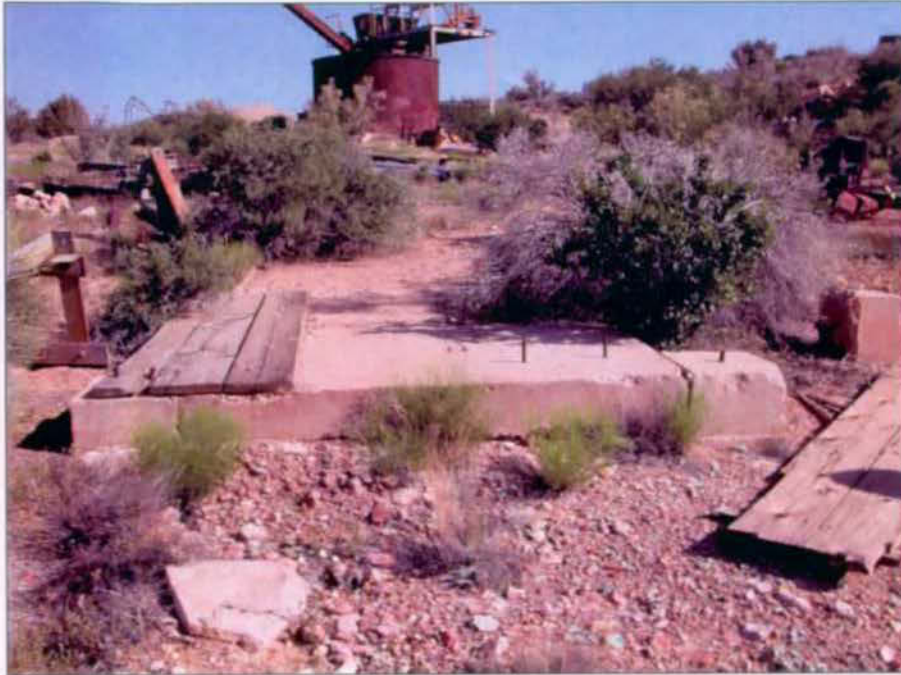
View from south.

This structure is in fair condition. The concrete is weathered and deteriorated, and some of the edges have been damaged or chipped off. The anchor bolts are rusty, but sound. The three wood planks are weathered and deteriorated.

Little needs to be done to this structure, nor is much possible, as concrete is very difficult to repair. If concrete repair is desired, refer to the section on this subject in the outline specifications, in Appendix A.

However, the vegetation which is growing against the slab should be removed. Not only should the vegetation be removed, but the roots should be removed, as well. If the roots from the large shrubs cannot be removed, they could be treated with an herbicide.

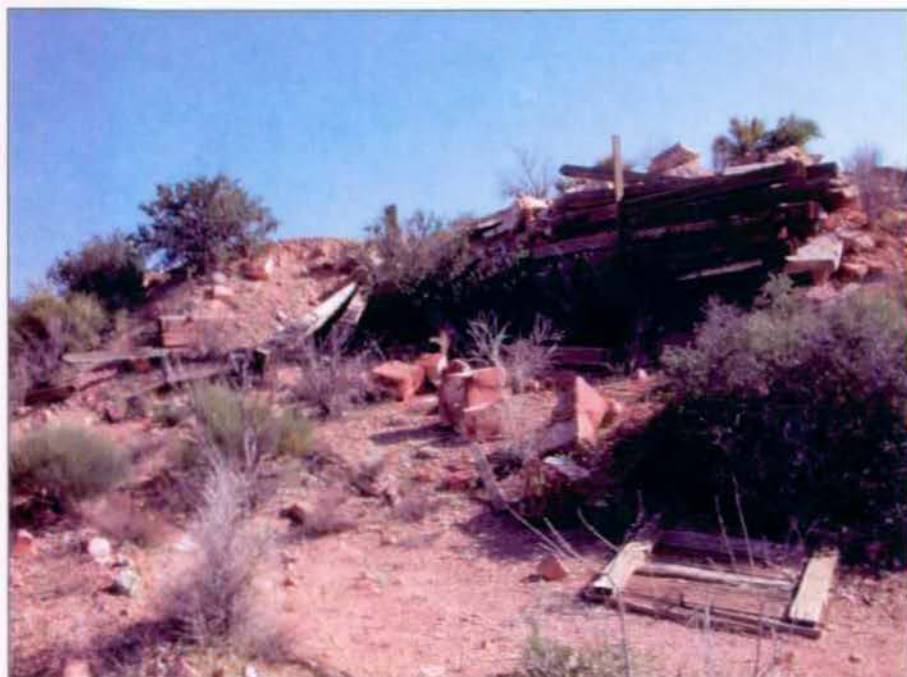
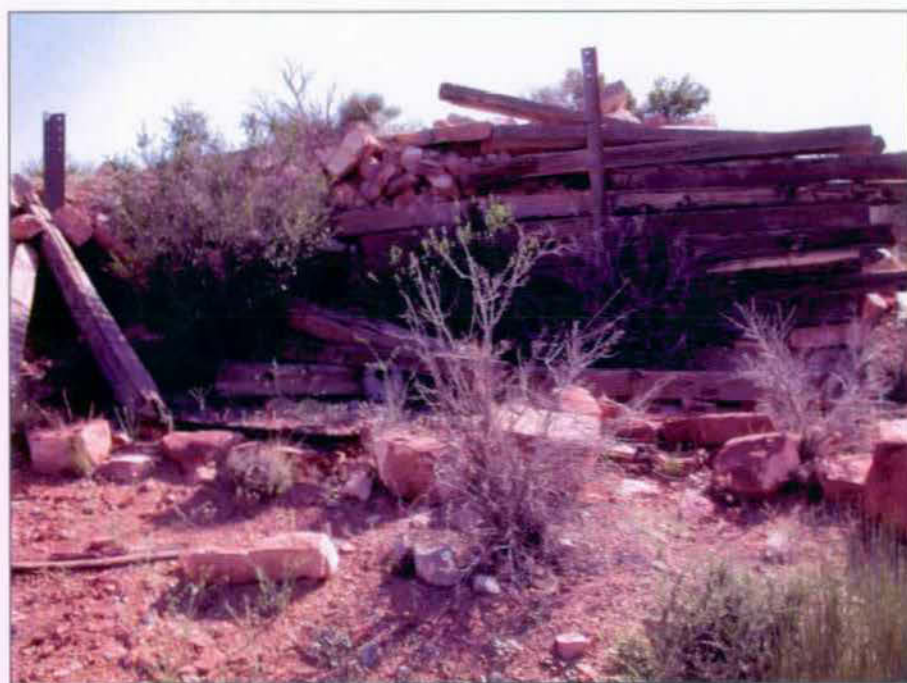
View from southwest.

Close-up from southwest.

This structure is in poor condition. The angle iron support on the west is no longer holding up the timbers, and the north wall has collapsed. Portions of the east wall have also collapsed. The wood itself is very weathered and deteriorated.

Next, the angle iron on the west (which held up the north wall), could be reinstalled, followed by reinstalling the timbers which have displaced or fallen out. Finally, the wall could be backfilled with earth and stone.

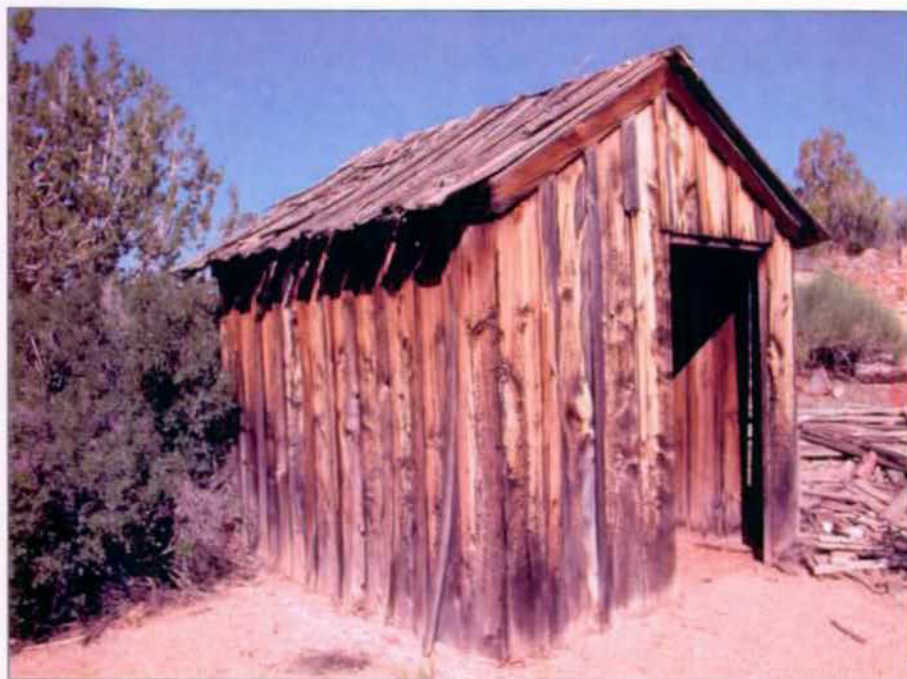
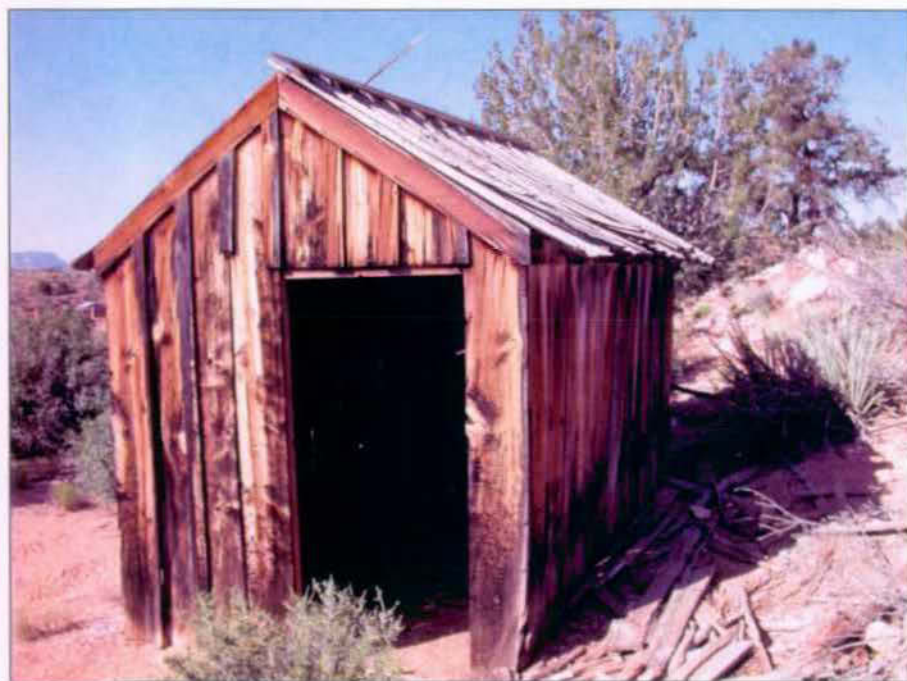
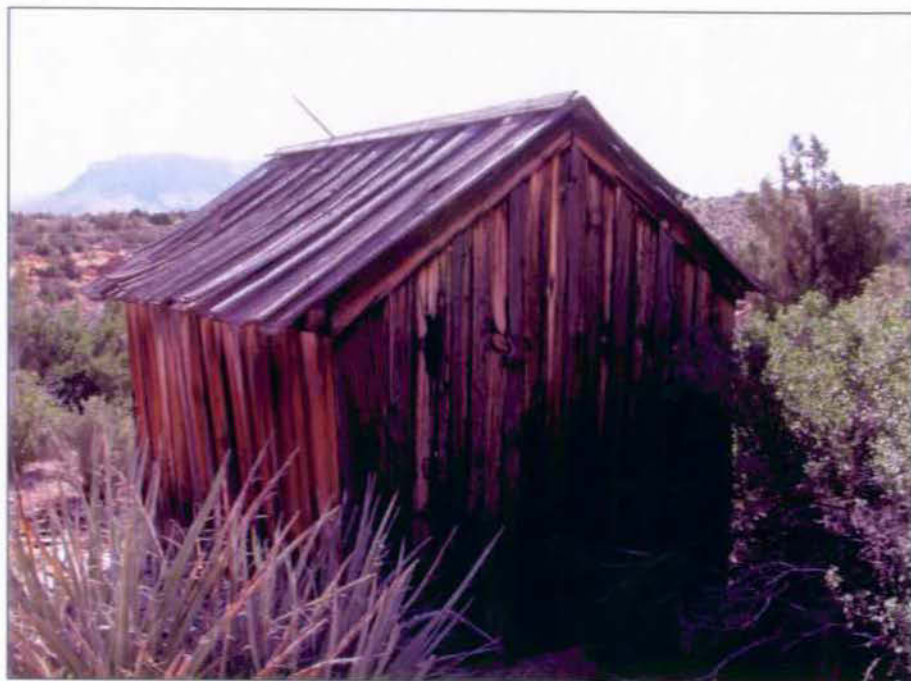
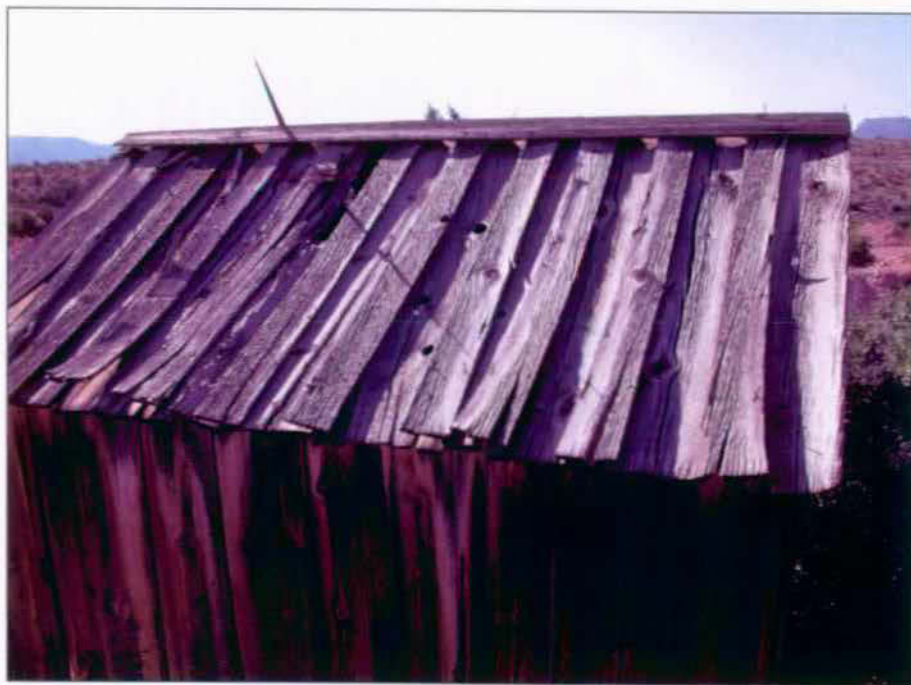
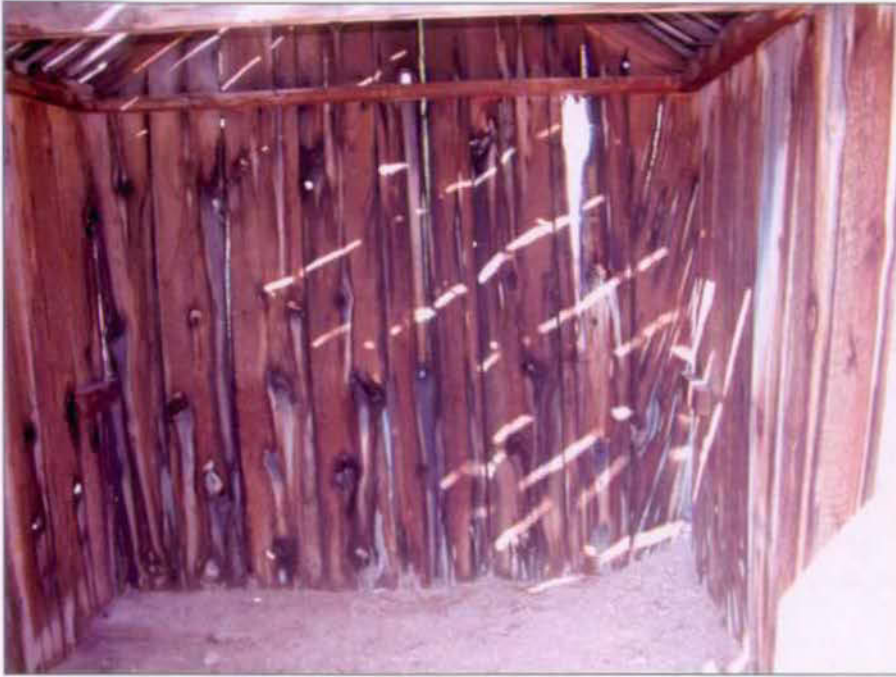
Detail of roof. Note board and batten structure.

This building is in poor condition, but it is still solid. The wood is very weathered and deteriorated, and the boards are warped, split, and loose. Some of the battens are missing.

The roofing and siding should be carefully inspected, and repaired or replaced as is necessary. Work should include reattaching loose boards, and replacing severely damaged or deteriorated boards. The same should be done for the roof and wall structural members, and the floor.
