# PARASHANT NATIONAL MONUMENT

## Historic Preservation Report

*Condition Assessment and Preservation Recommendations –  
Grand Gulch Mine and Pine Well Ranch*

SEPTEMBER 30, 2003

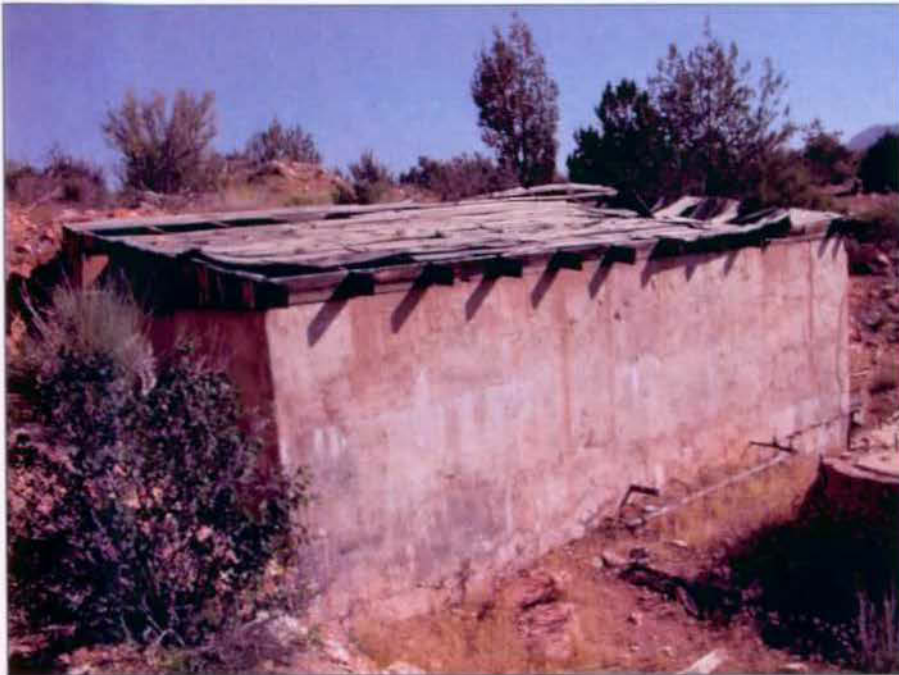
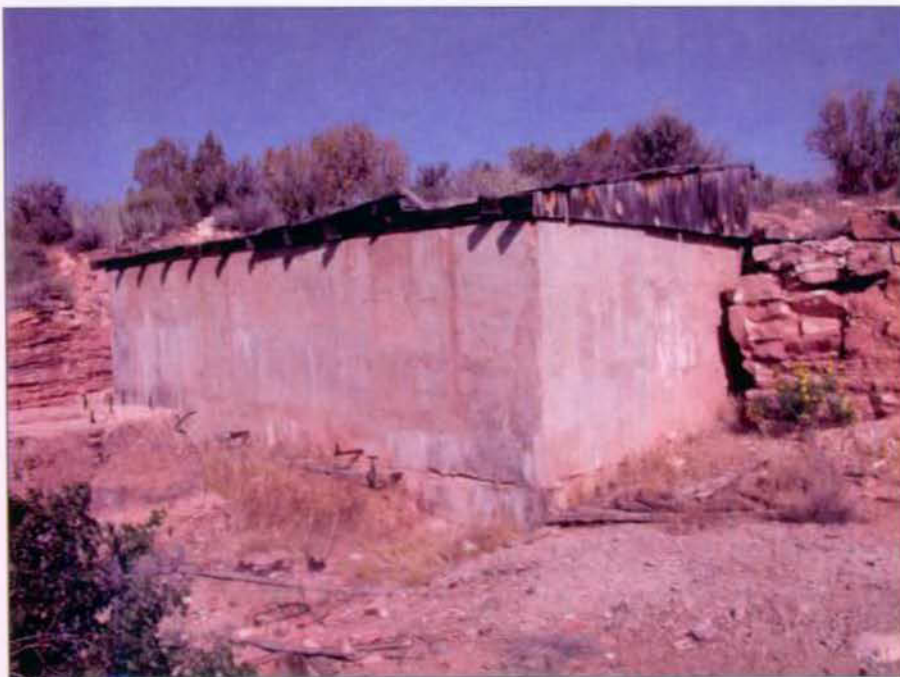
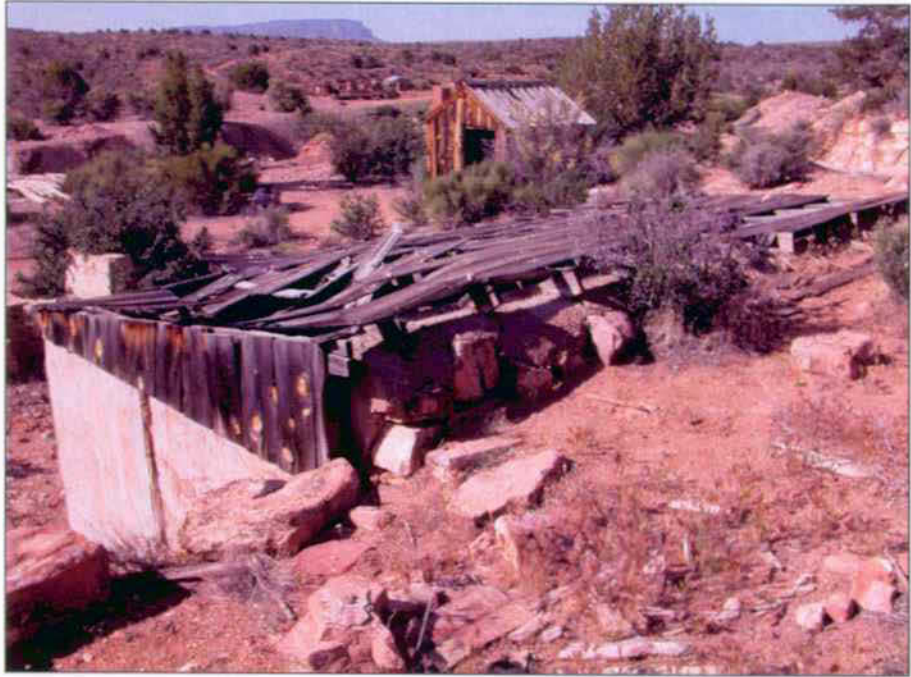
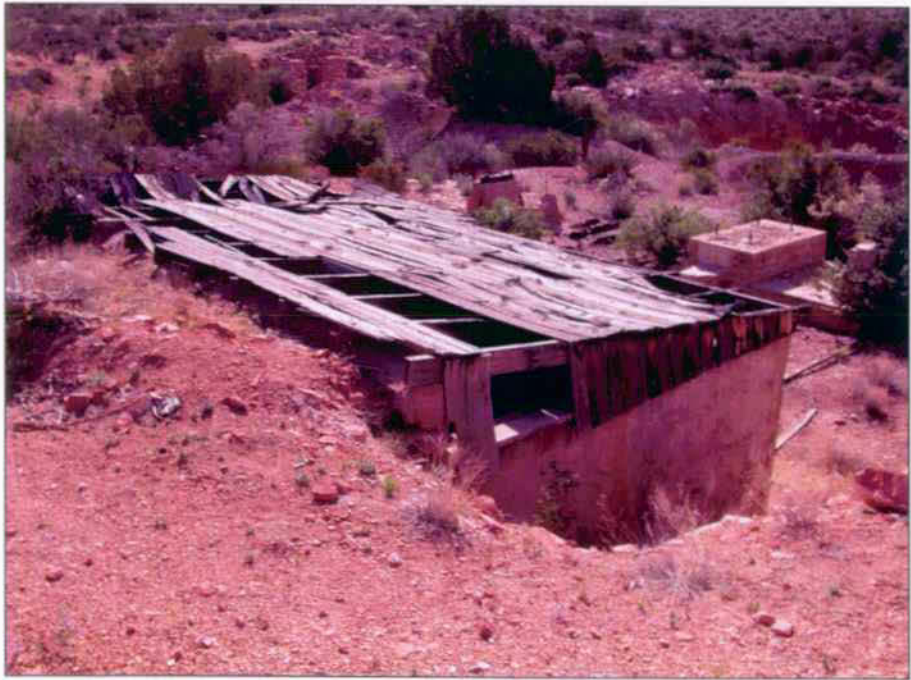
This structure is in poor condition. It is showing the effects of weathering and neglect.

The roof is very deteriorated, and partially collapsed. The framing and the roof deck boards are very weathered and deteriorated, cracked, warped, loose, and displaced. Many of the deck boards are missing. The boards on the wood side walls are in similar condition.

The concrete structure is in fair condition. The concrete is weathered, but appears to be sound. The stucco is weathered, crazed, and cracked, but still appears to be attached to the concrete structure. There are a couple of large cracks, most notably on the base of the south wall. (This may be a seam between the floor and the walls).

The roof should be carefully inspected, and repaired or replaced as necessary. Work would include repair or replacement of damaged or missing framing and roof sheathing, and reattachment of loose connections. Displaced members should be returned to their original positions.

Although not as high of a priority, the stucco could be repaired and recoated with a new finish coat.

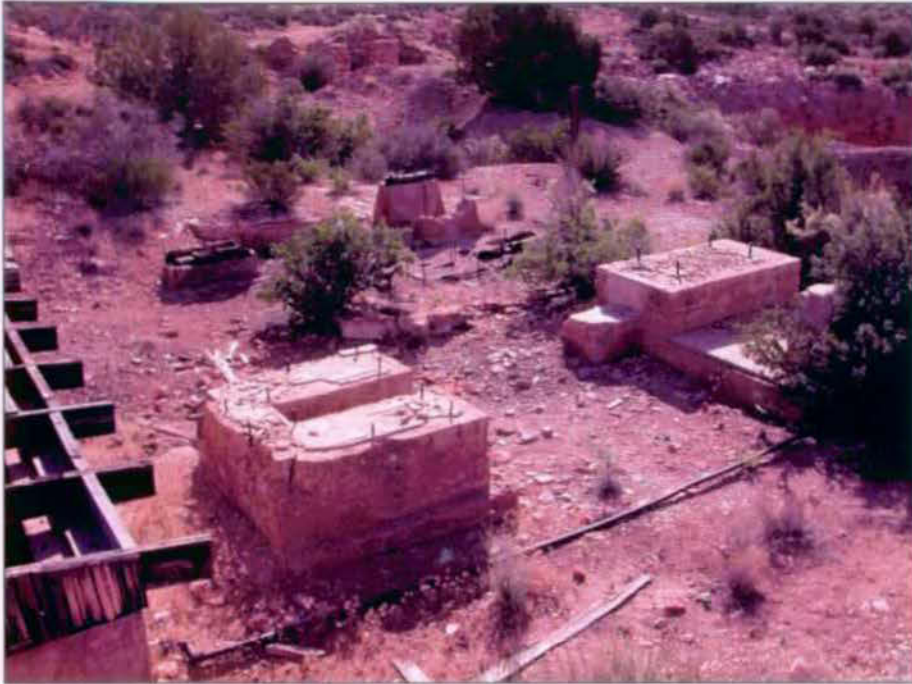
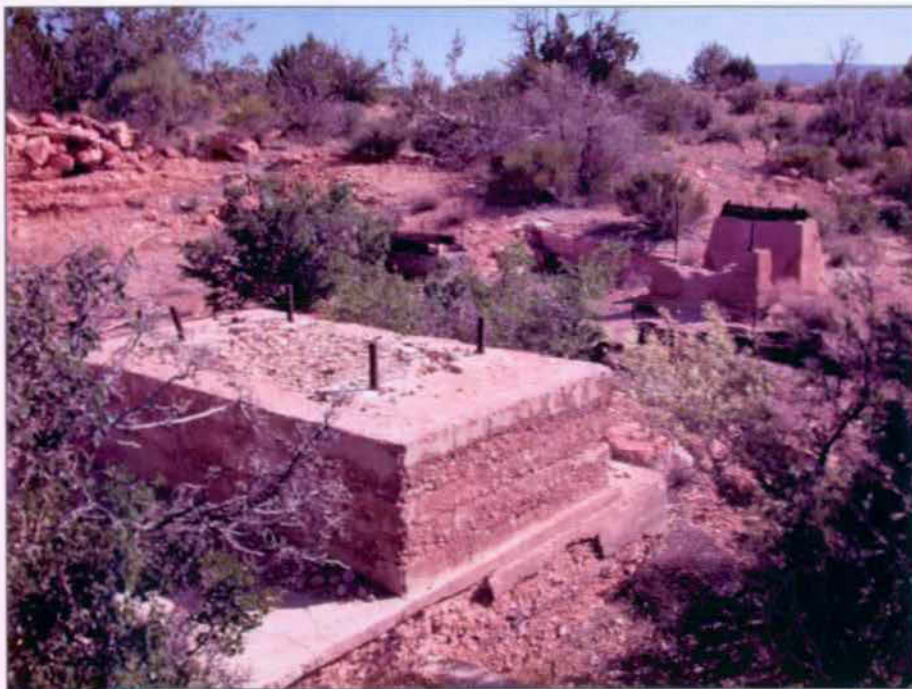
These piers are in poor condition. The concrete is very weathered and deteriorated. The surfacing is cracking and spalling, and much of it is missing. Many of the piers are damaged as well – most notably there are a lot of edges and corners that have been knocked off.

Little needs to be done to these piers, nor is much possible, as concrete is very difficult to repair. If concrete repair is desired, refer to the section on this subject in the outline specifications, in Appendix A.

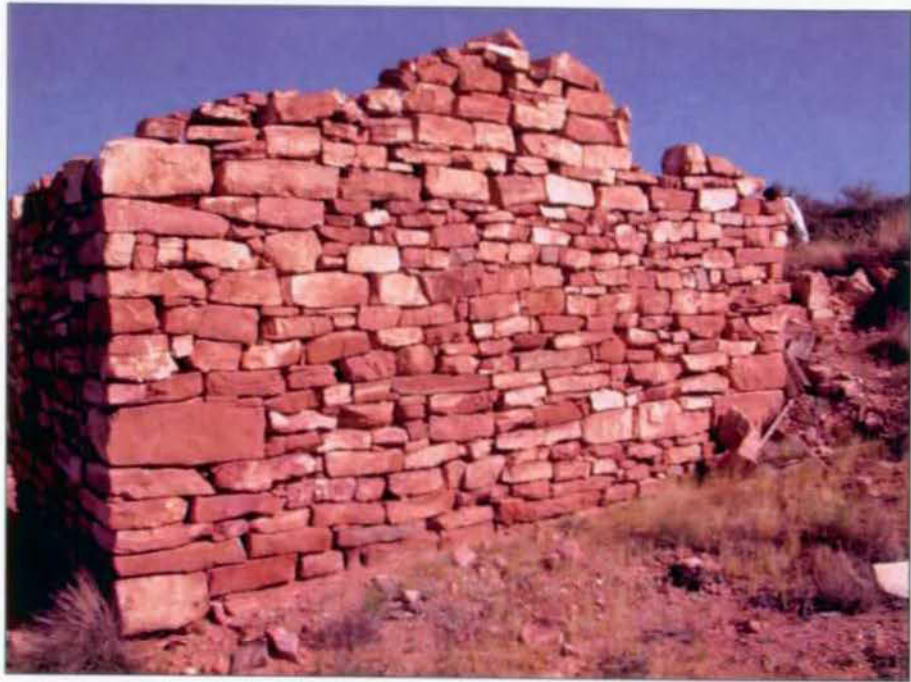
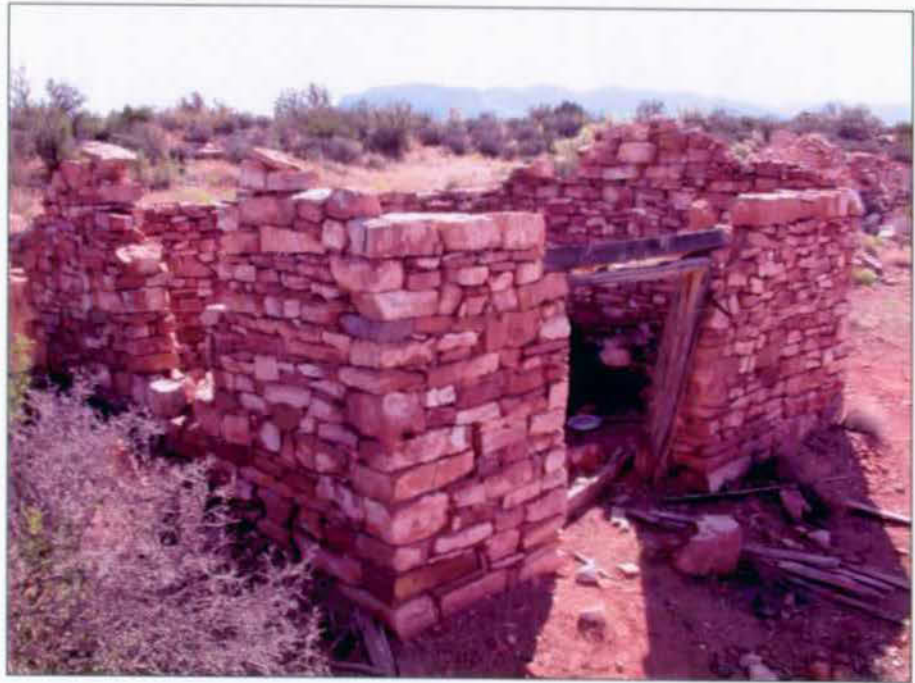
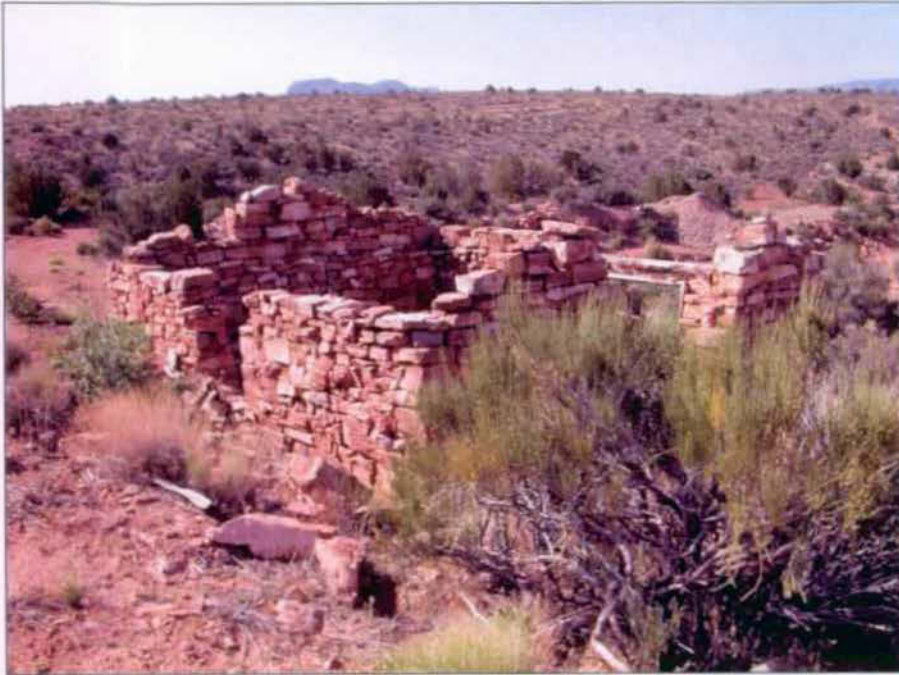
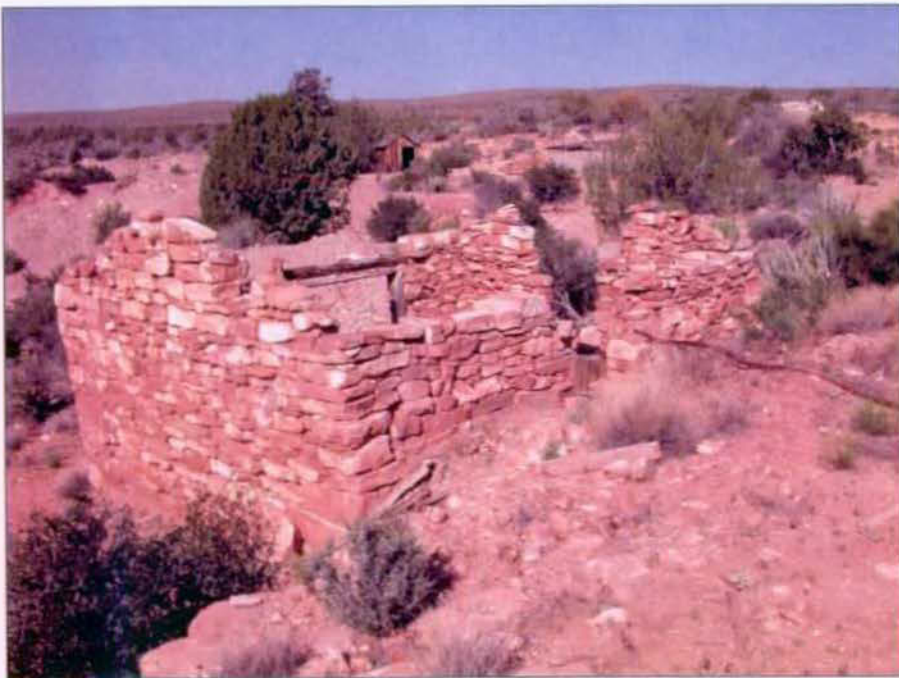
This building is in poor condition – it is basically a ruin. The roof is missing, and portions of the stone walls have collapsed or fallen out.

Many of the stones at the tops of the walls are loose. The mortar is eroding from the joints, especially at the tops of the walls. In several places, the mortar has eroded all the way through.

The southeast corner of the building is tipping out, and there is a large crack in the south end of the east wall.

The lintel over the door frame is rotten and loose, and the door frame is very deteriorated. It is loose and distorted, and one of the jambs is charred.

Stabilizing the walls would require several steps. Work would include stabilizing, repairing or rebuilding those portions of the walls that have loose stones or are in danger of further collapse, such as the tops of the walls, the southeast corner, the window openings and the gable ends, using earthen mortar, amended with an acrylic polymer admixture. The mortar joints should be re-pointed with earthen mortar, amended with an acrylic polymer admixture; and the tops of the walls should be capped with soil cement, in a manner that helps to hold the top stones in place, as well as aids in shedding water from the top of the walls.

The wood lintels and door frame should also be carefully inspected. The wood members should be repaired or replaced as necessary, and the door frame should be straightened out and re-anchored to the walls.

Vegetation which is encroaching on the structure should be removed. The interior of the building, and the site should be cleaned up and re-graded. Re-grading of the interior and the site should be done to smooth out the roughness, and provide proper drainage away from the structure. (Some of the rubble from the collapsed walls could be left in place, but definite circulation areas should be established, with a level, granular surface).

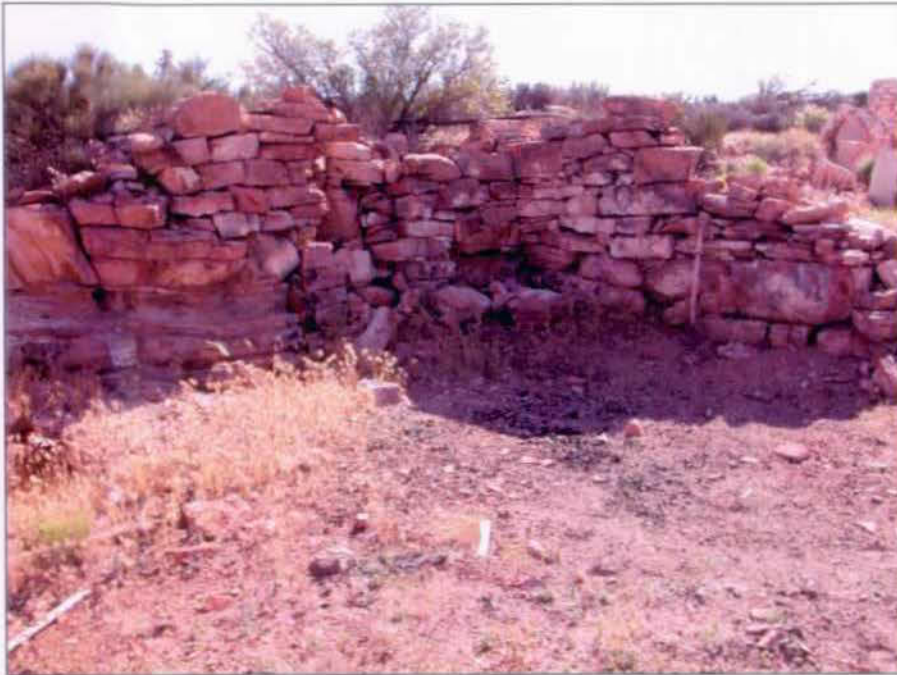
This structure is a ruin. Many of the stones at the tops of the walls are loose, and the mortar is eroding from the joints.

Work would include stabilizing the remaining walls. Any loose stones should be re-set using earthen mortar, amended with an acrylic polymer admixture. The mortar joints should be re-pointed with earthen mortar, amended with an acrylic polymer admixture; and the tops of the walls should be capped with soil cement, in a manner that helps to hold the top stones in place, as well as aids in shedding water from the top of the walls.

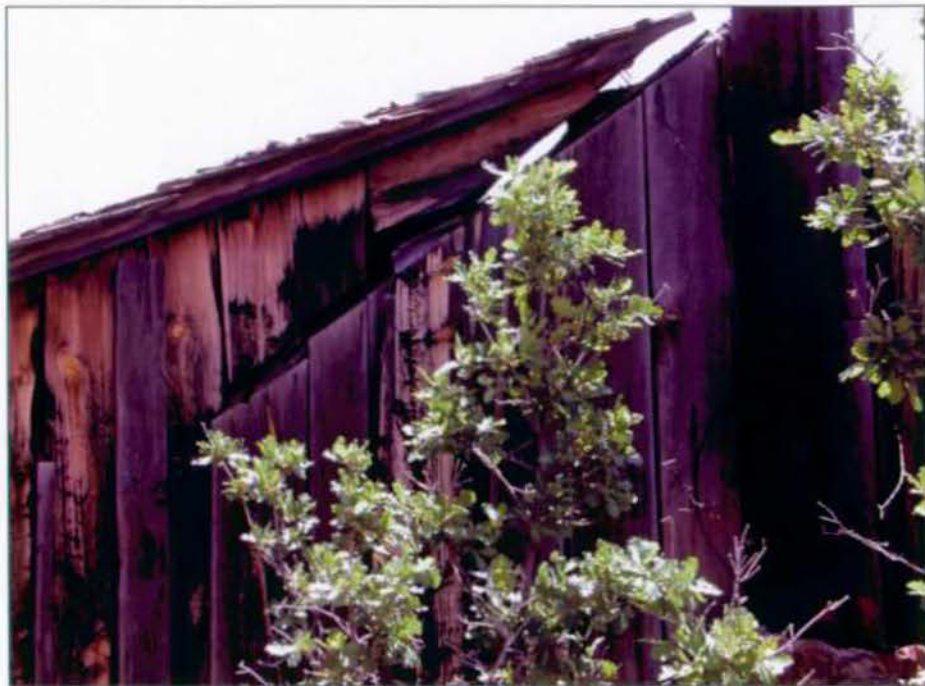
Detail of west elevation. Note seam where addition is separating from original building, and siding.

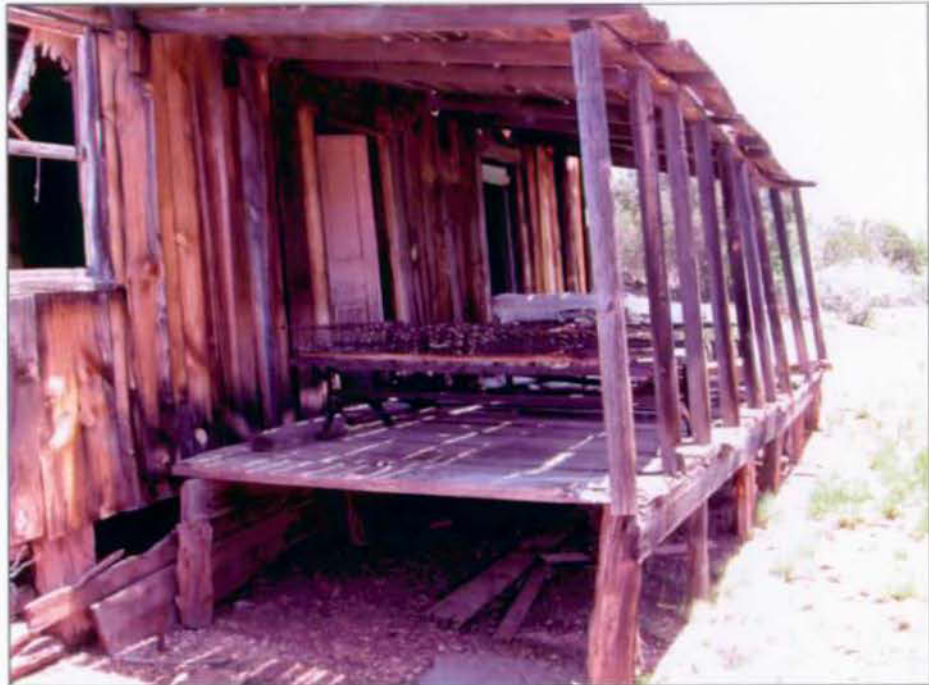
Detail of west end of porch, and south wall. Note posts and beams supporting floors and walls, displaced framing, and skirting at original cabin.

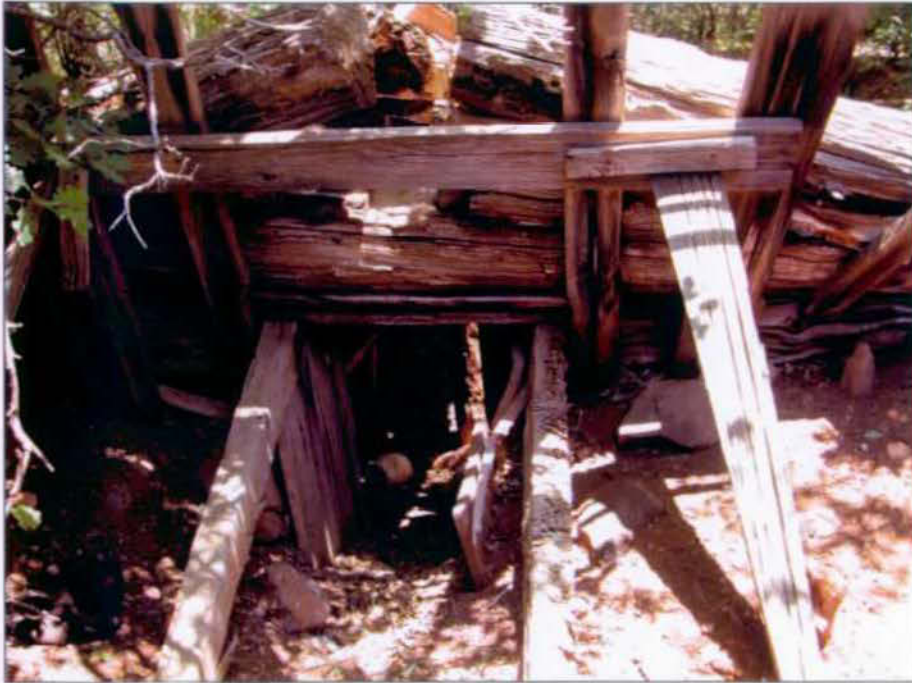
View from south. Note bracing holding up south wall.

This building is in poor condition. It is almost a ruin. The roof and walls are partially collapsed. The front wall is shored up with wood braces, but is still failing. Much of the earth covering the roof has fallen through into the inside of the structure.

The entrance ramp should be cleaned out, and the wood shoring should be repaired or replaced as is necessary. This wood should also be treated with a preservative.

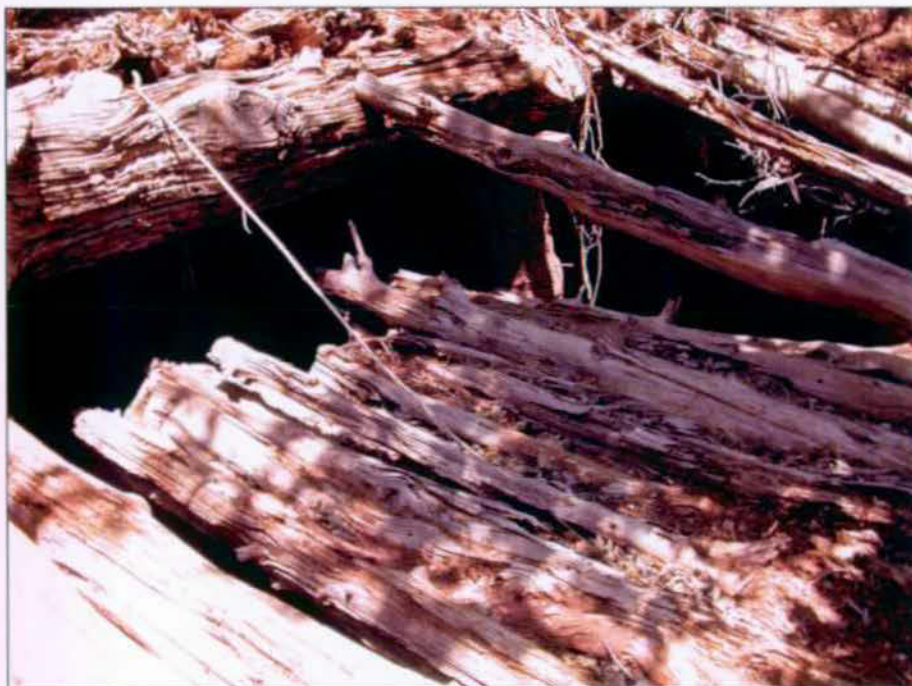
Detail of roof. Note center beam and collapsed roof poles.

First of all, the earth covering (and other debris) should be removed from the entire roof. The wood roof and wall members (logs and poles) should be carefully inspected for damage or deterioration. Any severely damaged or deteriorated members should be replaced. Although it is difficult to discern, if it can be determined that the front wall was self supporting, then it should be rebuilt in the same way. If not, then it should be rebuilt with shoring, to resemble its current appearance. All of the wood should be treated with a preservative.

Covering the roof with earth, while recreating the historic appearance of the structure, may not be such a good idea in terms of stabilization, as the earth sitting on top of the wood logs and poles contributes to their deterioration. Using a protective membrane, such as 90 pound mineral surfaced asphalt rolled roofing, would help. This decision will require consideration of the value of the historic appearance versus the reality of the deterioration of the replacement wood.

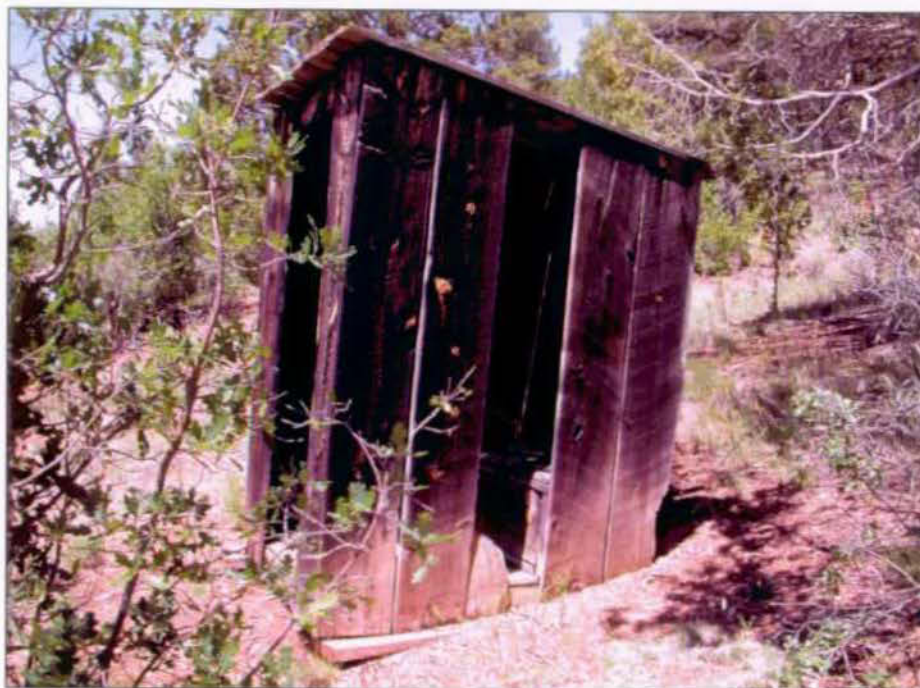
View from southeast. Note how structure is settling.

This structure is in poor condition. It appears to be steeling into the pit, especially on the north side. All of the wood is weathered and deteriorated, and the structure is rickety. The floor is soft, and the roof is sagging. One of the siding boards is missing on the east, and the door is no longer in place.

If this structure is not stabilized, collapse is inevitable. Activities should emphasize stabilization of the structure, as well as weatherization and repair of the exterior skin. Work should include shoring up the entire structure (or possibly even temporarily lifting or moving it), to inspect the flooring and support conditions. At a minimum, the pit should be modified to prevent further collapse, but for safety reasons, the pit should probably be filled in. Then the floor structure should be repaired as is necessary. The floor, siding, and roof boards should be carefully inspected, and repaired or replaced as necessary. Work should include reattaching loose connections, and replacing severely damaged, deteriorated, or missing members. Finally, the roof should be replaced, with new 90 pound mineral surfaced asphalt rolled roofing.

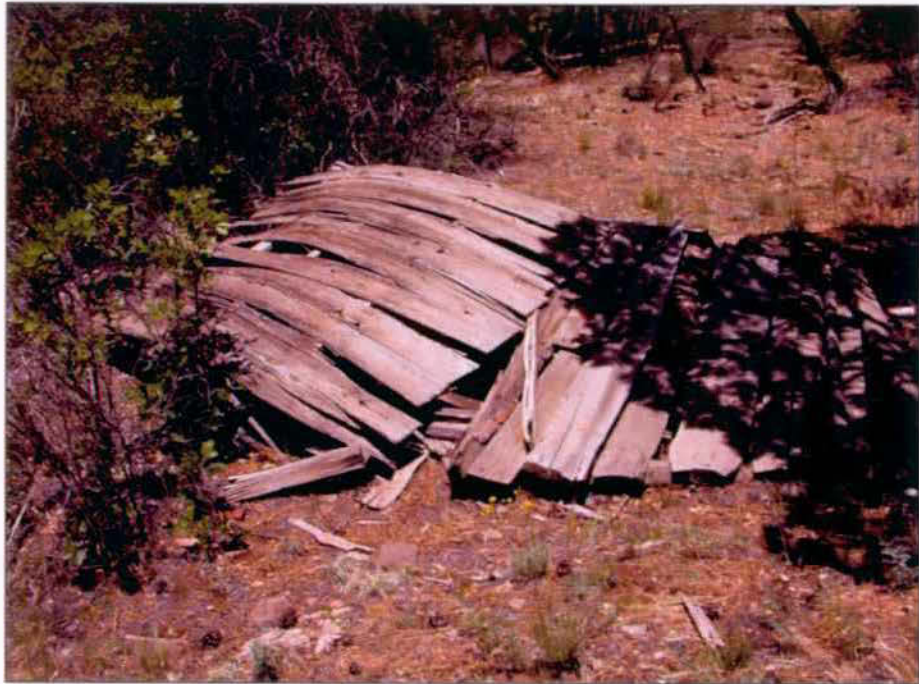
View from south.

This building is a ruin. It is completely collapsed. The structure and other wood members are very weathered and deteriorated.

No treatment is recommended for this structure.

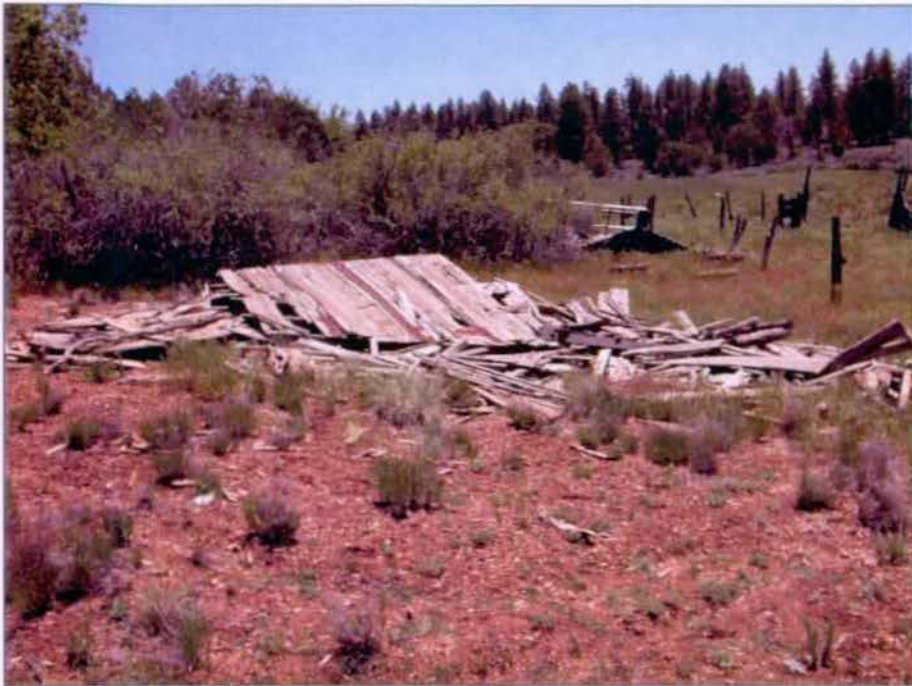
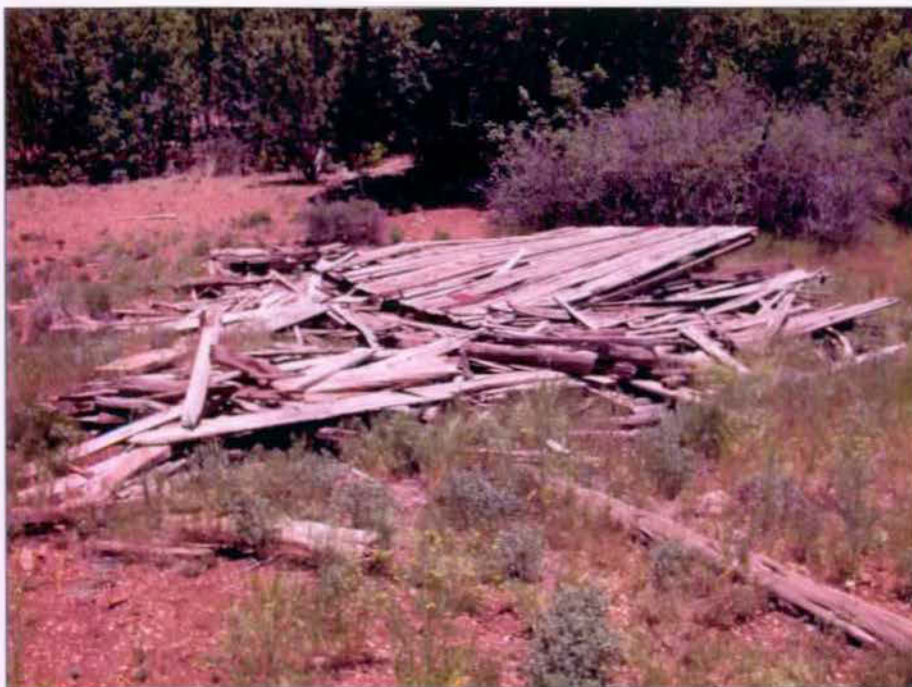
View from southwest.

This building is a ruin. It is completely collapsed. The structure and other wood members are very weathered and deteriorated.

No treatment is recommended for this structure.

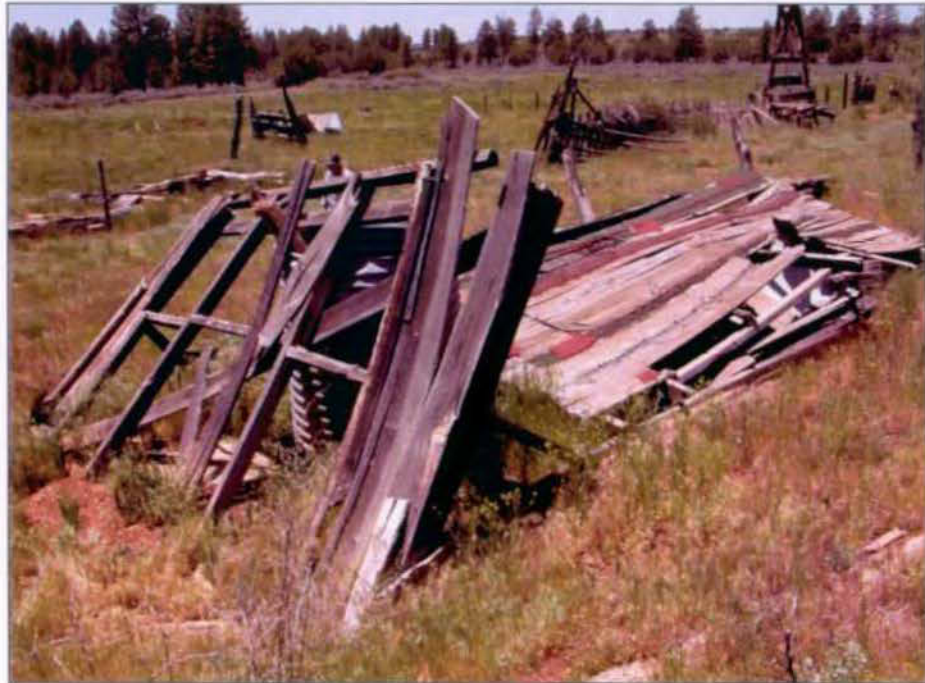
View from northeast. Note wall fragment.

This structure is a ruin. It is almost completely collapsed. All of the wood is very weathered and deteriorated.

No treatment is recommended for this structure.

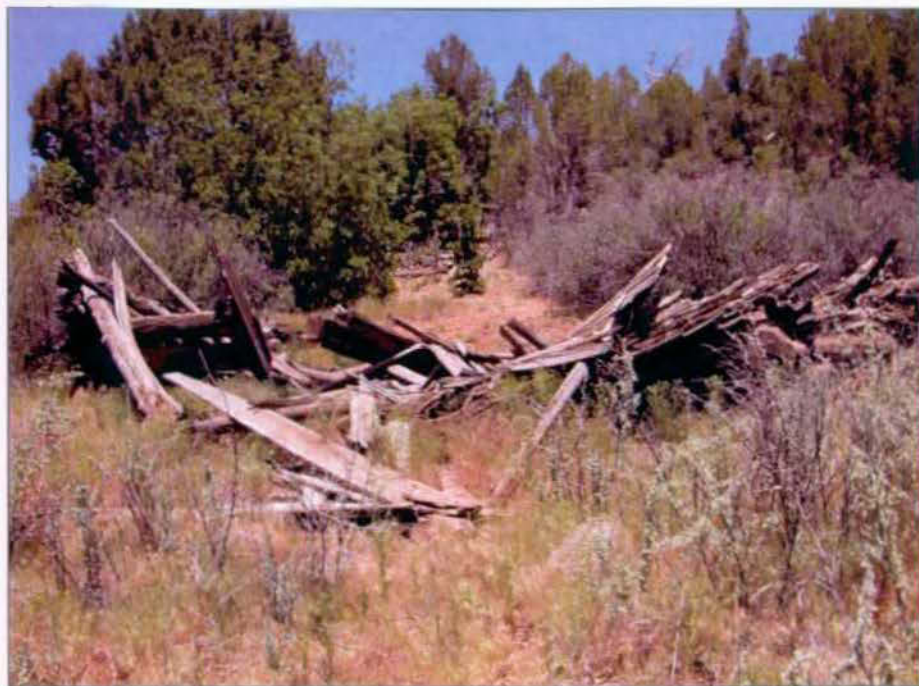
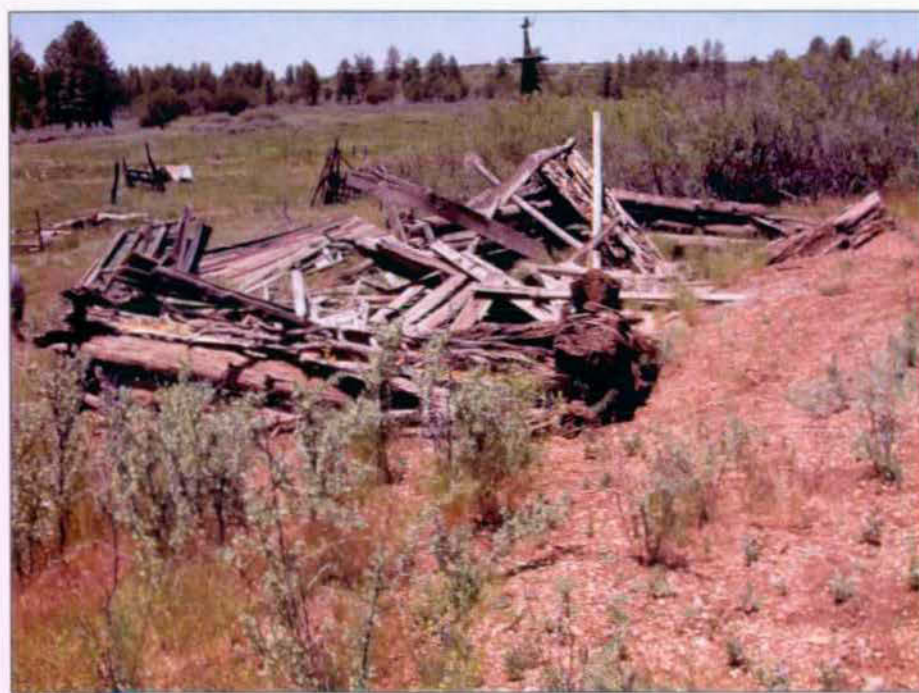
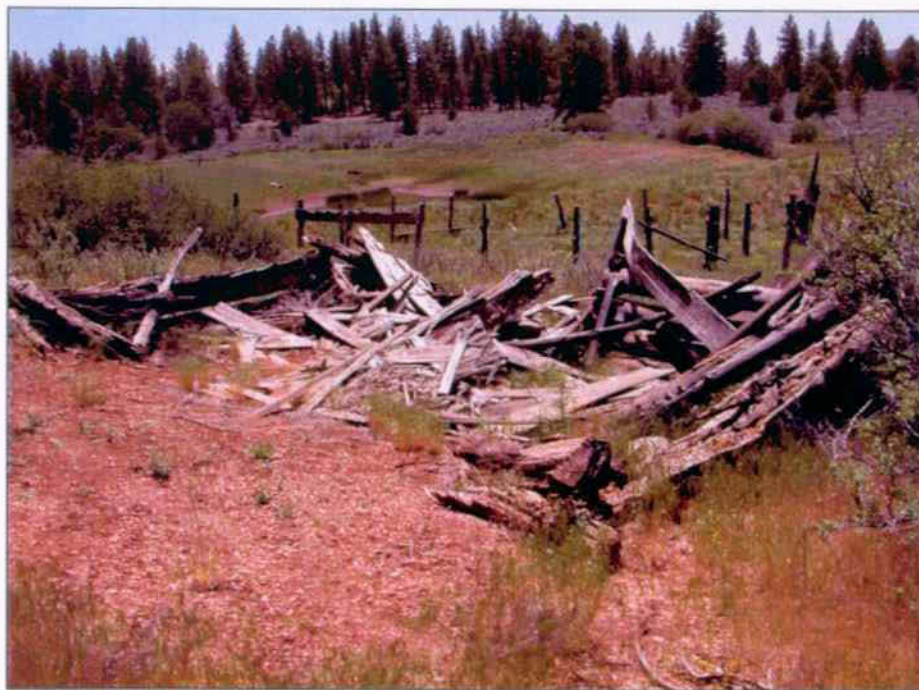
This building is a ruin. It is completely collapsed, and all of the remaining wood is very weathered and deteriorated. There is also some sedimentation on the north side of the structure, from soil washed down the hillside above.

No treatment is recommended for this structure.

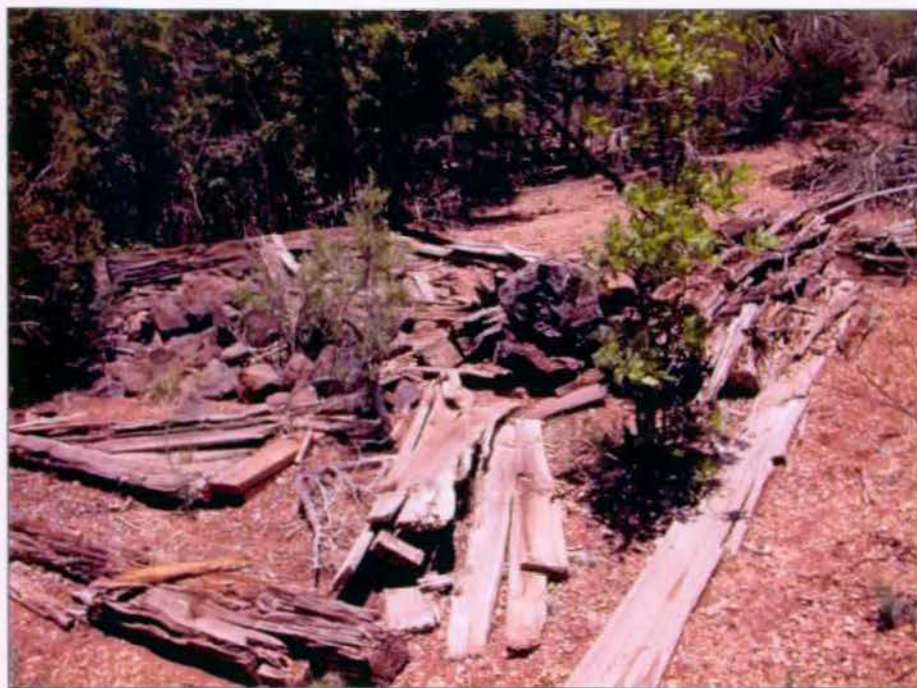
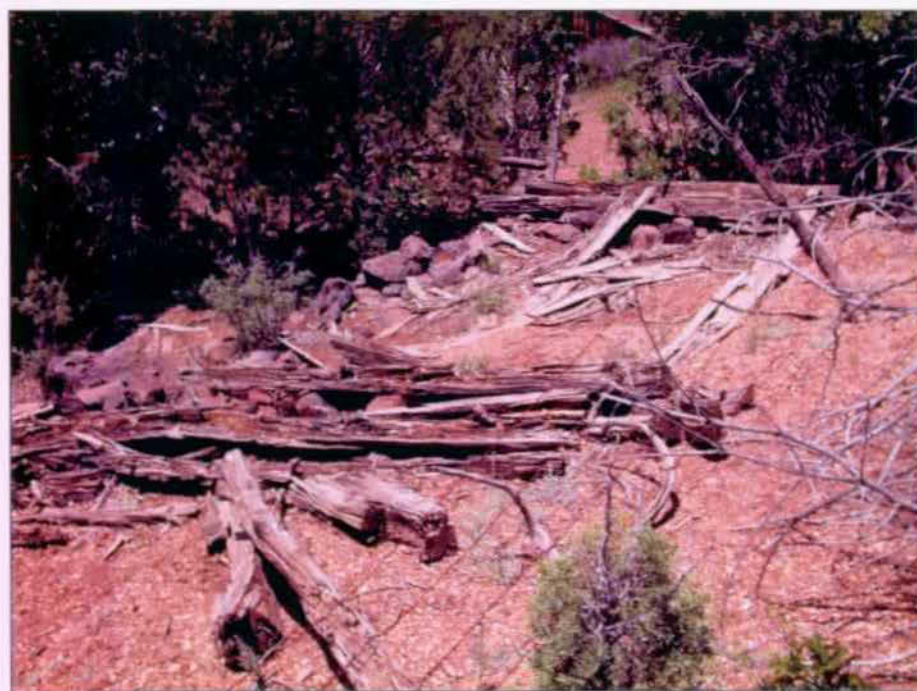
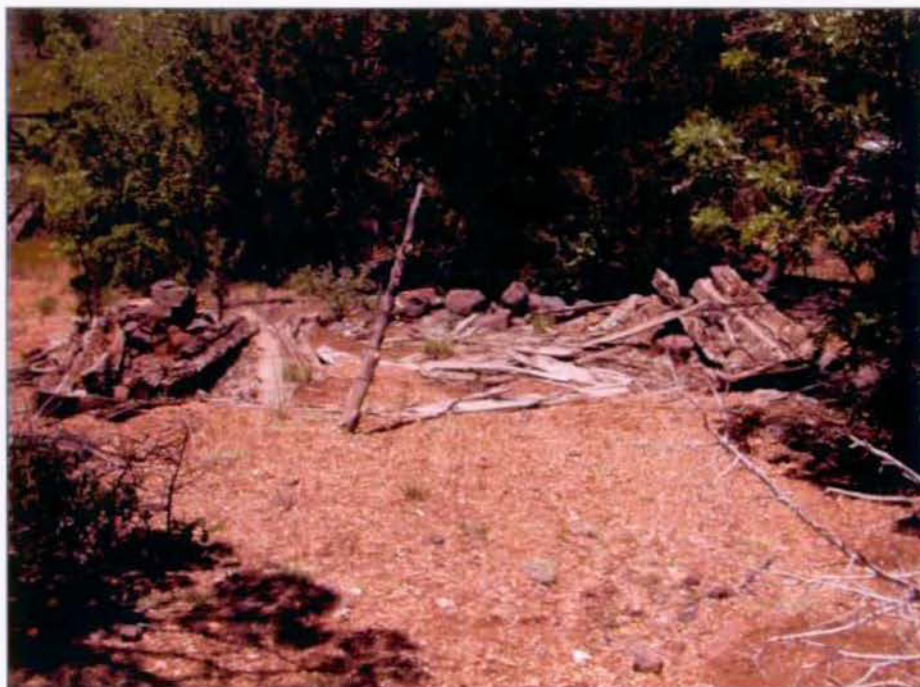
This structure is a ruin. It is completely collapsed, and all of the remaining wood is very weathered and deteriorated. There is also some sedimentation on the north side of the structure, from soil washed down the hillside above.

No treatment is recommended for this structure.

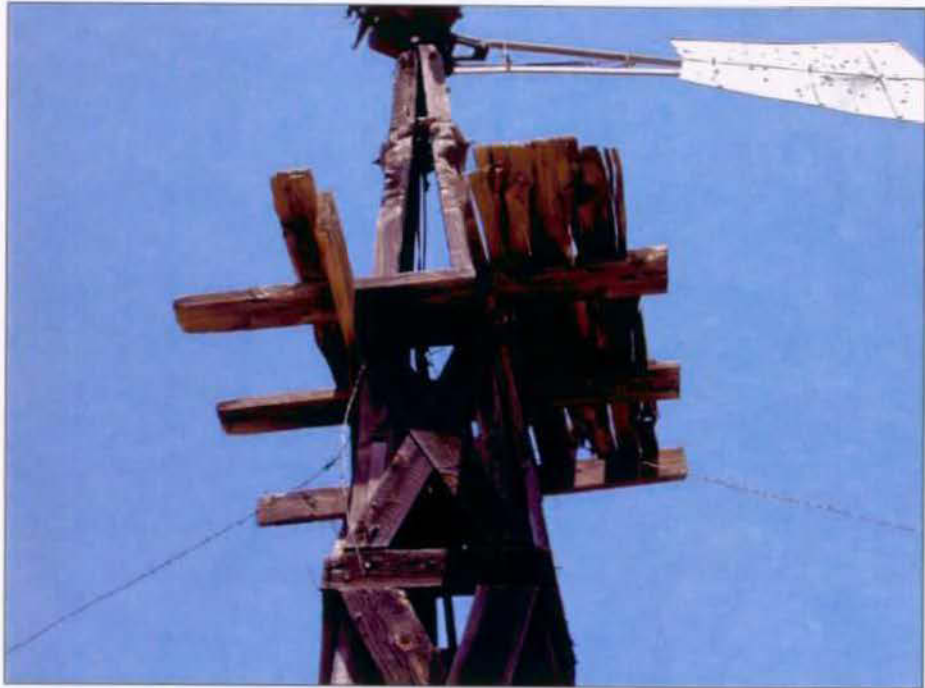
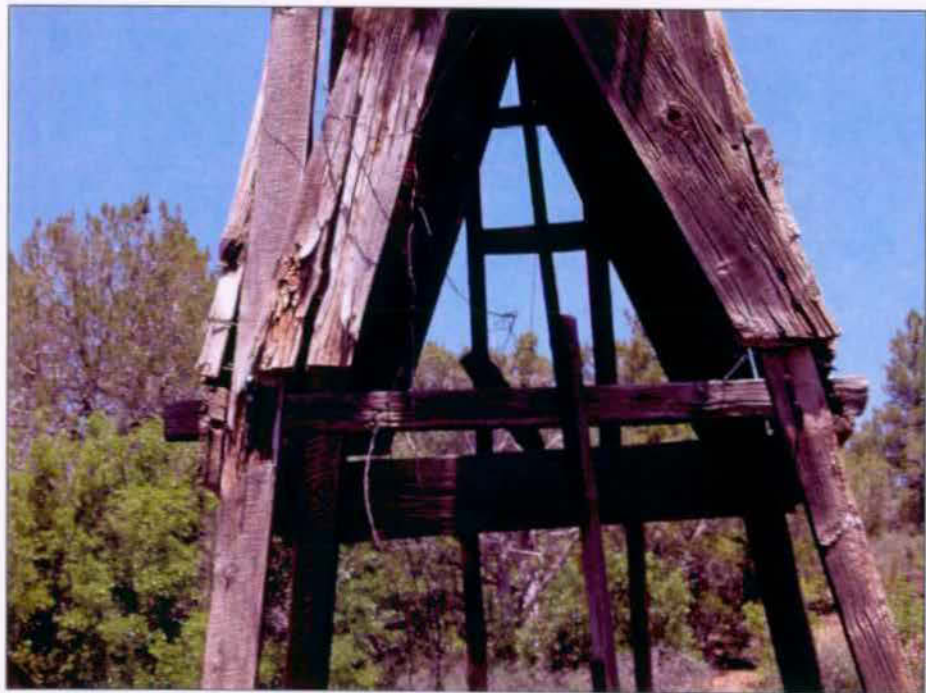
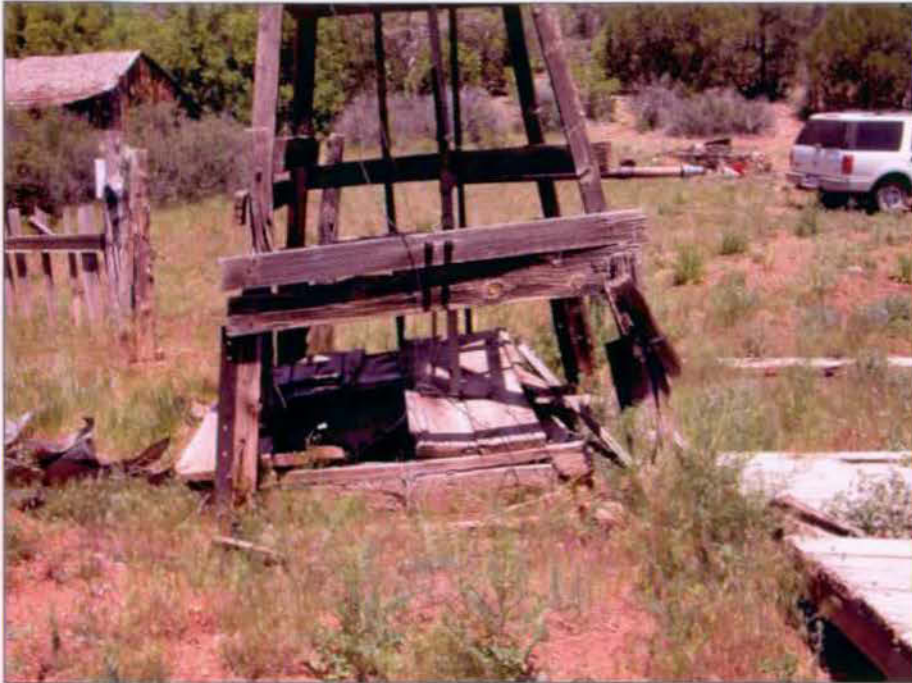
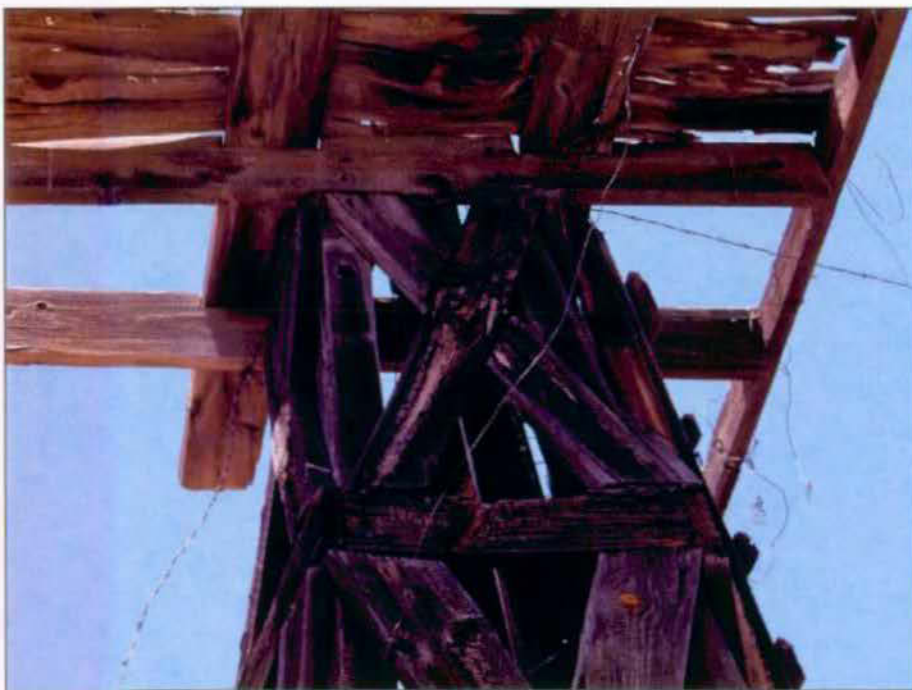
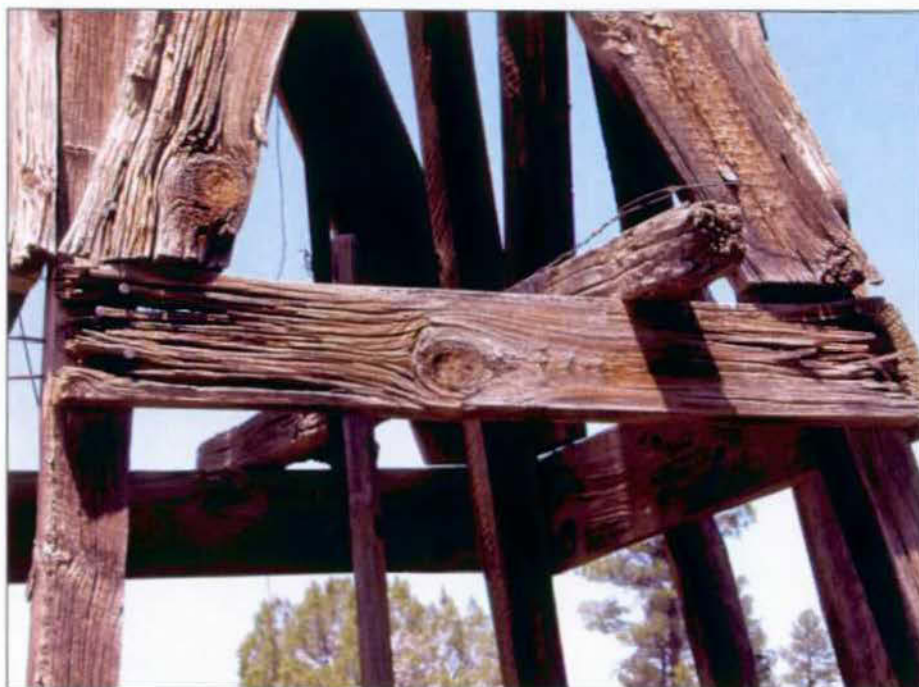
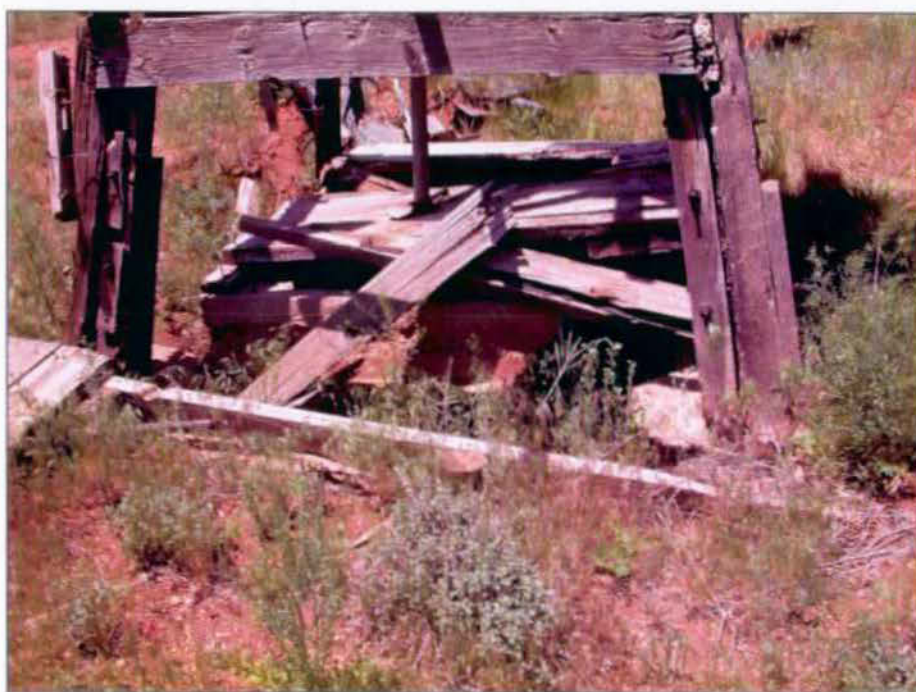
This structure is in poor condition, and appears to be dangerous.

The rotor blades are missing from the motor.

inspected, and replaced (if necessary), re-anchored, and securely reconnected to the corner posts.

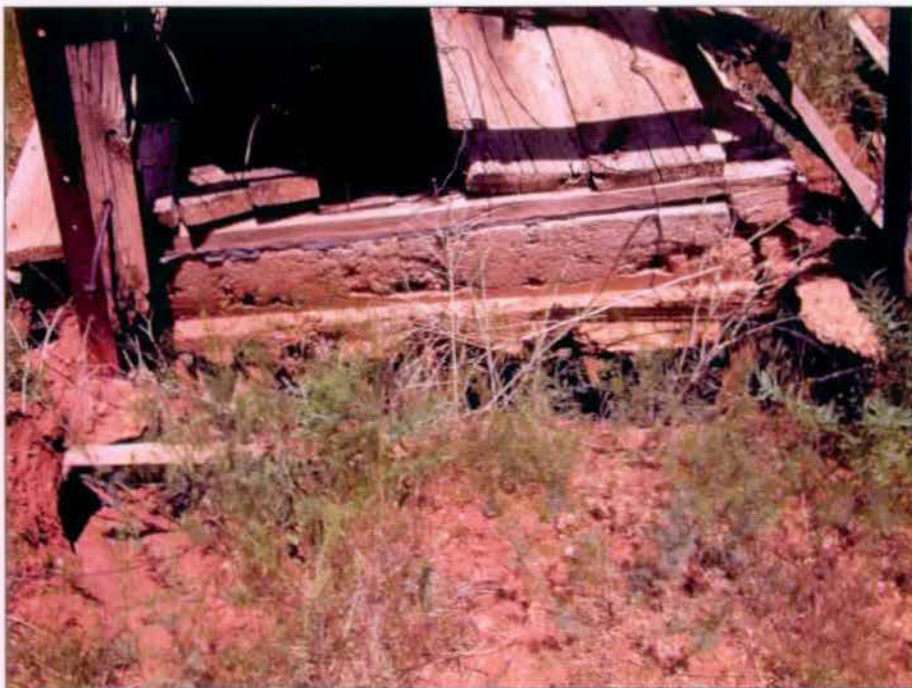
Detail of well underneath windmill. Note concrete enclosure, and wood cover.

As far as the wood poles are concerned, if the decision is made to keep the well as a well, they should all probably be replaced, possibly with a species more resistant to rotting from contact with water. (The use of treated wood would not be recommended in this case, as this would be a potential source of water contamination).
