# PARASHANT NATIONAL MONUMENT

## Historic Preservation Report

*Condition Assessment and Preservation Recommendations –  
Grand Gulch Mine and Pine Well Ranch*

SEPTEMBER 30, 2003

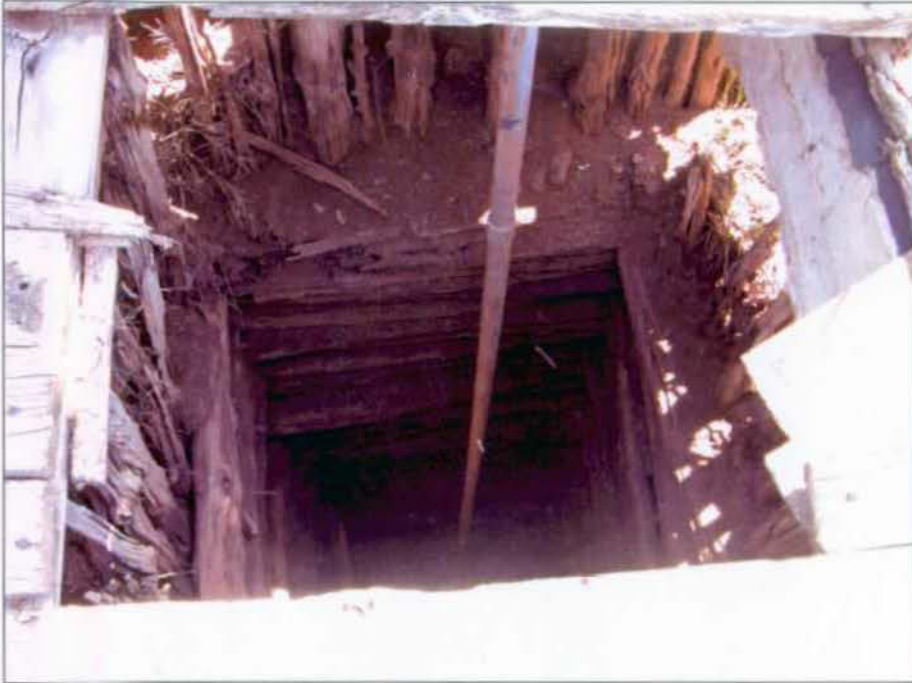
Detail of interior of well. Note log liner.

As far as the wood poles are concerned, if the decision is made to keep the well as a well, they should all probably be replaced, possibly with a species more resistant to rotting from contact with water. (The use of treated wood would not be recommended in this case, as this would be a potential source of water contamination).

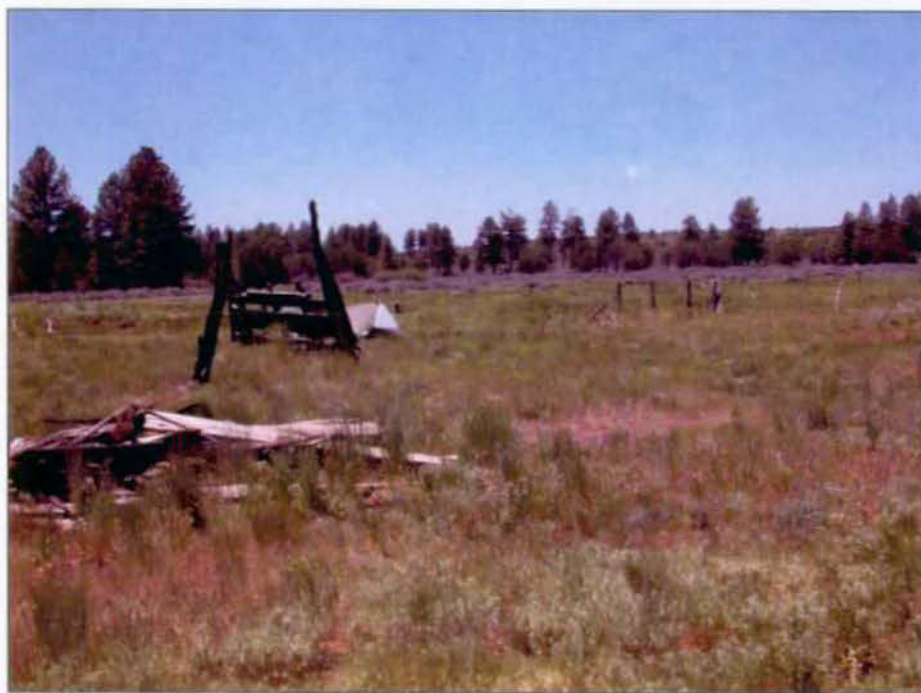
Gate near loading ramp.

All of these features are in poor condition. The wood members are very weathered and deteriorated, and many pieces are missing. Many of the posts and poles set into the earth are rotten, and many of the features are leaning or falling over.

Preservation of these features would be difficult, without reconstructing them. Temporary bracing would help to keep these features from falling over, but replacement of the vertical supports, with supports which would resist rotting (either a rot resistant species or treated wood), would be necessary for a more long lasting solution. Sound wood members should be reattached to each other, and severely

deteriorated, damaged, or missing members should be replaced. The wood could also be treated with a preservative, which would slow down the weathering and deterioration.

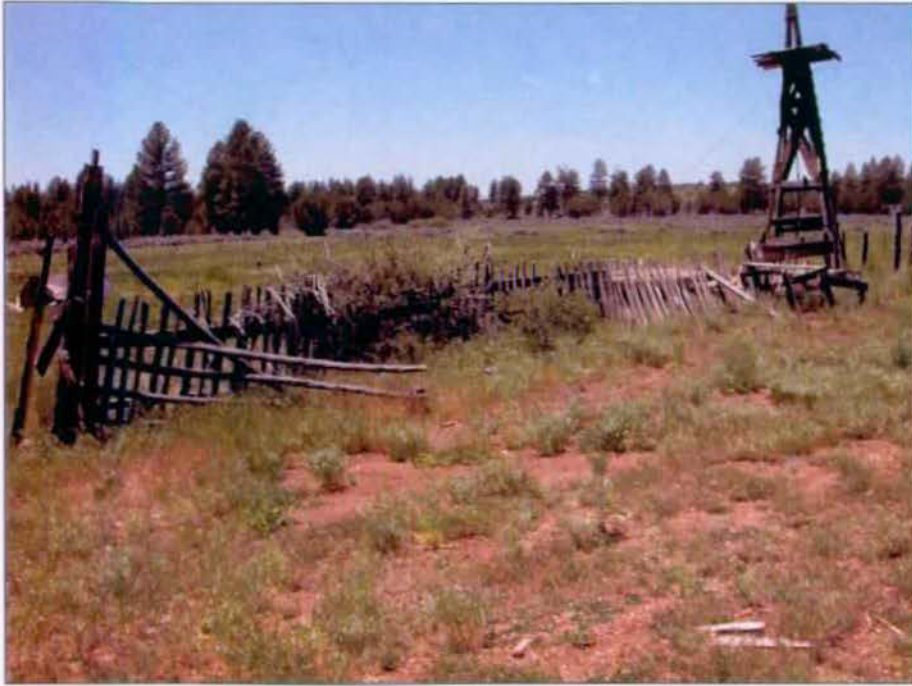
East portion of picket fence from northeast.

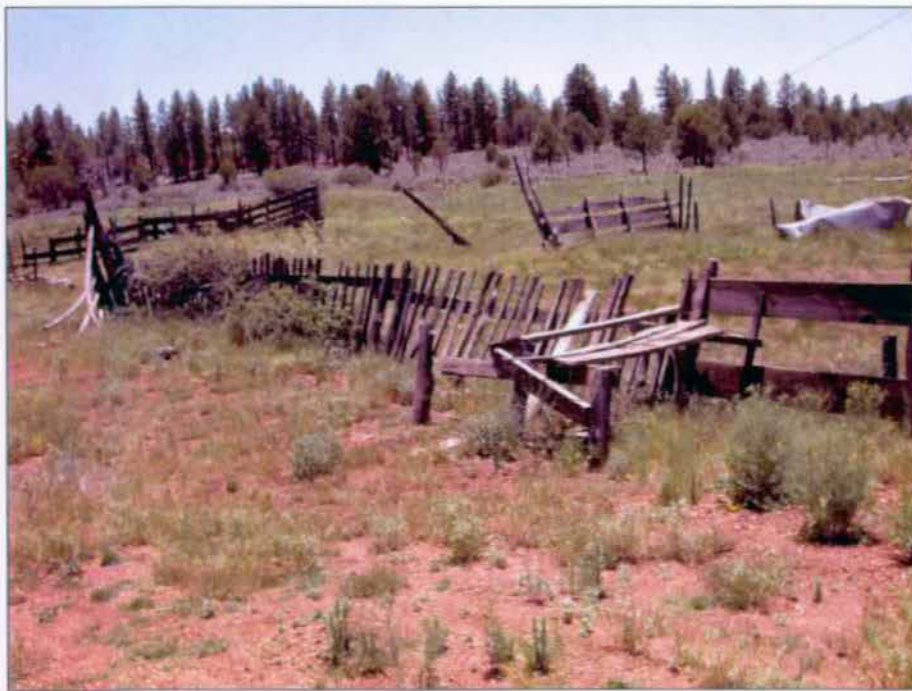
East portion of picket fence from northwest.

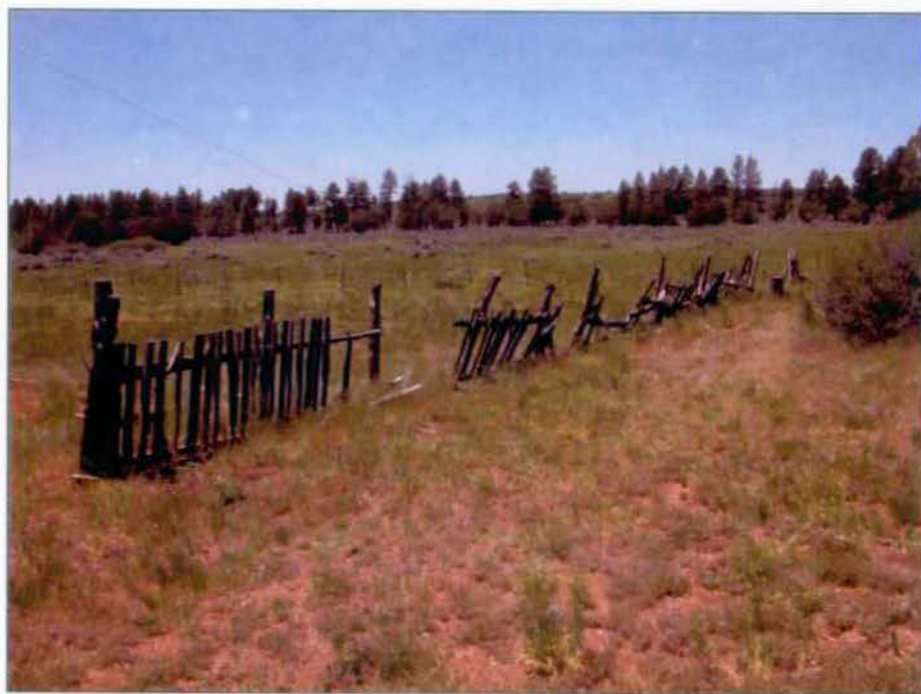
West portion of picket fence from northeast.
